**AGENDA
DRAINAGE DISTRICT 167
LANDOWNER MEETING
JULY 25, 2018 AT 11:00 A.M.**

Drainage Work Order Request For Repair Hardin County

Work Order #: WO00000208

Investigation Summary:

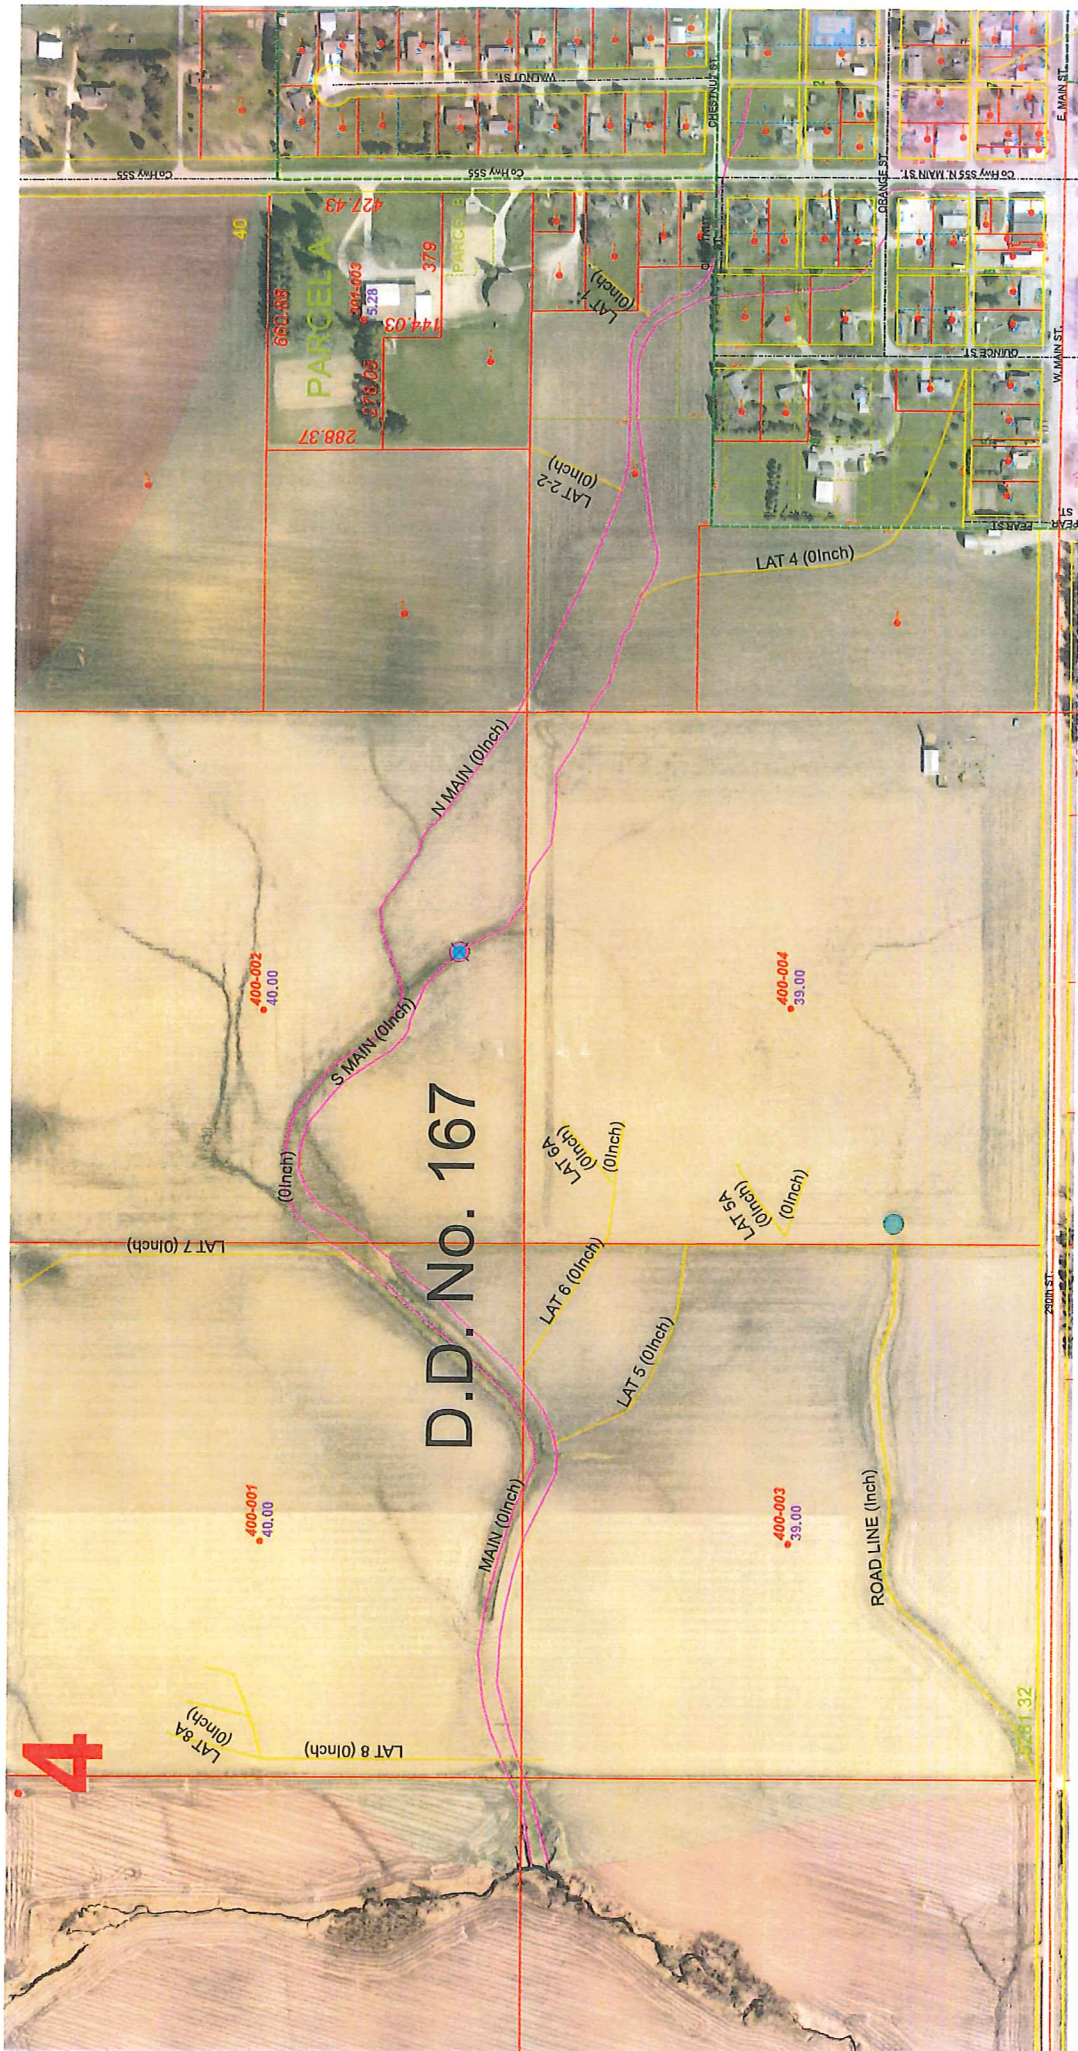
Description: Blowout in lower end of waterway in NE SE 4-86-20 with "babies" northwest of it. The ground cover over the tile in this area is very shallow.

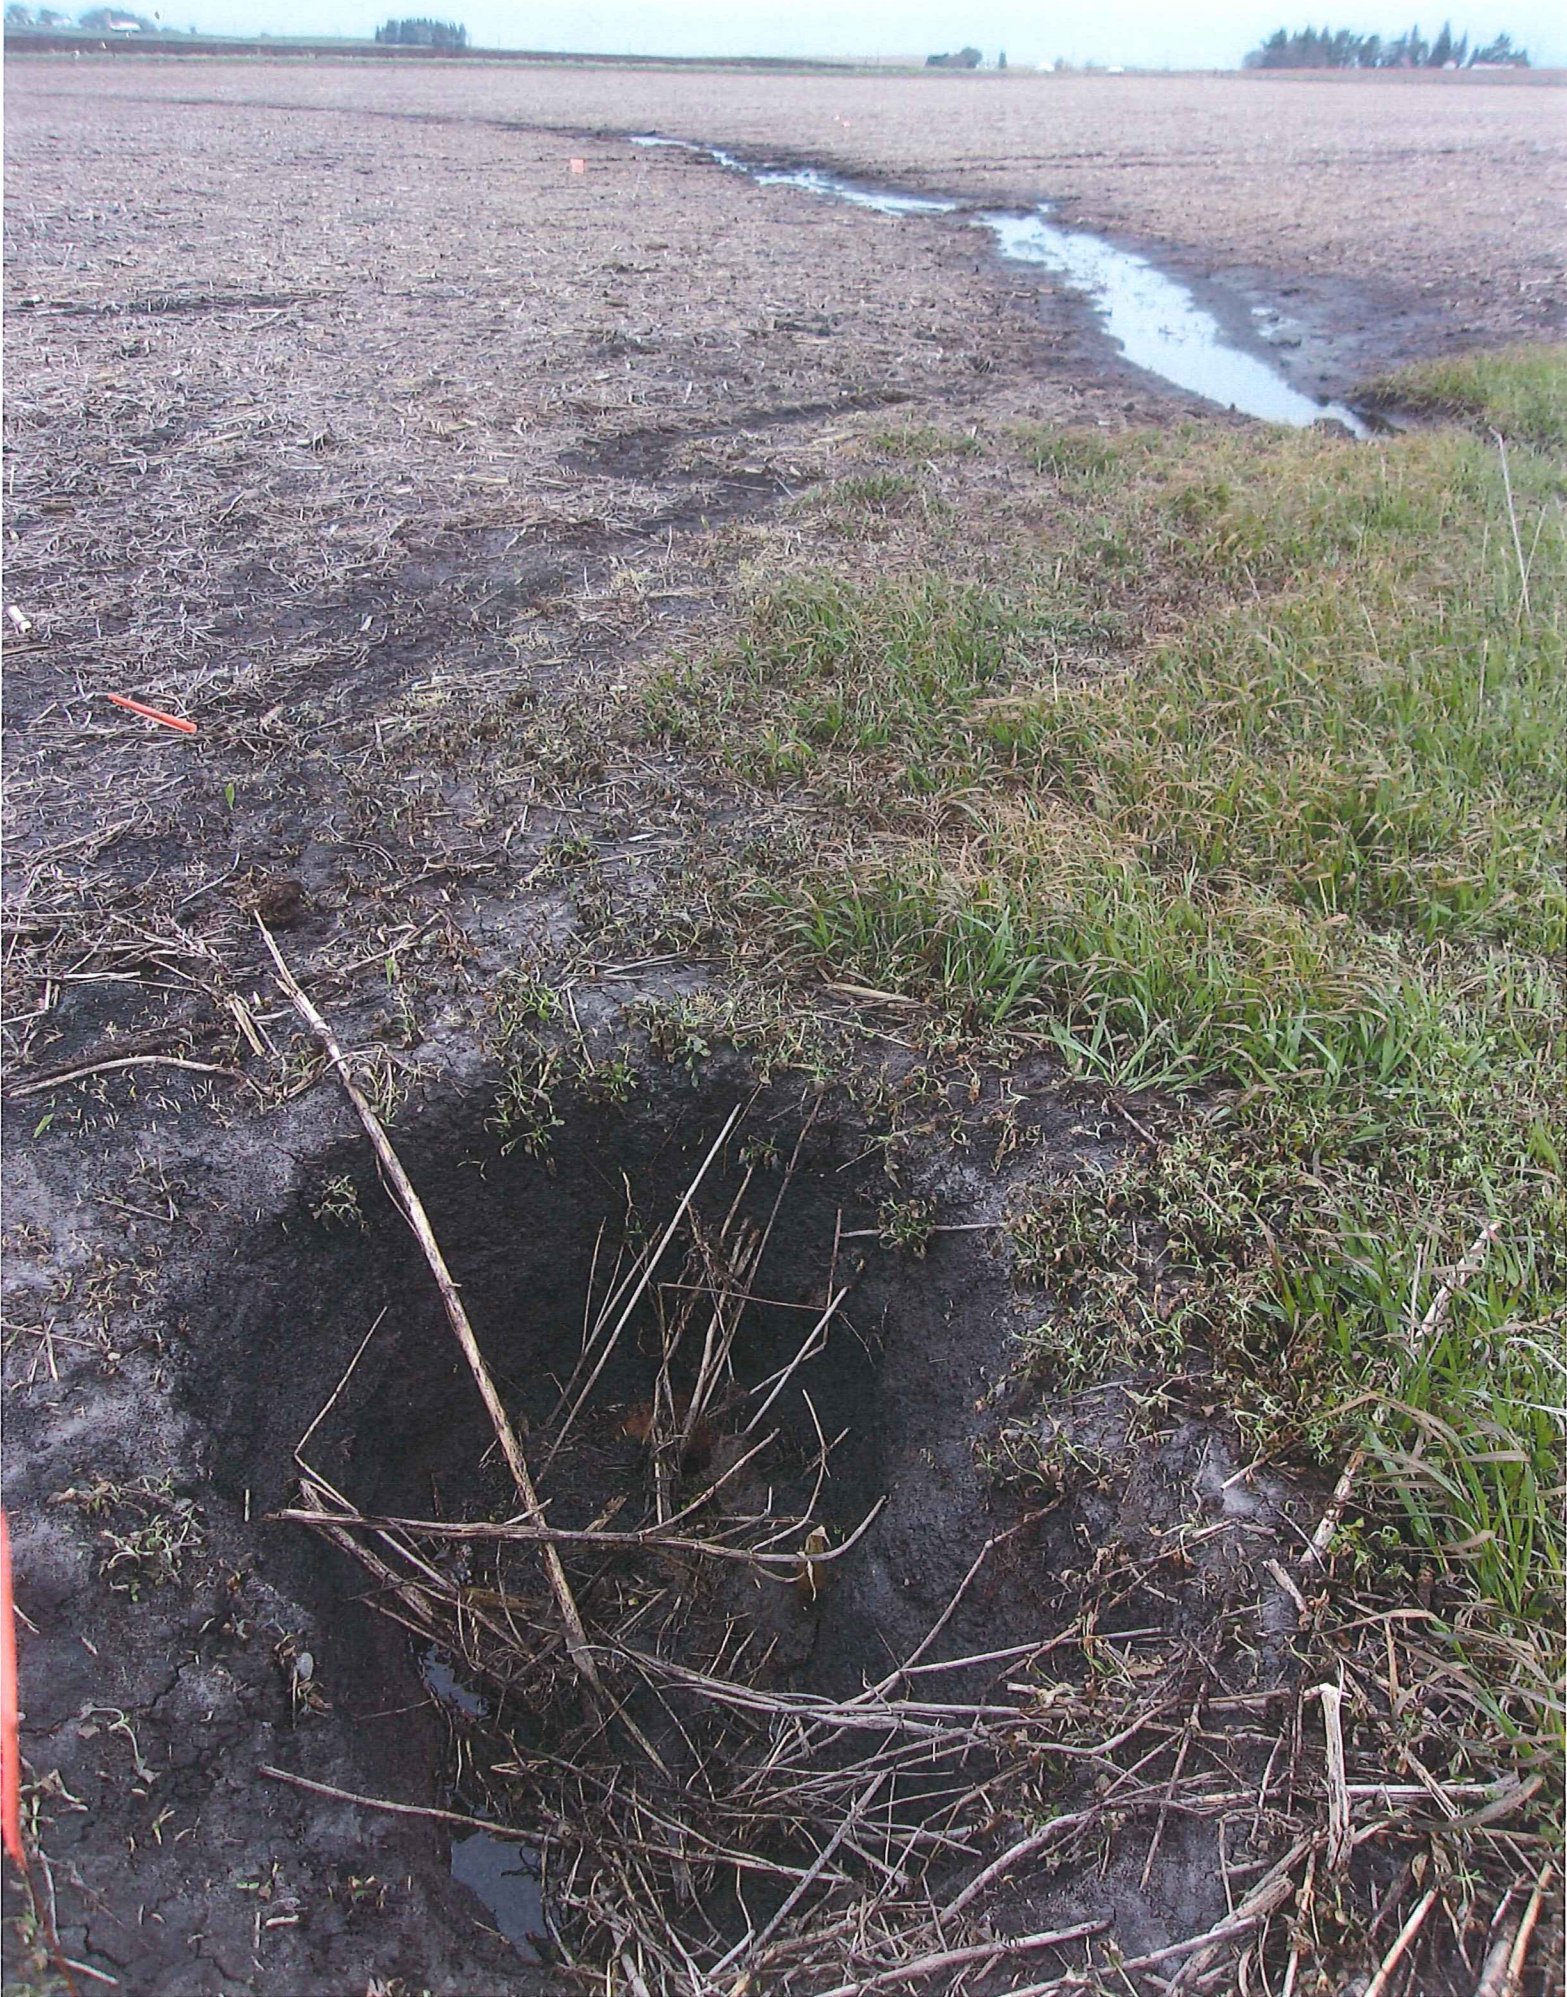
Landowner in the NE¼ SE¼ of Section 4 Township 86 North, Range 20 West reported a blowout/sinkhole in waterway, with smaller depressions upstream (northwest) of said larger blowout/sinkhole. Visual observation found a 6 inch VCP tile 1½'± to 2'± deep (assumed to be south main tile). Water is exiting the tile through multiple holes upstream, flowing overland flow to the southeast through the waterway, and then entering back into the tile.

Partly Sunny, 65°, Windy From East, Rain Earlier
Arrived @ Job Site 9:00 A.M., called and talked to Robert Jensen,
He met me and drove his pickup out to Blow-outs Found 6"± clay tile
1 1/2 - 2' deep, Blowing out water in multiple places (6 or more) All look to
be joints. Must have a collapse down stream causing water to surge up thru
butt joints and then go back into tile past the collapse or blockage.
This looks to be the S. main
Find and fix blockage ASAP, the rest of tile should be OK.
Talked to Robert about shifting swage or tile route to get more cover.
This will be a on going problem with the minimum cover this butt joint tile
has.

Looking NW @ Biggest Hole, 2' cover

Given the nature of the water flow, it is evident that a tile blockage exists within the area of investigation. Said blockage should be found, removed, and then both the blowout/sinkhole repaired. Also, the multiple holes upstream should be excavated and repaired as necessary. Due to the lack of soil cover, repairs would typically be performed with concrete pipe. However, concrete pipe is only available in 12 inch and larger diameter. Therefore, the repairs must either be performed with 6 inch dual wall HPDE tile or 12 inch concrete pipe.
