**AGENDA**  
**PUBLIC HEARING ON ENGINEER'S REPORT ON REPAIRS TO**  
**MAIN TILE, DRAINAGE DISTRICT 67, HARDIN COUNTY**

**ENGINEER'S  
REPORT ON  
REPAIRS TO  
MAIN TILE,  
DRAINAGE  
DISTRICT NO. 67  
HARDIN COUNTY**

# Engineer's Report on Repairs to Main Tile, Drainage District No. 67 Hardin County, Iowa

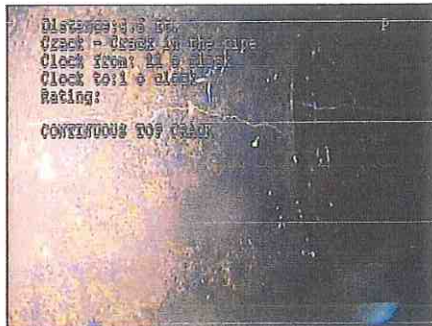
Distance	Dir. Length	From/To Code	Modifier/Severity	Rating	Comments
4.6 ft.	U 10.6 ft.	11 / 1	Crack, TILE SAGGING - PIPE EGG SHAPED.		CONTINUOUS TOP CRACK

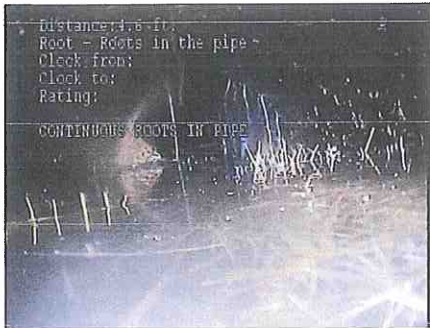
Distance	Dire Length	From/To Code	Modifier/Severity	Rating	Comments
4.6 ft.	U	10.6 ft.	/	Root	<b>CONTINUOUS ROOTS IN PIPE</b>

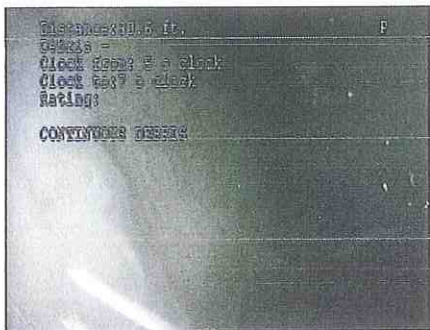
30.6 ft.	U	36.6 ft.	5 / 7	Debris (SILT) IN FLOWLINE, JOINT OFFSET (VERT), HEAVY ROOT INFILTRATION (END) - PIPE ROUND	<b>CONTINUOUS DEBRIS</b>
----------	---	----------	-------	--	--------------------------

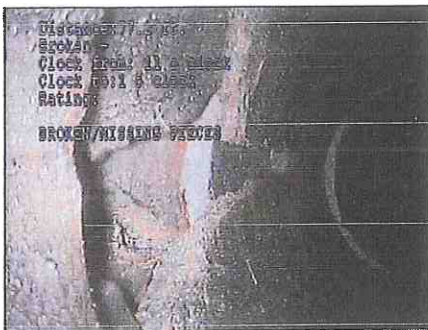
Distance	Dir.	Length	From/To	Code	Modifier/Severity	Rating	Comments
77.2 ft.	U		11 / 1		Broken, MISSING PIECES OF TILE - PIPE ROUND		BROKEN/MISSING PIECES

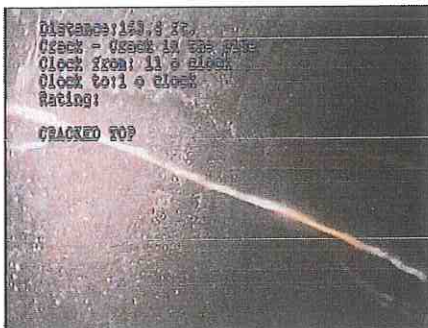
163.4 ft.	U		11 / 1		Crack, TOP (START) - PIPE EGG SHAPED		CRACKED TOP
-----------	---	--	--------	--	--------------------------------------	--	-------------

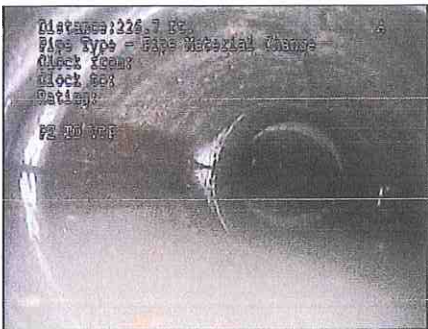
226.7 ft.	U	/	Pipe Type, SW HDPE ->VCP, TOP CRACK (START) - PIPE V SHAPED		PE TO VCP
-----------	---	---	---	--	-----------

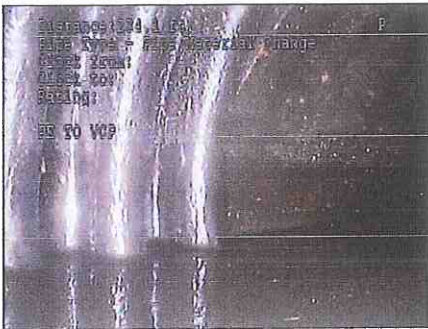
234.1 ft.	U	/	Pipe Type, SW HDPE -> VCP, COLLAPSE IMMINENT (TWO IN A ROW), SOIL VISIBLE IN JOINT GAPS - PIPE V SHAPED		PE TO VCP
-----------	---	---	---	--	-----------

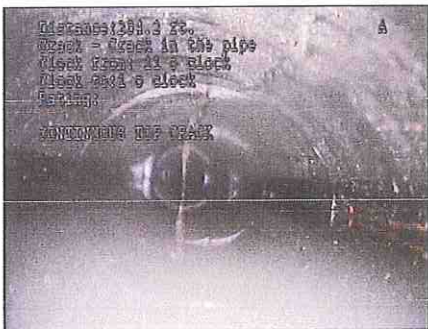
234.2 ft.	U	2.5 ft.	11 / 1 Crack		CONTINUOUS TOP CRACK
-----------	---	---------	--------------	--	----------------------

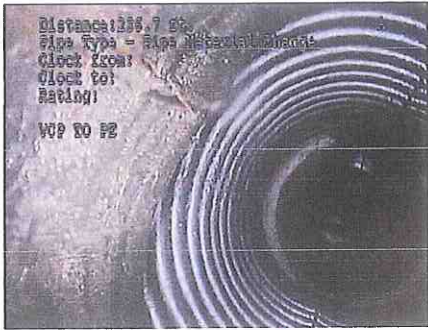
Distance	Dire Length	From/To Code	Modifier/Severity	Rating	Comments
236.7 ft.	U	/	Pipe Type, VCP -> SW HDPE - PIPE ROUND		VCP TO PE

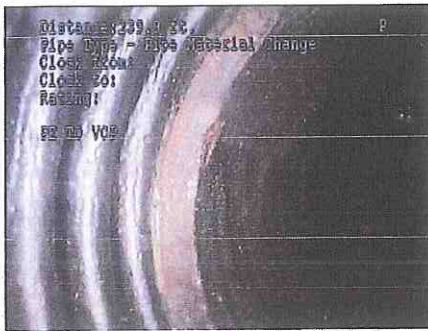
239.9 ft.	U	/	Pipe Type, SW HDPE -> VCP, PARTIAL COLLAPSE (TWO IN A ROW), TOP CRACK (START), SOIL VISIBLE - PIPE V SHAPED		PE TO VCP
-----------	---	---	--	--	-----------

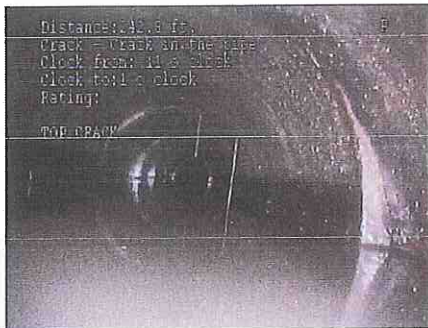
242.8 ft.	U	12.1 ft.	11 / 1	Crack	TOP CRACK
-----------	---	----------	--------	-------	-----------

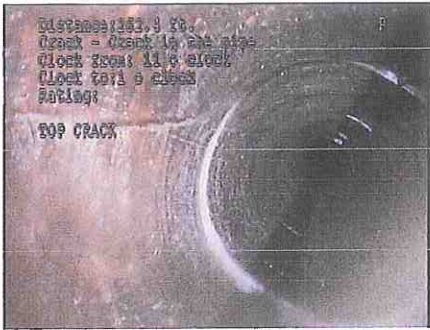
Distance	Dire Length	From/To Code	Modifier/Severity	Rating	Comments
262.4 ft.	U	73.2 ft. 11 / 1	Crack		TOP CRACK

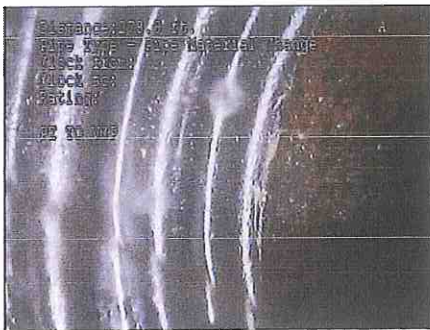
278.8 ft.	U	/	Pipe Type, SW HDPE -> VCP - PIPE ROUND		PE TO VCP
-----------	---	---	--	--	-----------

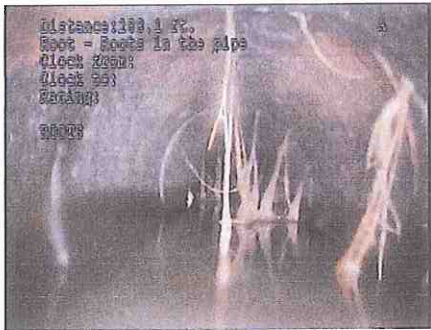
Distance	Dire Length	From/To Code	Modifier/Severity	Rating	Comments
288.1 ft.	U	/	Root	INFILTRATION (START) - PIPE ROUND	ROOTS

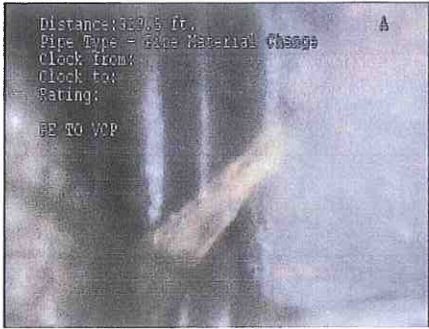
329.5 ft.	U	/	Pipe Type, SW HDPE -> VCP, TOP CRACK (START) - PIPE EGG SHAPED		PE TO VCP
-----------	---	---	---	--	-----------

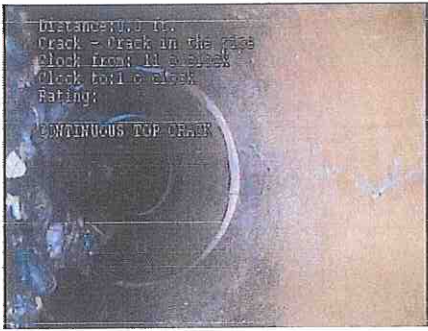
Distance	Dir.	Length	From/To Code	Modifier/Severity	Rating	Comments
0.0 ft.	D	279.5 ft.	11 / 1	Crack, TOP AND SIDE (START), DEBRIS (SILT, RAILROAD GRADE, AND SHATTERED TILE) IN FLOWLINE. CONTINUED SILT IN FLOWLINE (START) - PIPE ROUND		<b>CONTINUOUS TOP CRACK</b>

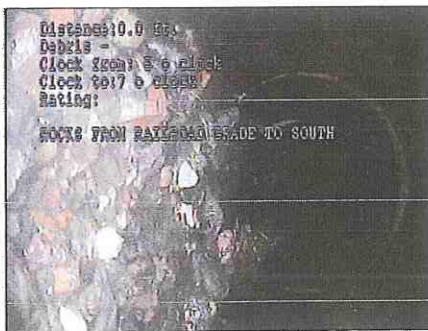
0.0 ft. D 465.3 ft. 5 / 7 Debris

**ROCKS FROM  
RAILROAD GRADE  
TO SOUTH**

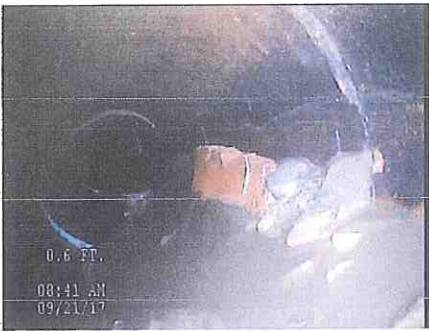
Distance	Dire Length	From/To Code	Modifier/Severity	Rating	Comments
0.6 ft.	D	4 /	Debris, LARGE TILE PIECE - PIPE ROUND		<b>LARGE PIECE OF BROKEN TILE IN FLOWLINE</b>

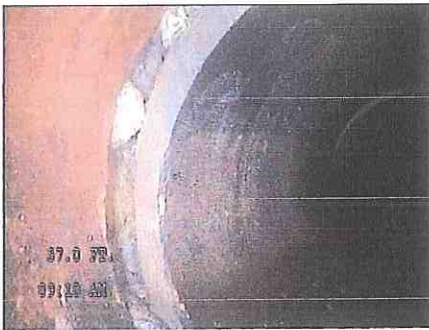
37.0 ft.	D	/	Joint - Separated, SOIL VISIBLE IN JOINT - PIPE ROUND		<b>WIDE JOINT</b>

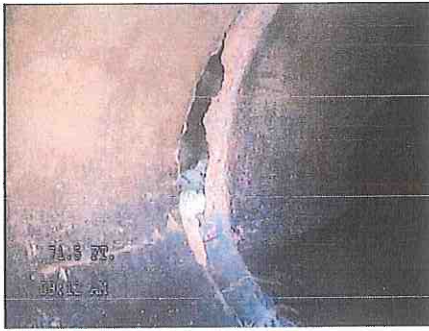
71.5 ft.	D	7 / 11	Joint - Separated, SOIL VISIBLE, TILE SAGGING - PIPE EGG SHAPED		<b>WIDE JOINT - SOIL SHOWING</b>

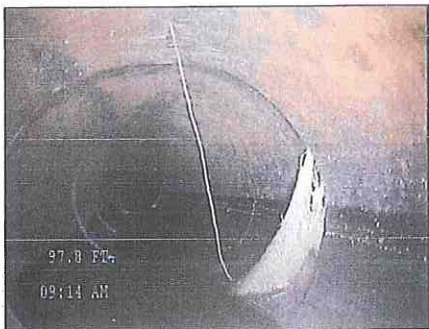
97.8 ft.	D	2 / 4	Root-in-Joint		<b>ROOTS</b>
----------	---	-------	---------------	--	--------------

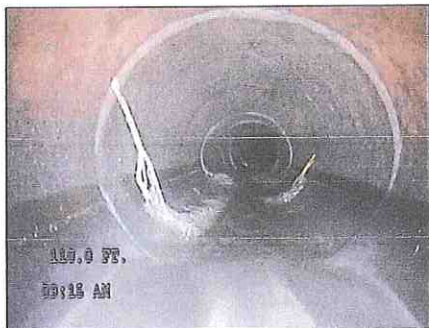
110.0 ft.	D	3 / 10	Root		TOP CRACK (START) - PIPE ROUND <b>ROOTS</b>
-----------	---	--------	------	--	--

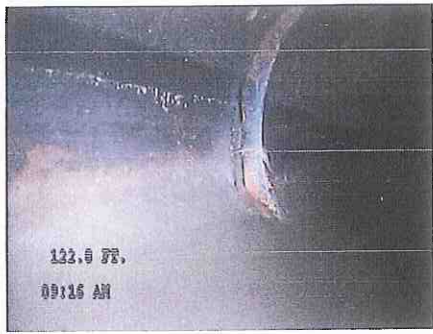
**122.8 ft. D**      **7 / 10 Joint Offset**      **SOIL VISIBLE IN GAP (TWO IN A ROW), TOP CRACK (END) - PIPE ROUND**      **OFFSET**

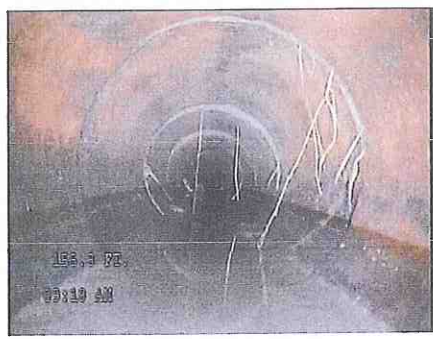
**155.3 ft. D**      **/ Root**      **SLIGHT INFILTRATION (20') - PIPE ROUND**      **ROOTS**

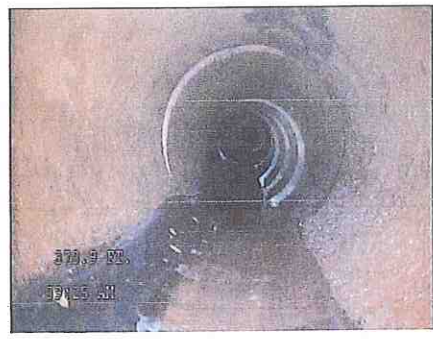
**370.9 ft. D**      **108.0 ft. 12 / 6 Joint Offset**      **CONTINUOUS OFFSETS**

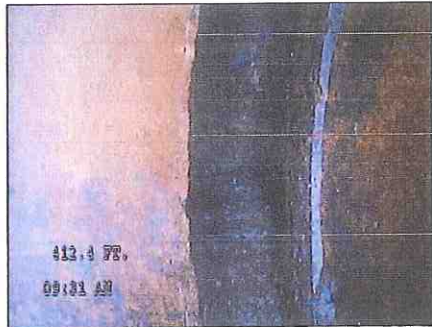
412.4 ft.	D	7 / 11	Joint - Separated		<b>LARGE VOID</b>
-----------	---	--------	-------------------	--	-------------------

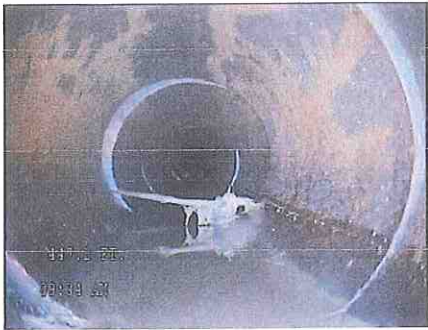
Distance	Dire Length	From/To Code	Modifier/Severity	Rating	Comments
447.2 ft.	D	4 / 8	Root		ROOTS

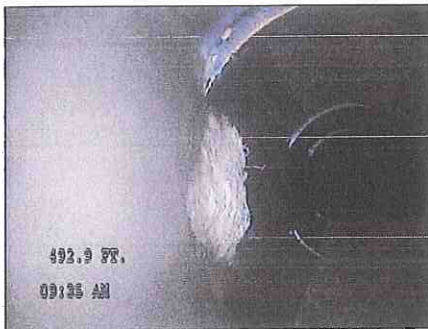
492.9 ft.	D	5 / 7	Root		ROOTS
-----------	---	-------	------	--	-------

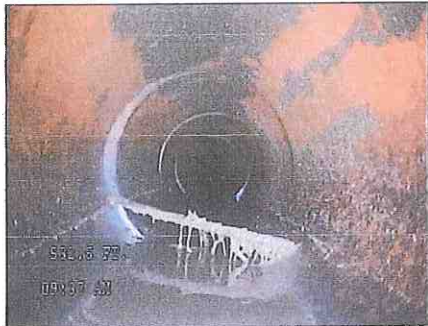
532.5 ft.	D	5 / 8	Root		TOP CRACK (ONE TILE), SILT IN FLOWLINE (START) - PIPE ROUND ROOTS
-----------	---	-------	------	--	--

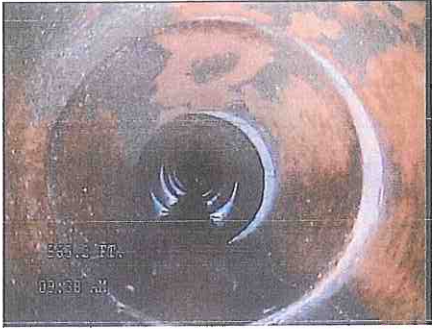
Distance	Dire Length	From/To Code	Modifier/Severity	Rating	Comments	
563.2 ft.	D	62.8 ft.	/	Joint Offset	(SOIL VISIBLE), BOTTOM CRACK (ONE TILE) - PIPE ROUND	<b>CONTINUOUS OFFSETS</b>
			5+70	TOP CRACK (START) - PIPE ROUND

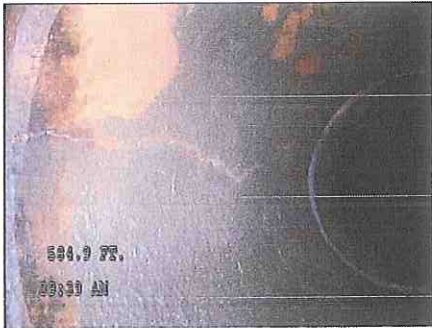
584.9 ft.	D	105.1 ft.	11 / 1	Crack		<b>CONTINUOUS TOP CRACK</b>

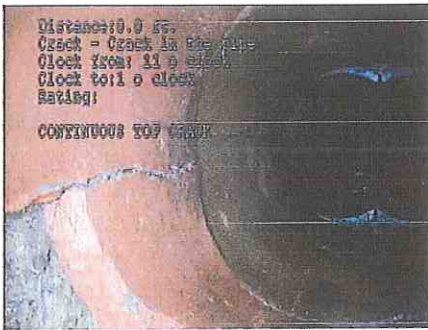
Distance	Dir.	Length	From/To Code	Modifier/Severity	Rating	Comments
0.0 ft.	U	31.9 ft.	11 / 1	Crack, TOP (START), SILT IN FLOWLINE - PIPE ROUND		CONTINUOUS TOP CRACK
