AGENDA
REGULAR DRAINAGE MEETING
JANUARY 2, 2018

Drainage District:

Repair Summary:

CONSTRUCTION ENGINEERING
OBSERVATION REPORT

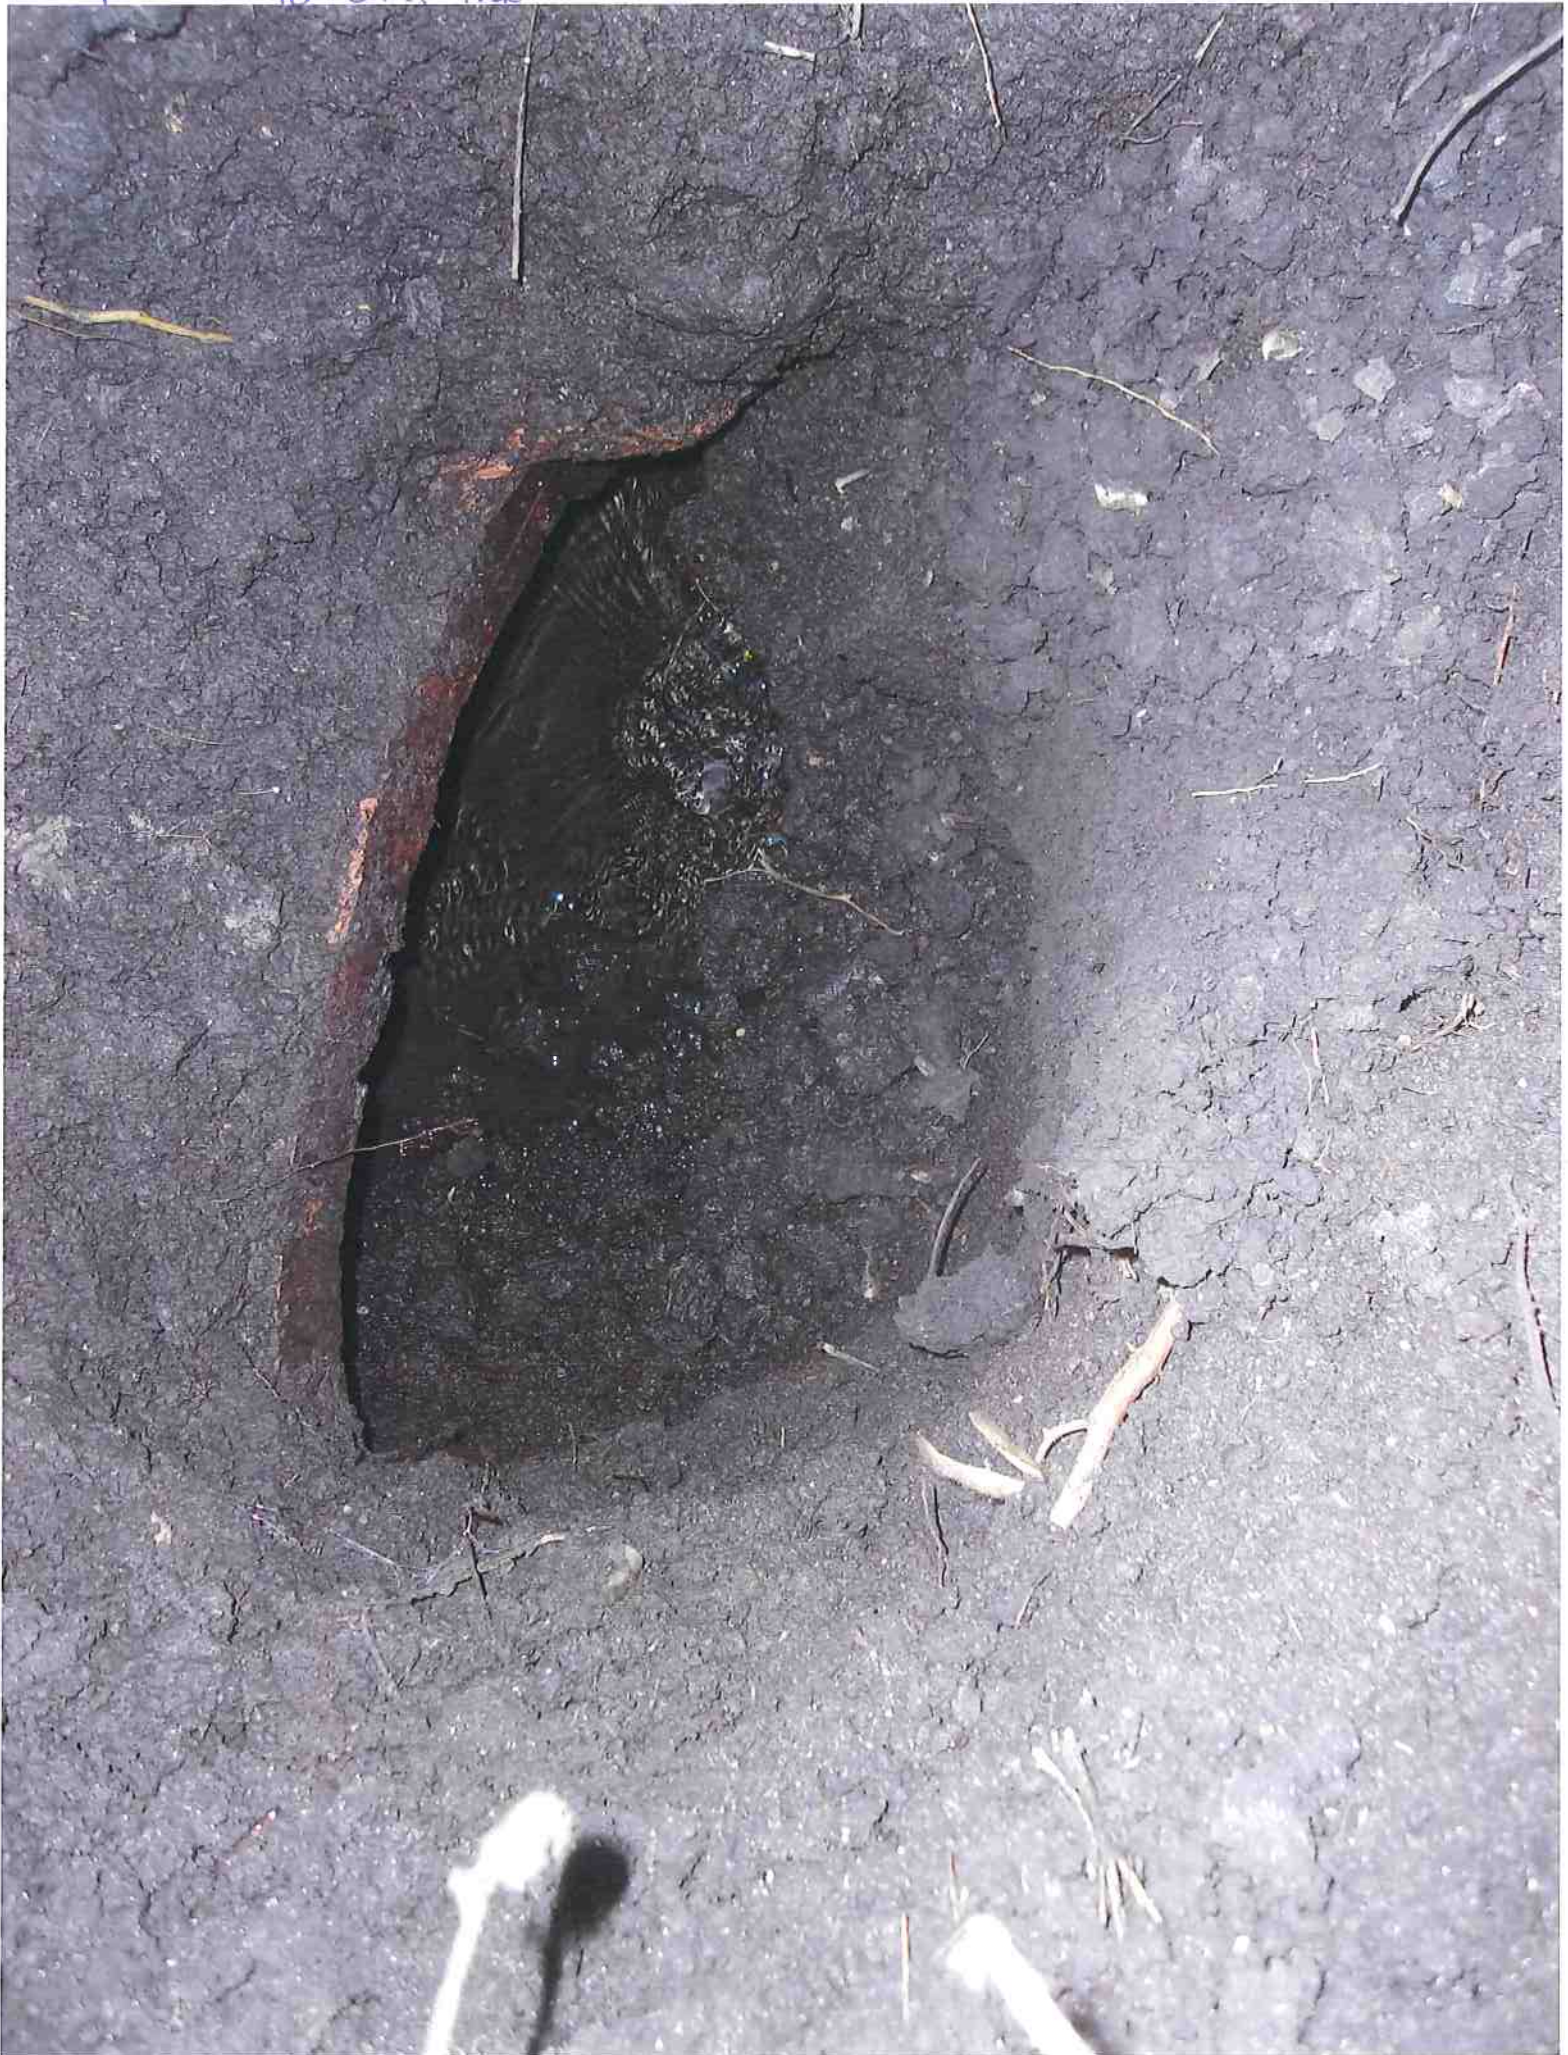
ARRIVED @ Randy SILVEST FARM, PARKED IN FARM DRIVE, NE OF HIS HOUSE, WALKED TO HOLE JUST NW OF HIS FARM ACARRAGE. FOUND 6' Ø HOLE WITH BROKEN 18"± CLAY TILE RUNNING 1/2 FULL ± FROM NE TO SW. TILE HAS 45-50' OF COVER. TOOK PIC. UPSTREAM (DOWNSTREAM BLOCKED BY MUDD + DIRT.

UPSTREAM 18" CLAY TILE

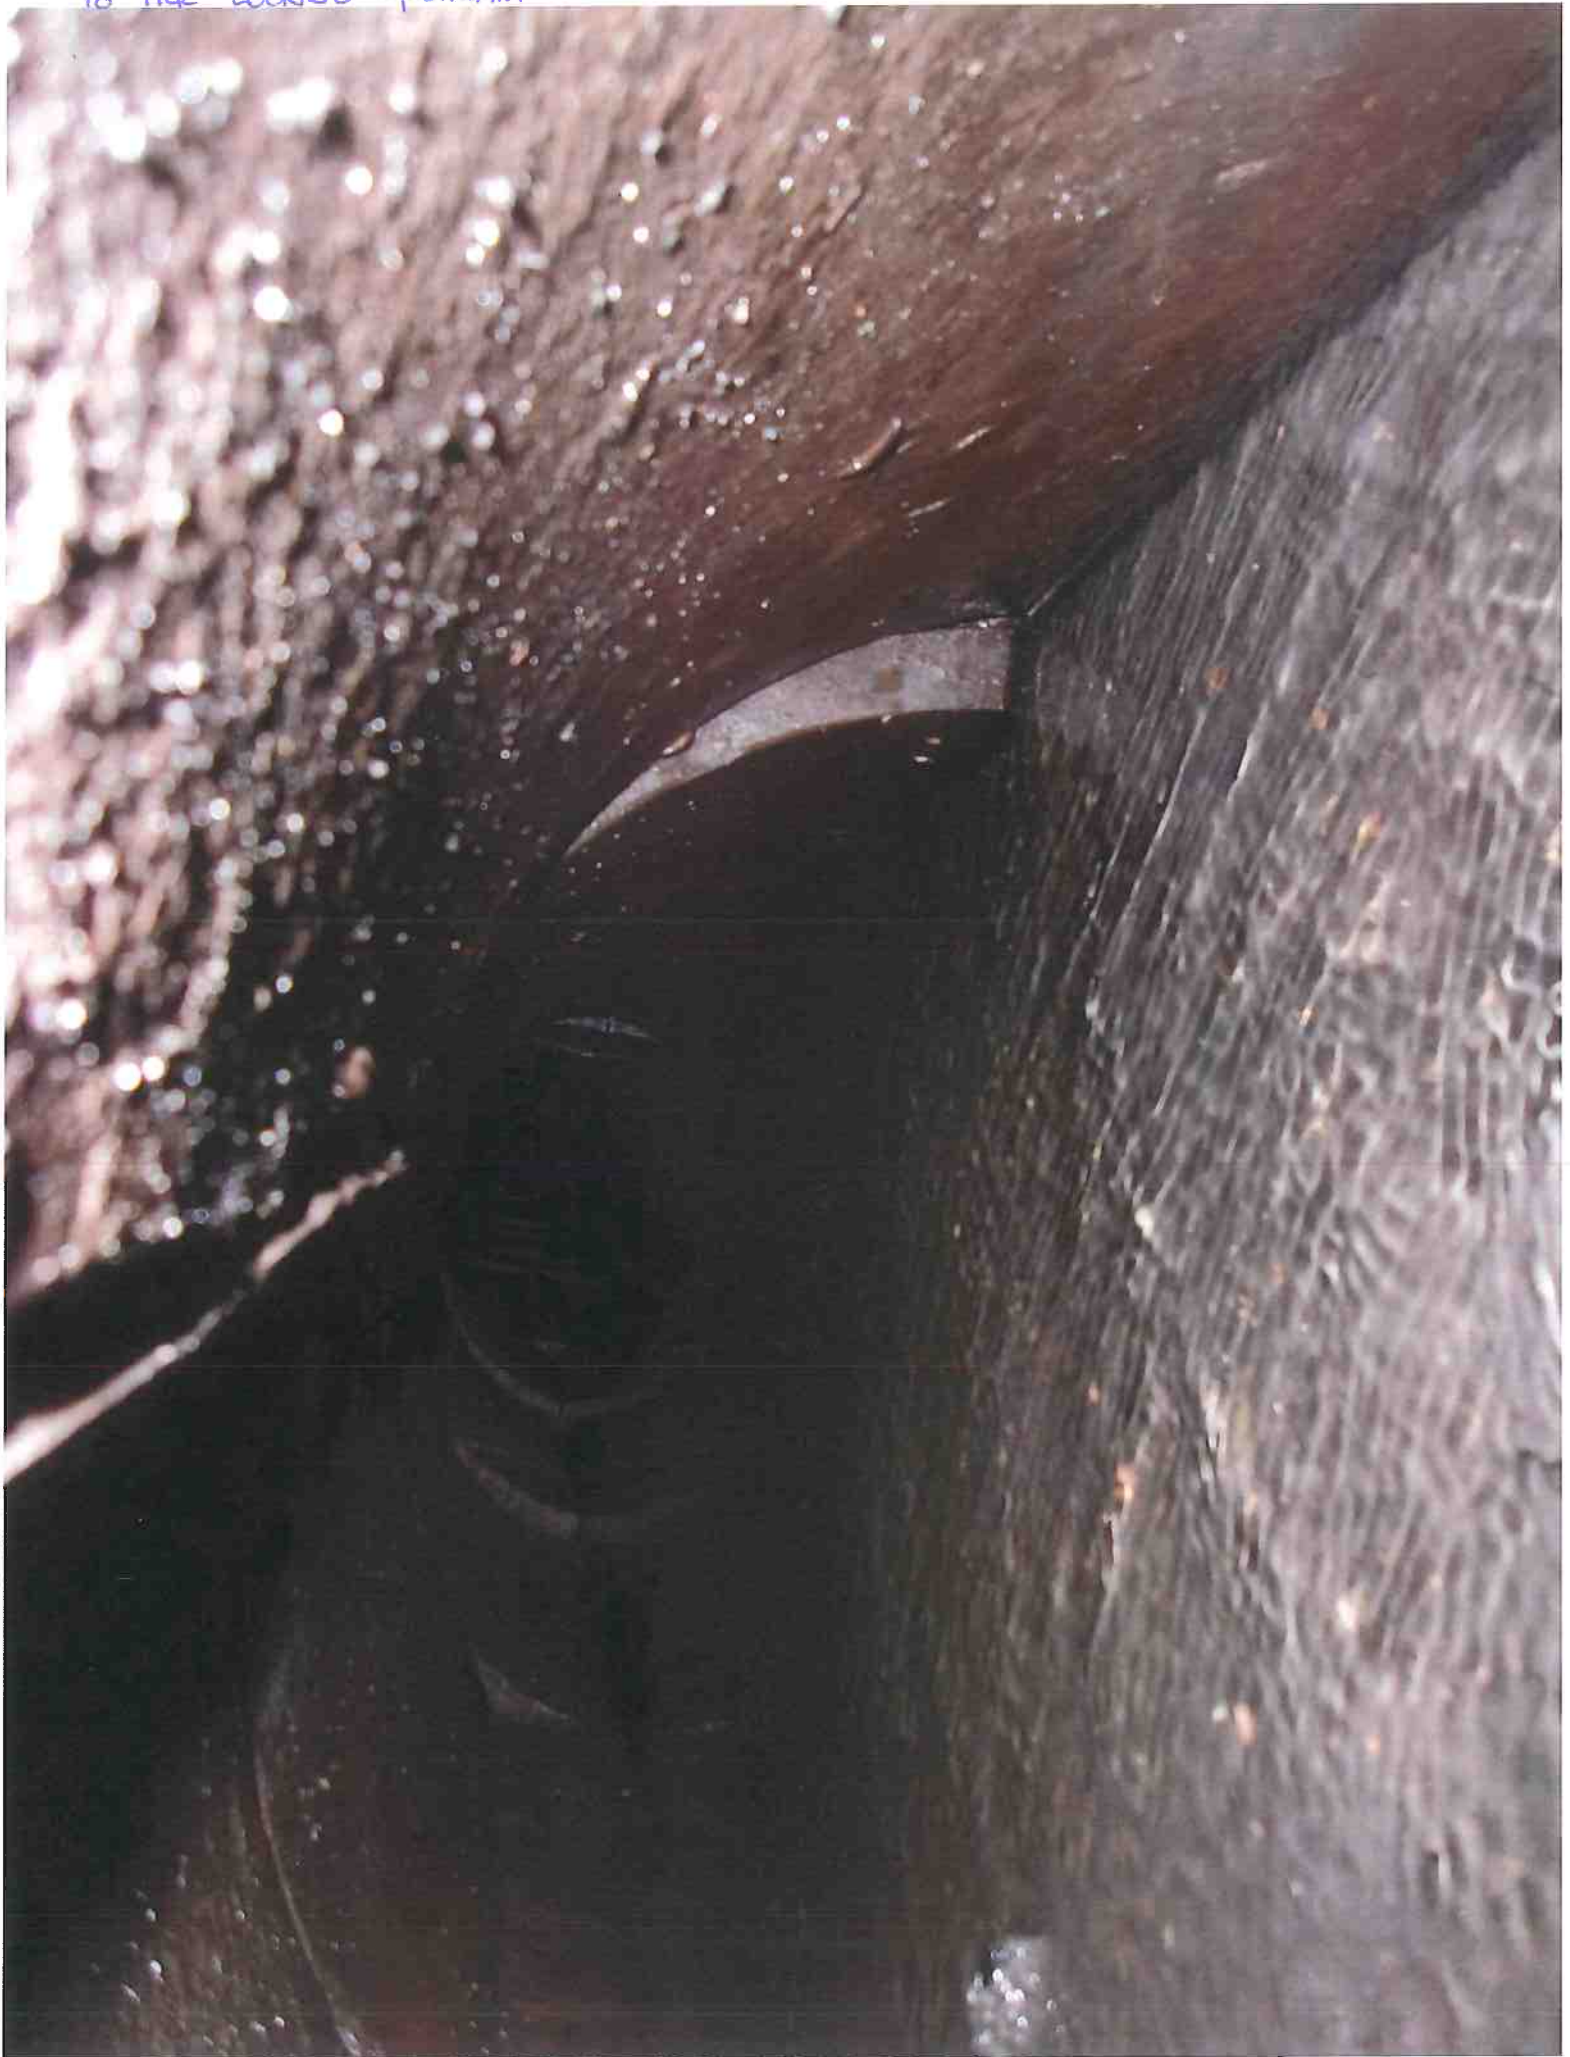
18" TIE Looking Upstream

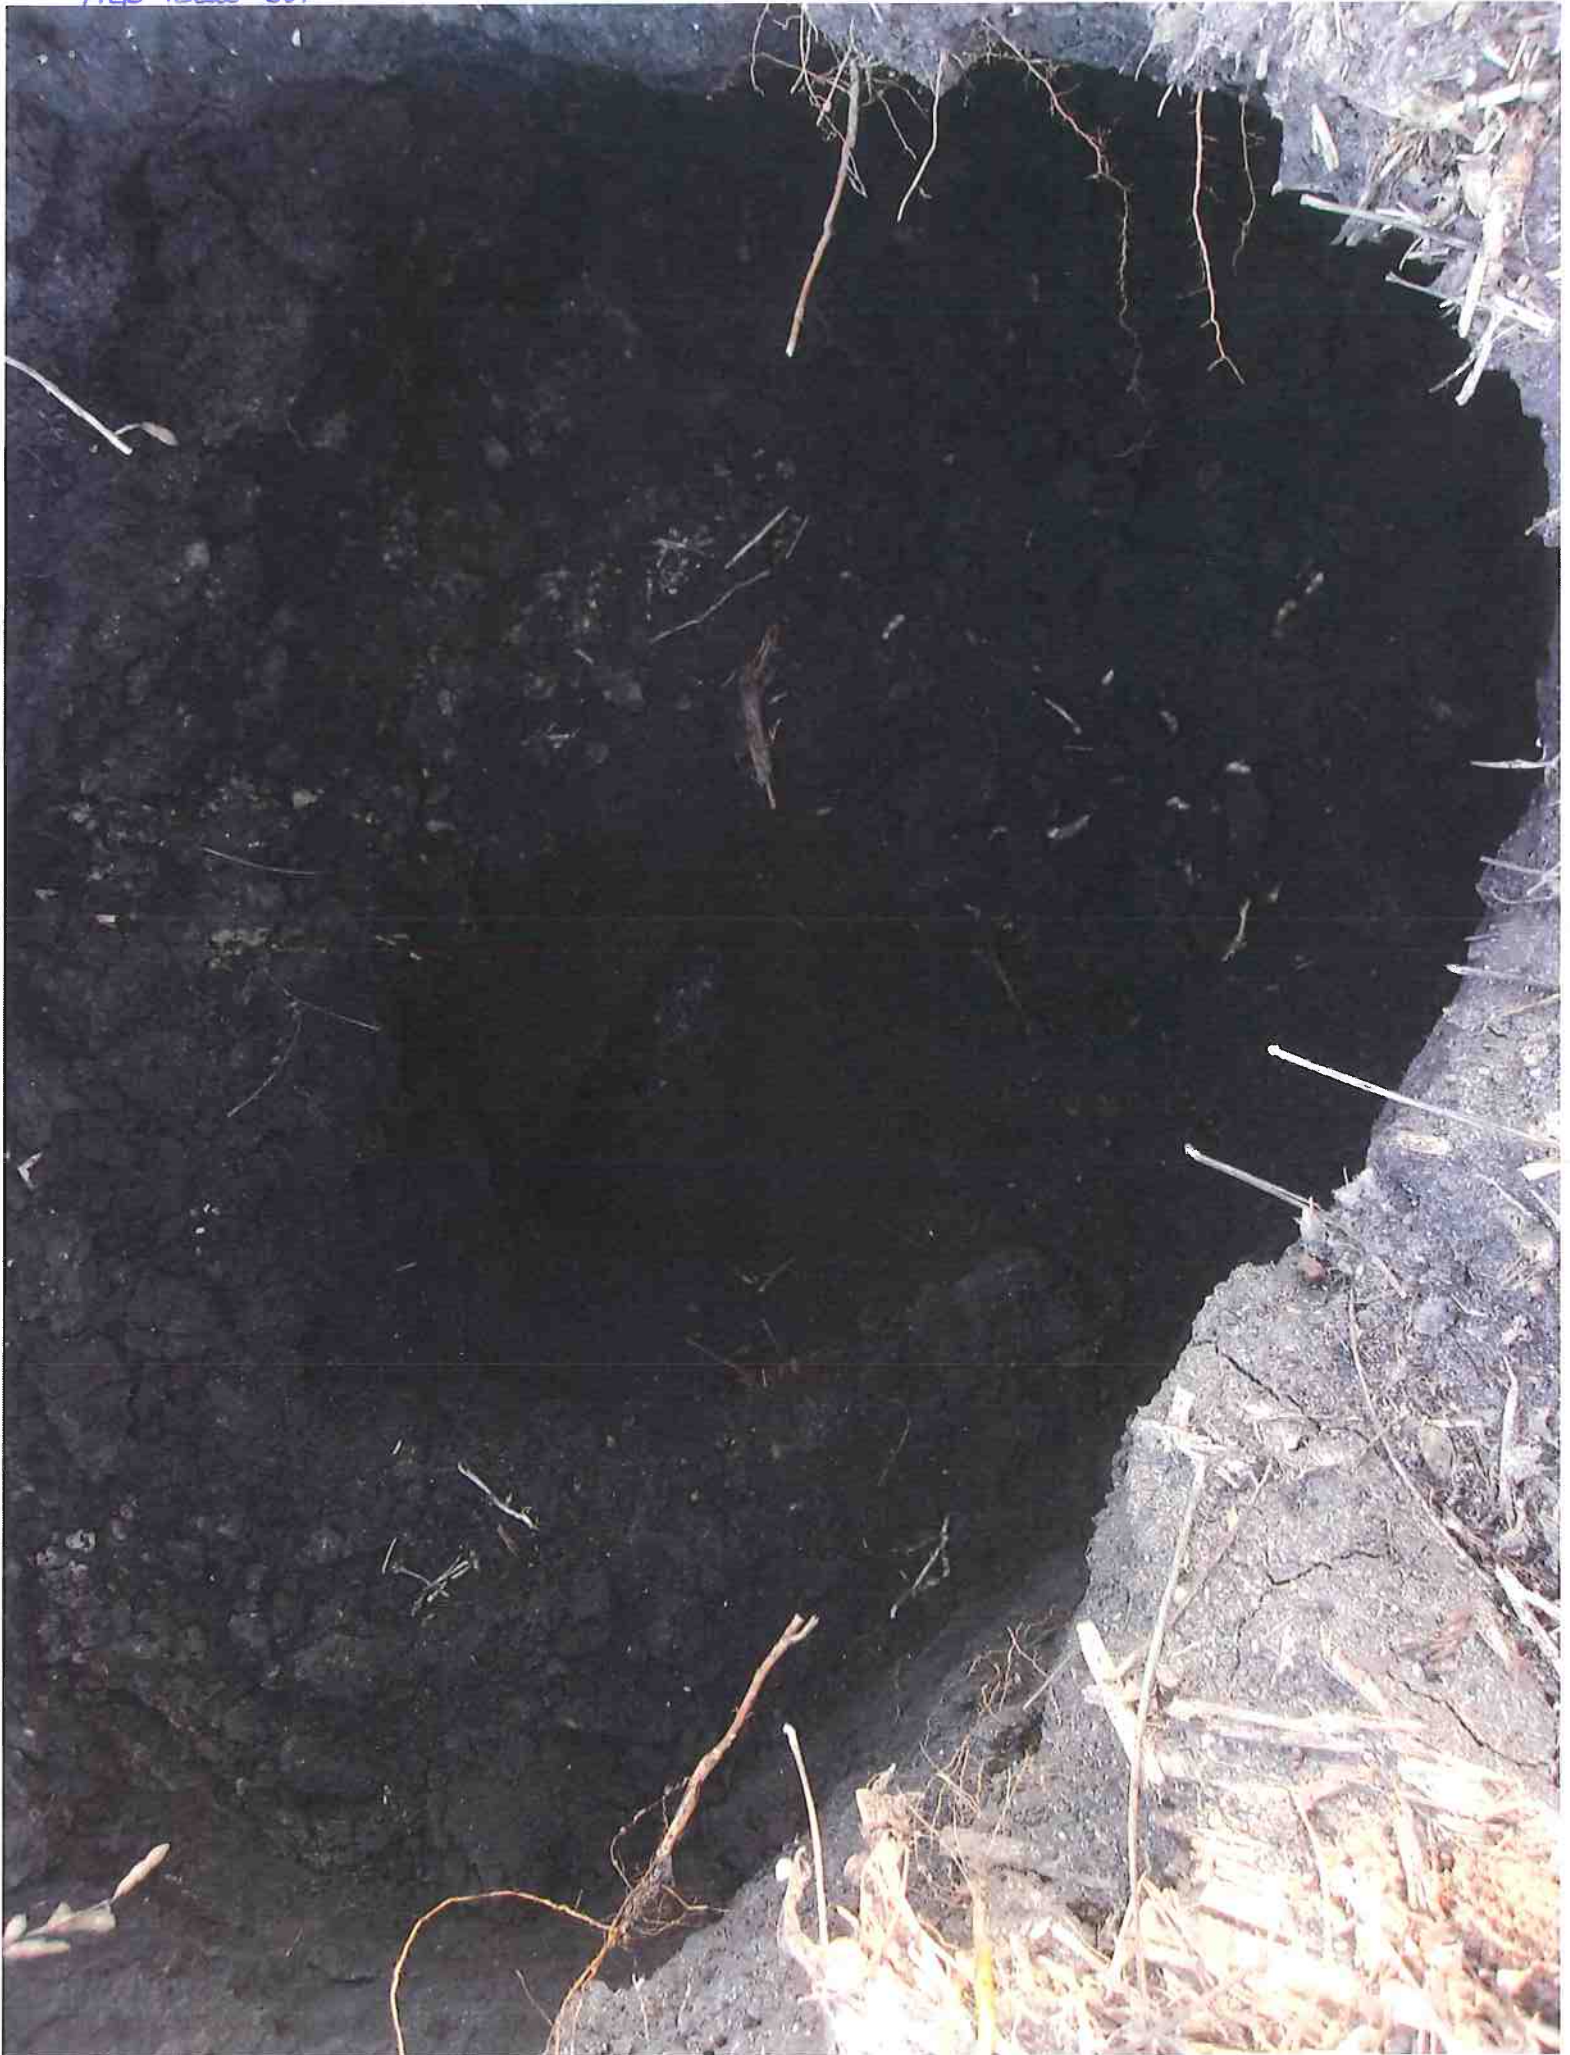
- Landowner reported a sinkhole/blowout on the original Main tile in the SE¼ of Section 19, Township 88 North, Range 22 West.
- Visually inspected area and found 6'± diameter hole with 24" diameter VCP original main tile running half full of water. Tile has 4½'± to 5'± of soil cover. The District Trustees authorized CCTV inspection of original main tile.
- Conducted CCTV inspection of the original main tile from sinkhole/blowout location for 1,473'± downstream and only 44'± upstream (couldn't go any further as this is the pipe size change and wye where the original main tile and original lateral 1 tile meet). Findings are tabulated on attached sheet (key issues highlighted in yellow) with specific observations described in CCTV reports.
- No repair was performed as the purpose was to investigate to determine extent of problem.

TILE BLEW-OUT

- If the District Trustees choose not to pursue additional televising, the original main tile at the existing sinkhole/blowout should be repaired. It is my opinion that based on the amount of soil cover, dual wall polypropylene, dual wall HDPE, or RCP (all with rock bedding) would be adequate for repair.

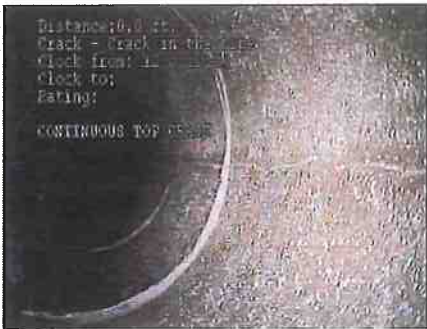
Distance	Dir.	Length	From/To Code	Modifier/Severity	Rating	Comments
0.0 ft.	D	6.1 ft.	12 / Crack			CONTINUOUS TOP CRACK

0+00 => START TOP CRACKED - START SOIL IN FLOWLINE

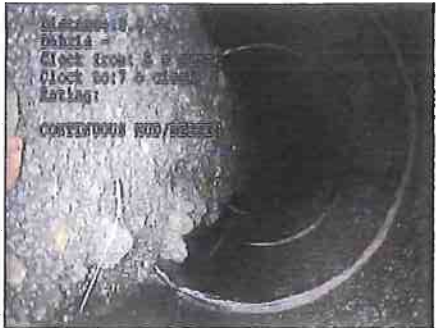
0.0 ft.	D	148.1 ft.	5 / 7 Debris		CONTINUOUS MUD/DEBRIS
---------	---	-----------	--------------	--	-----------------------

0+04 => END TOP CRACKED - CONTINUE SOIL IN FLOWLINE - PIPE ROUND

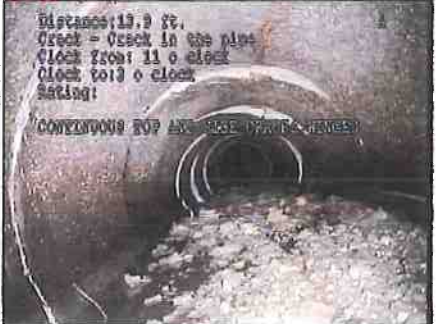
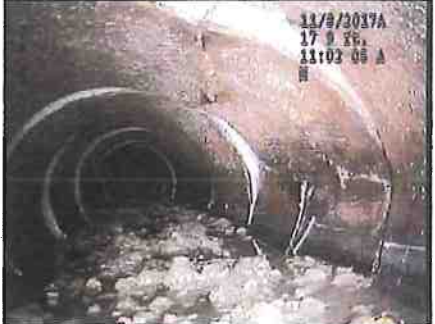
13.9 ft.	D	34.2 ft.	11 / 3 Crack		CONTINUOUS TOP AND SIDE CRACKS/HINGES
----------	---	----------	--------------	--	---------------------------------------

0+14 => START TOP CRACKED - CONTINUE SOIL IN FLOWLINE - PIPE ROUND
 0+16 => CONTINUE TOP CRACKED - CONTINUE SOIL IN FLOWLINE - PIPE 'VED
 0+18 => " " " " " " " " " " " "

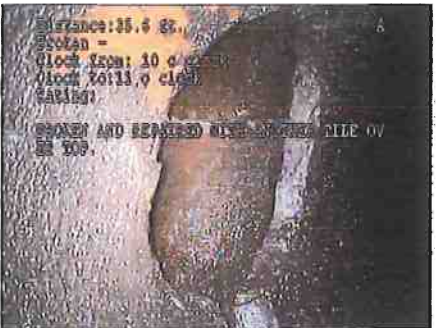
35.6 ft.	D	10 / 11 Broken			BROKEN AND REPAIRED WITH ANOTHER TILE OVER TOP.
----------	---	----------------	--	--	---

0+36 => BROKEN PIPE - CONTINUE SOIL IN FLOWLINE - REPAIRED WITH BRICK BATS
 0+42 => START TOP CRACK - CONTINUE SOIL IN FLOWLINE - PIPE ROUND

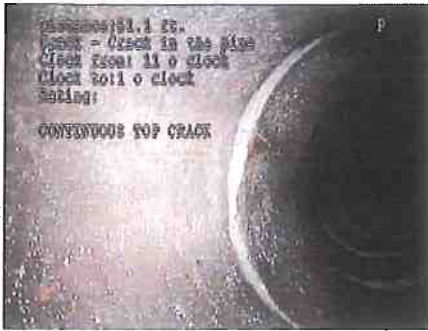
Distance	Dire Length	From/To	Code	Modifier/Severity	Rating	Comments
51.1 ft.	D	340.9 ft.	11 / 1	Crack - CONTINUE TOP CRACK - PIPE ROUND		CONTINUOUS TOP CRACK

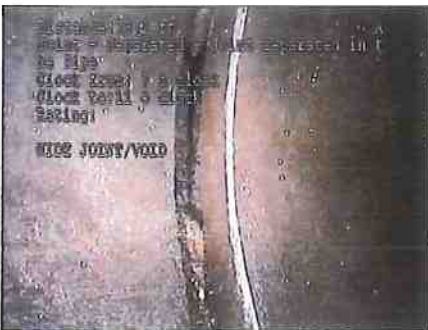
79.2 ft.	D		7 / 11	Joint - Separated - CONTINUE TOP CRACKED - CONTINUE JOINT OFFSETS - PIPE ROUND		WIDE JOINT/VOID
----------	---	--	--------	---	--	-----------------

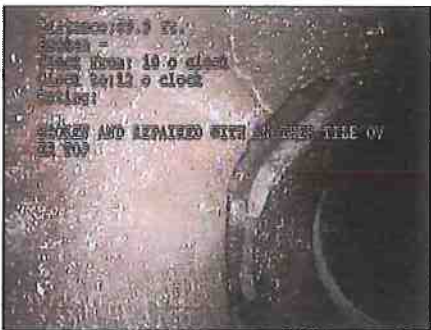
89.9 ft.	D		10 / 12	Broken		BROKEN AND REPAIRED WITH ANOTHER TILE OVER TOP
0+90 => CONTINUE TOP CRACKED - CONTINUE JOINT OFFSETS - REPAIRED TOP - ROUND						
0+94 => CONTINUE TOP CRACKED - END JOINT OFFSETS - PIPE ROUND

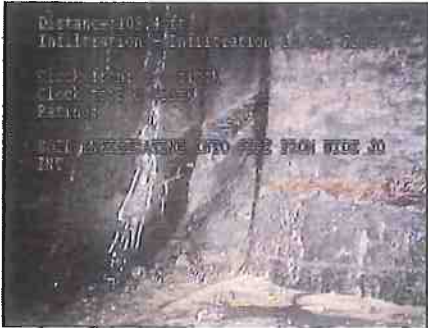
109.4 ft. D **3 / 6 Infiltration**
 1+10 => END TOP CRACK - JOINT GAP - REPAIRED WITH BRICK BATS - PIPE ROUND
 1+20 => START TOP CRACK - PIPE ROUND

SOIL INFILTRATING INTO PIPE FROM WIDE JOINT

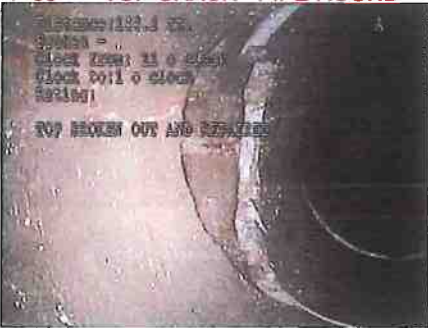
144.2 ft. D **11 / 1 Broken**
 1+40 => END TOP CRACK - HOLE IN TOP OF PIPE - REPAIRED
 1+83 => TOP CRACK - PIPE ROUND

TOP BROKEN OUT AND REPAIRED

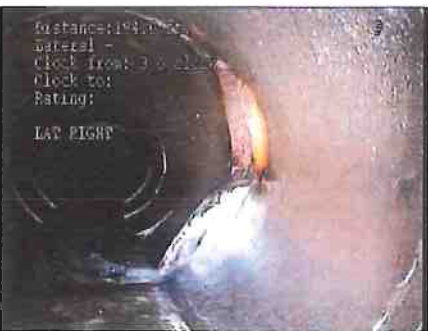
LAT RIGHT

194.0 ft. D **3 / Lateral - TOP CRACKED - PIPE 'V'ED**

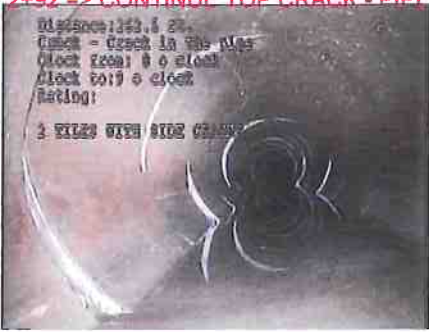
Distance	Dire Length	From/To Code	Modifier/Severity	Rating	Comments
262.5 ft.	D	8 / 9	Crack		2 TILES WITH SIDE CRACKS
2+62 => CONTINUE TOP CRACK - JOINT OFFSET					
2+92 => CONTINUE TOP CRACK - PIPE 'V'ED

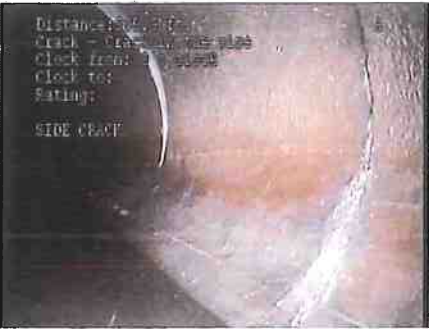
2+98 => CONTINUE TOP CRACK - PIPE 'V'ED					
3+00 => CONTINUE TOP CRACK - JOINT OFFSET - PIPE 1/4 FULL OF WATER					
3+02 => CONTINUE TOP CRACK - SIDE OF PIPE CRACKED					
305.3 ft.	D	3 /	Crack		SIDE CRACK

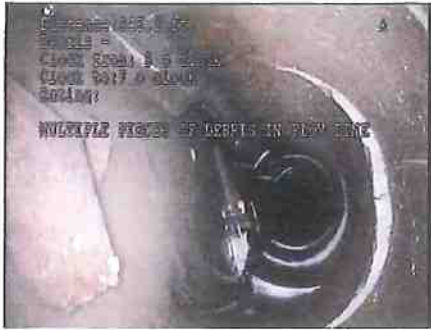
345.2 ft.	D	5 / 7	Debris - CONTINUE TOP CRACK- CONTINUE EGG SHAPE - BROKEN TILE IN FLOWLINE		MULTIPLE PIECES OF DEBRIS IN FLOW LINE
-----------	---	-------	--	--	---

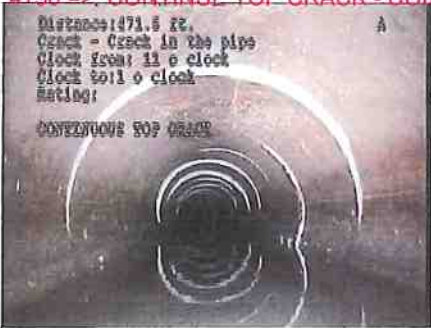
471.5 ft.	D	651.6 ft. 11 / 1	Crack -CONTINUE TOP CRACK - CONTINUE JOINT OFFSET		CONTINUOUS TOP CRACK
-----------	---	------------------	---	--	-----------------------------

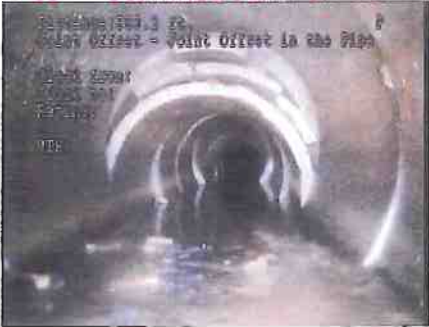
Distance	Dire Length	From/To Code	Modifier/Severity	Rating	Comments
583.2 ft.	D	/	Joint Offset		WTH? 5+88 => CONTINUE JOINT OFFSET - DEBRIS IN FLOWLINE - JOINT OFFSET REPAIRED WITH BRICK BATS

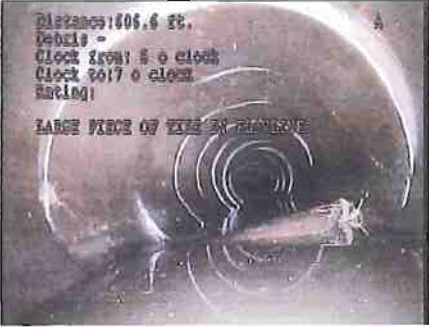
606.6 ft.	D	5 / 7	Debris		LARGE PIECE OF TILE IN FLOWLINE
6+08 => CONTINUE JOINT OFFSET - CONTINUE TOP CRACK - PIPE 'V'ED

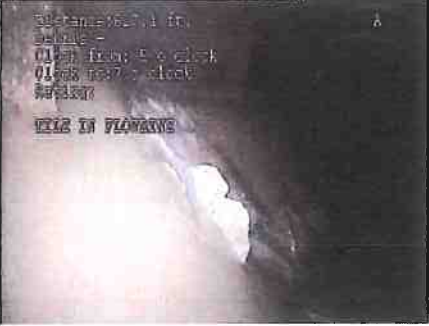
627.1 ft.	D	5 / 7	Debris		TILE IN FLOWLINE
6+27 => CONTINUE JOINT OFFSET - CONTINUE TOP CRACK - DEBRIS IN FLOWLINE

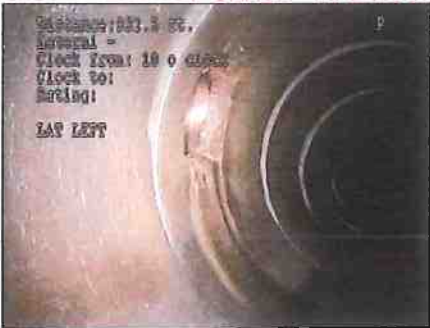
932.5 ft.	D	10 /	Lateral		LAT LEFT
9+34 => END TOP CRACK - PIPE ROUND - LATERAL VCP

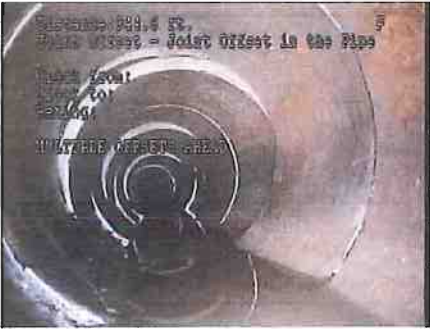
944.6 ft.	D	/	Joint Offset		MULTIPLE OFFSETS AHEAD
9+48 => START JOINT OFFSET - PIPE ROUND - REPAIRED WITH BRICK BATS					
9+52 => CONTINUE JOINT OFFSET - PIPE ROUND - SOIL VISSIBLE					
9+65 => CONTINUE JOINT OFFSET - TOP CRACKED - PIPE 'VED

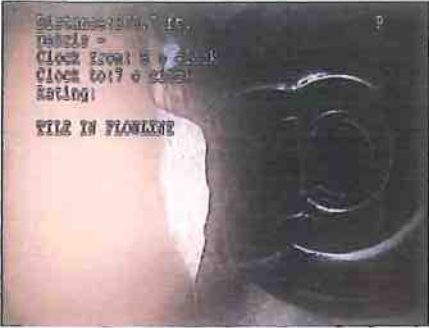
Distance	Dire Length	From/To Code	Modifier/Severity	Rating	Comments
979.7 ft.	D	5 / 7	Debris		TILE IN FLOWLINE
9+80 => CONTINUE JOINT OFFSET - PIPE ROUND - BROKEN TILE IN FLOWLINE

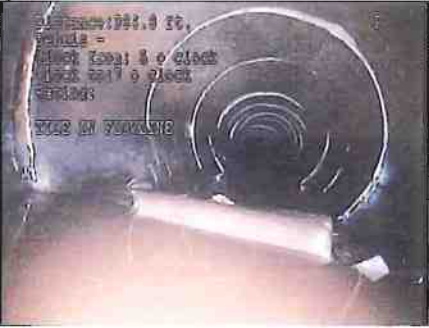
984.8 ft.	D	5 / 7	Debris		TILE IN FLOWLINE
9+85 => END JOINT OFFSET - TOP CRACKED - PIPE ROUND					
9+92 => TOP CRACKED - PIPE EGG SHAPED					
9+95 => TOP CRACKED - PIPE EGG SHAPED					
10+05 => TOP CRACKED - START 'VED PIPE					
10+23 => TOP CRACKED - CONTINUE 'VED PIPE - BROKEN TILE IN FLOWLINE

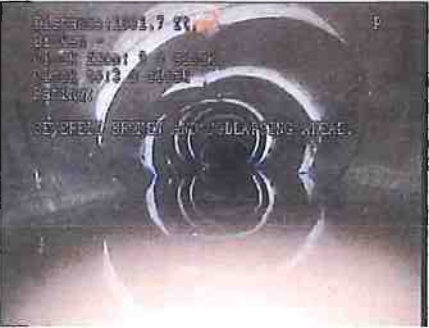
1,031.7 ft.	D	91.4 ft.	9 / 3	Broken	SEVERELY BROKEN AND COLLAPSING AHEAD.
10+35 => TOP CRACKED - CONTINUE 'VED PIPE - SOIL VISSIBLE

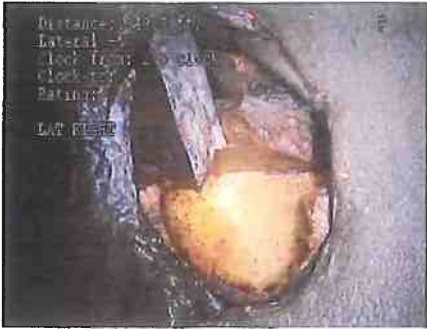
Distance	Dire Length	From/To	Code	Modifier/Severity	Rating	Comments
1,049.7 ft.	D	2 /	Lateral	- LATERAL VCP TILE		LAT RIGHT

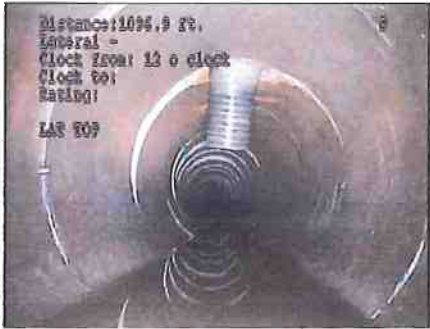
1,096.9 ft.	D	12 /	Lateral	- HDPE LATERAL - INTRUDING		LAT TOP
-------------	---	------	---------	----------------------------	--	---------

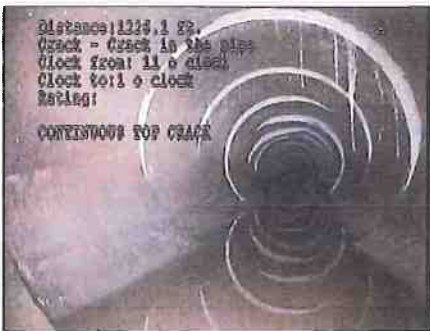
1,226.1 ft.	D	175.4 ft. 11 / 1	Crack			CONTINUOUS TOP CRACK
-------------	---	------------------	-------	--	--	----------------------

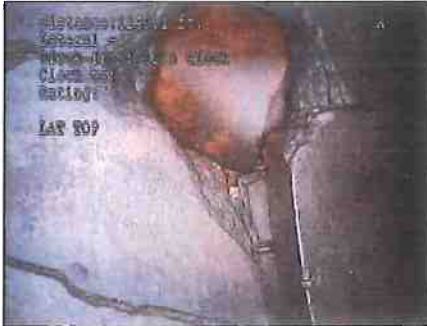
Distance	Dire Length	From/To	Code	Modifier/Severity	Rating	Comments
1,240.1 ft.	D	12 /	Lateral	- LATERAL - VCP - NON INTRUDING		LAT TOP

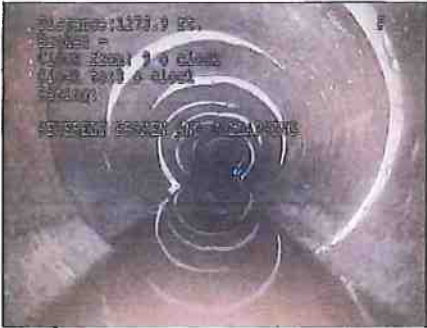
1,273.9 ft.	D	9 / 3	Broken			SEVERELY BROKEN AND COLLAPSING
----------------	---	-------	--------	--	--	---

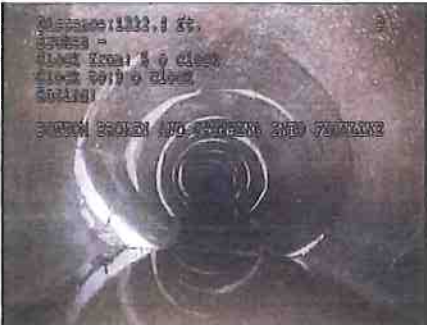
1,322.4 ft.	D	5 / 9	Broken			BOTTOM BROKEN AND CRUSHING INTO FLOWLINE
----------------	---	-------	--------	--	--	---

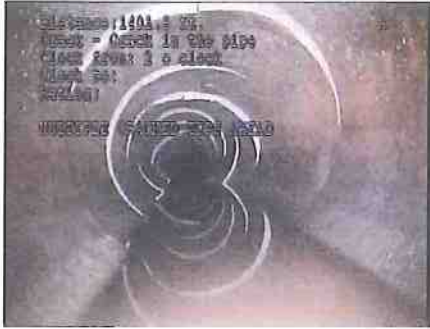
Distance	Dire Length	From/To	Code	Modifier/Severity	Rating	Comments
1,401.5 ft.	D	2 /	Crack			MULTIPLE CRACKED TOPS AHEAD
				14+04 =>		TOP CRACKED - PIPE 'VED
				14+09 =>		TOP CRACKED - PIPE 'VED
				14+13 =>		JOINT GAP - SOIL VISSIBLE
				14+35 =>		TOP CRACKED - PIPE ROUND
				14+41 =>		JOINT GAP - SOIL VISSIBLE - START TOP CRACKED - PIPE EGG SHAPED

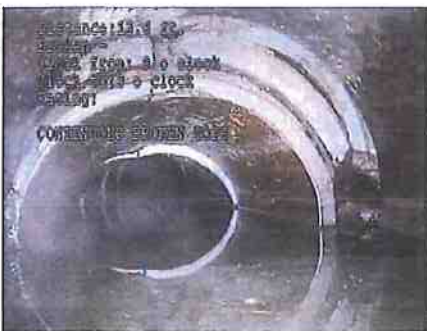
0+14

13.6 ft.	U	11.9 ft.	9 / 3	Broken - TOP CRACKED - 2 PIPE 'VED - REPAIRED WITH - BRICK BATS	CONTINUOUS BROKEN TOPS
----------	---	----------	-------	--	---------------------------

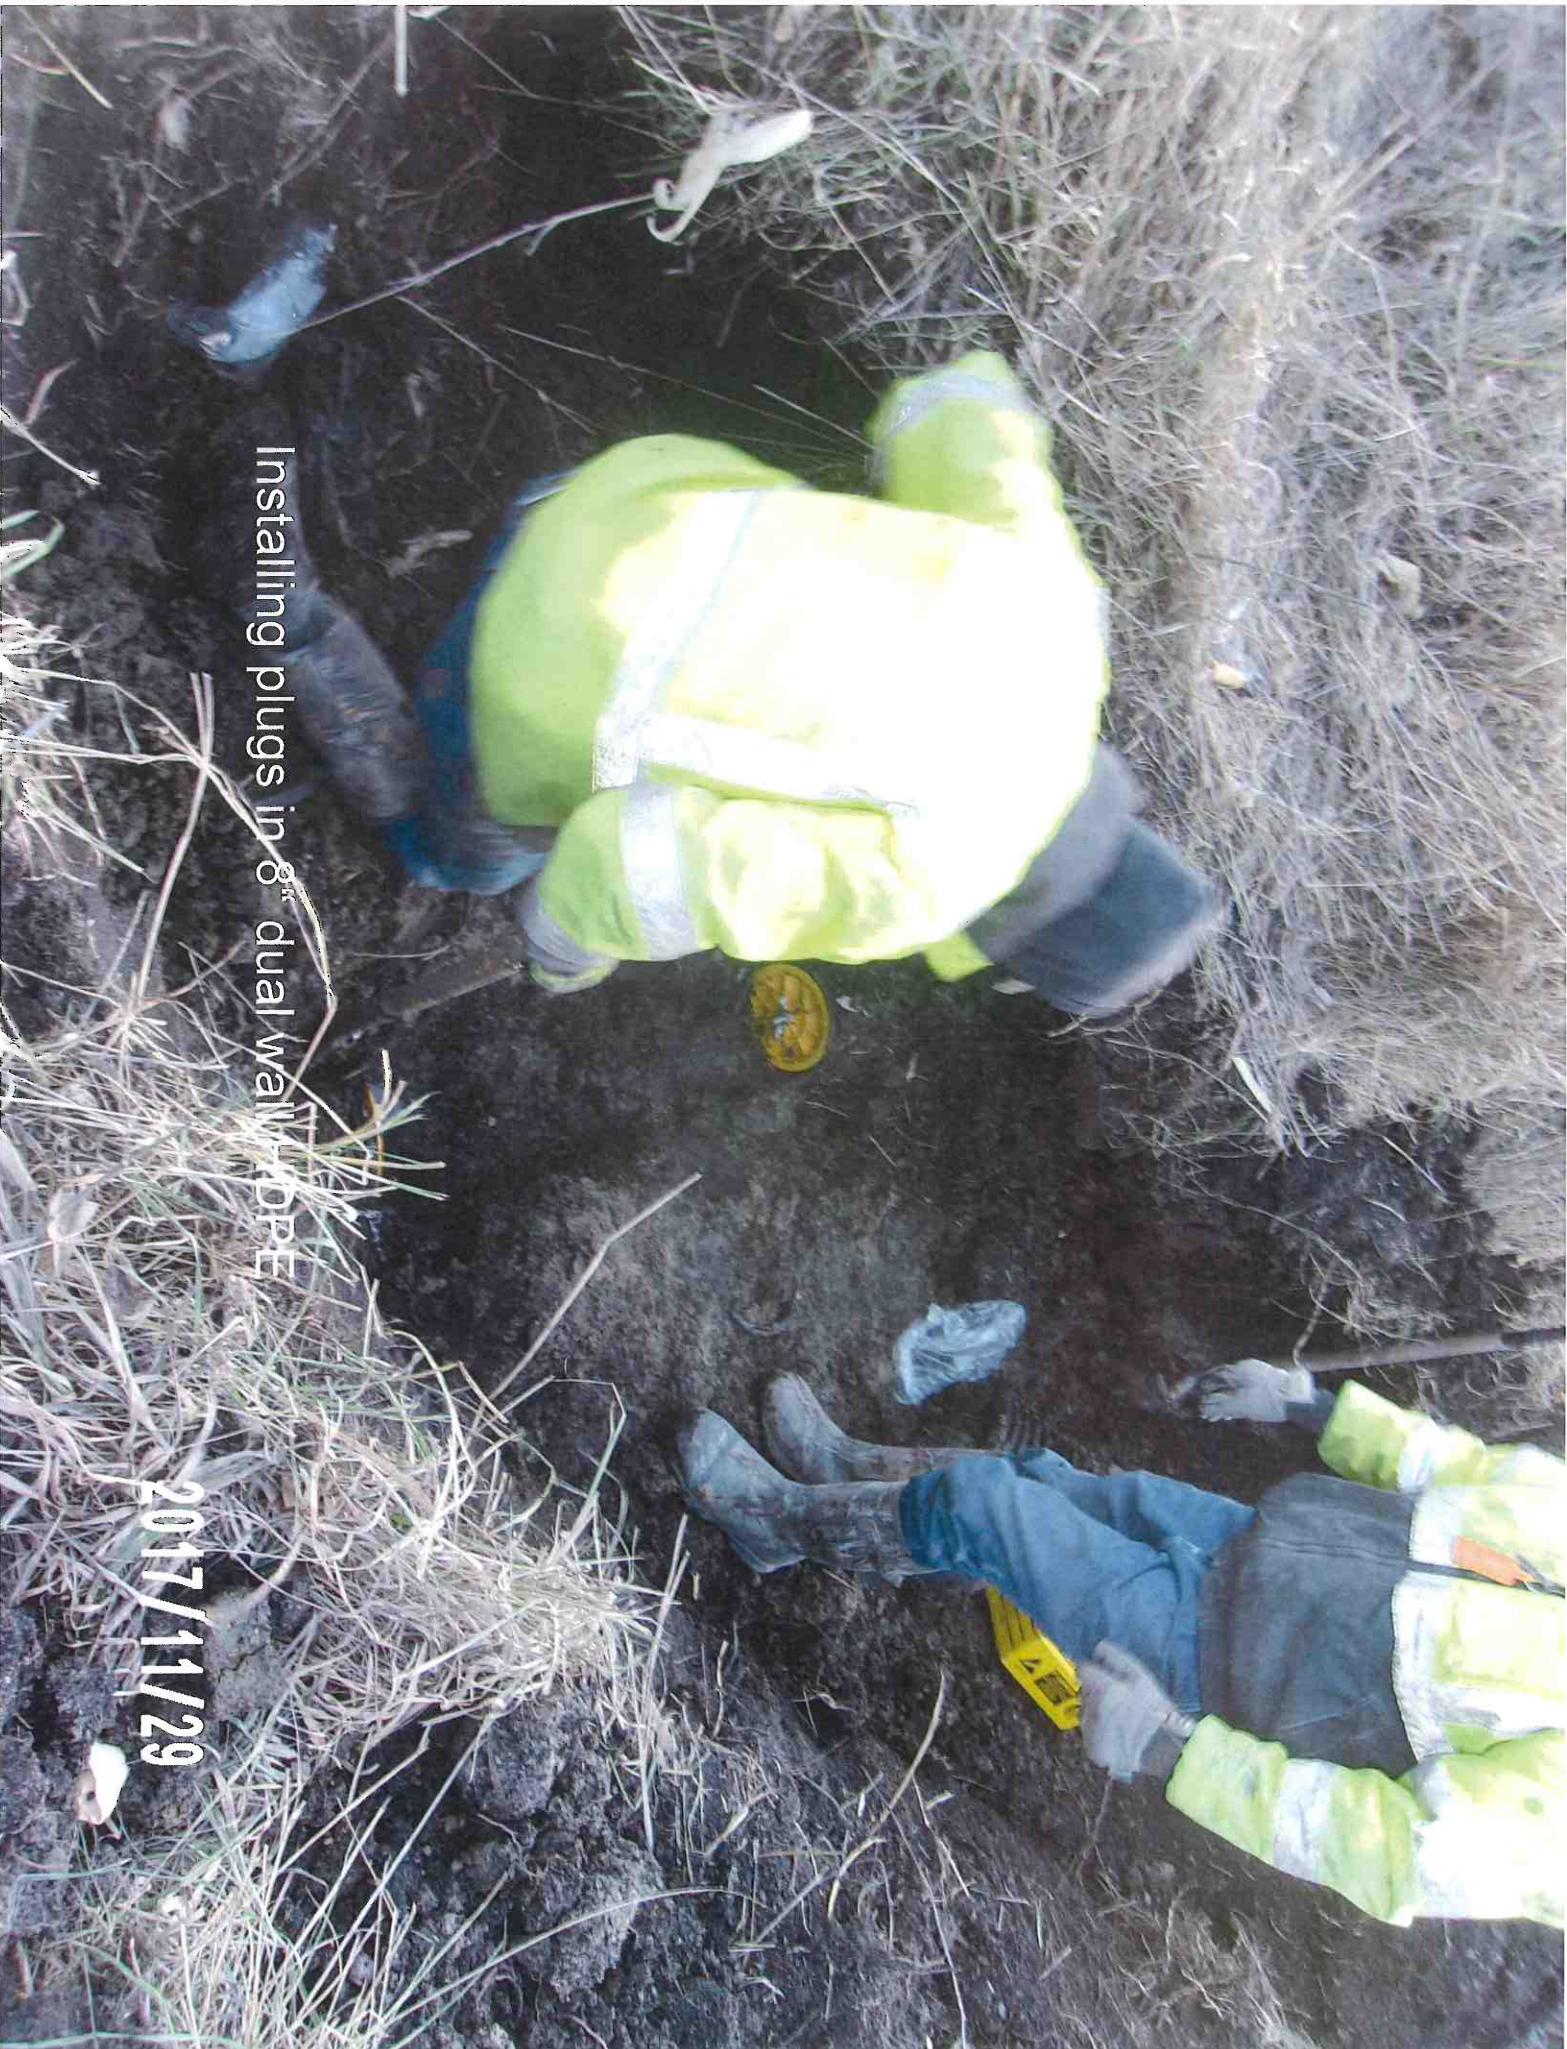
Installing plugs in 8" dual wall HDPE

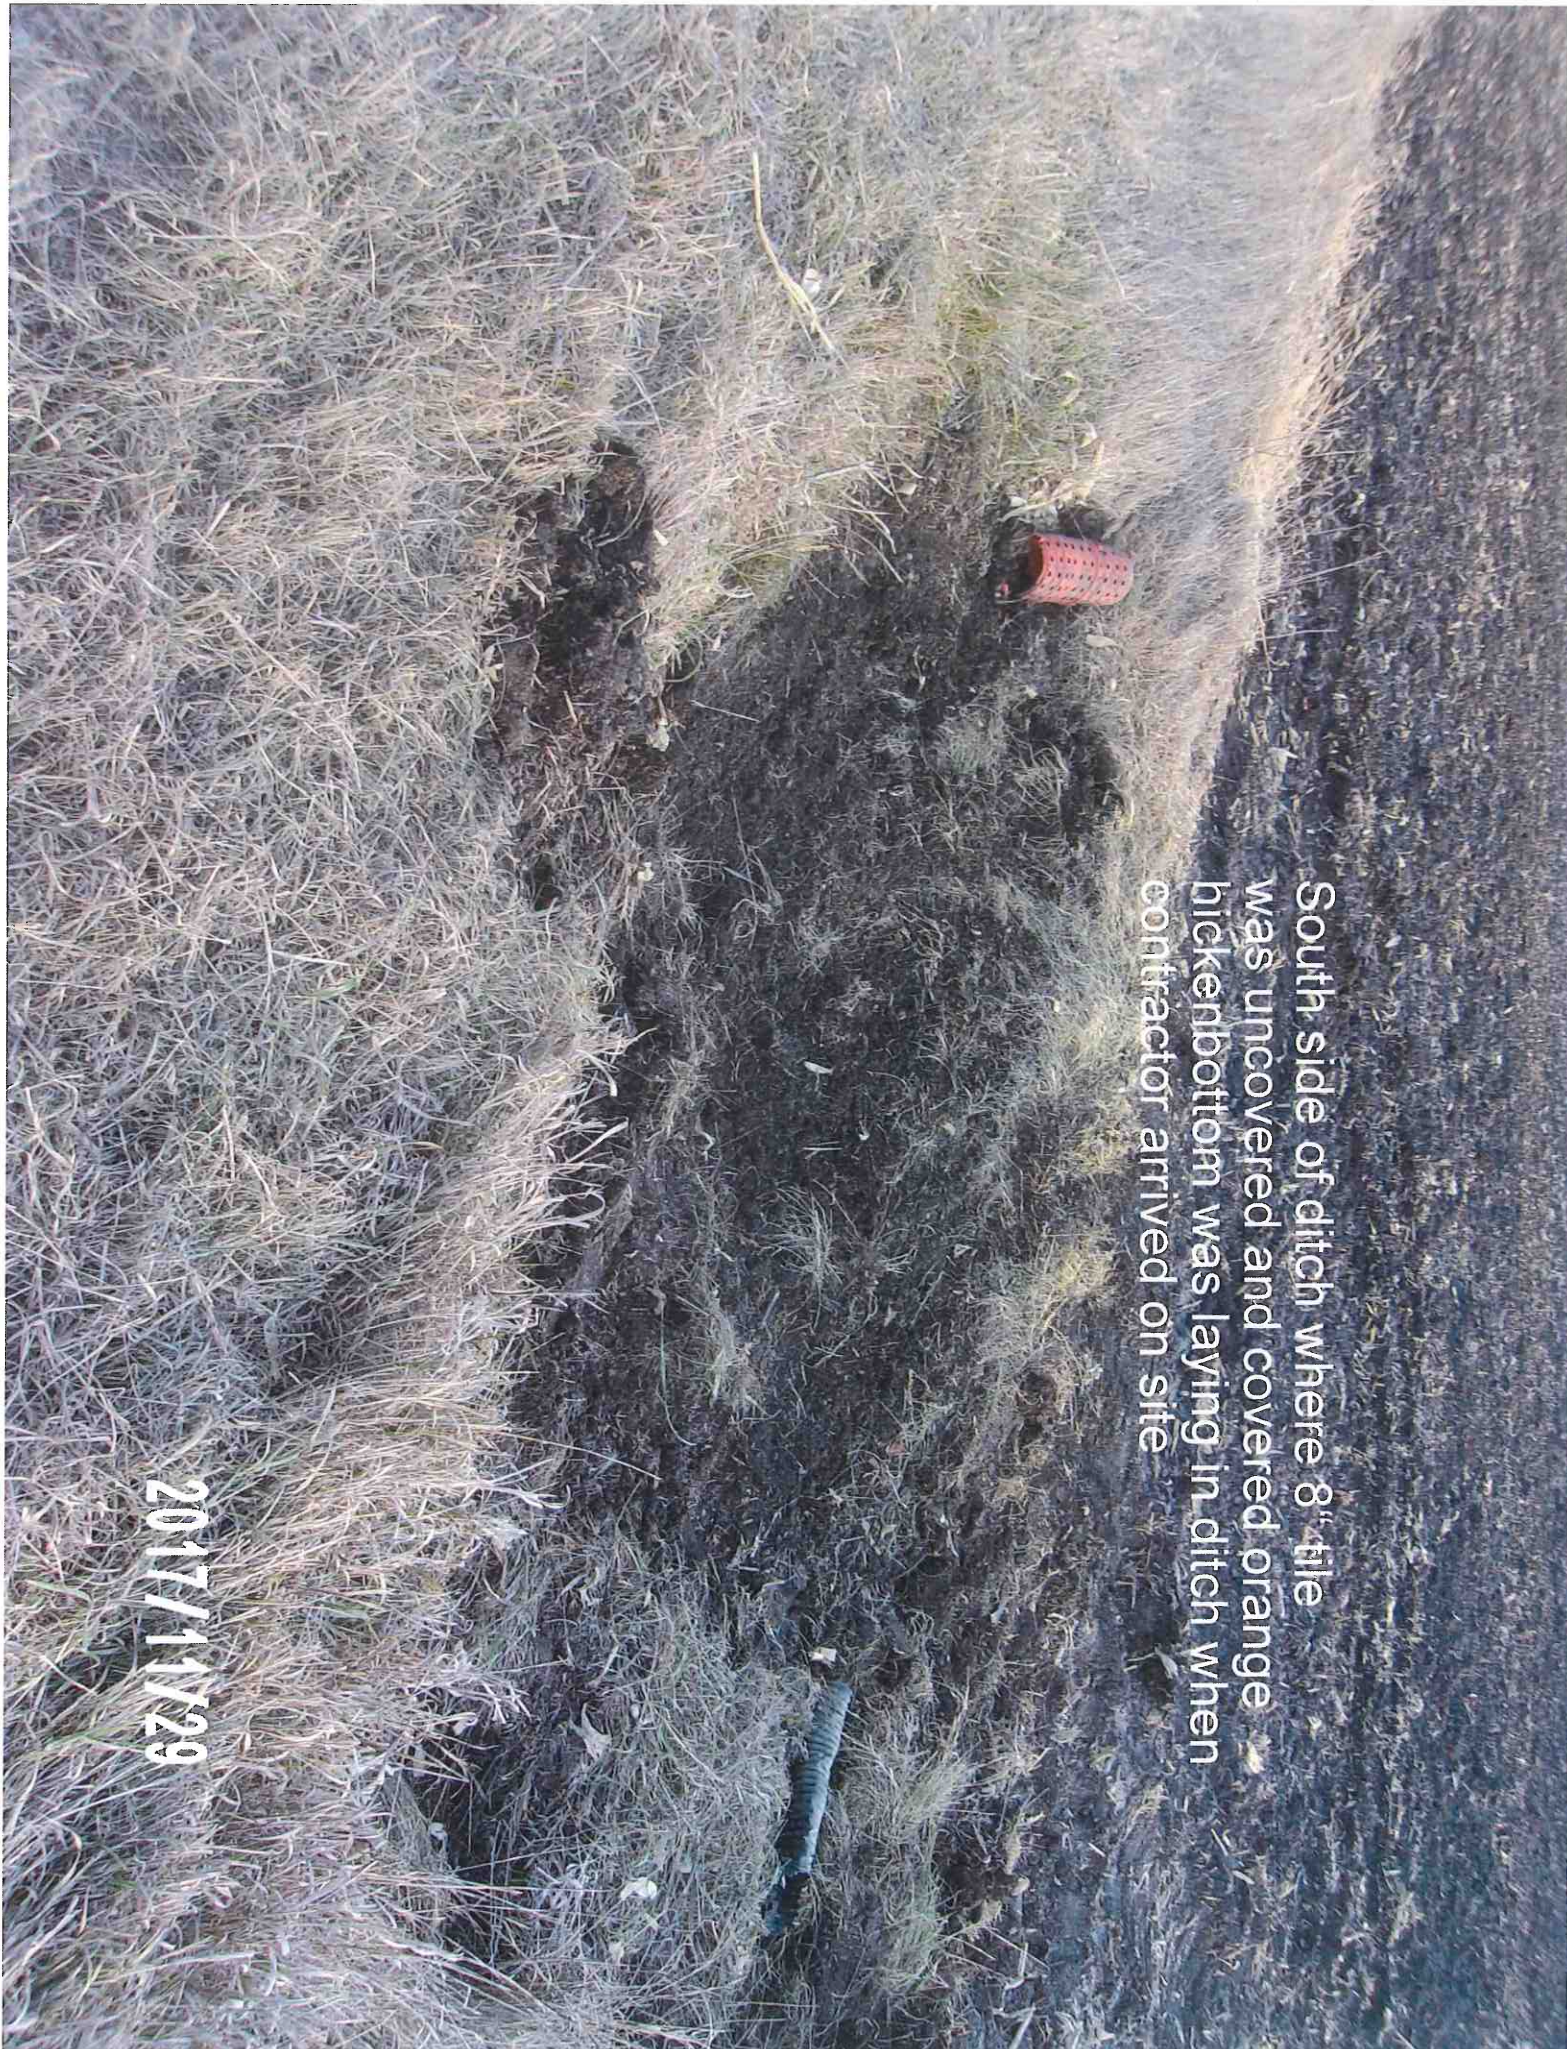
South side of ditch showing 8" hickenbottom and 6" hickenbottom
