**AGENDA**  
**REGULAR DRAINAGE MEETING**

# REGULAR DRAINAGE MEETING

## Drainage District:

## Repair Summary:

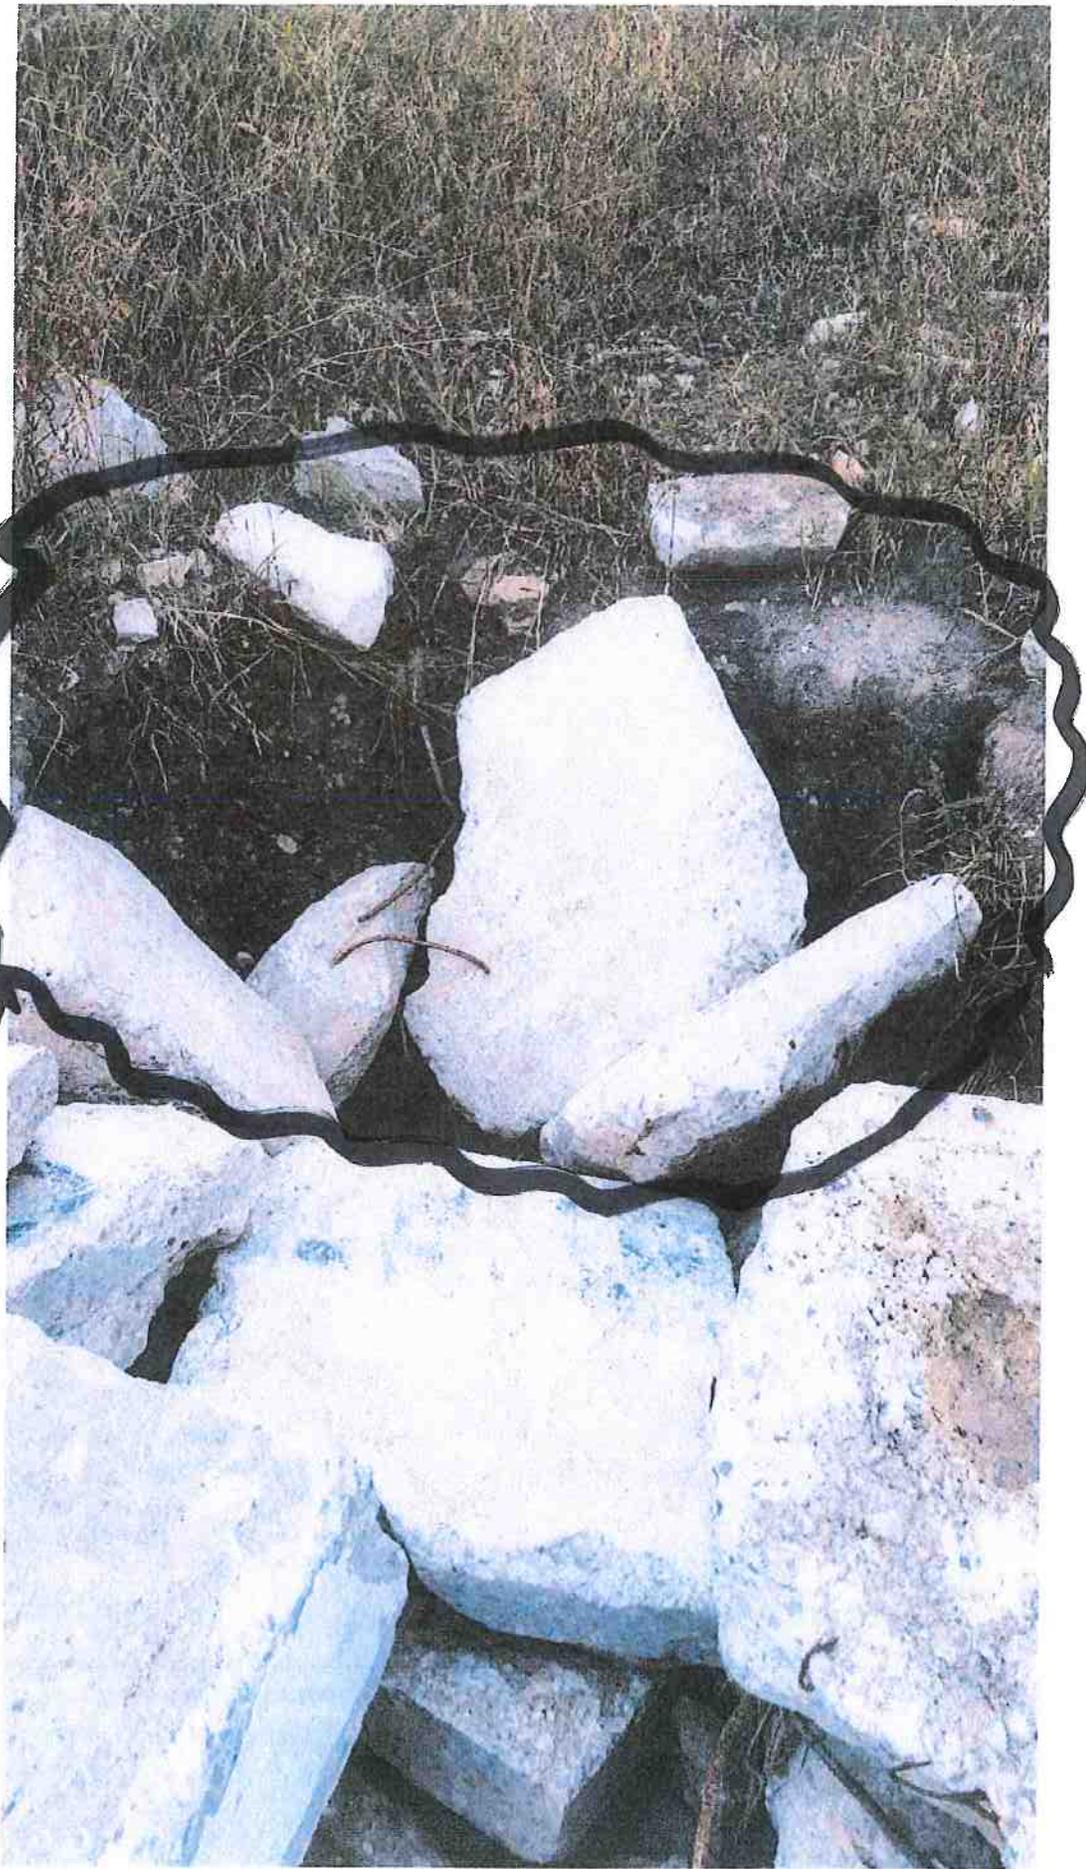
- Some of the broken concrete that was placed as bank stabilization had moved and is partially blocking one of the tile outlets. Attached are some pictures (6428 - Warranty Issues - DD #34). The District Trustees would ask that you move the broken concrete before they accept the project and release your project retainage.
- At the top/start of the riprap, some erosion has occurred. Attached are some pictures showing the erosion along with a sketch showing some proposed work in this area (6428 - Erosion Issues (Add) - DD #34) to remedy the same. The District Trustees would like to know if you are interested in performing this work, what the cost would be, and what your timeframe is for completing this. If you are interested, this work would be performed separately from your existing contract. If not interested, please let me know so that the District Trustees can find somebody else.

Erosion starting @ upper end of  
Rip-Rap

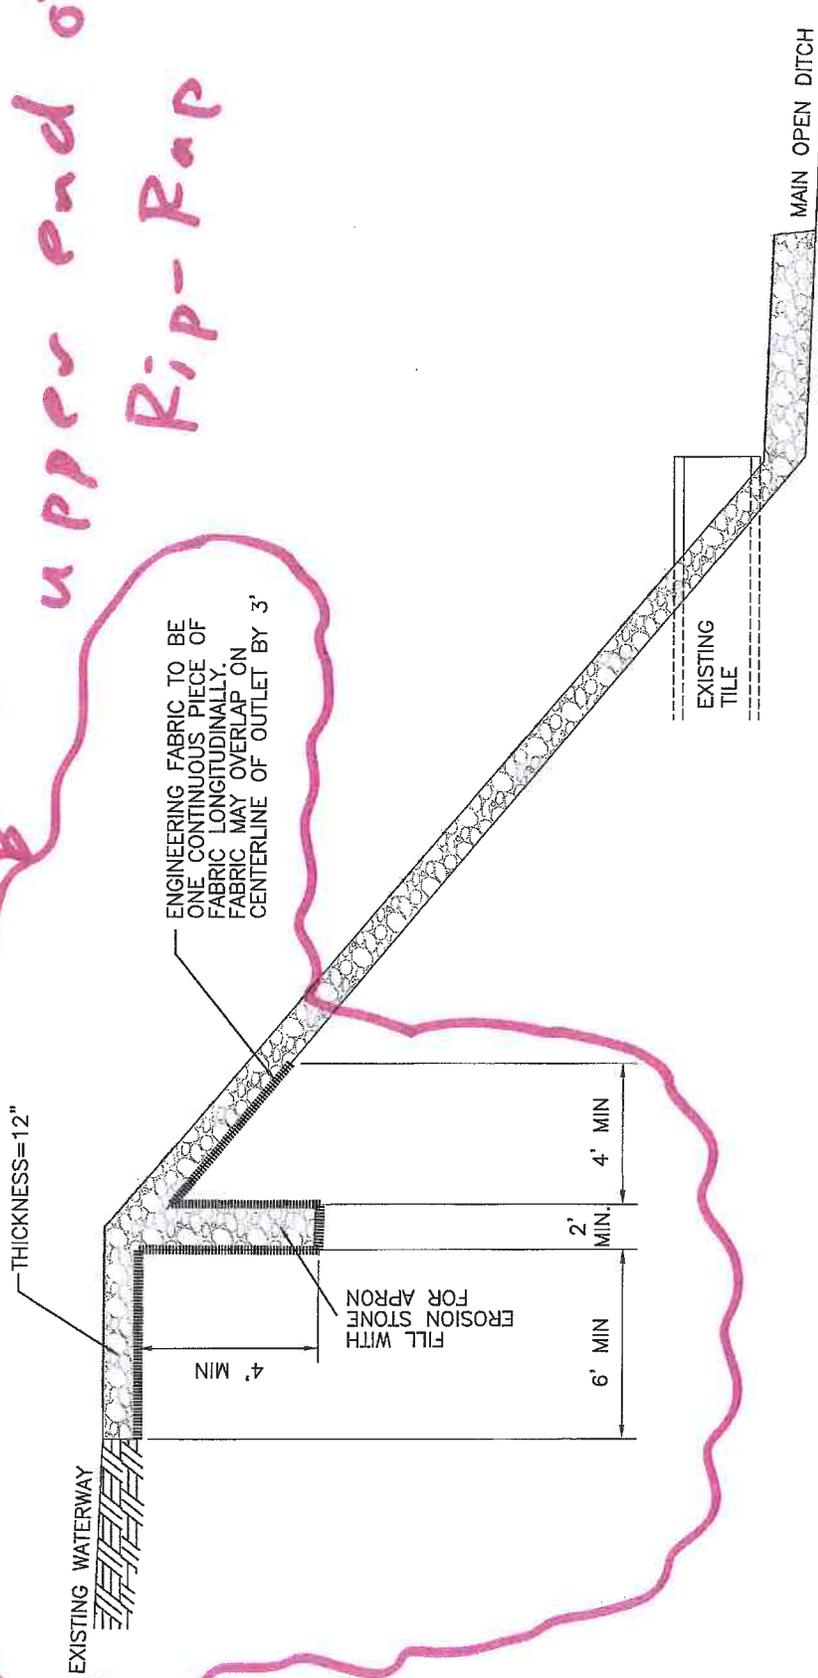
Proposed work  
@ eroded area  
upper end of  
Rip-Rap

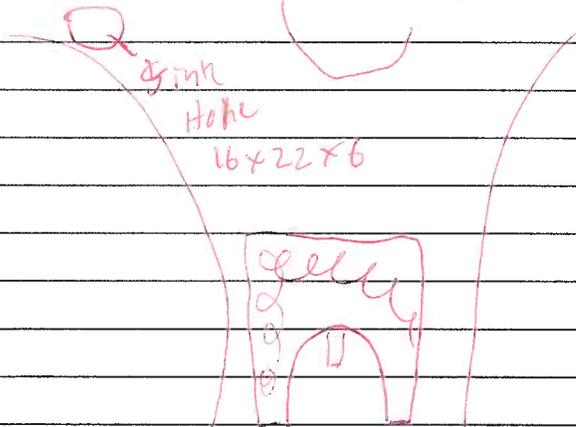
Found sink hole 100-150ft North of outlet tile visible

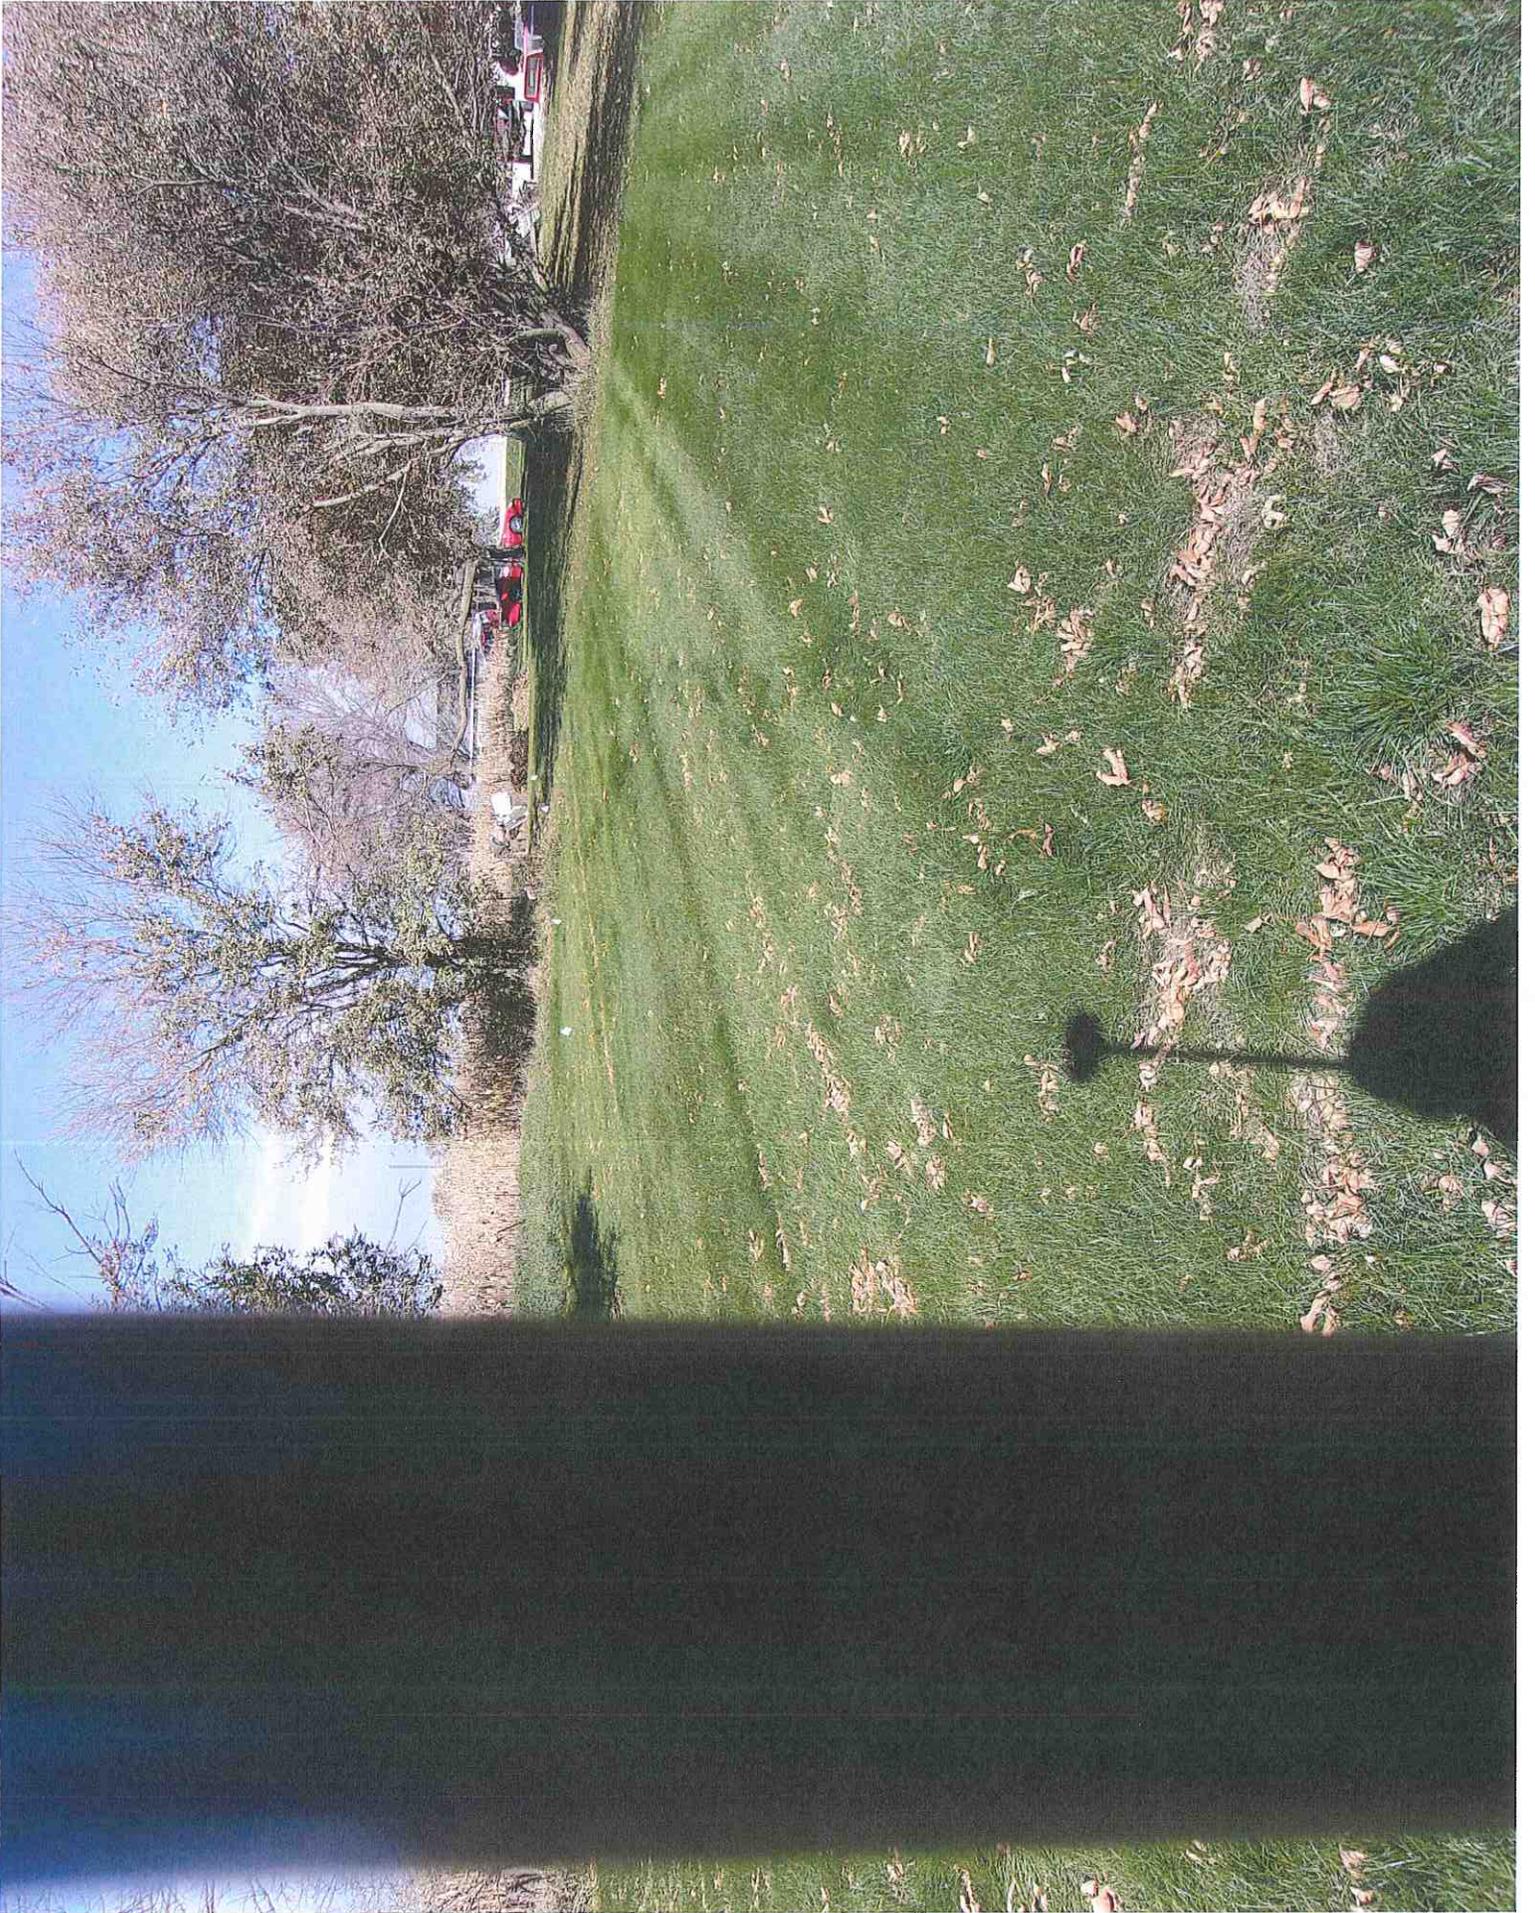
- Landowner in NW¼ SW¼ Section 22, Township 86 North, Range 22 West reported water boiling out of ground in area of fenceline beside field near previous repair.
- Visual observation found soil to be totally saturated in area where Lateral 3 tile intersects said fenceline. Adjacent to said intersection, two trees were found to be growing within the fenceline.
- This area is approximately 150 feet upstream of upstream end of previous tile repair.

Based on the above, it appears that tree roots have plugged the Lateral 3 tile. Therefore, CGA recommends the following:

WALKED OUT TO PLACE WHERE TILE REPLACEMENT ENDED, WALKED UPSTREAM @ WHITE FLAG AREA, TOTALLY SATURATED GROUND @ TREE LOCATION. IM SURE TILE GOES UNDER A 24" ASH, AND 18" MULBERRY. TREES NEED TO BE REMOVED AND TILE REPLACE FROM #218 @ TILE REPLACEMENT TILL ROOT BOX LOCATION 150'±

Looking upstream on the route, wet area @ white flags

- Remove trees from area affecting Lateral 3 tile and either remove or treat stumps to prevent regrowth.
- Excavate and replace affected Lateral 3 tile with dual wall HDPE and concrete collars. This could be either just at the tree location or from the previous repair upstream to the tree location.
- It is the opinion of CGA that the total construction cost of these repairs would be approximately \$5,000 to \$12,000 (depending on which option is selected). This cost is low enough that neither a hearing nor an engineer's report would be required.

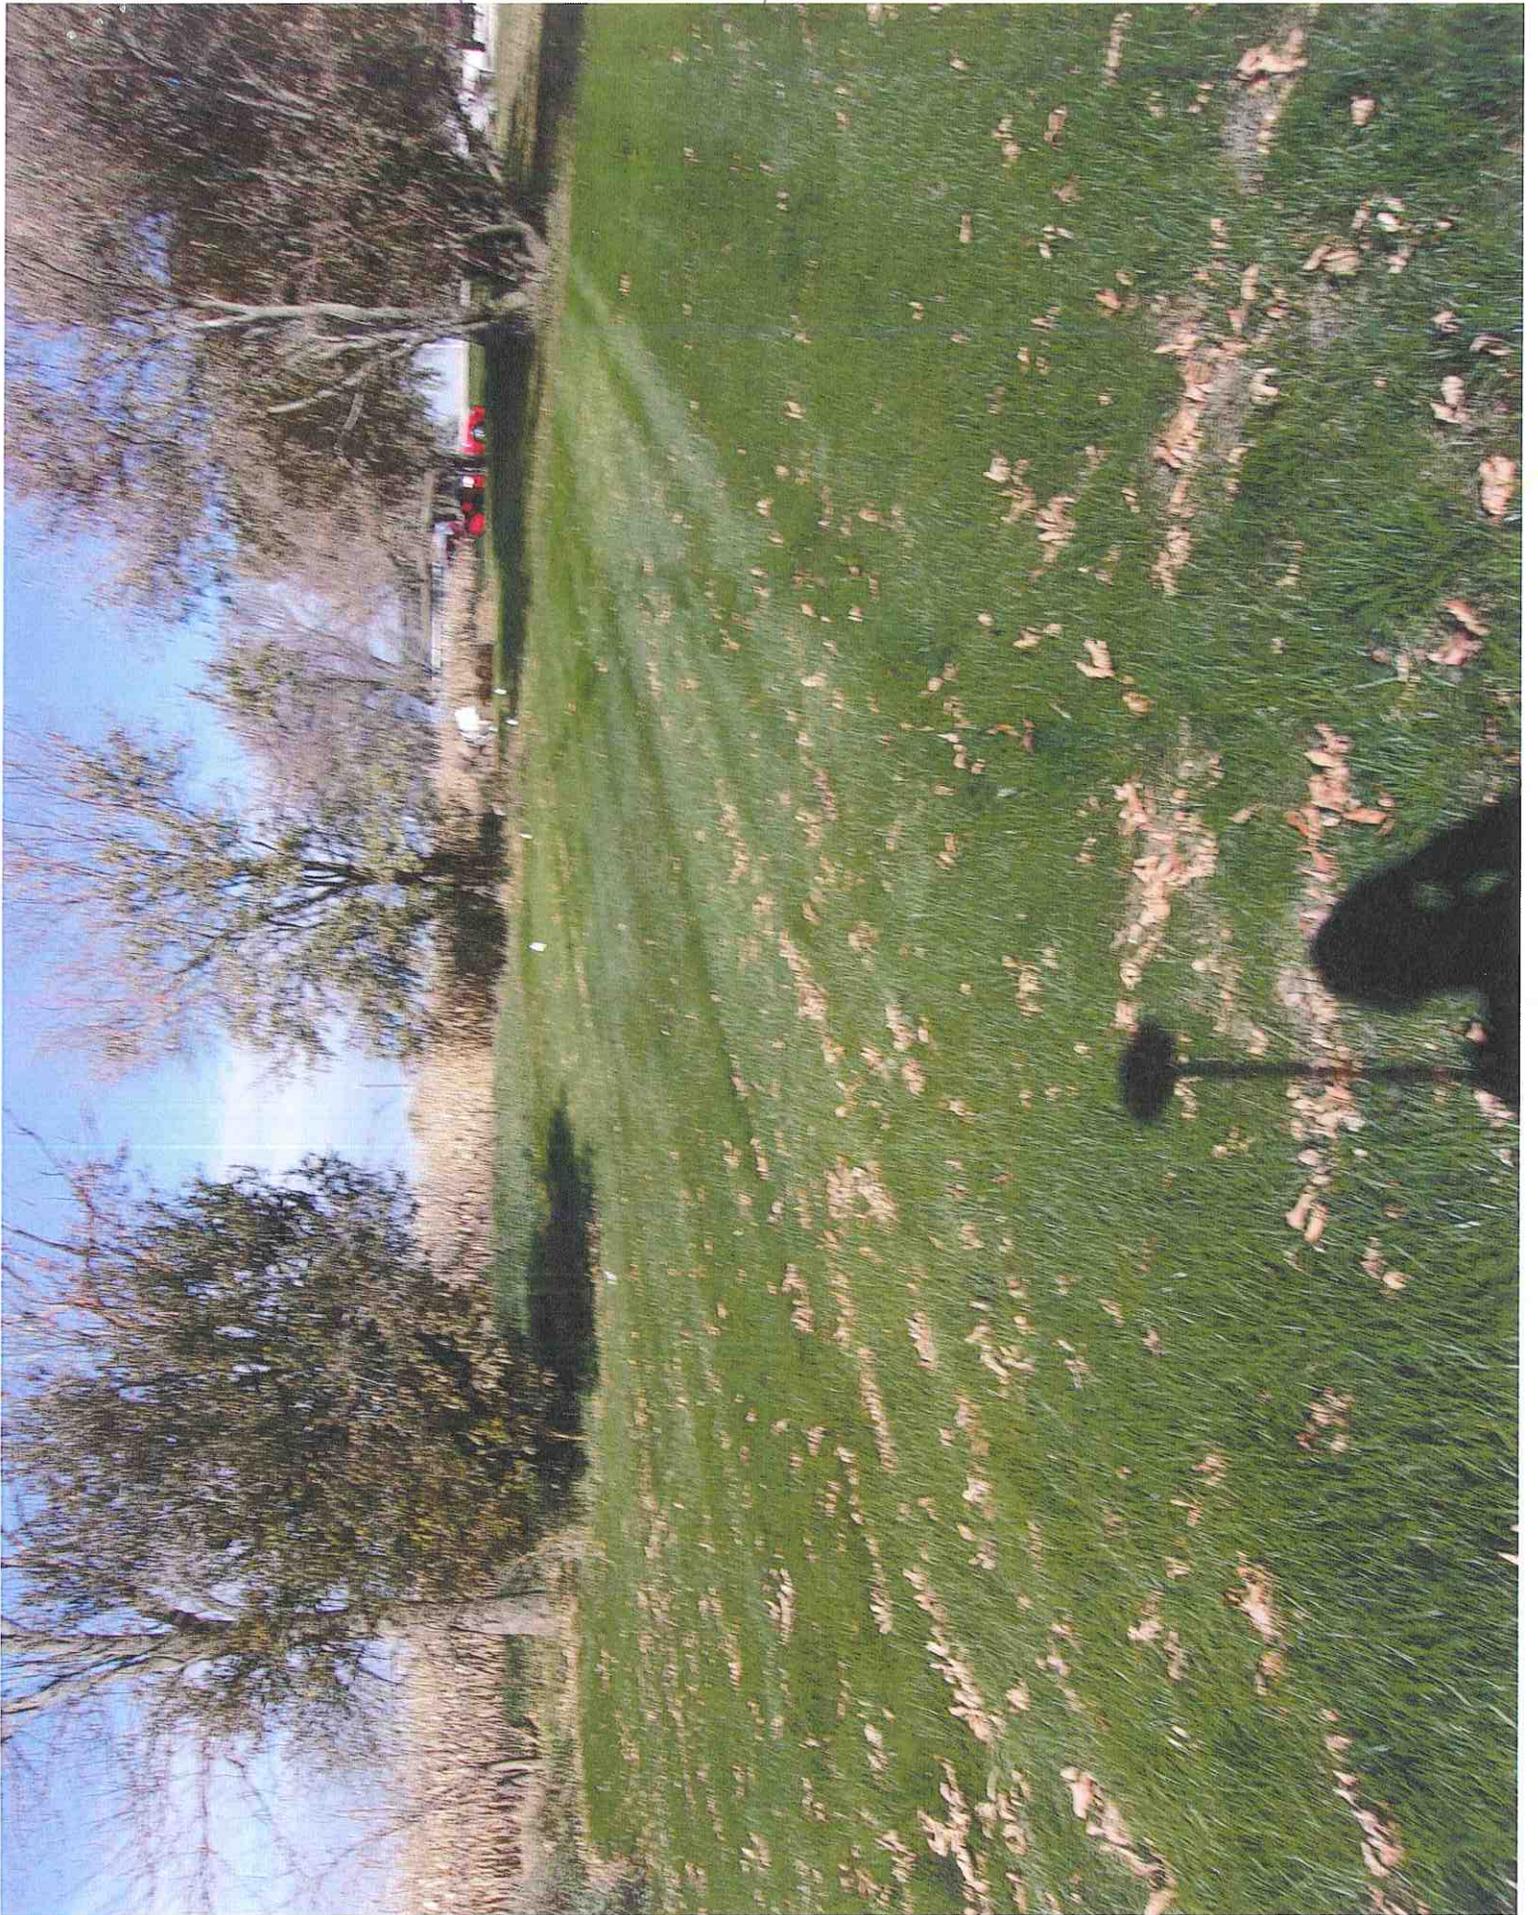
STANDING WATER TILE REPLACEMENT ENDED, LOOKING UPSTREAM

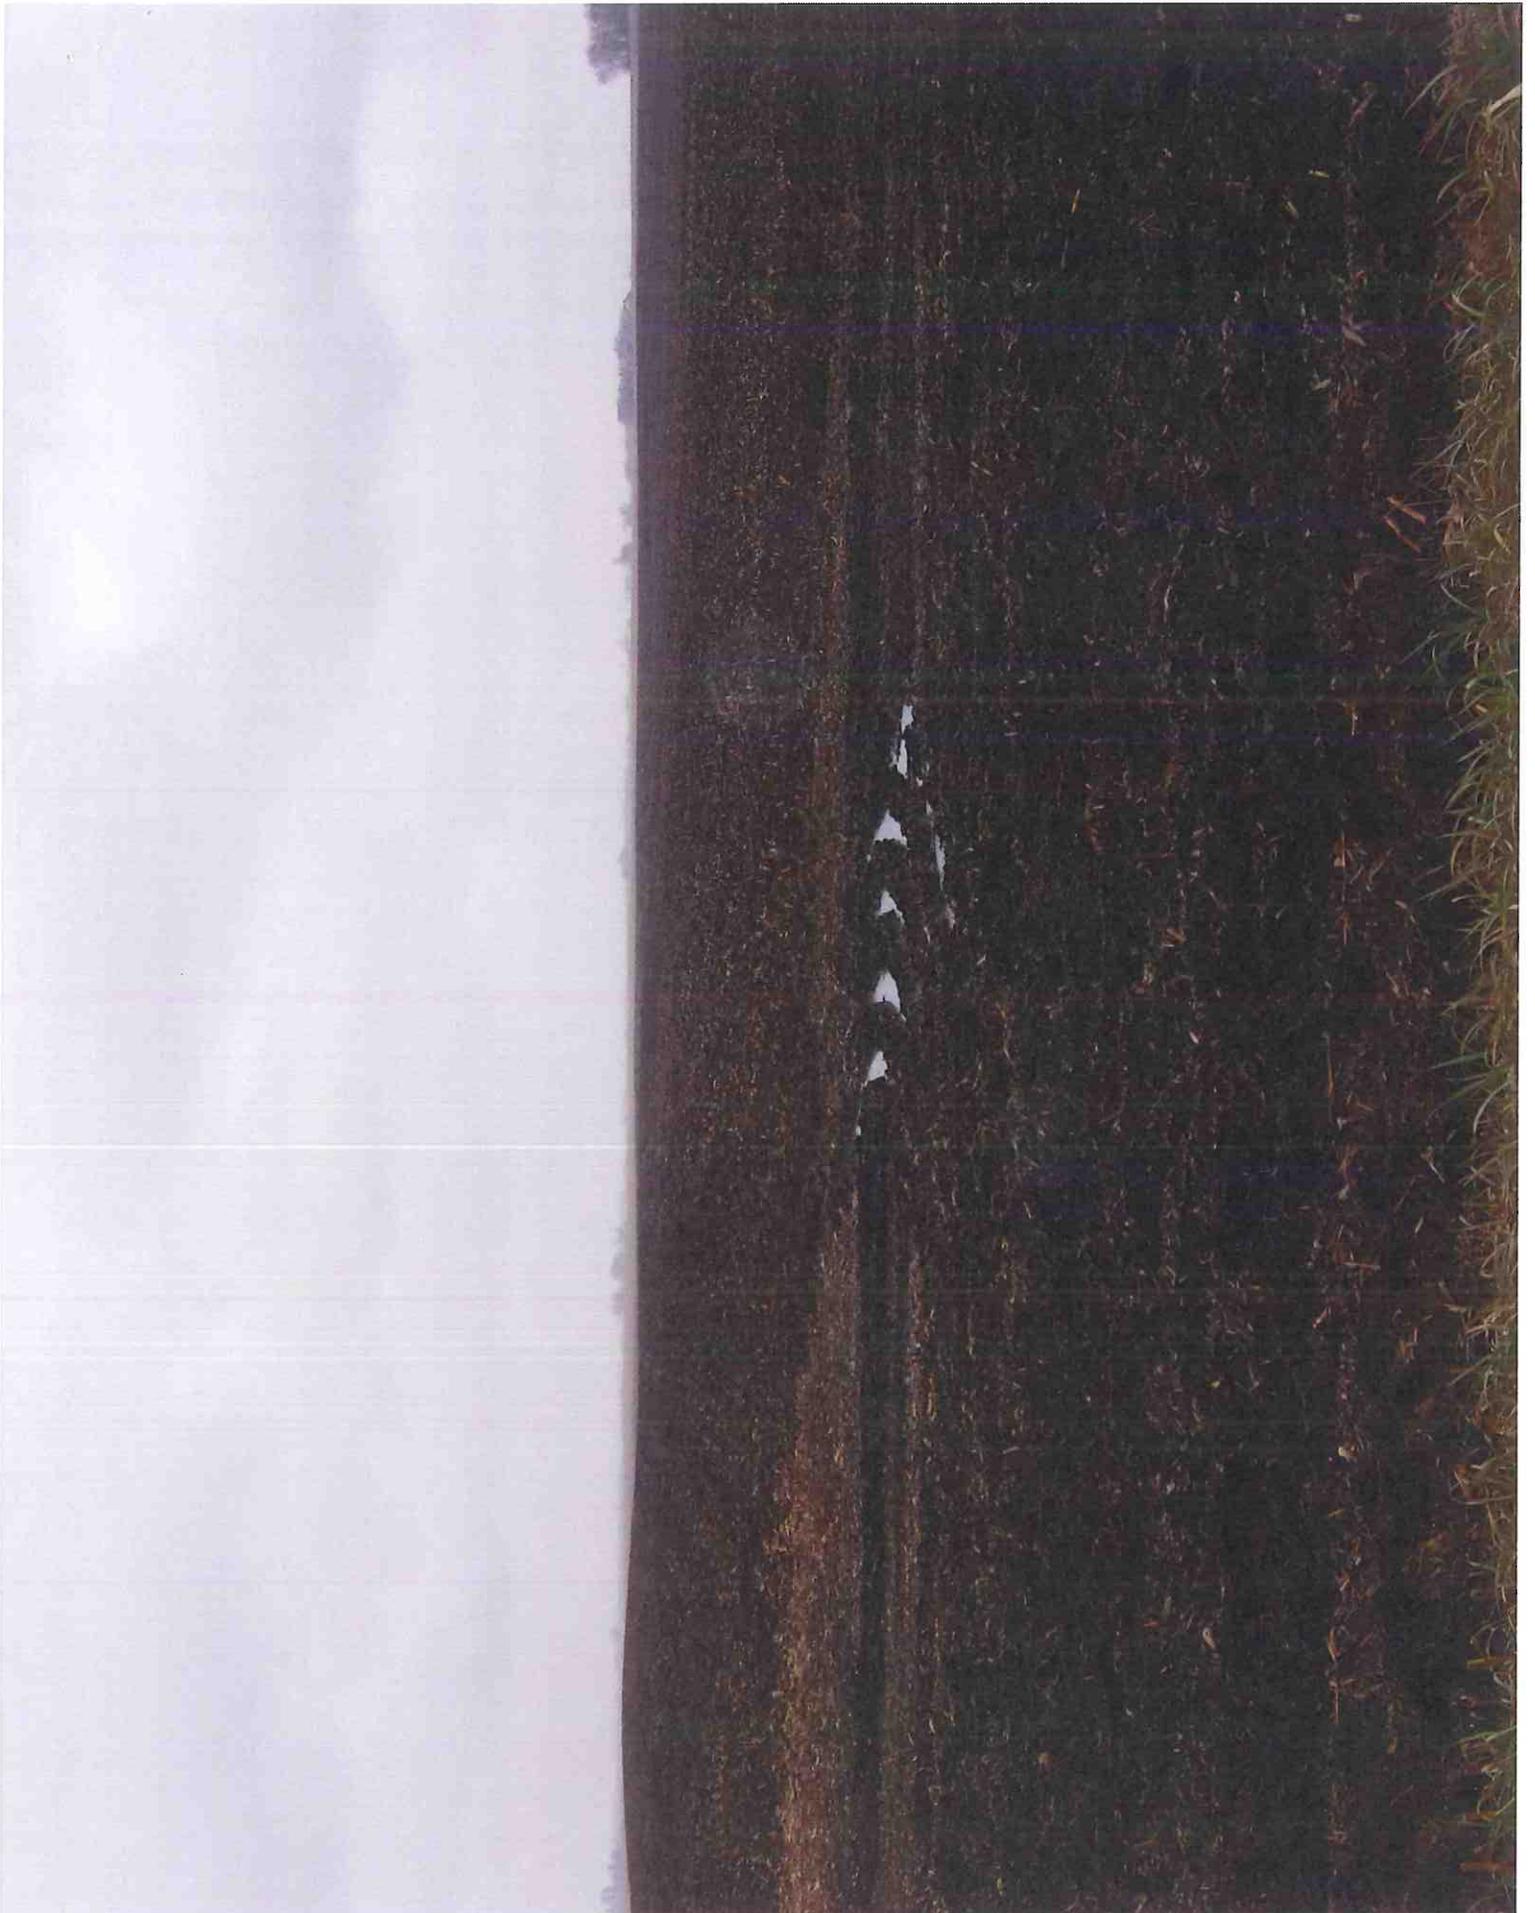
- Visual observation also found standing water just north of 120<sup>th</sup> Street at the presumed connection of the Lateral 4 tile and the Main tile in the SW¼ SE¼ of Section 10.

WET AREA @ MAIN AND LAT 4

- If landowner does not have a contractor on call, assign project to the lottery system.
- Starting on north side of 120<sup>th</sup> Street and working upstream, excavate Lateral 4 tile at regular intervals to determine cause of standing water.

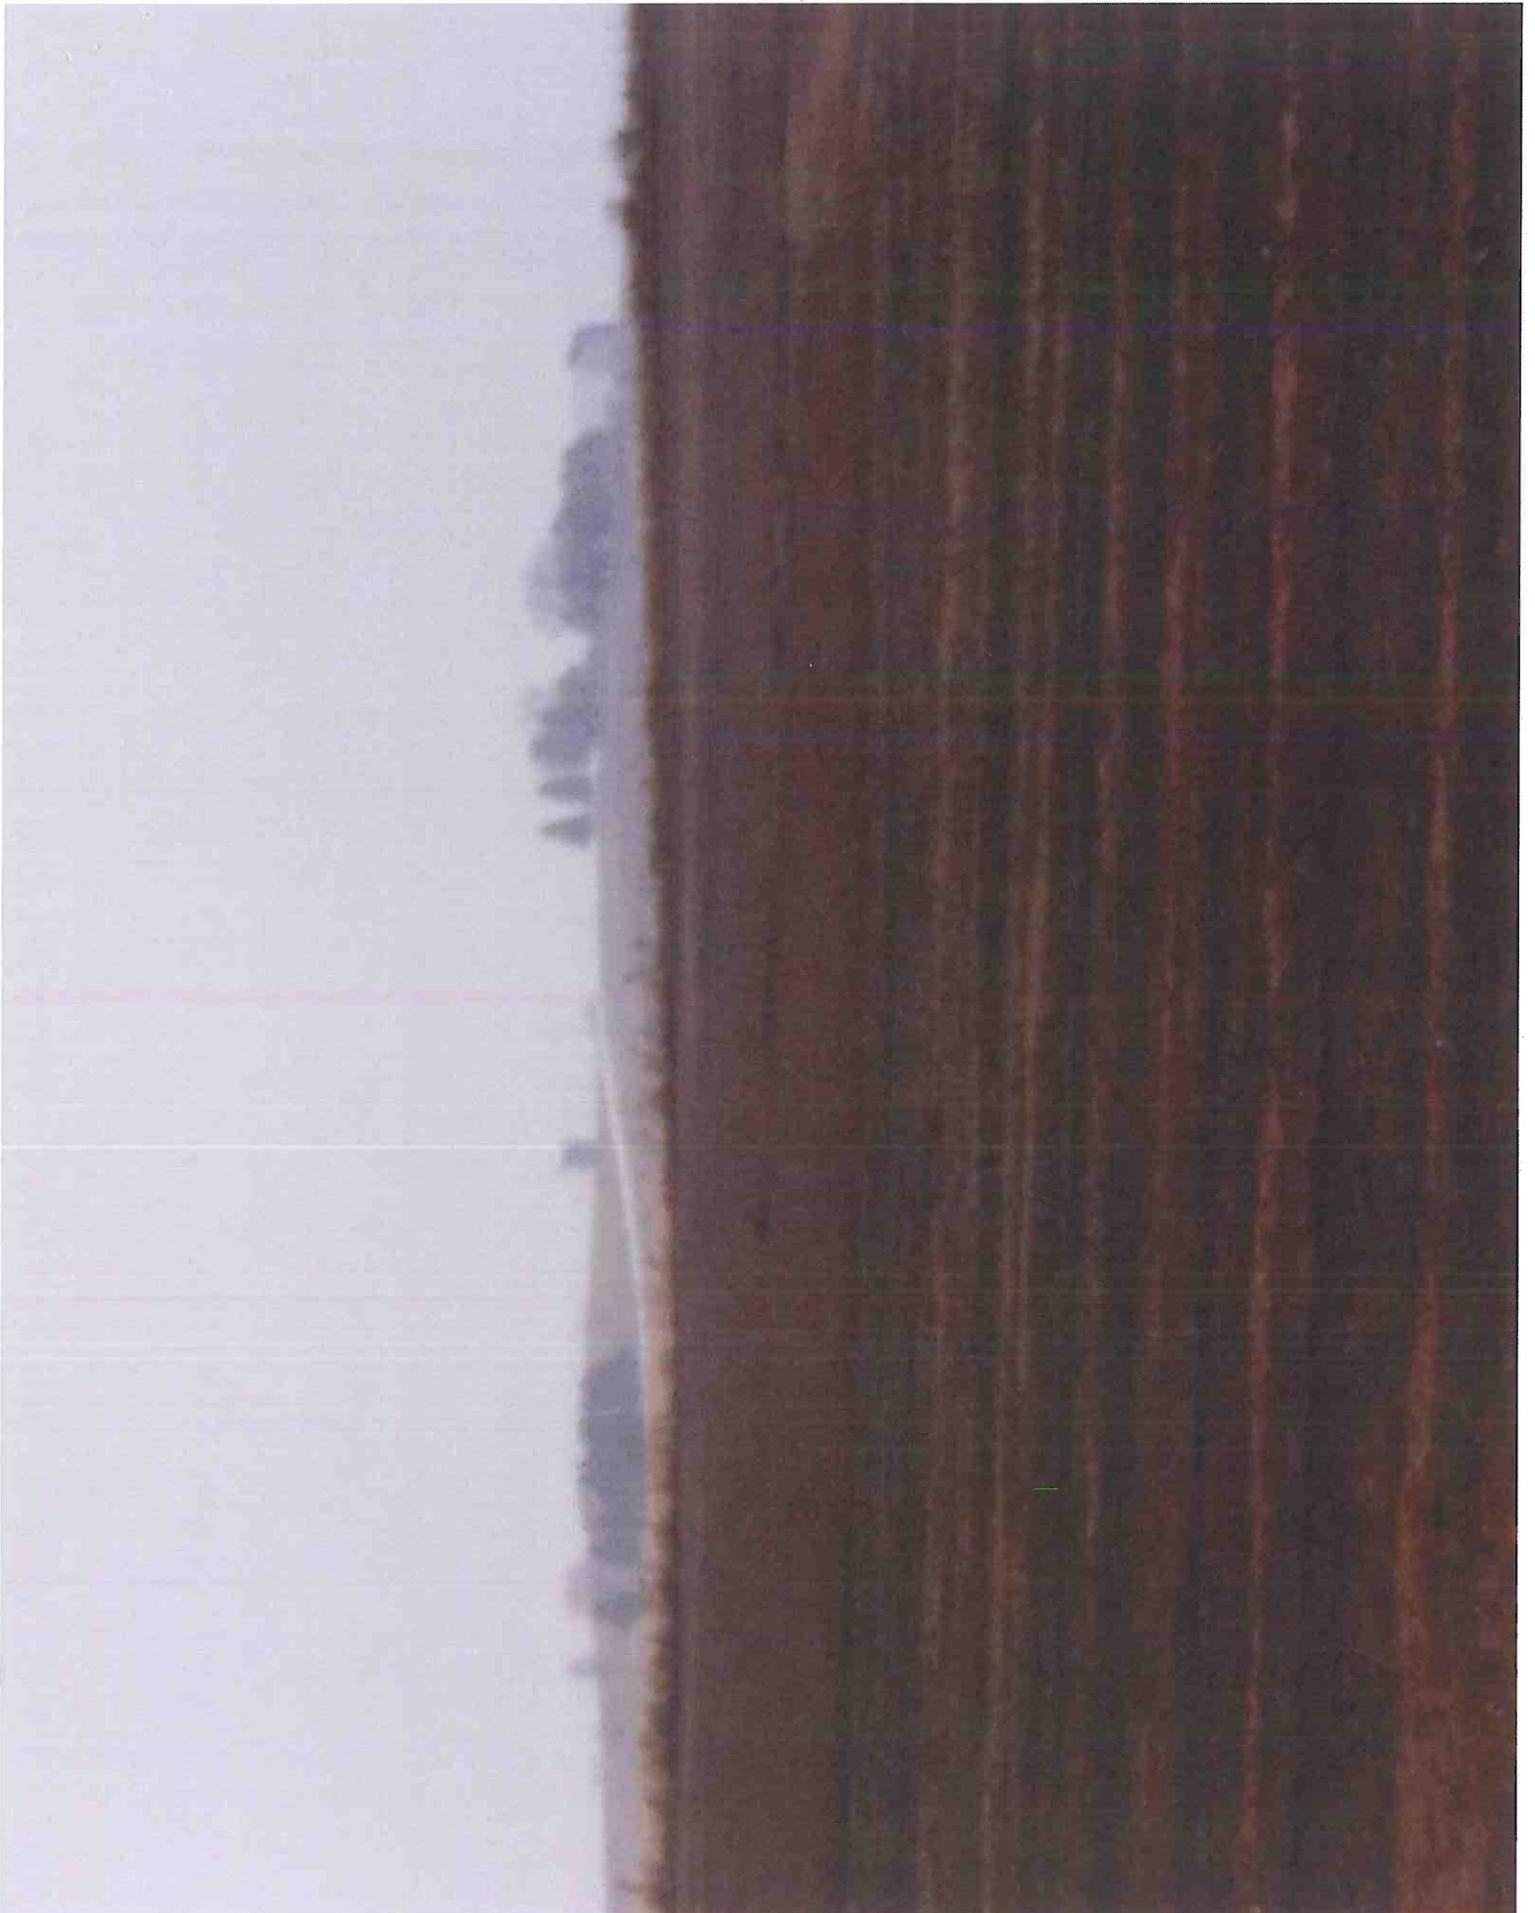
- Called landowner on November 1, 2018 and left message with no response to date.
- Visual observation found standing water along the presumed route of the Lateral 4 tile on both sides of the fenceline between landowner and neighbor to the north. Landowner has harvest corn at location of standing water, but neighbor to the north has unharvested beans in the standing water.

BEANS STANDING IN WET AREA, S. OF 120TH

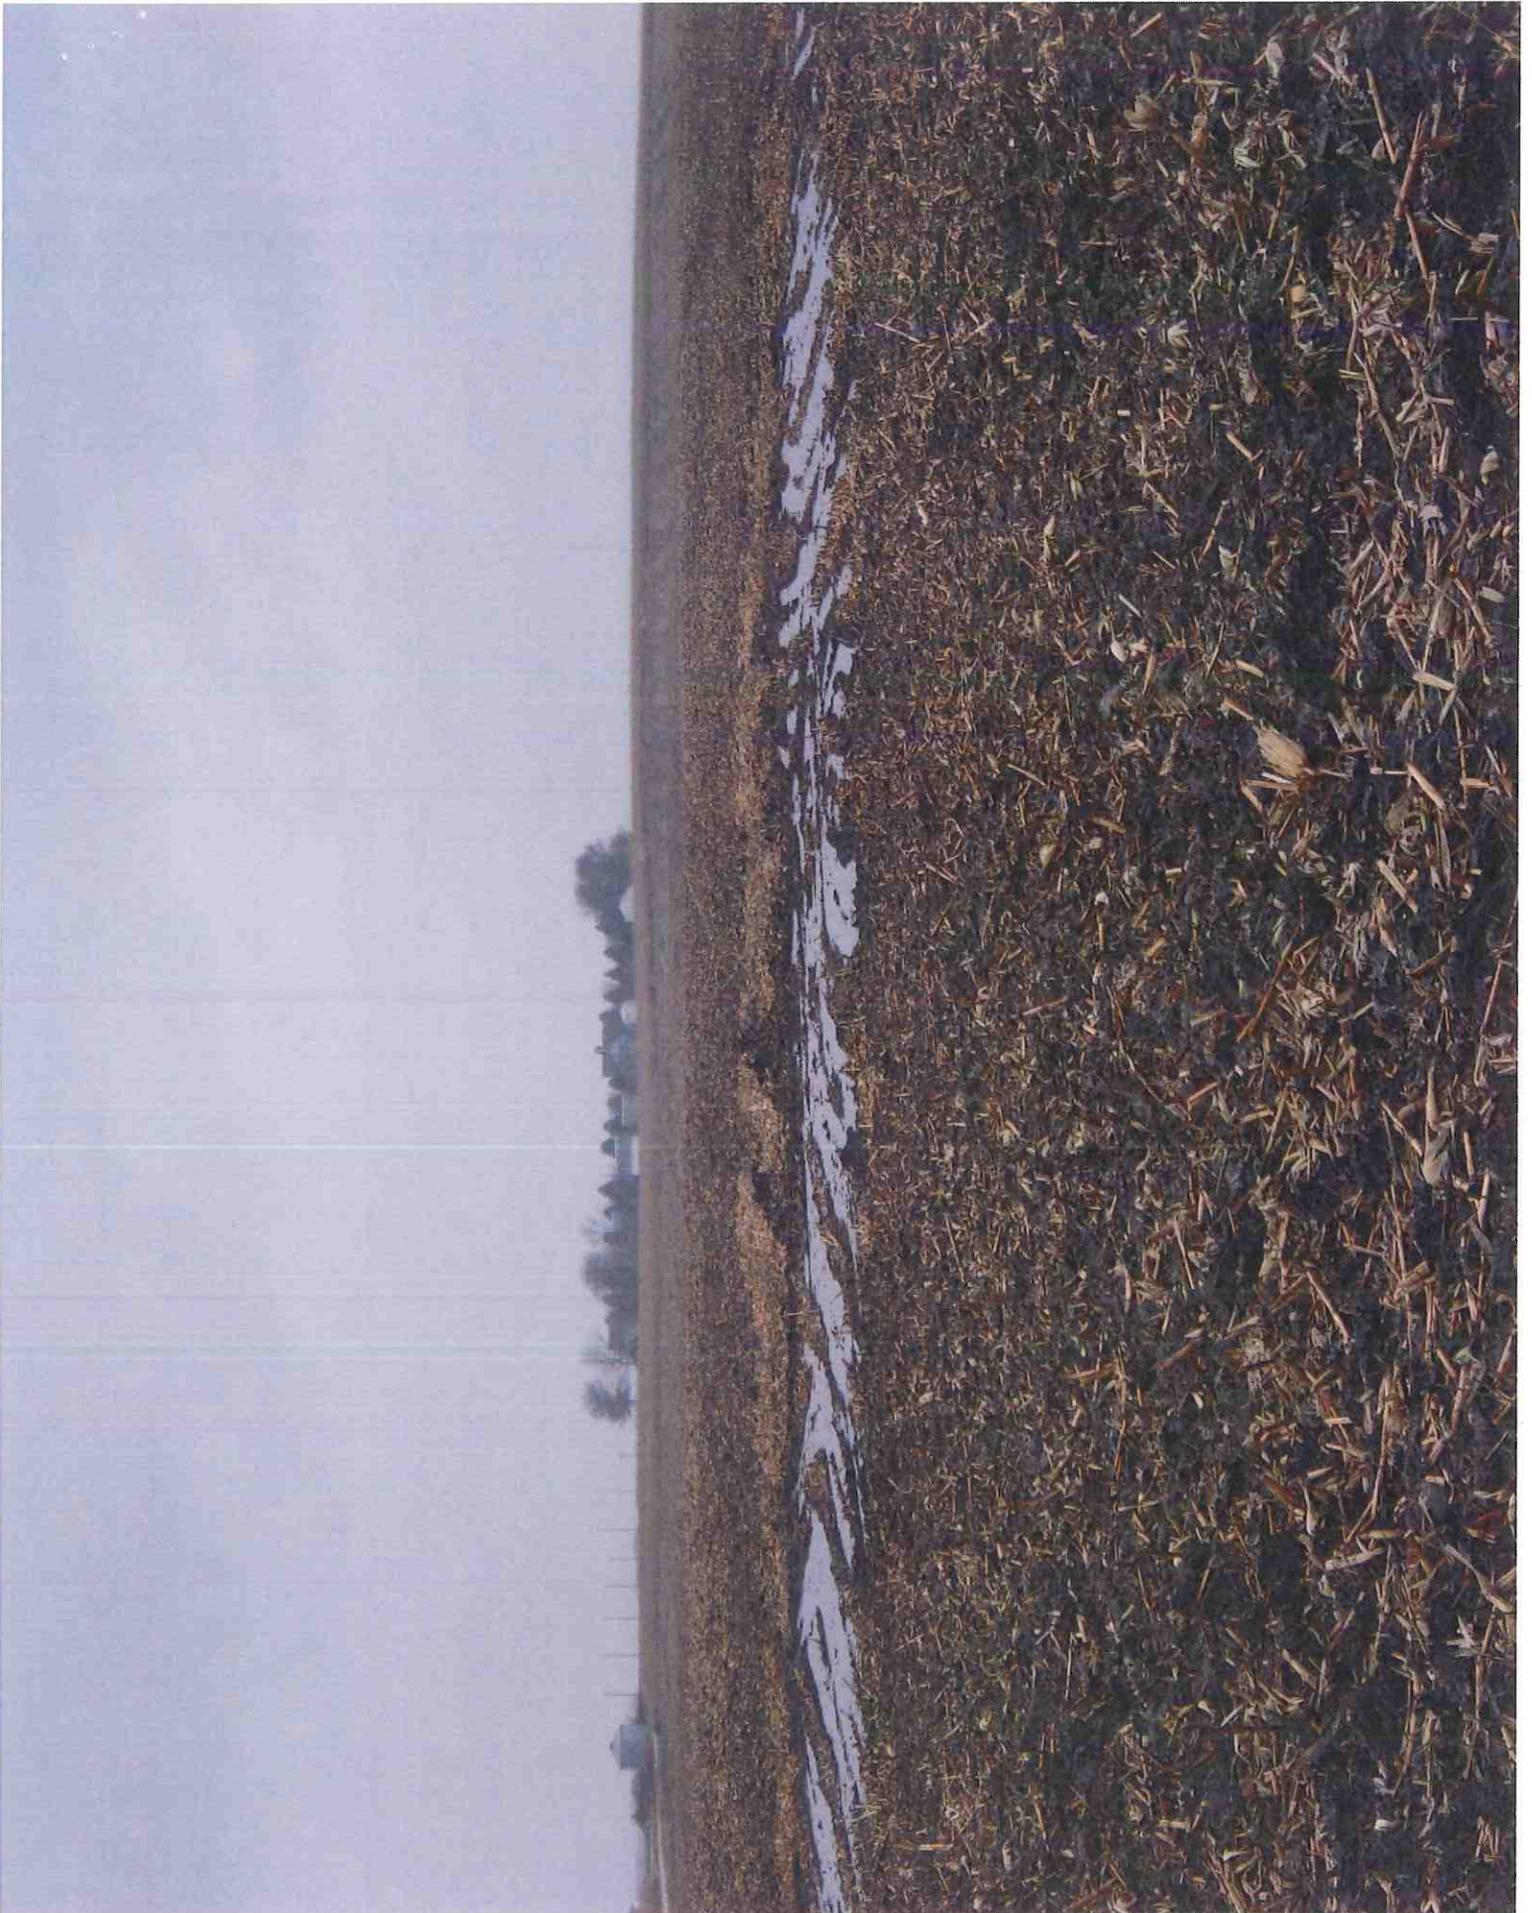
LOOKED @ SITE WITH STANDING WATER SW OF HOG HOUSE. CORN HAS BEEN PICKED. GOING DOWN STREAM ON LAT 4, THERE IS STANDING BEANS IN WATER JUST S. OF 120TH ST., ALSO THERE IS STANDING WATER JUST N. OF 120TH @ MAIN (20") AND LAT 4 (14"). THIS IS PROBABLY THE FIRST PLACE TO INVESTIGATE. THEN WORK UPSTREAM. THERE IS A 4" PE INTAKE RISER IN S. DITCH OF 120TH ST., NOT ON LAT 4 AND IS DRY. COULD NOT SEE ANY OTHER WET AREAS ON MAIN TO LAT 1 (BIG 4)

WATER STANDING @ UPPER END OF LATH @ HOG HOUSE

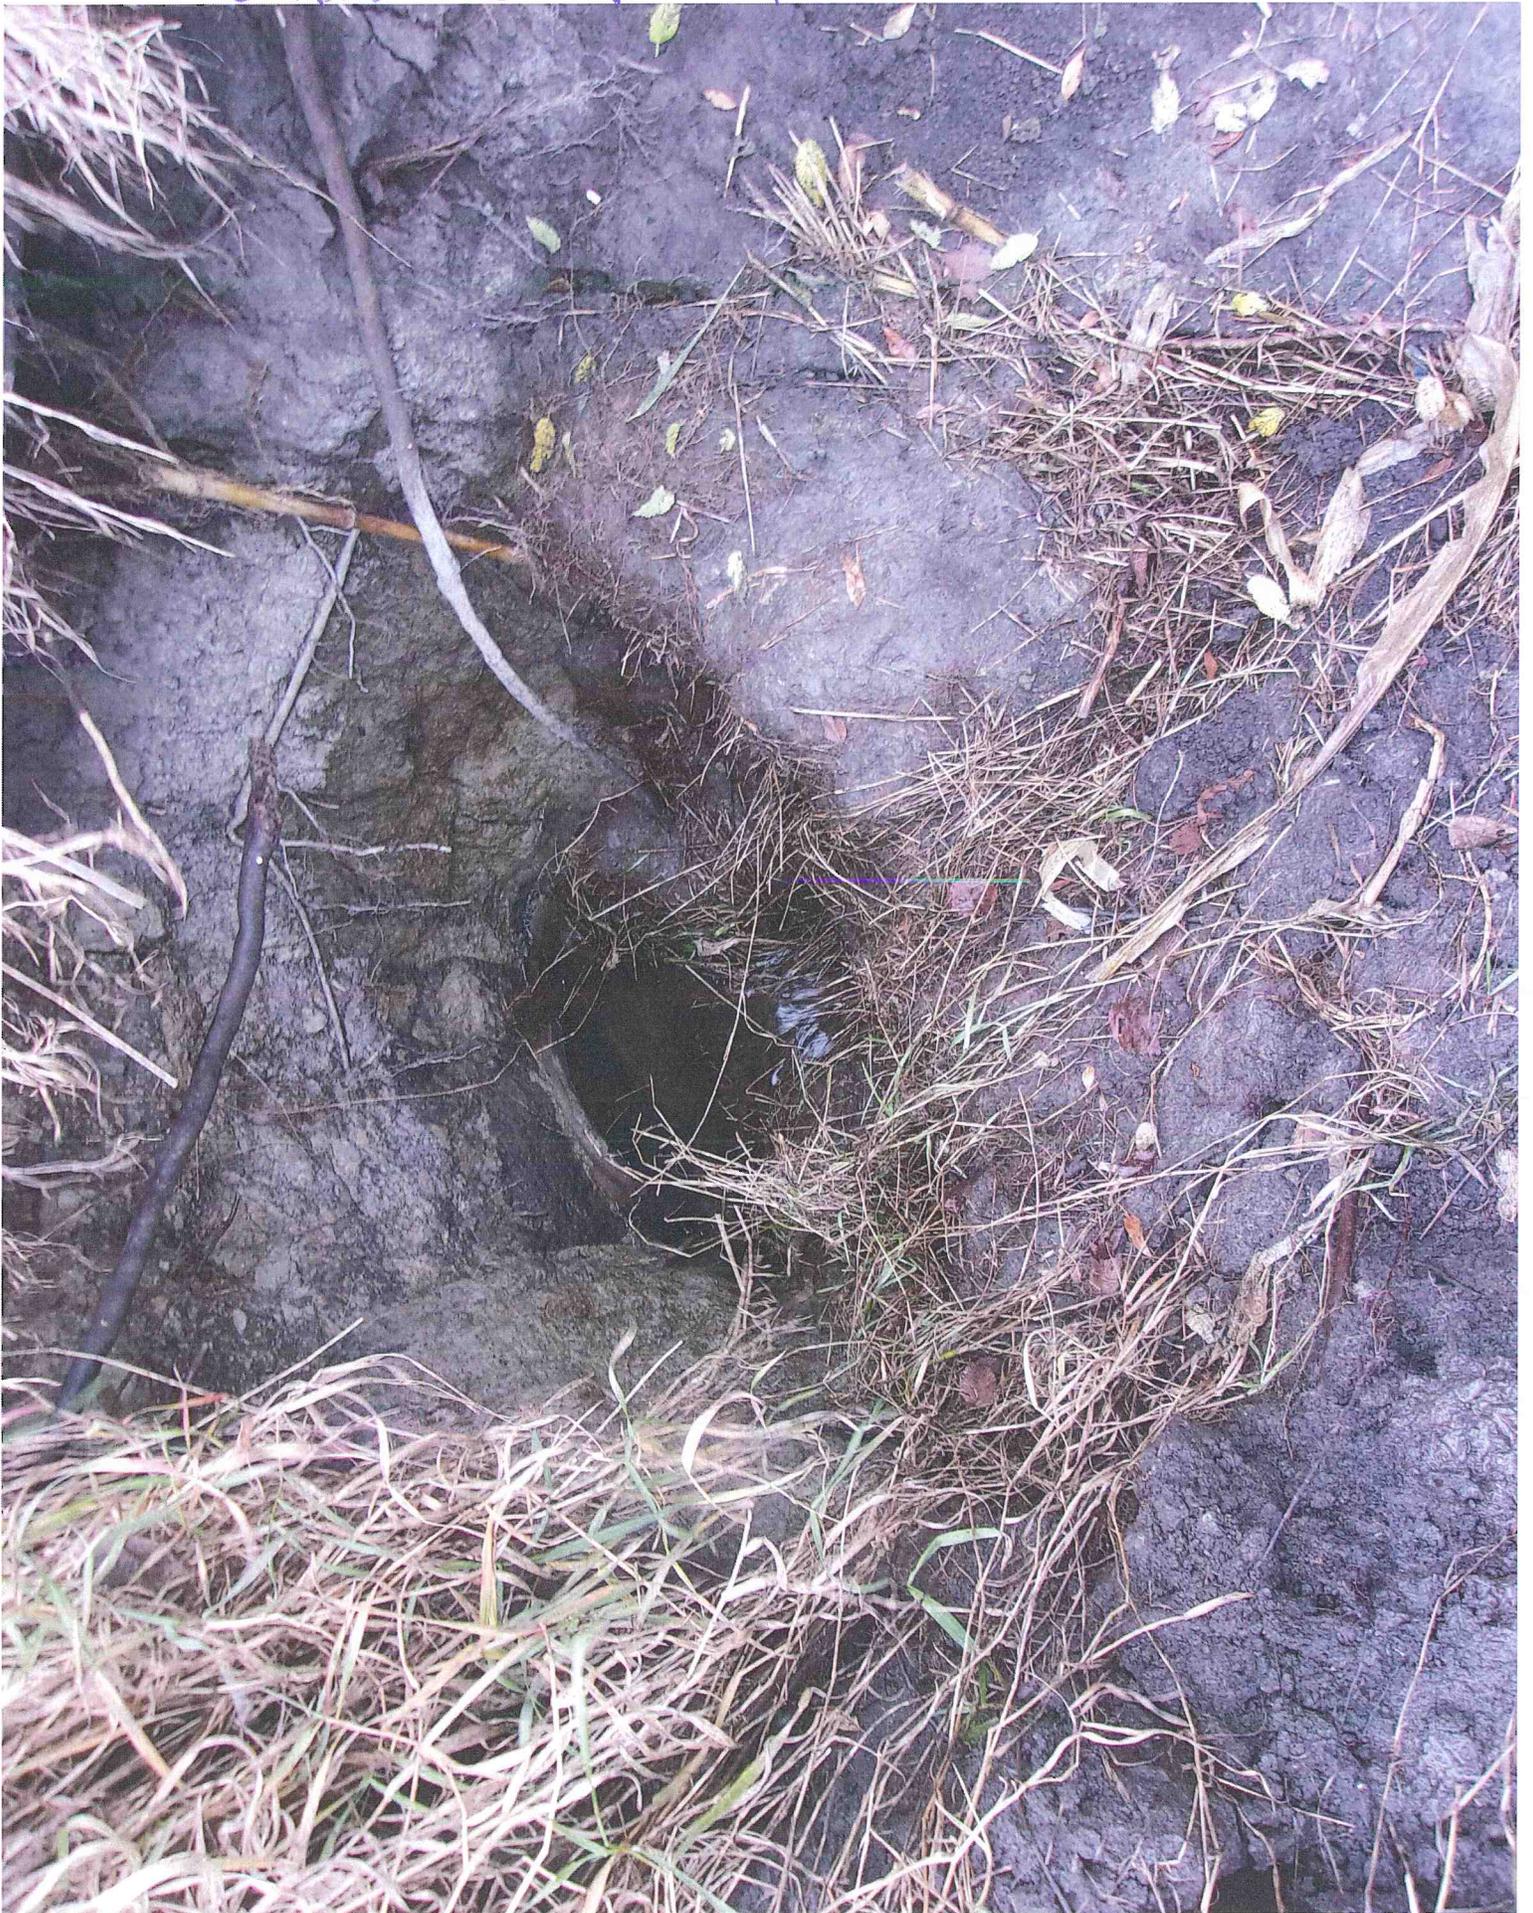
- Landowner in NE¼ Section 15 Township 86 North, Range 20 West reported an eroded outlet possibly due to beaver activity from previous year.
- Visual observation found 20 feet of 18-inch rusty CMP (presumed Main tile outlet) washed out and exposed due to erosion. Just upstream, found a collapsed section of presumed Main tile.
- Visual observation also found large area eroded to east due to overland flow of water with possible eroded surface drain. Erosion area begins near presumed Main tile path upstream of existing outlet.
- Finally, visual observation tree in vicinity of Main tile outlet.

Found 20' sec of 18" rusty comp, disconnected from tile, maybe a collapsed tile @ comp connection, all dirt is washed away from comp. Would like to see a 40' section of 24" alum. comp with riprap protection @ outlet bank. Old tile route to east has long wash-out with old comp remnants to east of working outlet.

Collapsed Tile @ Gmp Hookup Site

- Remove tree and either treat stump or remove stump to prevent regrowth.
- Remove existing rusty CMP Main tile outlet and excavate Main tile upstream far enough to install new 40-foot long CMP Main tile outlet with rodent guard.
- Install said new outlet and armor bank around the same with revetment stone.
- Total estimated construction cost will be between \$10,000-\$15,000 depending on amount of Main tile that needs to be replaced at collapsed section of Main tile.
- If desired the eroded area to the east could be repaired, but it is unclear at this point if this is the responsibility of the Drainage District or not and what regulatory permitting there would be.
