**AGENDA**  
**REGULAR DRAINAGE MEETING**

# REGULAR DRAINAGE MEETING

## Drainage District:

## Repair Summary:

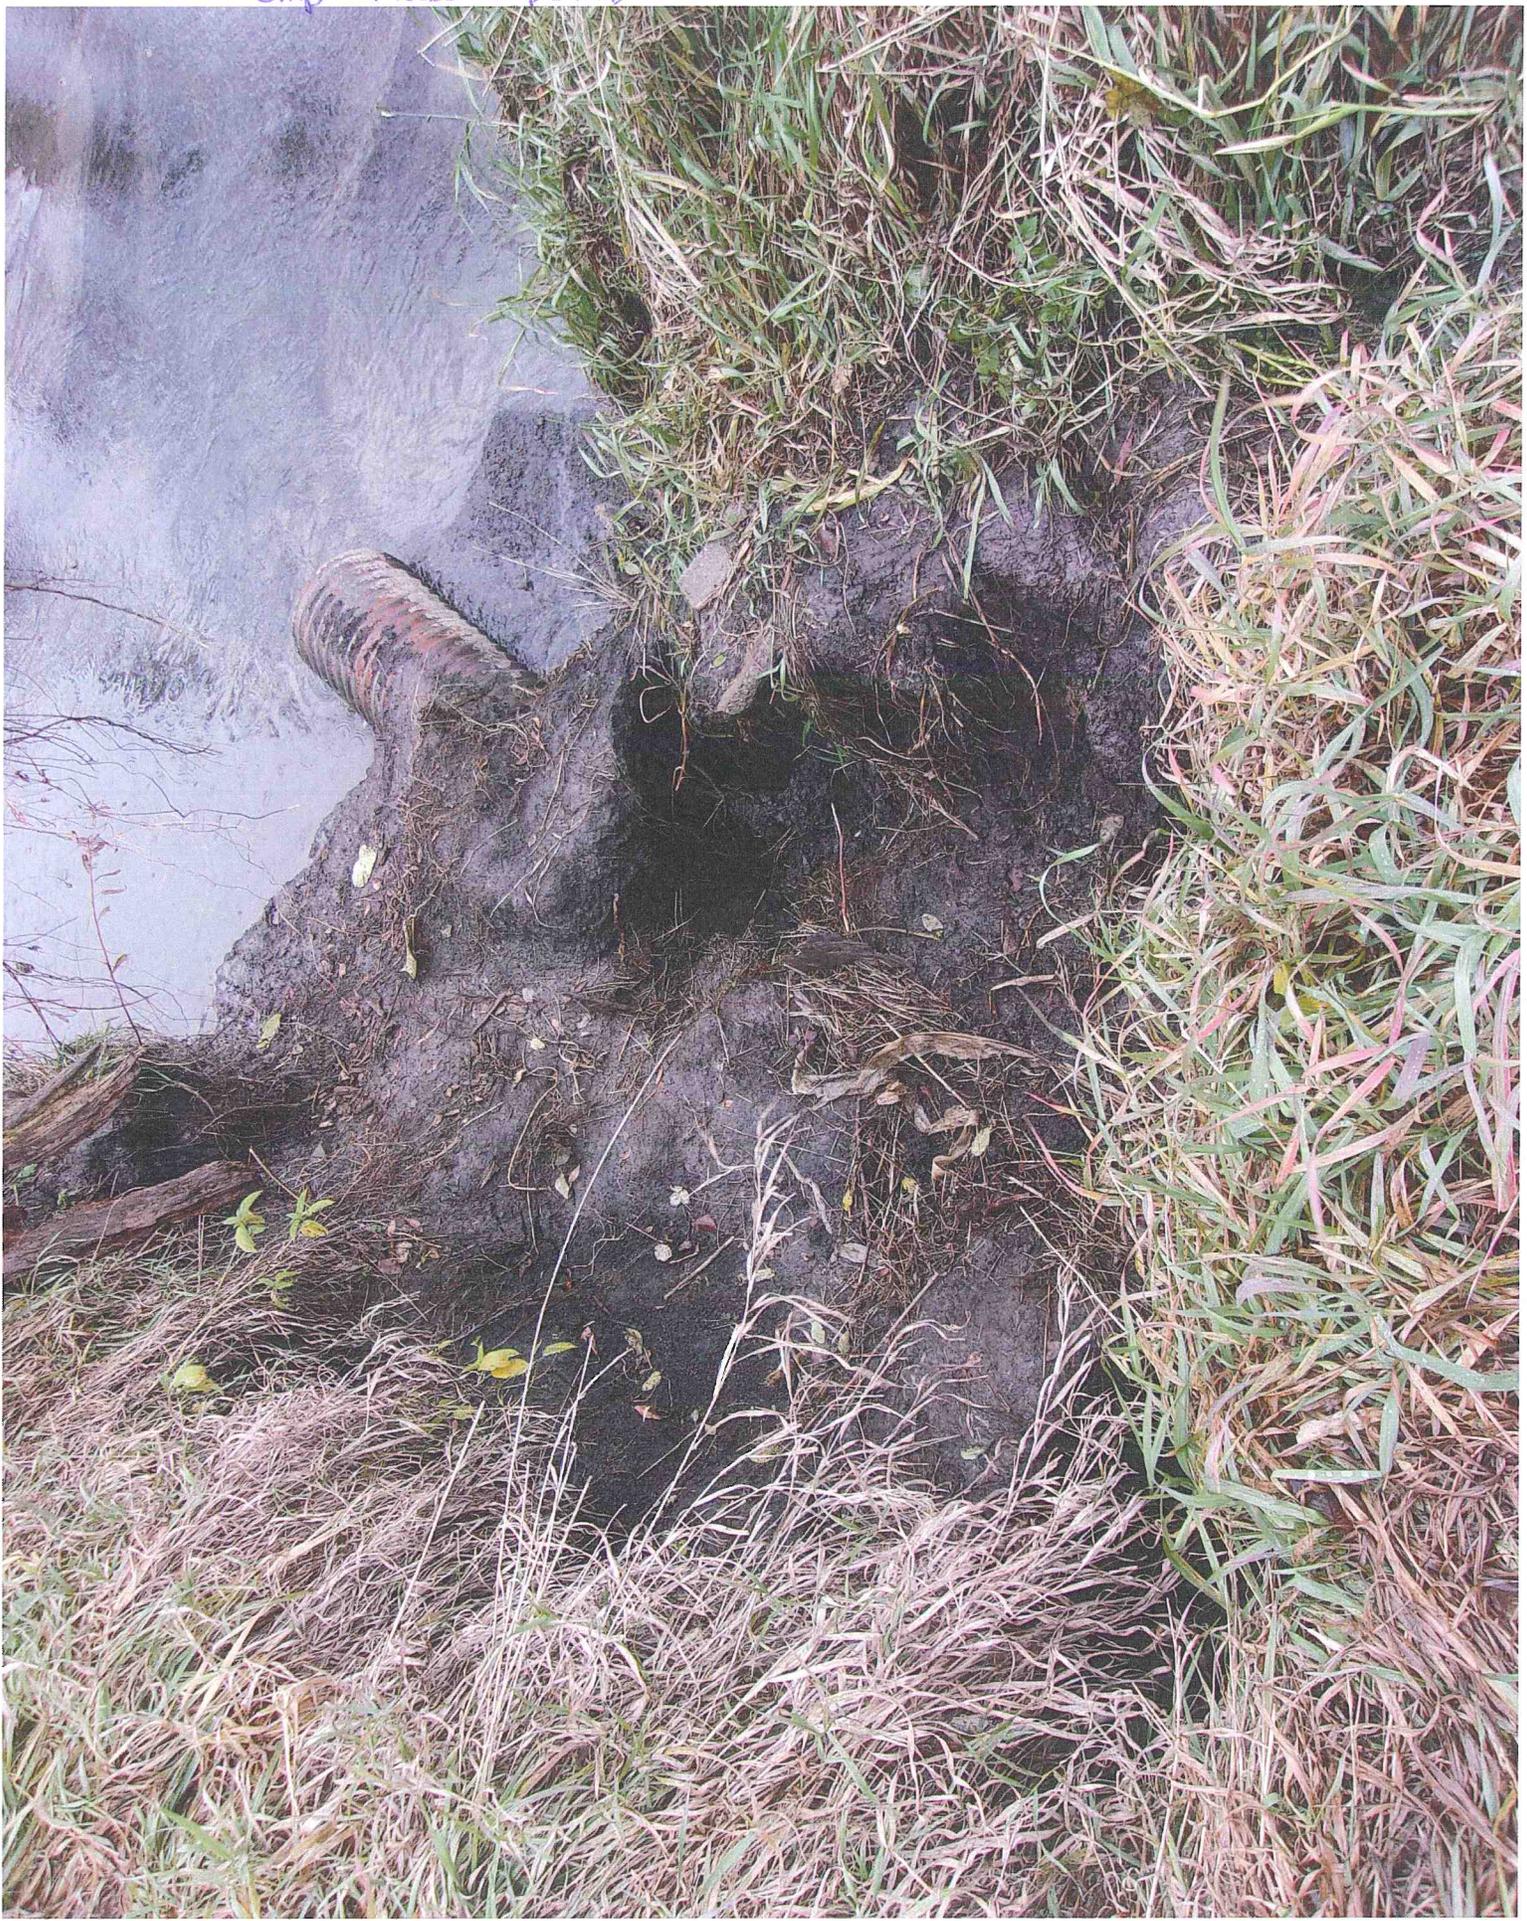
Cmp NEEDS REPLACED

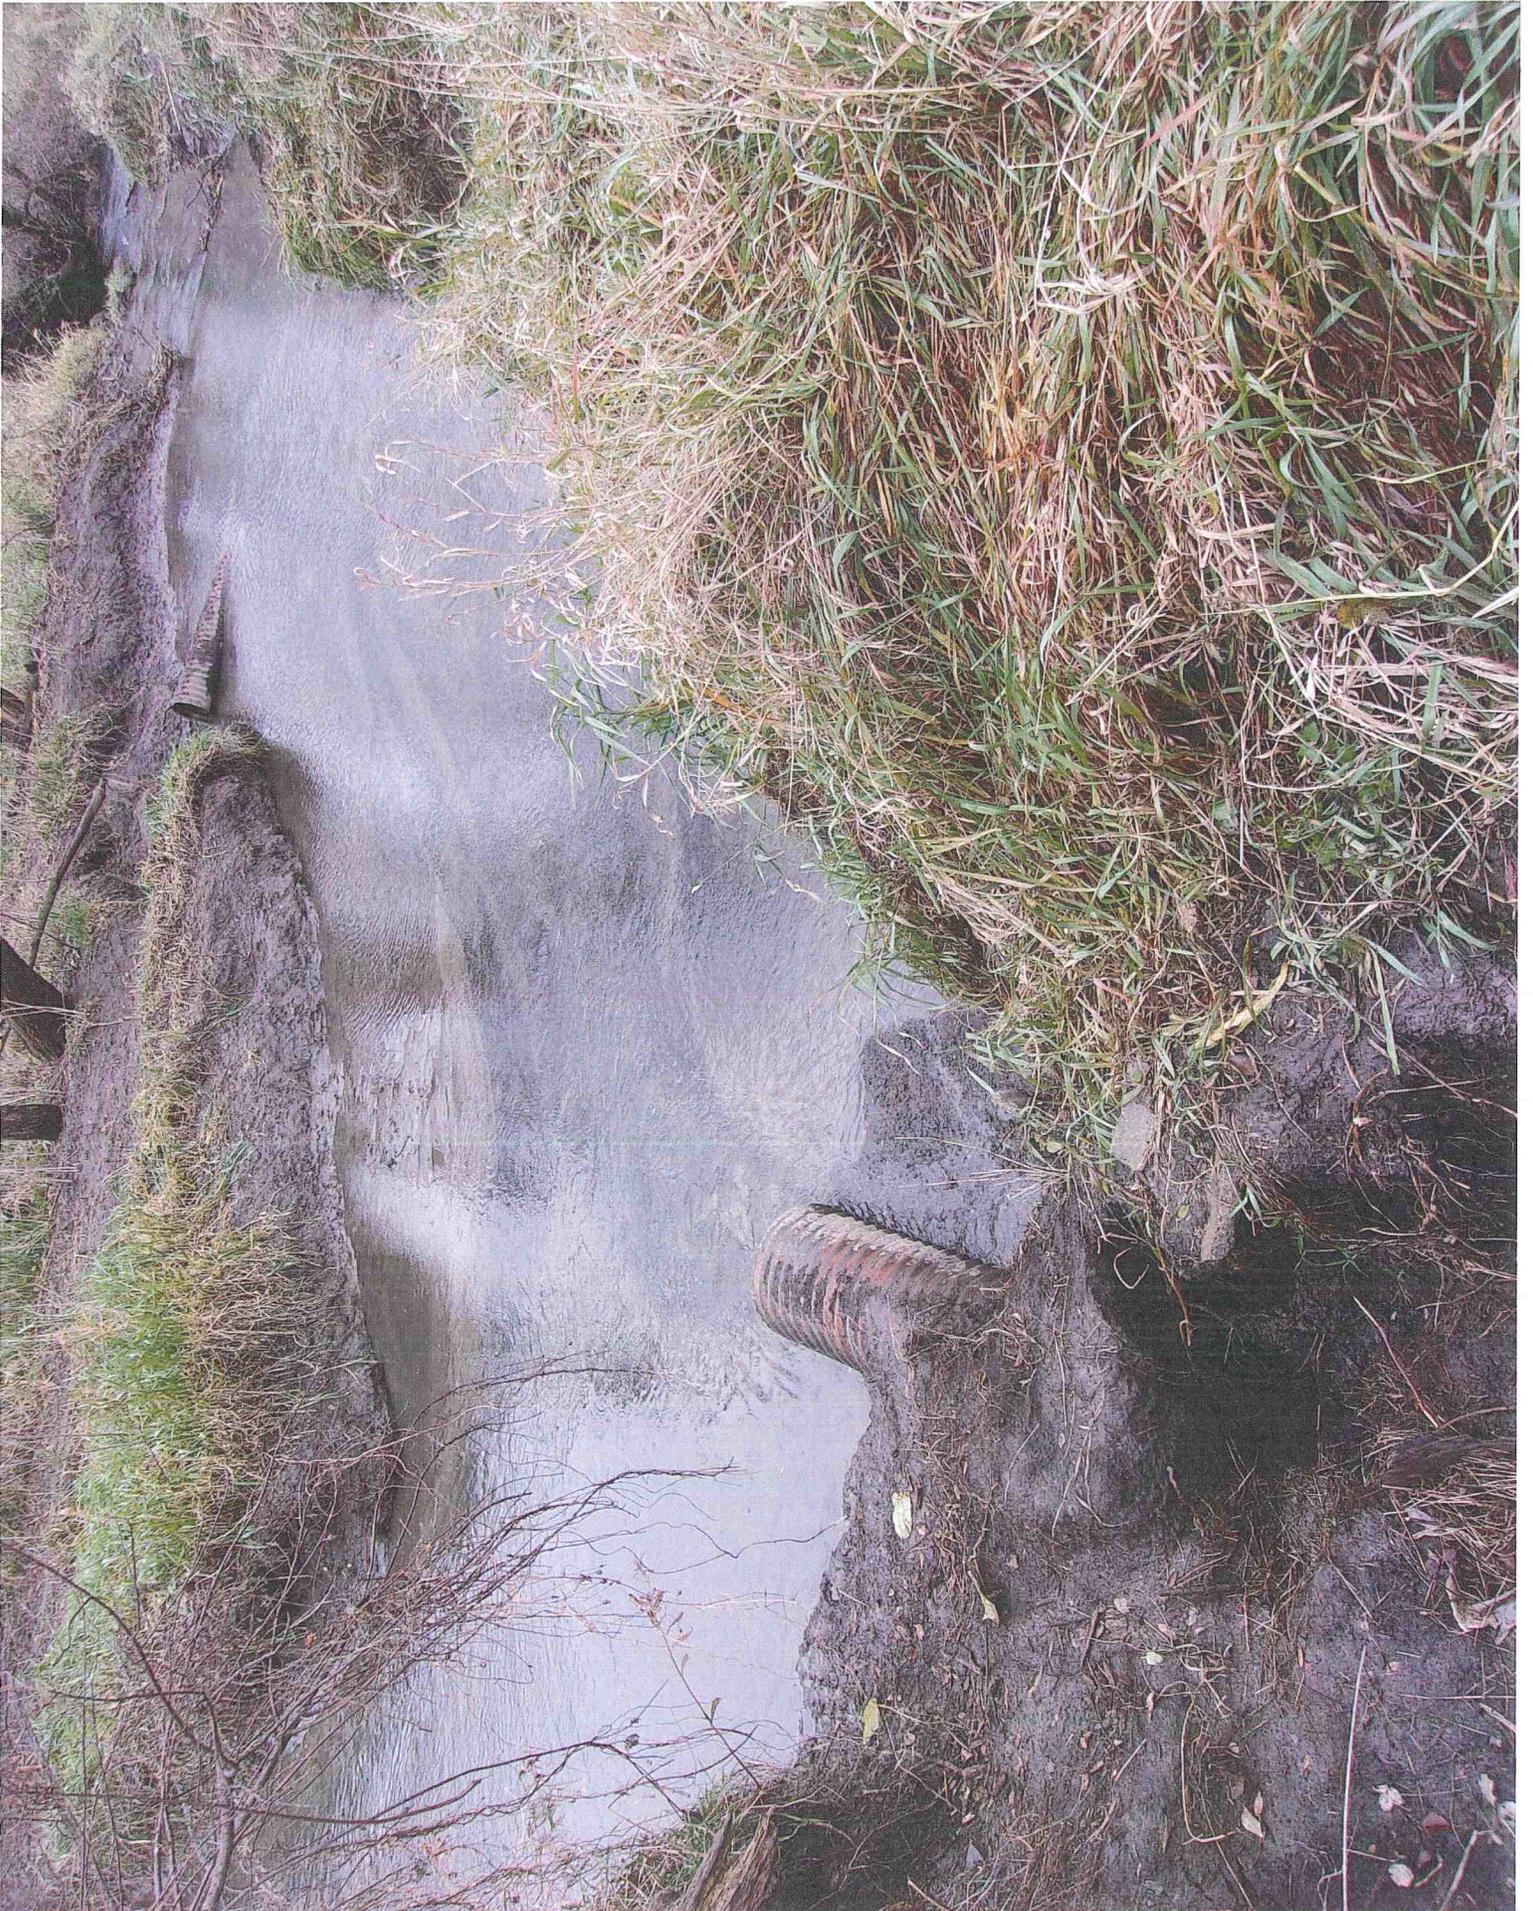
CURVE IN CREEK NEEDS ARMOUR

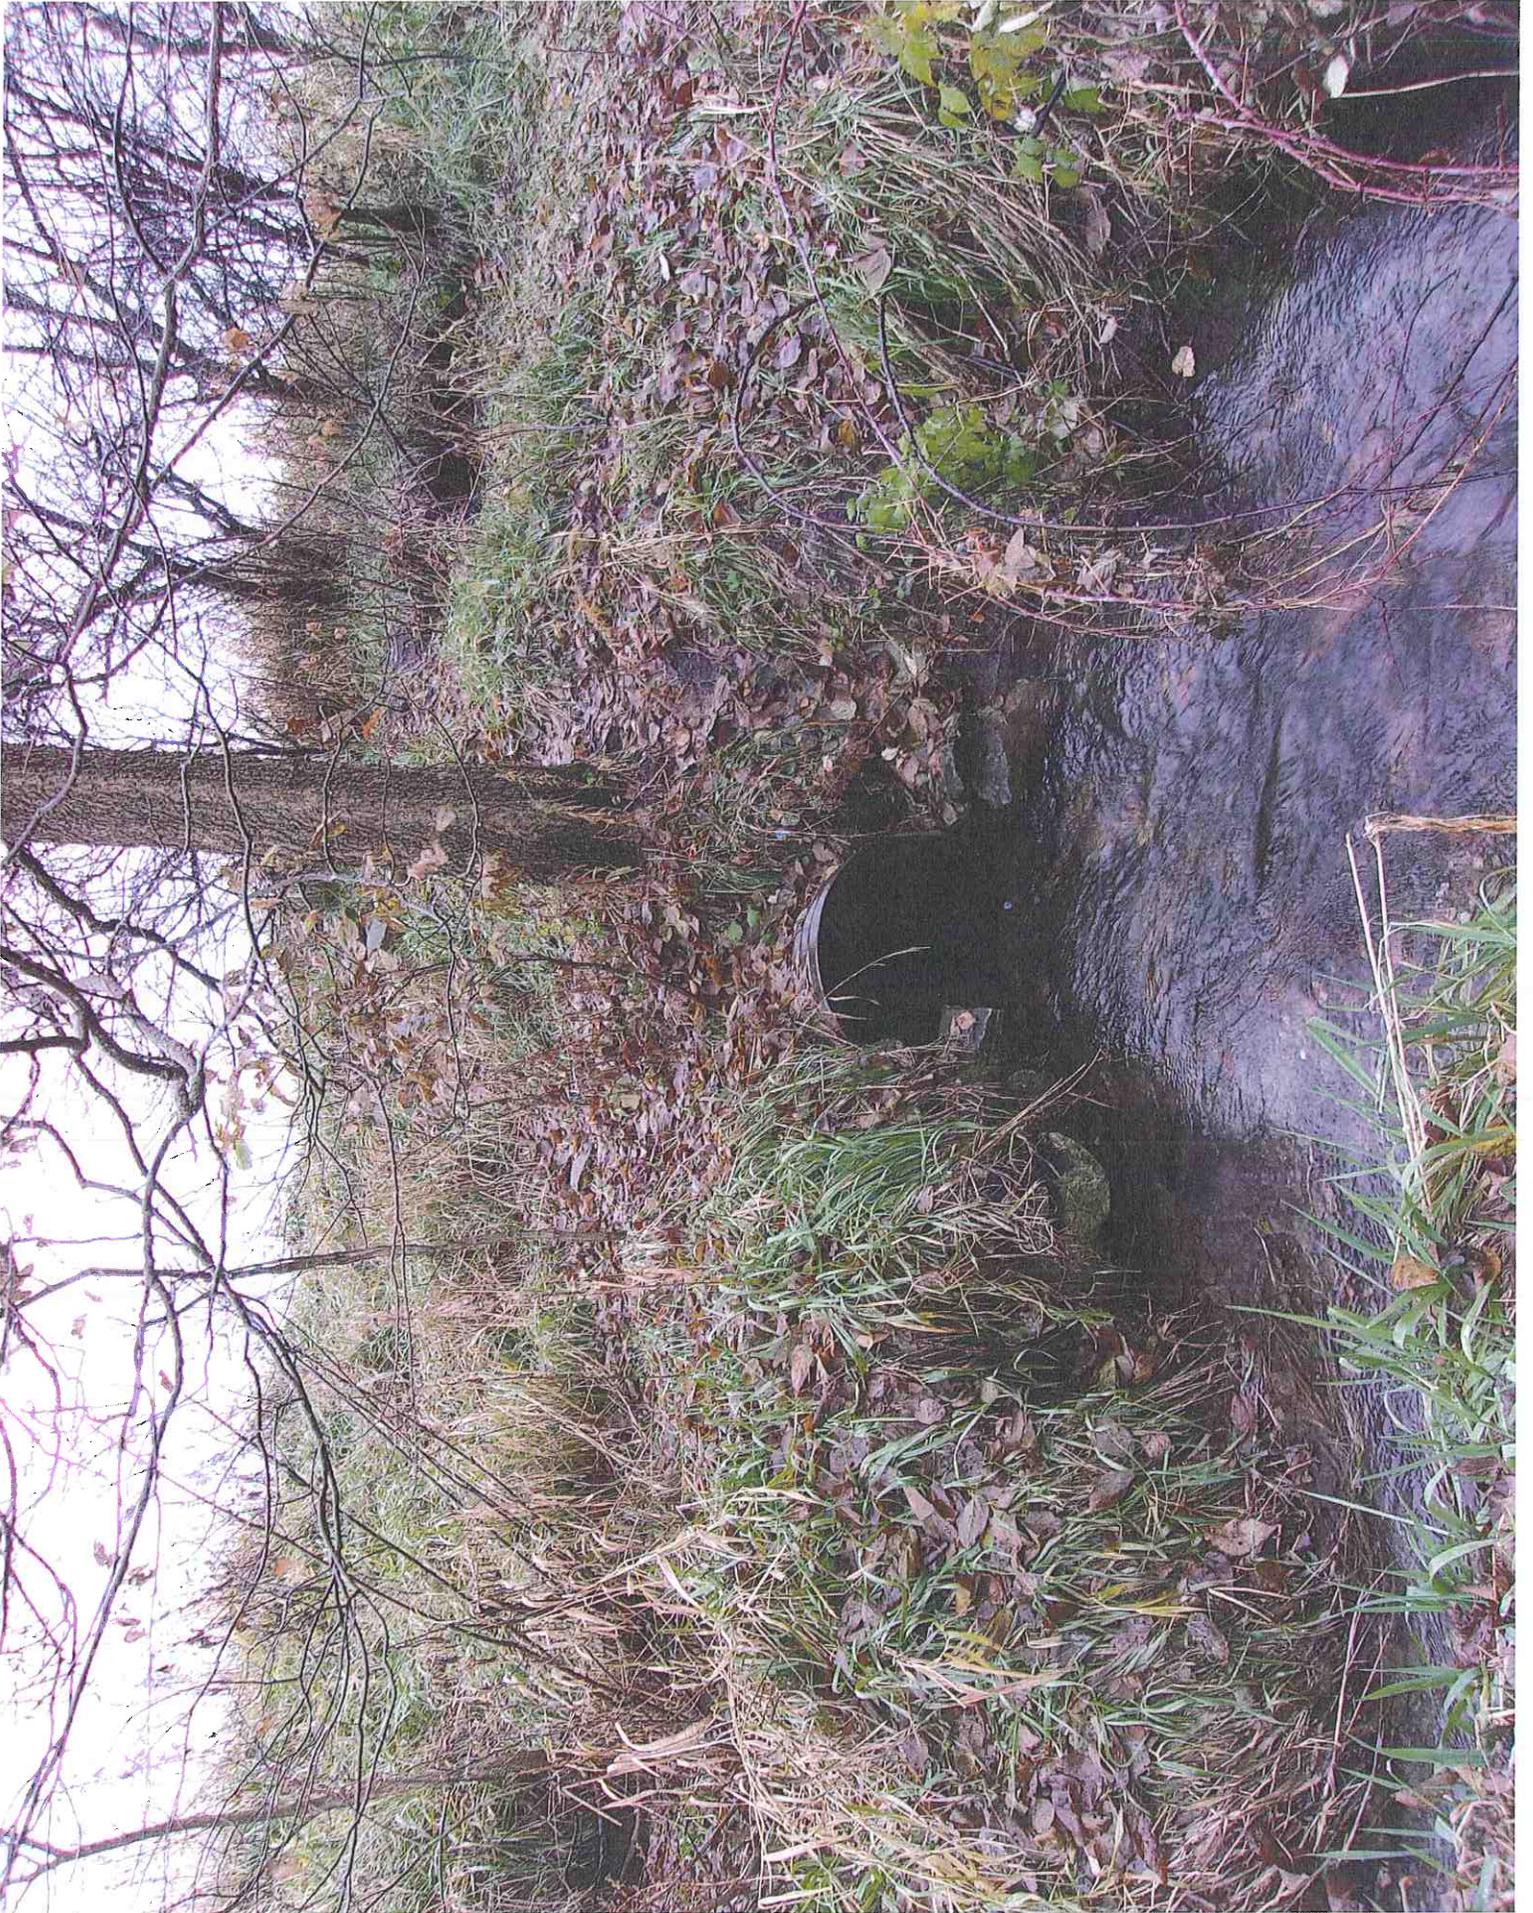
- Landowner reported a 3 feet deep depression between the fence and creek east of S Avenue in the SW¼ of Section 5 Township 89 North, Range 19 West.
- Visual observation found rusty 15-inch CMP (presumed Main tile) outlet with tree and brush in the immediate vicinity of said outlet.
- Visual observation also found blowout/sinkhole upstream (on presumed Main tile route) in fenceline. Tile is not visible since blowout/sinkhole is filled with approximately 15 tons of field stone.
- Finally, visual observation found that there are unharvested beans upstream in standing water on presumed route of Lateral 1 tile.

drove to E-W Fence Ln, E. of S. Ave @ 00165 outlet, found 15" cmp  
rusty with Hackberry 6" tree on top. Plum brush also in area  
40' S. (upstream) from outlet, tire must be collapsed and farmers have  
put 15 tons of field stone in hole. farther upline to SW, I think lat 1,  
beans are standing in water. many have collapsed tire on lat 1,

DD165 OUTLET Cmp

- Remove tree and brush and either treat stumps or remove stumps to prevent regrowth.
- Remove existing rusty CMP Main tile outlet and excavate Main tile upstream far enough to install new 40-foot long CMP Main tile outlet with rodent guard.
- Install said new outlet.
- Remove field stone from blowout/sinkhole and reuse the same to armor bank around the new outlet.
- Supplement said field stone with revetment stone as needed.
- Replace Main tile as needed in sinkhole/blowout.
- Total estimated construction cost will be between \$10,000-\$20,000 depending on amount of Main tile that needs to be replaced at sinkhole/blowout.
- If desired, additional investigation into the standing water on Lateral 1 could be ordered.

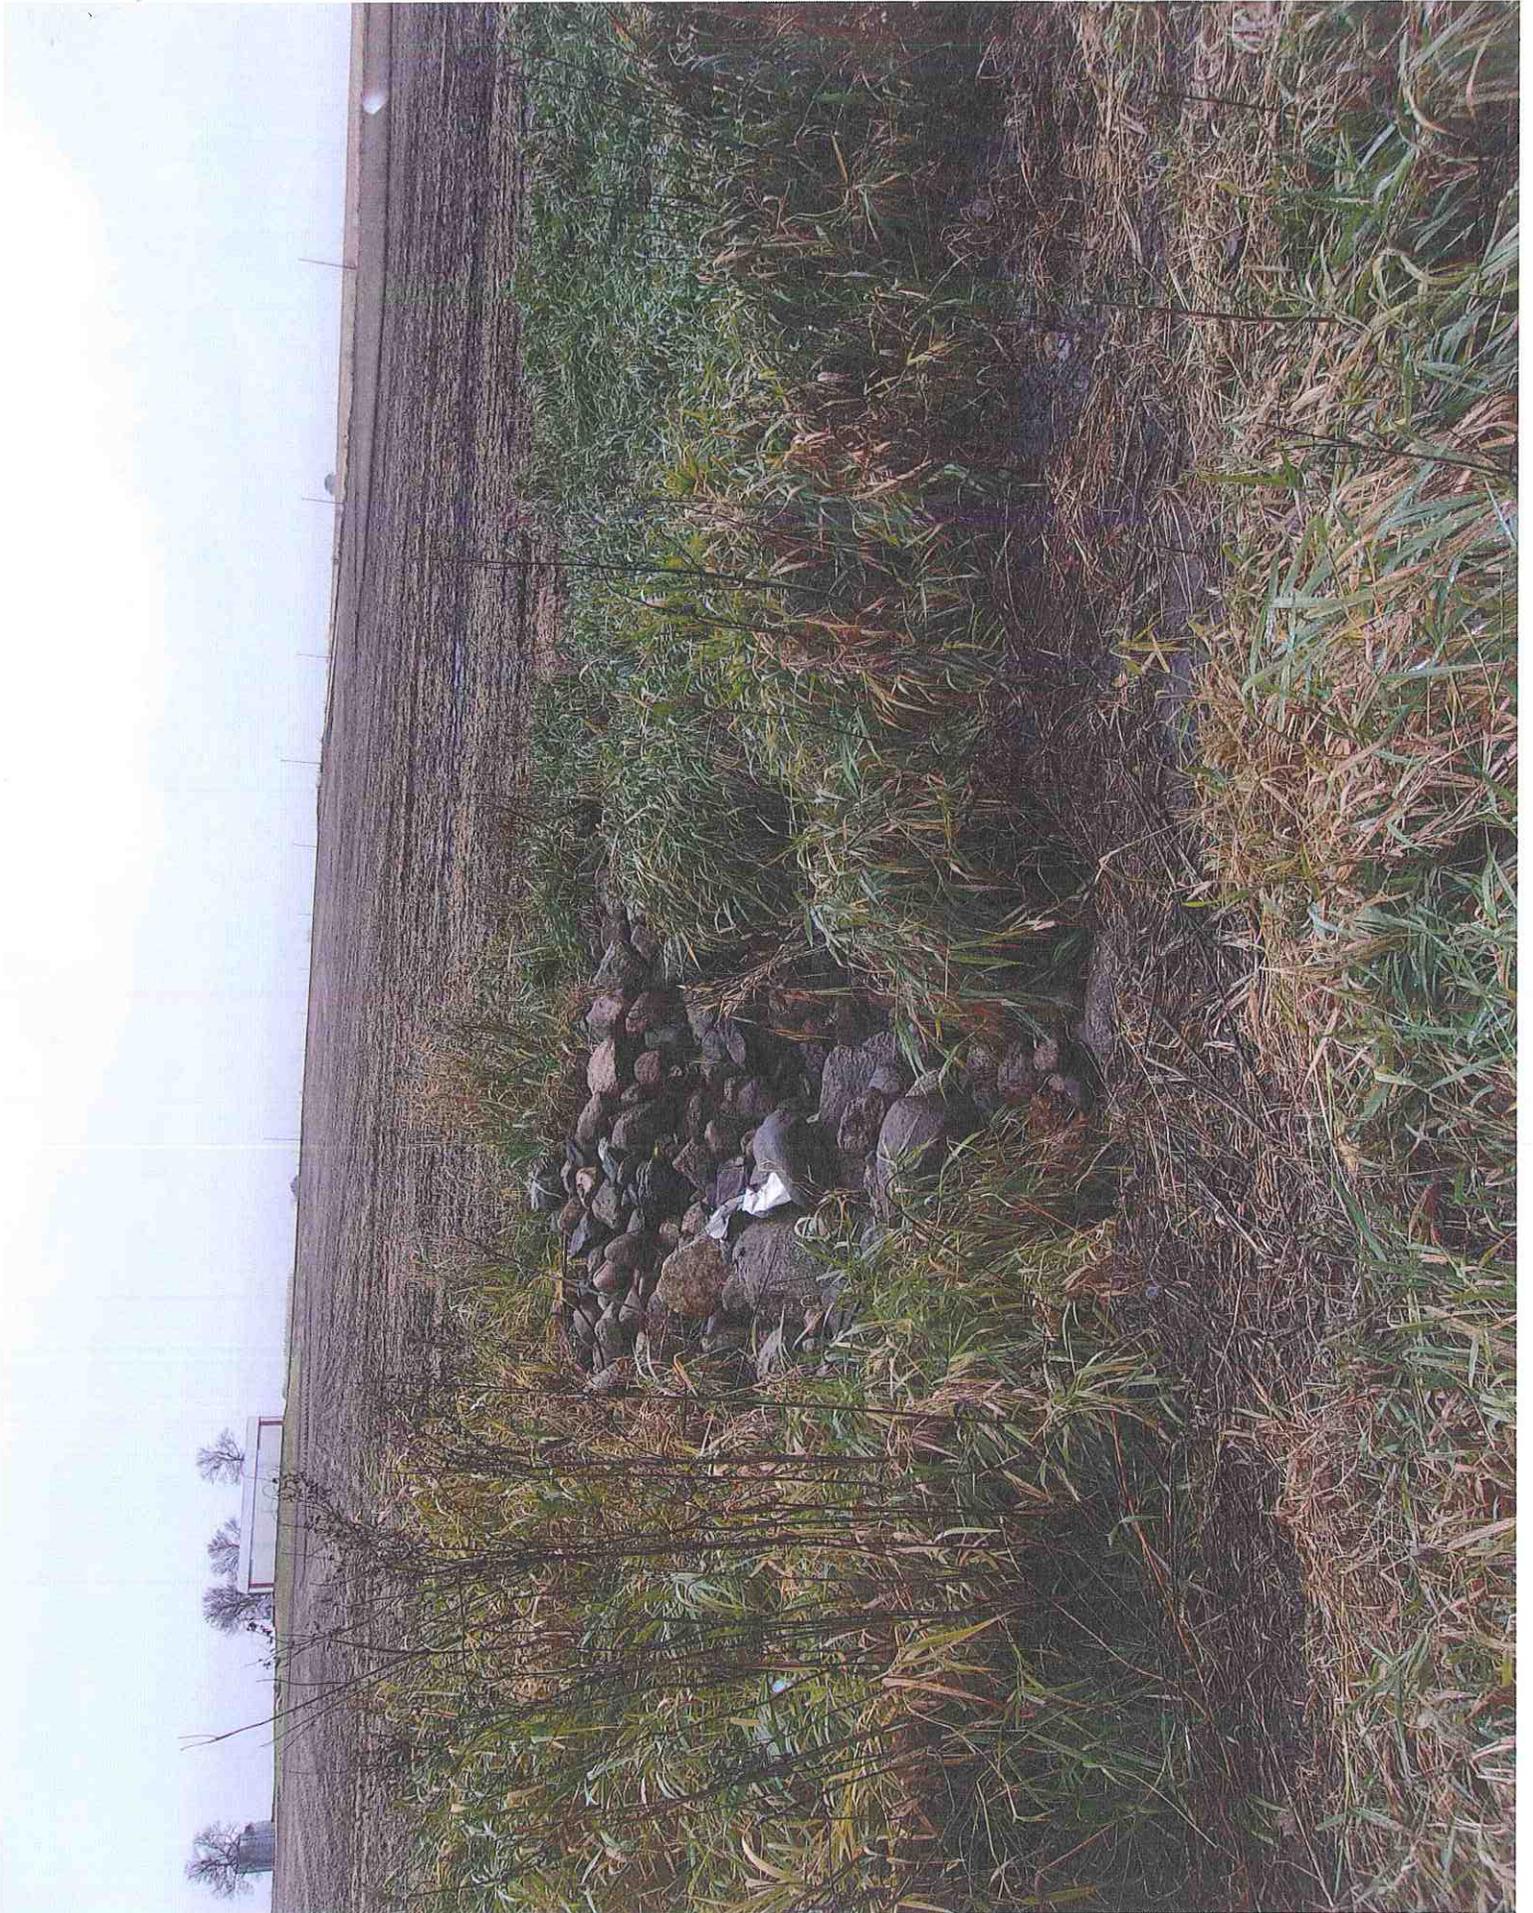
Looking South @ Main Route

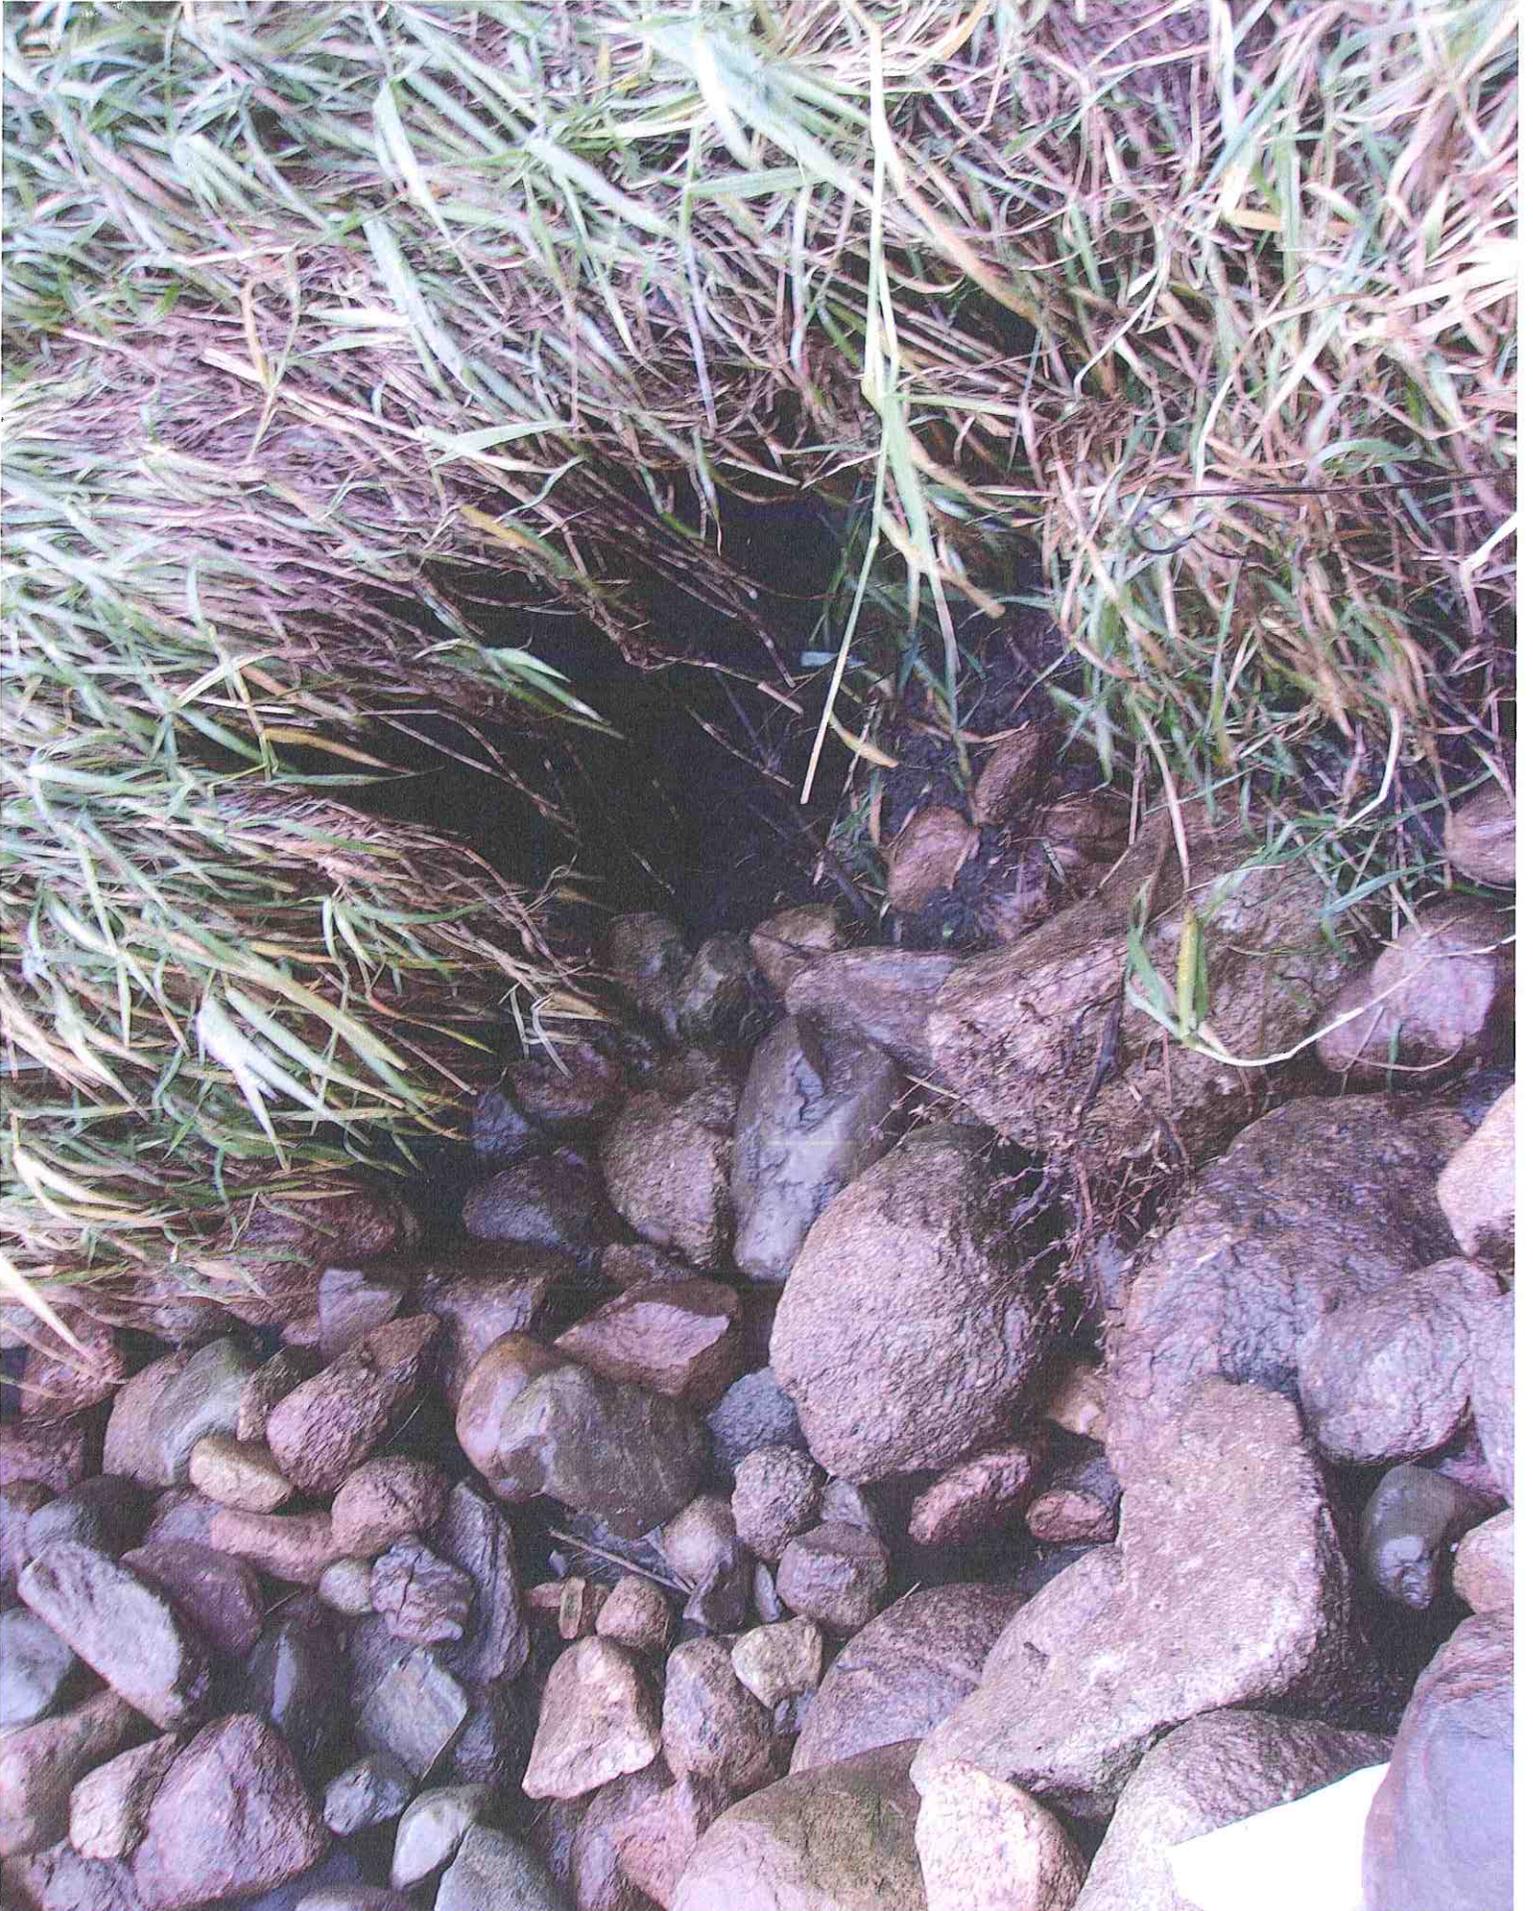
WATER BOUNCES UP IN SHIK HOLE
