**ENGINEER'S REPORT
ON
REPAIRS TO
MAIN OPEN DITCH
DRAINAGE DISTRICT
NO. 148
HARDIN COUNTY,
IOWA**

Engineer's Report on Repairs to Main Open Ditch, Drainage District 148, Hardin County, Iowa

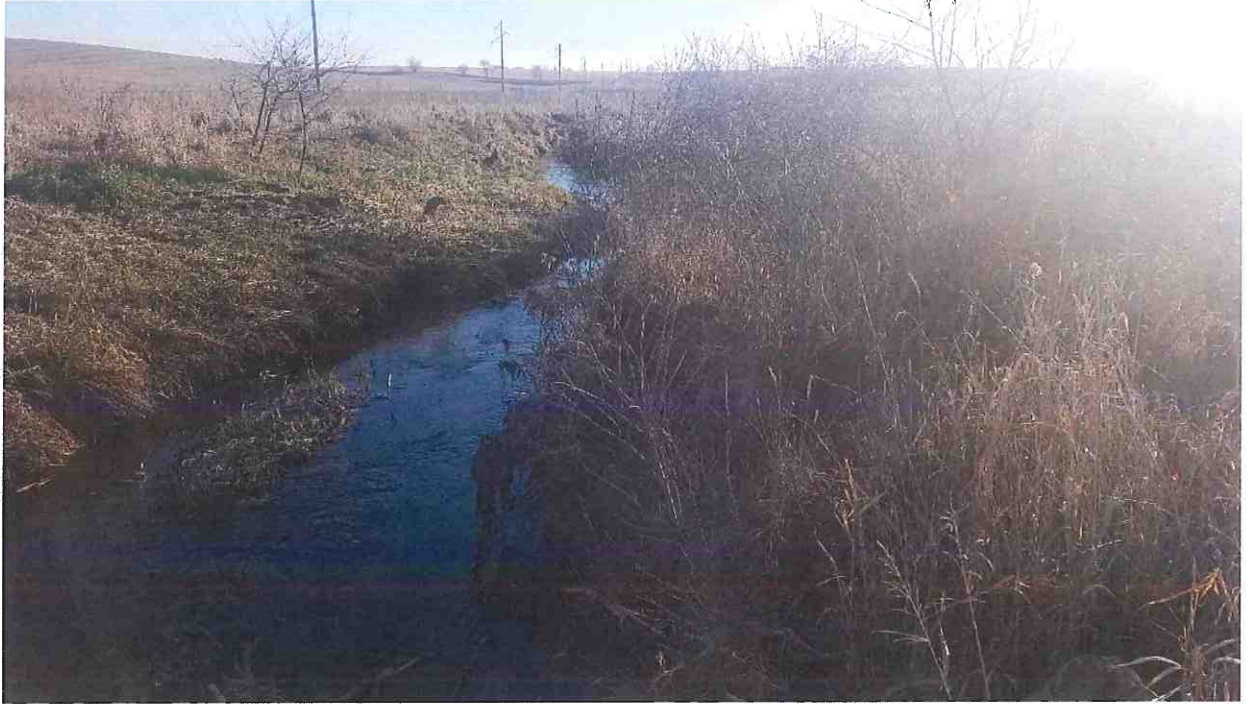
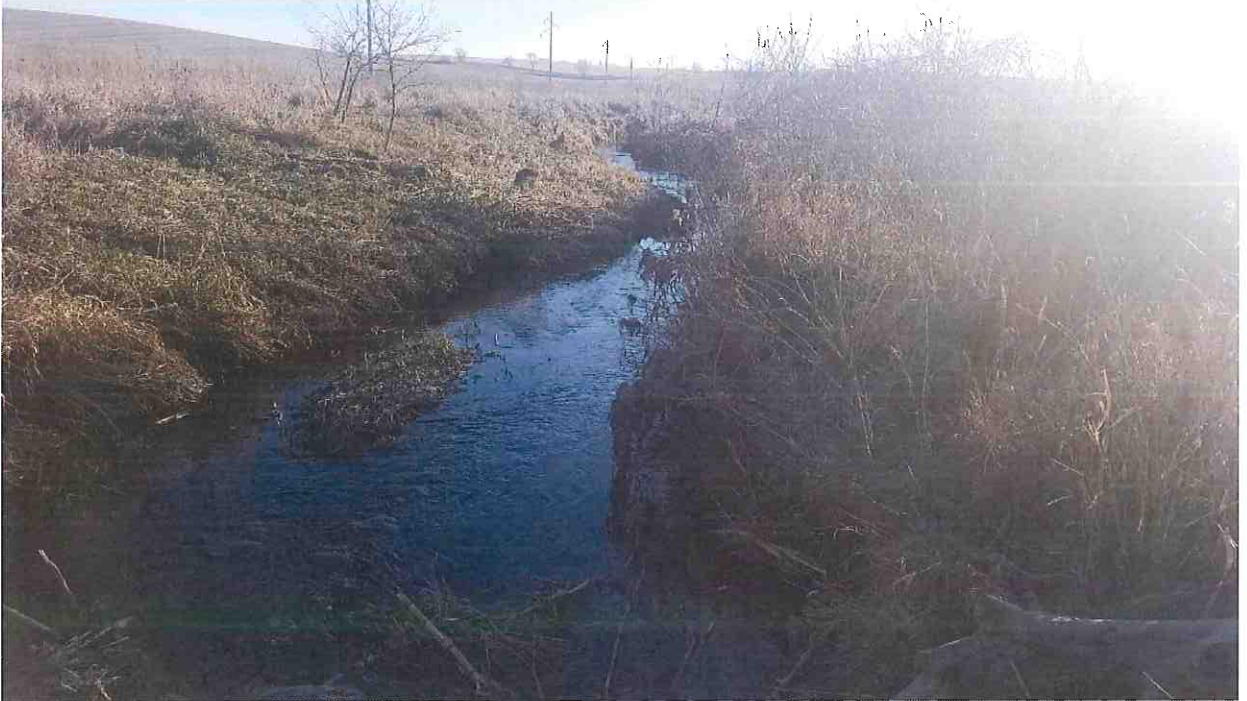
Sedimentation, woody vegetation, and meandering of Open Ditch at Sta. 4+00 +/- looking downstream (both pictures).

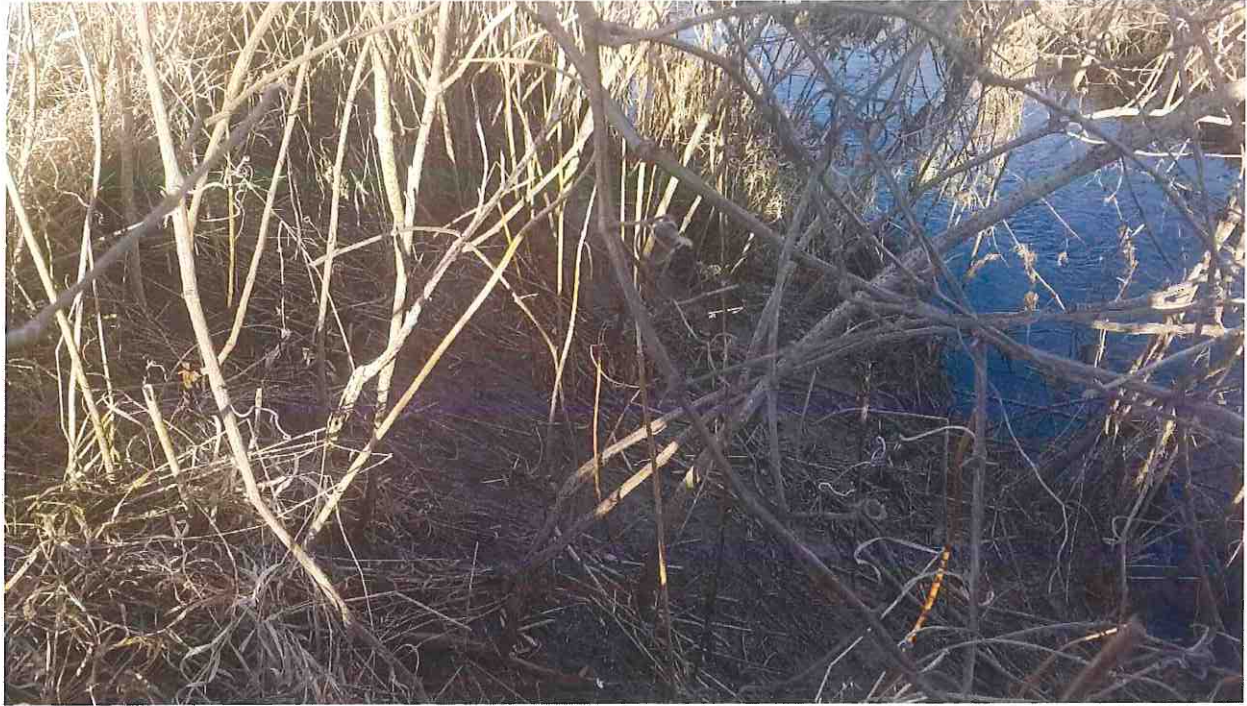
Woody vegetation and erosion near Sta. 4+00 +/-.

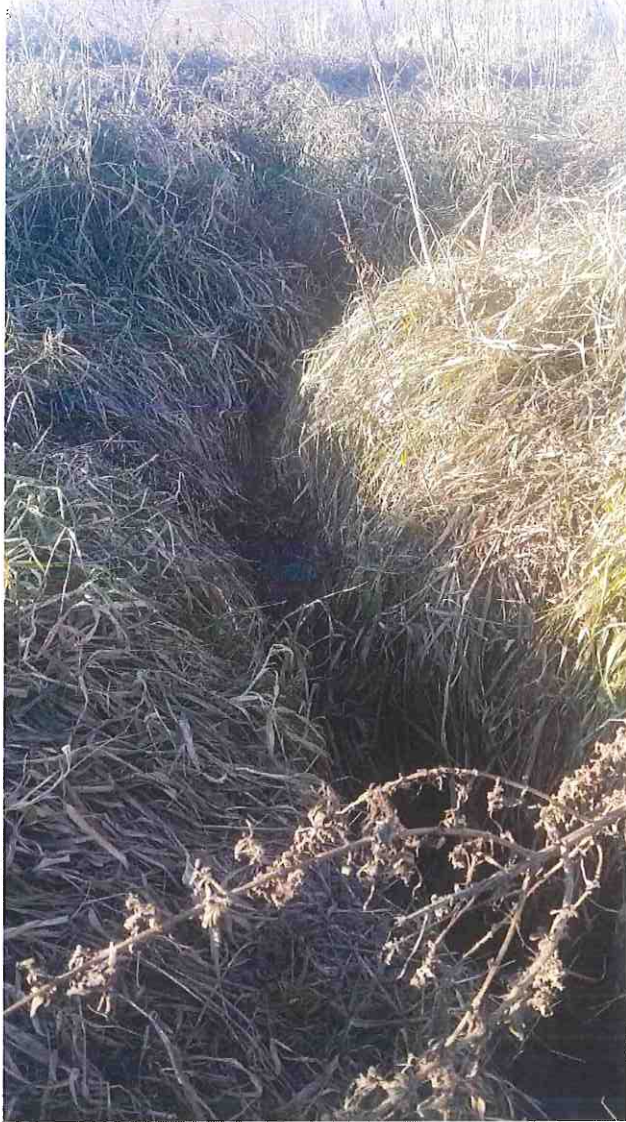
←Lack of proper outlet to Main Open Ditch.
Water eroding ditch.

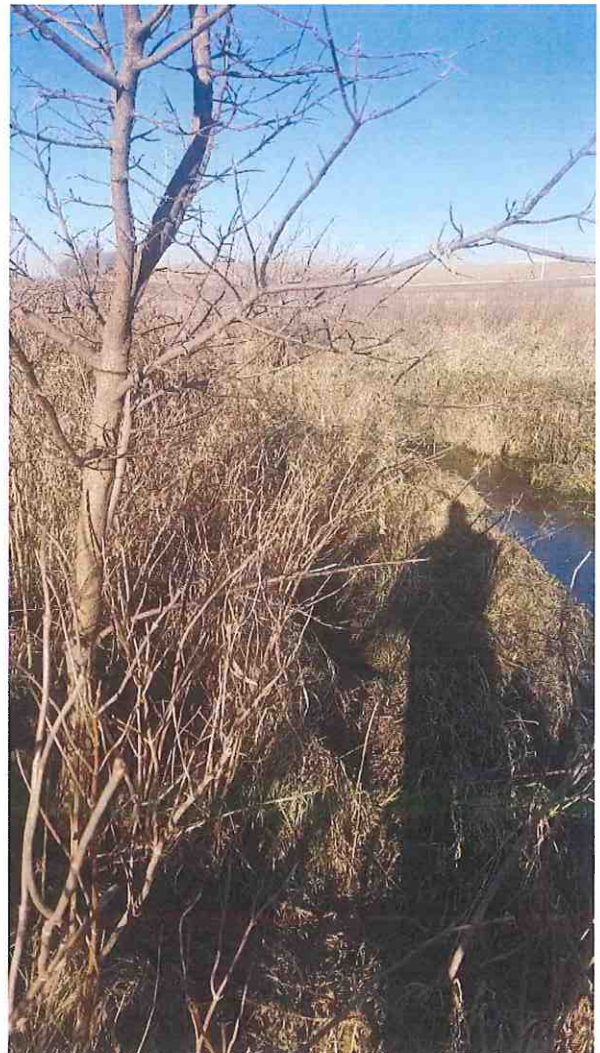
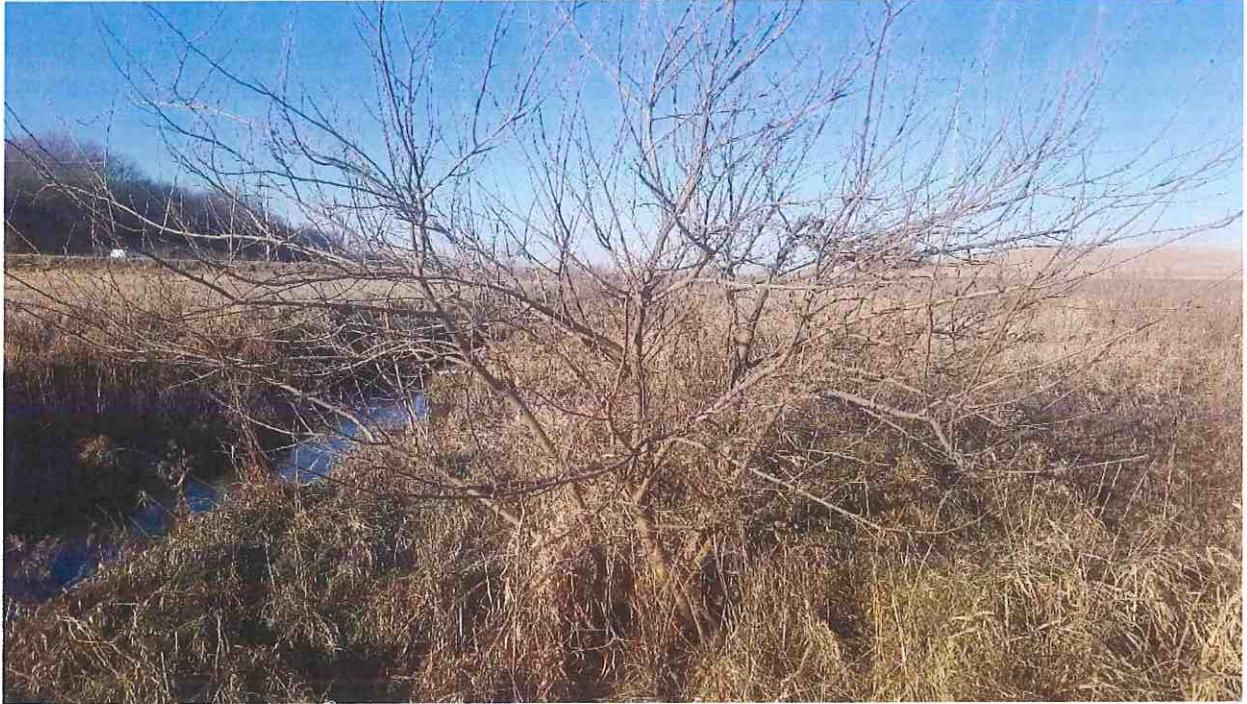
Woody vegetation near Sta. 2+00 +/- →

Woody vegetation near Sta. 2+00 +/-.

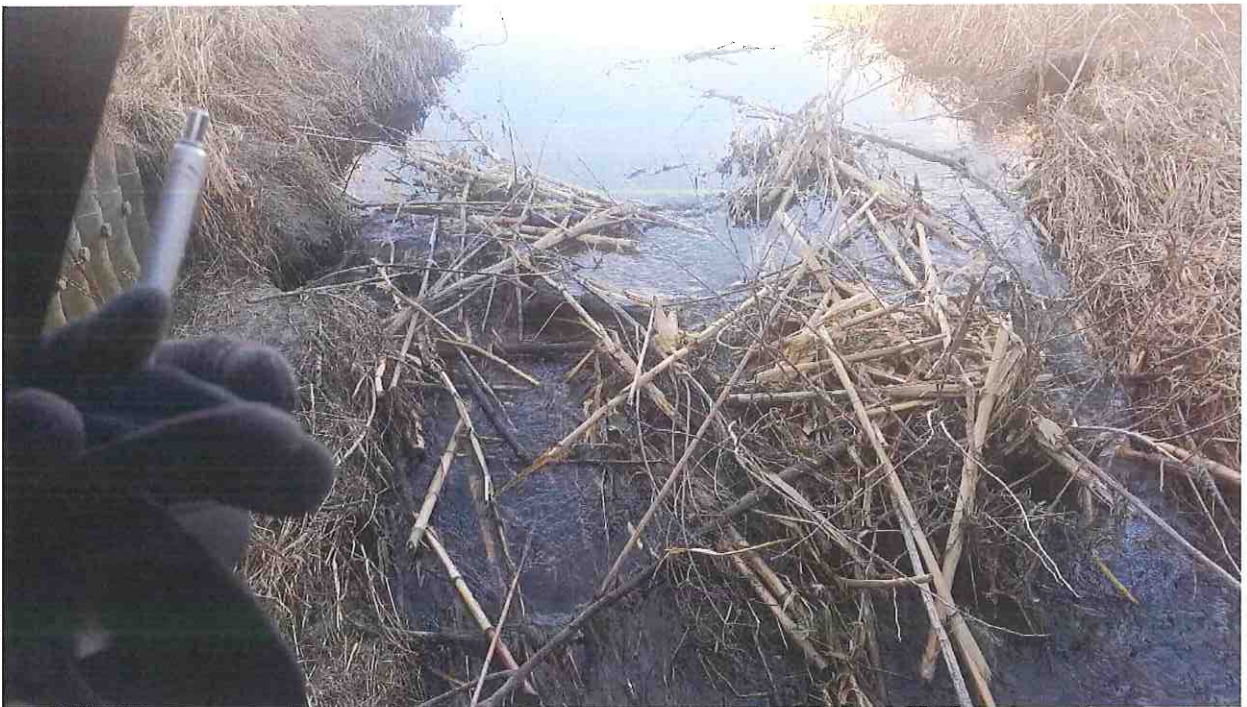
Beaver dam looking west from Sta. 4+00 +/-.

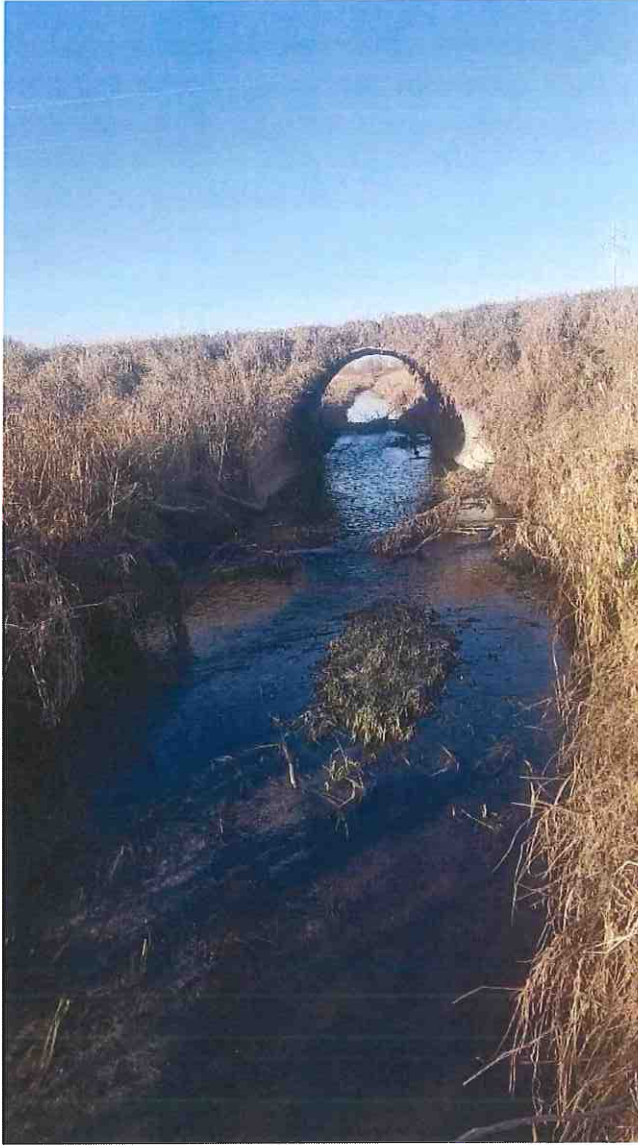
← Silt bar near Sta. 4+00 +/-

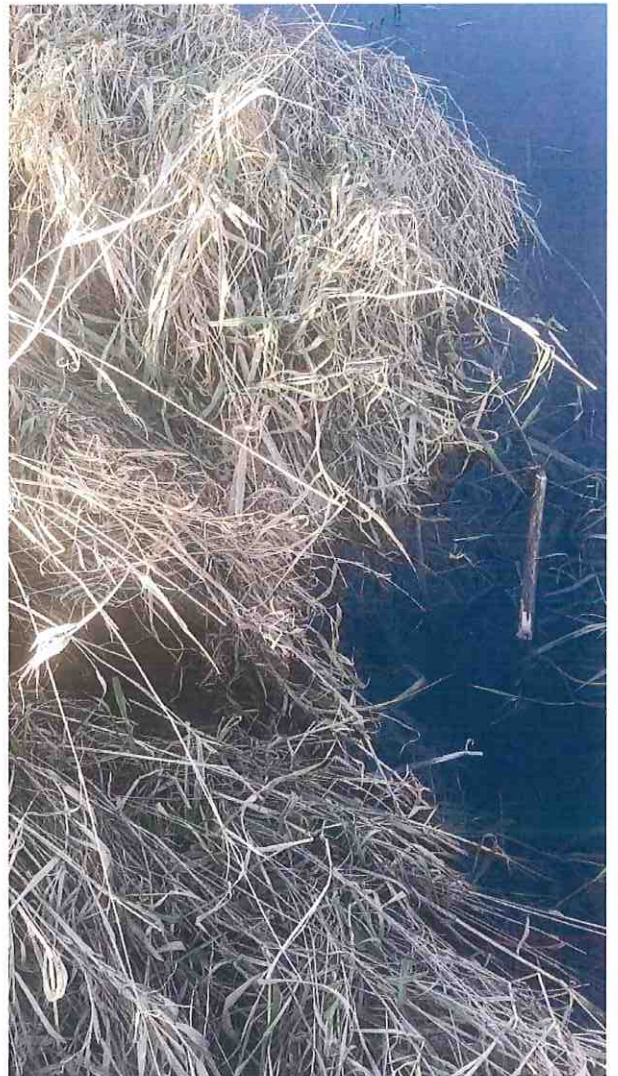
Signs of beaver activity. →

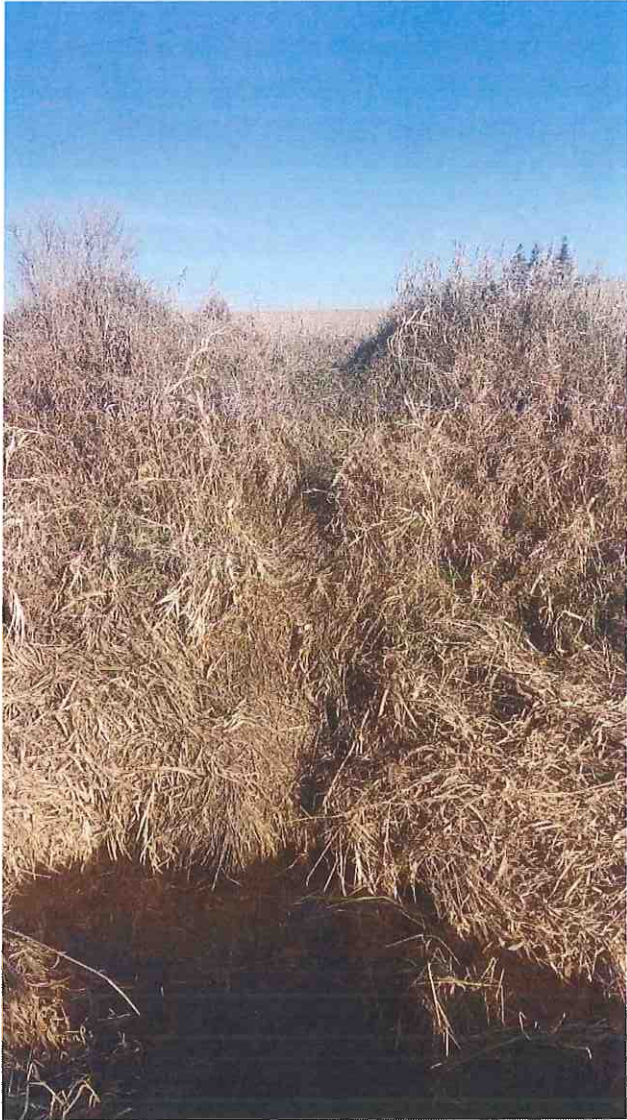
← Beaver path for dragging dam material.

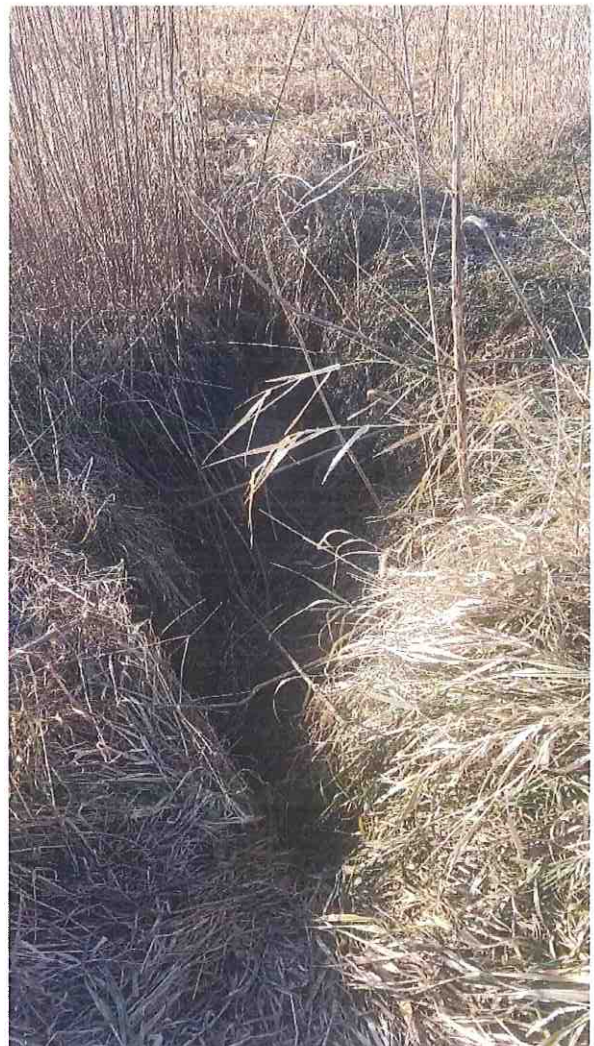
Heavy erosion on the south ditch bank. →

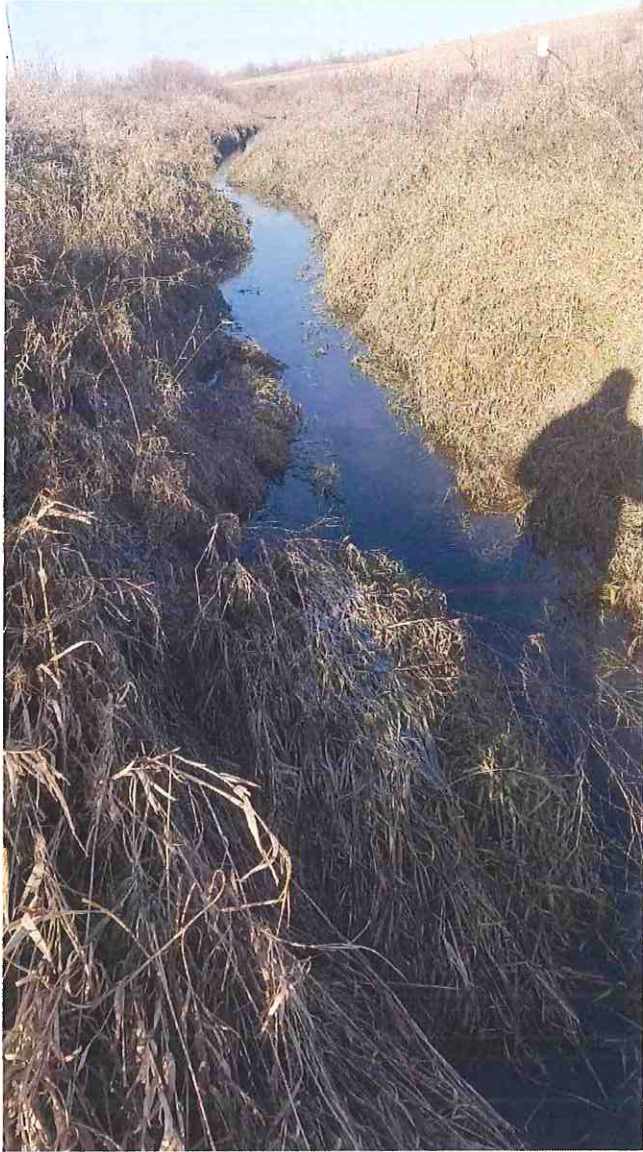
←Bank sloughing off into flowline and slight meandering of Open Ditch near Sta. 15+00 +/-.

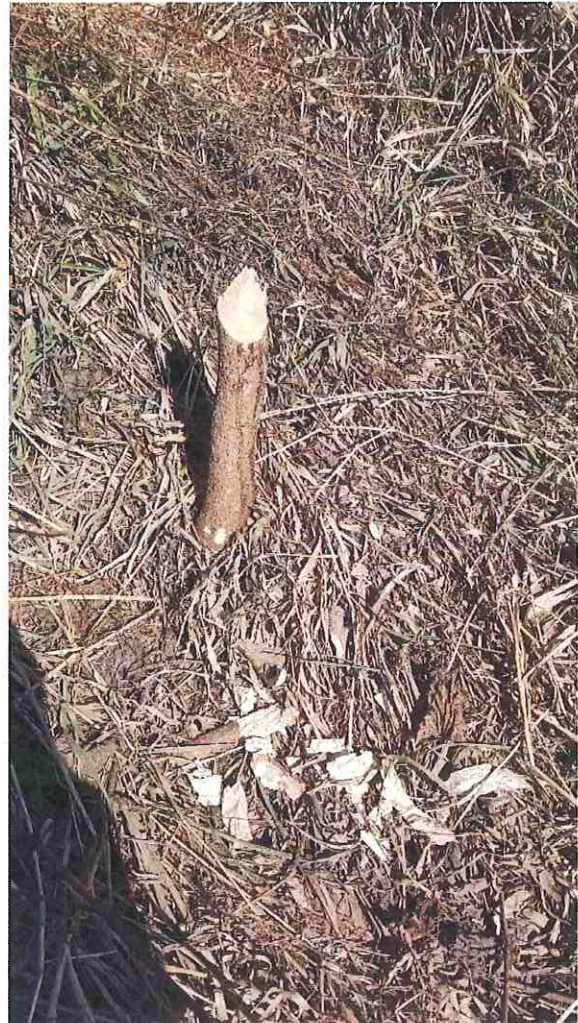
Signs of recent beaver activity. Beaver seen darting below water surface. →

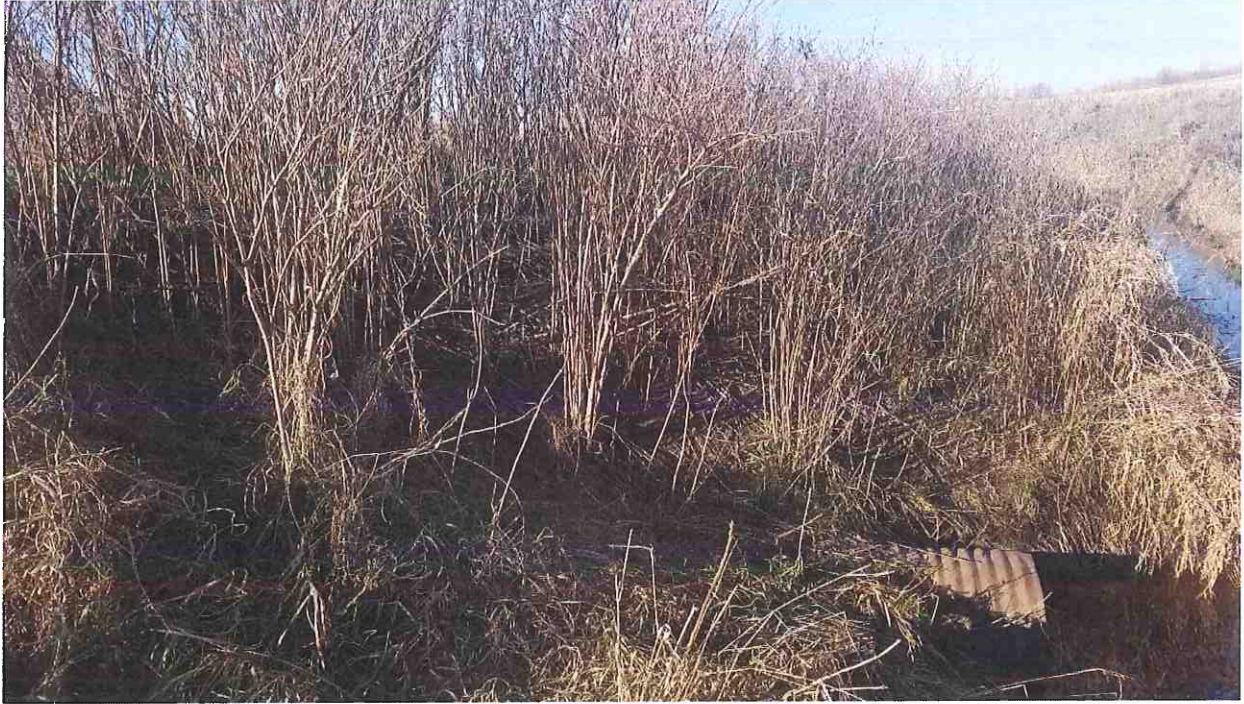
Woody vegetation and surface drain partially submerged, deformed, and rusty.

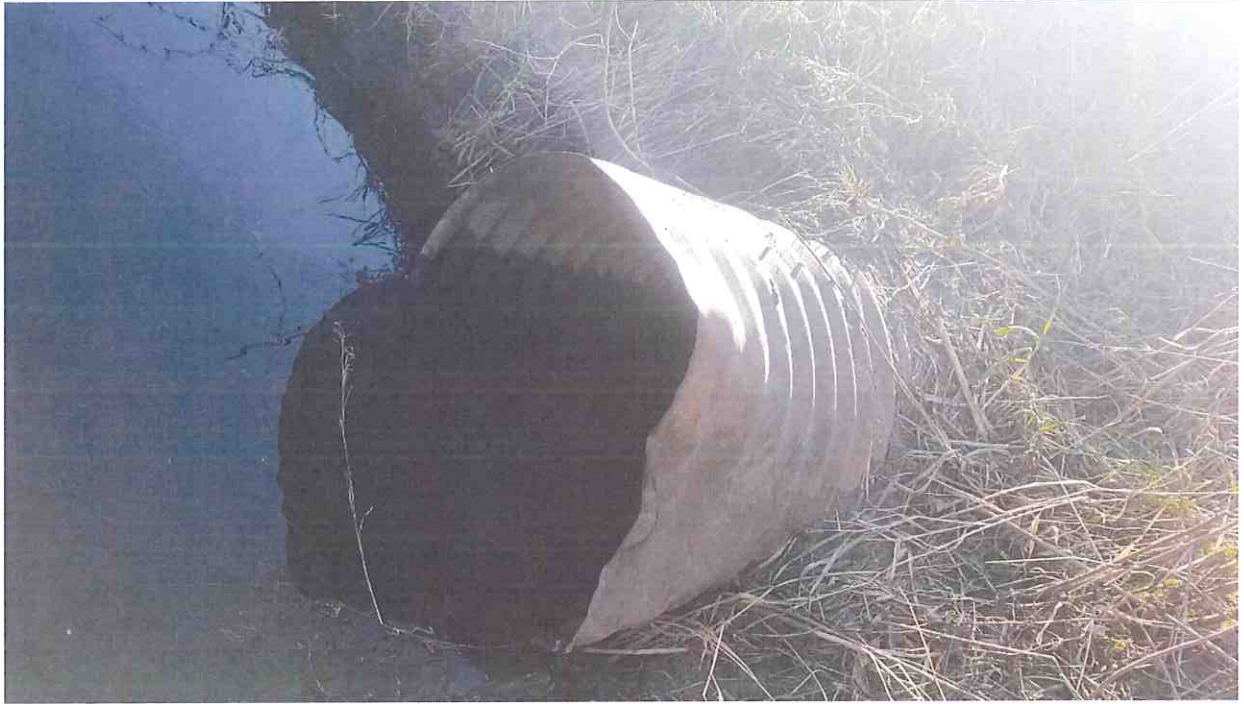
Close-up of above surface drain.

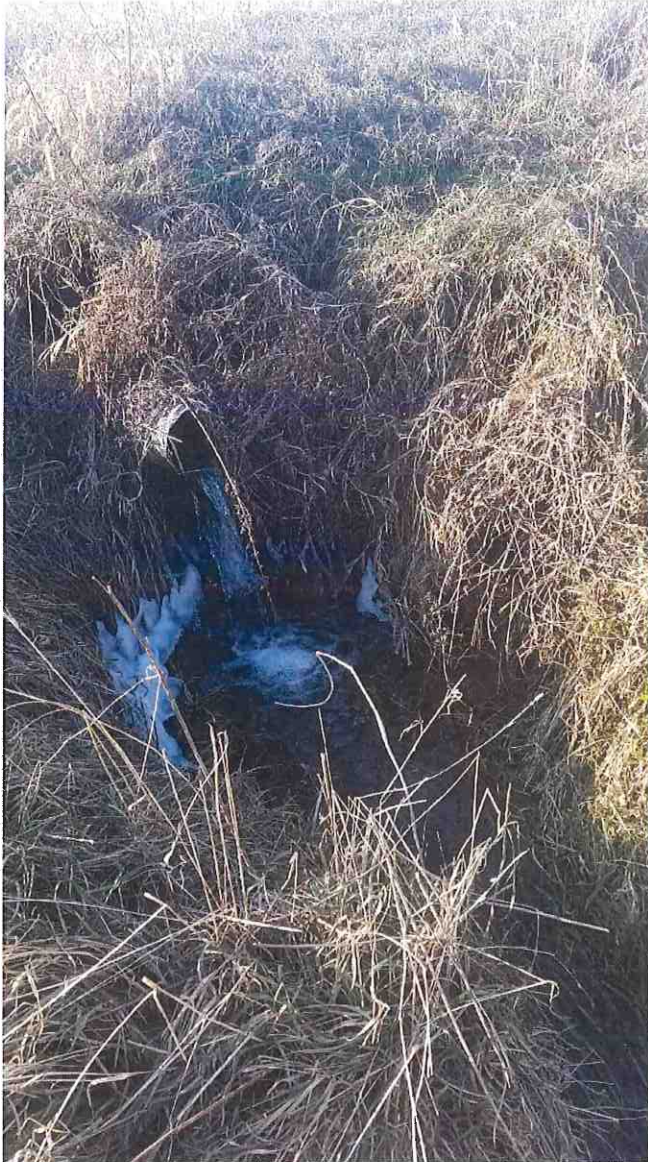
←Tile outlet near Sta. 18+25 +/- cut 8' into bank and causing erosion.

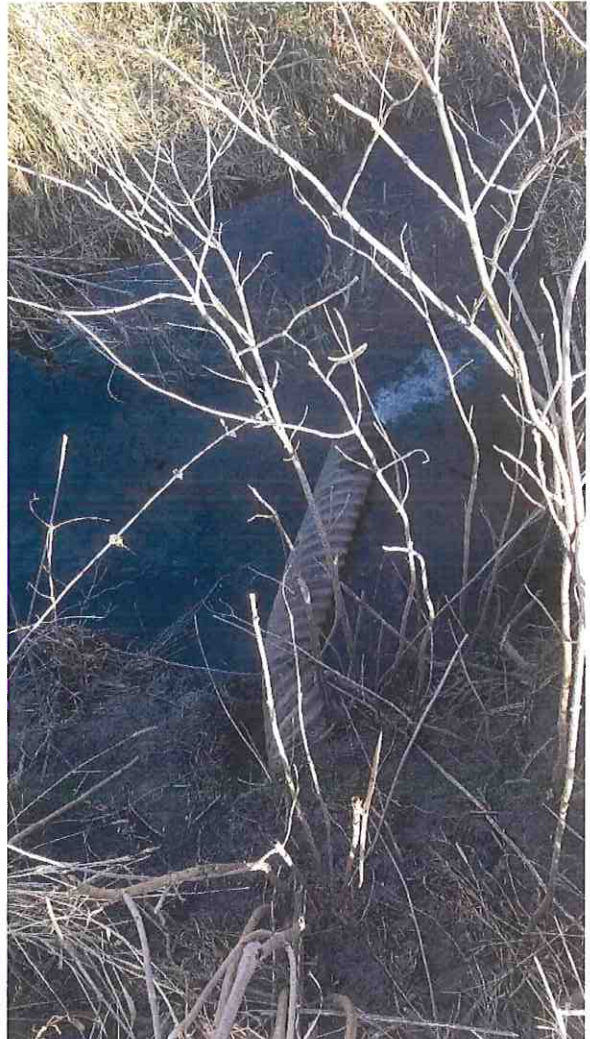
Bent and broken tile outlet with erosion into bank near Sta. 20+40 +/- →

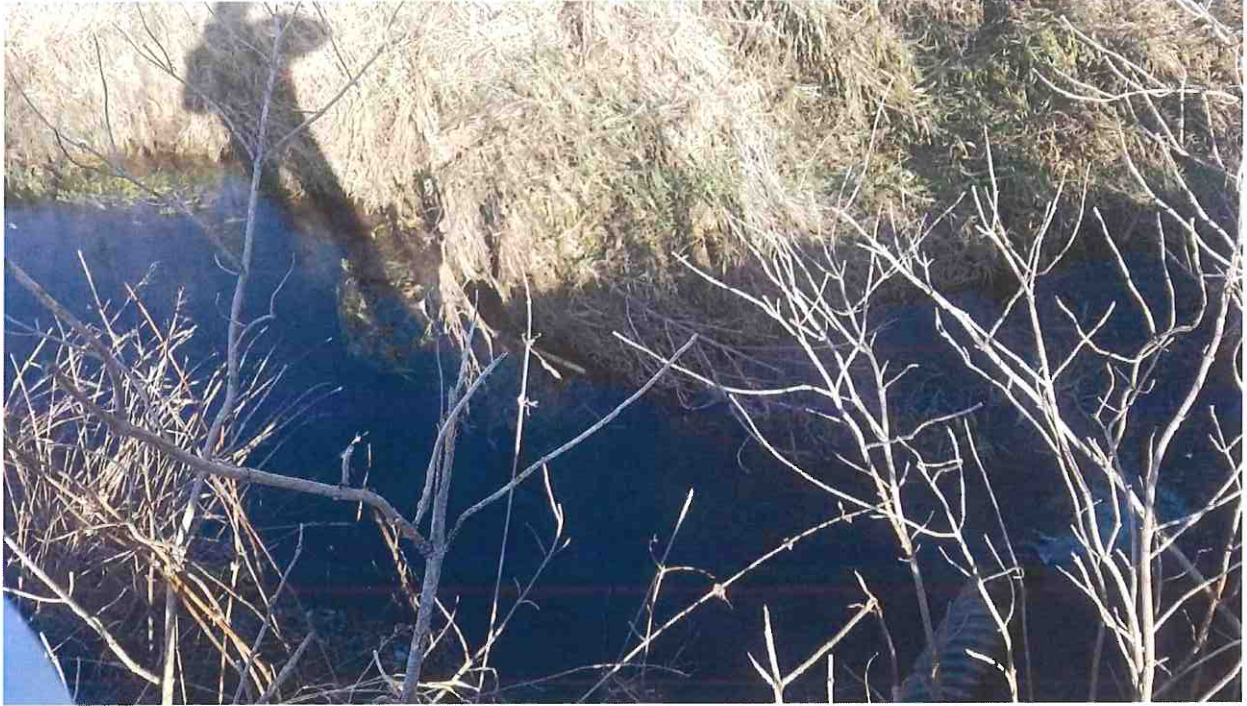
Bank sloughed into Open Ditch toward bent tile outlet.

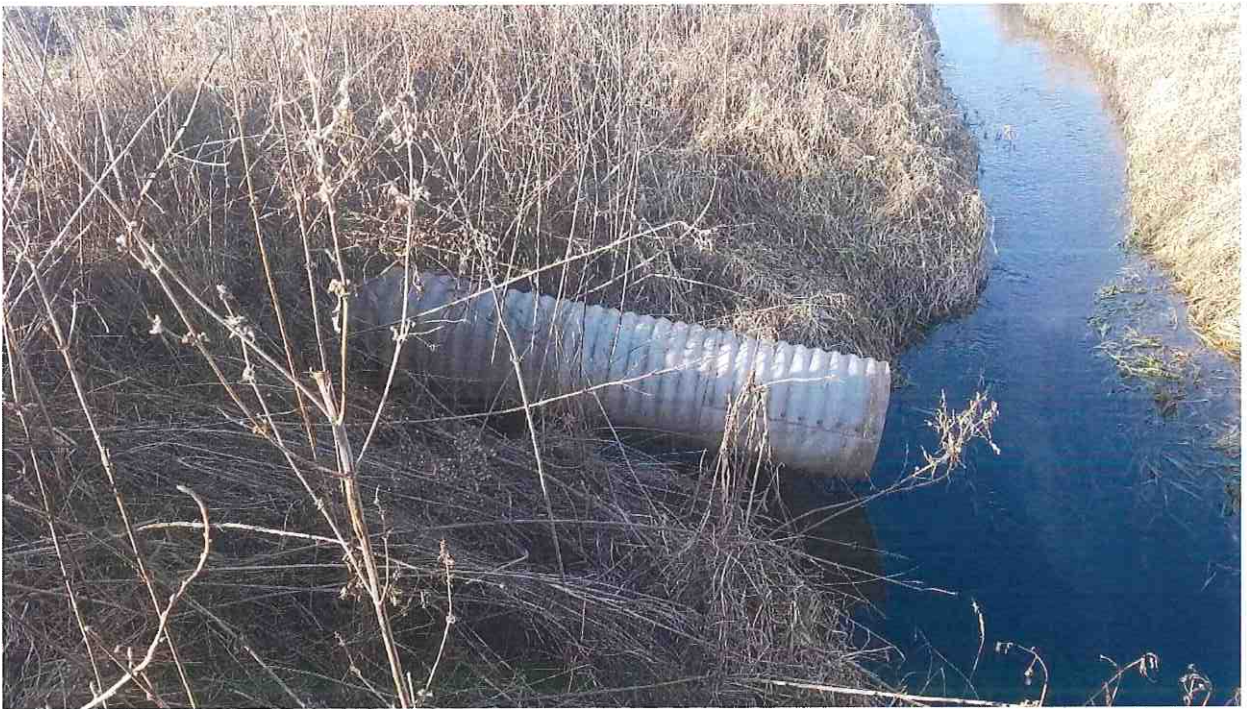
Surface drain with no support beneath near Sta. 23+00 +/-.

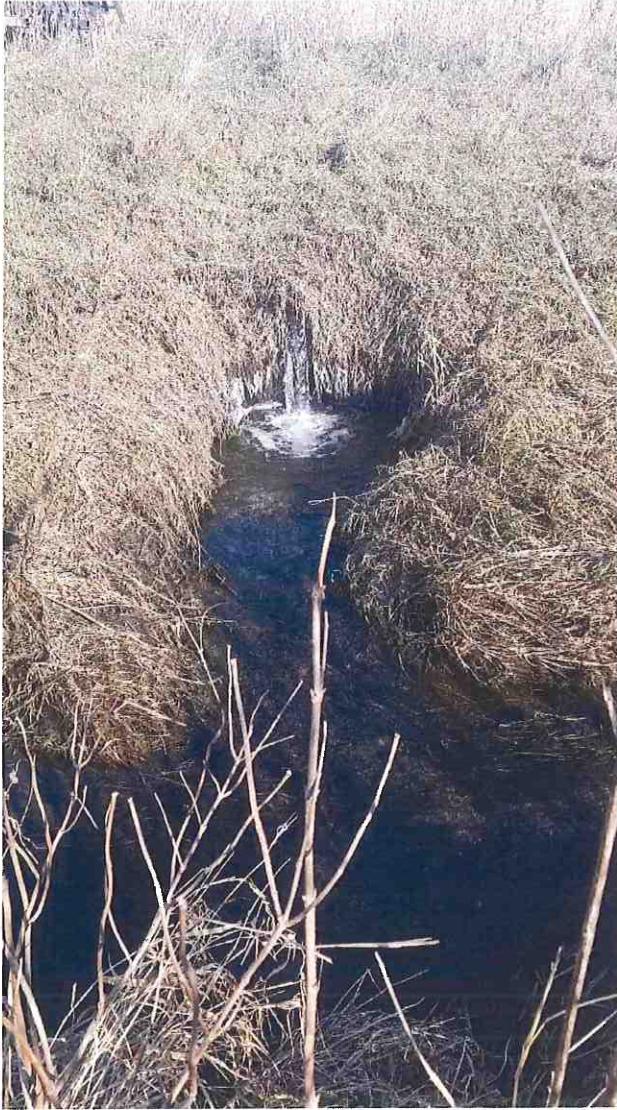
←Tile outlet cut 8' into bank and causing erosion.

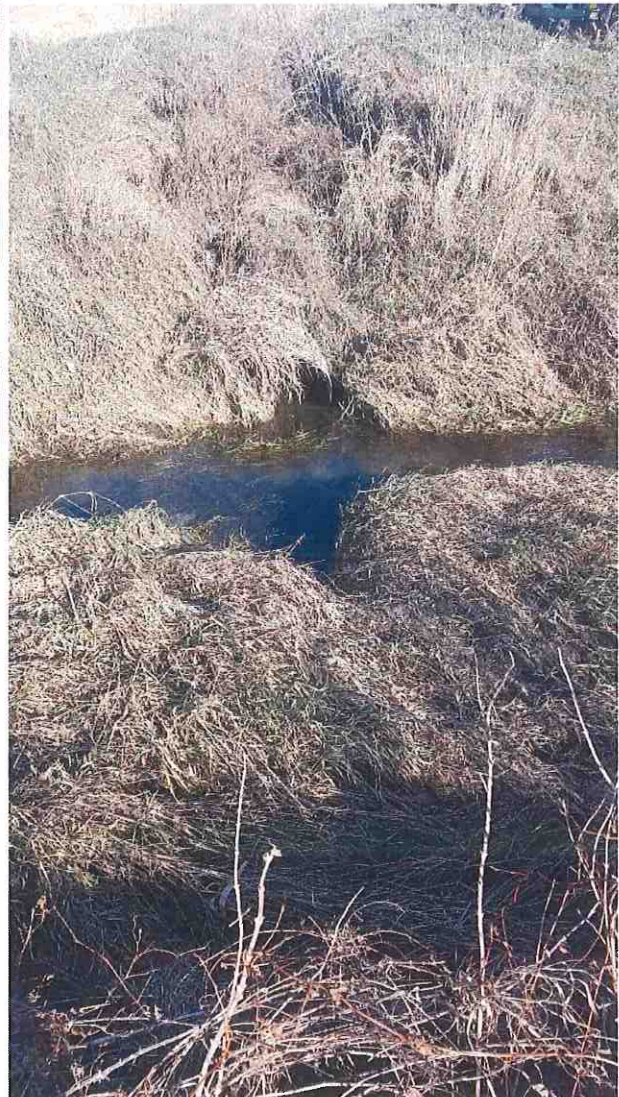
Surface drain on north bank submerged with heavy erosion around structure. South bank sloughed off into Open Ditch.→

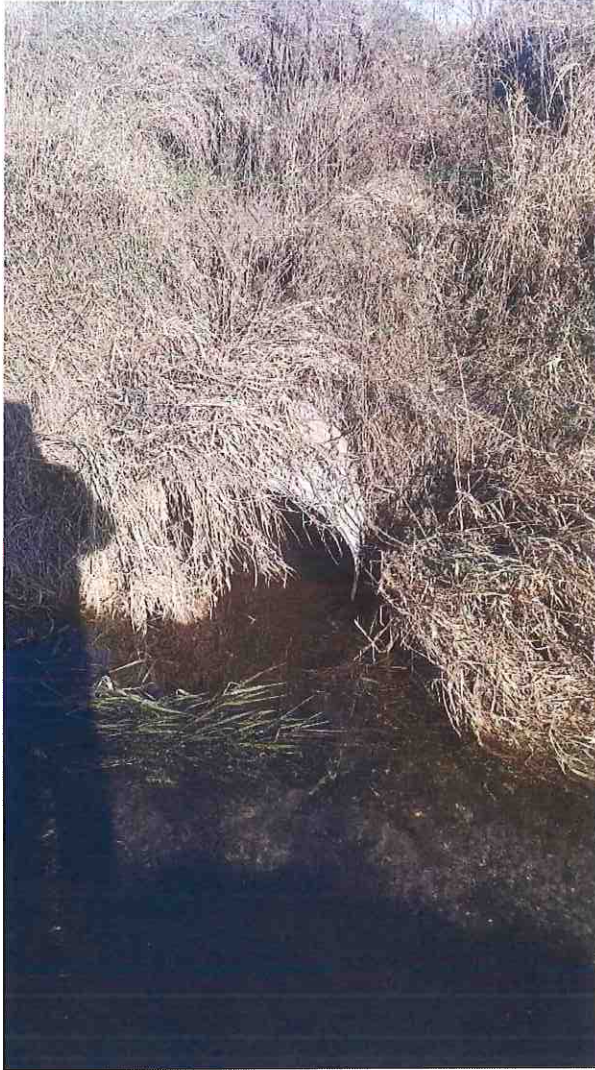
←Partially submerged surface drain.

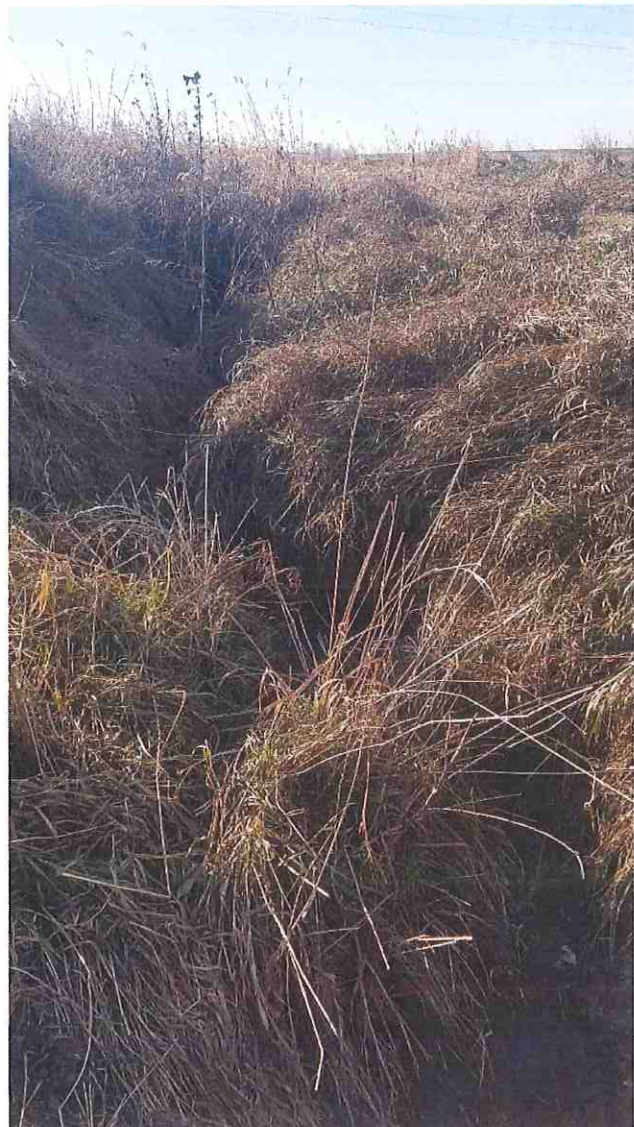
Tile outlet collapsed and buried. Tile is dumping water and cut 30' into bank causing erosion.→

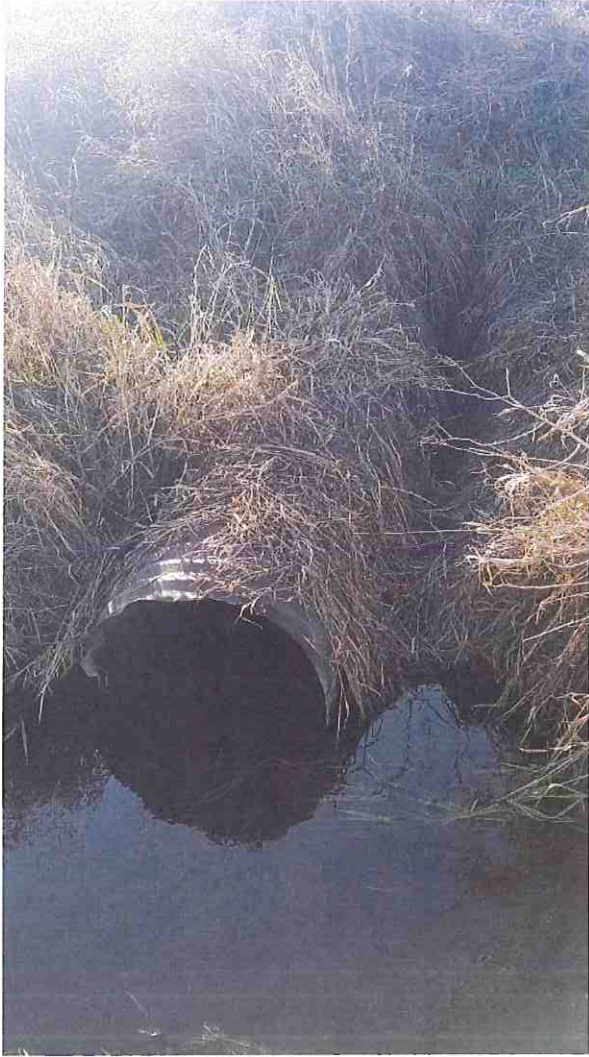
←Partially submerged surface drain with heavy erosion.

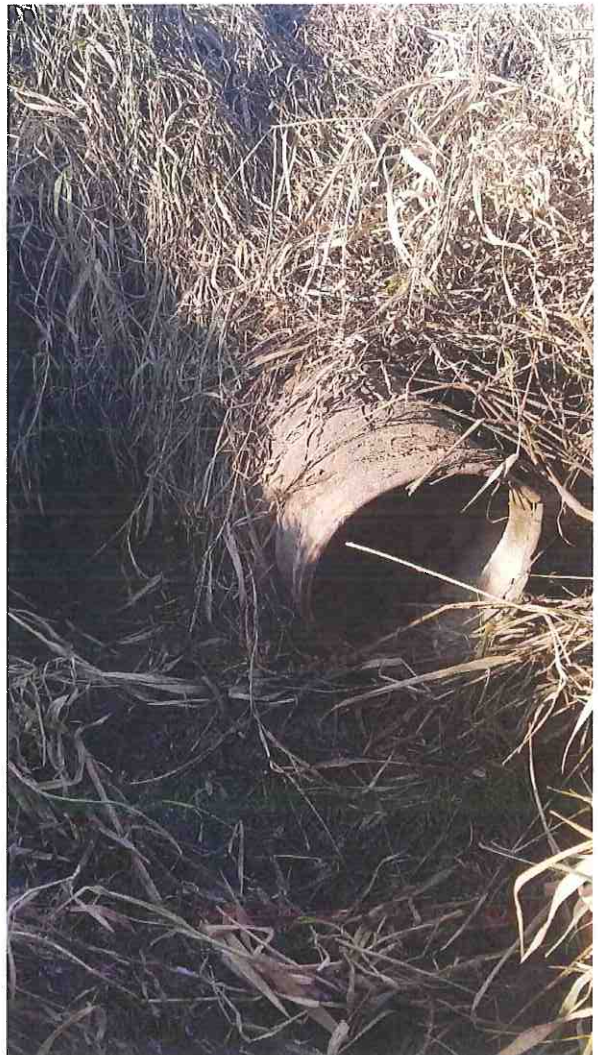
Rusty tile outlet partially crushed, surrounded by heavy erosion, and cut into bank.→

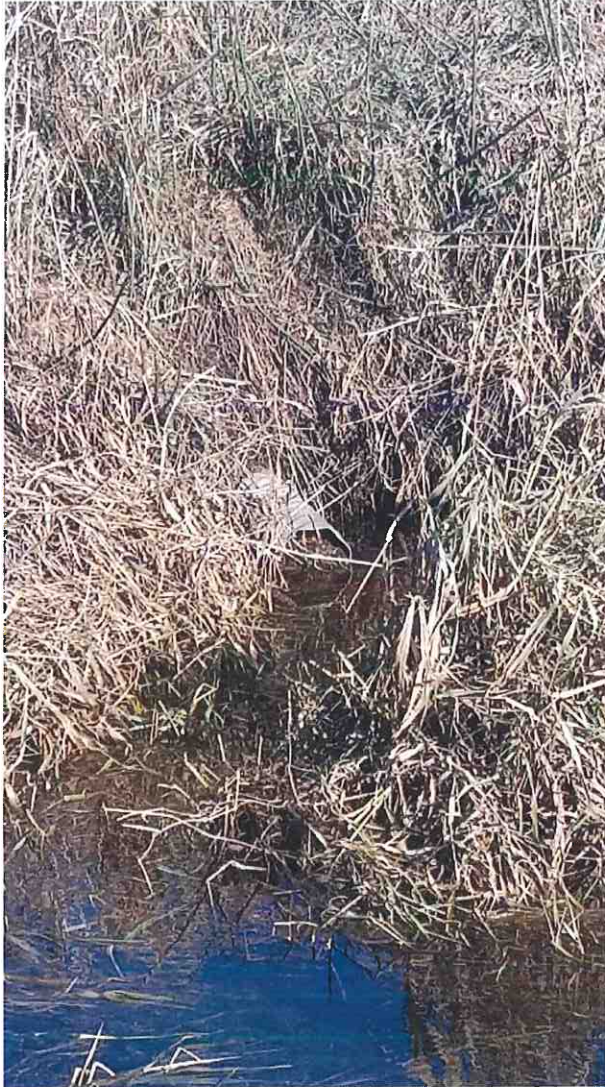
← Tile outlet half submerged with sediment at 4' cut into Open Ditch bank.

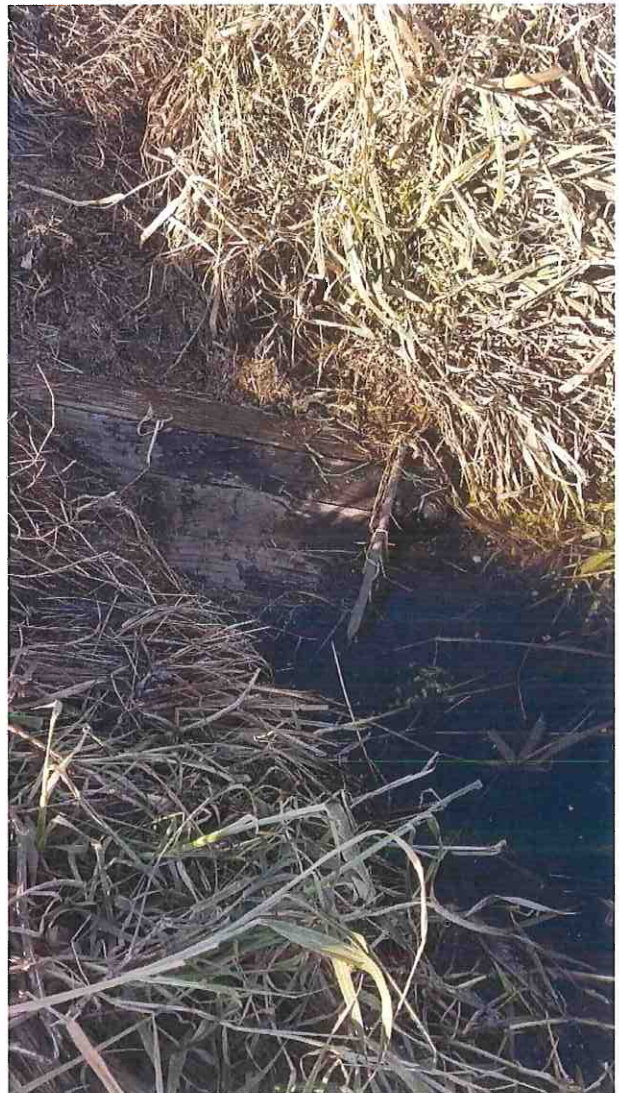
Wooden tile outlets on opposite sides of Open Ditch. Both near collapse and submerged. →

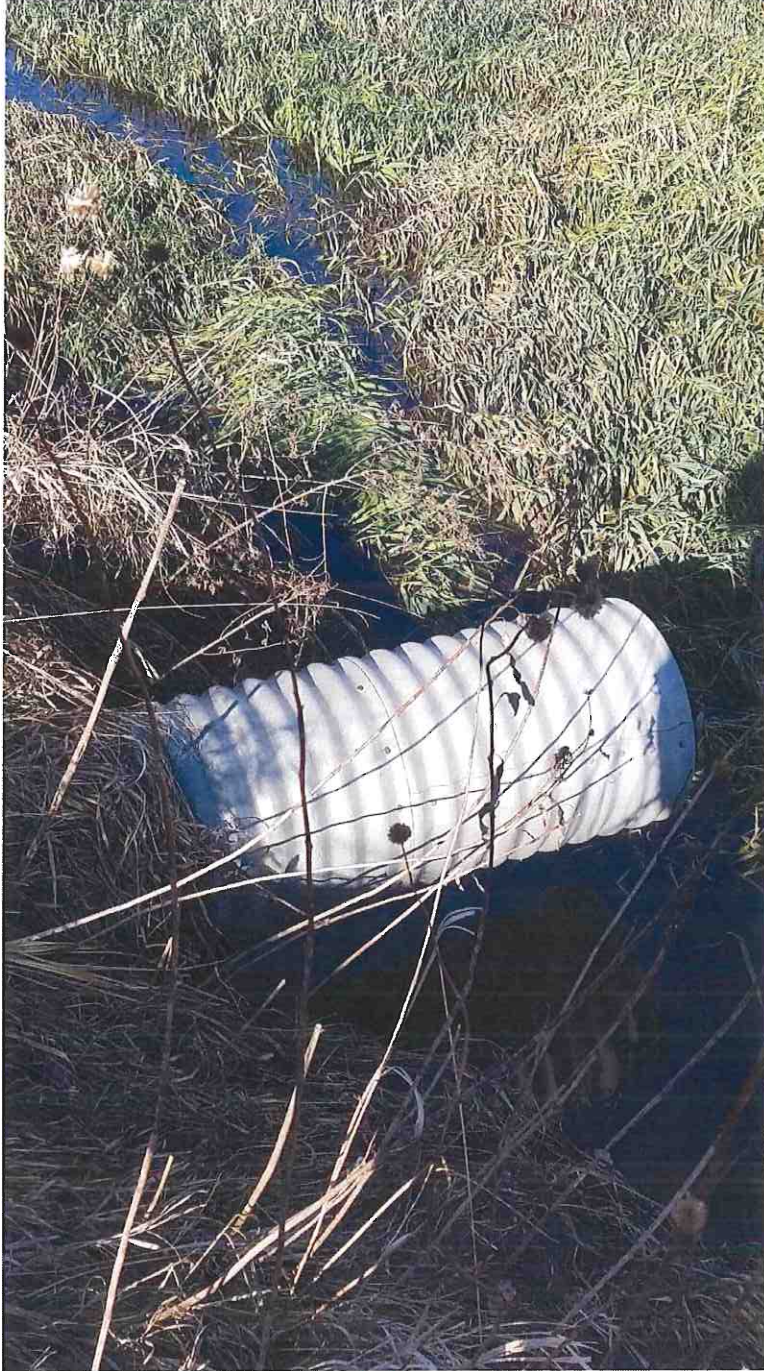
←Surface drain protruding into Open Ditch, lack of support beneath. Open Ditch heavily silted.

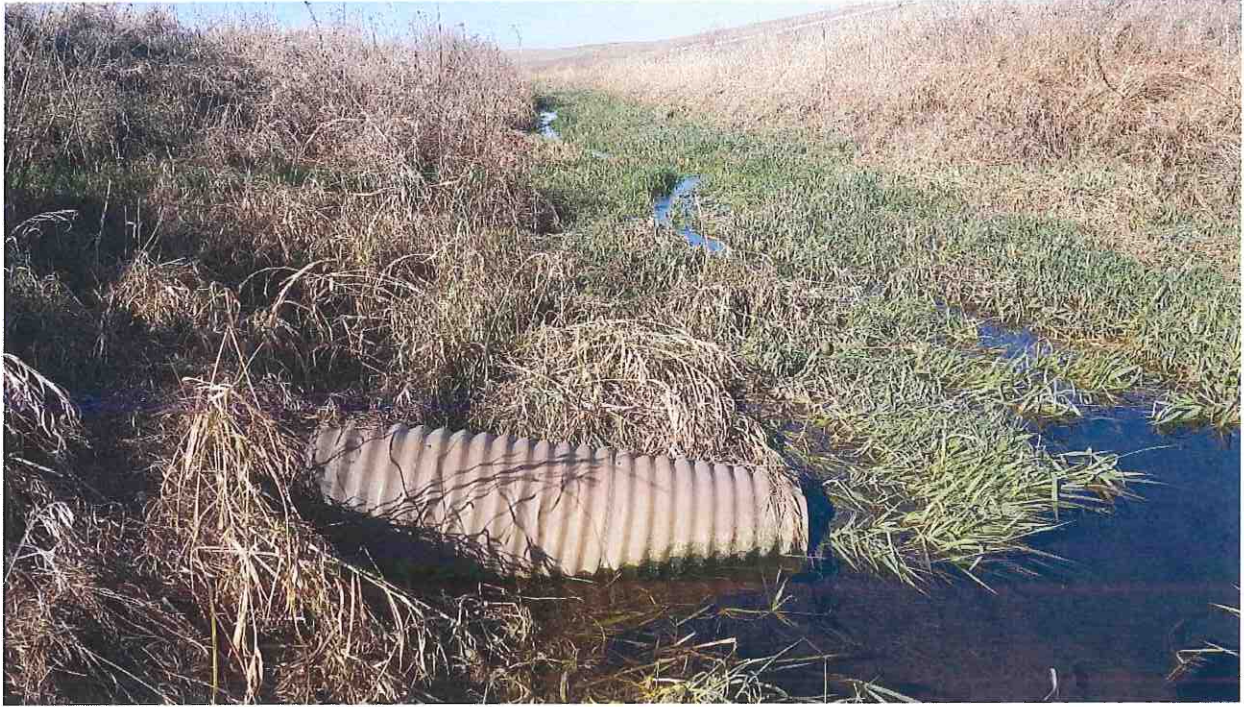
Surface drain collapsed into Open Ditch. Open Ditch heavily silted and meandering.

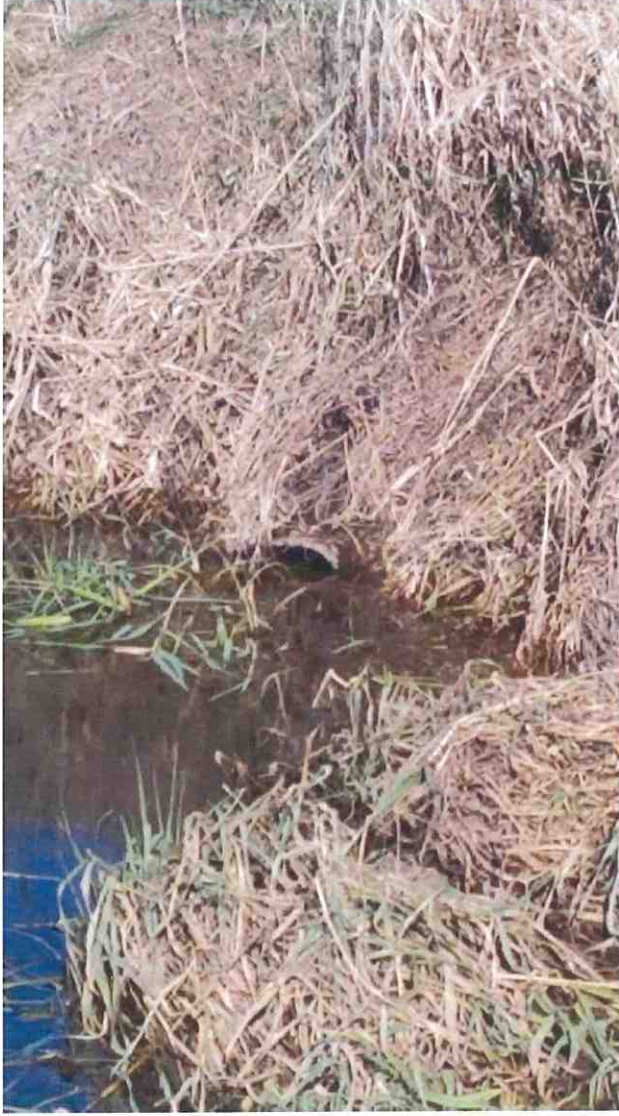
← Submerged surface drain.
