**ENGINEER'S REPORT
ON
REPAIRS TO
MAIN OPEN DITCH
DRAINAGE DISTRICT
NO. 148
HARDIN COUNTY,
IOWA**

Engineer's Report on Repairs to Main Open Ditch, Drainage District 148, Hardin County, Iowa

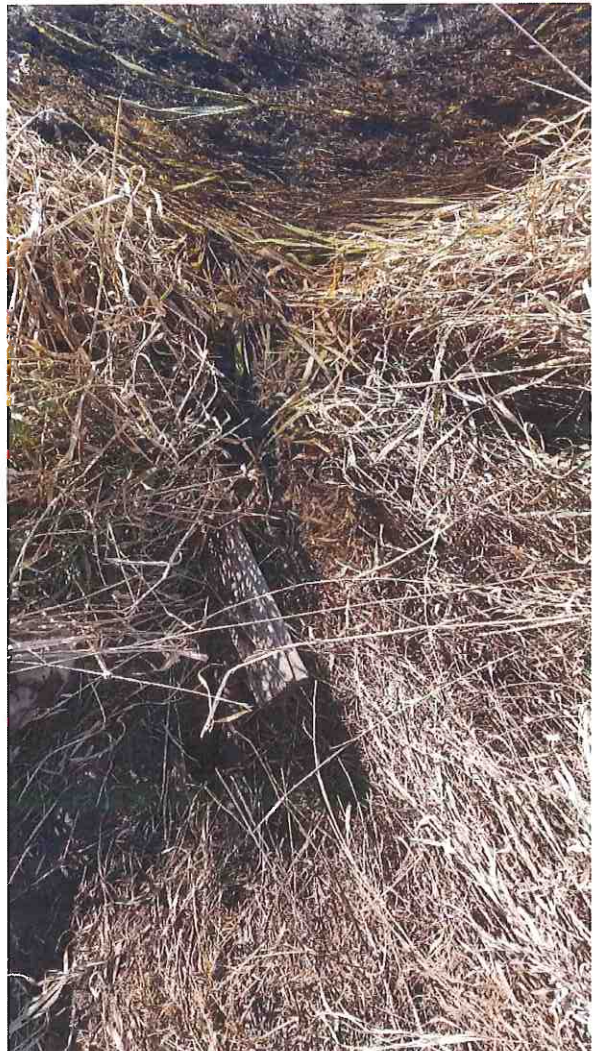
Collapsed and buried wooden tile outlet. →

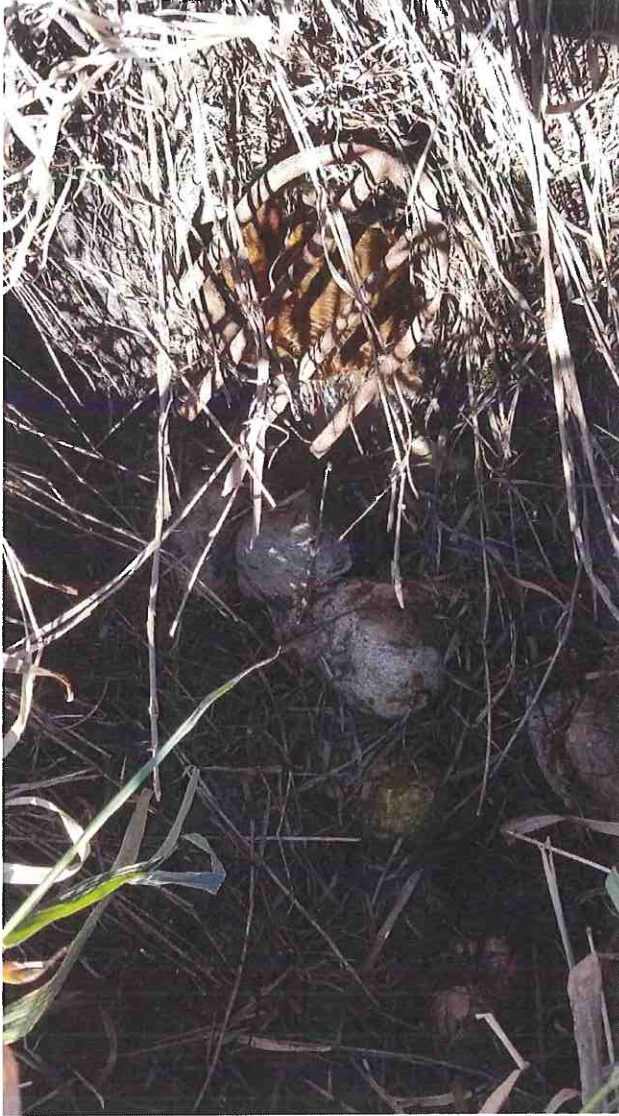
← Tile outlet cut into Open Ditch bank and causing erosion.

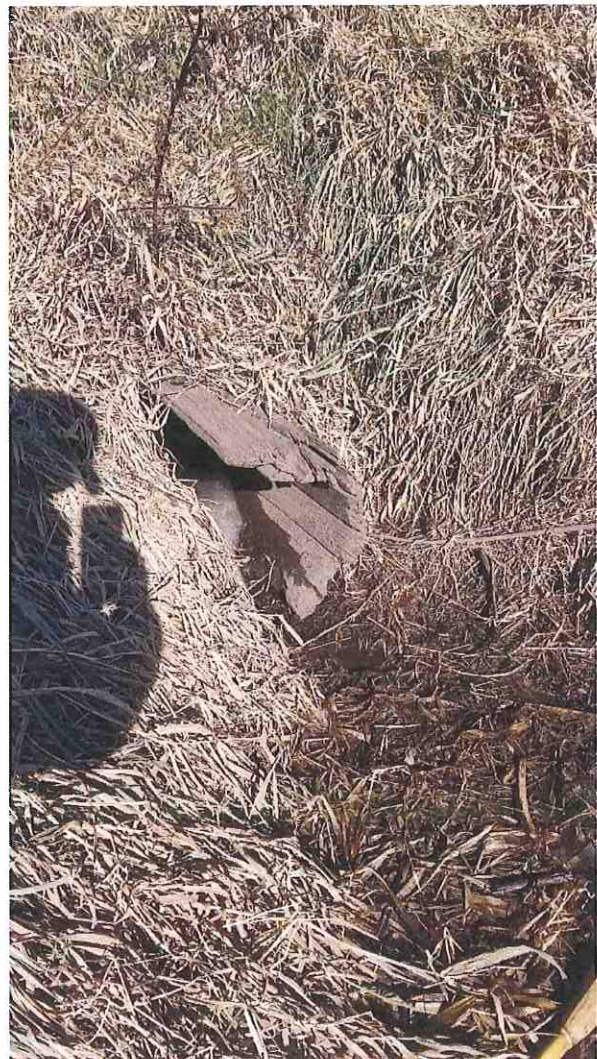
Wooden tile outlet collapsing and cut into bank. →

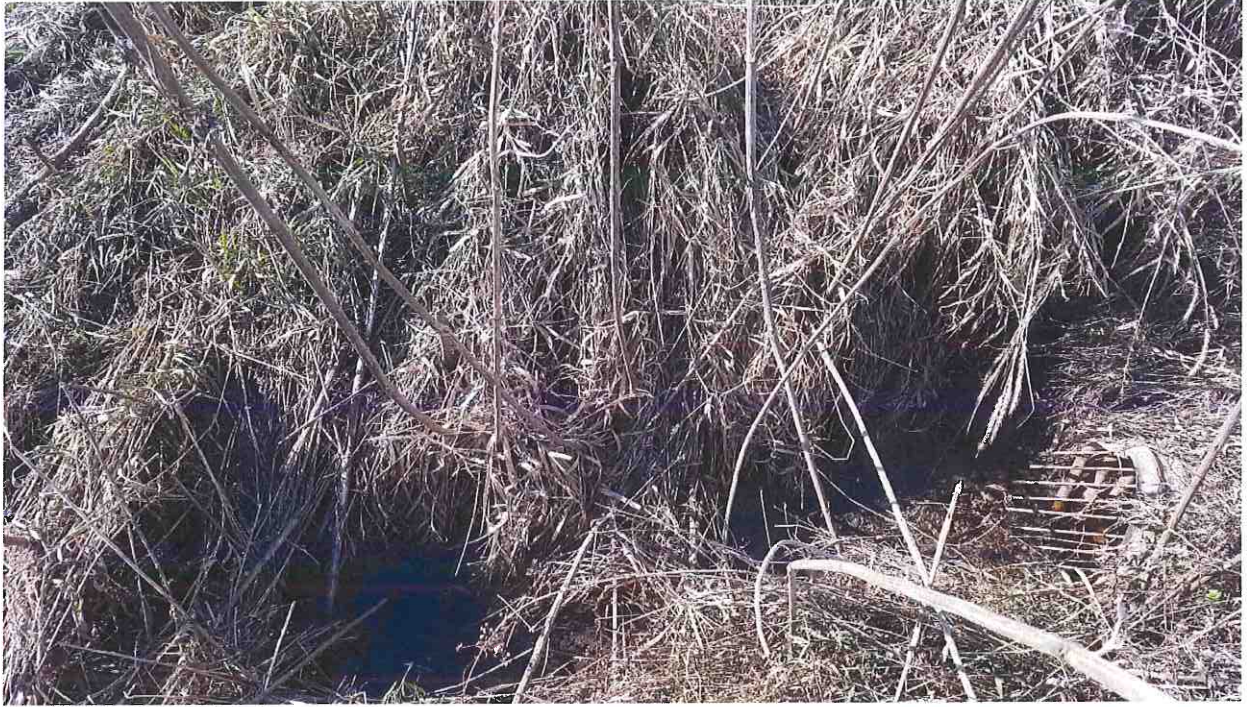
Tile outlet cut 8' into bank.

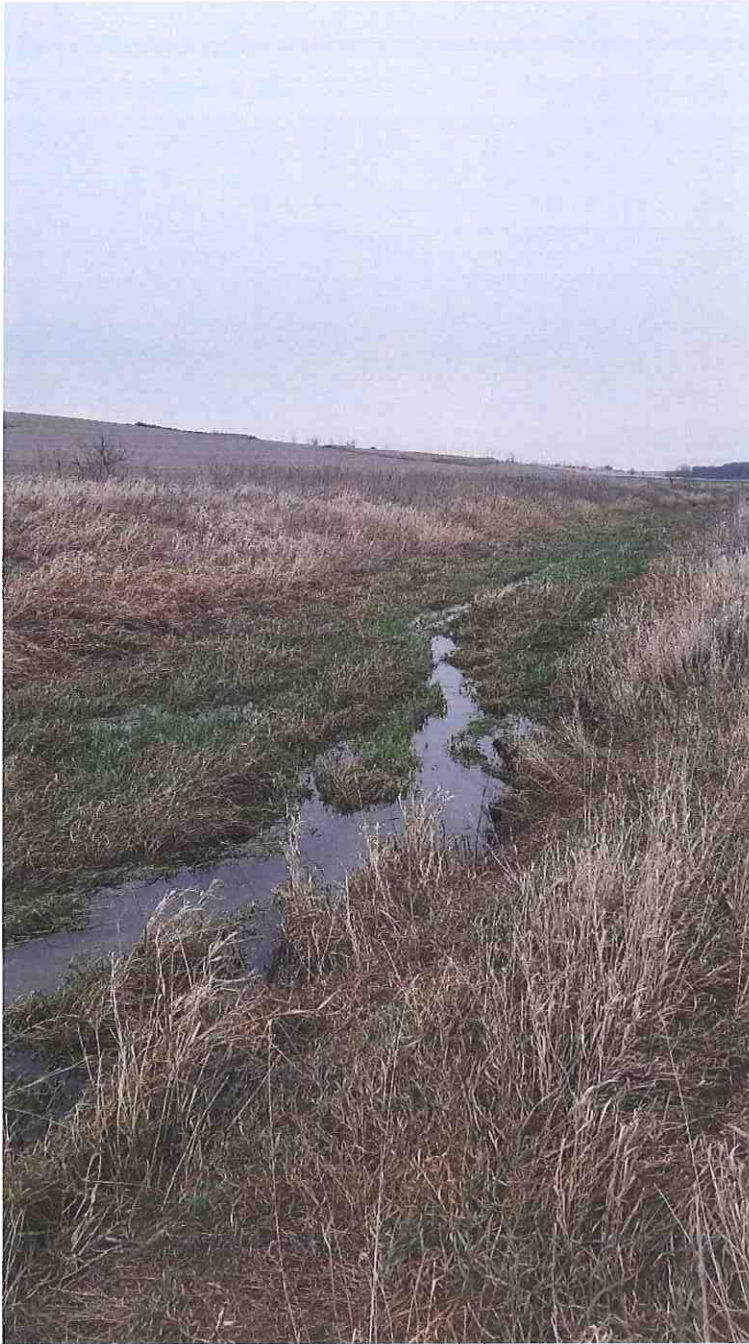
← Sedimentation levels between Sta. 31+75 +/- and bulkhead.

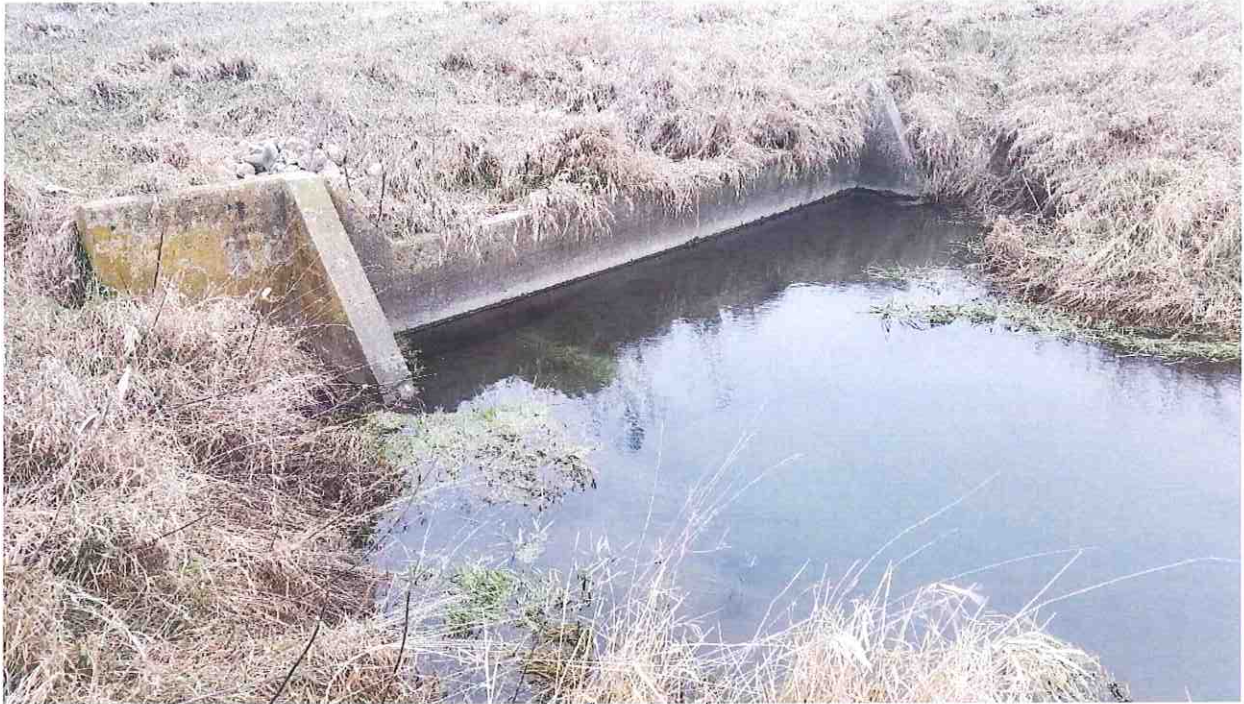
Main tile outlet fully submerged under water and not visible at bulkhead.

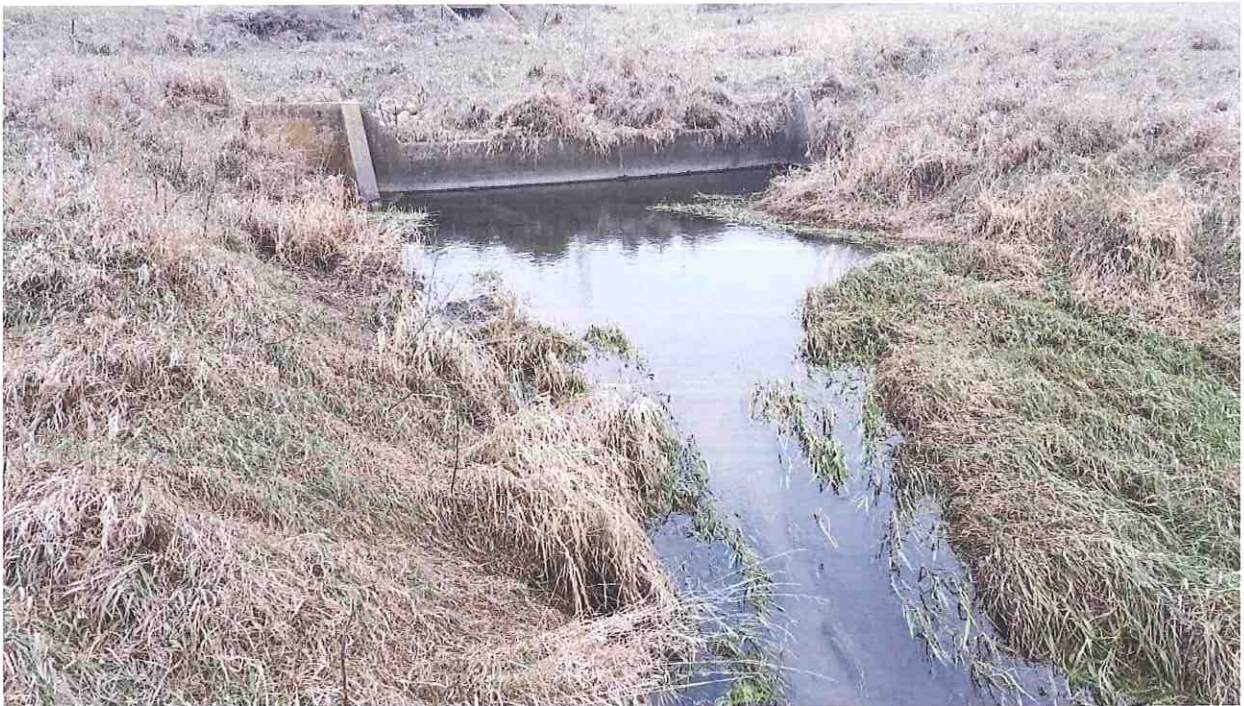
Sedimentation downstream of Main tile outlet.

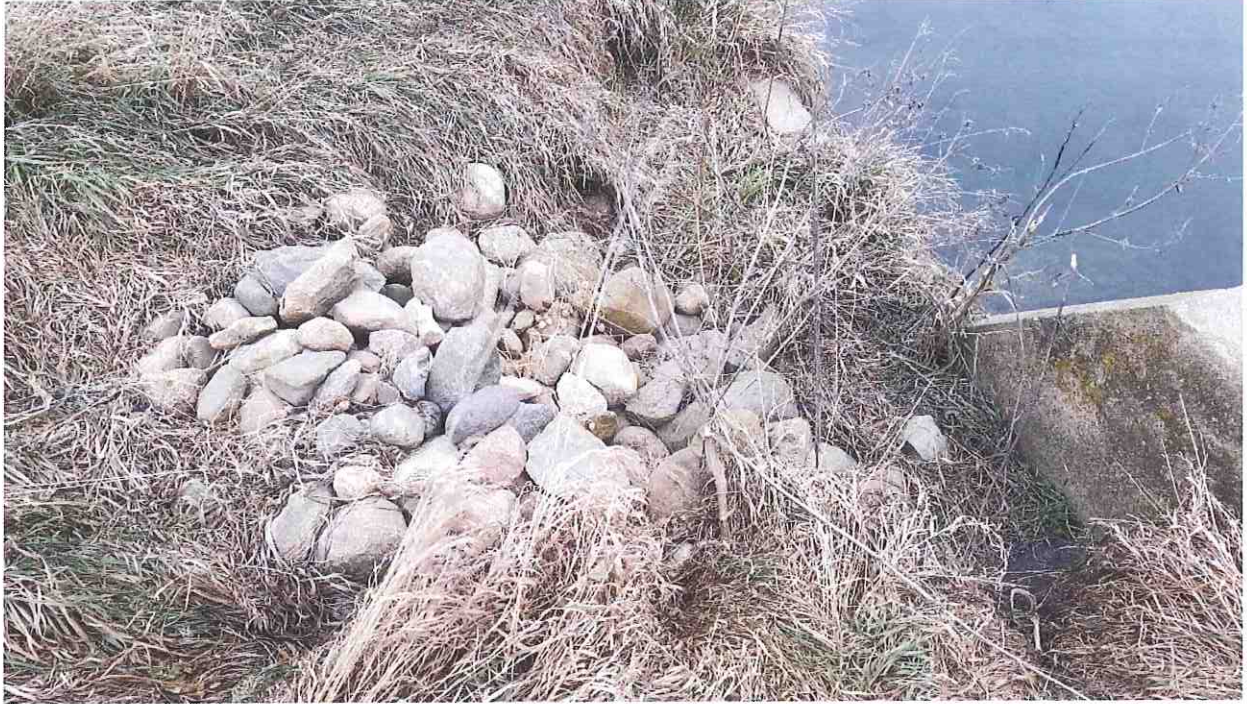
Erosion and field stone on top of bulkhead.

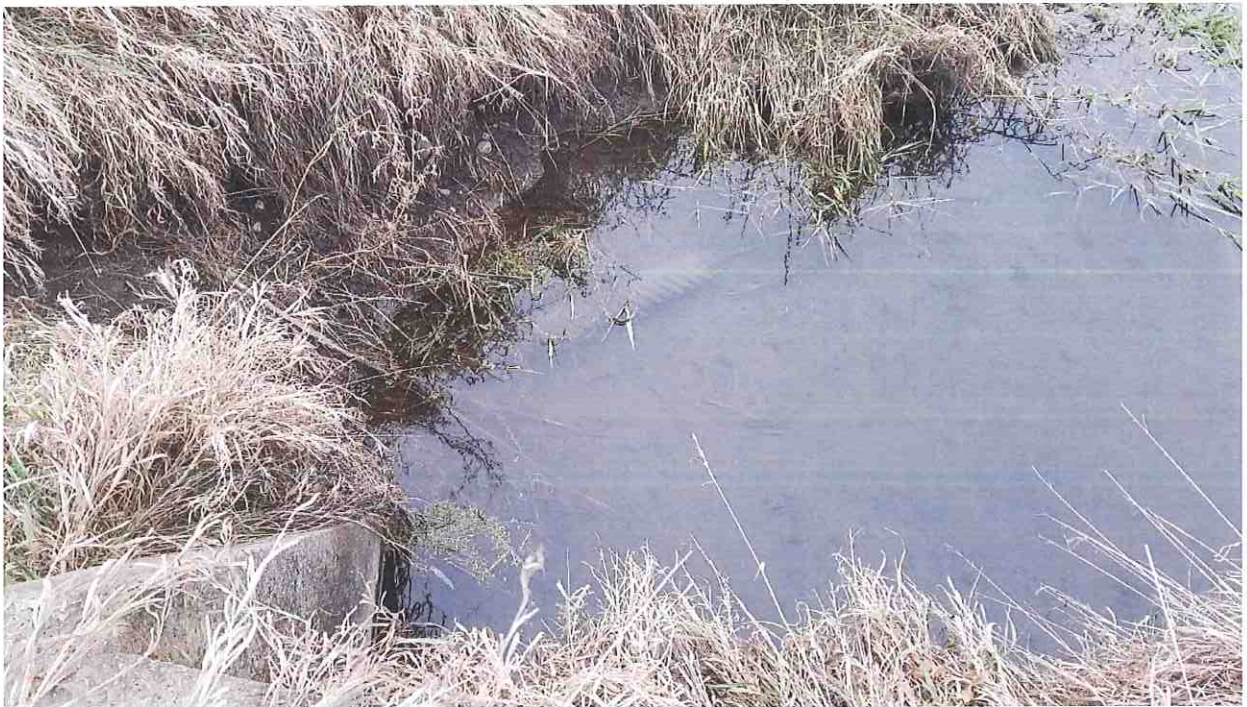
Tile outlet submerged under water at bulkhead.

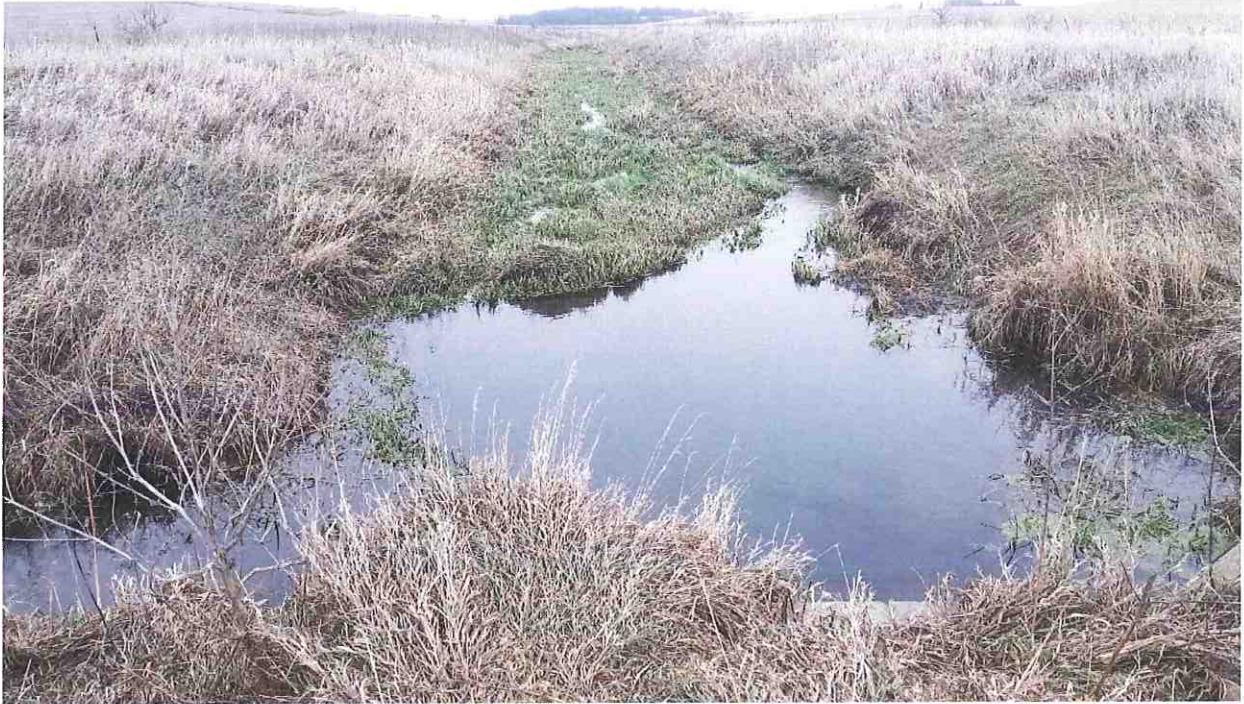
Heavy sedimentation downstream of bulkhead with meandering channel.

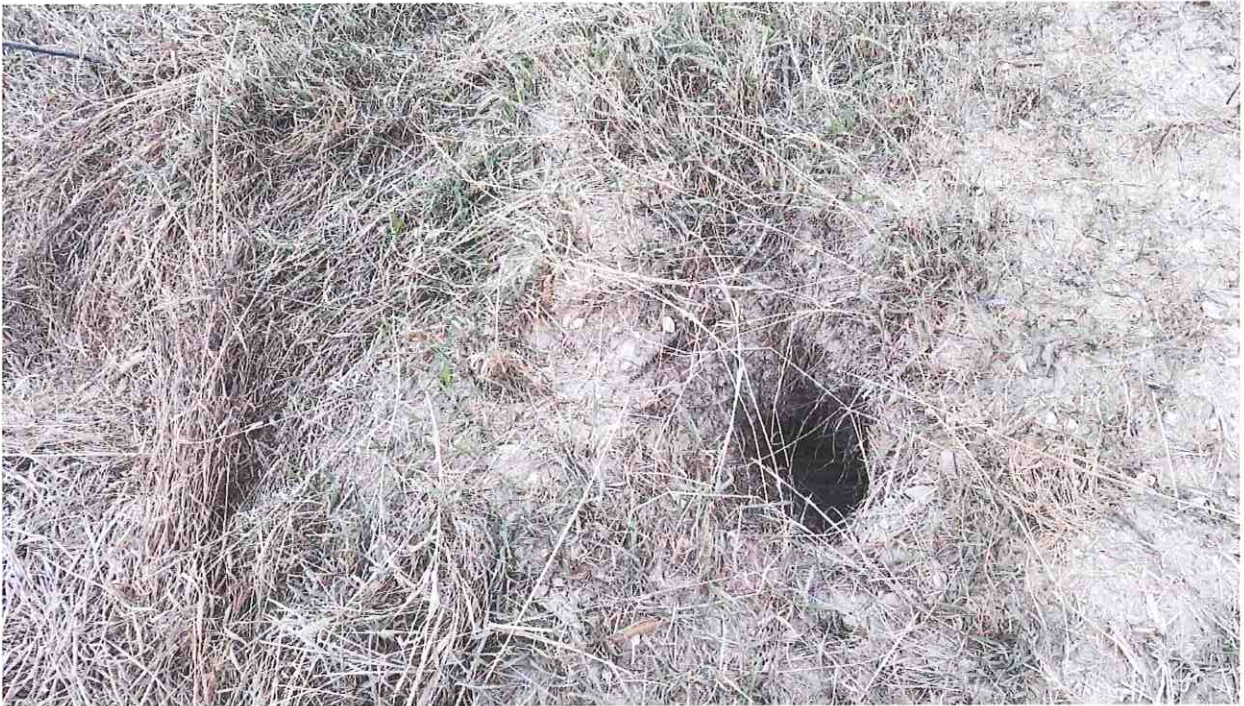
Sinkhole above Main tile on east shoulder of S Avenue.
