**PUBLIC HEARING AGENDA
ENGINEER'S REPORT ON REPAIRS OR IMPROVEMENTS TO MAIN TILES
DRAINAGE DISTRICT 167, HARDIN COUNTY, IOWA
MARCH 6, 2019 AT 1:00 P.M.**

**ENGINEER'S REPORT
ON REPAIRS OR
IMPROVEMENTS TO
MAIN TILES
DRAINAGE DISTRICT
NO. 167
HARDIN COUNTY,
IOWA**

Engineer's Report on Repairs or Improvements to Main Tiles, Drainage District No. 167 Hardin County, Iowa

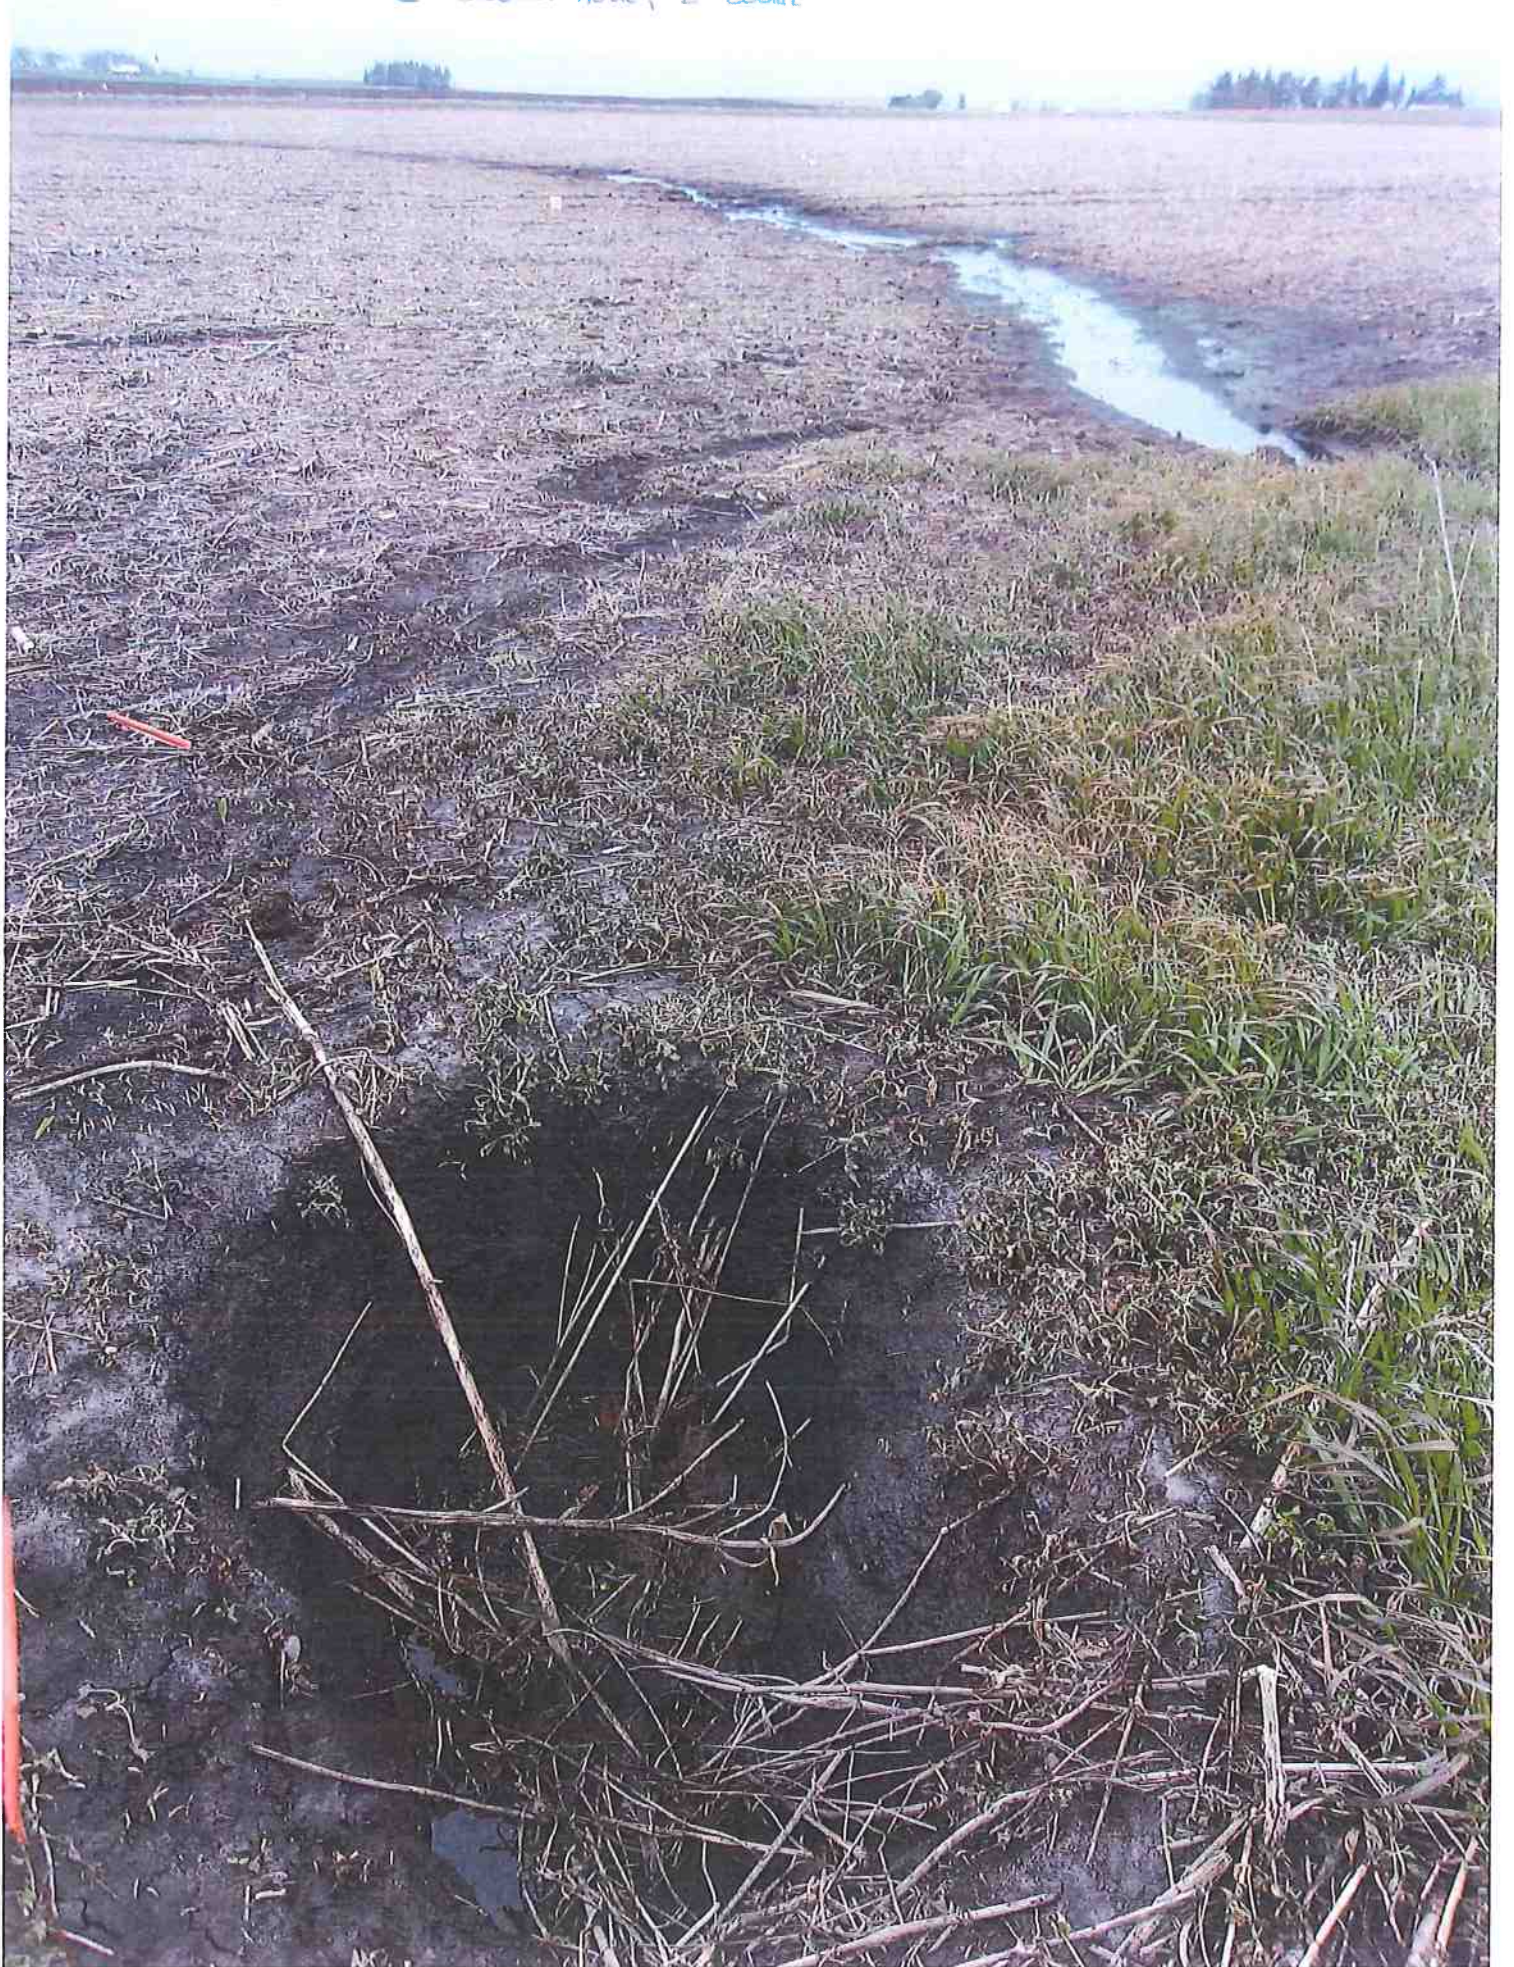
Partly Sunny, 65°, Windy From East, Rain Earlier
Arrived @ Job Site 9:00 AM, Called and Talked to Robert Jensen,
He met me and drove his pickup out to Blow-outs Found 6" clay tile
1 1/2 - 2' deep, Blowing out water in multiple places (6 or more) All look to
be joints, must have a collapse down stream causing water to surge up thru
butt joints and then go back into tile past the collapse or blockage.
This looks to be the S. main
Find and fix blockage ASAP, the rest of tile should be OK.
Talked to Robert about shifting swale or tile route to get more cover.
This will be a on going problem with the minimum cover this butt joint tile
has.

Looking NW @ Blodgett House, 2' cover

Given the nature of the water flow, it is evident that a tile blockage exists within the area of investigation. Said blockage should be found, removed, and then both the blowout/sinkhole repaired. Also, the multiple holes upstream should be excavated and repaired as necessary. Due to the lack of soil cover, repairs would typically be performed with concrete pipe. However, concrete pipe is only available in 12 inch and larger diameter. Therefore, the repairs must either be performed with 6 inch dual wall HPDE tile or 12 inch concrete pipe.

Since this is the second work order in 2 years in this area, the District Trustees may wish investigate relocation or replacement of the district tile to provide for more soil cover, extended lifespan, and fewer repairs.

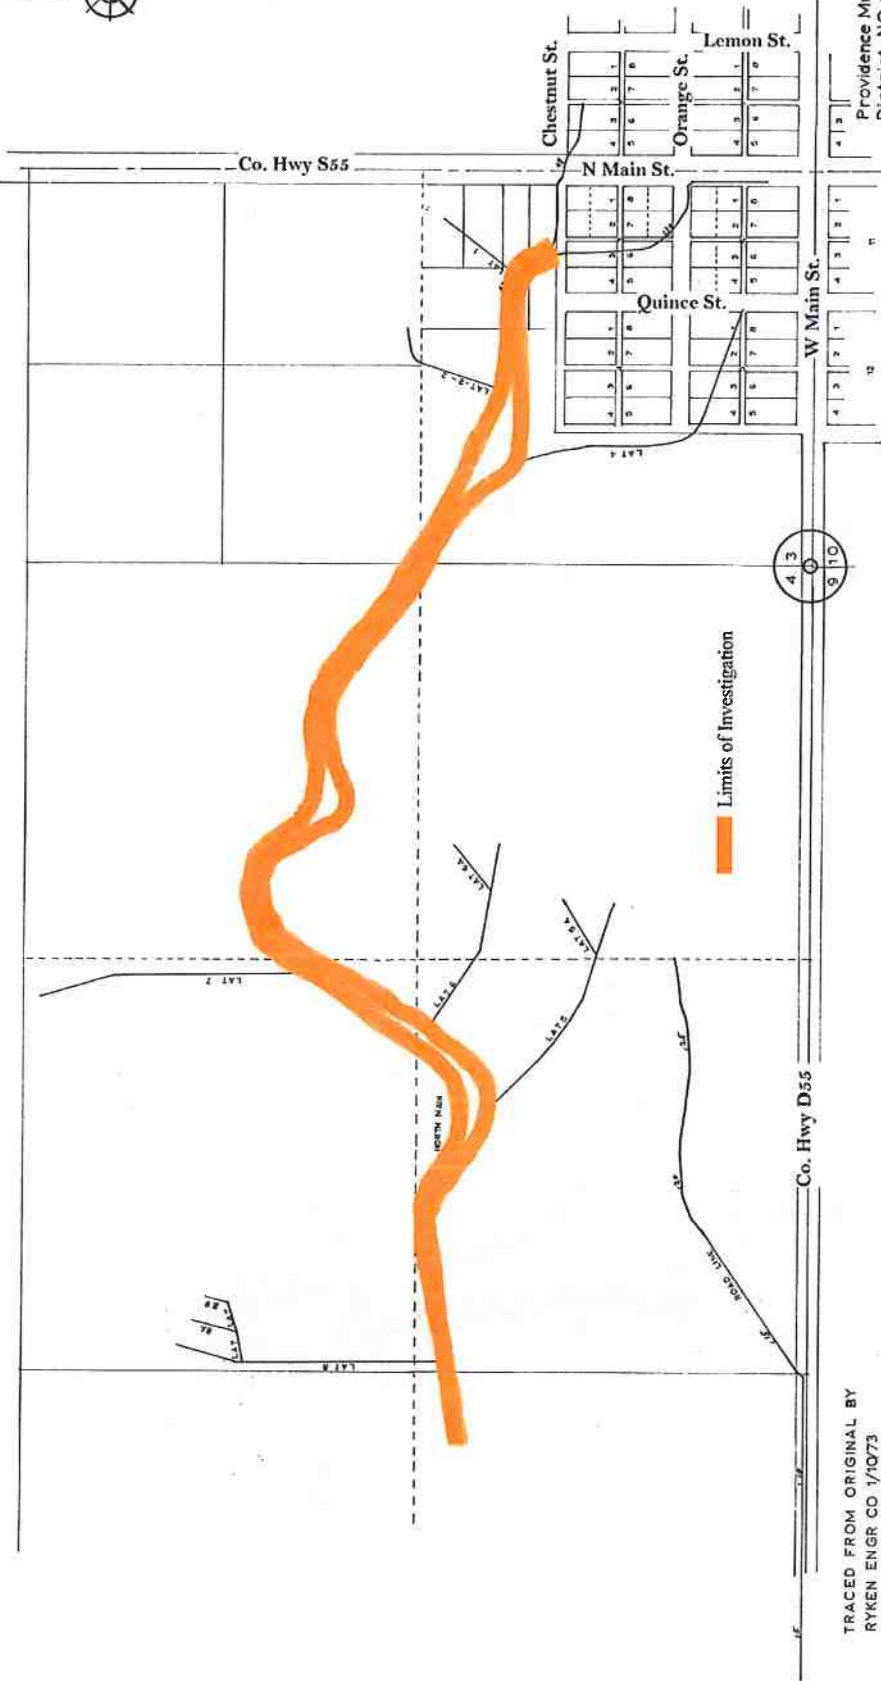
Providence Mutual Title
 District NO. 167
 SE 1/4 Sec. 1, Twp 88N, R. 20W
 SW 1/4 Sec. 3, Twp 88N, R. 20W
 FEB 29 1949 Scale: 1" = 200'

Limits of Investigation
