AGENDA
DD 86 LANDOWNER MEETING
JULY 17, 2019 AT 11:00 AM

Drainage District:

86

Investigation Report:

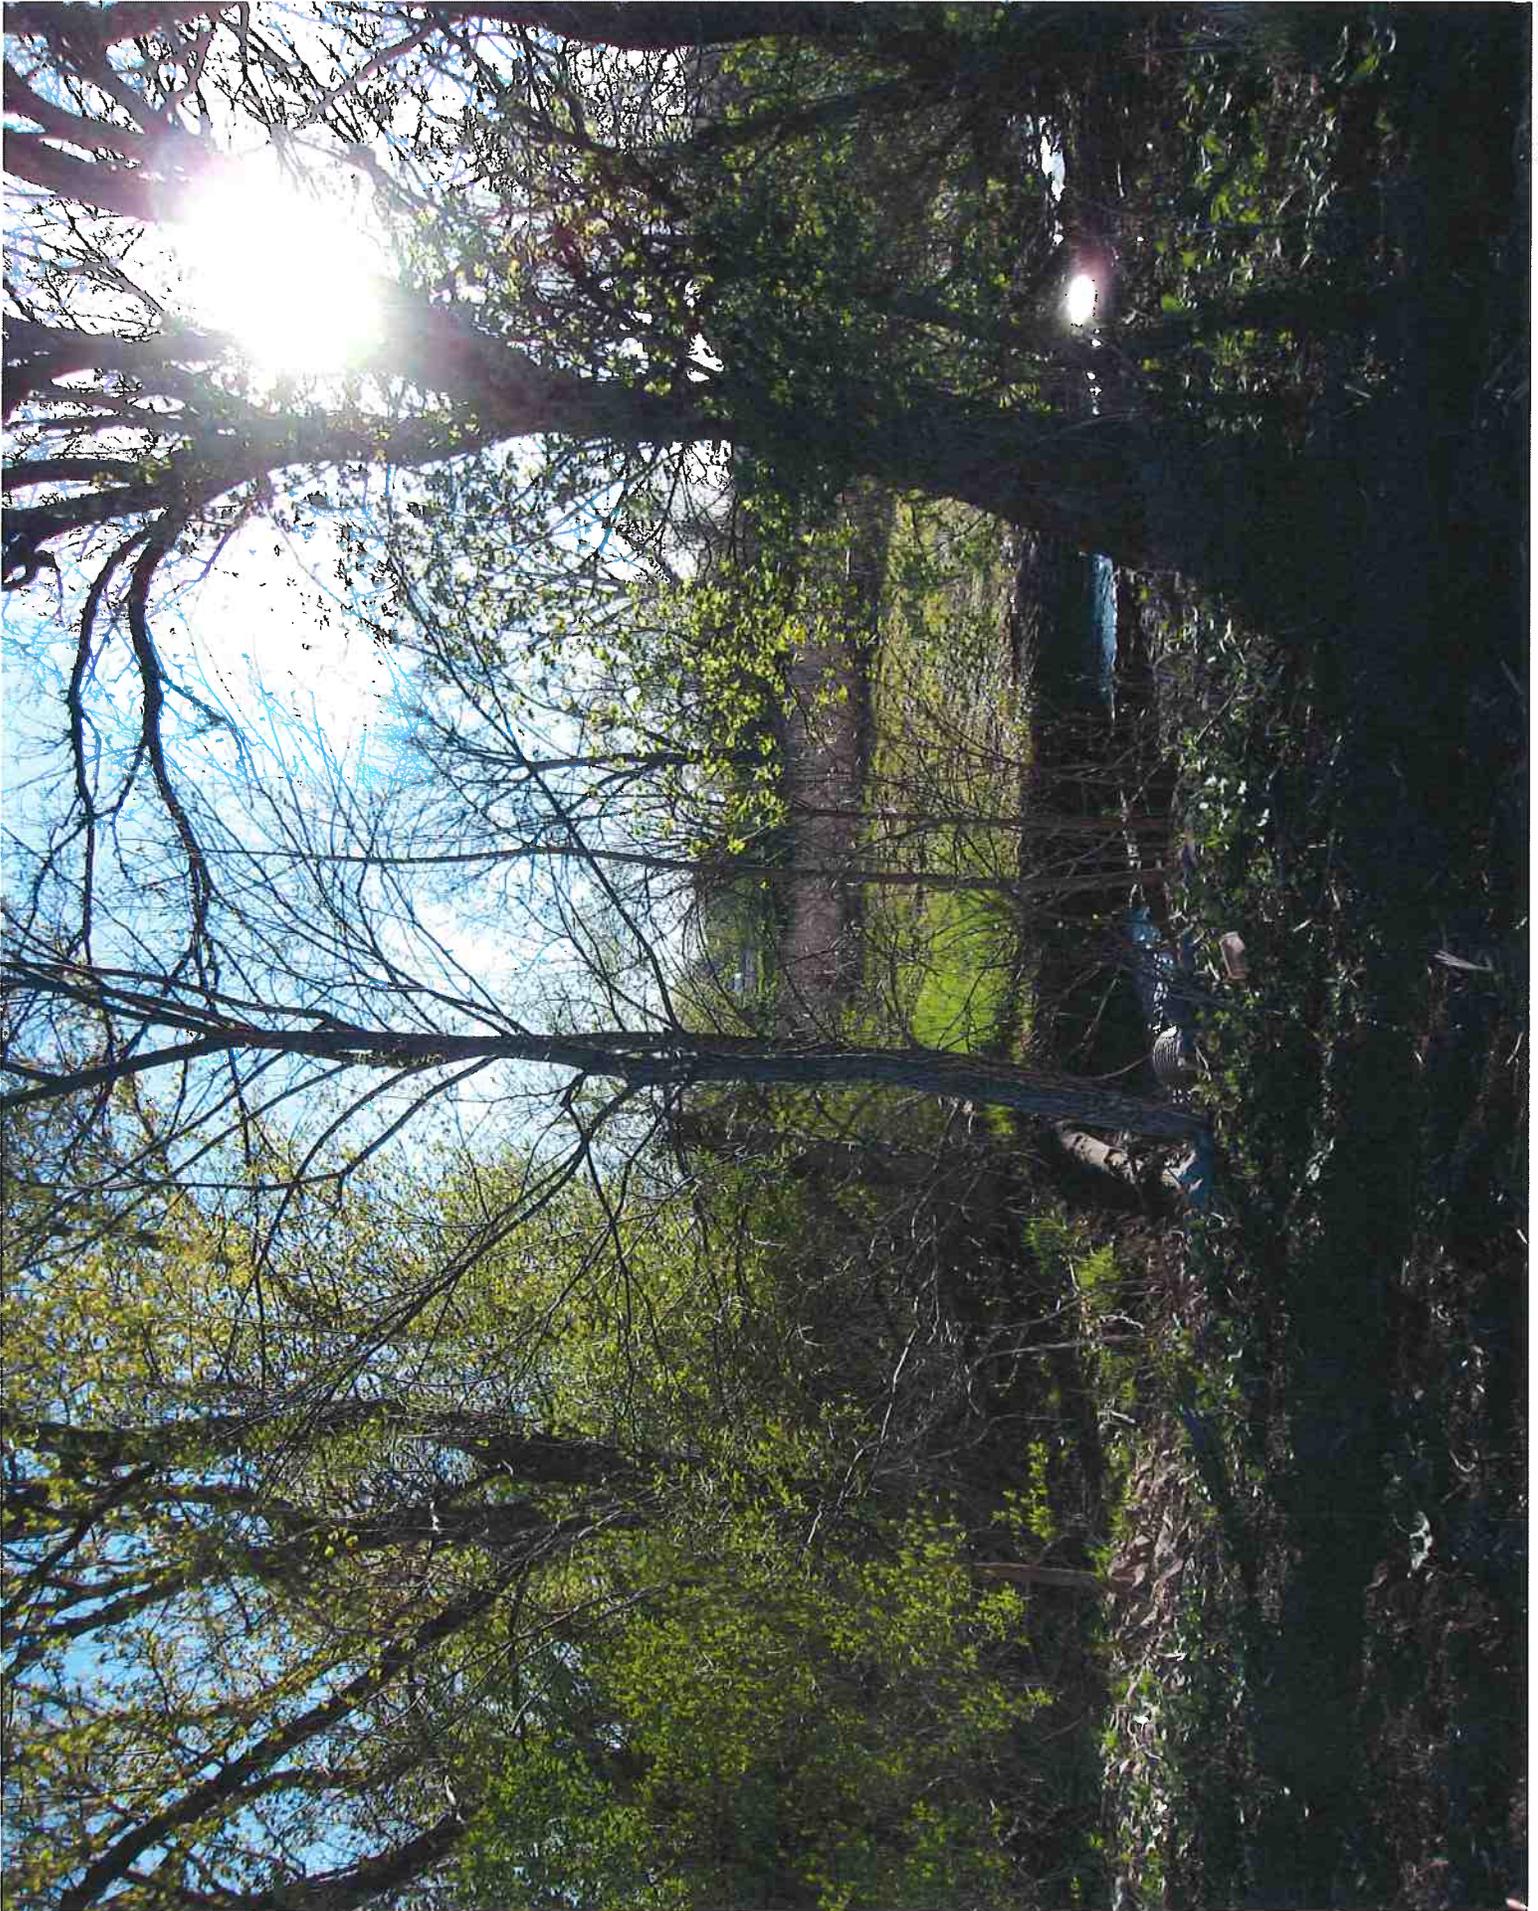
DAGO LAKE INLET (DD86 OLD MAIN) (14) 15" BOX ELDER AND HONEYSUCKEE BRUSH NEEDS REMOVED

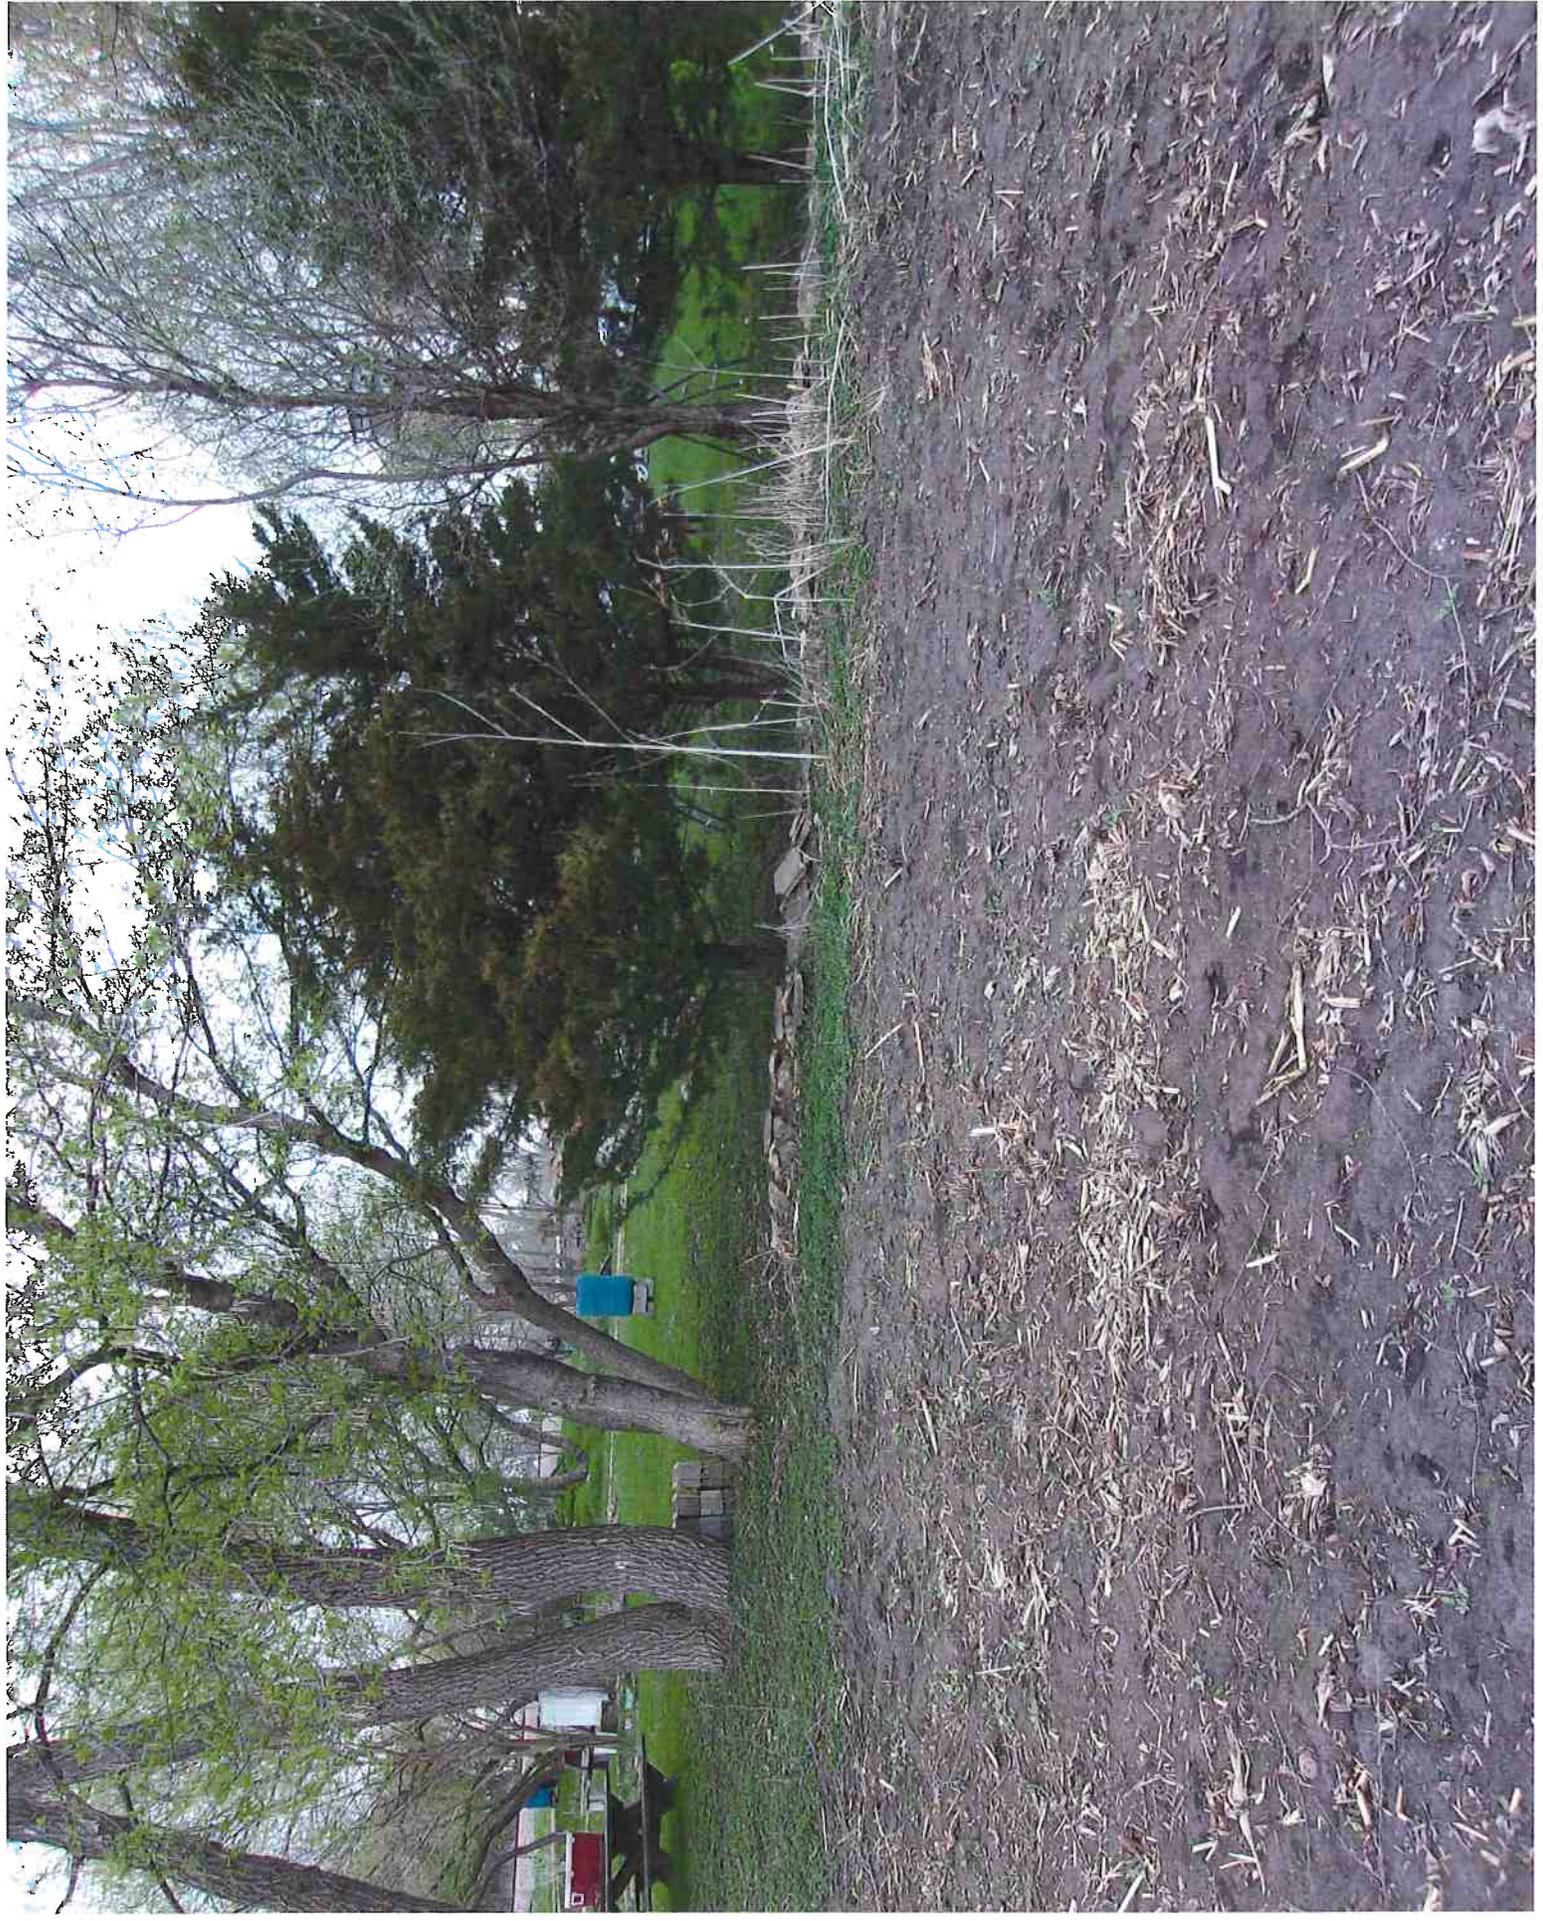
Looking East @ Monarch Lake Tye Route (5) Trees Need Removed (Not Cedar Trees)

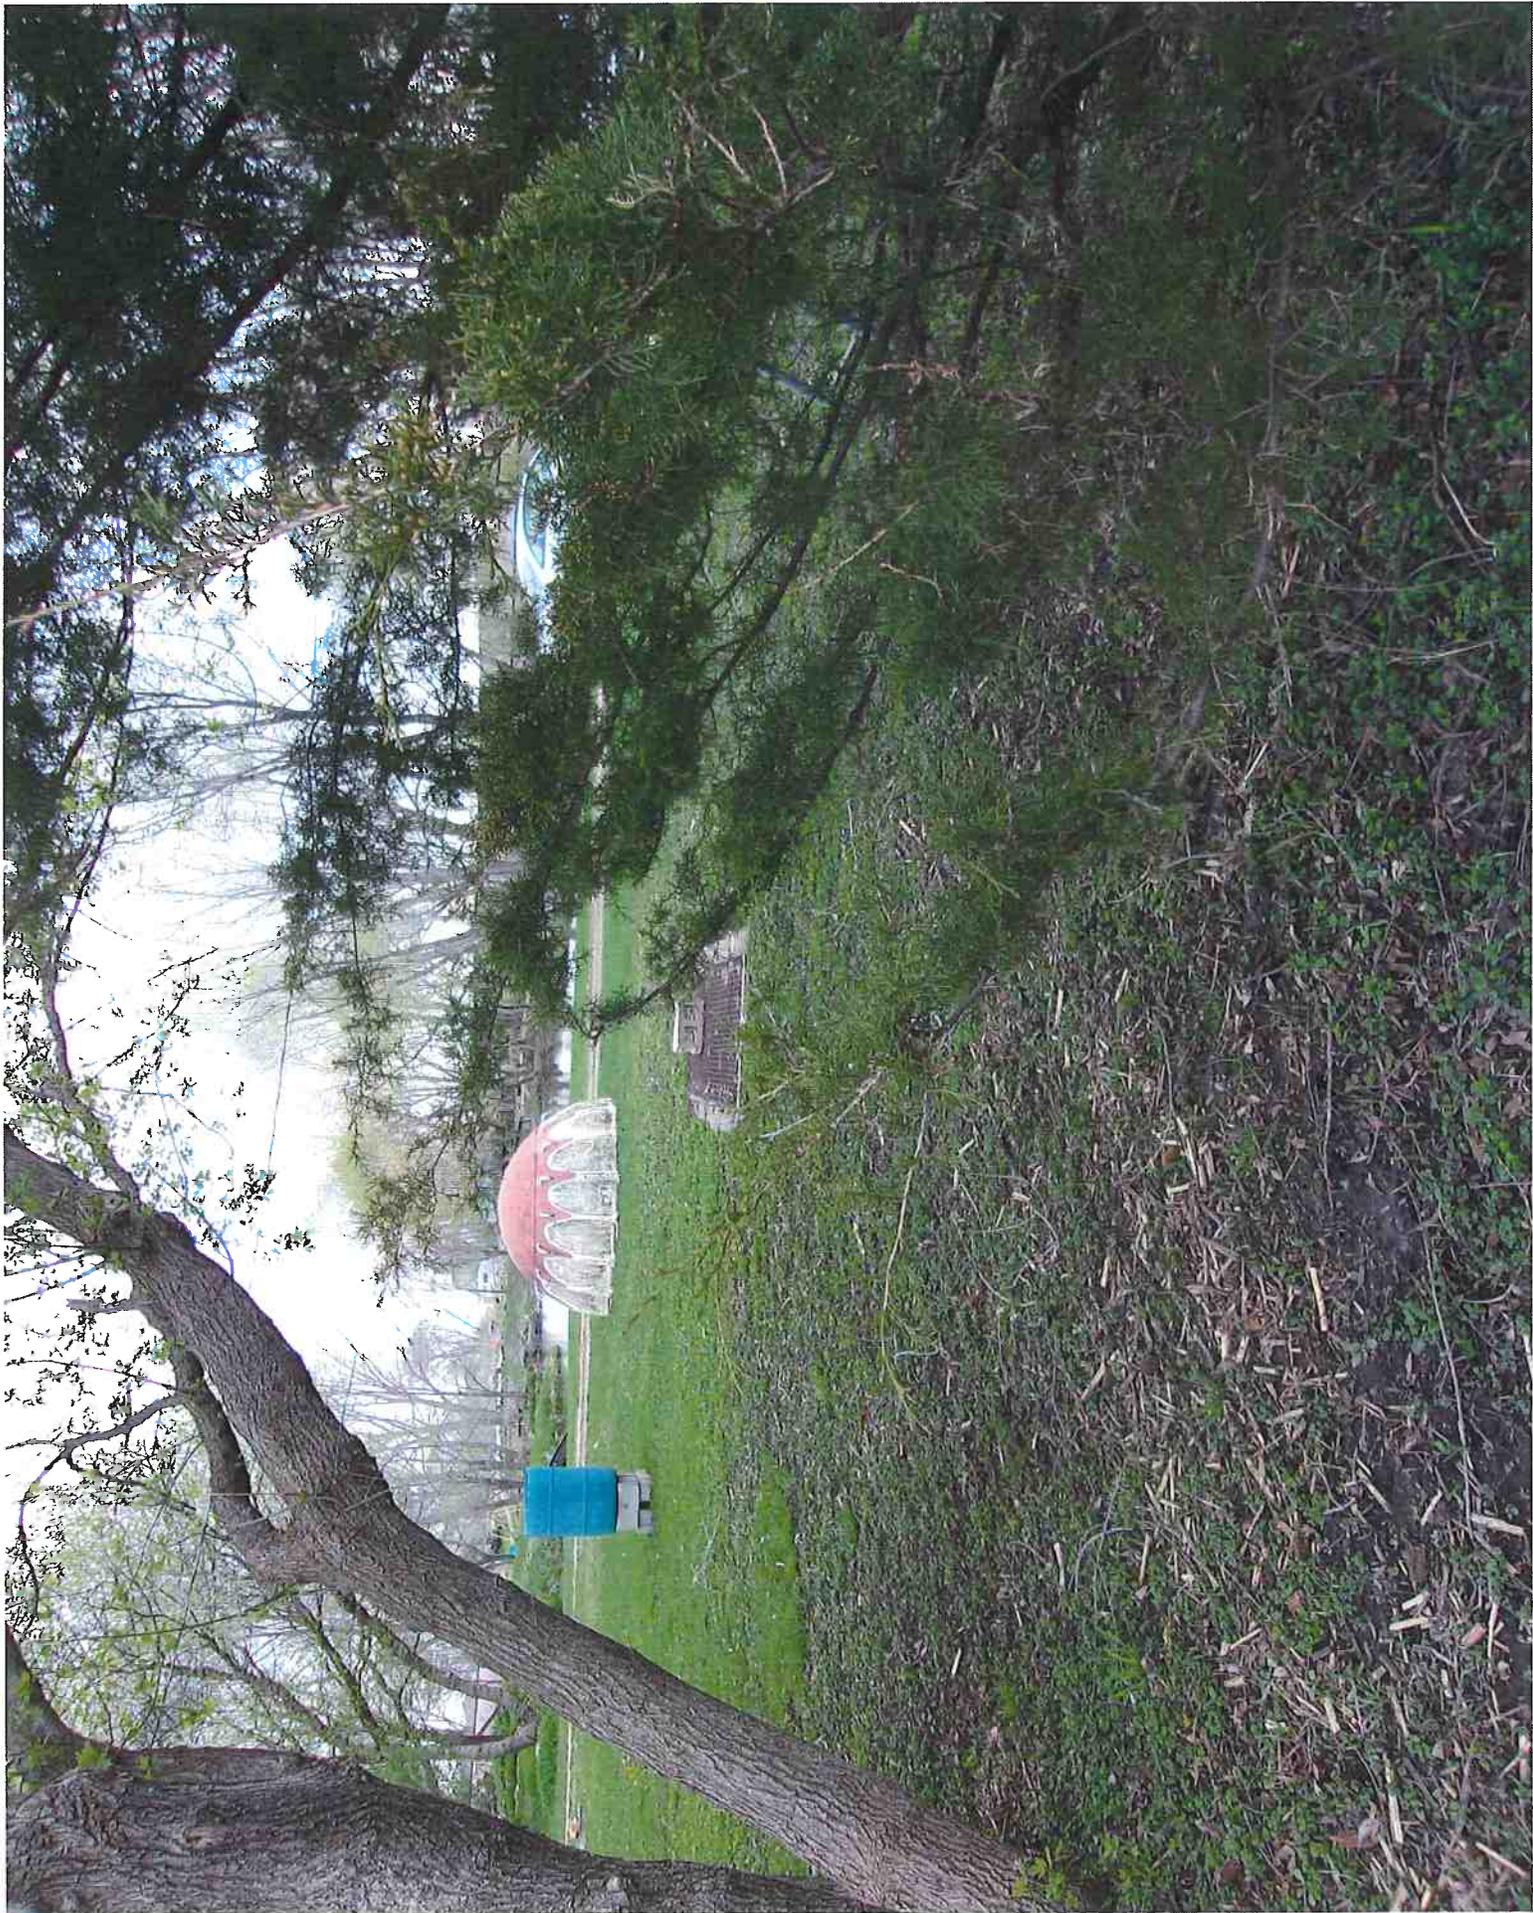
INTAKE ON TILE @ E. END OF MONARCH LAKE

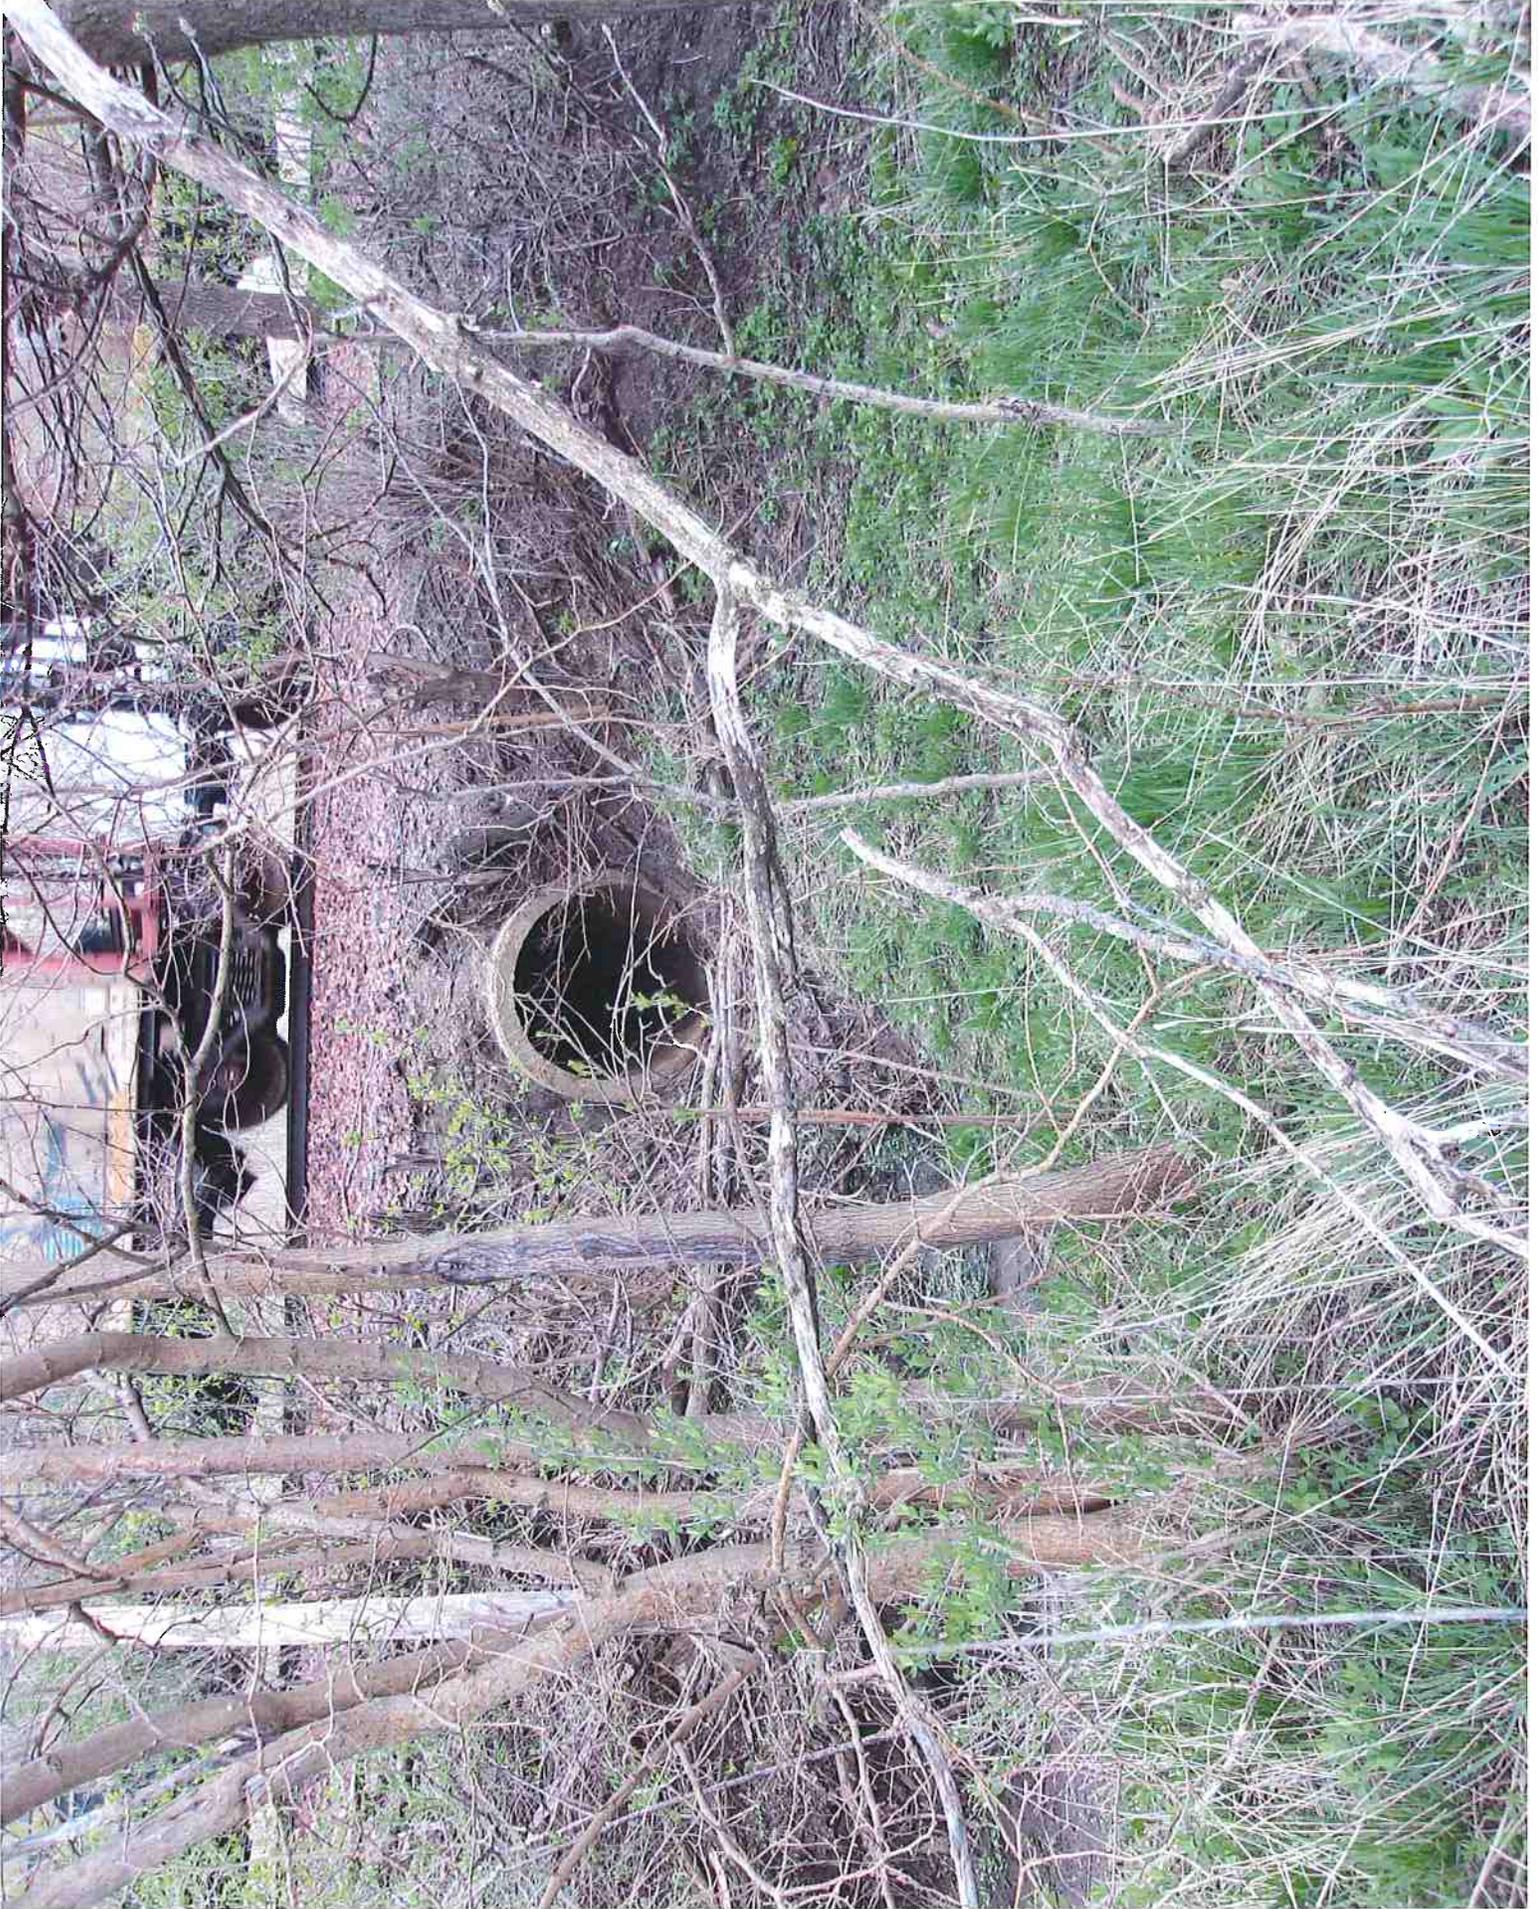
- Sand washing onto Monarch pond property is from surface water south of railroad tracks and from field to the west (both are within district boundaries).

SURFACE DRAINAGE From S. RR @ MONARCH LAKE

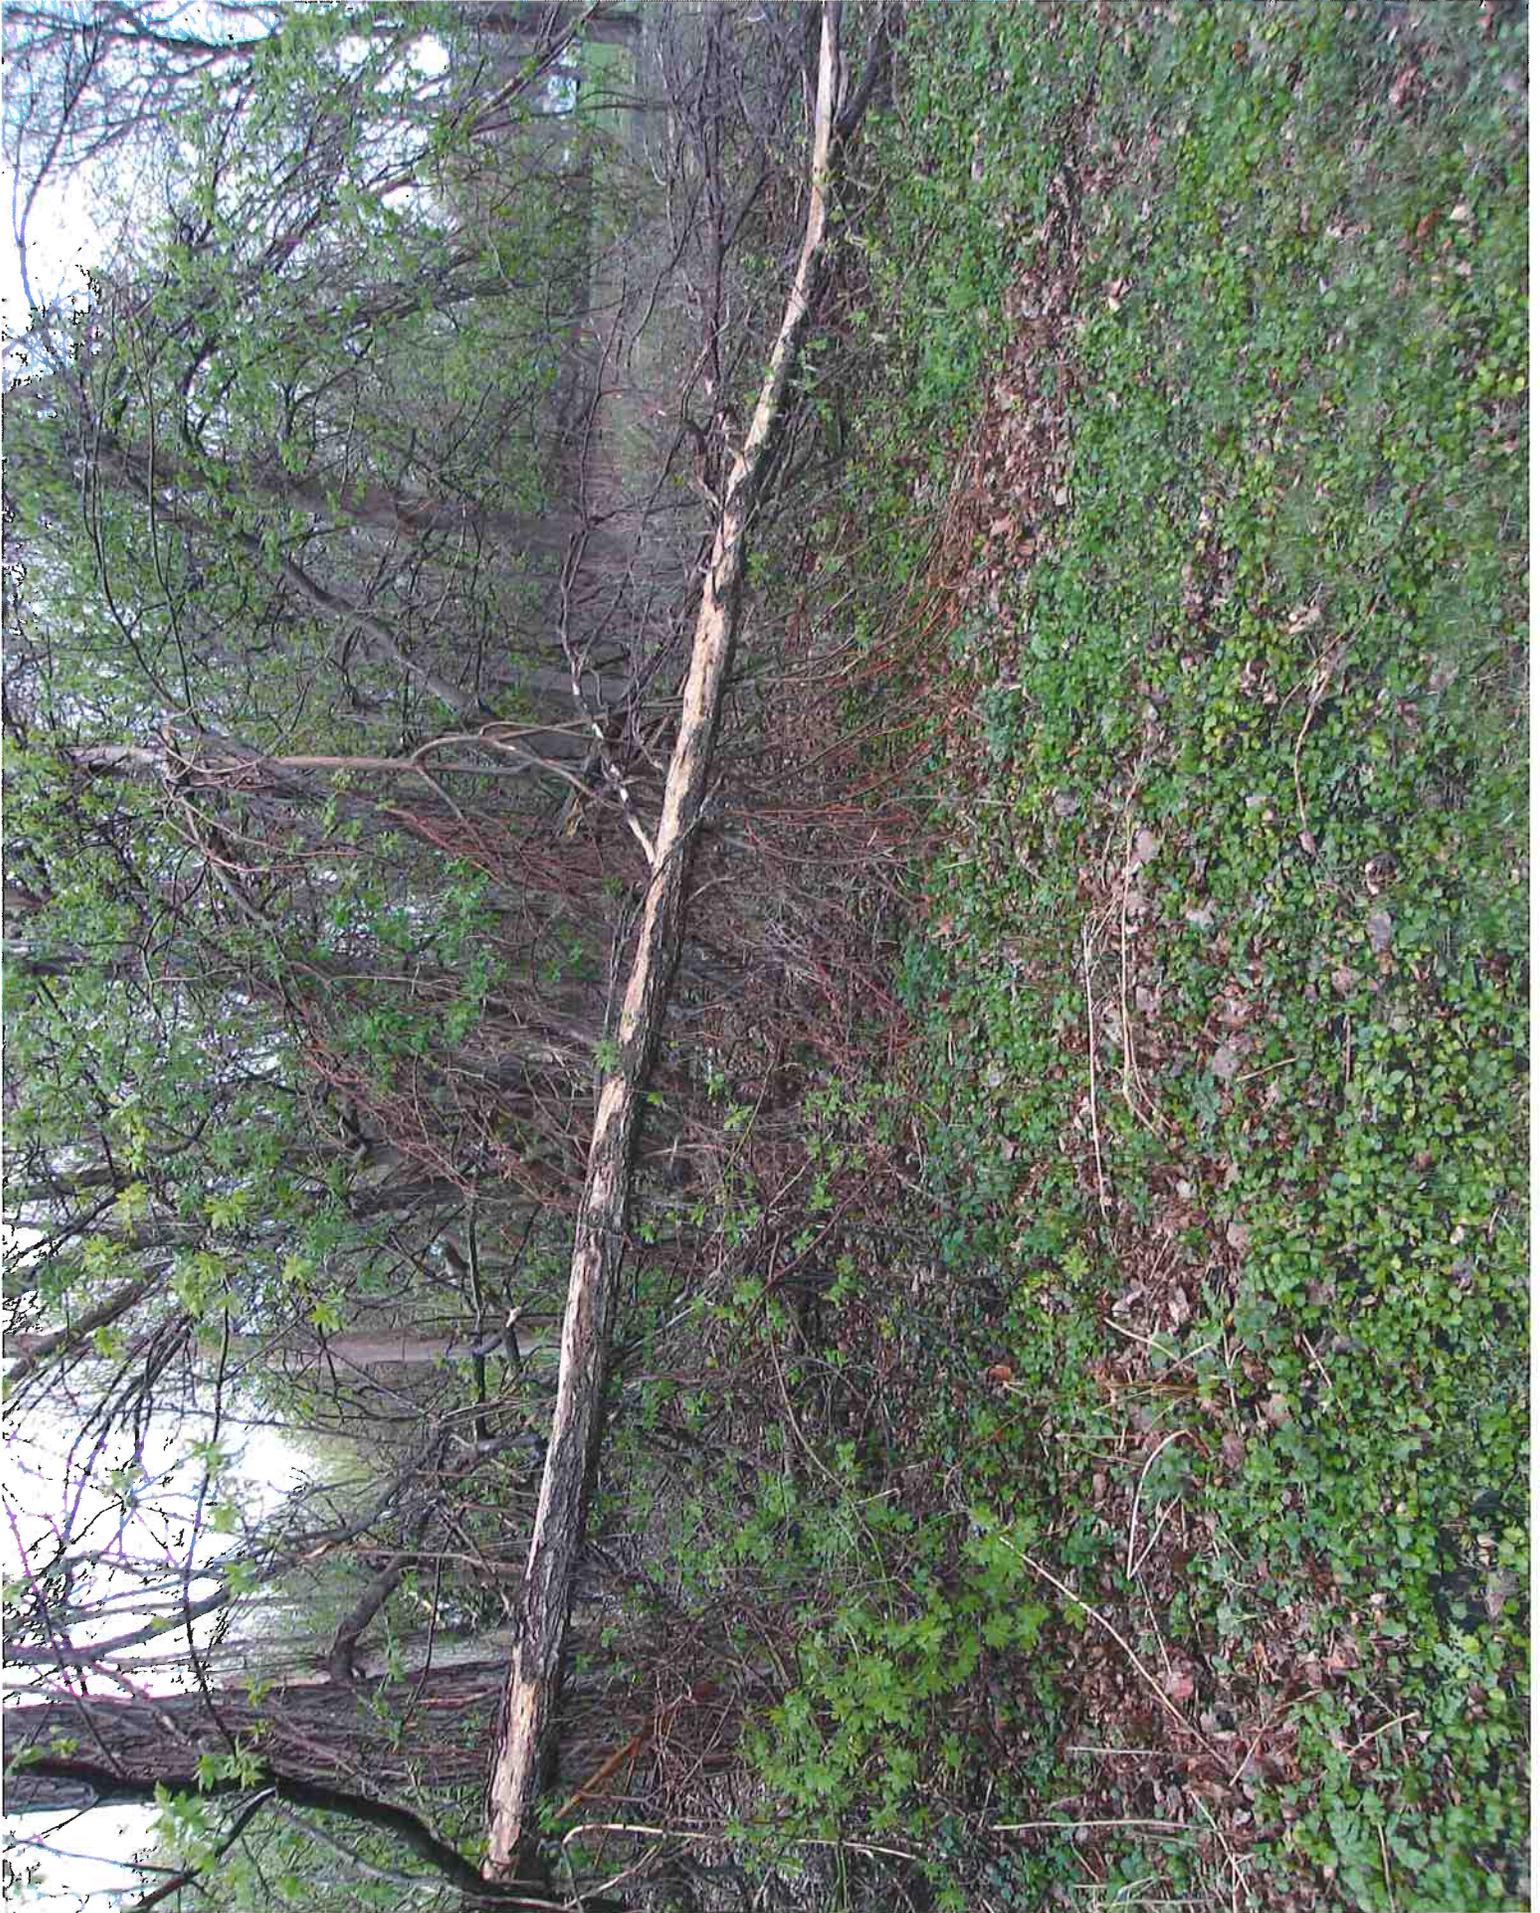
BEEHIVE INTAKE IS IN TREES SOMEWHERE 90+ TREES IN THE R/W N. OF RR

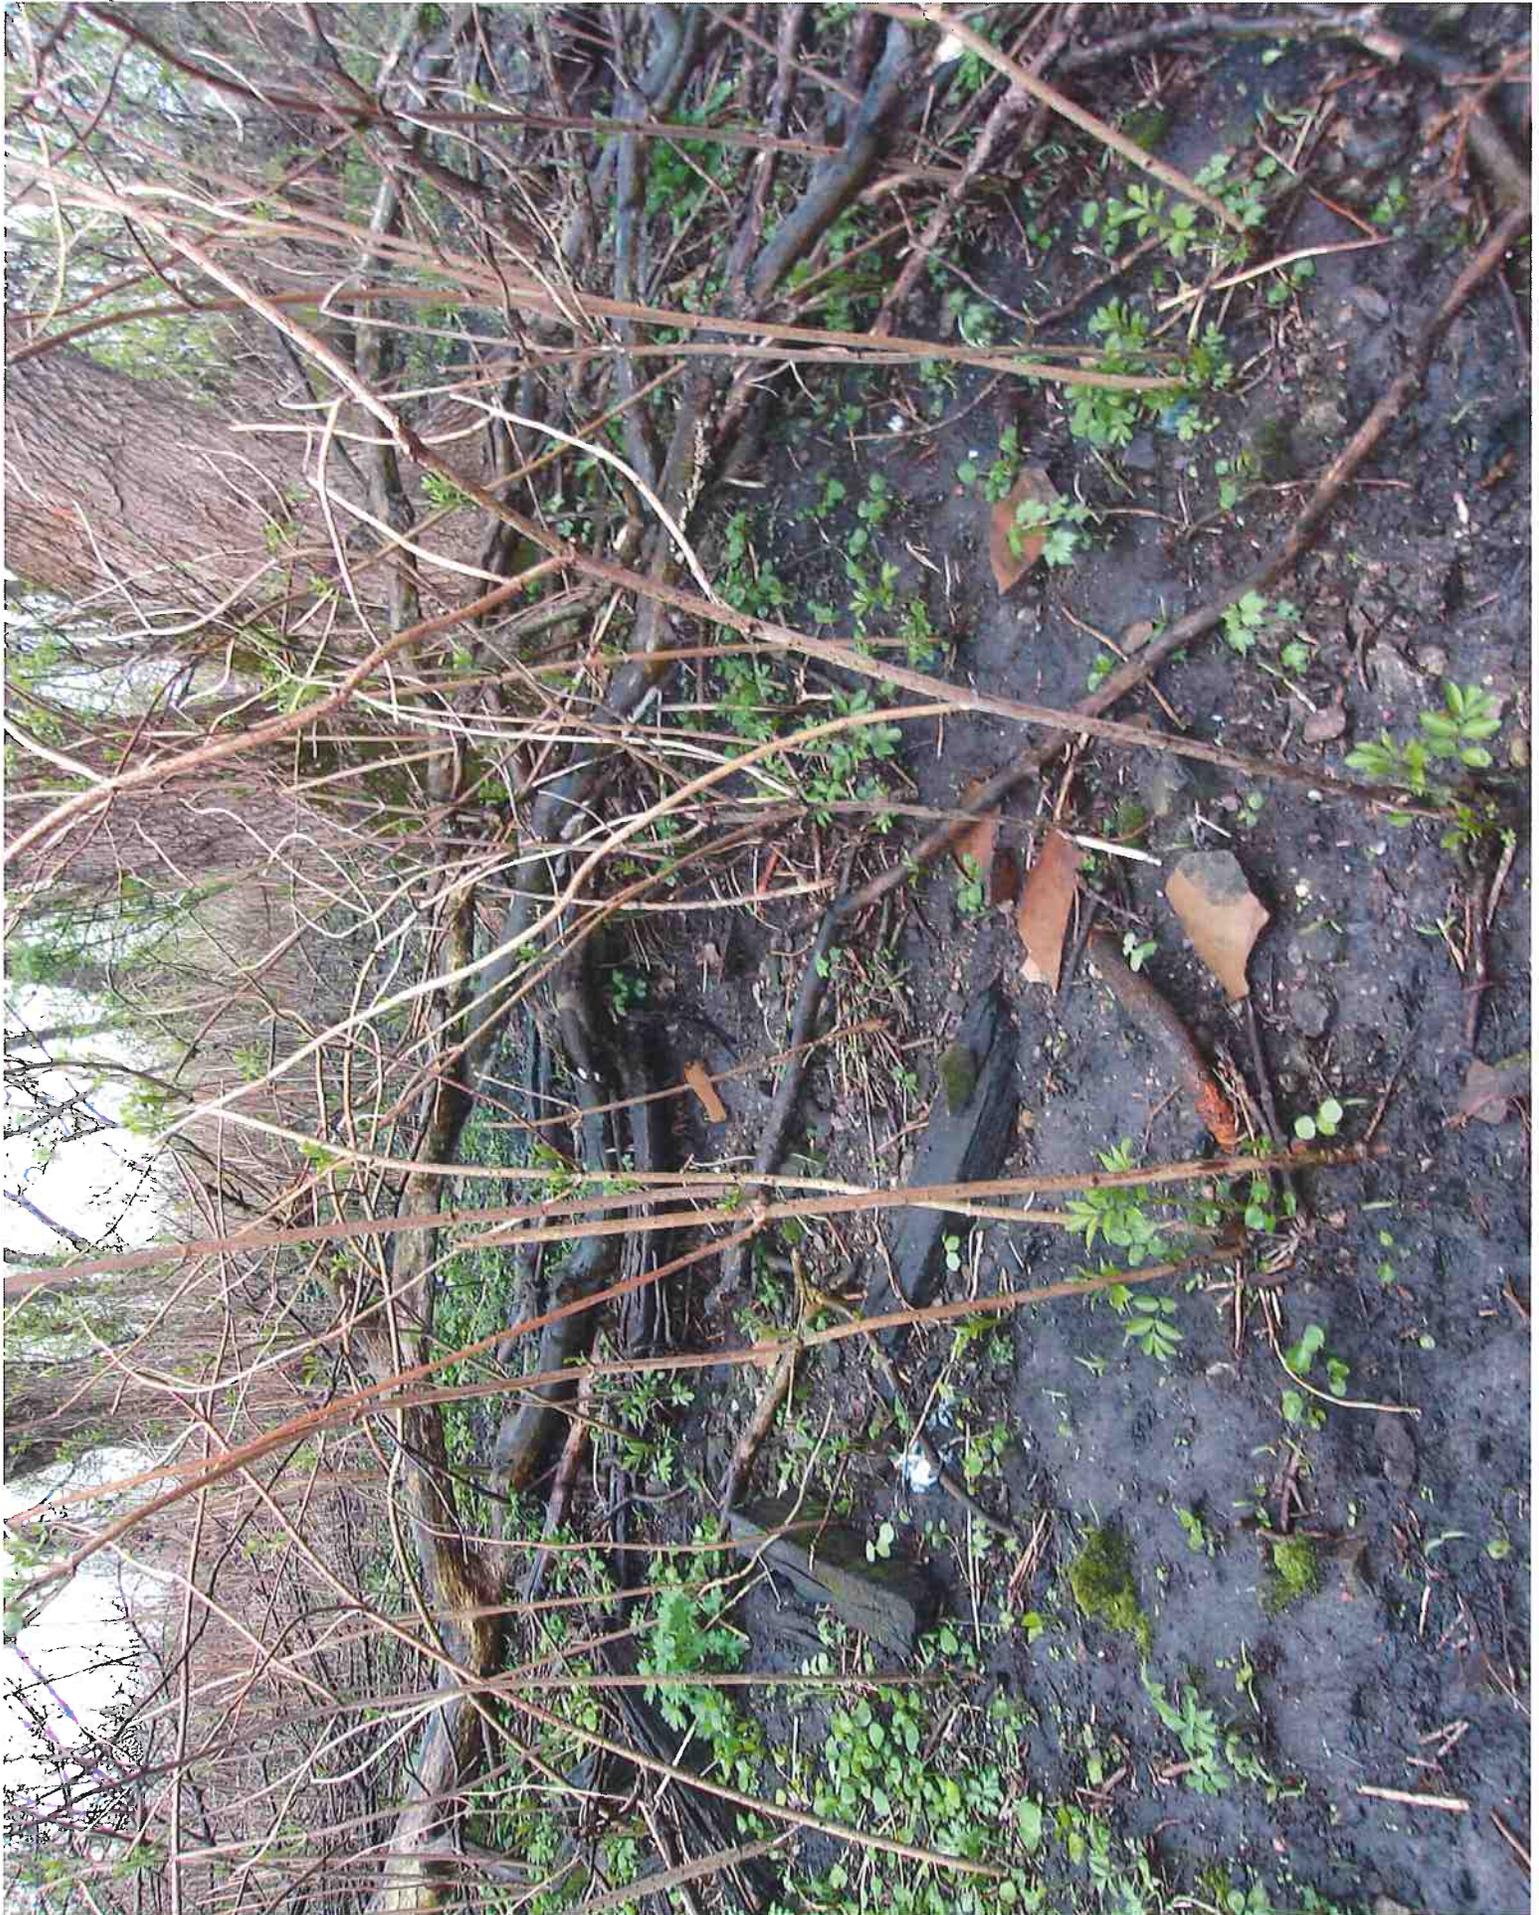
TILE ROUTE MARKED WITH BROKEN TILE

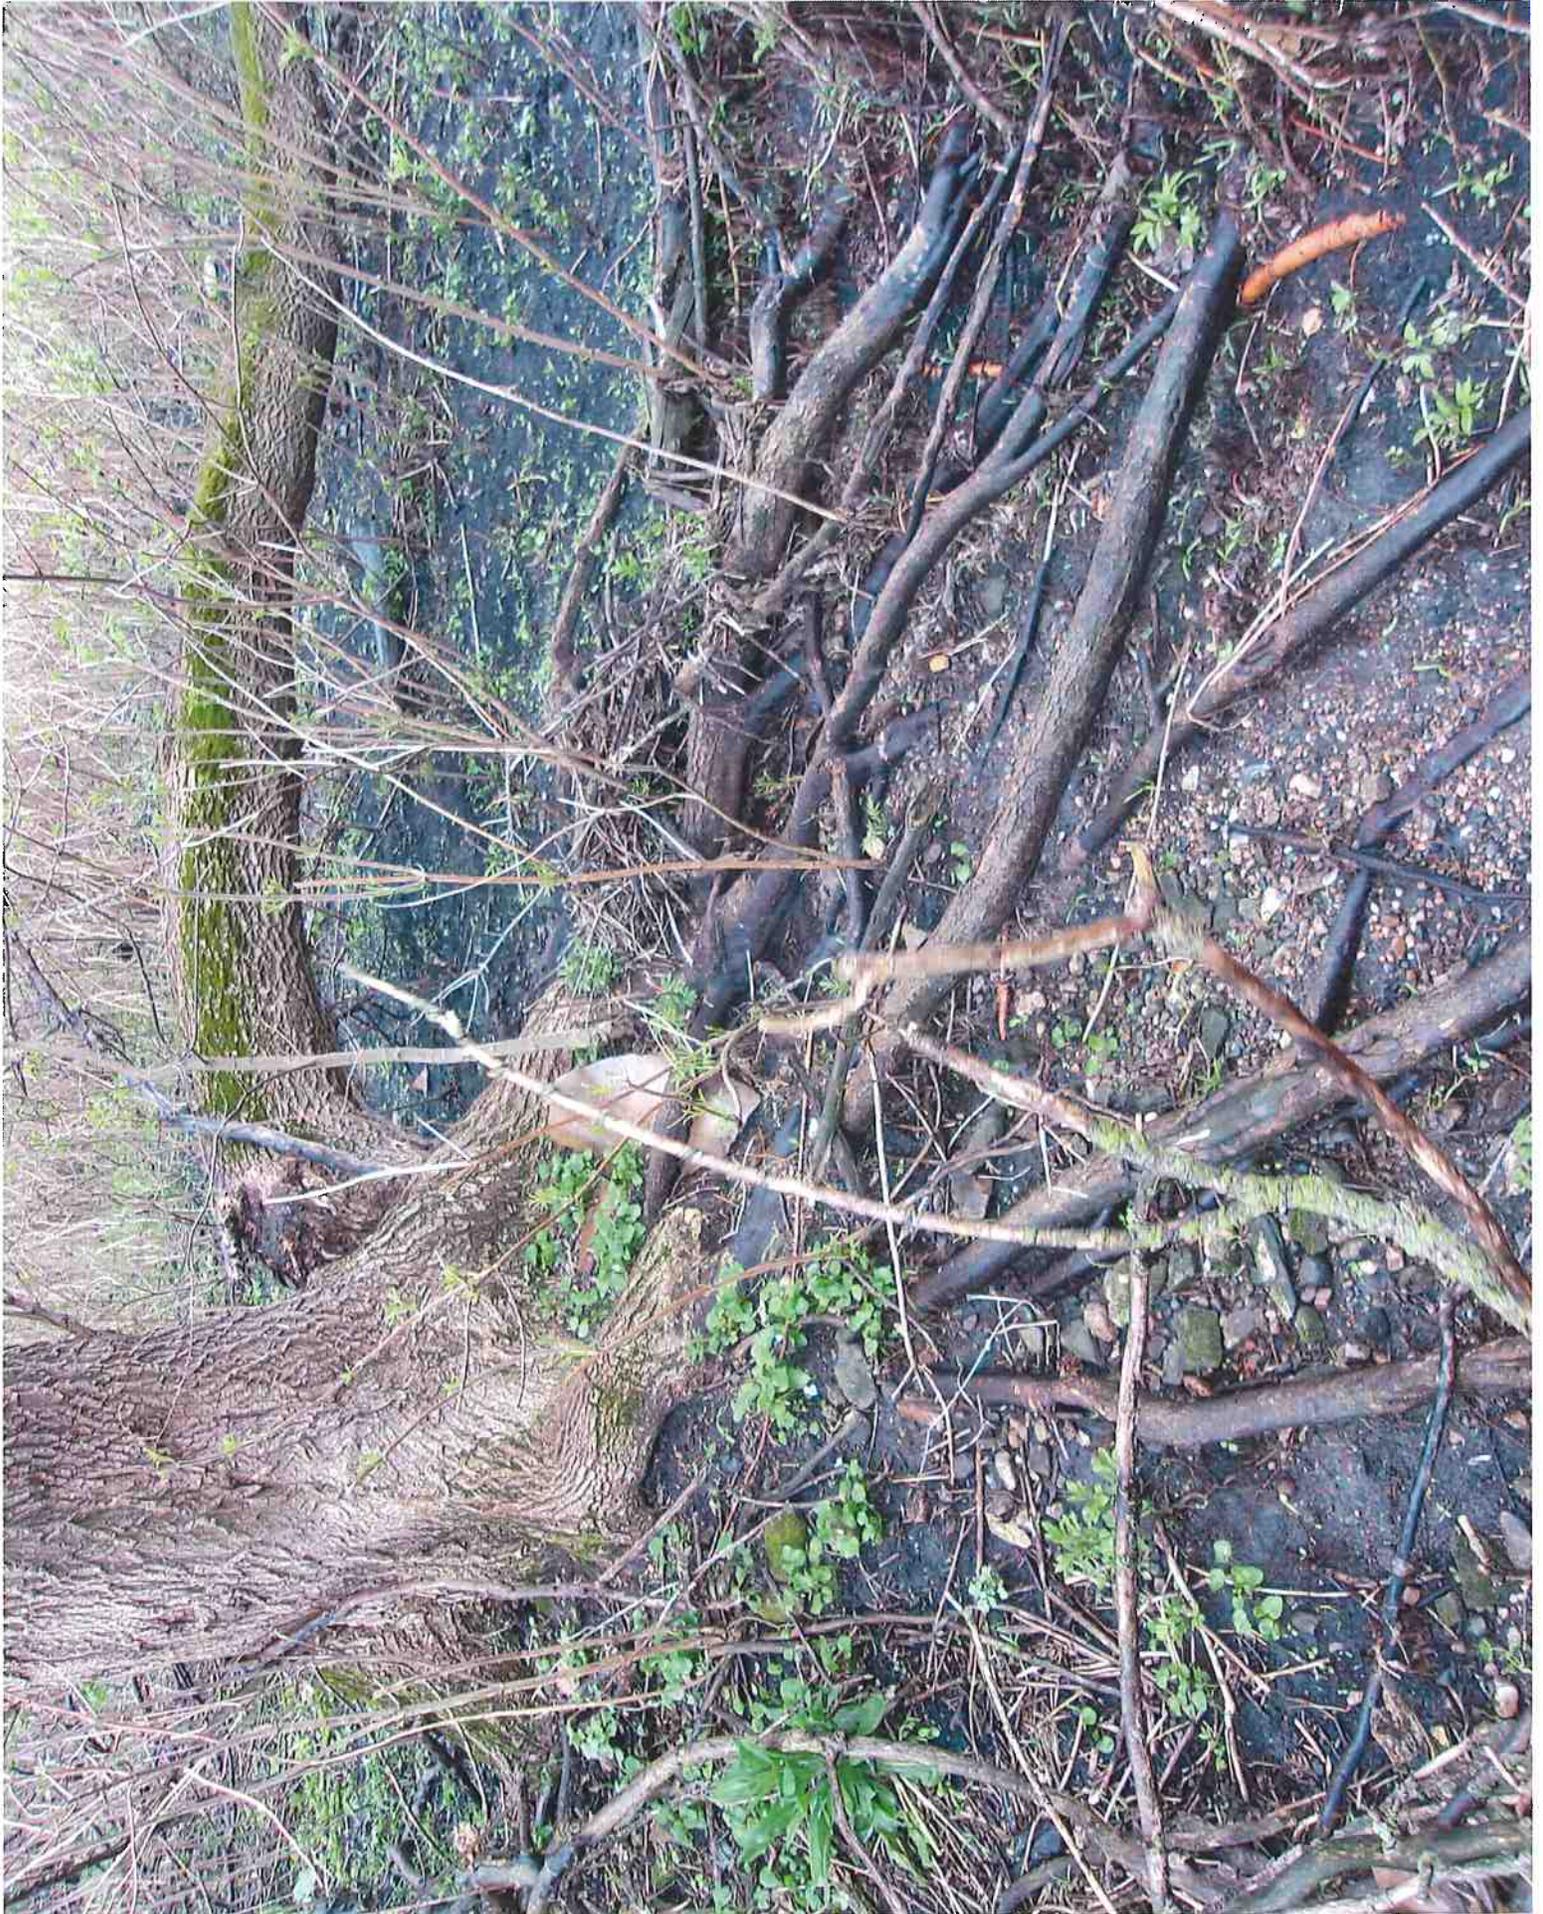
TILE ROUTE WITH CHARDS IN TREE ROOTS
