AGENDA
DD 86 LANDOWNER MEETING
JULY 17, 2019 AT 11:00 AM

Drainage District:

86

Investigation Report:

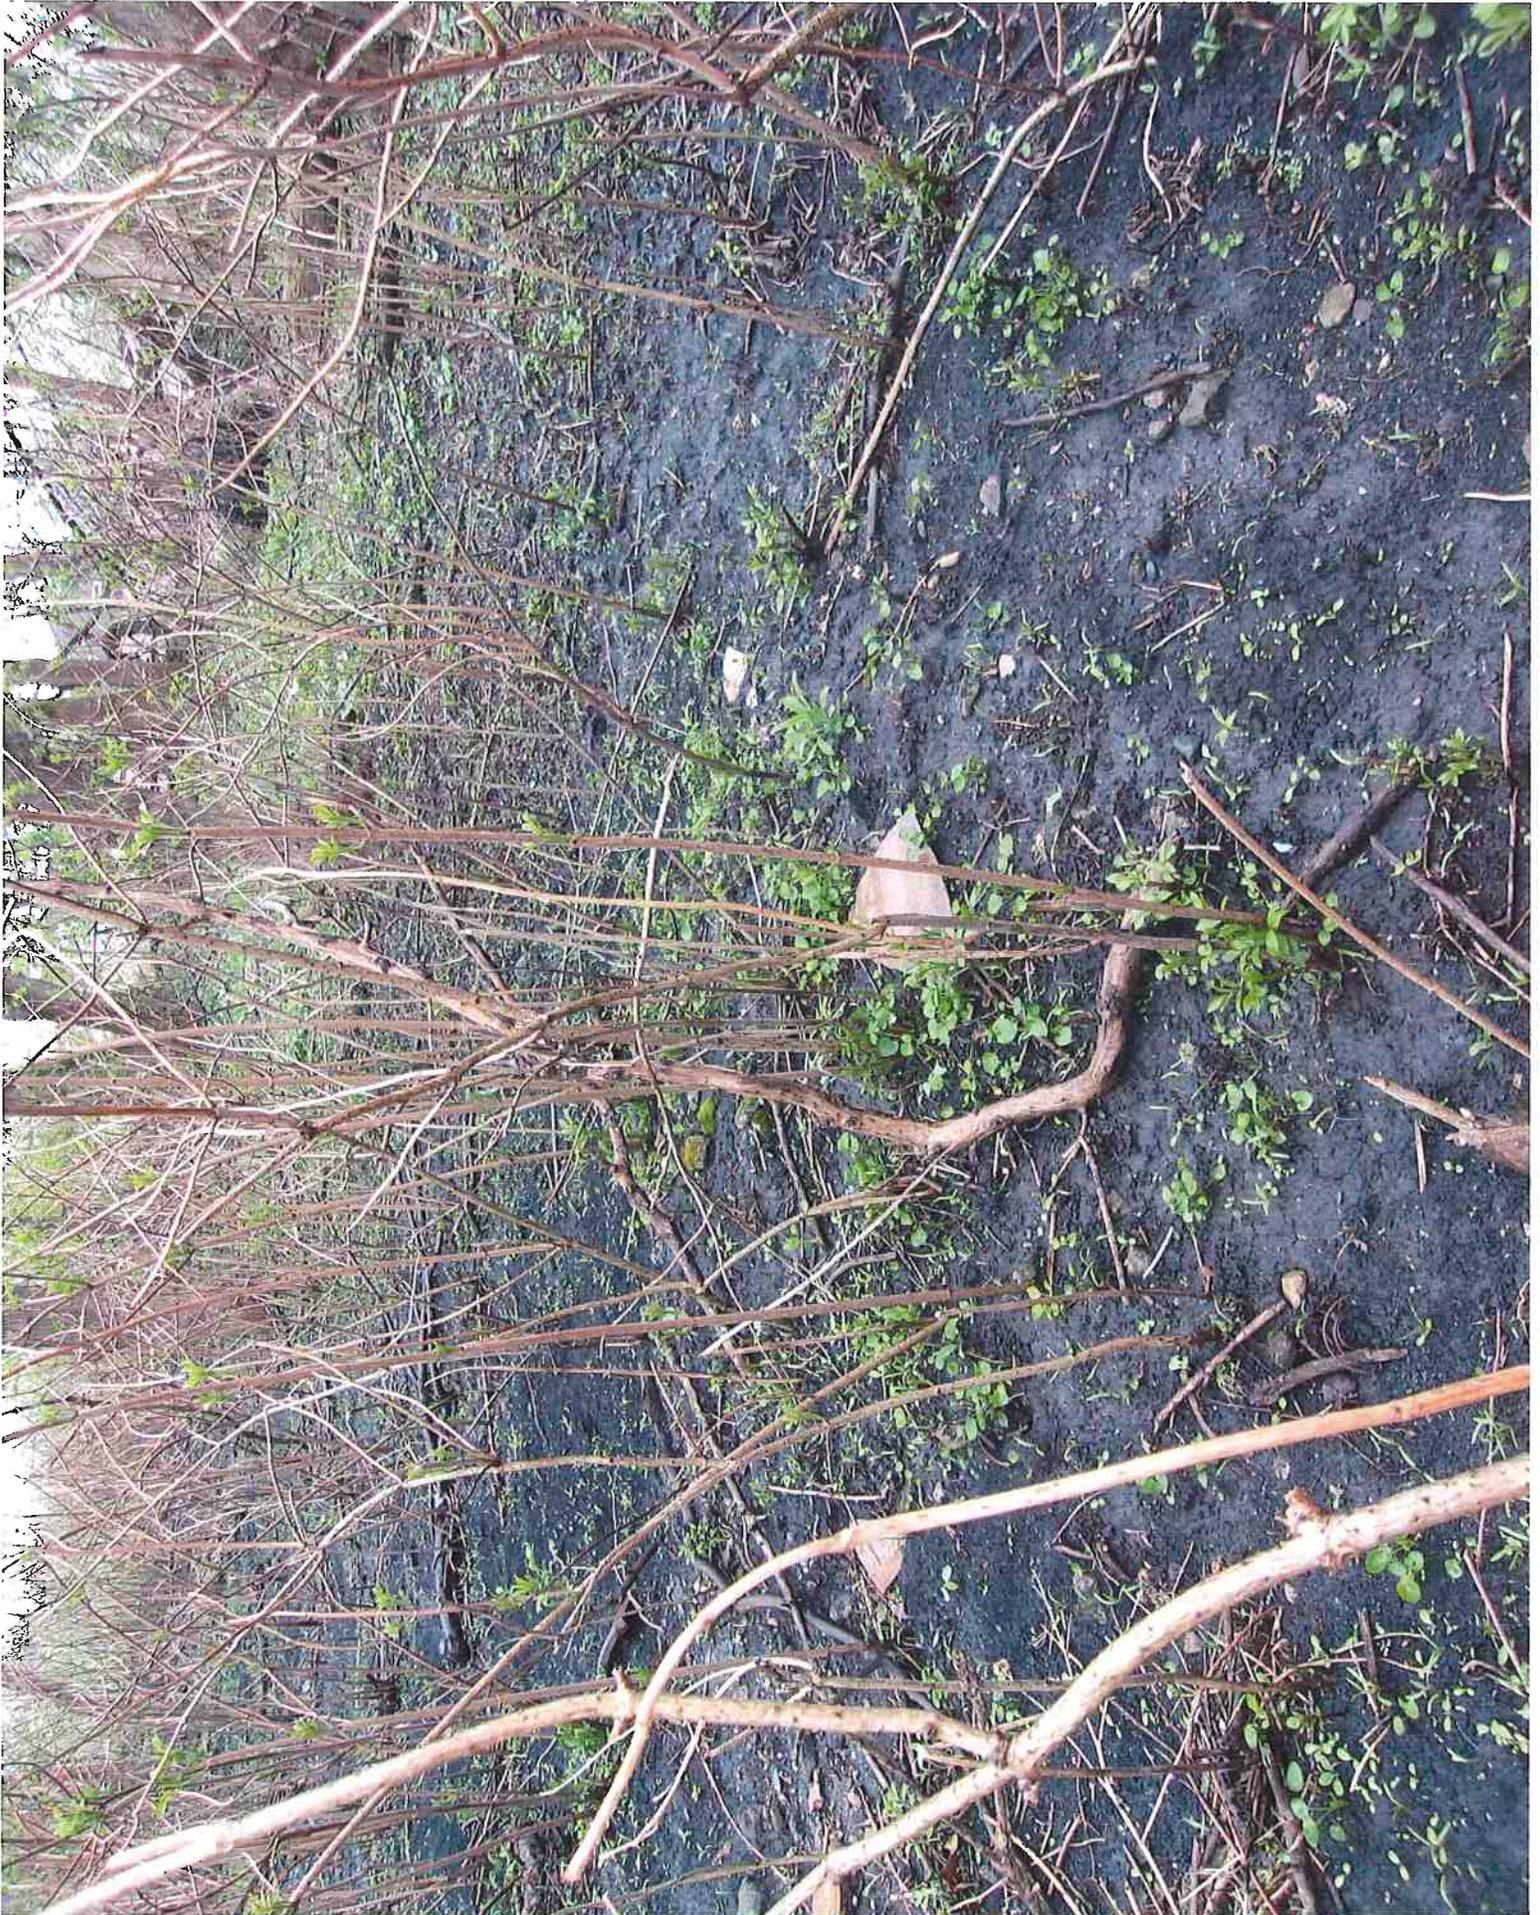
TILE CHARDS THRU ELDERBERRY BRUSH

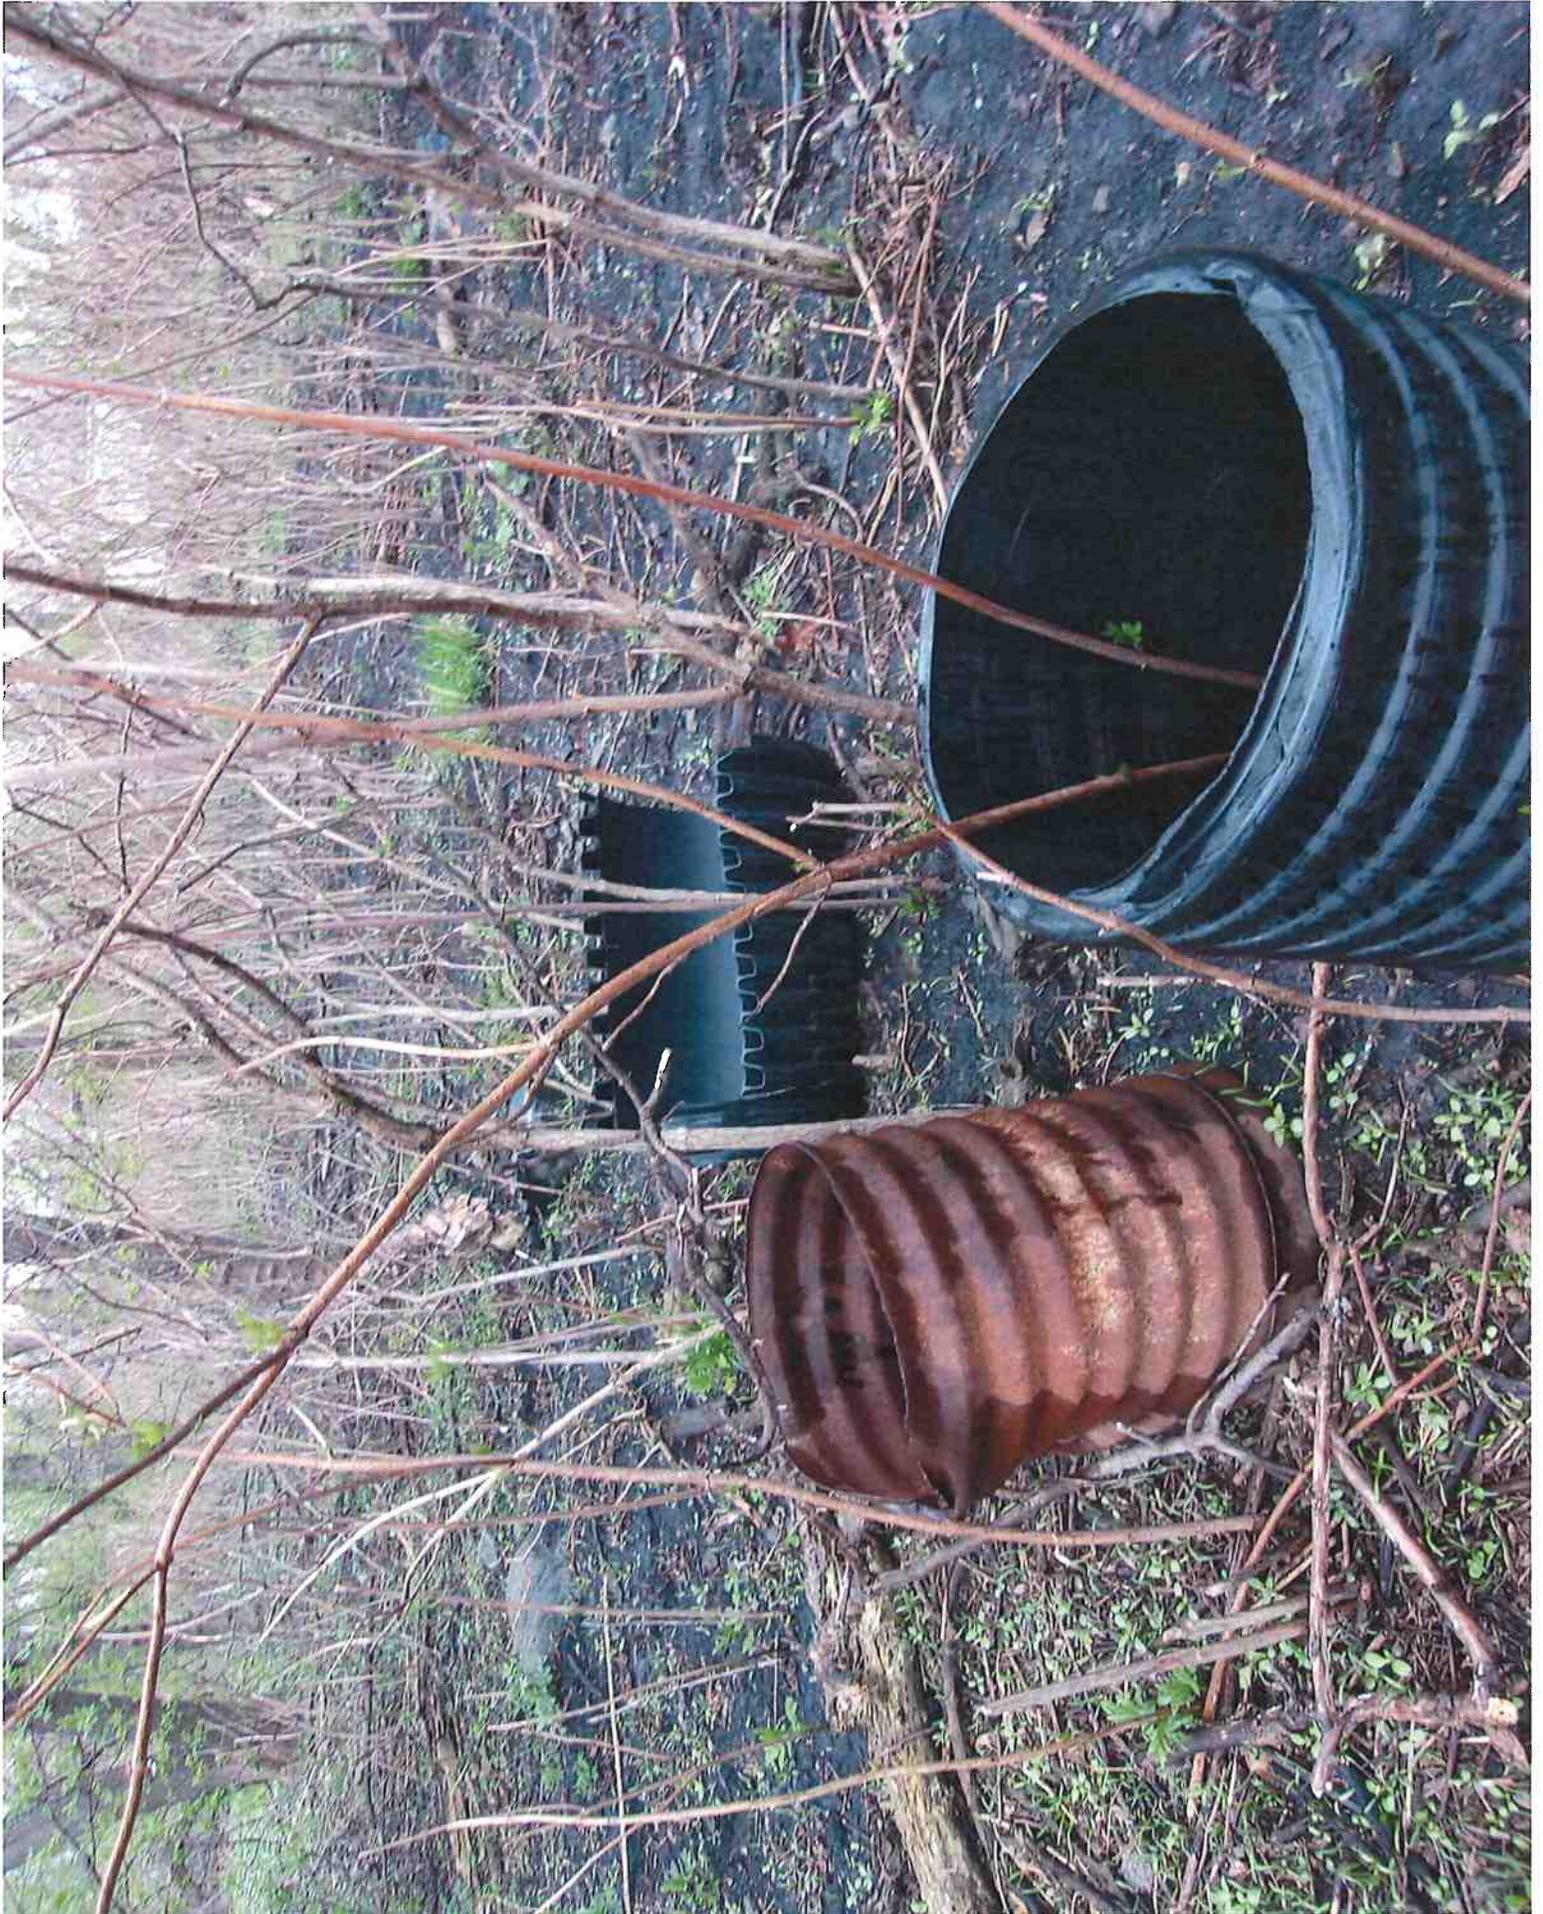
TILE REPAIR PIECES DISCARDED

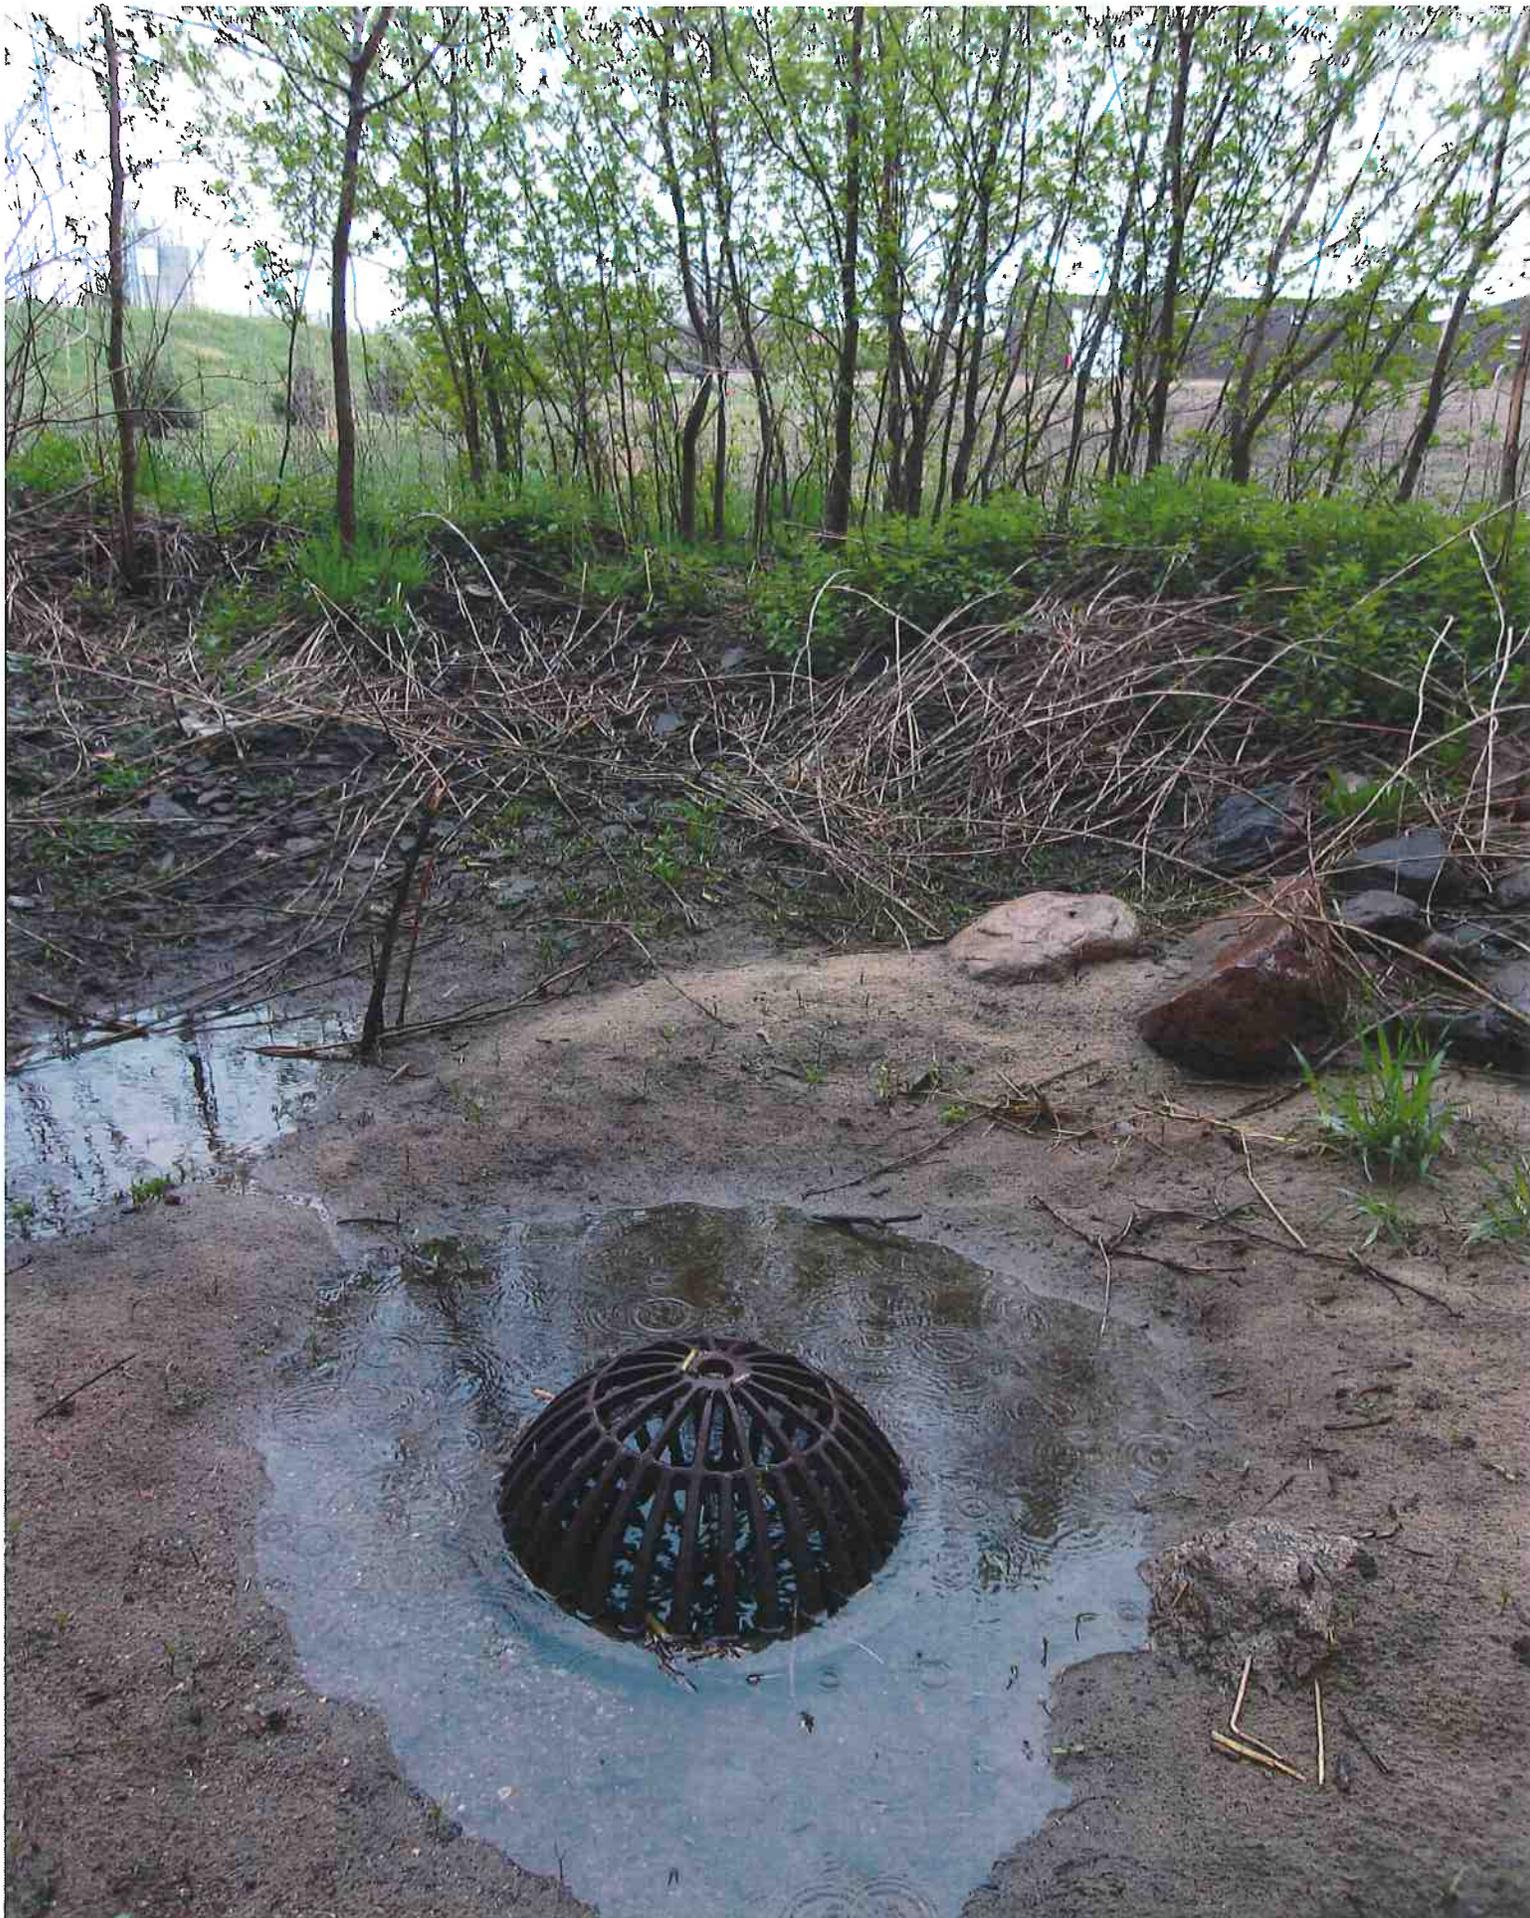
Said trees appear to be impeding drainage as there are intakes downstream of Georgetown Road that are full of stagnant water and surrounded by siltation (evidence of overflow).

BEEHIVE OVERFLOWING @ NE COR OF GEORGETOWN ADD.

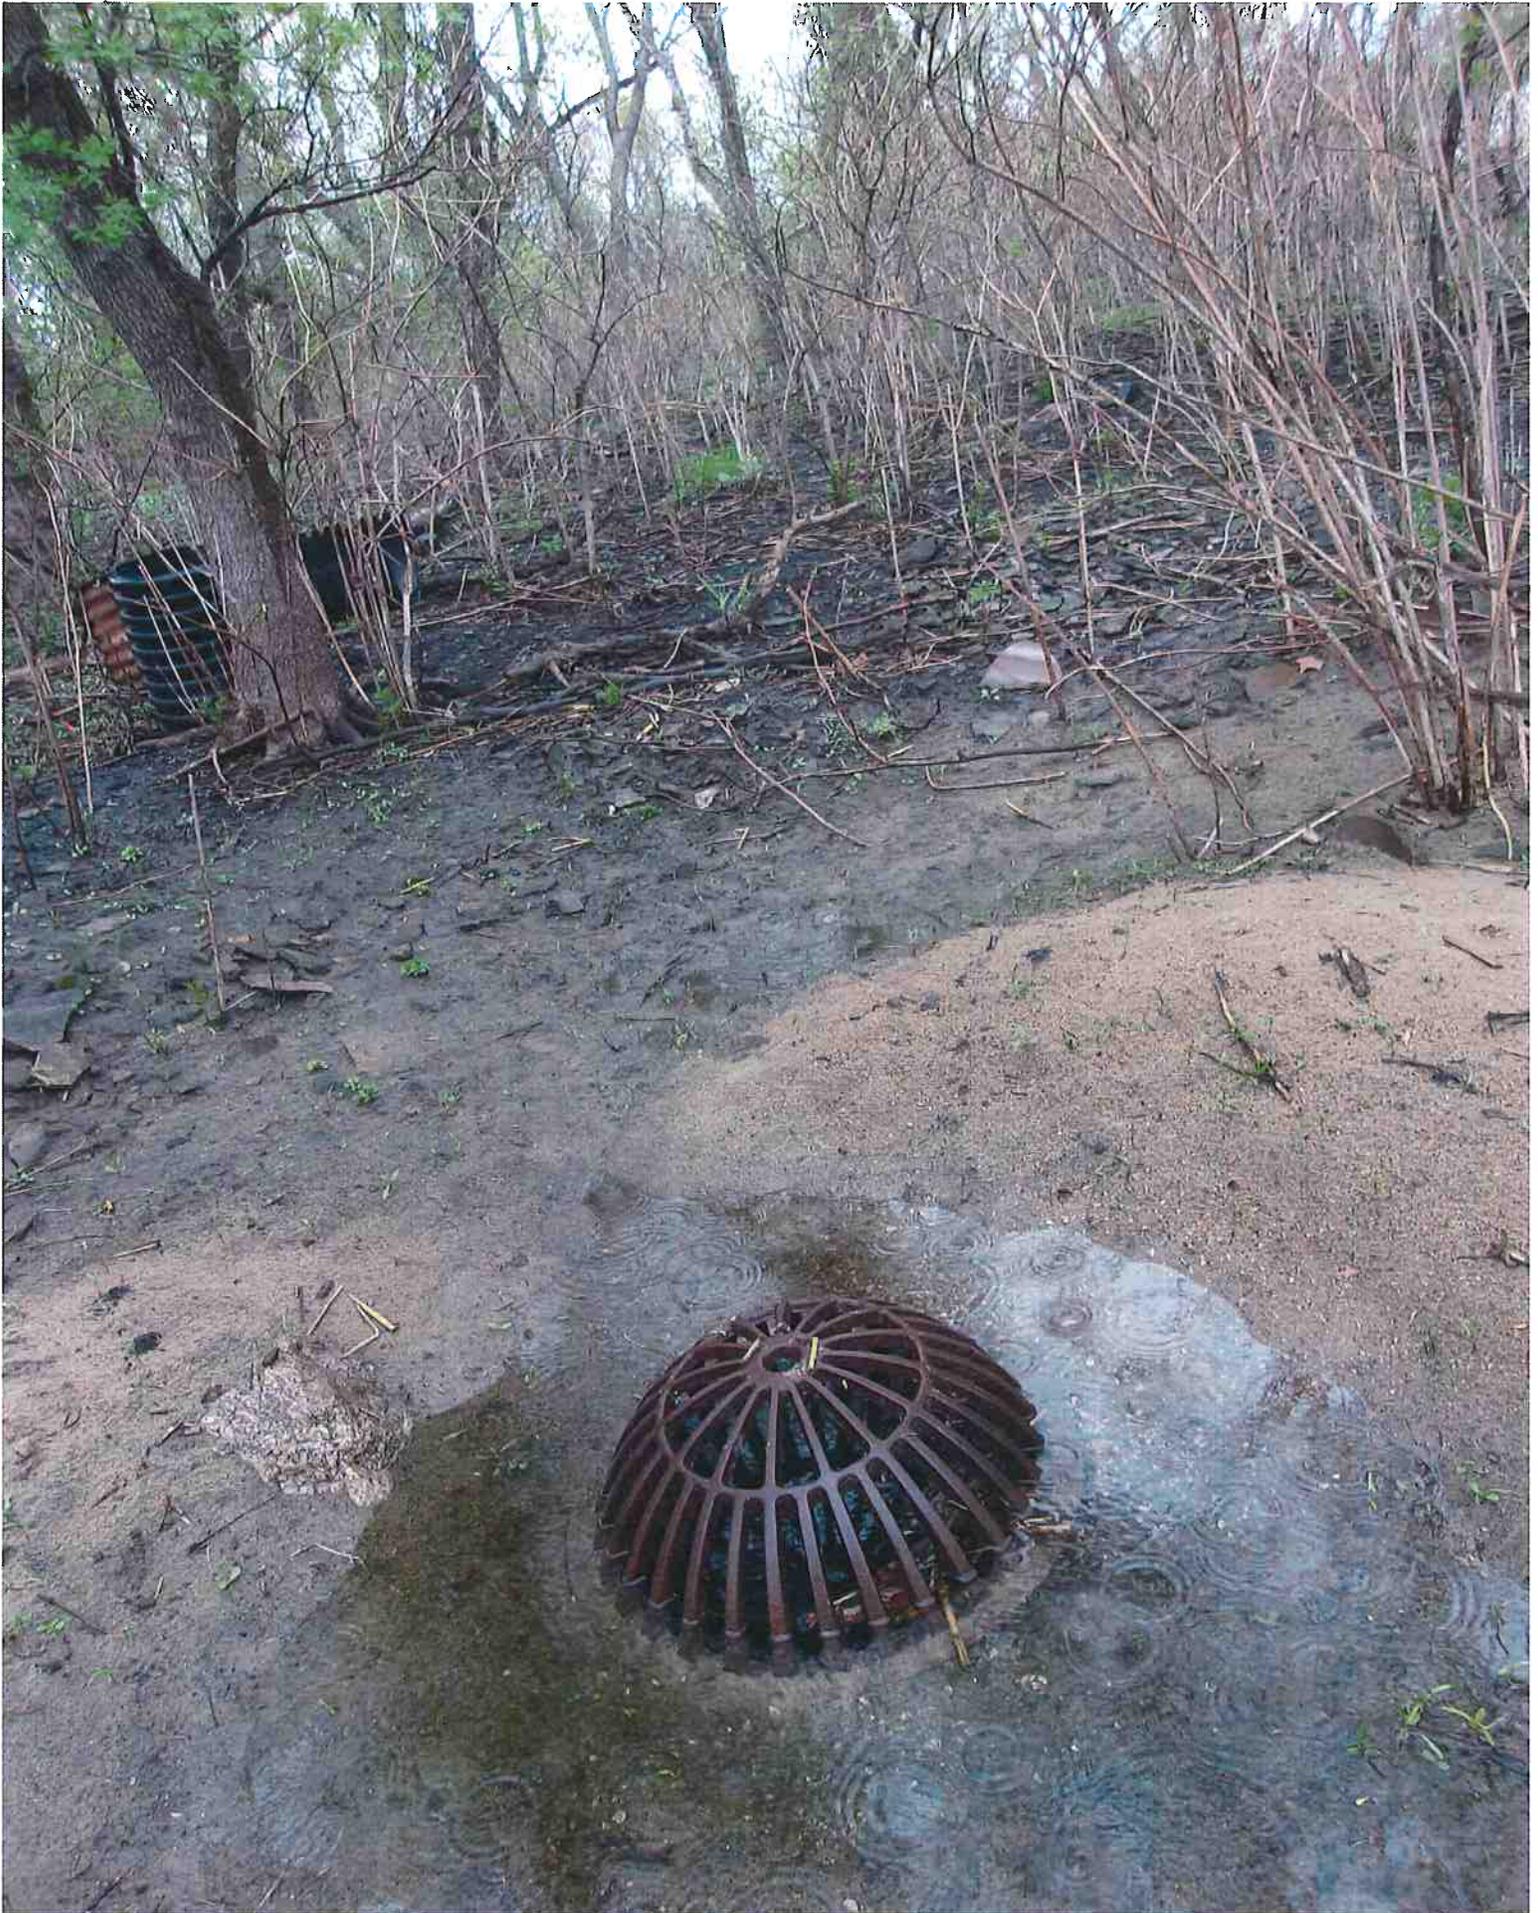
TILE HAS BEEN PARTIALLY PLUGGED FOR SOME TIME
LOOKING DOWN STREAM, NOTE ALL SEDIMENT SAND BLOWN OUT OF INTAKE

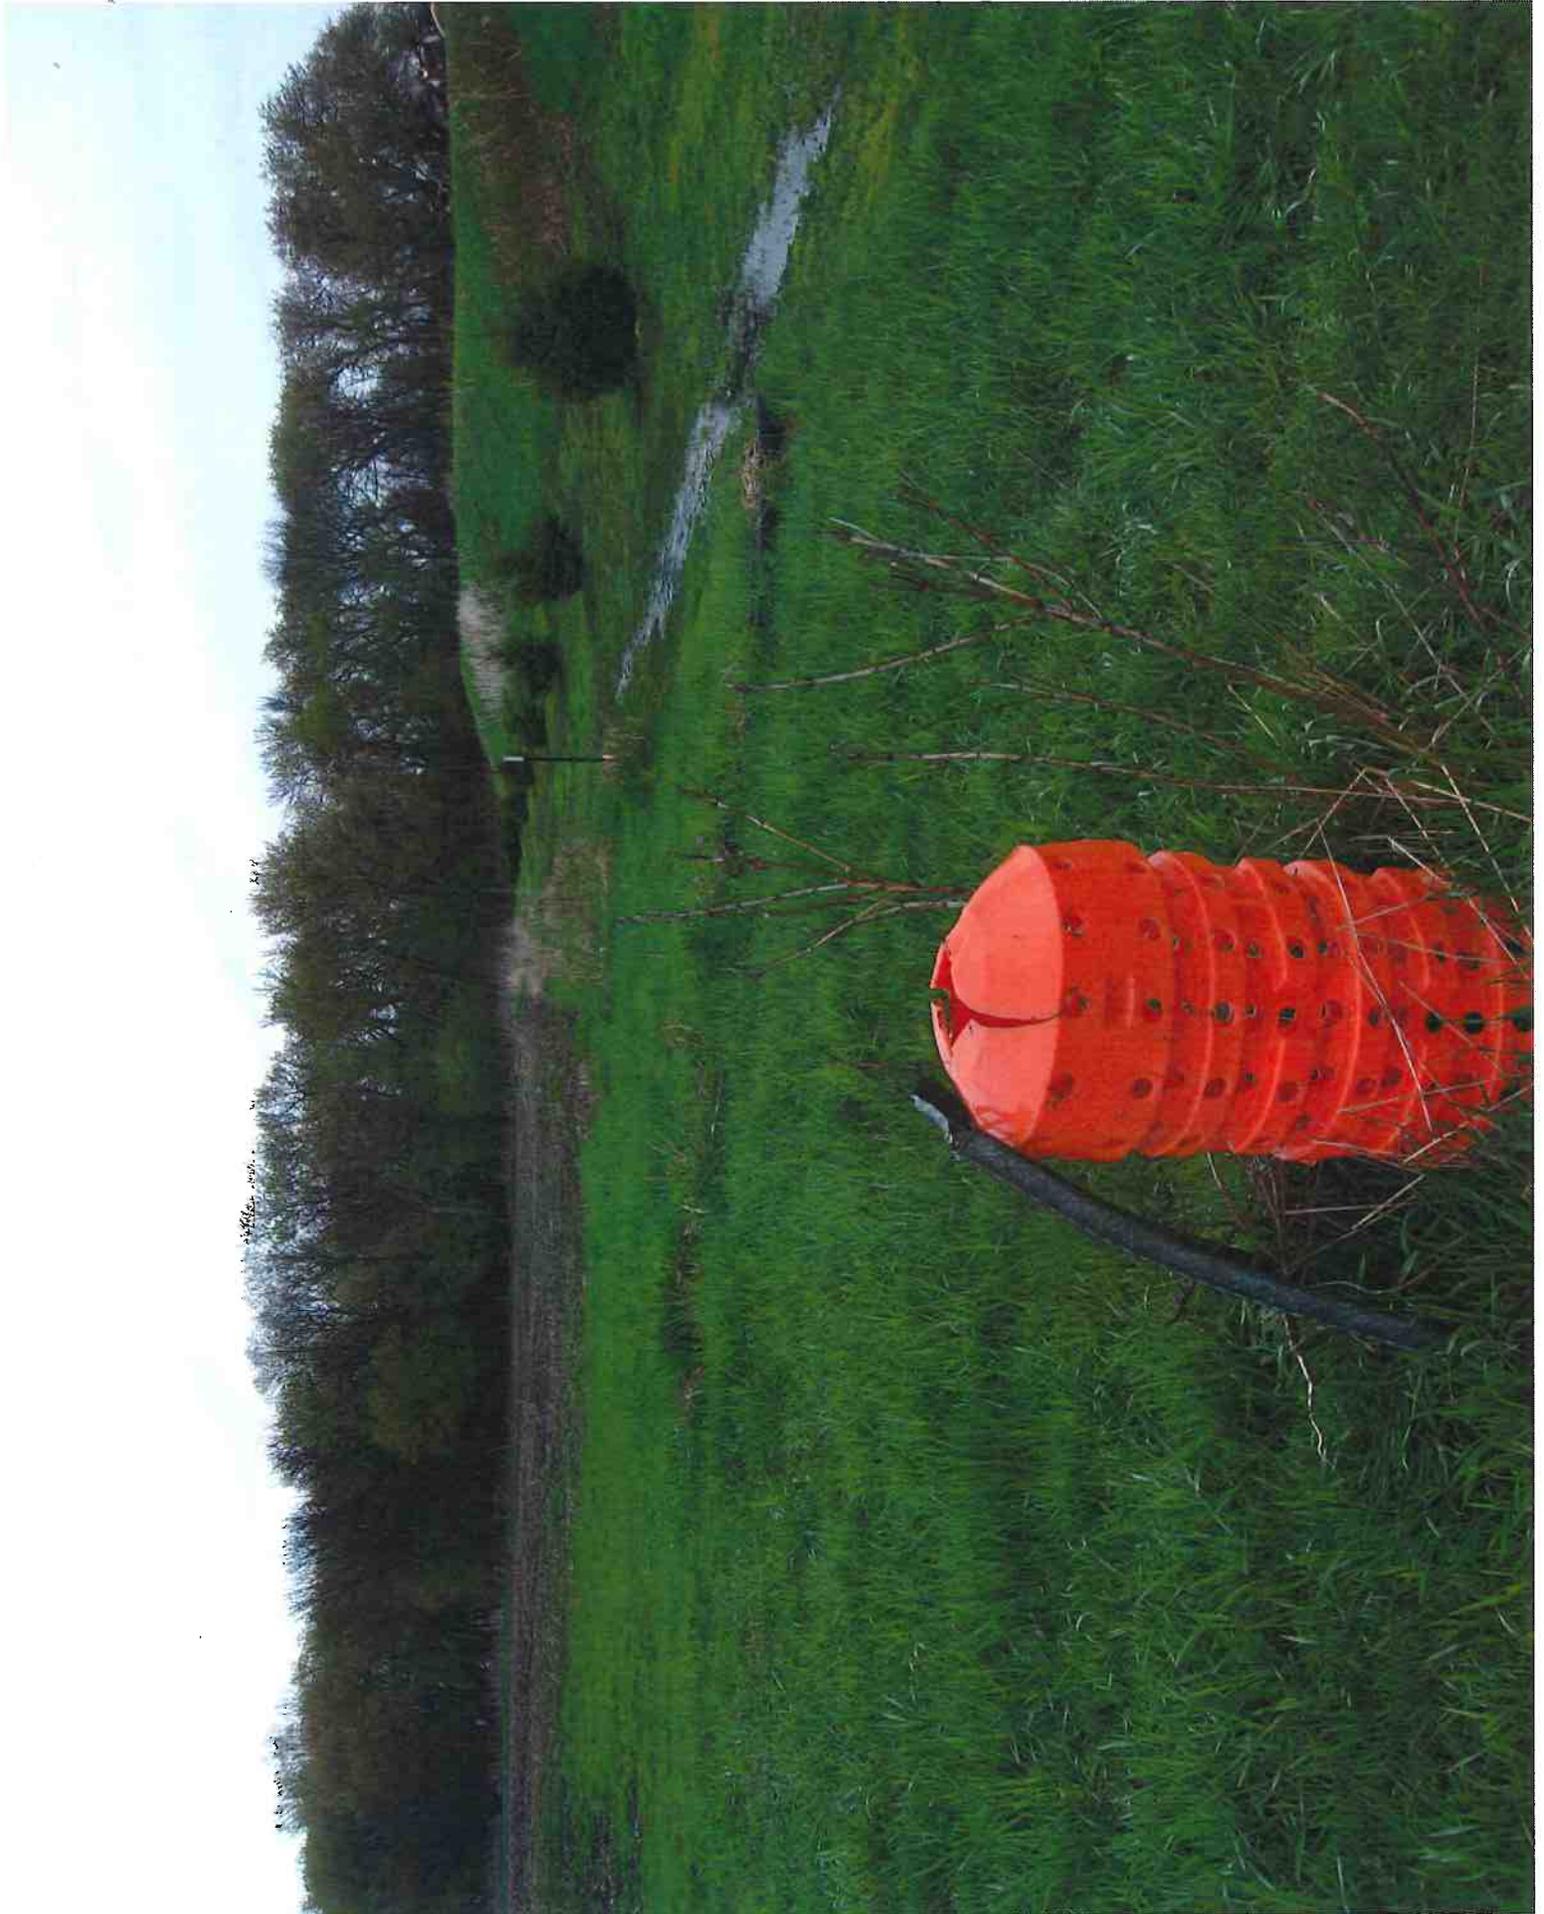
12" HICK INTAKE FULL OF WATER, SWIRLING

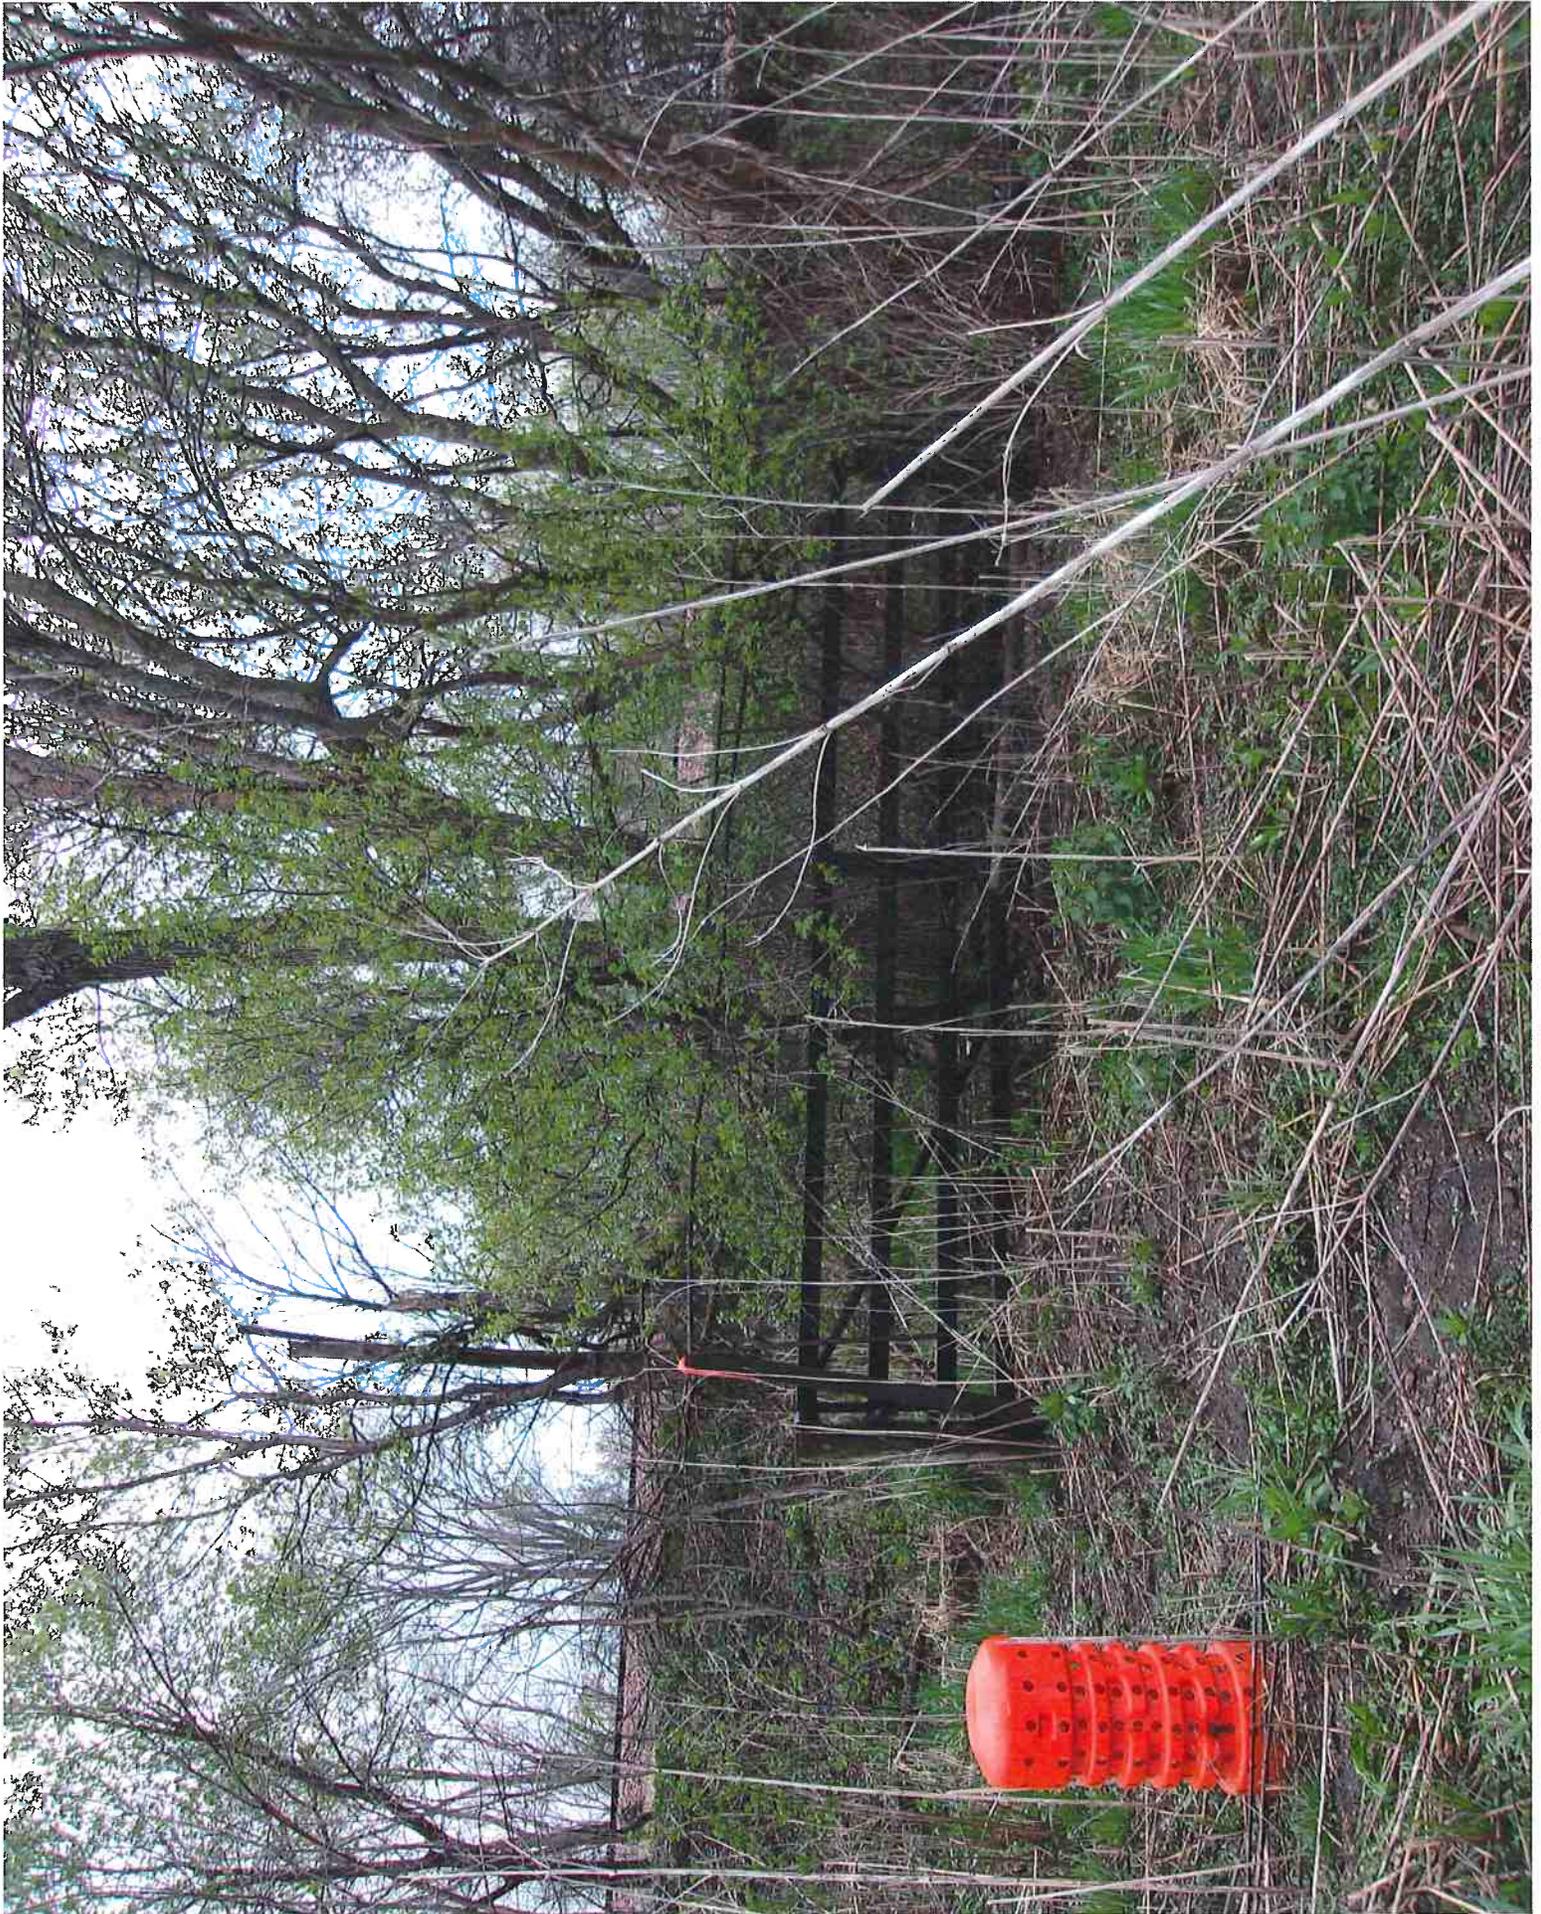
LOOKING UPSTREAM @ RR @ N. SIDE MONARCH LAKE, 40+ <12"Ø TREES IN RR R/W

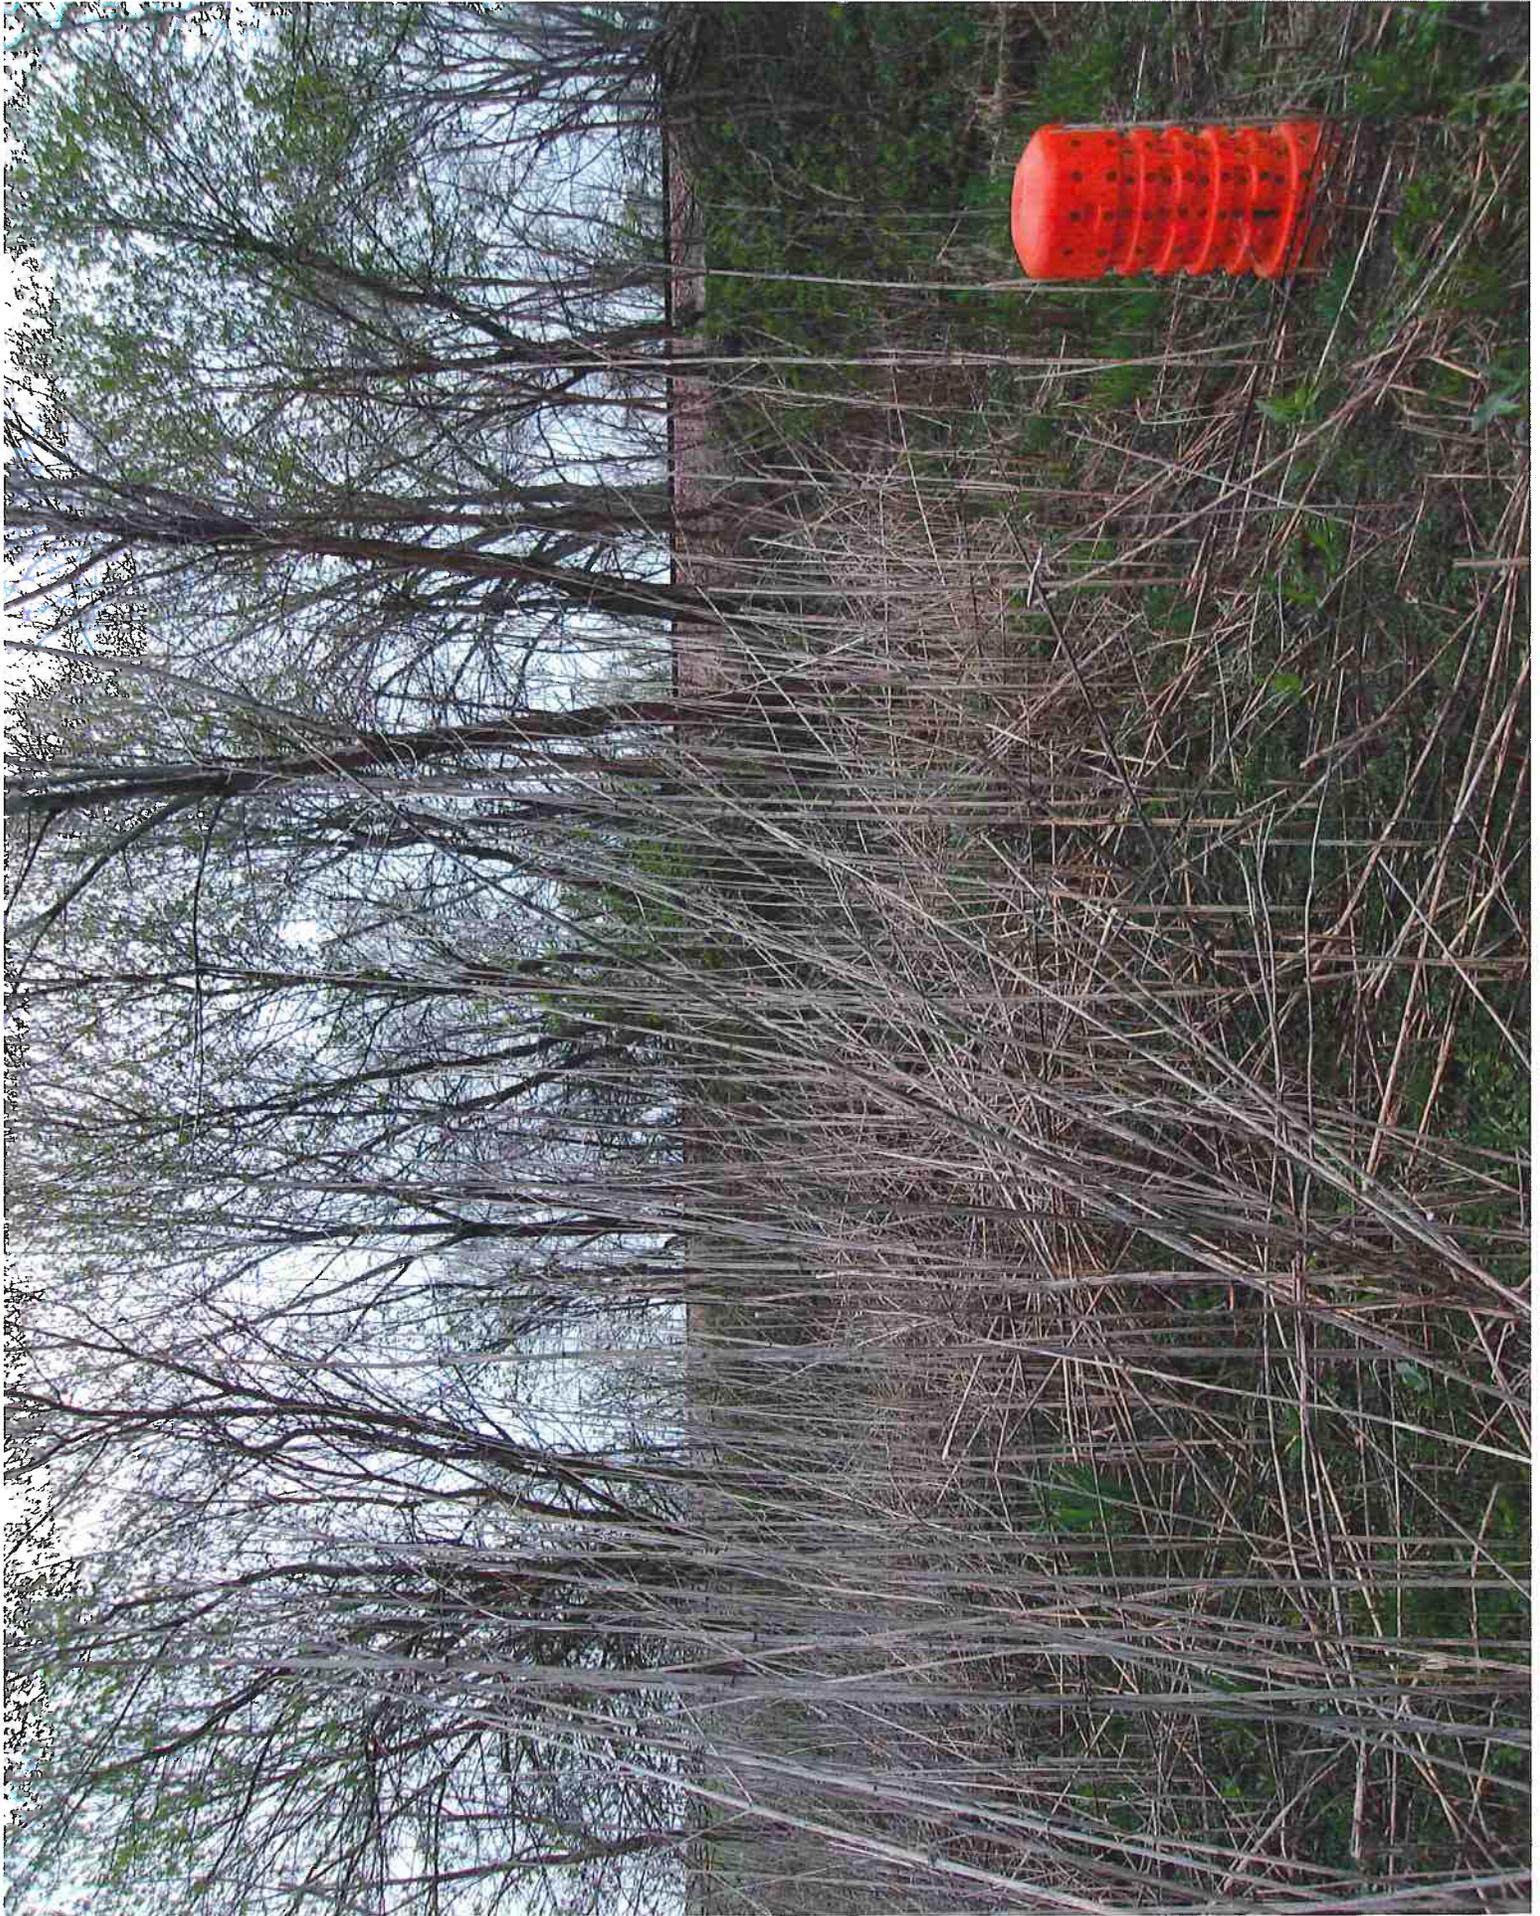
TREES IN RR R/W
