AGENDA
DD 86 LANDOWNER MEETING
JULY 17, 2019 AT 11:00 AM

Drainage District:

86

Investigation Report:

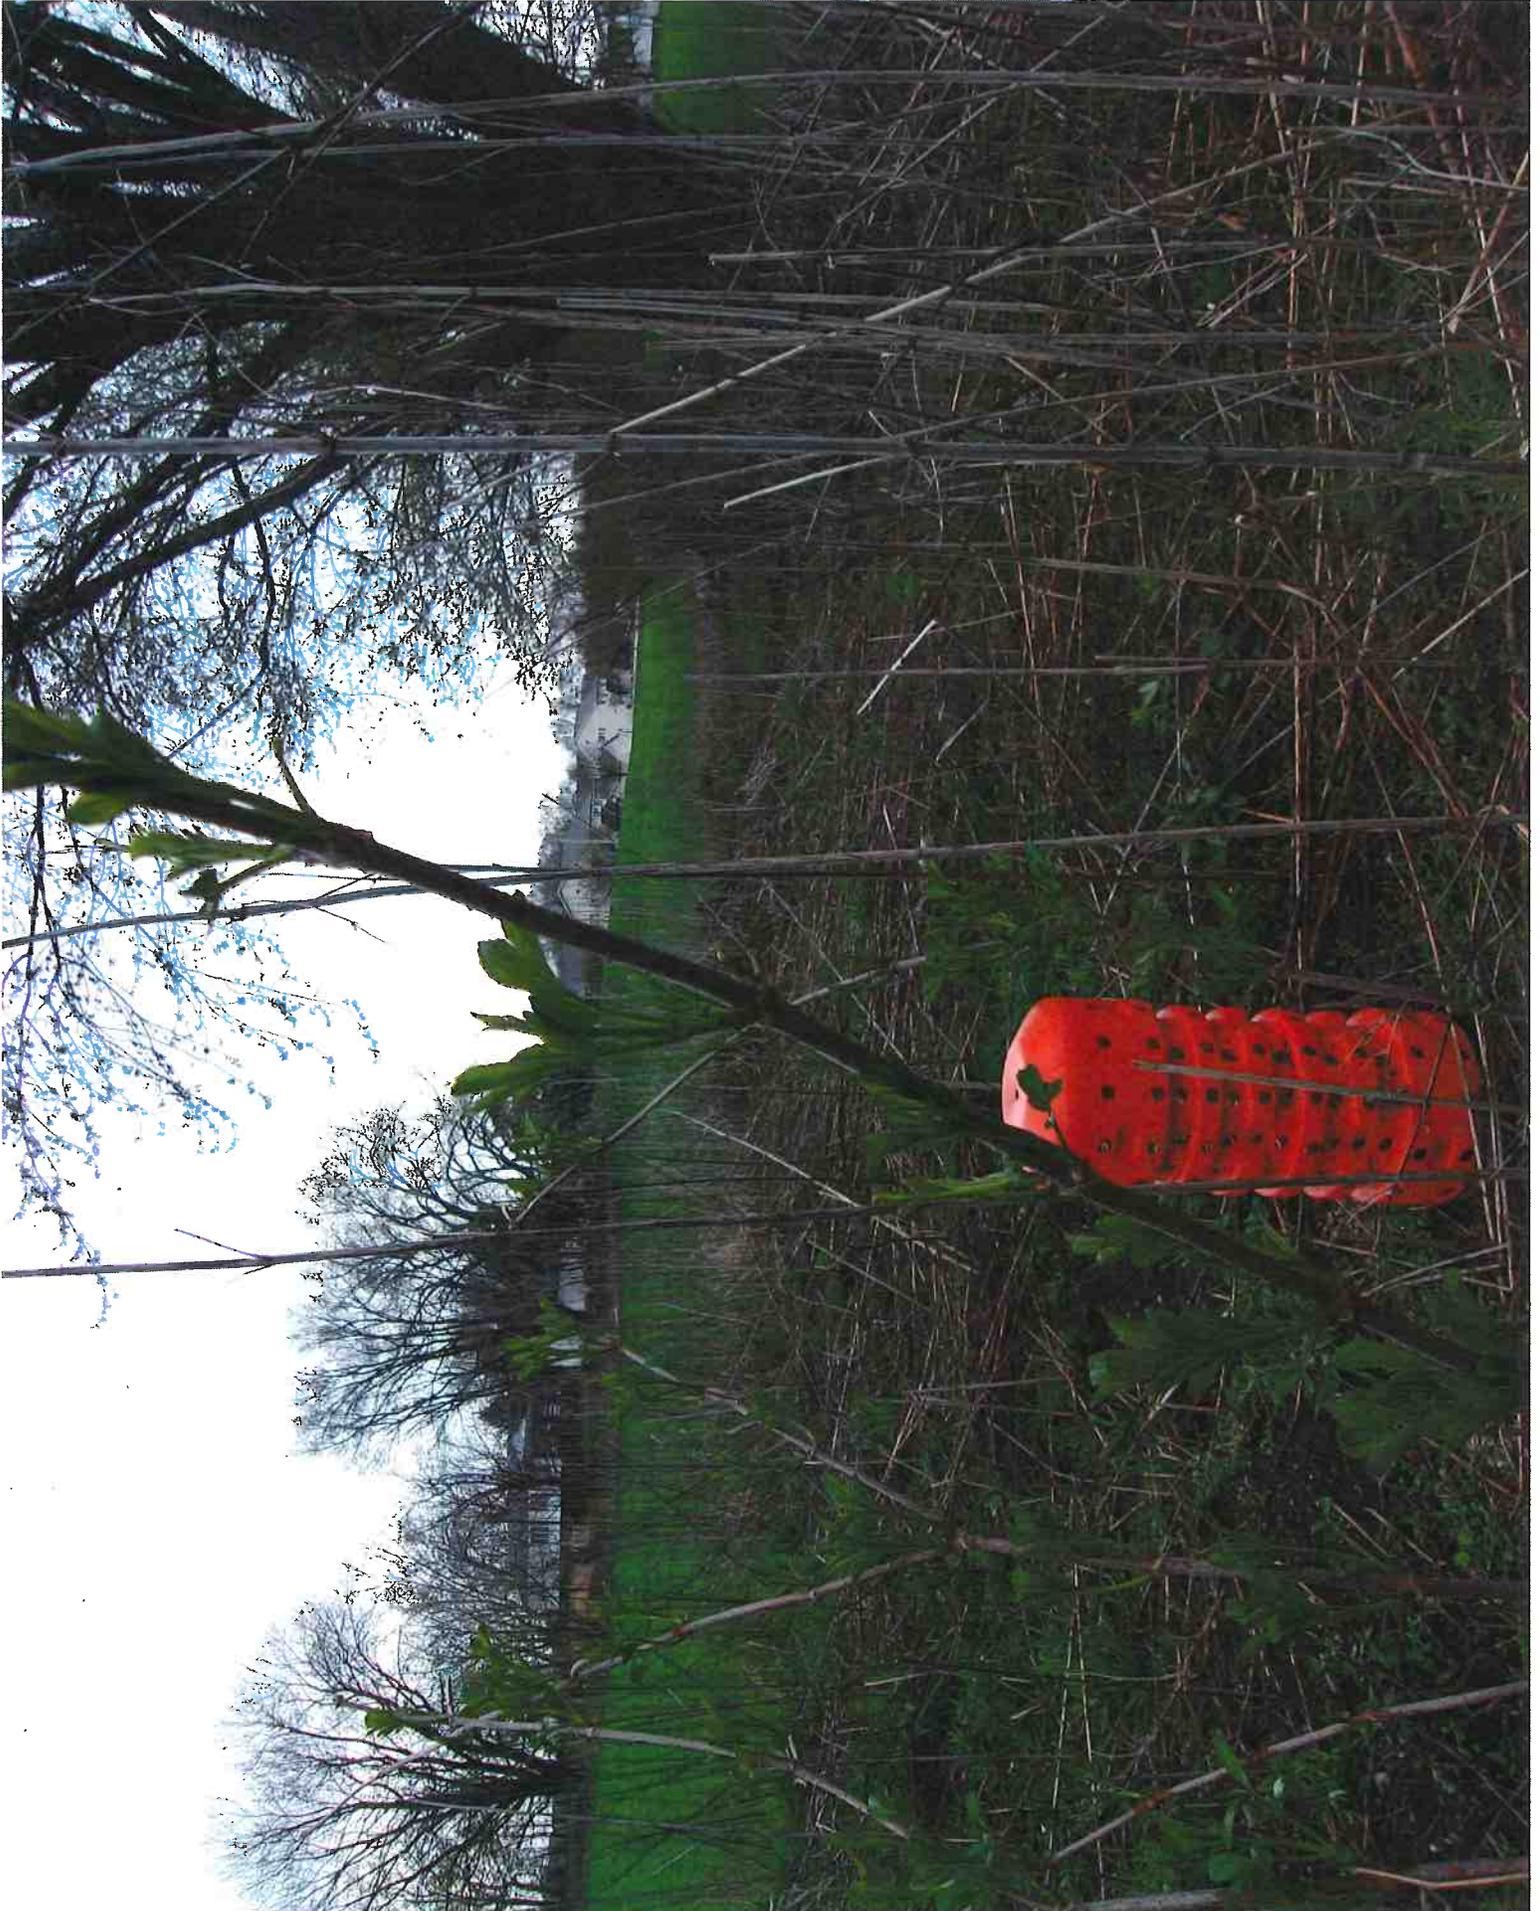
Looking downstream with 5' \varnothing maple that needs removed
