### DD 121 Landowners Meeting

# Drainage Work Order Request For Repair

## Investigation/Repair Summary:

CONSTRUCTION ENGINEERING  
OBSERVATION REPORT

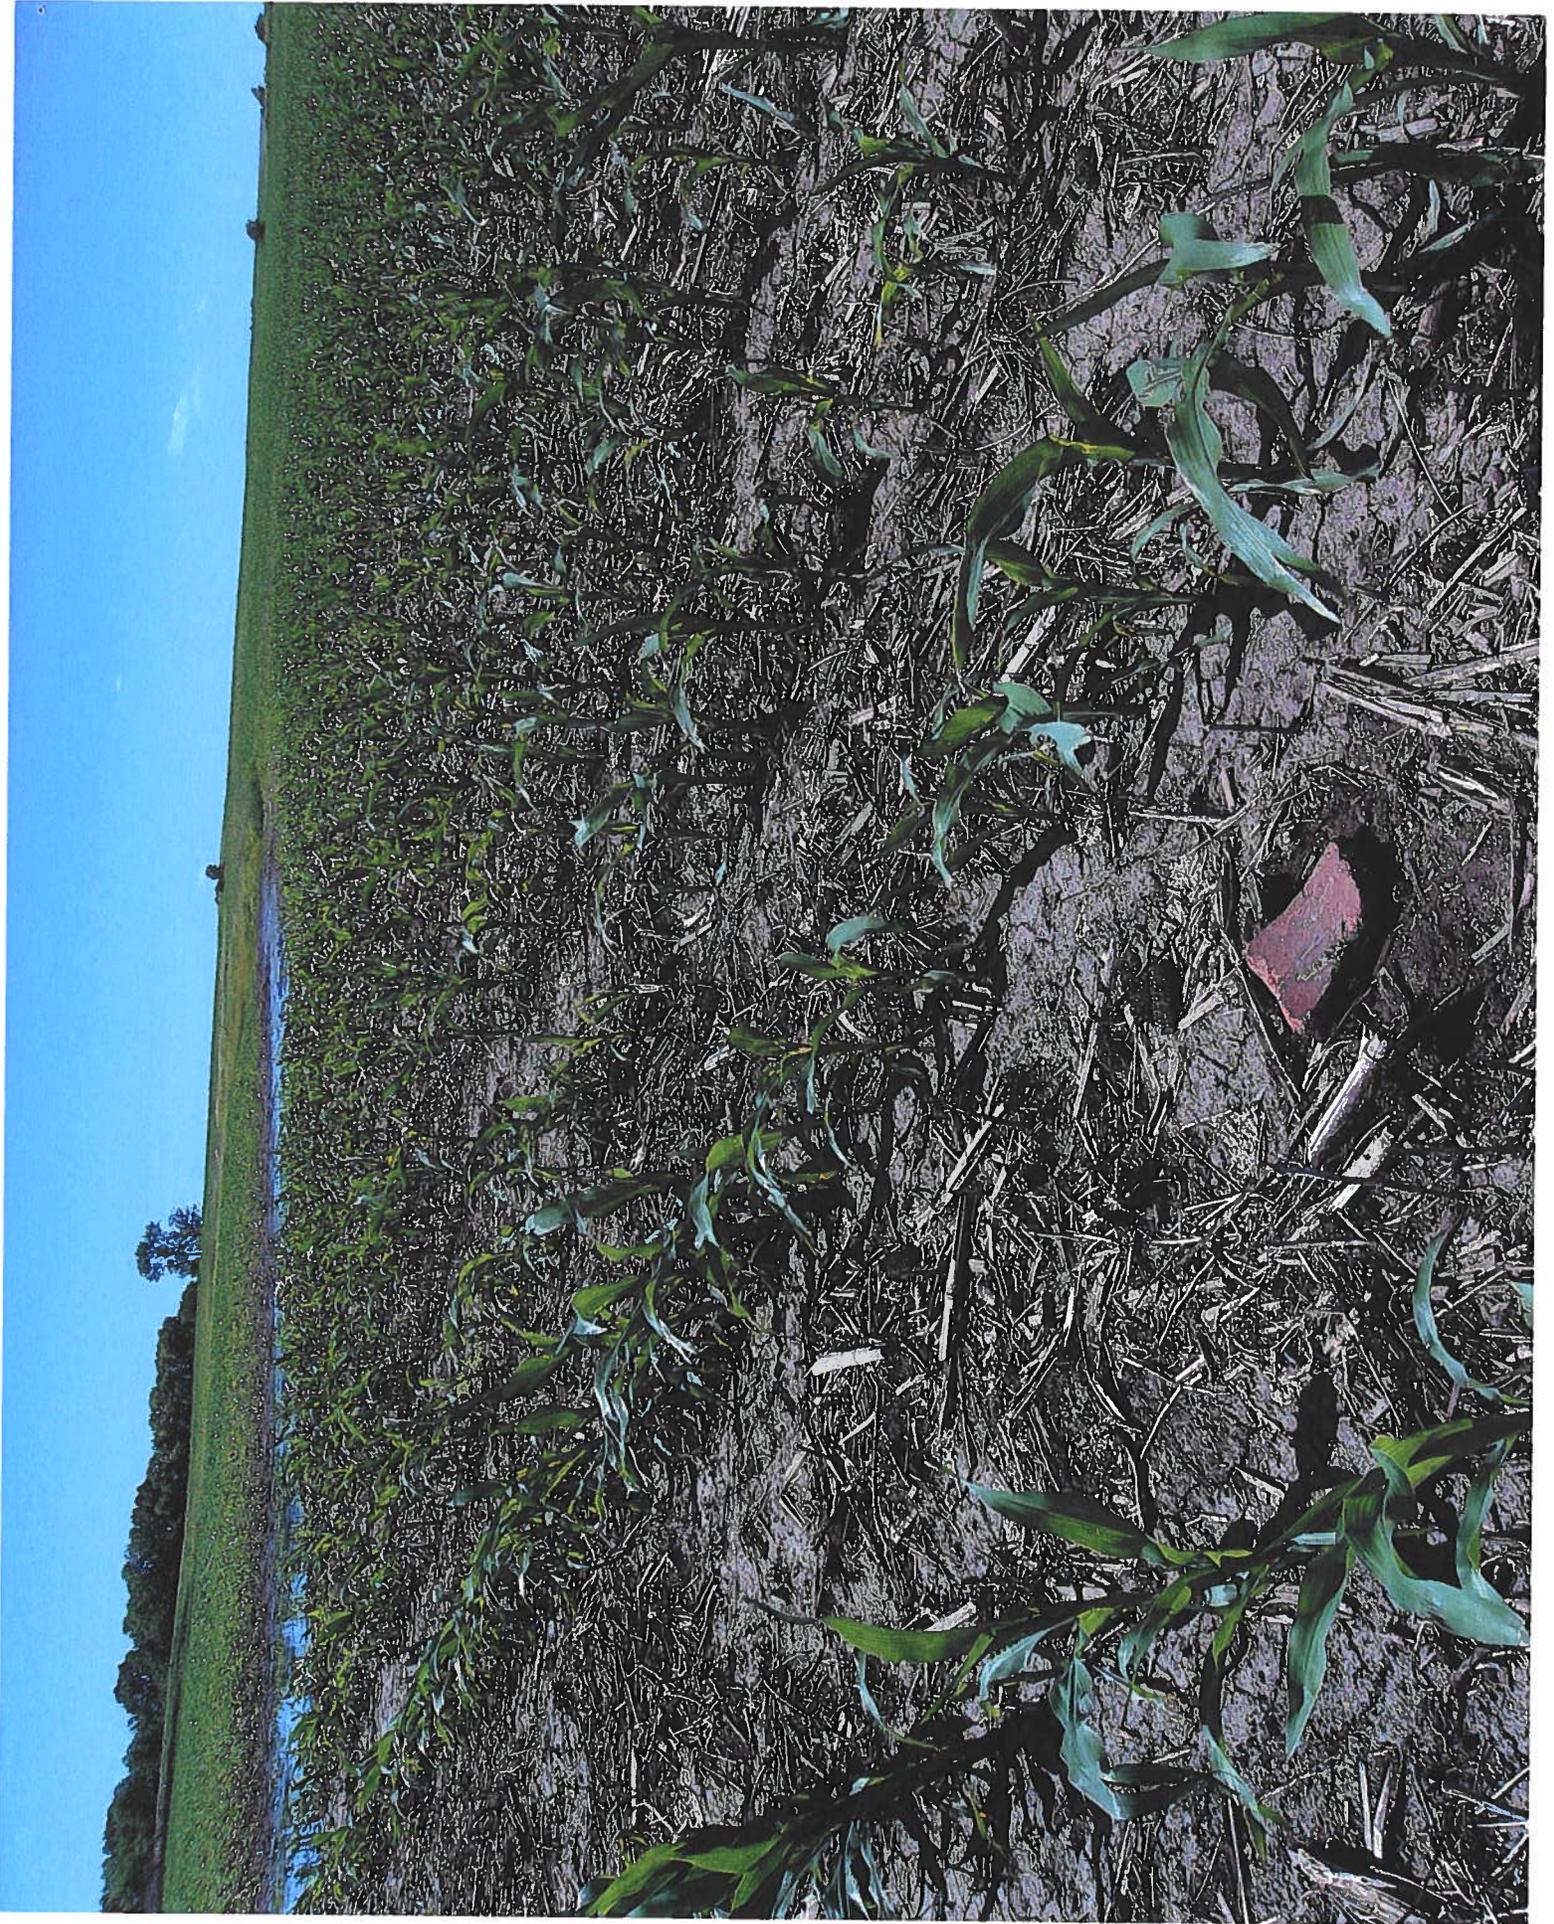
LOOKING NW ON TILE ROUTE

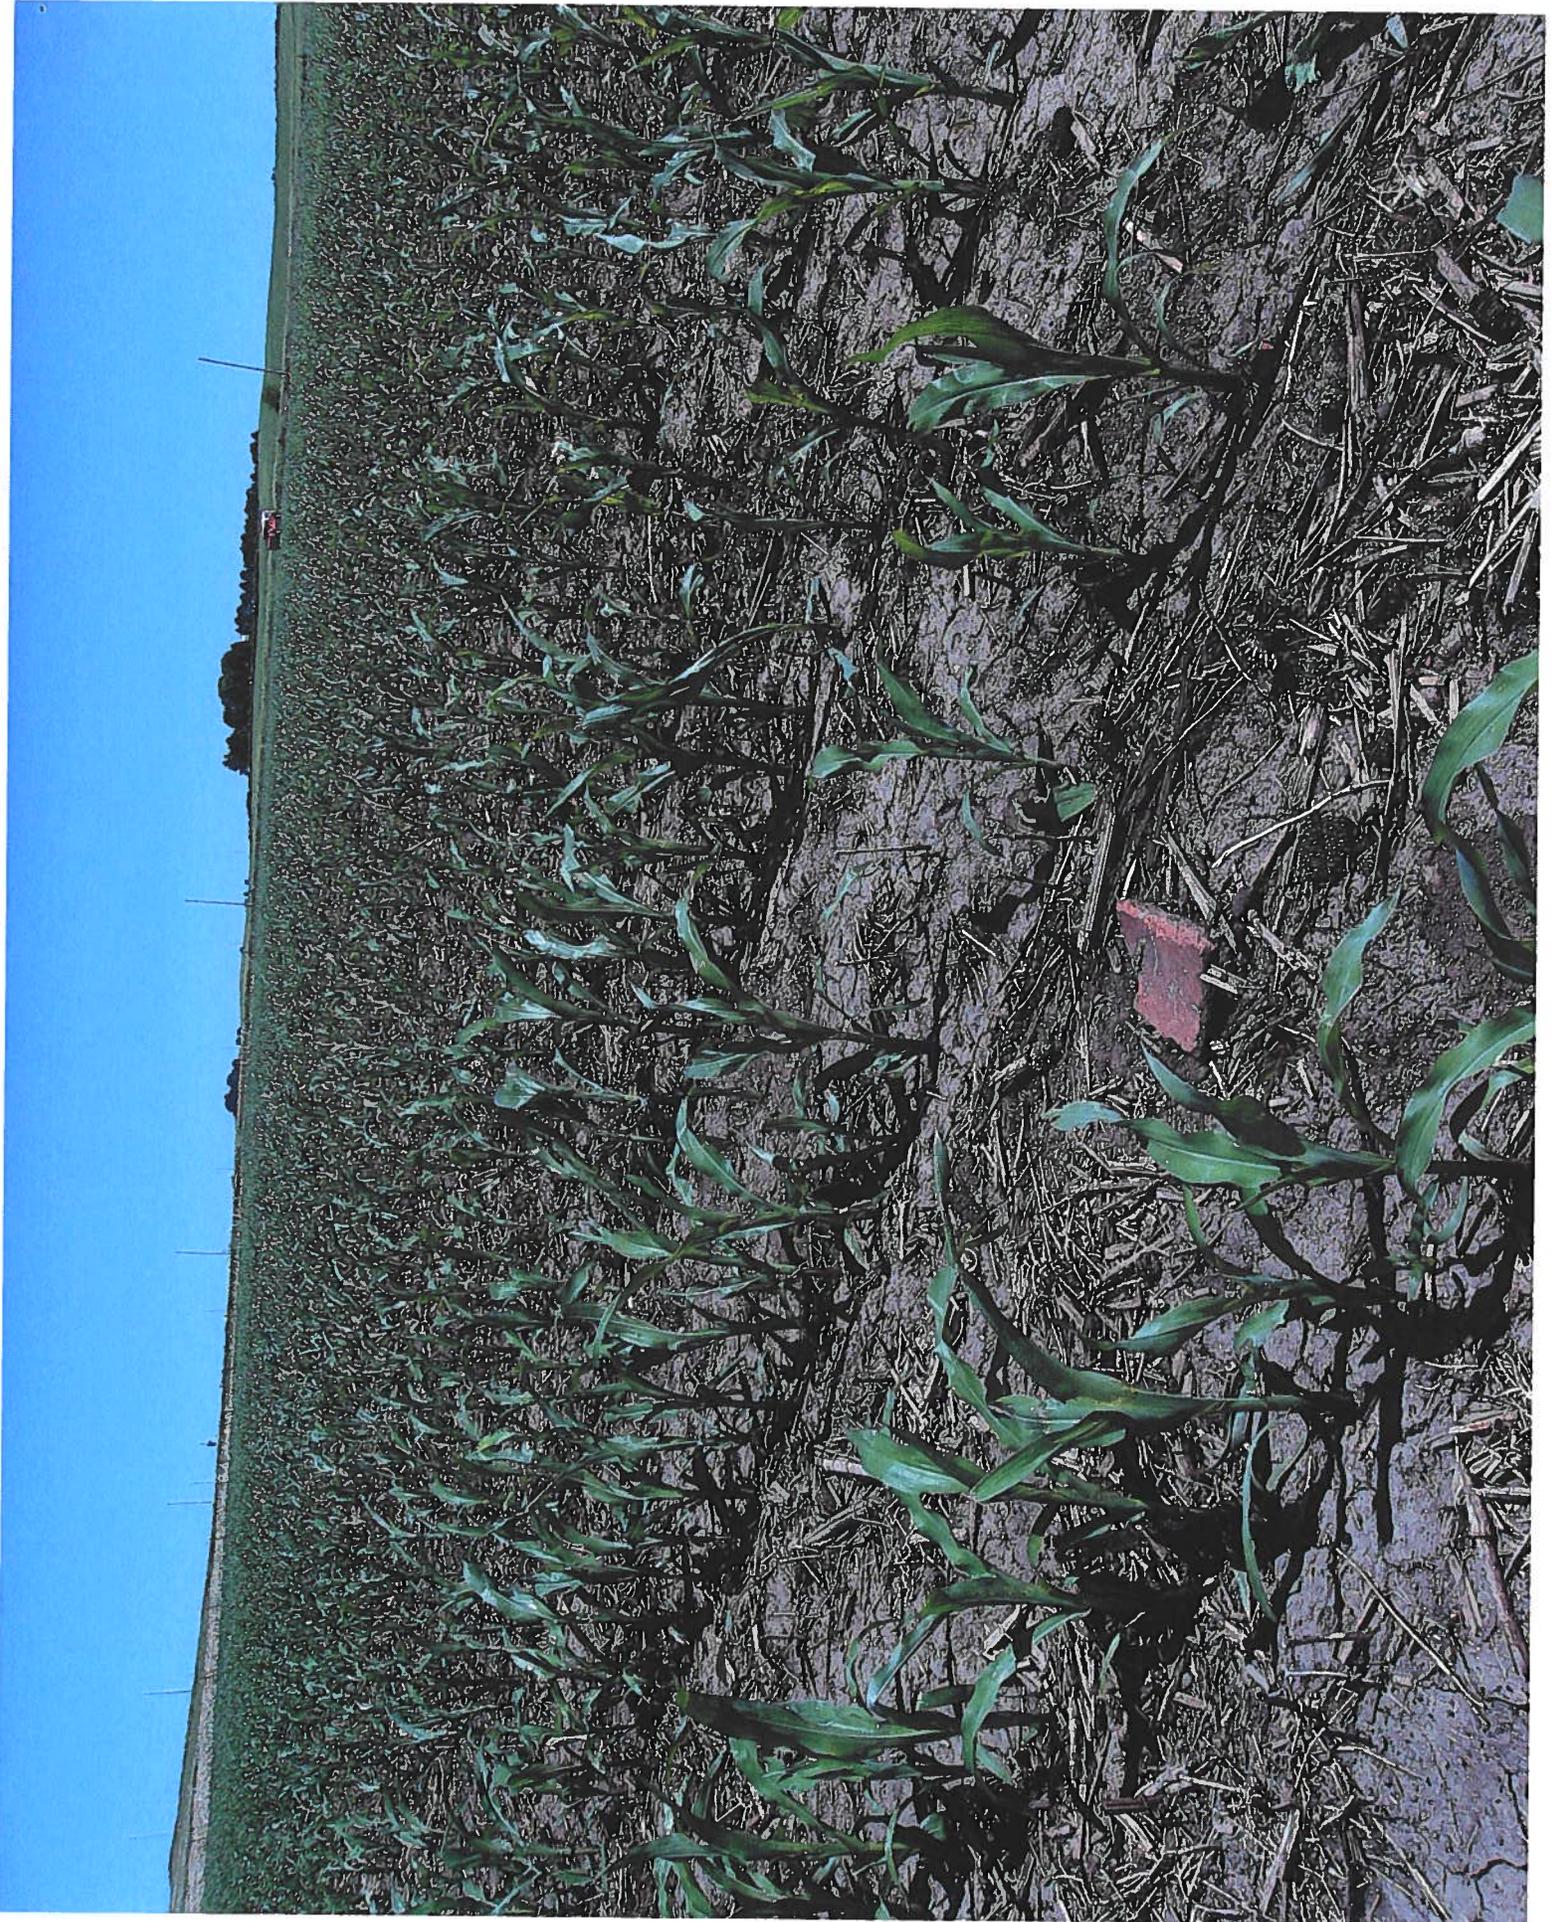
LOOKING SE FROM TIRE CHAINS ON MAIN ROUTE

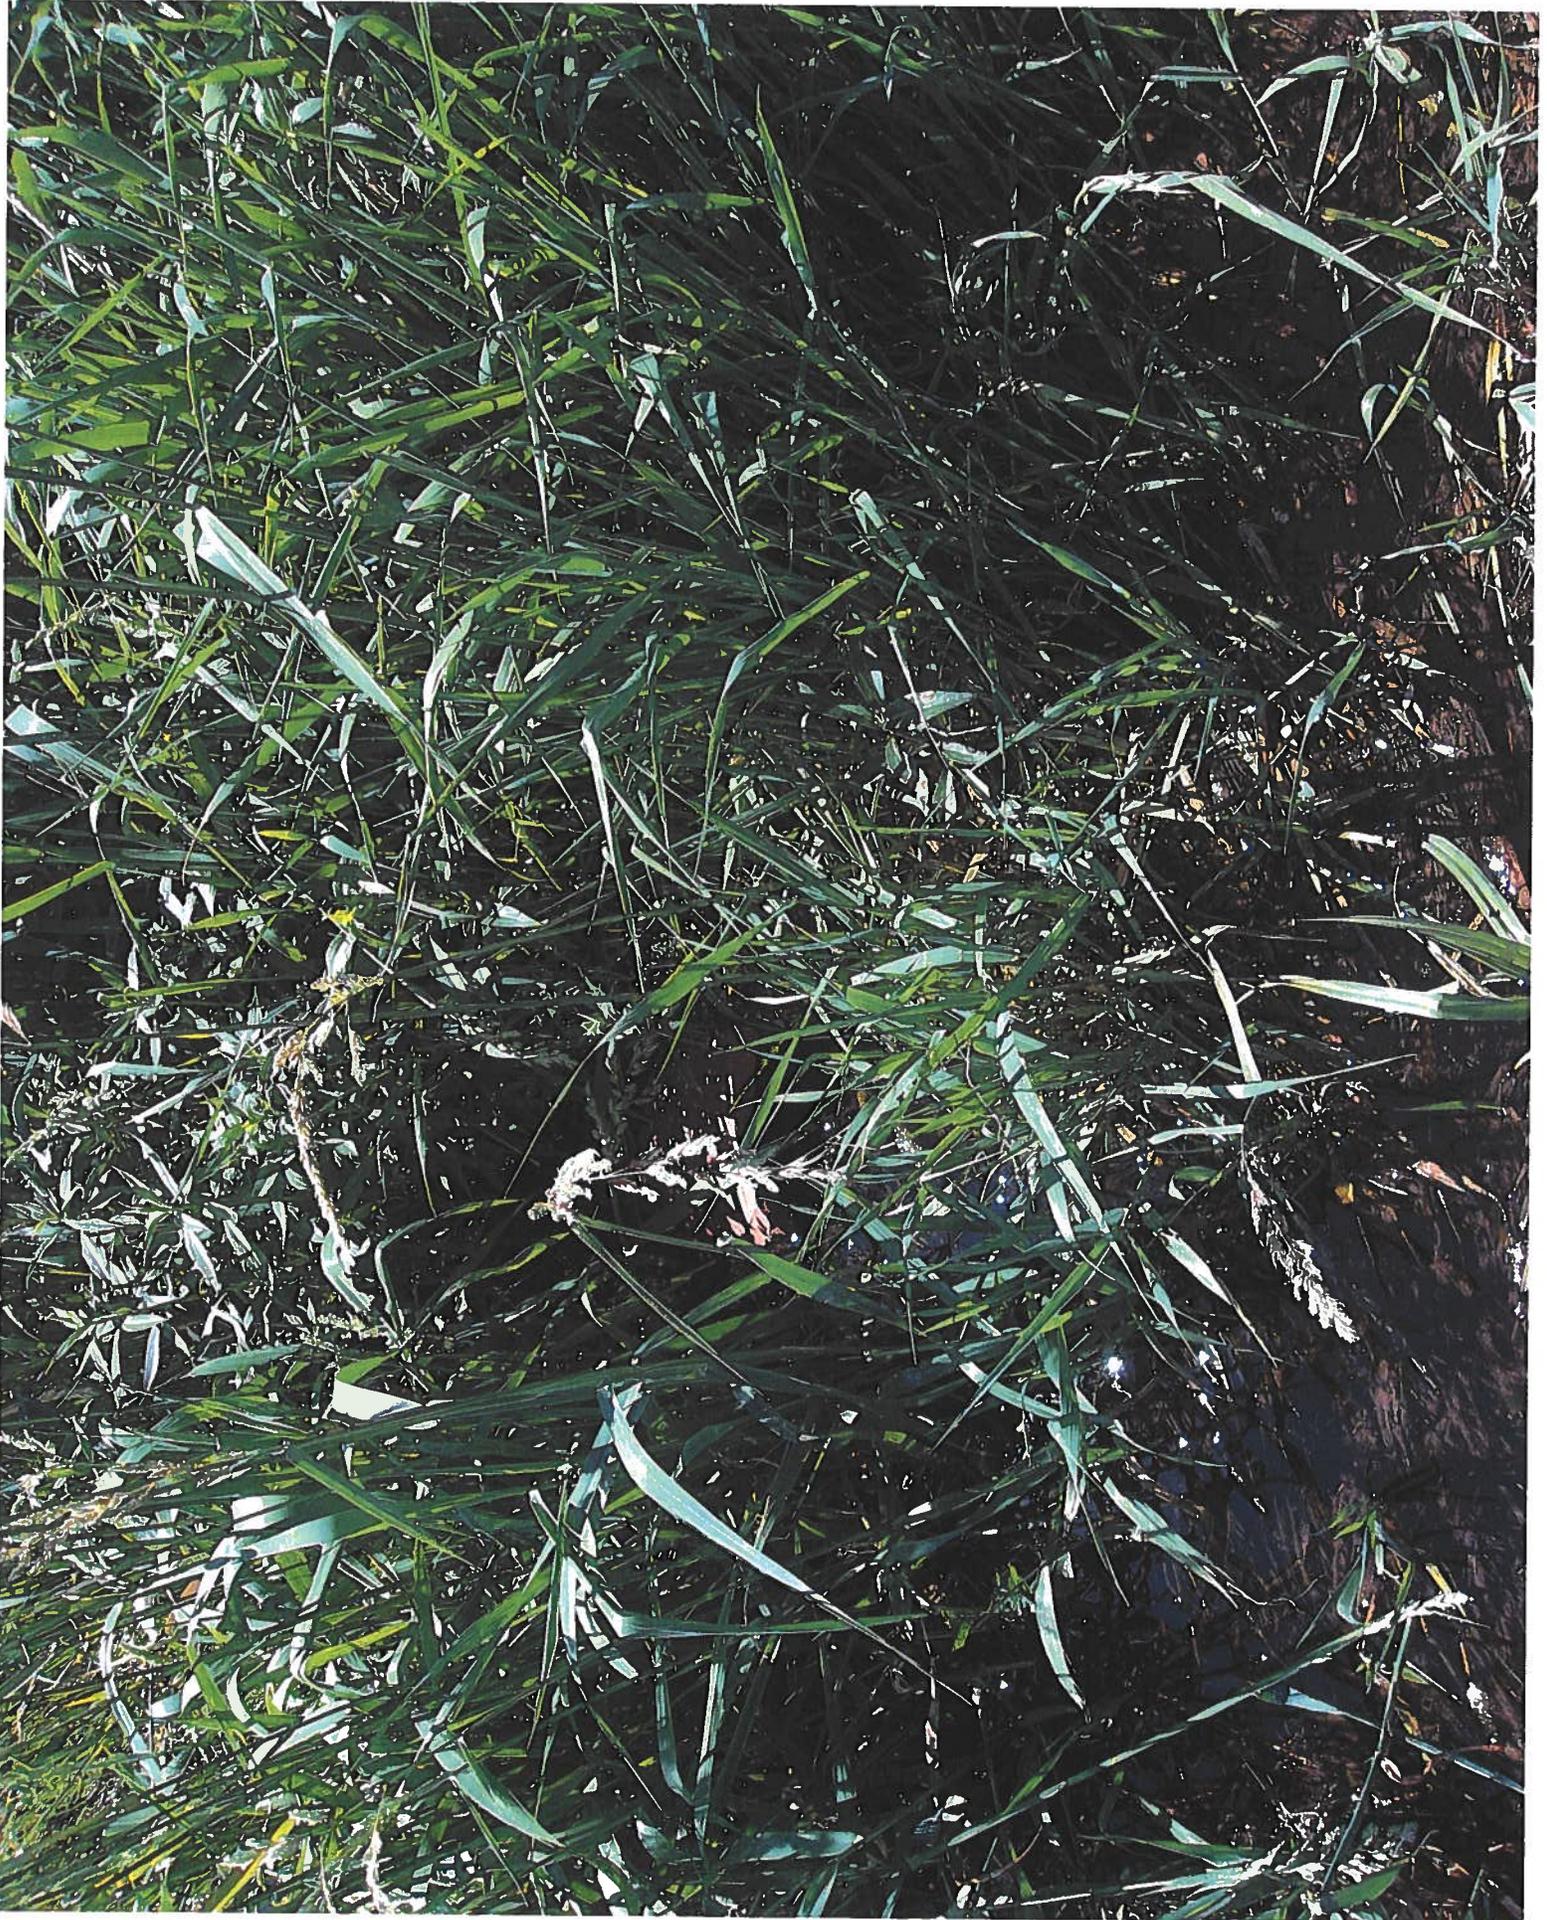
Exposed TILE CHARDS @ SE COR. OF GRASS SWALE

Due to the lack of soil cover over the tile, broken pieces of tile found in the field, and recently cut trees, CGA recommends locating and CCTV inspecting the tile in both directions from the blowout/sinkhole as the observed issue may be due to a larger-scale deterioration of the Main tile's physical condition.

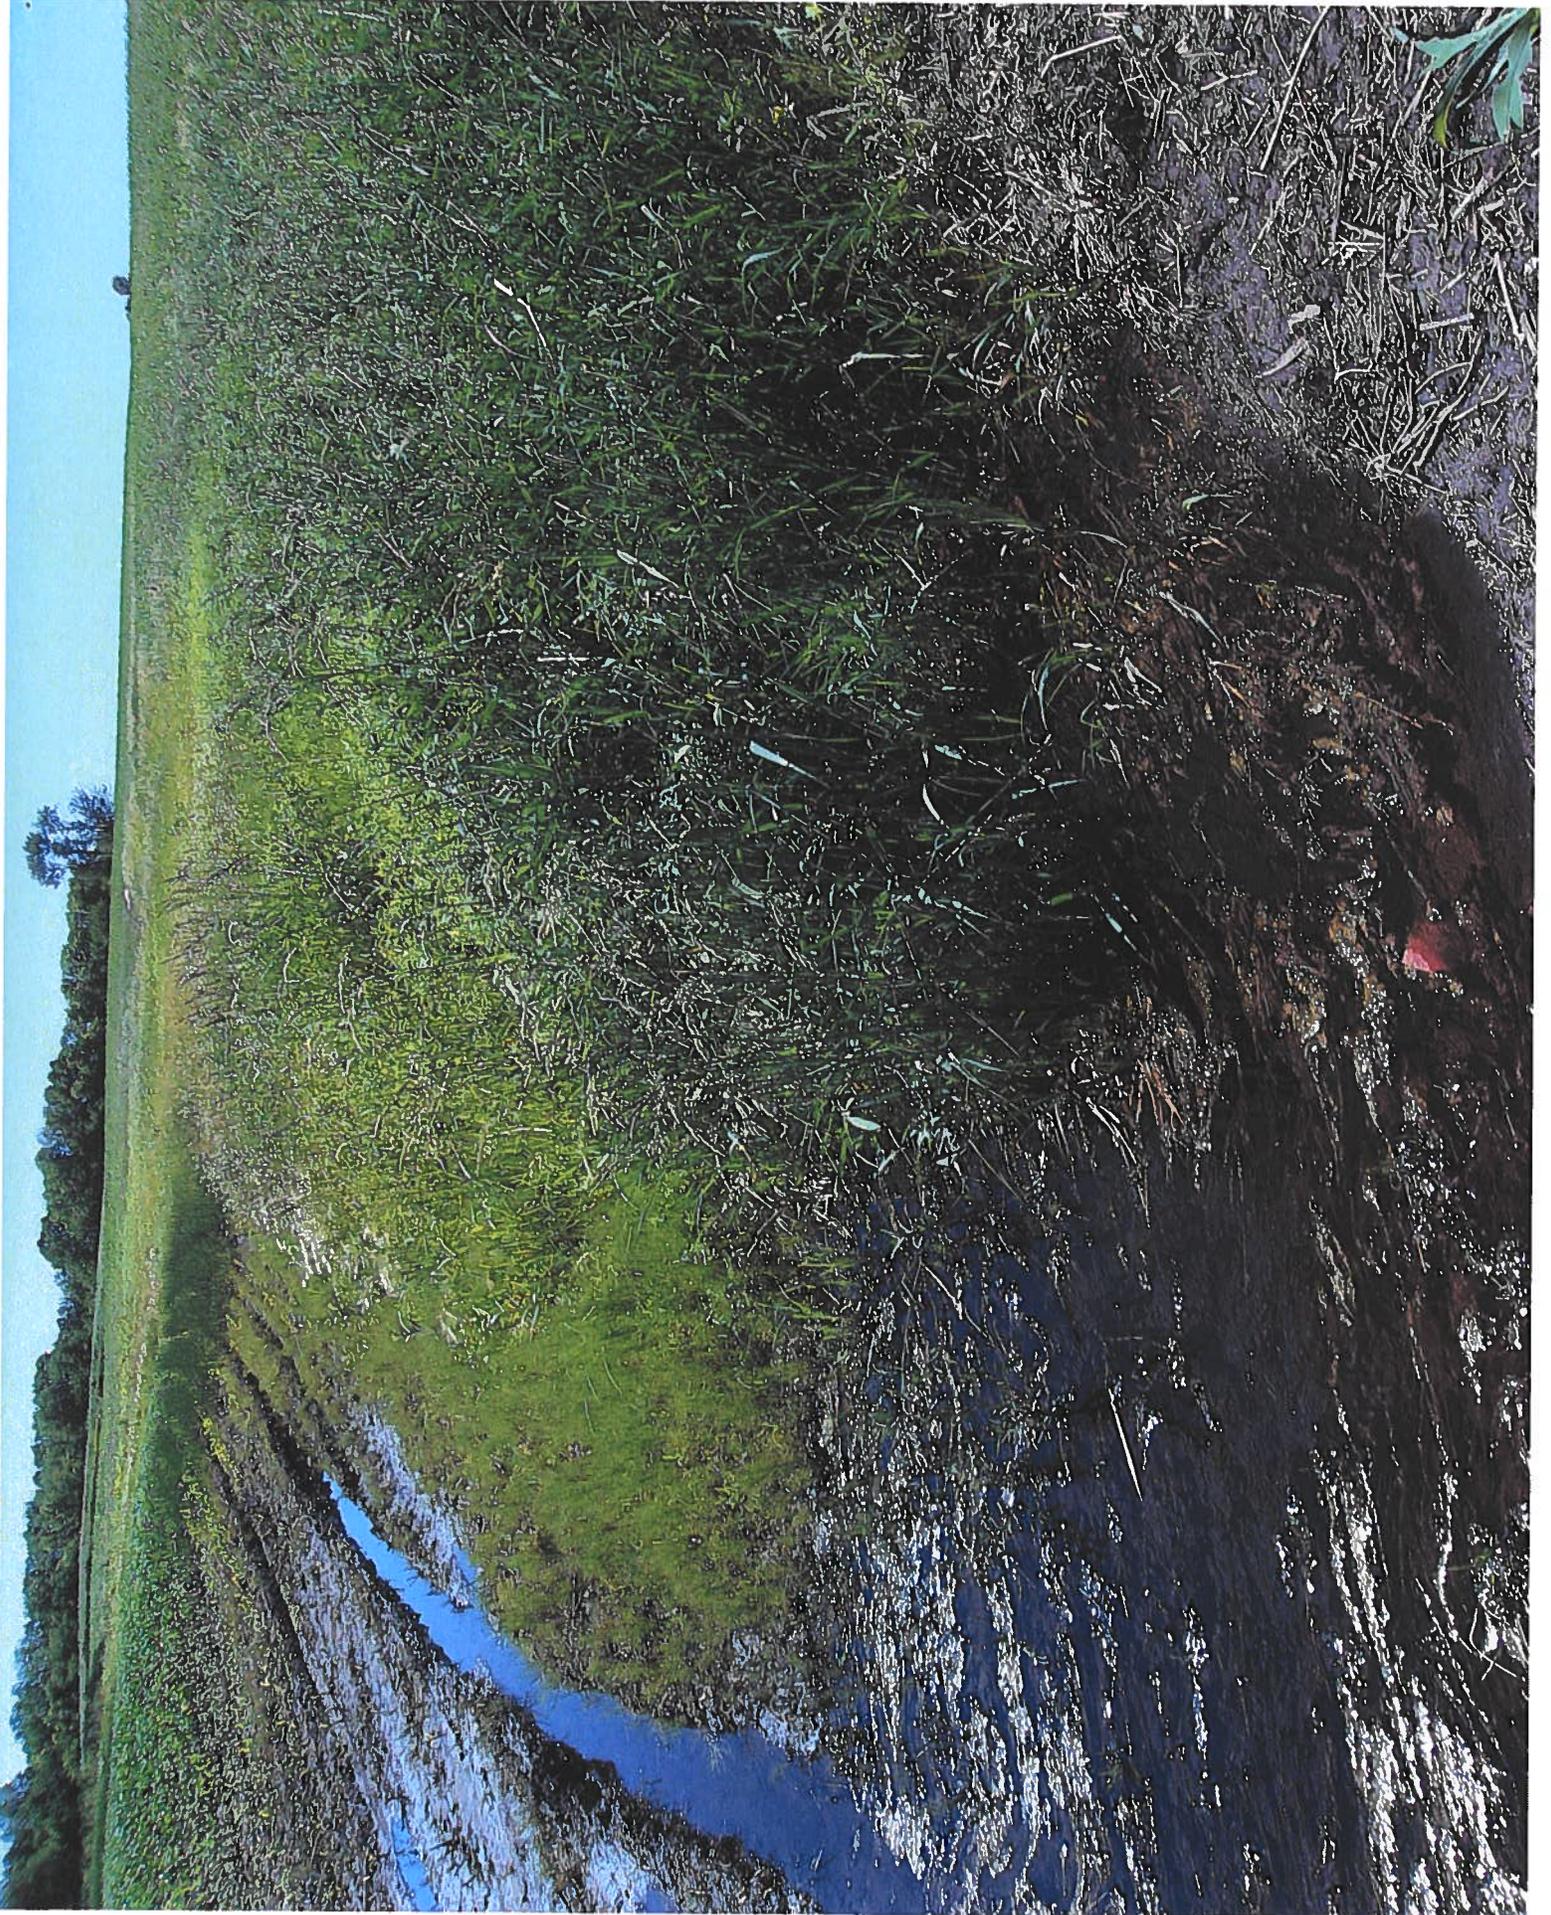
START OF GRASS SWALE

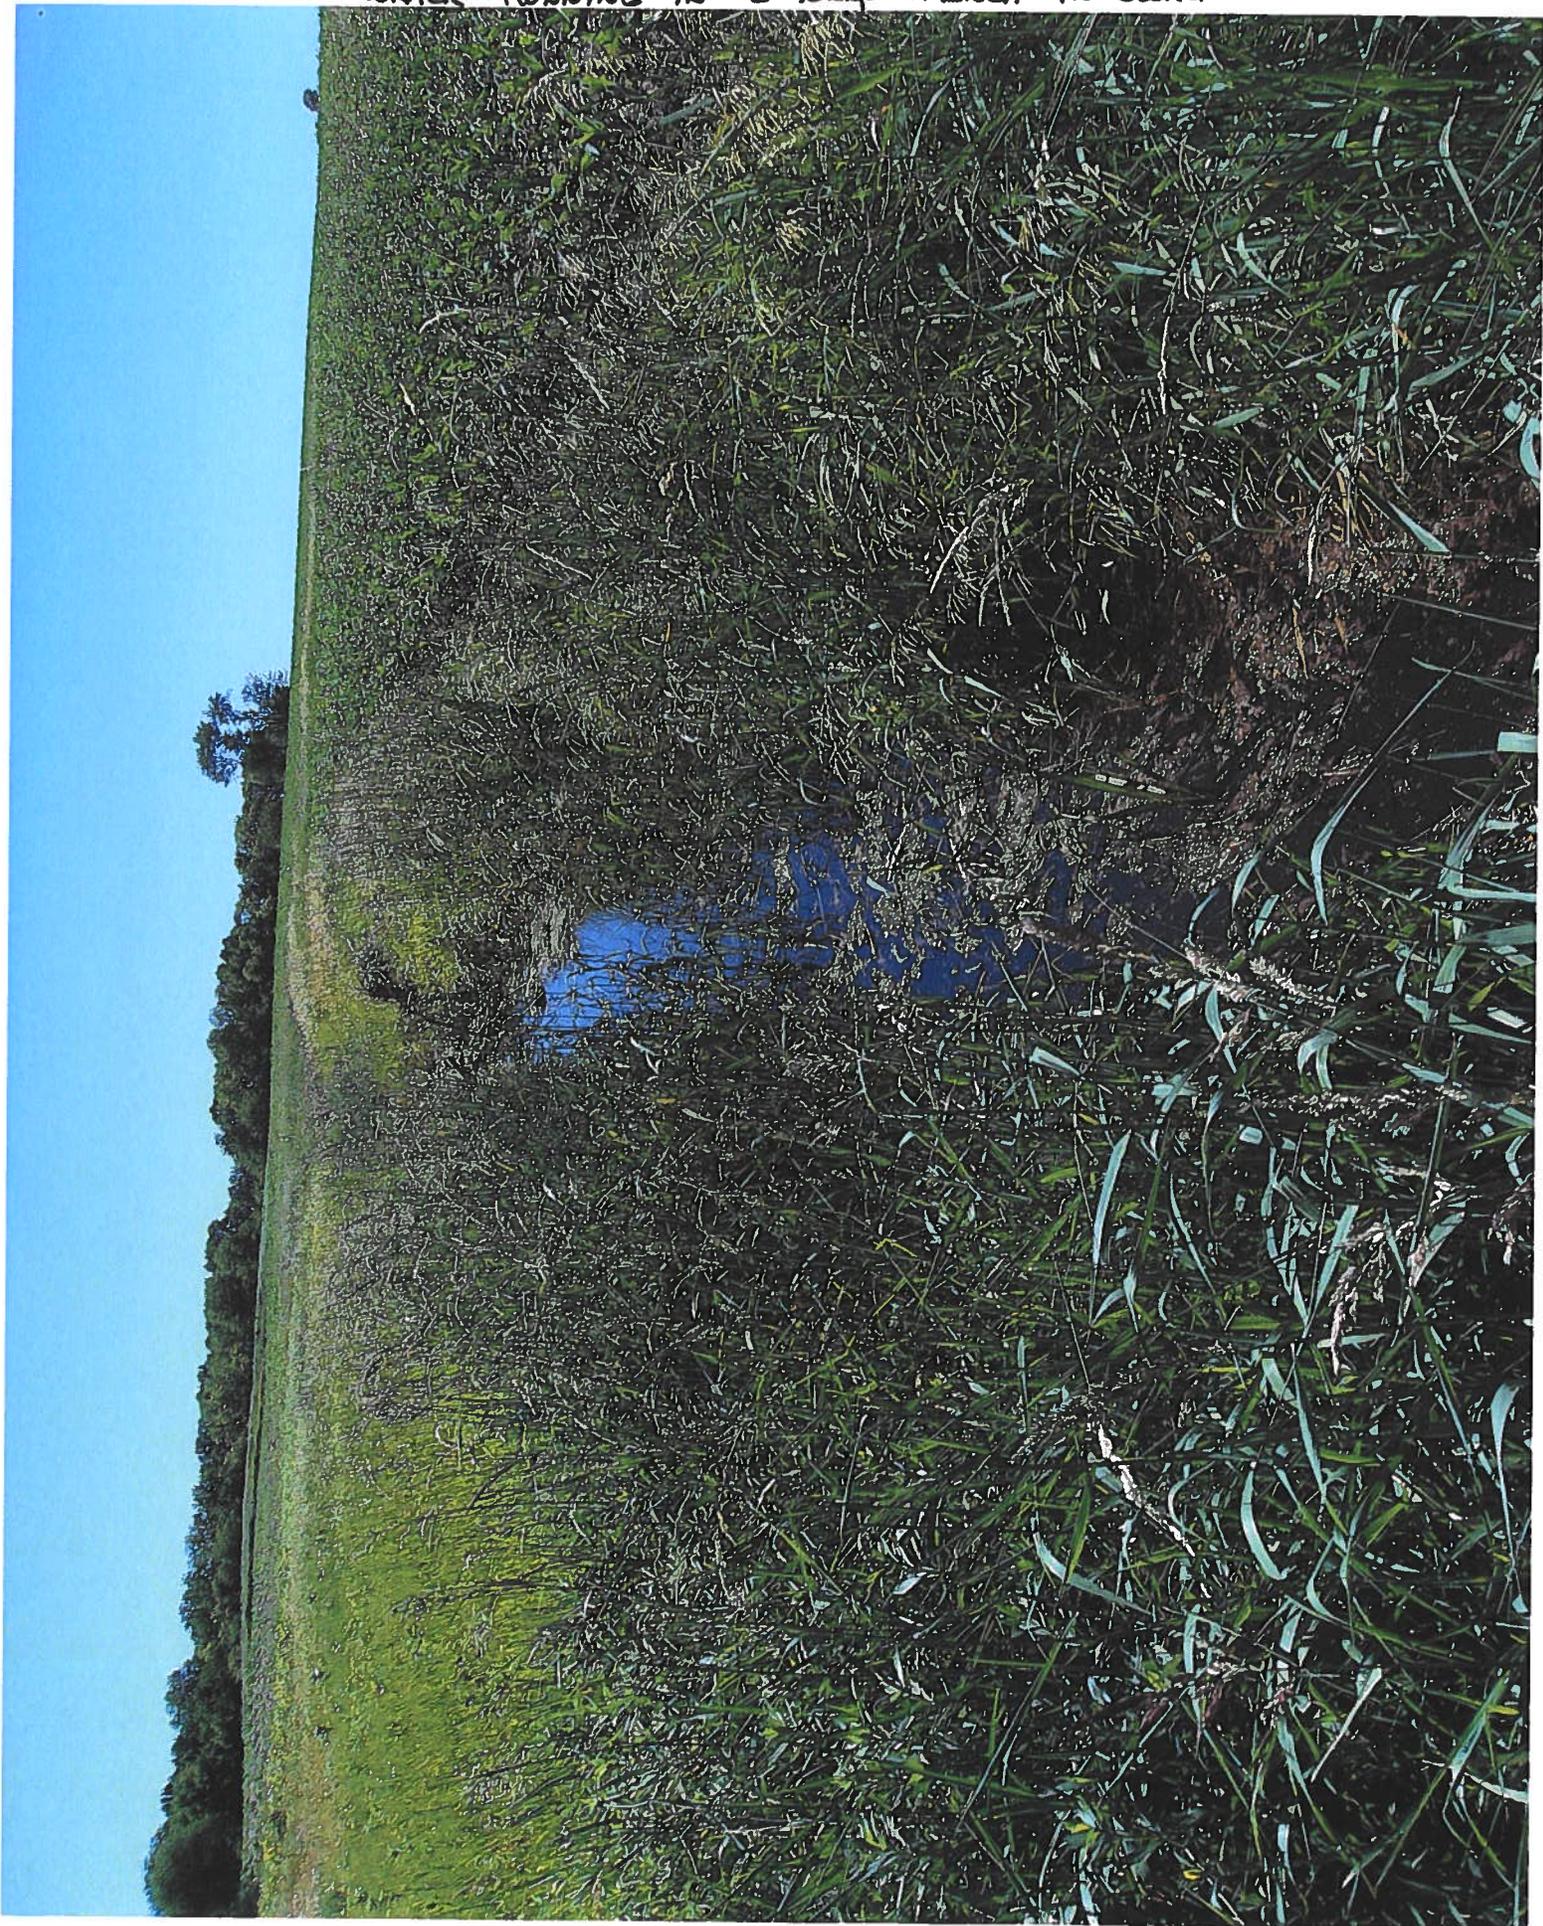
Parked @ 1/4 1/4 cor, WALKED TILE ROUTE FOLLOWING CHARDS IN FIELD 12" + CLAY. FOUND NOISY WATER RUNNING OUT OF GRASS SWALE TO N. SIDE OF 40 ACRES. IT LOOKS LIKE TILE IS VERY SHALLOW OR REMOVED IN SWALE AREA. SOME WATER IN SWALE IS 2' DEEP. I HAVE NO IDEA WHY TILE DOESN'T RUN TO CREEK

WATER RUNNING IN 2' DEEP TRENCH IN SWALE

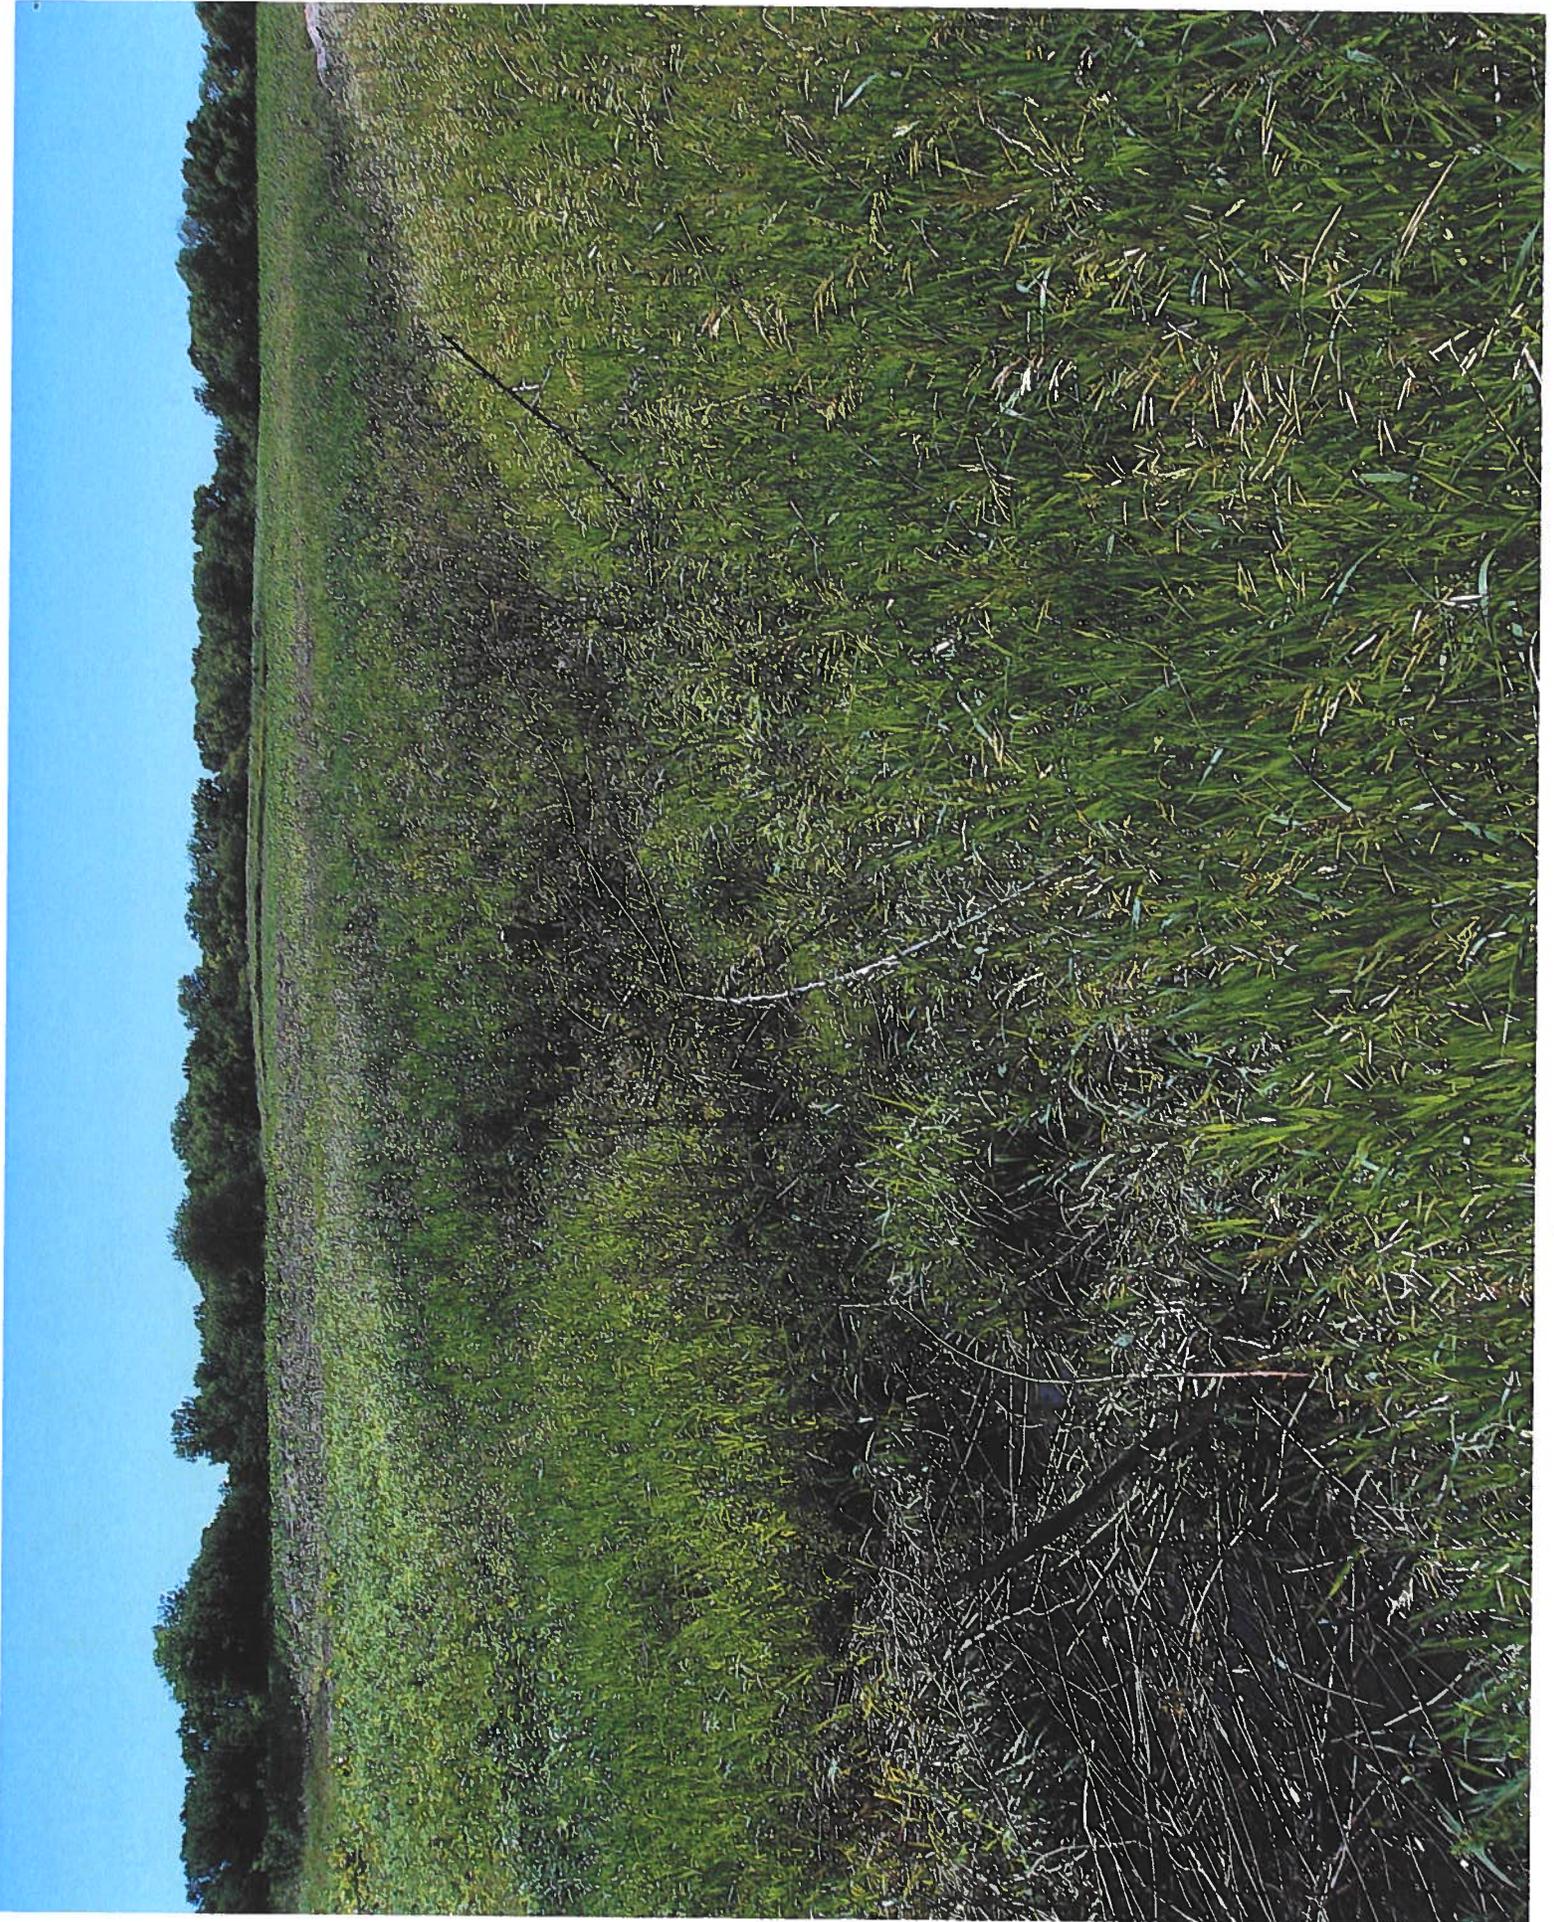
TREES CUT DOWN LAST YEAR

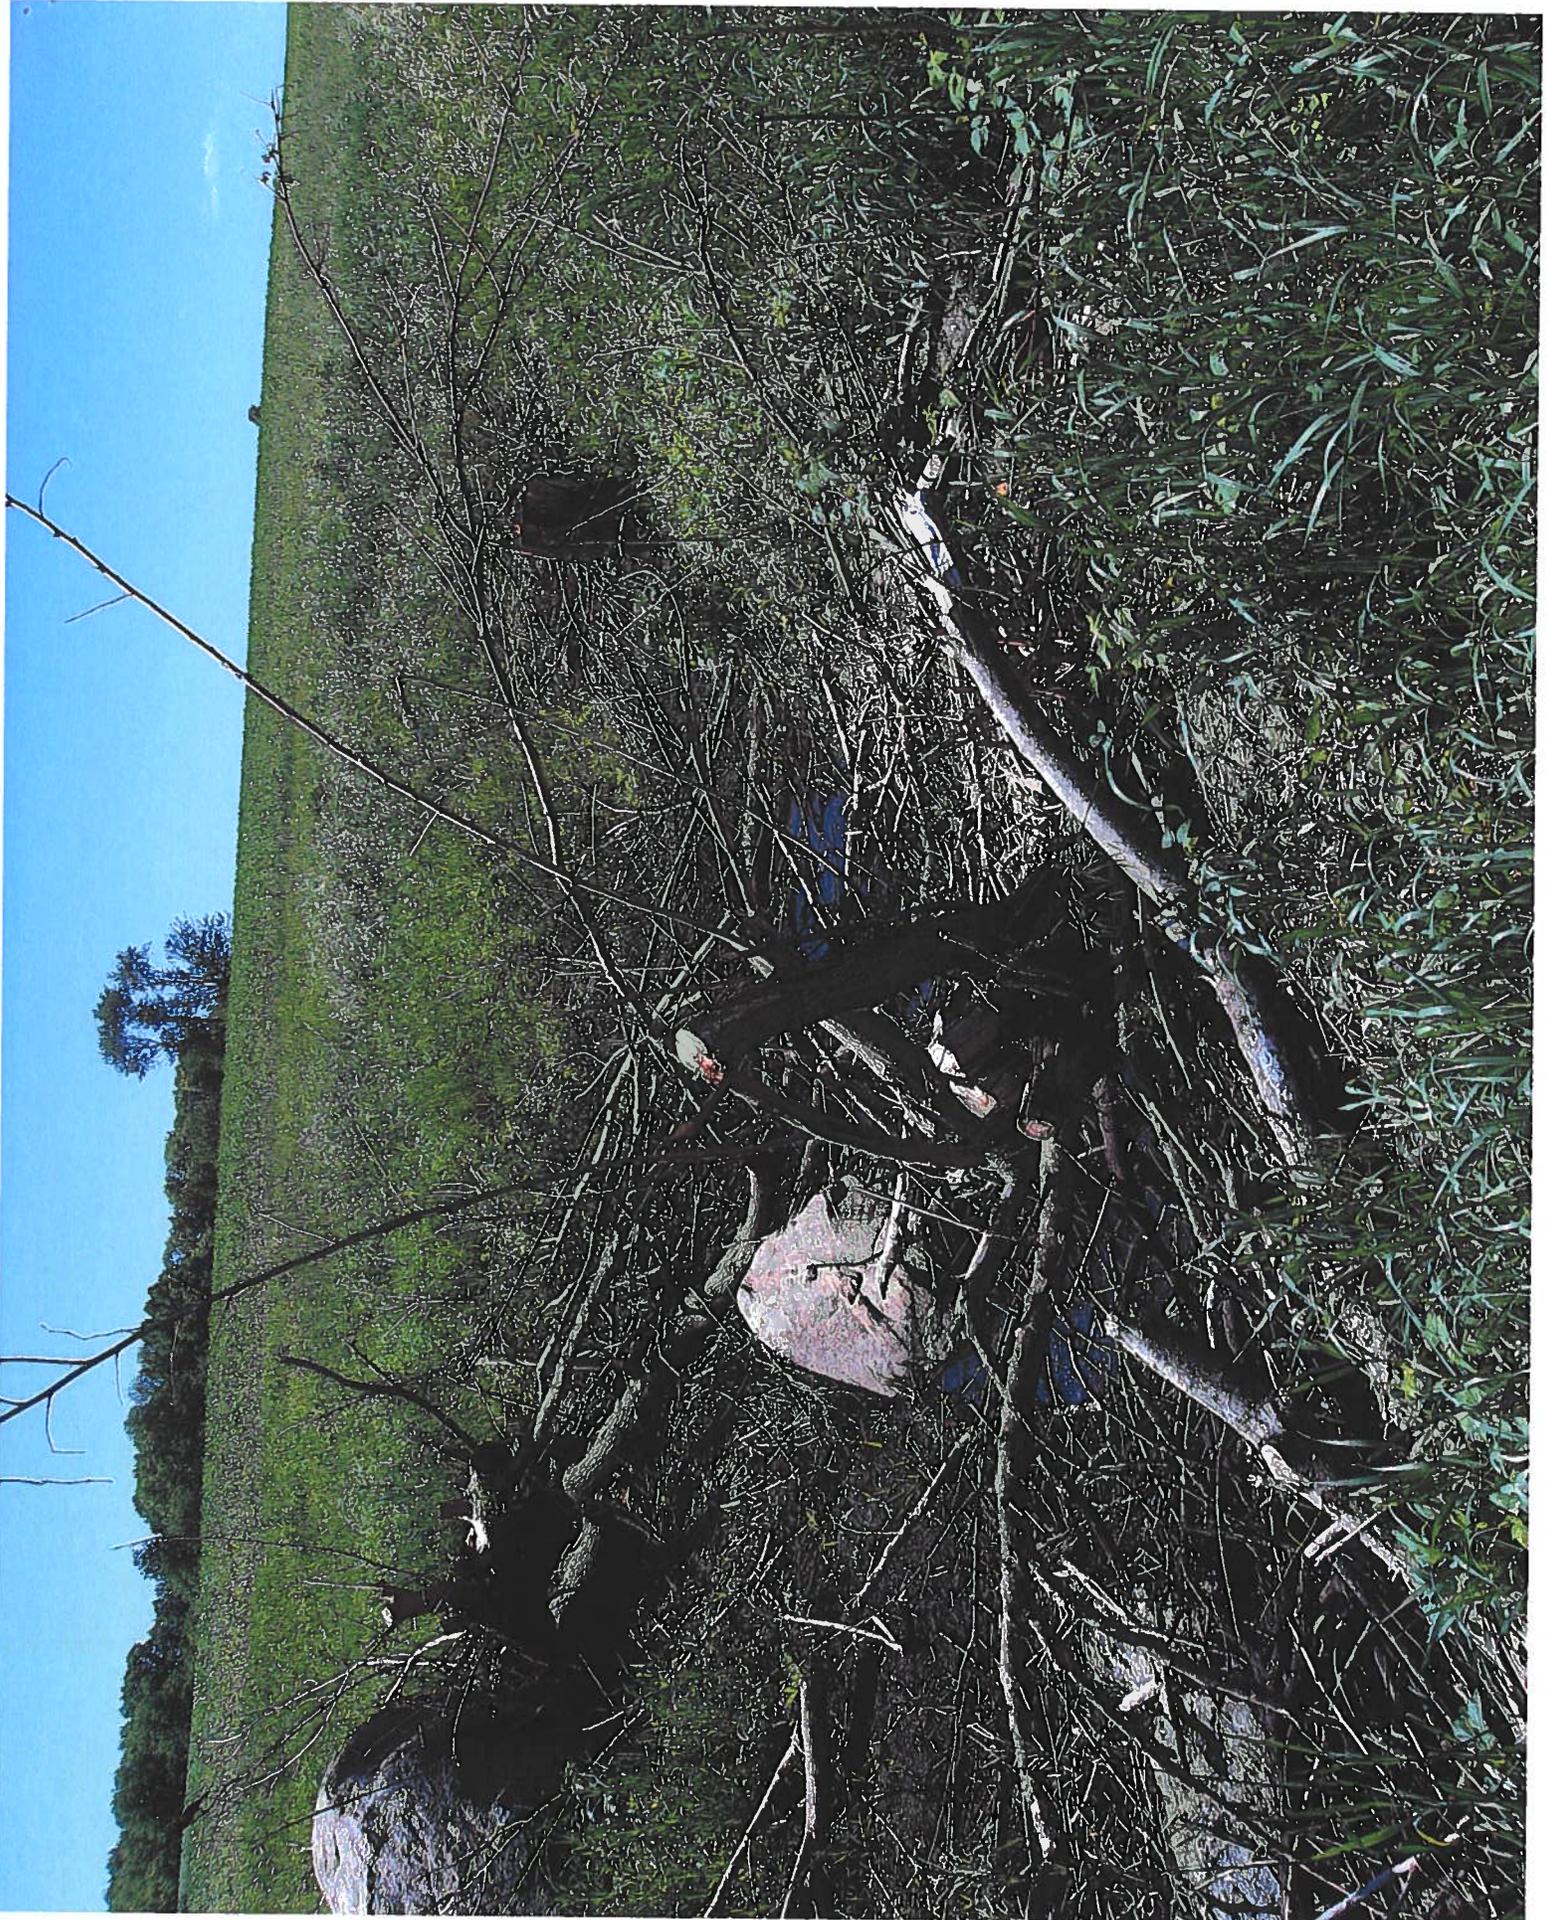
TREES JUST DOWNSTREAM FROM Blow-out
