### DD 121 Landowners Meeting

# Drainage Work Order Request For Repair

## Investigation/Repair Summary:

CONSTRUCTION ENGINEERING  
OBSERVATION REPORT

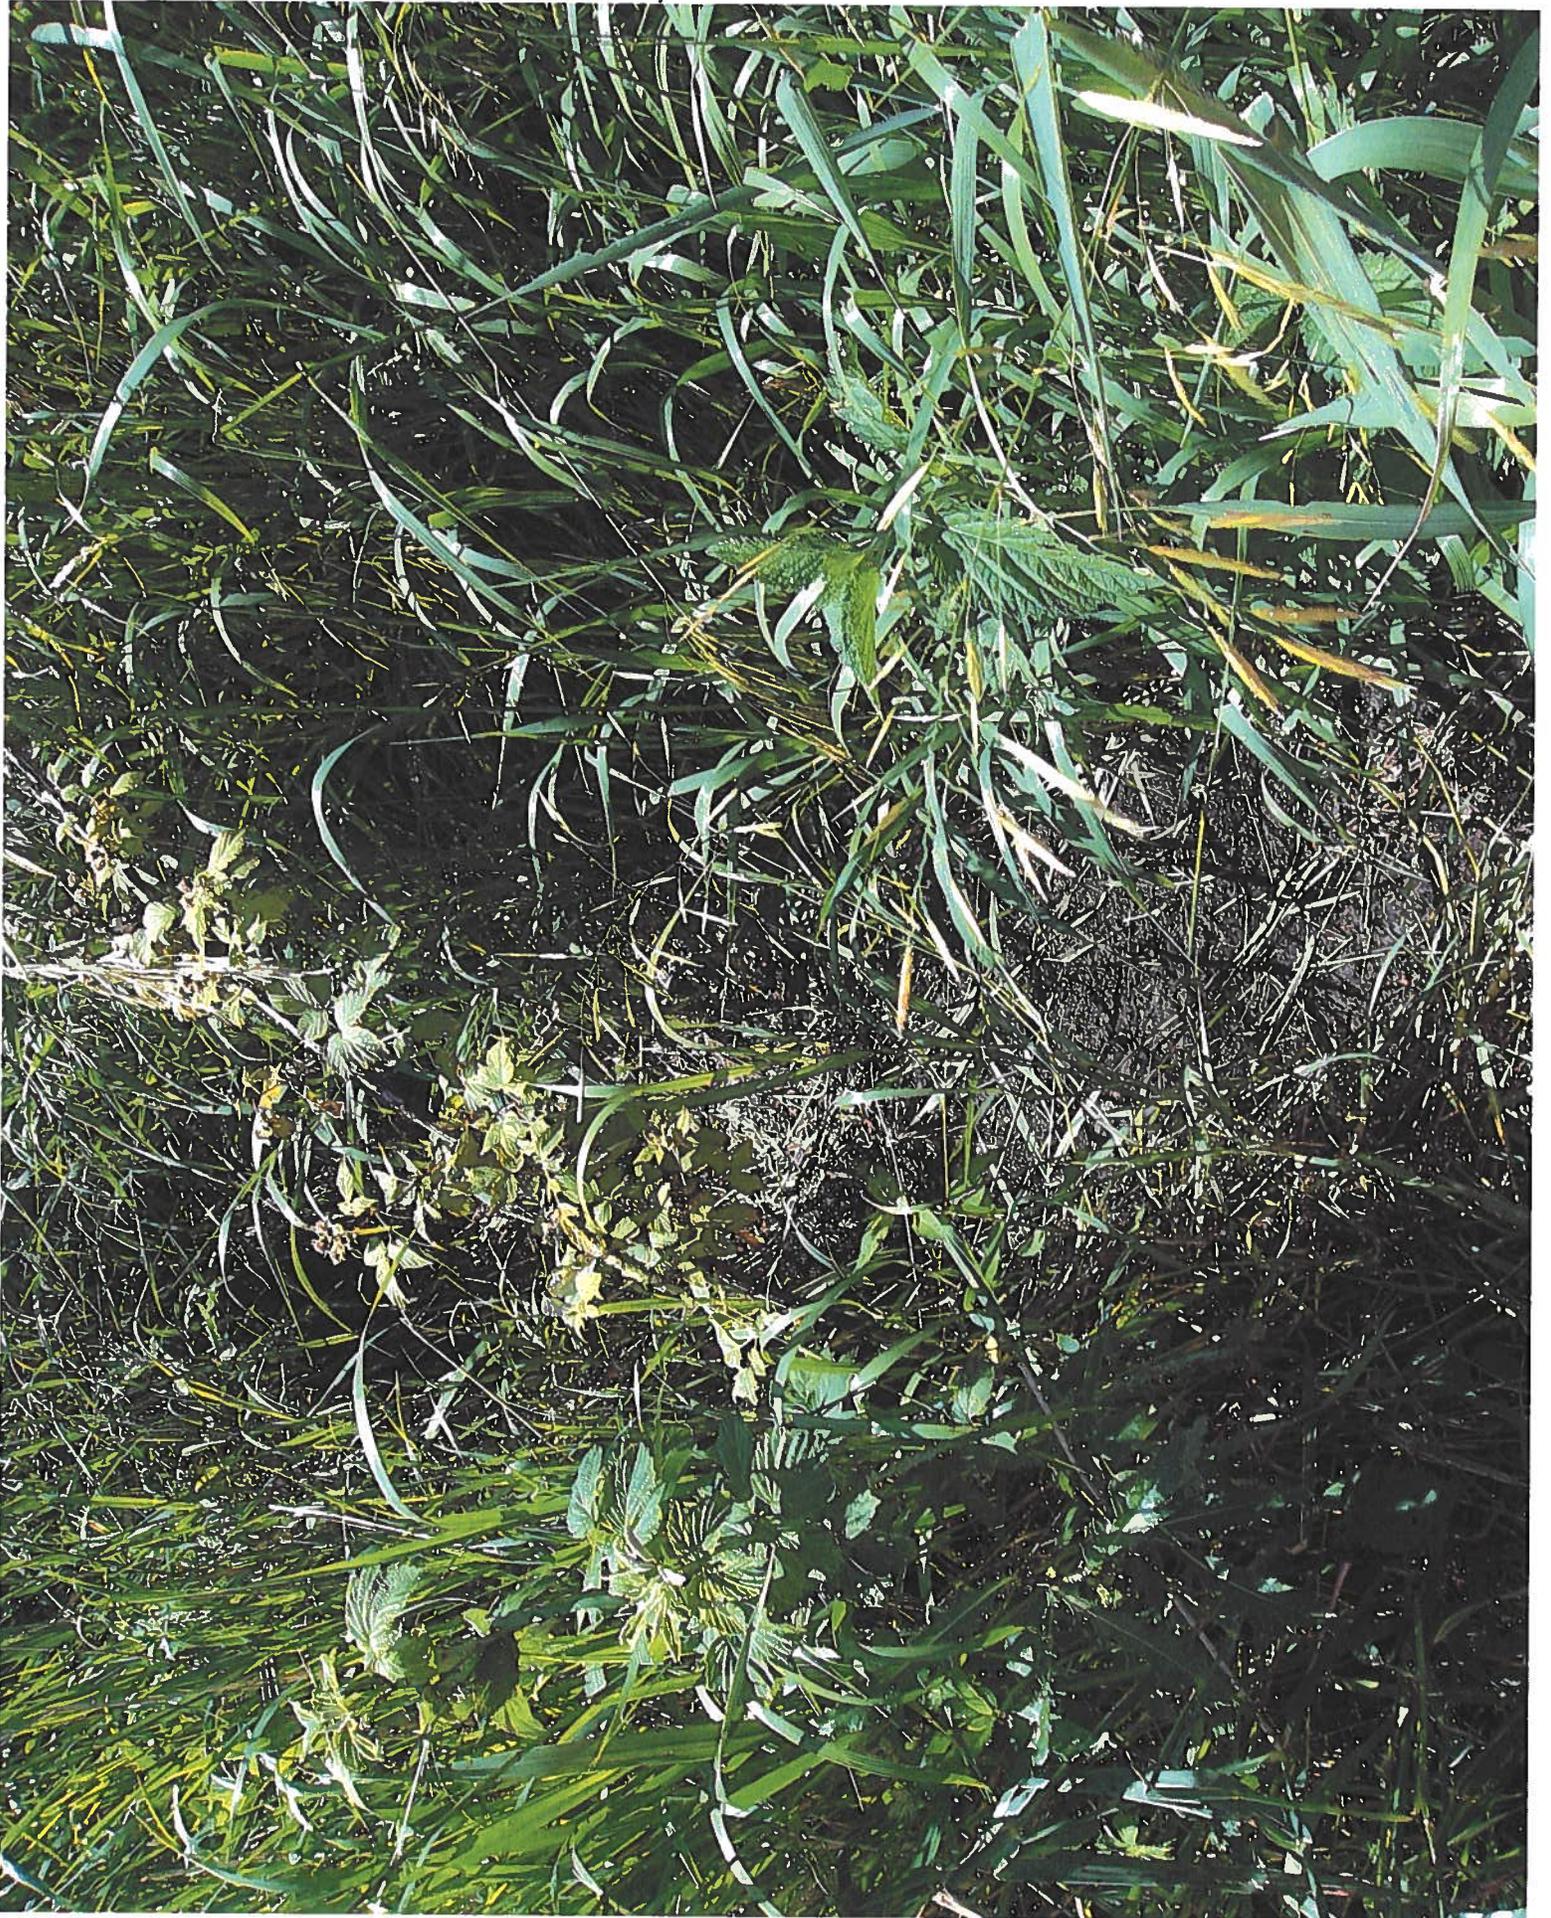
- Tenant in the SW¼ SE¼ Section 30, Township 86 North Range 20 West reported a blowout/sinkhole, with the tile plugged, and water flowing overland as a result.
- Visual observation found a wet area on the north fenceline, multiple wet areas in the grass swale, a blowout/sinkhole, and water running overland to the downstream of the observed blowout/sinkhole. Also found exposed tile, multiple pieces of broken tile and in the in the field, and large rocks and remnants of trees that had been removed just downstream of the blowout/sinkhole.

BLOW-OUT, CAN HEAR WATER

Due to the lack of soil cover over the tile, broken pieces of tile found in the field, and recently cut trees, CGA recommends locating and CCTV inspecting the tile in both directions from the blowout/sinkhole as the observed issue may be due to a larger-scale deterioration of the Main tile's physical condition.
