**AGENDA  
DRAINAGE DISTRICT 34  
LANDOWNER MEETING  
February 12, 2020 10:00 AM**

# Drainage Work Order Request For Repair

## Drainage District:

**D.D. 34 REPAIR MAP**  
HARDIN COUNTY, IOWA

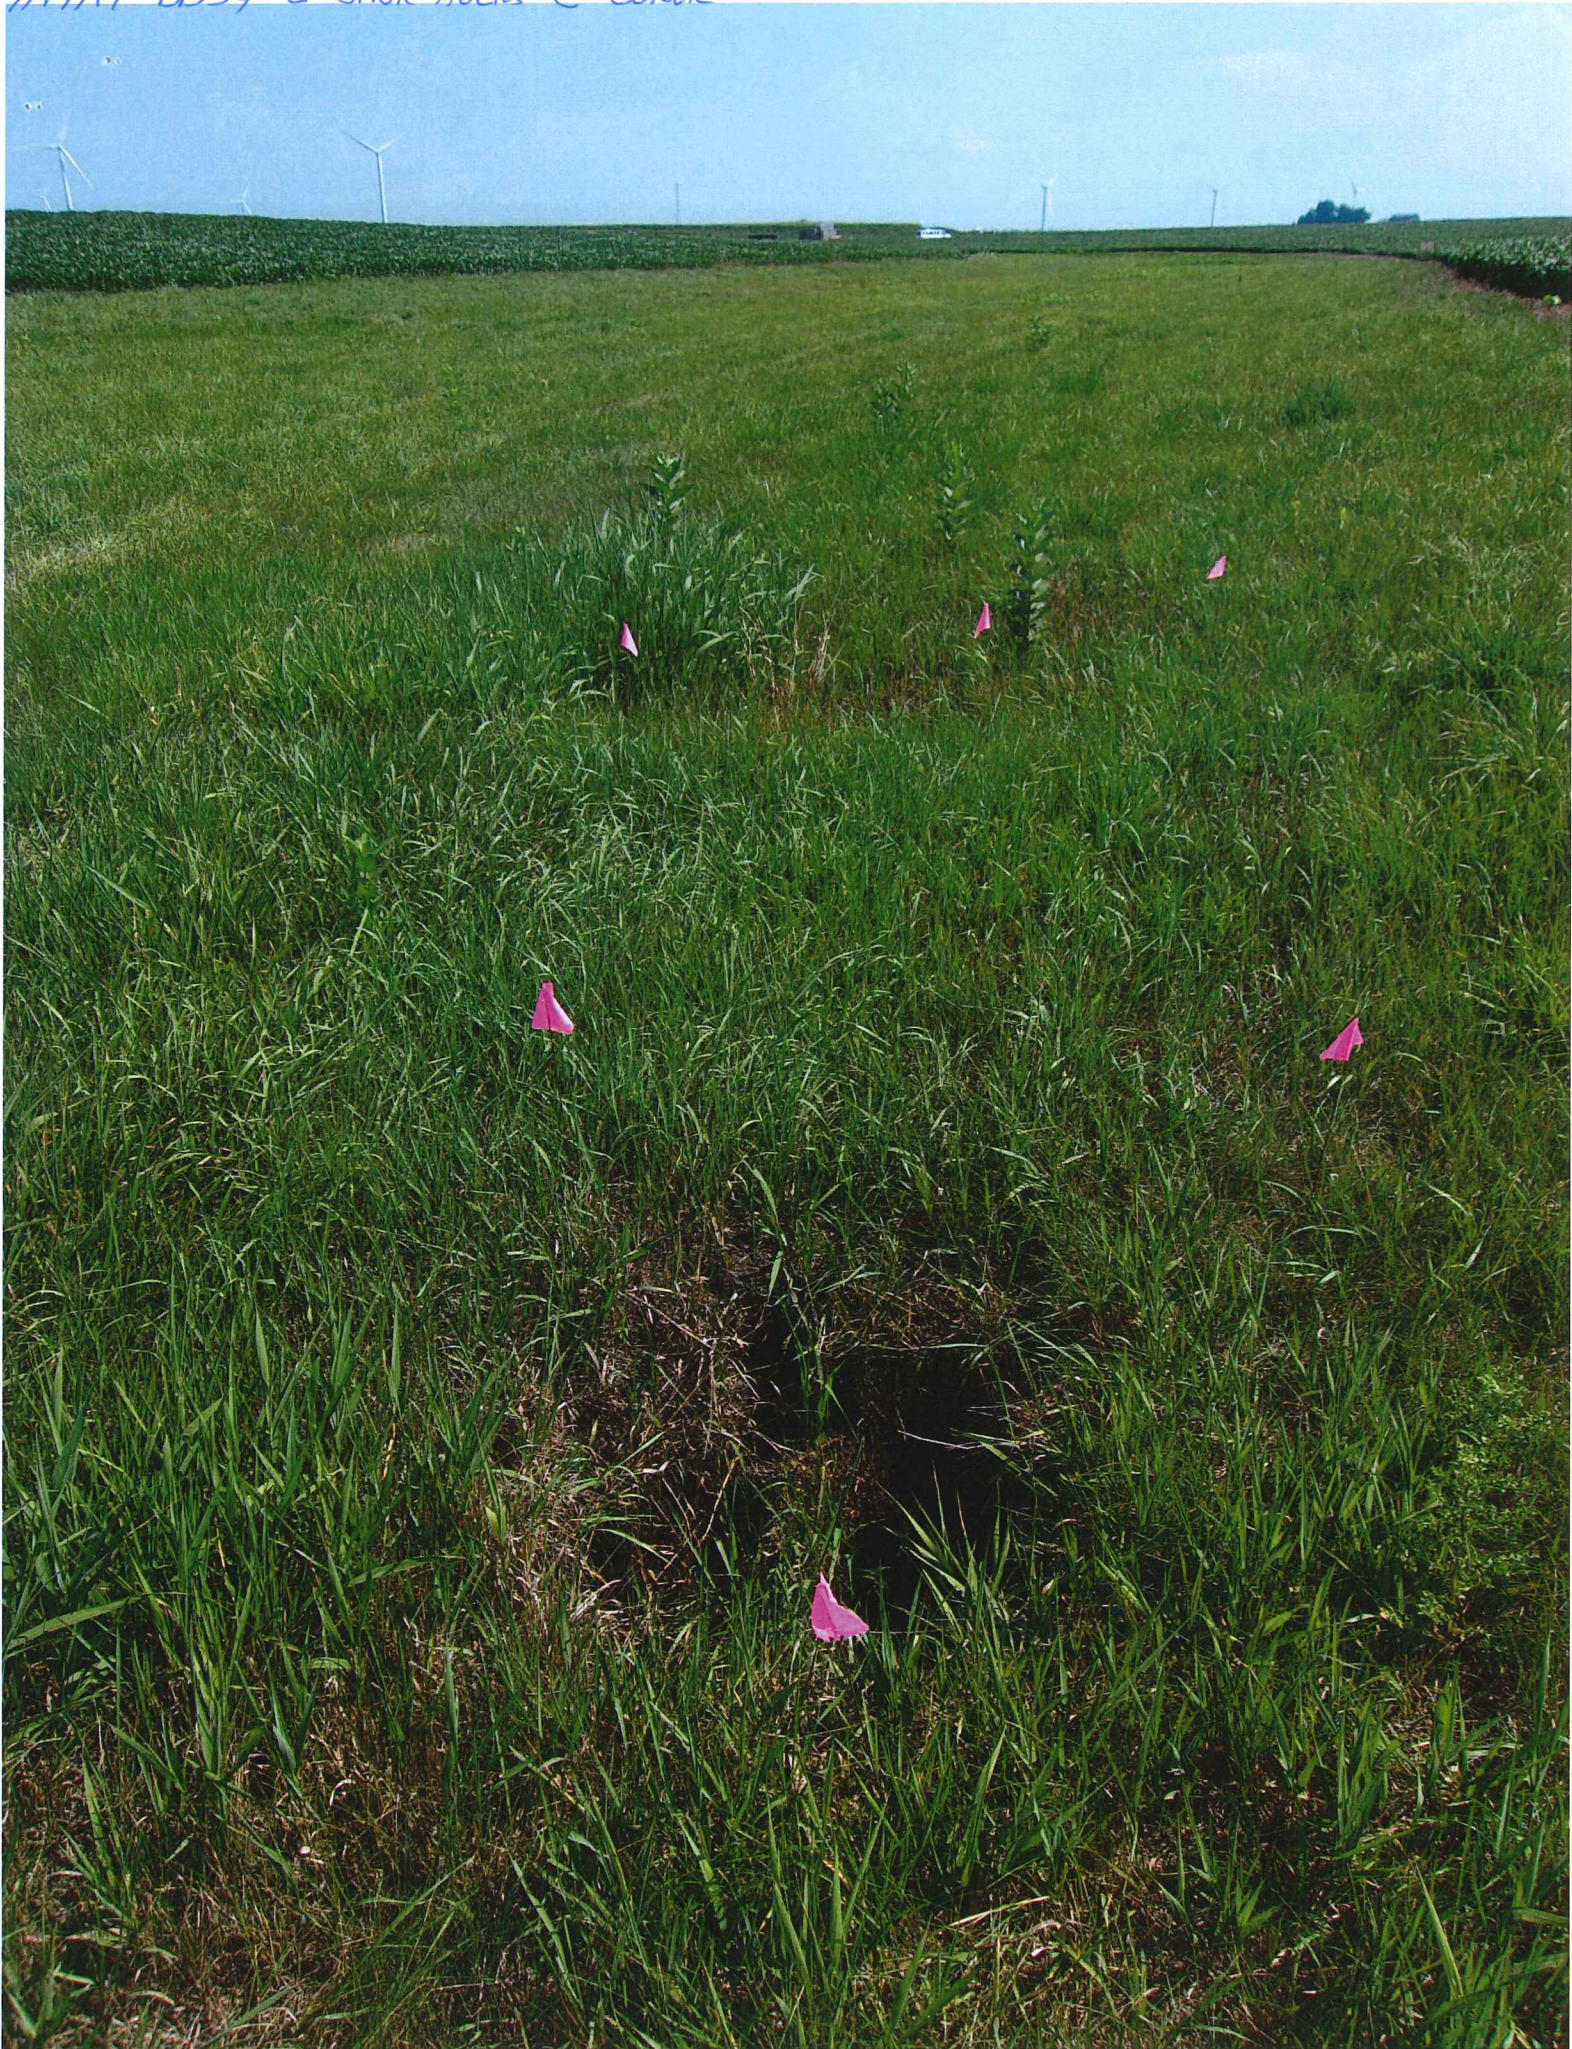
7/19/17 DD34 2 Sink Holes @ Curve

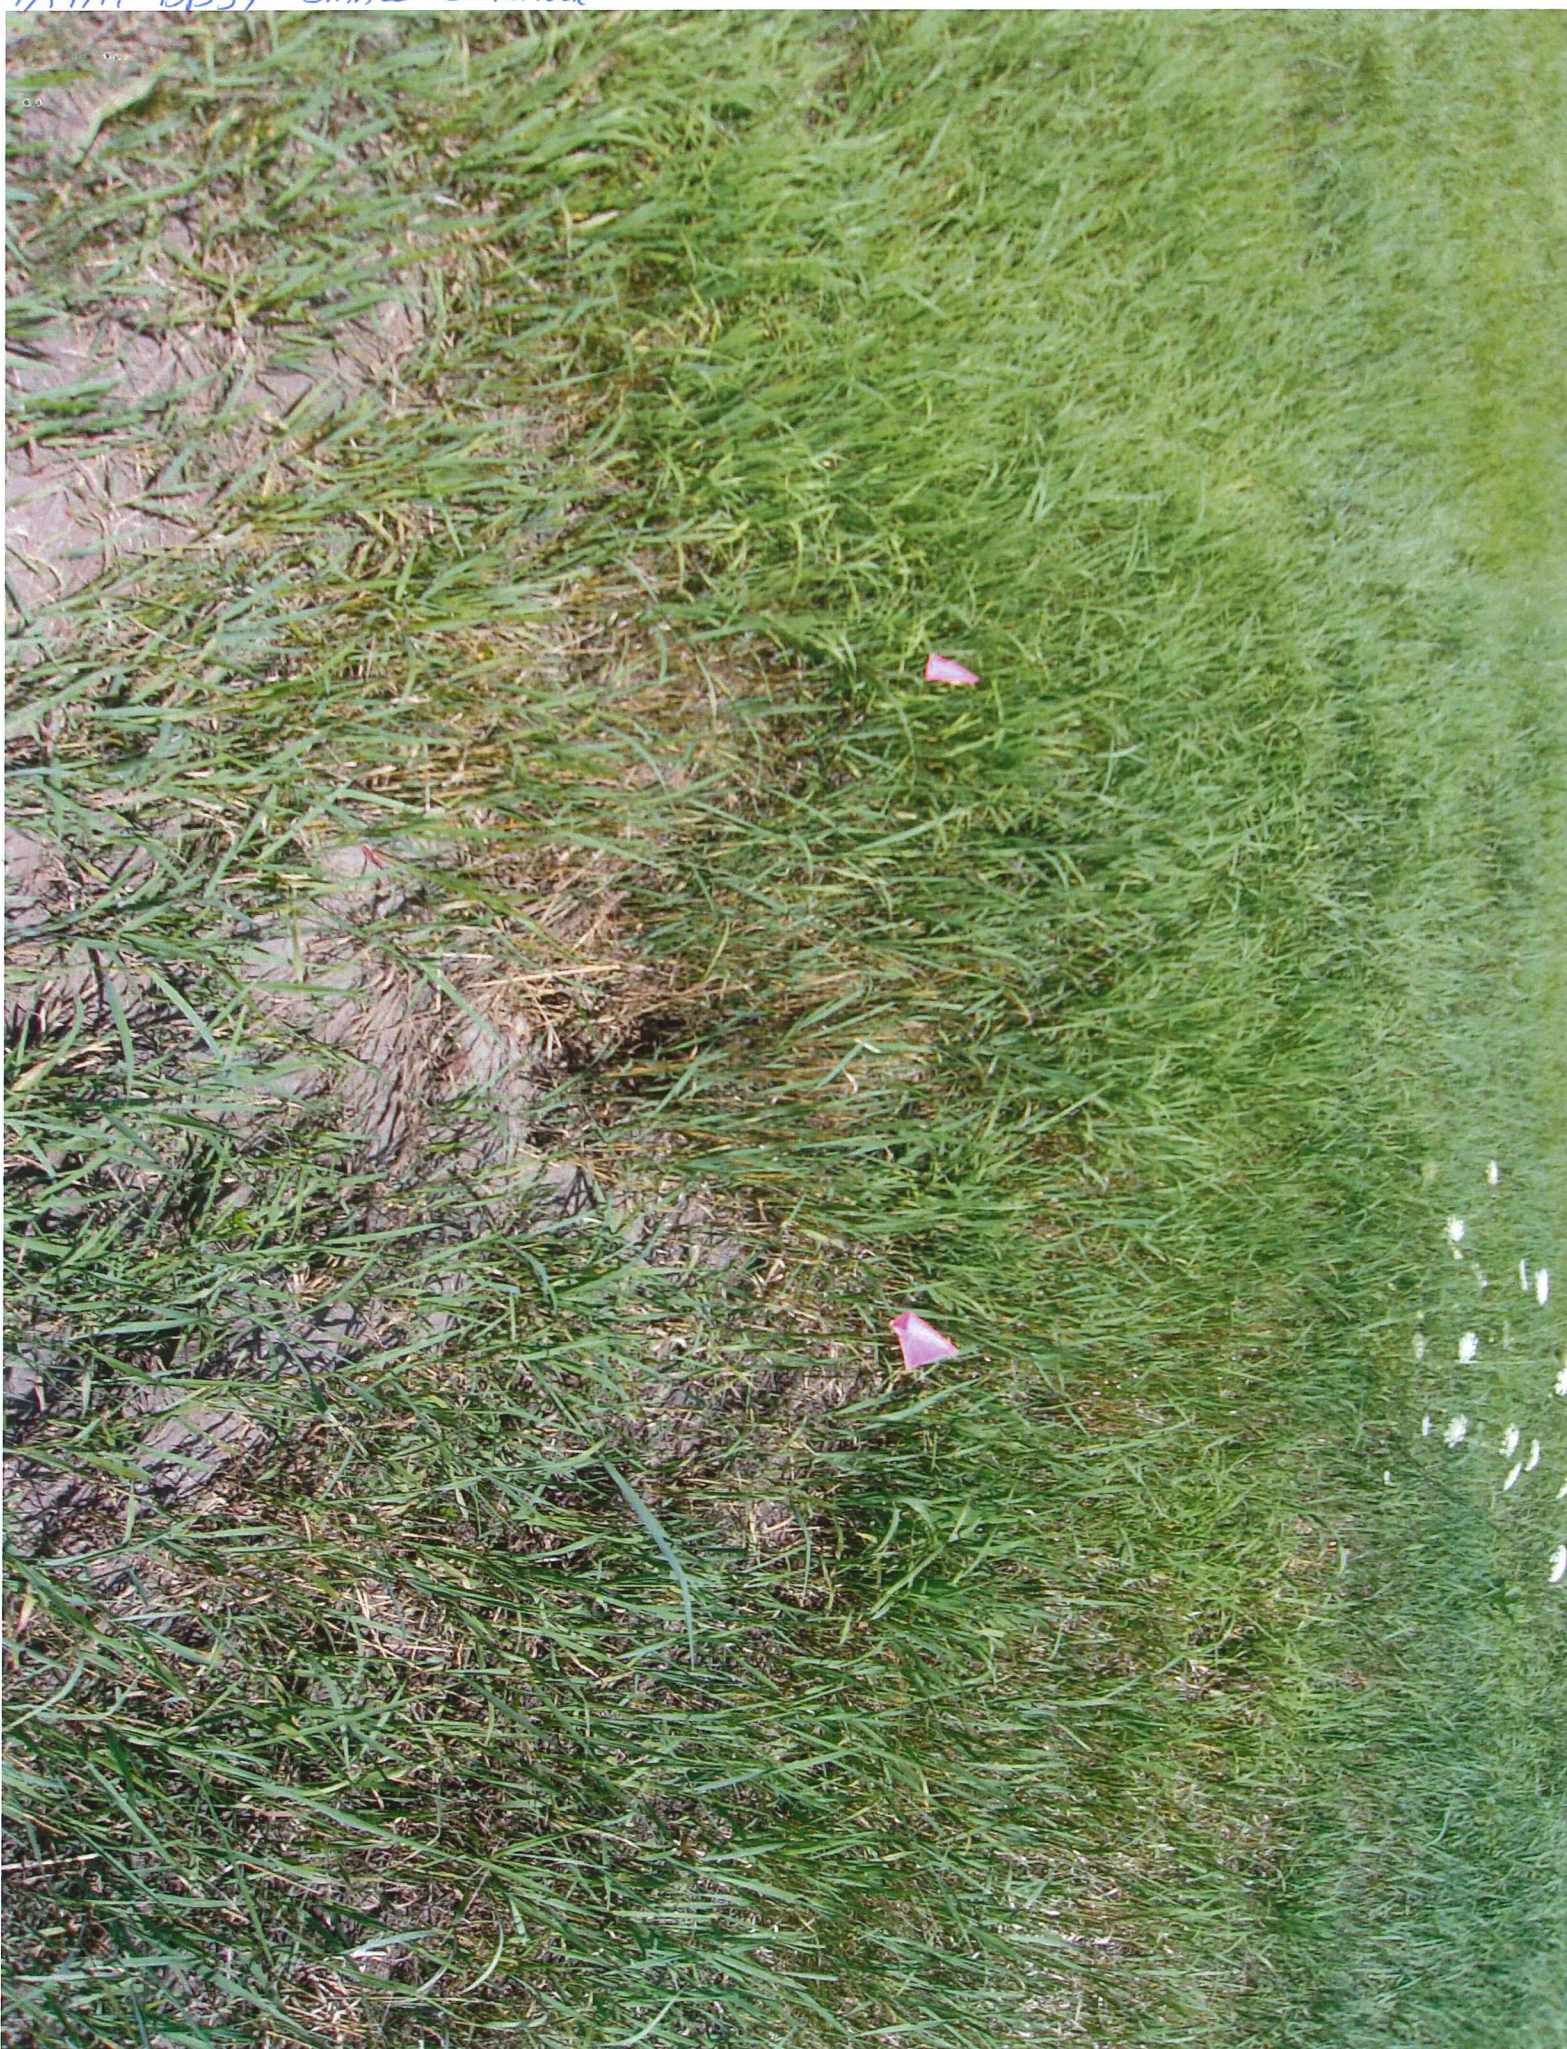
7/19/17 DP34 SMALL SWIRL HOLE

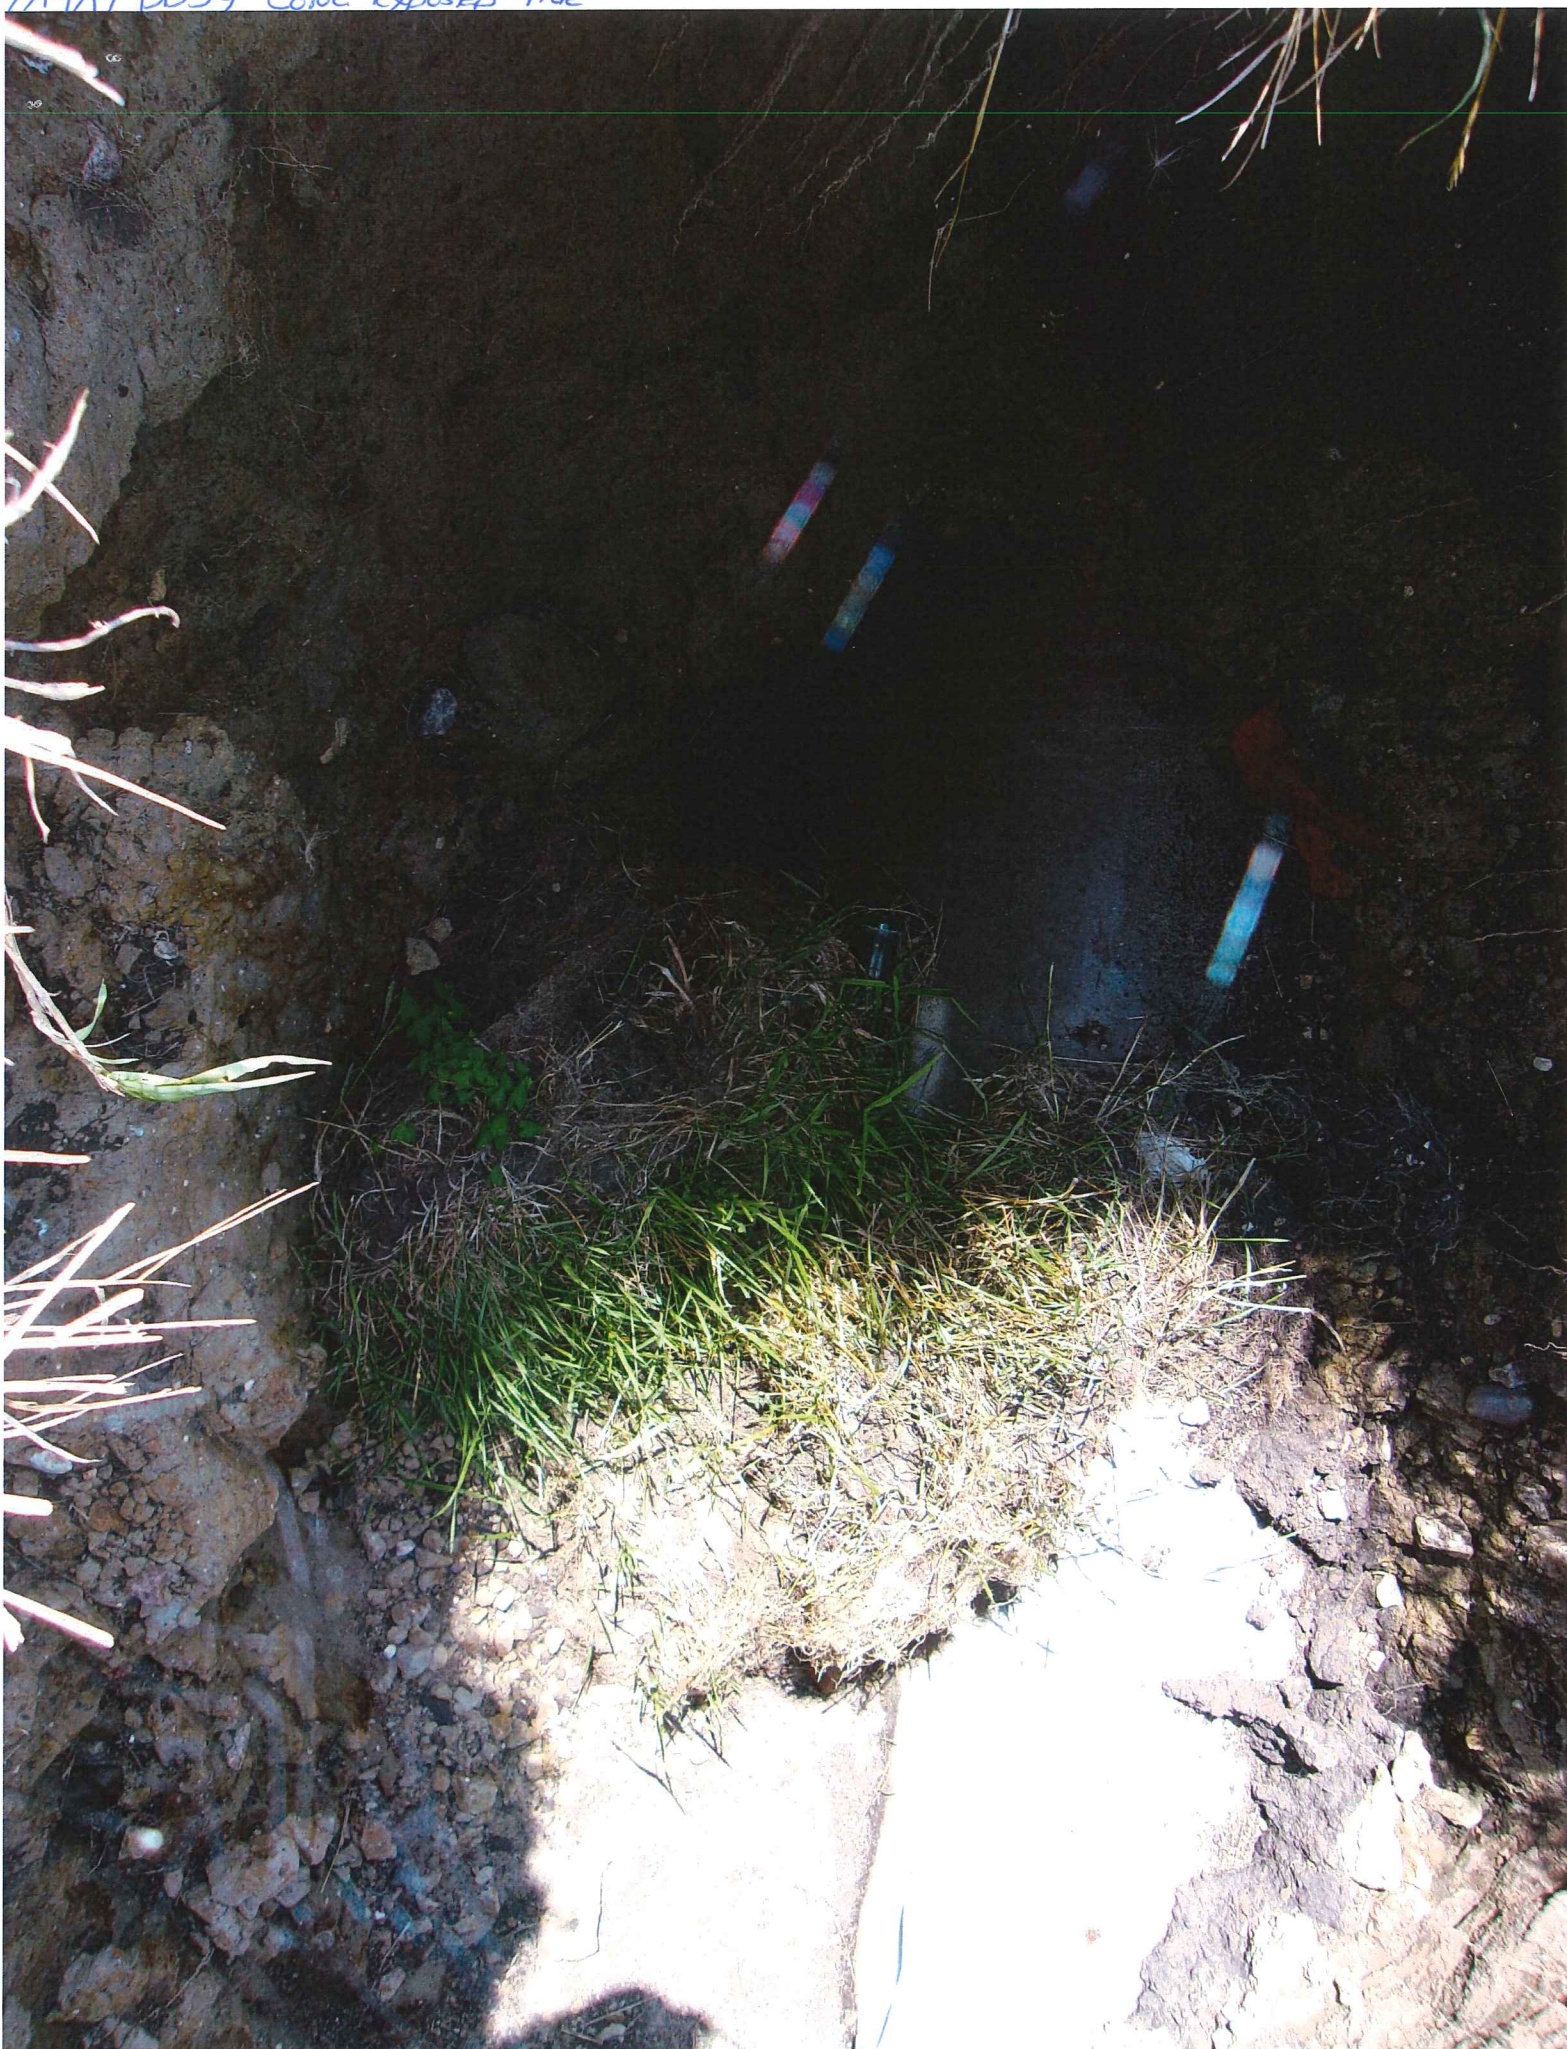
7/19/17 PD34 CONC EXPOSED TUE

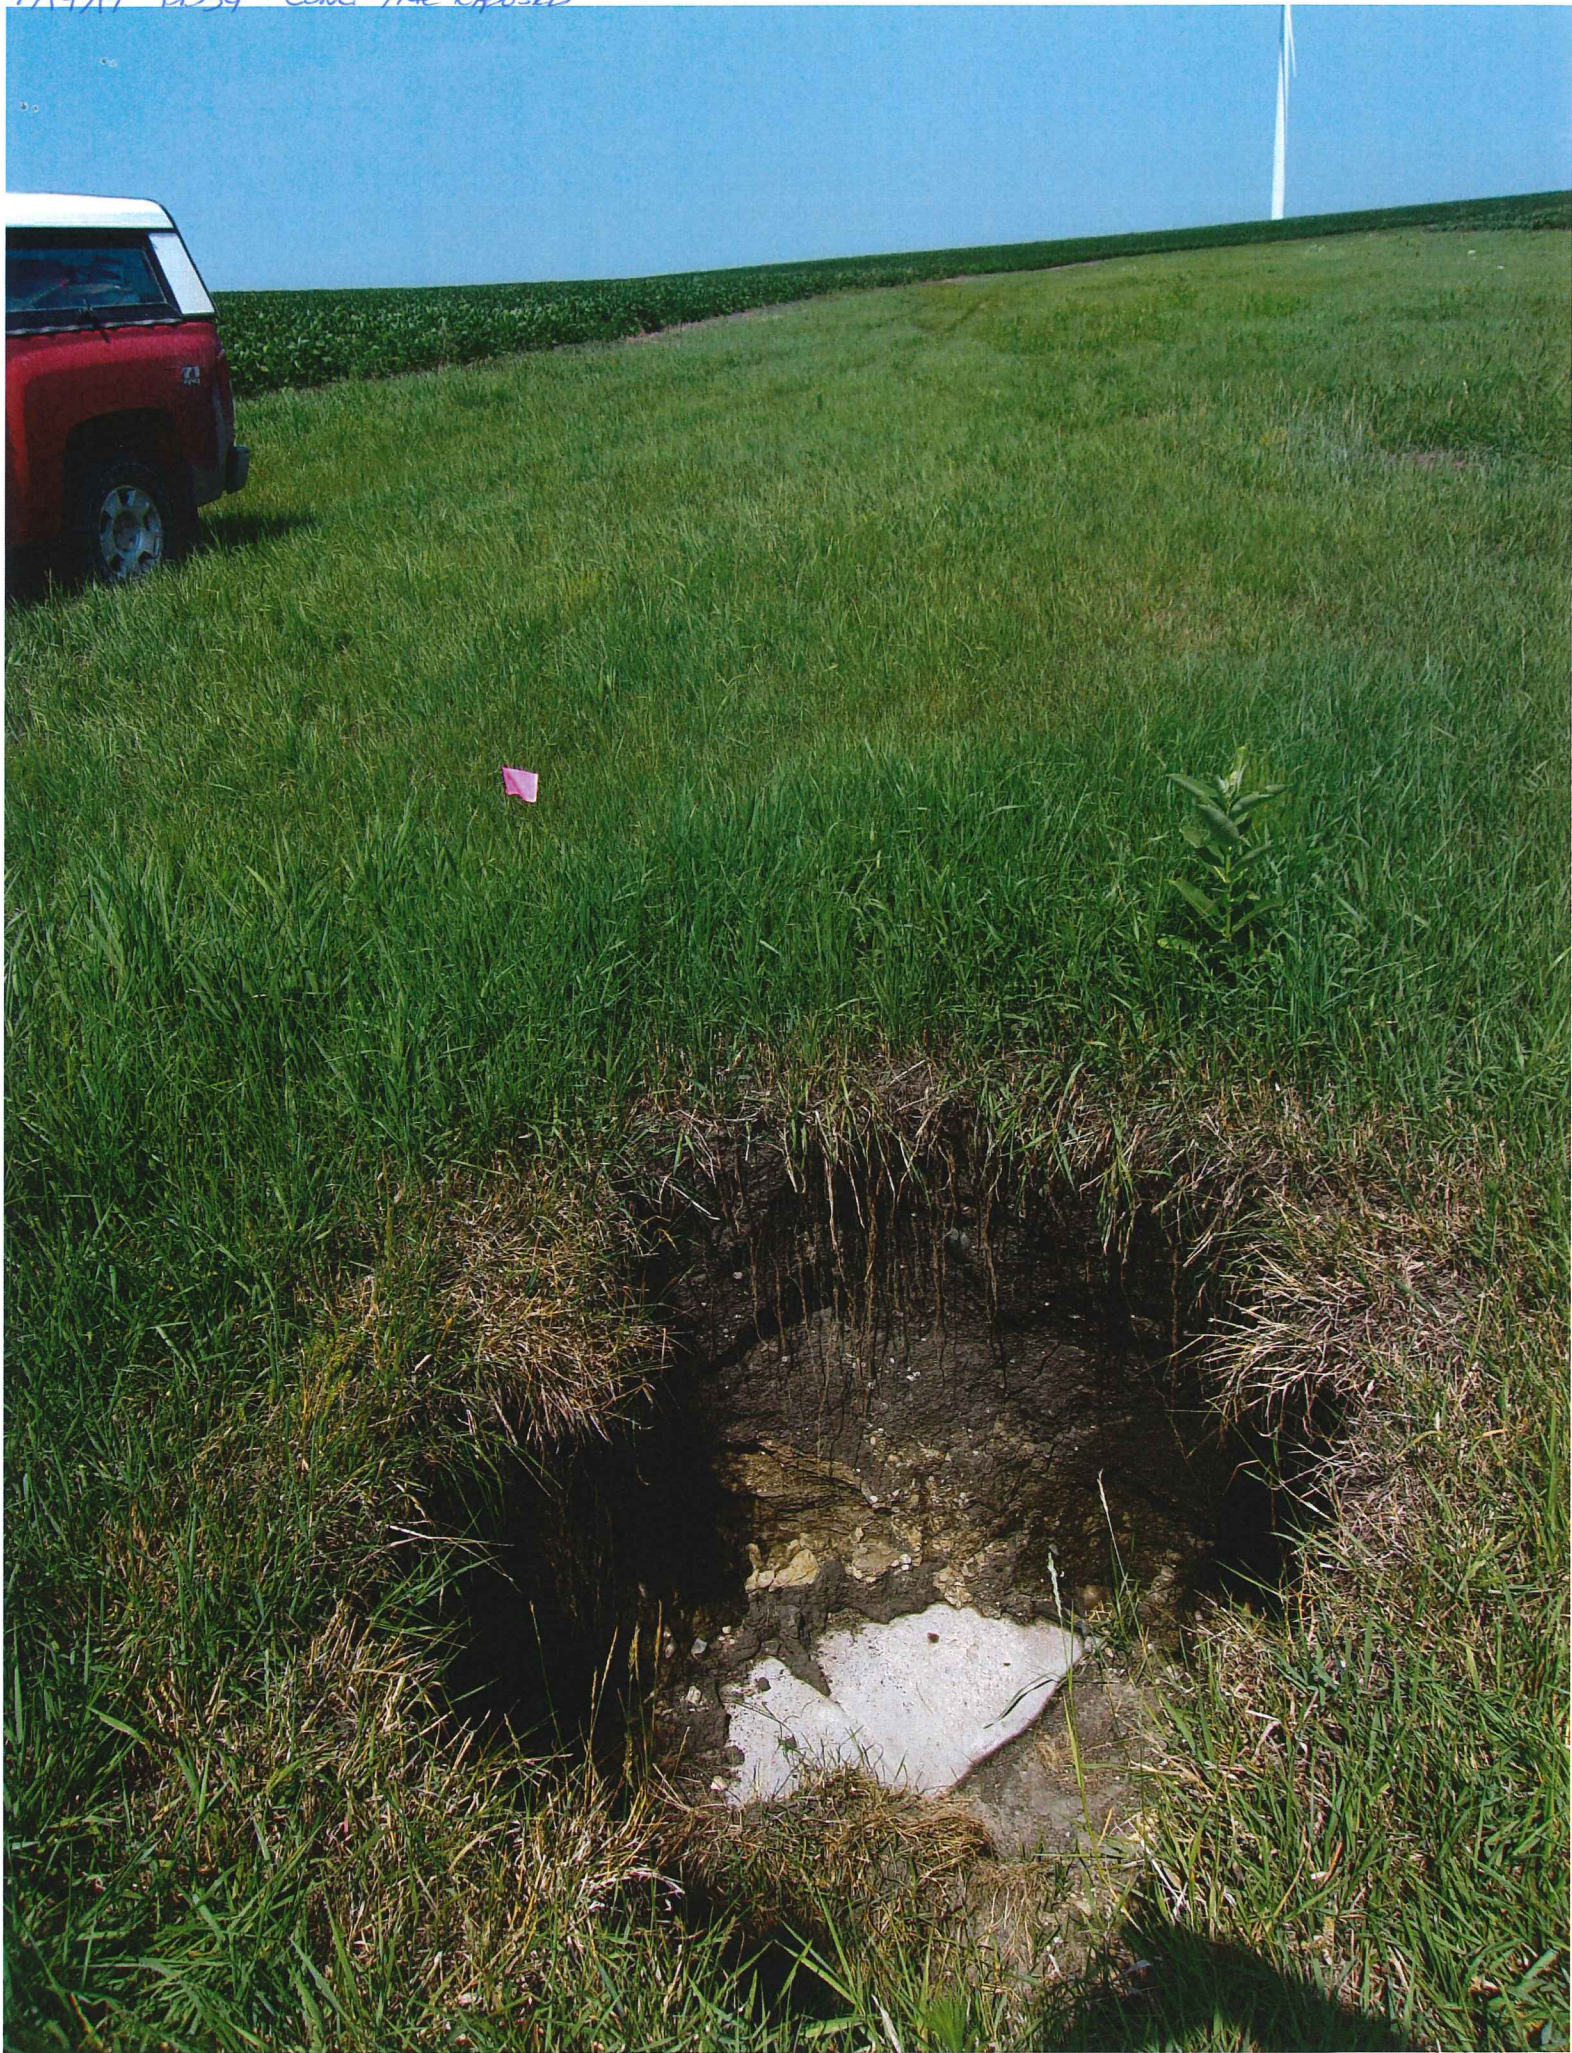
7/19/17 0034 CONC. TUBE EXPOSED

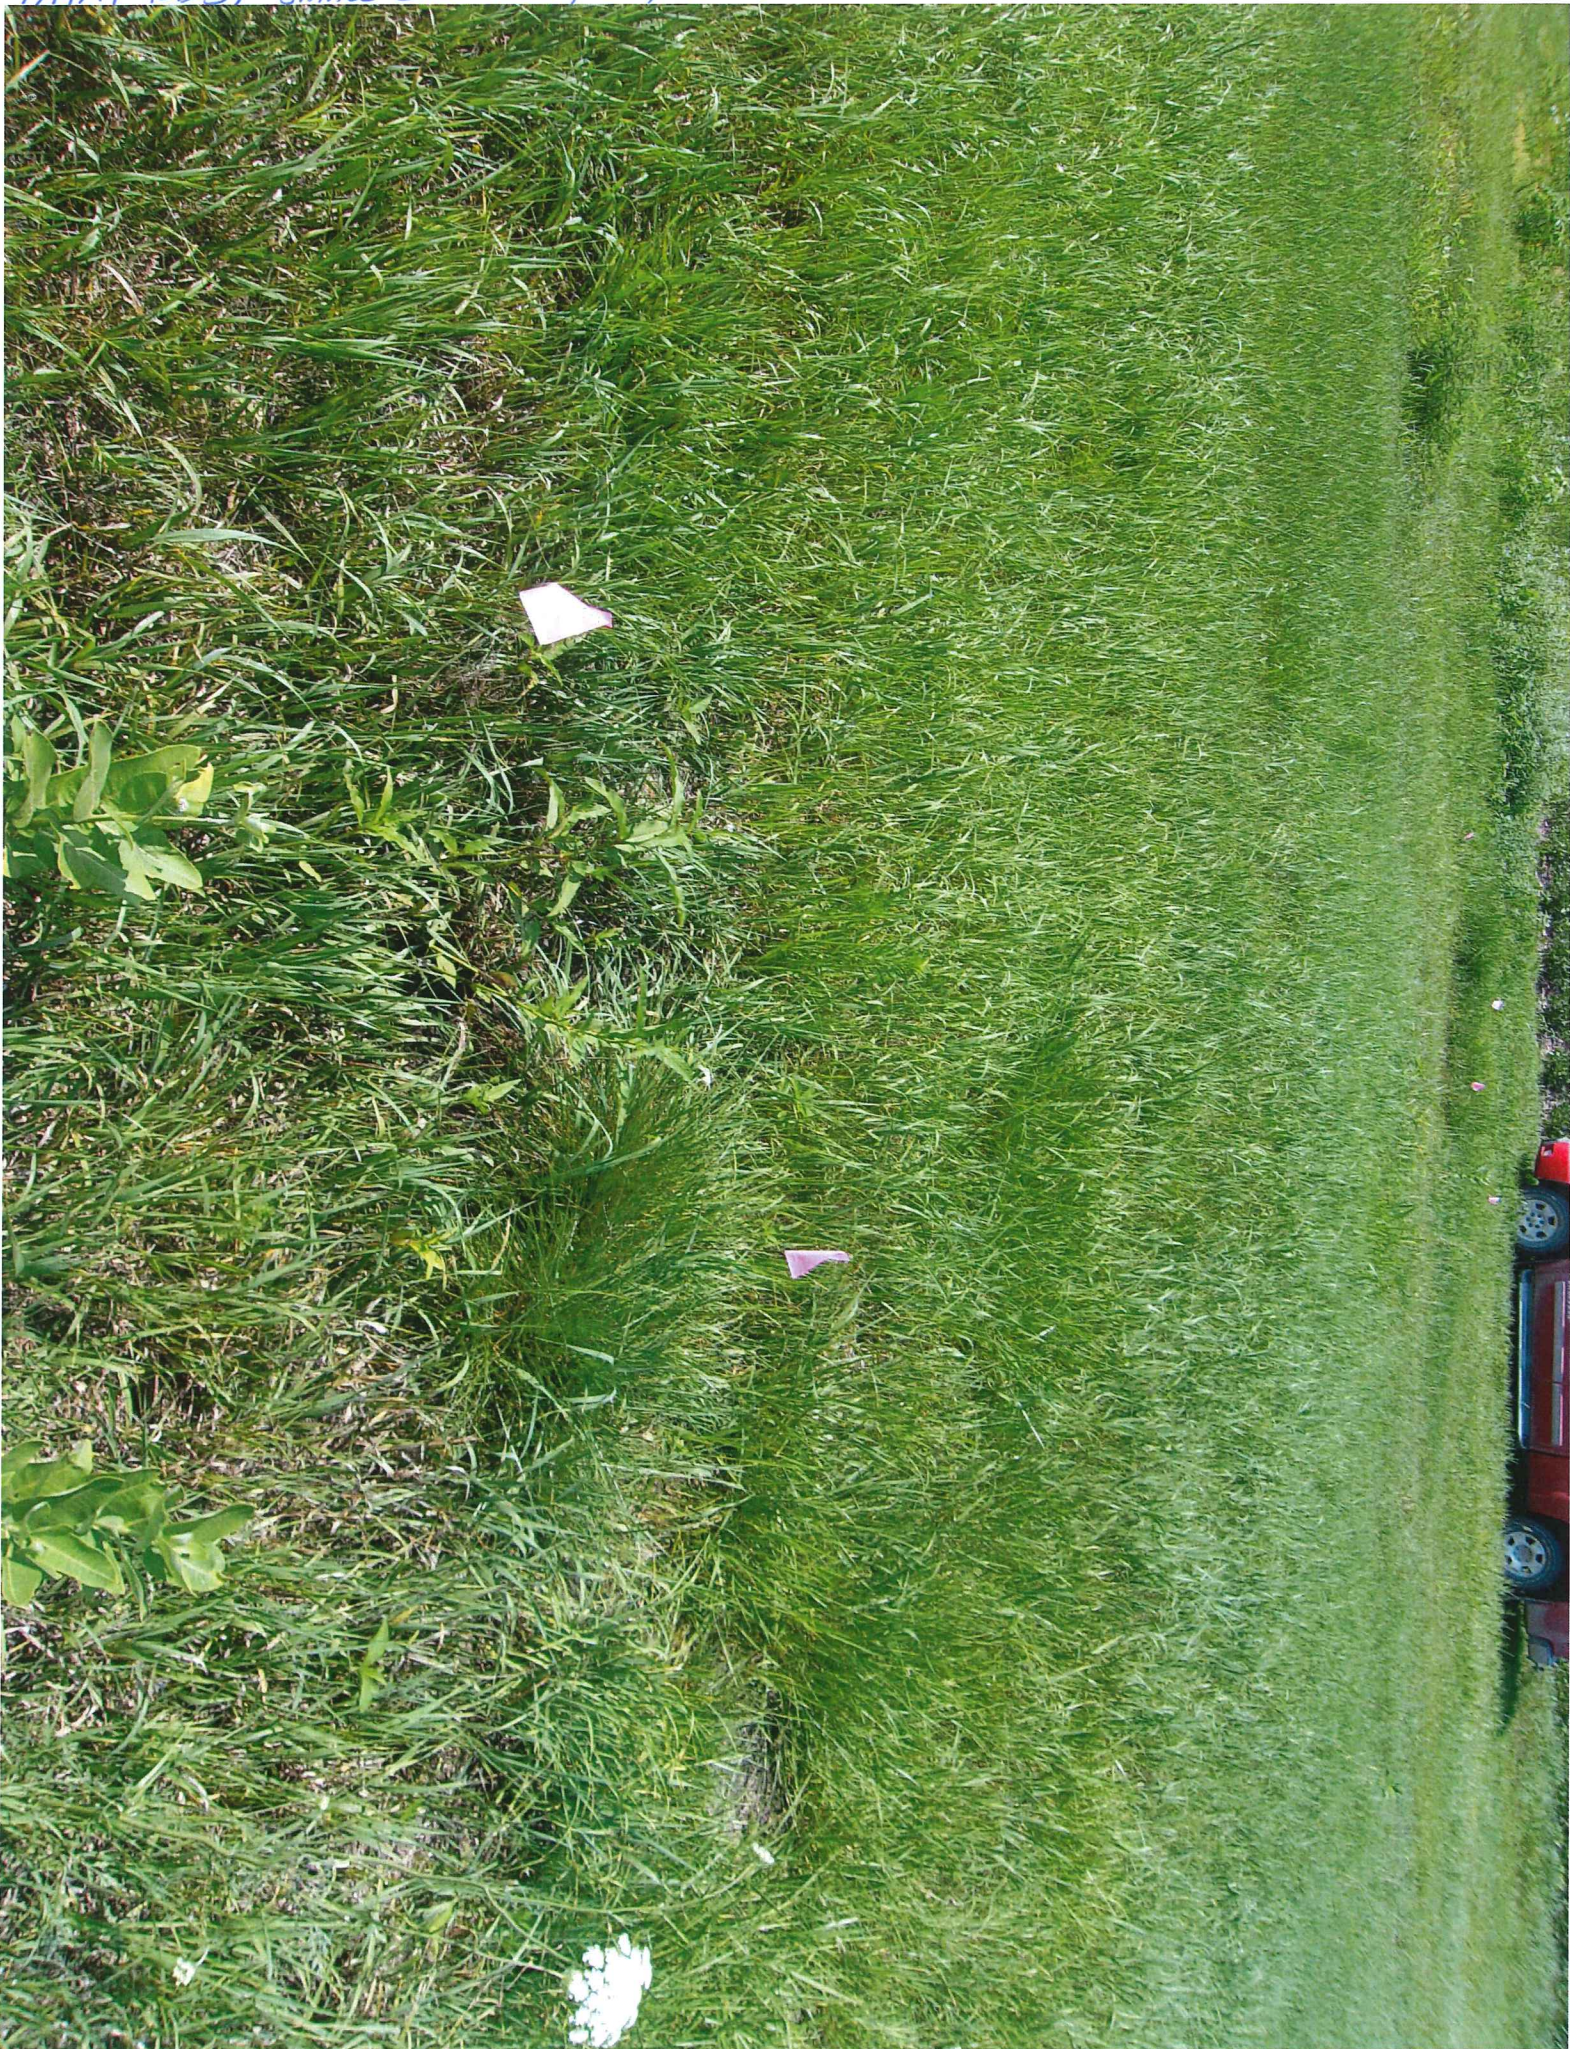
7/19/17 DD34 SMALL SINK HOLE, CLAY TILE?

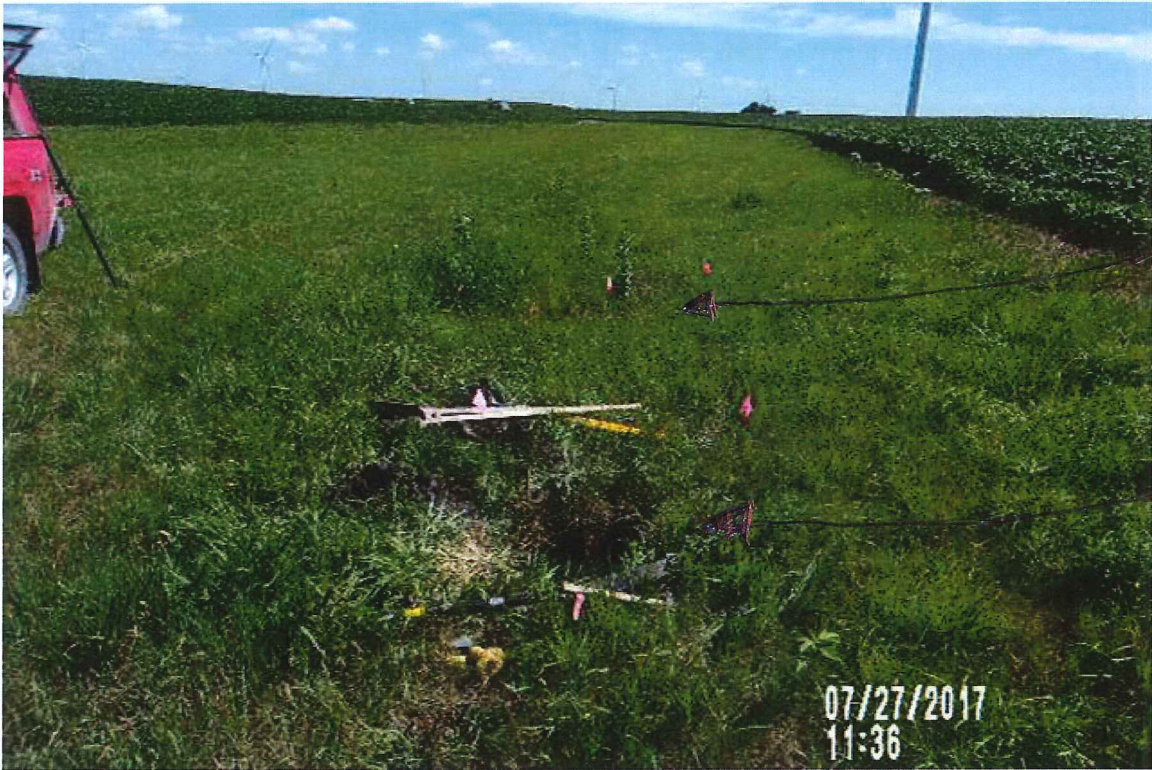
2ND TILE BLOW OUT HOLE SOUTH HAD A 2.5' Ø X 1.5' DEEP HOLE WITH  
TILE RUNNING SSW - NNE ON EAST SIDE OF BLOWOUT  
HOLE (NO CONCRETE PIPE BELL OR FABRIC OVER JOINT)  
PIPE IS 3.8' DEEP.

1ST TILE BLOWOUT HOLE SOUTH HAD A 2.0' E-W X 2.5' N-S X 2.5' DEEP  
HOLE WITH PIPE RUNNING SSW - NNE ON WEST SIDE OF  
BLOWOUT (CONCRETE PIPE). PIPE IS 3.5' DEEP.

PICT #6065 IS LOOKING NE AT 1ST & 2ND TILE BLOWOUT HOLE SOUTH

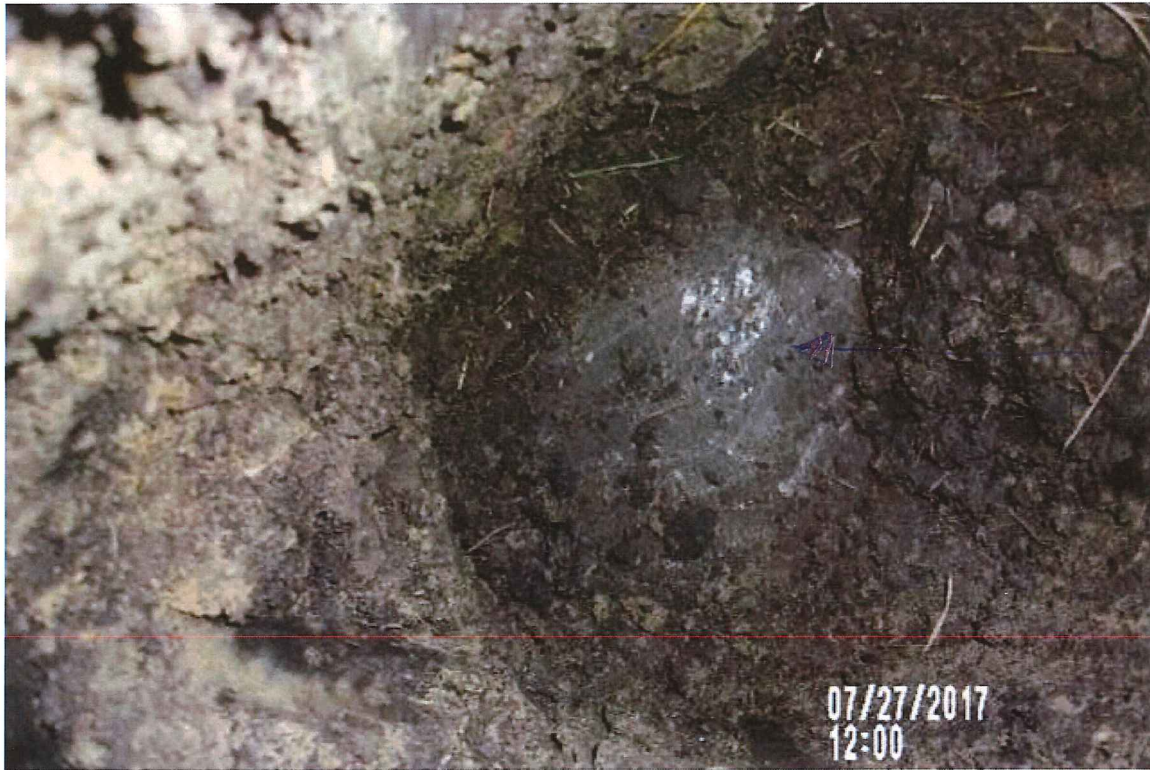
PICT #6066 IS LOOKING WEST AT EXPOSED CONCRETE PIPE JOINT IN 2ND TILE BLOWOUT HOLE SOUTH (JOINT DID NOT LOOK LIKE IT HAD BEEN SUCKING SOIL; NOT SURE WHAT IS CAUSING BLOWOUT ASSUMING JOINT SUCKING SOIL INSIDE OF PIPE)

PICT # 6067 IS LOOKING WEST AT EXPOSED CONCRETE PIPE  
IS 1ST TILE BLOWOUT HOLE SOUTH. UNSURE OF CAUSE FOR BLOWOUT,  
POSSIBLE PIPE JOINT SUCKING SOIL ON SIDES

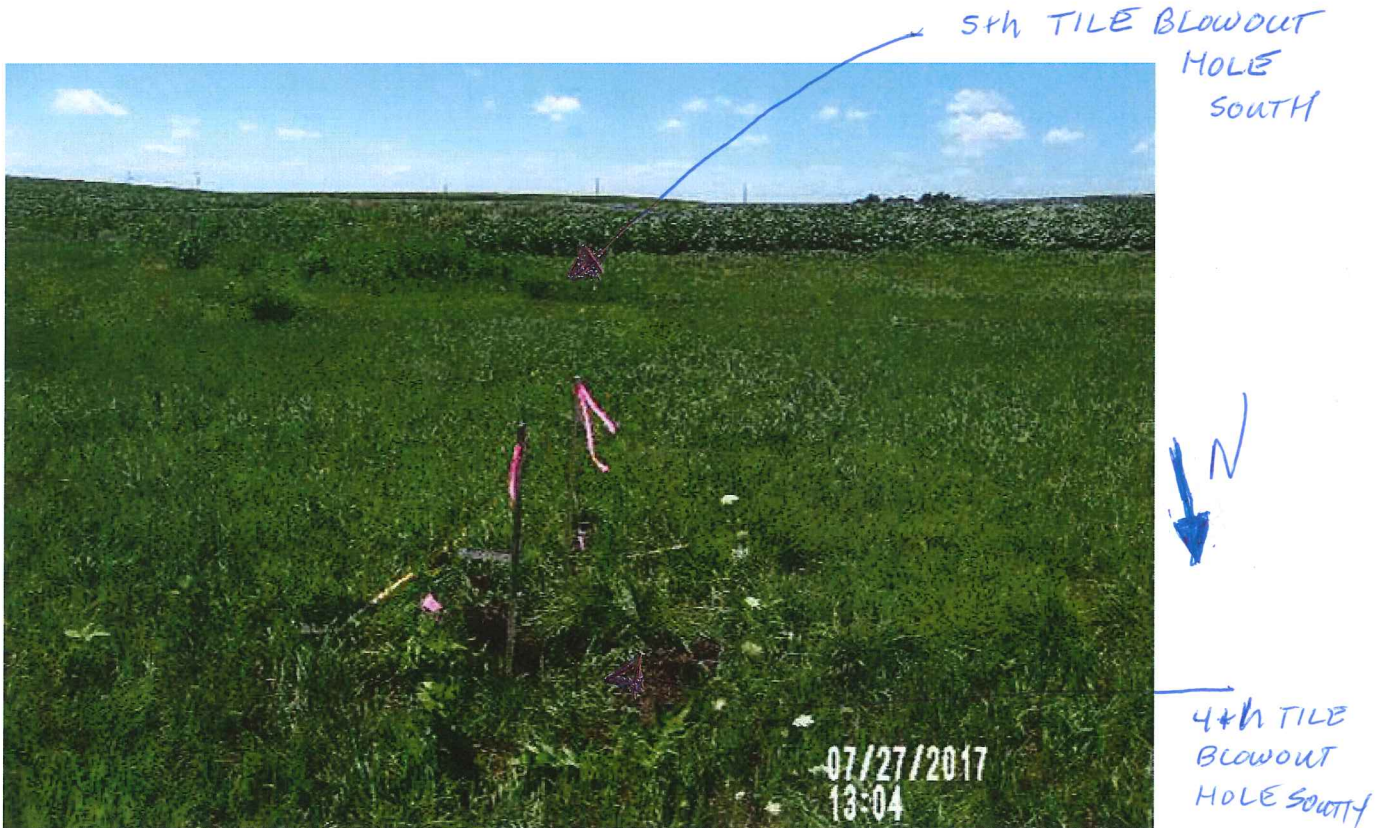
4TH TILE BLOWOUT HOLE SOUTH 1.5' Ø X 1.0' DEEP HOLE LOOKS  
LIKE DRAINAGE SWALE HAD ENGINEERING FABRIC  
KNIFED IN ACROSS SWALE FOR EROSION CONTROL (SILT FENCE?)  
AND CUT THROUGH TILE TOP 4" SINGLE WALL PERFORATED TILE 1.0' DEEP.

PICT# 6072 IS LOOKING SW AT 4th & 5th TILE BLOWOUT HOLES SOUTH

PICT# 6074 IS LOOKING AT CUT THROUGH 4" SW PERF CPP  
IN 4TH TILE BLOWOUT HOLE SOUTH

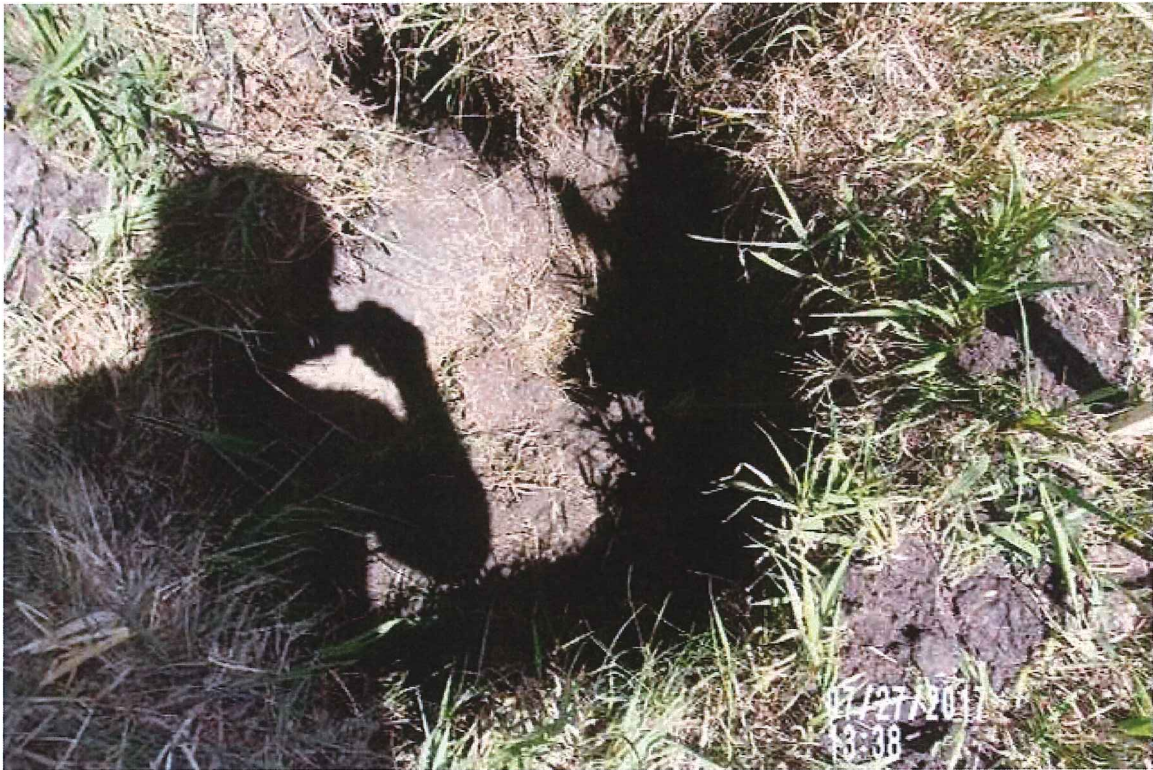
PICT# 6079 IS LOOKING NE AT 1ST TILE BLOWOUT HOLE SOUTH

GPS#5105  
0.5' Ø  
X 0.5' DEEP  
TILE BLOWOUT

PICT# 6080 IS LOOKING NE SHOWING ADDITIONAL TILE BLOWOUT HOLE BETWEEN 1ST AND 2ND TILE BLOWOUT HOLE SOUTH

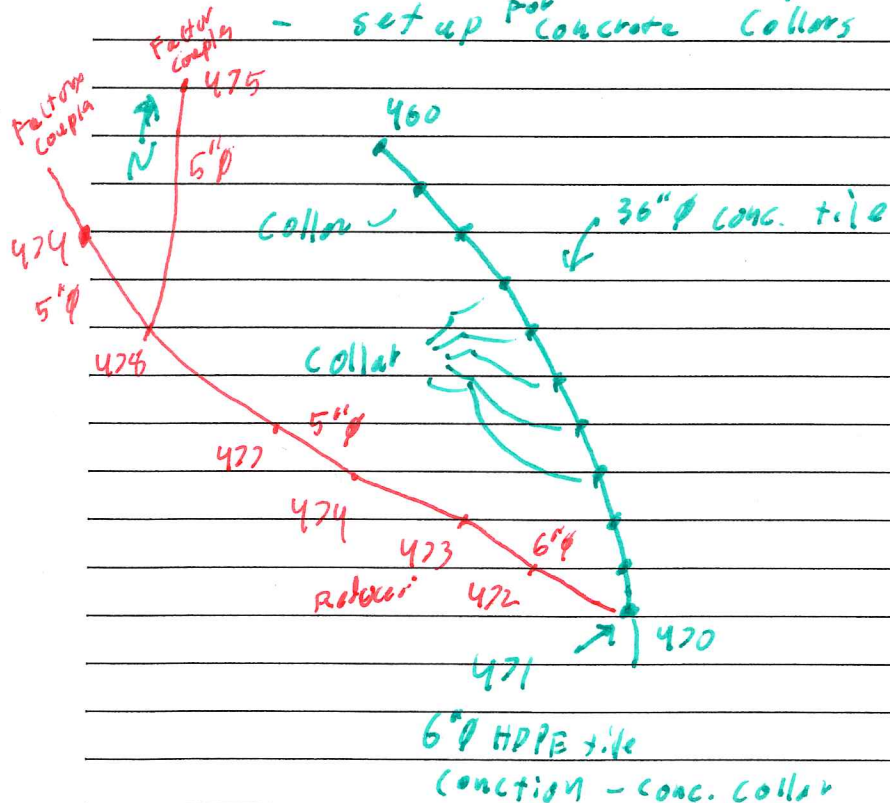
9:45 - Found 5 wide Joints in a row that was causing sinkhole plus an additional wide joint  
 - shot tile line GPS # 460 - 470  
 - set up <sup>Pop</sup> concrete collars

11:20 - crew left  
 1:00pm - crew back  
 - conc truck arrived  
 - poured 12 conc. collar + 1 connection  
 2:15pm - done pouring  
 - they ordered to make conc. put an additional 3 bucket loads on one repair  
 3:15pm - started back filling  
 6:00pm - crew left
