AGENDA
PUBLIC HEARING ON ENGINEER'S REPORT ON REPAIRS TO MAIN TILES,
DRAINAGE DISTRICT 86, HARDIN COUNTY
JANUARY 22, 2020 AT 11:00 A.M.
HARDIN COUNTY COURTHOUSE, LOWER LEVEL CONFERENCE ROOM

**ENGINEER'S REPORT
ON REPAIRS
TO MAIN TILE
DRAINAGE DISTRICT
NO. 86
HARDIN COUNTY,
IOWA**

Engineer's Report on Repairs to Main Tile, Drainage District No. 86 Hardin County, Iowa

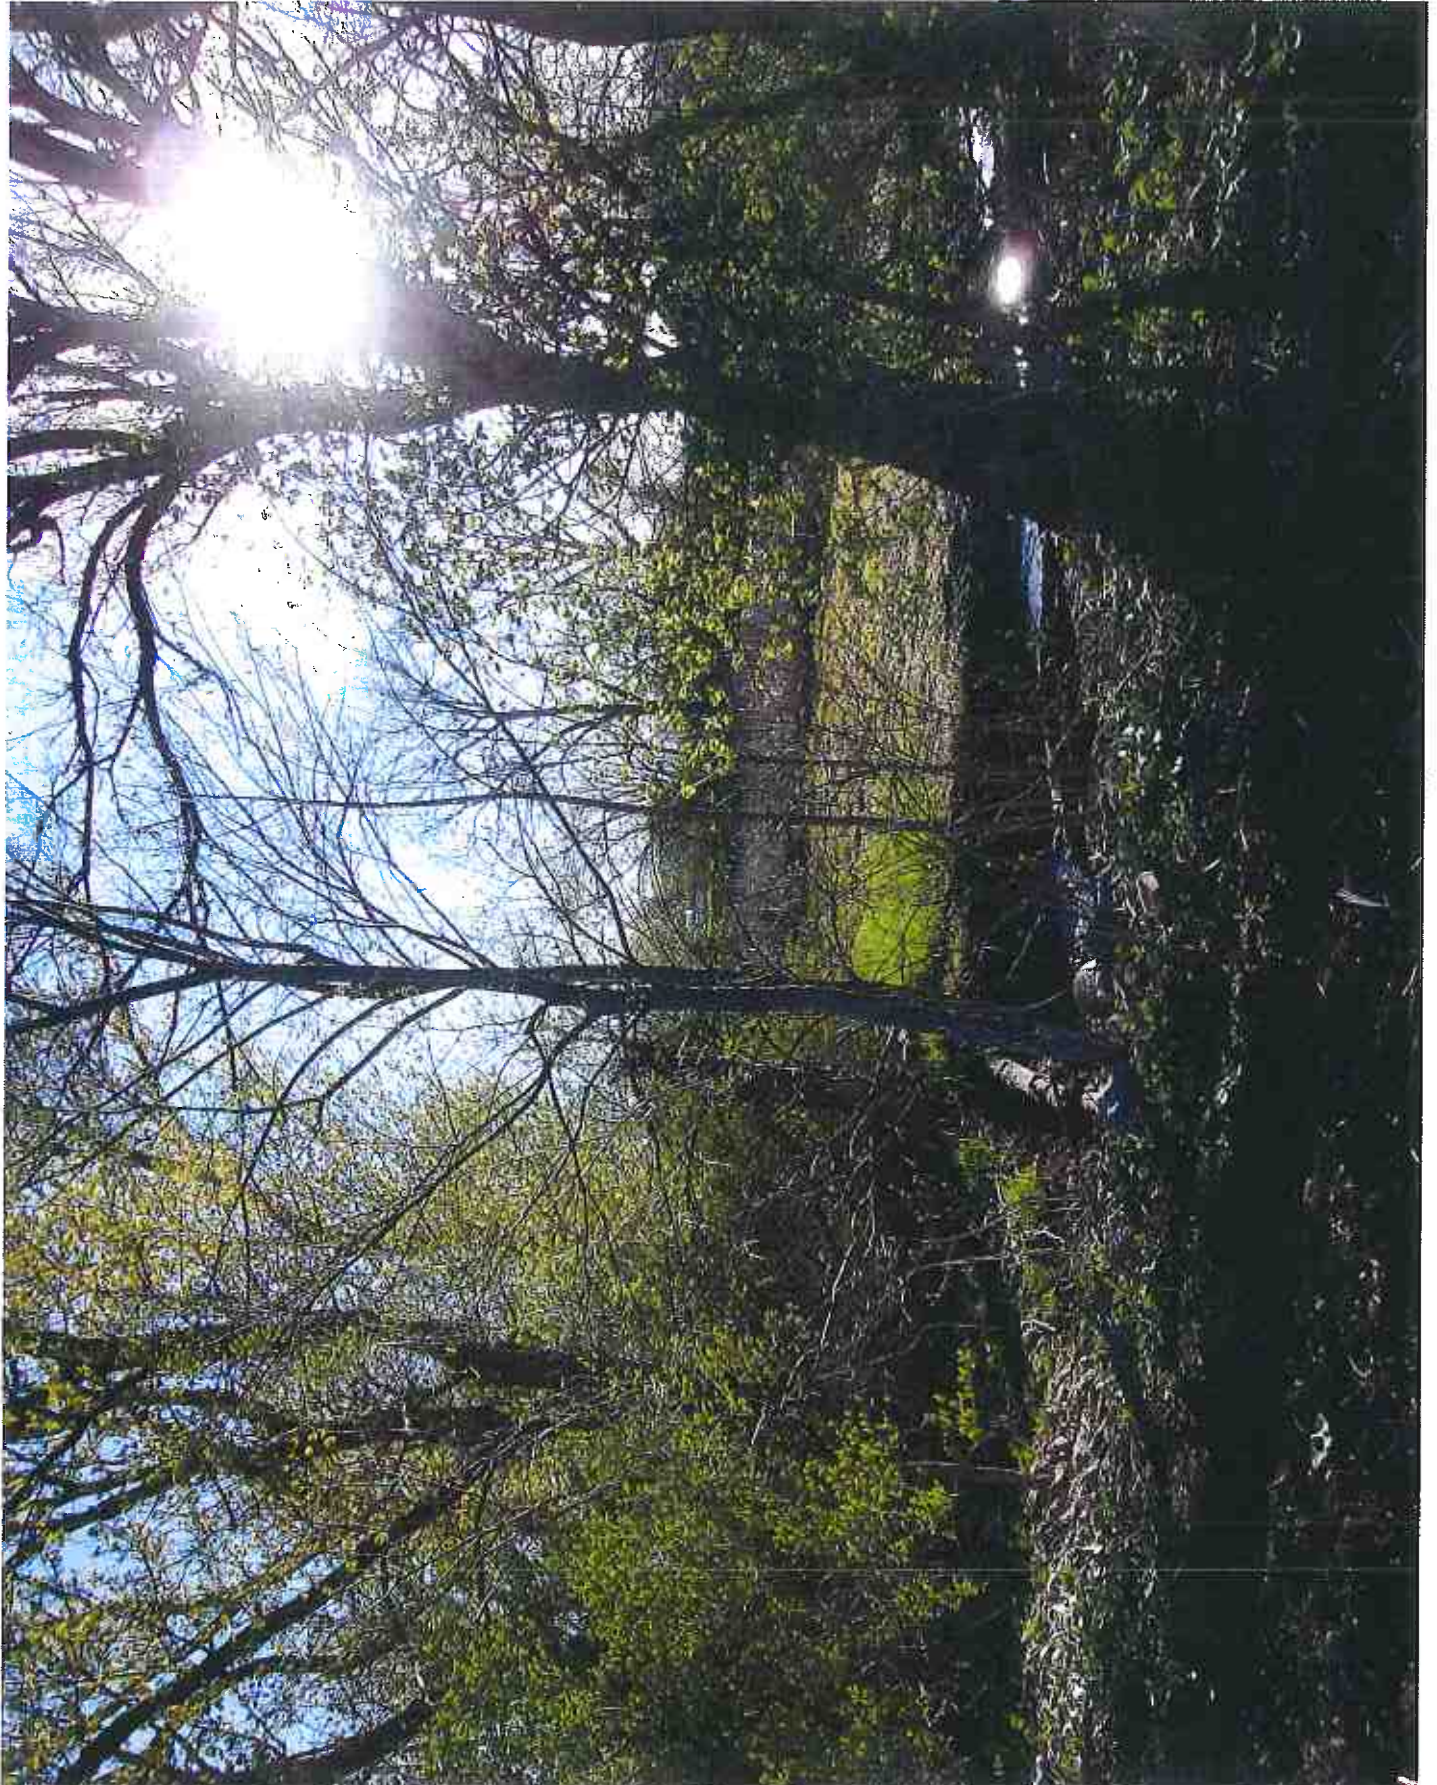
DAGO LAKE INLET (DD86 OLD MAIN) (14) 15" BOX ELDER AND HONEYSUCKLE BRUSH NEEDS REMOVED

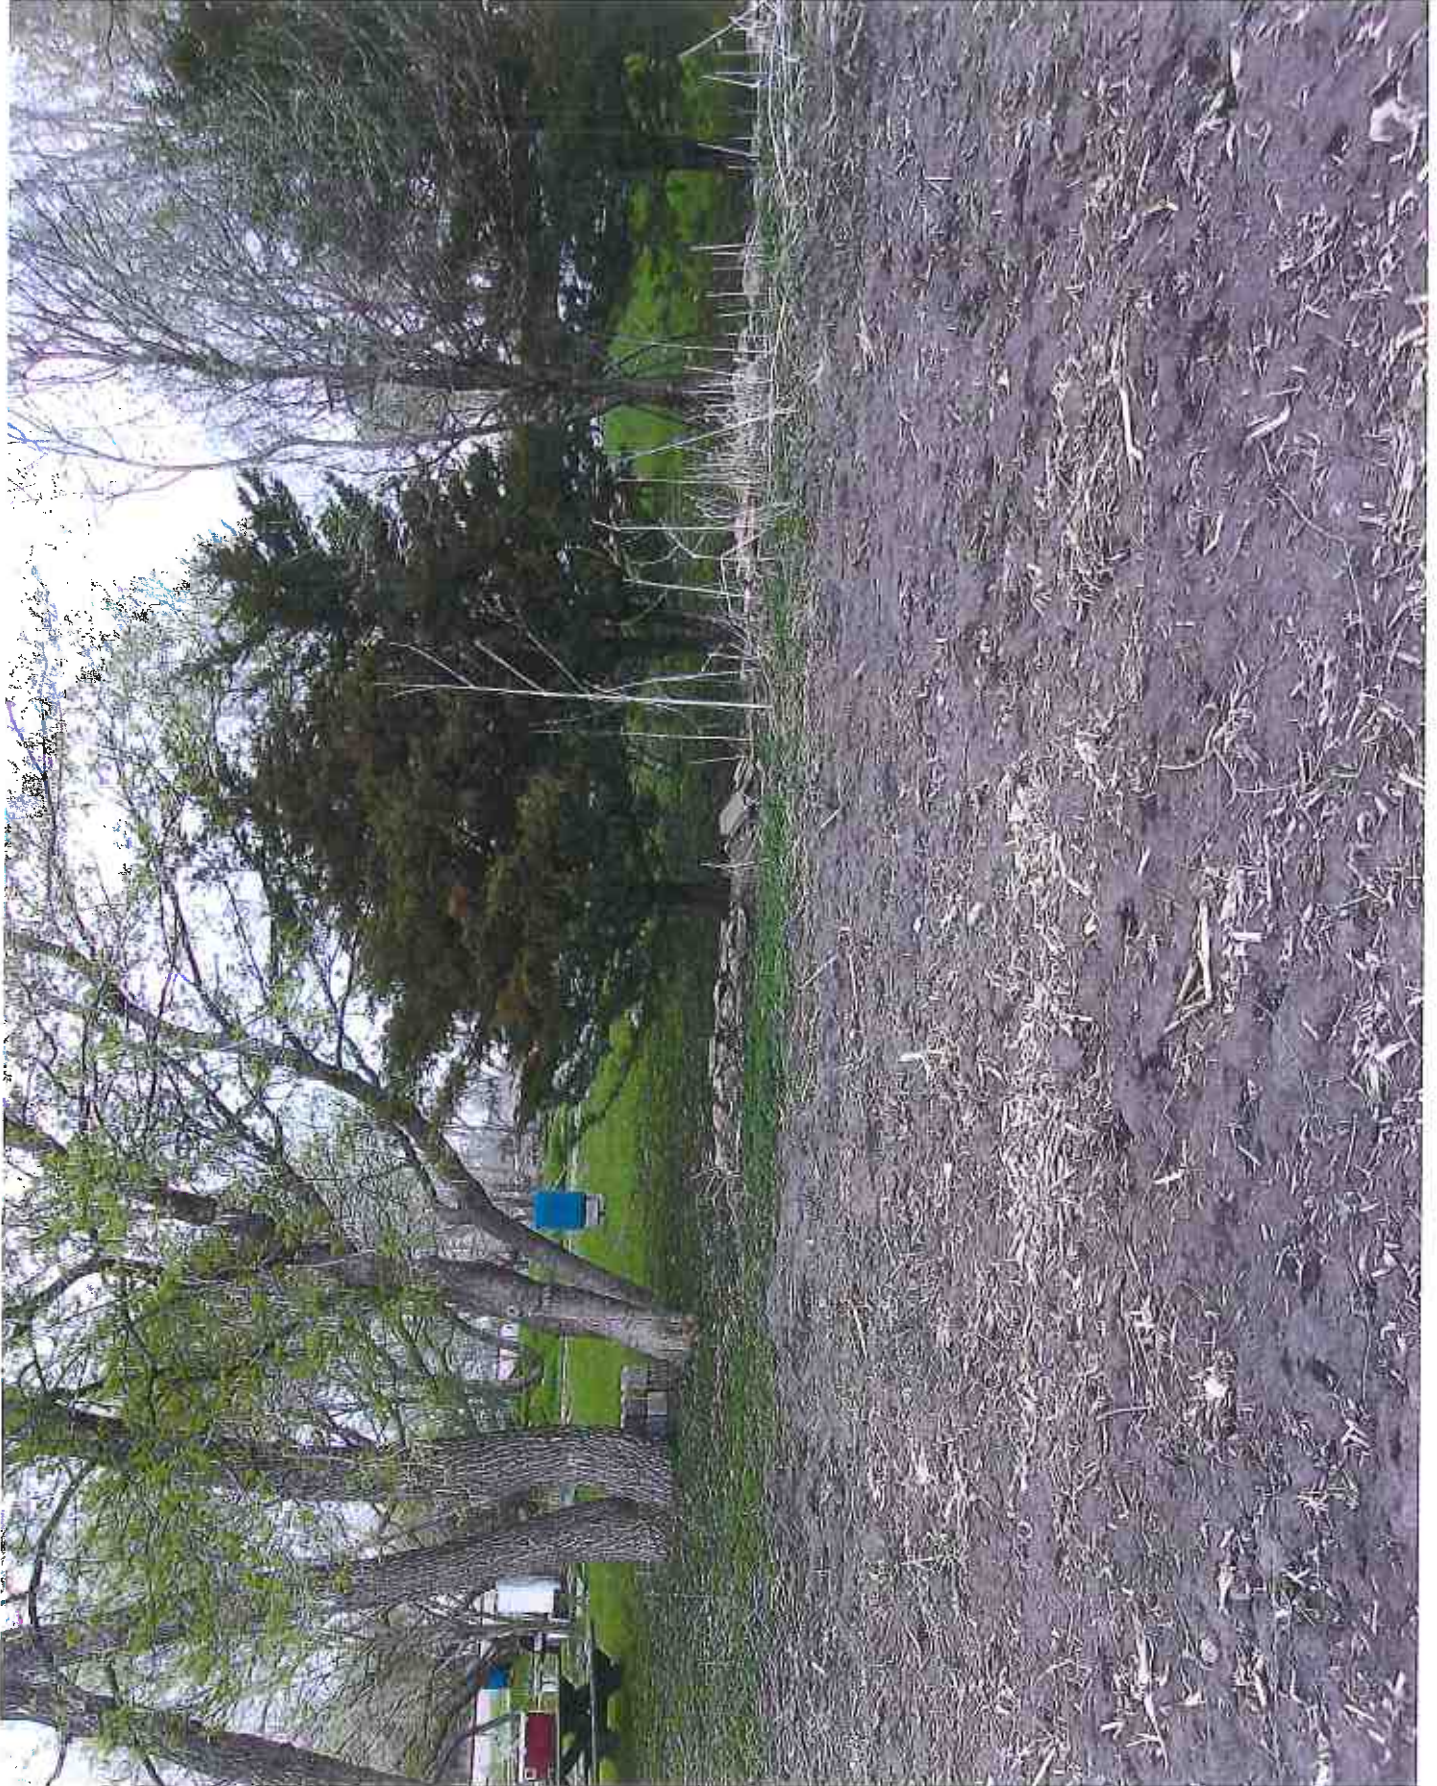
LOOKING EAST @ MONARCH LAKE TIRE ROUTE (5) TREES NEED REMOVED (NOT CEDAR TREES)

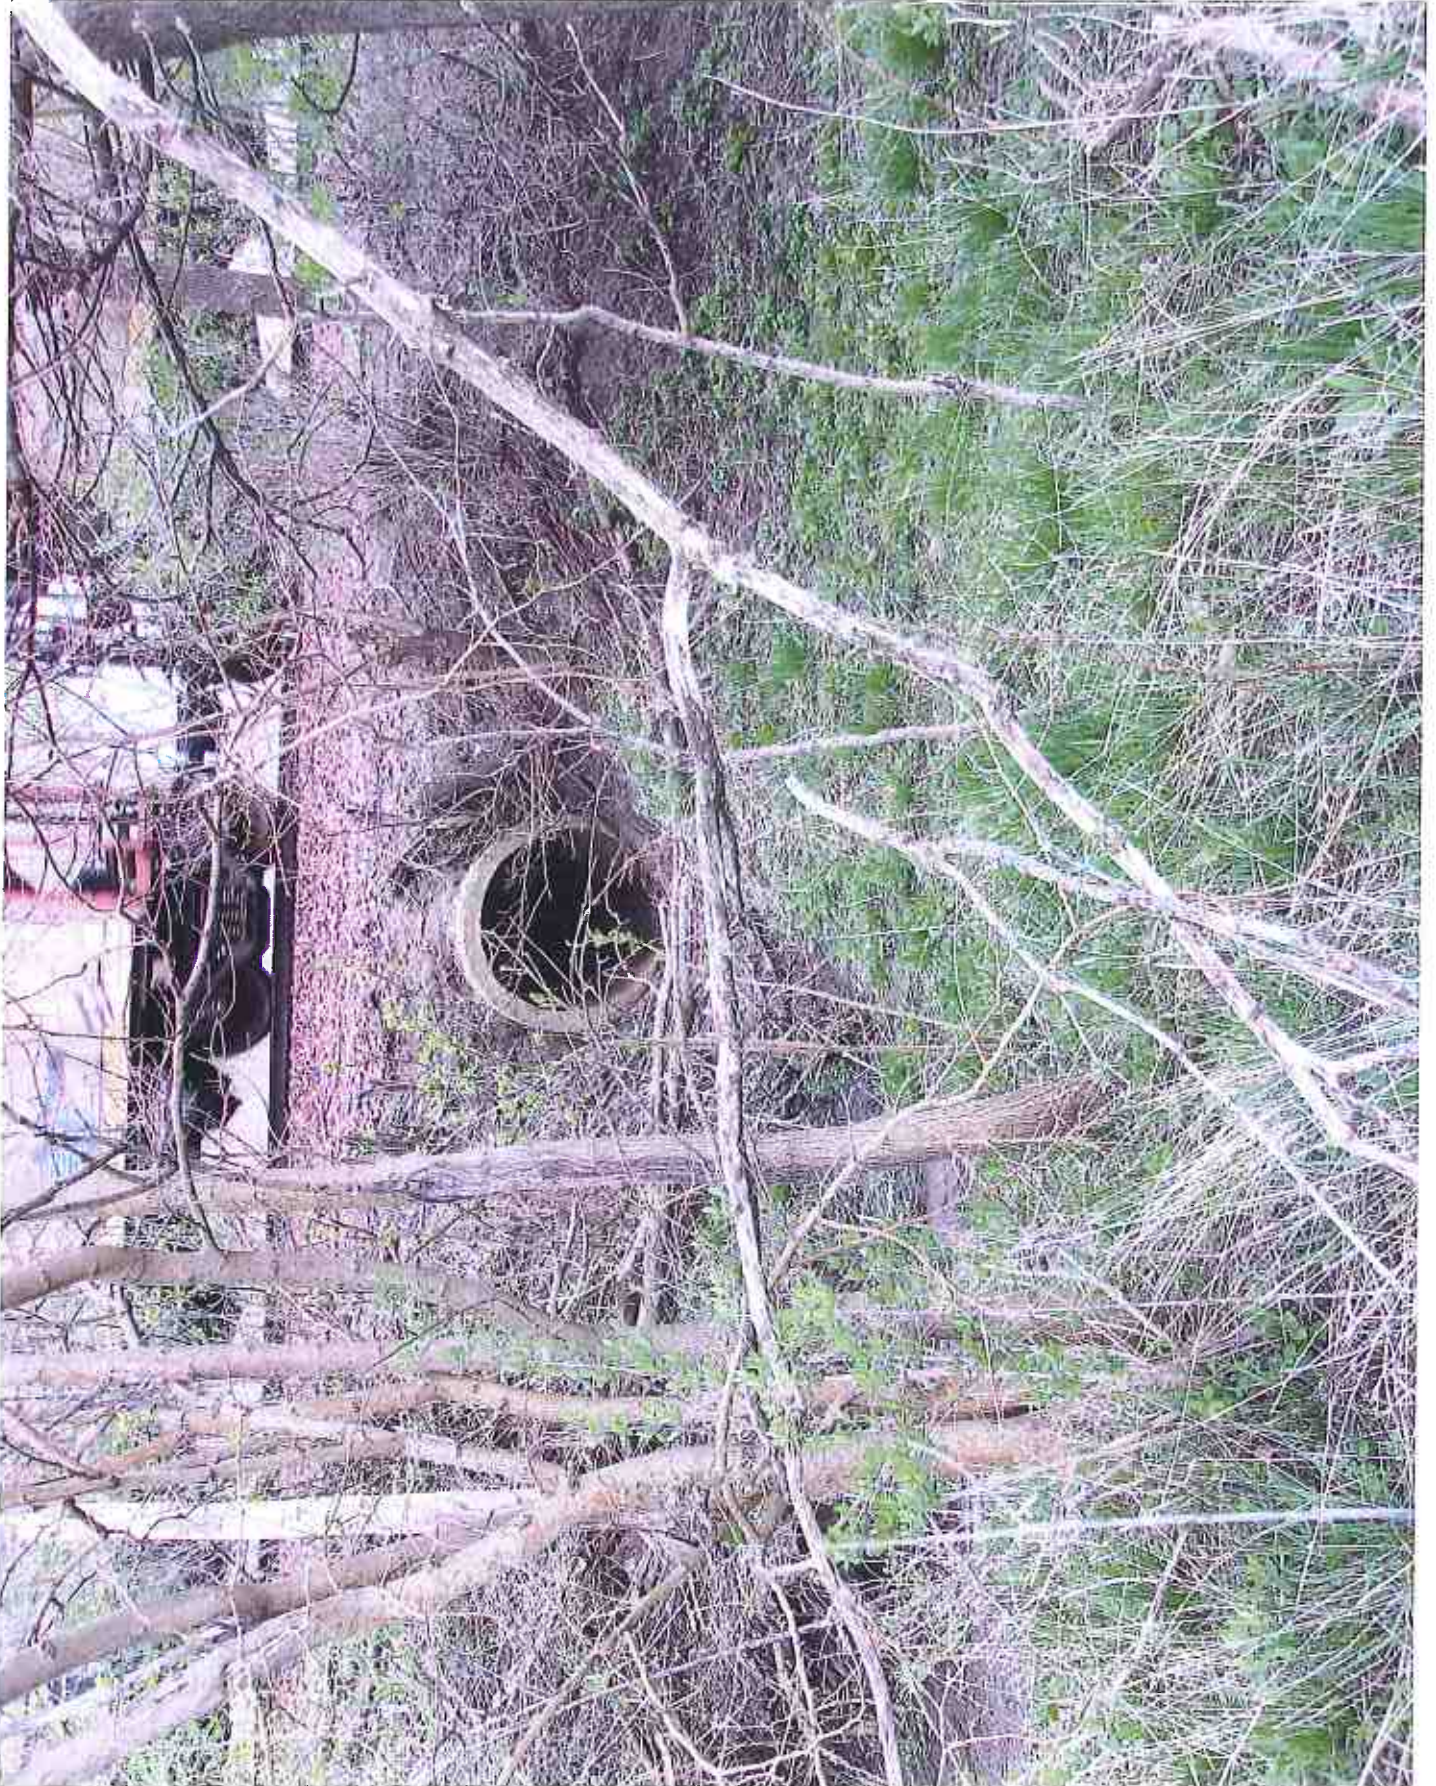
SURFACE DRAINAGE From S. RR @ MONARCH LAKE

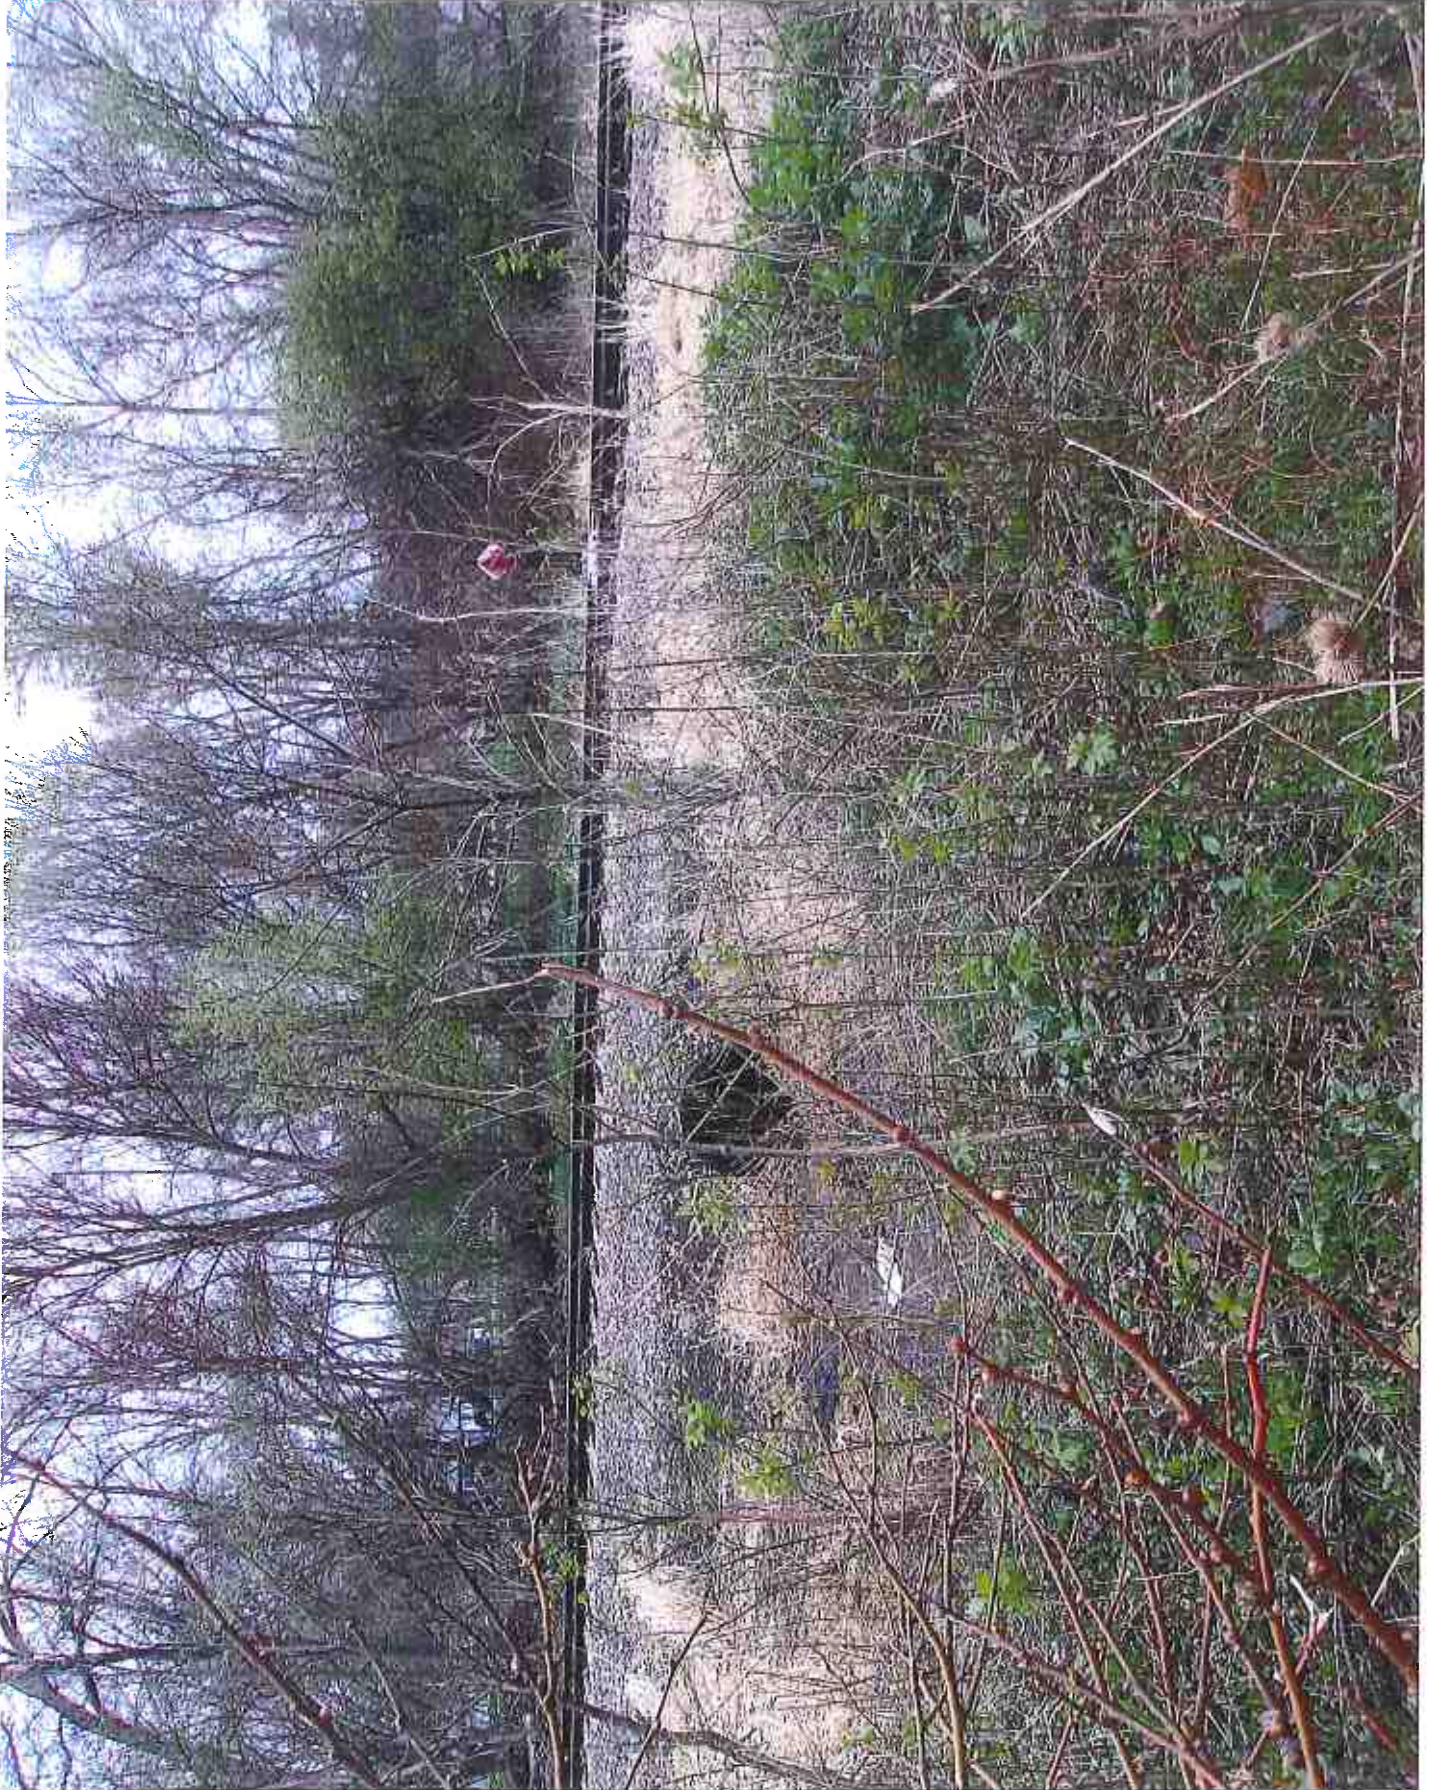
LOOKING DOWNSTREAM @ RR MAINLINE, SURFACE TUBE DRAINS INTO DD86 TILE

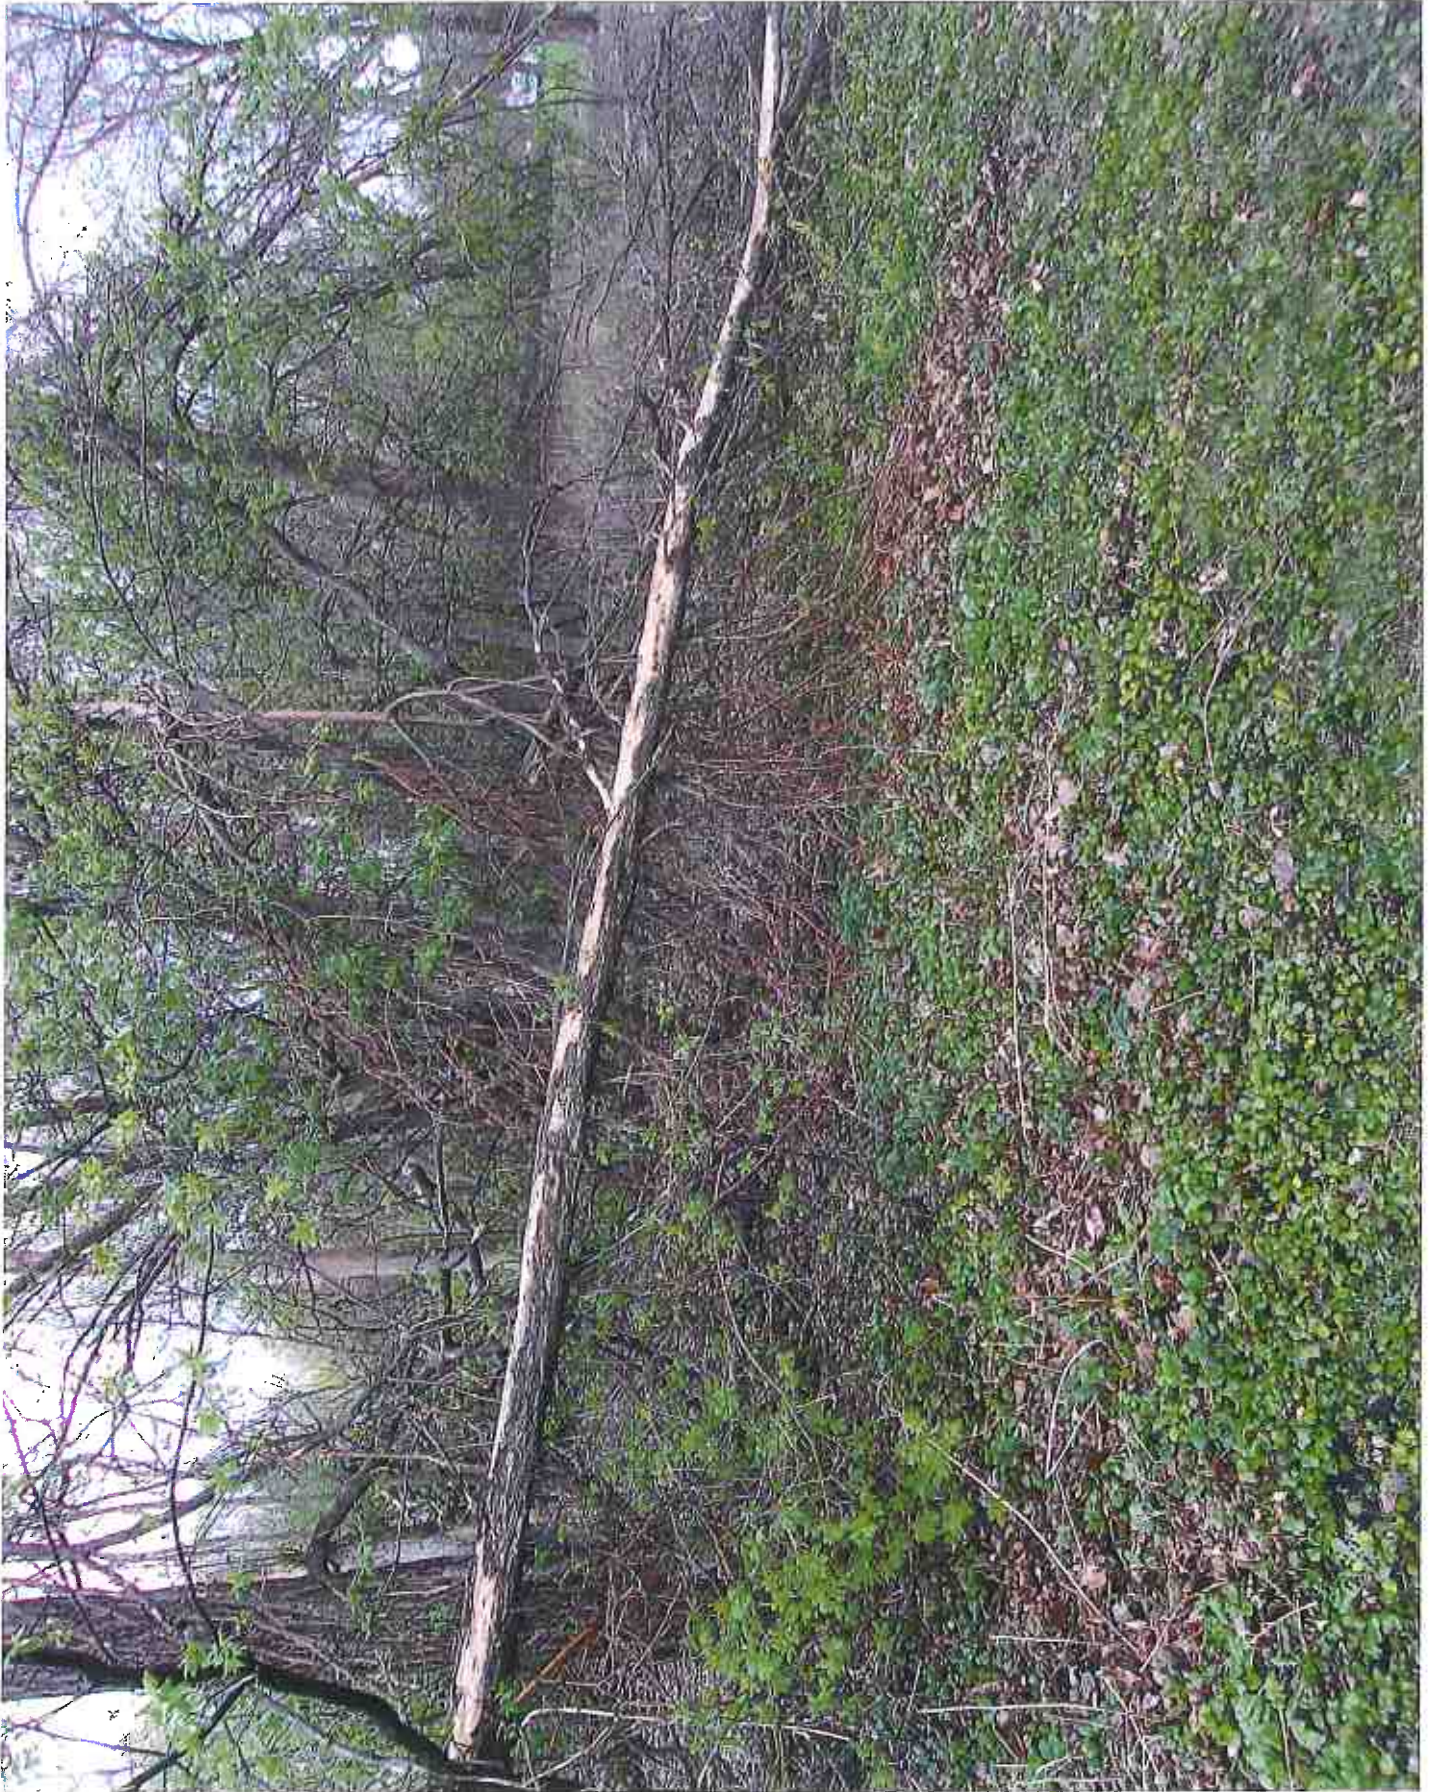
BEEHIVE INTAKE IS IN TREES SOMEWHERE 90+ TREES IN THE R/W N. OF RR

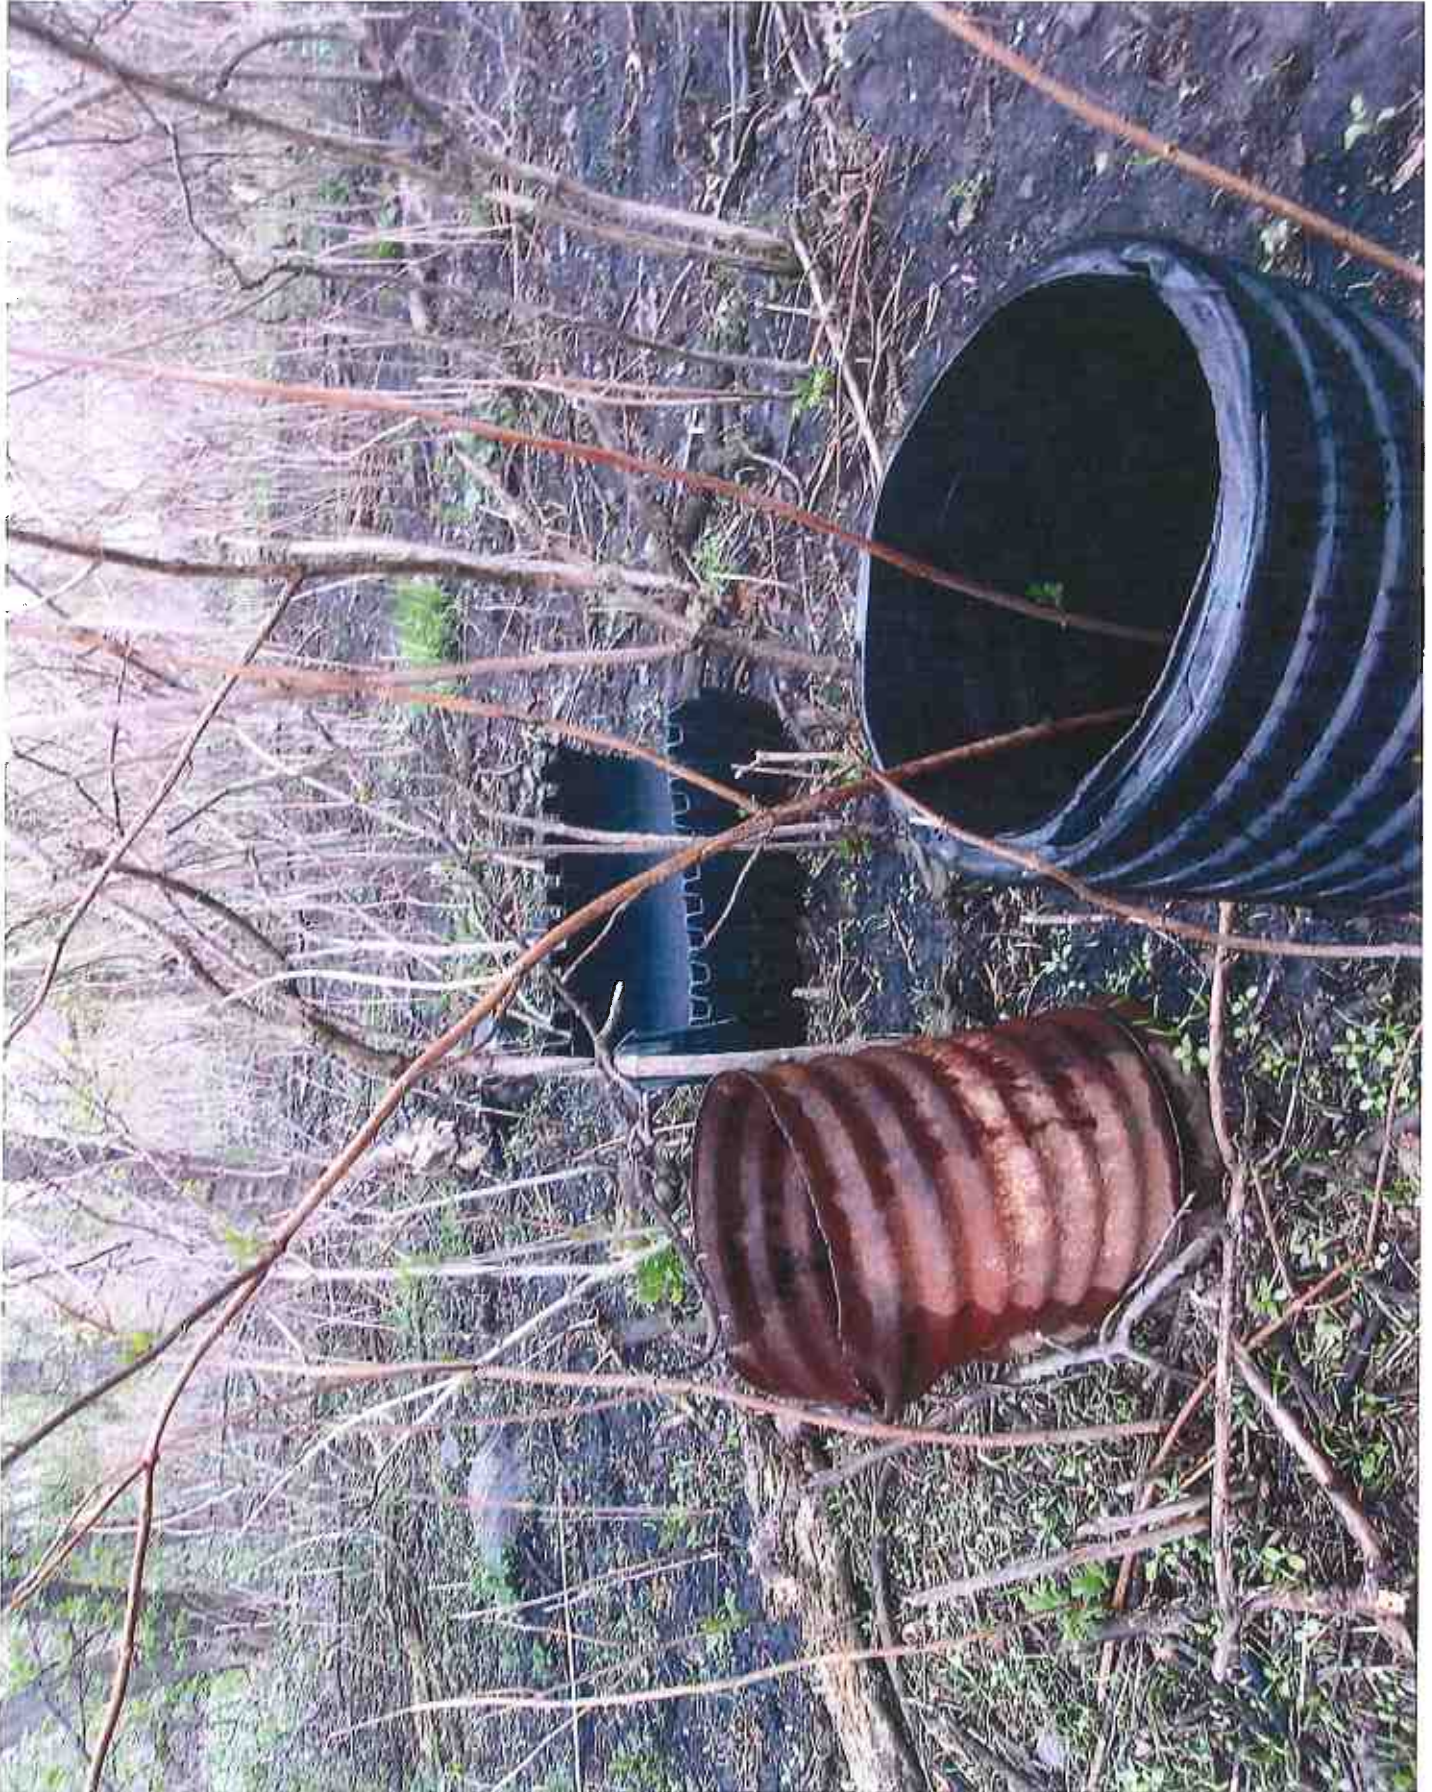
TILE REPAIR PIECES DISCARDED

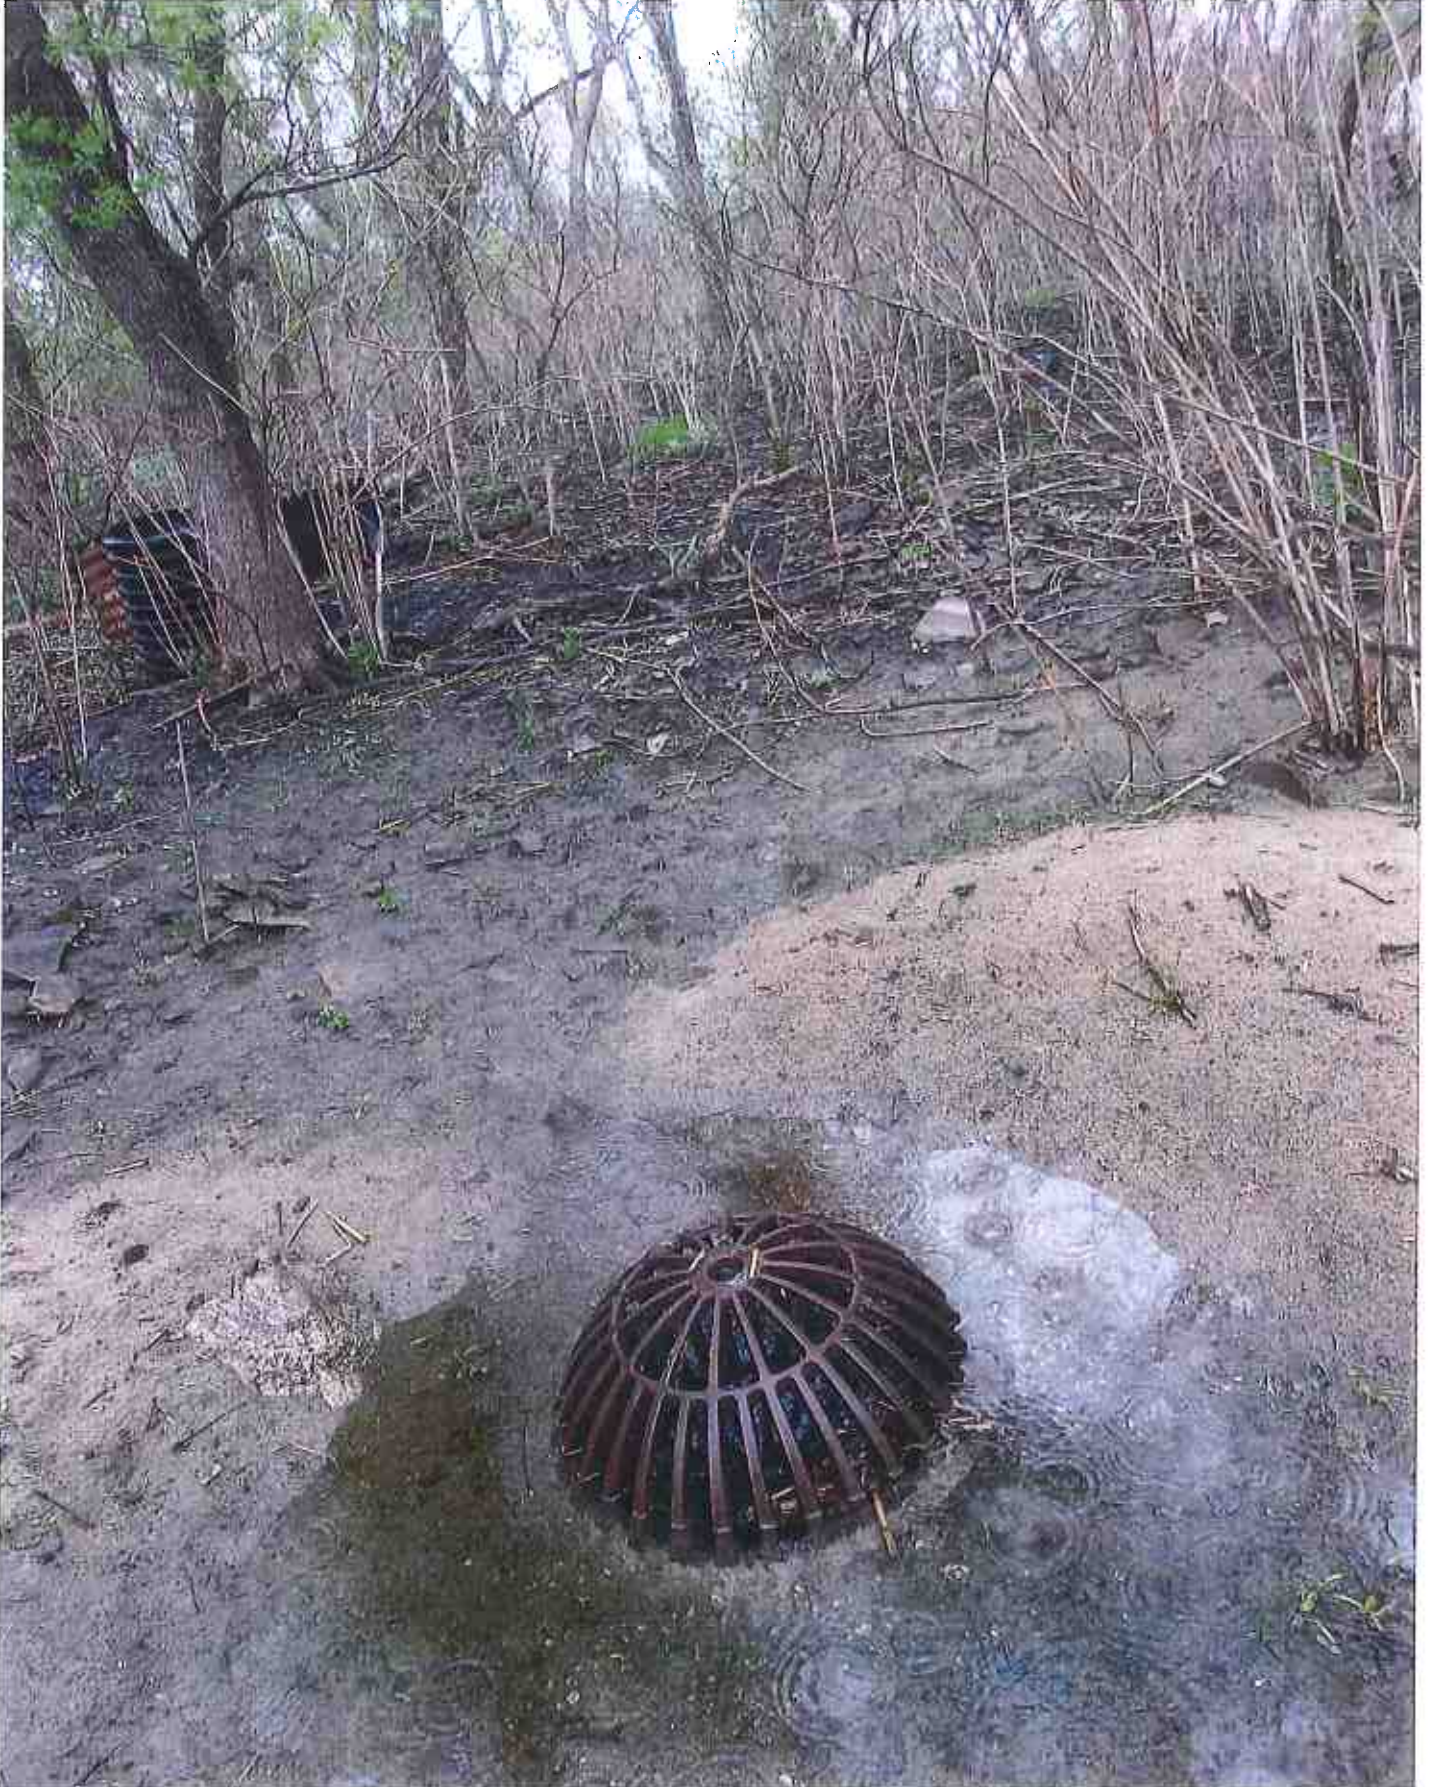
TILE HAS BEEN PARTIALLY PLUGGED FOR SOME TIME
LOOKING DOWN STREAM, NOTE ALL SEDIMENT SAND BLOWN OUT OF INTAKE

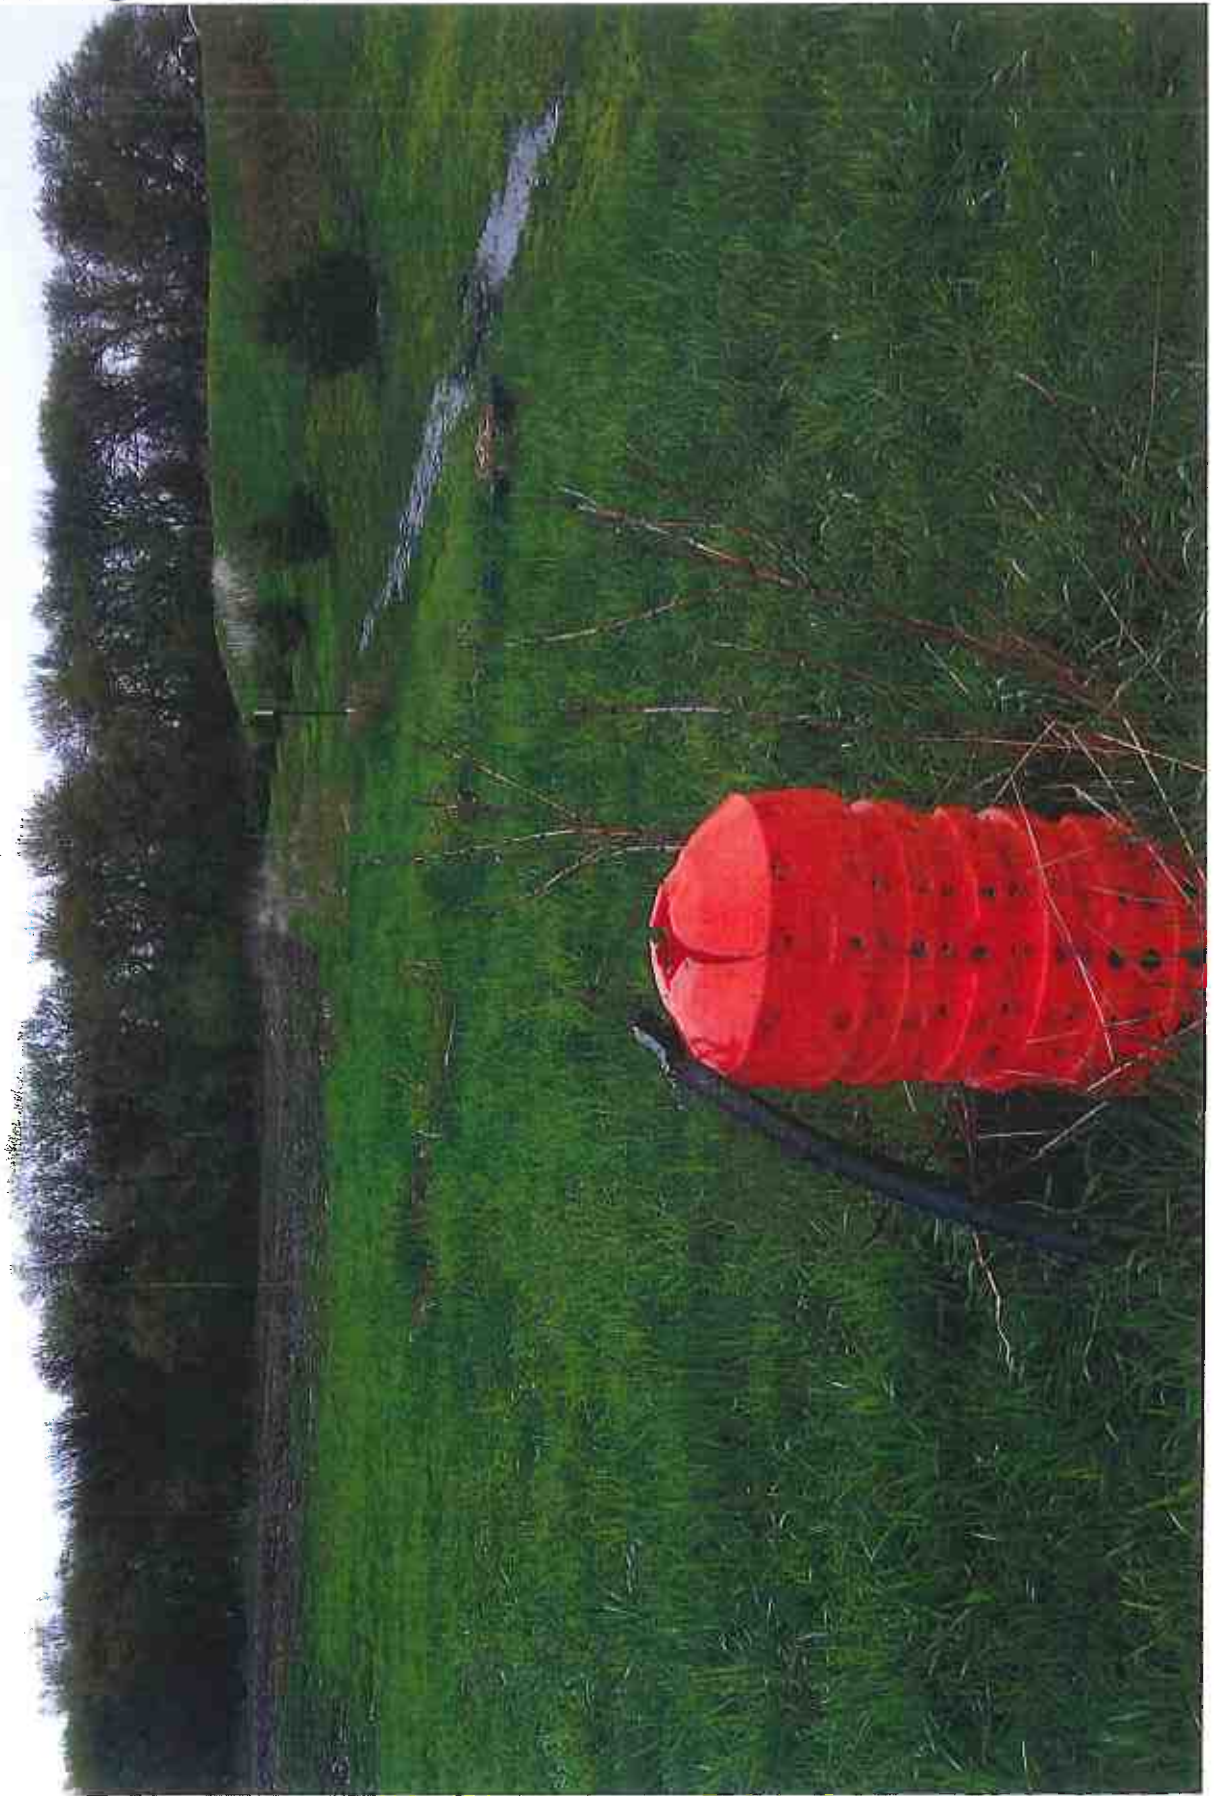
12" HICK INTAKE FULL OF WATER, SWIRLING

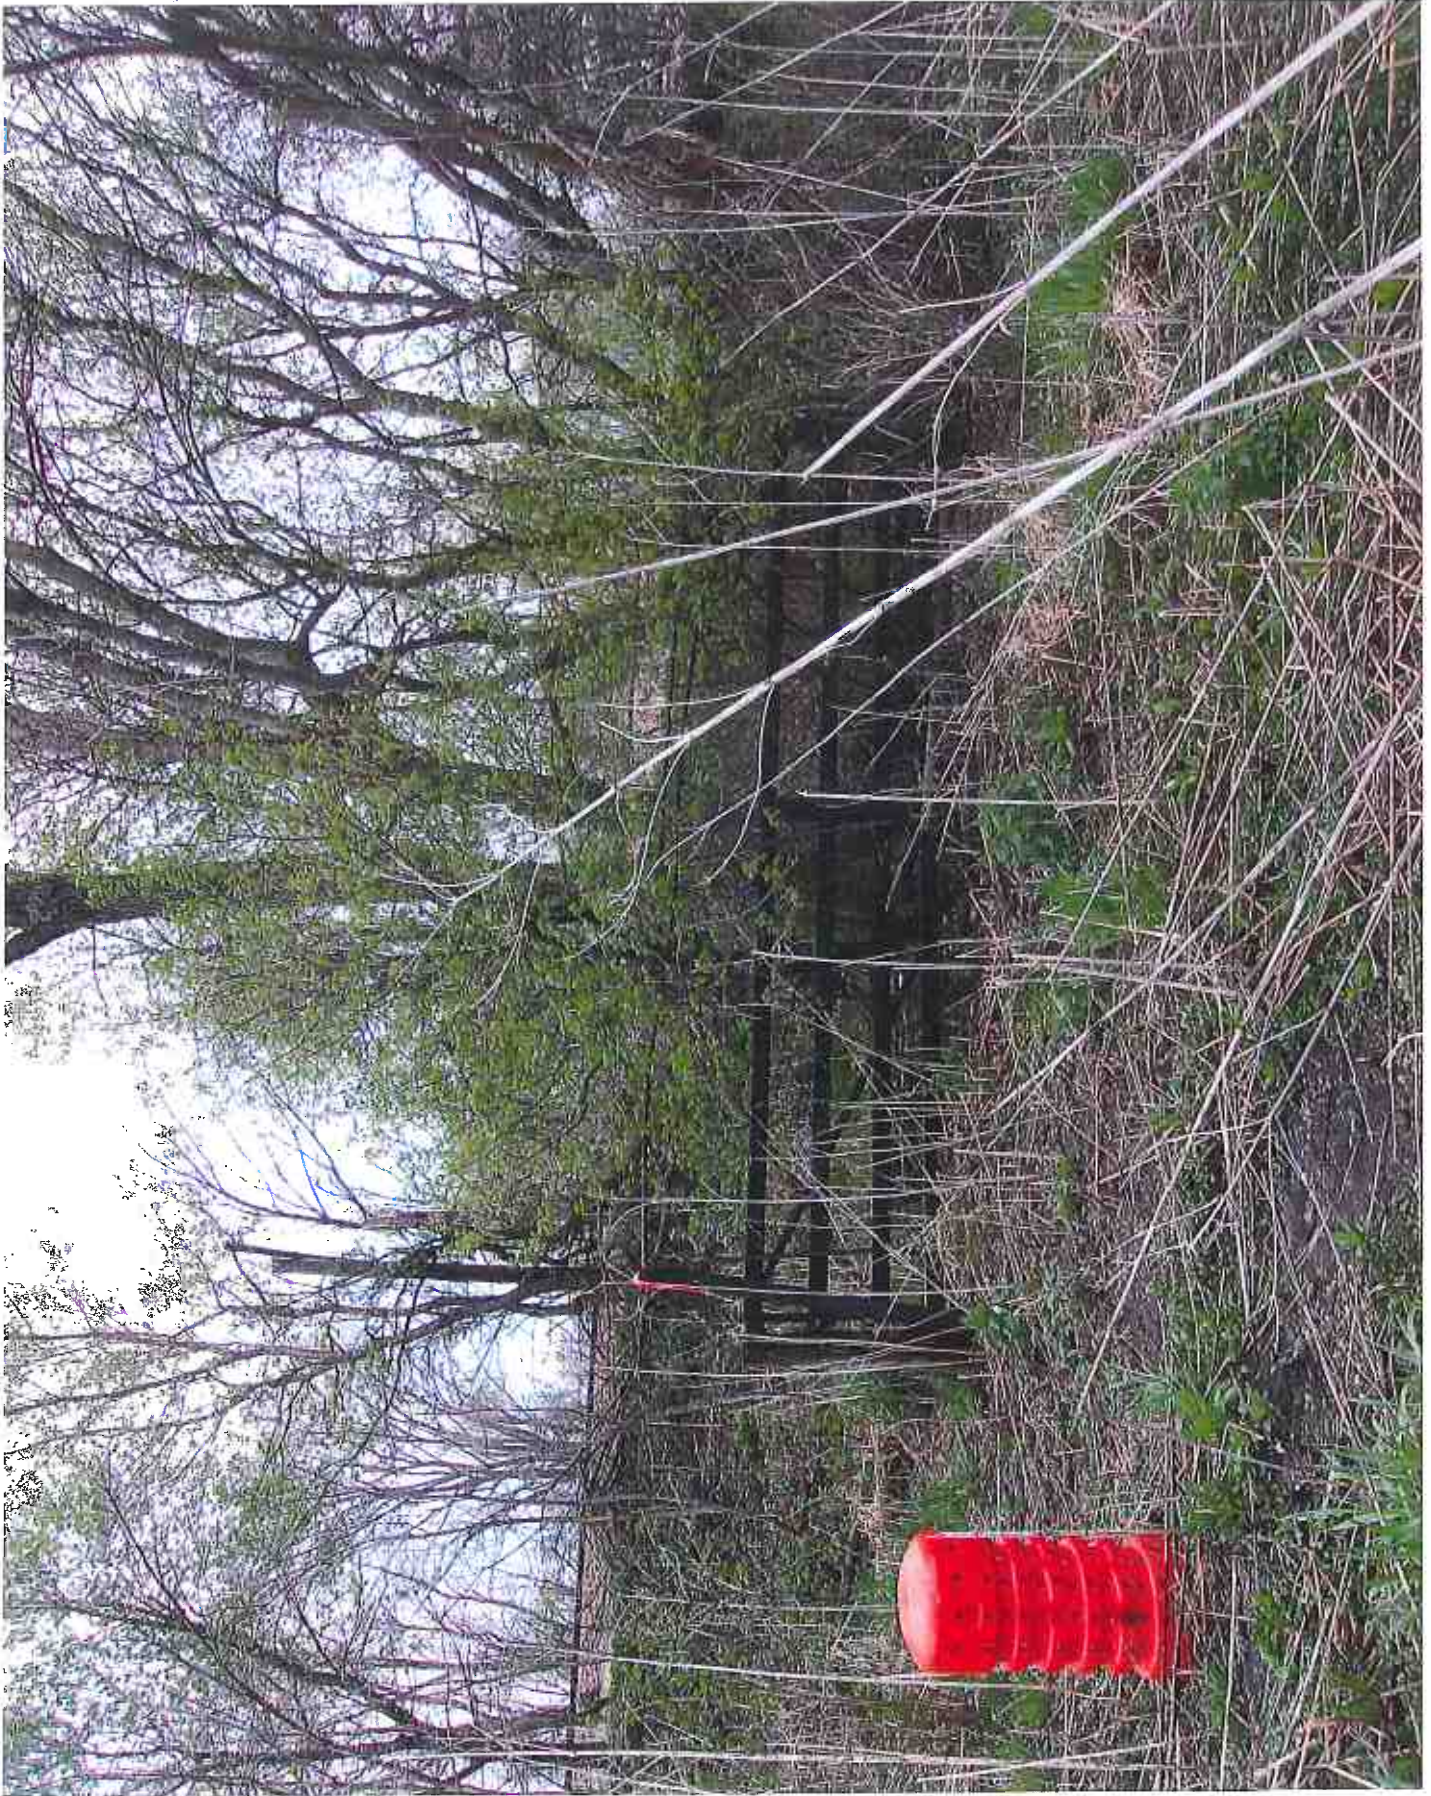
LOOKING UPSTREAM @ RR @ N. SIDE MONARCH LAKE, 40± <12"Ø TREES IN RR R/W
