AGENDA
PUBLIC HEARING ON ENGINEER'S REPORT ON REPAIRS TO MAIN TILES,
DRAINAGE DISTRICT 86, HARDIN COUNTY
JANUARY 22, 2020 AT 11:00 A.M.
HARDIN COUNTY COURTHOUSE, LOWER LEVEL CONFERENCE ROOM

**ENGINEER'S REPORT
ON REPAIRS
TO MAIN TILE
DRAINAGE DISTRICT
NO. 86
HARDIN COUNTY,
IOWA**

Engineer's Report on Repairs to Main Tile, Drainage District No. 86 Hardin County, Iowa

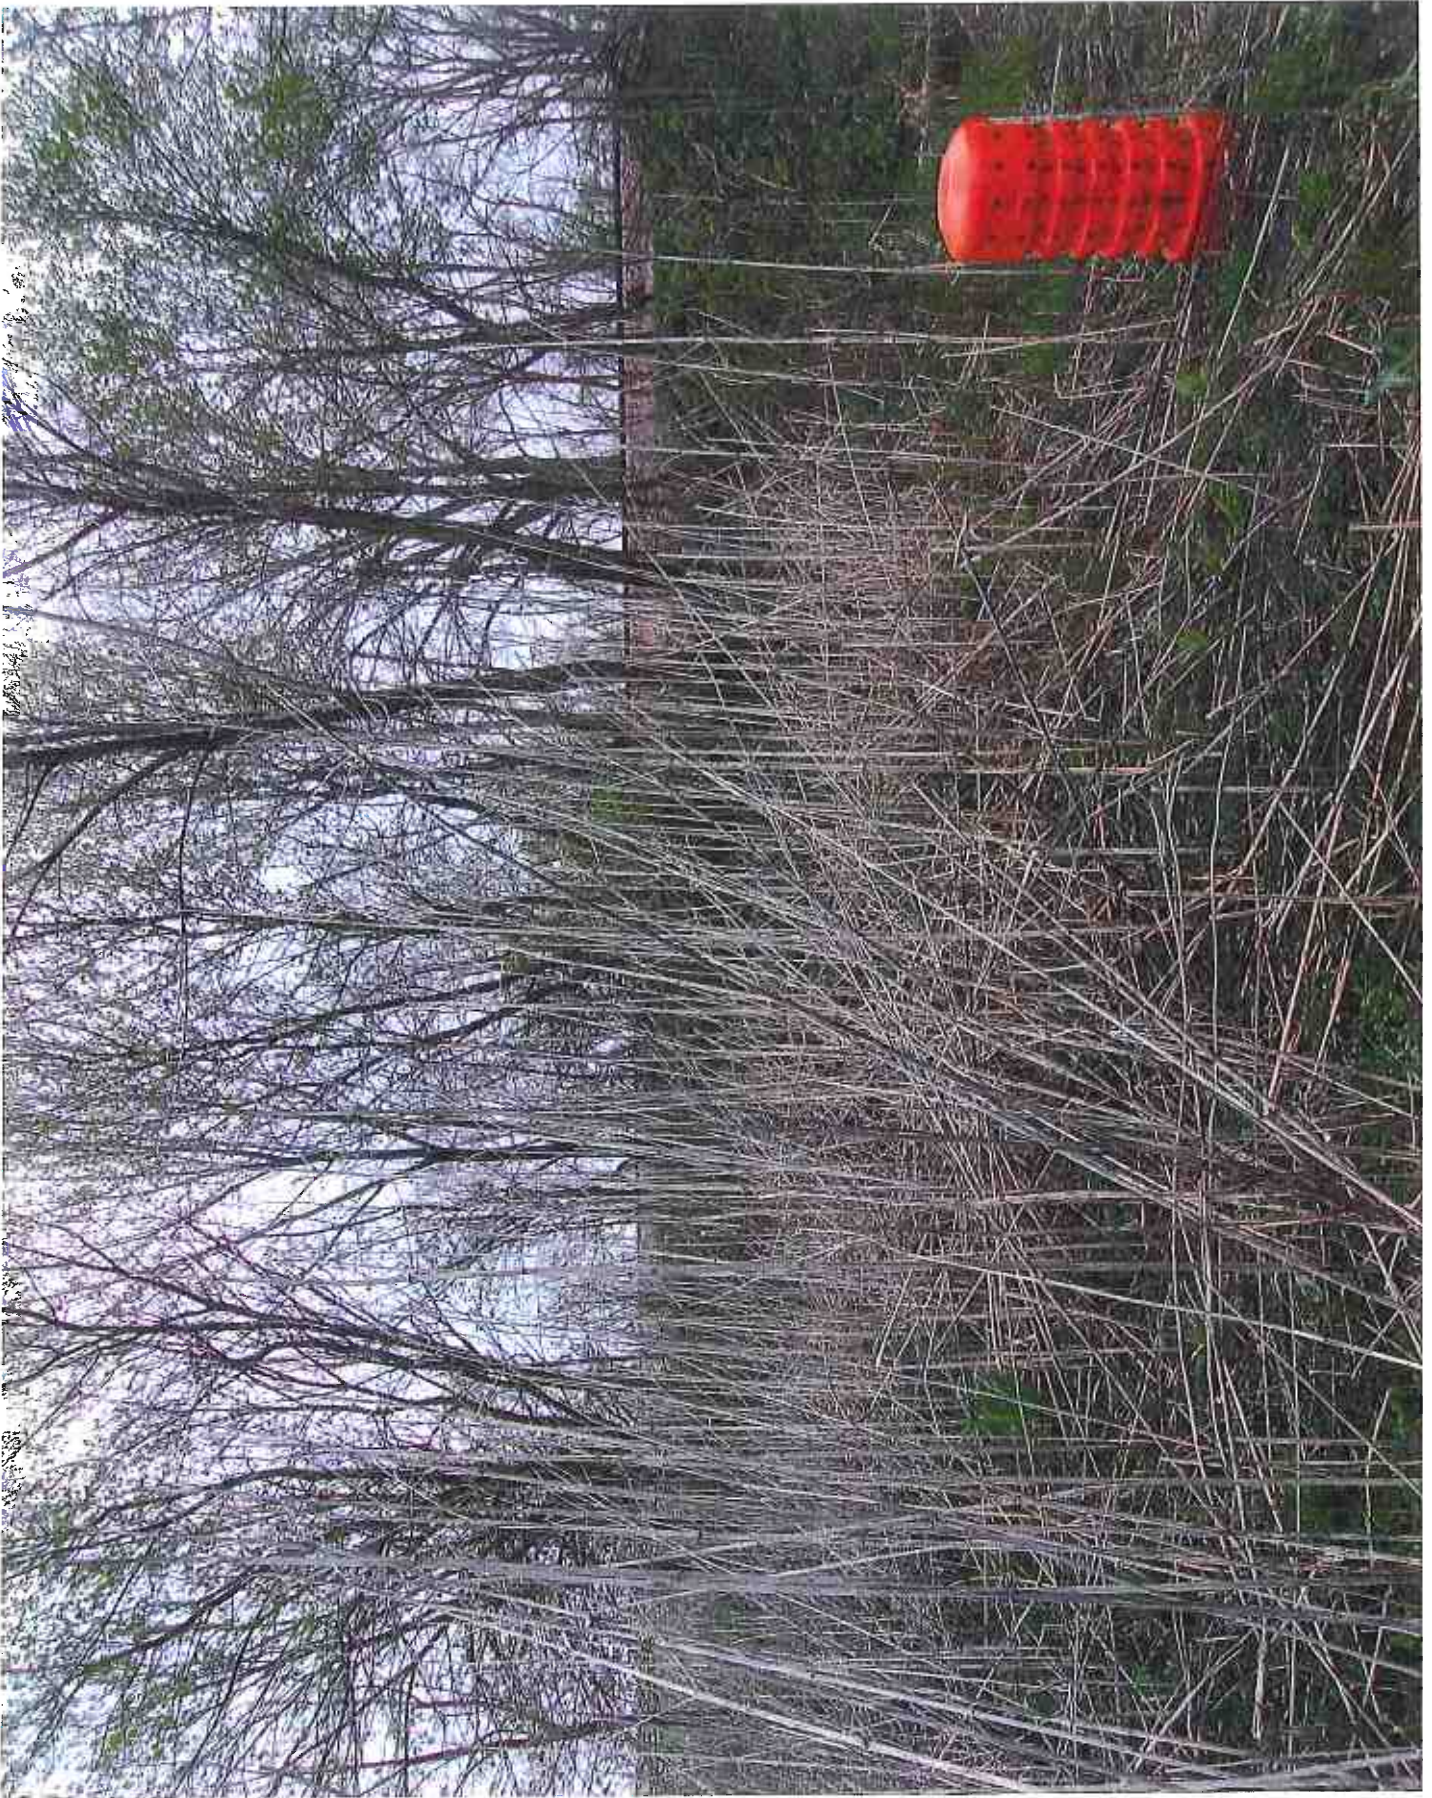
TREES IN RR R/W

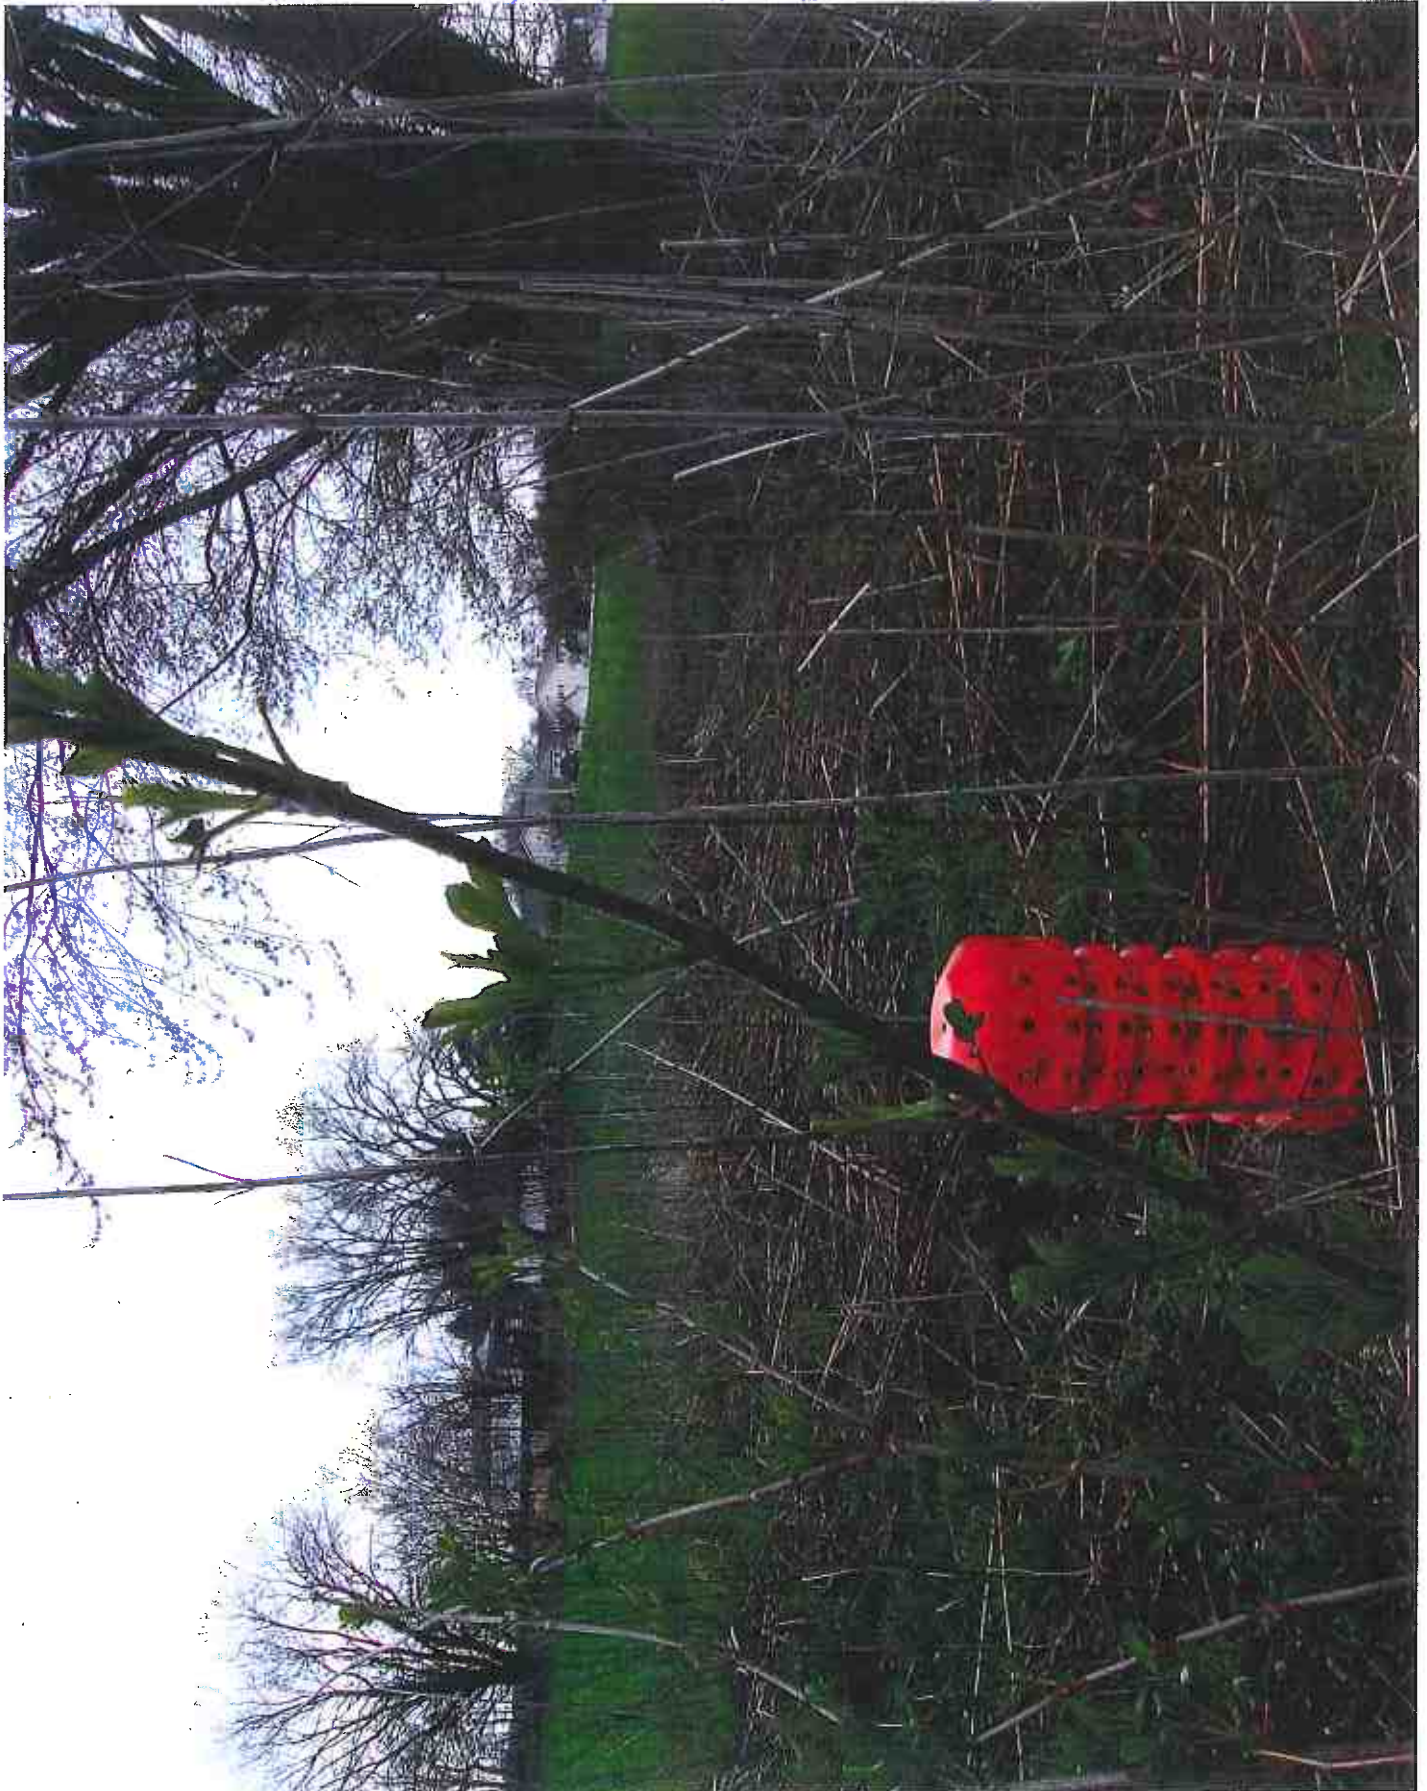
LOOKING DOWNSTREAM WITH 5' Ø MAPLE THAT NEEDS REMOVED
