AGENDA
REGULAR DRAINAGE MEETING
Wednesday, April 29, 2020 9:30 AM
Large Conference Room

Project Description: Main Tile Repairs to Drainage District 22 Facilities
Hardin County, Iowa
Project Nos. DD-6532.2 and 8712

Hardin County Work Order: WO00000276

Investigation Summary:

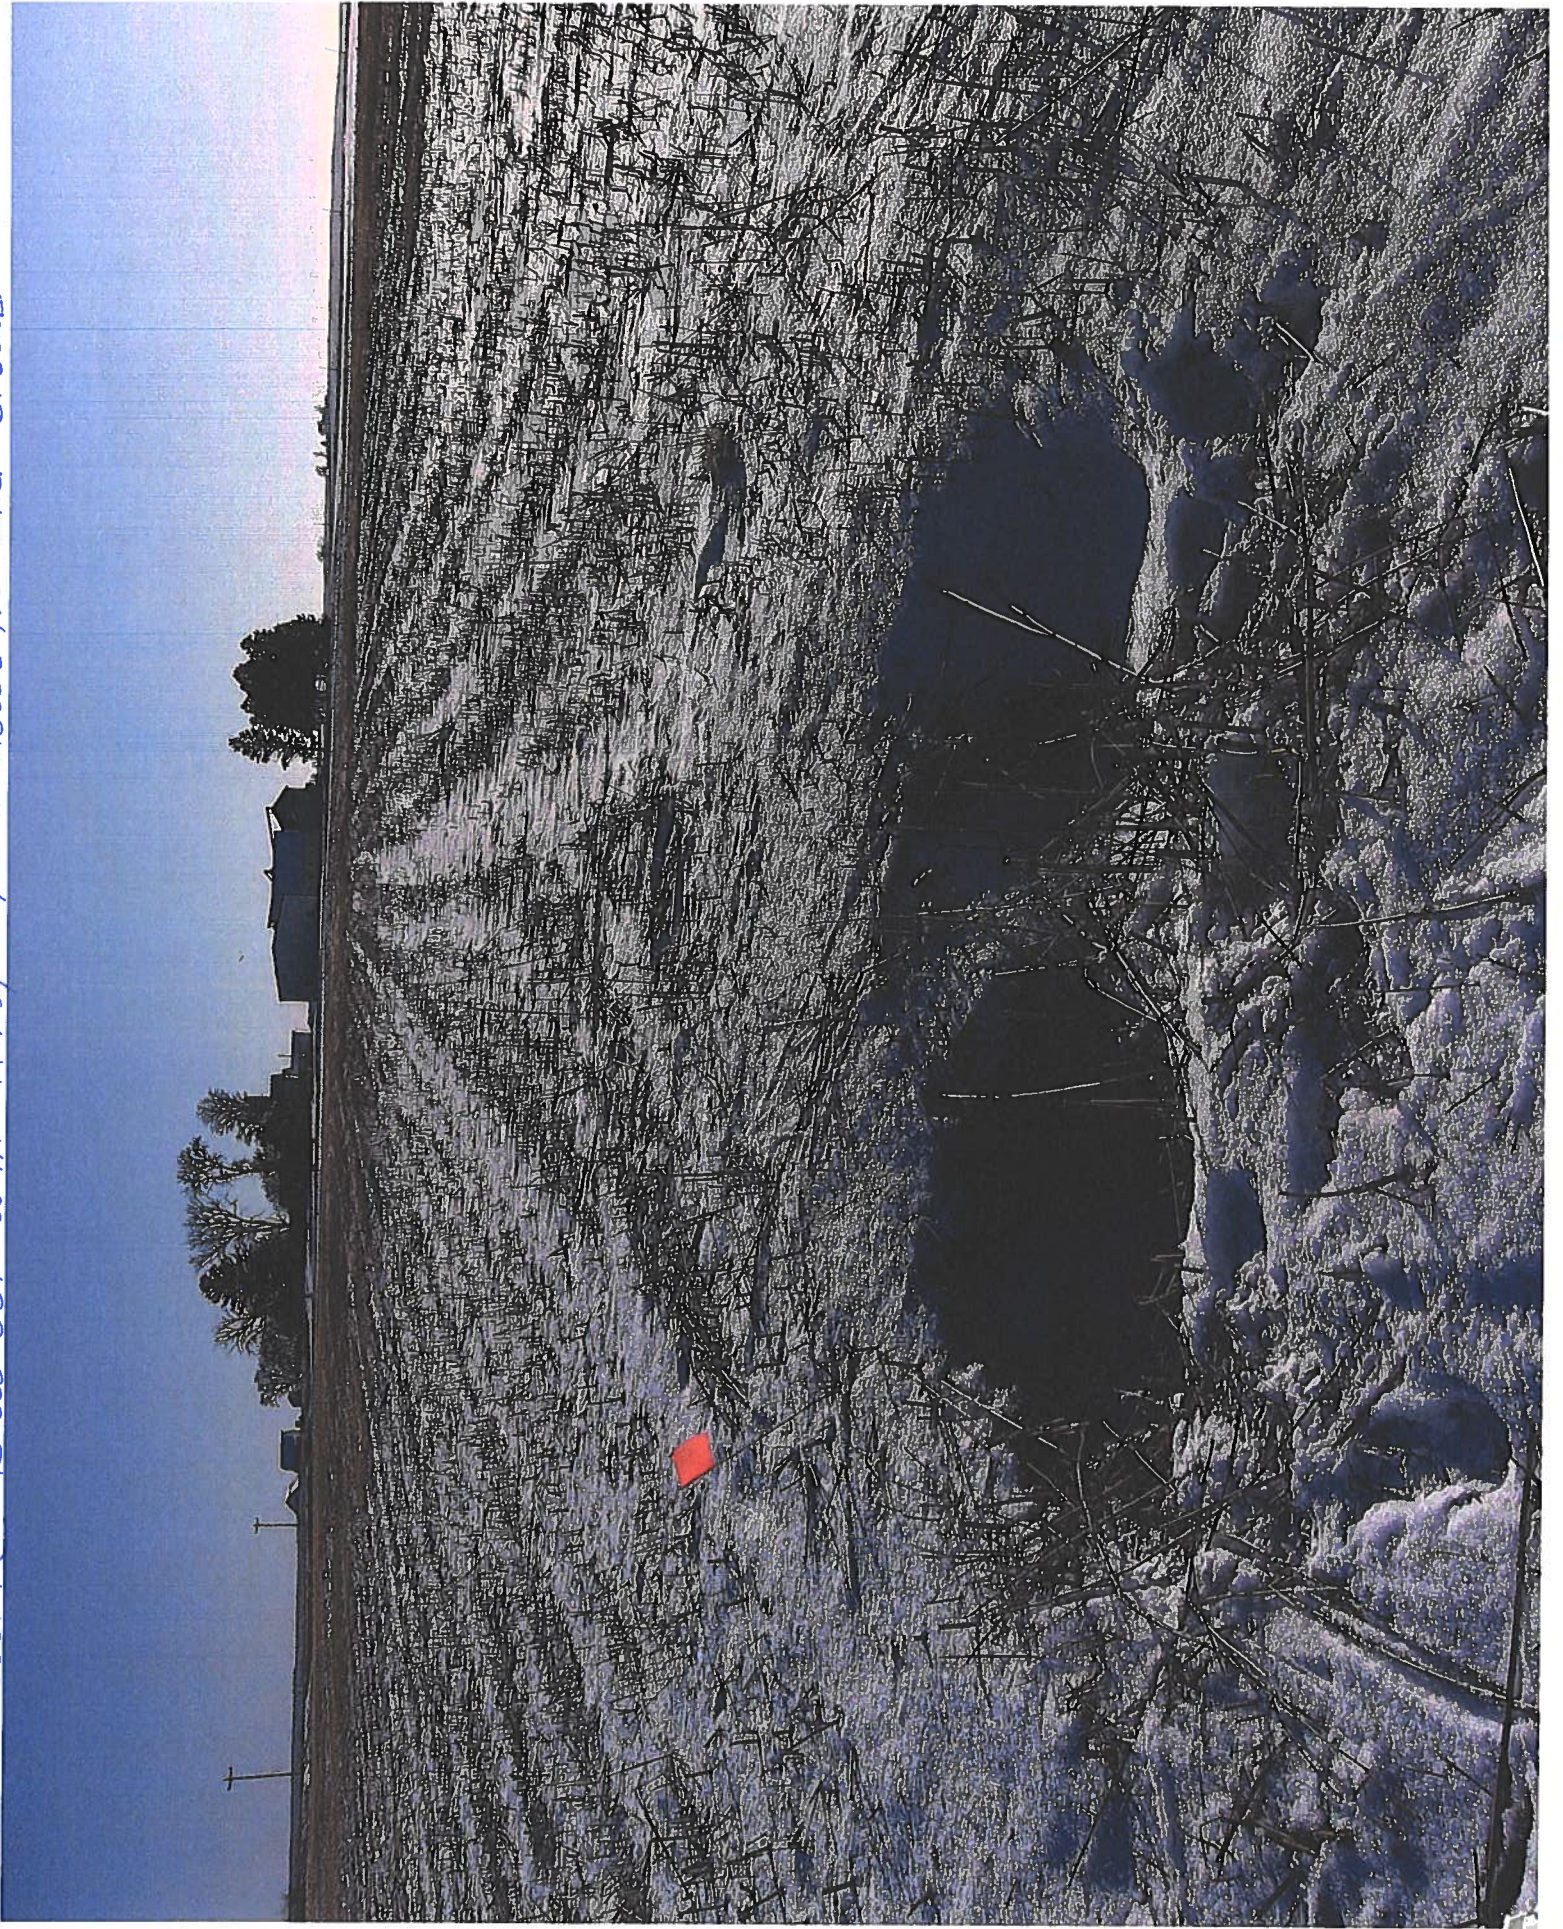
- Landowner in the NE¼ of Section 19 (T88N R22W) reported a sinkhole in his wetland area nearby where he believes Lateral 1 of DD22 to run.
- Visual observation discovered a sinkhole with two locations that appeared to be taking in soil in nearby proximity to each other. CGA probed the area with a 4' tile probe and was unable to hit/locate the tile line. The sinkhole is consistent with what we would expect to find with a tile line that has a wide joint or damaged tile and is taking soil from both sides of the tile.

| <p>1. General Remarks and Work Accomplished:</p> <p><u>DRIVE UP TO MARKED BLOW-OUT IN CRP FIELD N. OF RANDY SYLVESTER HOUSE. FOUND DOUBLE BLOW-OUT, PROBABLY CAUSED BY WIDE JOINT IN TIE. PROBES DOWN 4' IN BOTH HOLES, DIDN'T HIT TIE. SHOT BLOW OUT #879 ON LAT 1, USE JOB #6532.3 DD22 REPAIR ASP, ACCESS @ NE CORNER OF FIELD ON "C" AVE.</u></p> | | | |

LOOKING SOUTH (O) BLOW-OUT WITH RANDY -> LUREST HOUSE IN DARK GROUND

We recommend this be spot repaired through the lottery process.

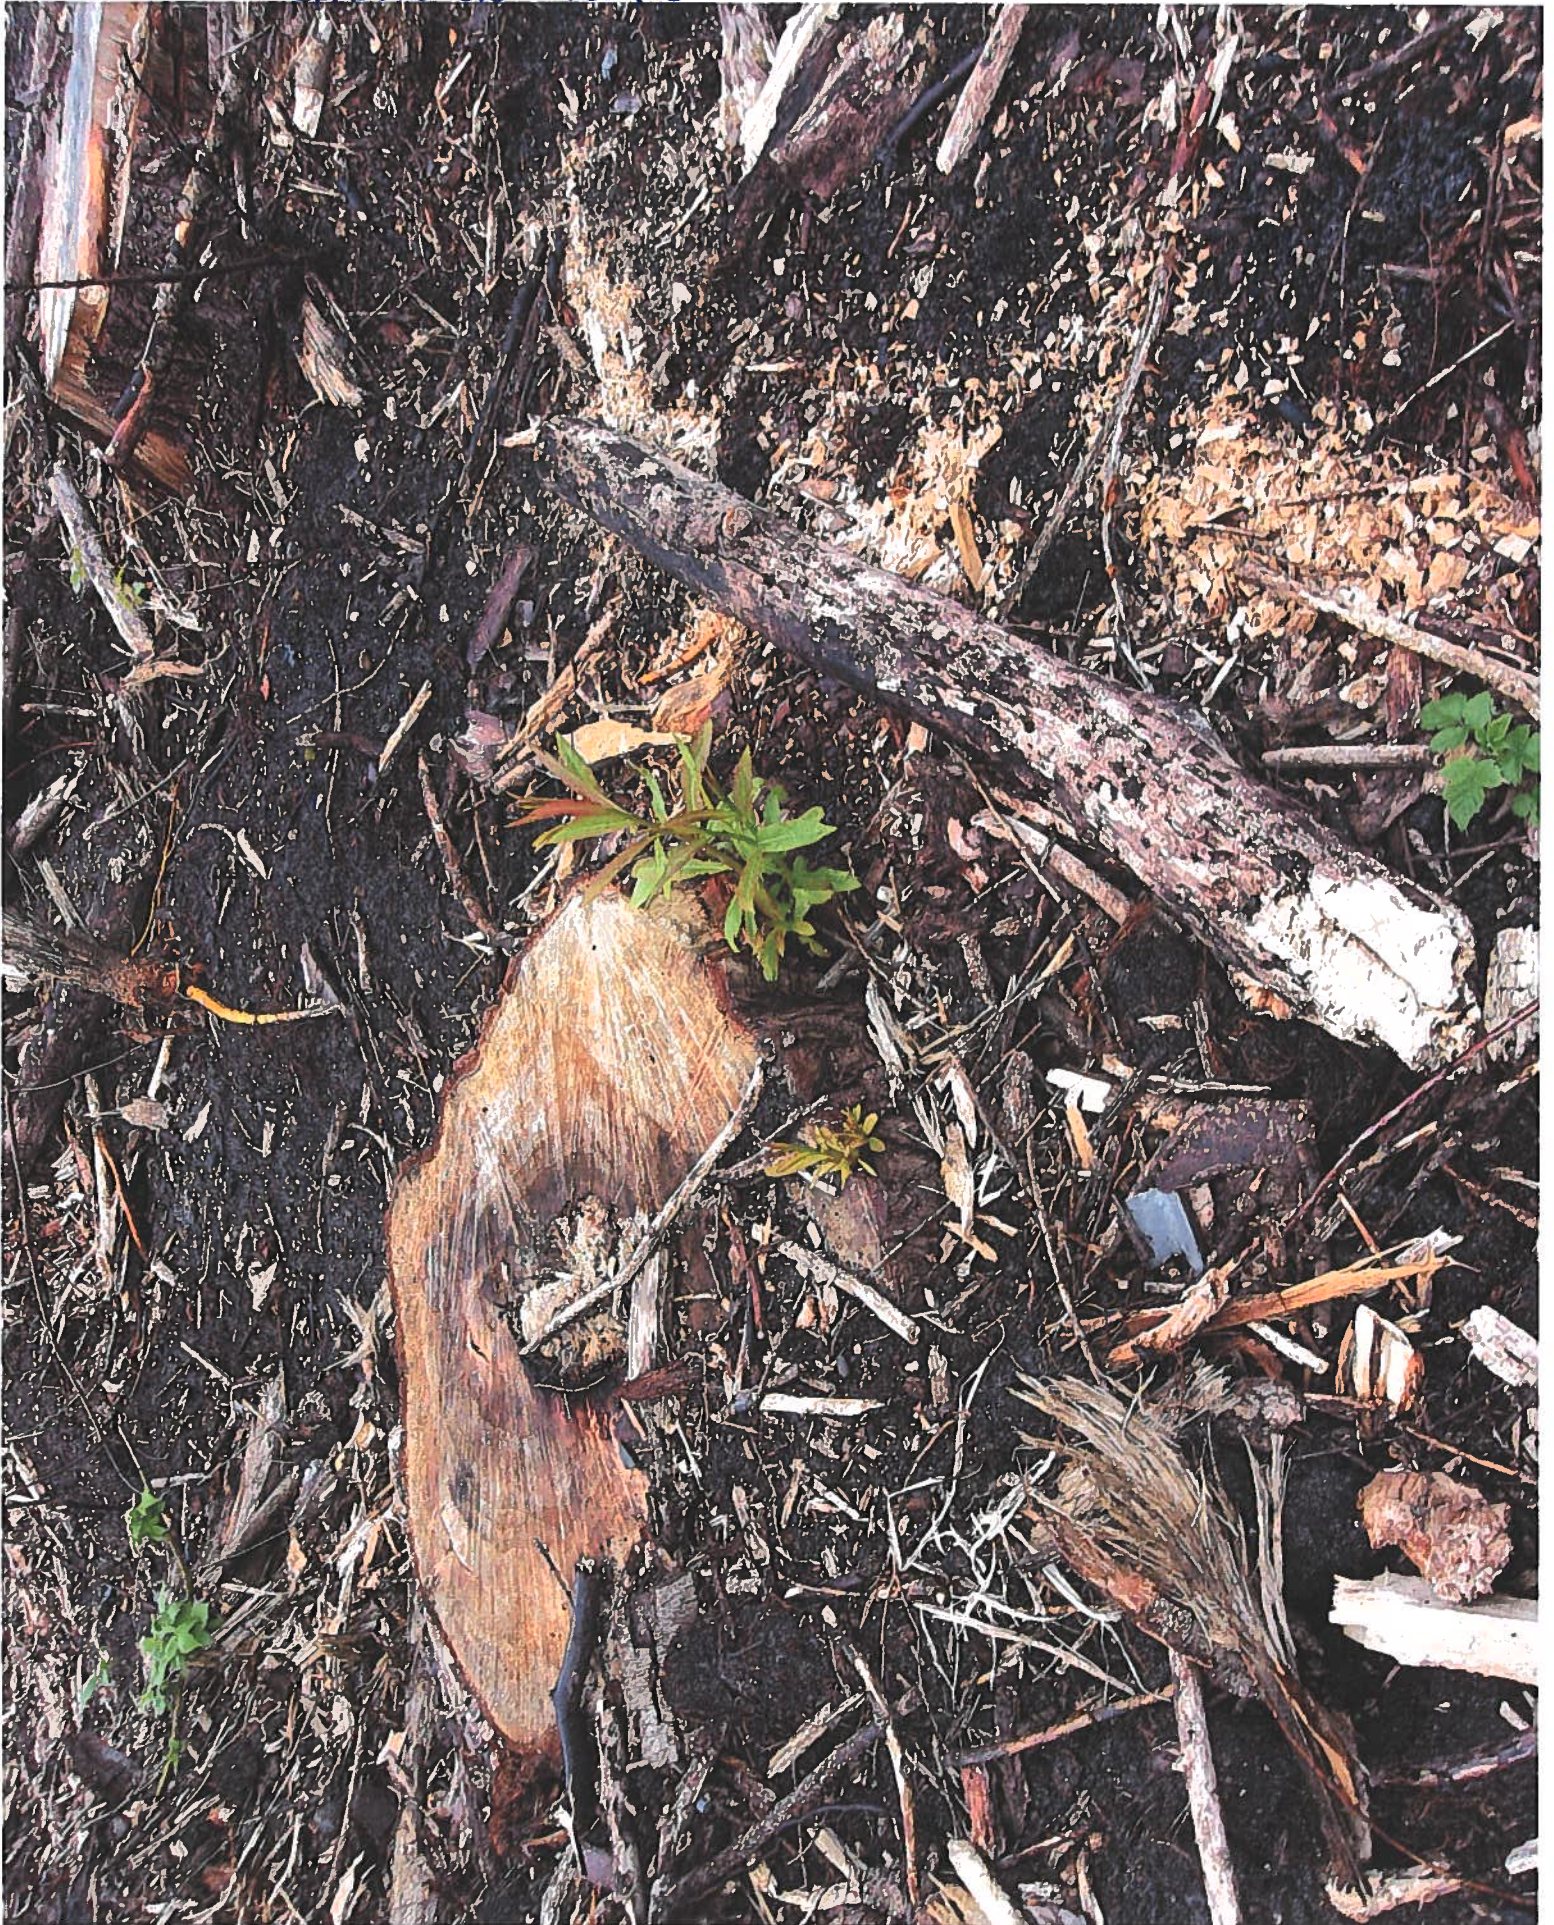
- Per the recommended actions of the previous investigation summary, the trees and woody brush were cut down. Some of said stumps were chipped, while others were not. However, sprouts on these stumps showed signs of reemergence and regrowth.

Sprouts on Stumps

- All stumps of trees and woody brush needs to be treated to prevent regrowth immediately.
- At the direction of the Trustees, the remaining brush needs to be removed from site or burned on-site.
- Repair affected tile in the area as needed.
- Area may need to be sprayed to kill additional regrowth.

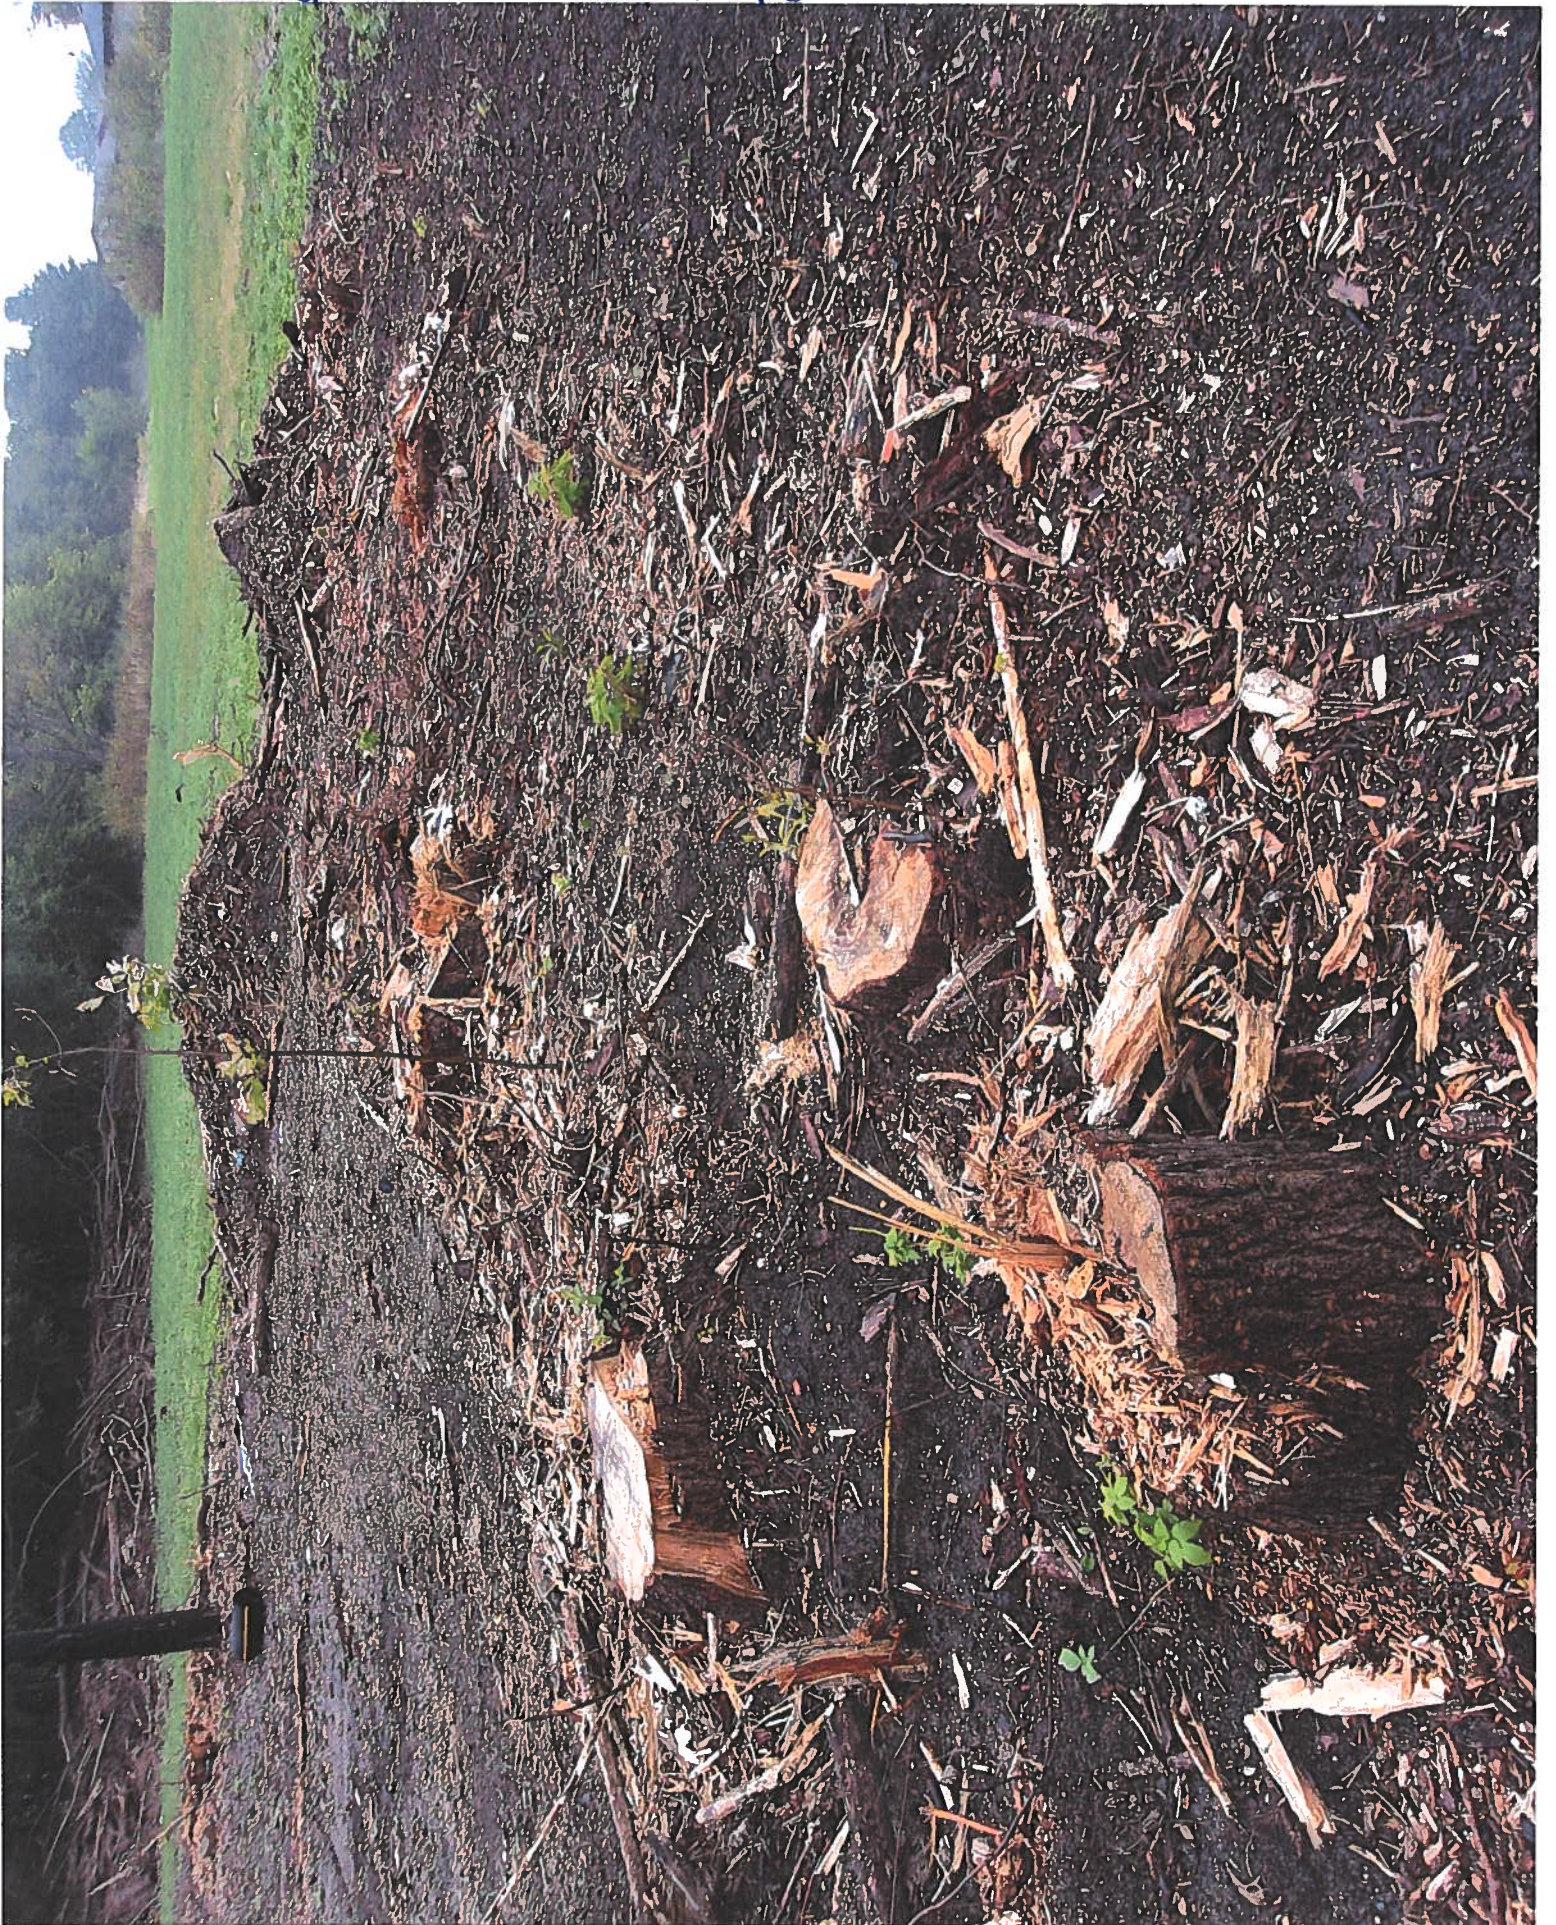
SPROUTS ON TREE STUMPS

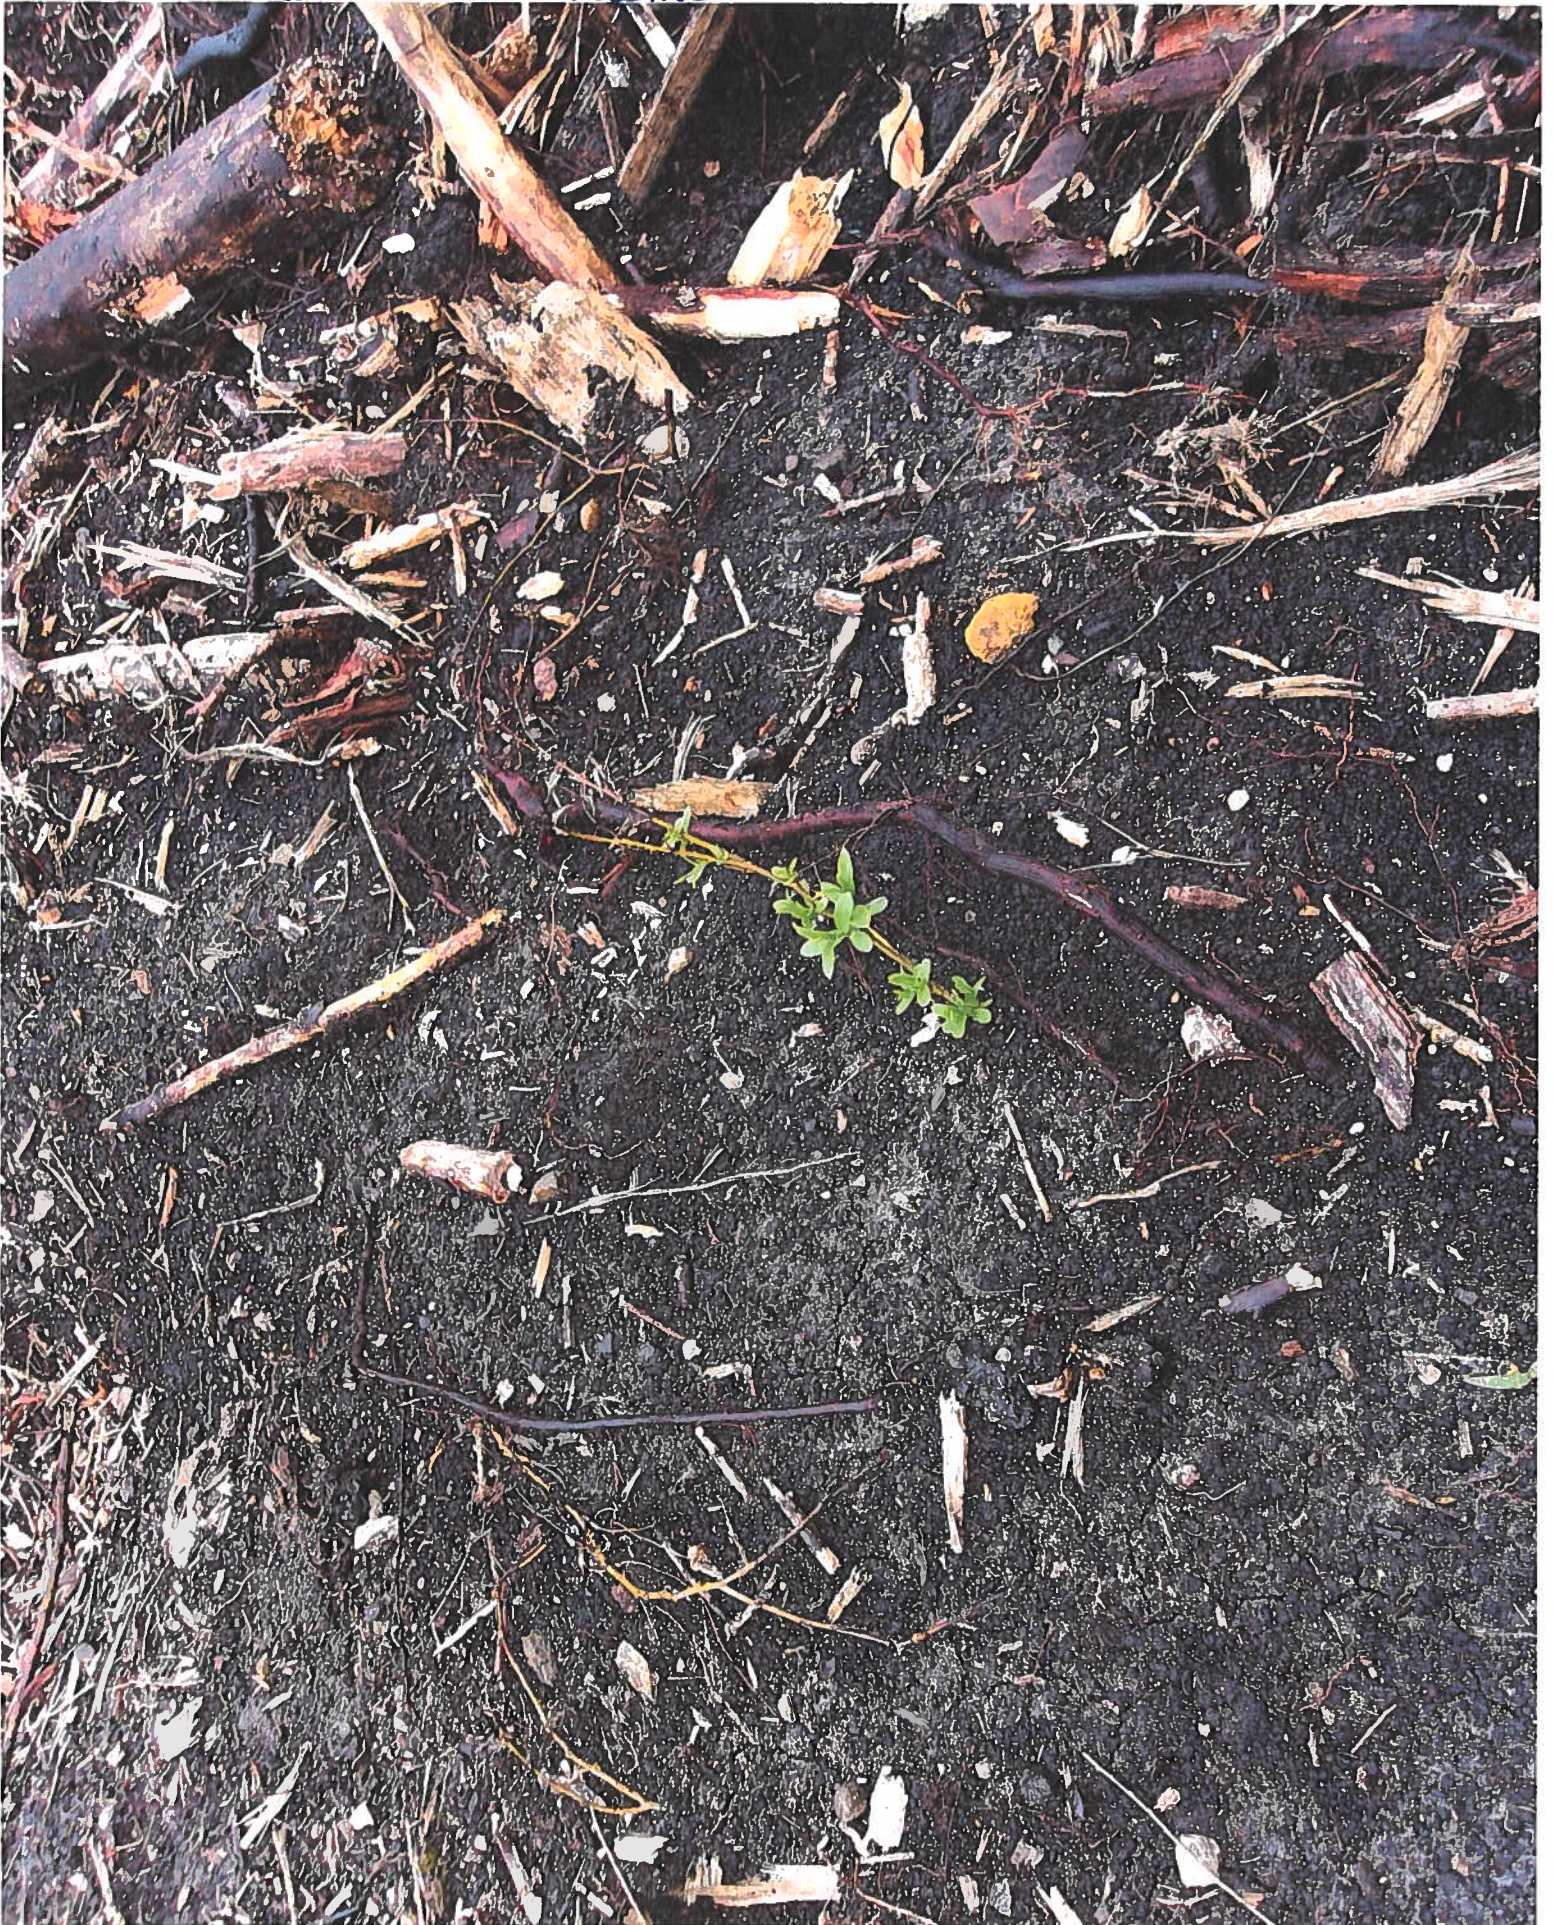
NEW AUSSIE TREE GROWING

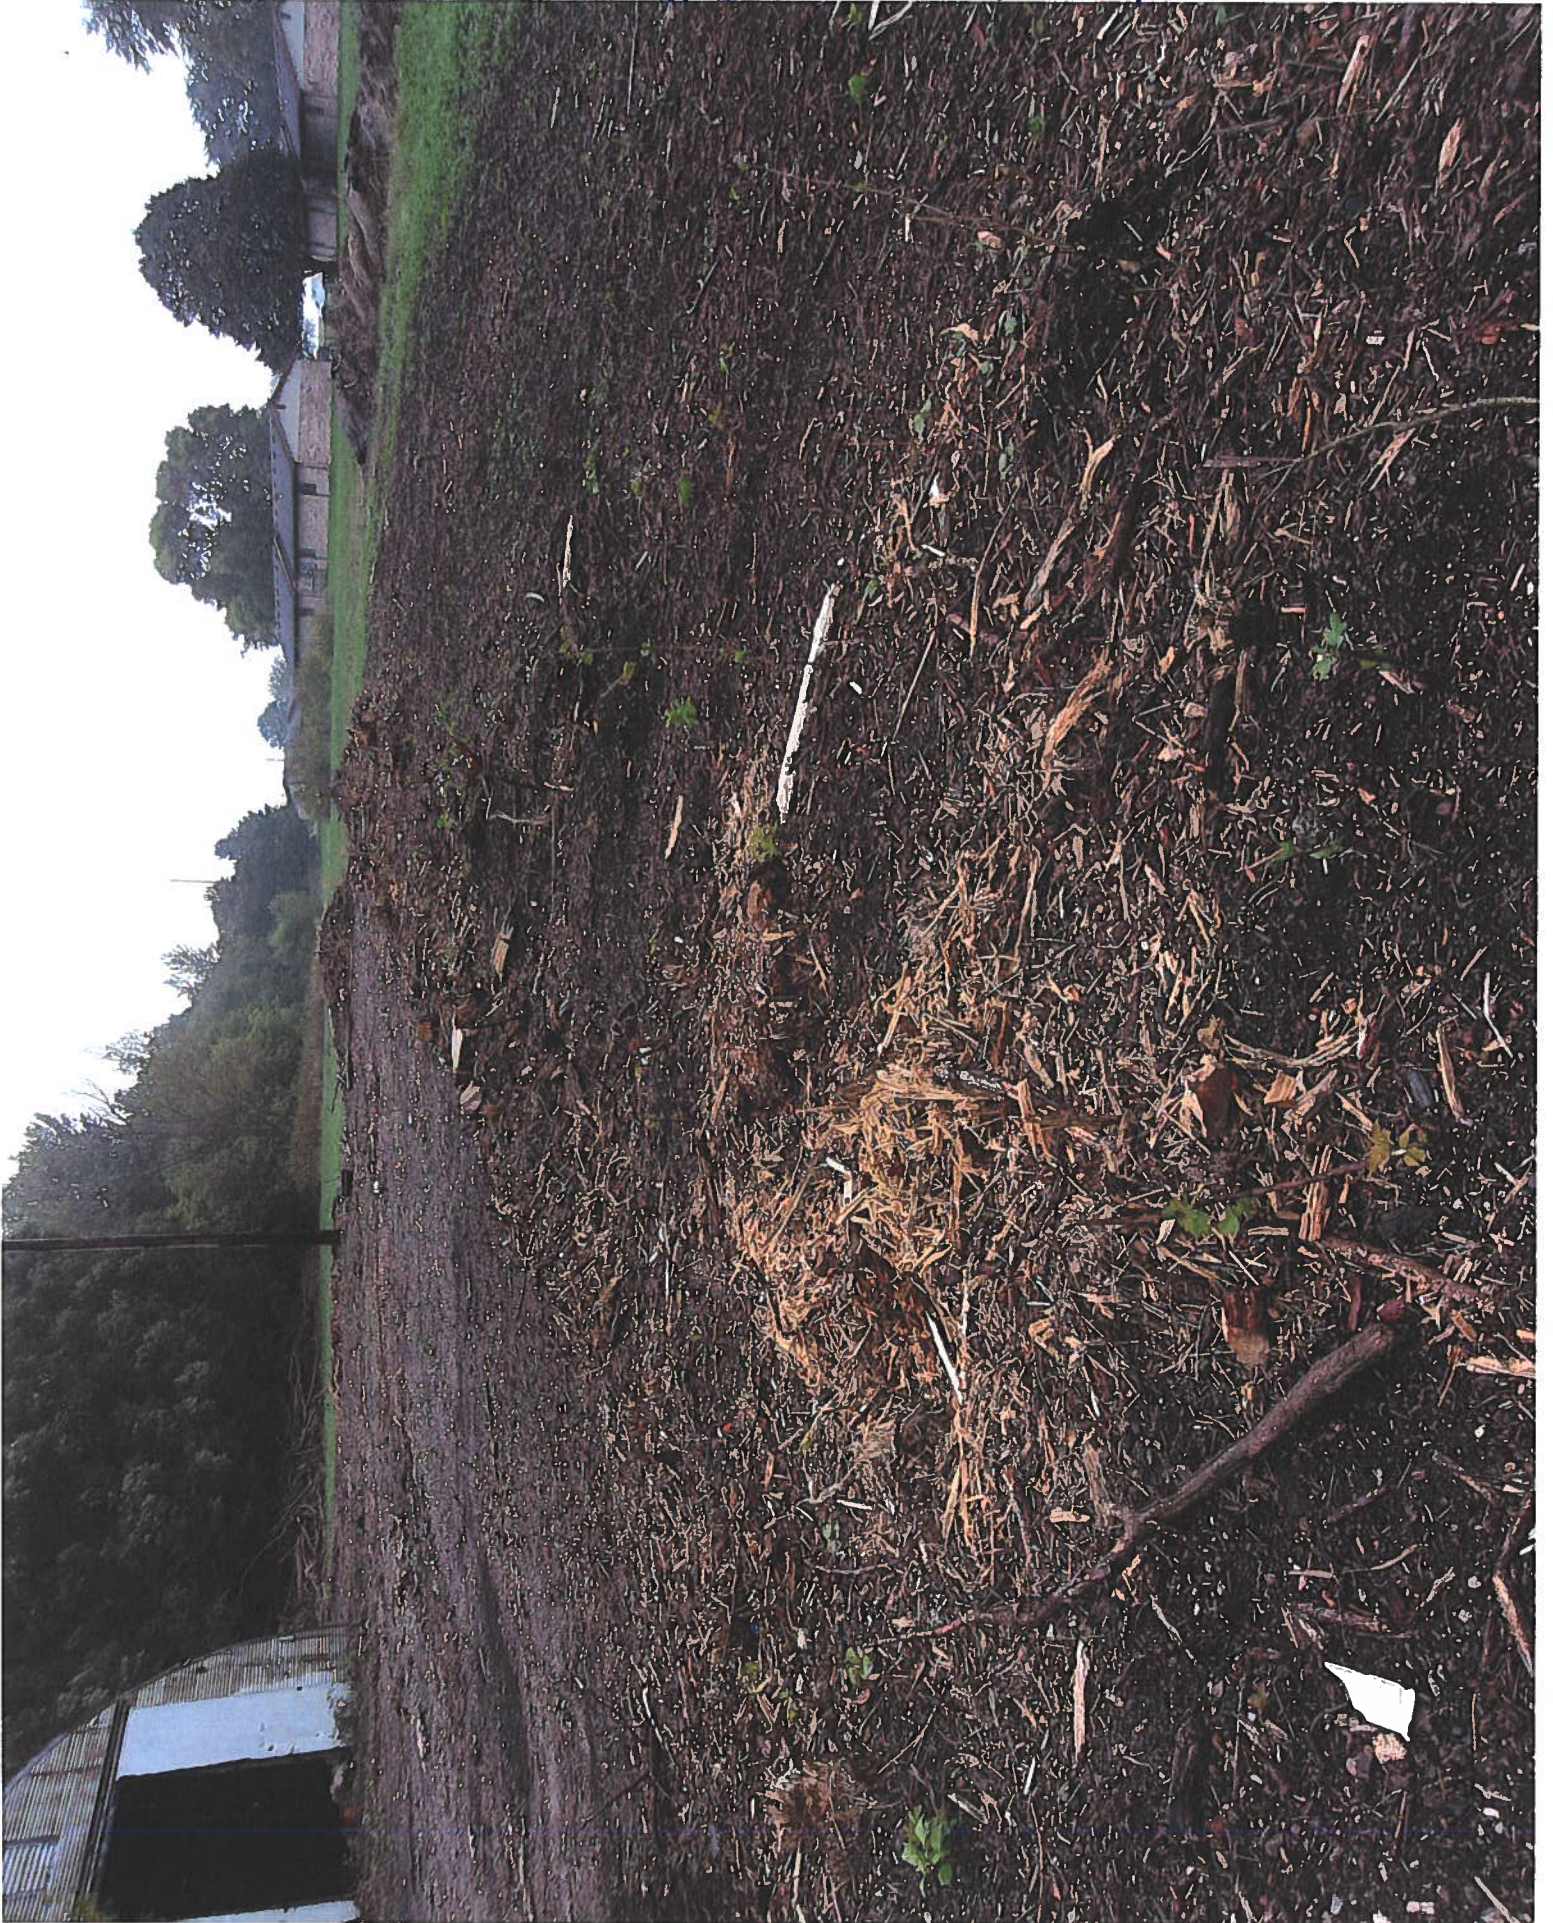
E-W TREE LINE WITH CHIPPED AND MANGLED STUMPS

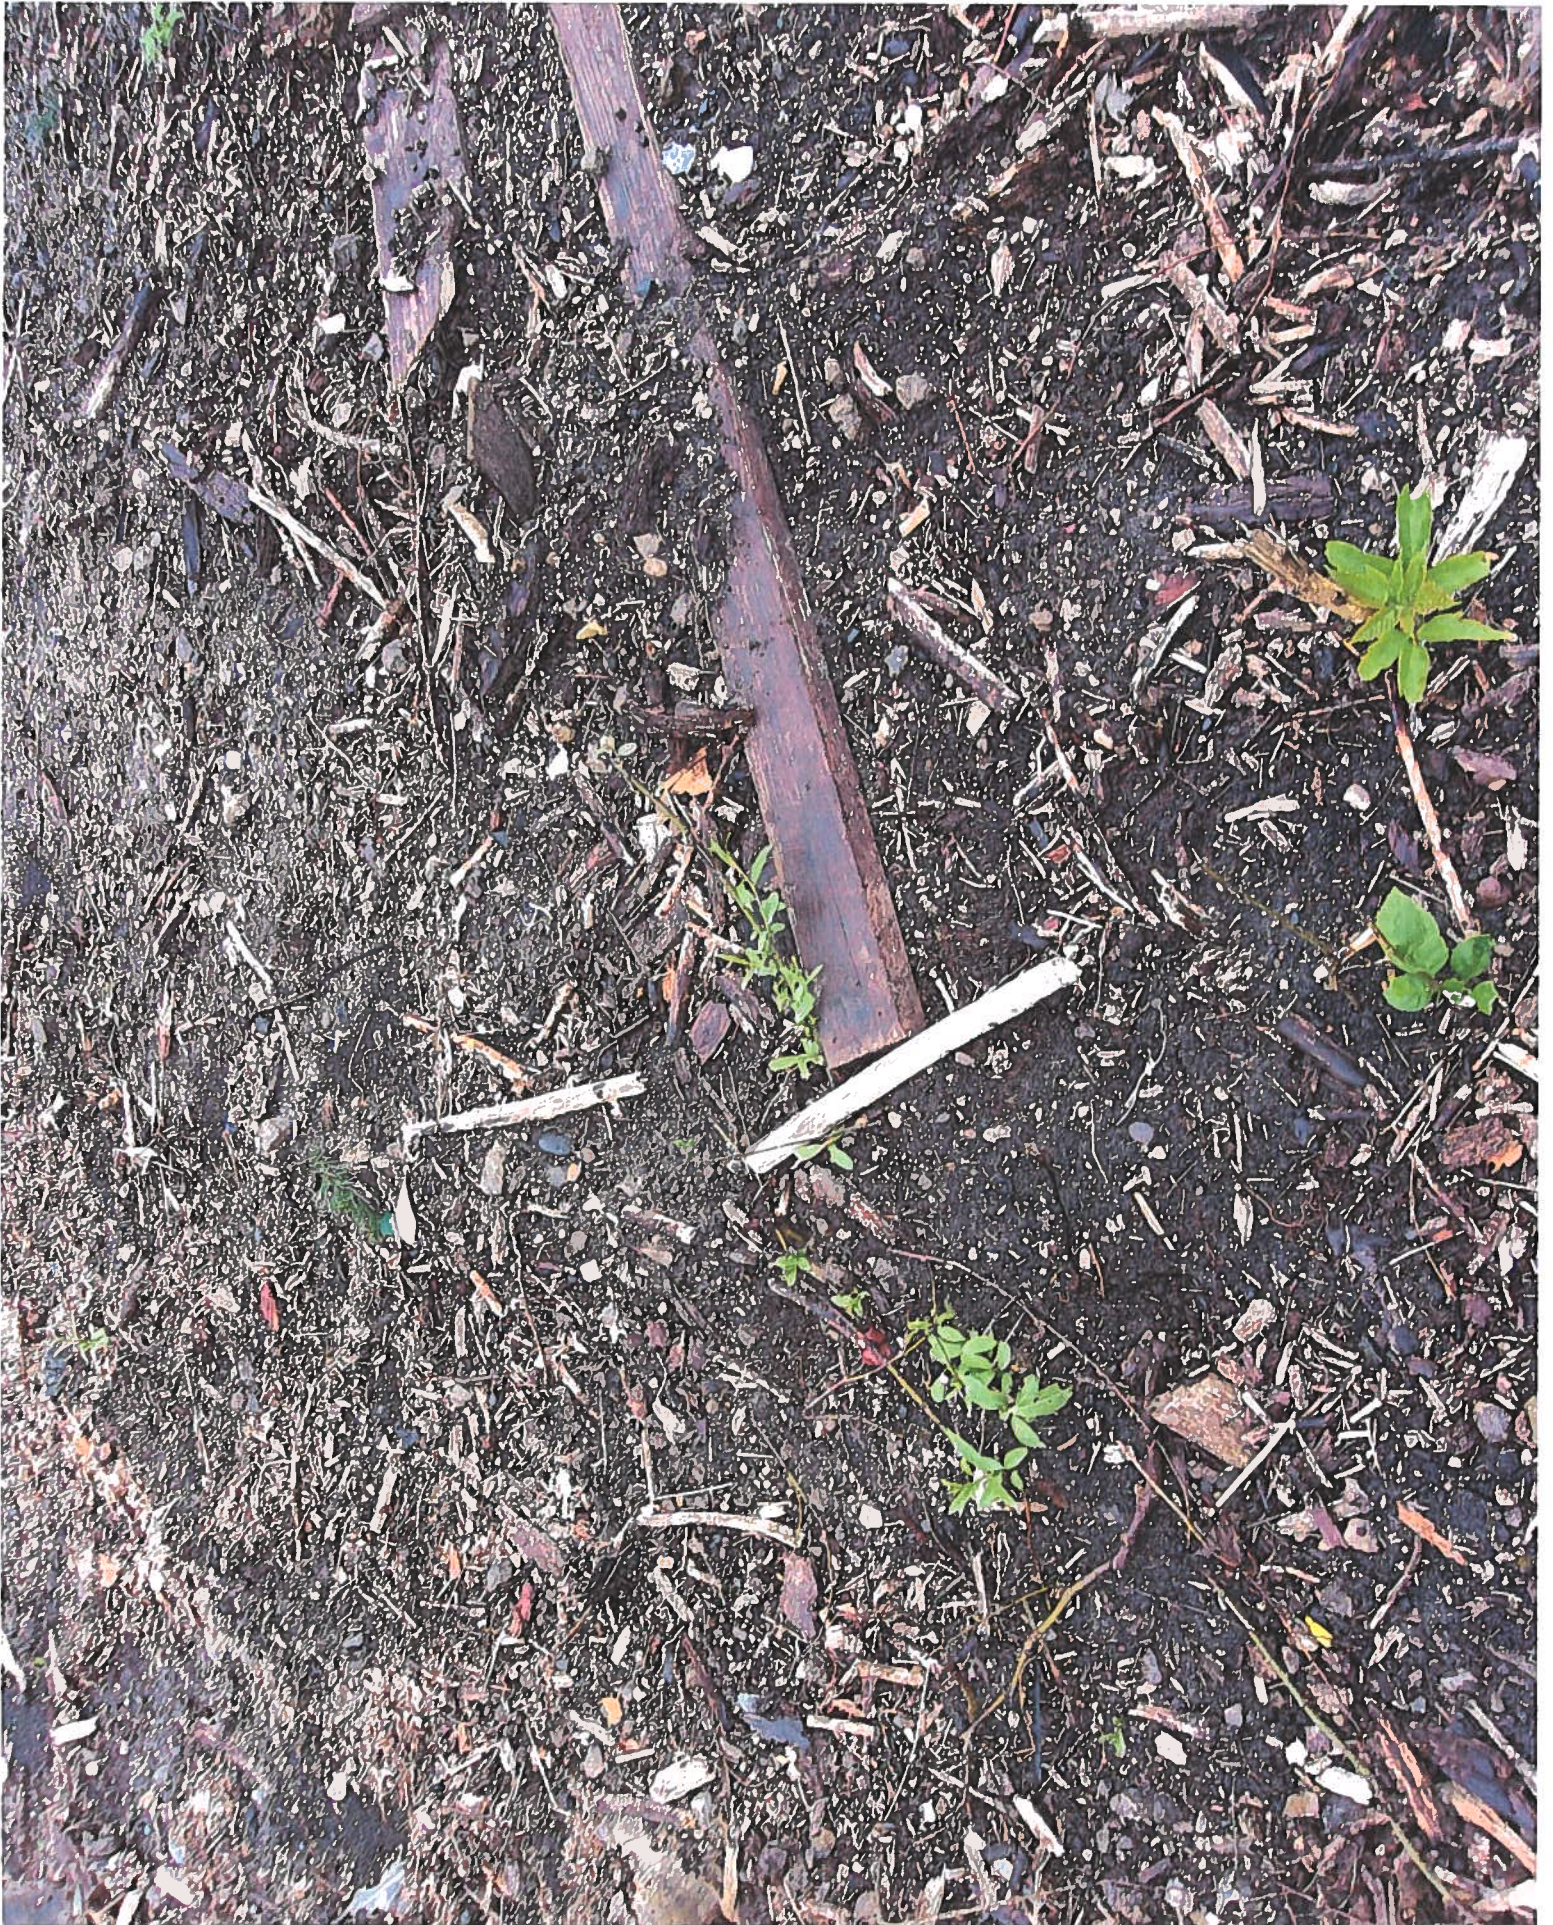
NEW AUSSTREEE GROWING NEXT TO 2x4 WOOD

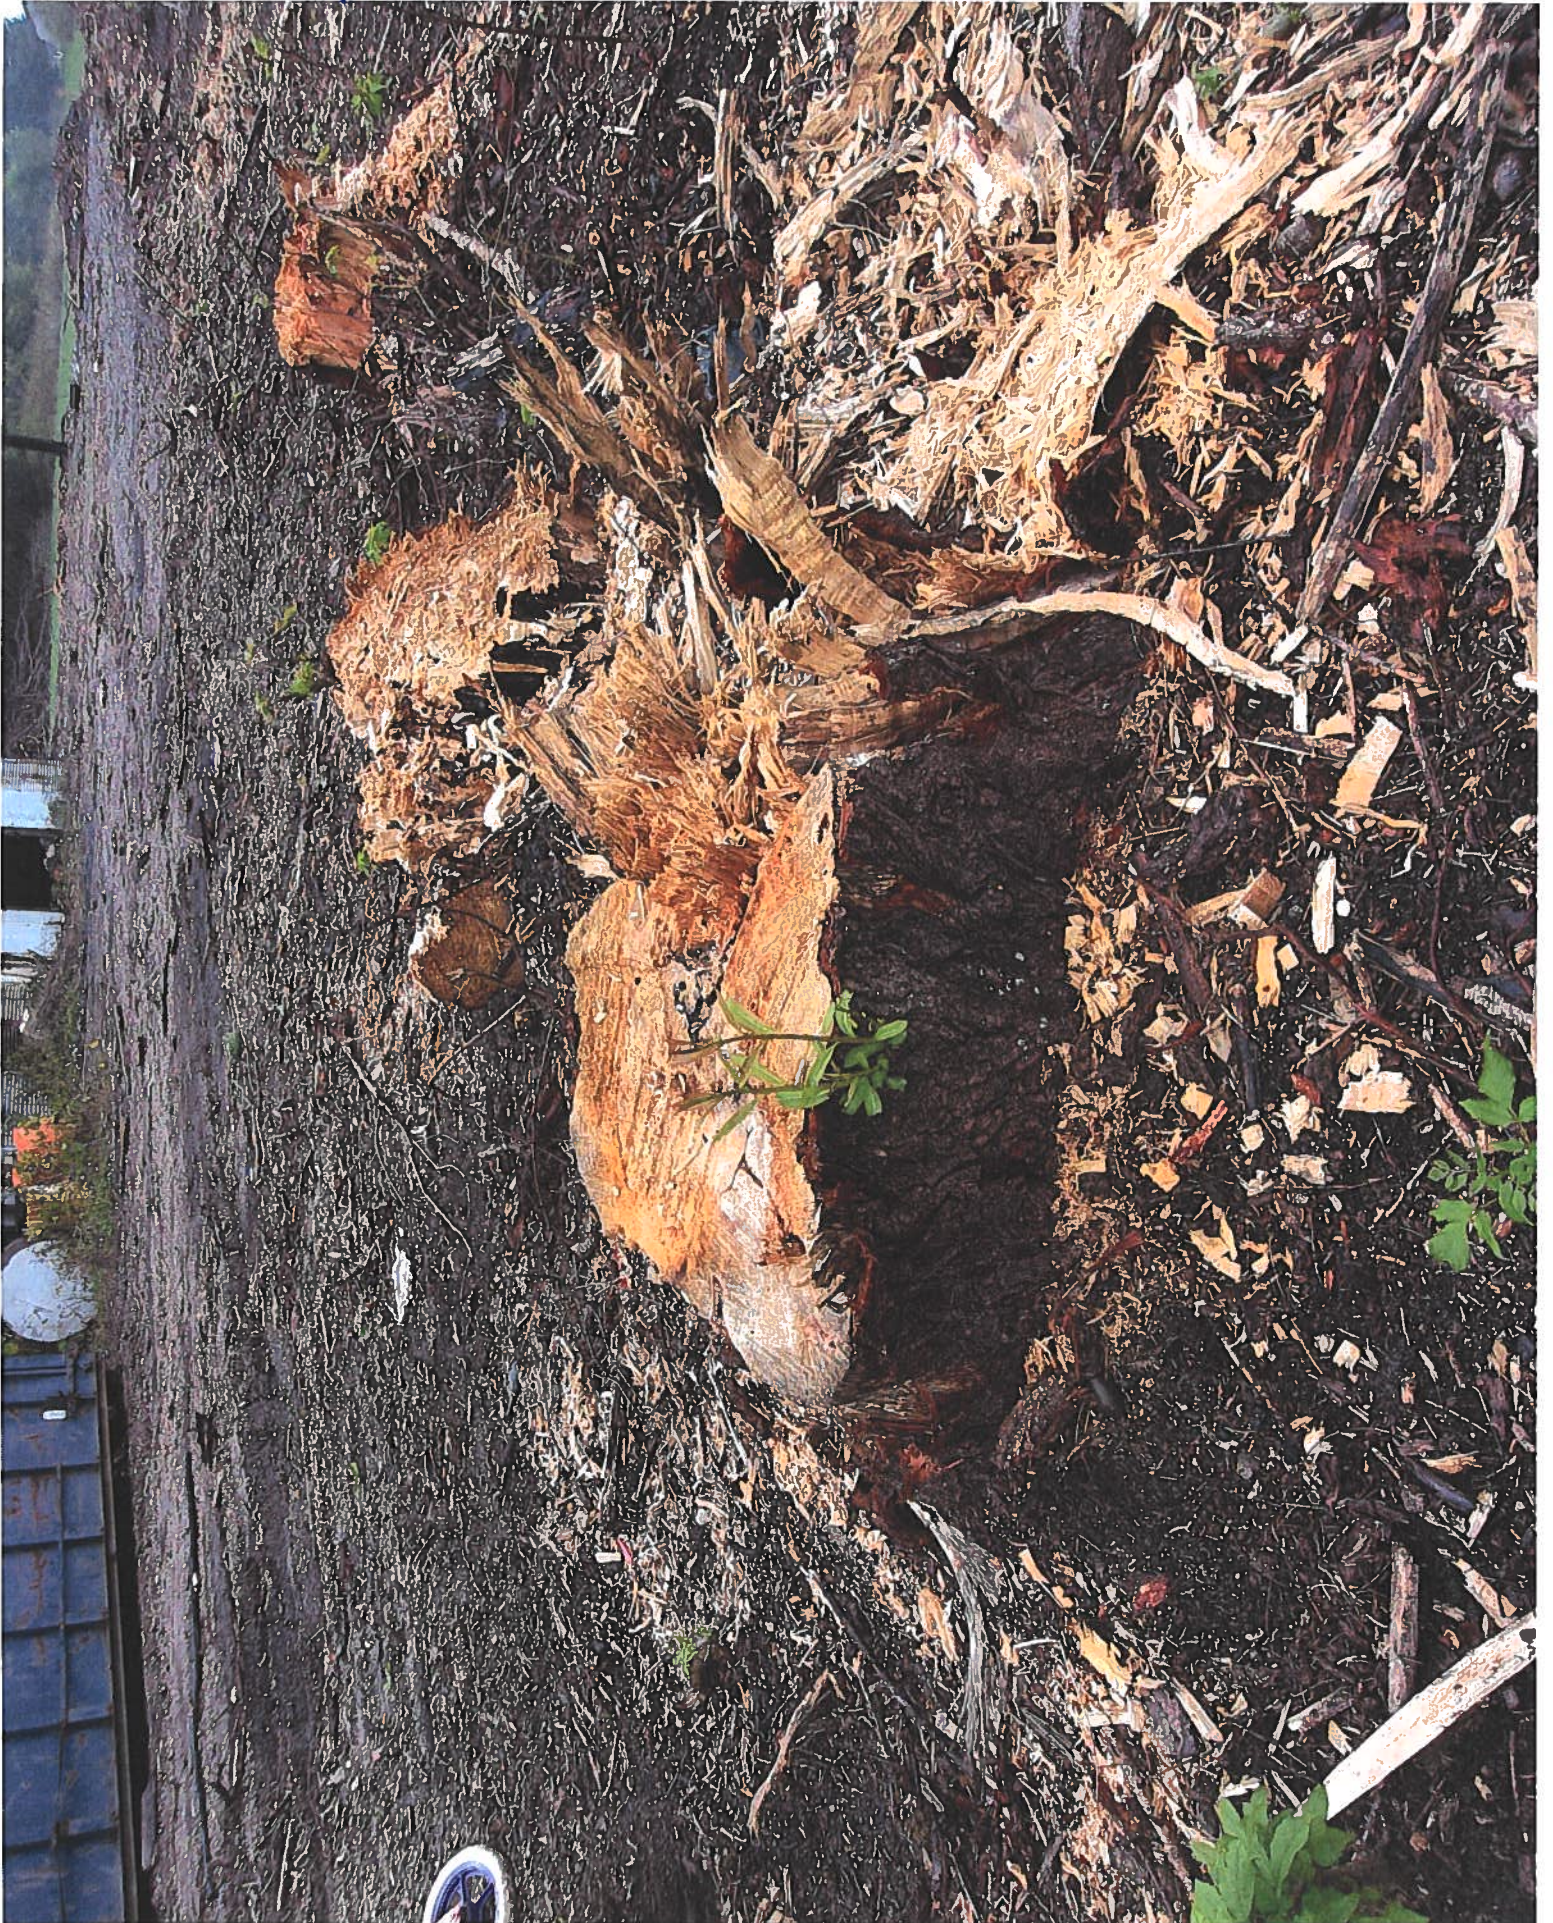
6" sprouts on stumps
