AGENDA
REGULAR DRAINAGE MEETING
Wednesday, April 29, 2020 9:30 AM
Large Conference Room

Project Description: Main Tile Repairs to Drainage District 22 Facilities
Hardin County, Iowa
Project Nos. DD-6532.2 and 8712

Hardin County Work Order: WO00000276

Investigation Summary:

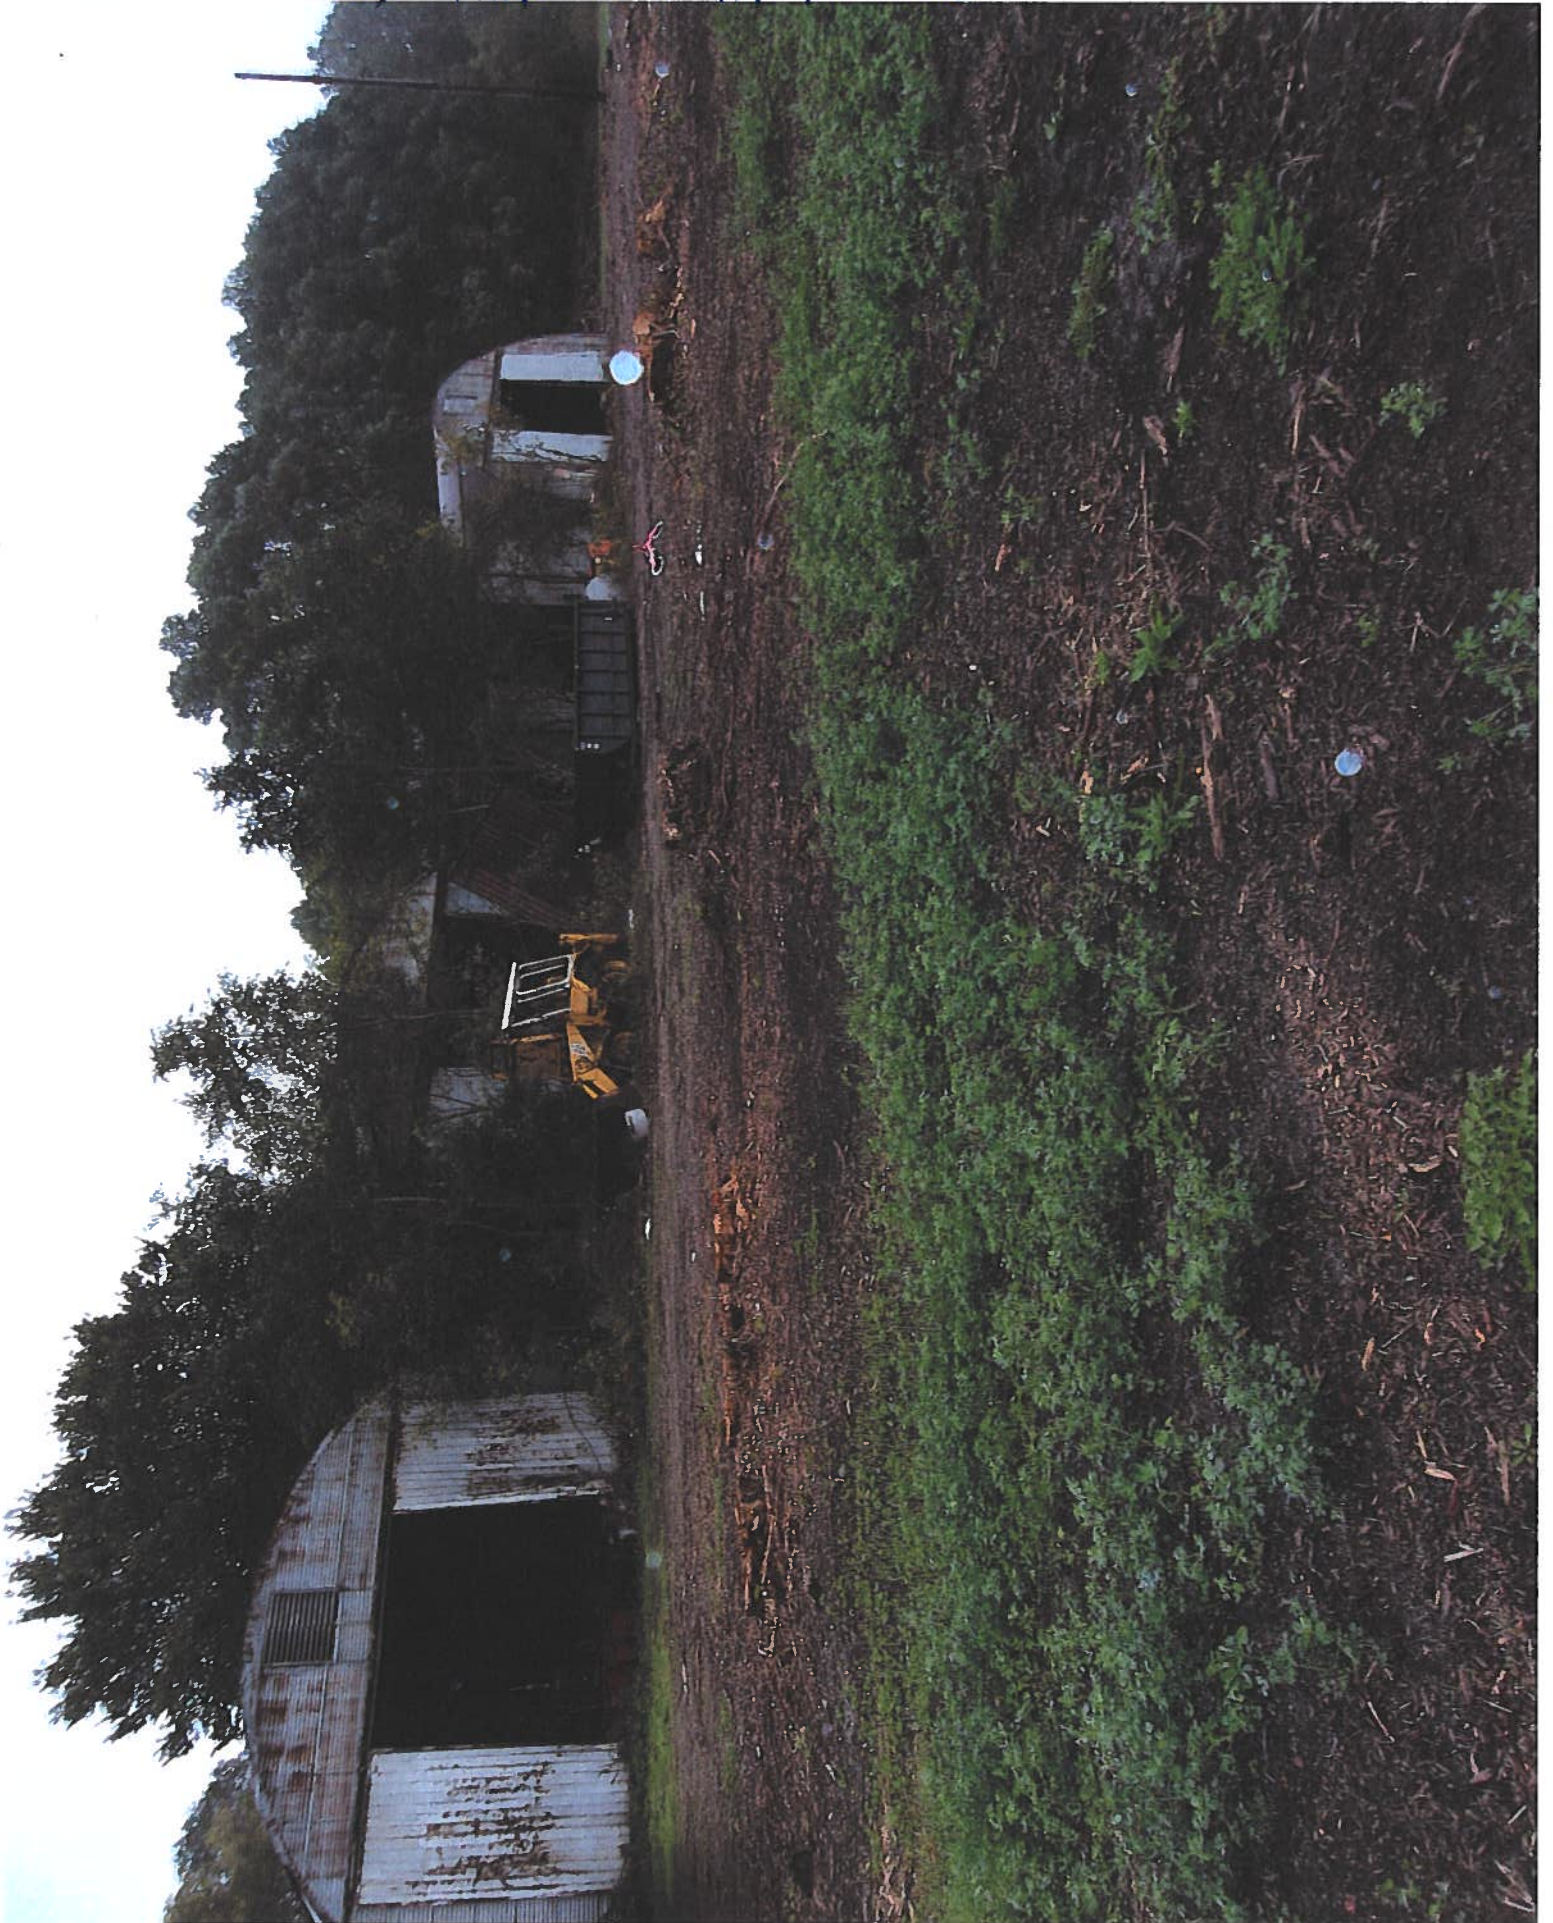
WESTERLY STUMPS 1' HIGH, SPROUTING

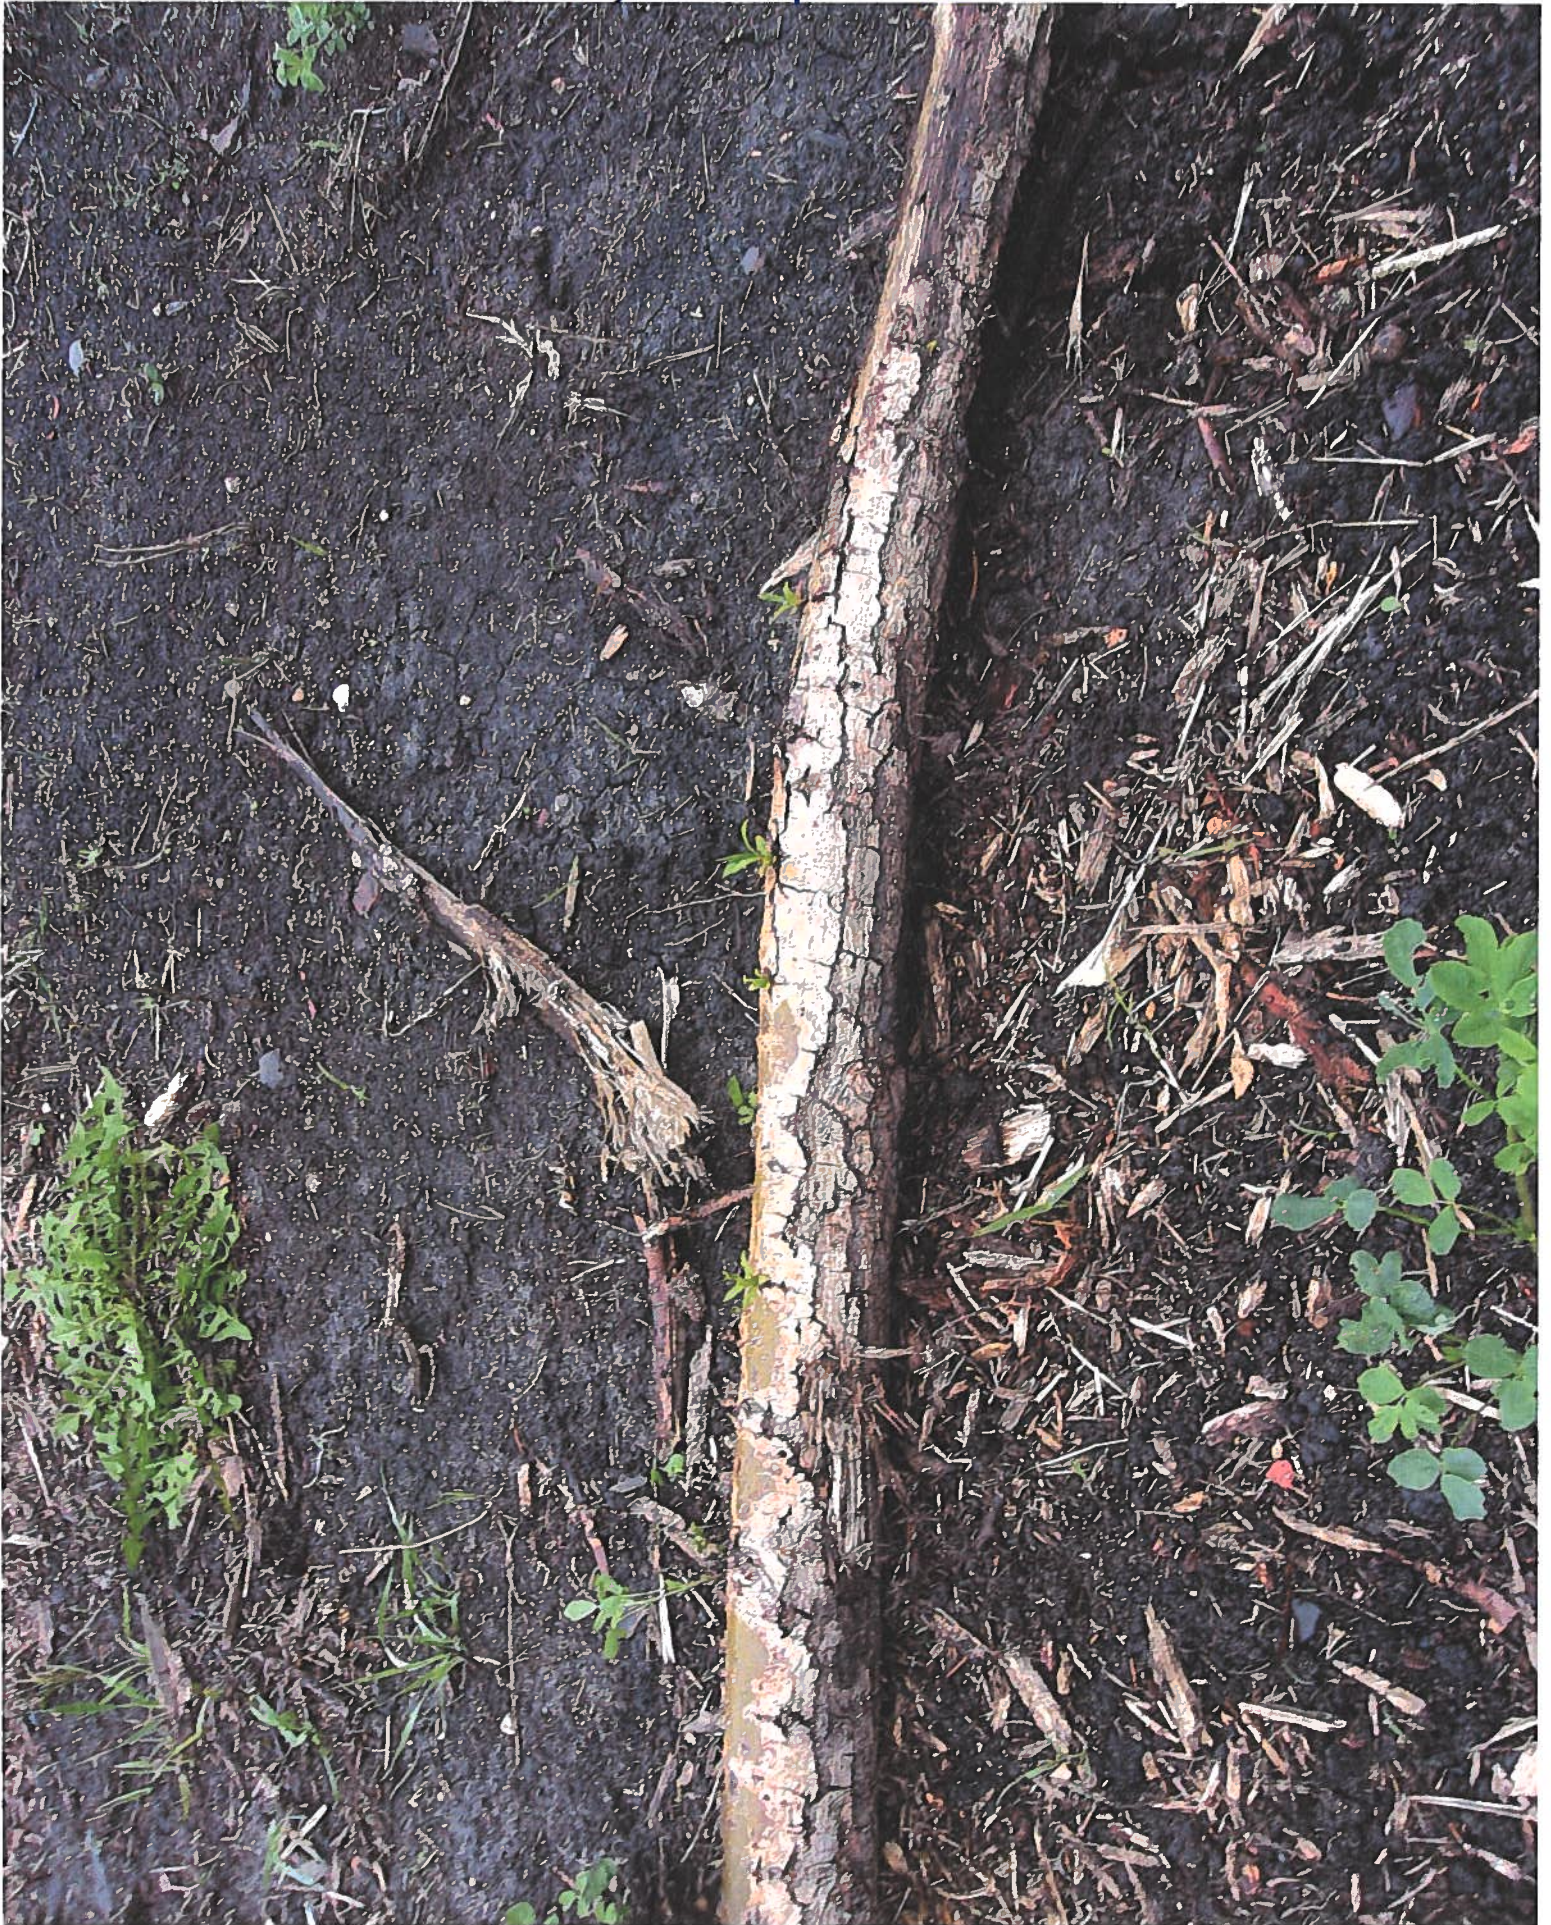
LIMB LOG NEXT TO HAYFIELD SPROUTING

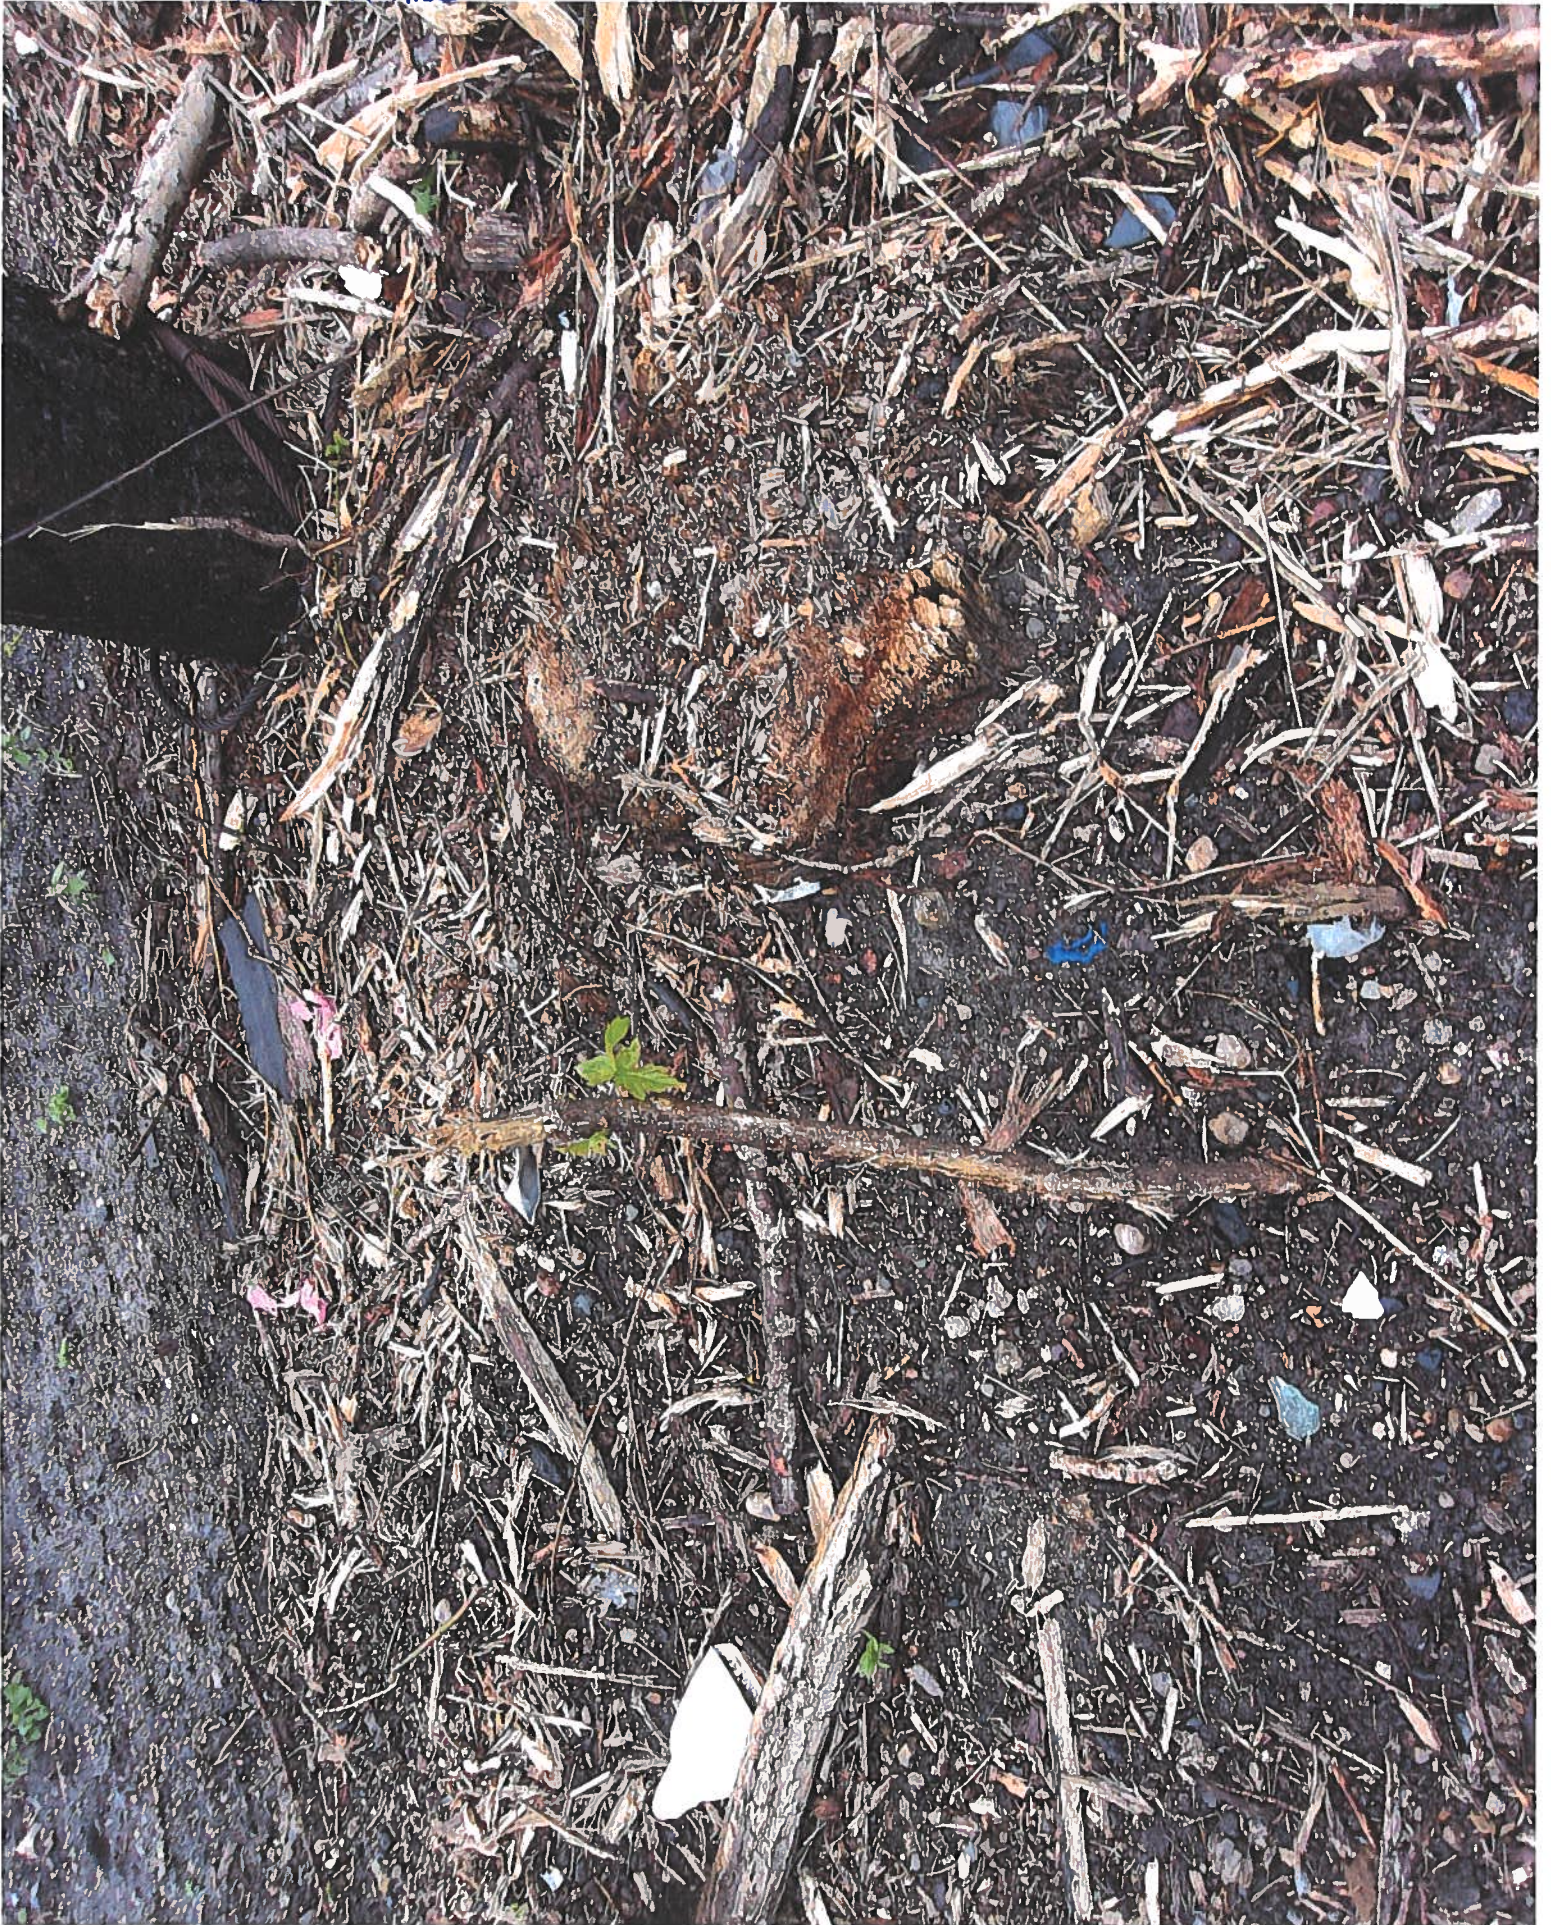
TREE STARTING TO GROW AGAIN

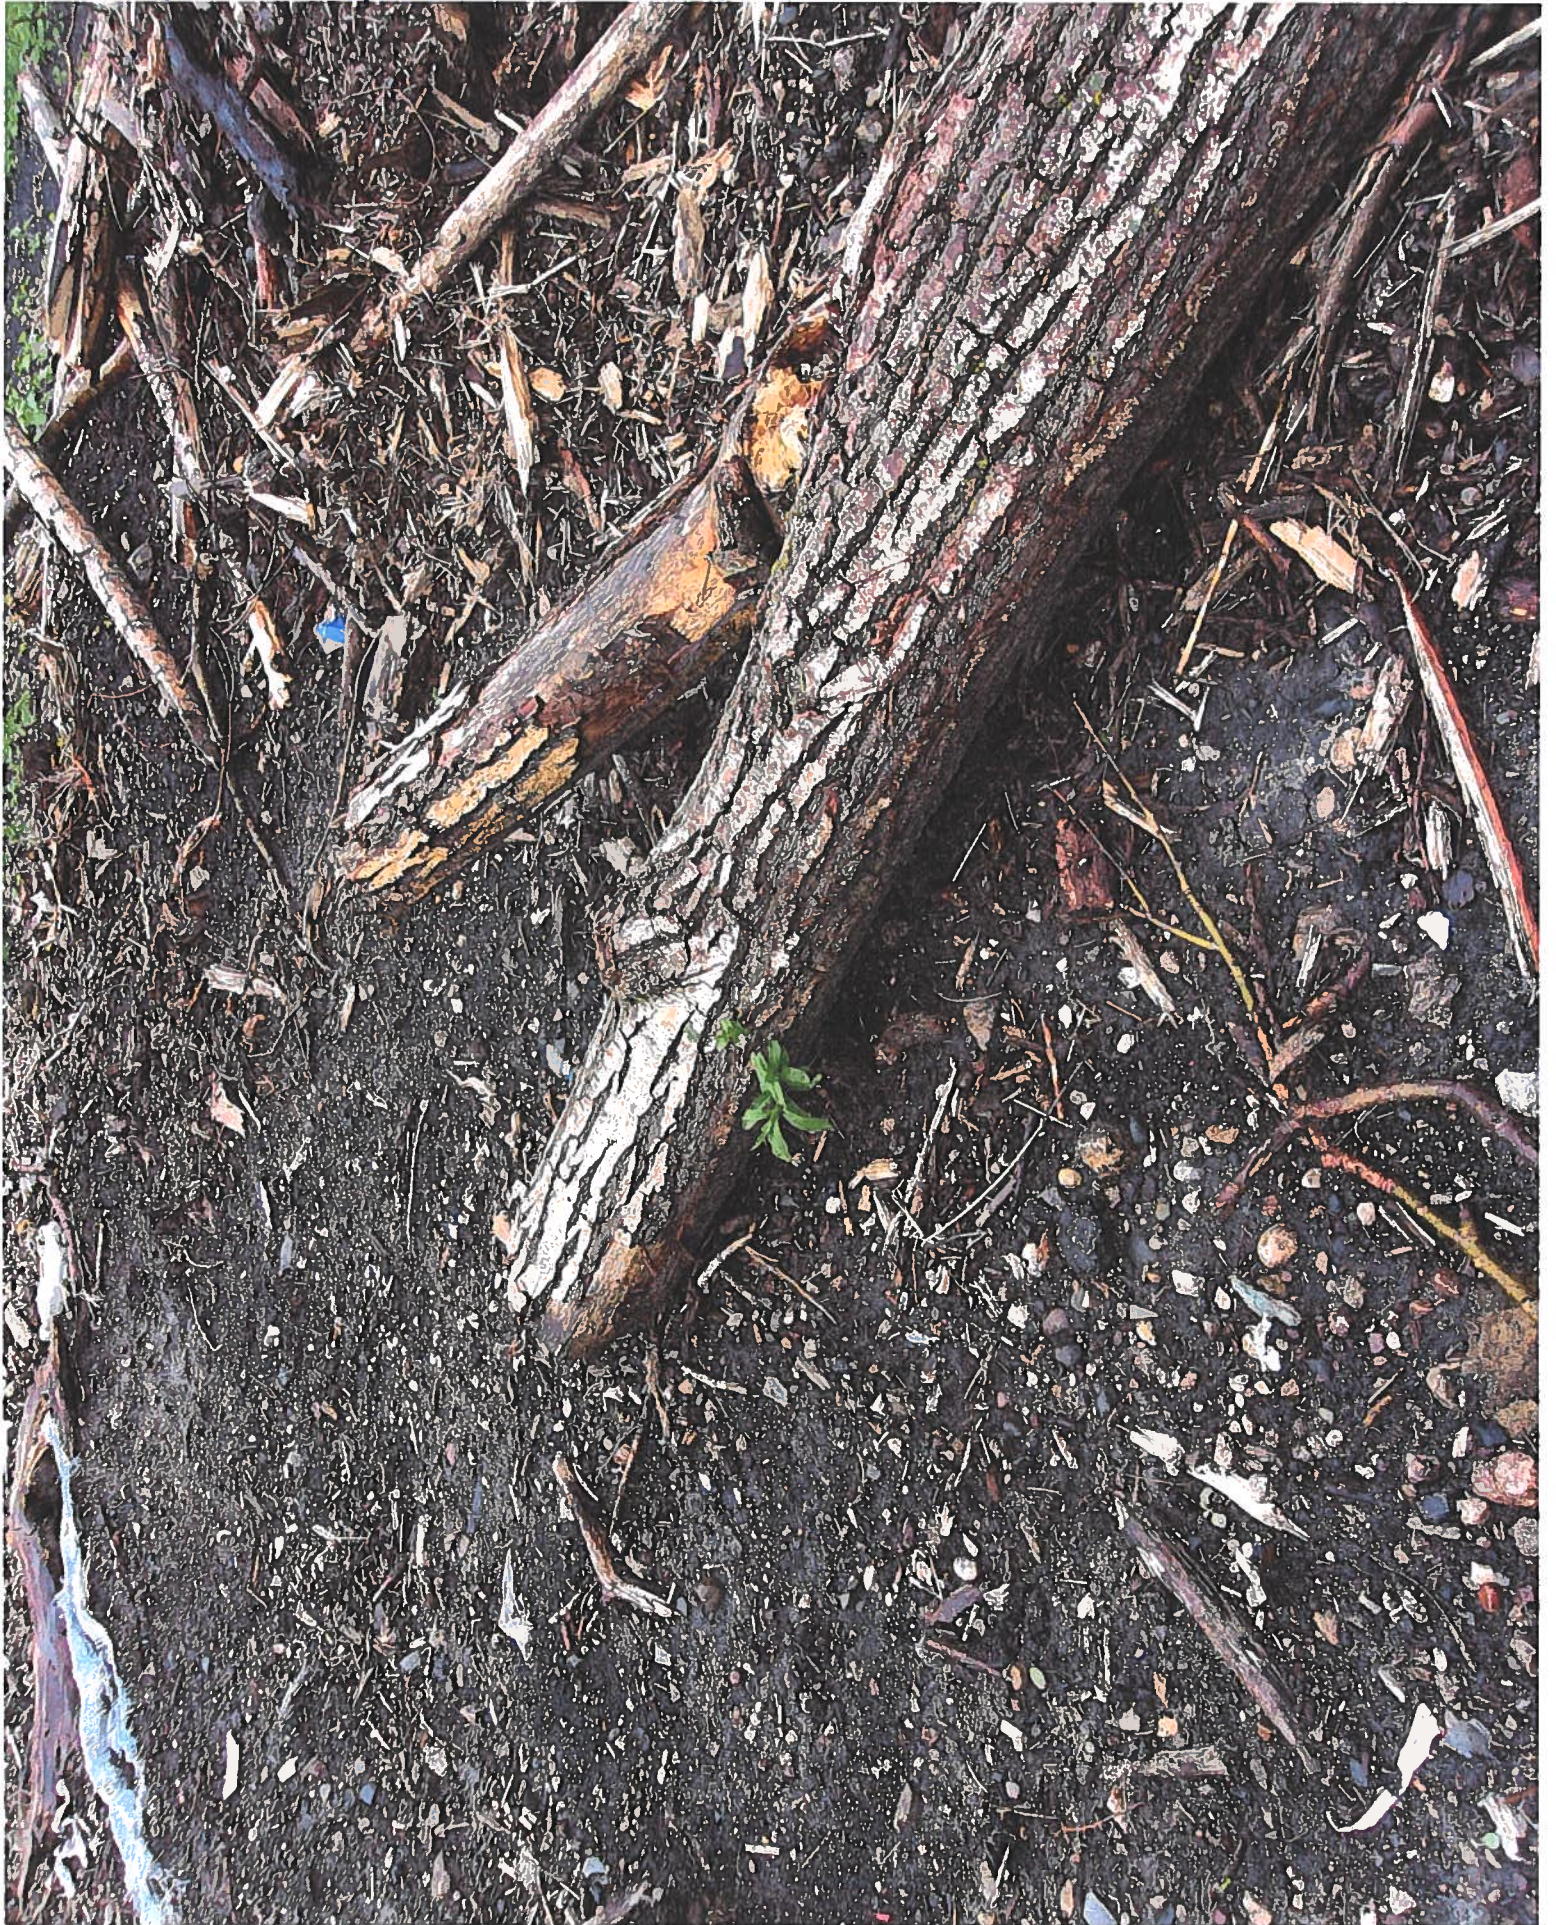
LIMS LOG SPROUTING AND ROOTING down

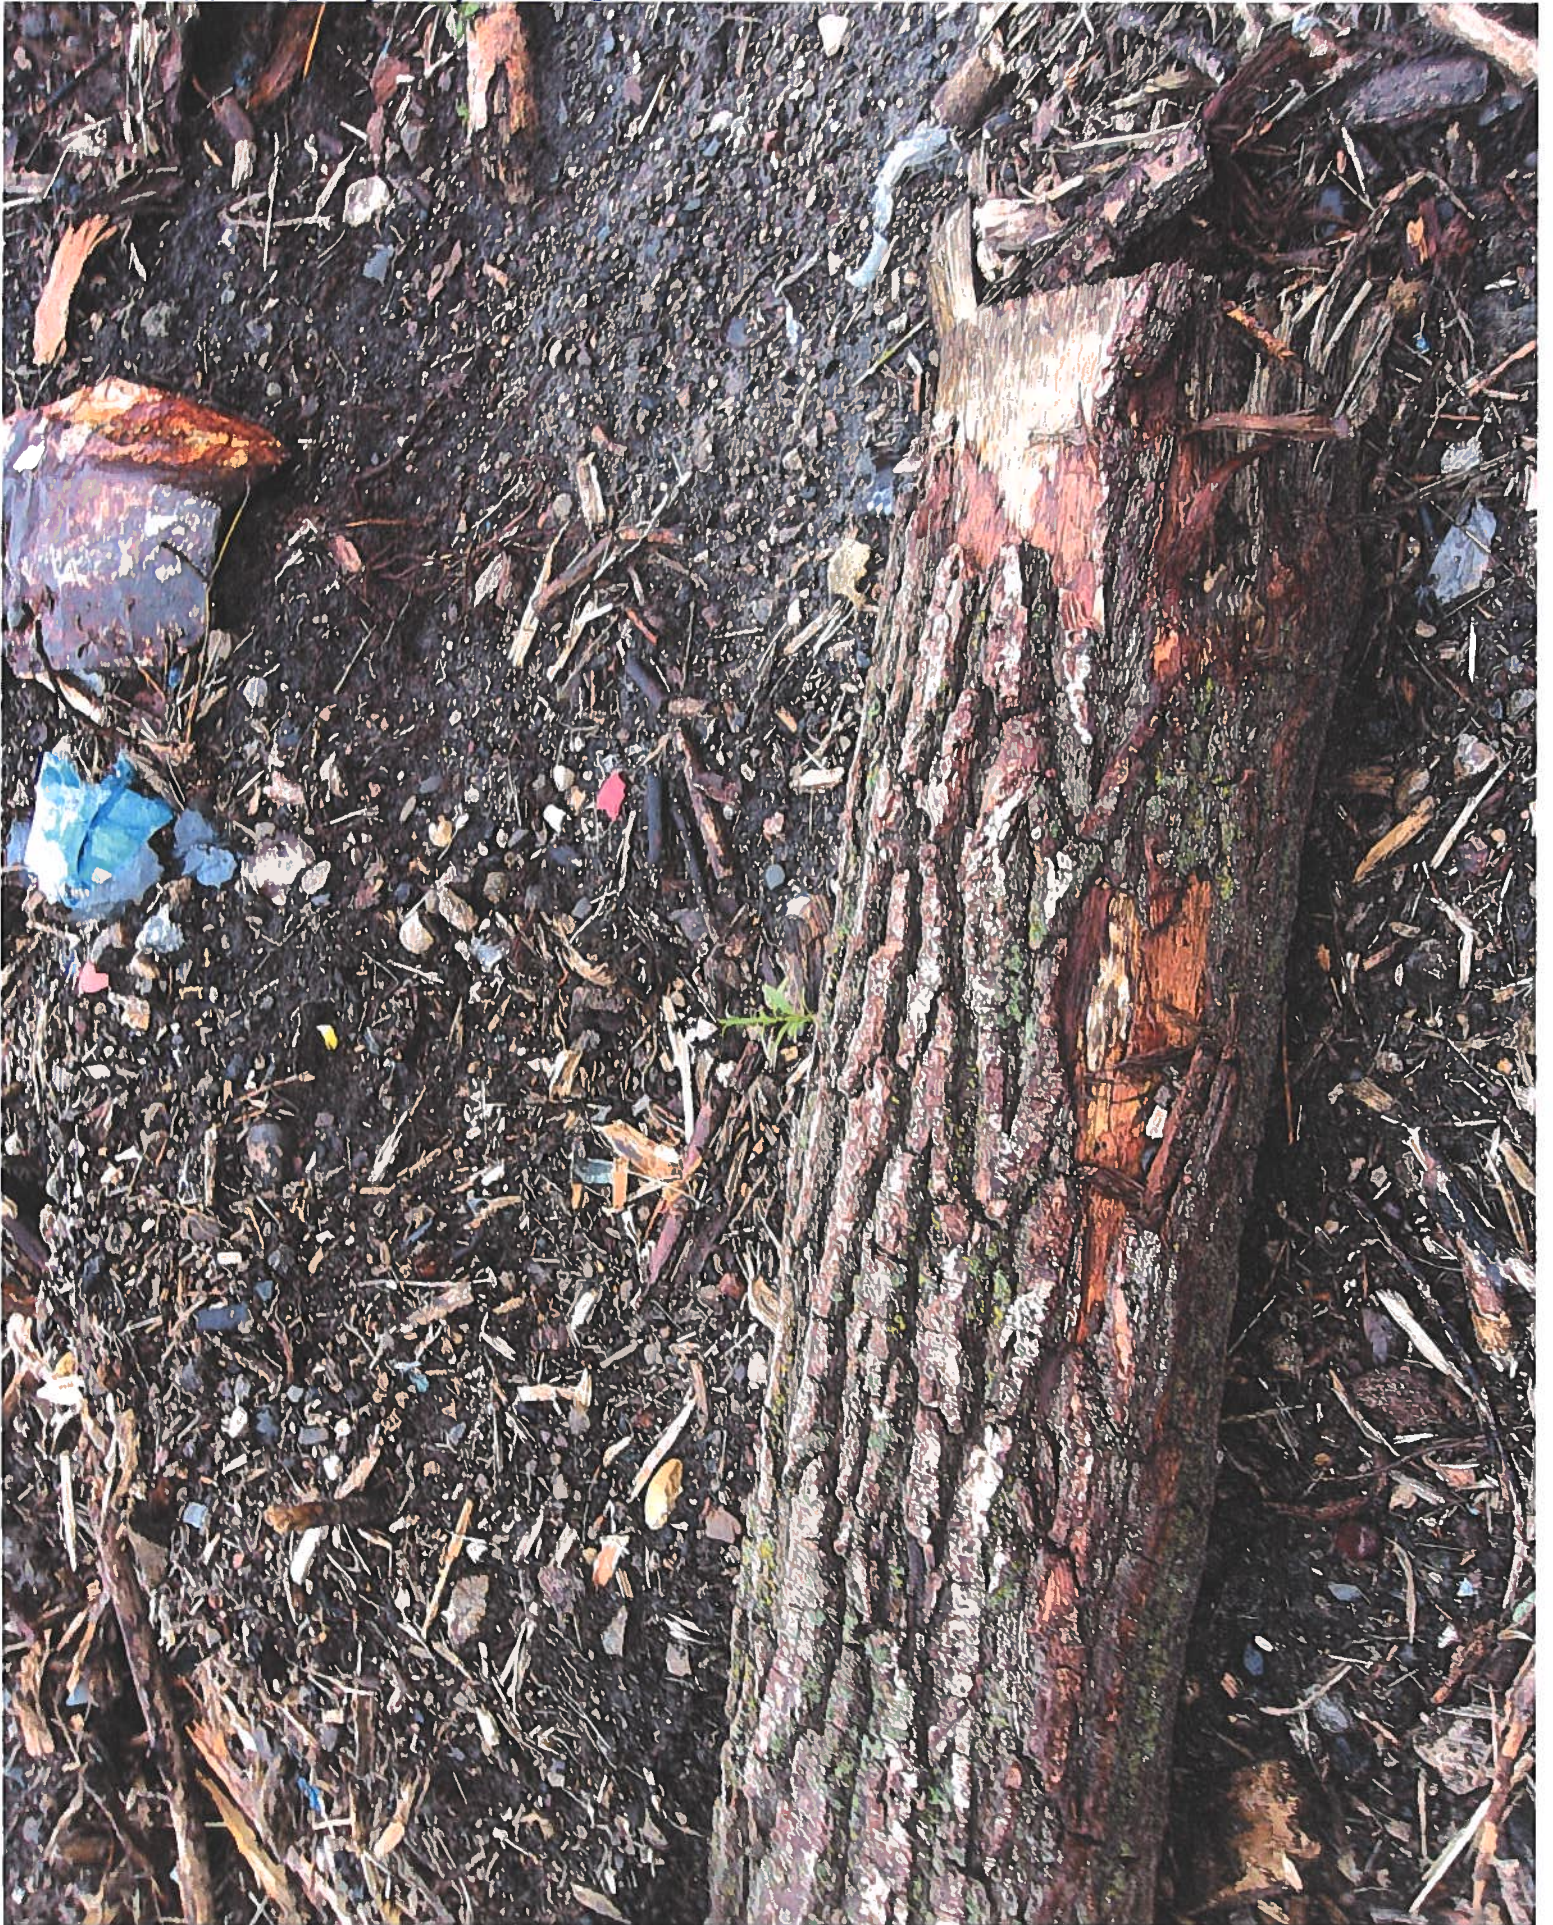
LIME LOG BY HAYFIELD STARTING TO TAKE ROOT

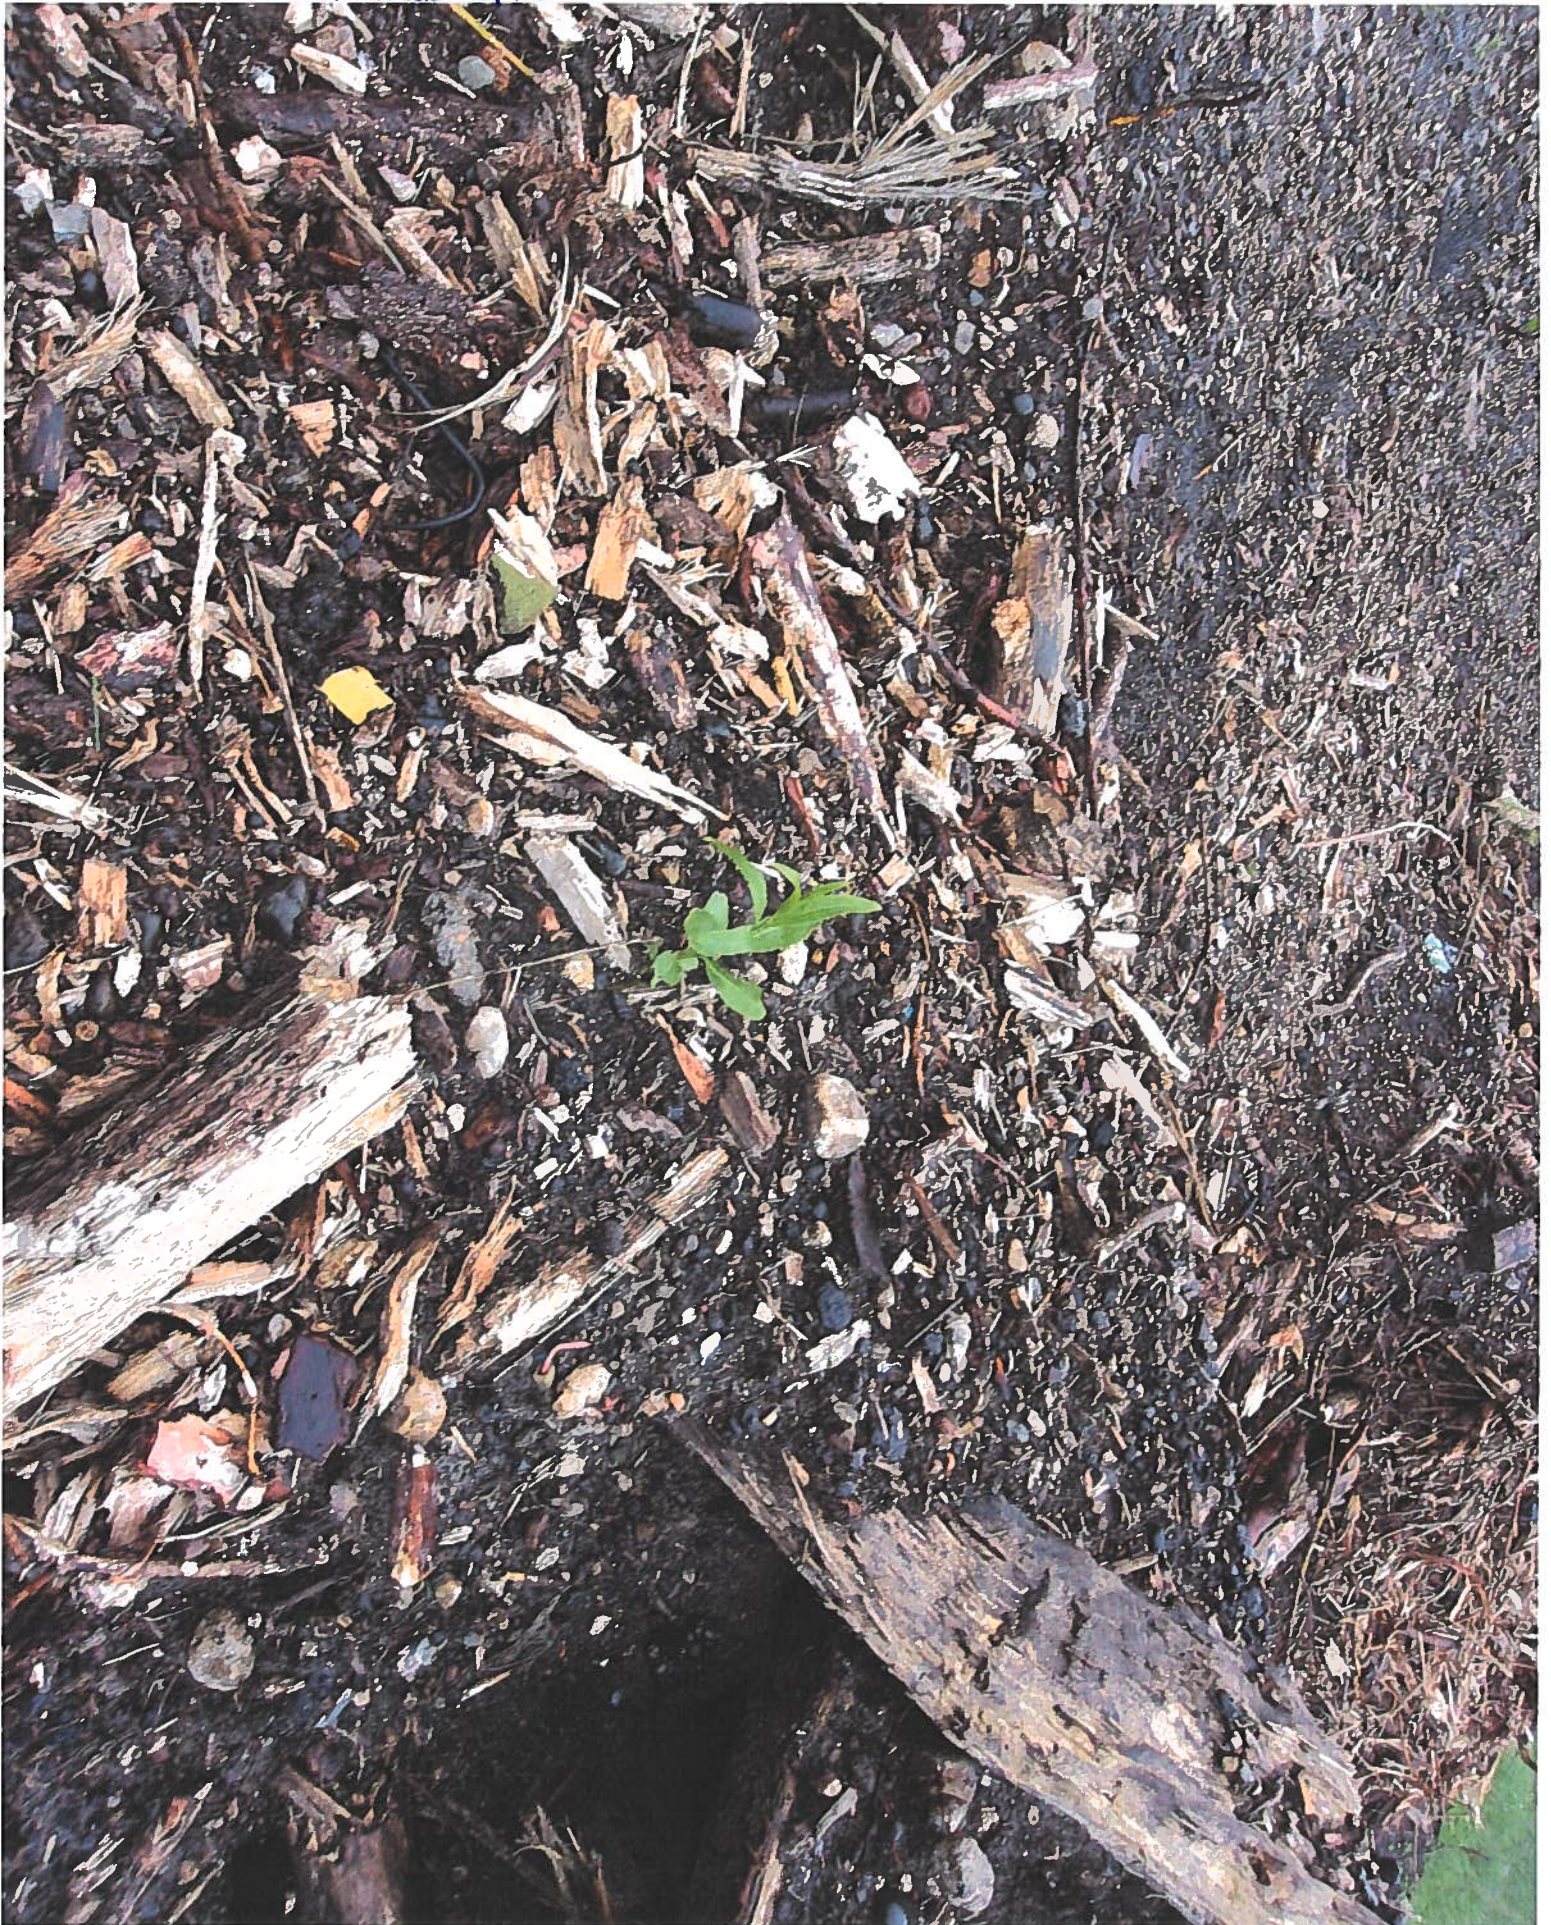
NEW AUSTREE SPROUT

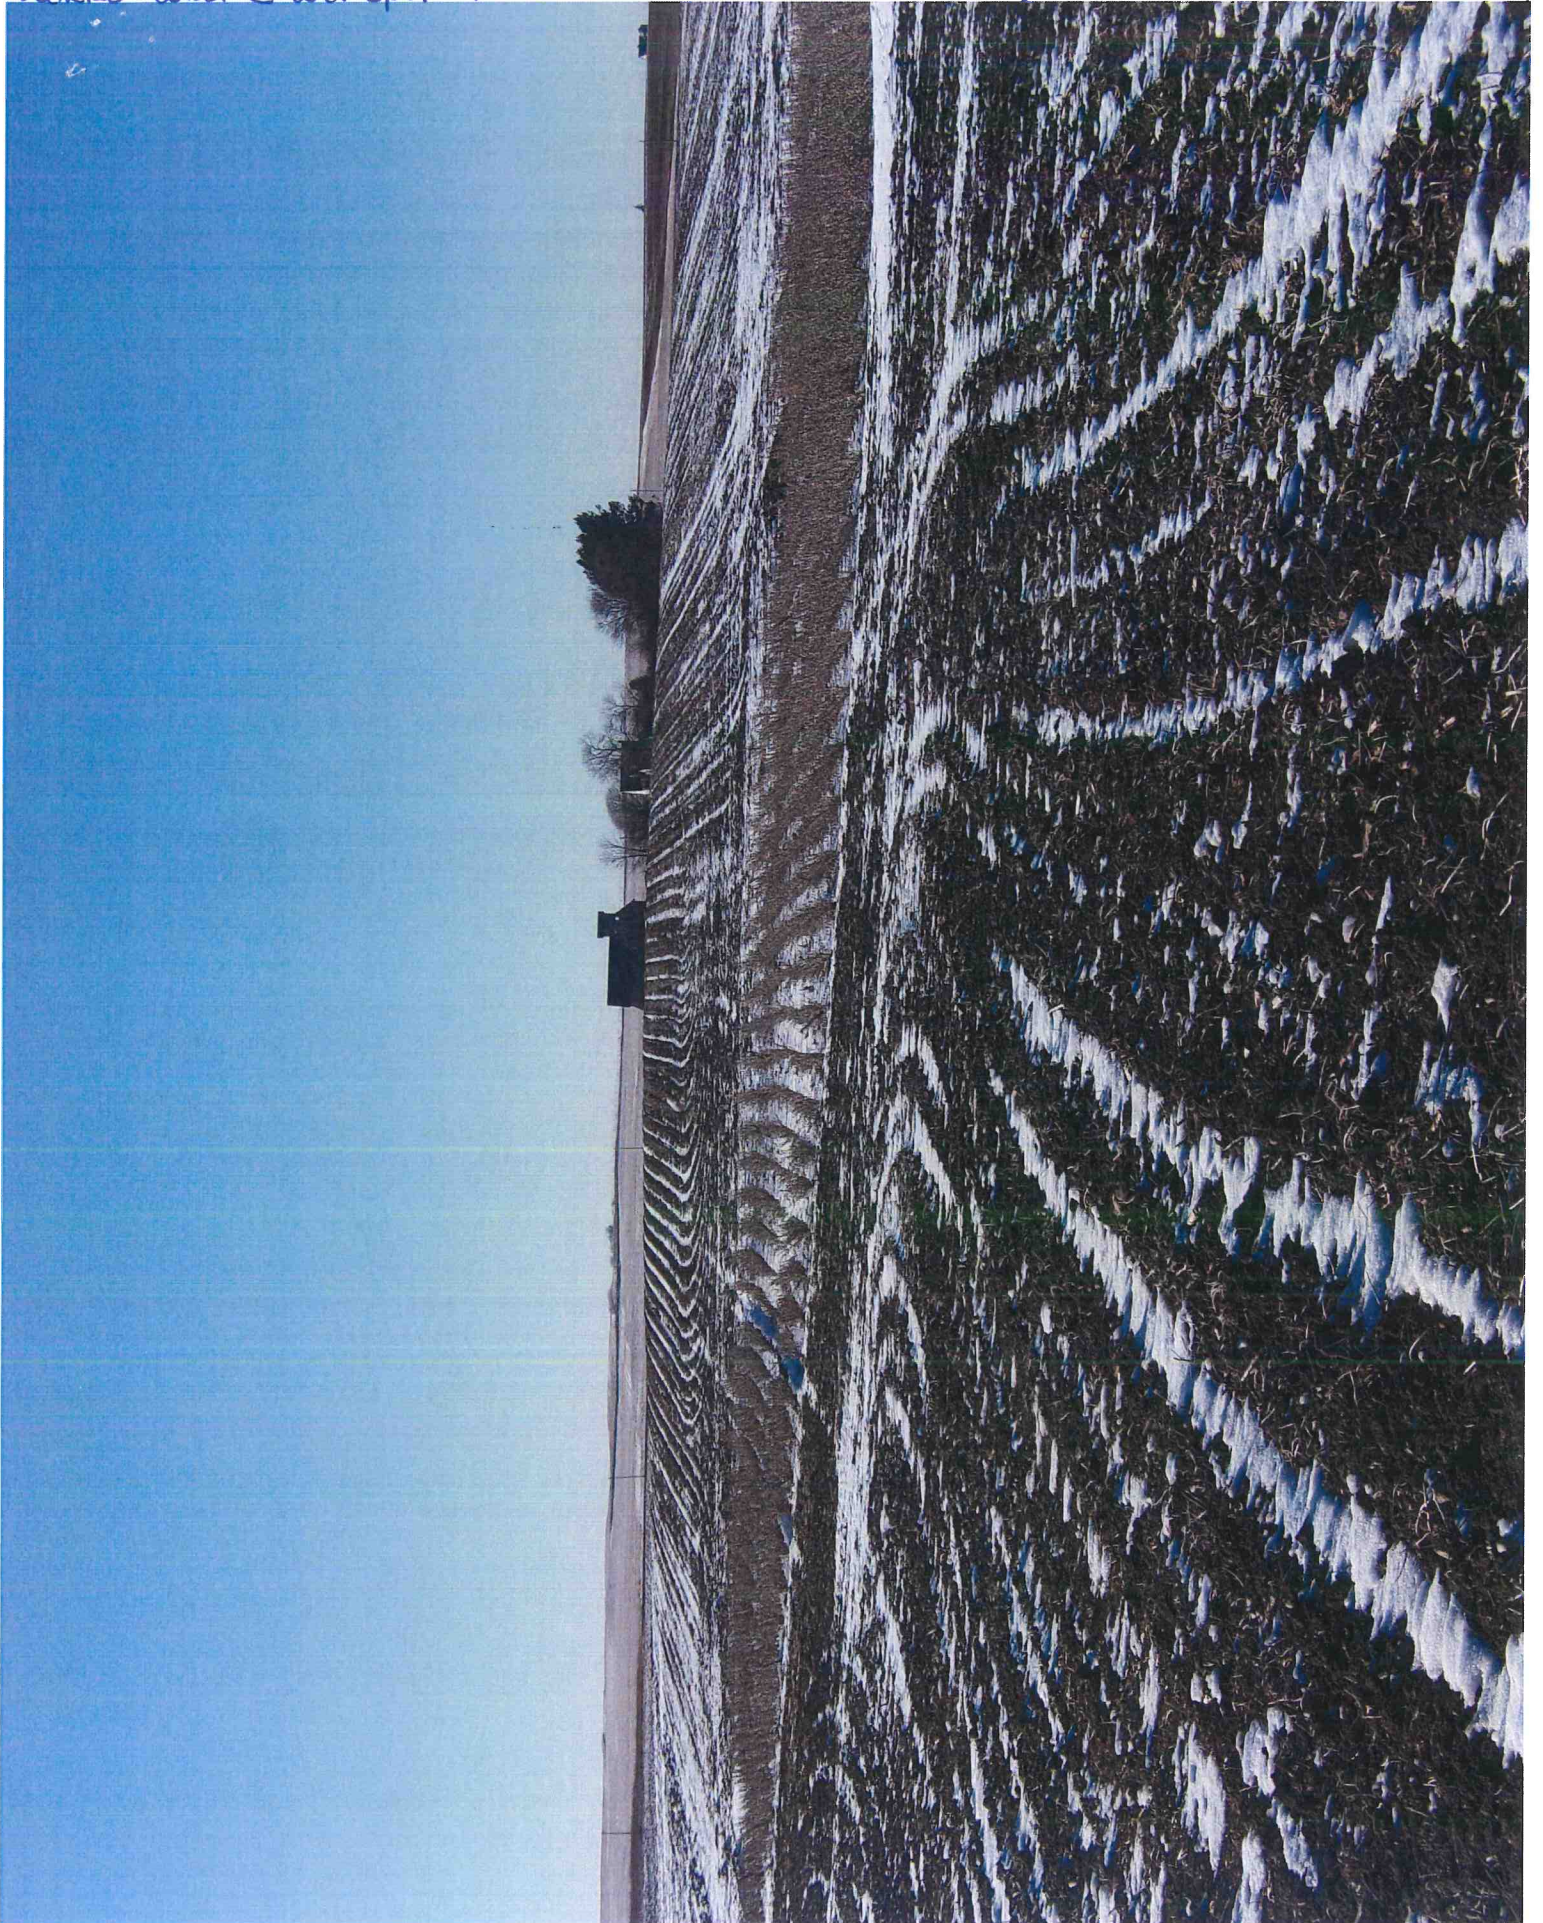
- CGA visually searched area and found a wet spot with standing beans that measured approximately 0.3 acres. The location is just west of the Supplemental Lateral 4 tile that was installed, as shown on the attached map.

- On-site visual inspection, reviewing historical aerials, and reviewing as-built information was unable to determine the cause for the wet spot; however, confirmed its presence.

LOOKING WEST @ WET SPOT (ACREAGE IN BACKGROUND ON "C" AVE)

We recommend sharing these findings with the landowner / tenant and asking if they have any knowledge of a private tile in this area. If they do, we recommend that the private tile be connected to the Supplemental Lateral 4 tile.
