AGENDA
REGULAR DRAINAGE MEETING
Wednesday, April 29, 2020 9:30 AM
Large Conference Room

Project Description: Main Tile Repairs to Drainage District 22 Facilities
Hardin County, Iowa
Project Nos. DD-6532.2 and 8712

Hardin County Work Order: WO00000276

Investigation Summary:

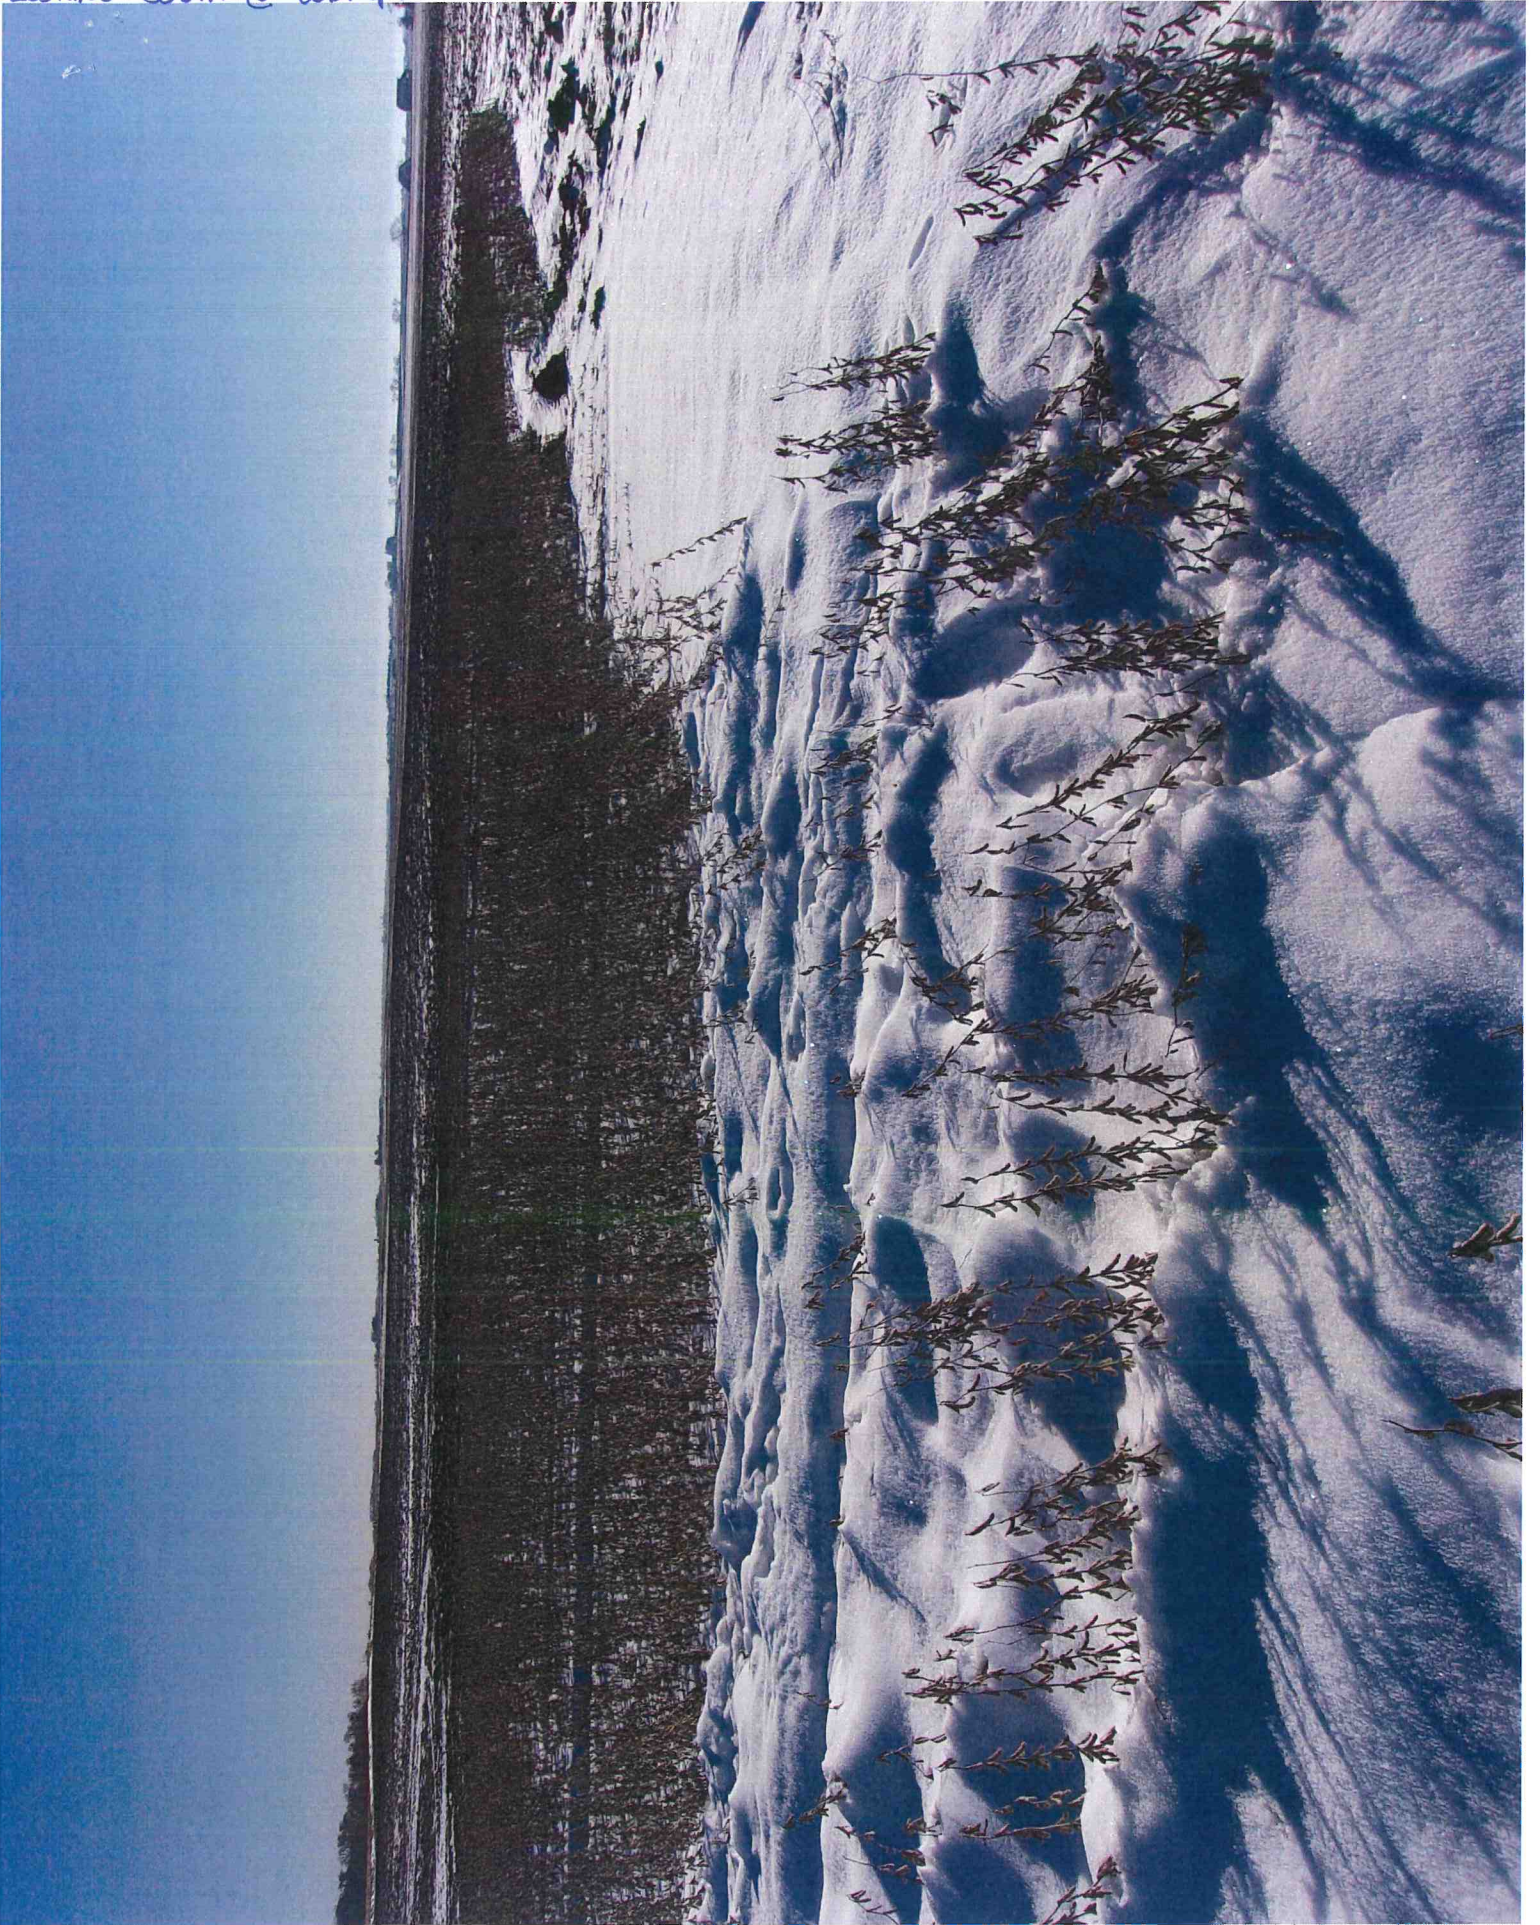
LOOKING SOUTH @ WET SPOT

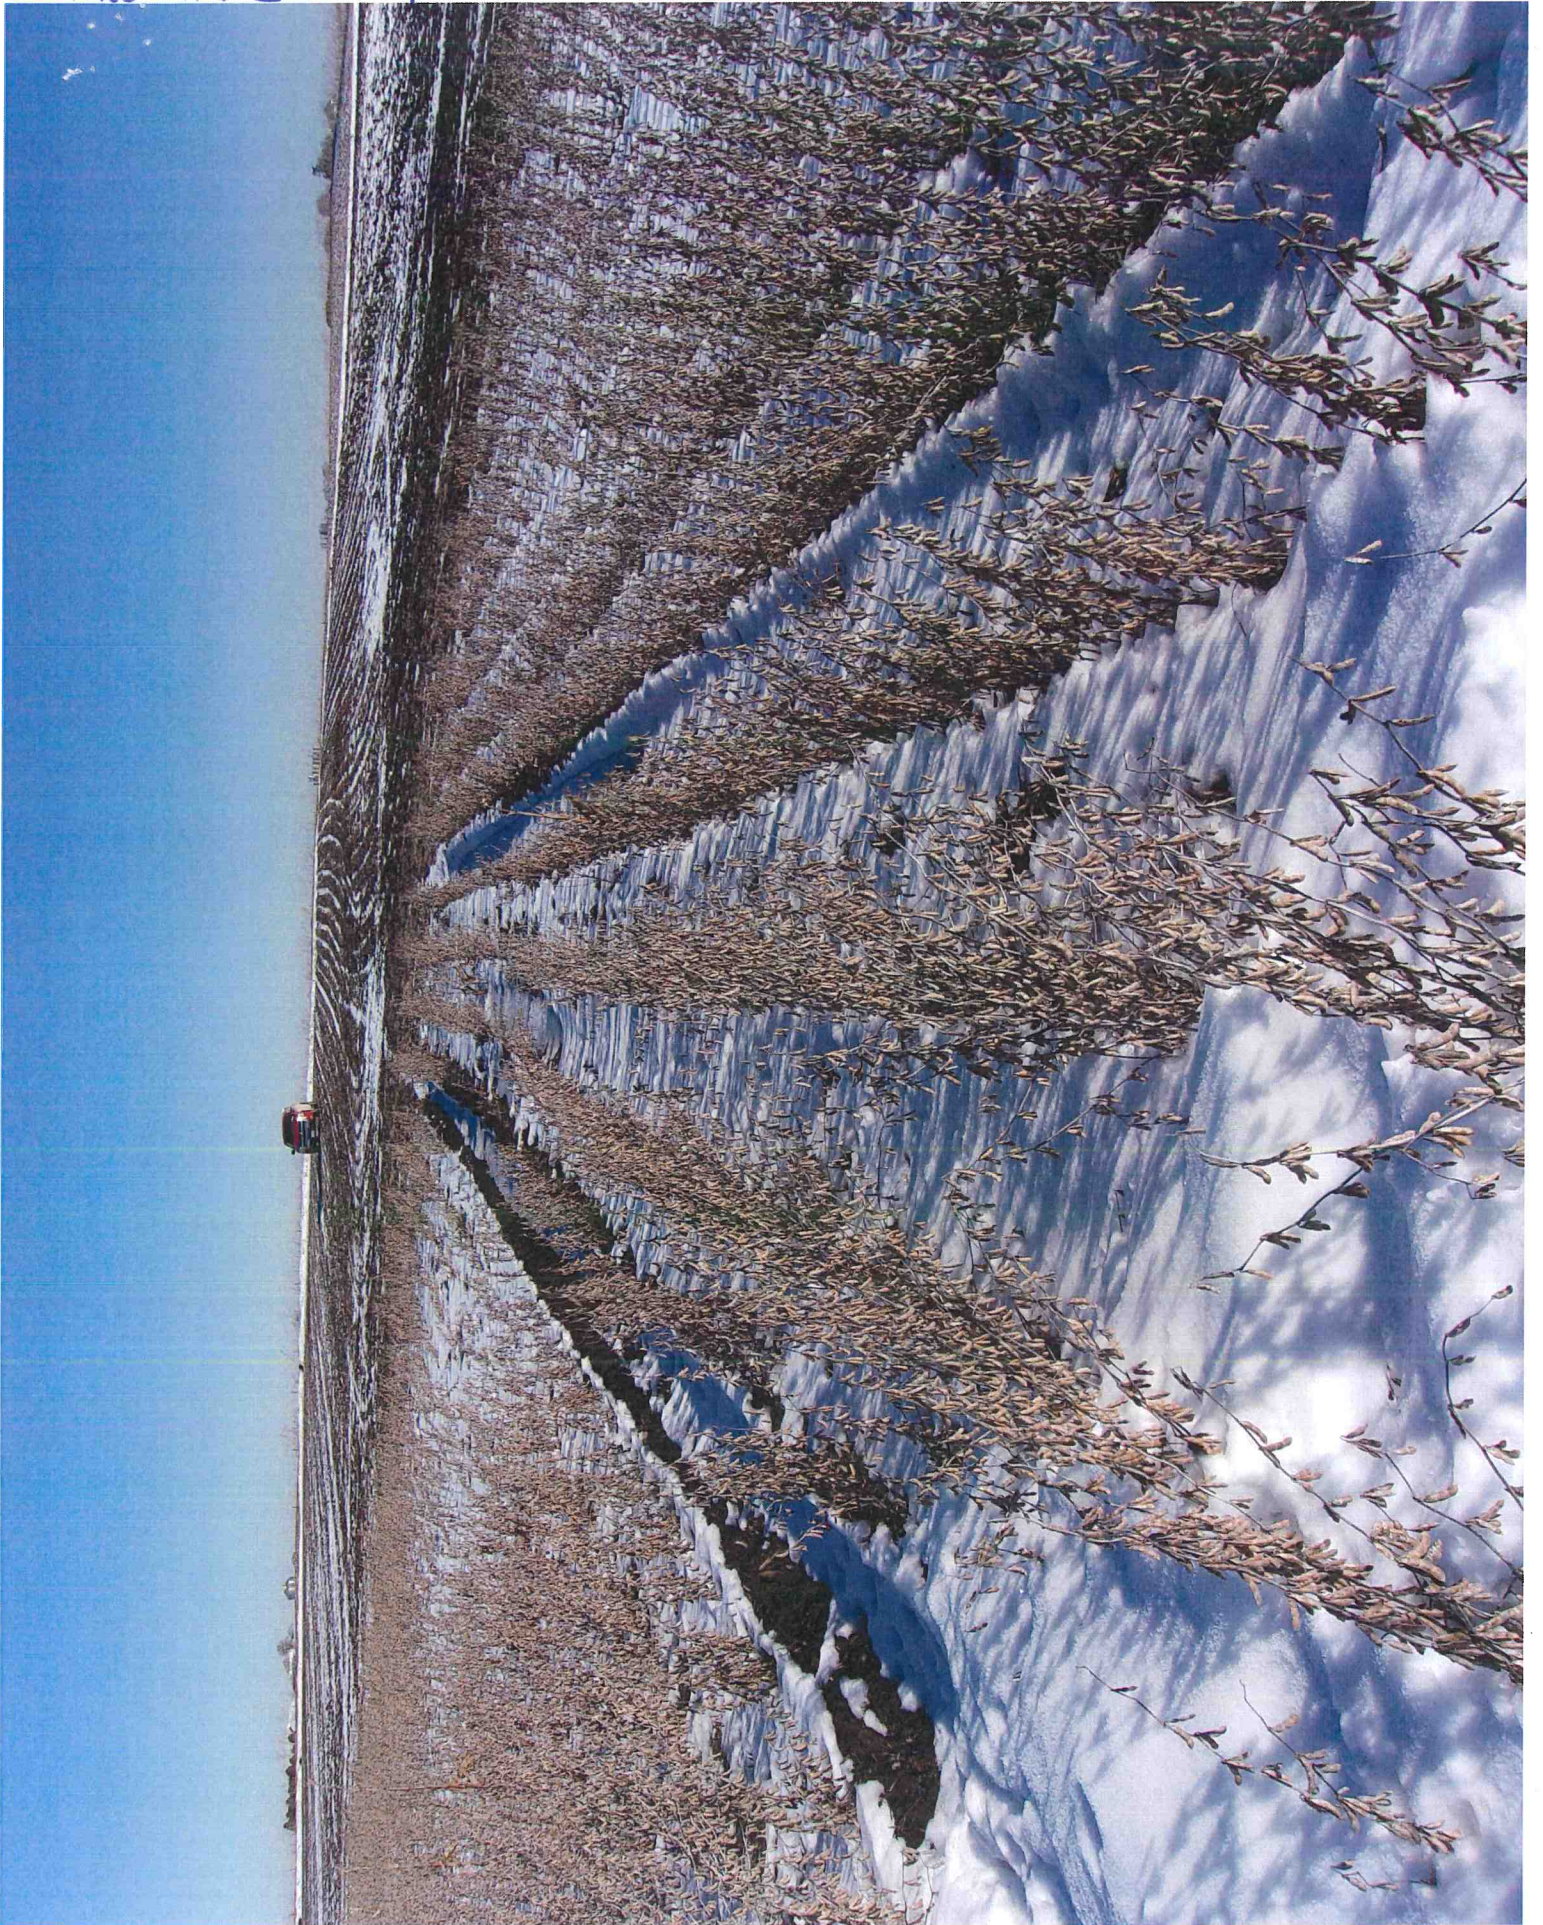
LOOKING EAST @ WET SPOT

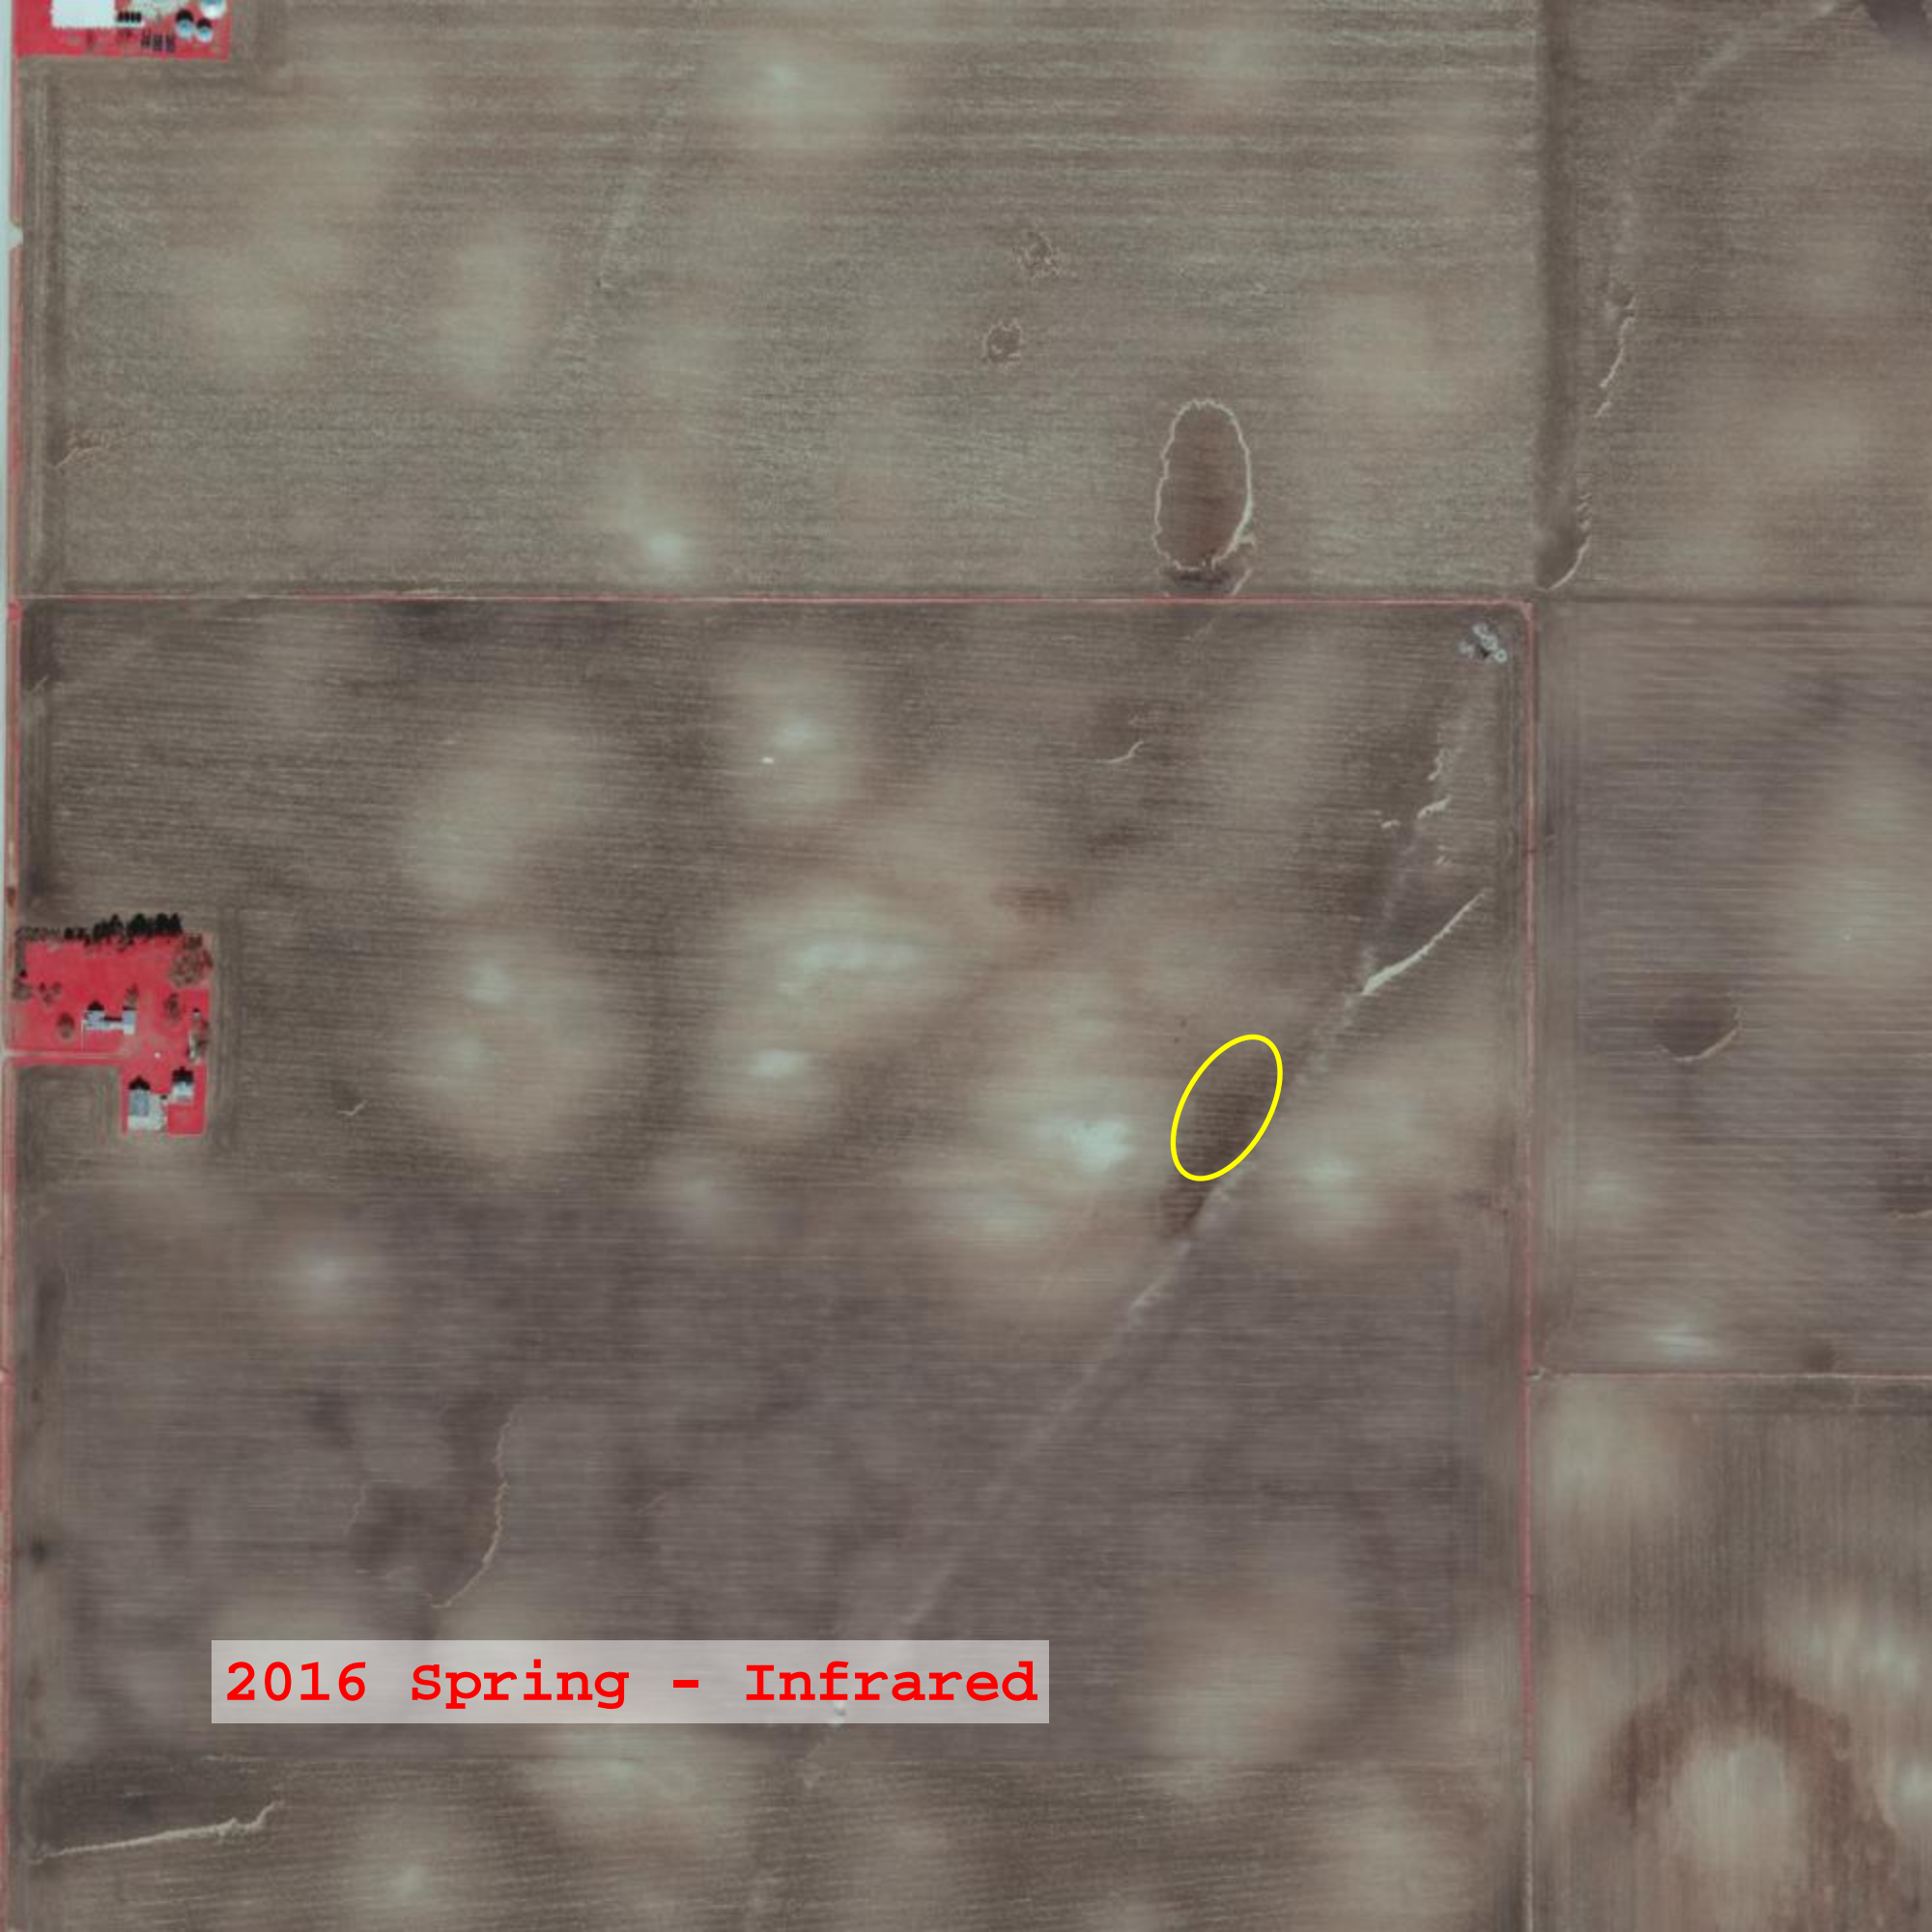
2016 Spring

- CGA reviewed historical photos of this area from 1971-2017 (attached) and noted that the wet spot first appeared on aerial photography in the spring of 2016. It also appeared in aerial photos from 2017 and was visually confirmed in the field in 2018. No observable wet spots were there in prior years including the reviewed 2013, 2014, and 2015 aerials.
