AGENDA
REGULAR DRAINAGE MEETING
Wednesday, August 19, 2020 9:30 AM
Large Conference Room

[DD 48 WO 237 - 6486.4 - REPAIR SUMMARY - 08_03_20.PDF](#)

[DD BIG 4 LAT 4 - WO 195 - 5585.1 - REPAIR SUMMARY - 08_03_2020.PDF](#)

[DD BIG 4 MAIN - WO 247 - 5734.1 - REPAIR SUMMARY - 08_03_2020.PDF](#)

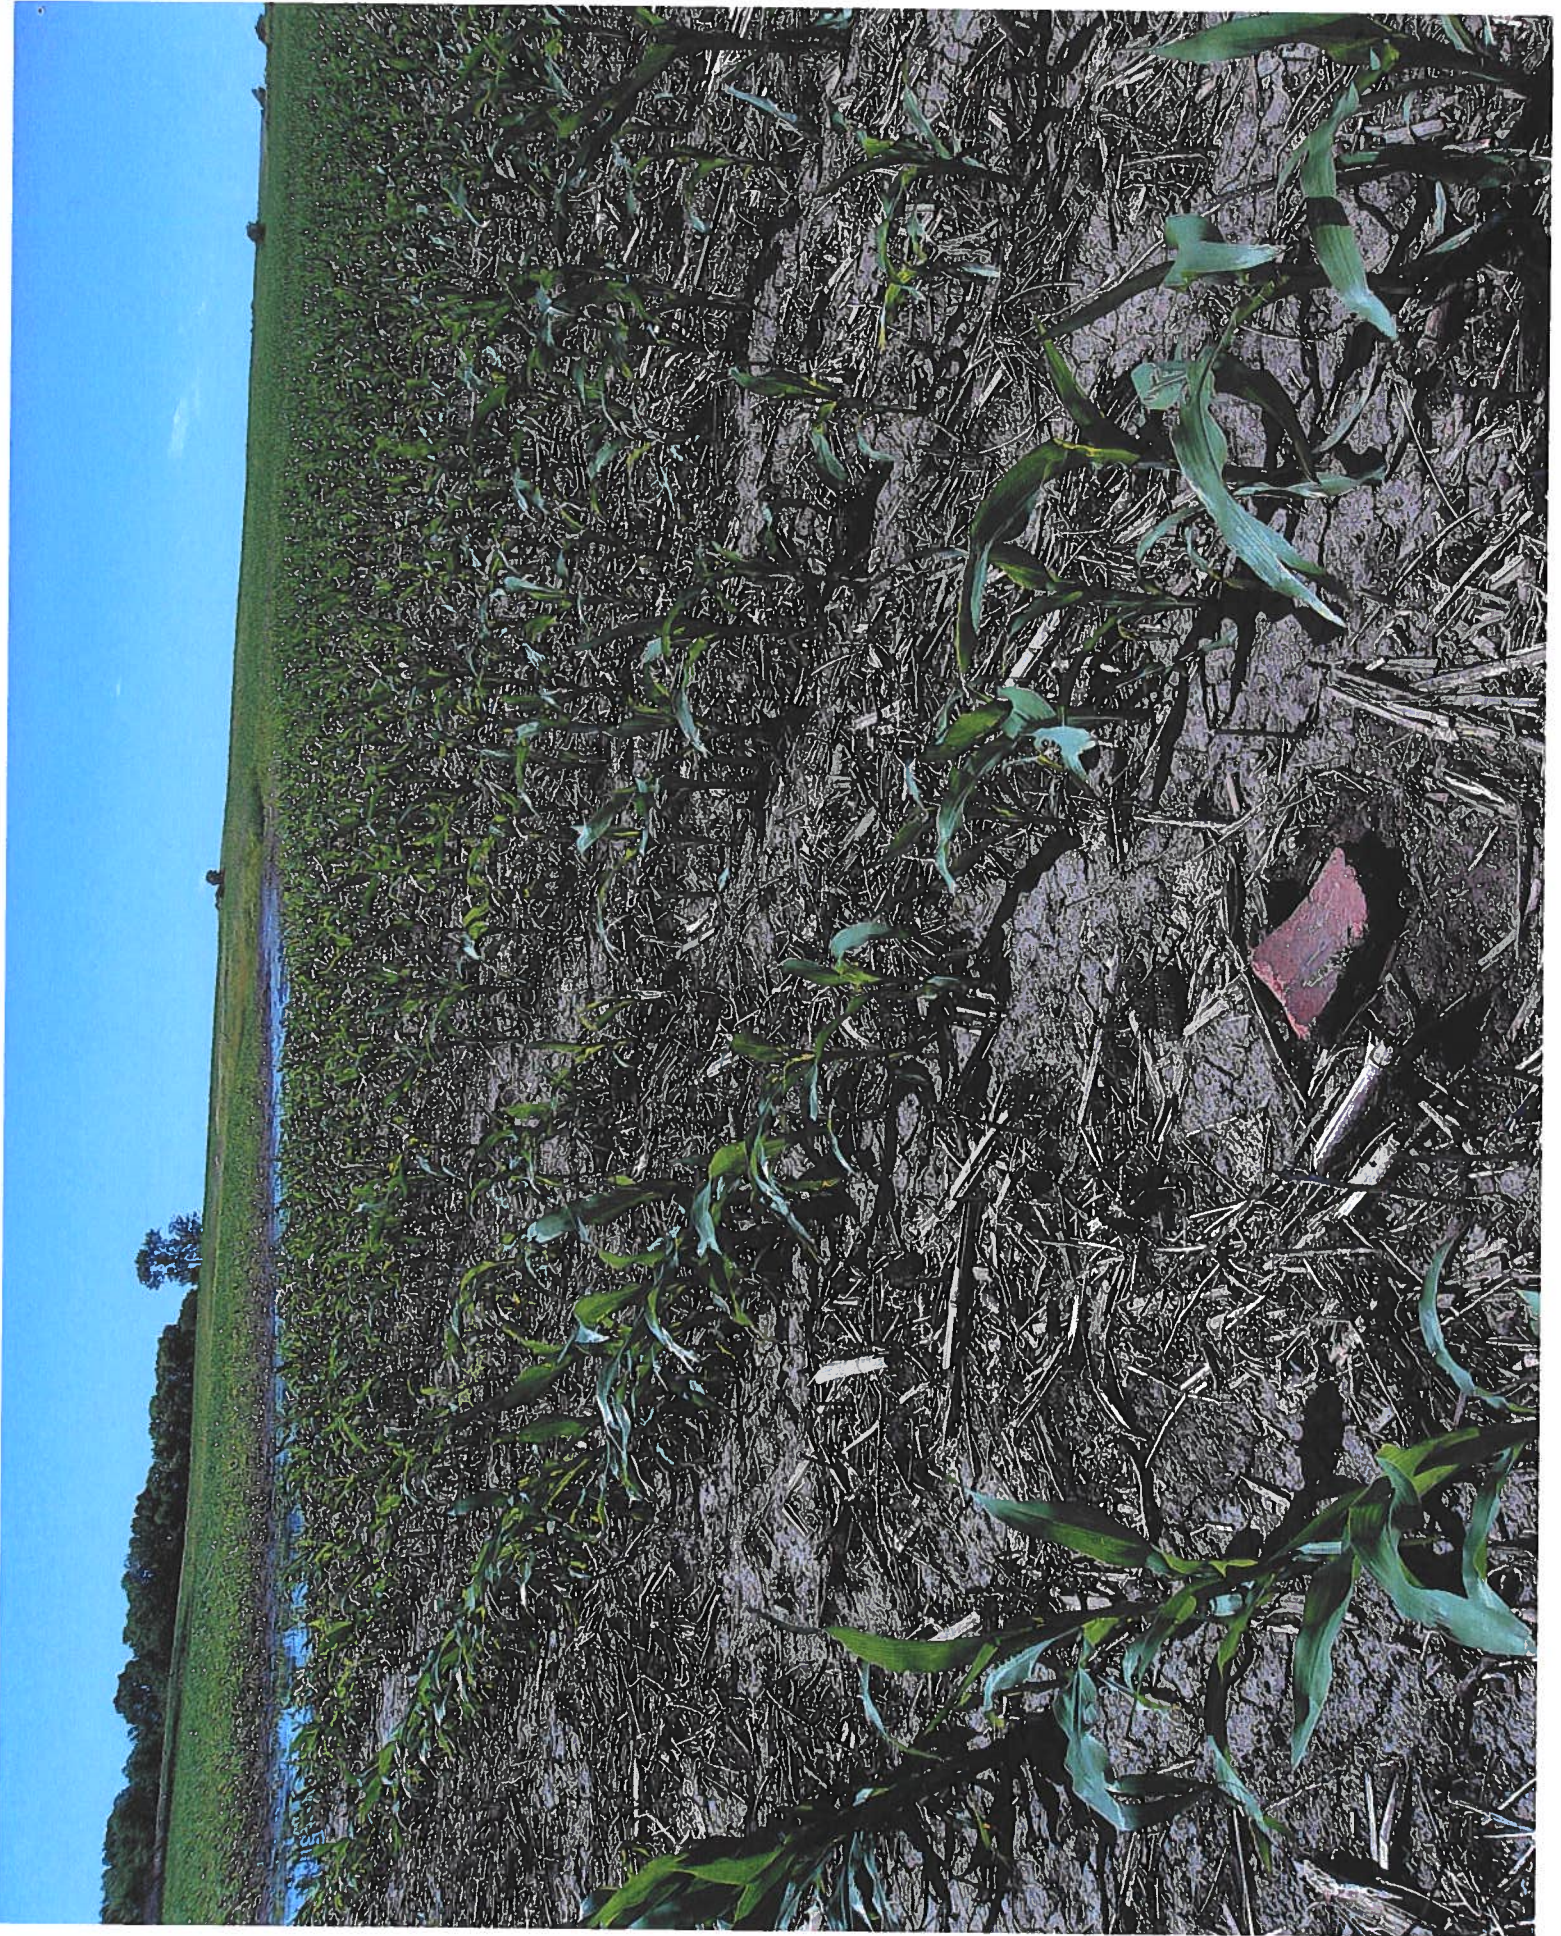
LOOKING NW ON TILE ROUTE

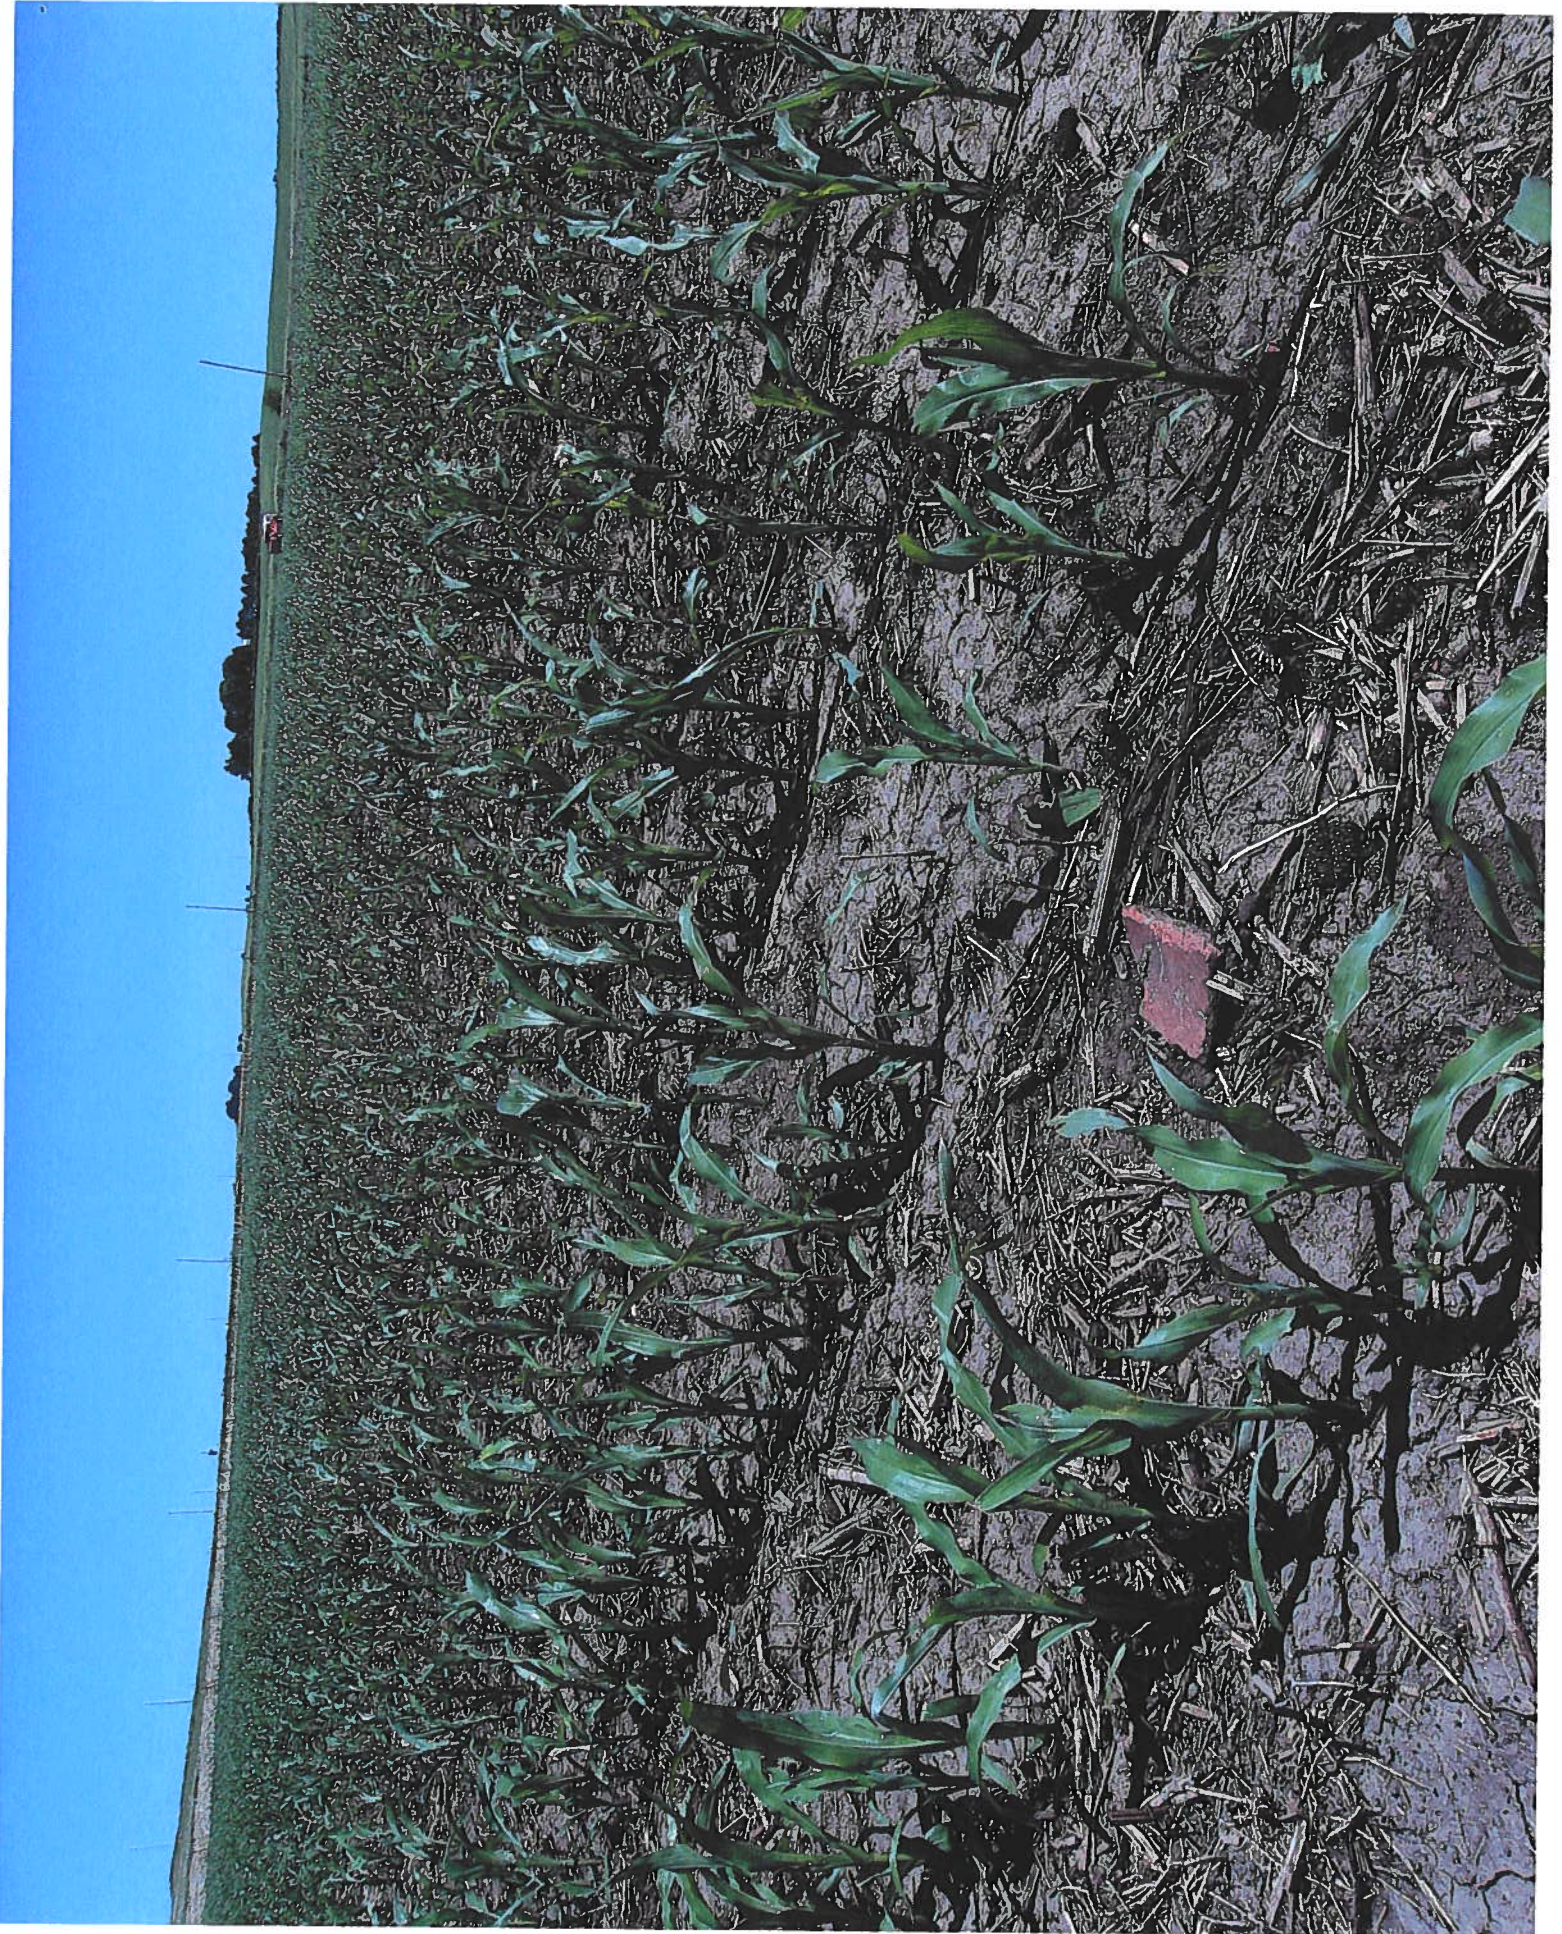
LOOKING SE FROM TIRE CHAIRS ON MAIN ROUTE

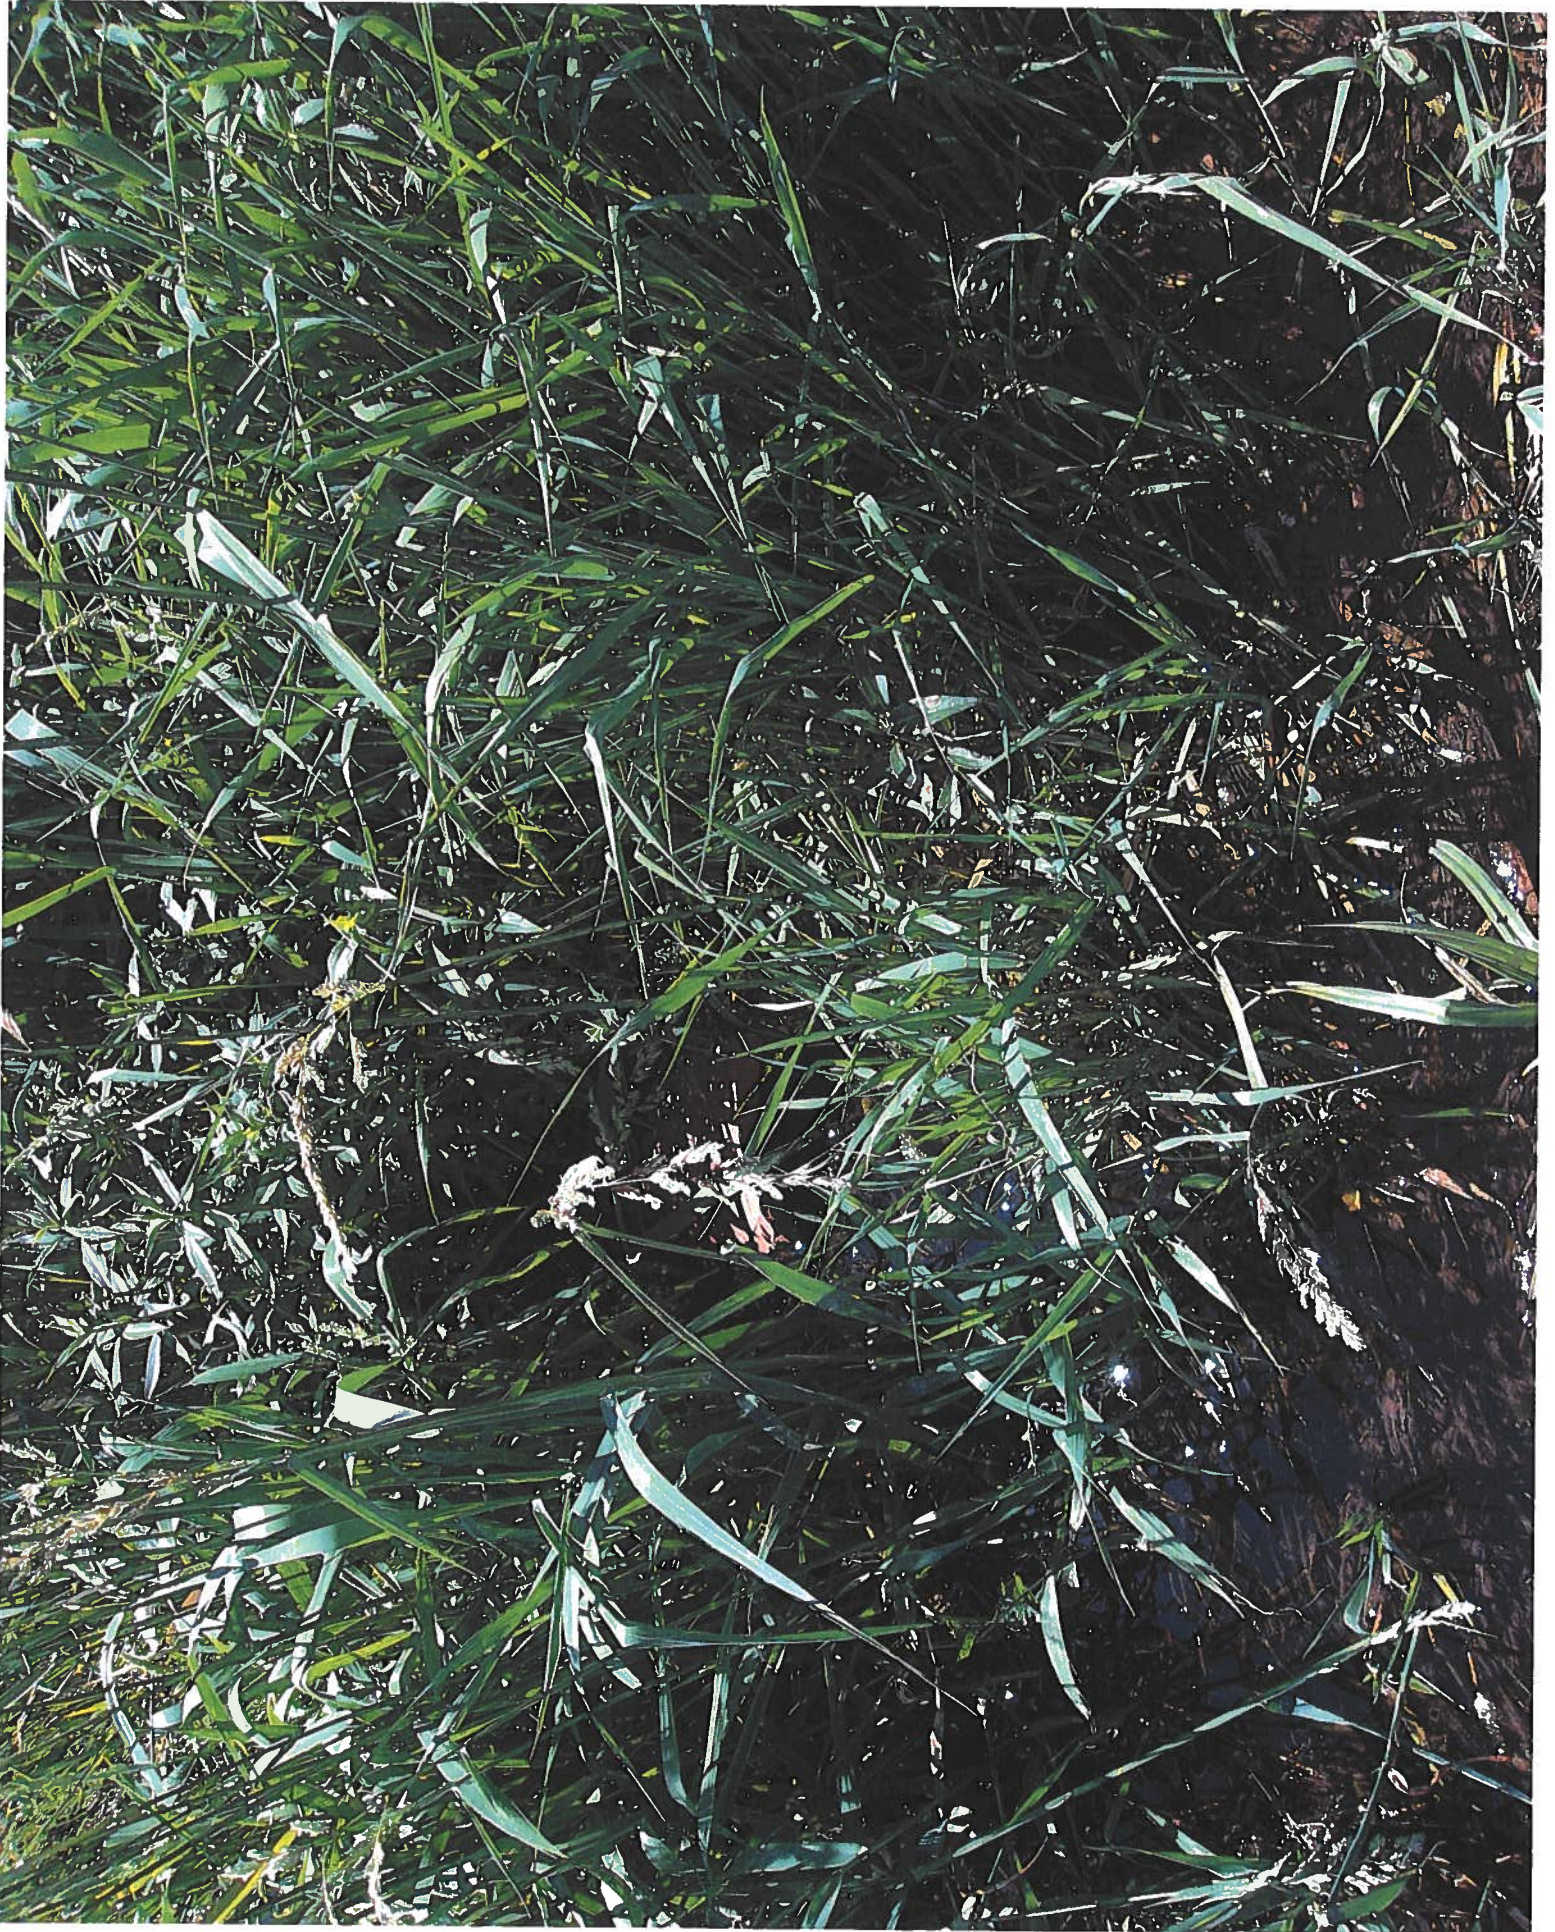
Exposed TILE CHARDS @ SE COR. OF GRASS SWALE

Due to the lack of soil cover over the tile, broken pieces of tile found in the field, and recently cut trees, CGA recommends locating and CCTV inspecting the tile in both directions from the blowout/sinkhole as the observed issue may be due to a larger-scale deterioration of the Main tile's physical condition.

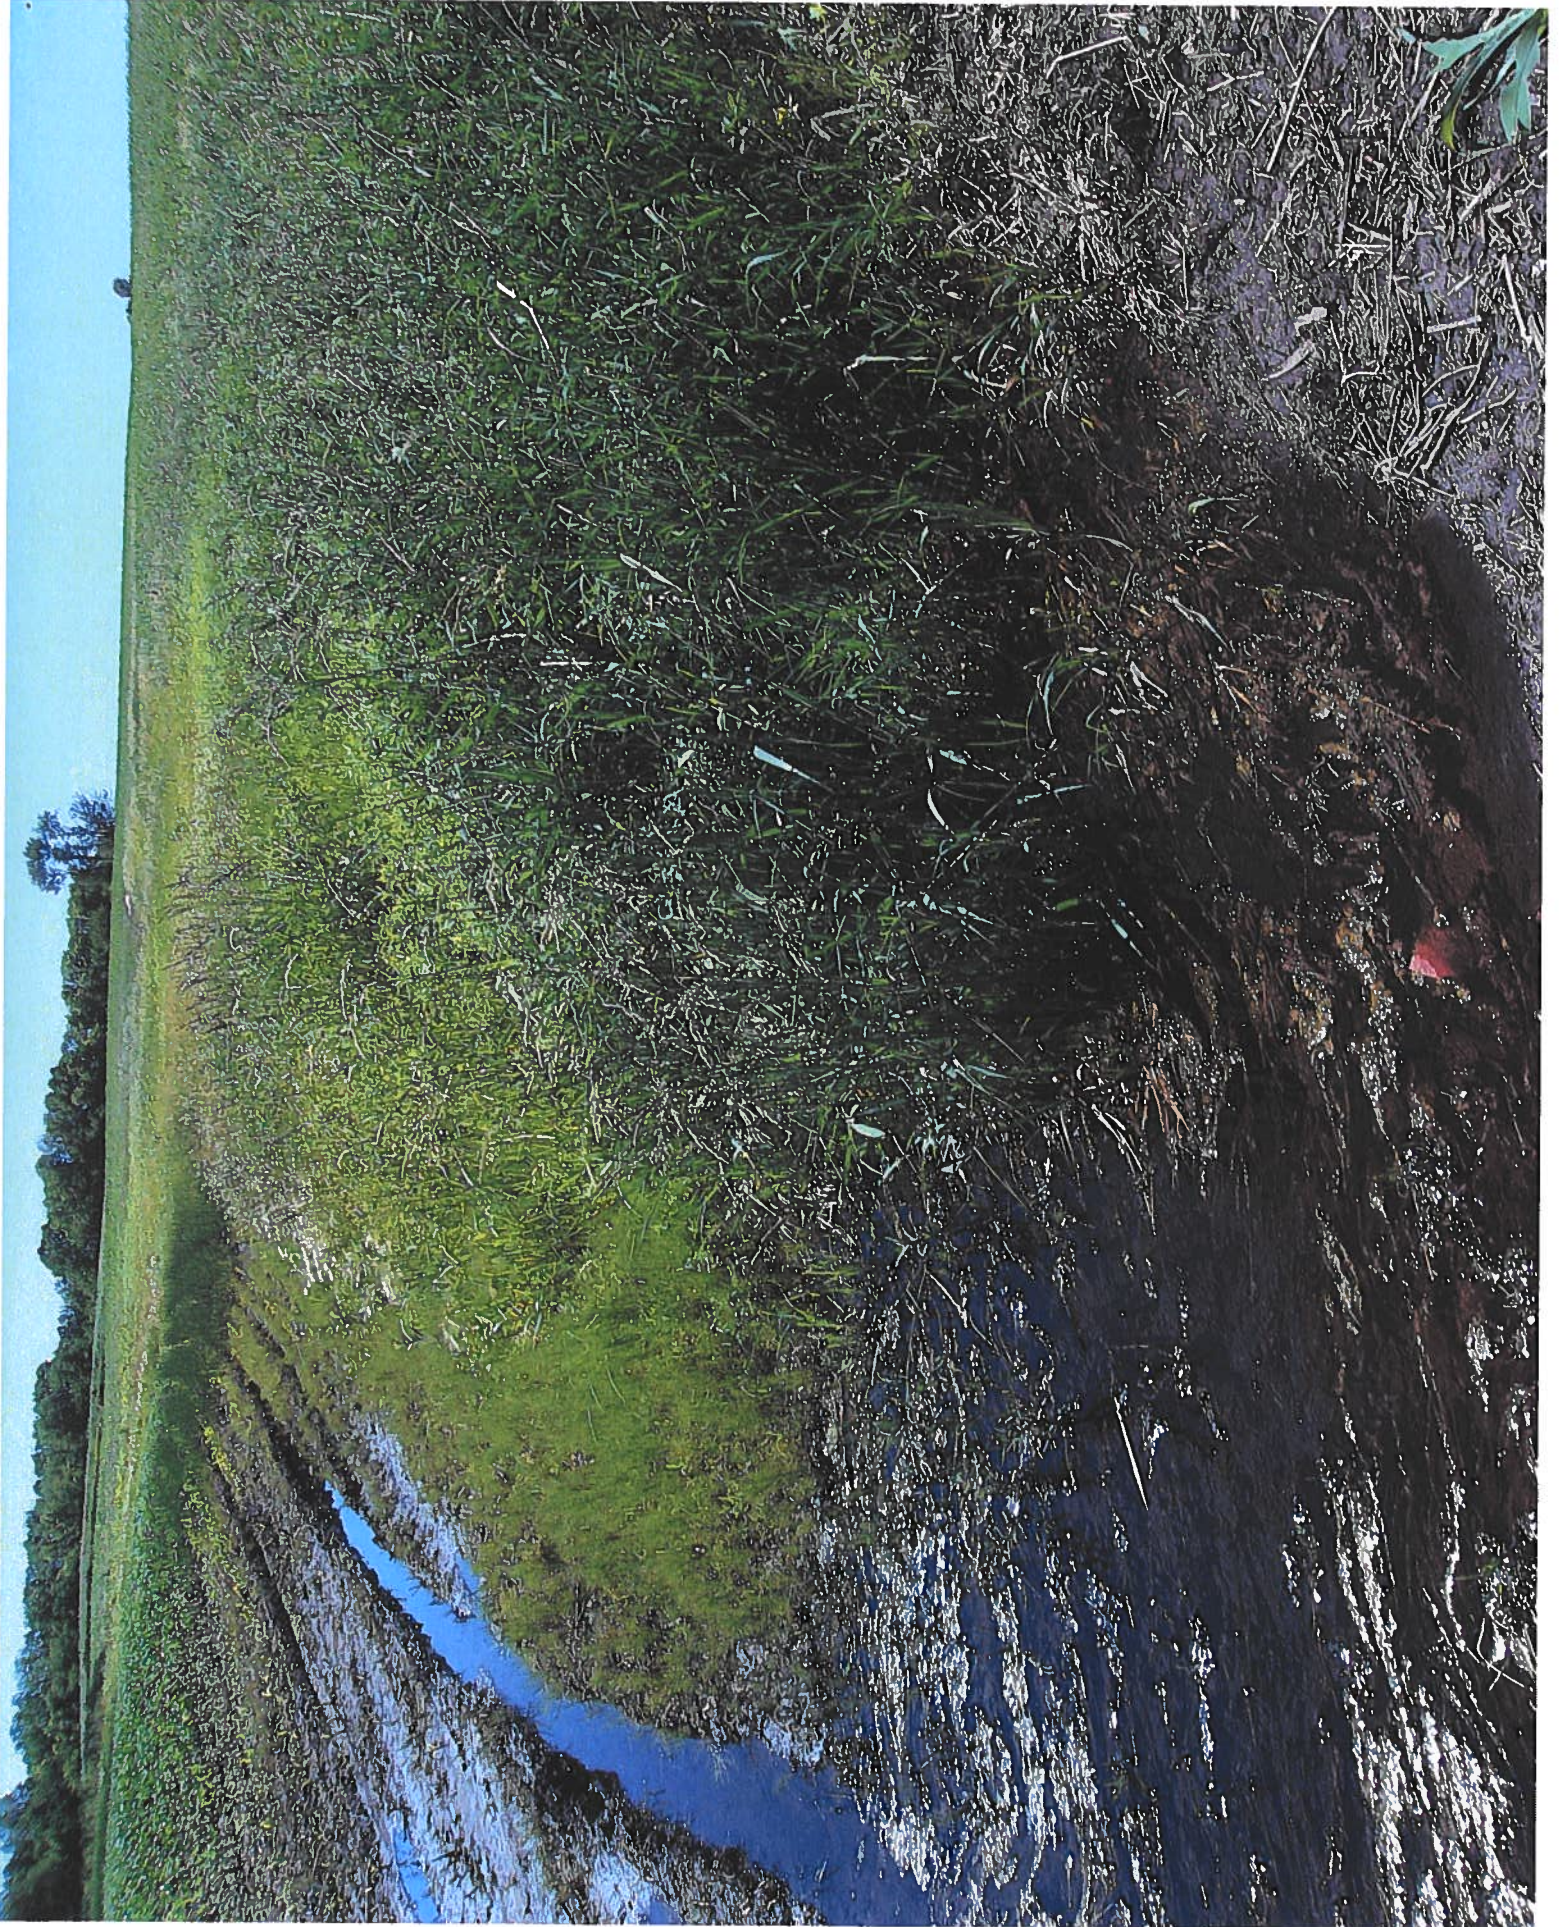
START OF GRASS SWALE

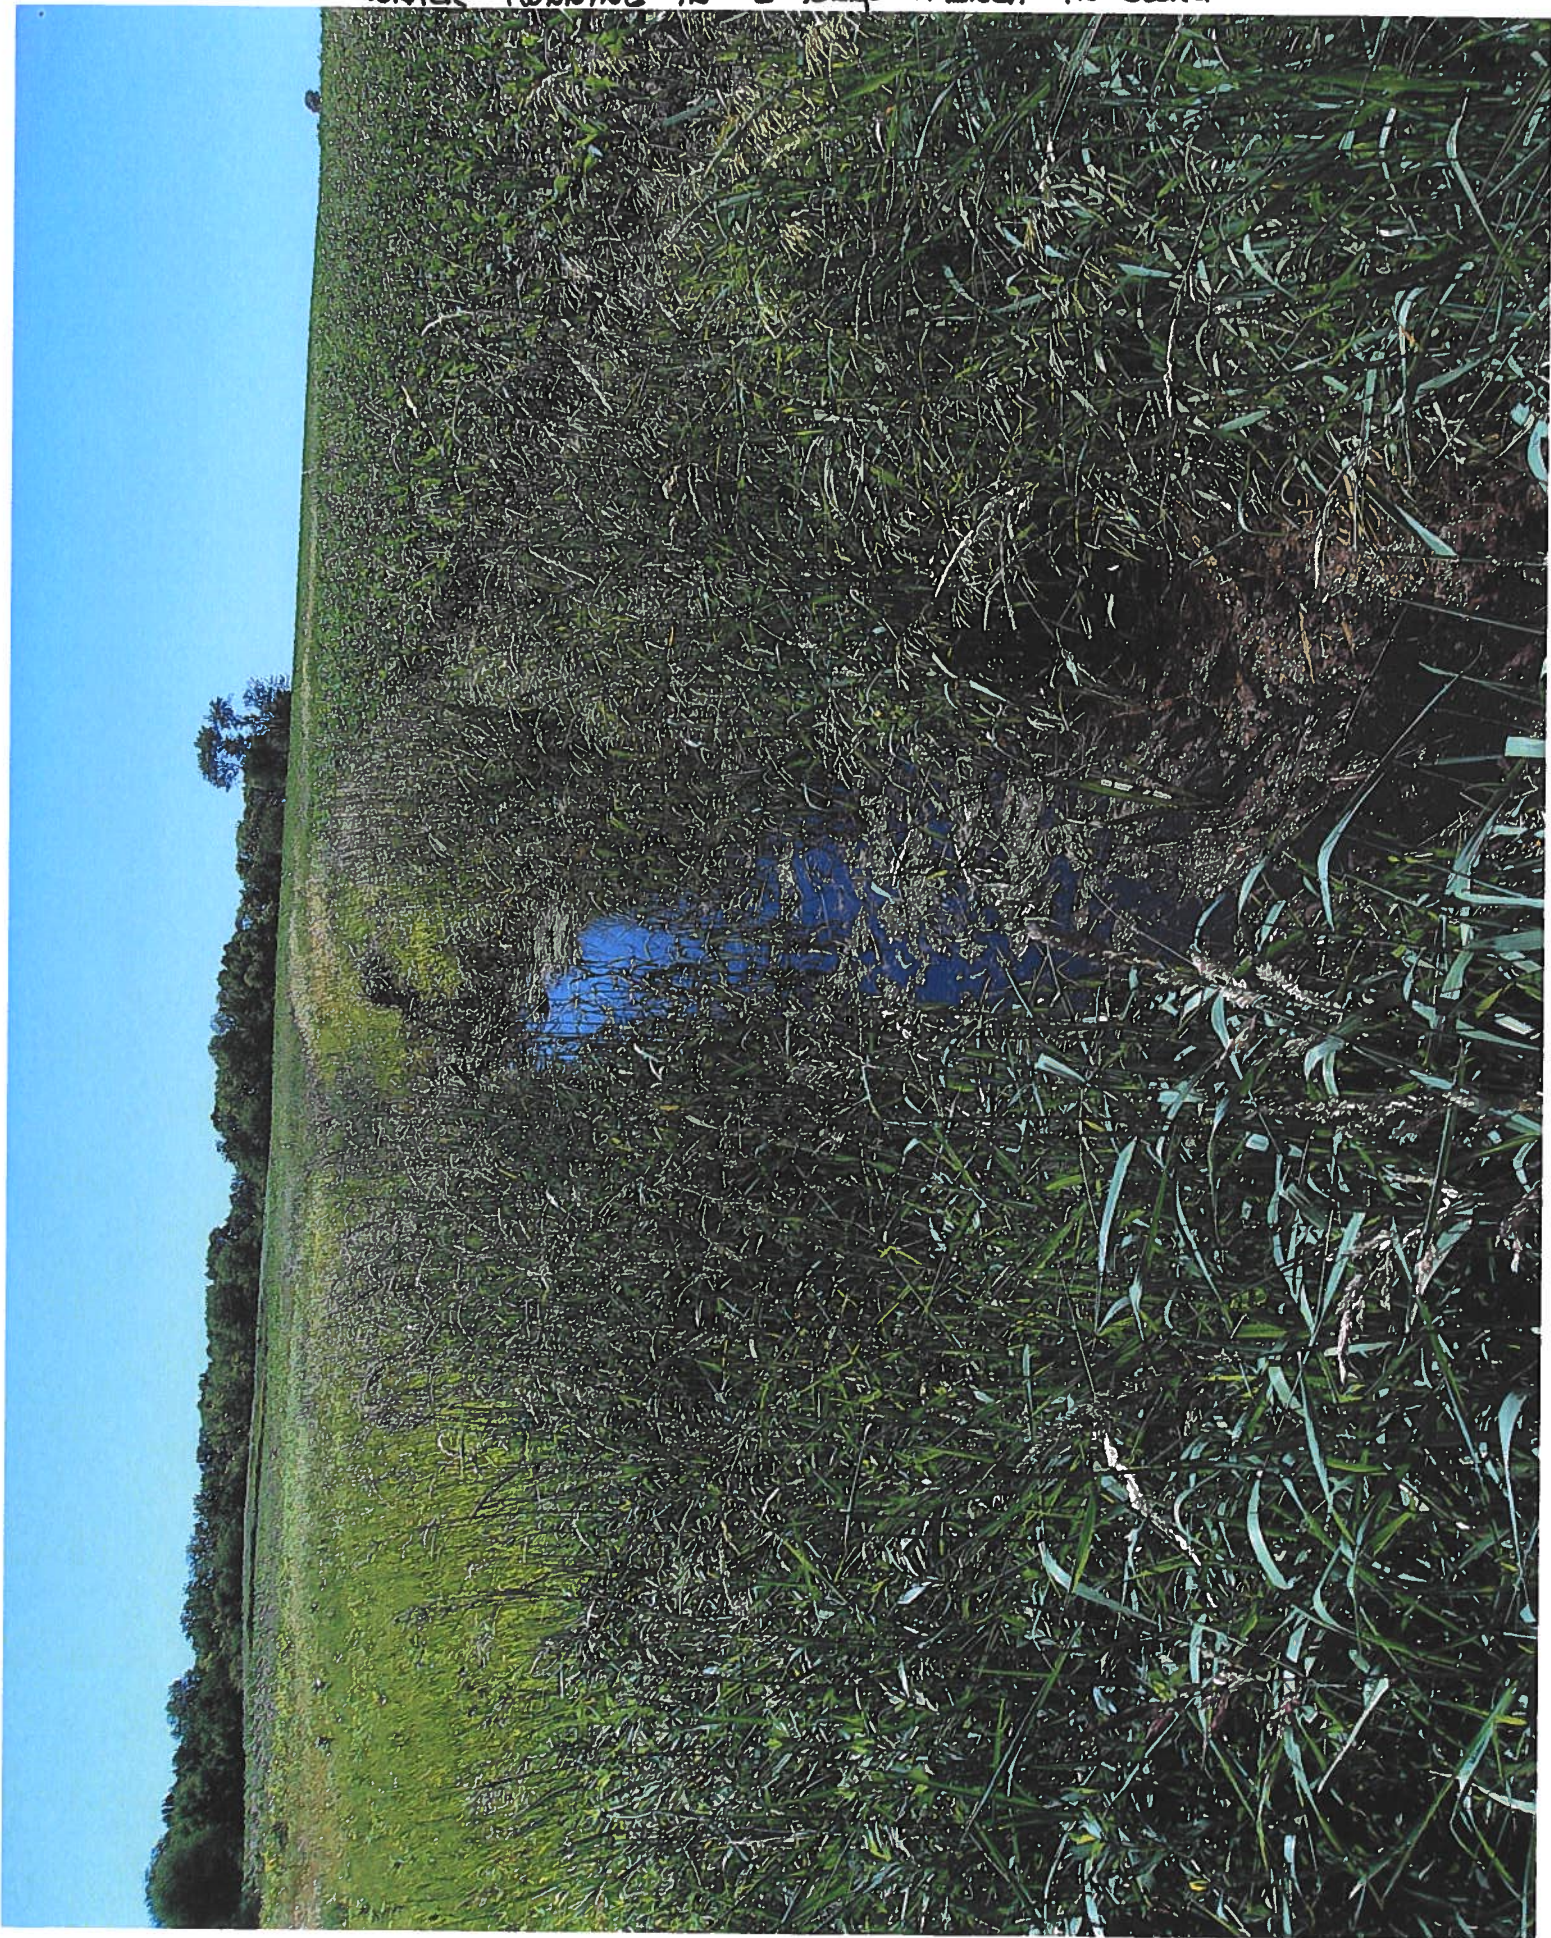
WATER RUNNING IN 2' DEEP TRENCH IN SWALE

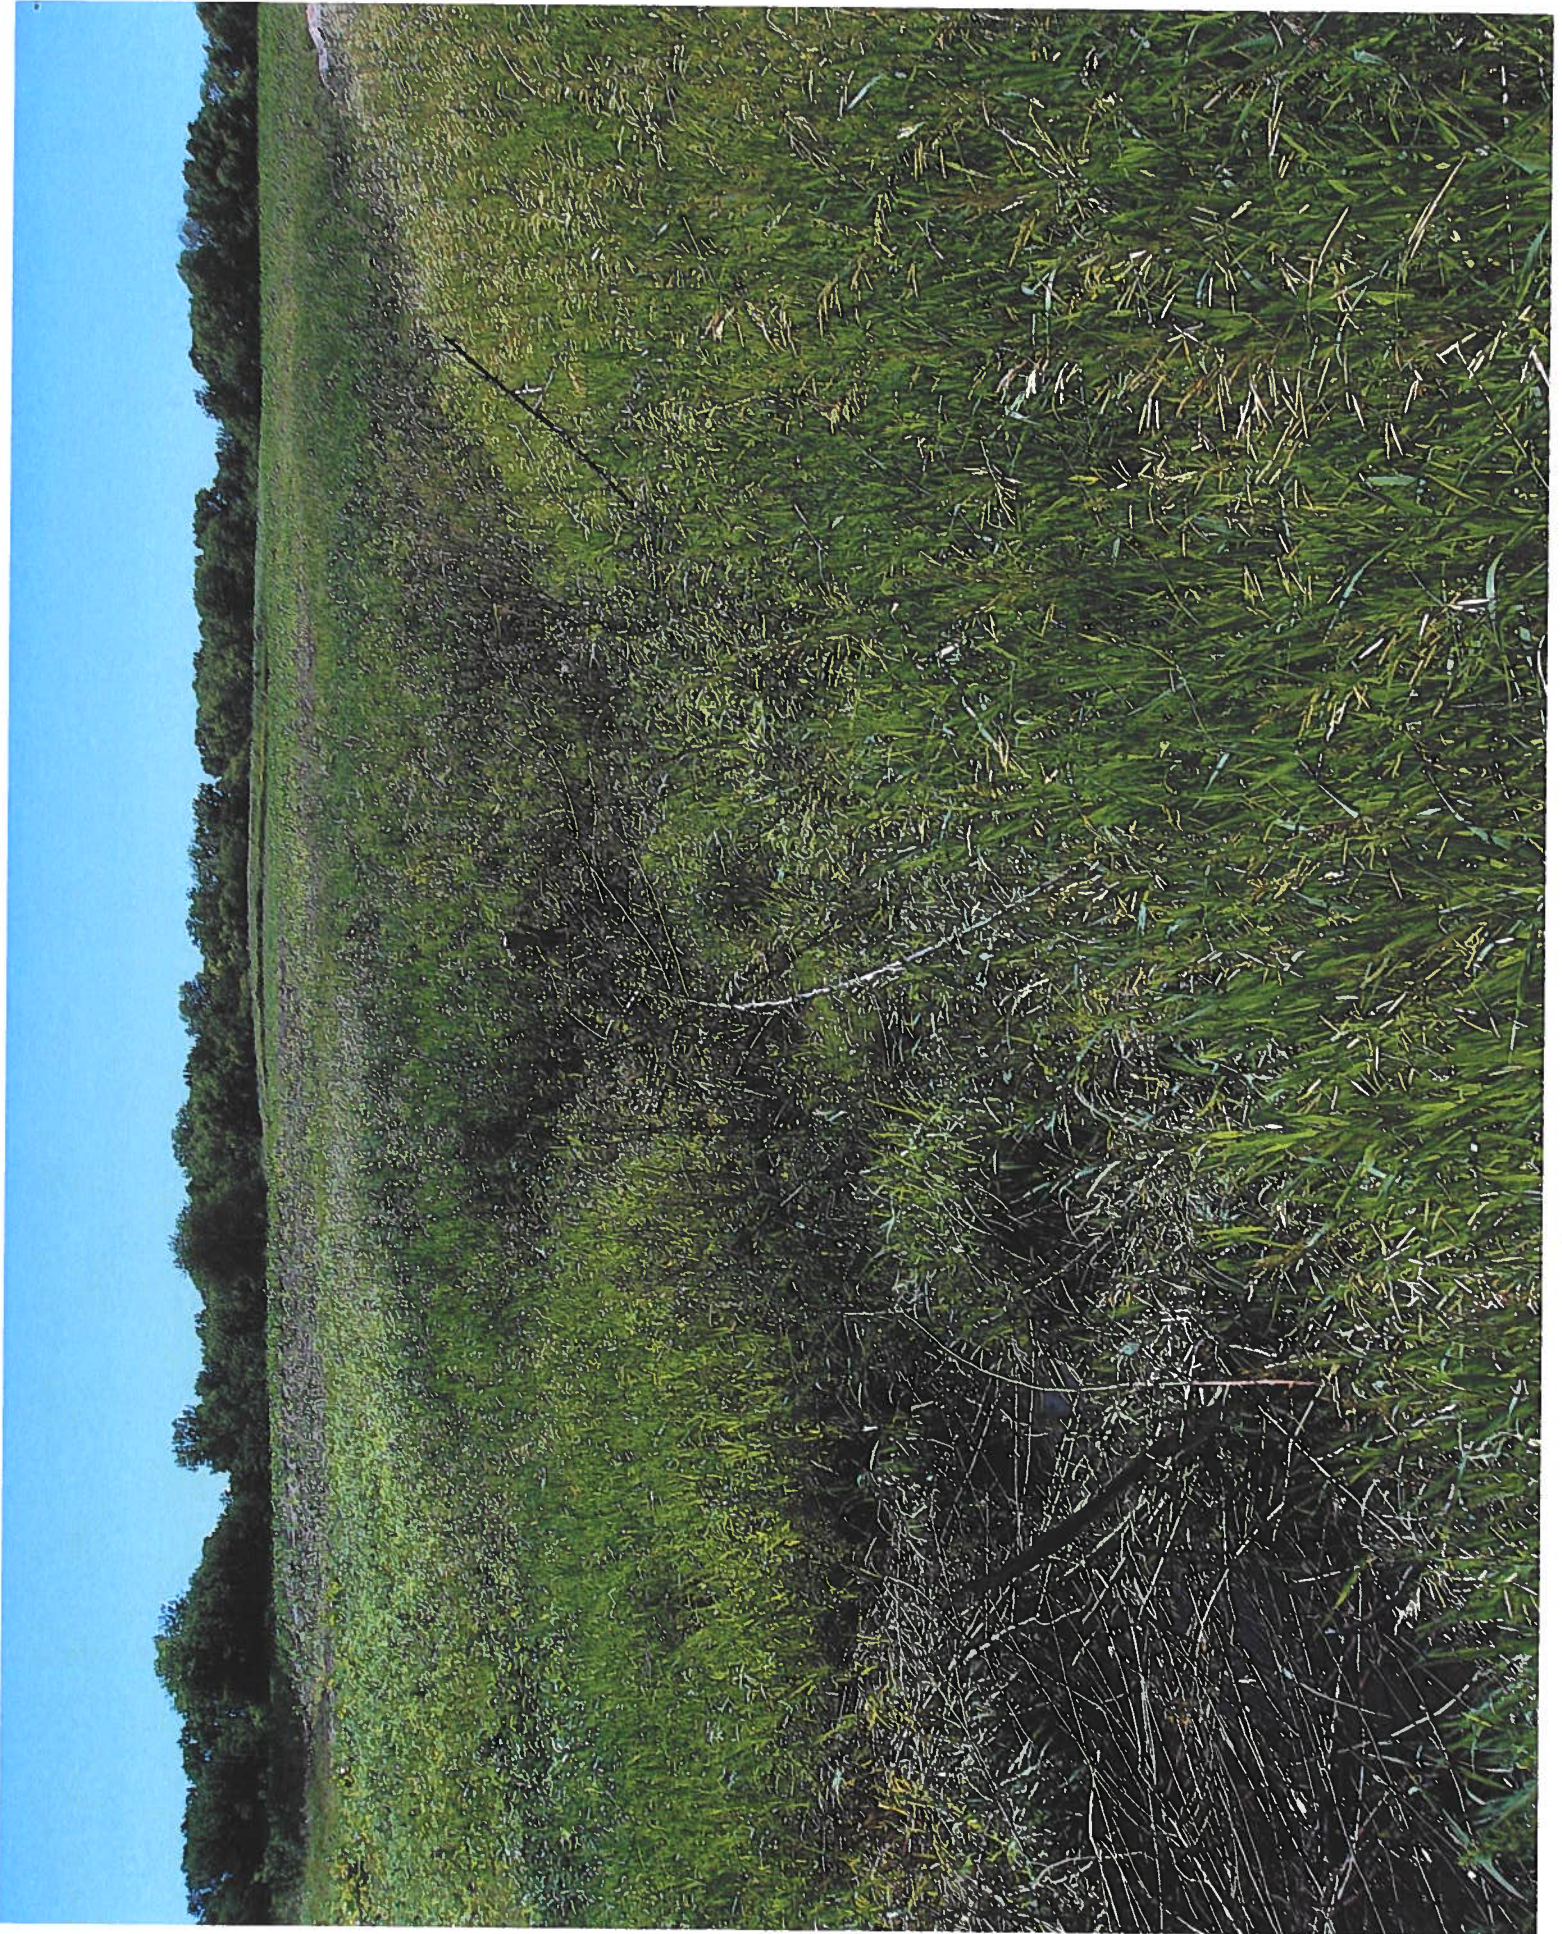
TREES CUT DOWN LAST YEAR

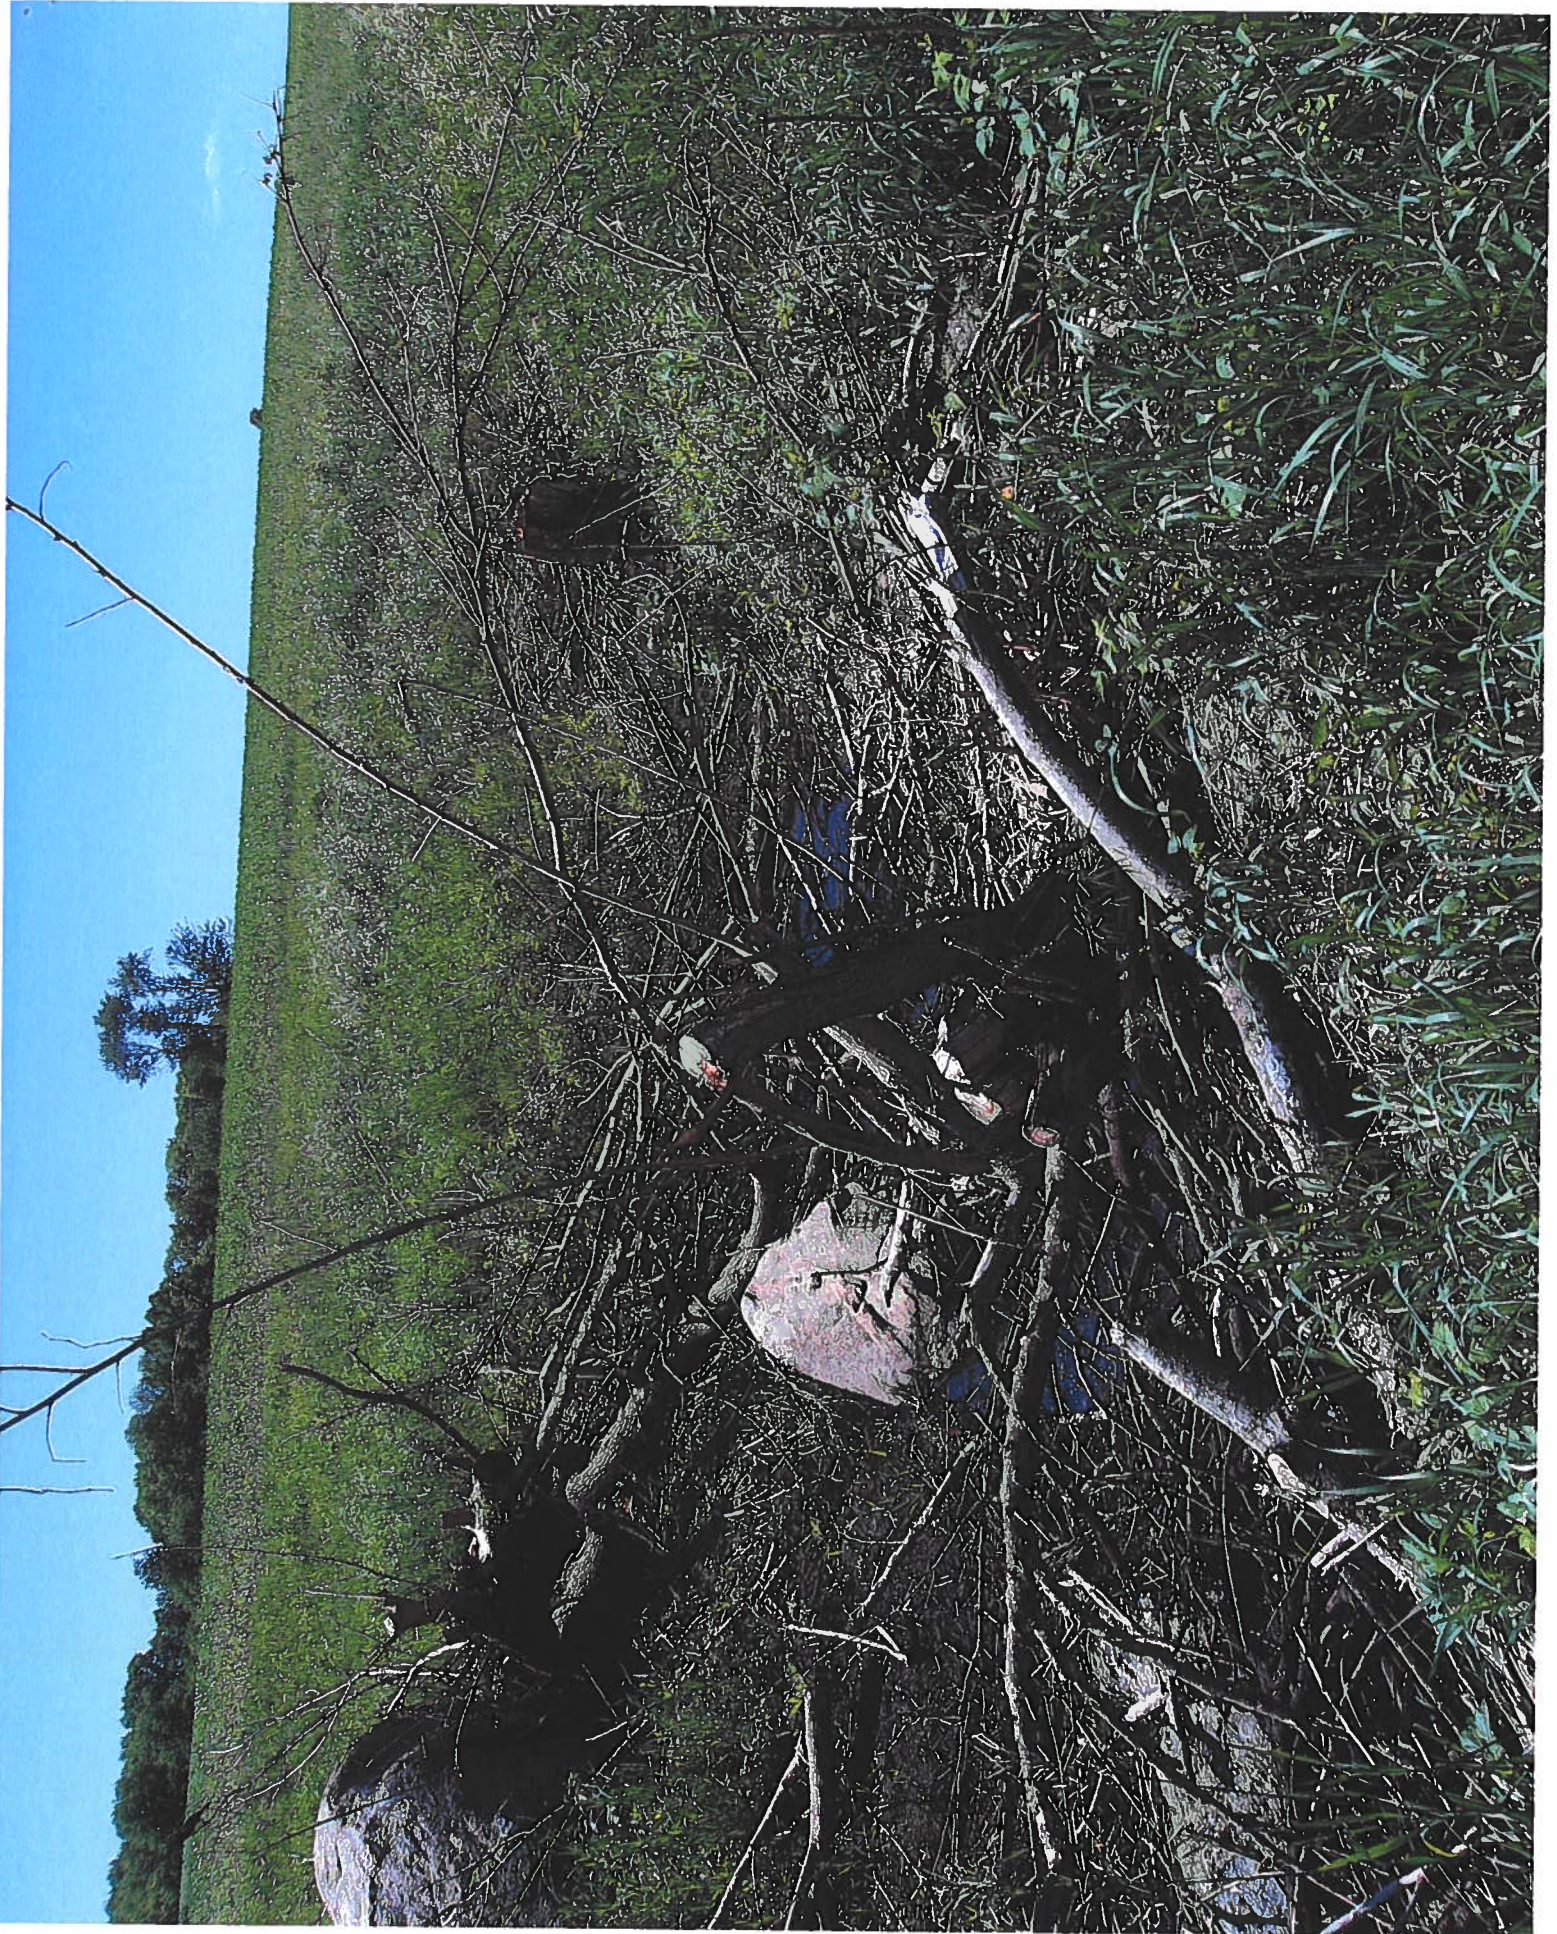
TREES JUST DOWNSTREAM FROM Blow-out
