AGENDA
REGULAR DRAINAGE MEETING
Wednesday, August 19, 2020 9:30 AM
Large Conference Room

[DD 48 WO 237 - 6486.4 - REPAIR SUMMARY - 08_03_20.PDF](#)

[DD BIG 4 LAT 4 - WO 195 - 5585.1 - REPAIR SUMMARY - 08_03_2020.PDF](#)

[DD BIG 4 MAIN - WO 247 - 5734.1 - REPAIR SUMMARY - 08_03_2020.PDF](#)

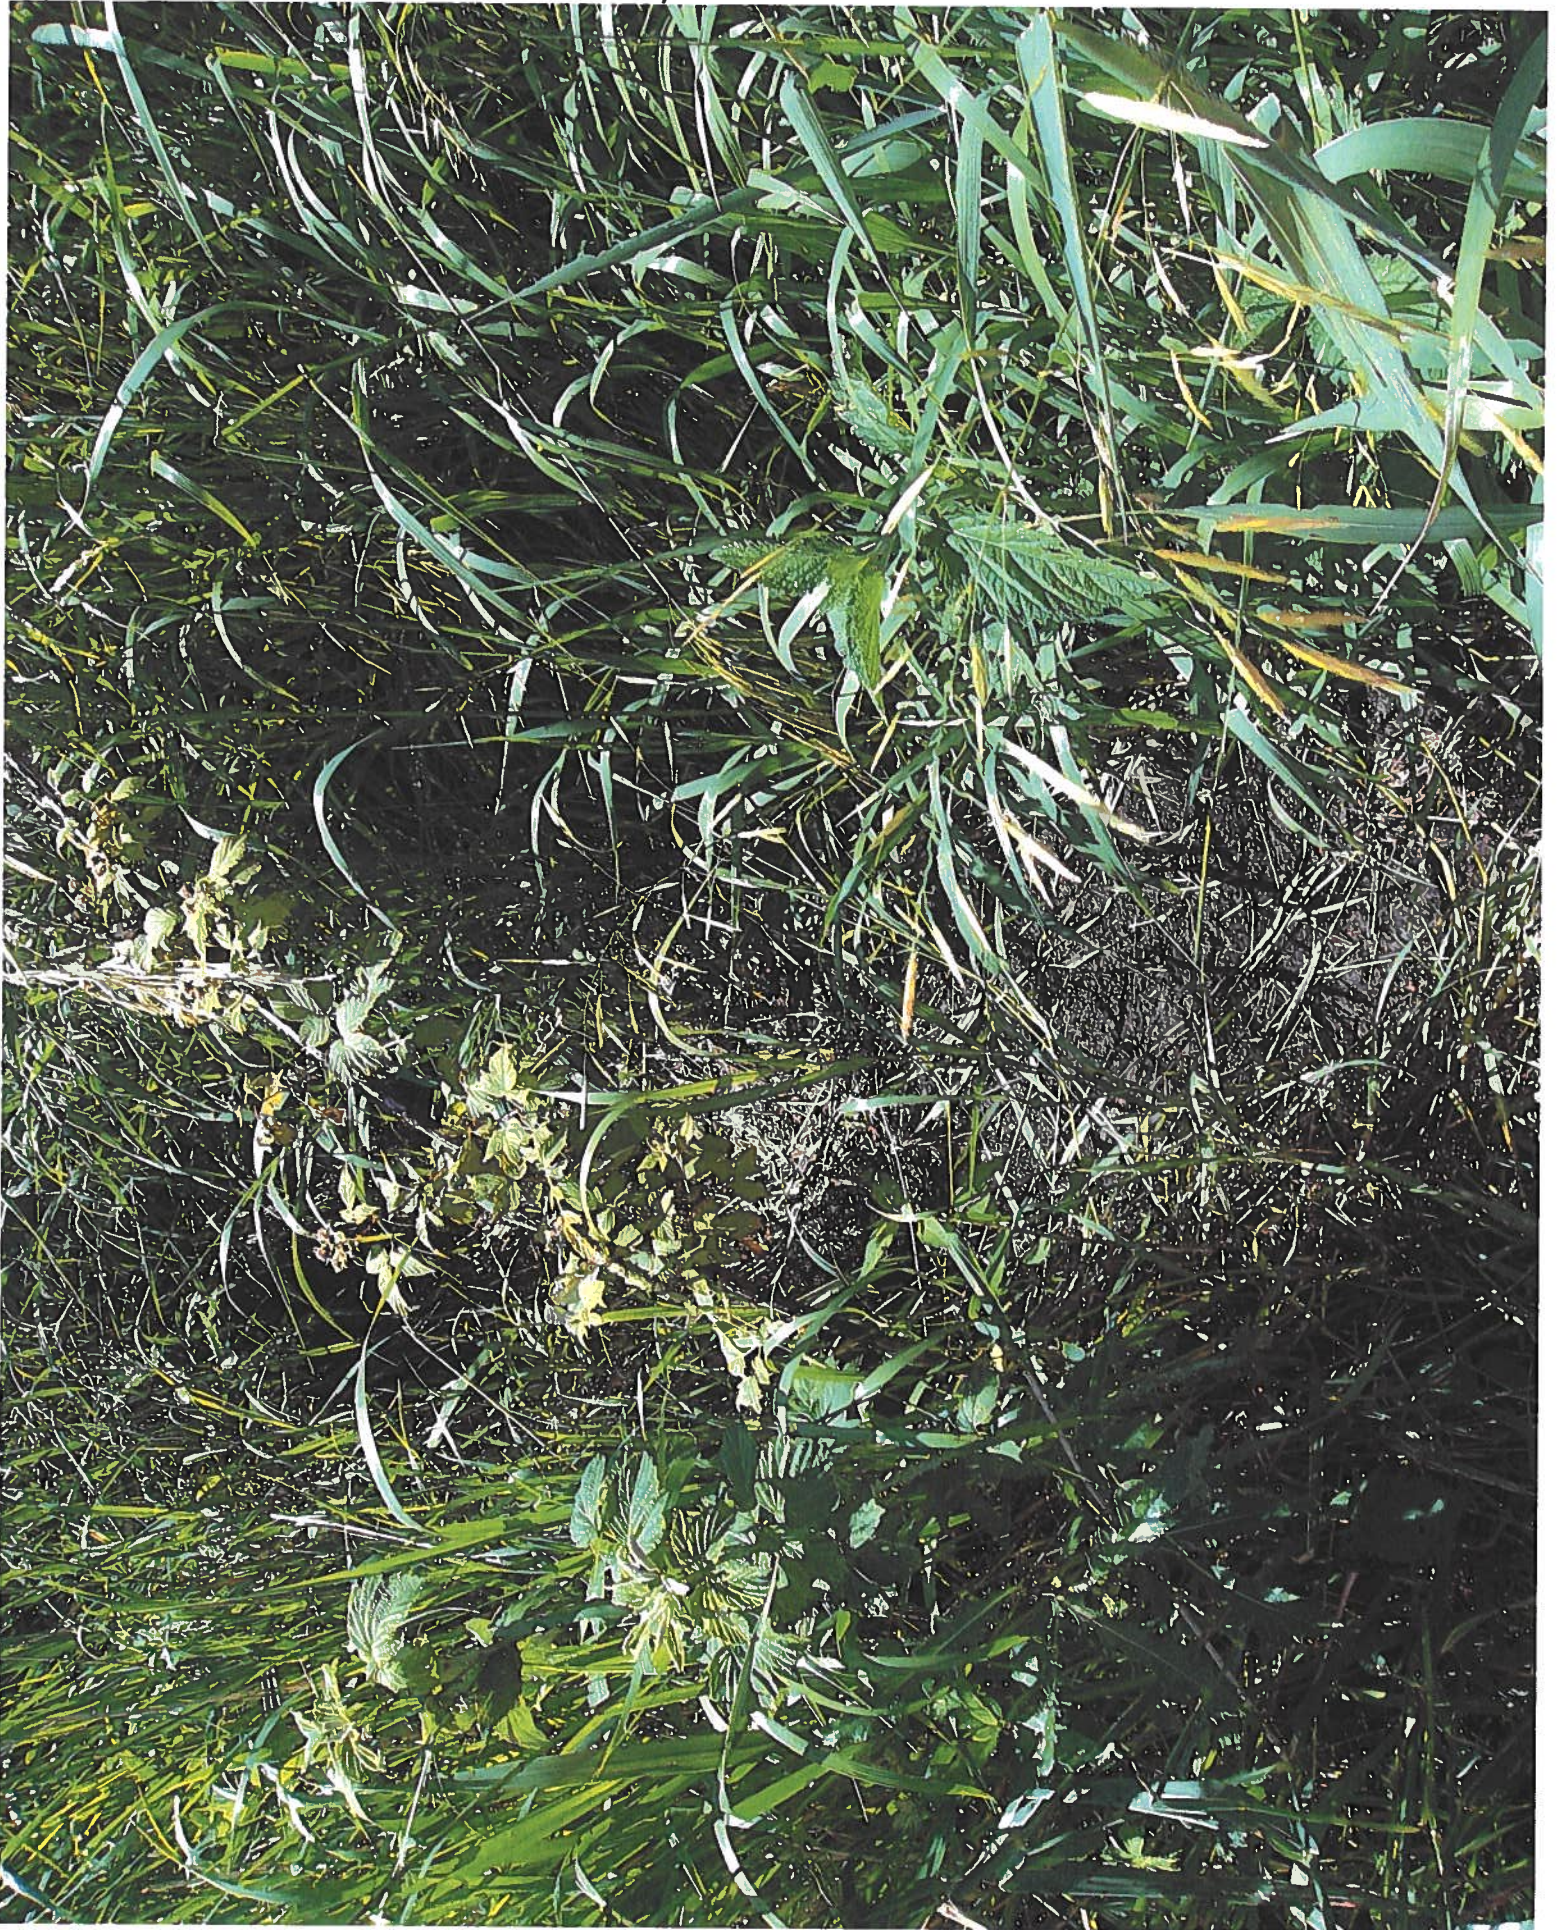
- Tenant in the SW¼ SE¼ Section 30, Township 86 North Range 20 West reported a blowout/sinkhole, with the tile plugged, and water flowing overland as a result.
- Visual observation found a wet area on the north fenceline, multiple wet areas in the grass swale, a blowout/sinkhole, and water running overland to the downstream of the observed blowout/sinkhole. Also found exposed tile, multiple pieces of broken tile and in the in the field, and large rocks and remnants of trees that had been removed just downstream of the blowout/sinkhole.

BLOW-OUT, CAN HEAR WATER

Due to the lack of soil cover over the tile, broken pieces of tile found in the field, and recently cut trees, CGA recommends locating and CCTV inspecting the tile in both directions from the blowout/sinkhole as the observed issue may be due to a larger-scale deterioration of the Main tile's physical condition.

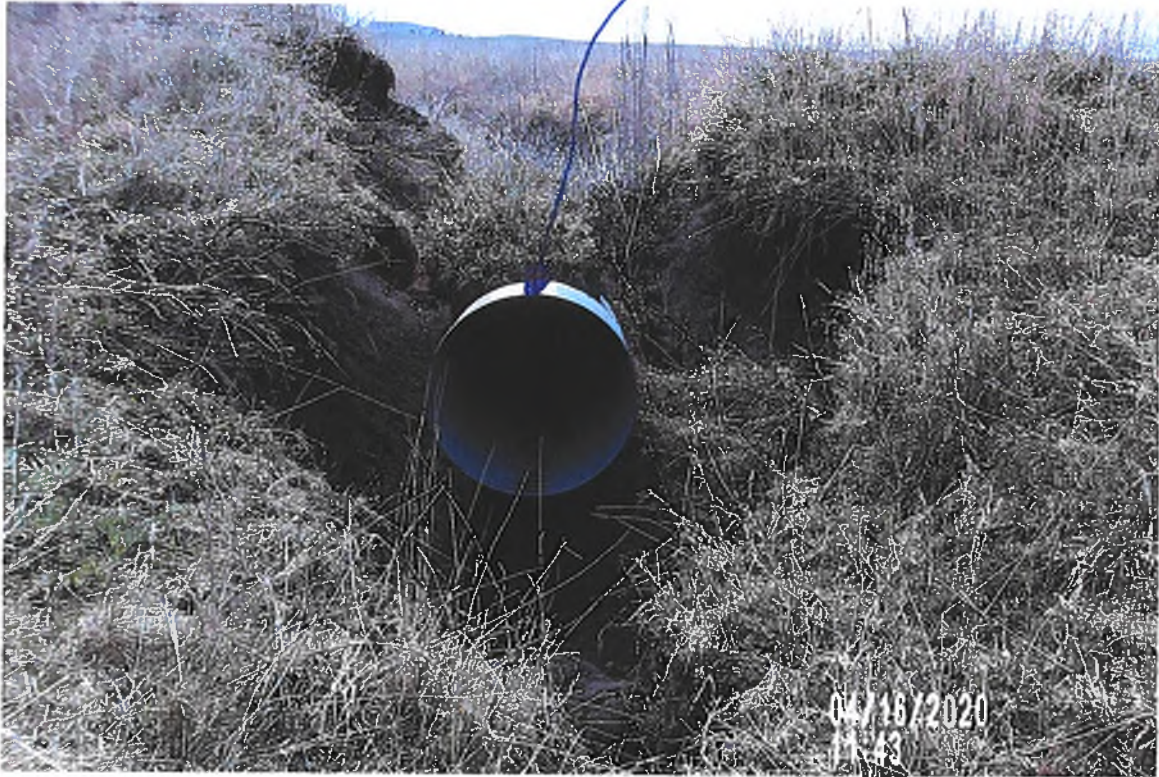
PICTURE# 3370 IS LOOKING SE AT 36" CMP INLET SHOWING DRAINAGE DITCH BANK ERODED AROUND SURFACE DRAIN INLET

- Contractor did not send photographic confirmation that remaining grading and grass seeding was completed to the disturbed soil at the jobsite. He should be contacted to verify said work was completed.
- The reused surface drain as found did not have stone erosion revetment, nor an apron on the inlet side. CGA recommends these two items be installed to prevent erosion if erosion is reported at this surface drain again.

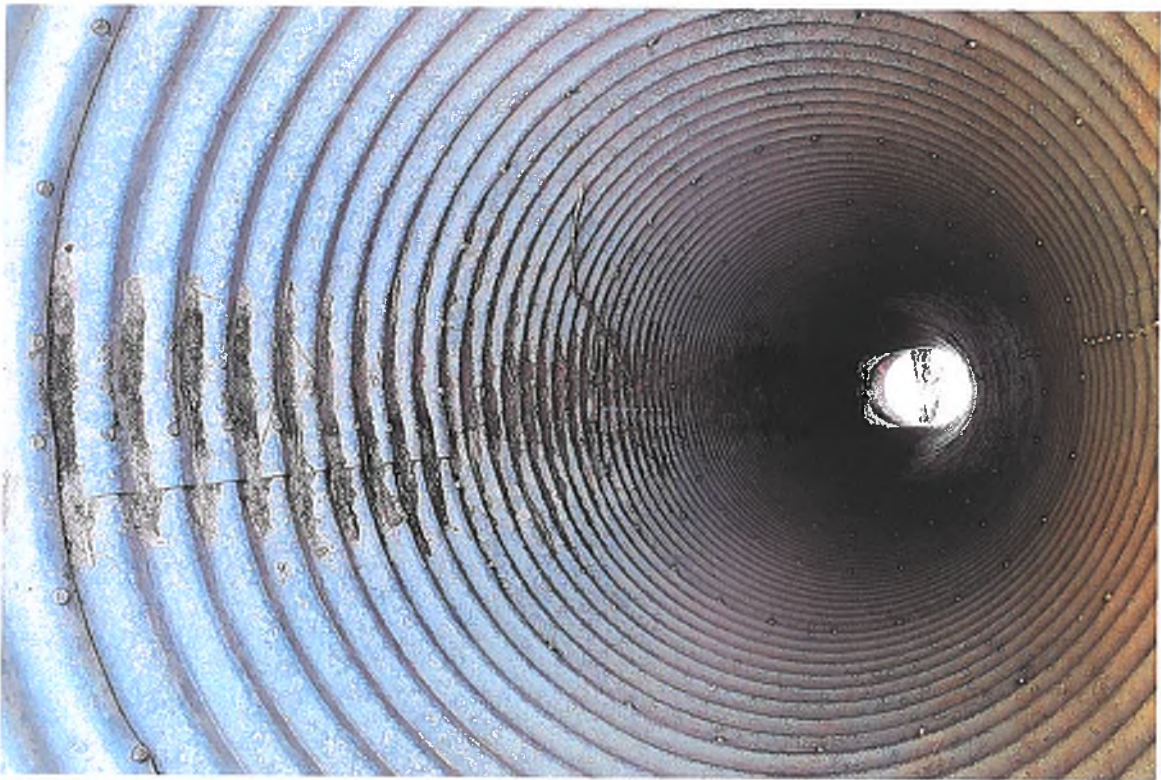
PICTURE #1

PICTURE IS LOOKING SE INSIDE 36" CMP SHOWING SURFACE DRAIN IN GOOD CONDITION. CREW WILL REUSE SURFACE DRAIN.

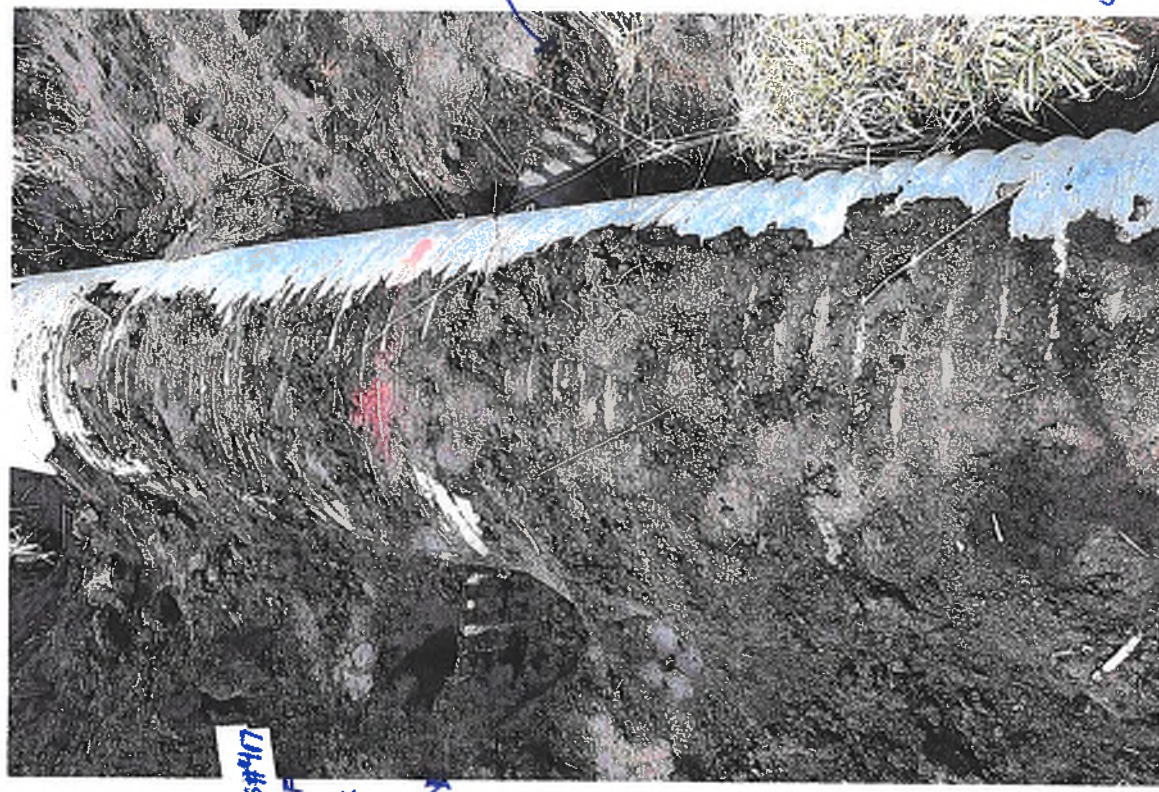
PICTURE #11 IS LOOKING NW AT EXISTING METAL ANTISEEP COLLAR EXPOSED 11.1' SE OF NORTH INLET

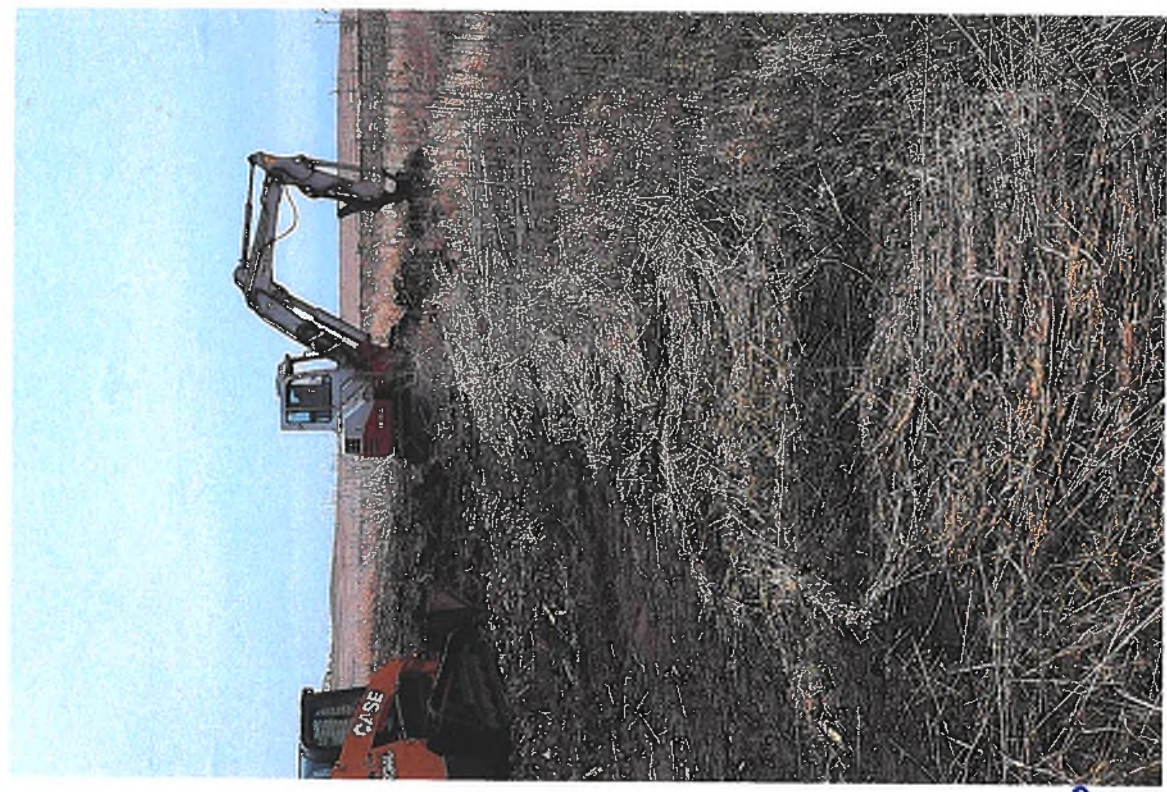
PICTURE #10 IS LOOKING SOUTH SHOWING GREW STRIPING OFF TOPSOIL FROM AROUND 36" CMP SURFACE DRAIN

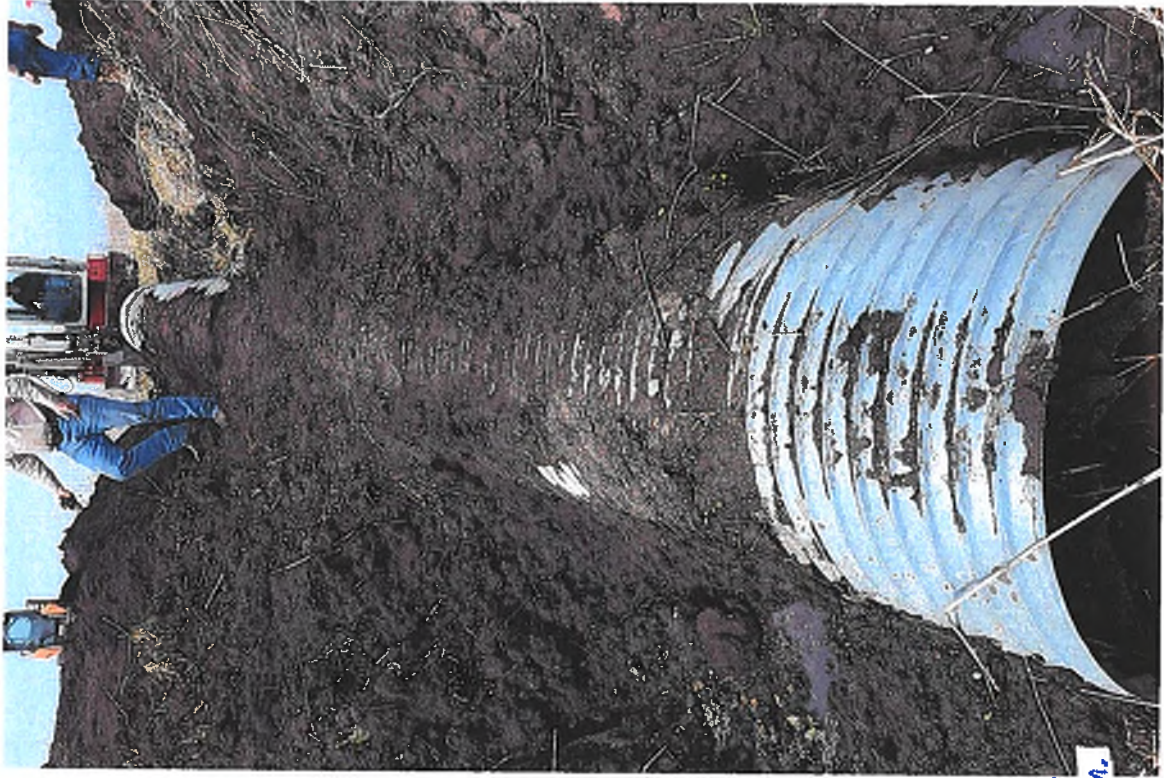
PICTURE #12 IS LOOKING NW SHOWING MOST OF TOP OF 36" CMP SURFACE DRAIN EXPOSED & CREW READY TO REMOVE,

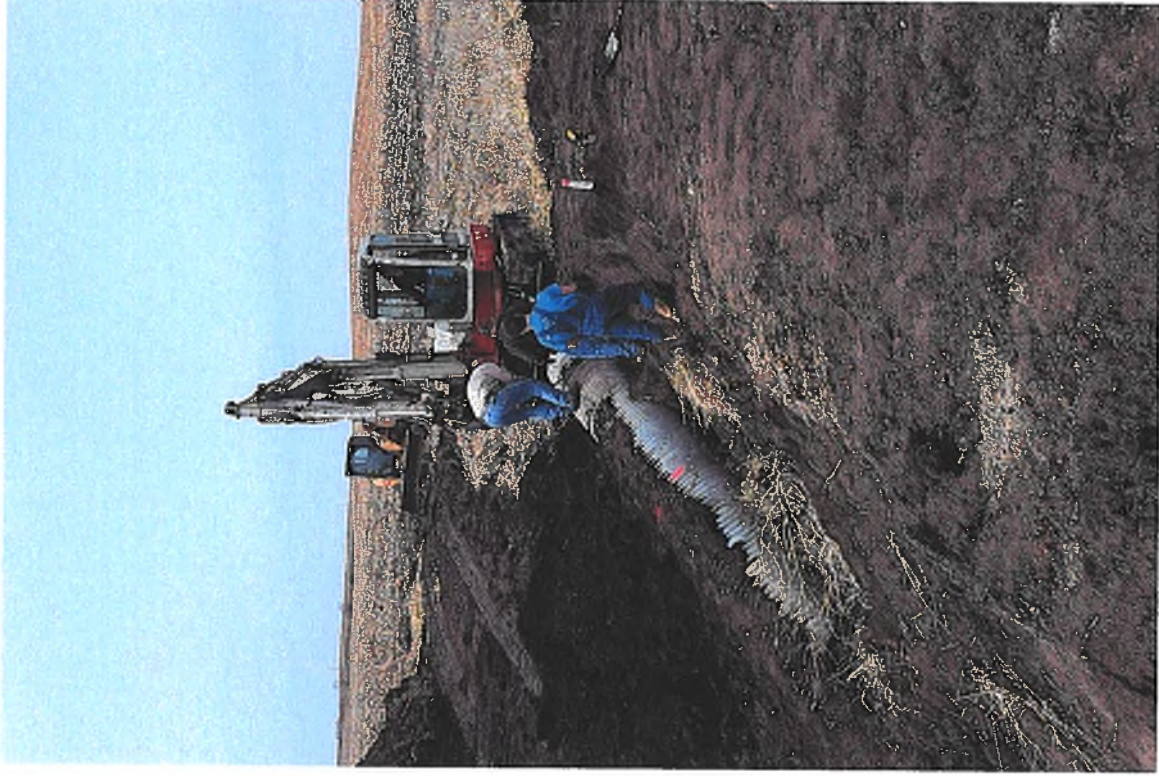
PICTURE #13 IS LOOKING NW SHOWING CREW GETTING READY TO REMOVE 36" CMP SURFACE DRAIN

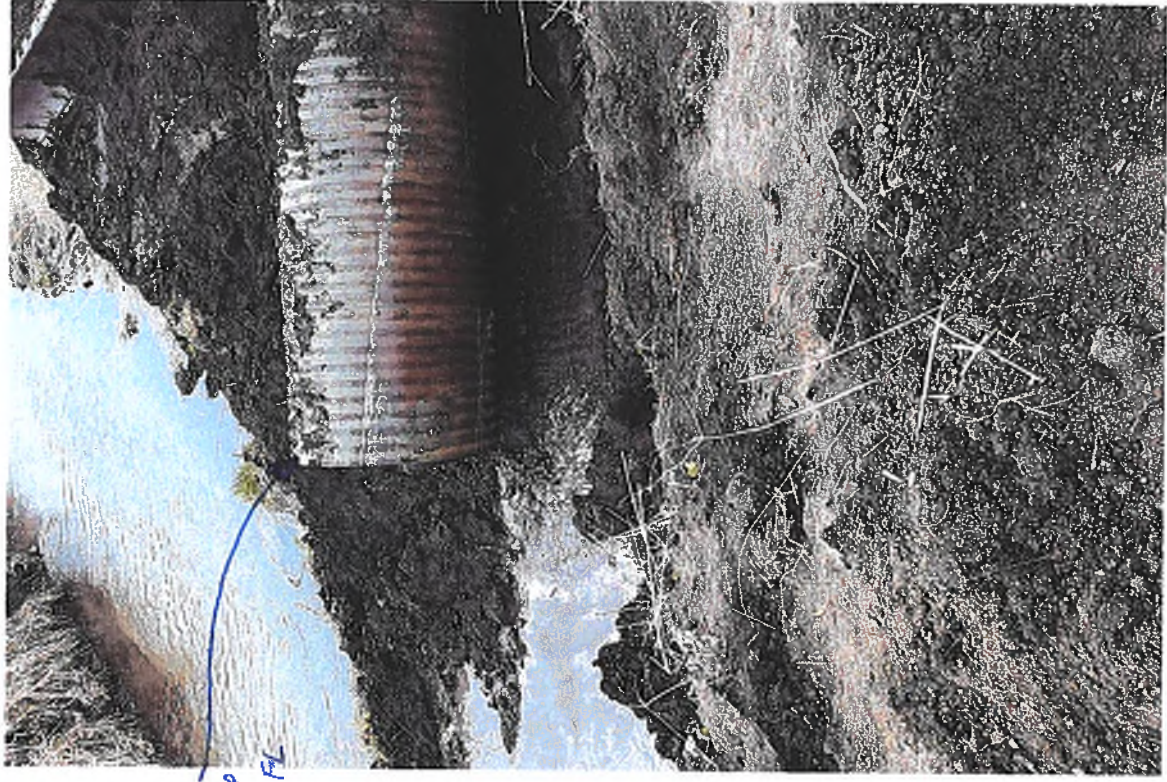
PICTURE # 14 IS LOOKING SW SHOWING
CONDITION OF 36" CMP THAT WAS BURIED
BELOW GROUND ON OUTLET END @ DD

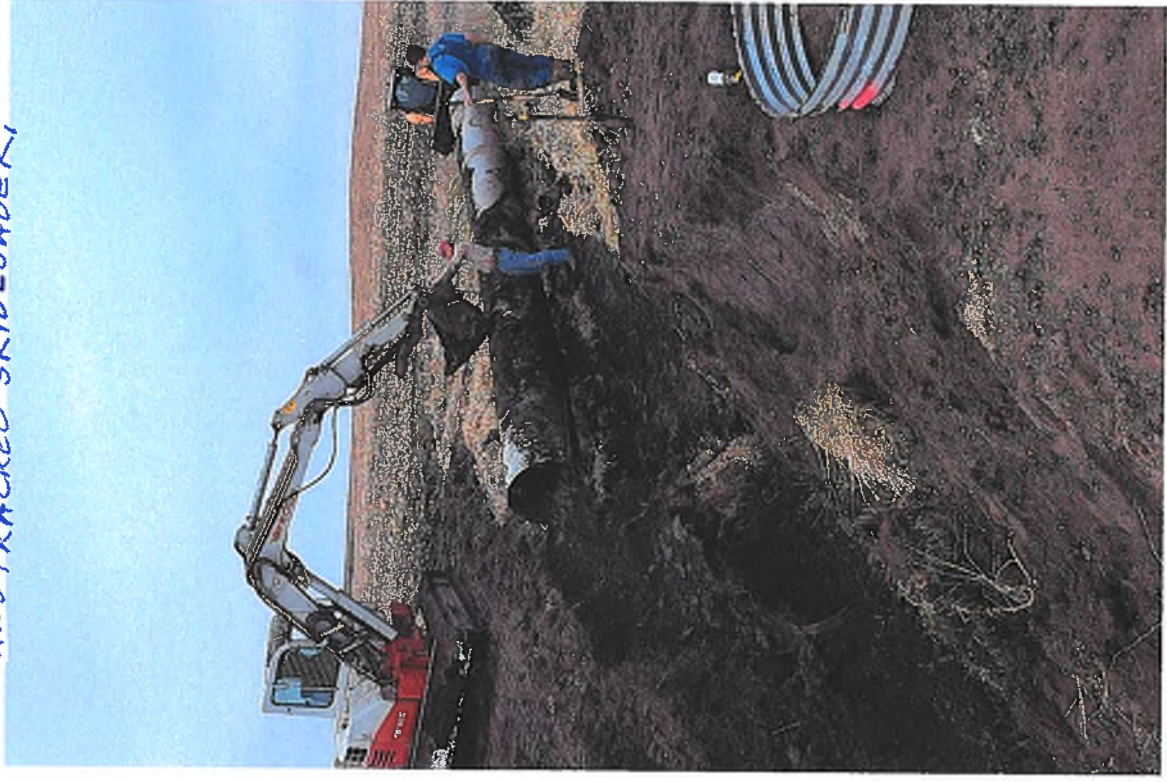
PICTURE #15 IS LOOKING NW SHOWING
36" CMP SURFACE DRAIN THAT WAS
REMOVED USING MINI EXCAVATOR
, AND TRACKED SKIDLOADER,

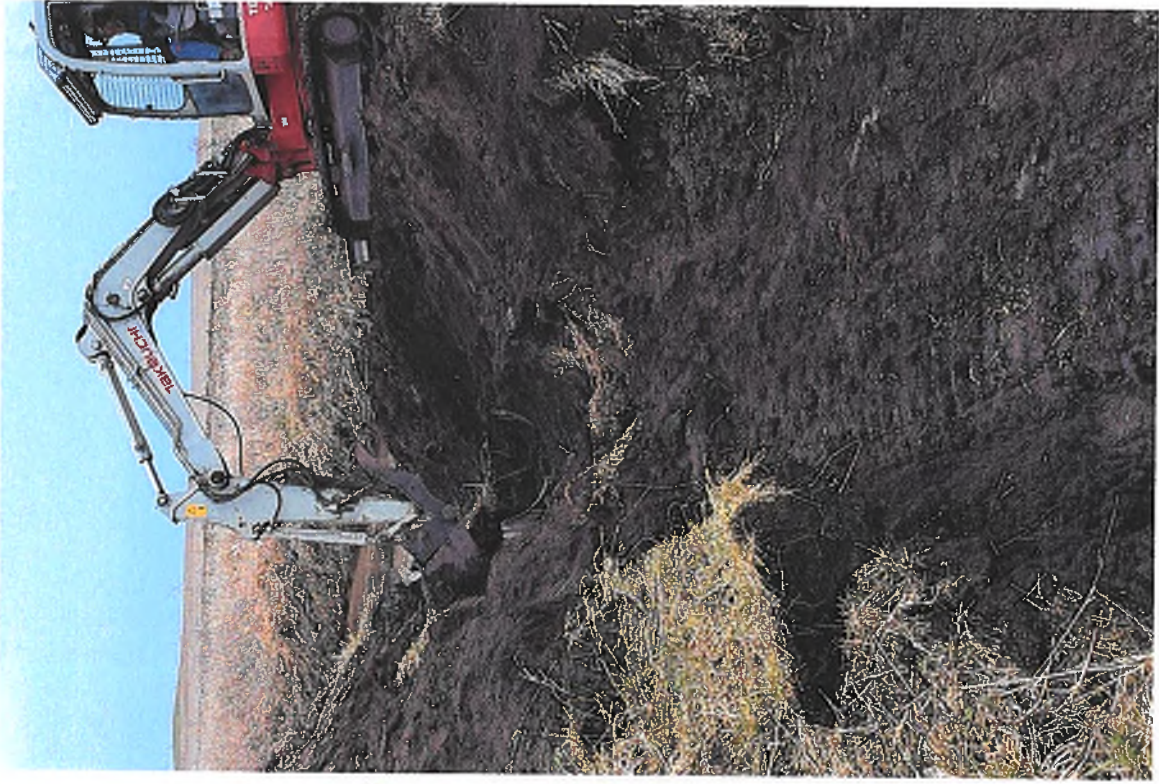
PICTURE # 16 IS LOOKING SOUTH SHOWING
EXCAVATOR DIGGING TO REMOVE
ANTI SEEP COLLAR.

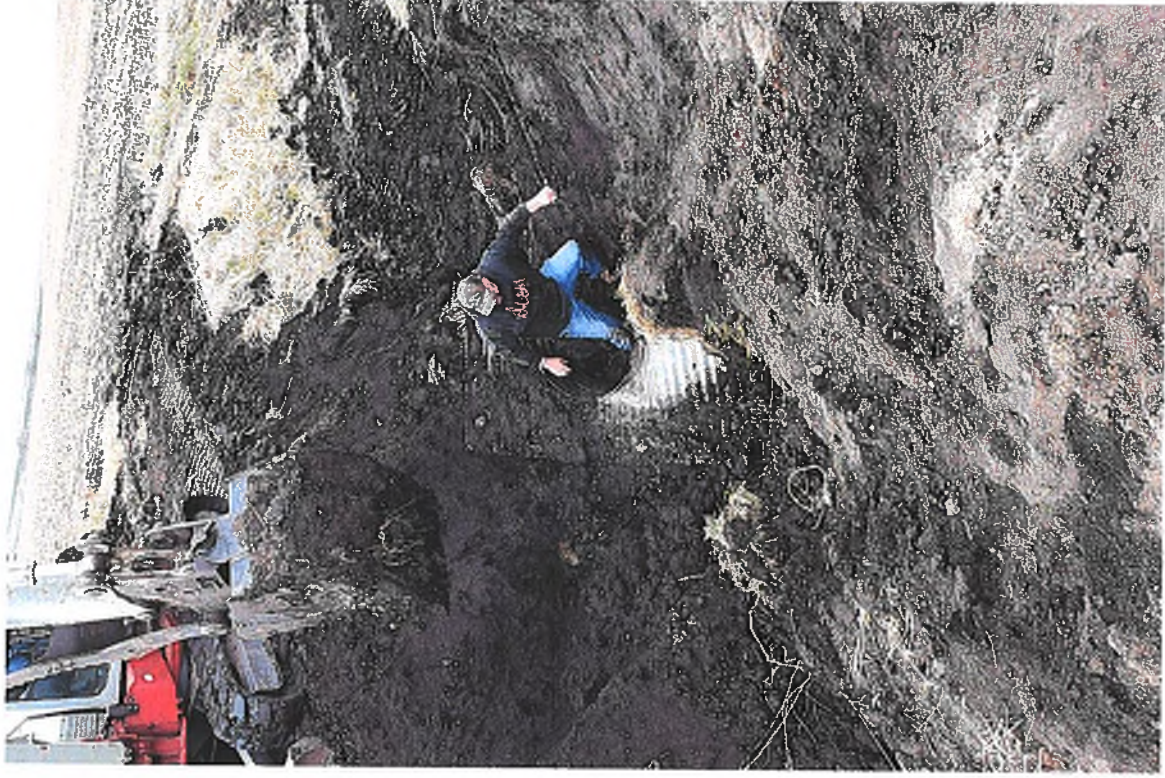
PICTURE # 17 IS LOOKING NW SHOWING
CREW REMOVING EXISTING METAL
ANTI SEEP COLLAR

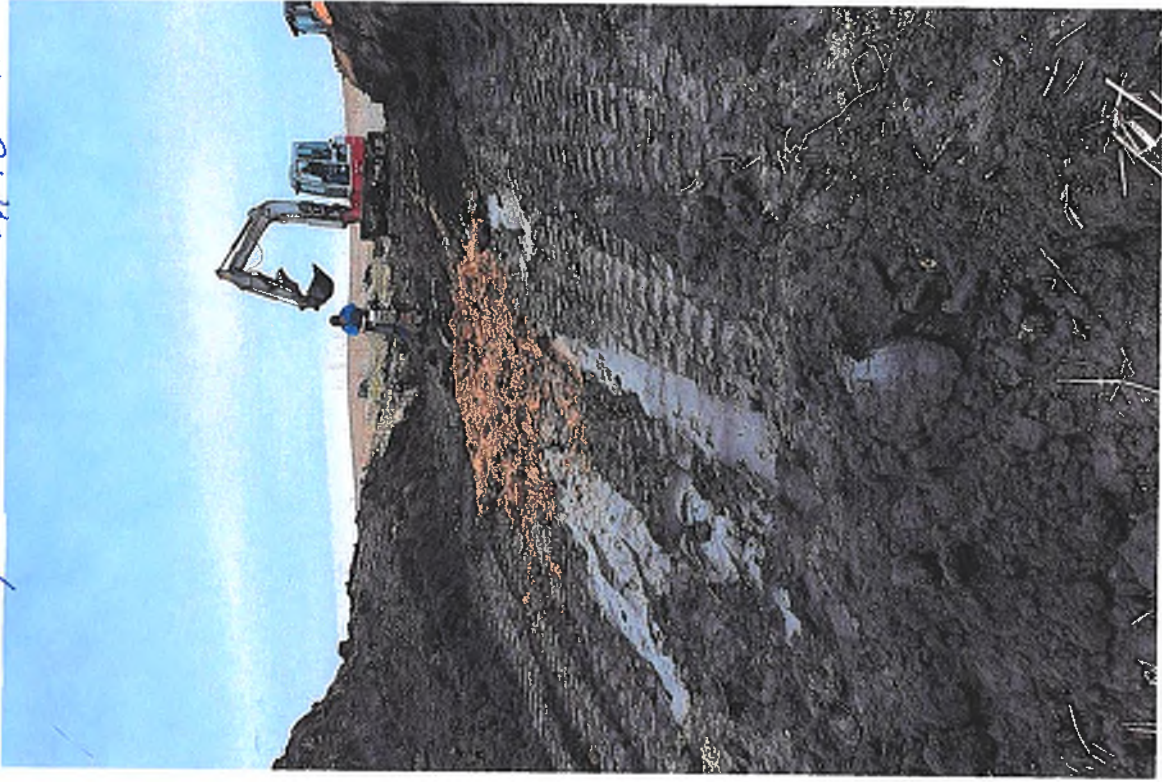
PICTURE# 19 IS LOOKING NW SHOWING CREW
COMPACTING SUBGRADE WITH JUMPING JACK
COMPACTOR & NOW CREW HAULING IN LIMY
CLAY SOIL INTO TRENCH TO PUT BELLYTILE

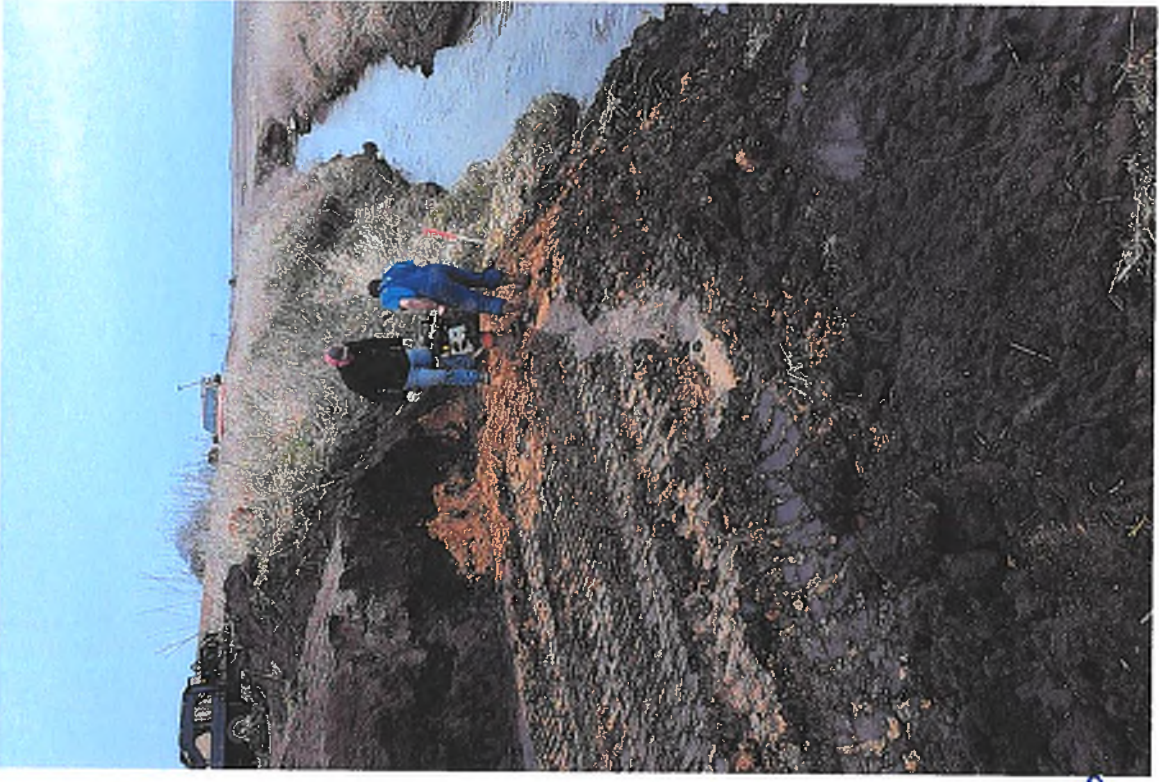
PICTURE #20 IS LOOKING SE SHOWING
CREW JUMPING JACK COMPACTING SOUTH
END OF TRENCH FOR SURFACE DRAIN
PIPE.

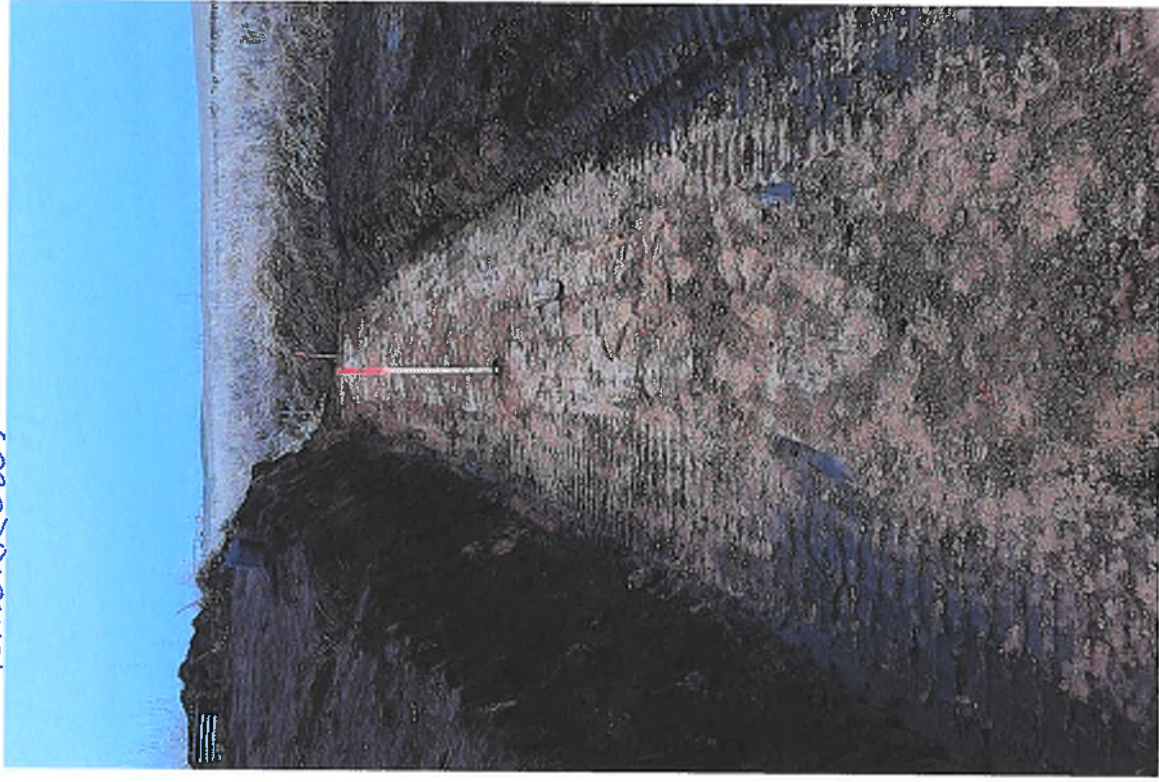
PICTURE #21 IS LOOKING SE SHOWING
LATH SET FOR GRADE FOR SURFACE
DRAIN. CREW WILL NEED TO FINISH GRADE
TOMORROW.

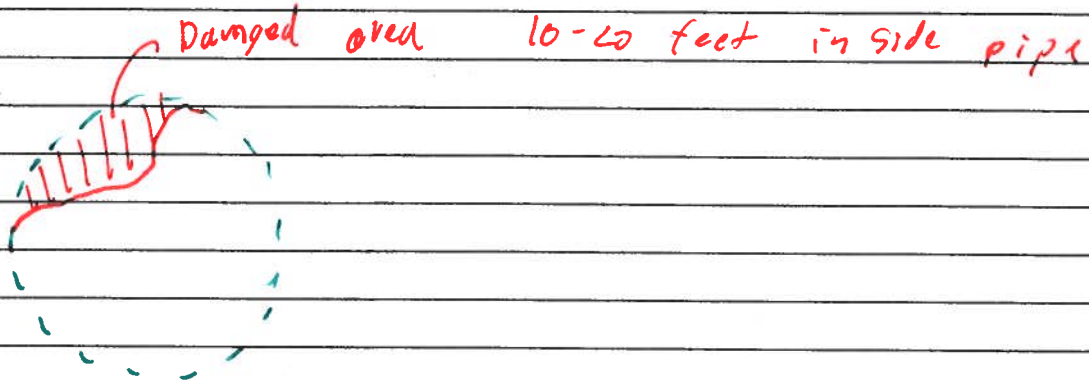
- pipe is damaged on inside (see photos)

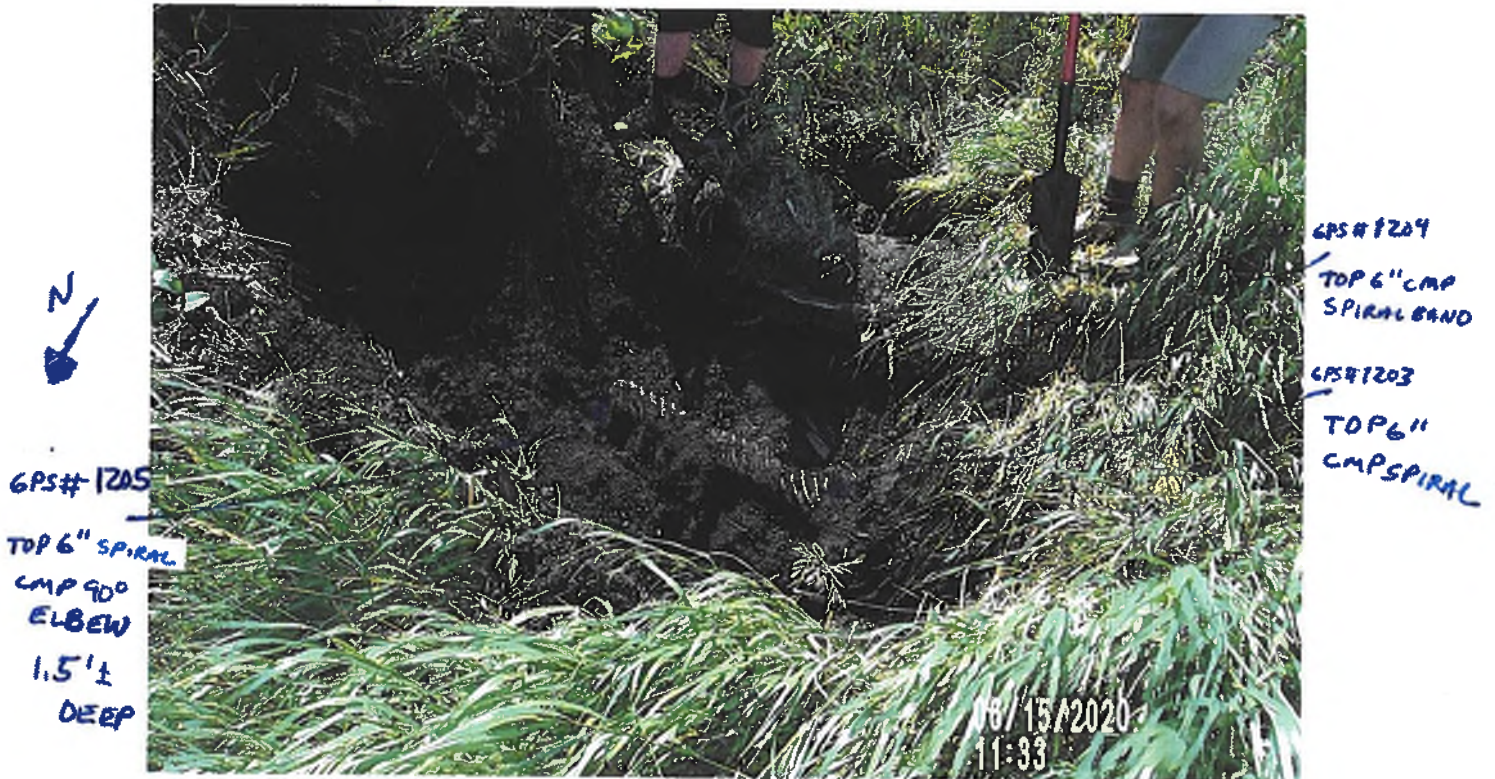
PICTURE #3744 IS LOOKING SE SHOWING 6" SPIRAL CMP TILE FROM FIELD TIED INTO 8" SPIRAL CMP OUTLET TILE FOR BEEHIVE INTAKE

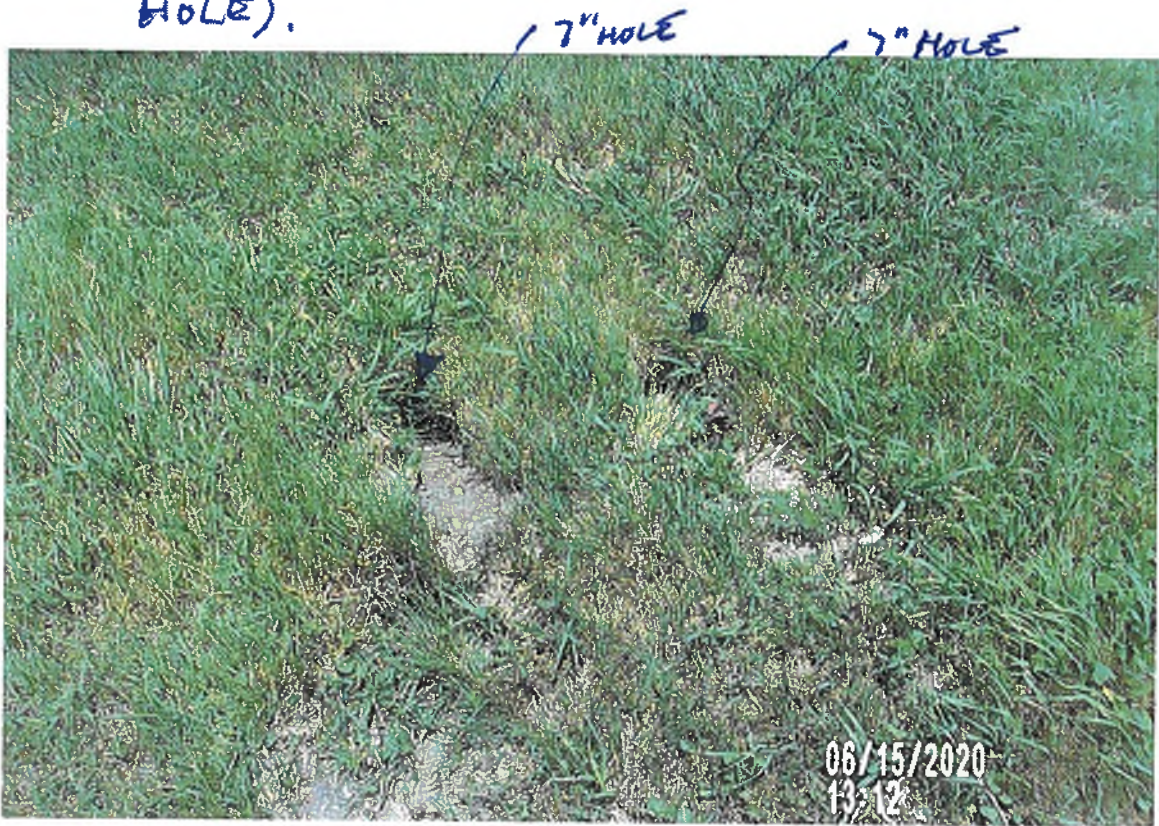
PICTURE # 3752 IS LOOKING NORTH TOWARDS CO HWY D25
SHOWING 6 HOLES WITH SOIL DUG OUT IN FRONT (ANIMAL
HOLE).
