AGENDA
REGULAR DRAINAGE MEETING
Wednesday, August 26, 2020 9:30 AM

Repair Summary:

SE NE 30-88-22 REPAIR SMASHED
END OF EXISTING 24" CMP INLET &
INSTALL NEW 24" CMP WITH ANTISEEP COLLAR
IN BLOWOUT

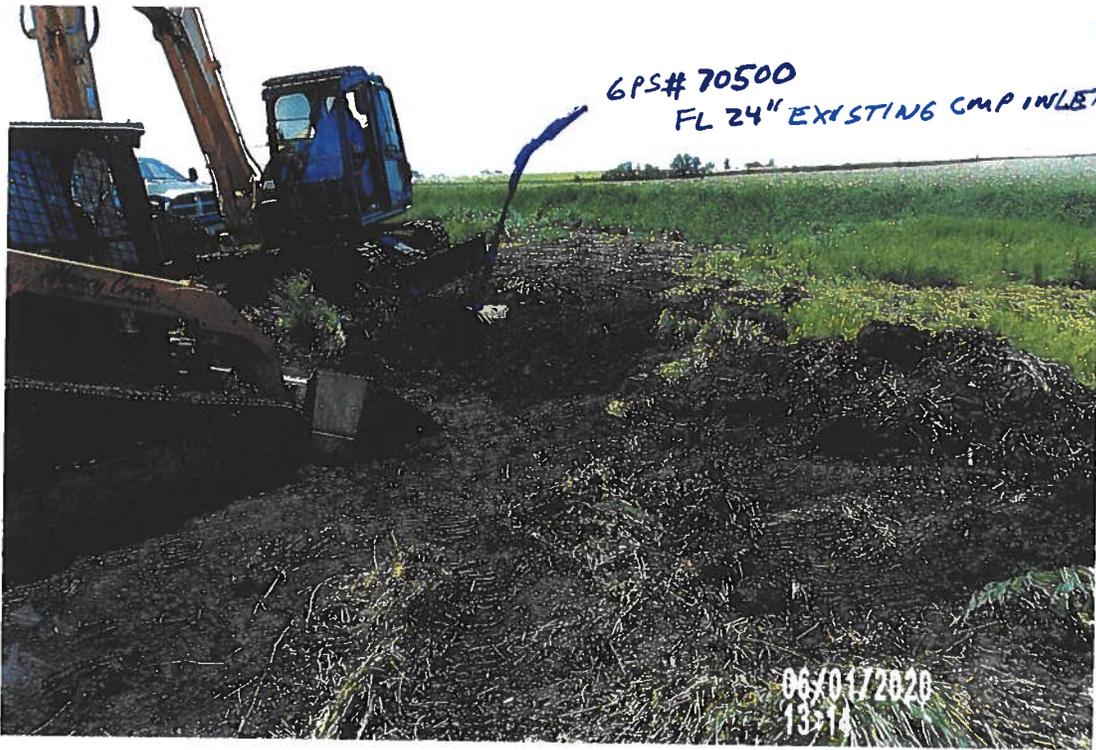
PICTURE# 3619 IS LOOKING SW SHOWING CREW BACK FILLING SOIL AROUND 24" EXISTING CMP INLET.

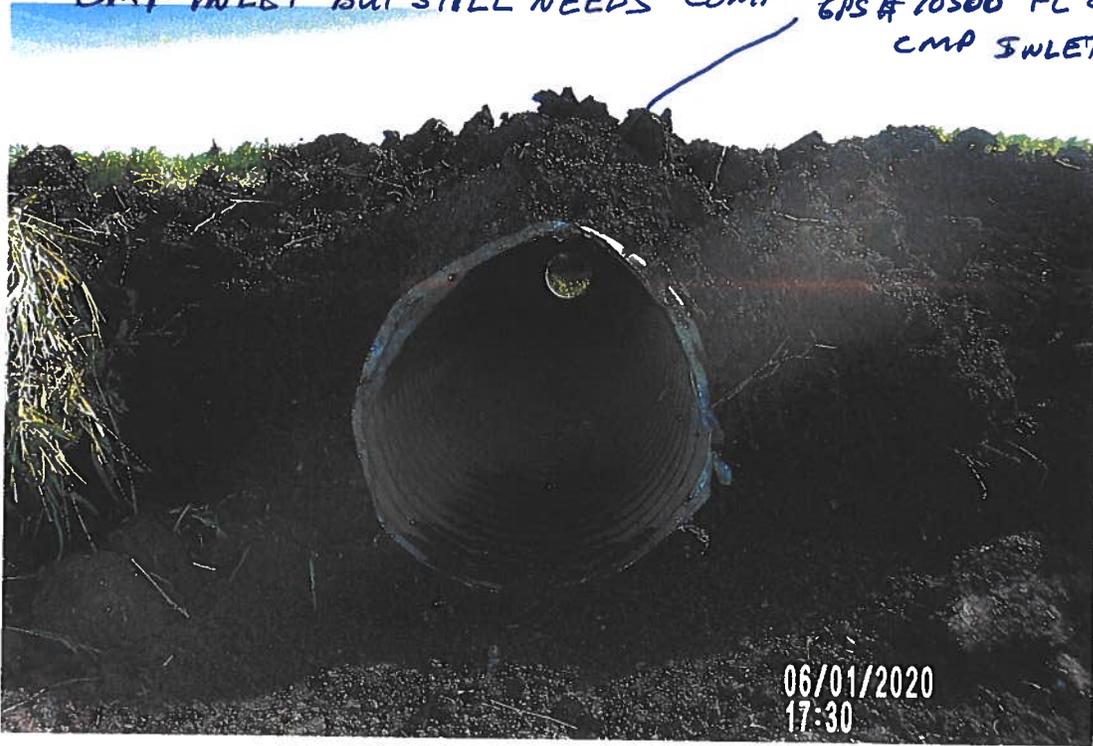
PICTURE # 3631 IS LOOKING SW SHOWING EXISTING 24" CMP
SURFACE DRAIN INLET WITH STRAIGHTENED MANGLED END.
LOOKS LITTLE ROUGH. CREW HAS BACKFILL SOIL AROUND
CMP INLET BUT STILL NEEDS COMPACTED.
GPS # 70500 FL 24"
CMP INLET

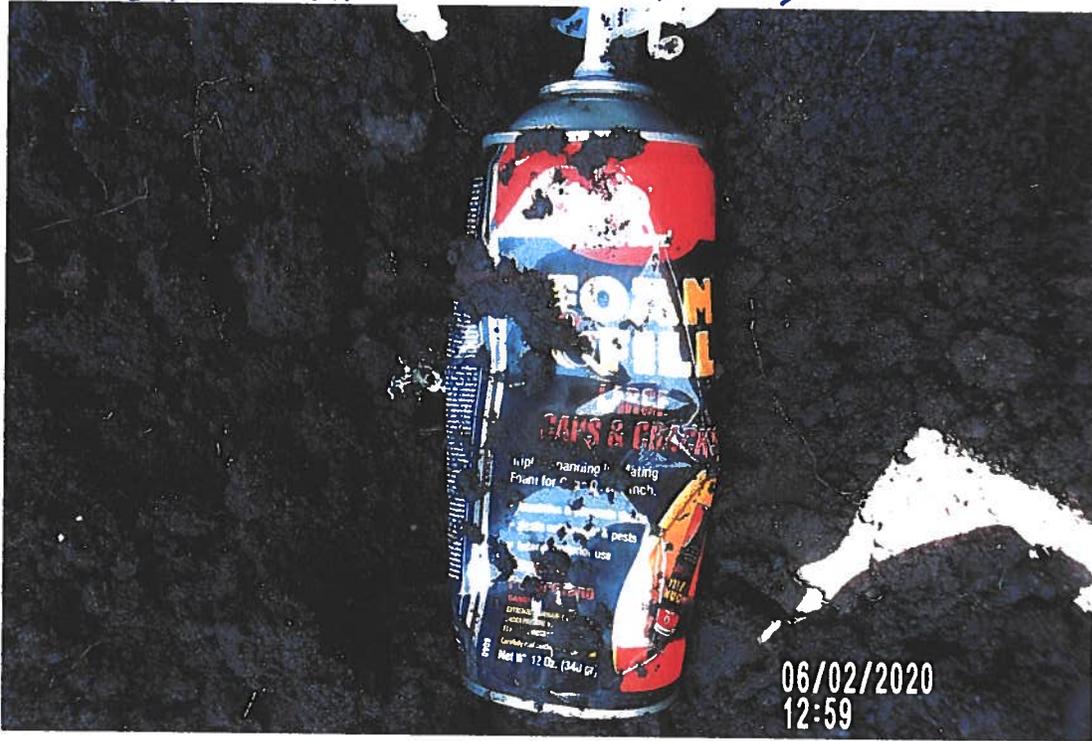
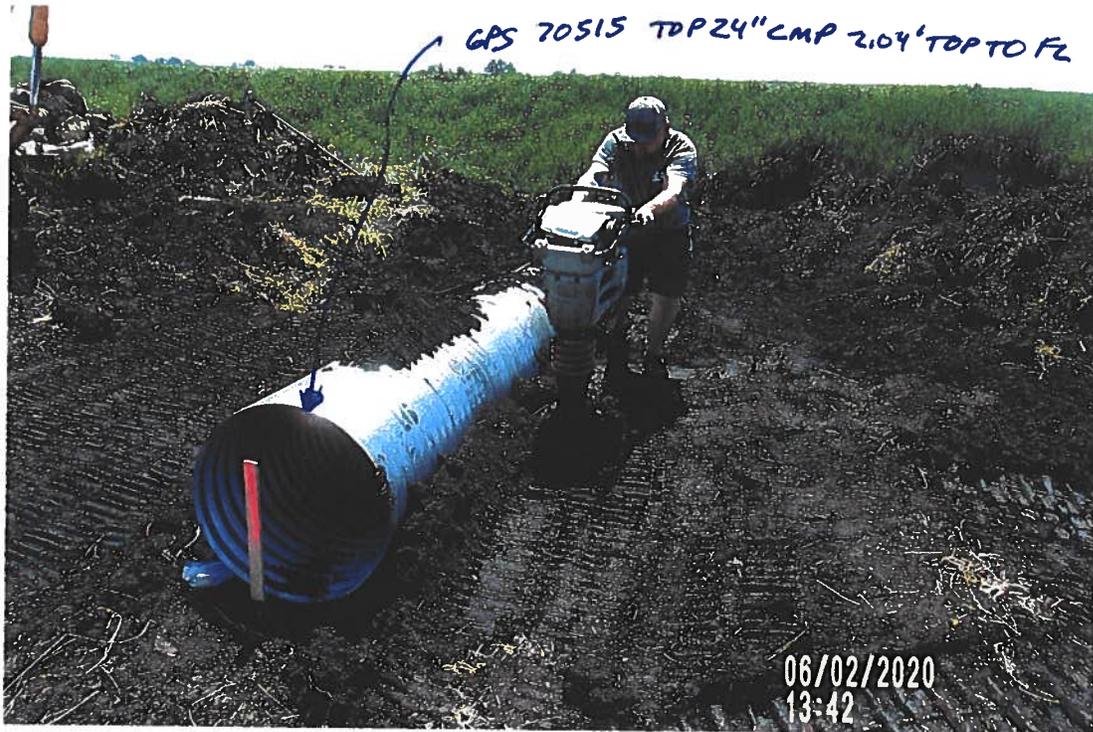
PICTURE # 3636 IS LOOKING EAST SHOWING CREW USING FOAM FILL TO SEAL BETWEEN HDPE ANTISEEP COLLAR AND 24" CMP SURFACE DRAIN, (SUDAS SHOWS SHOULD BE BITUMINOUS MATERIAL)

PICTURE # 3638 SHOWING FOAM FILL USED TO SEAL VOID BETWEEN HDPE ANTISEEP COLLAR AND CMP SURFACE DRAIN (OBSERVER INFORMED CREW THAT SUDAS CALLS FOR BITUMINOUS MATERIAL AND THIS IS WHAT CREW BROUGHT BACK)

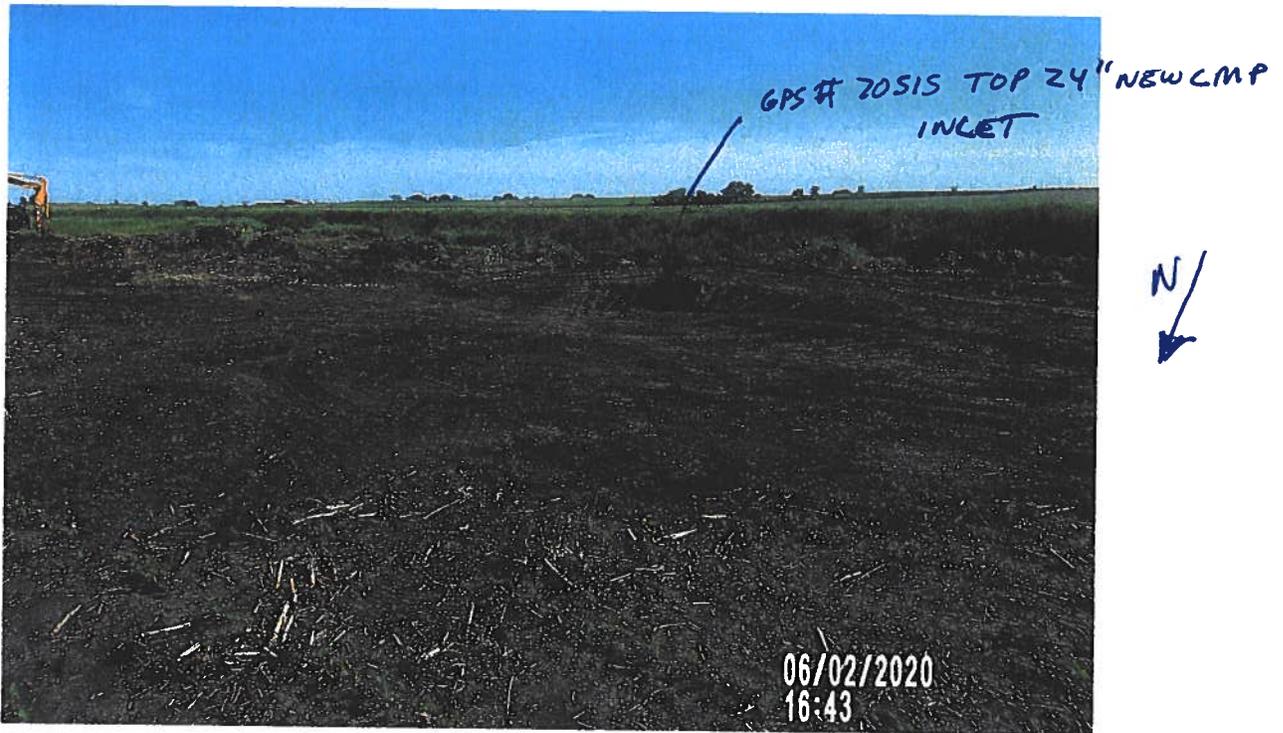
PICTURE #3641 IS LOOKING SE AT 0.14' AC OF BEAN
DAMAGE DURING REPAIR

- Verify with landowner that the seeding, grading, and clean-up of the area is acceptable as this was performed without CGA representative present.
- Pay landowner/tenant for the approximately 0.14 acres of crop damage to the beans that were planted.

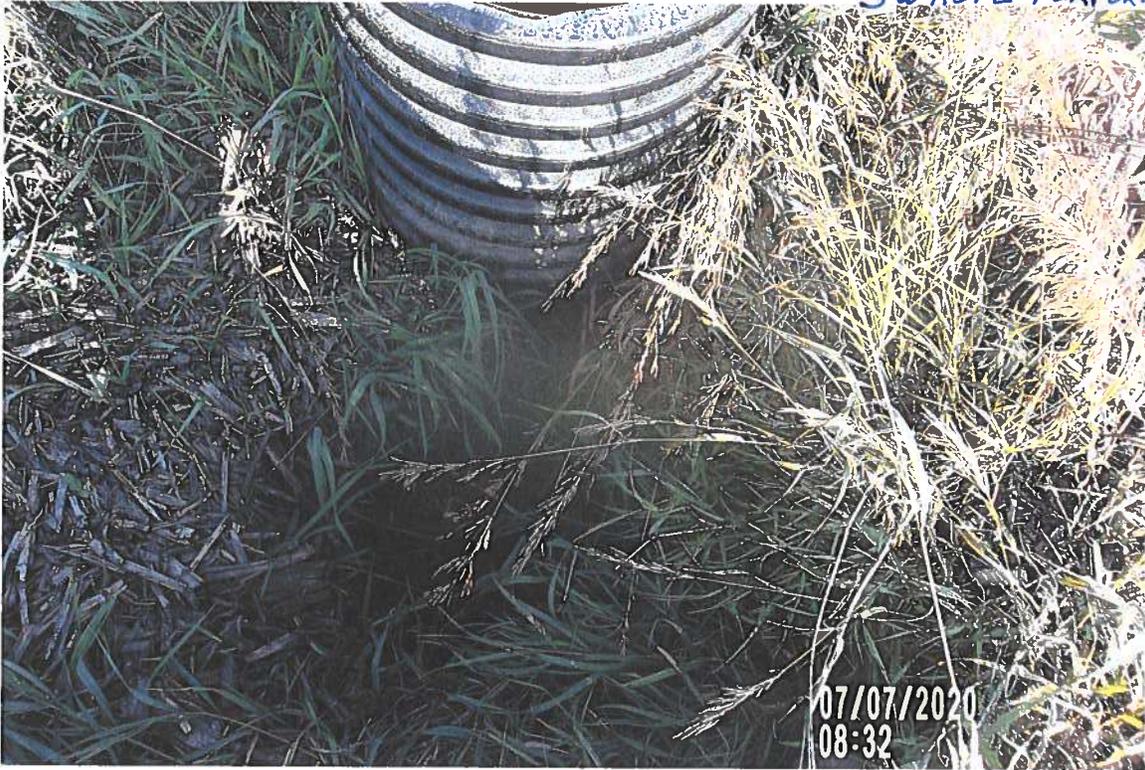
PICTURE #4026 IS LOOKING WEST SHOWING HDPE
STAND PIPE WITH 18" BEEHIVE TOP OVER 12" HDPE STAND
PIPE WITH 1.3' E-W X 2.0' N-S HOLE ON WEST SIDE & 1.8' DEEP
← GPS #140 N RIM OF 12"
SW HDPE PERFORMED
STAND PIPE
WITH 12"

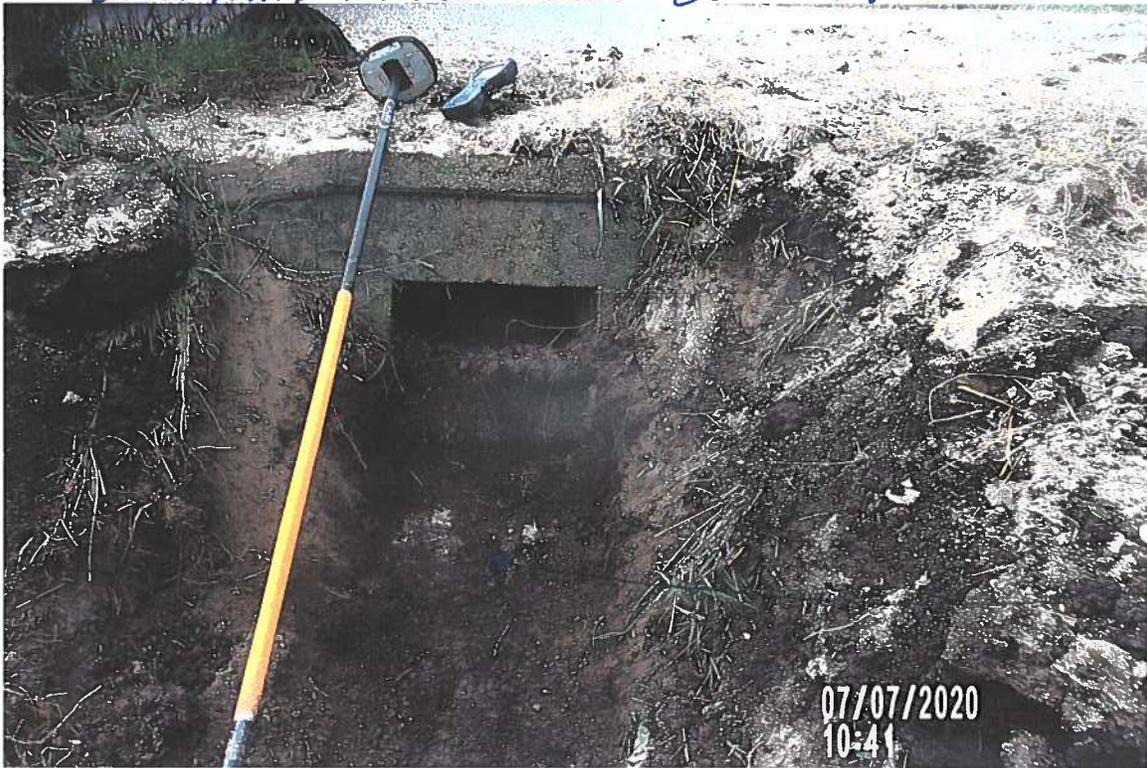
PICTURE#4037 IS LOOKING SOUTH AT NORTH END OF CONCRETE BOX
 CULVERT UNDER 110TH STREET HAVING 4.0' PLUS OF
 SOIL THAT NEEDS CLEANED OUT. (COUNTY NEEDS TO CLEAN OUT) CREW GRADED
 FROM FL CONCRETE BOX CULVERT

- The surrounding road ditch on both sides of the road was found to be filled with excess sediment. Secondary roads should be contacted so that ditch can be cleaned out. The road box culvert had approximately 1-foot of sediment in its base that also needs to be cleaned out.
- After work was completed, no seeding was applied to the disturbed soil. Secondary Roads or the contractor should be informed that seeding needs to be done.
- Crop damage claims should be paid as submitted by landowners and verified as shown in the attached tabulation.

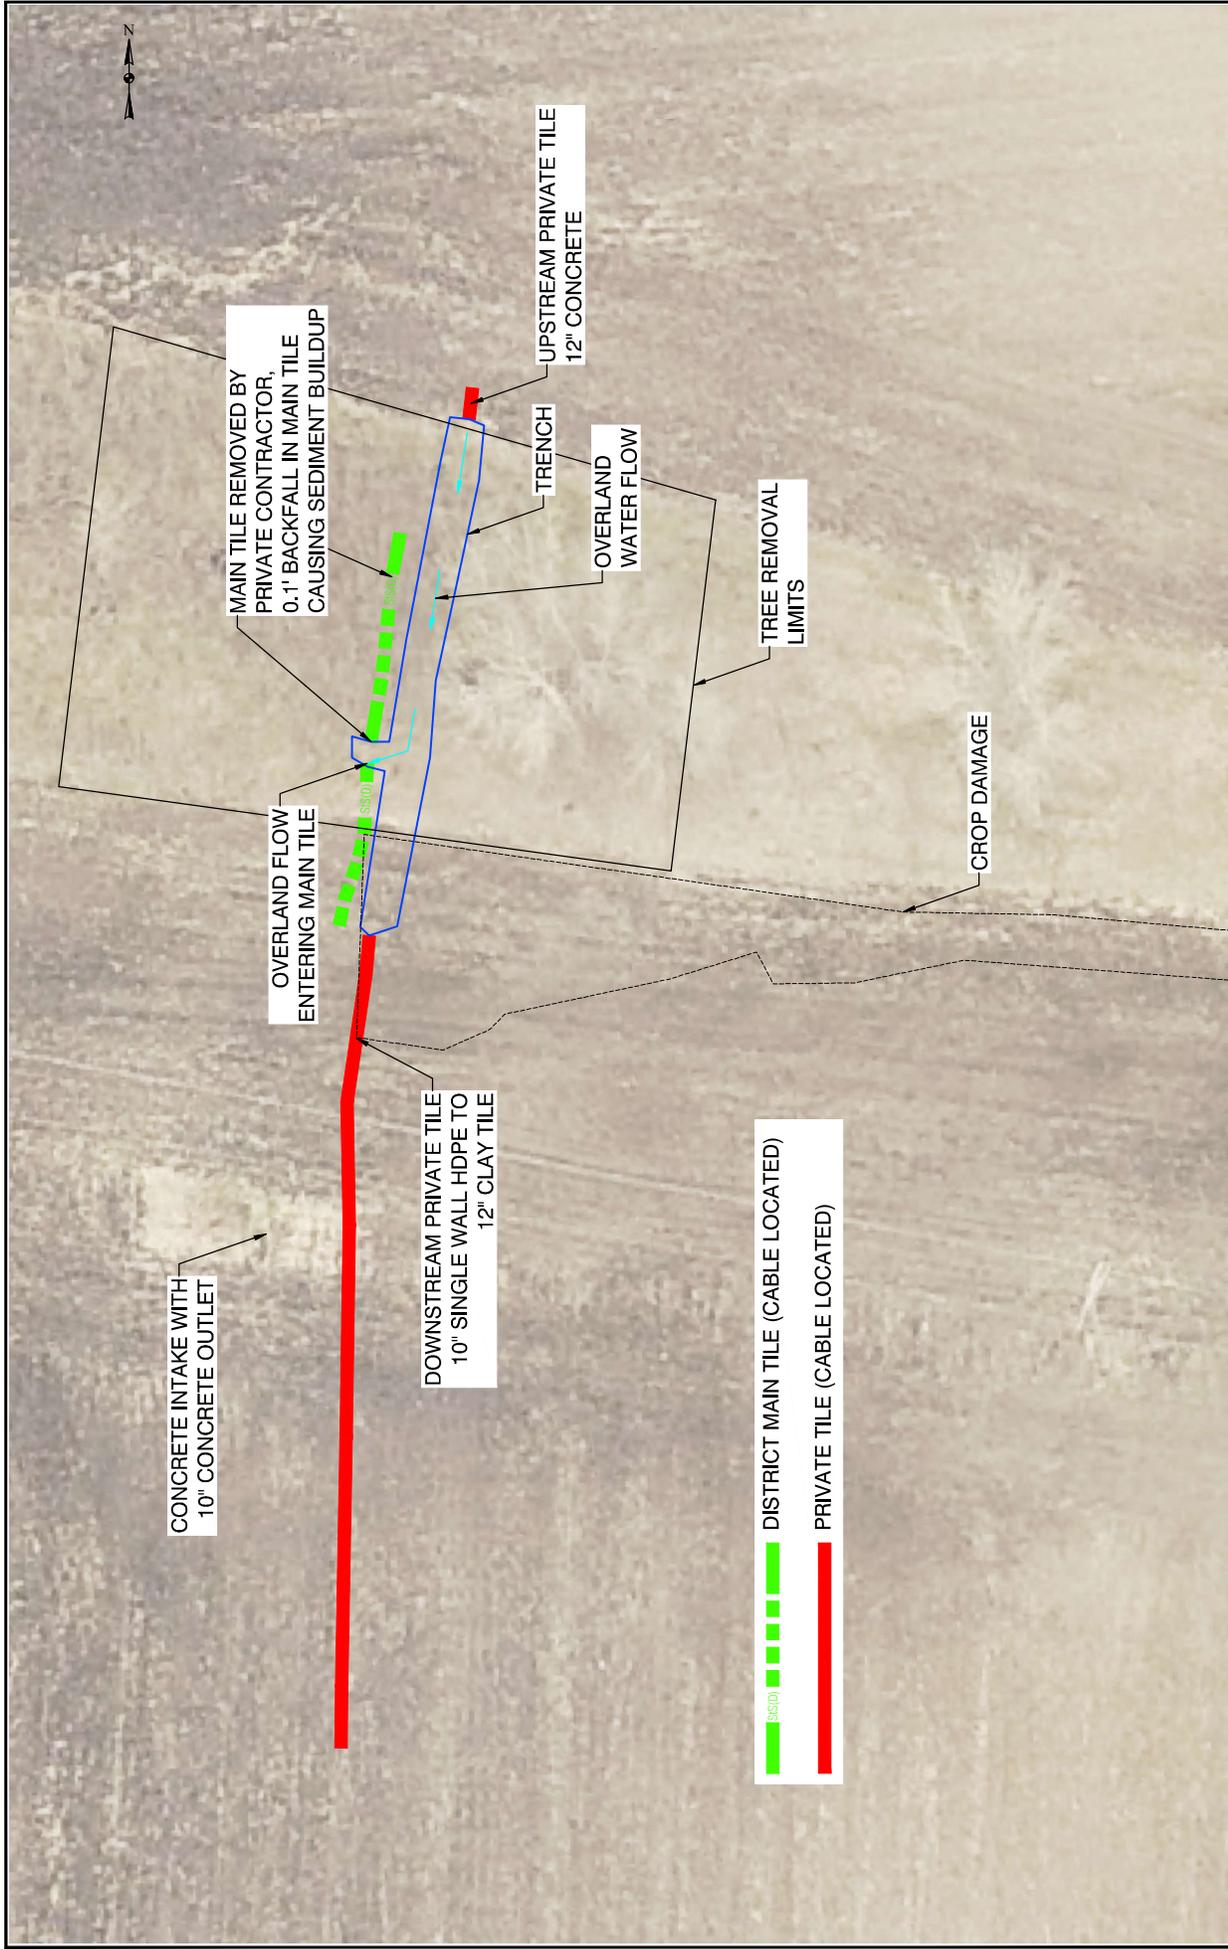
MAIN TILE REMOVED BY PRIVATE CONTRACTOR, 0.1' BACKFALL IN MAIN TILE CAUSING SEDIMENT BUILDUP

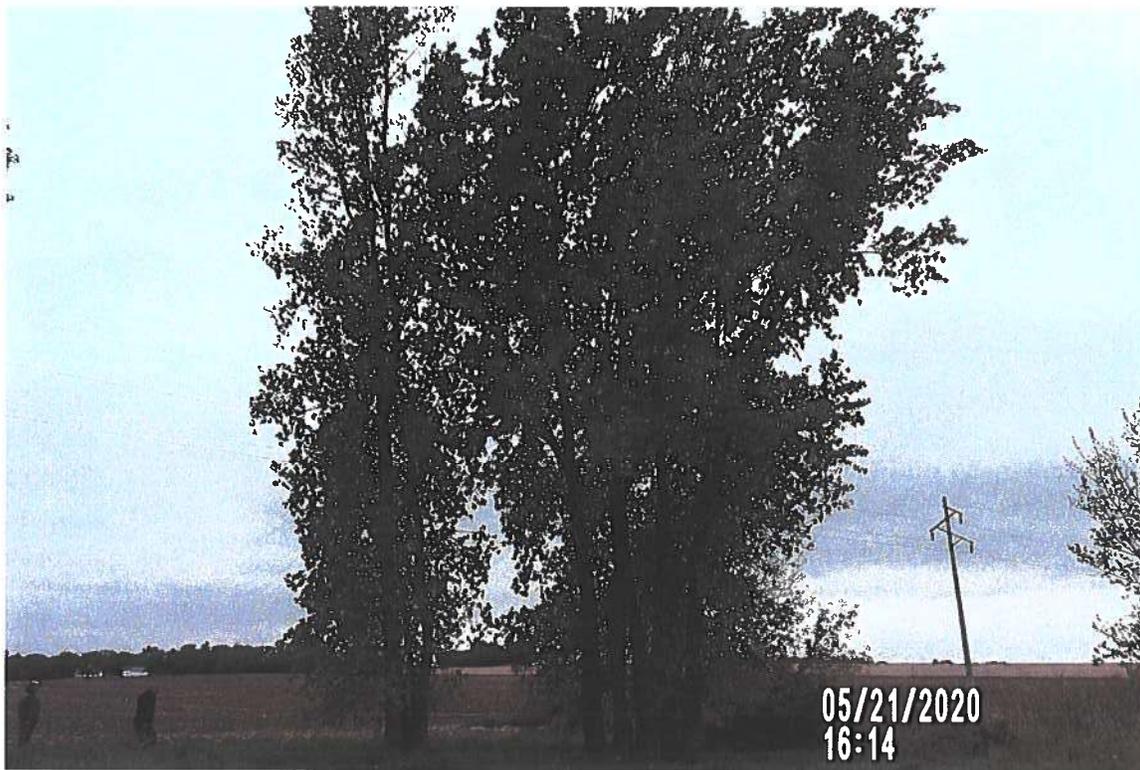
PICTURE#3589 IS LOOKING SW SHOWING 2 CLUSTER OF TREES THAT WILL BE REMOVED (WITHIN 50' OF DISTRICT TILE)

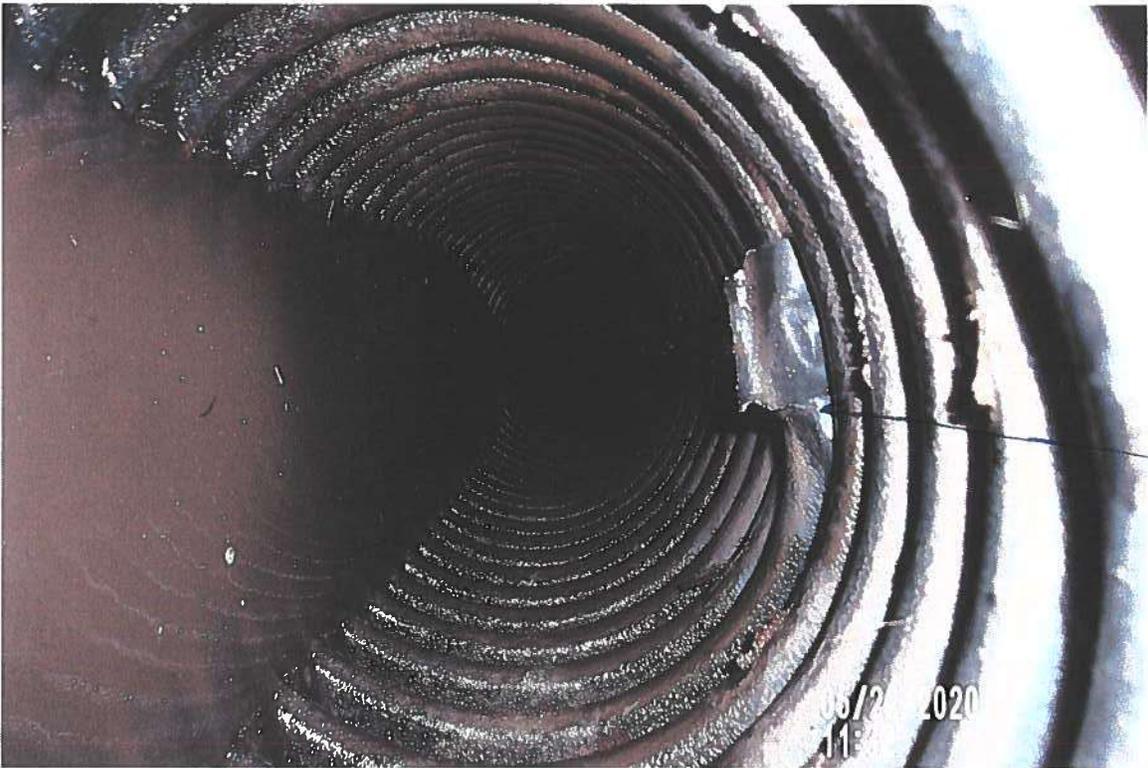
HOLE IN
HDPE TILE

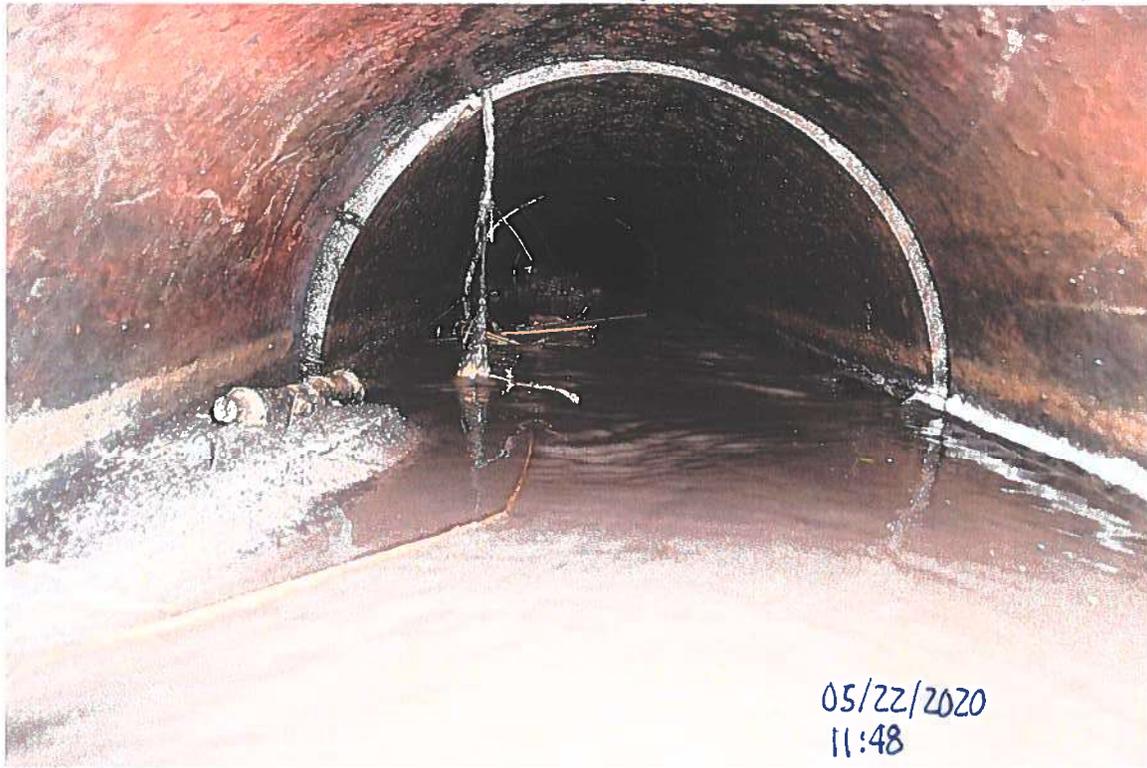
PICTURE 3594 IS LOOKING SOUTH DOWNSTREAM FROM GPS#15
TOP 12" CLAY TILE (1.05' TOP TO FL) SHOWING WATER LEVEL
AT 5" WITH ABOUT 3" OF MUCK IN FL & SOME OTHER DEBRIS.

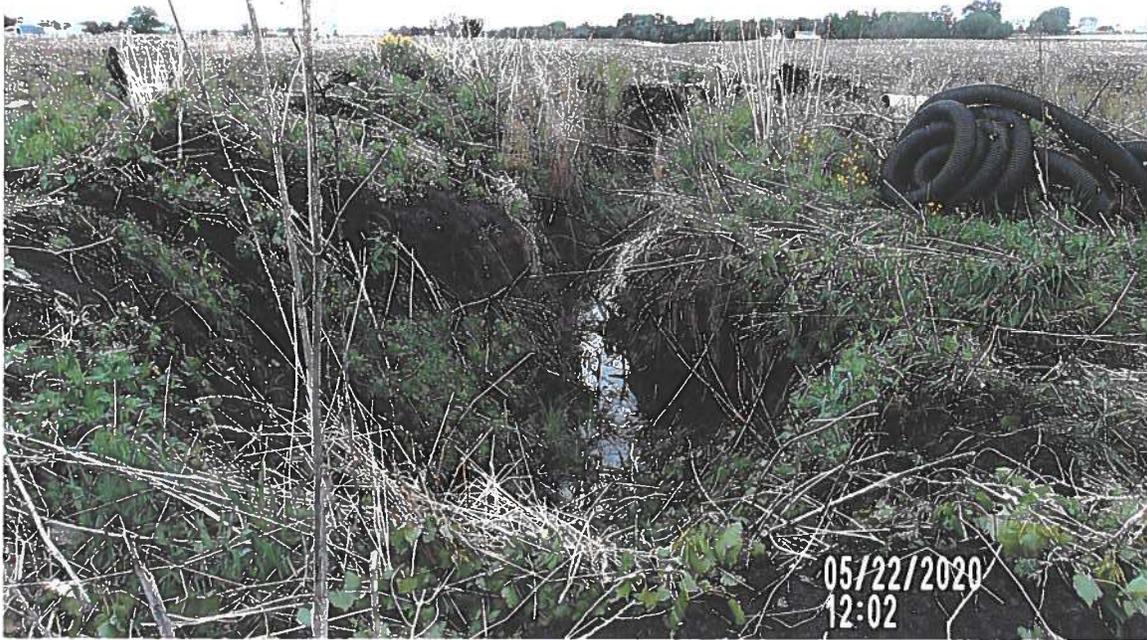
PICTURE # 3596 IS LOOKING SOUTH AT TRENCH WHERE 12" CONCRETE
TILE WAS PREVIOUSLY REMOVED UP TO 12" CLAY TILE (GPS# 14)
& GPS# 16 12" CONCRETE TILE IS FLOWING INTO TRENCH FROM
NORTH END TO (GPS# 14) 12" CLAY TILE.

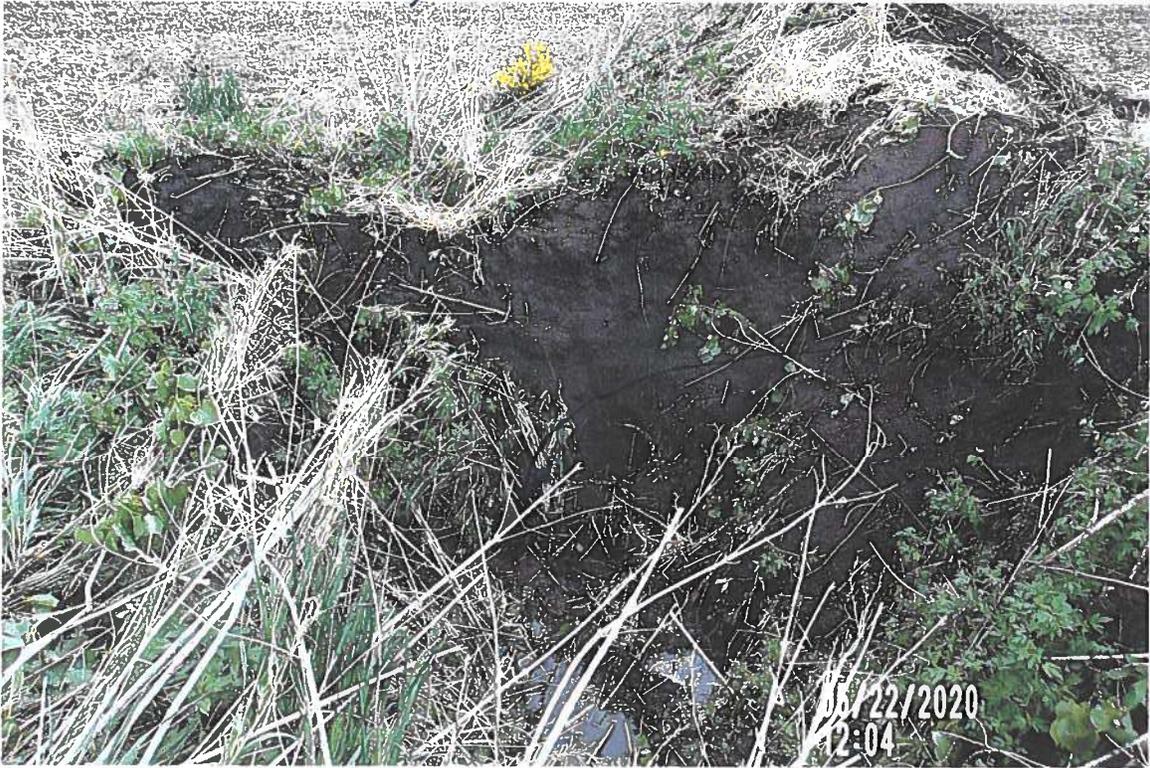
PICTURE # 3597 IS LOOKING NORTH SHOWING 12" CONCRETE TILE FLOWING INTO TRENCH WHERE 12" CONCRETE TILE WAS ALREADY REMOVED UP TO 12" CLAY TILE. THAT NEEDS REPAIRED.

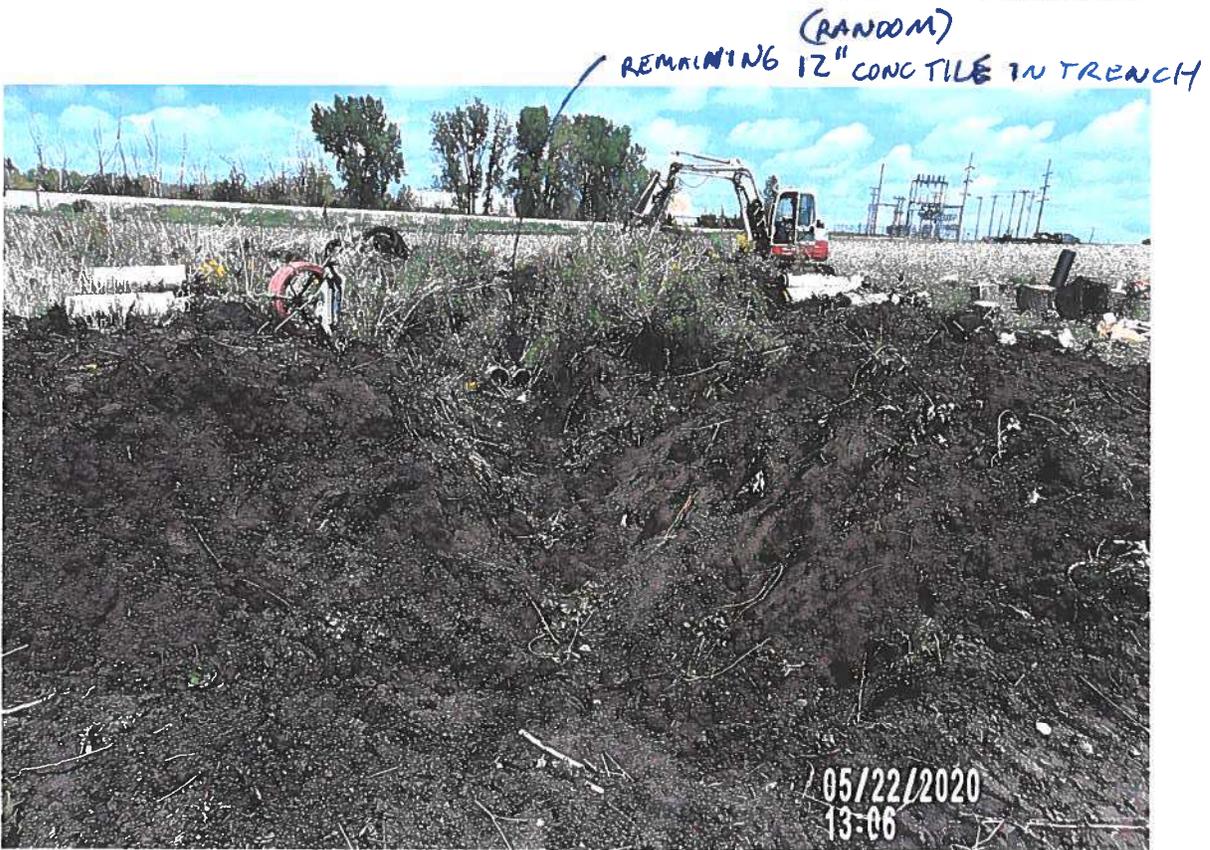
PICTURE # 3606 IS LOOKING SLIGHTLY NE AT TRENCH THAT
NEEDS TILE REPAIRED

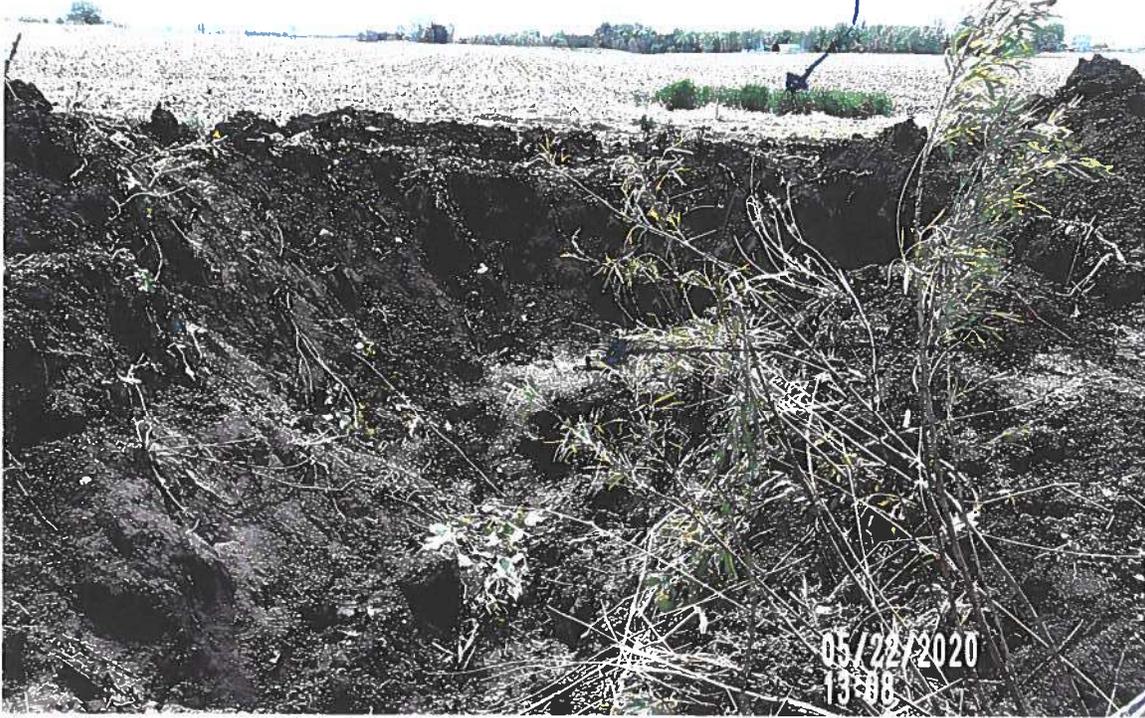
PICTURE # 3611 IS LOOKING AT SOUTH END OF TRENCH THAT NEEDS REPAIRED
