**AGENDA**  
**REGULAR DRAINAGE MEETING**  
**February 12, 2020 9:30 AM**

**ENGINEER'S REPORT  
ON REPAIRS  
TO MAIN TILE  
DRAINAGE DISTRICT  
NO. 86  
HARDIN COUNTY,  
IOWA**

**SUPPLEMENT TO  
ENGINEER'S REPORT  
ON REPAIRS  
TO MAIN TILE  
DRAINAGE DISTRICT  
NO. 86  
HARDIN COUNTY,  
IOWA**

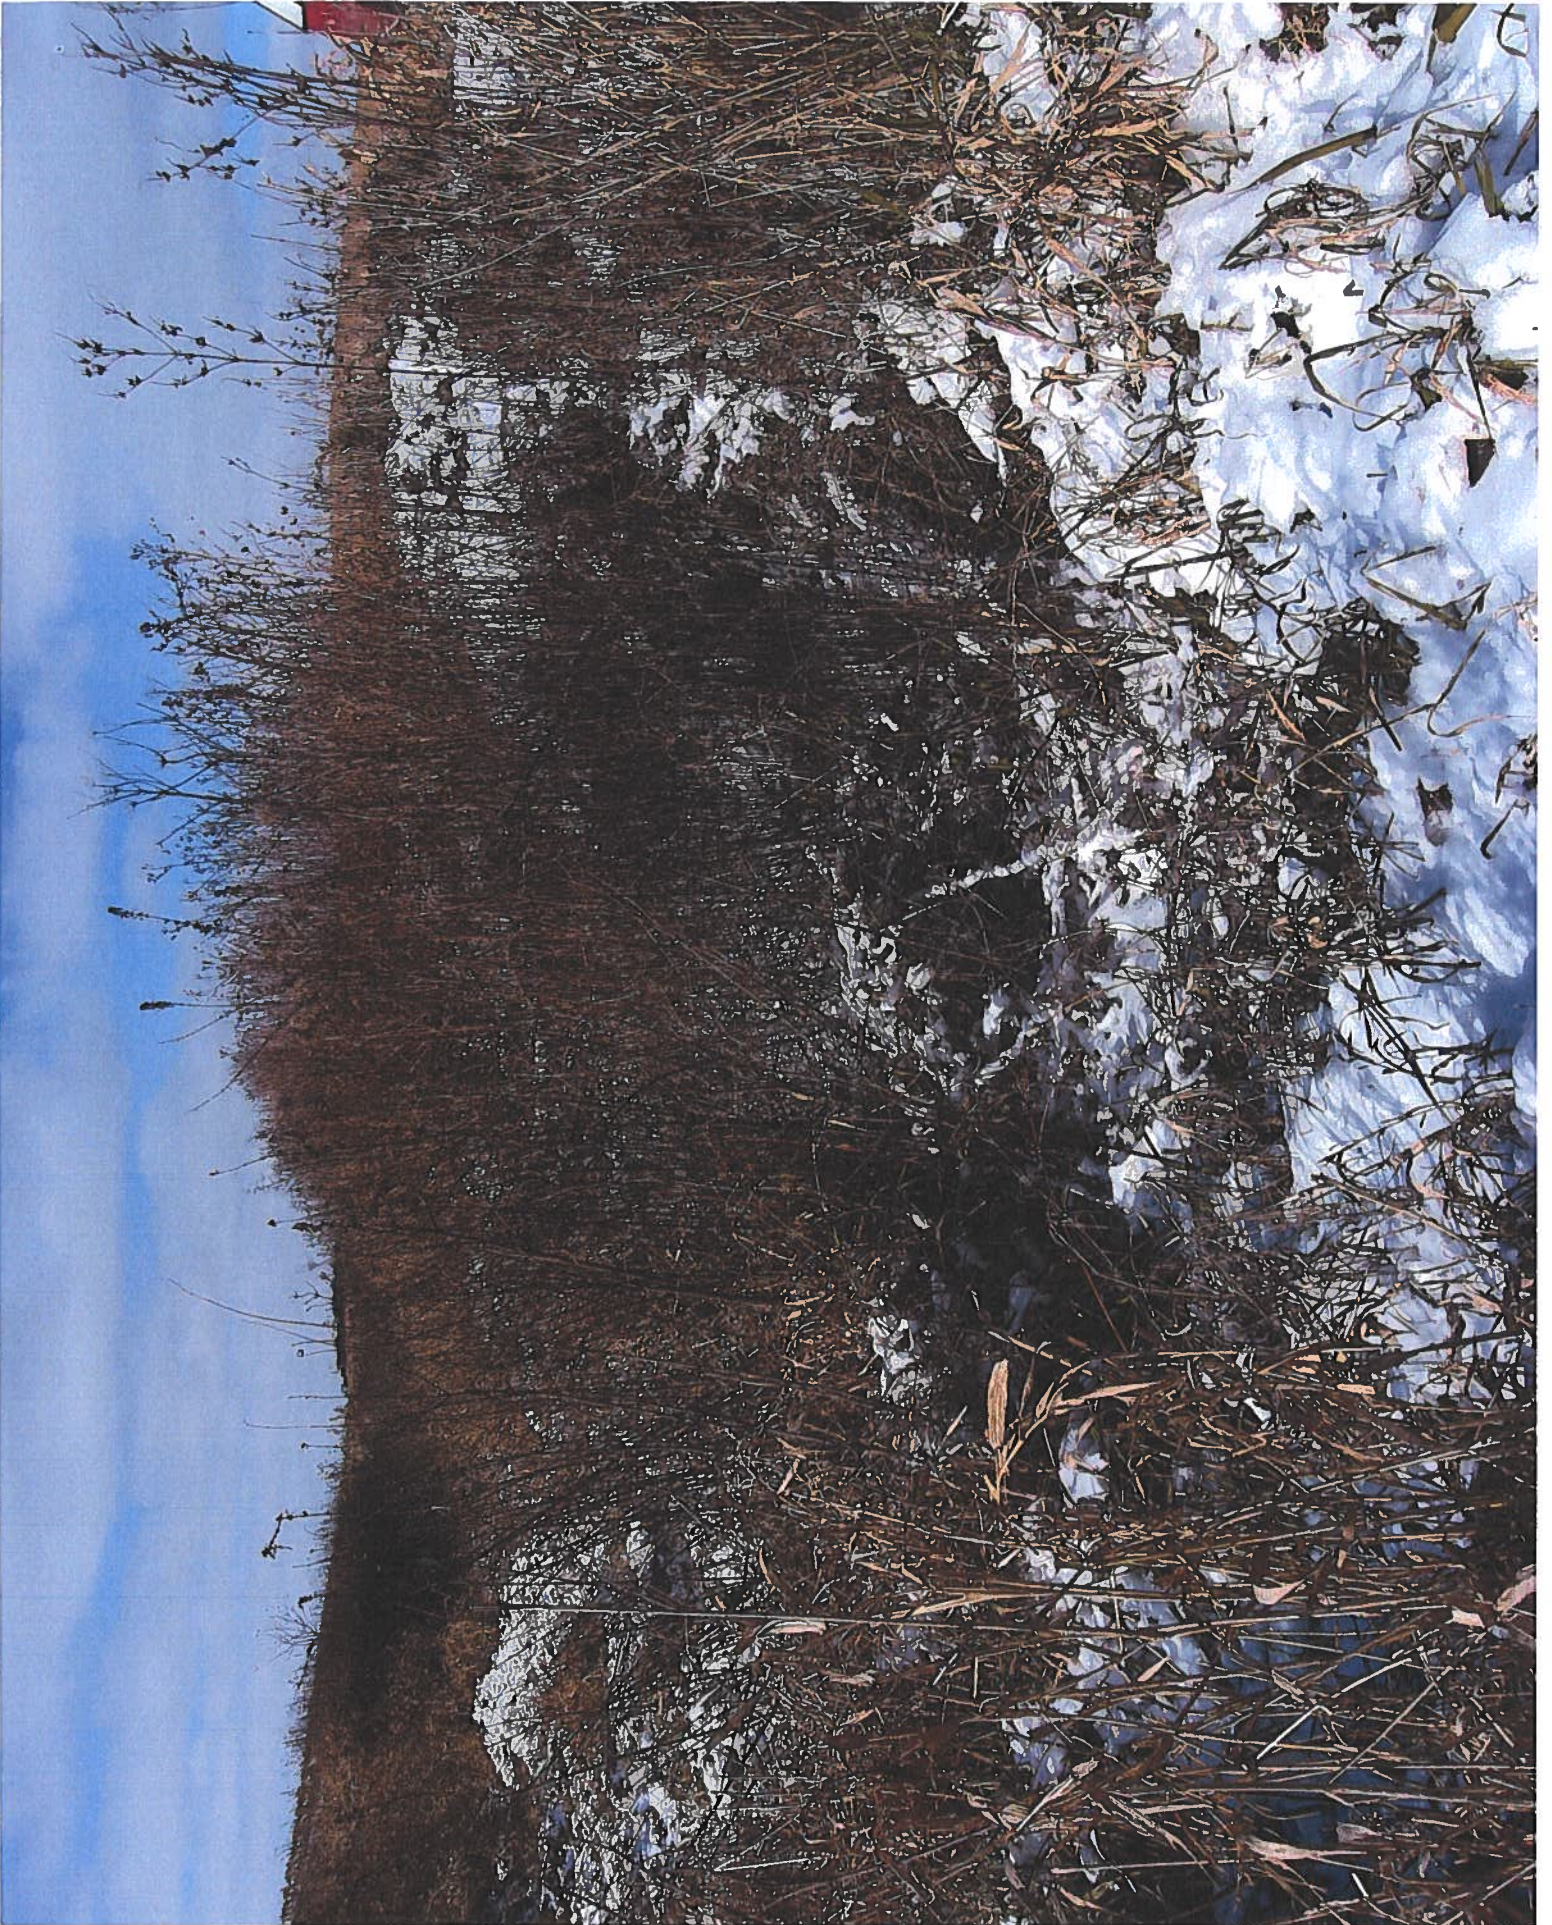
Looking W. @ D.O.T. Hwy 20 R/W

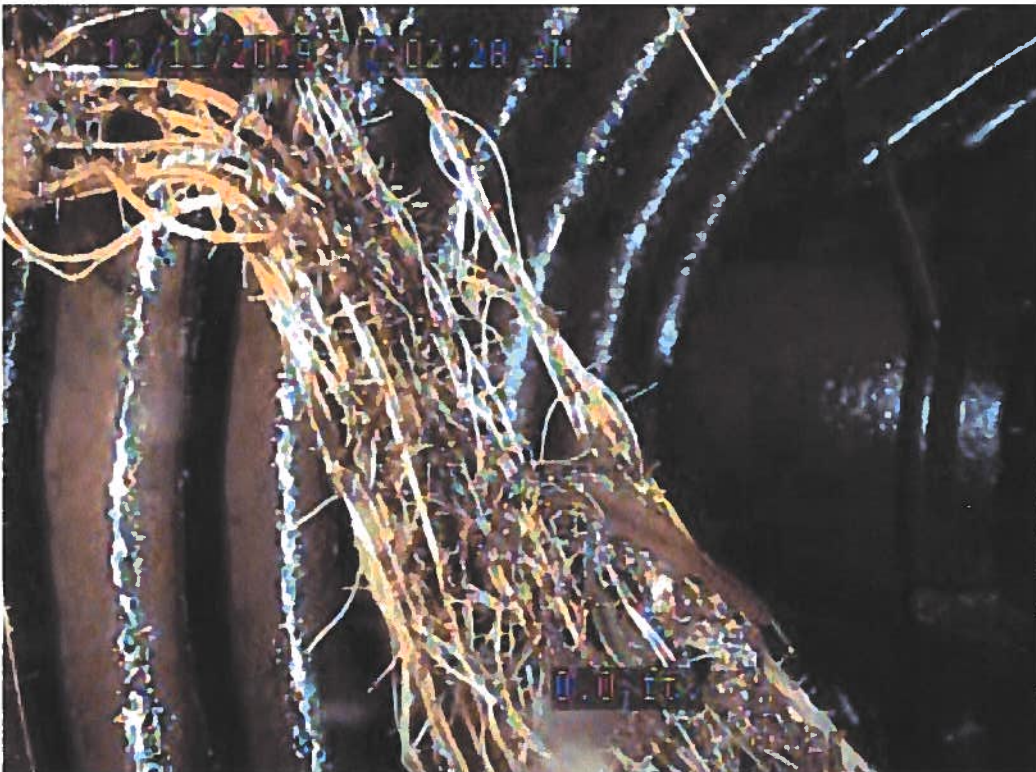
Figure 2: Roots infiltrating joint between VCP and single wall HDPE.

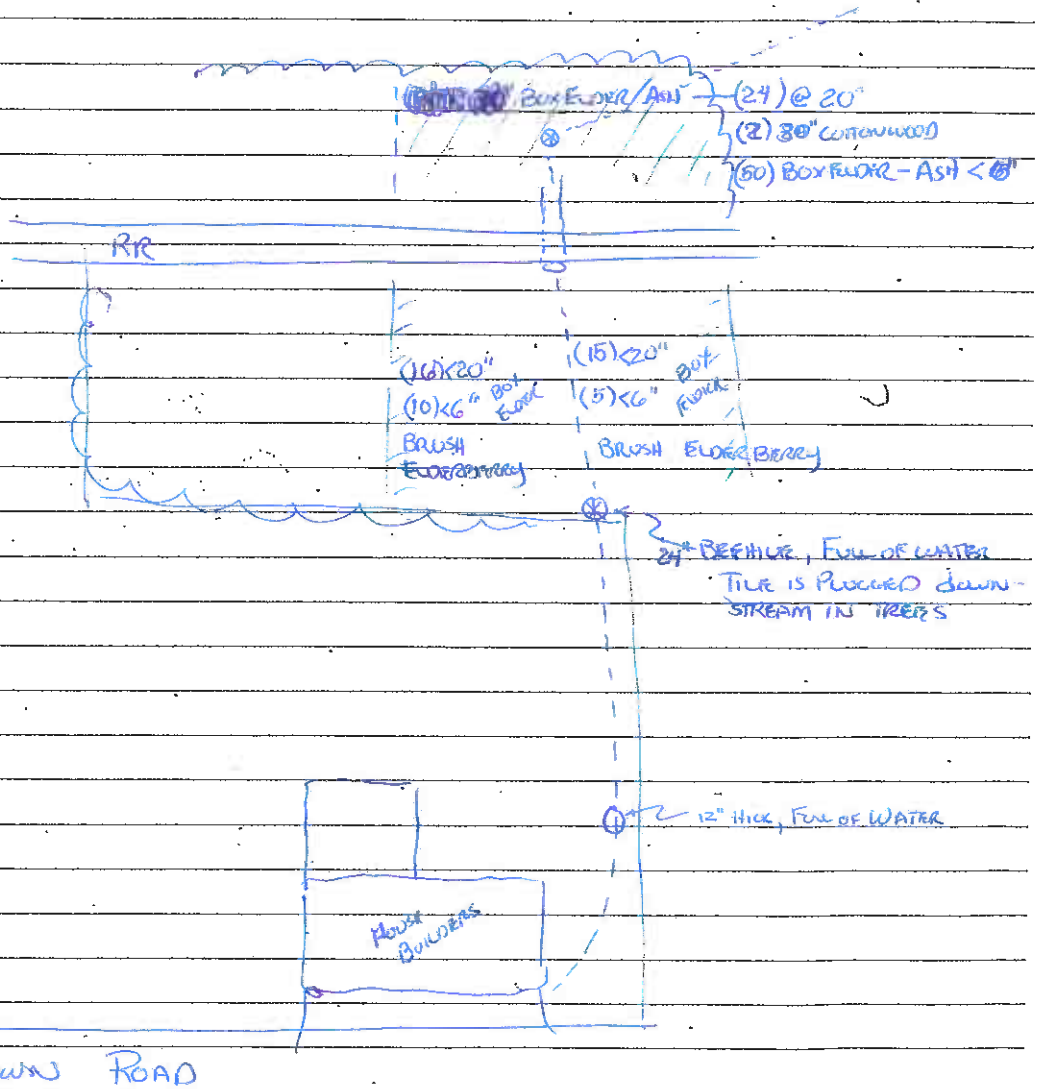
DAGO LAKE INLET (DD86 OLD MAIN) (14) 15" BOX ELDER AND HONEYSUCKLE BRUSH NEEDS REMOVED

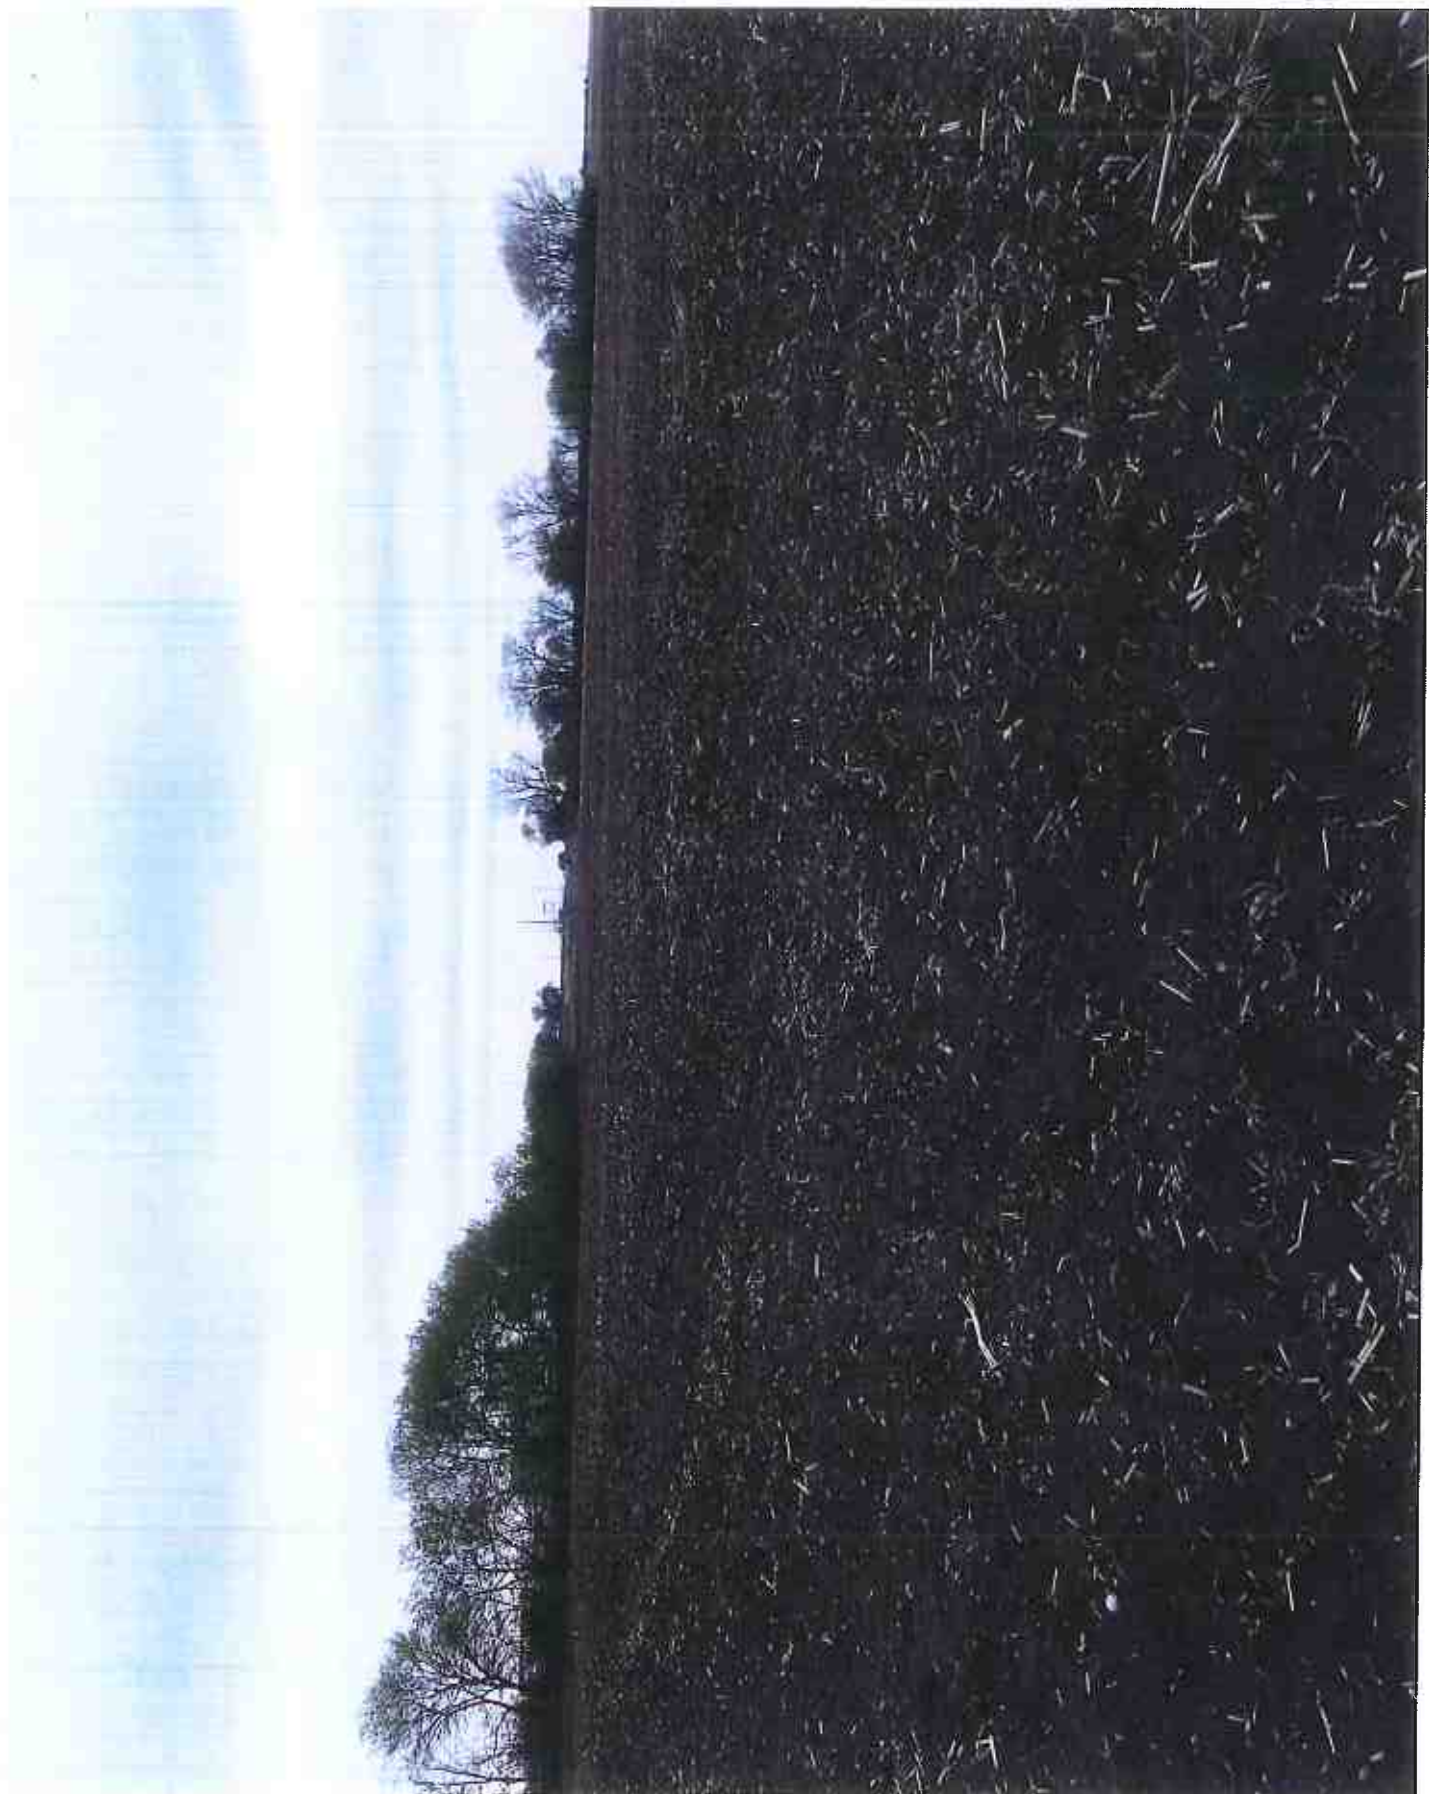
LOOKING EAST @ MONARCH LAKE TIRE ROUTE (5) TREES NEED REMOVED (NOT CEDAR TREES)

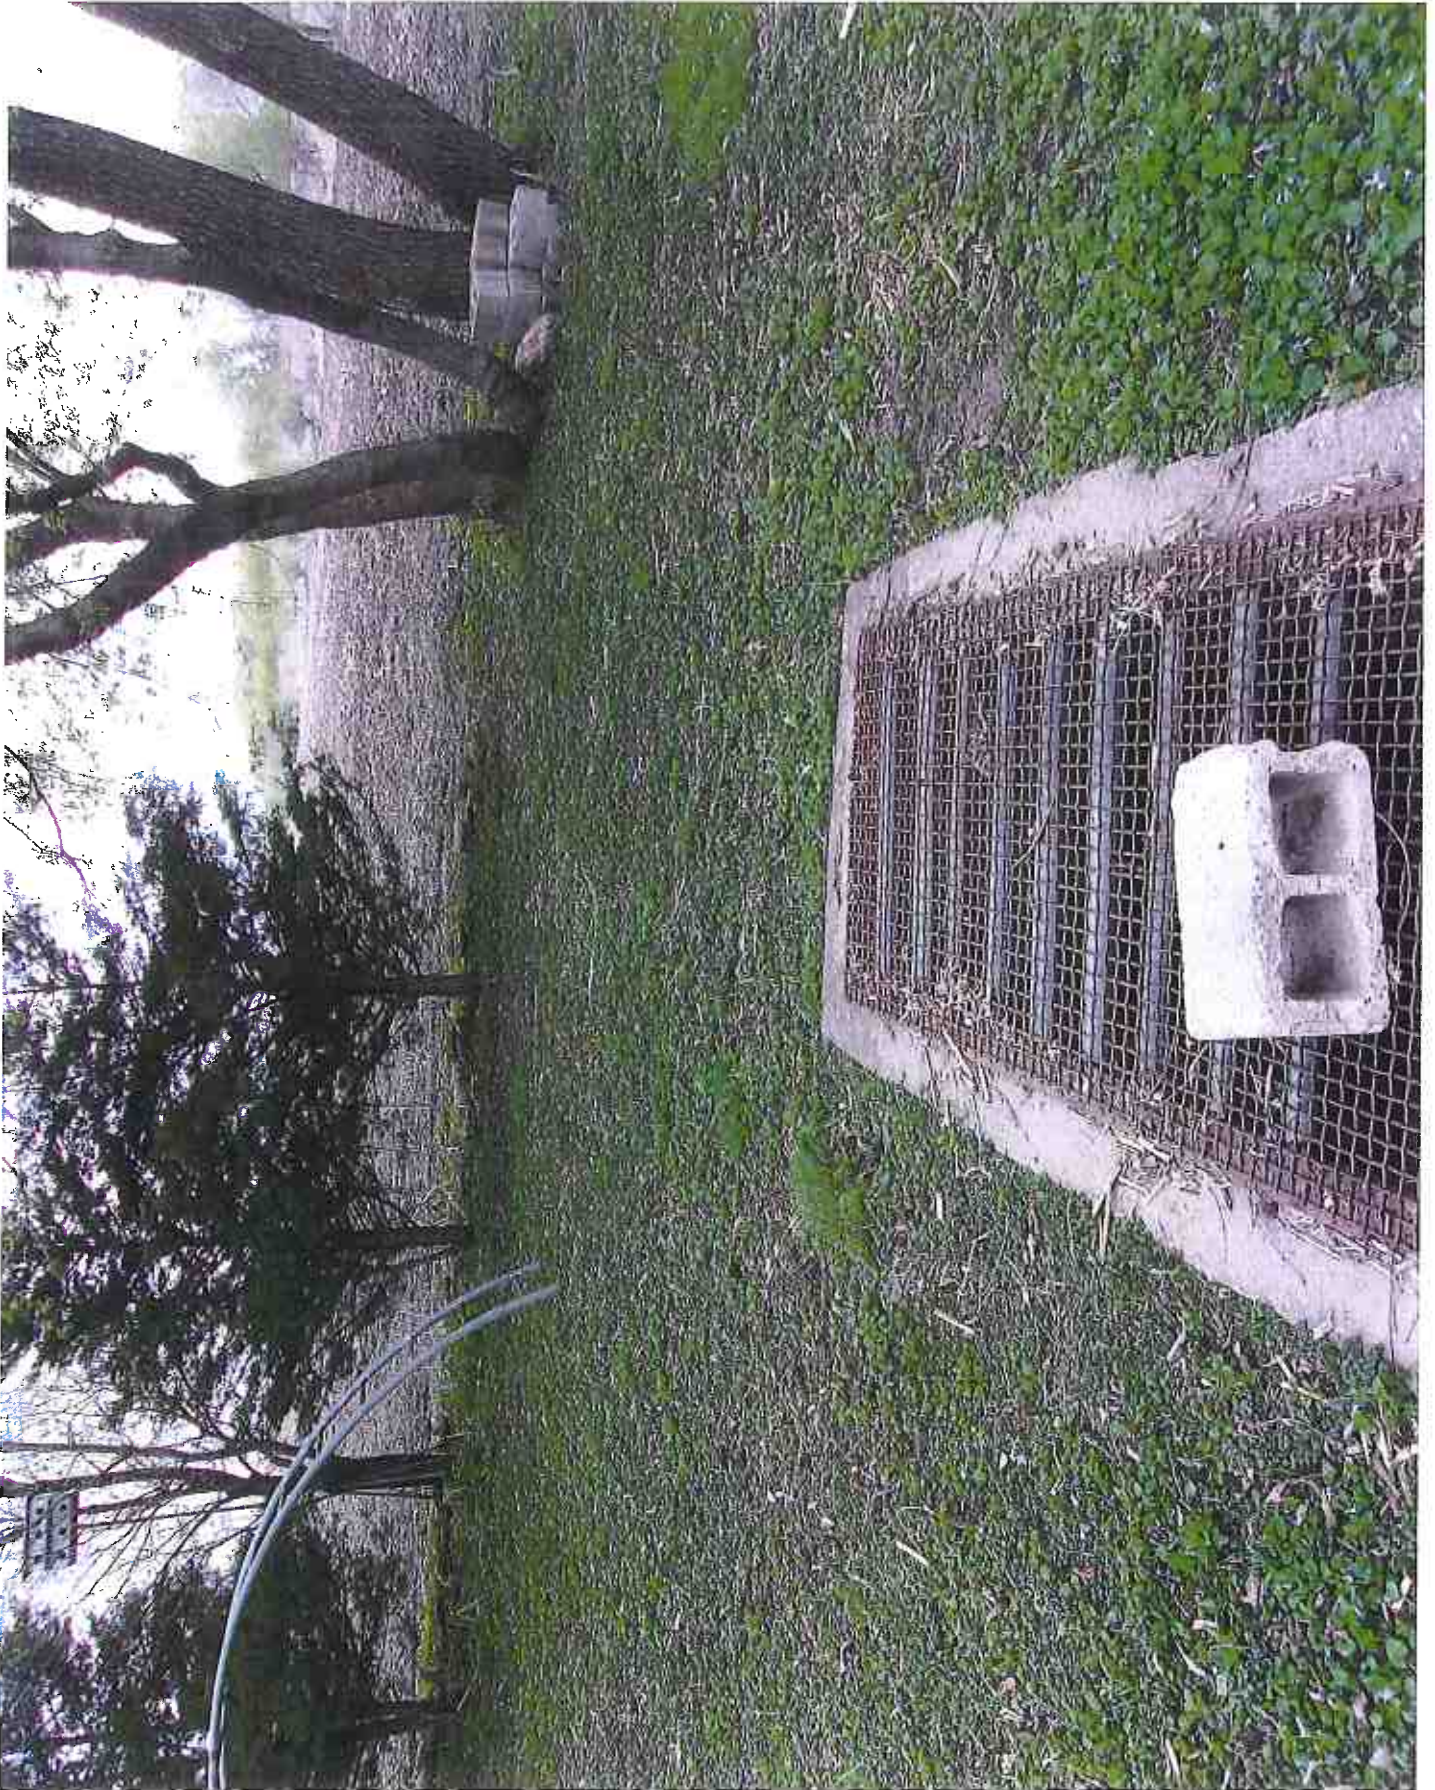
SURFACE DRAINAGE From S. RR @ MONARCH LAKE

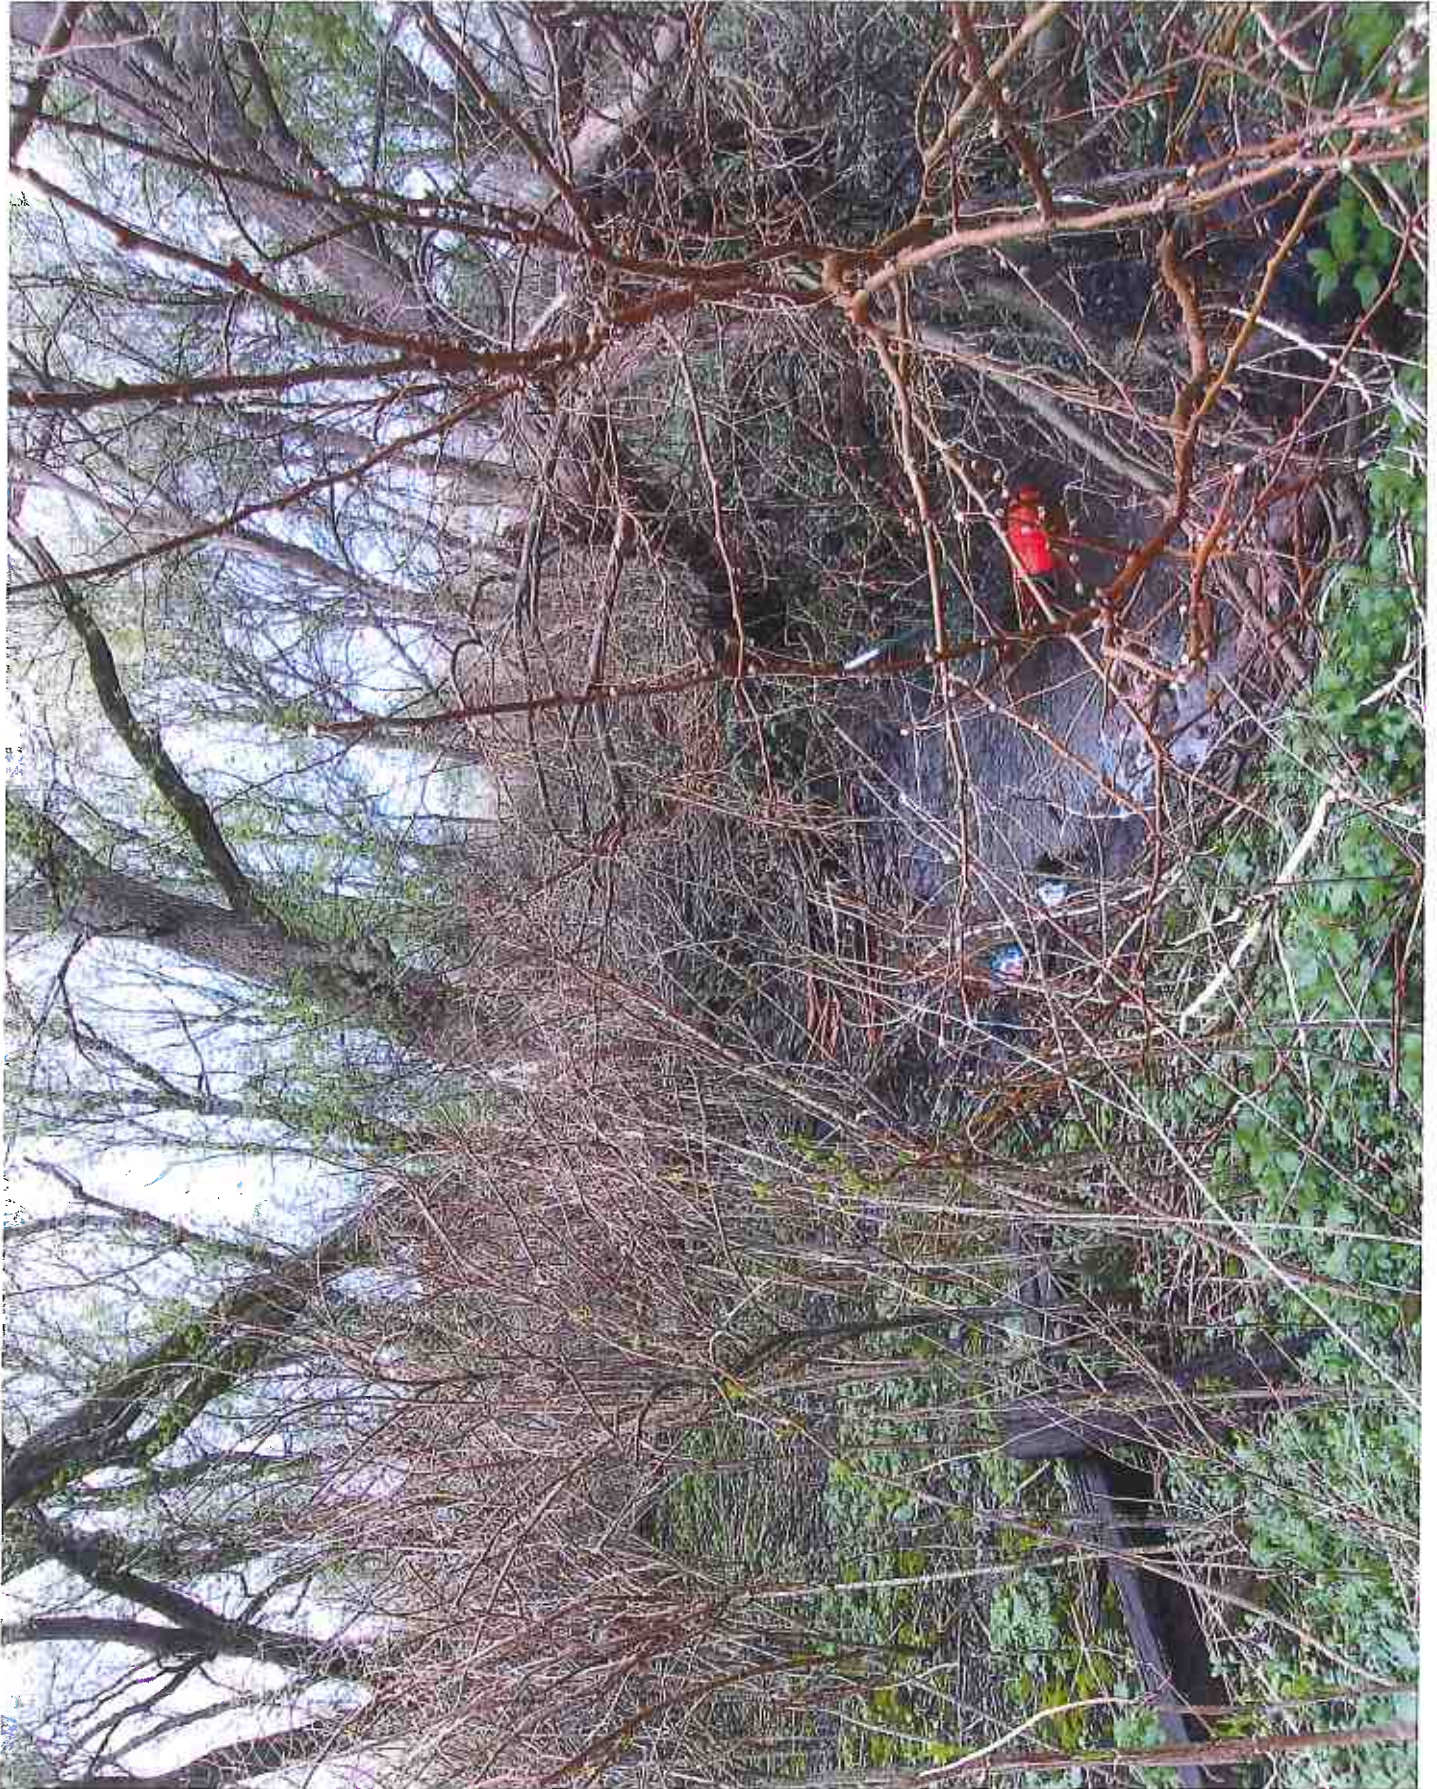
LOOKING DOWNSTREAM @ RR MAINLINE, SURFACE TUBE DRAINS INTO DD86 TILE

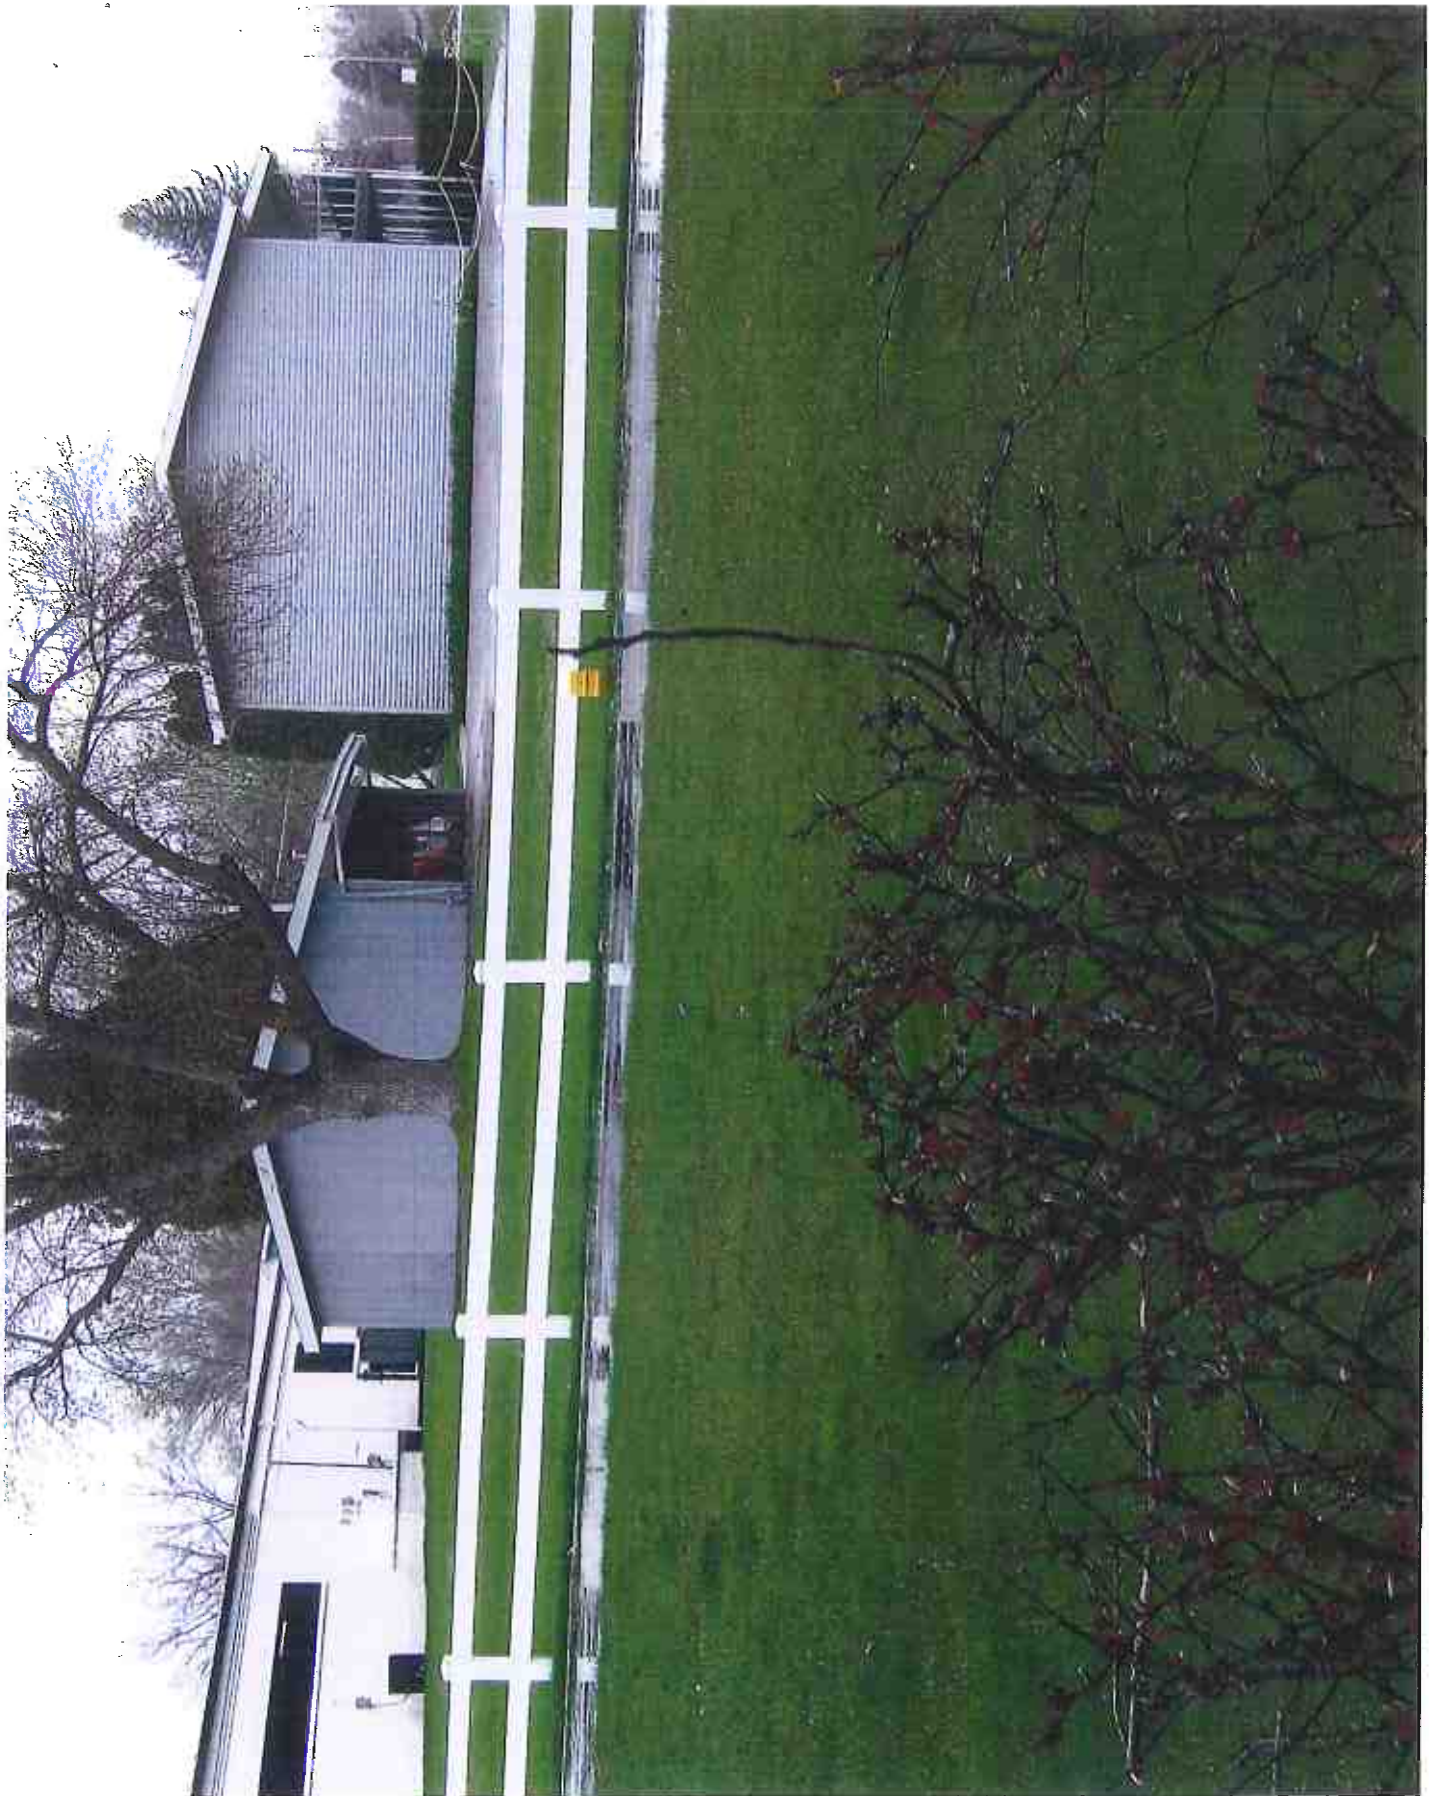
BEEHIVE INTAKE IS IN TREES SOMEWHERE 90+ TREES IN THE R/W N. OF RR

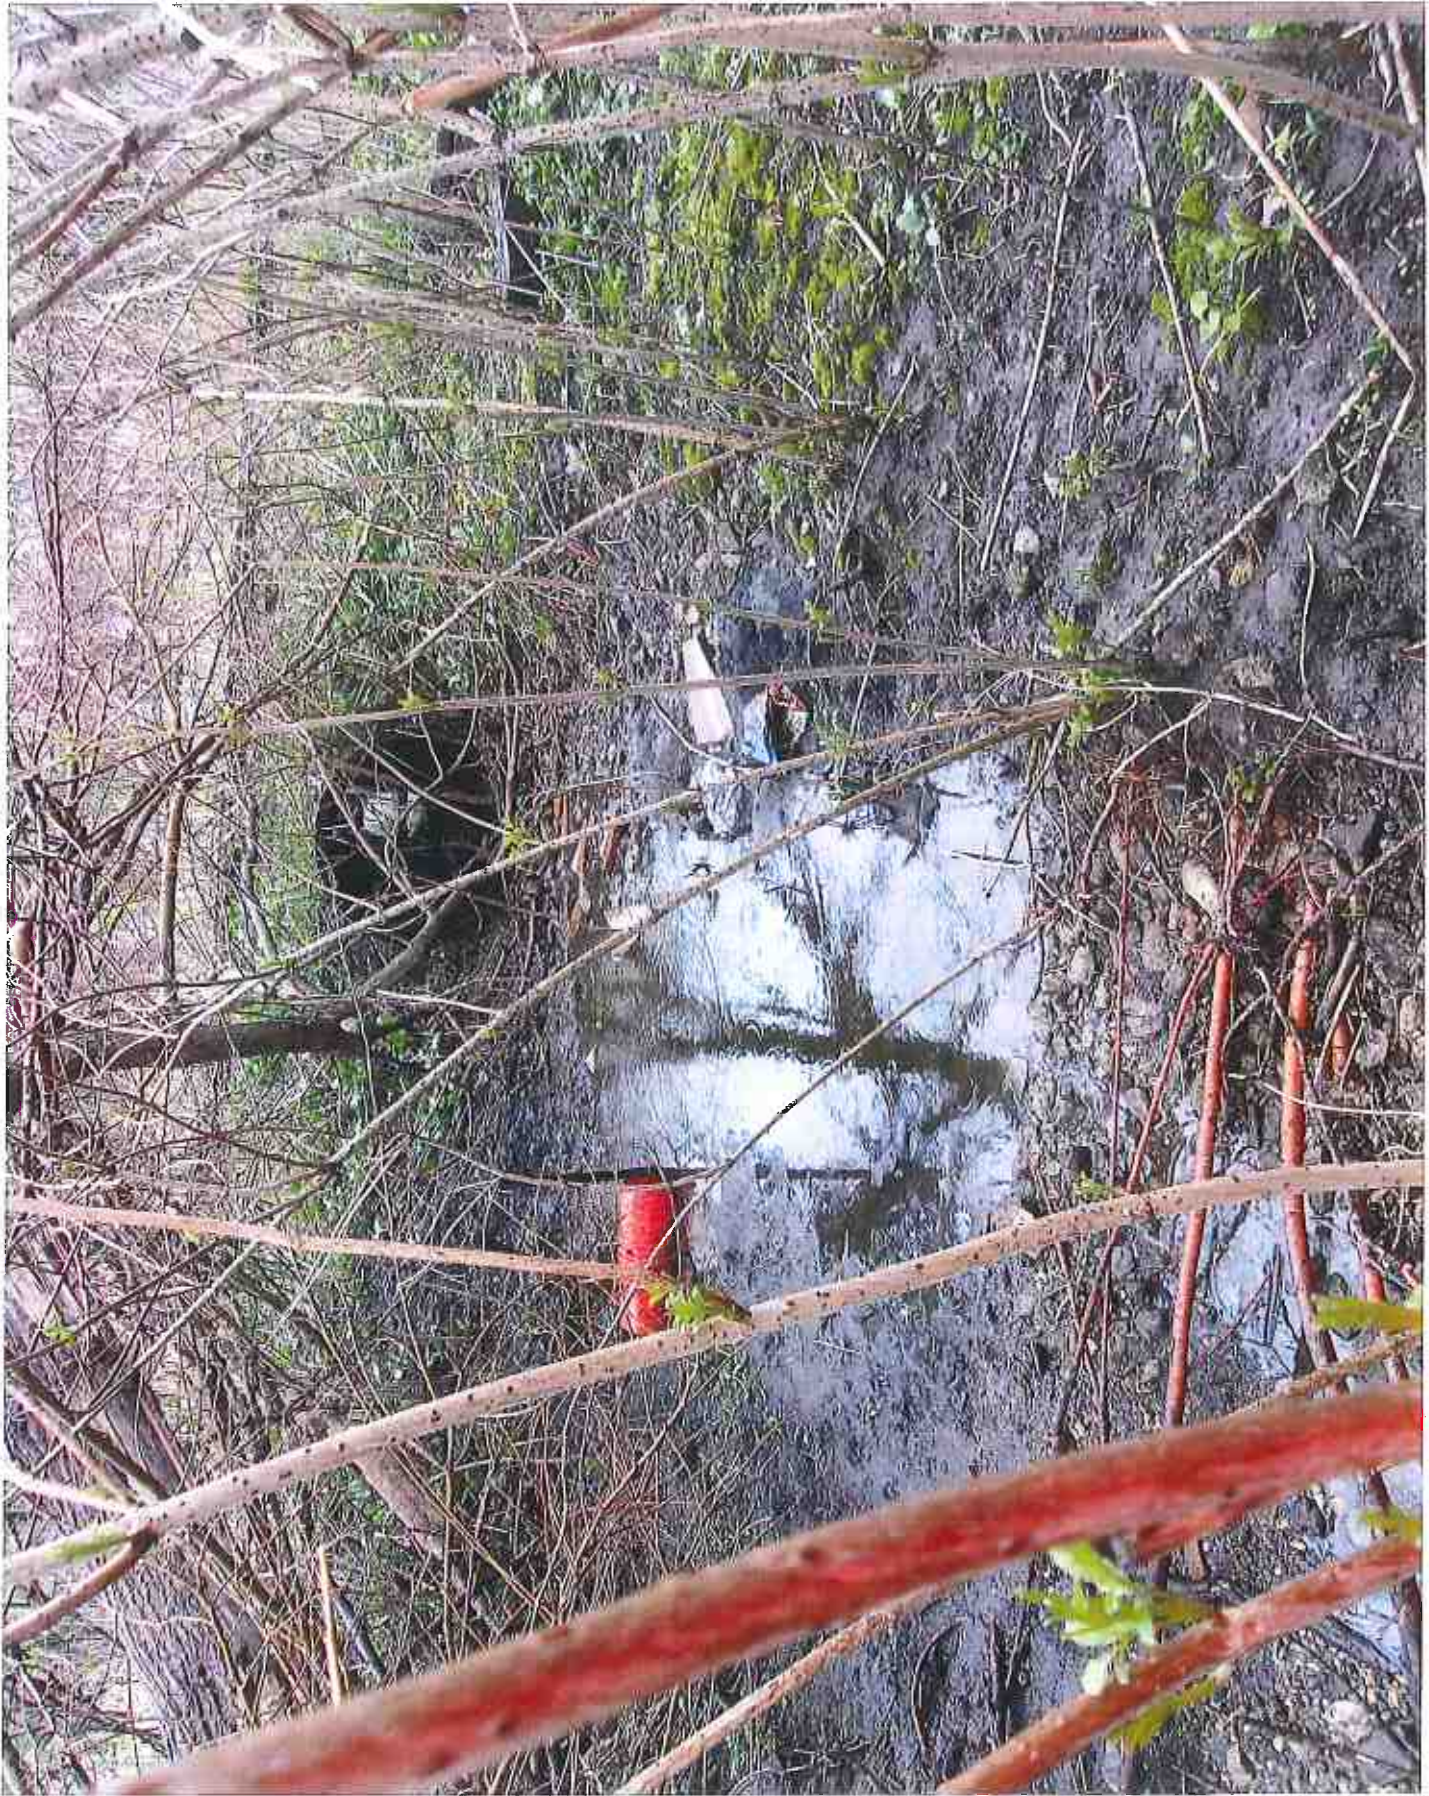
TILE ROUTE MARKED WITH BROKEN TILE

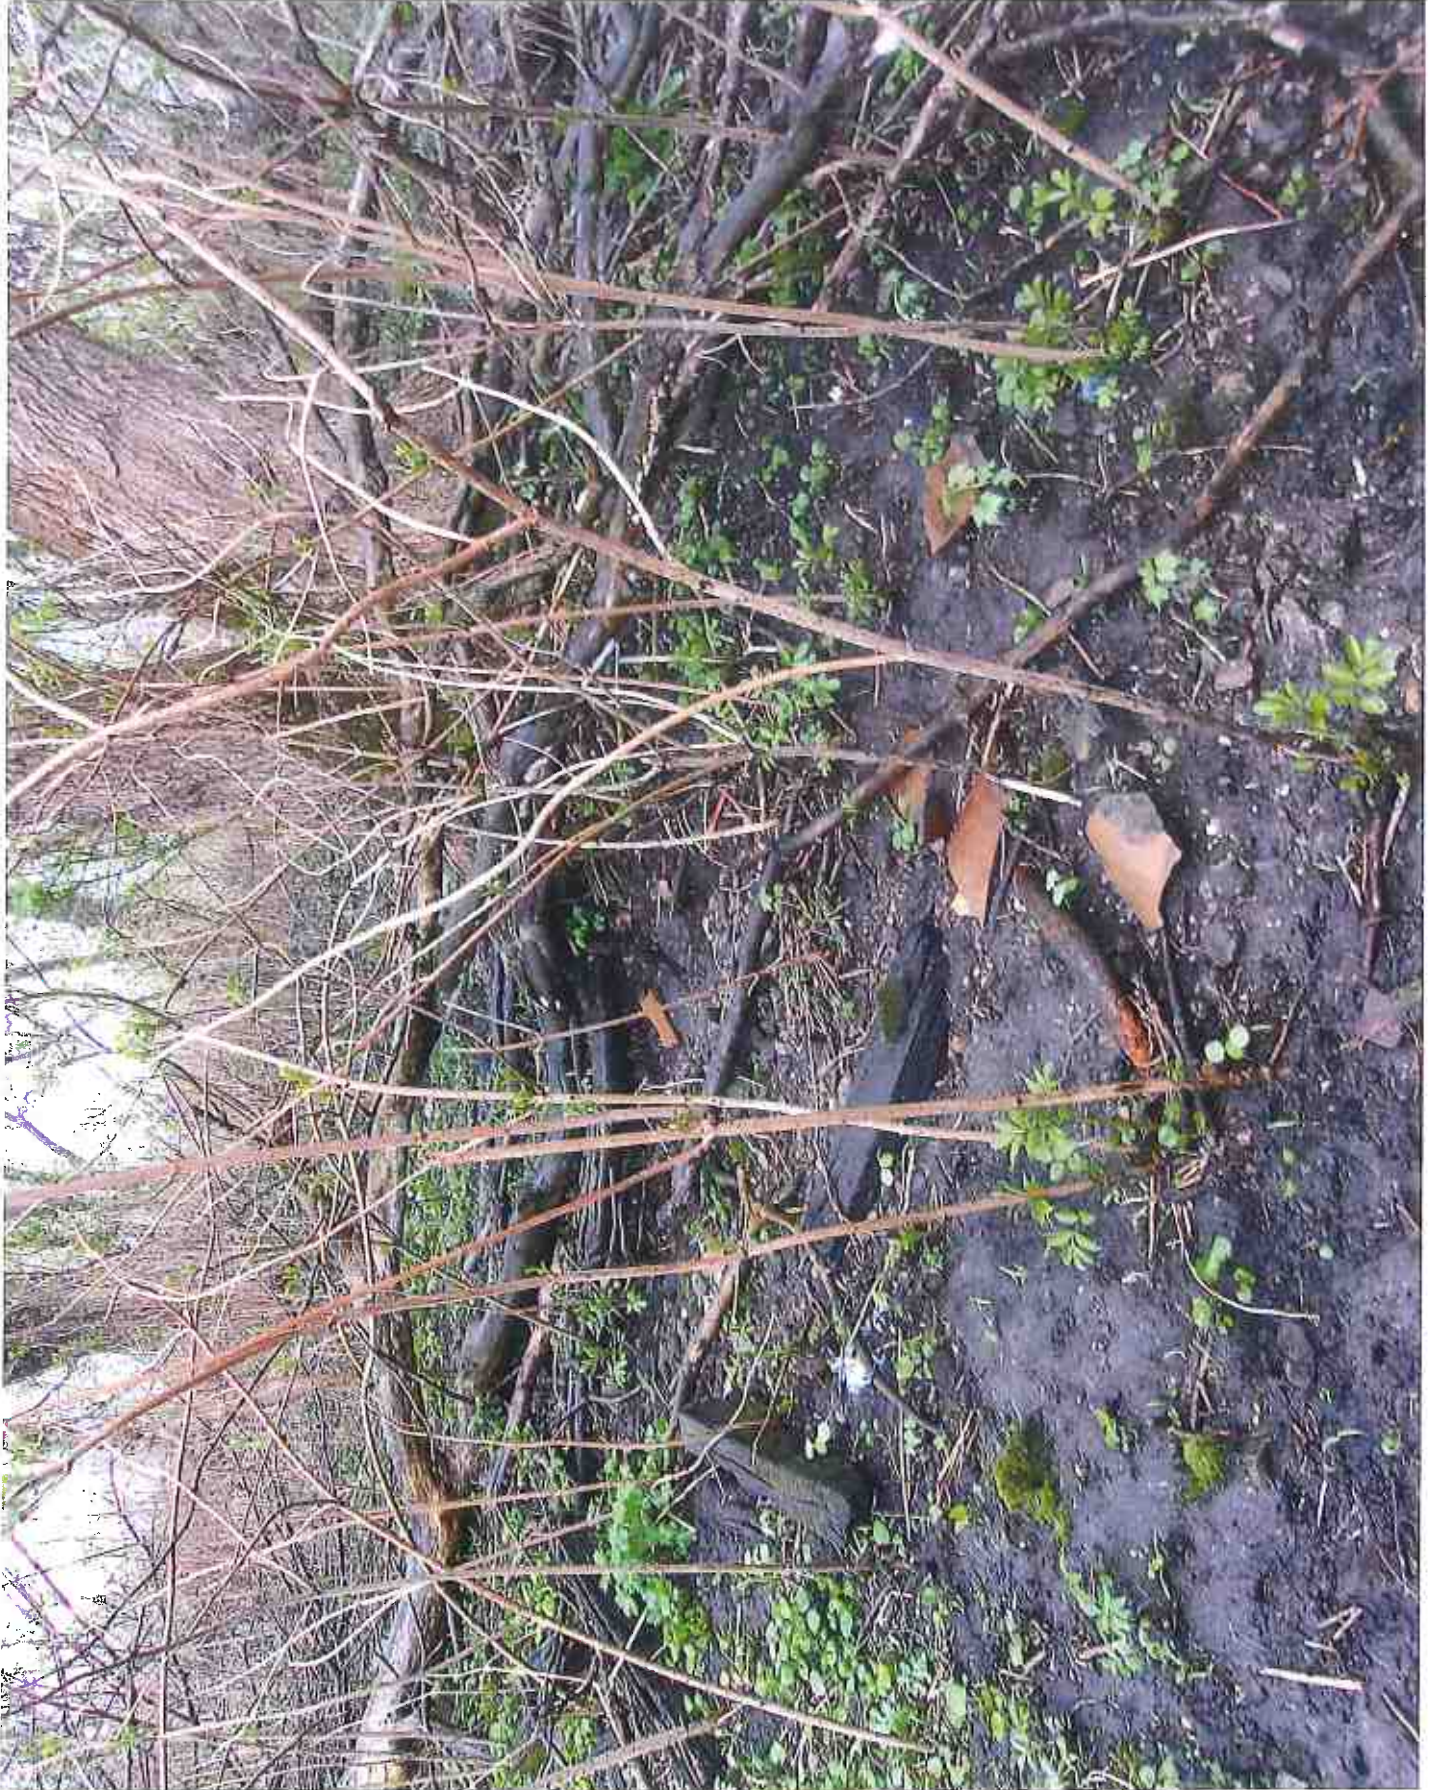
TILE ROUTE WITH CHARDS IN TREE ROOTS

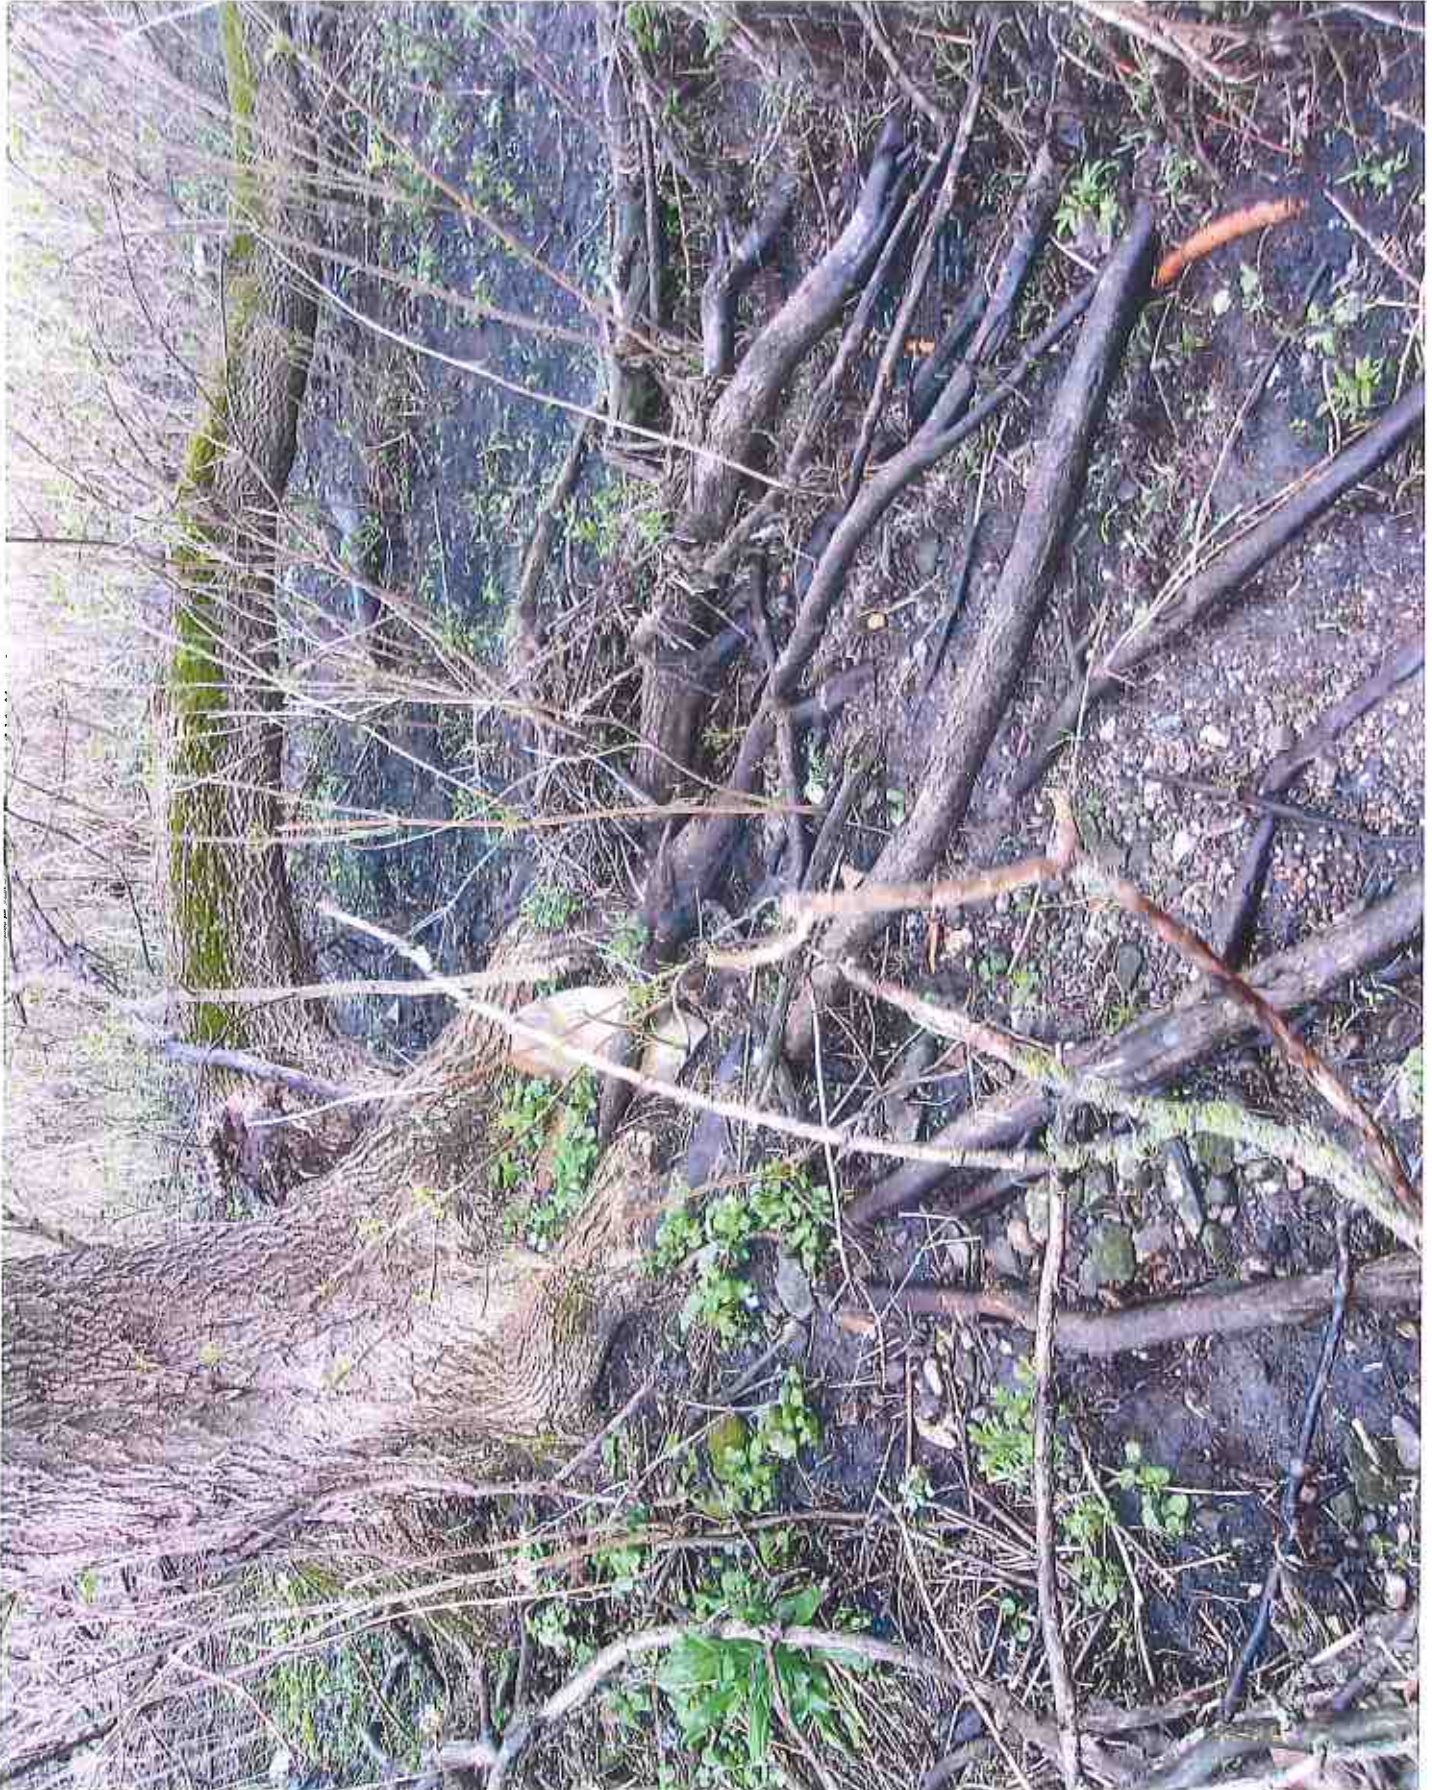
TILE CHARDS THRU ELDERBERRY BRUSH
