**AGENDA**  
**REGULAR DRAINAGE MEETING**  
**February 12, 2020 9:30 AM**

**ENGINEER'S REPORT  
ON REPAIRS  
TO MAIN TILE  
DRAINAGE DISTRICT  
NO. 86  
HARDIN COUNTY,  
IOWA**

**SUPPLEMENT TO  
ENGINEER'S REPORT  
ON REPAIRS  
TO MAIN TILE  
DRAINAGE DISTRICT  
NO. 86  
HARDIN COUNTY,  
IOWA**

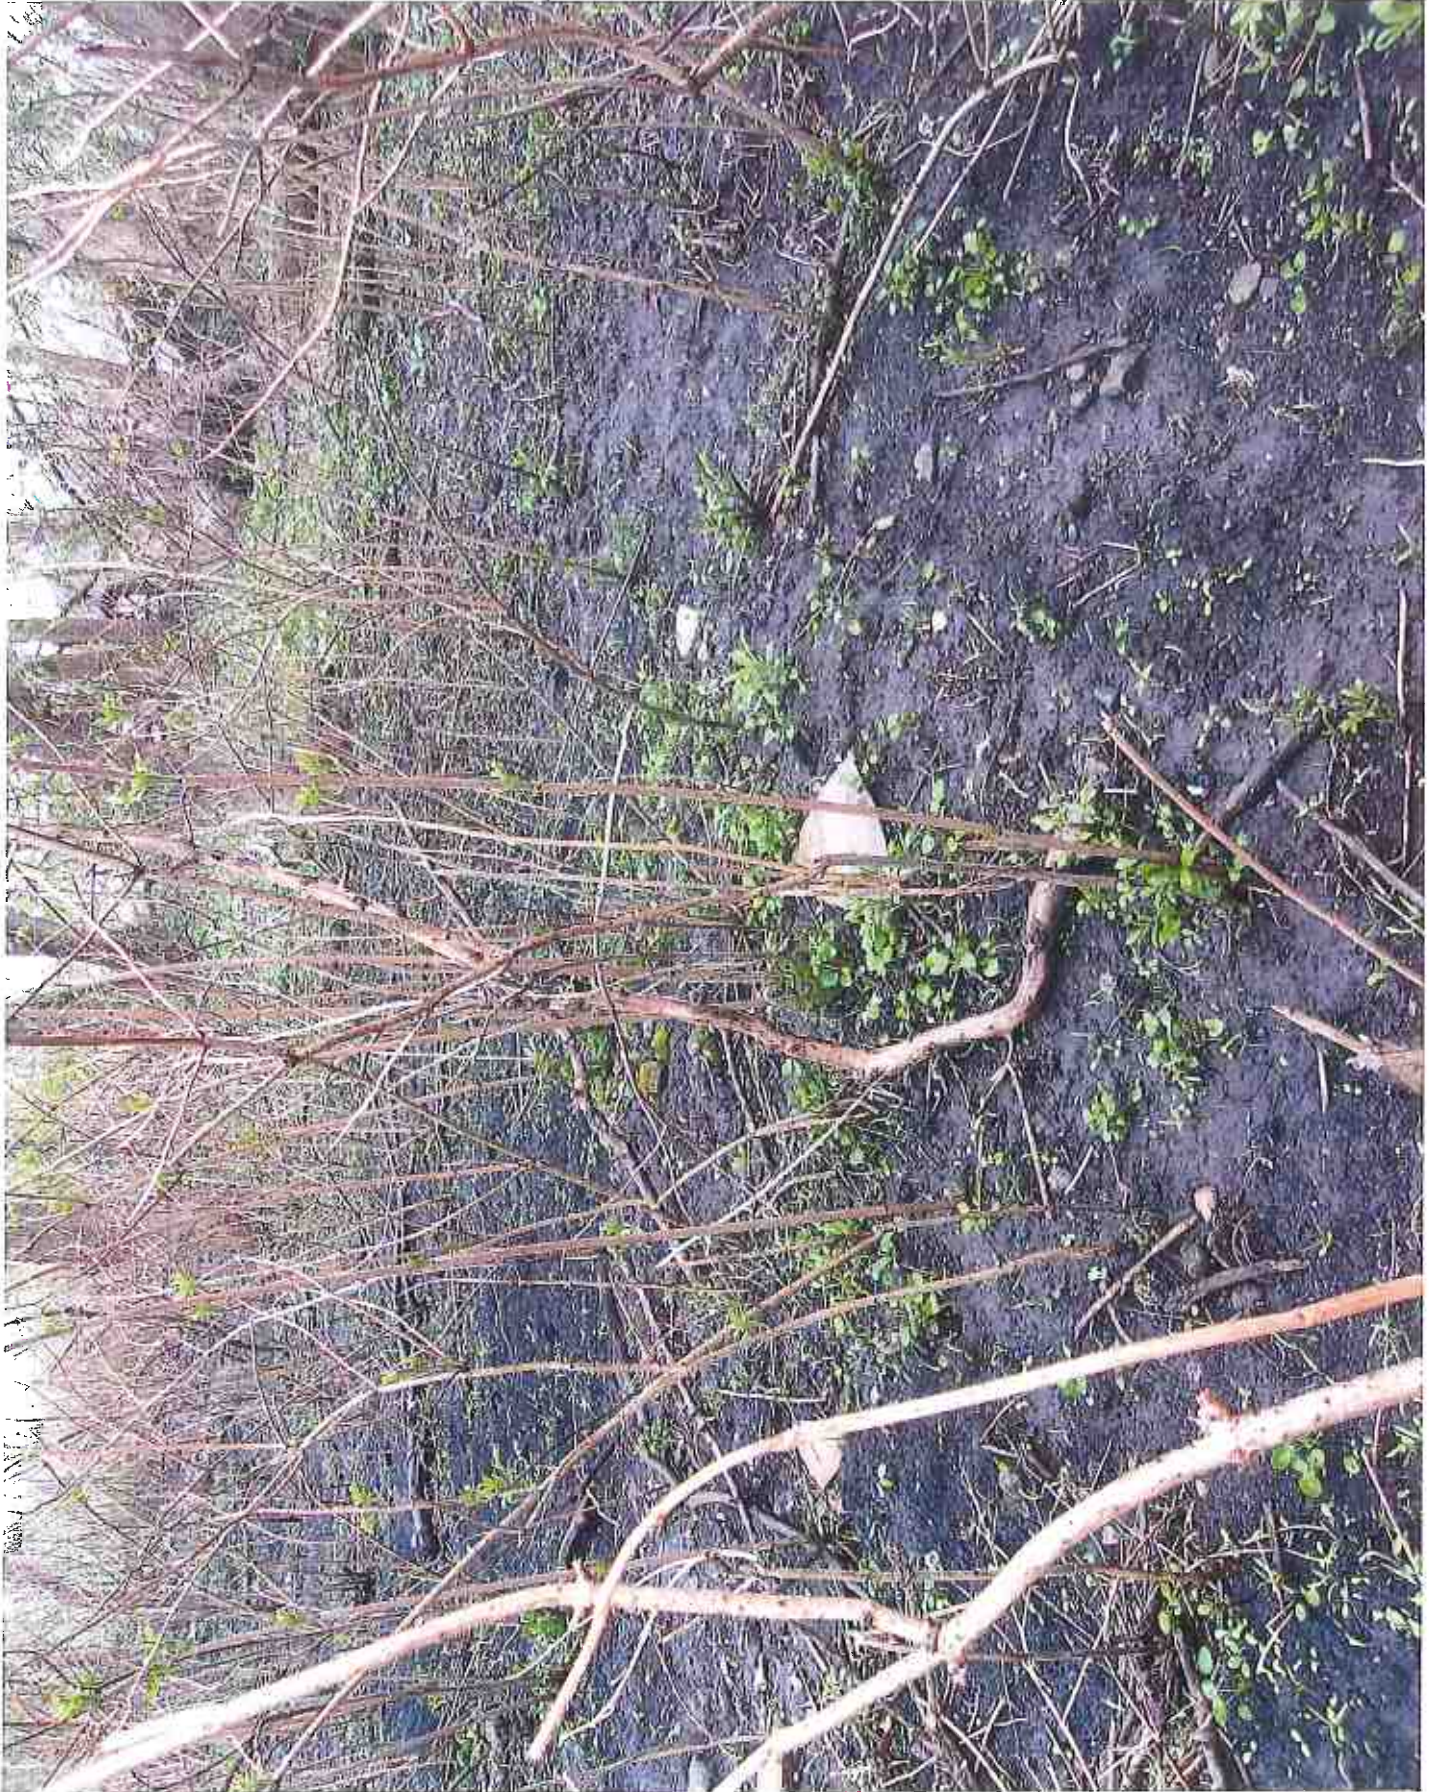
TILE REPAIR PIECES DISCARDED

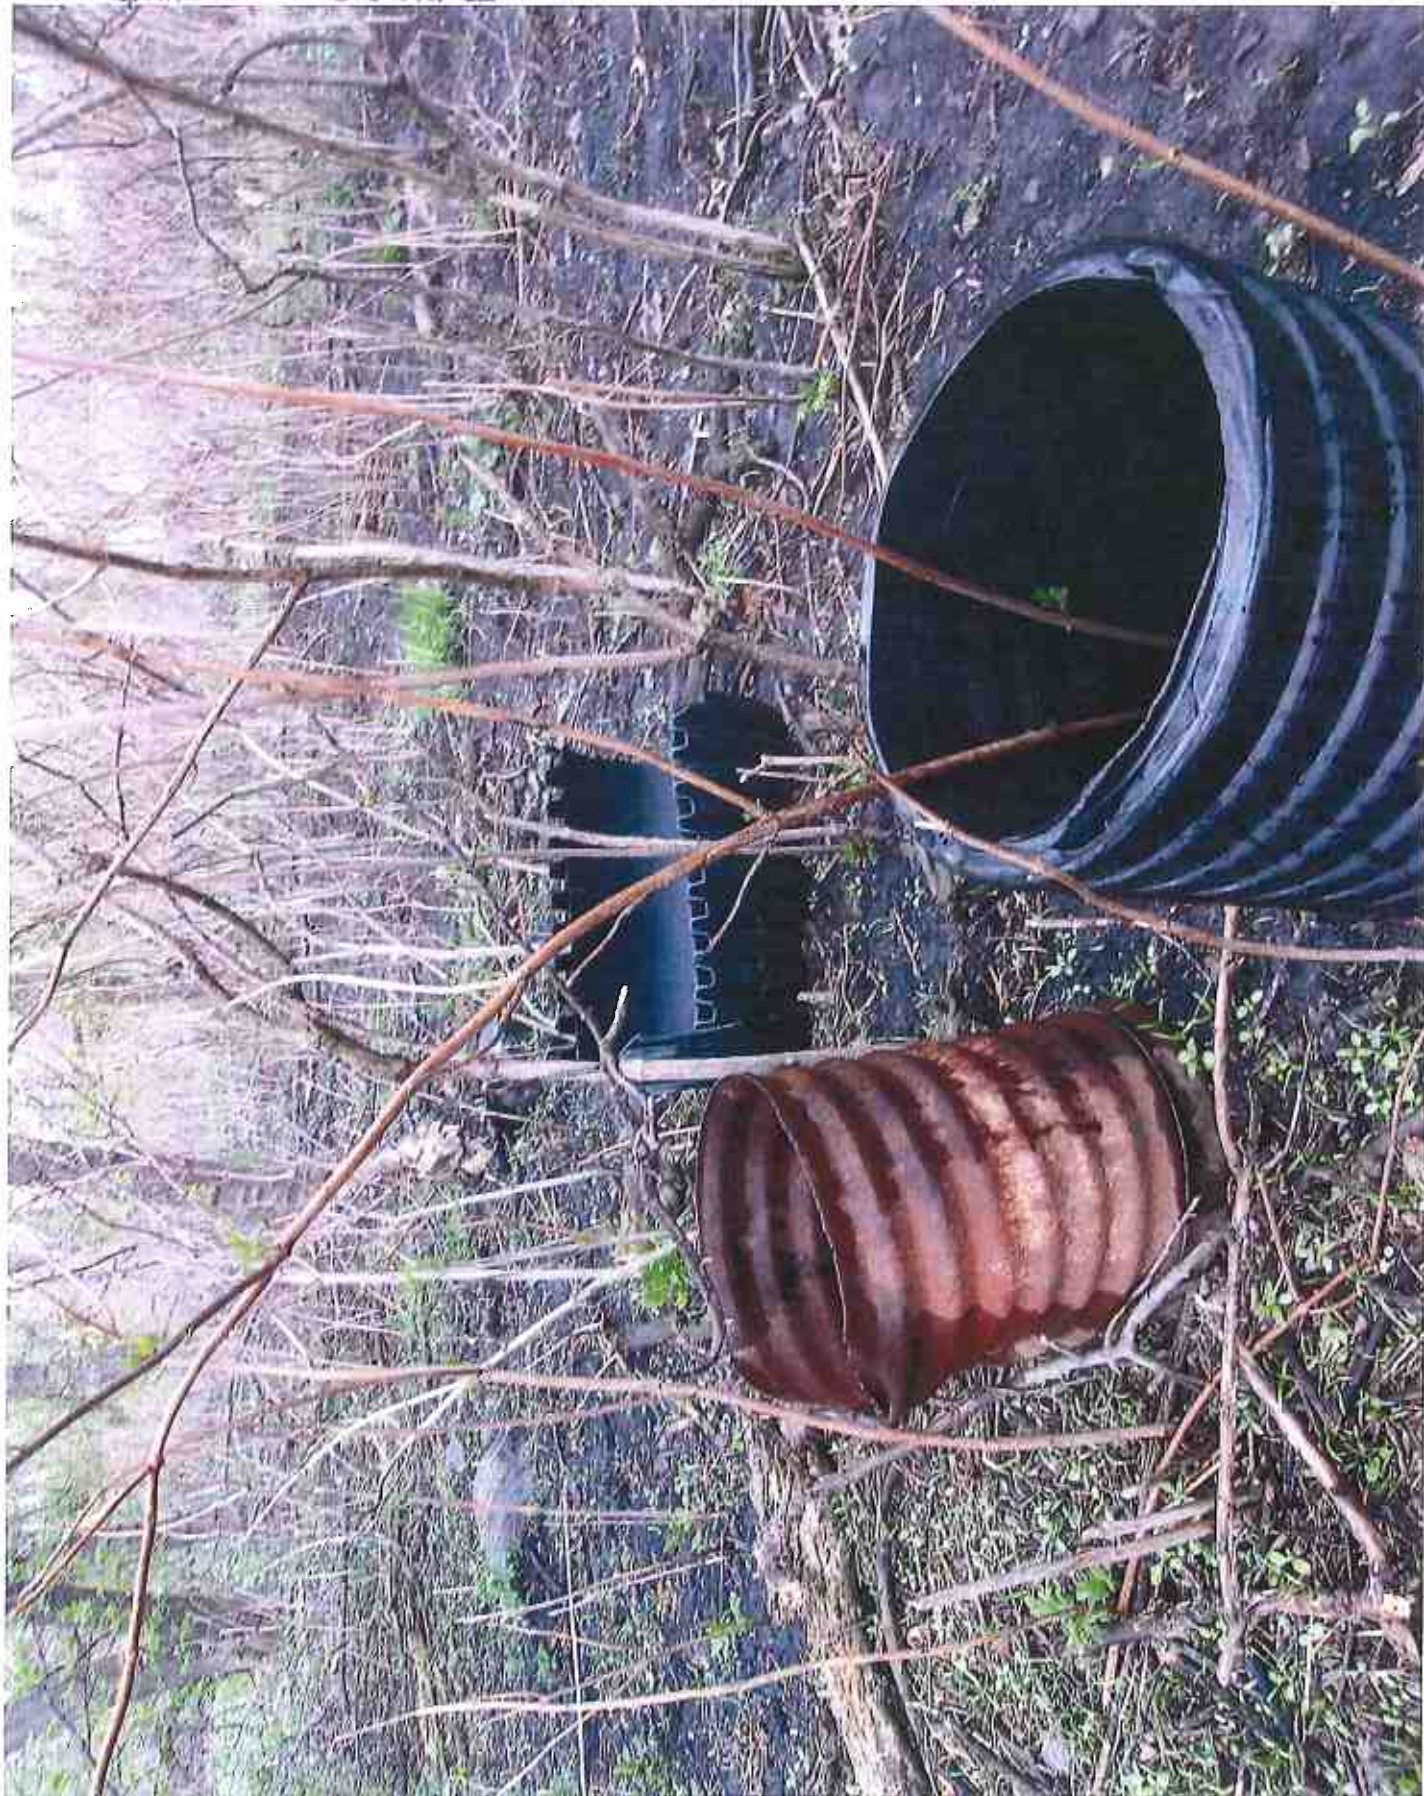
BREEZIE OVERFLOWING @ NE COR OF GEORGETOWN ADD.

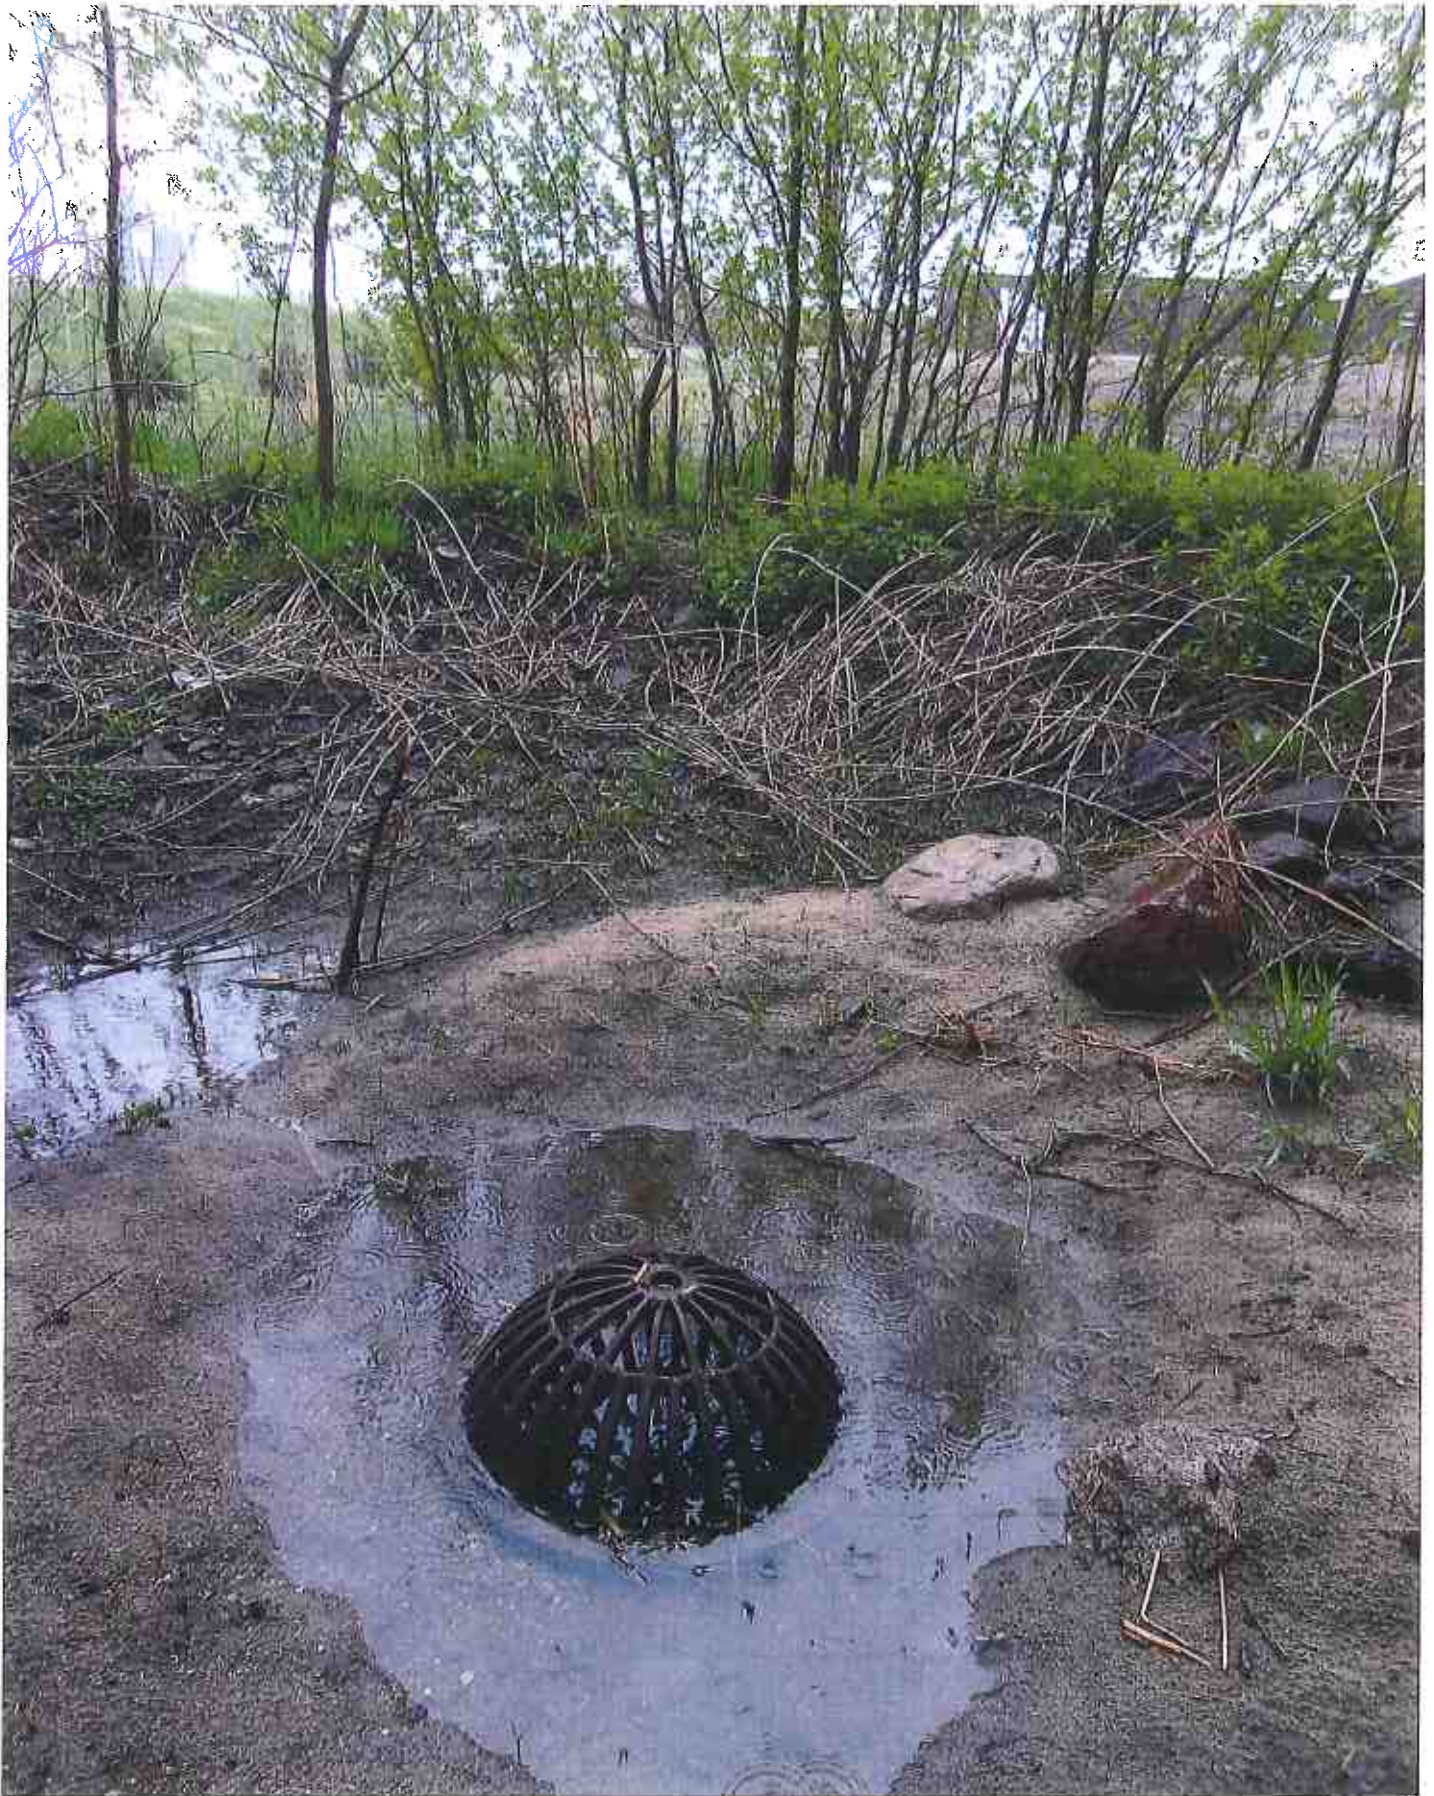
TILE HAS BEEN PARTIALLY PLUGGED FOR SOME TIME  
LOOKING DOWN STREAM, NOTE ALL SEDIMENT SAND BLOWN OUT OF INTAKE

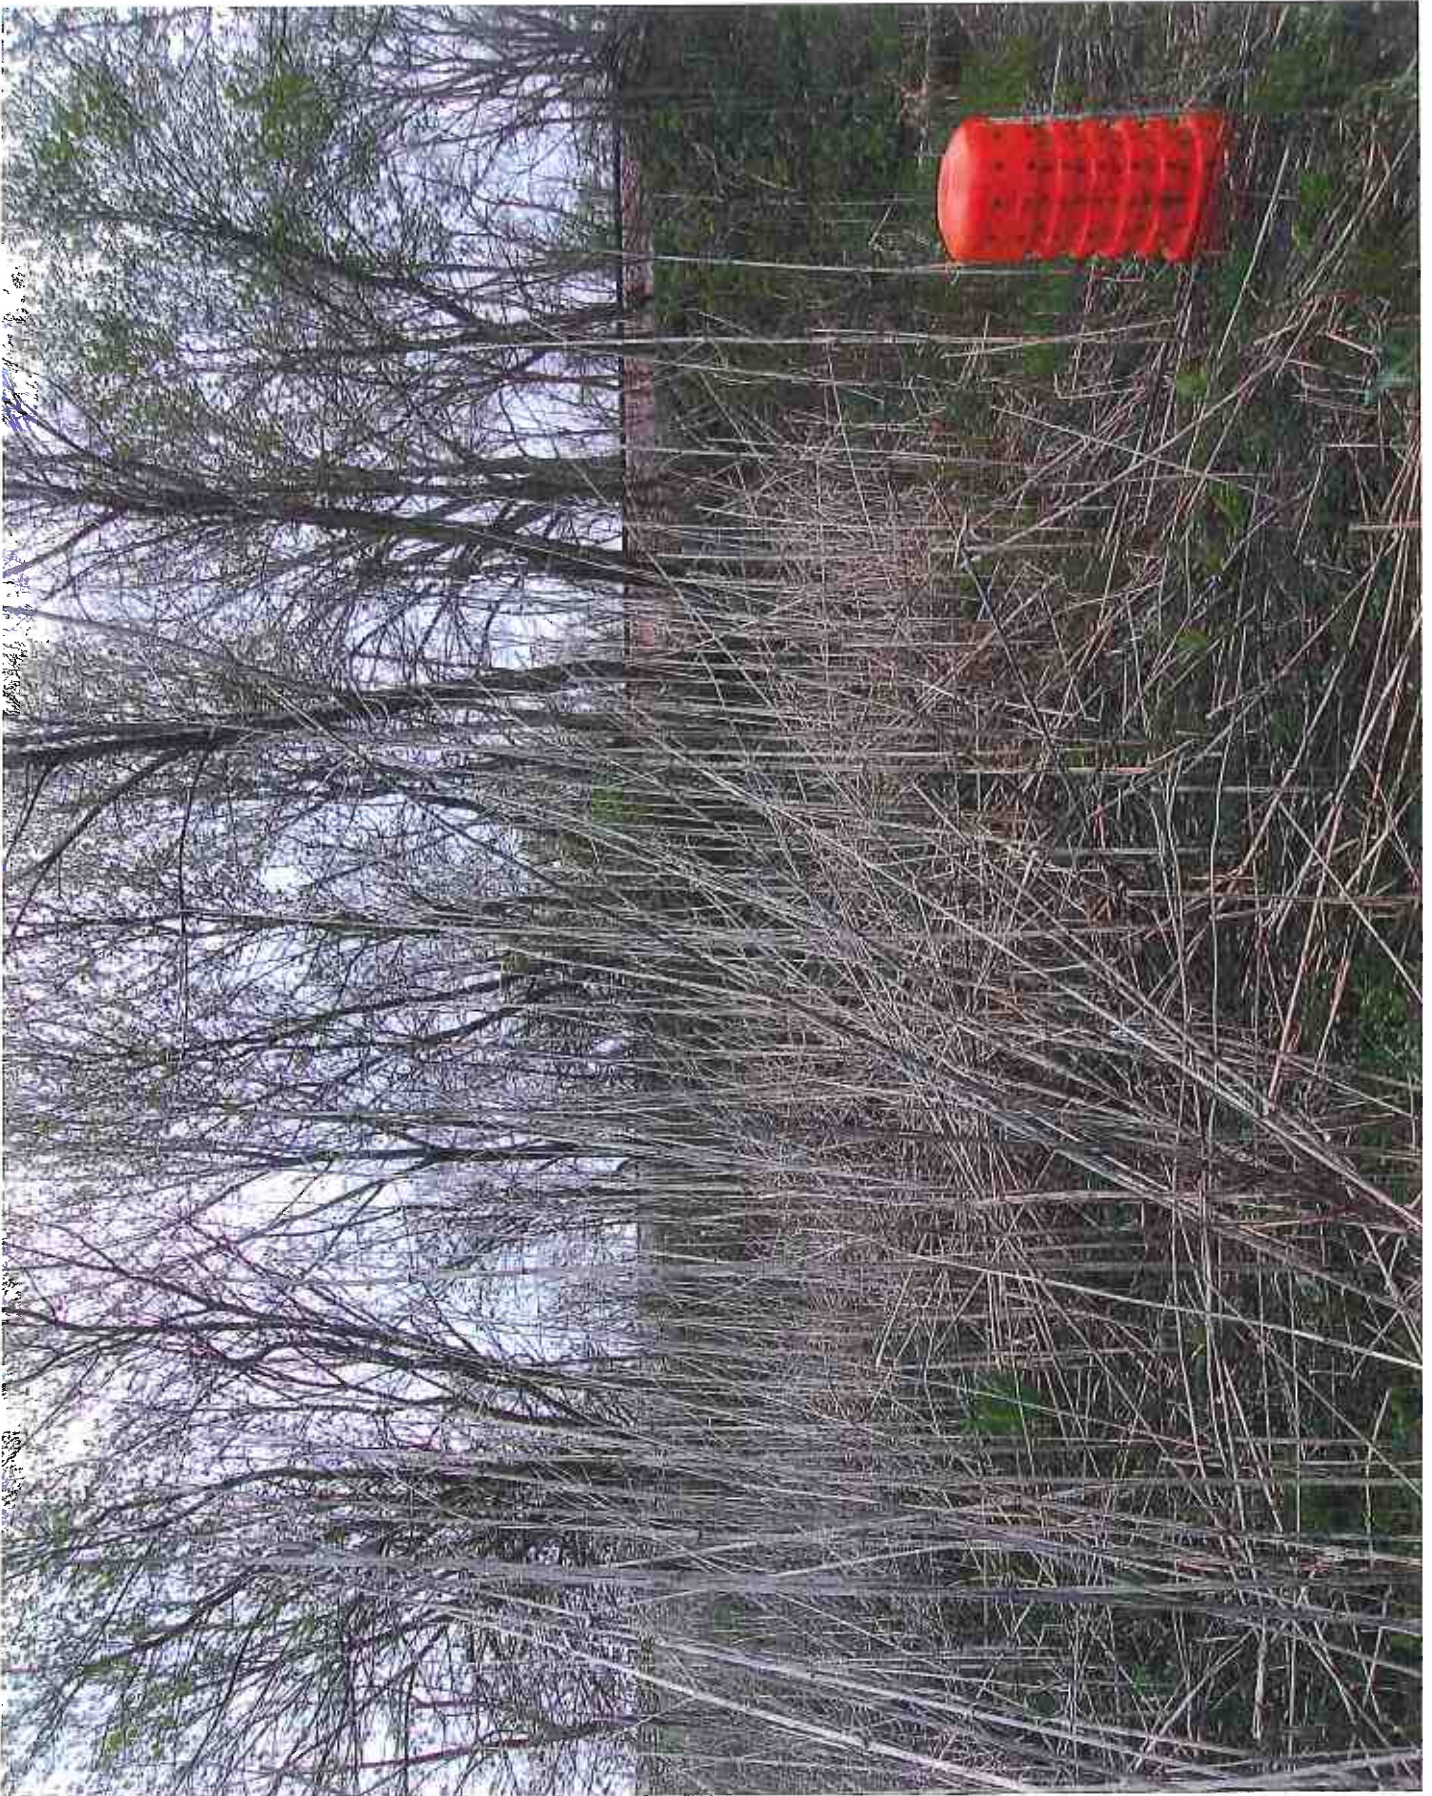
LOOKING DOWNSTREAM WITH 5' Ø MAPLE THAT NEEDS REMOVED
