AGENDA
REGULAR DRAINAGE MEETING
Monday, June 22, 2020 10:30 AM
Large Conference Room

1. Open Meeting
2. Approve Agenda
3. DD H-F 2 WO 286 - Discuss W Possible Action - Request For Tile Upsize
DD H-F 2 - Landon Aldinger has requested a tile upsize on Joint Drainage District H-F 2, Hardin County WO # 286. Franklin County Trustees will also be in attendance electronically for discussion on this Joint Drainage District work order.

Drainage District:

Investigation/Repair Summary:

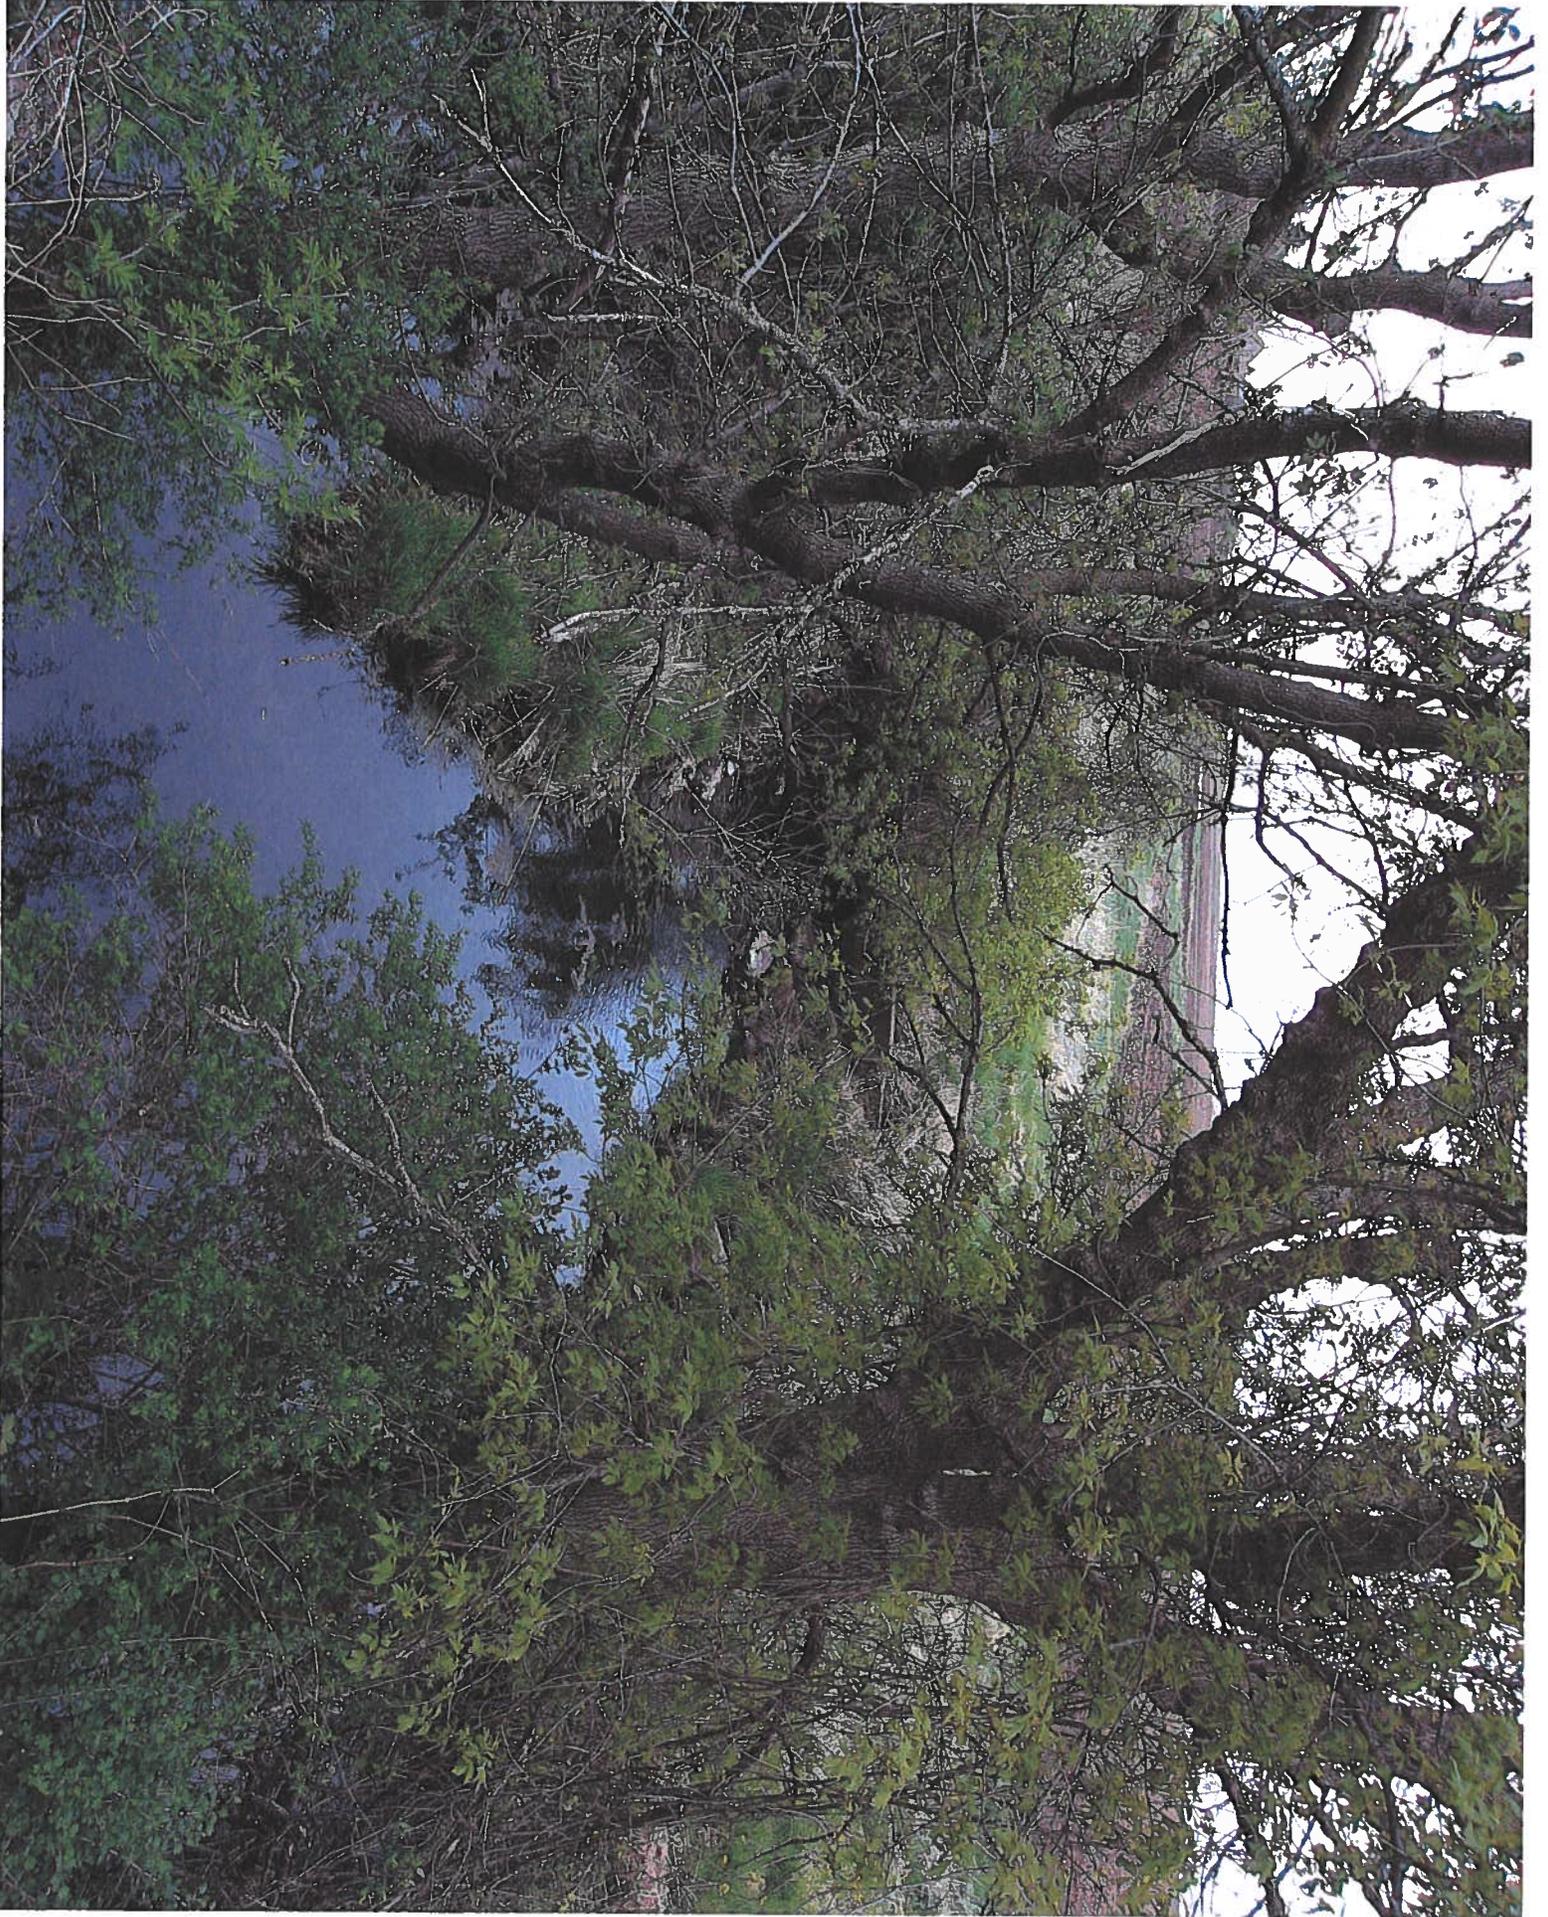
STANDING ON OLD RR BERM, LOOKING N. @ HEADWALL

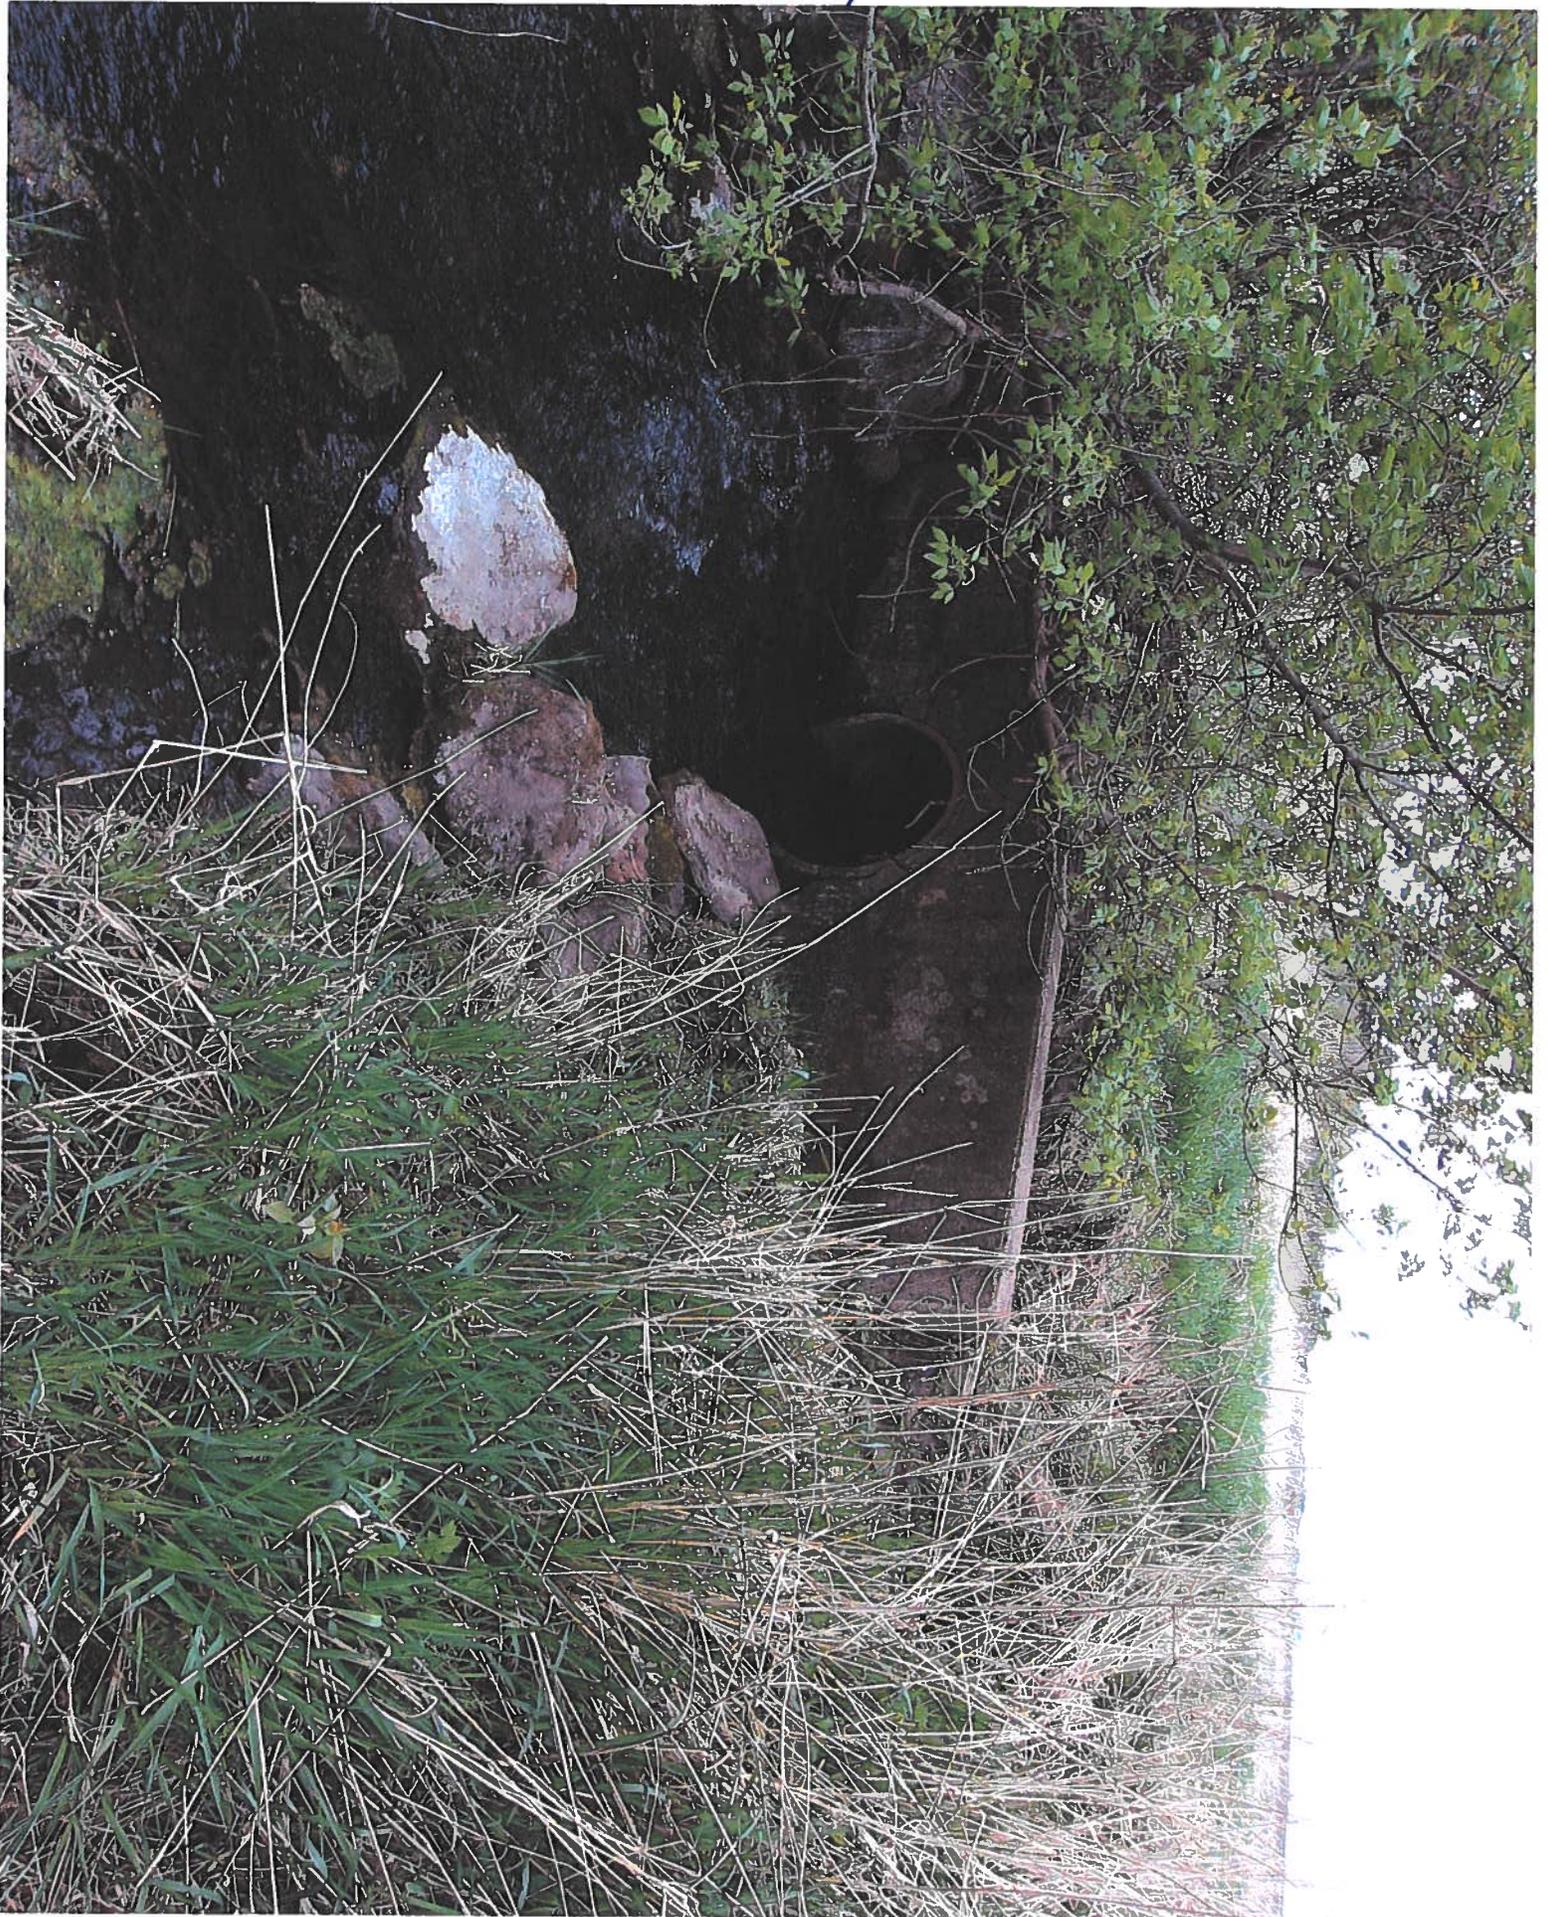
- The 24-inch VCP tile outlet at the concrete headwall was found to be freely flowing with some water found to be leaking along the bottom side and no rodent guard. On the upstream side of the headwall significant erosion has taken place, exposing the tile.

HEADWALL IS FUNCTIONING WELL, HAS LEAK @ BOTTOM TILE.

CGA also recommends that the soil at the Main tile outlet headwall be re-graded and stabilized with engineering fabric and erosion stone and a rodent guard installed at the outlet.

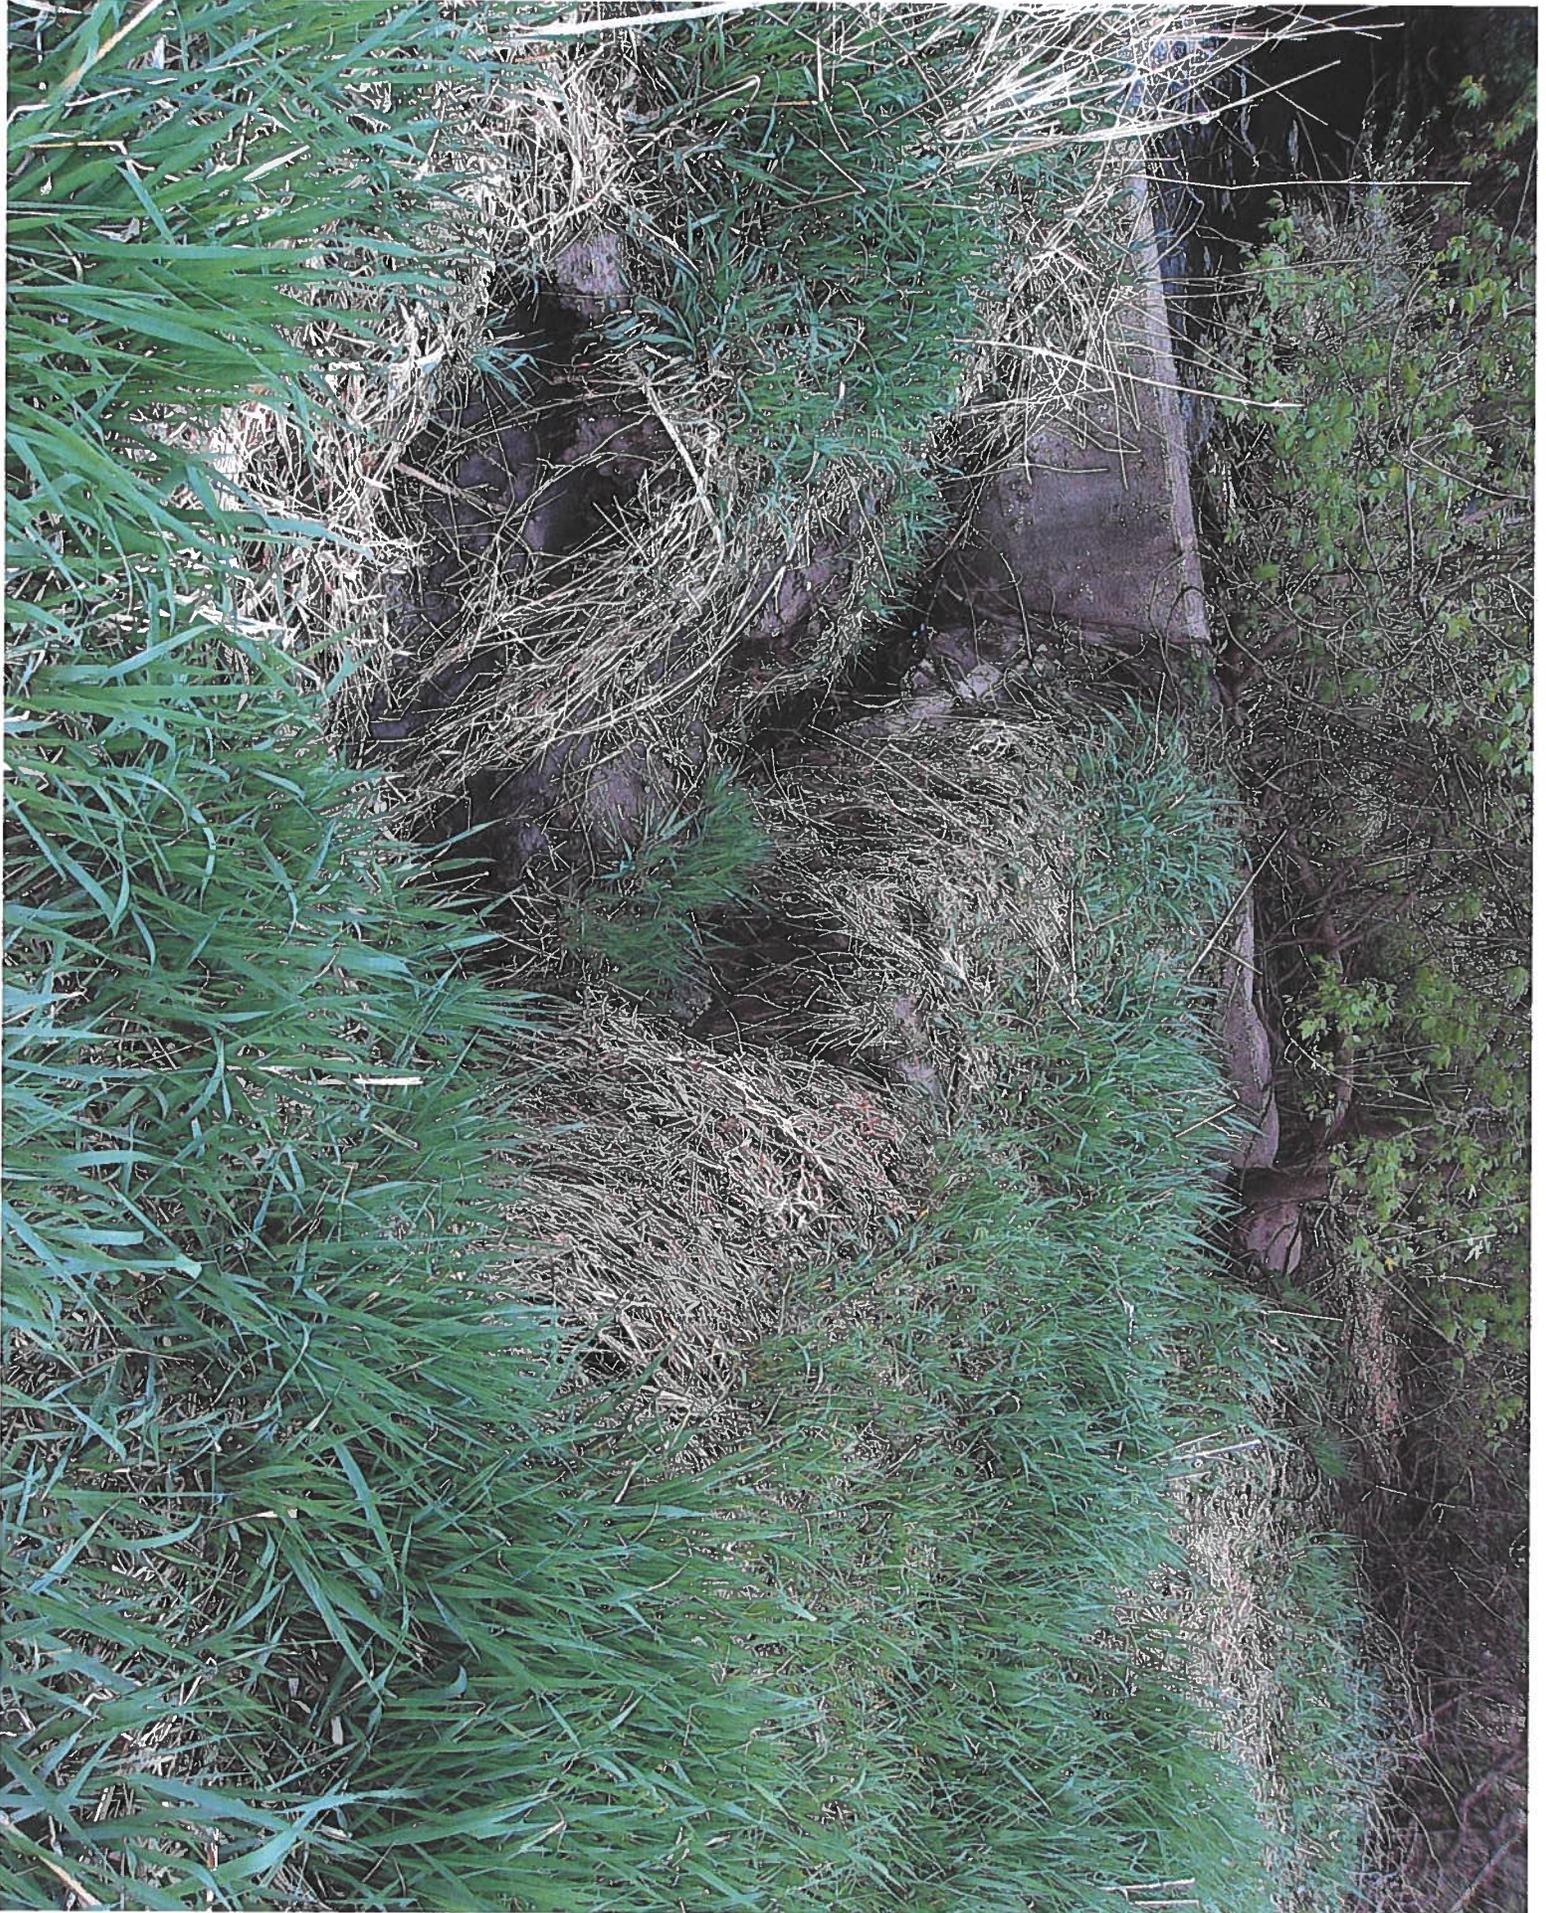
BACKSIDE OF HEADWALL, CLAY TILE IS ENCASED IN CONC

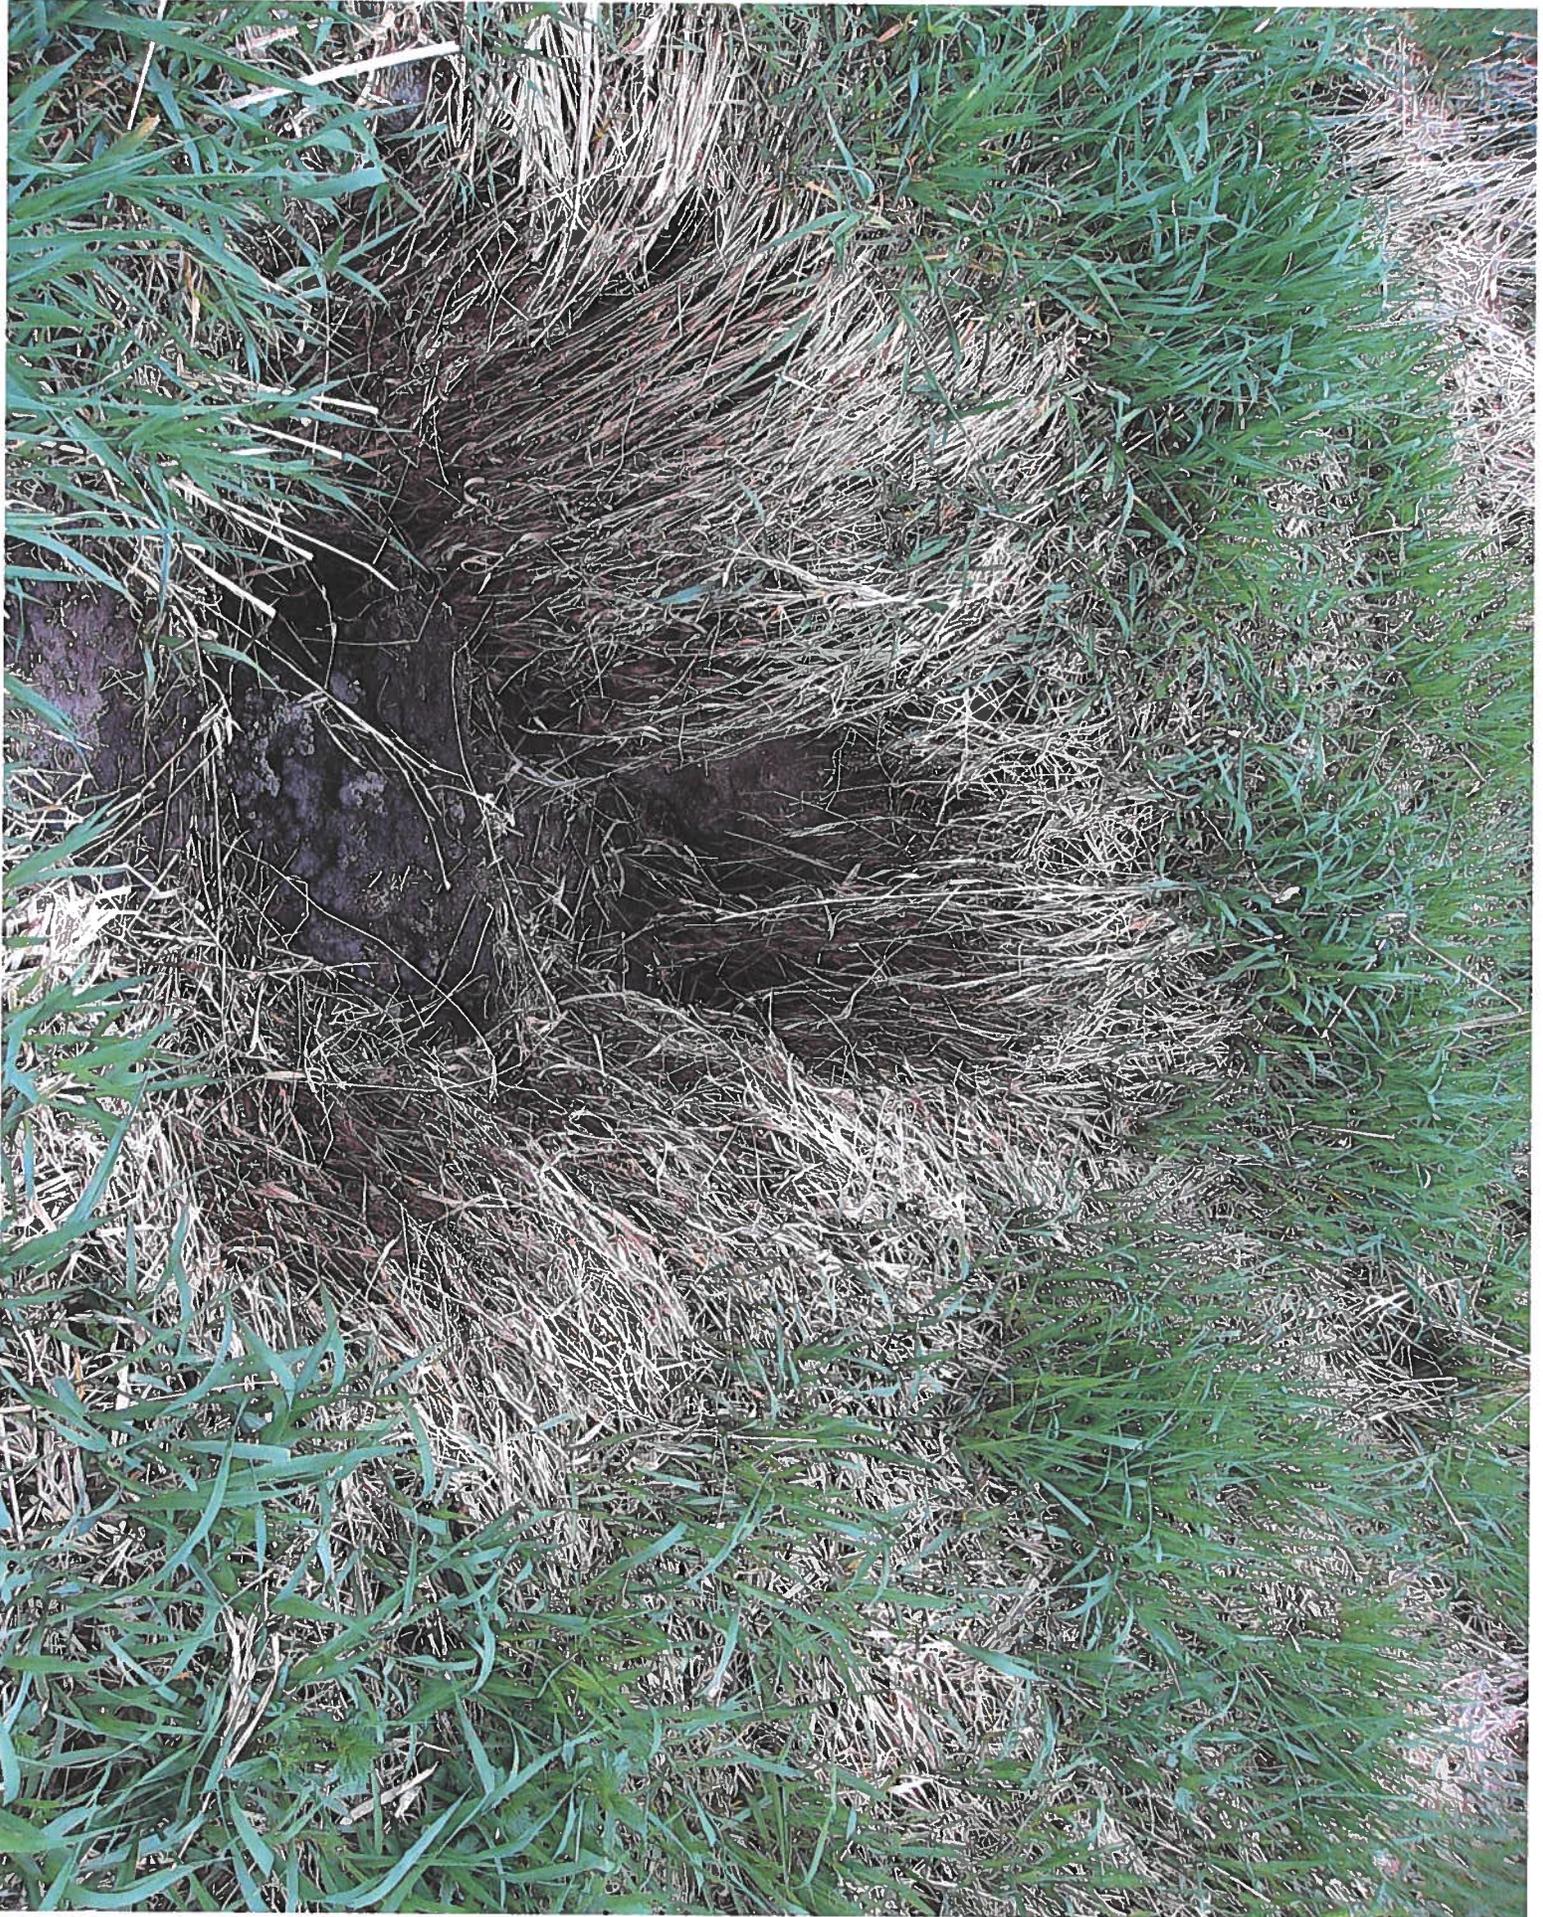
WATER ERODING CONC. ENCASUREMENT @ HEADWALL

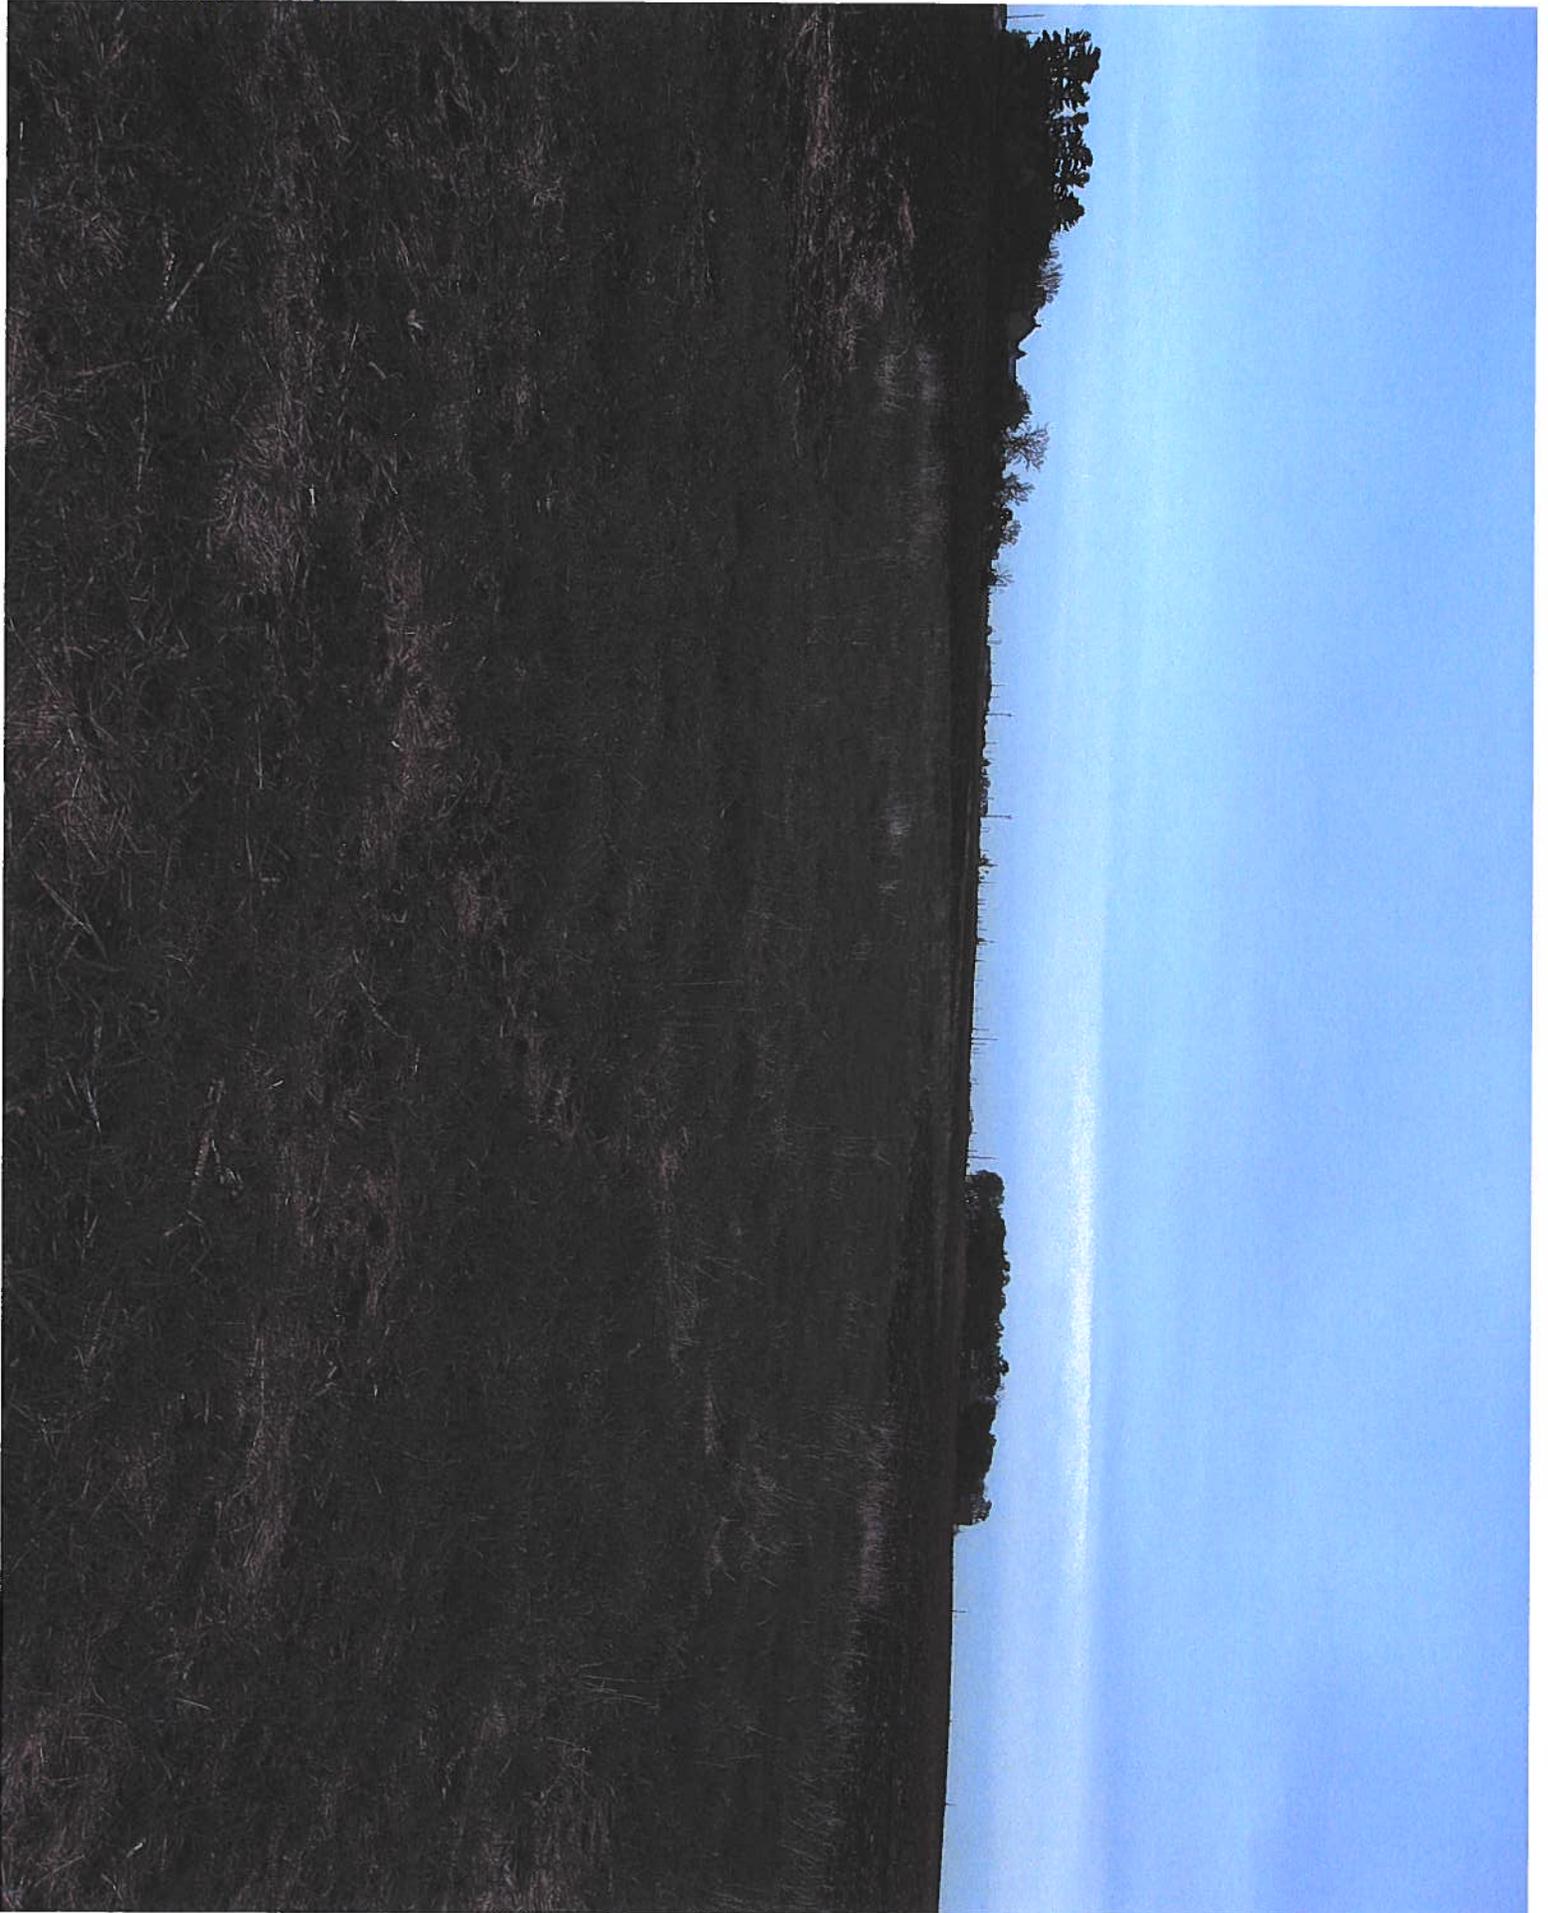
LOOKING UPSTREAM IN GRASS SWALE

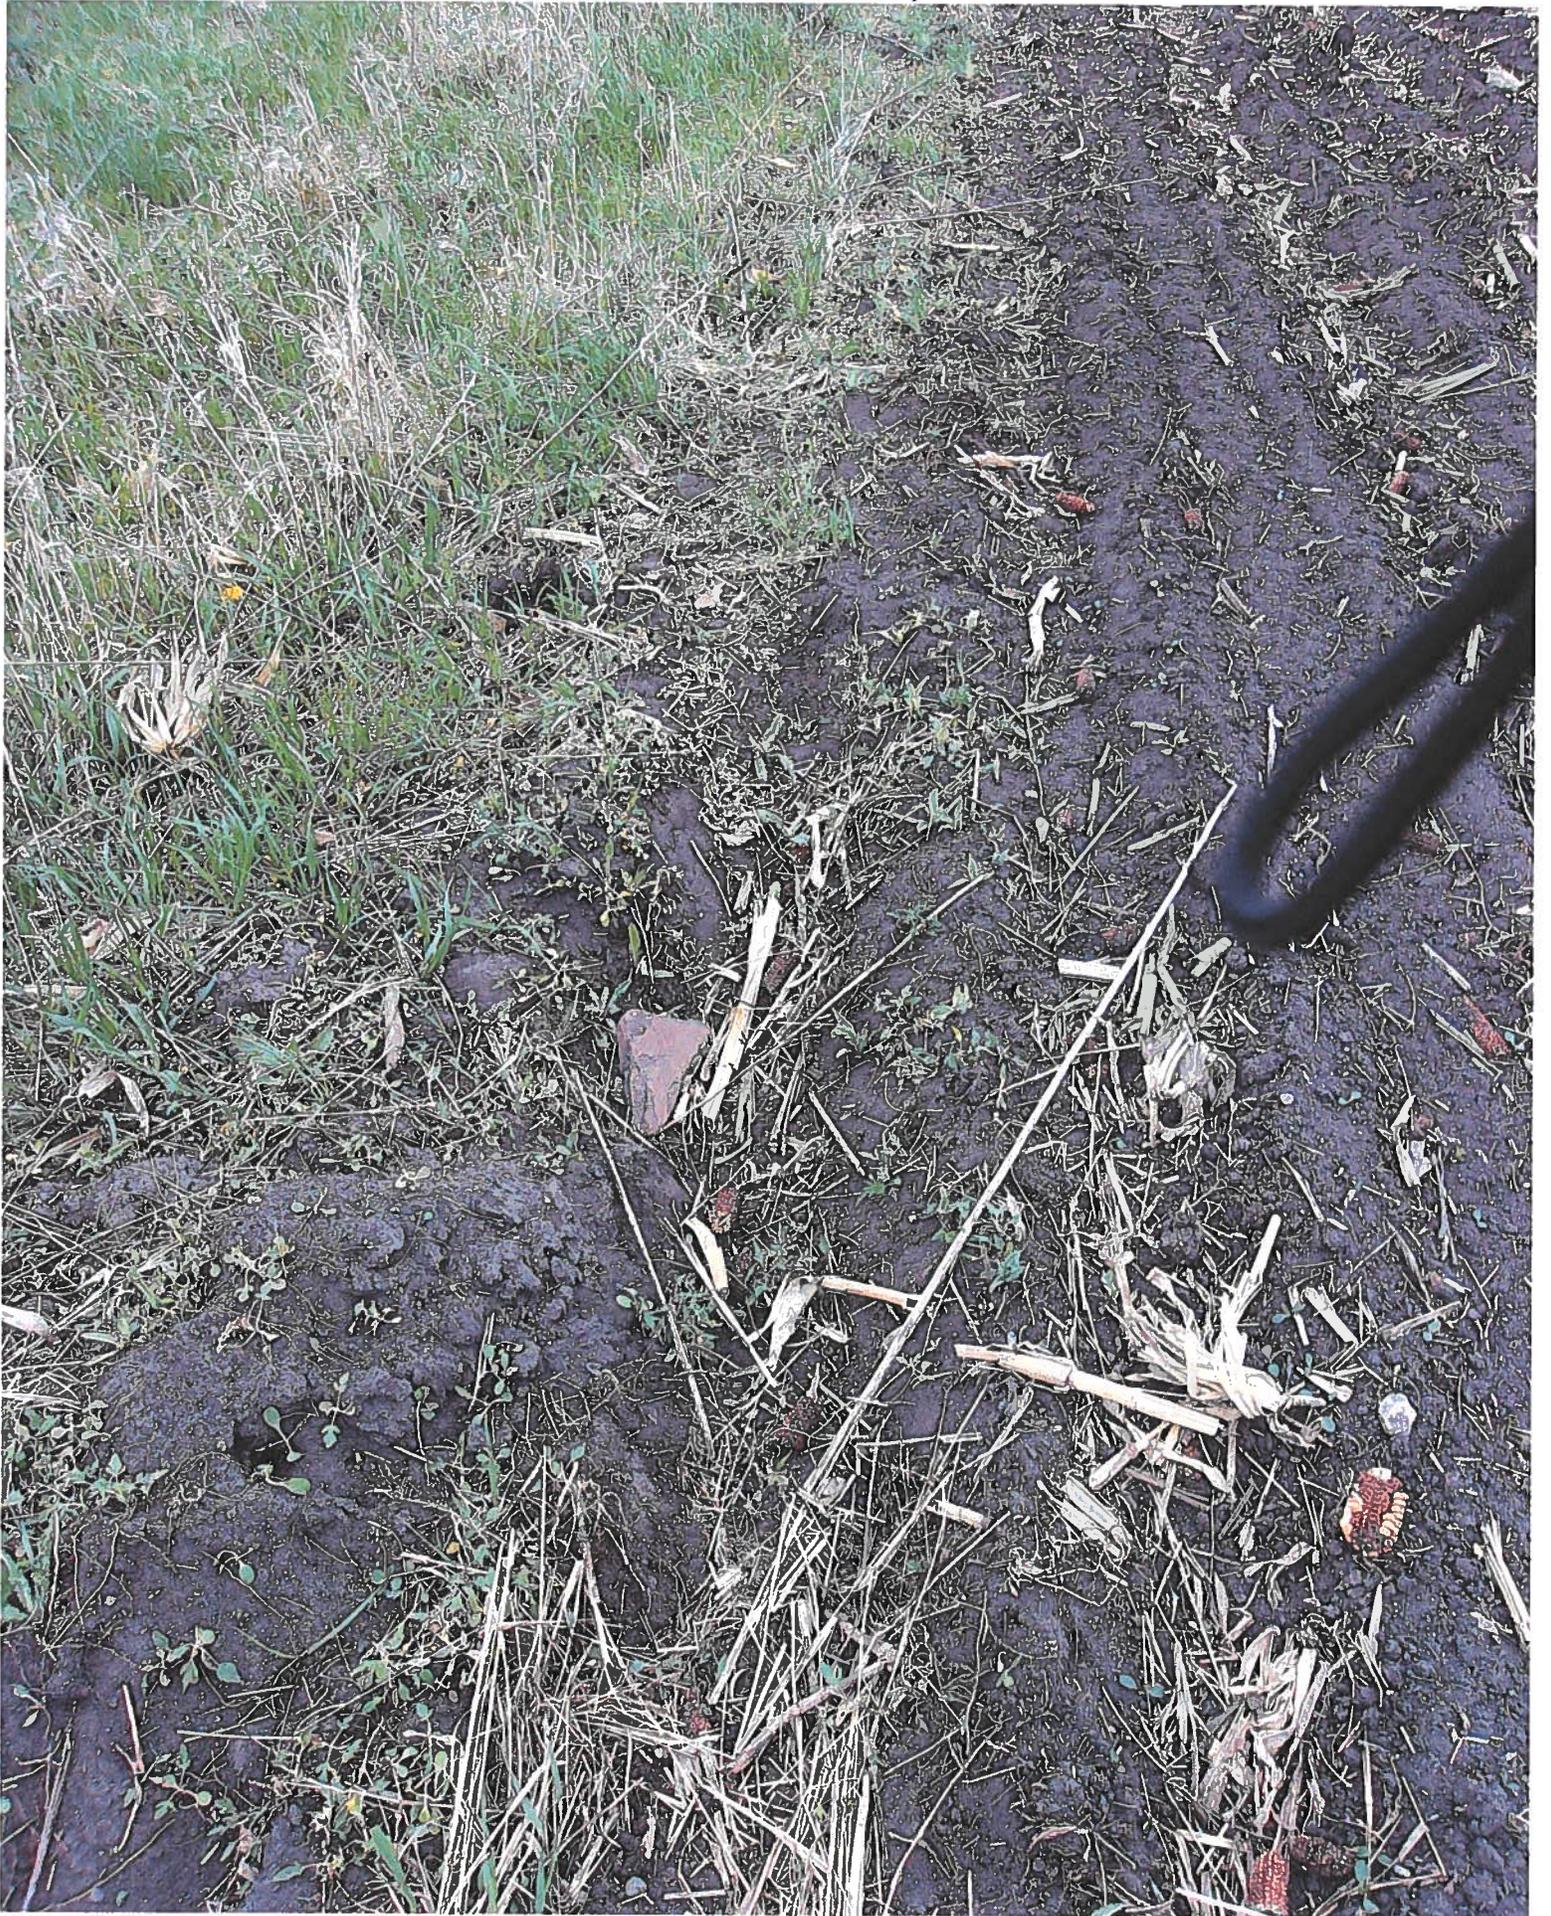
- Only one area on the affected property was found to have signs of potential problems within the tile. A slight depression in the soil with tile shards on the surface were found on the side of the grass swale on the assumed Main tile route.

SLIGHT DEPRESSION WITH TILE CHARD, BIG TILE.

- Excavate at County Highway C73 north of the affected property and use a tile locator to determine if the Main tile runs beneath the areas of excessive moisture as well as to determine if any blockages exist within the flowline.
- Excavate at the location where the depression and tile shards were found to determine if a collapse may have occurred on the Main tile, and repair if necessary.

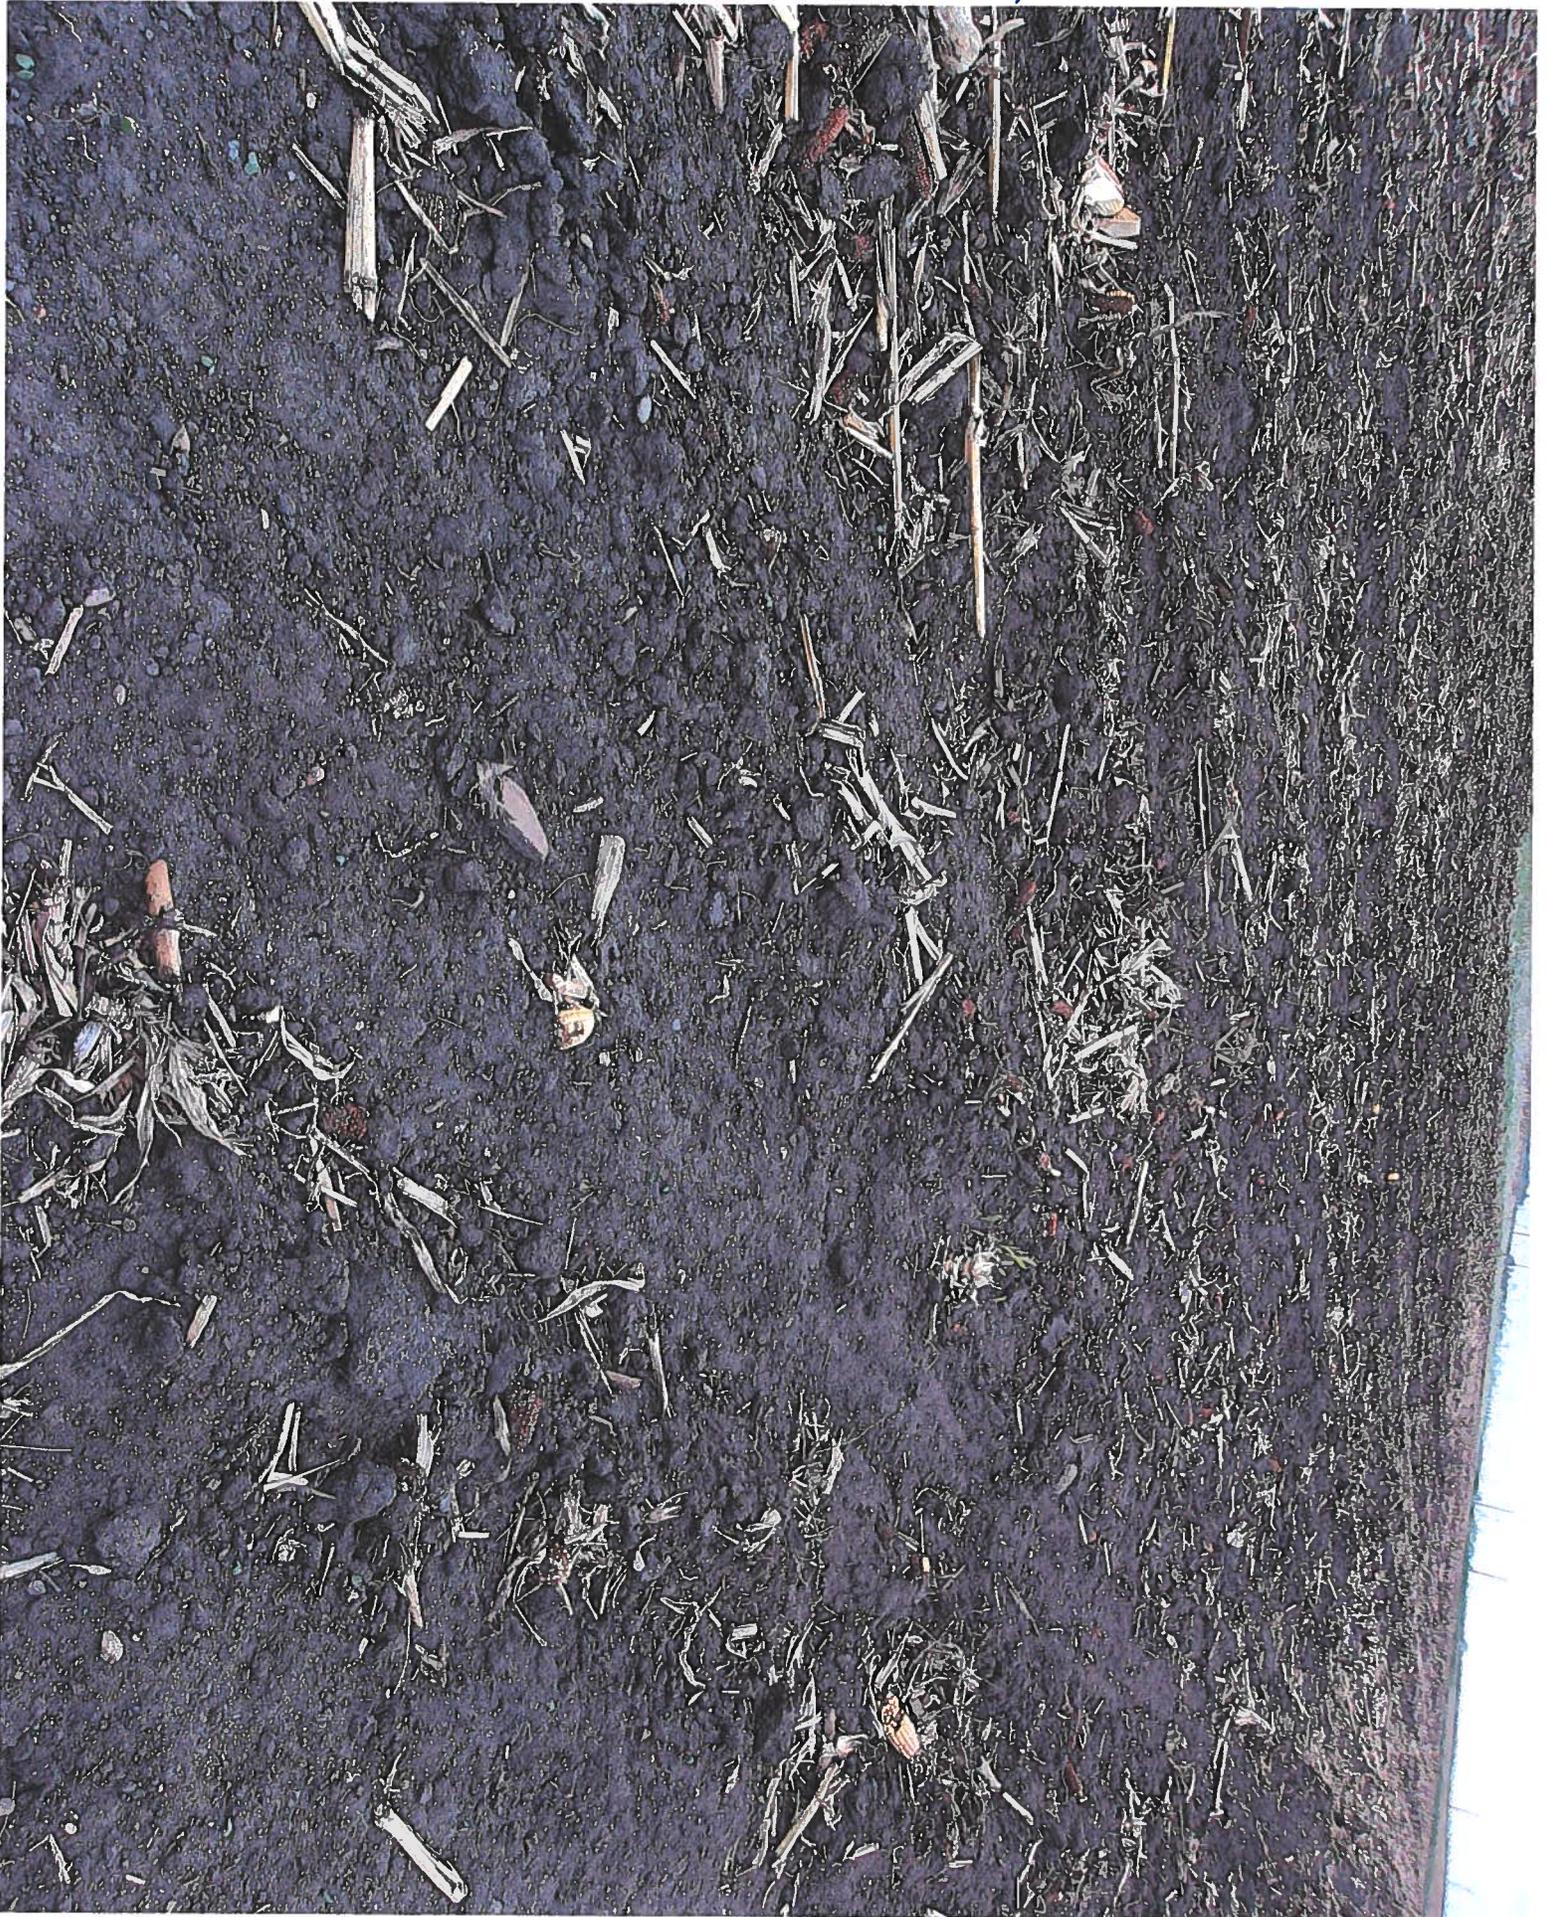
- Excessive moisture was observed in the affected property near the assumed Main tile route on the south side of County Highway C73 (no intakes visible at County Highway C73).

LOOKING N-W IN LANDONS FIELD Co. Hwy INTERSECTION IN BACKGROUND
