**AGENDA**  
**REGULAR DRAINAGE MEETING**  
**Wednesday, September 2, 2020 9:30 AM**  
**Large Conference Room**

4. DD 14 WO 290 - Discuss W Possible Action - Investigation Summary

[DD 14 WO 290 - 6844.4 - INVESTIGATION REPORT - 2020-08-31.PDF](#)

**COMPLETION REPORT ON  
MAIN TILE REPAIRS TO  
DRAINAGE DISTRICT 22  
FACILITIES  
HARDIN COUNTY, IOWA  
(PROJECT NOS. DD-6532.2 AND 8712)**

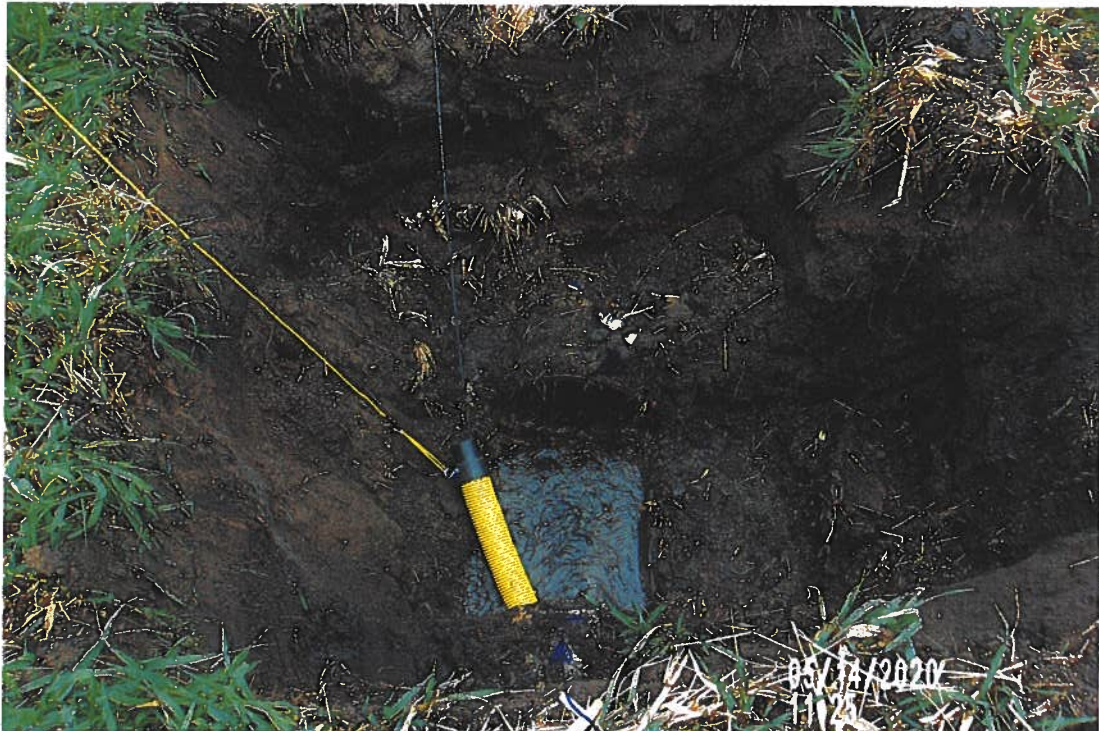
PICTURE # 3538 IS LOOKING SW @ BLOWOUT # 1 IS SHOWING CREW  
TELEVISIONING WASSTREAM FROM GPS# 177

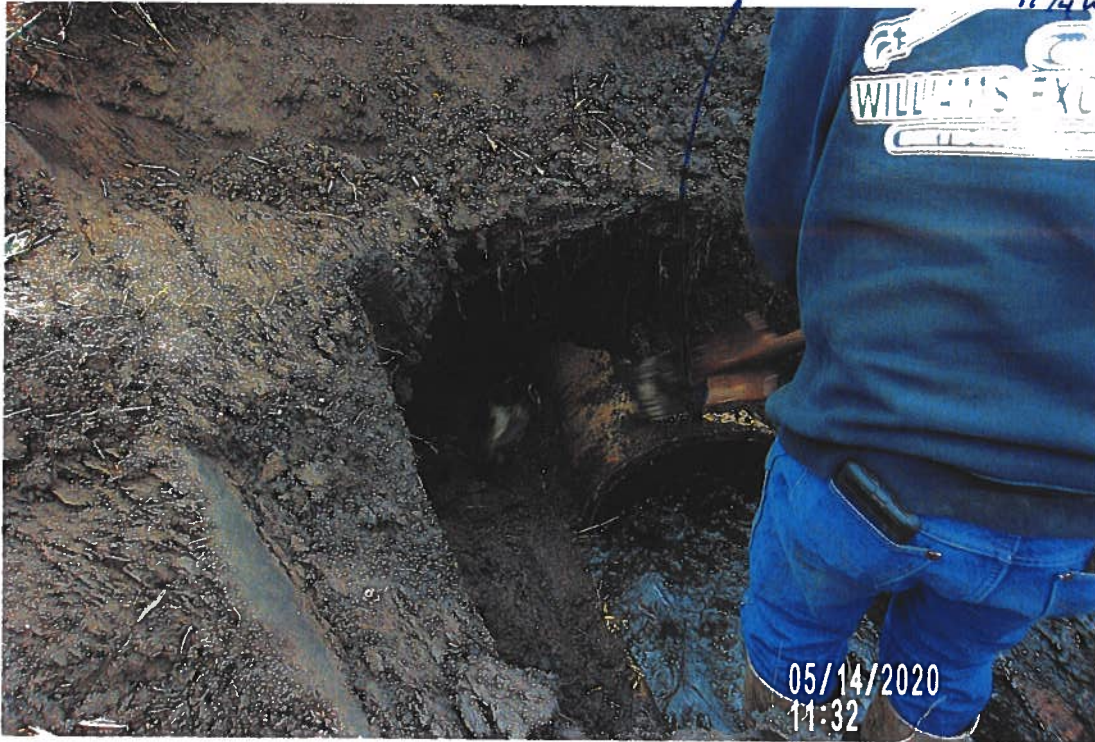
PICTURE 354I IS LOOKING SW INSIDE CLAY TILE DOWNSTREAM  
INSIDE BLOWOUT 2S SHOWING NEXT COUPLE SECTIONS  
IN BAD SHAPE WITH CRACKS AND LEAVING DOWN. FROM GPS# 118

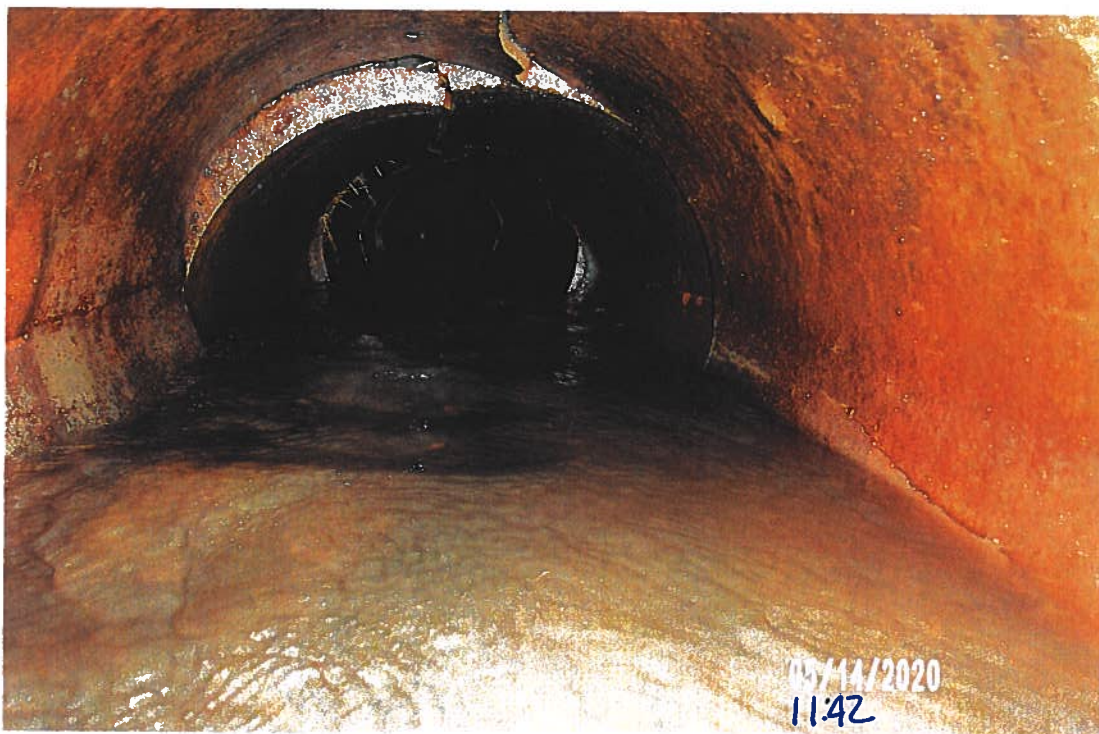
PICTURE # 3542 IS LOOKING NE INSIDE CLAY TILE UPSTREAM INSIDE BLOWOUT 2S SHOWING NEXT COUPLE SECTIONS IN BAD SHAPE WITH CRACKS AND APPEAR TO BE CAVING DOWN, FROM GPS # 119

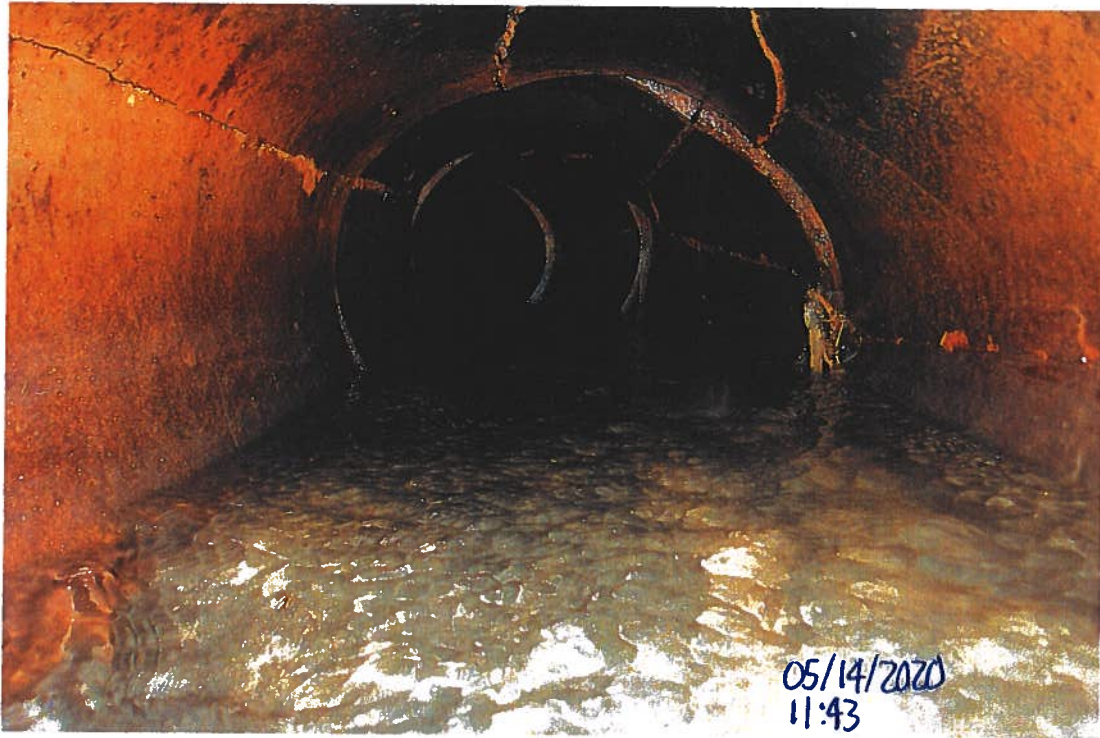
PICTURE # 3543 IS LOOKING NE ON EAST SIDE OF TILE AT 5.0' LONG SOIL BROODED CAVITY IN BLOWOUT # 2S FROM GPS # 119

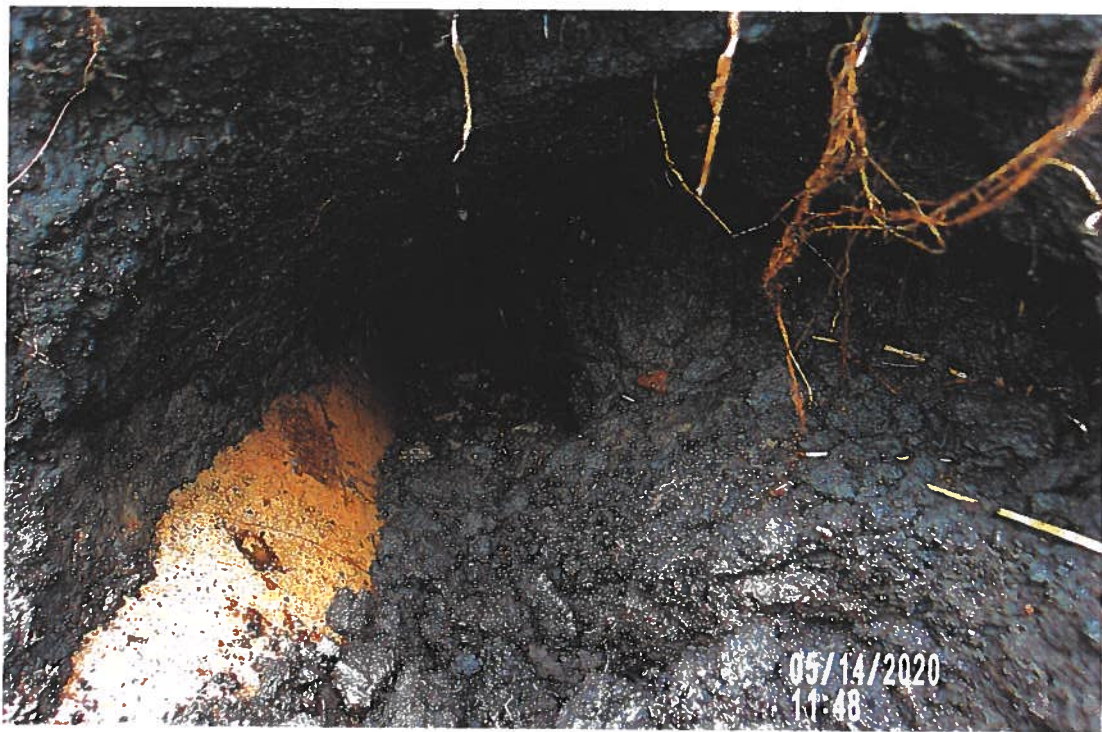
PICTURE # 3544 IS LOOKING SW ON EAST SIDE OF TILE AT 5.5' LONG  
SOIL ERODED CAVITY IN BLOWOUT # 28 FROM GPS # 118

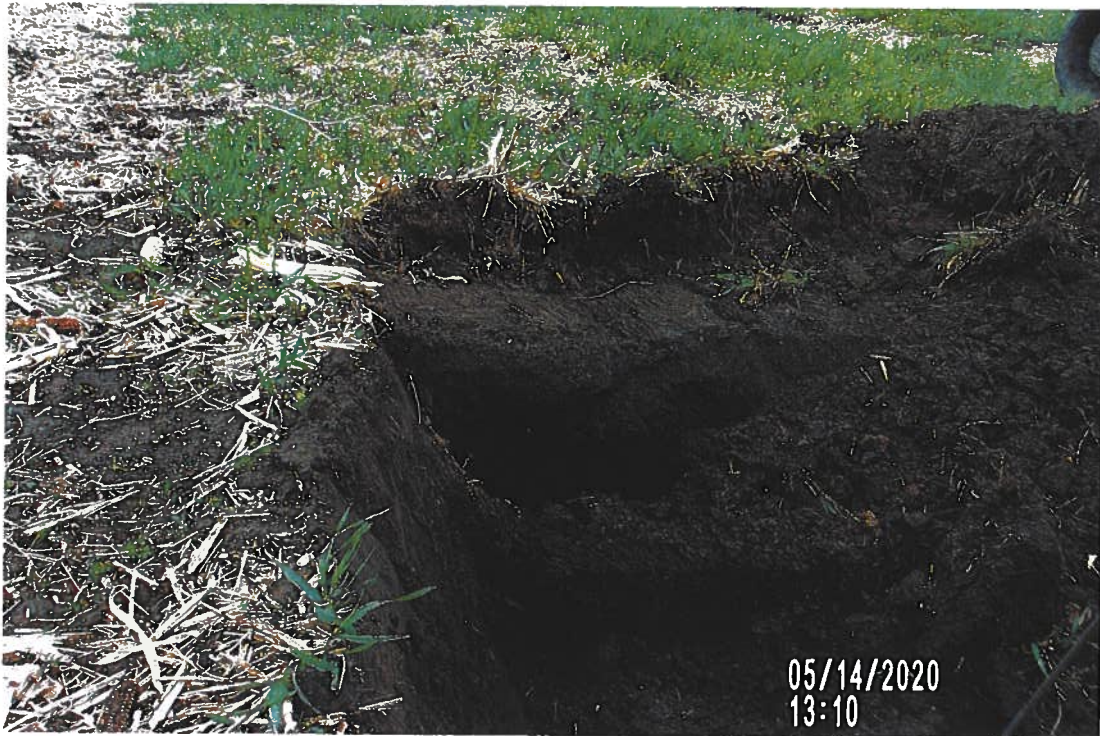
PICTURE # 3551 IS LOOKING NW SHOWING 1ST SECTION OF TILE WITH SEVERE LONGITUDINAL CRACK AND CAVING DOWN. UPSTREAM FROM GPS# 138 WITH SEVERAL OTHER TILE CRACKED AND CAVING DOWN SEVERAL FEET UPSTREAM.

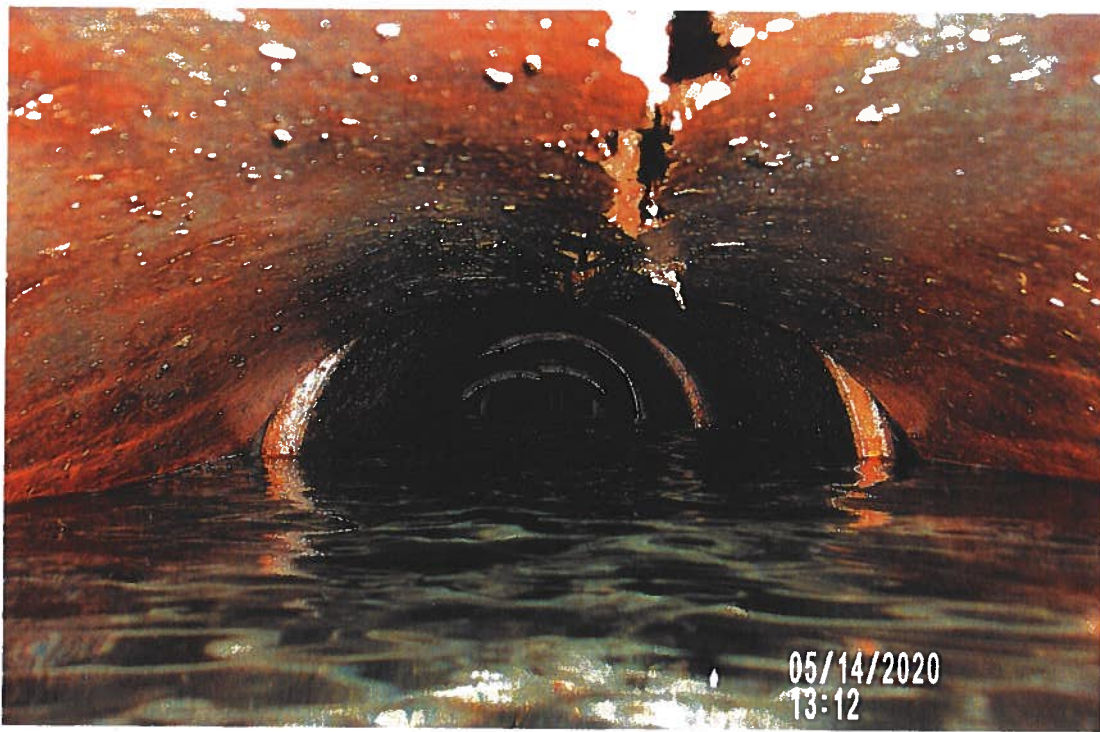
PICTURE # 3552 IS LOOKING SE SHOWING 1ST SECTION OF CLAY TILE WITH LONGITUDINAL CRACKS AND CAVING DOWN DOWNSTREAM FROM CPS# 139 WITH REST OF SECTIONS OF TILE NOT LOOKING TOO BAD

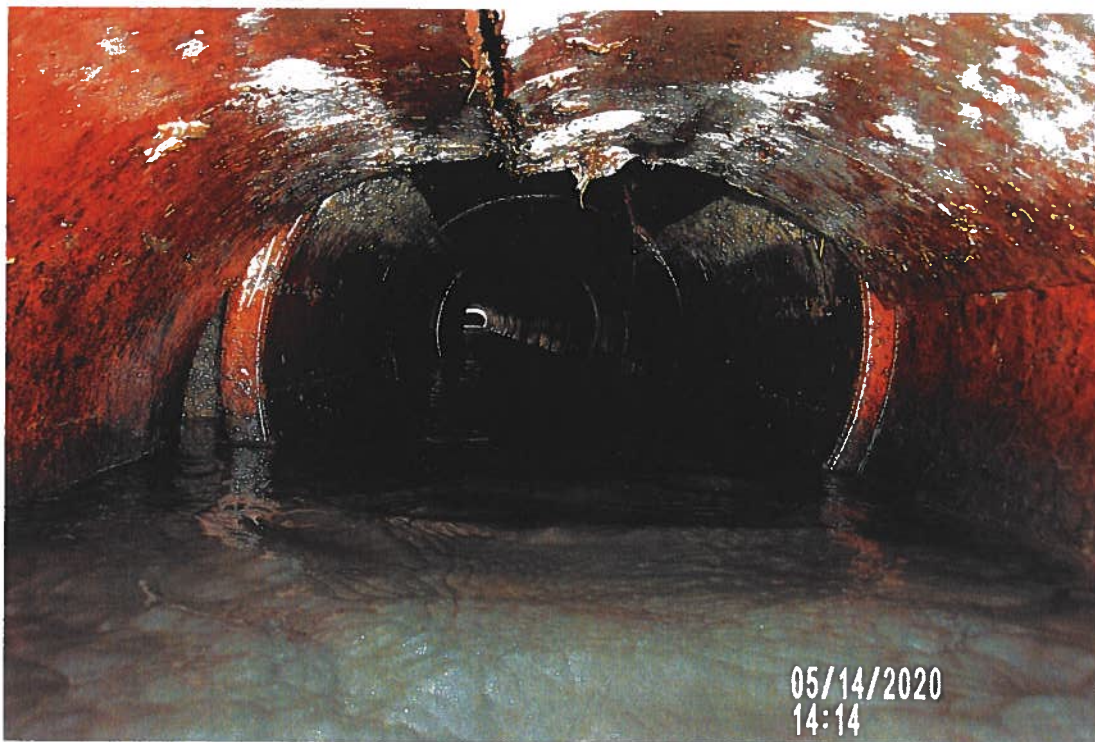
PICTURE# 3558 IS LOOKING SE INSIDE CLAY TILE IN TILE BLOWOUT # IN FROM GPS# 146 SHOWING TILE CRACKED BUT NOT GIVING DOWN,

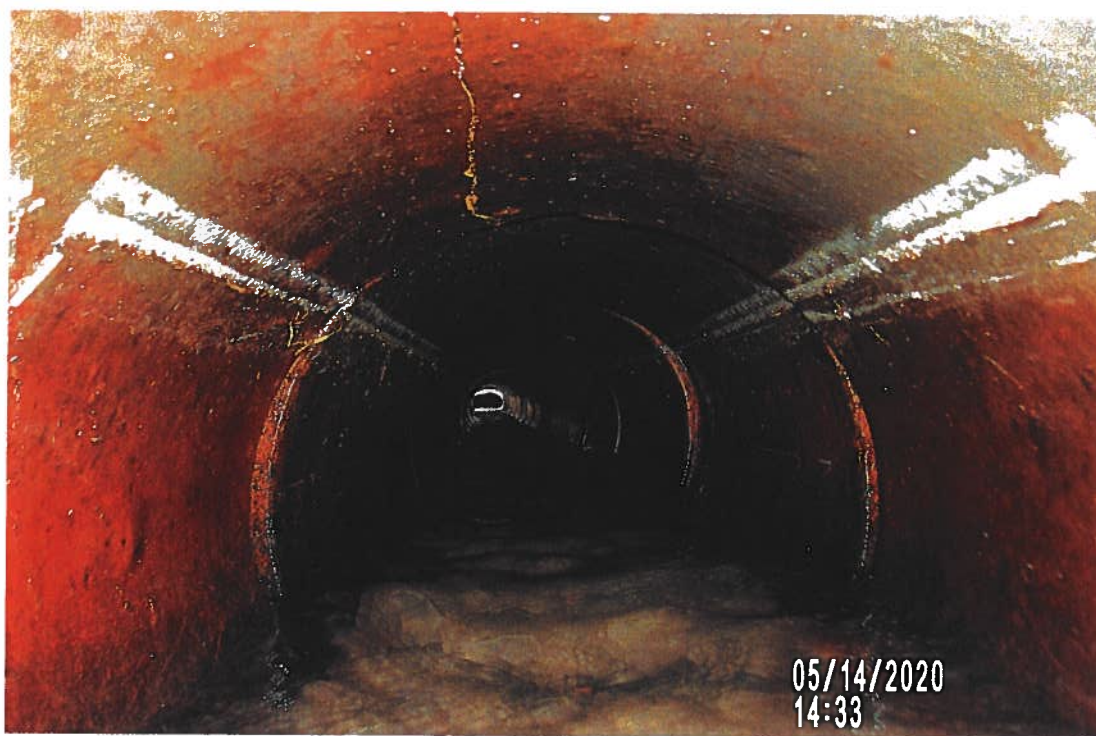
PICTURE #3559 IS LOOKING NW INSIDE CLAY TILE FROM GPS# 147 IN TILE BLOWOUT # IN SHOWING TOP CRACKED AND CAVING DOWN

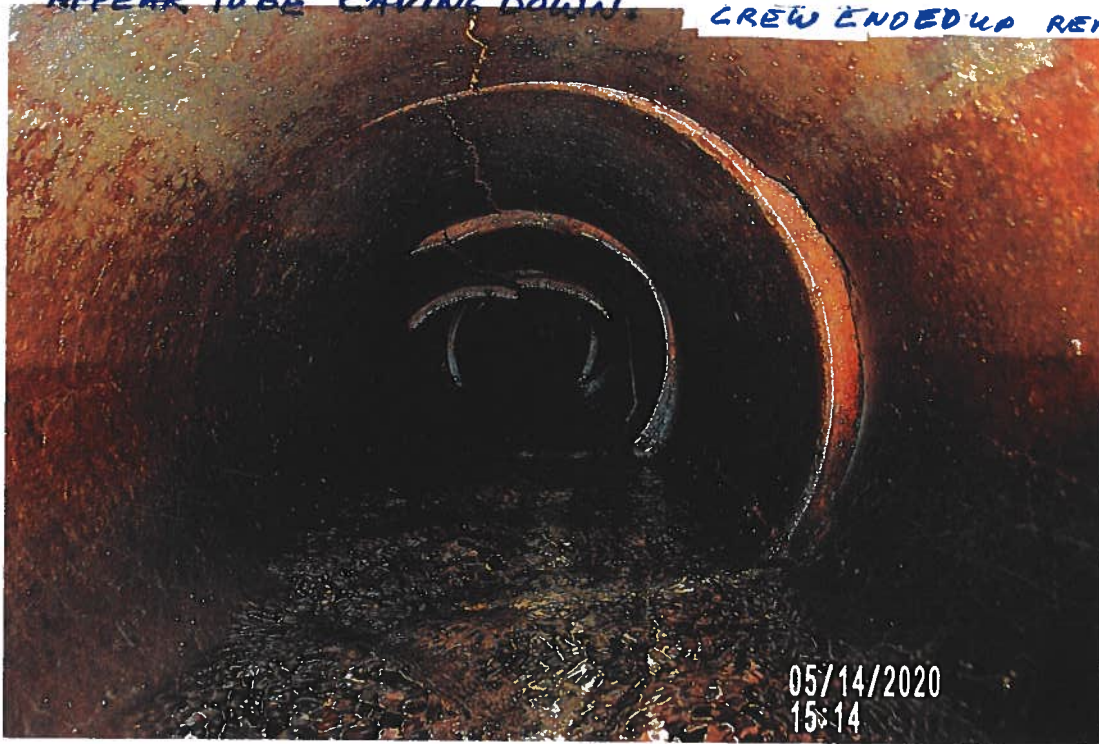
PICTURE # 3562 IS LOOKING SE INSIDE CLAY TILE FROM GPS# 175 IN TILE BLOWOUT # 2N SHOWING TILE WITH FINE CRACKS BUT NOT CAVING DOWN

PICTURE #3563 IS LOOKING NW INSIDE CLAY TILE FROM GPS #176  
 IN TILE BLOWOUT # 2N SHOWING TILE WITH FINE CRACKS BUT  
 NOT CAVING DOWN IN 1ST TWO SECTIONS BUT NEXT TWO SECTIONS  
 APPEAR TO BE CAVING DOWN. CREW ENDED UP REMOVING

2 SECTIONS  
 OF CLAY  
 TILE ON  
 NORTH END  
 DUE TO NEXT  
 SECTION  
 COLLAPSING  
 DURING  
 REMOVAL  
 N ↑

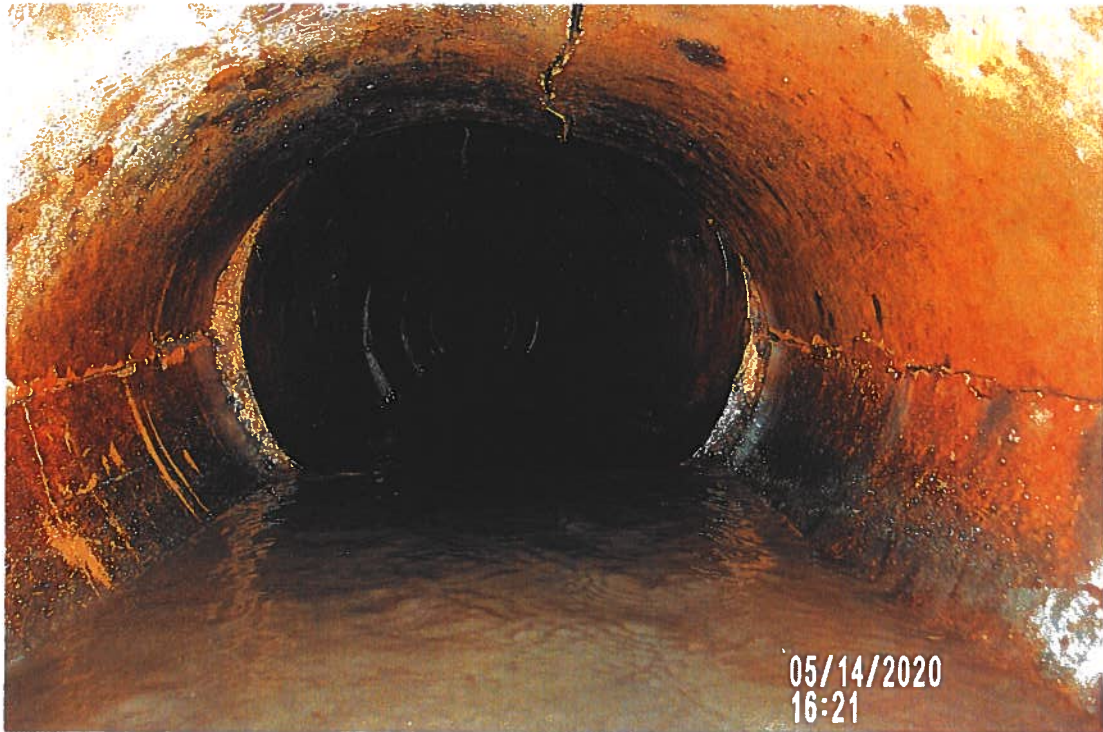
PICTURE# 3566 IS LOOKING NW SHOWING TILE BLOWOUT# 1.N  
BACK FILLED AND DRESSED UP IN GRASS WATERWAY BUT  
STILL NEEDS SEEDED

PICTURE#3569 IS LOOKING SW INSIDE CLAY TILE DOWNSTREAM  
 INSIDE BLOWOUT#15 SHOWING TILE CRACKED AND CAVING DOWN  
 SOME FROM GPS# 178

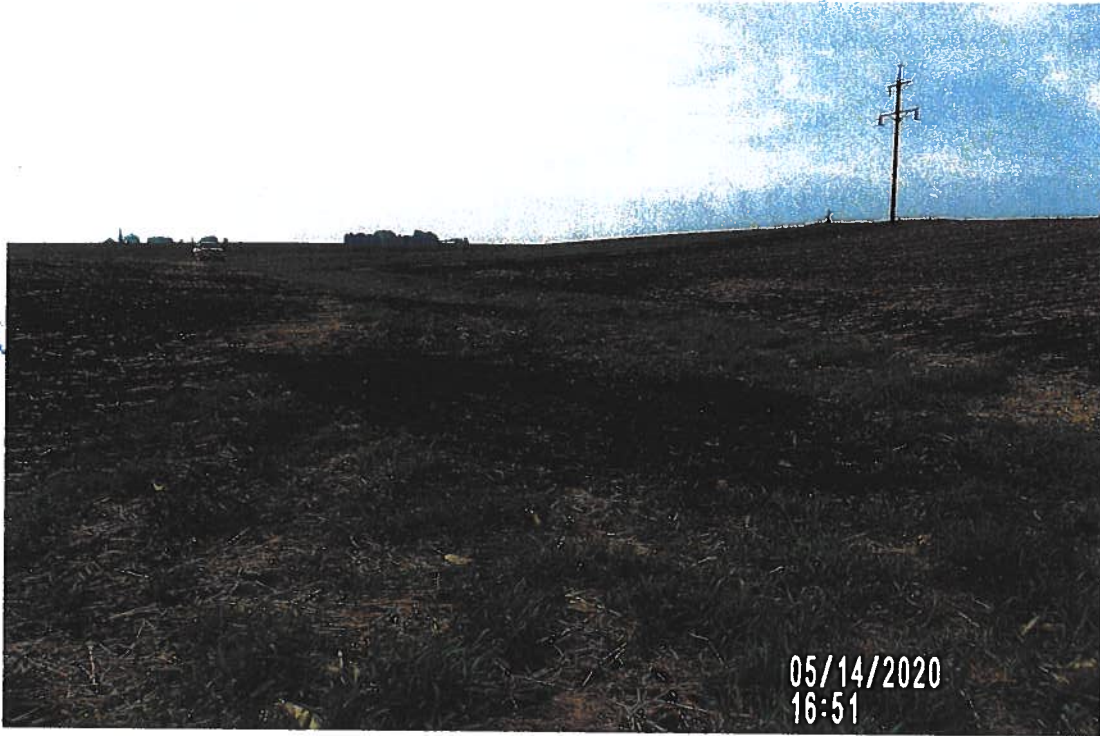
PICTURE # 3571 IS LOOKING NORTH SHOWING BLOWOUT 2S  
BACKFILLED AND DRESSED UP BUT NEEDS SEEDS  
YET.

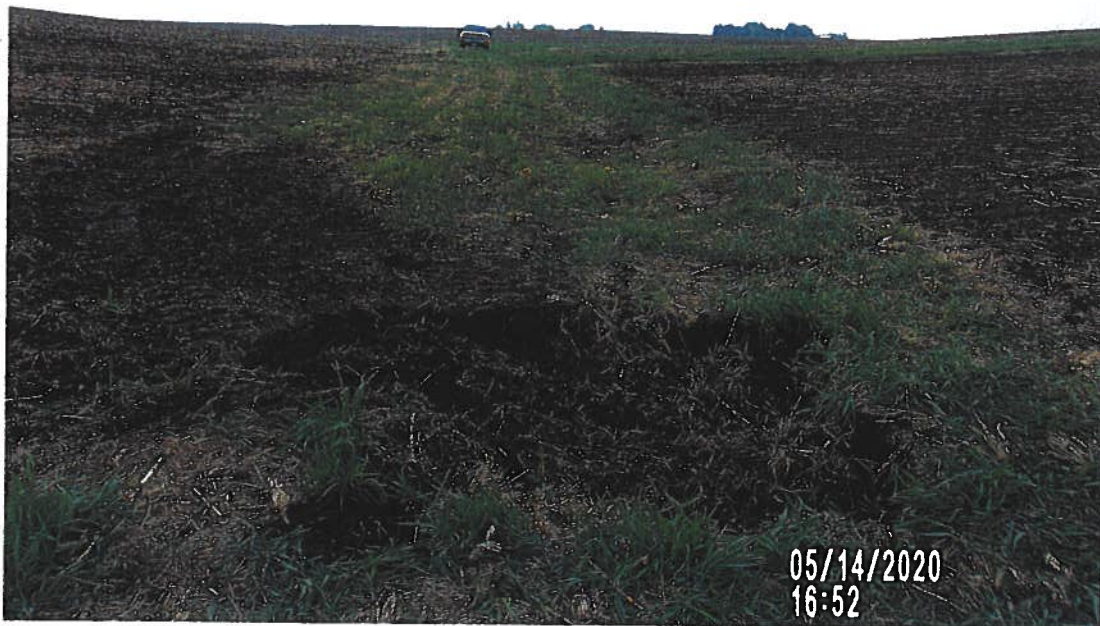
PICTURE # 3572 IS LOOKING NORTH SHOWING BLOWOUT IS  
BACKFILLED. HOLE IS STILL SHORT OF SOIL IN 6.0' X 6.0'  
& 1.0'± DEEP AREA. NEED TO BACK FILL MORE SOIL AND SEED
