AGENDA
DRAINAGE DISTRICT 121 MEETING
Wednesday, September 1, 2021 10:00 AM
Large Conference Room

Drainage District:

#121

Investigation Summary:

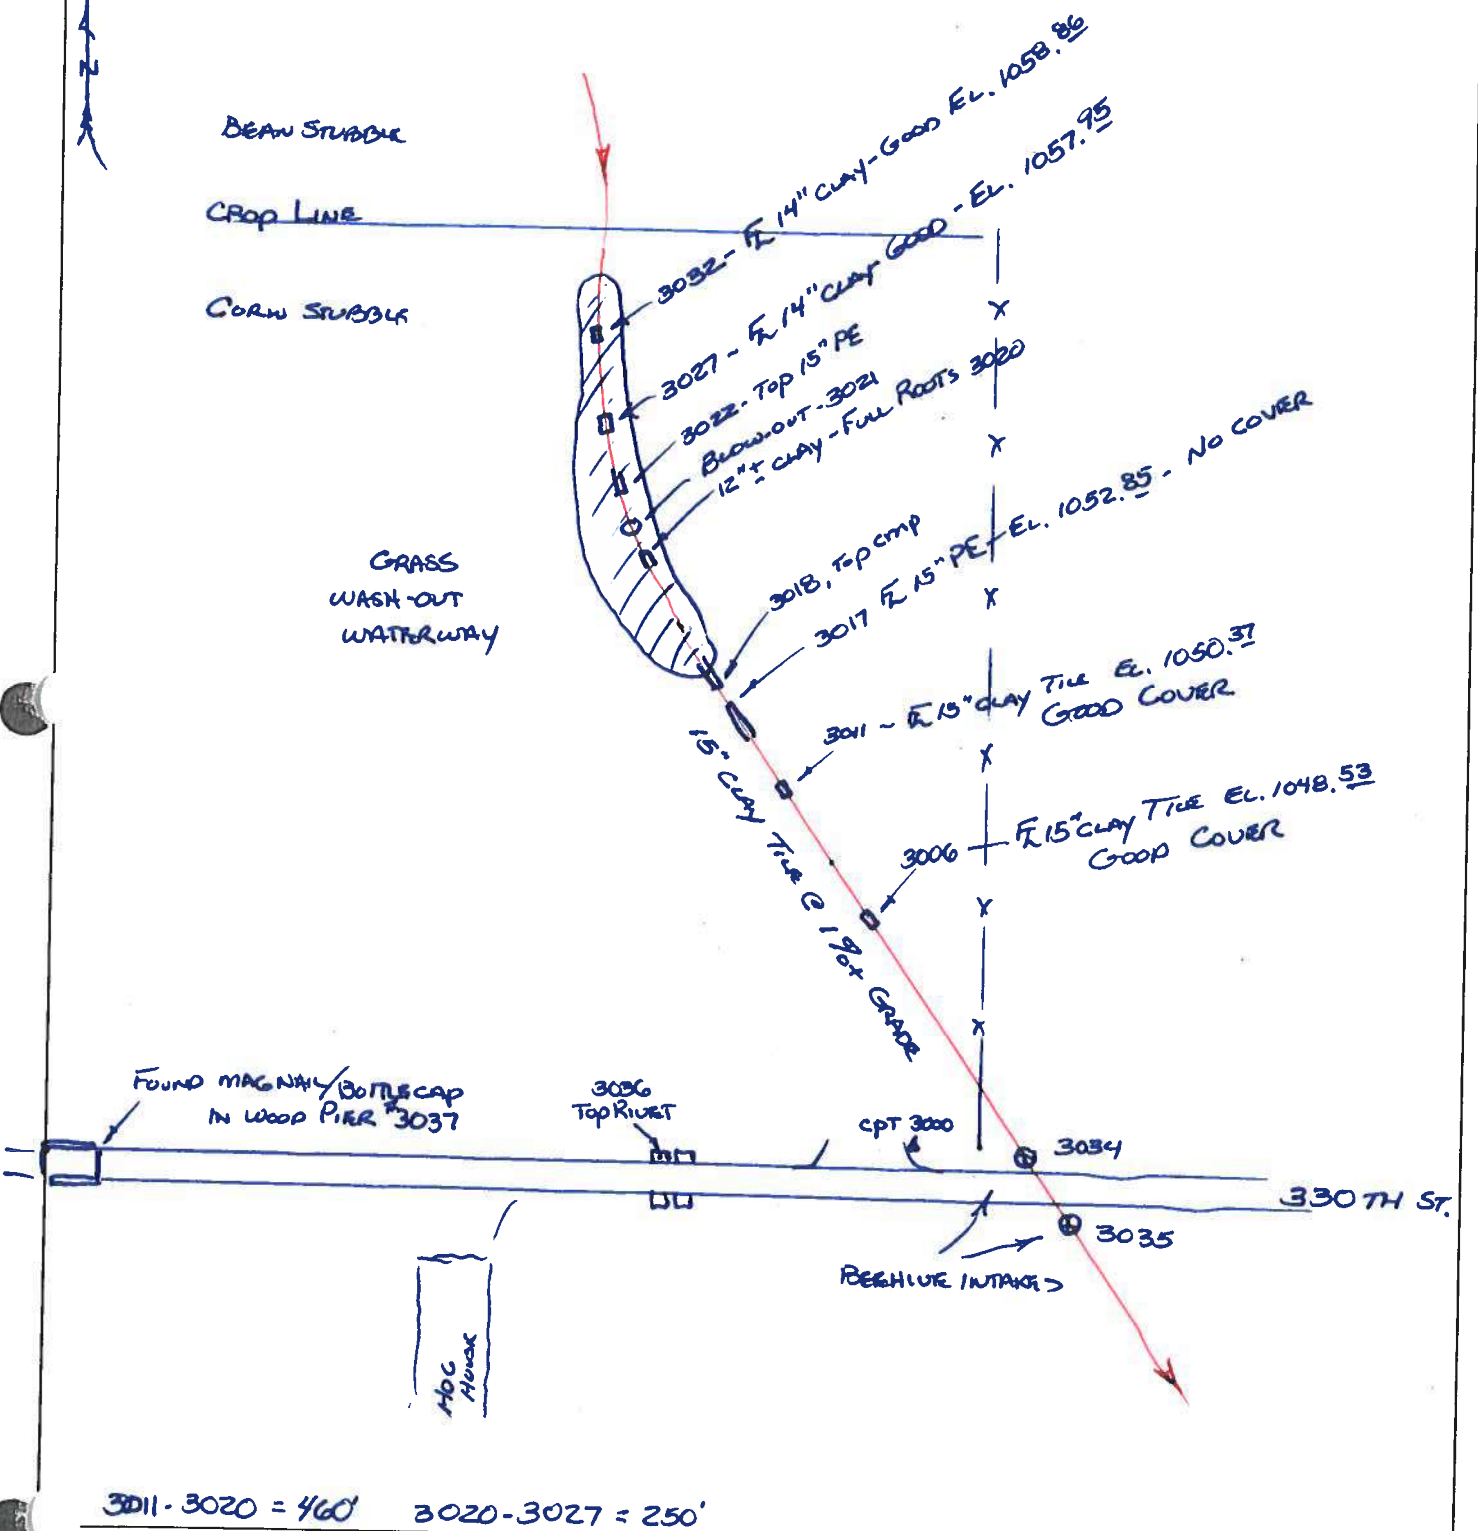
Roots @ Blow-out # 3020

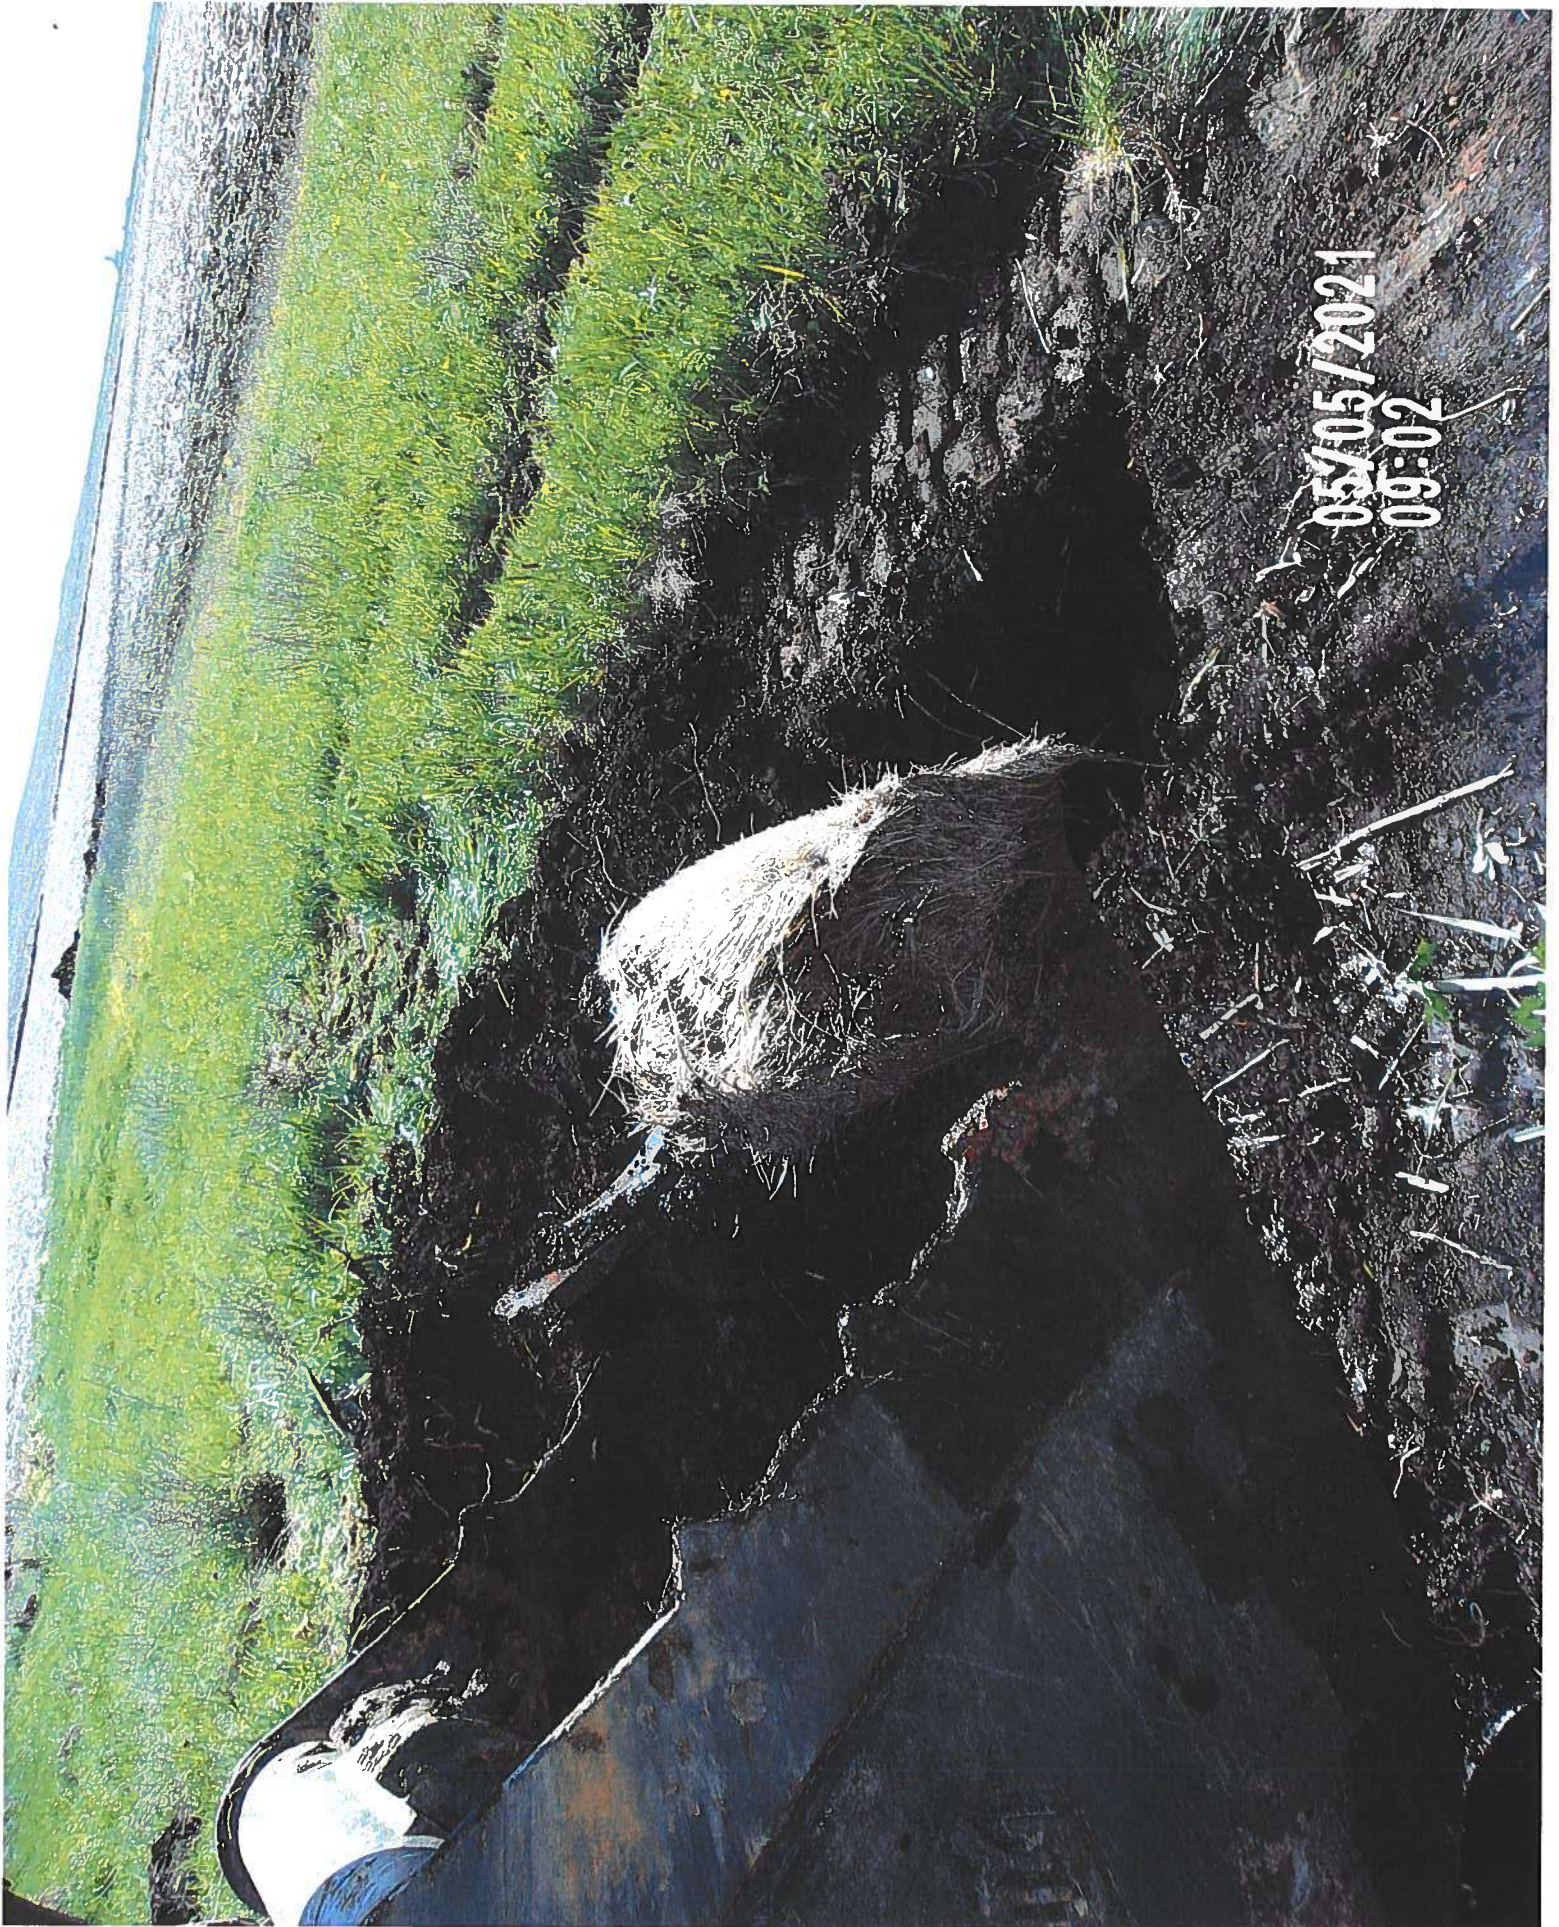
PE-CLAY COLLAPSE TO Cmp @ 2017-2018

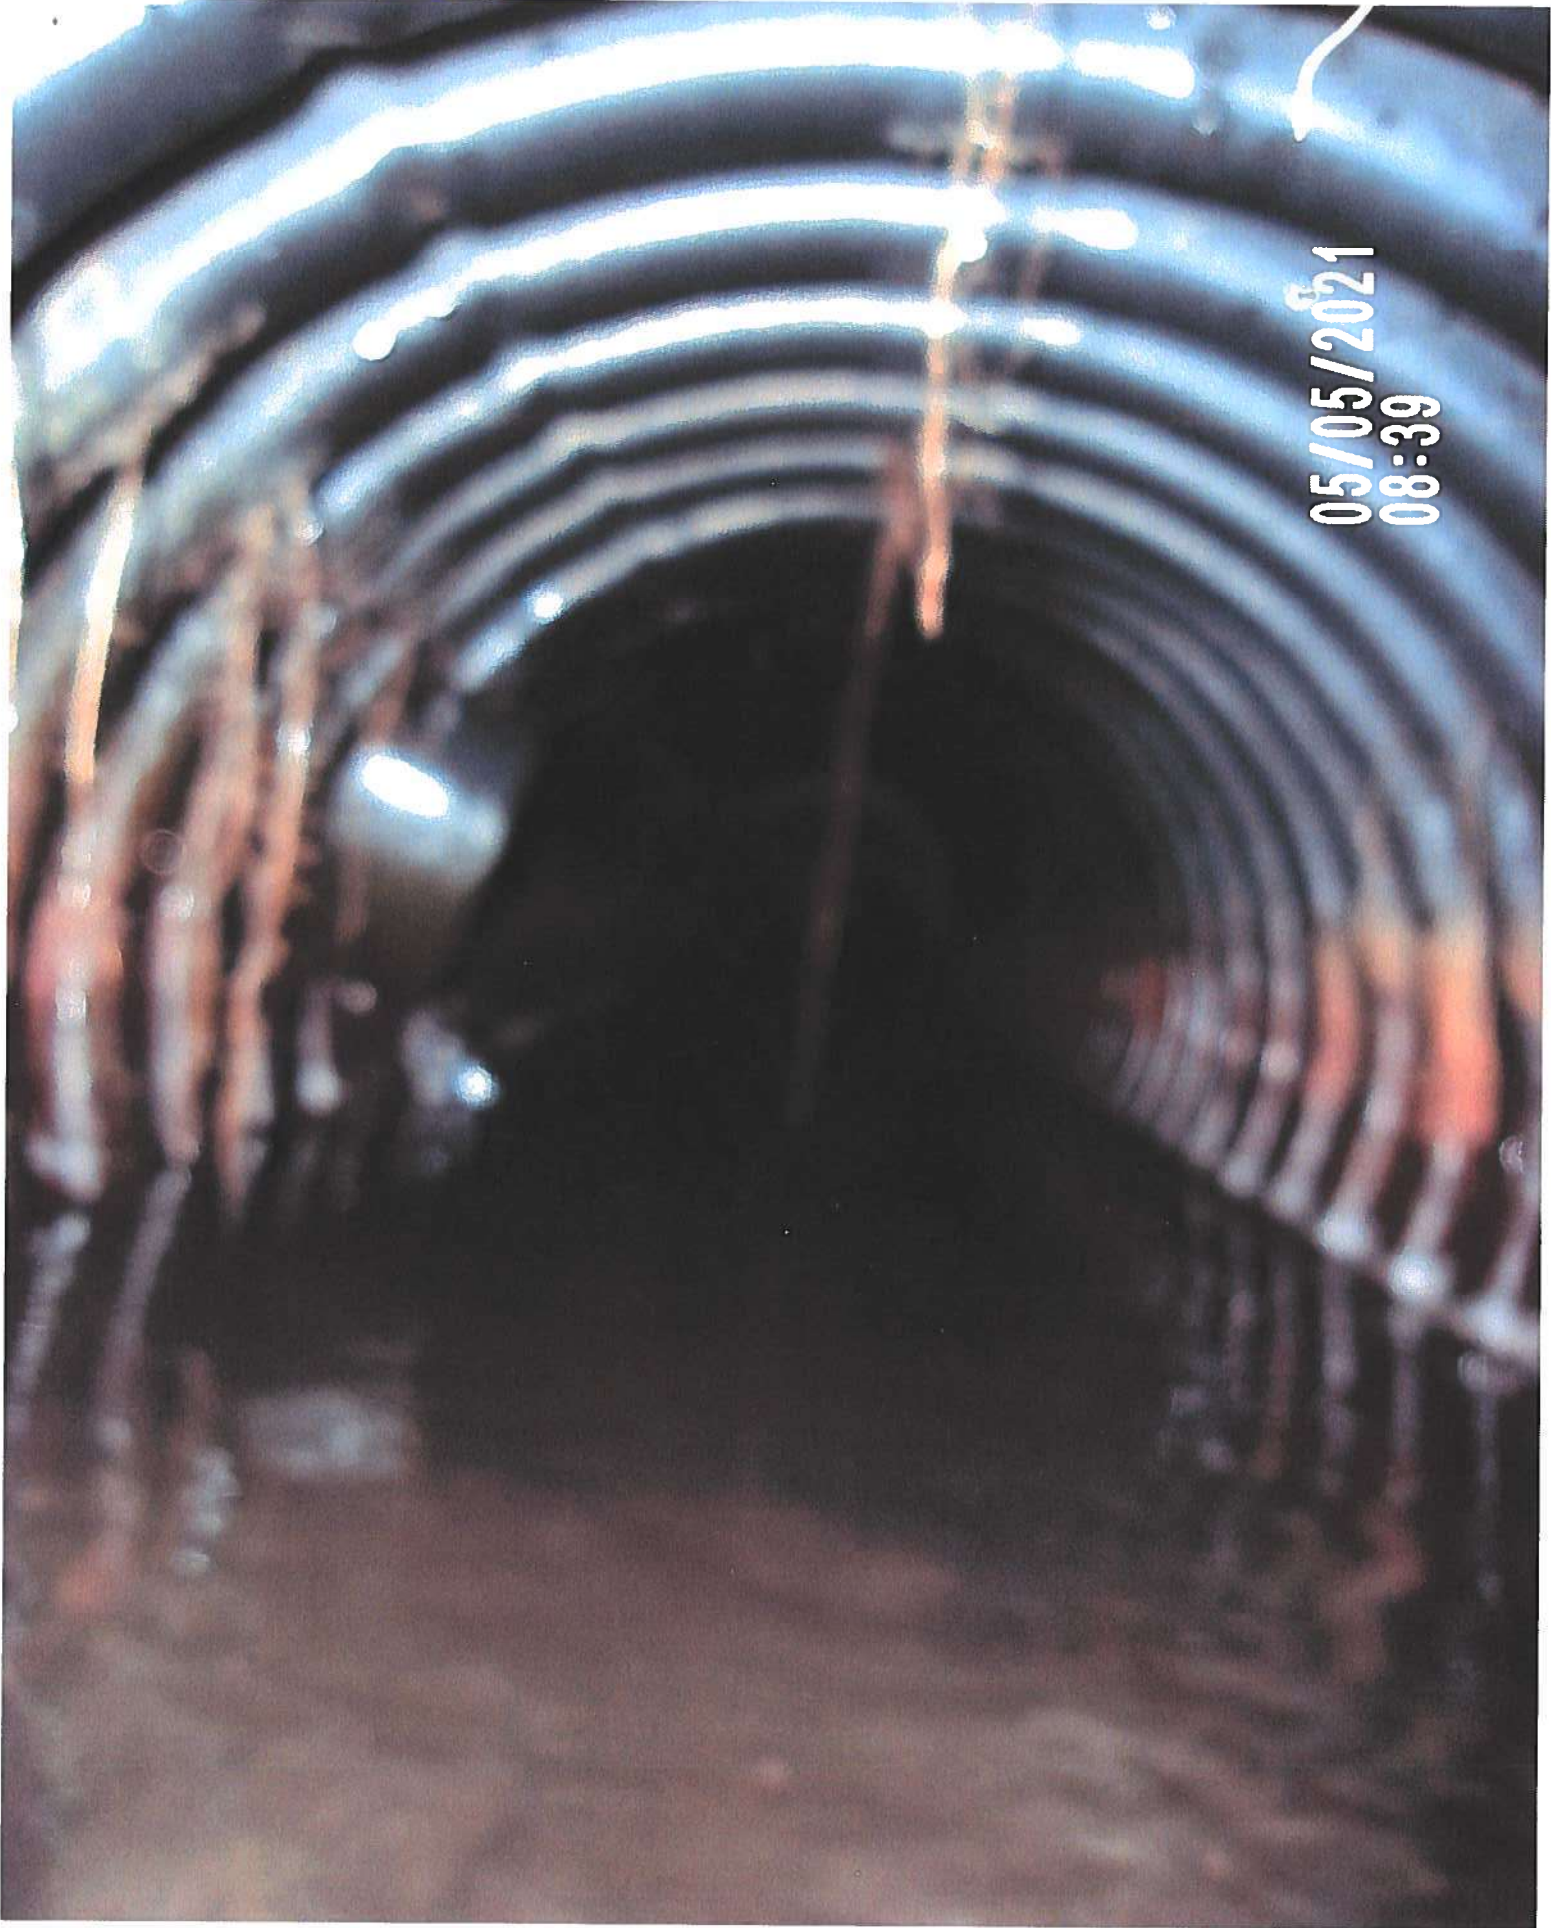
PE © ~~2017~~ ²⁰¹⁷, NOTE COLLAPSED CLAY
