AGENDA
DRAINAGE DISTRICT 48 LANDOWNER MEETING
Wednesday, June 23, 2021 1:00 PM
Emergency Operations Center, 1031 Edgington Ave., Eldora, Iowa.
This meeting will be held electronically and in-person due to Covid-19 concerns.
To access the meeting call: 1-(312)-626-6799, when prompted enter meeting
ID code: 820 7567 2007
You can also access the meeting online at:
<https://us02web.zoom.us/j/82075672007>

Drainage Work Order Request For Repair

Investigation Summary:

INVESTIGATION MAP

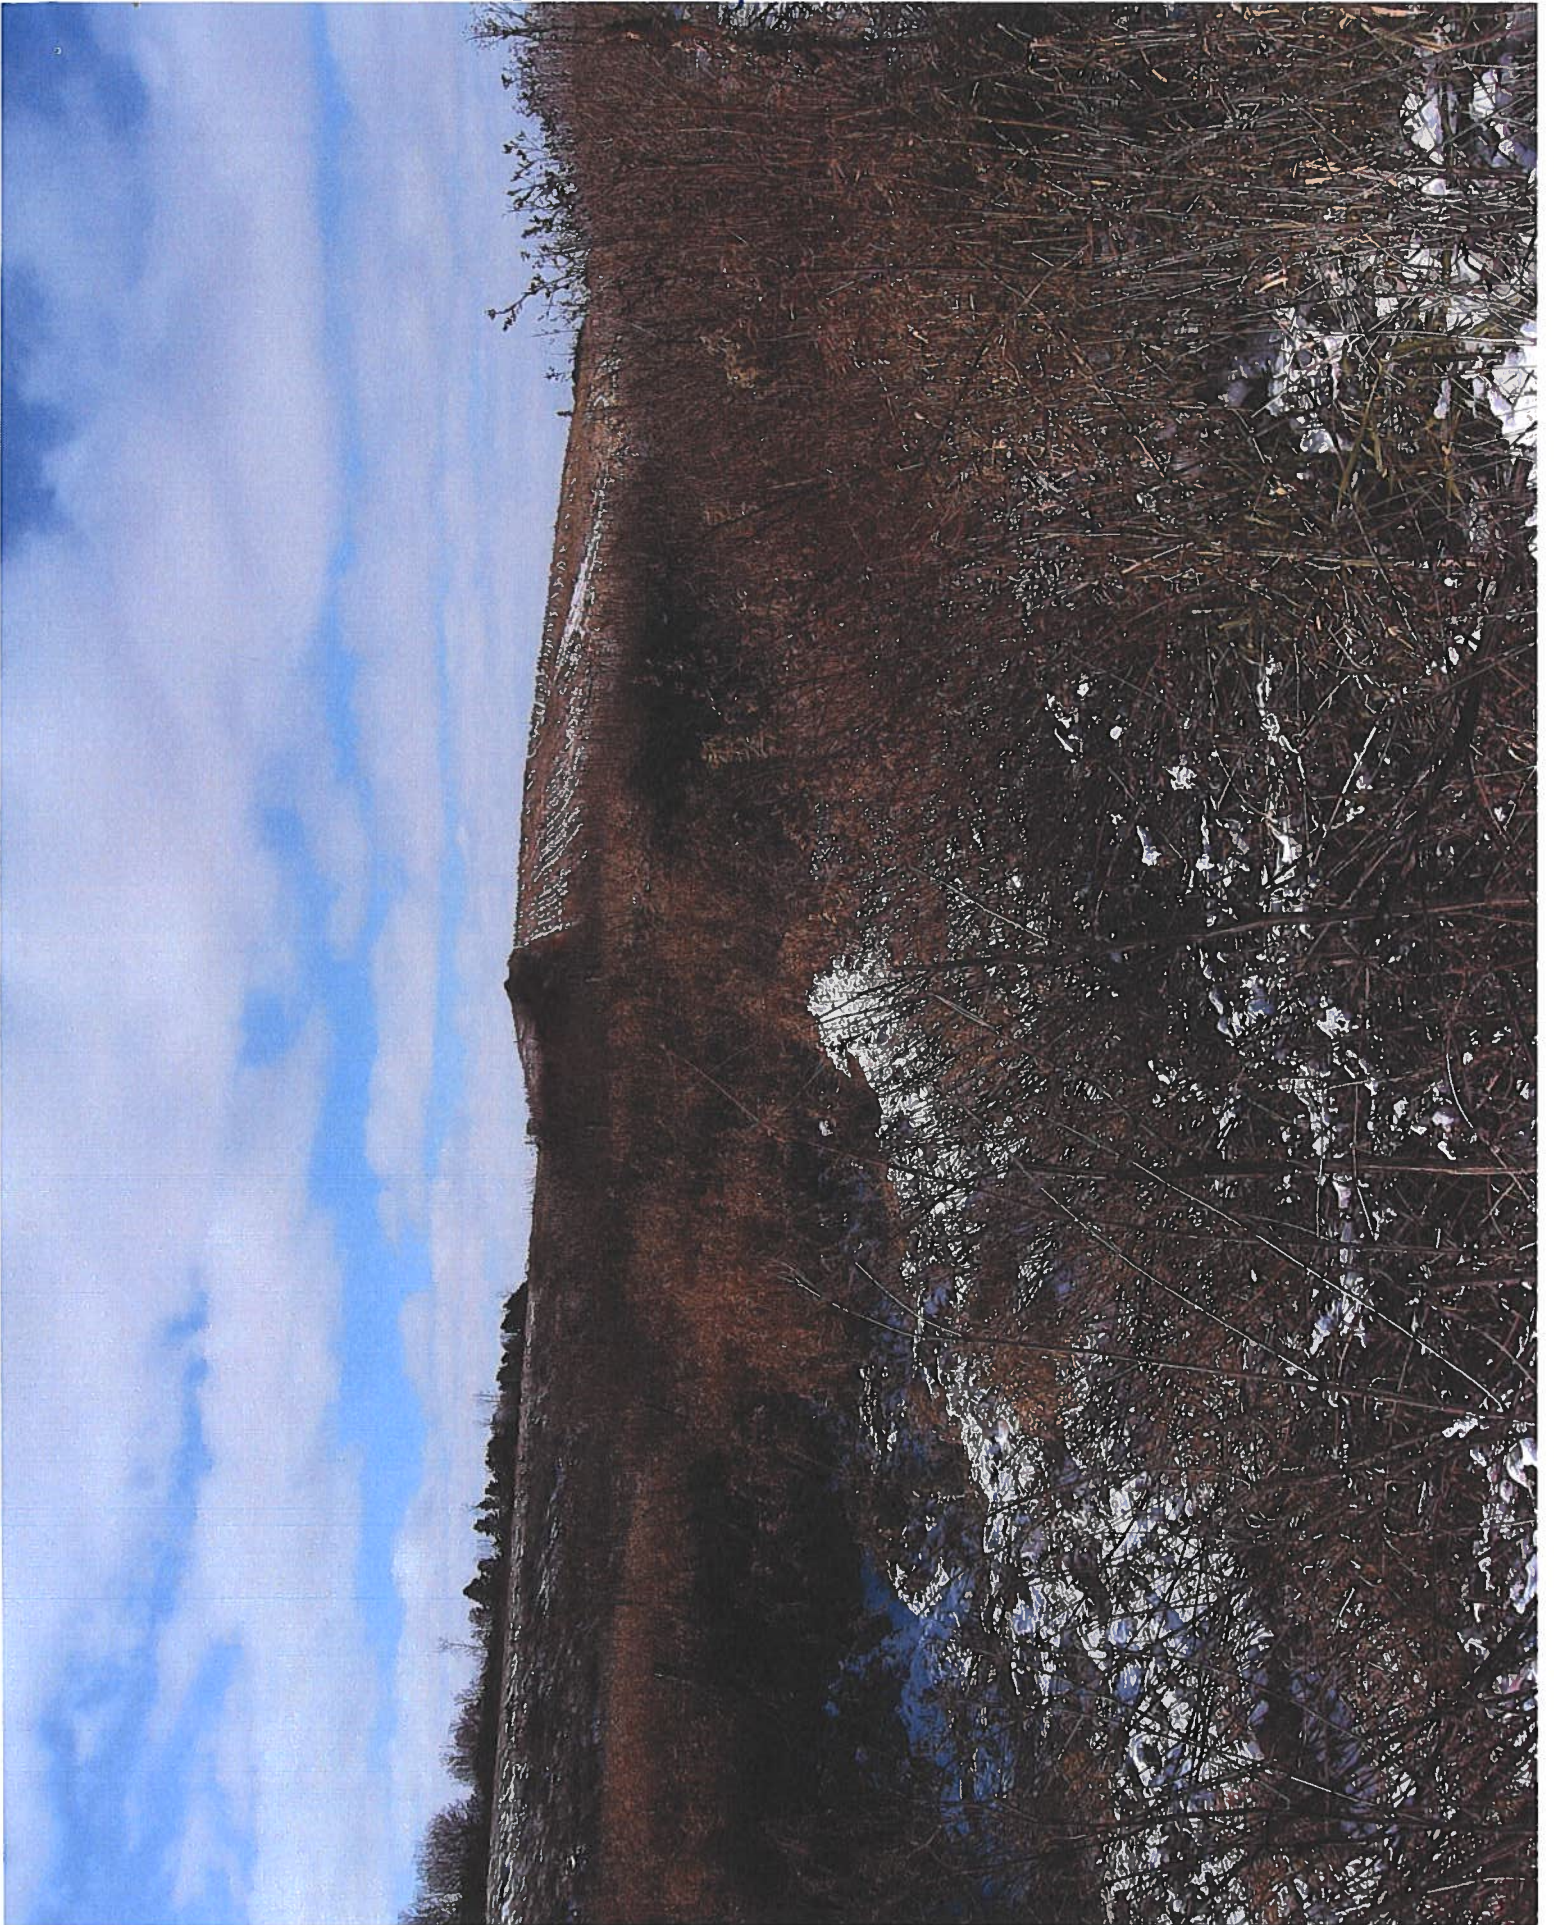
Looking W. @ D.O.T. Hwy 20 R/W

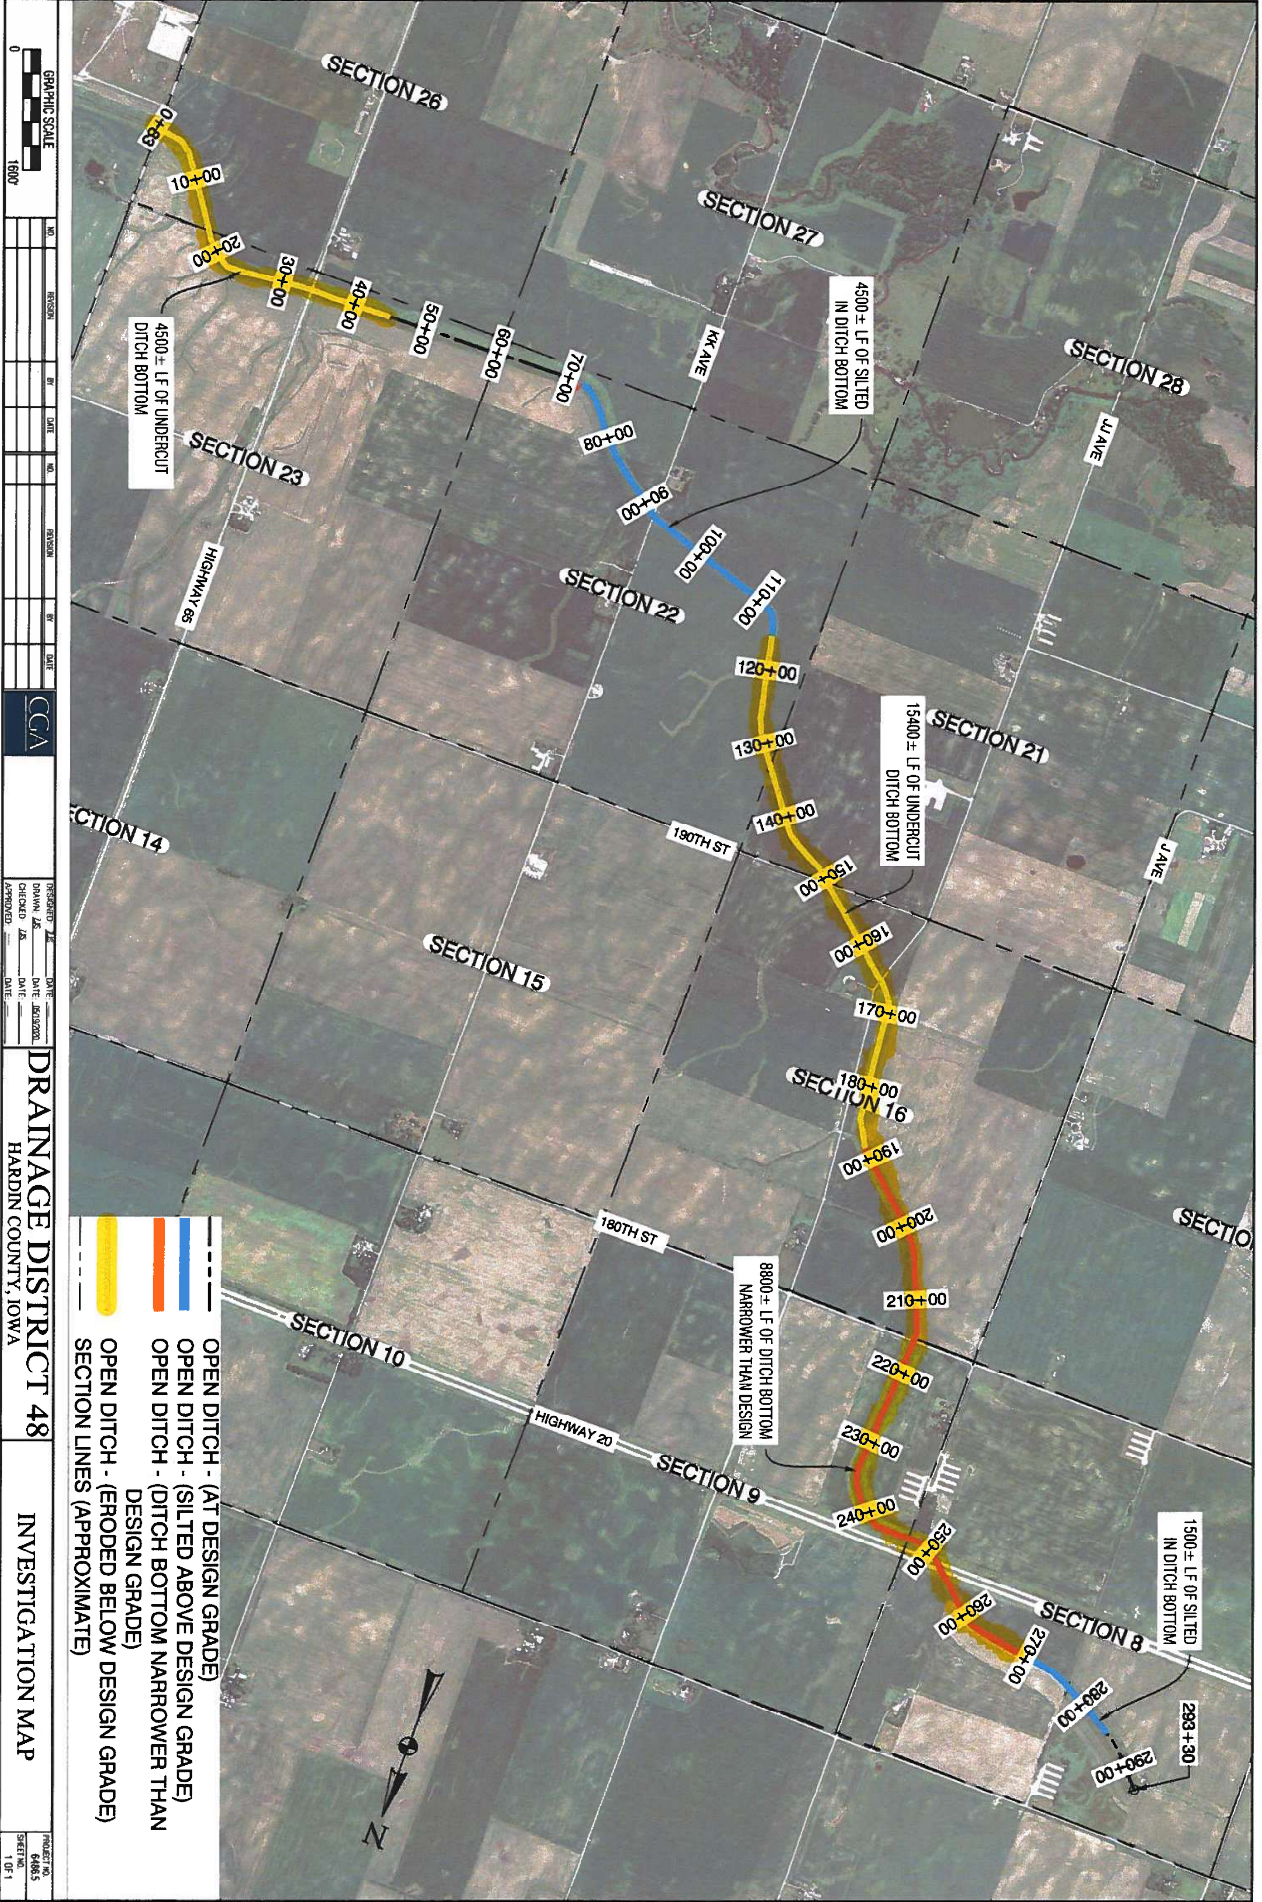
1. 6,000± feet of the main open ditch that has silt accumulation of ½ feet to 1½ feet (see attached map for locations).
 2. 15,460± feet of the main open ditch that has eroded below the original design grade (see attached map for locations).

3. 8,800± feet of the main open ditch that has a bottom width narrower than the original design (see attached map for locations).
 4. Erosion around the outlet of the main tile at the upper end of the main open ditch.

4500 ± LF OF UNDERCUT DITCH BOTTOM

4500 ± LF OF SILTED IN DITCH BOTTOM

15400 ± LF OF UNDERCUT DITCH BOTTOM

8800 ± LF OF DITCH BOTTOM NARROWER THAN DESIGN

1500 ± LF OF SILTED IN DITCH BOTTOM

Given all of the above issues that could negatively impact drainage capacity, we would recommend a large scale project to remedy them. Since these issues are spread throughout the length of the main open ditch, the construction cost would be well over \$50,000. This amount is high enough that a hearing and an engineer's report would be required.
