**AGENDA**  
**REGULAR DRAINAGE MEETING**  
**Monday, February 8, 2021 9:30 AM**  
**Large Conference Room**

**This will be a joint meeting with the Franklin County Board of Supervisors acting as Drainage Trustees for DD H-F 4-53.**

## Drainage District:

## Investigation Summary:

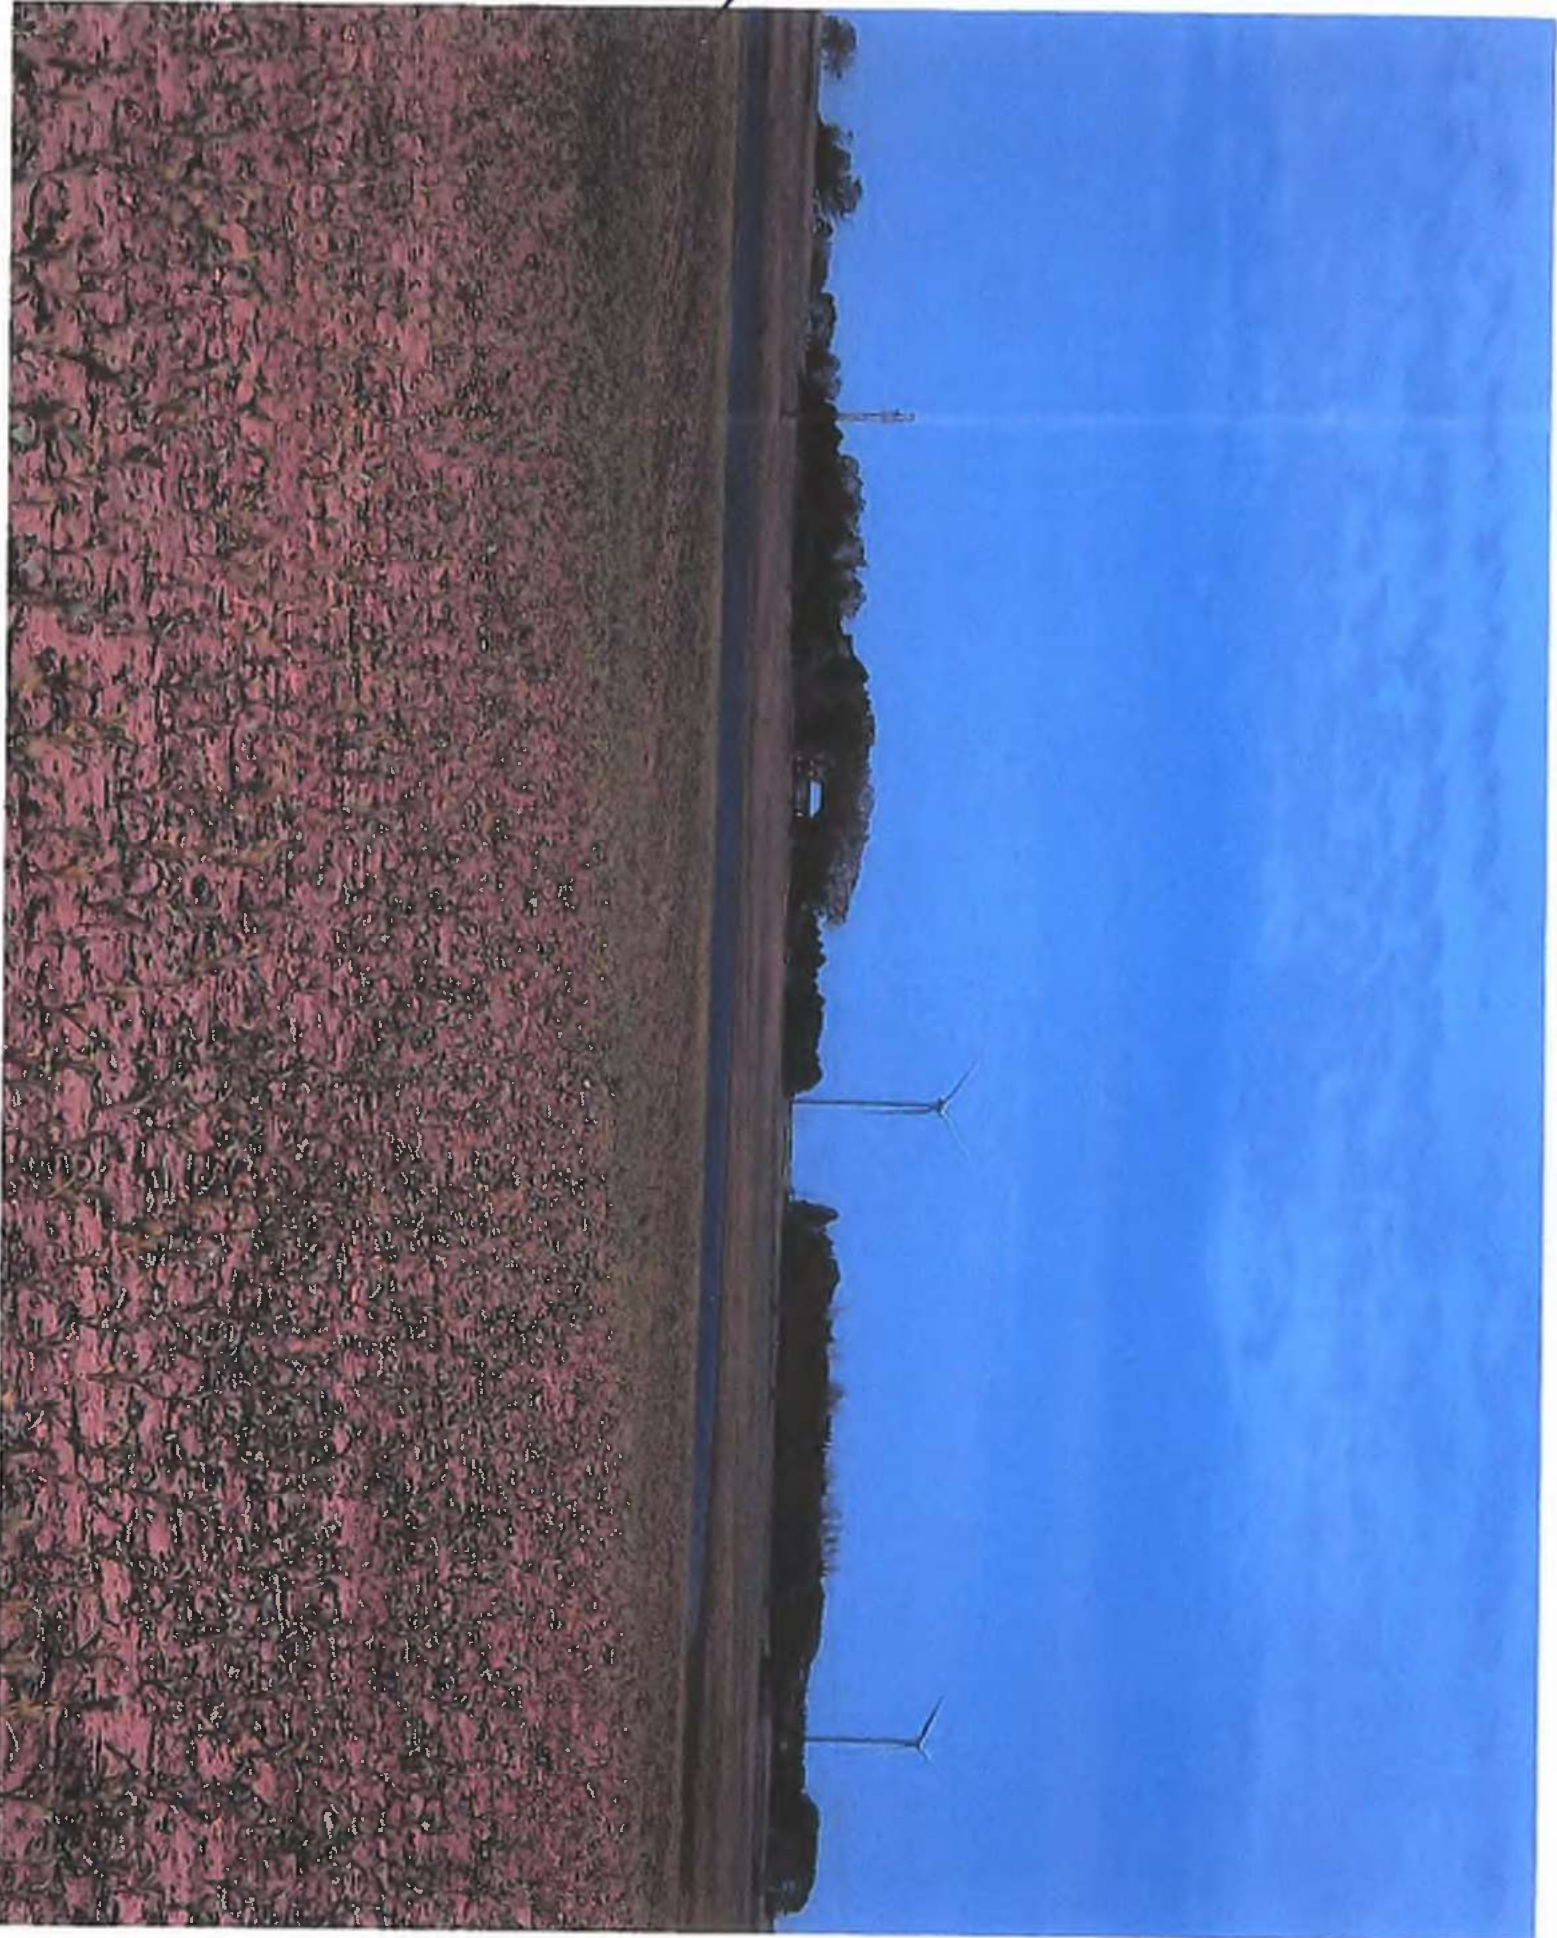
Problem Area @ LAT 4 / LAT 4B CONNECTION

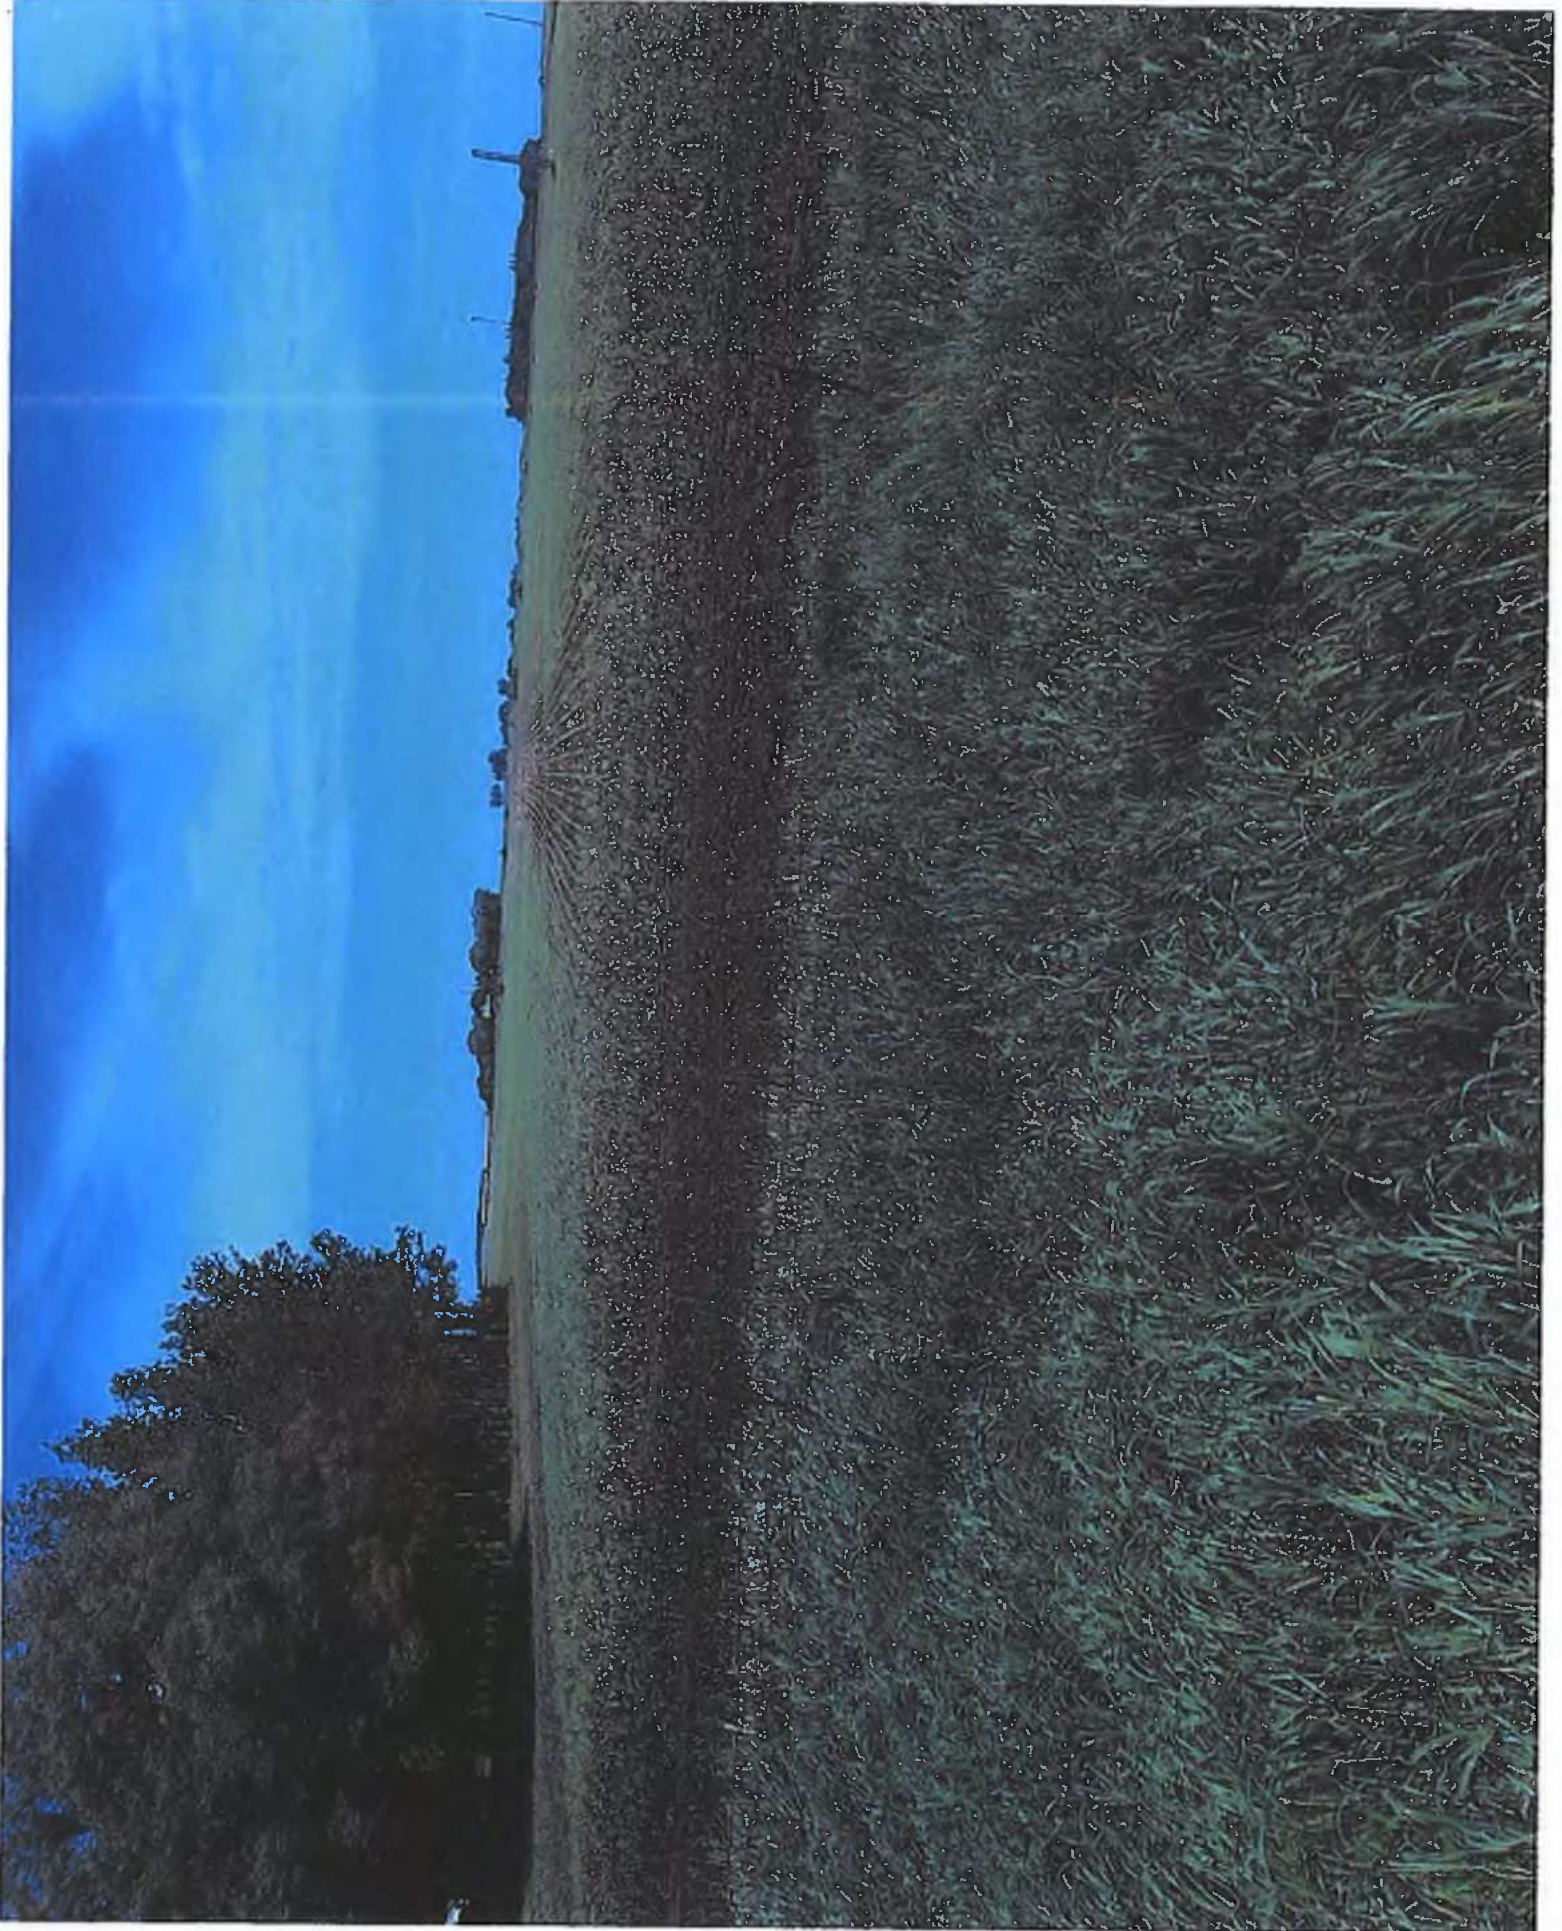
LOOKING DOWNSTREAM ON LAT 4B PASS AUSTREES + COTTONWOOD

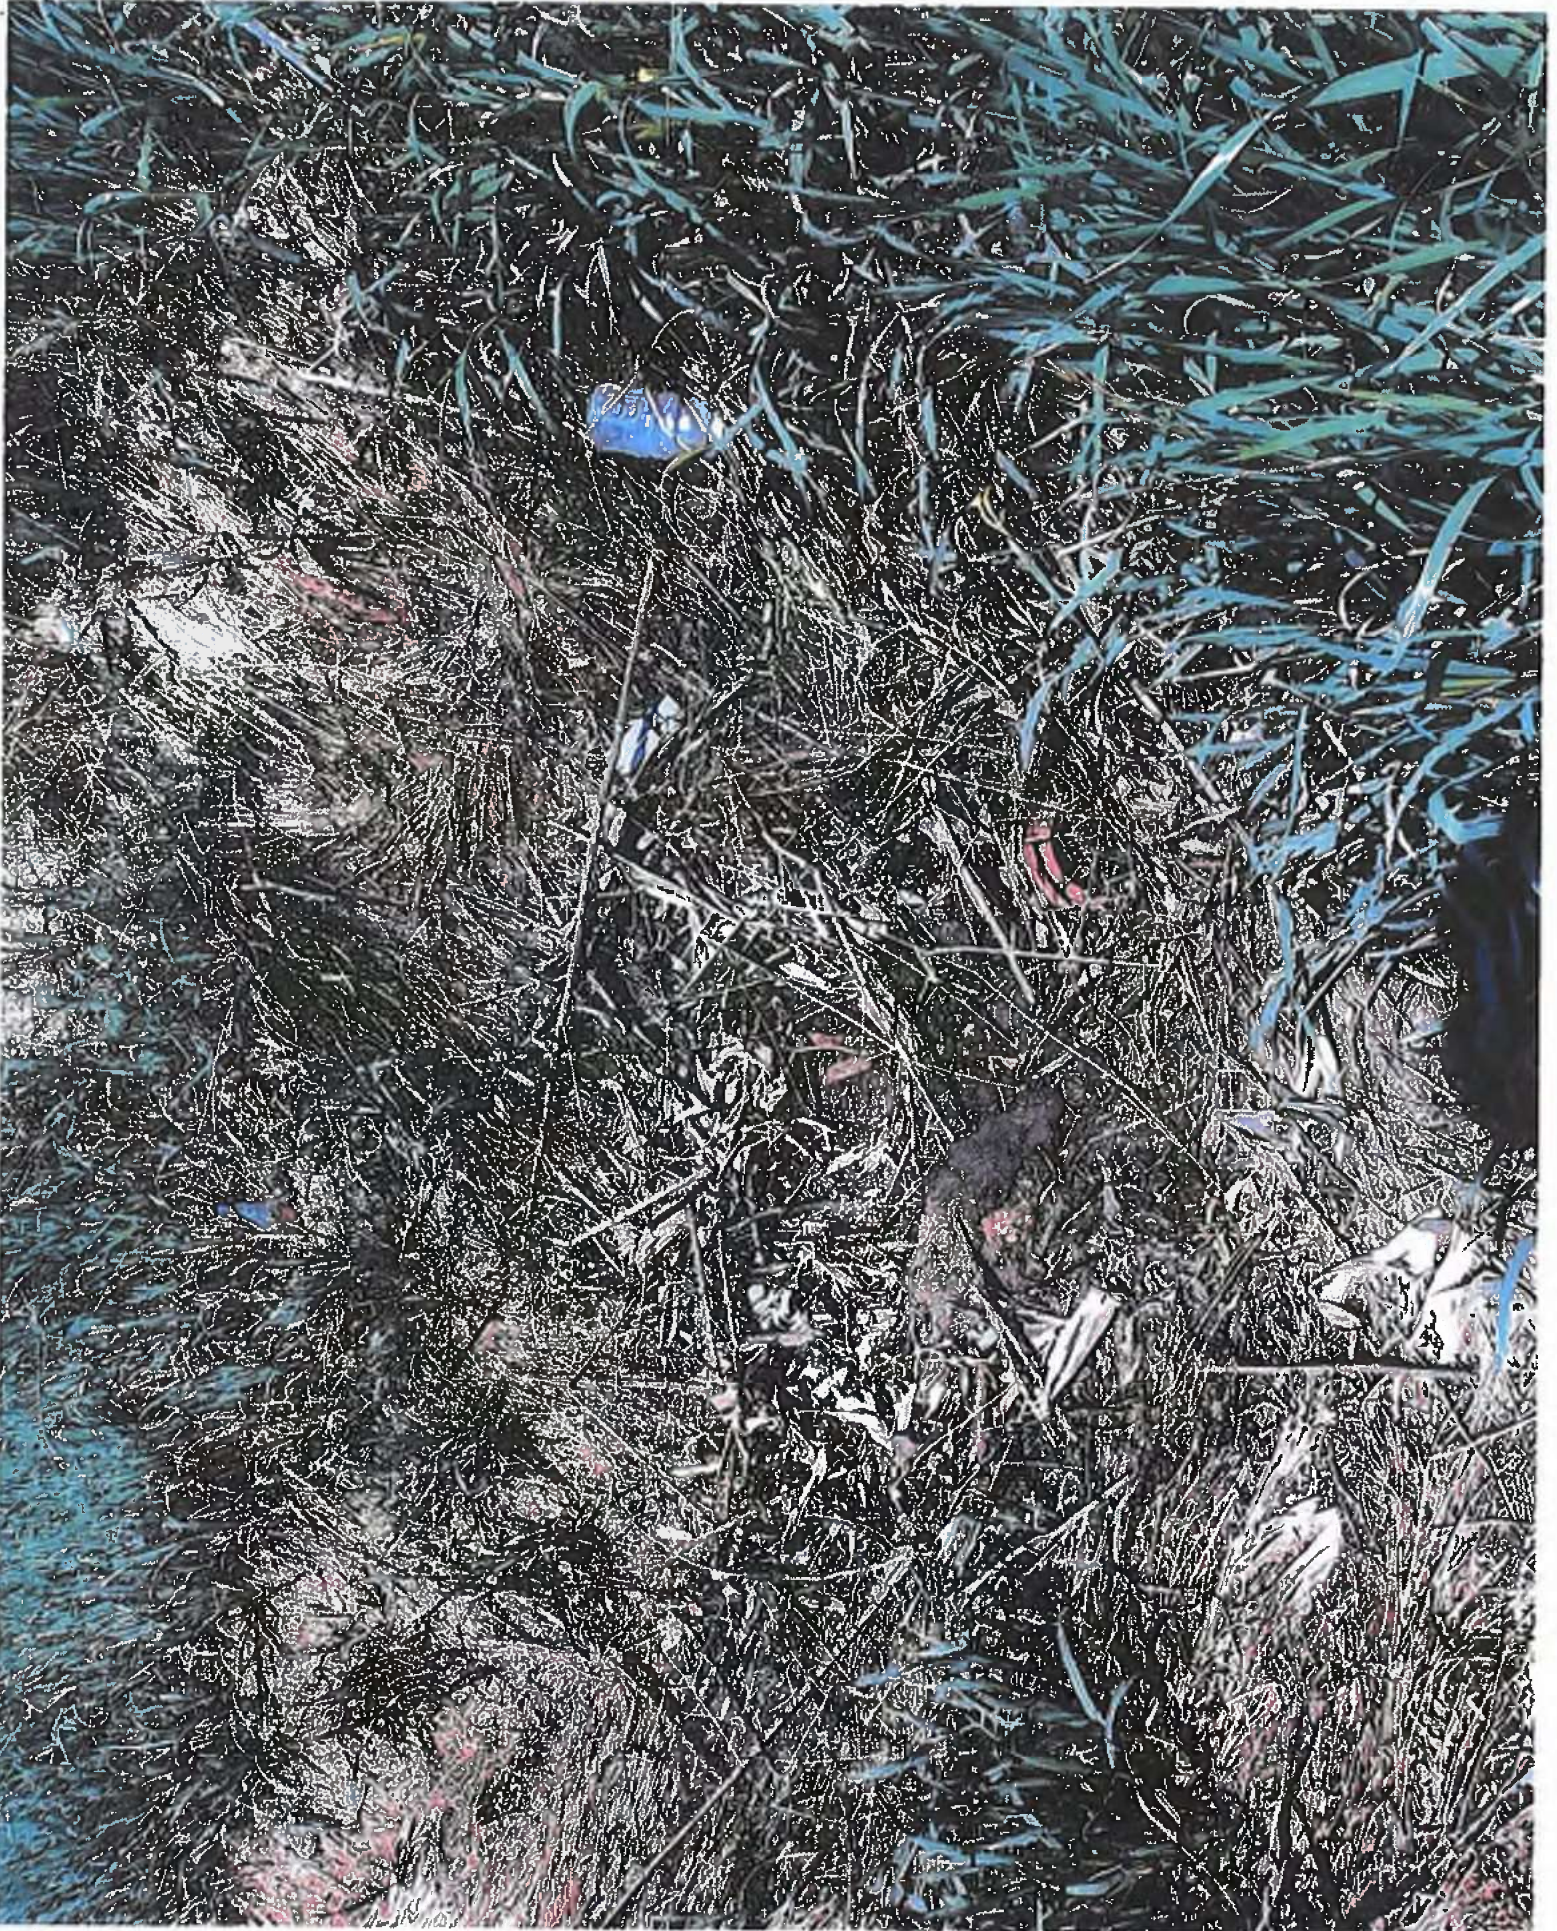
- A collapsed intake on the south side of Hardin Road (Highway C73).
    - Excess moisture near the connection of 4B & 4B4.
    - Ponding and pieces of broken tile near the intersection of Lateral 4B & the abandoned railroad.

COLLAPSED INTAKE ON LAT 40, S. SIDE HARDIN ROAD (HMA) C73

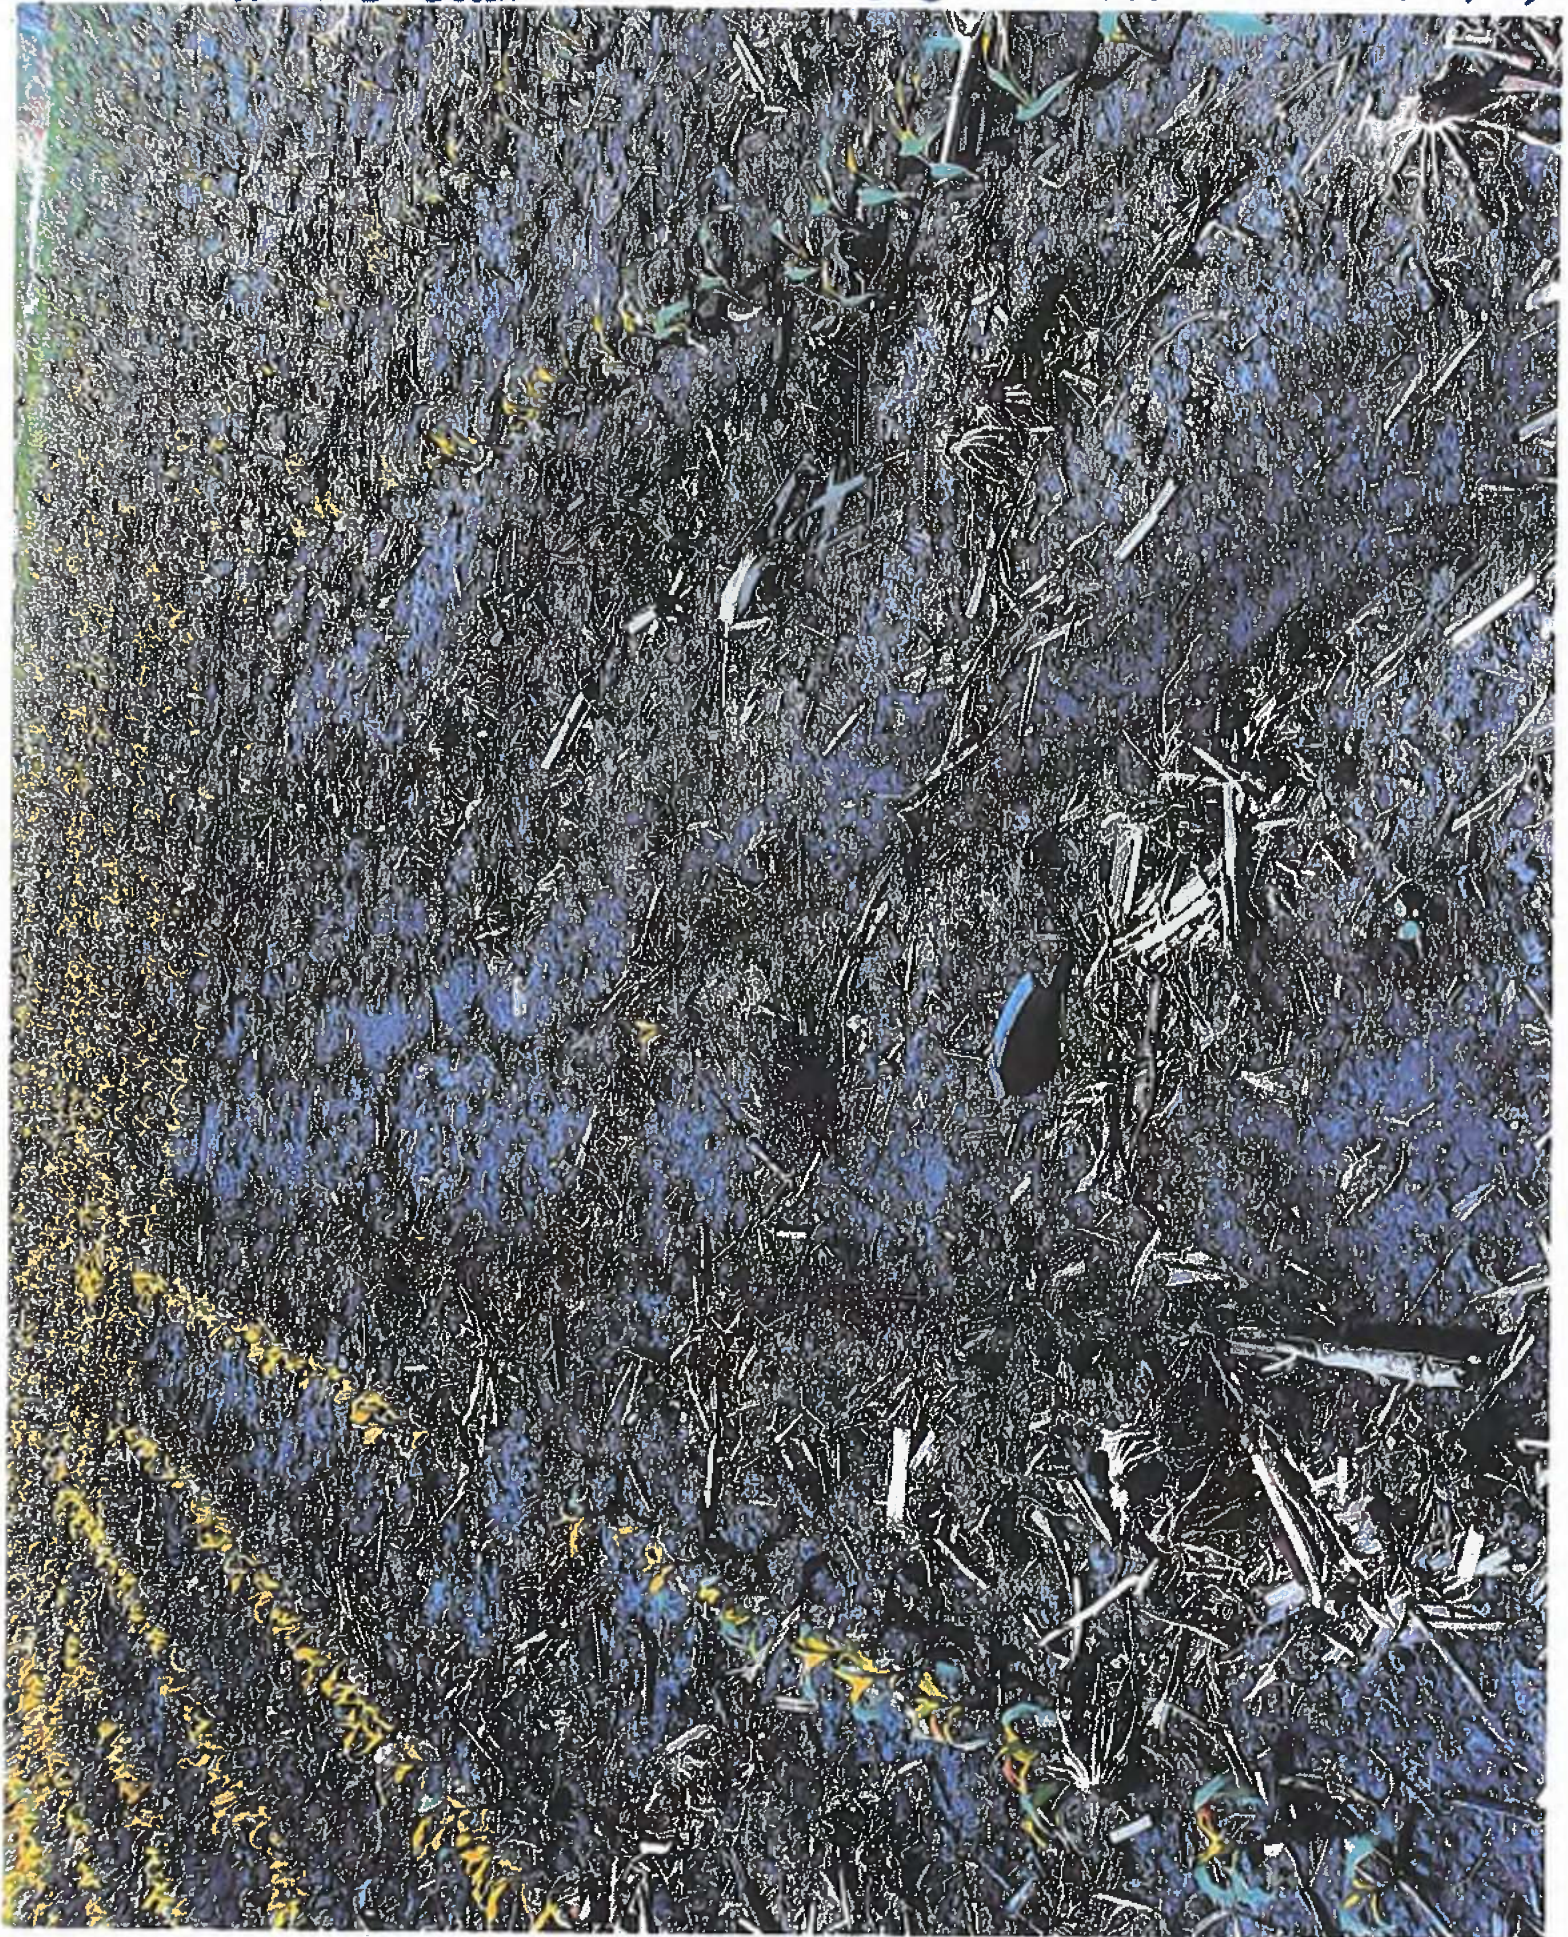
LOOKING DOWNSTREAM ON LOT 4B @ OLD RR. TIM CHARD (Purple)

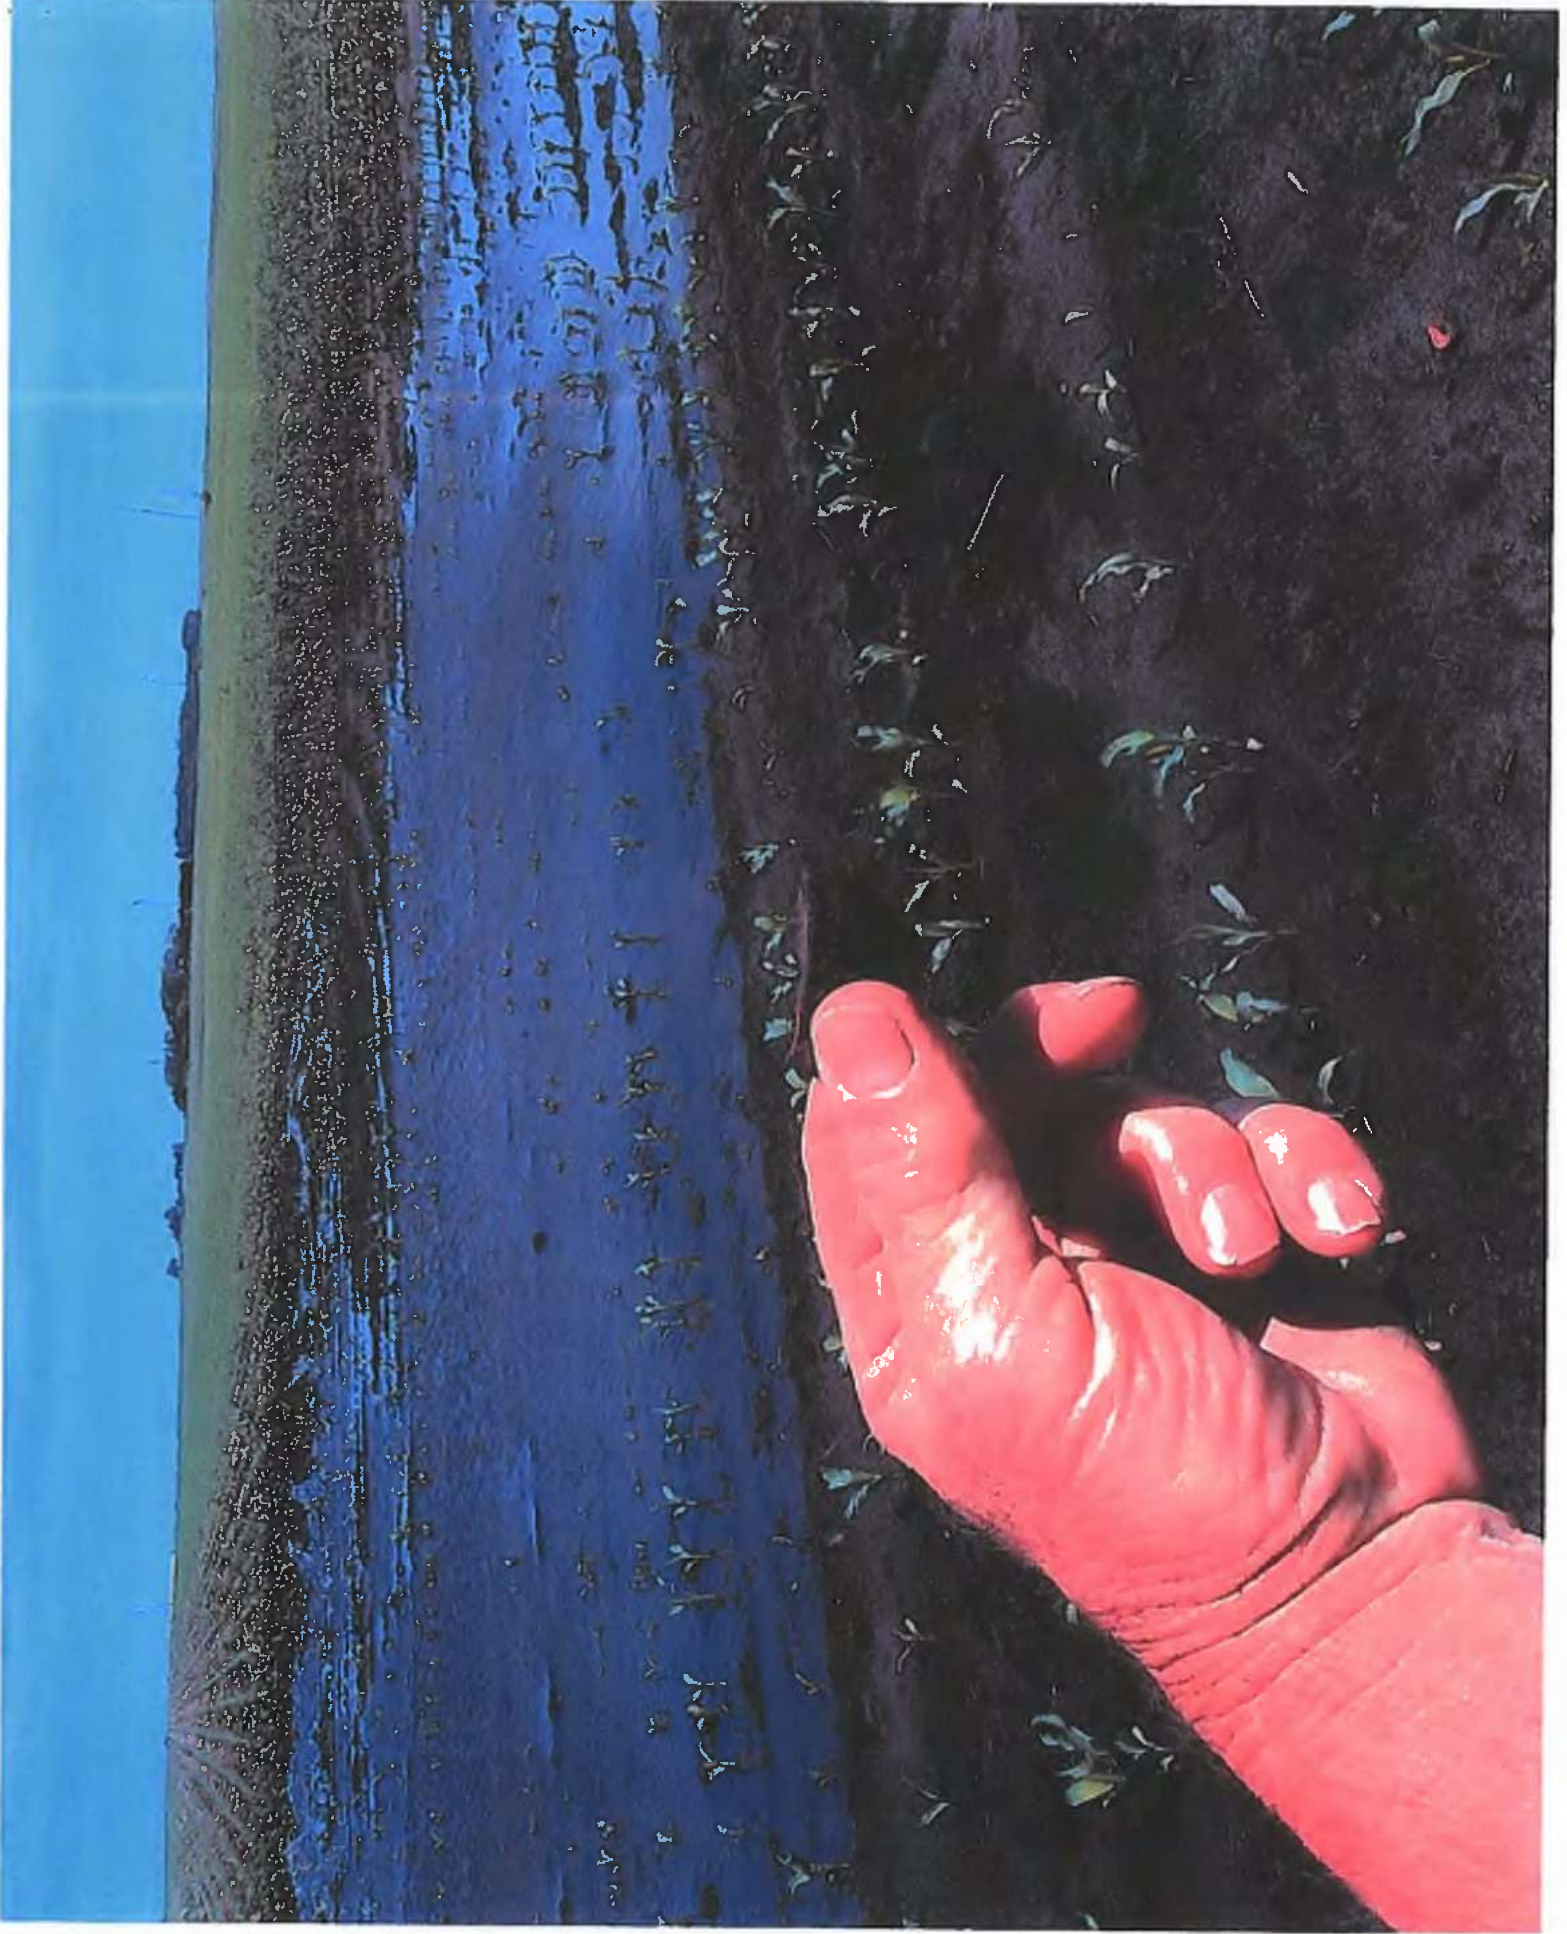
LOOKING UPSTREAM ON LAT 4 @ C73, LOTS OF TILIA CITRARDOS

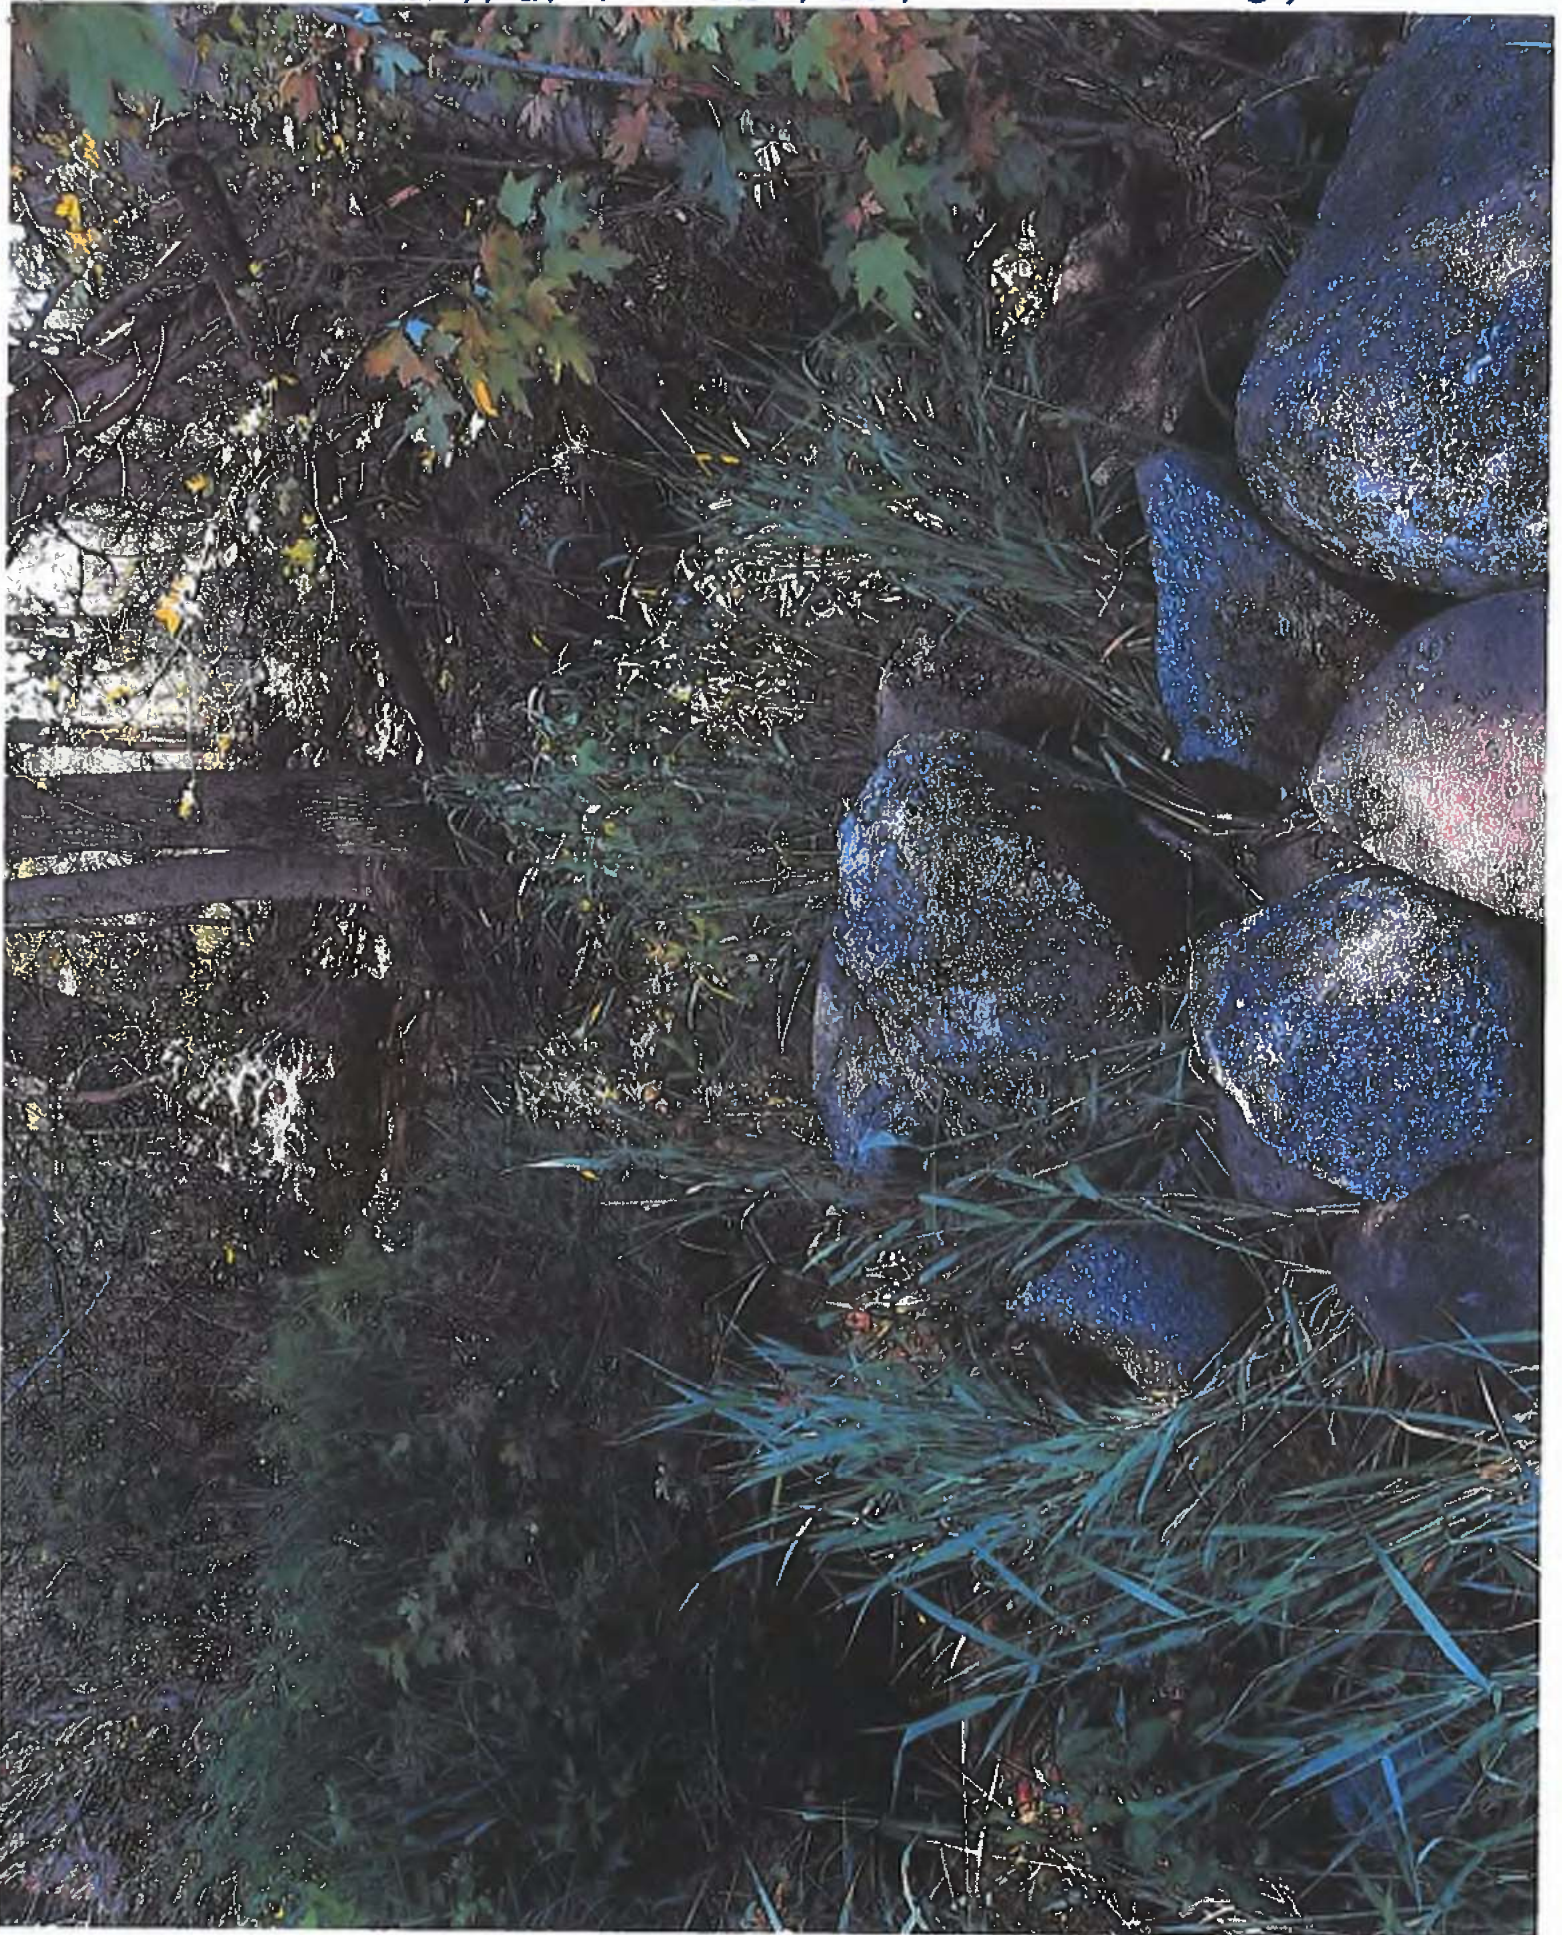
OUTLET AREA FOR JDD 4-53, CANT FIND EASILY, CANT HEAR WATER

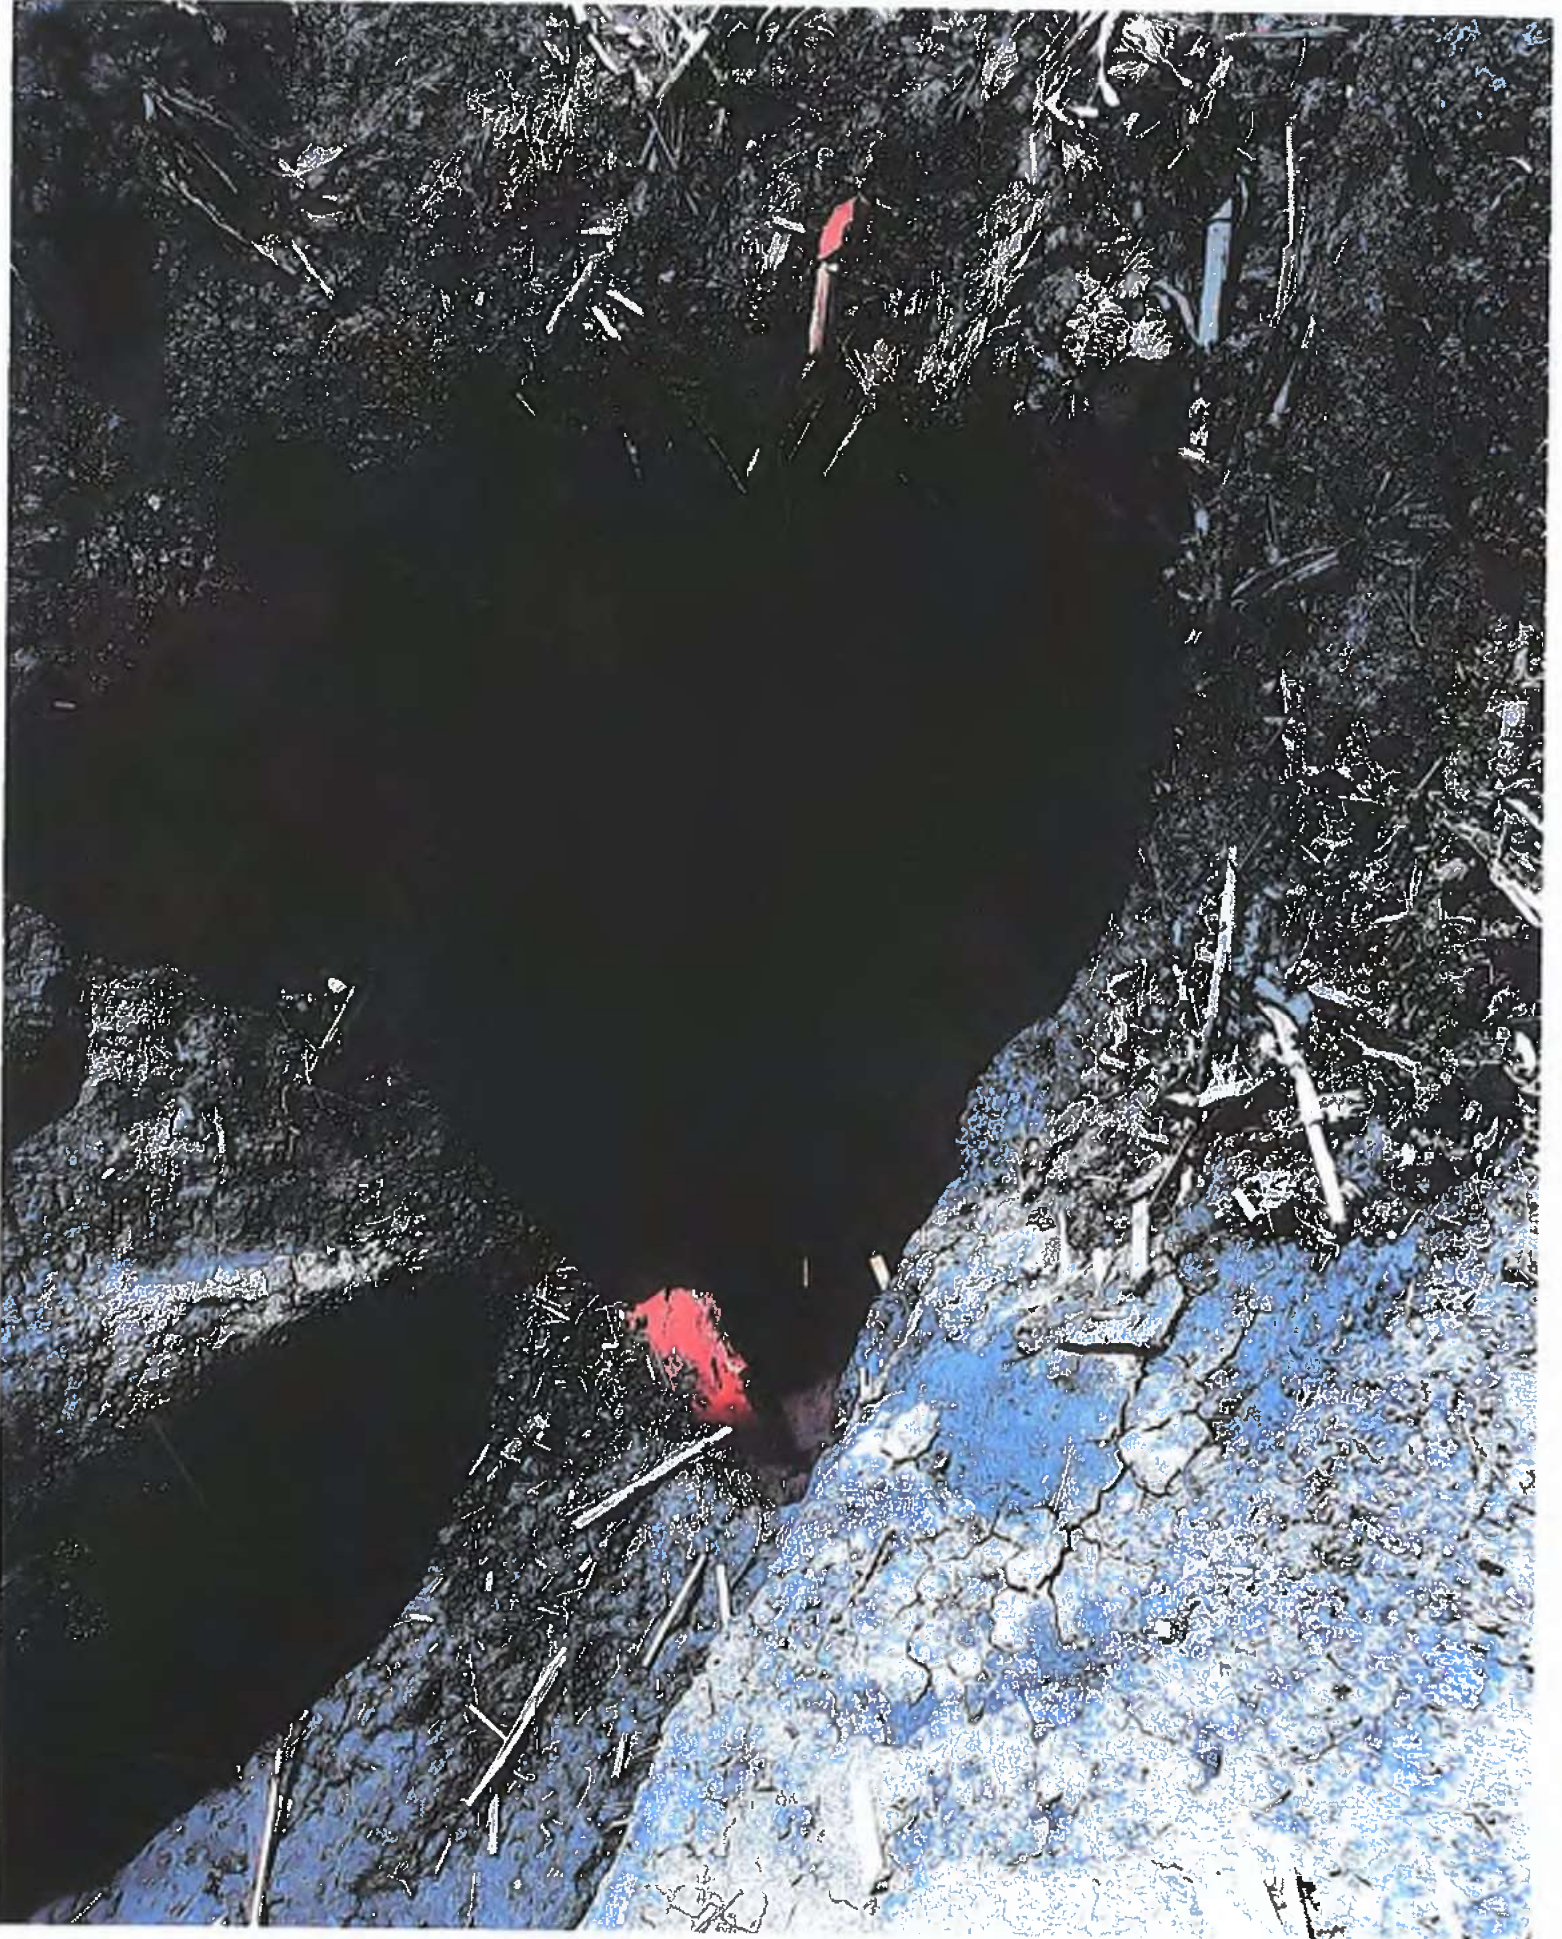
Parked on S. Side Hardin Rd. (C73), Walked to Blow-out in Field Found 12" x 12" x 12" Clay Y Gove. Looks Like Farmer was Digging Hole and Exposed Tile. Lat 4A is Visibly Flowing, Priv. Lat to NW, Not so much. Tile is Full 1" Above Tile Top. Walked downstream to Lat 4A - Lat 4 Connection. Lots of Tile Channels on Surface, No Water Standing. Walked downstream to Lat 4 - Main Connection, Some Water Standing, No Blow-outs. Walked back to C73, Lined up 12" Clay Lat 4A to NE to Mulberry Tree @ R/W, Cottonwood Tree to East may be @ 100'. Walked North across C73, Found Wet Spot/Tile Channels and 6" Steel Intake in N Ditch of C73 (E-W) across from Cottonwood Tree (that has Bicycle in Crown,

MISSING "Y"

Repair Blow-out with man. HOPE "Y", Pump up with short sticks of HOPE/long. Columns, Rock. Tile is 3' deep. Remove @ least the Mulberry on R/W may want to locate Lat 4A from Blow-out.
