**AGENDA**  
**REGULAR DRAINAGE MEETING**  
**Monday, February 8, 2021 9:30 AM**  
**Large Conference Room**

**This will be a joint meeting with the Franklin County Board of Supervisors acting as Drainage Trustees for DD H-F 4-53.**

## Drainage District:

## Investigation Summary:

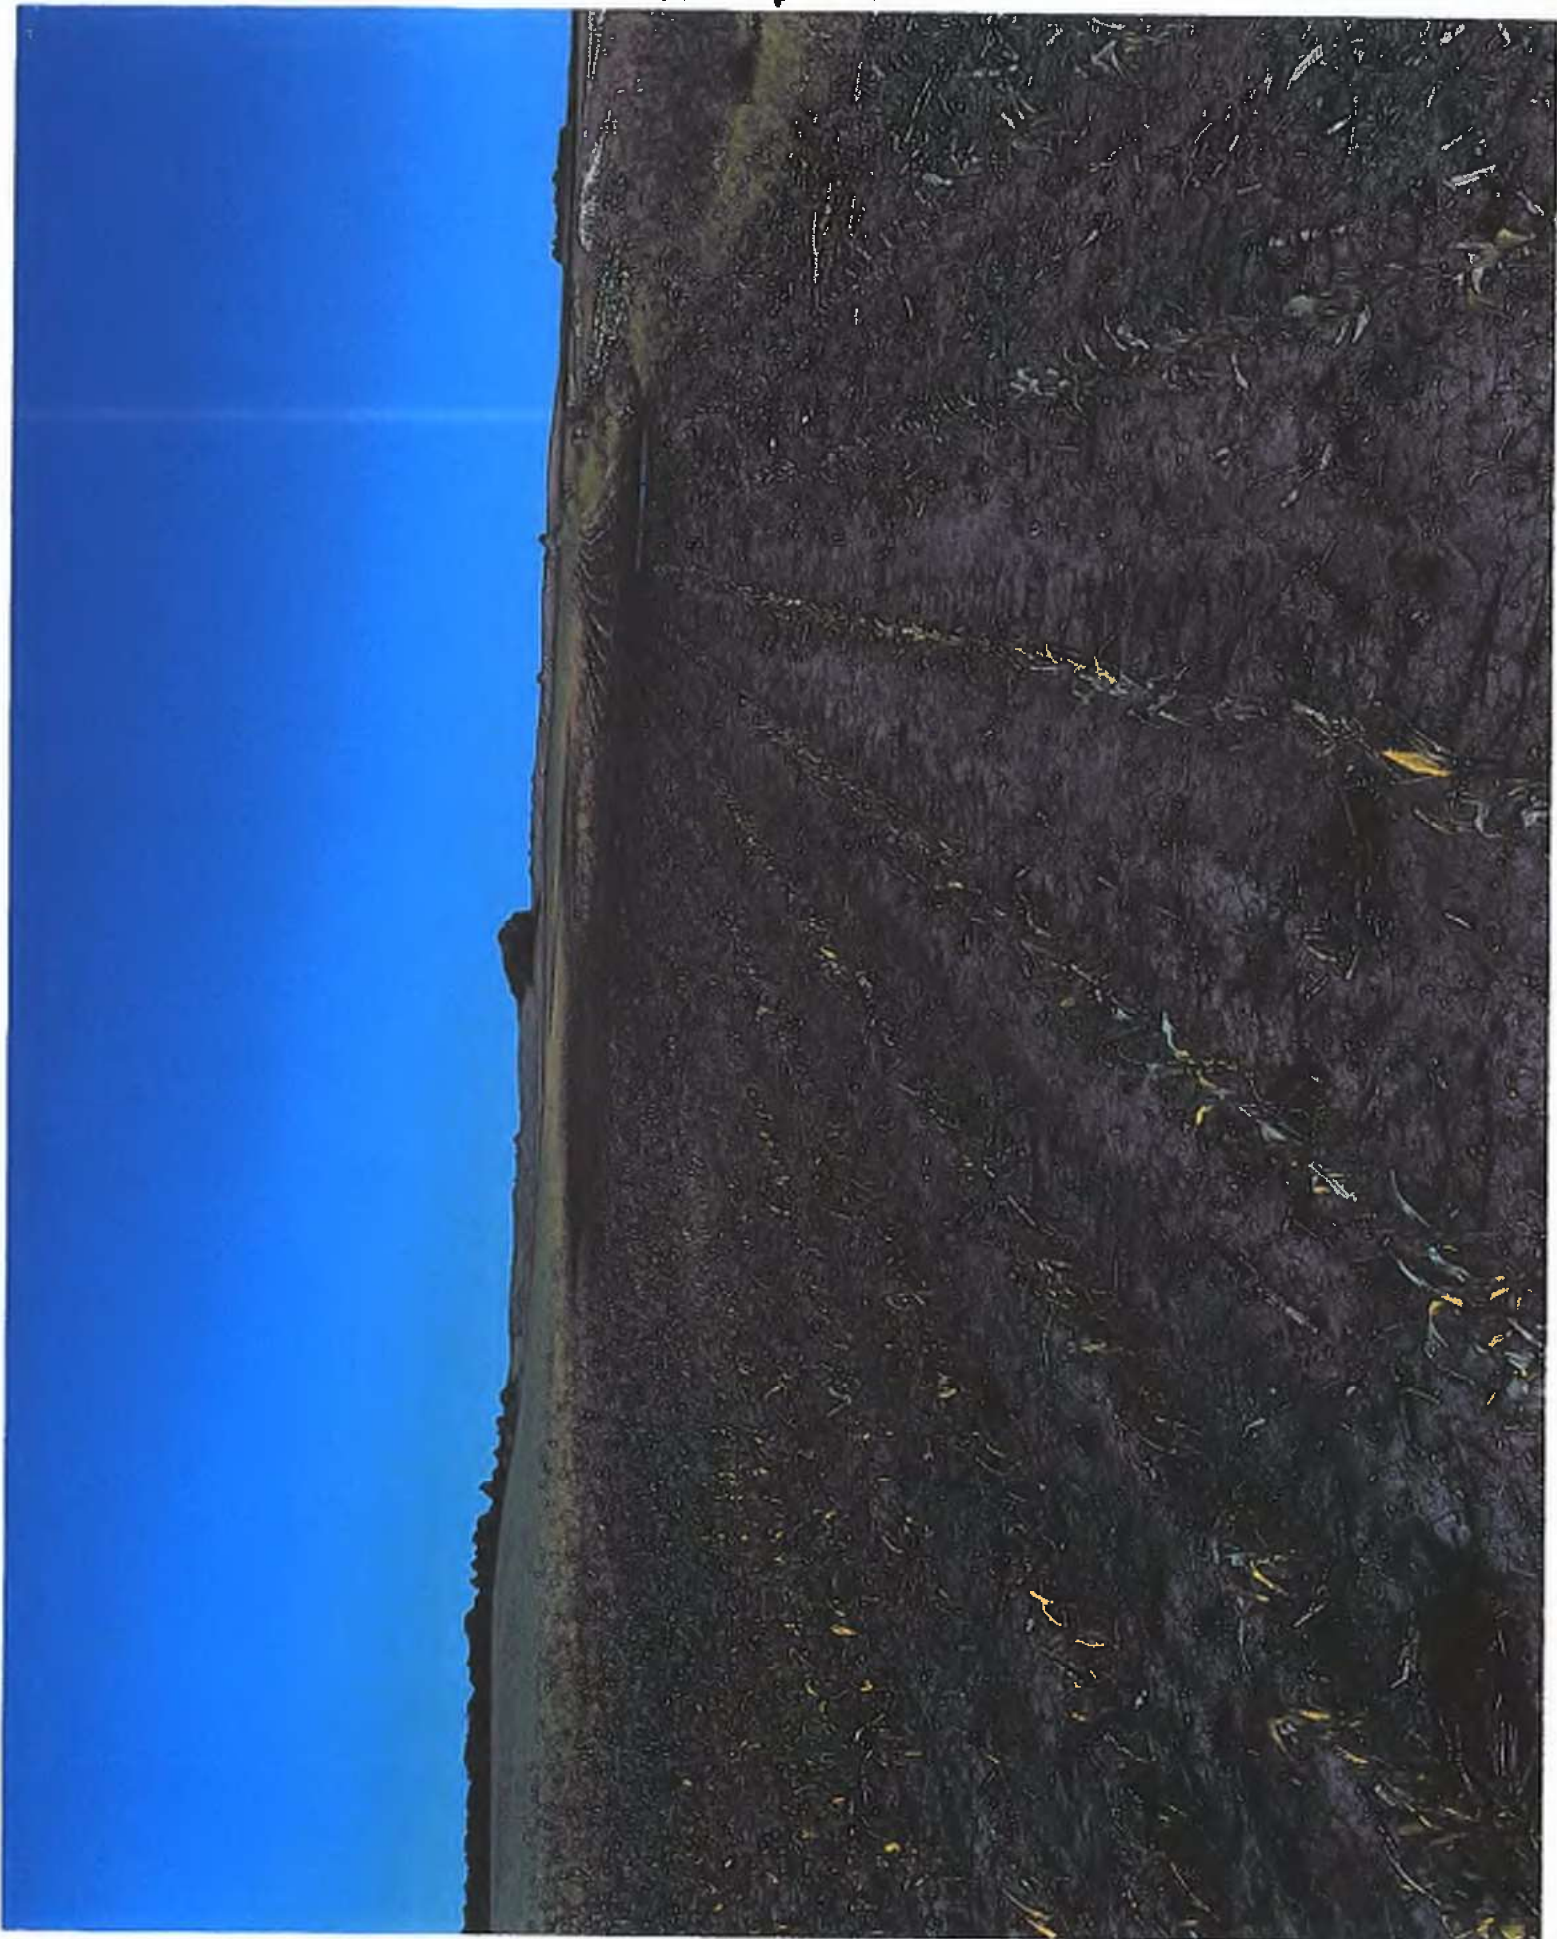
Water Stagnant over Top main

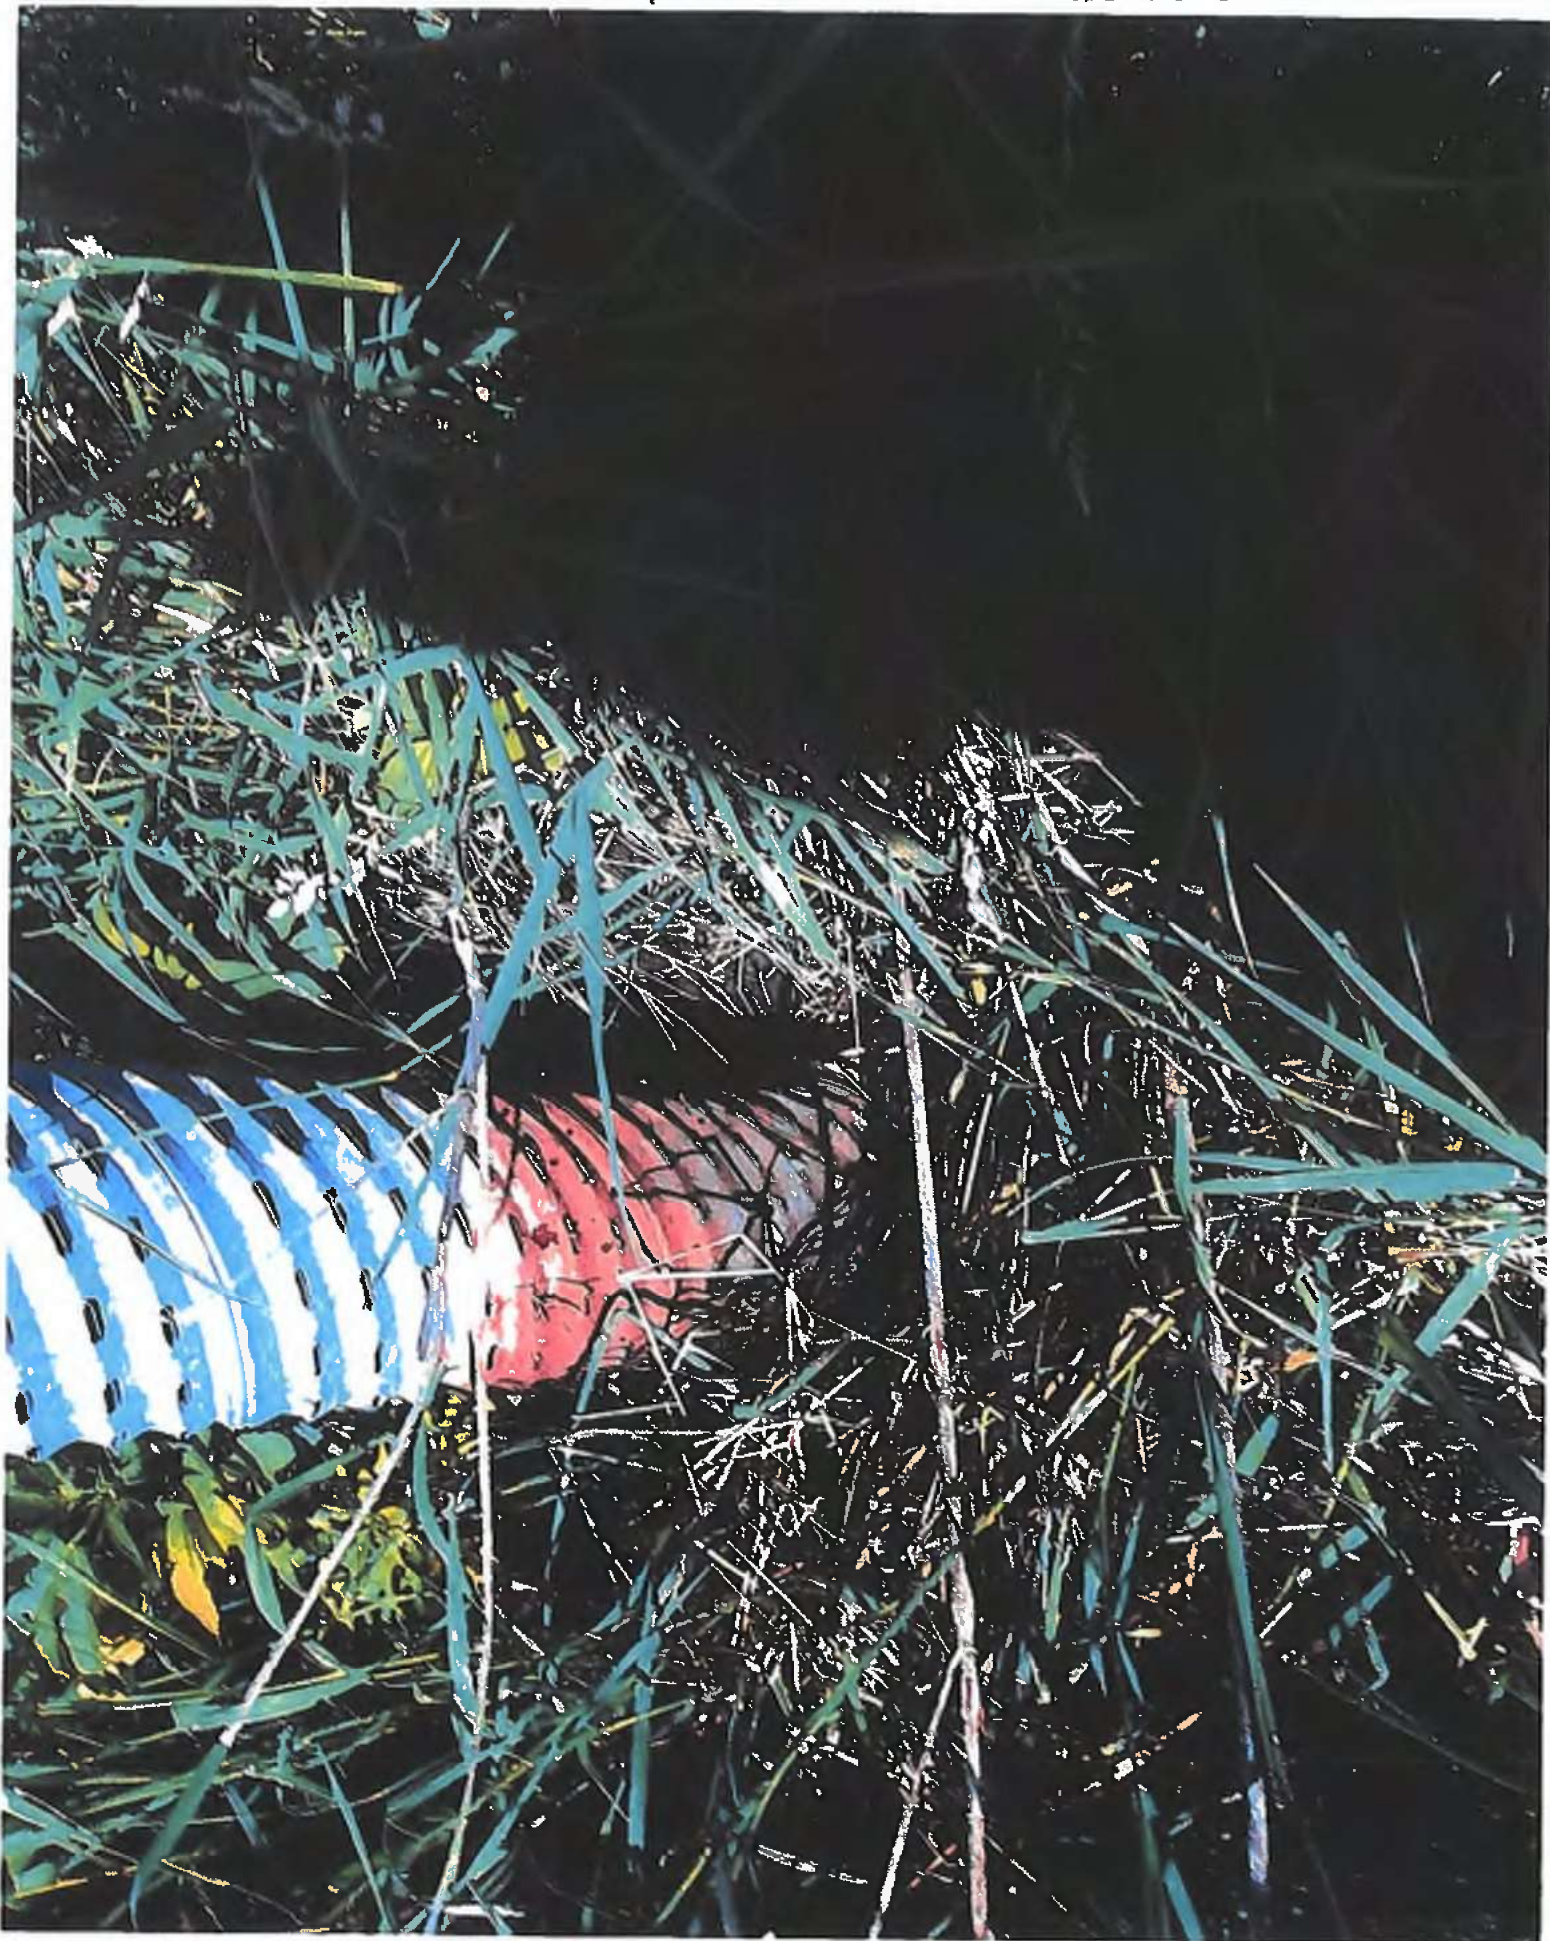
GRAND PIPER ON INTAKE OFFSET NEEDS WORK

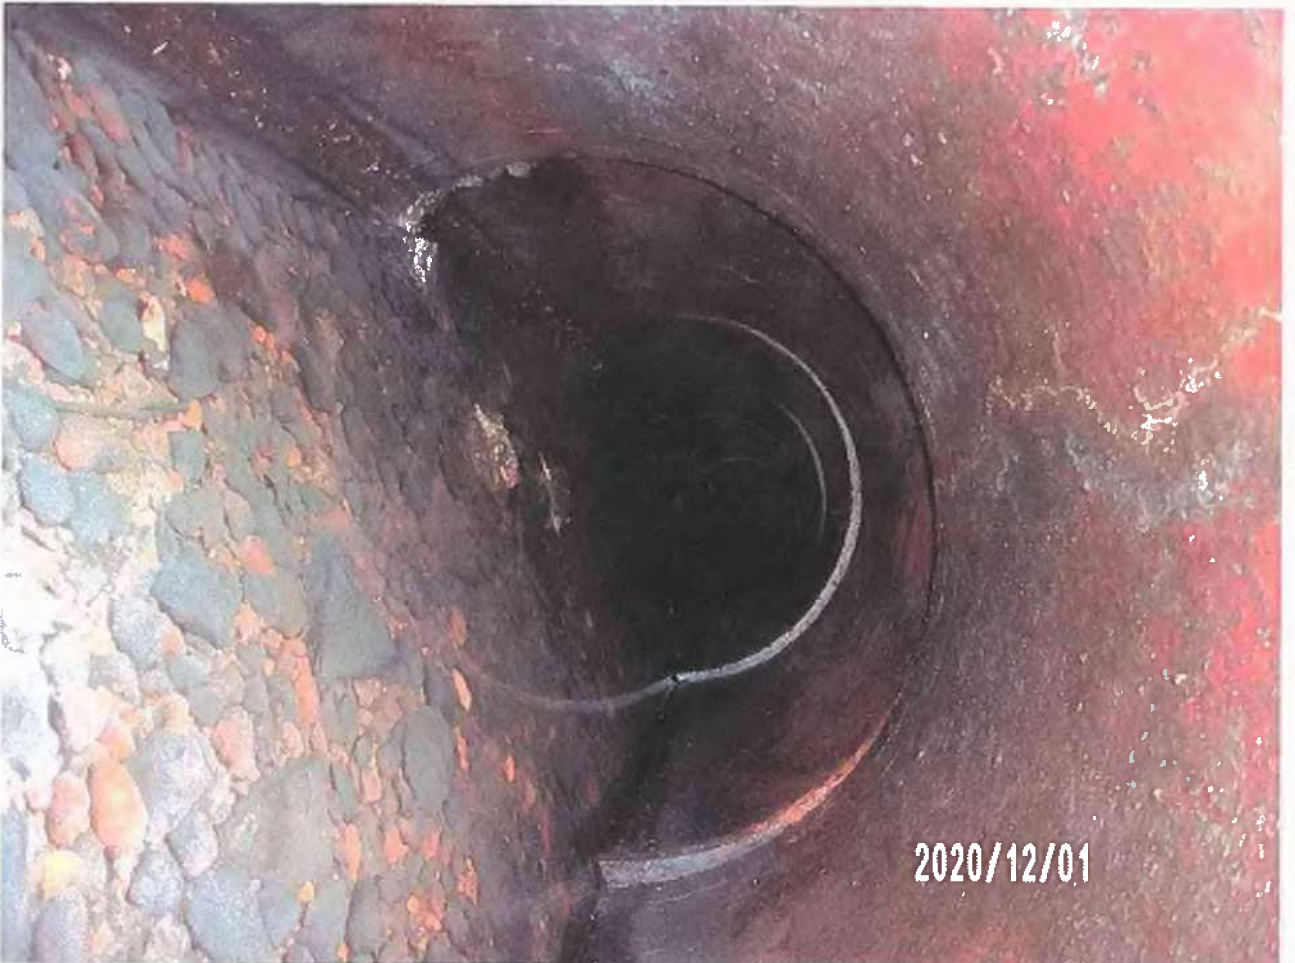
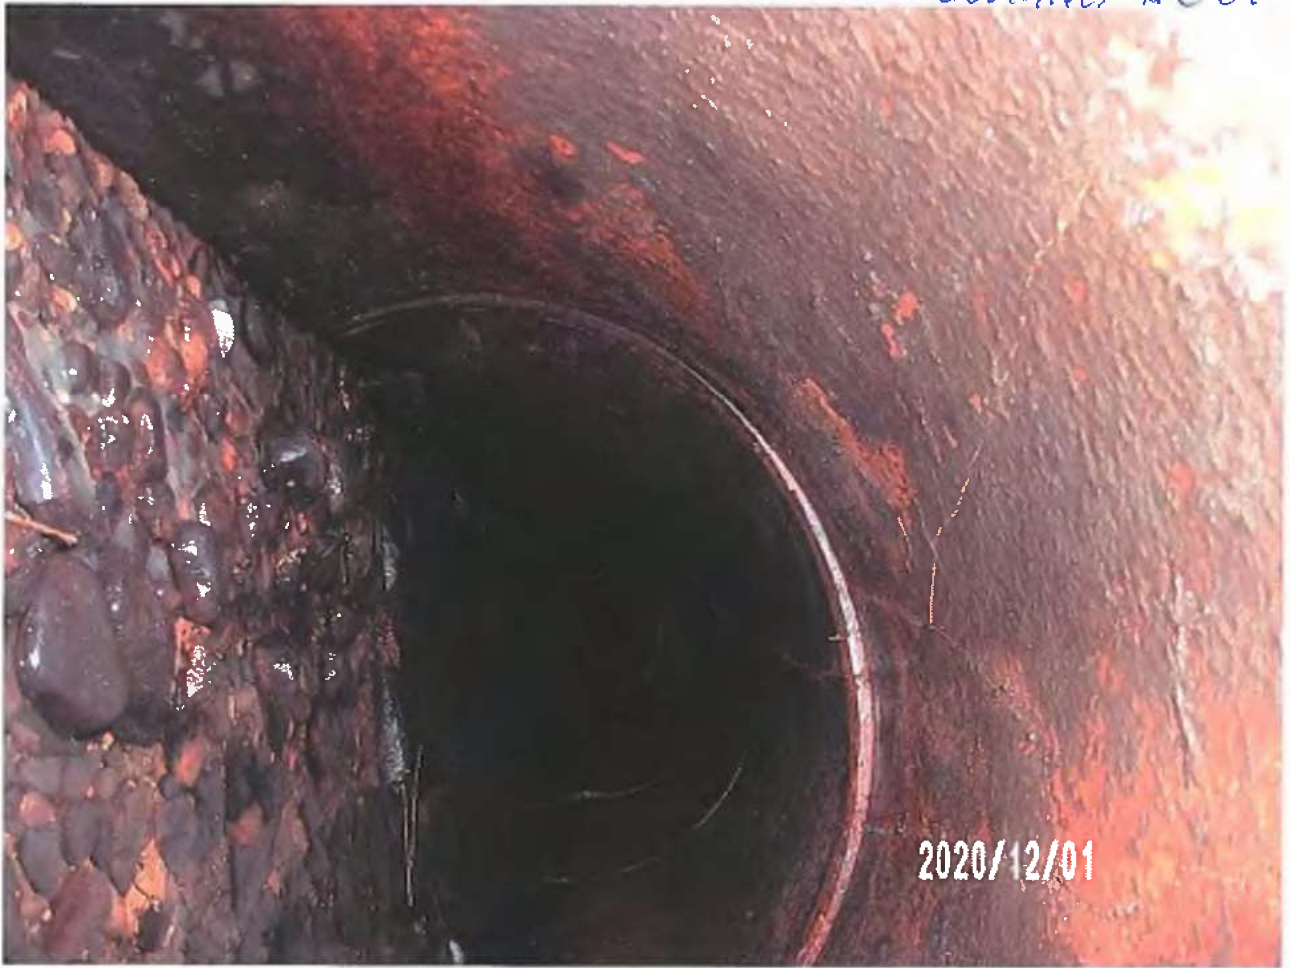
- 8:15 ARRIVED ON SITE SET UP BASE @ #2 (GAS METER 8022)  
CUT A HOLE IN THE TOP OF TILE @ 69 TILE HAS  
HAS ROCKS IN FLOW LINE W/ 3" OF SLOW MOVING WATER
- 9:30 STARTED LOOKING FOR TILE @ N ROW OF C-73 FND  
22" VCP @ # 73 TILE IS FLOWING SLOWLY @ 3" DEEP  
A 4" FIELD TILE IS STICKING INTO TILE @ 2' ± FURTHER  
N.
- 12:00 STARTED LOOKING FOR TILE @ INT #65 FND 5" CLAY  
TILE + STARTED LOCATING FND TILE @ # 79, 80, + 83  
RAN LOCATOR N.
- 2:00 FND TILE @ # 89 CUT HOLE IN TOP TILE HAS 3" OF  
WATER AND IS FLOWING SLOWLY
- 3:00 CREW BLEW A HOSE ON THE BACKHOLE AND HAD TO  
REPAIR IT. I SCOUTED THE 6 NW QUA OF THE  
INTERSECTION OF JUNIPER + C-73 FOUND A 8" HICKY-  
BOTTOM INTAKE W/ A HOPE TILE RUNNING N-S 3' E OF  
INTAKE @ 90
- 4:45 PICKED UP BASE AND LEFT SITE CREW WAS GOING TO  
BACK FILL HOLES

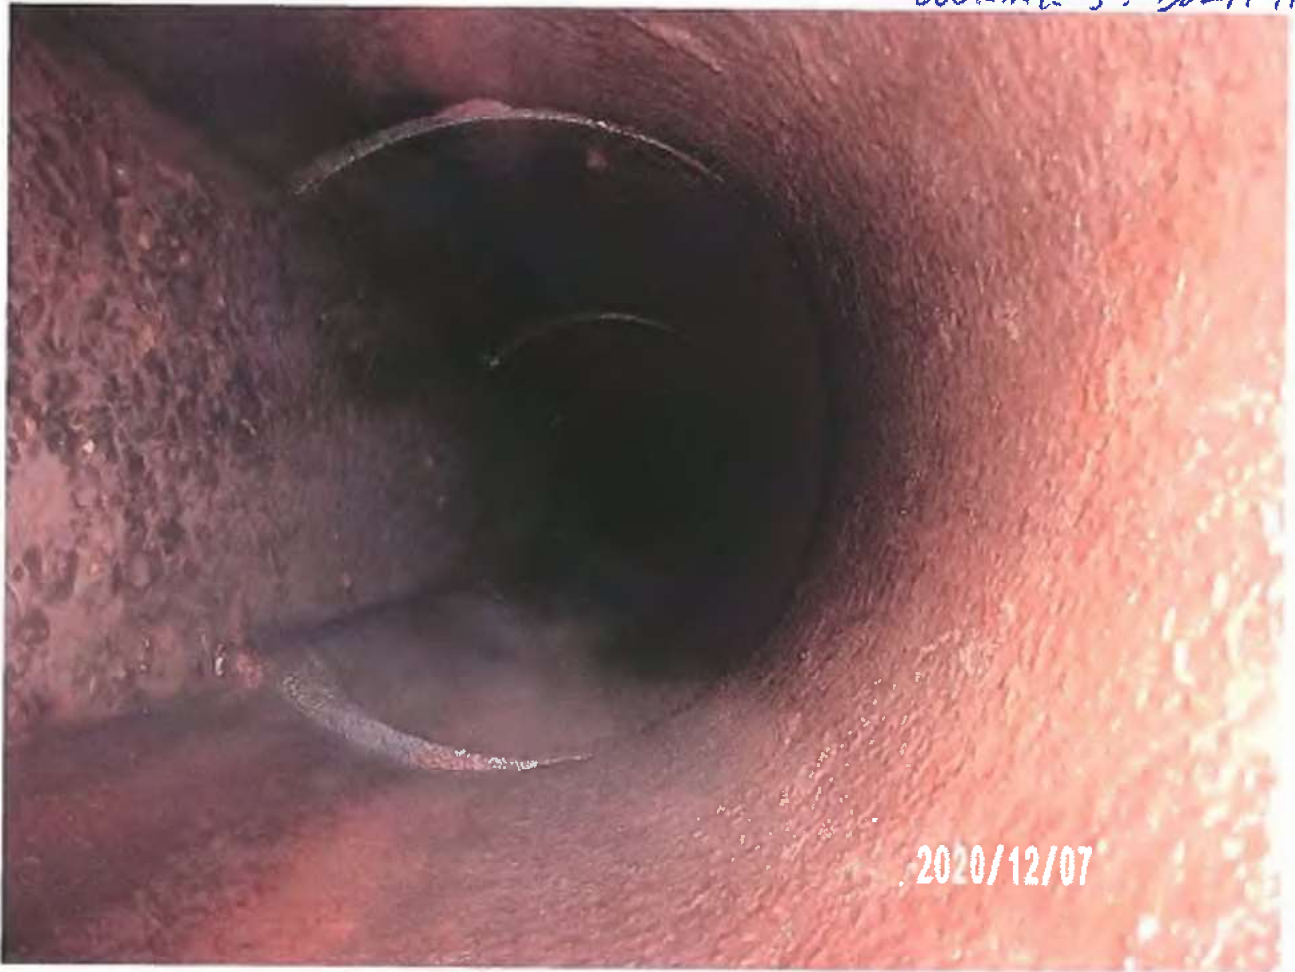
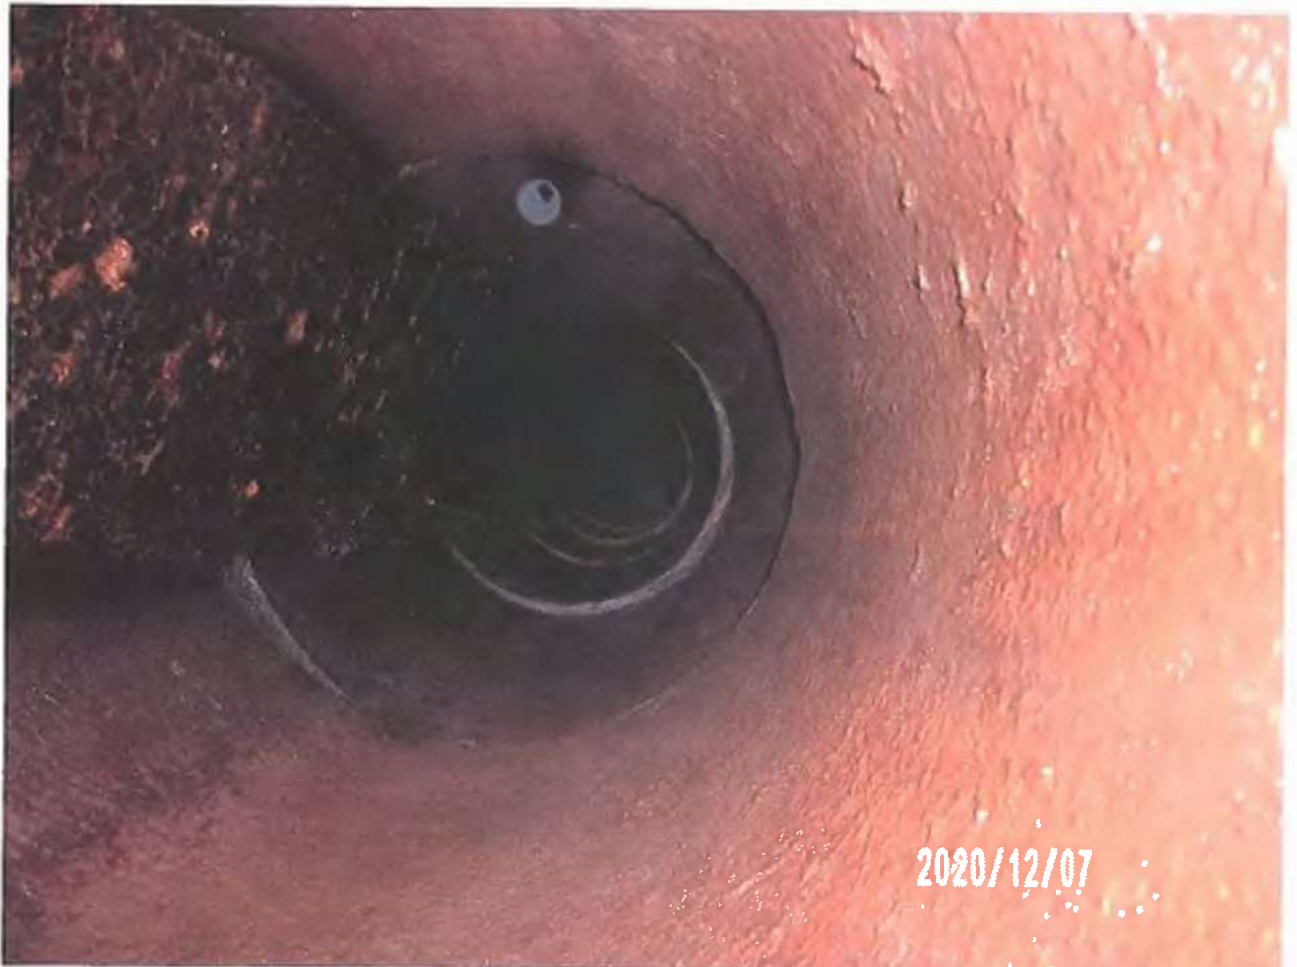
9:15 CREW STARTED DIGGING ON OF RR + FND A 10" CLAY (#91) RUNNING N-S THIS TILE IS FULL OF DIRT FND 15" CLAY TILE RUNNING N-S OPENED TILE @ 92 TILE HAS 1-2" OF DEBRIS + WATER IN THE BOTTOM OF TILE THE REST OF THE TILE IS IN GOOD CONDITION. CREW PATCHED TILE @ 92

LOOKING S. DOWN TILE @ 92

LOOKING N. UP TILE @ 92

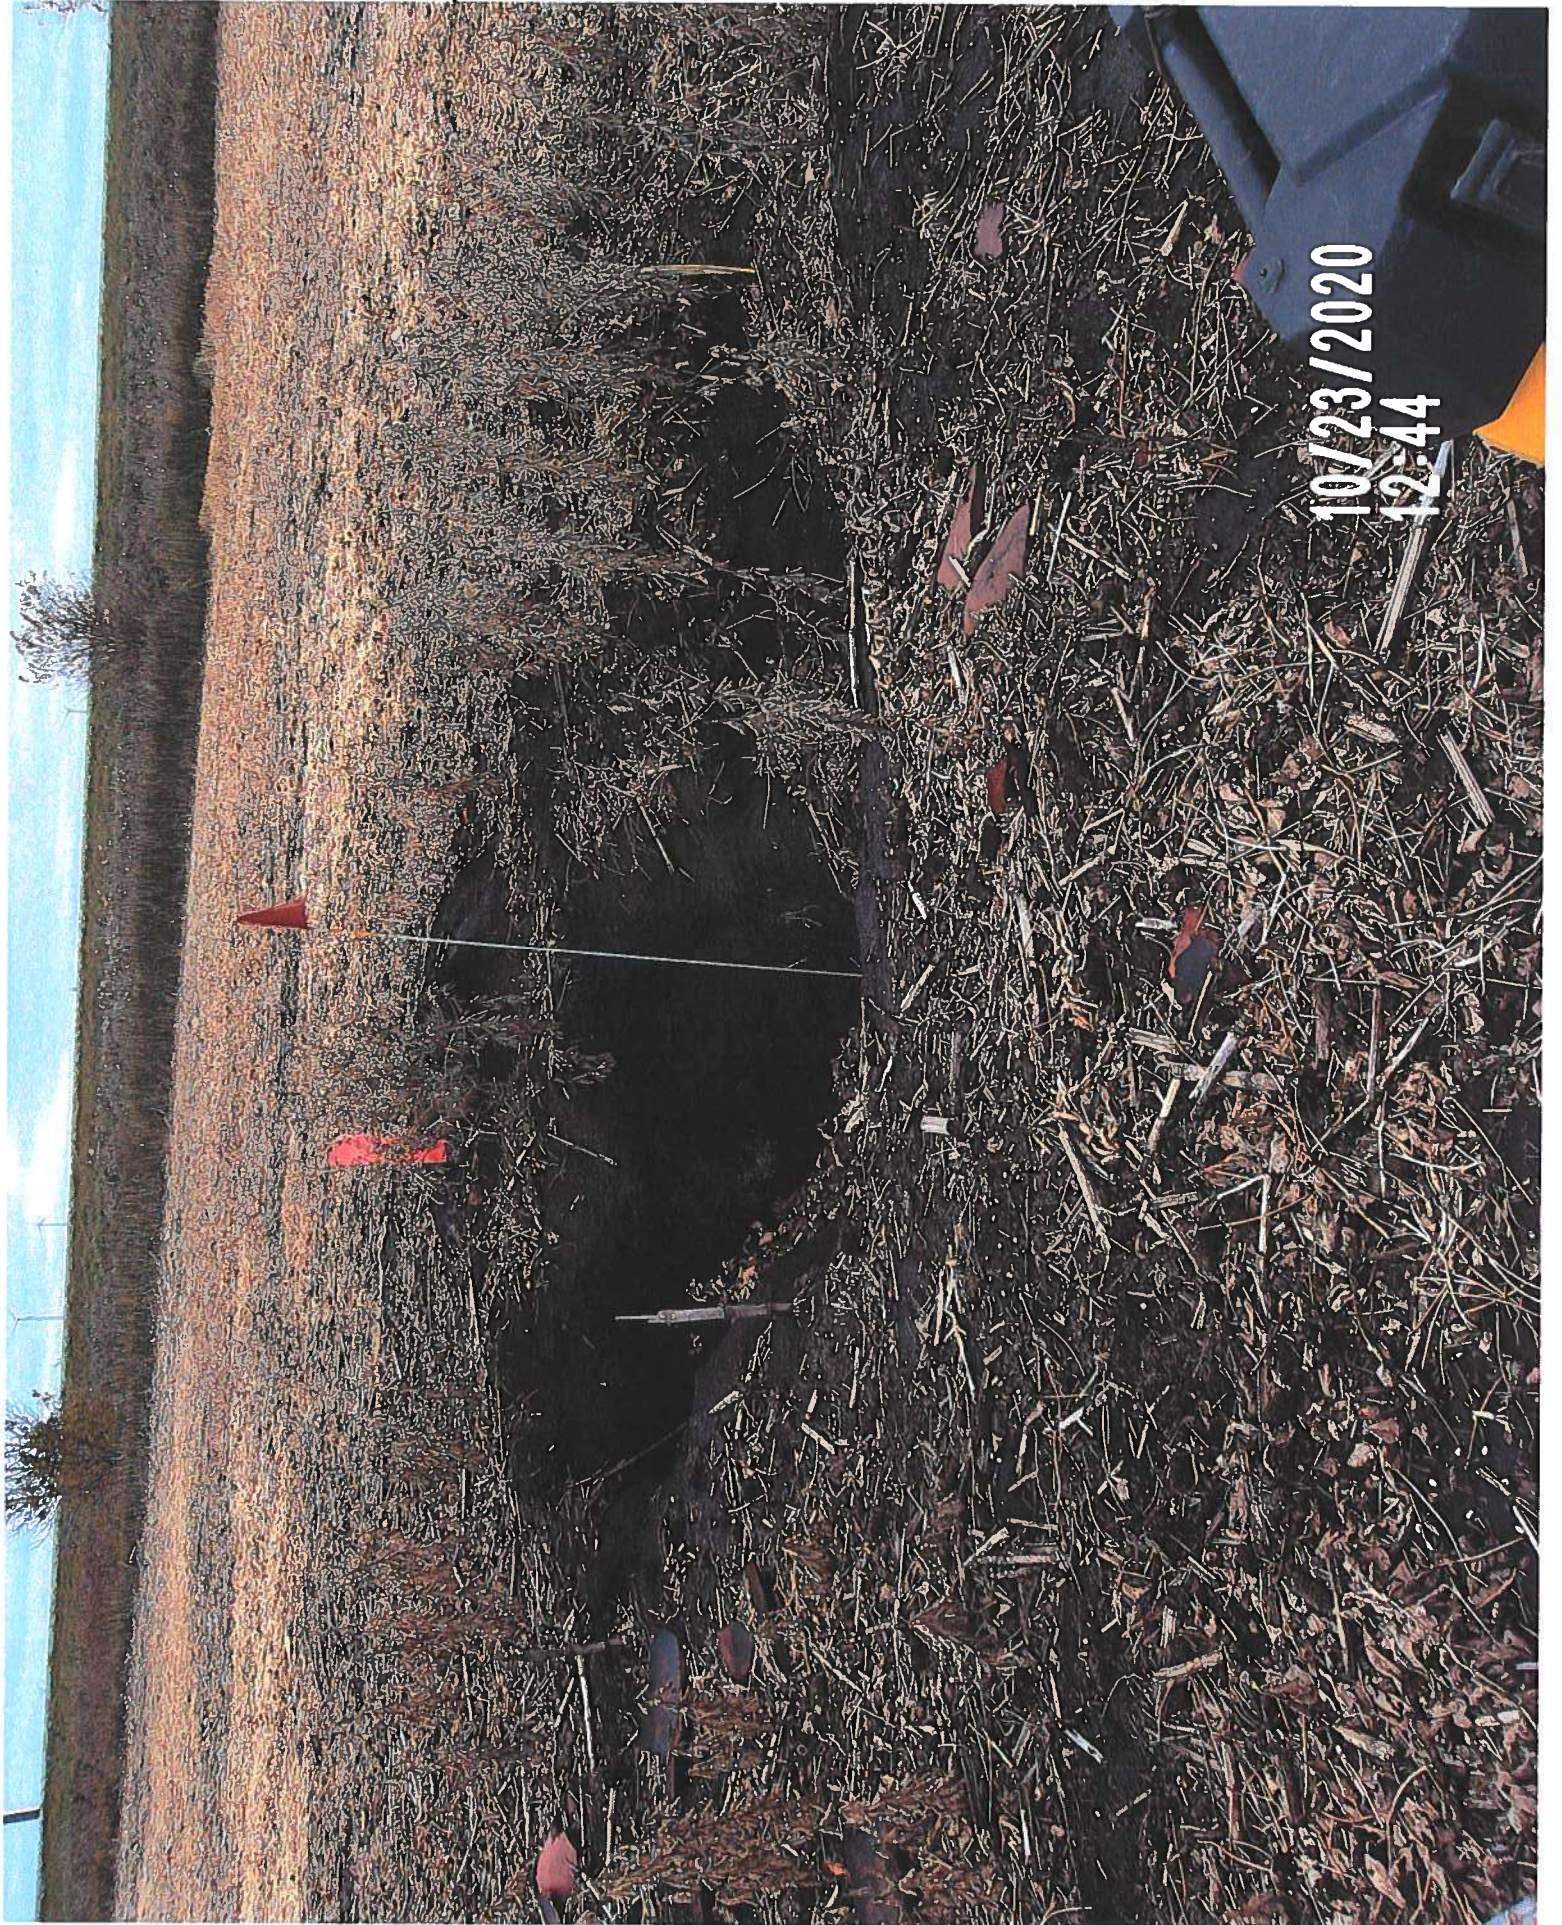
ORIGINAL SPRING 2020 Blow-out #49

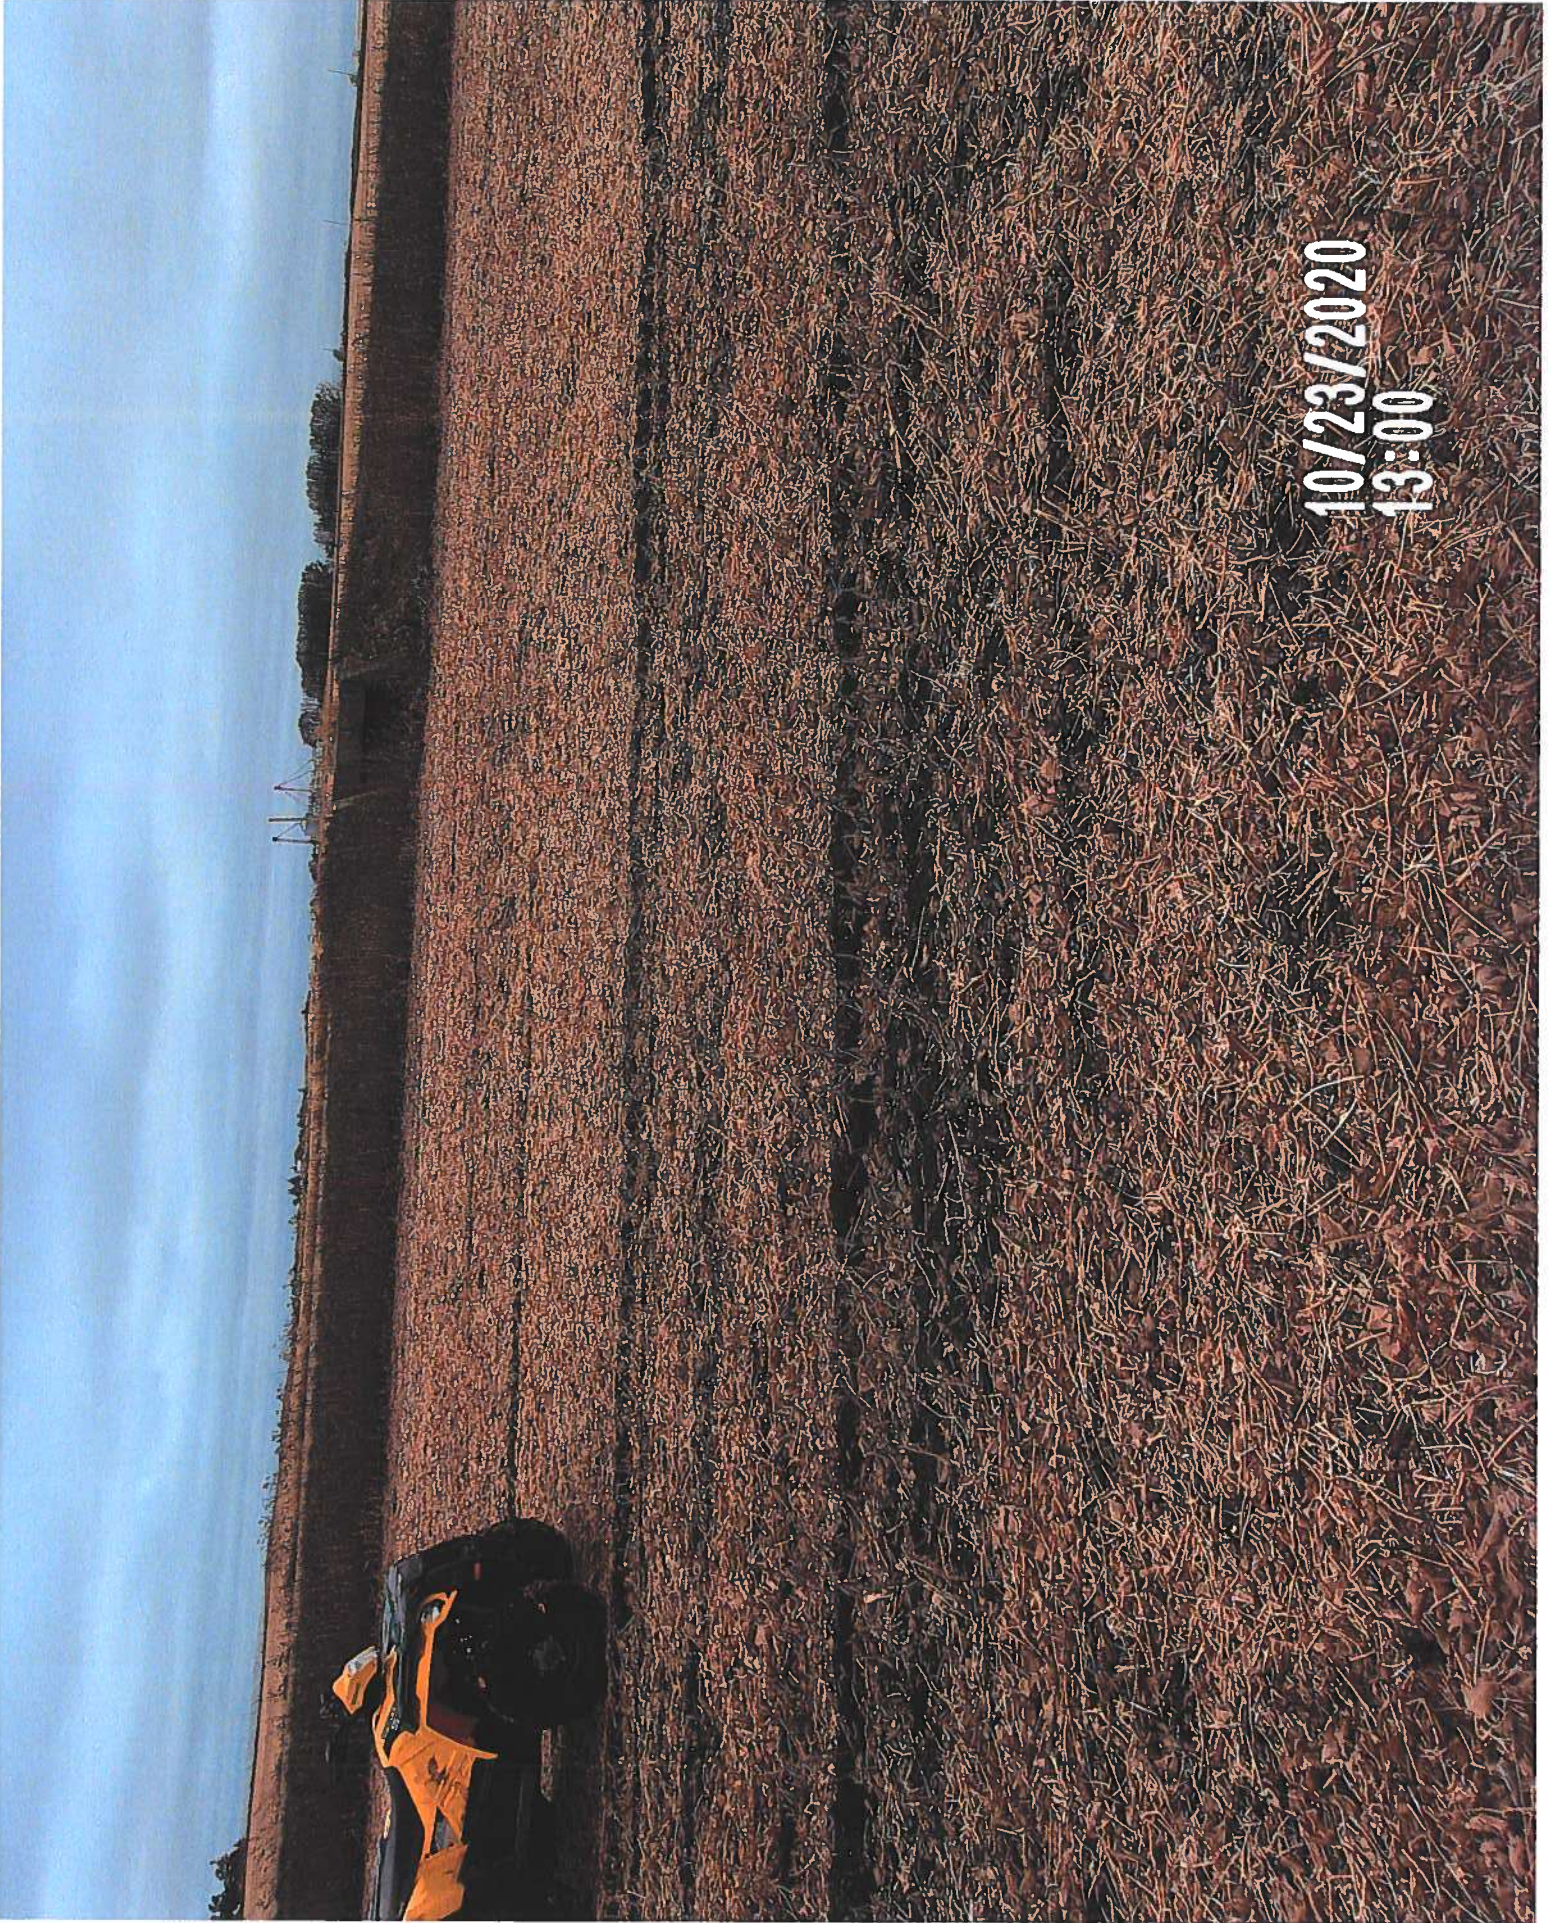
WET SPOT E. OF H.H. AVE, S. OF ACRAGE, NO BLOW-OUT
