**AGENDA**  
**REGULAR DRAINAGE MEETING**  
**Wednesday, March 3, 2021 9:30 AM**  
**Large Conference Room**

5. DD 14 WO 290 - Discuss W Possible Action - Landowner Concerns

[DD 14 WO 290 INVESTIGATION SUMMARY 05\\_11\\_20.PDF](#)  
[DD 14 WO 290 - 6844.4 - INVESTIGATION REPORT - 2020-08-31.PDF](#)

CONSTRUCTION ENGINEERING  
OBSERVATION REPORT

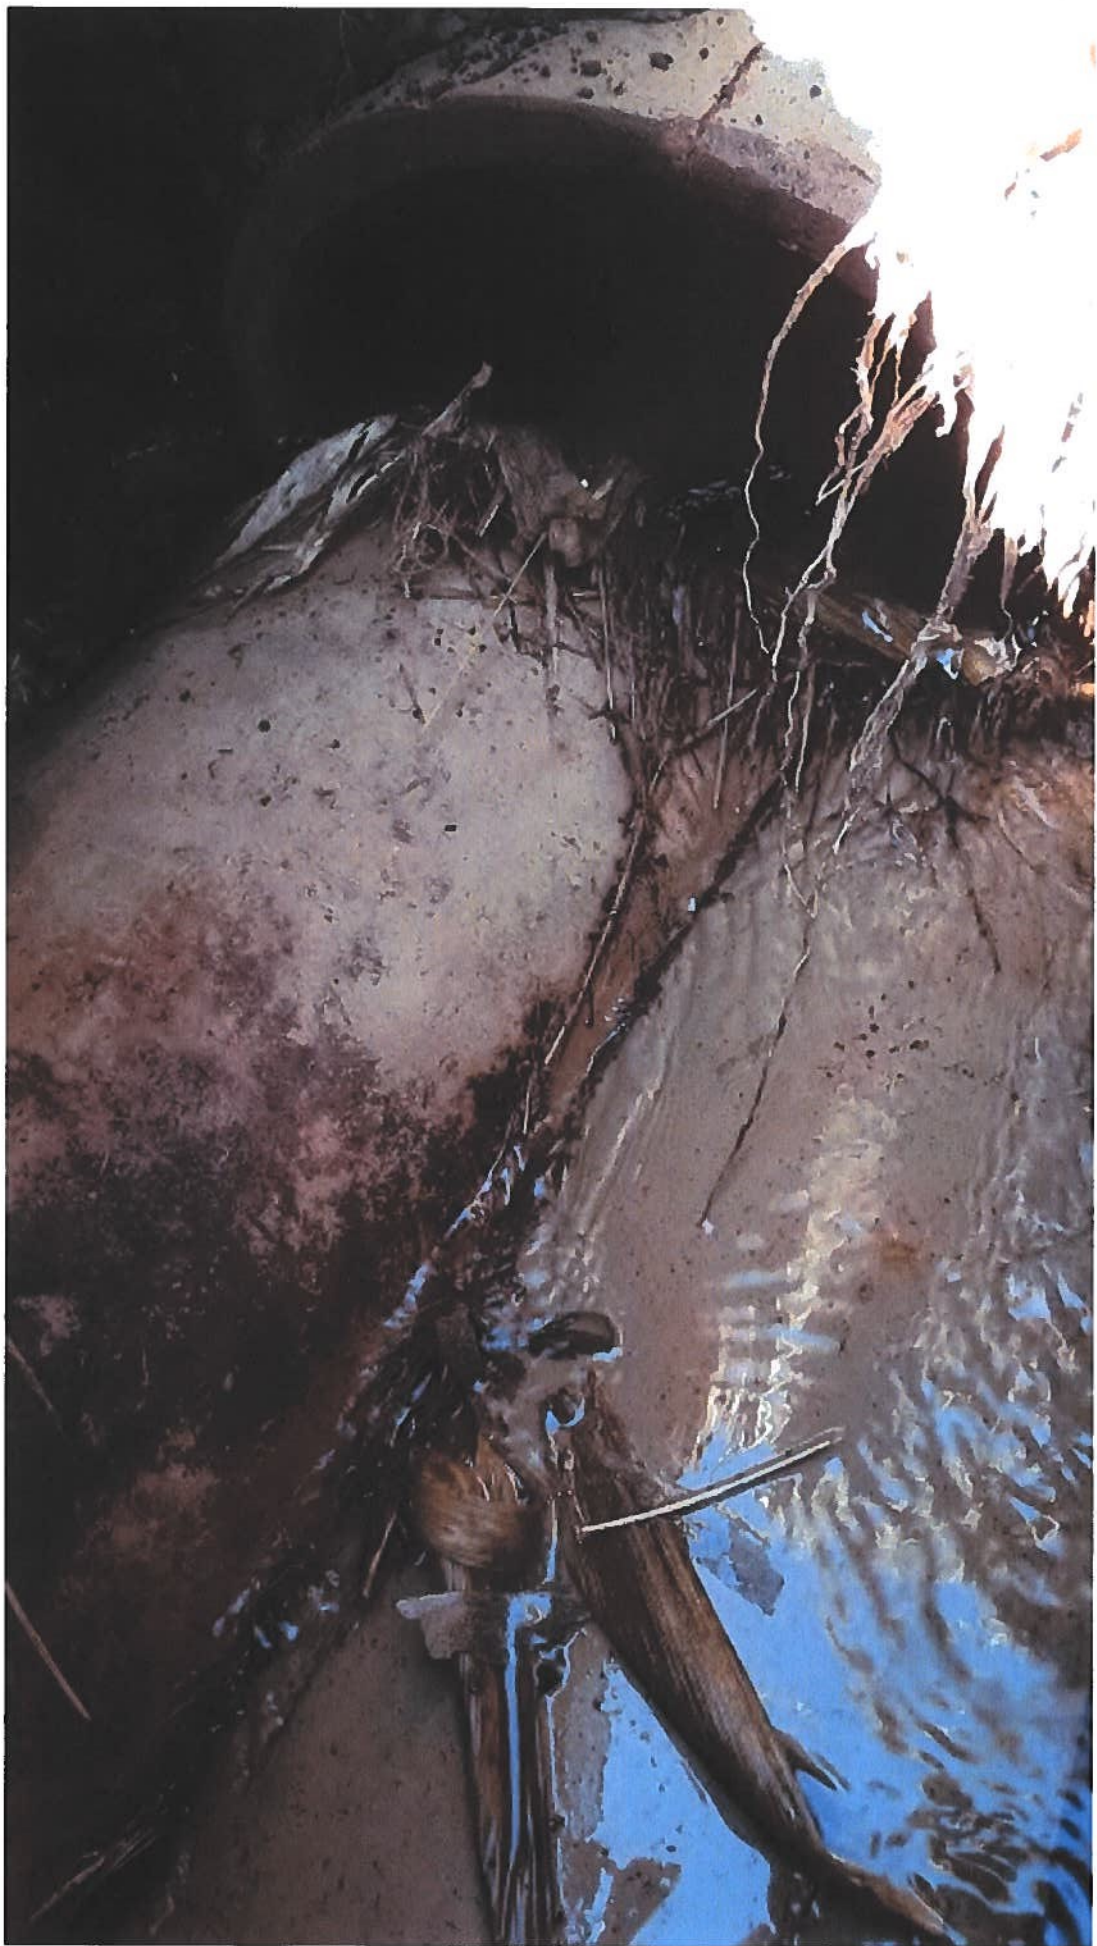
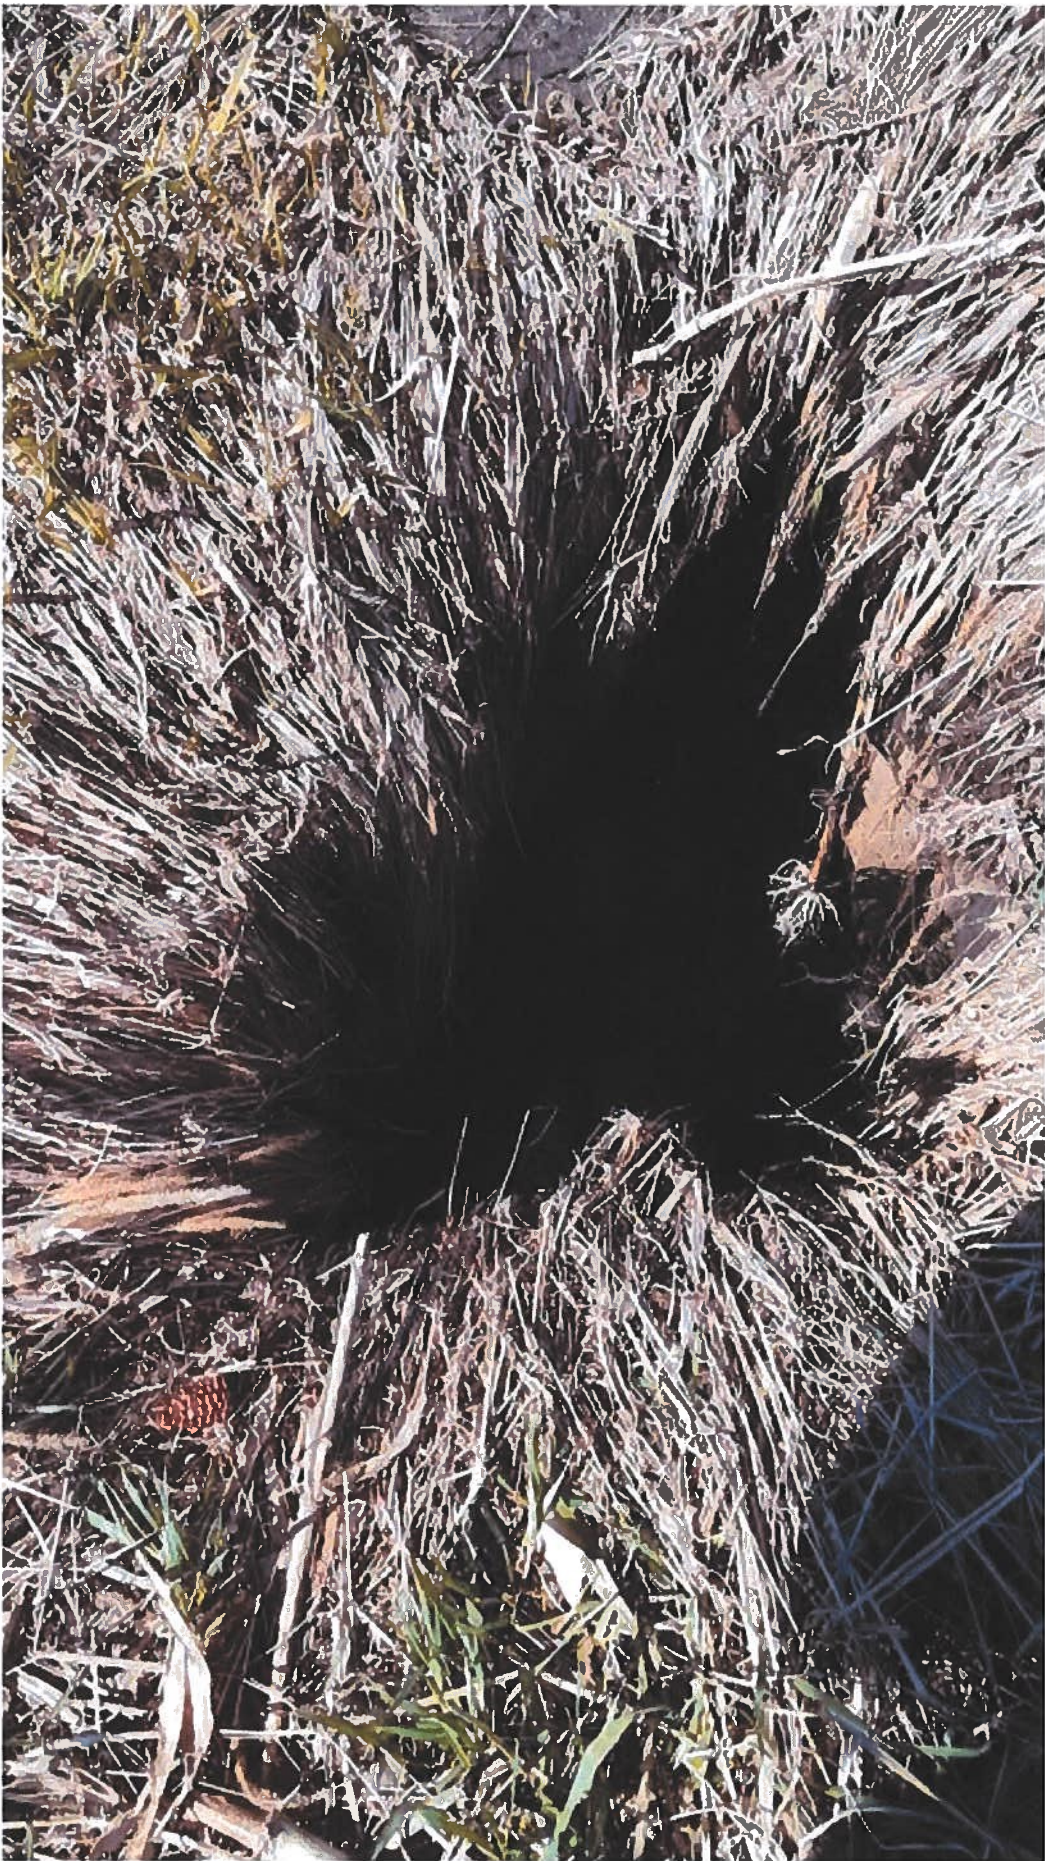
South blowout

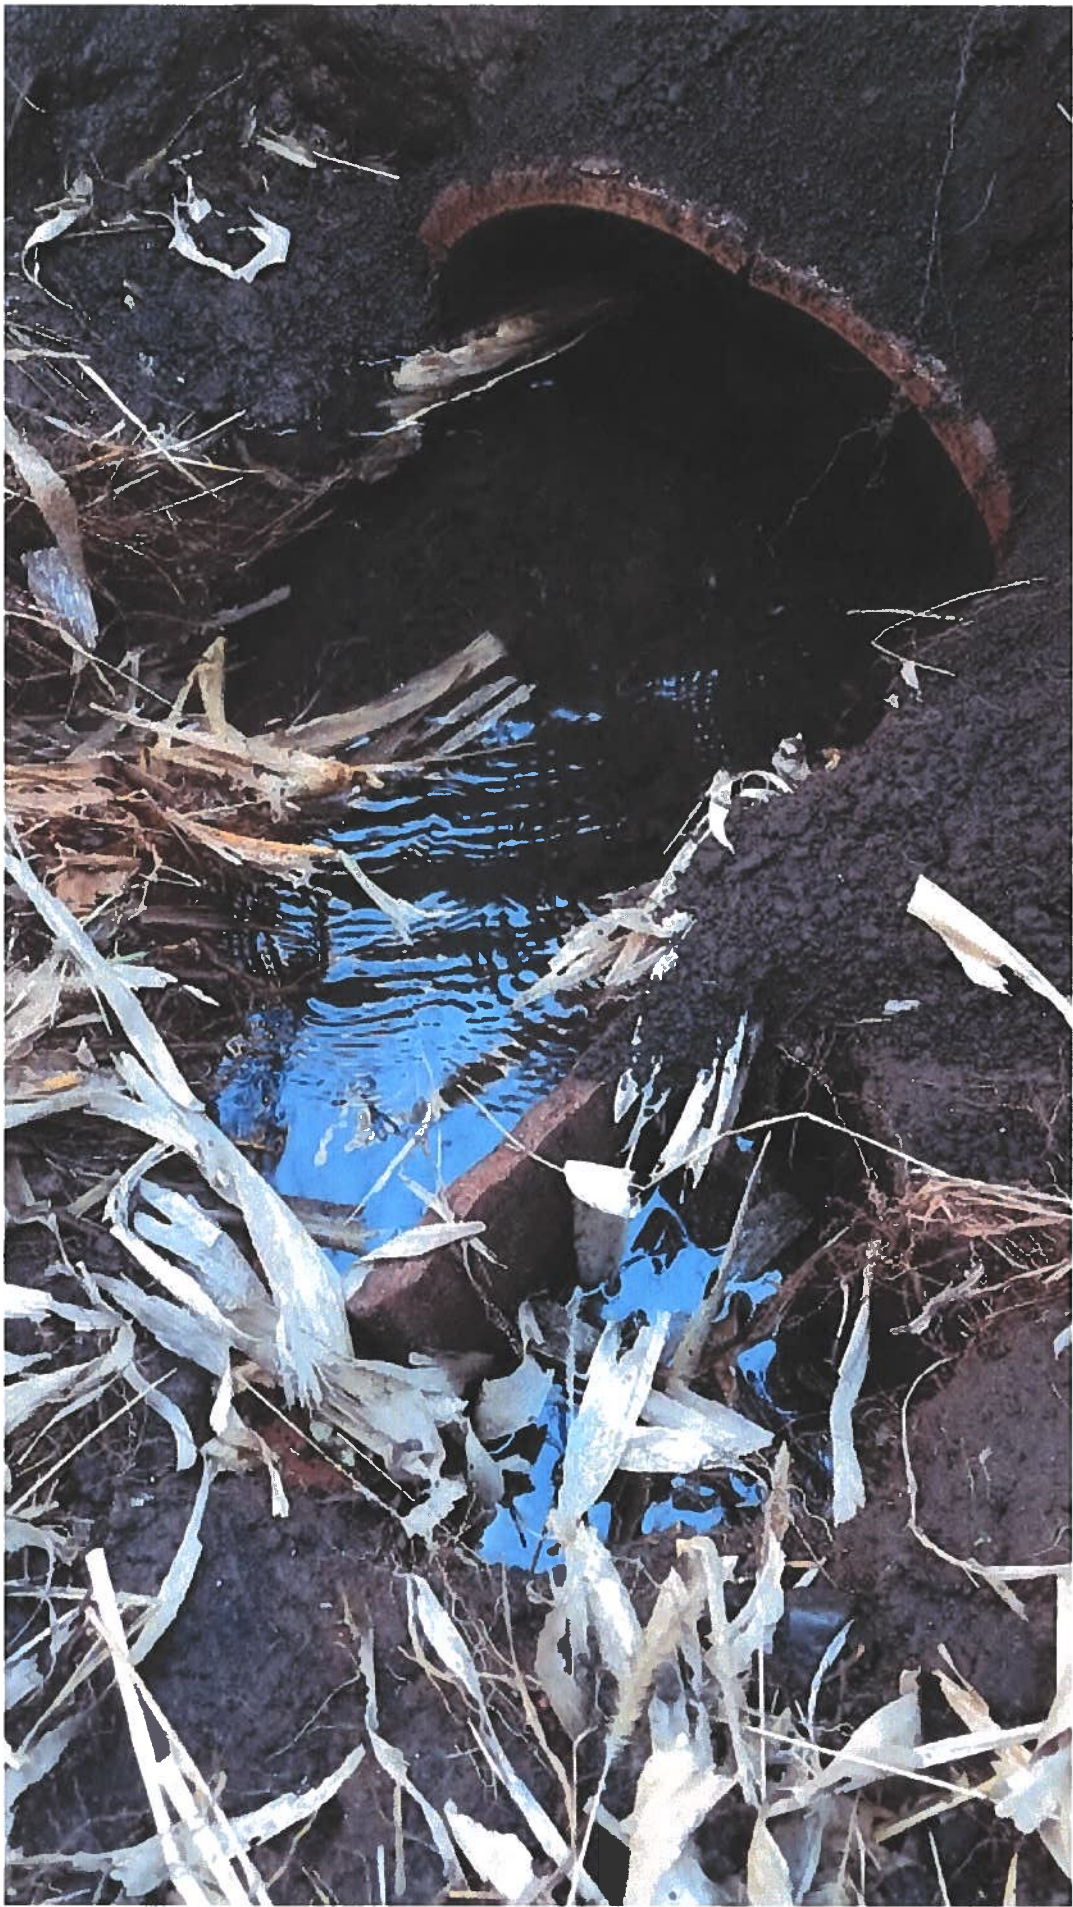
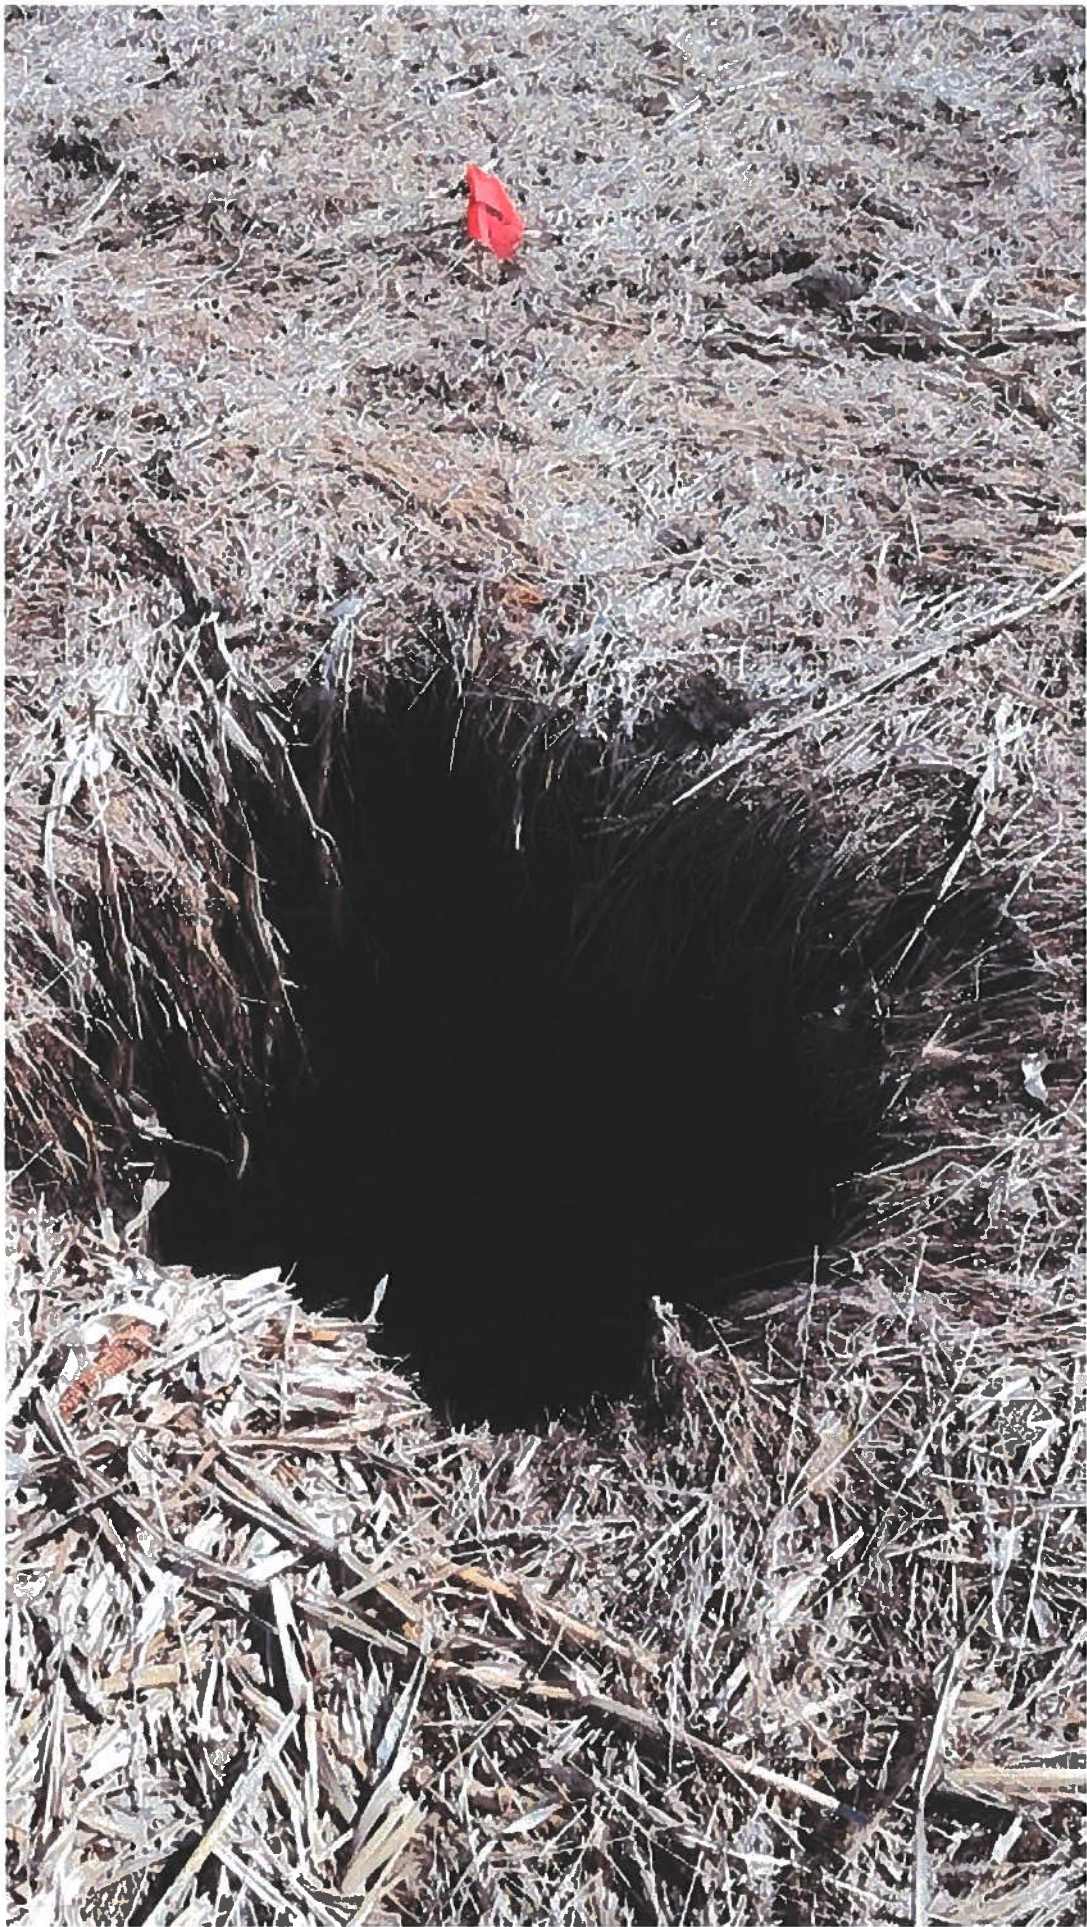
North blowout

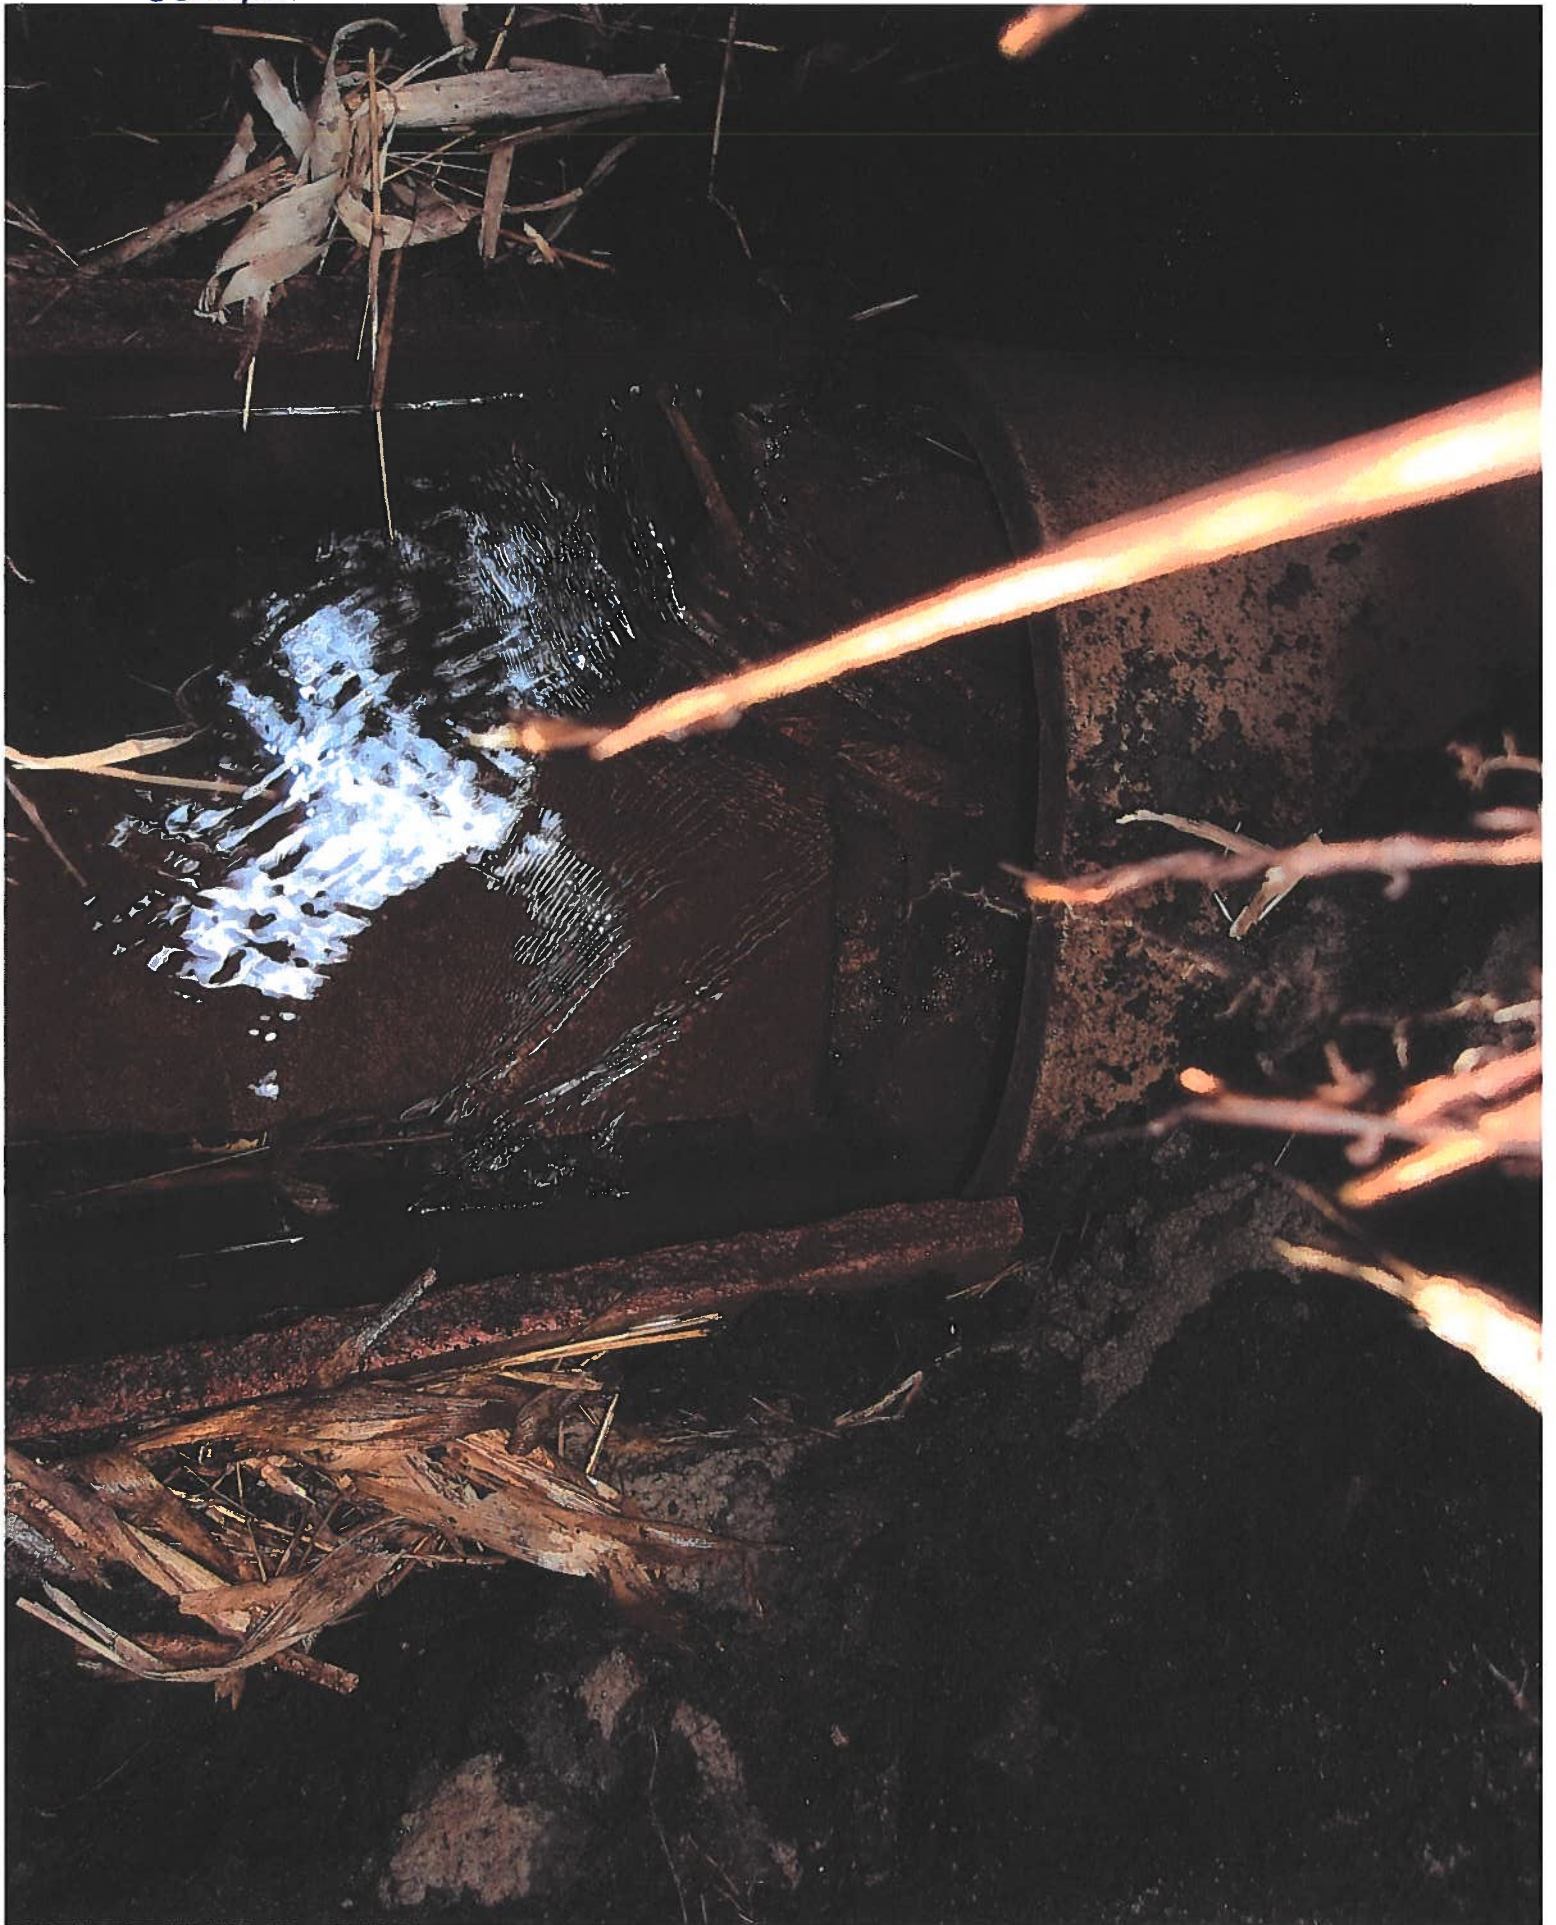
COLLAPSED 15" E TILE

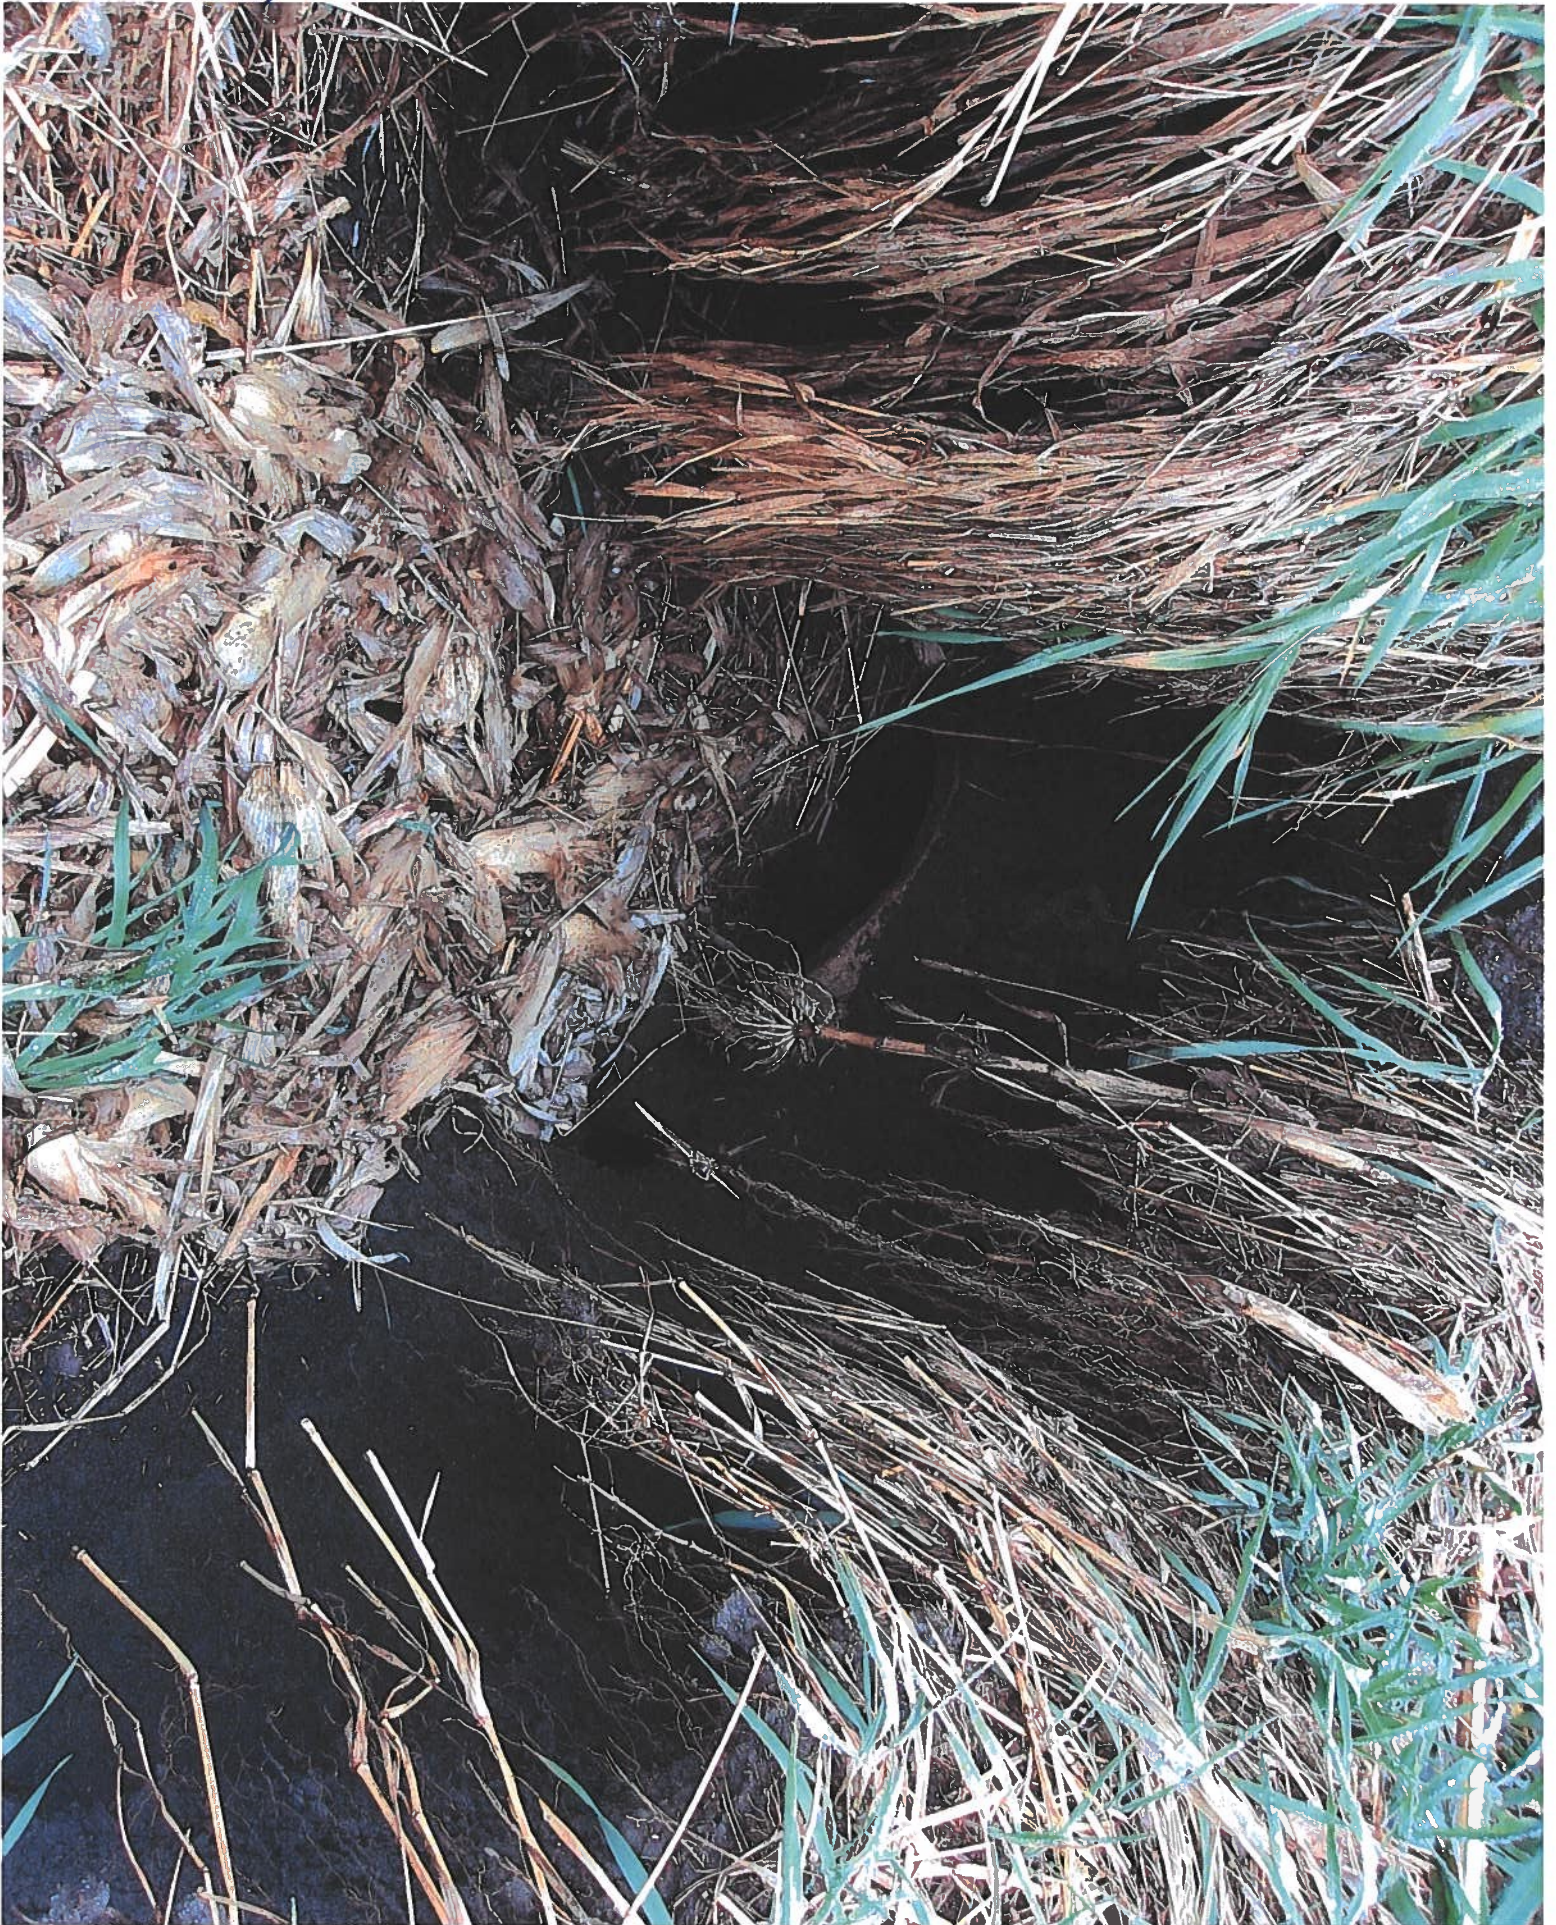
Clay FILL COLLAPSED

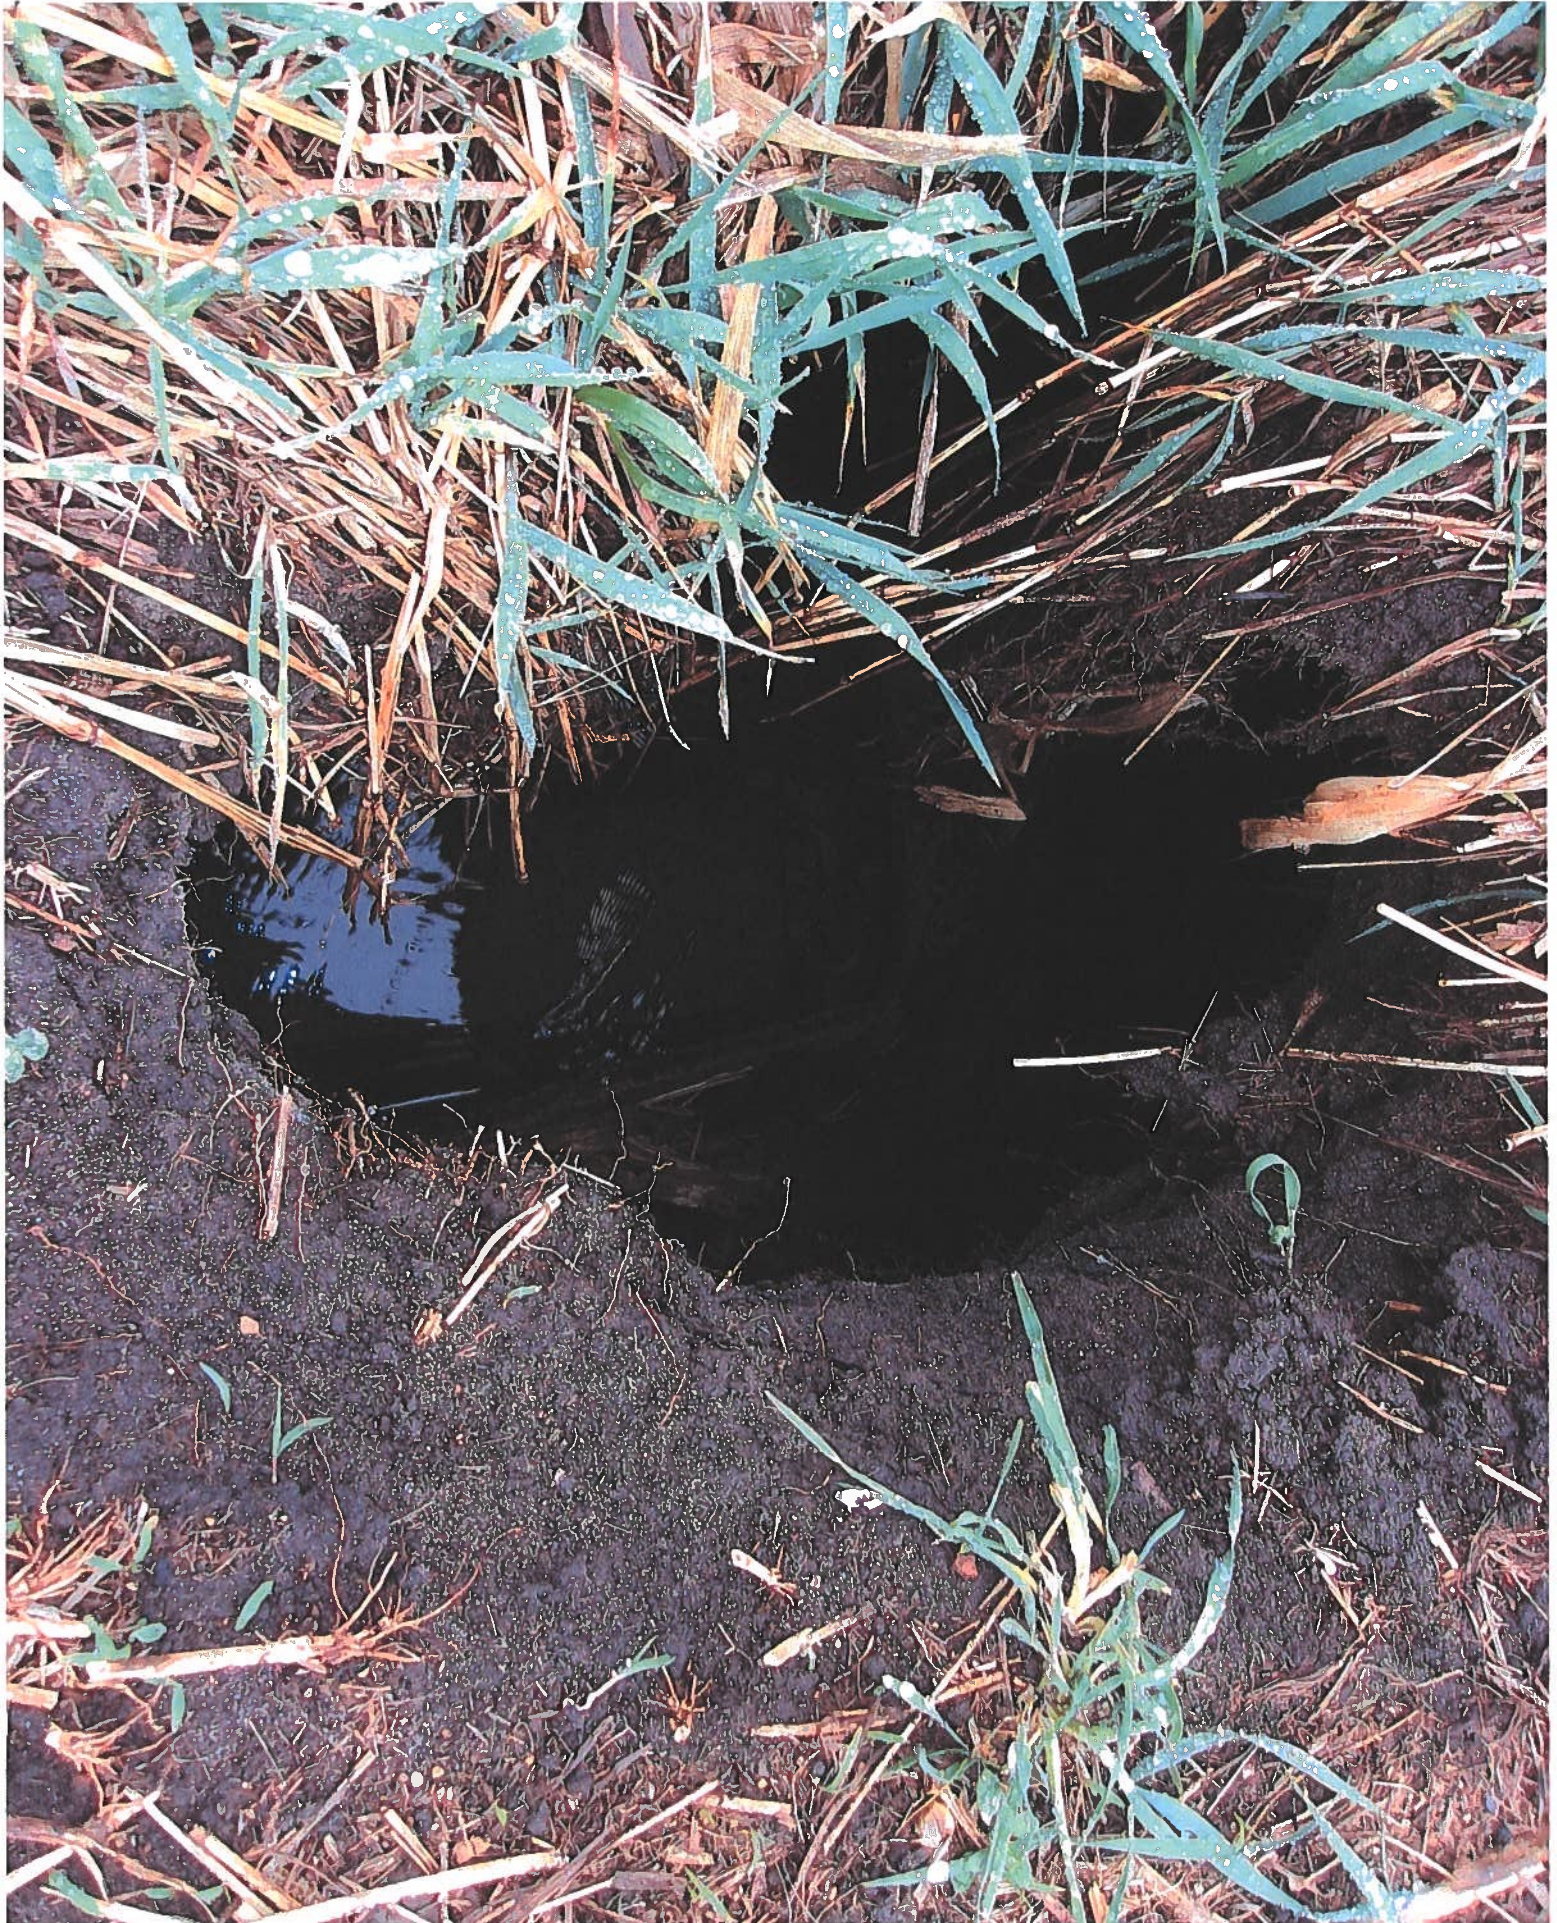
Collapsed Clay Tine

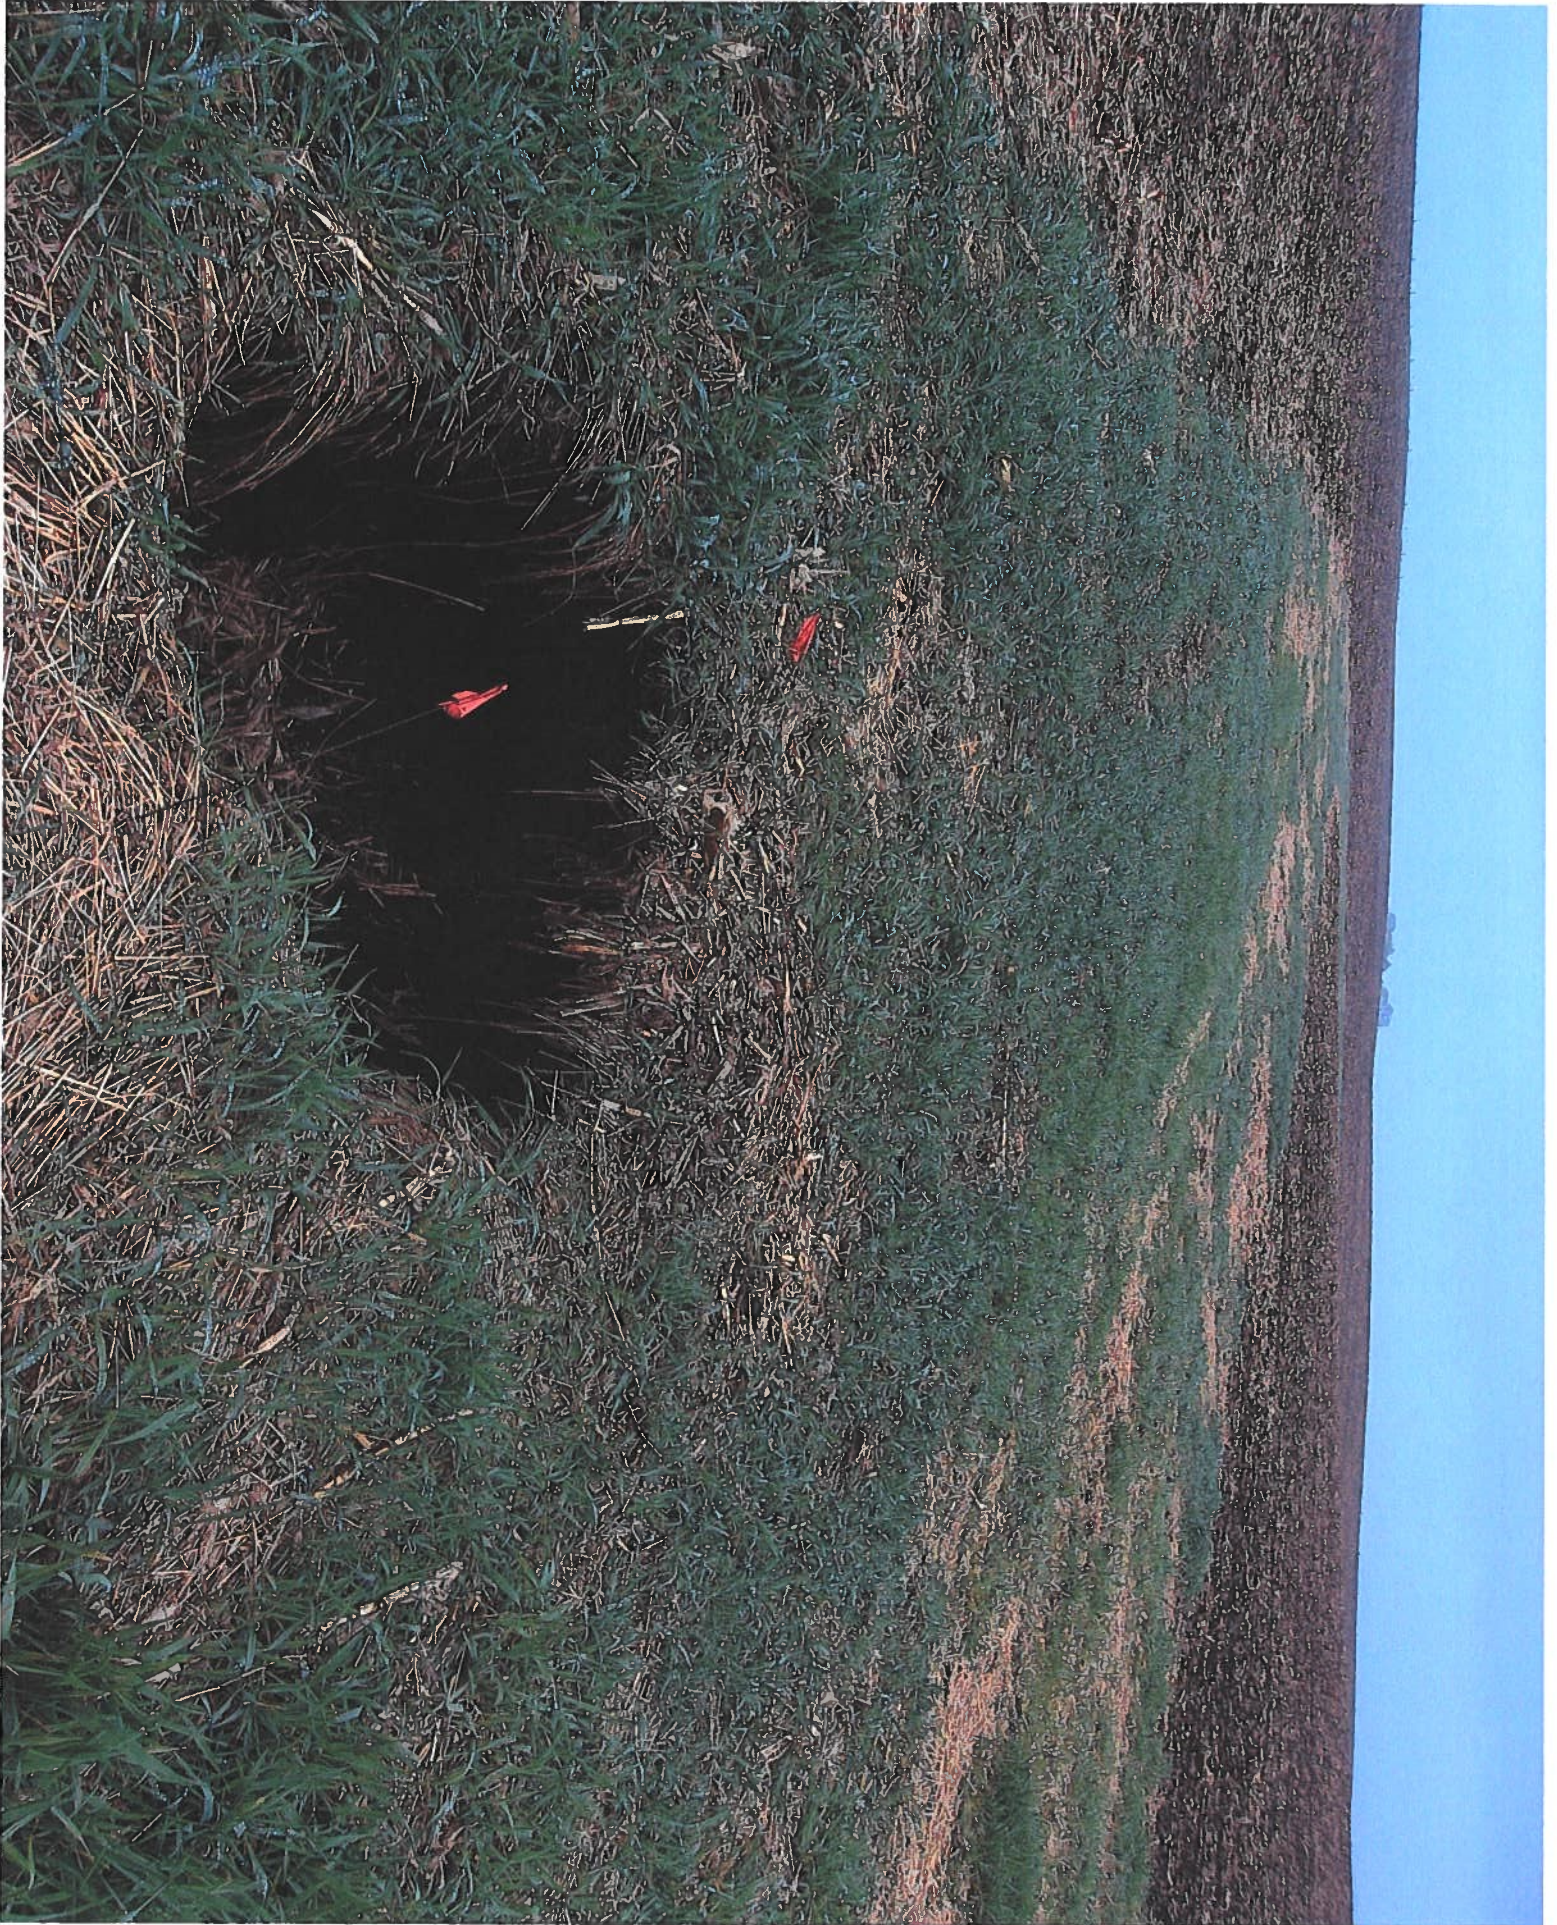
NORTHERN MOST Blow-out, COLLAPSED TILE 15"  $\phi$  ±

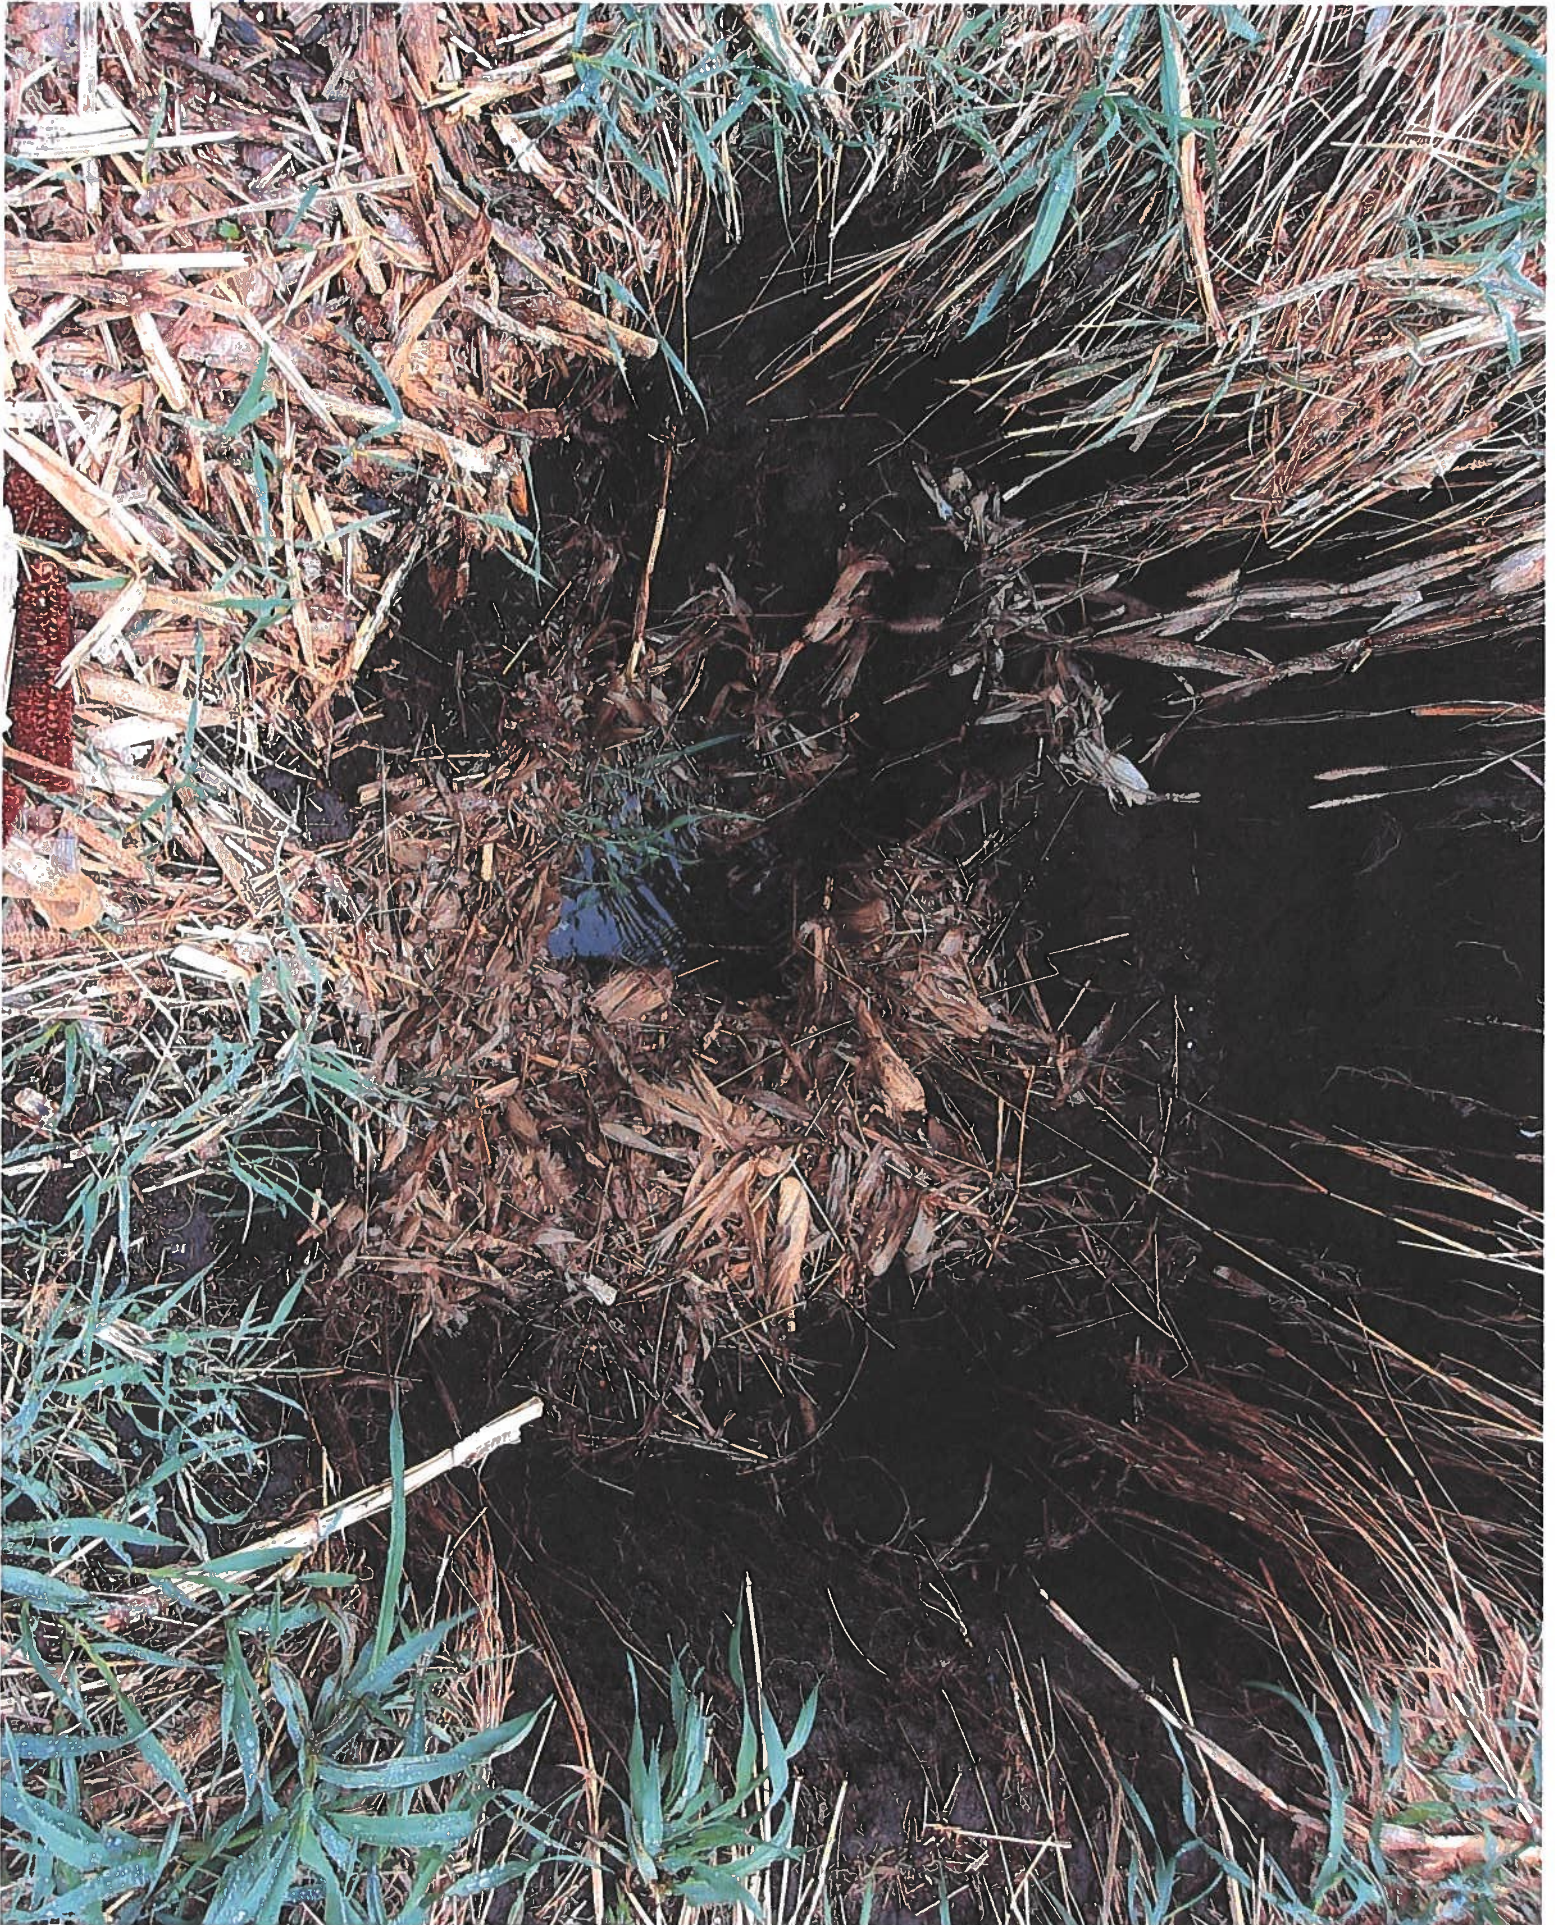
Collapsed Tile
