**AGENDA**  
**REGULAR DRAINAGE MEETING**  
**Wednesday, March 3, 2021 9:30 AM**  
**Large Conference Room**

5. DD 14 WO 290 - Discuss W Possible Action - Landowner Concerns

[DD 14 WO 290 INVESTIGATION SUMMARY 05\\_11\\_20.PDF](#)  
[DD 14 WO 290 - 6844.4 - INVESTIGATION REPORT - 2020-08-31.PDF](#)

CONSTRUCTION ENGINEERING  
OBSERVATION REPORT

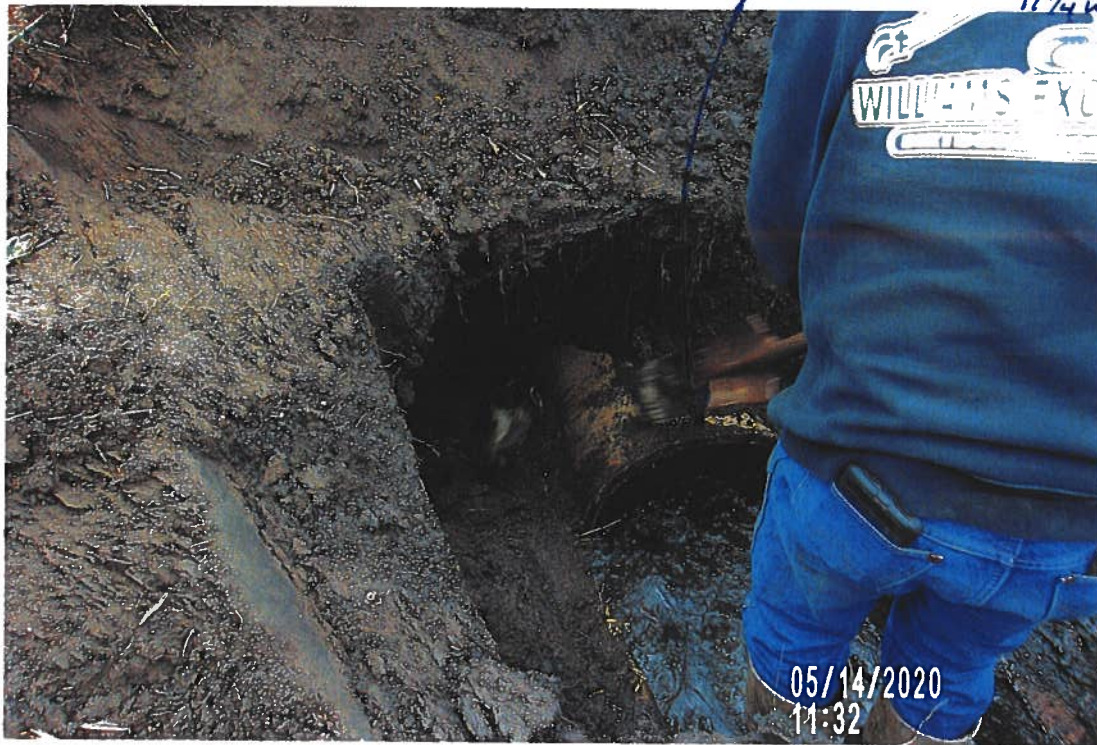
PICTURE #354D IS LOOKING SW IN BLOWOUT #2S SHOWING 5.5' LONG ERODED SOIL CAVITY ON EAST SIDE OF TILE

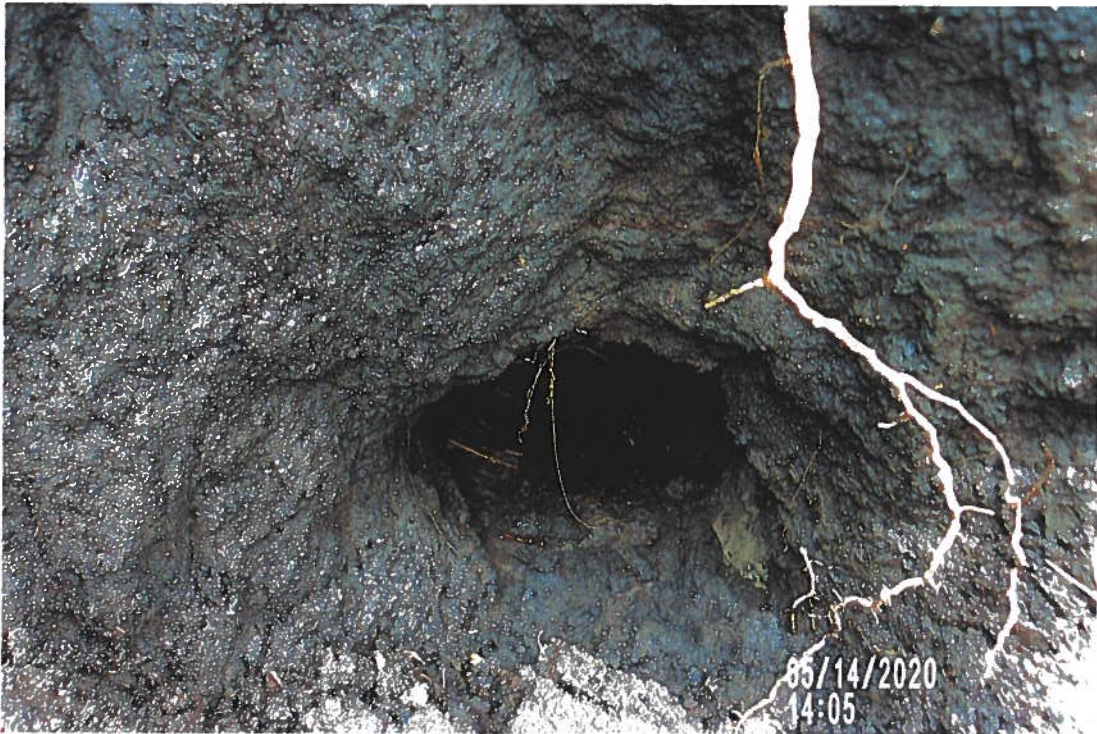
PICTURE # 3551 IS LOOKING NW SHOWING 1ST SECTION OF TILE WITH SEVERE LONGITUDINAL CRACK AND CAVING DOWN. UPSTREAM FROM GPS# 138 WITH SEVERAL OTHER TILE CRACKED AND CAVING DOWN SEVERAL FEET UPSTREAM.

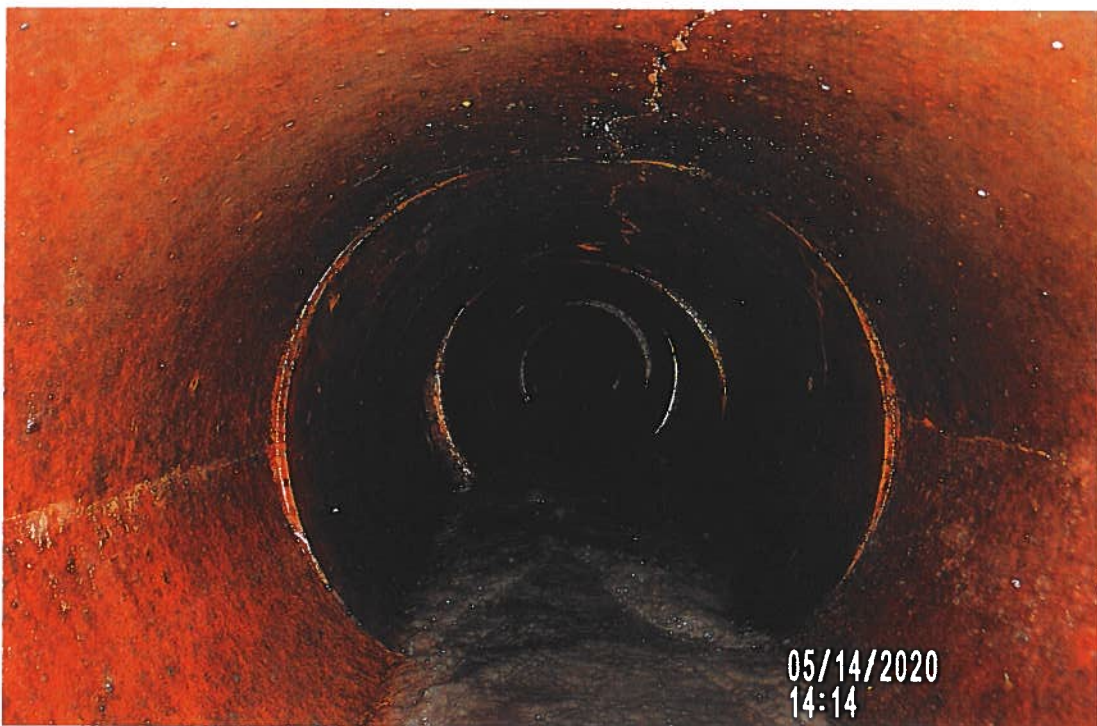
PICTURE # 3552 IS LOOKING SE SHOWING 1ST SECTION OF CLAY TILE WITH LONGITUDINAL CRACKS AND CAVING DOWN DOWNSTREAM FROM CPS# 139 WITH REST OF SECTIONS OF TILE NOT LOOKING TOO BAD

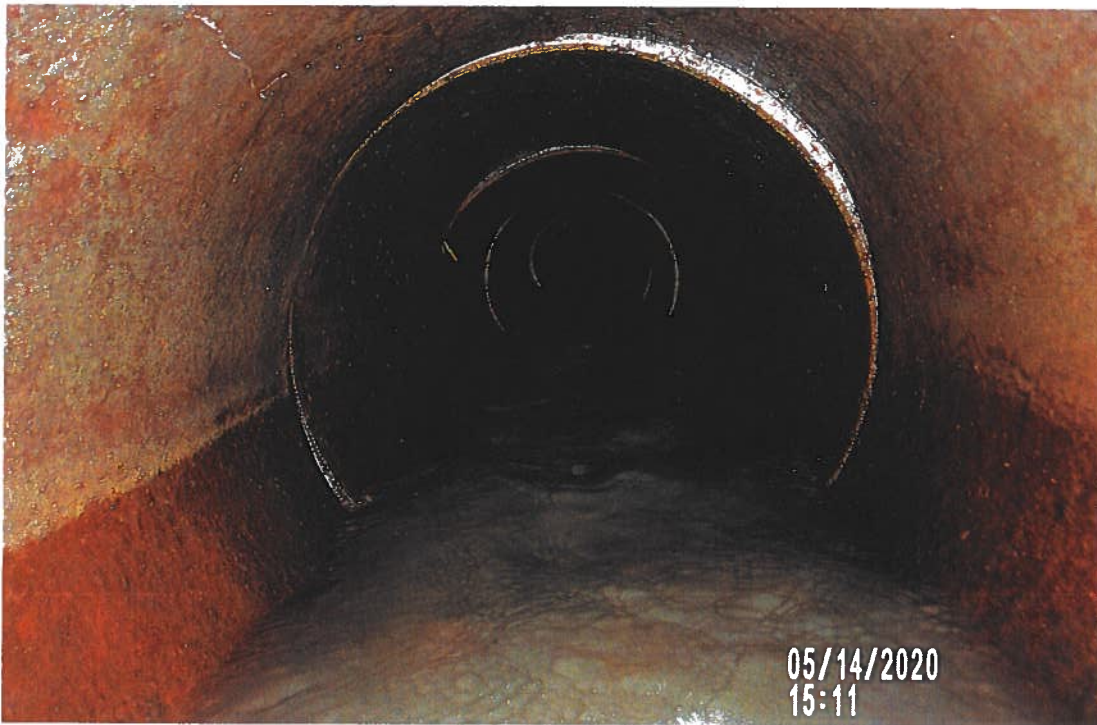
PICTURE # 3560 IS LOOKING NW INSIDE CLAY TILE FROM GPS # 152 IN TILE BLOWOUT # IN SHOWING TILE CRACKED BUT NOT CAVING DOWN.

PICTURE # 3561 IS LOOKING NW SHOWING TEMPORARY REPAIR OF 6.3 LF OF 15" Ø DUAL WALL NON PERFORATED TILE INSTALLED IN TILE BLOWOUT # 1N WITH BOTH JOINTS WRAPPED WITH FABRIC.

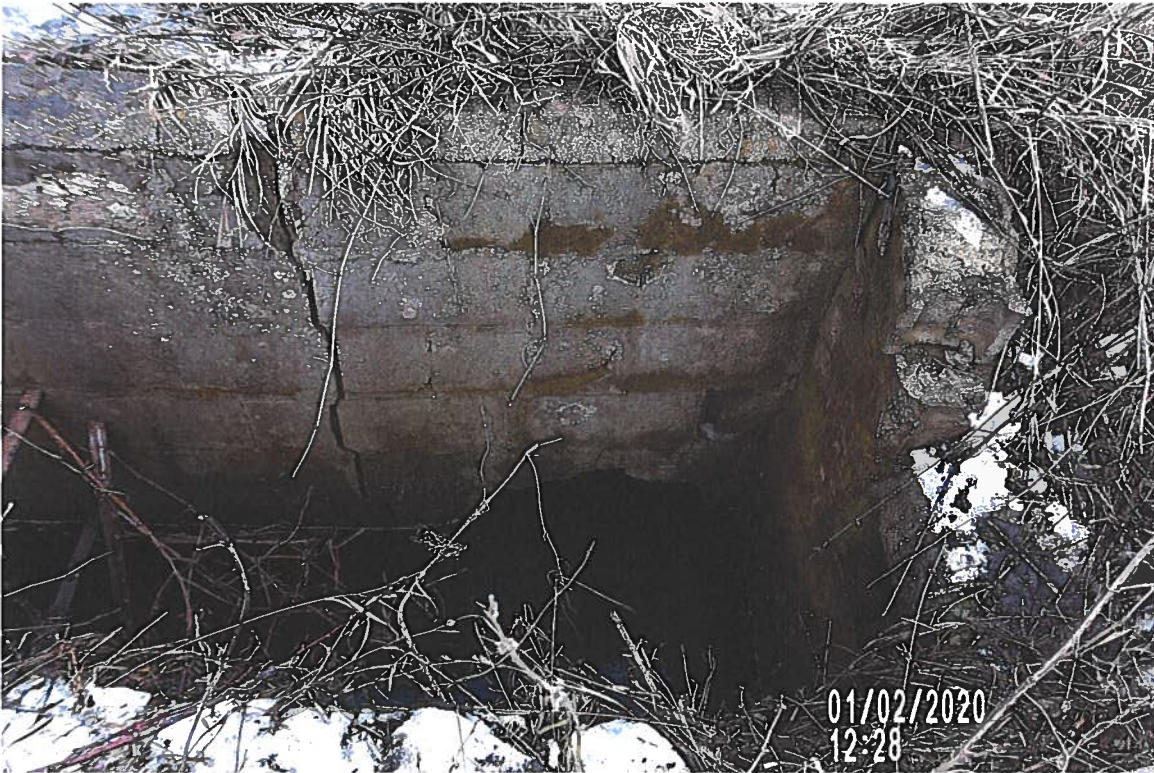
PICT# 2611 IS LOOKING NE AT DRAINAGE STRUCTURE OUTLET  
SHOWING IT IS IN POOR CONDITION.

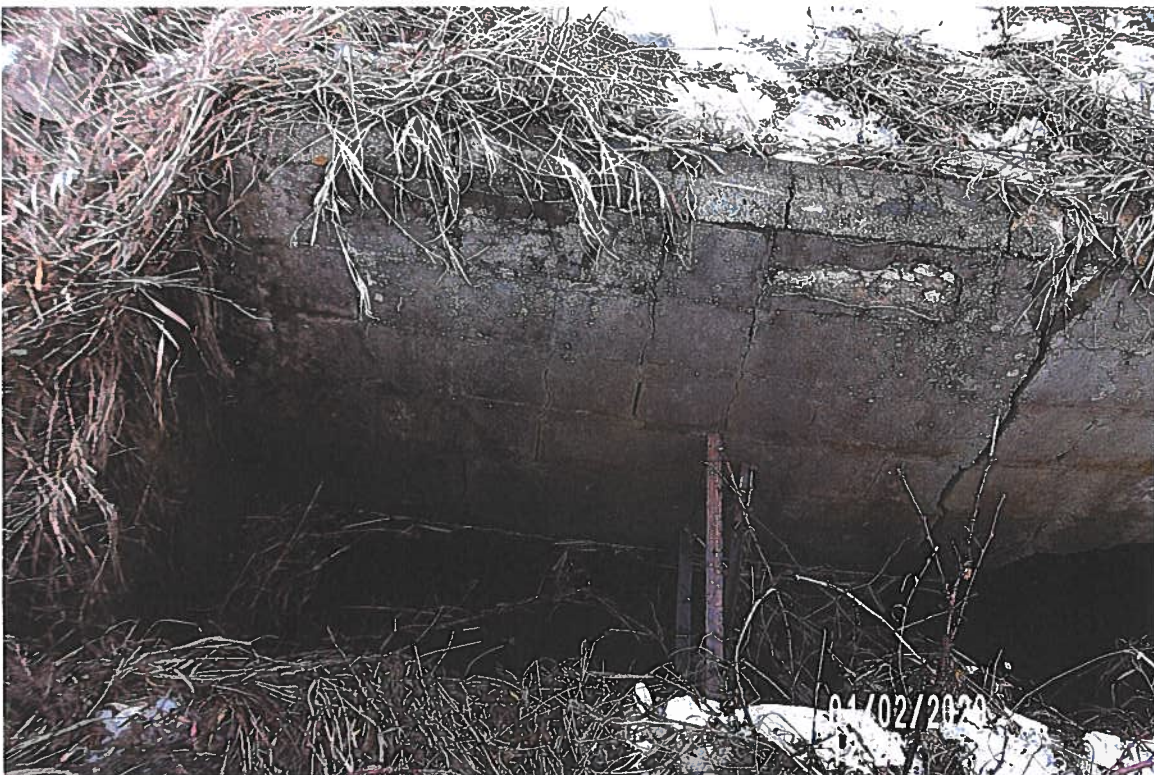
PICT# 2612 IS LOOKING NE AT DRAINAGE STRUCTURE (NW 1/2  
OF STRUCTURE SHOWING IT IS IN POOR CONDITION,

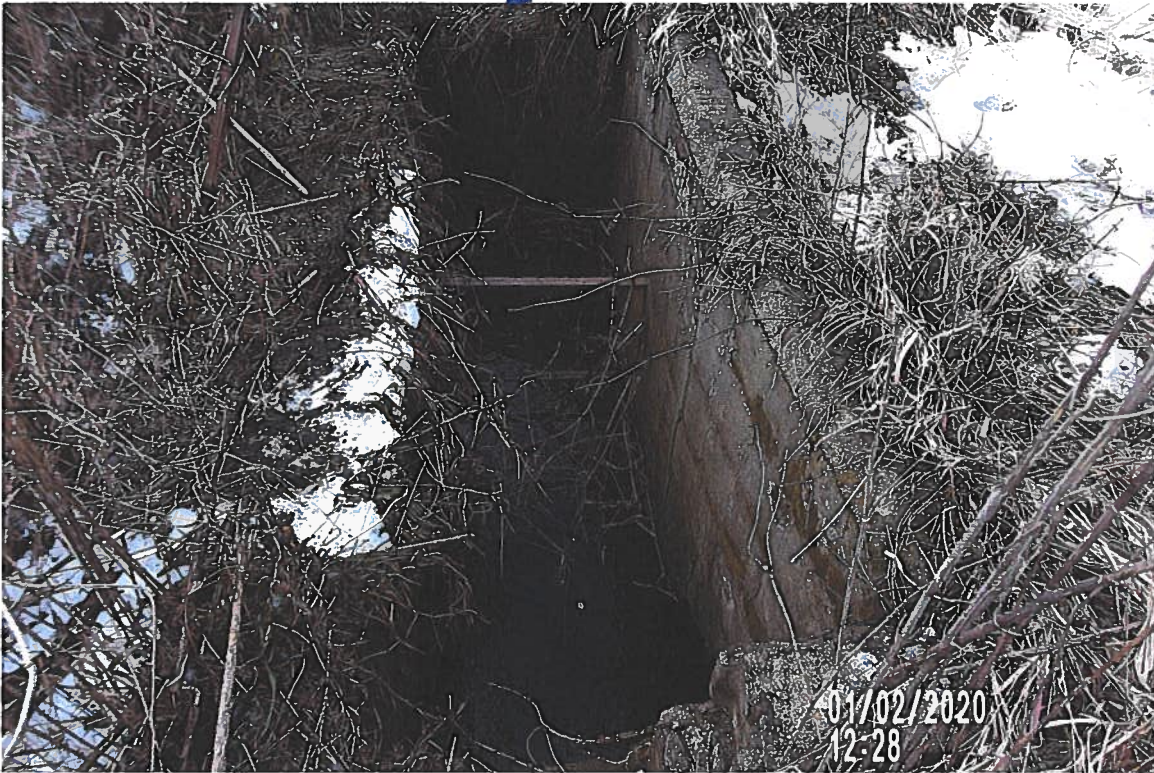
PICT# 2613 IS LOOKING NW AT DRAINAGE STRUCTURE SHOWING IT IS IN POOR CONDITION
