**Drainage District 11 Landowner Meeting
Wednesday, August 03, 2022, 10:00 A.M.**

Investigation/Repair Summary:

DRAINAGE DISTRICT #11
HARDIN, IOWA

MAIN TILE INVESTIGATION

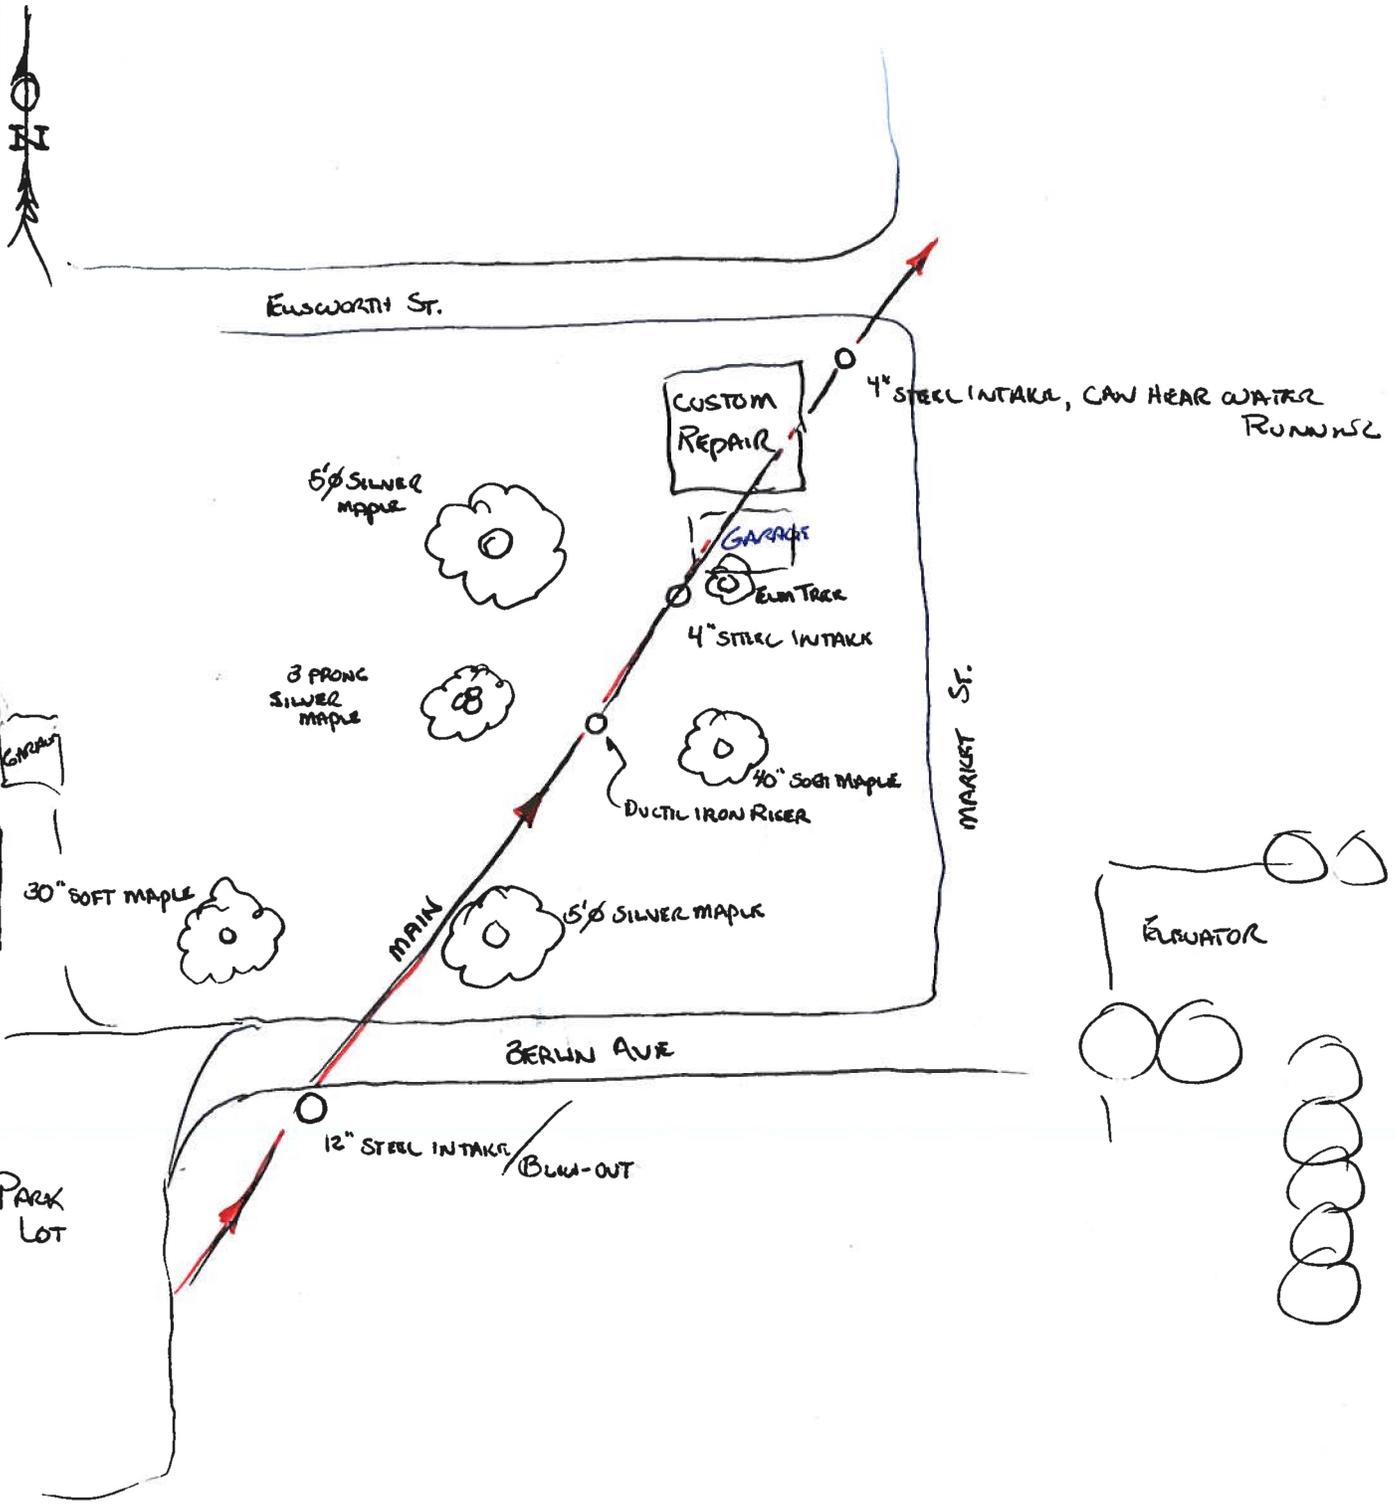
INTAKE ON S. SIDE BERLIN ST. AND NE COR SEMI; PARK LOT

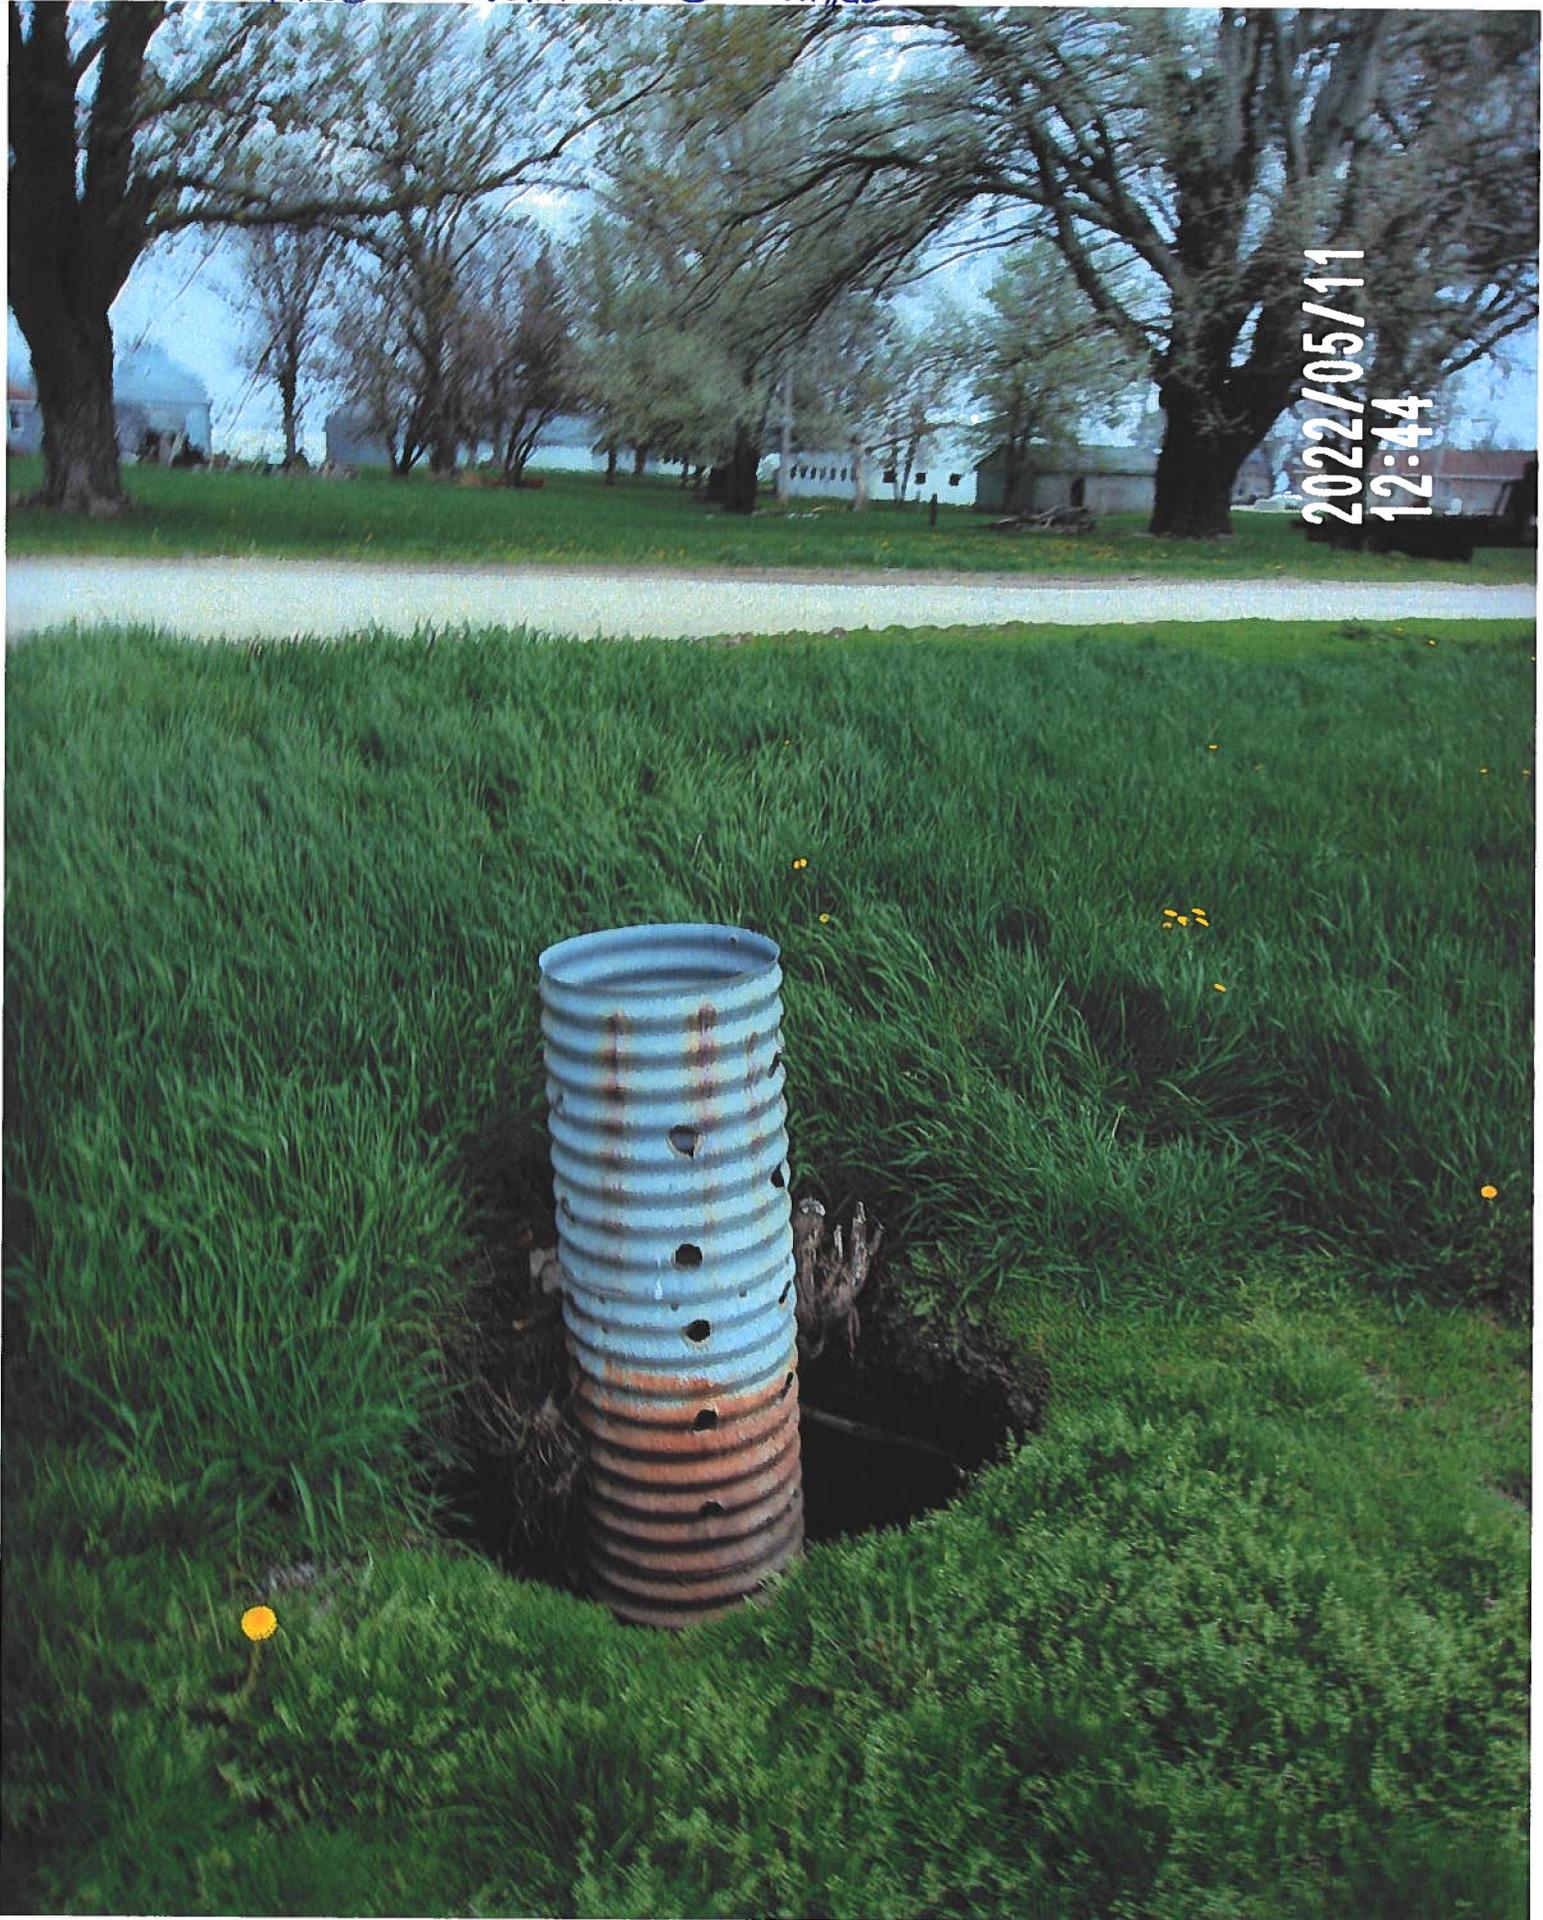
INTAKE @ BERLIN AND PARK LOT

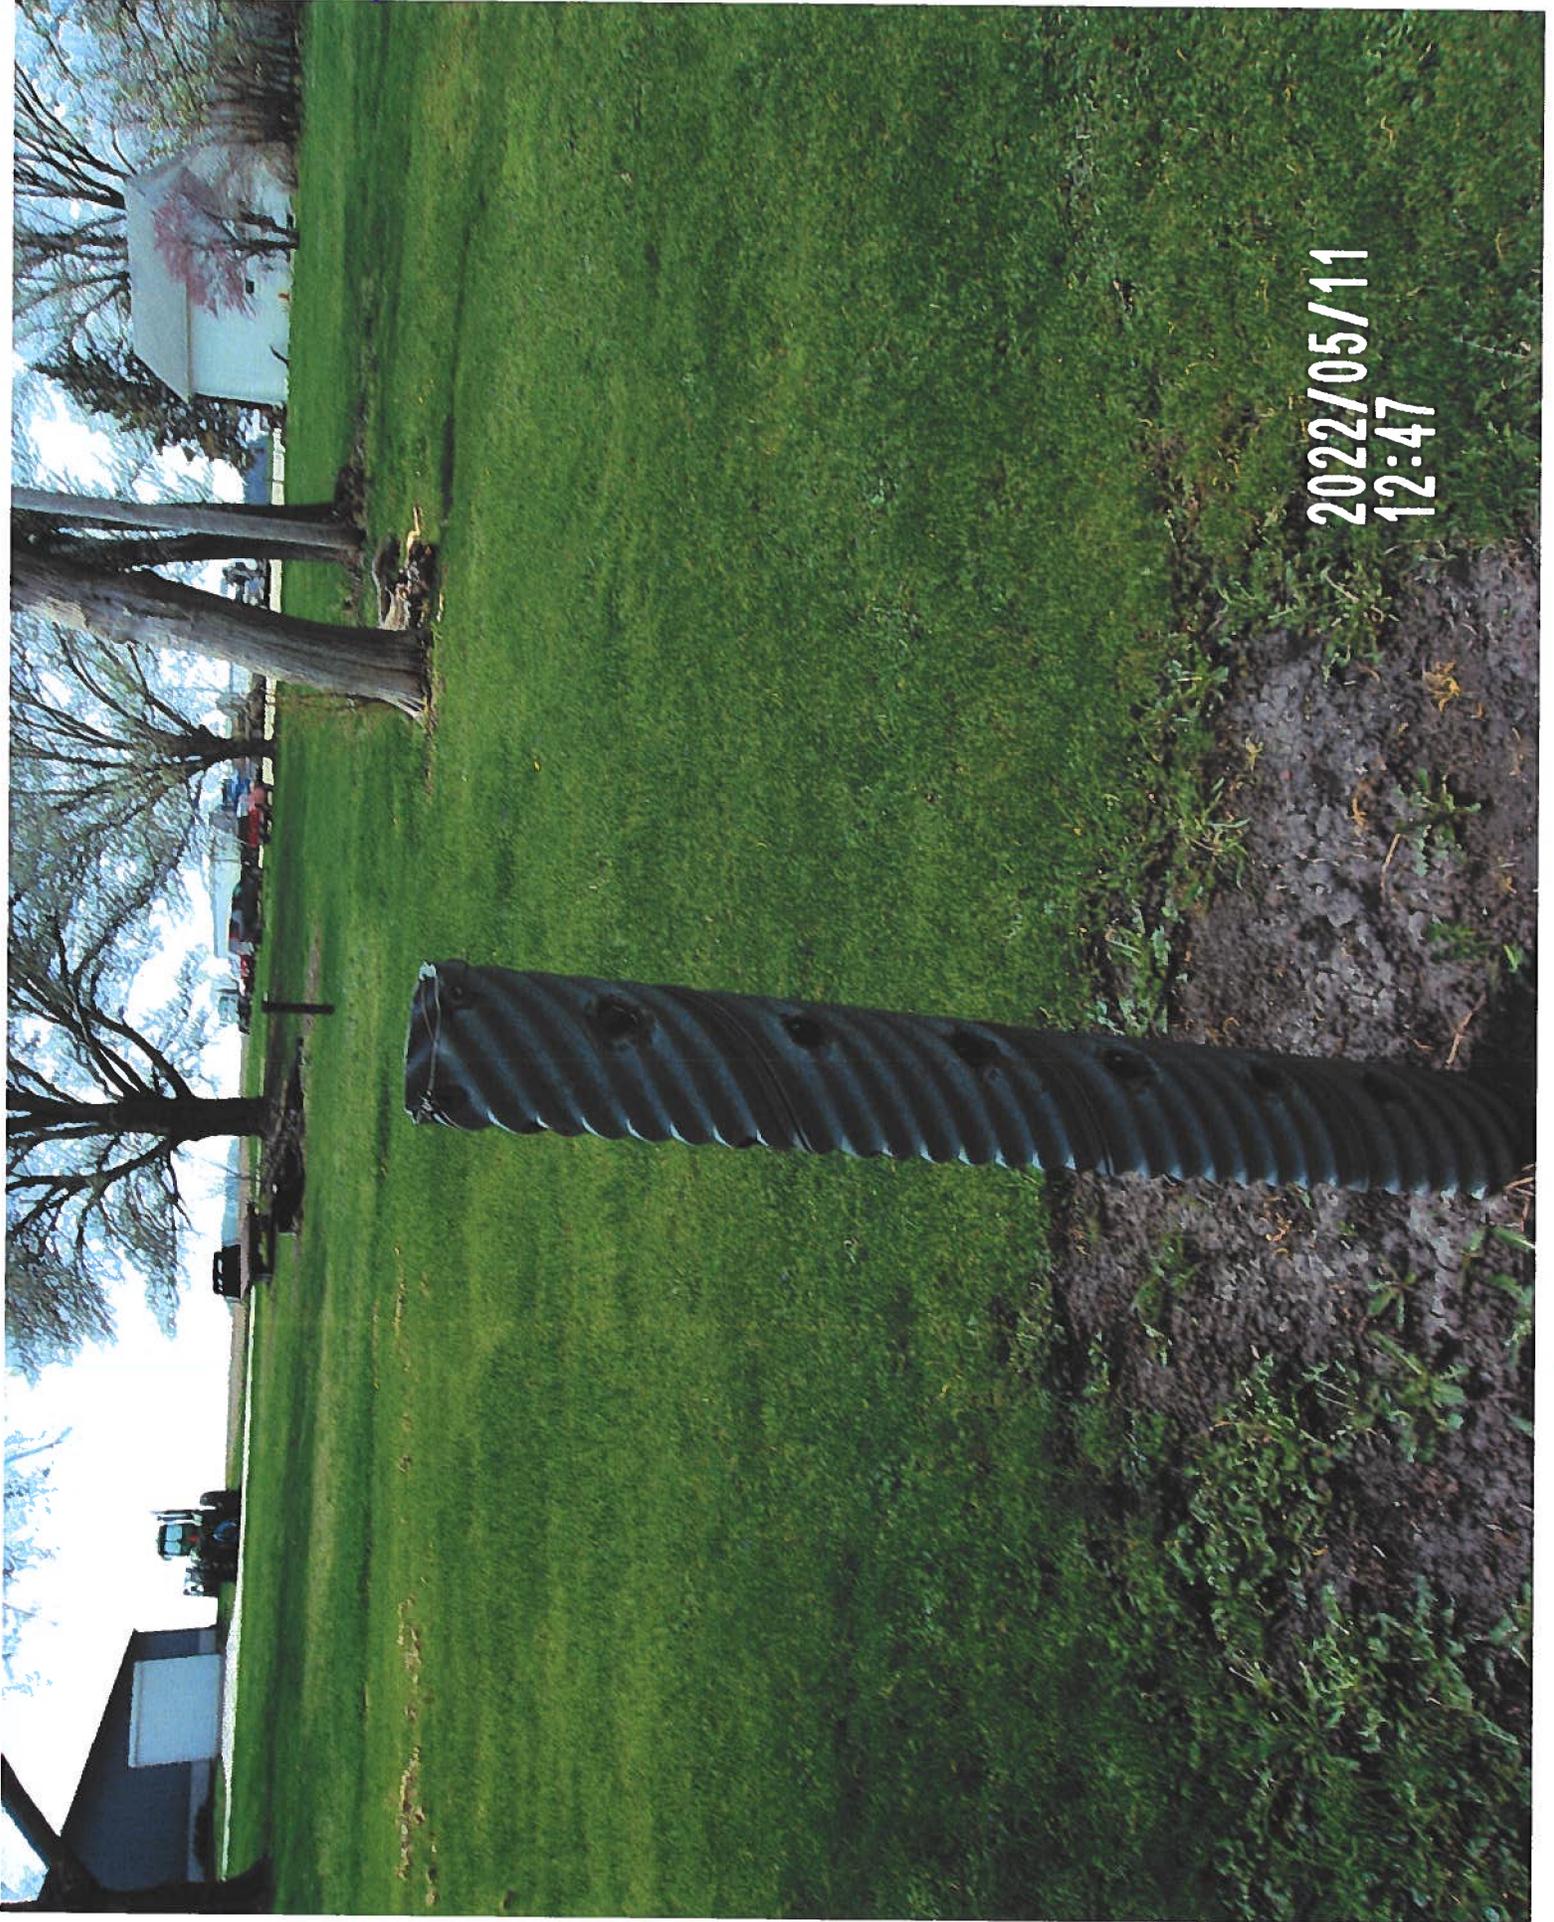
INTAKE @ SW COR. FULSWORTH AND MARKET ST.

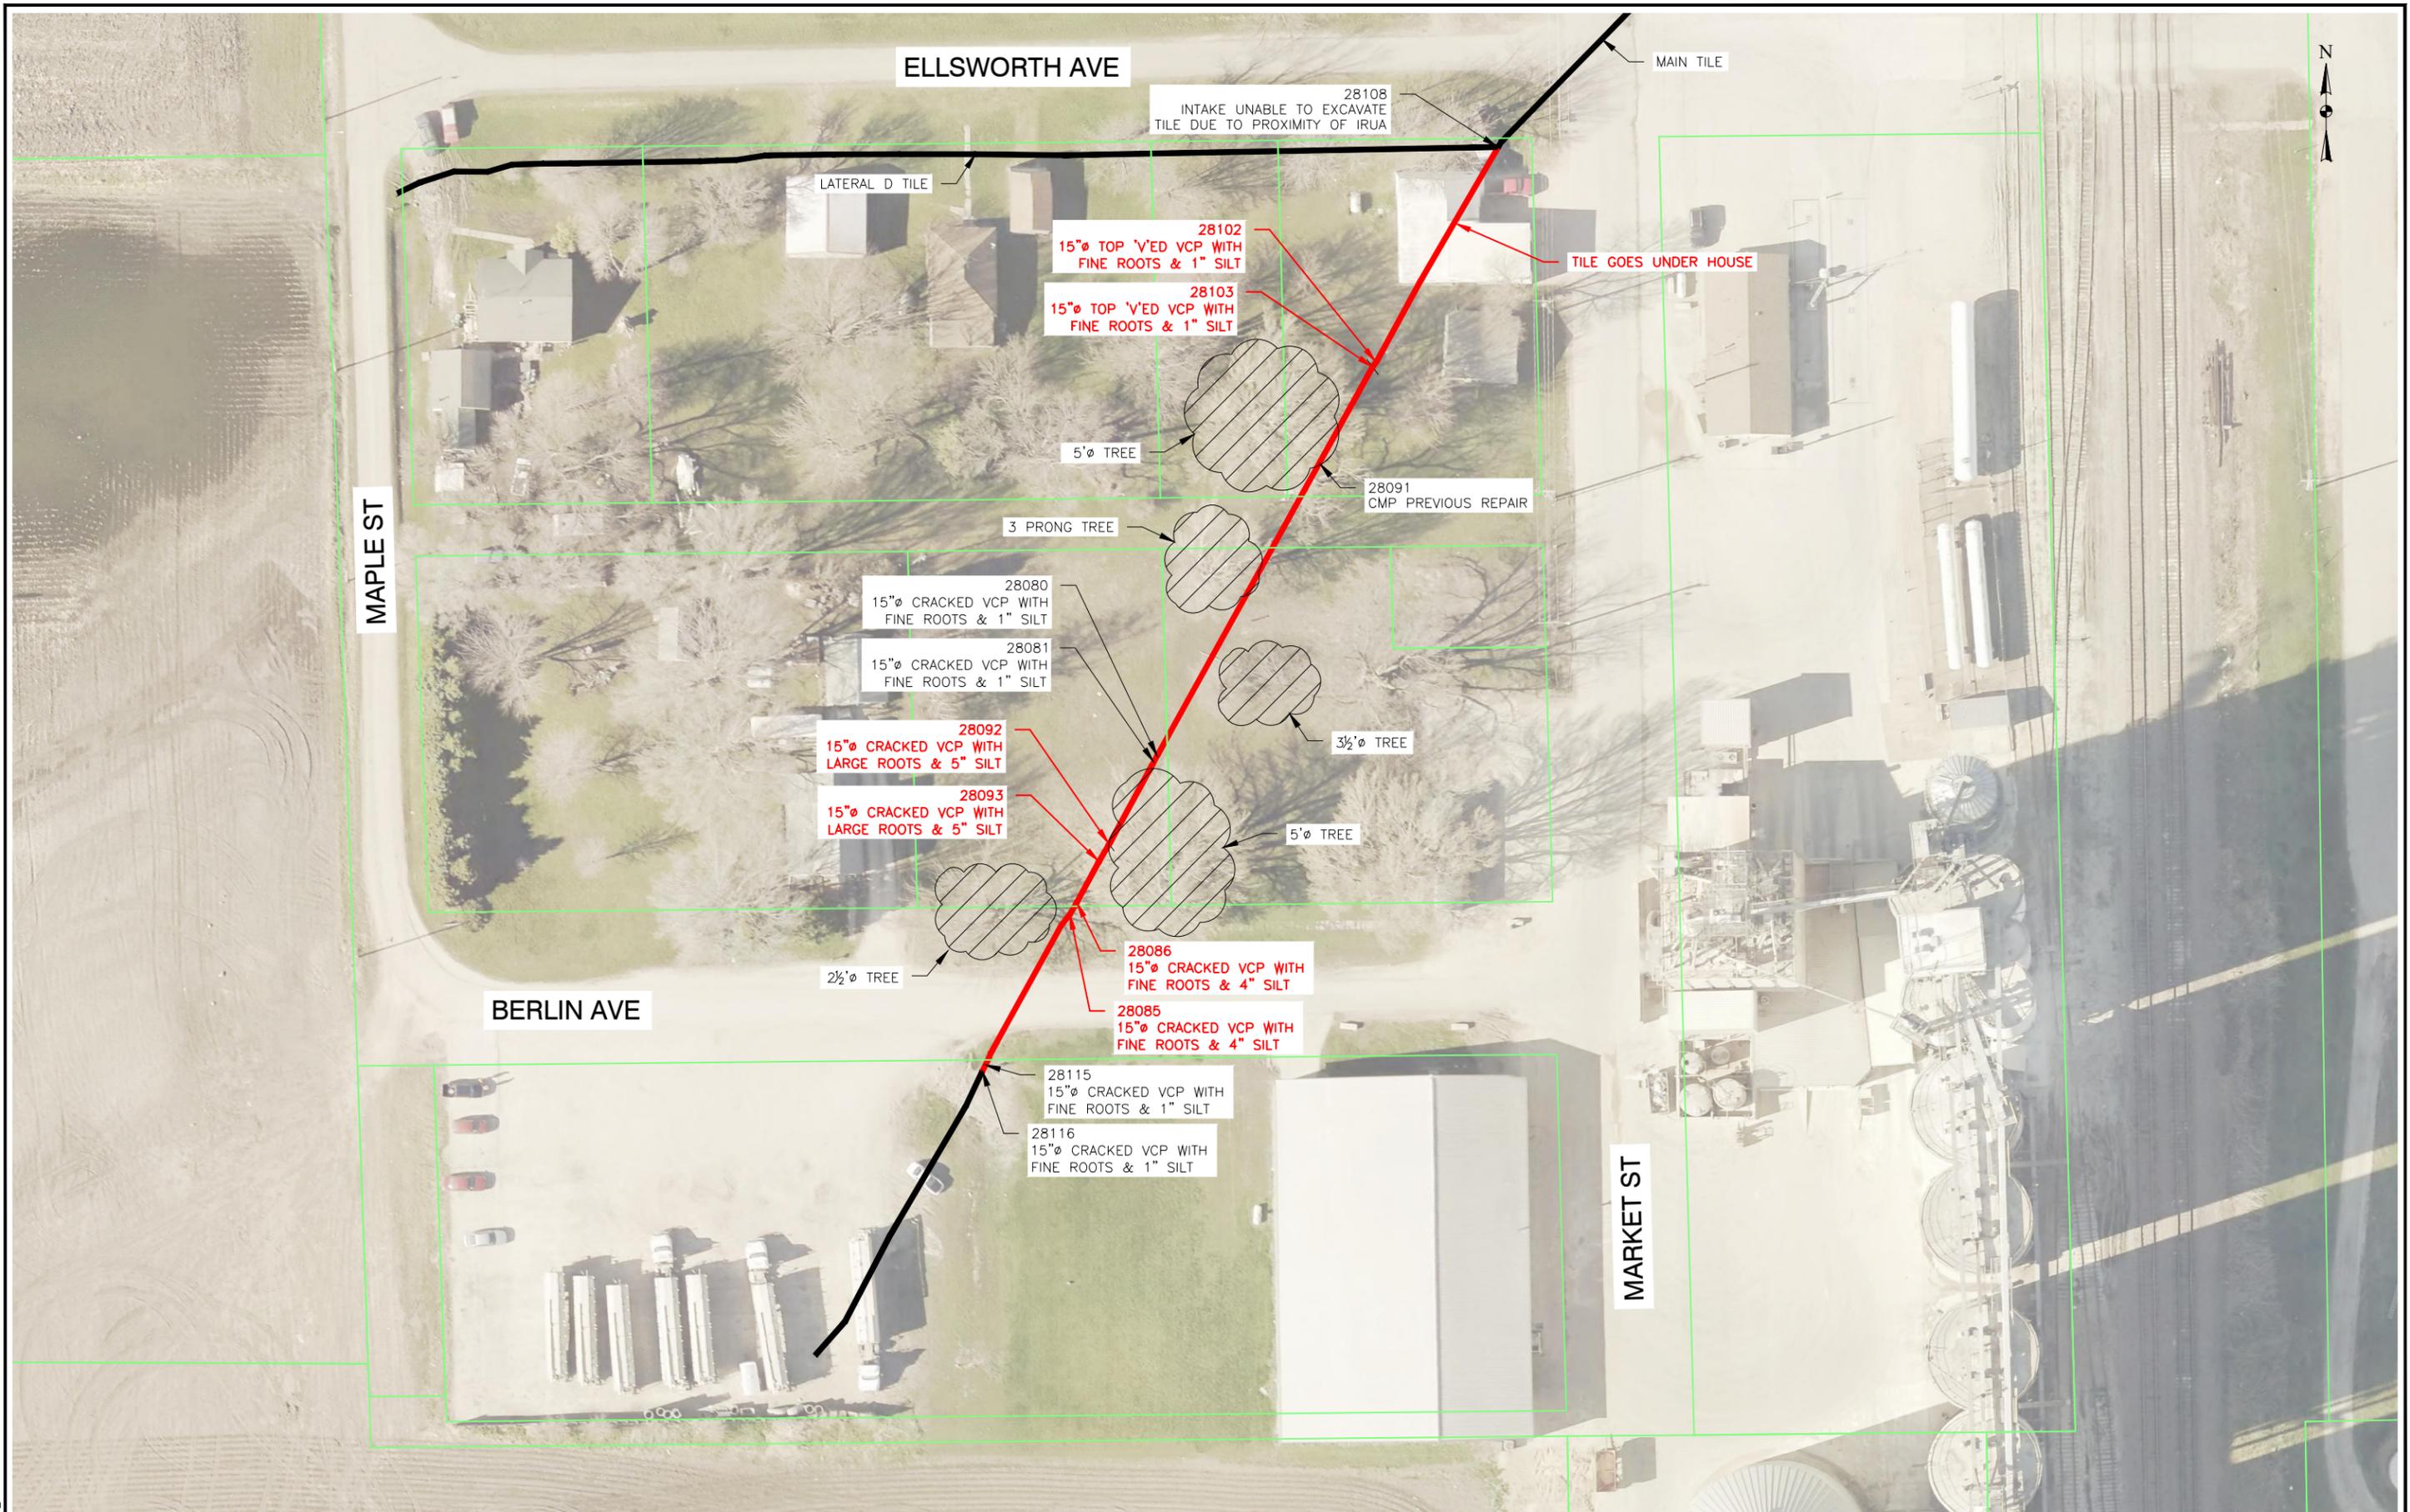
28108
INTAKE UNABLE TO EXCAVATE
TILE DUE TO PROXIMITY OF IRUA

28102
15"Ø TOP 'V'ED VCP WITH
FINE ROOTS & 1" SILT

28103
15"Ø TOP 'V'ED VCP WITH
FINE ROOTS & 1" SILT

28091
CMP PREVIOUS REPAIR

28080
15"Ø CRACKED VCP WITH
FINE ROOTS & 1" SILT

28081
15"Ø CRACKED VCP WITH
FINE ROOTS & 1" SILT

28092
15"Ø CRACKED VCP WITH
LARGE ROOTS & 5" SILT

28093
15"Ø CRACKED VCP WITH
LARGE ROOTS & 5" SILT

28086
15"Ø CRACKED VCP WITH
FINE ROOTS & 4" SILT

28085
15"Ø CRACKED VCP WITH
FINE ROOTS & 4" SILT

28115
15"Ø CRACKED VCP WITH
FINE ROOTS & 1" SILT

28116
15"Ø CRACKED VCP WITH
FINE ROOTS & 1" SILT
