Drainage District 14 Continuation Of Public Hearing On Engineer's Report On Repairs Or Improvements To The Main Tile Of DD 14

**ENGINEER'S REPORT
ON REPAIRS OR
IMPROVEMENTS TO
THE MAIN TILE
DRAINAGE DISTRICT
NO. 14
HARDIN COUNTY,
IOWA**

Engineer's Report on Repairs or Improvements to the Main Tile, Drainage District No. 14 Hardin County, Iowa

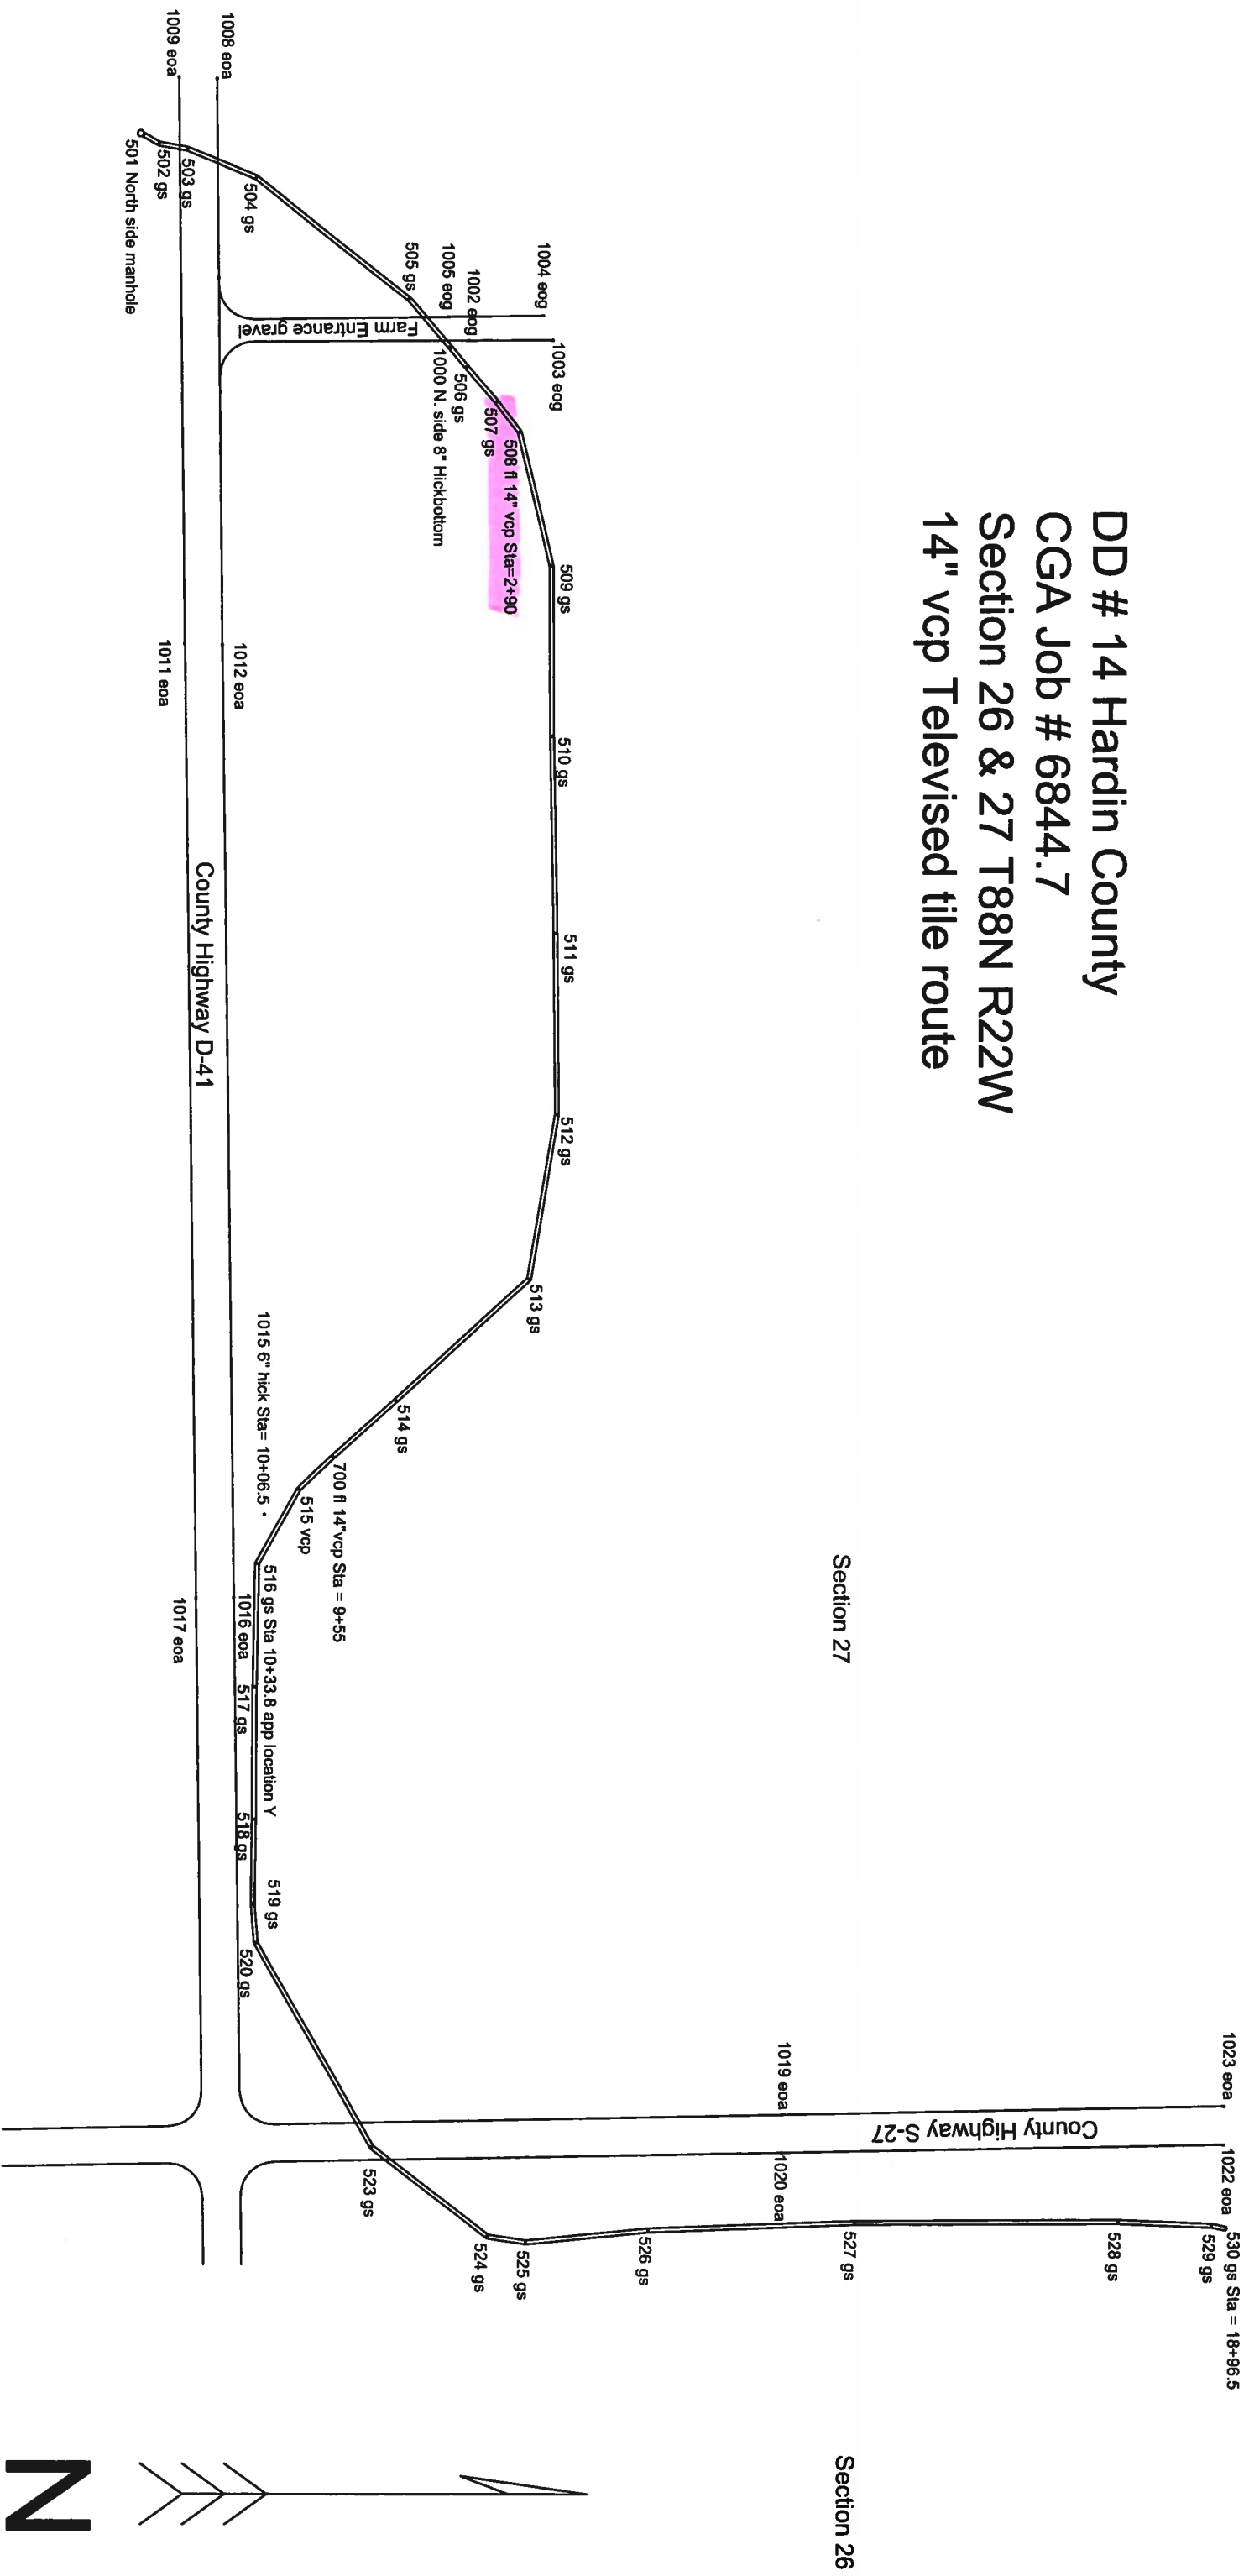
DD # 14 Hardin County
CGA Job # 6844.7
Section 26 & 27 T88N R22W
14" vcp Televised tile route

- Per District Trustees' request at hearing, CCTV inspection of the Main tile was conducted for approximately 1900'. Downstream limit was the south side of County Highway D41 (existing access point) at approximately ¼ mile west of intersection of County Highways D41 and S27. Upstream limit was east side of County Highway S27 approximately ¼ mile north of intersection of County Highways D41 and S27. See attached map for exact locations and attached CCTV reports for defects found.
- Access points where 14" VCP was cut (along with 8" tile) were repaired with dual wall HDPE with ¾ concrete collars at connections with existing VCP tile.

Although the CCTV has revealed that the existing VCP is cracked and there is evidence of previous spot repairs, the majority of the VCP appears stable and round (see attached CCTV reports for list of defects found). Most concerning of the defects would be the spot repair that was performed with single wall HDPE that is now deformed and has a protruding tap connection at it. This would be followed by the rusty CMP and the multiple longitudinal fractures in VCP. It is our recommendation that at least the deformed single wall HDPE and protruding tap connection be repaired and the timing/necessity of repair of the remaining defects prioritized by the District Trustees.
