**Regular Drainage Meeting**

4. DD 11 WO 331 - Discuss W Possible Action - Investigation Summary

#11

## Investigation/Repair Summary:

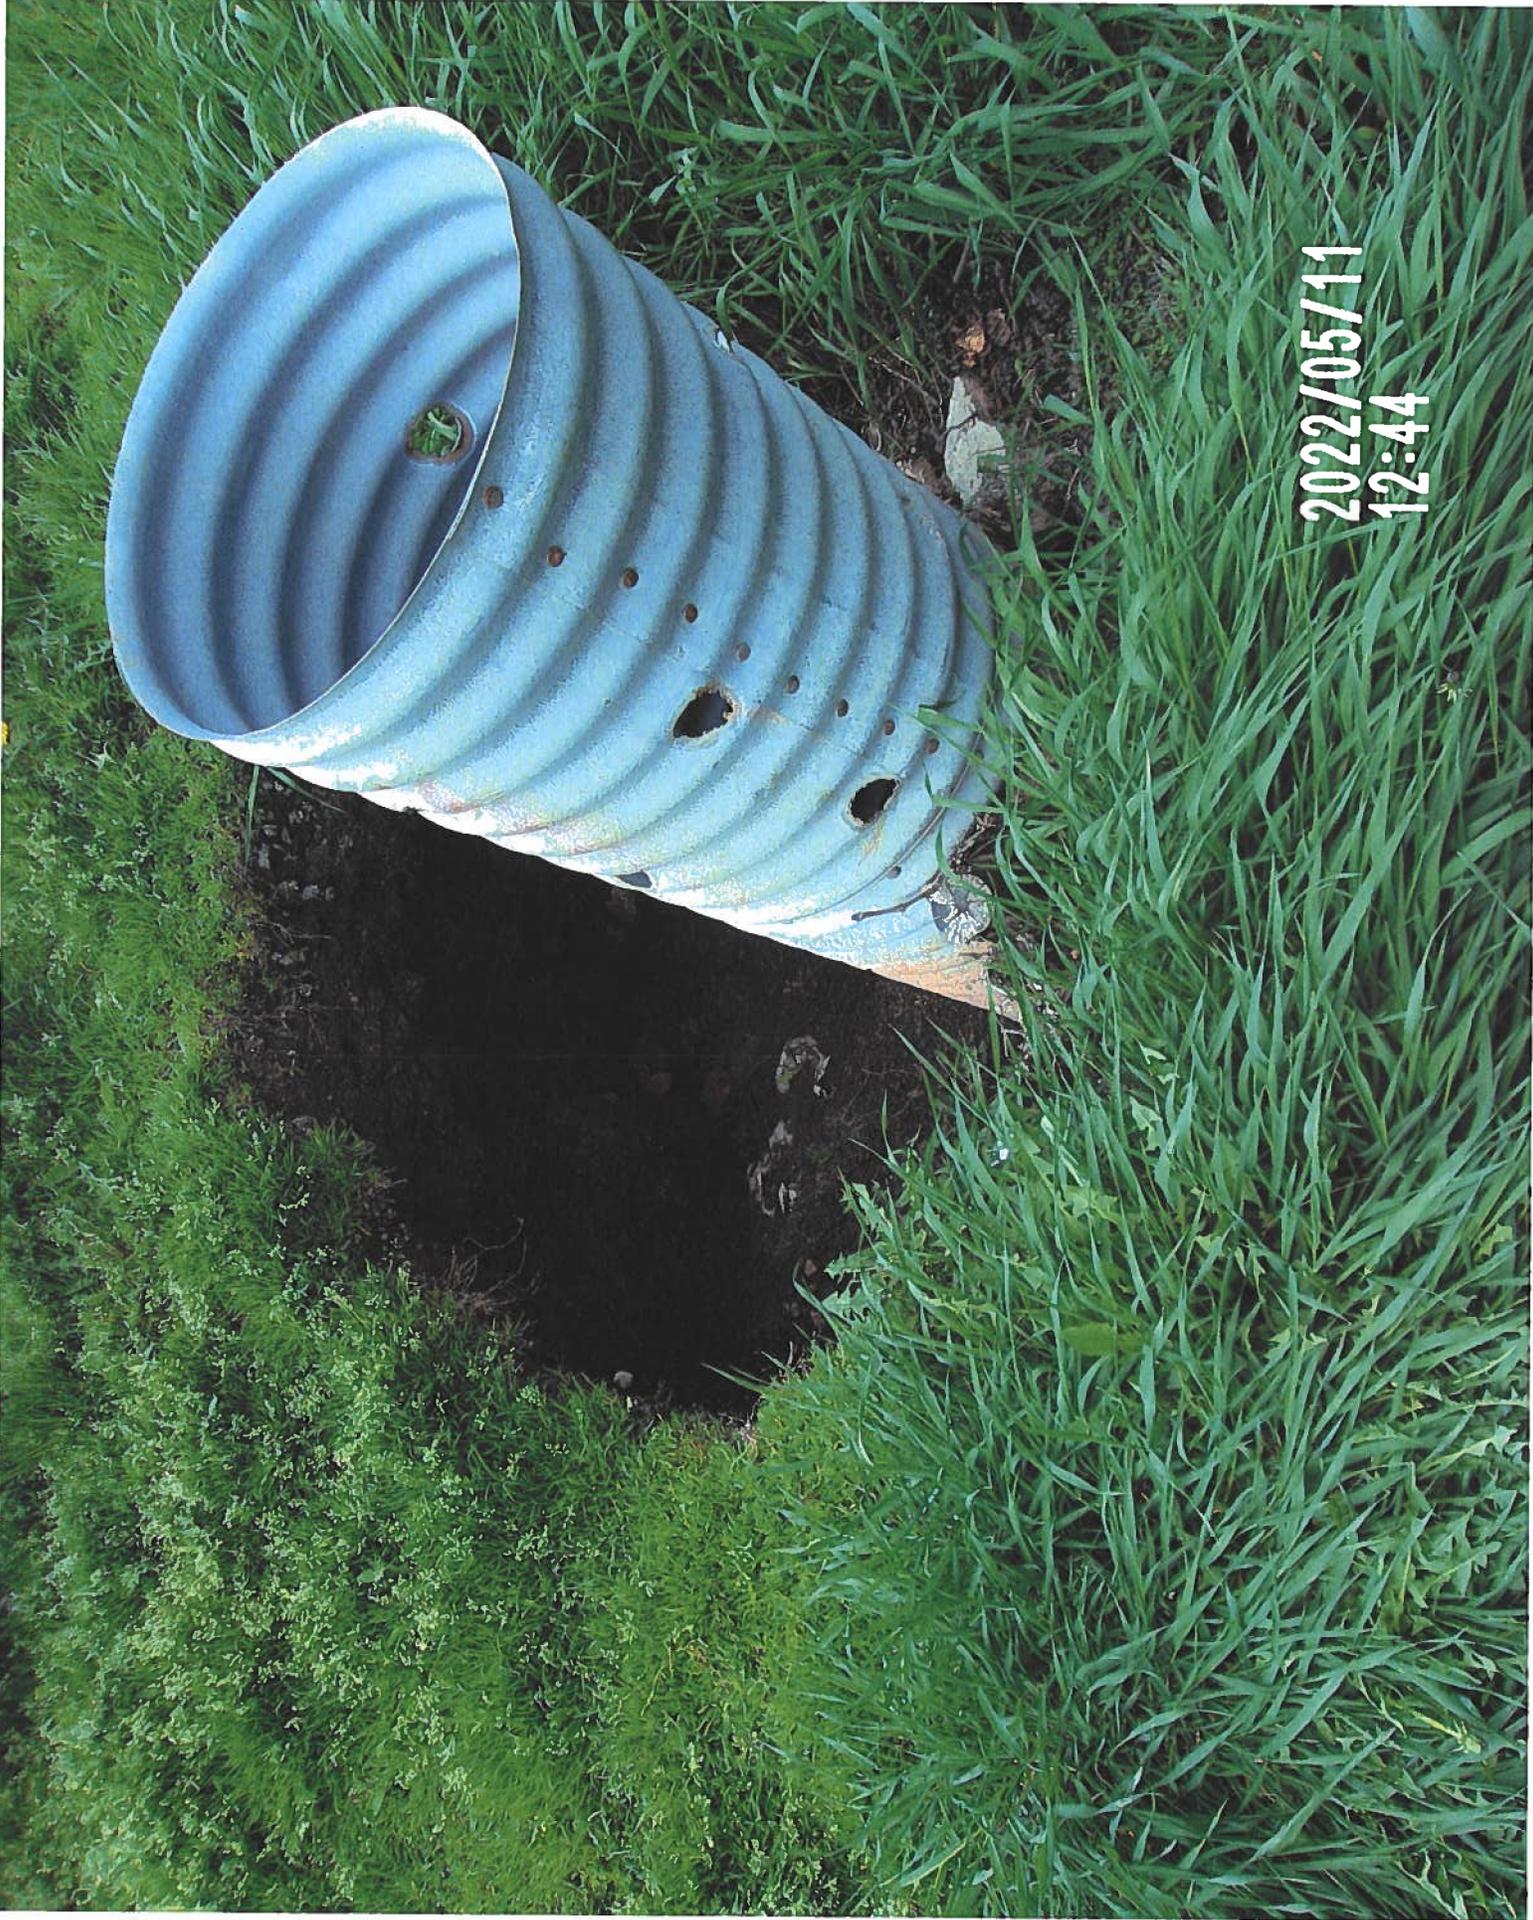
- Employee of landowner in town of Buckeye reported broken tile intake in Block 10.
- Visual observation found a 3 foot +/- diameter blowout/sinkhole around the 12 inch metal intake on Main tile with water visible swirling in intake above the Main tile itself.
- Downstream of intake in Block 10, there are several large maple trees in close proximity of the assumed Main tile route.

Based on the swirling water and the blowout/sinkhole around the intake, it appears that the Main tile is restricted downstream of the intake. Due to the type and proximity of the trees, this is probably due to tree roots plugging the Main tile. Moving forward, it is our recommendation that the District Trustees proceed with one of the following actions:

LOOKING DOWNSTREAM @ INTAKE

- Verify that the roots are the cause of the Main tile restriction either through CCTV or location/excavation of the Main tile at intervals and perform repairs as needed based on these results.  
OR
- Assume that tree roots are the cause of the Main tile restriction and have all trees within 50 feet of the Main tile removed and the remaining stumps treated along with replacing the Main tile that is restricted.

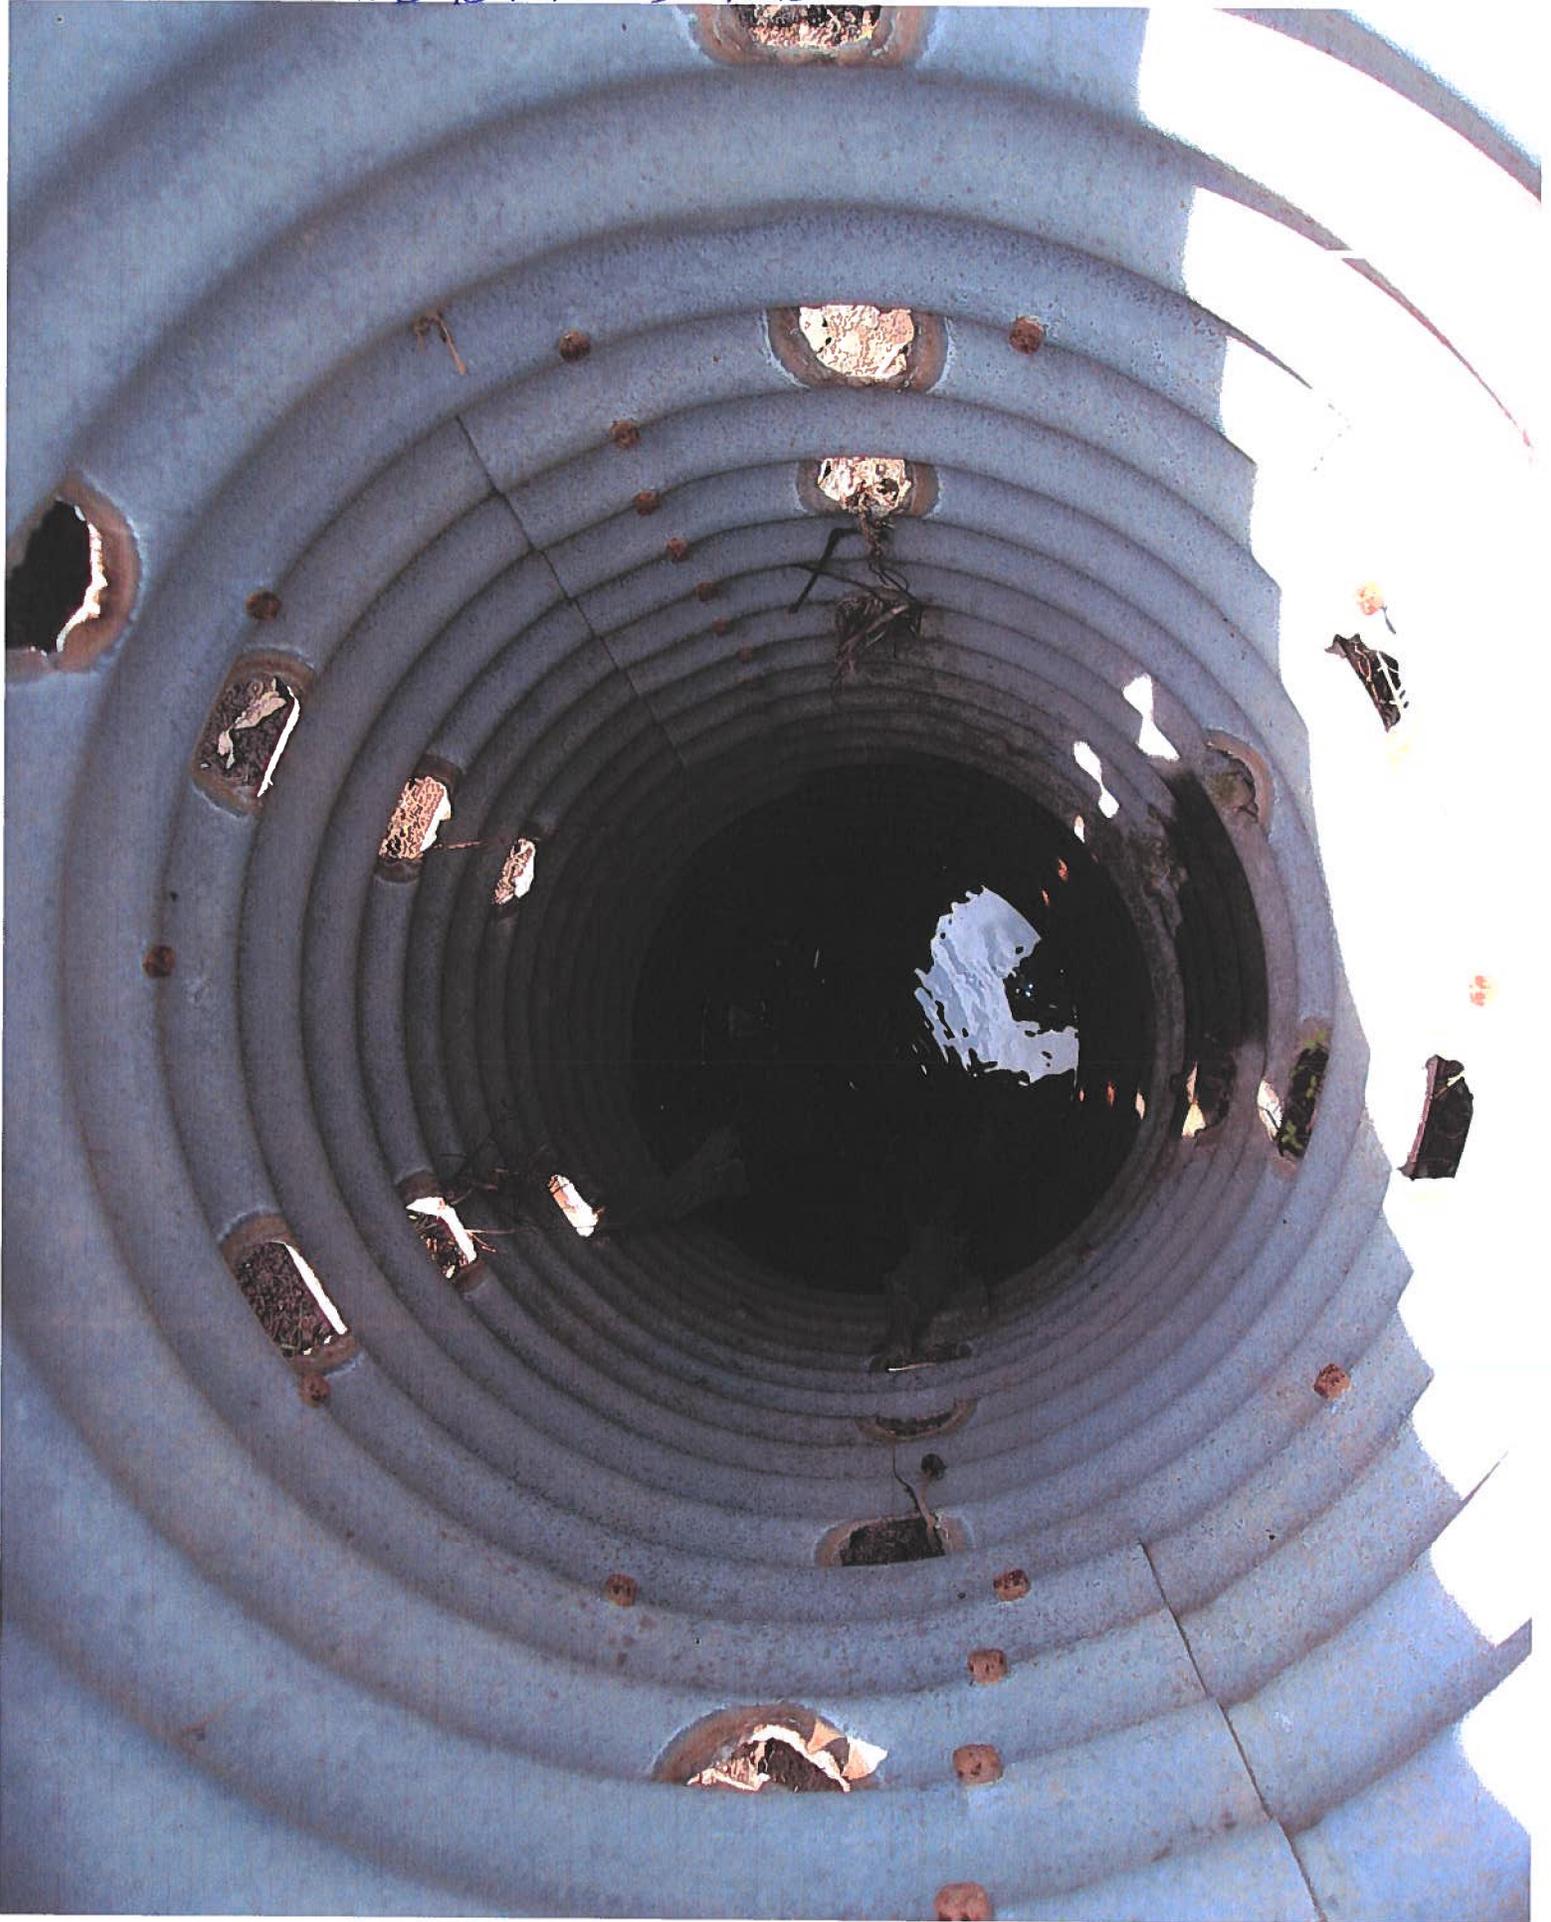
LOOKING DOWNSTREAM @ INTAKE BY SW COR. GARAGE

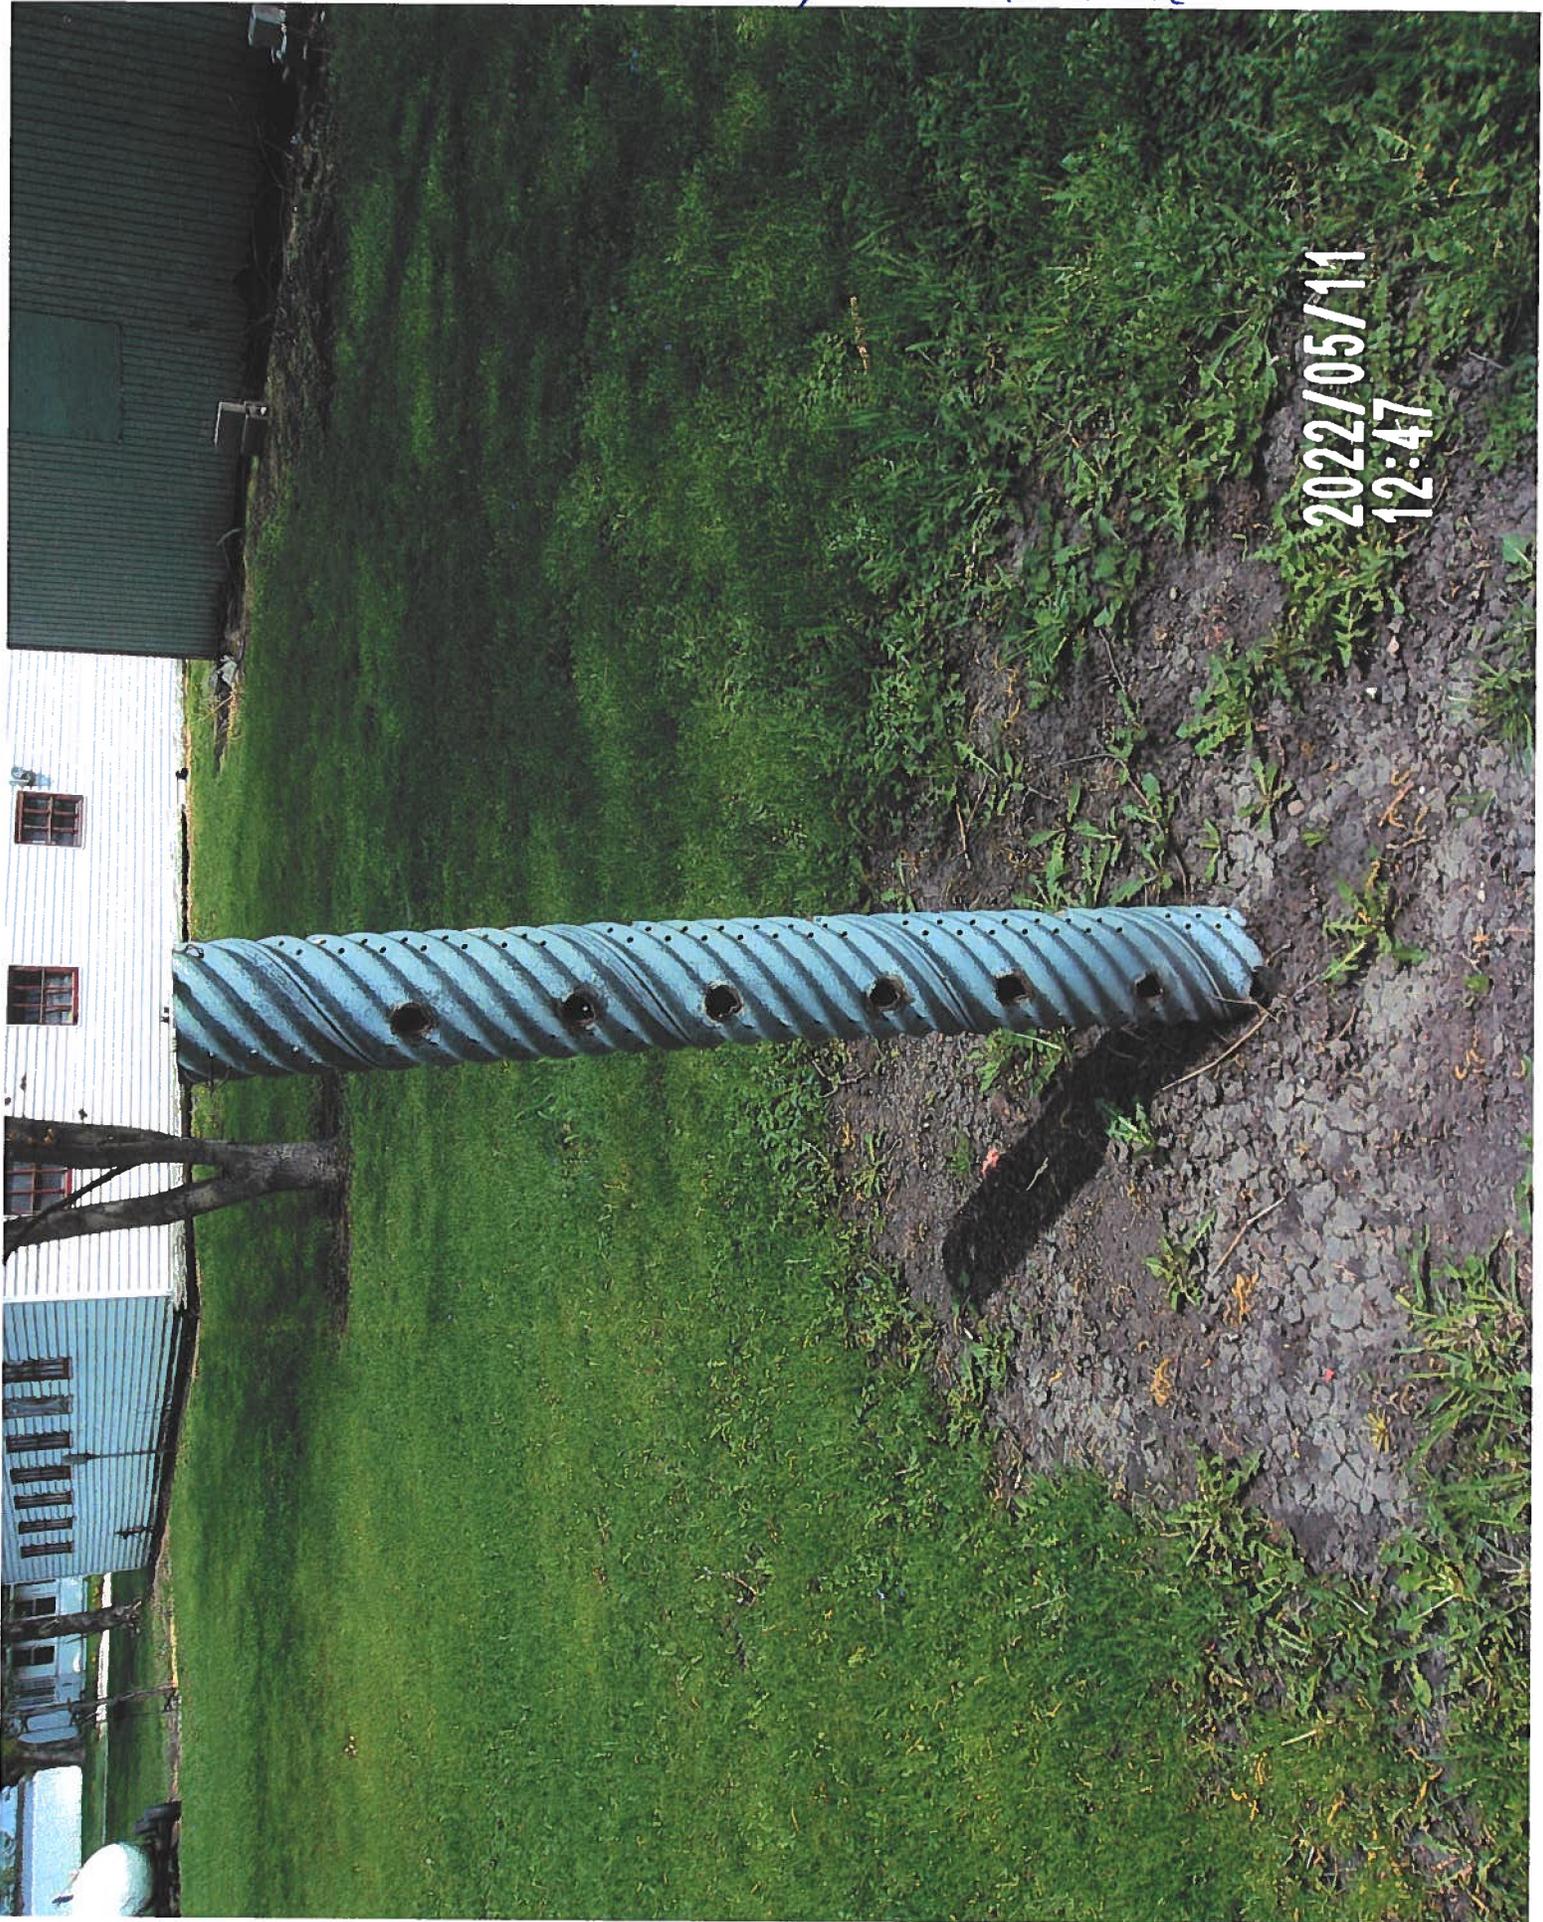
• Looking upstream from intake @ SW cor. GARAGE
