**AGENDA**  
**DRAINAGE DISTRICT 14 LANDOWNER MEETING**  
**Wednesday, November 18, 2020 12:00 PM**  
**Large Conference Room**

# Drainage Work Order Request For Repair

LOCATION: DD14 MARIETTA TILE LOCATED SWNE & NWSE  
34-88-22 HARDIN COUNTY  
INVESTIGATE & TEMPORARILY REPAIR 3 TILE BLOWOUTS

## Investigation and Repair Summary:

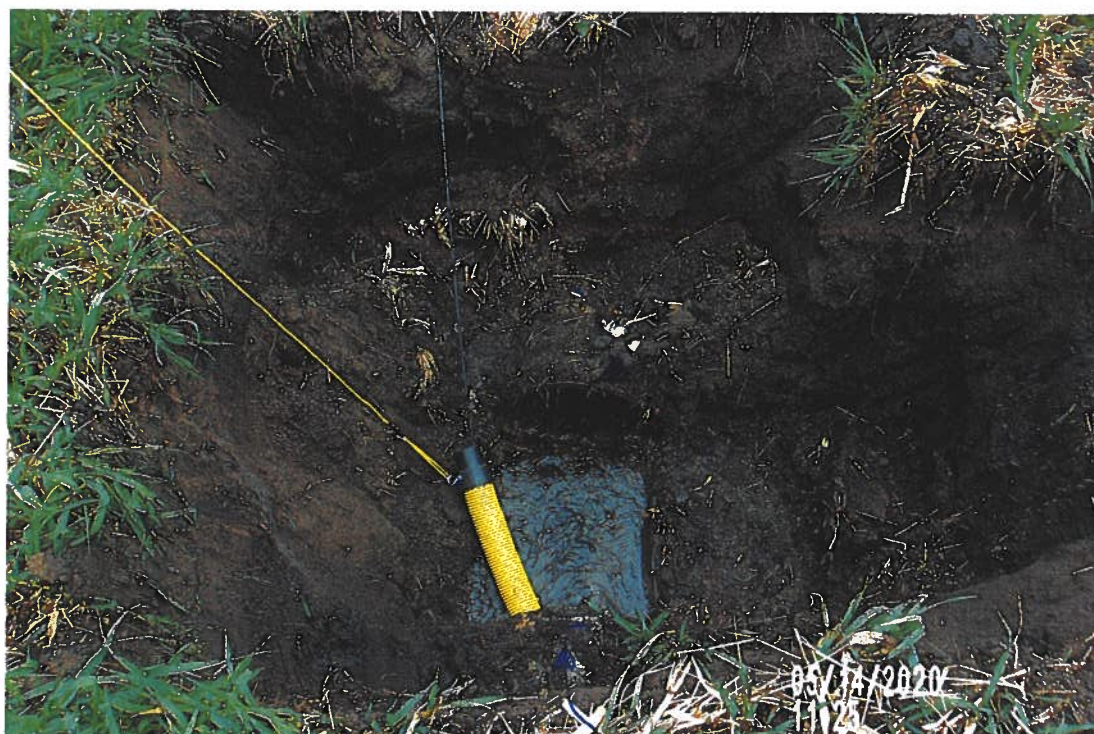
PICTURE # 3538 IS LOOKING SW @ BLOWOUT #18 SHOWING CREW  
TELEVISIONING WASTEWATER FROM GPS#177

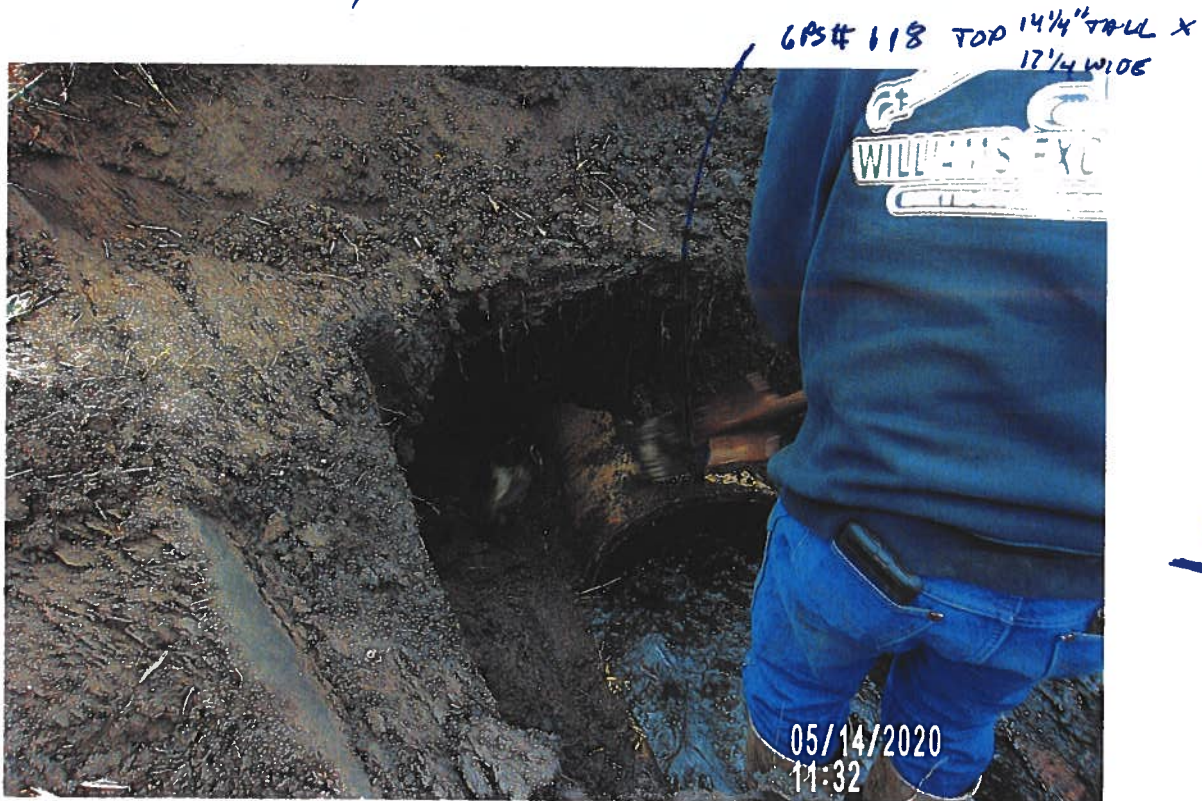
PICTURE#354D IS LOOKING SW IN BLOWOUT #2S SHOWING 5.5' LONG  
ERODED SOIL CAVITY ON EAST SIDE OF TILE

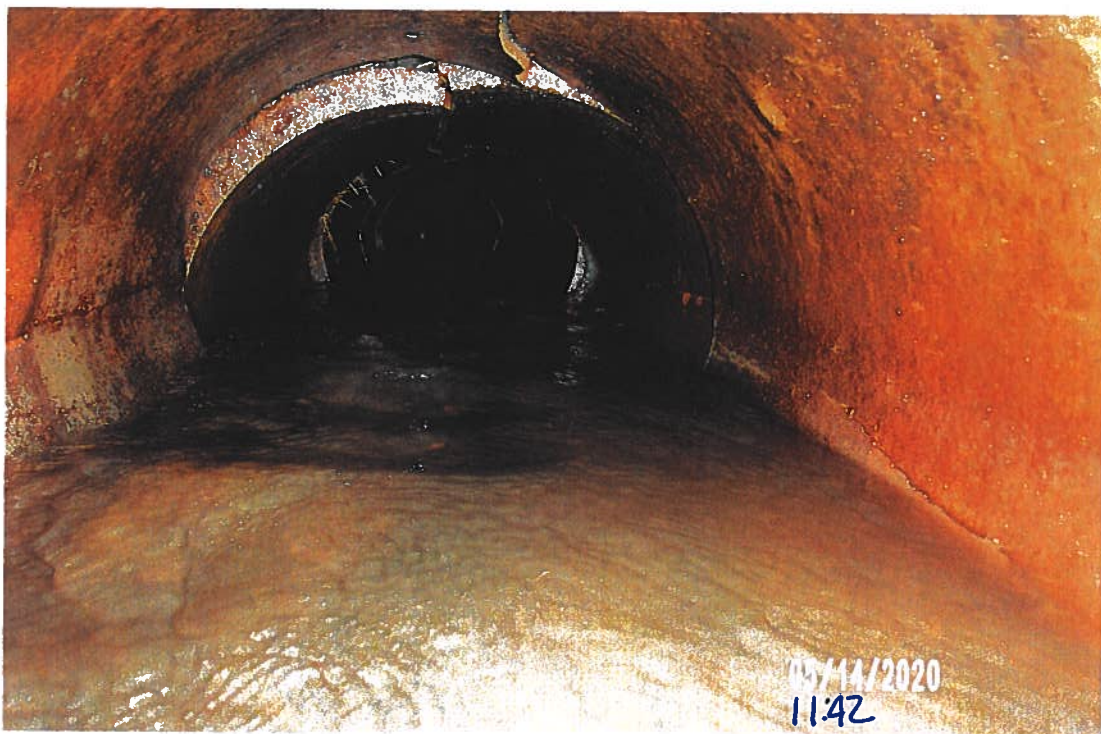
PICTURE 354I IS LOOKING SW INSIDE CLAY TILE DOWNSTREAM  
INSIDE BLOWOUT 2S SHOWING NEXT COUPLE SECTIONS  
IN BAD SHAPE WITH CRACKS AND LEAVING DOWN, FROM GPS# 118

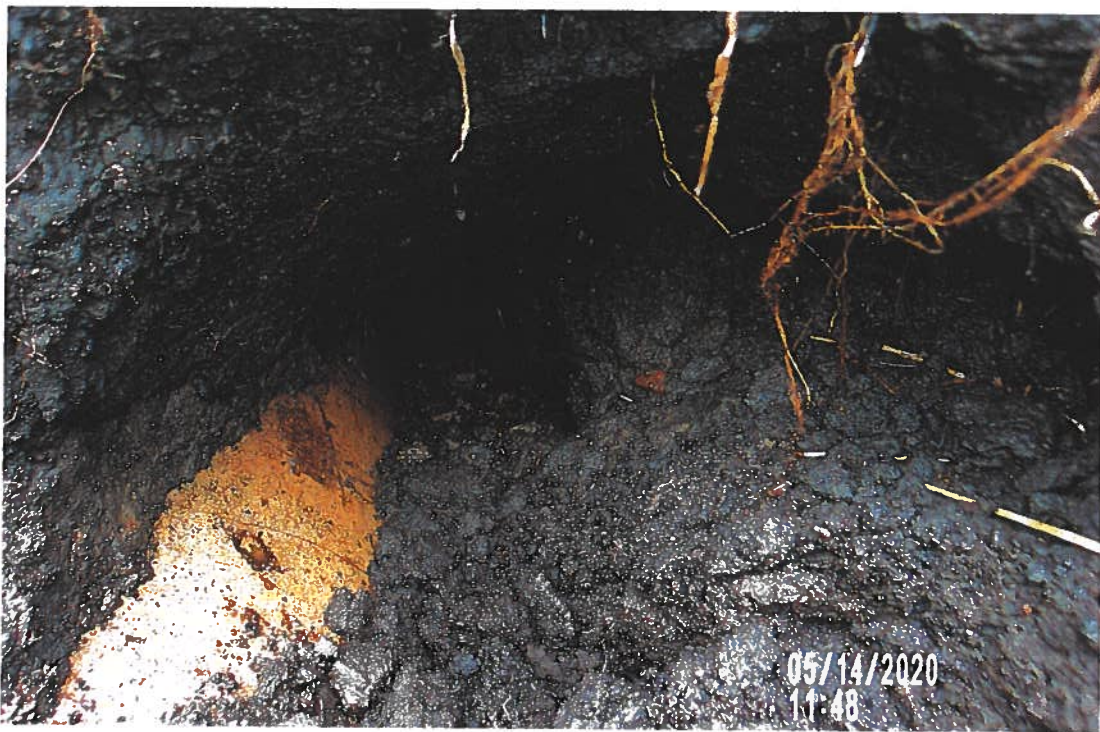
PICTURE # 3543 IS LOOKING NE ON EAST SIDE OF TILE AT 5.0' LONG SOIL ERODED CAVITY IN BLOWOUT 2S FROM GPS # 119

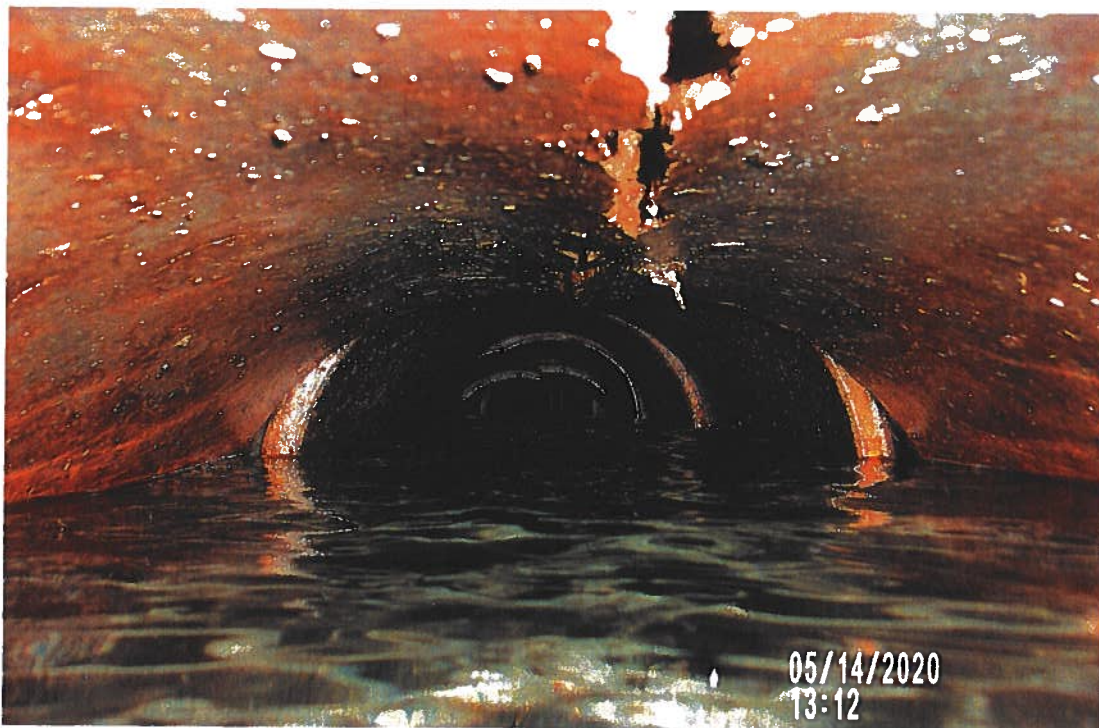
PICTURE # 3551 IS LOOKING NW SHOWING 1ST SECTION OF TILE WITH  
SEVERE LONGITUDINAL CRACK AND CAVING DOWN. UPSTREAM FROM  
GPS# 138 WITH SEVERAL OTHER TILE CRACKED AND CAVING DOWN  
SEVERAL FEET INTO THE GROUND.

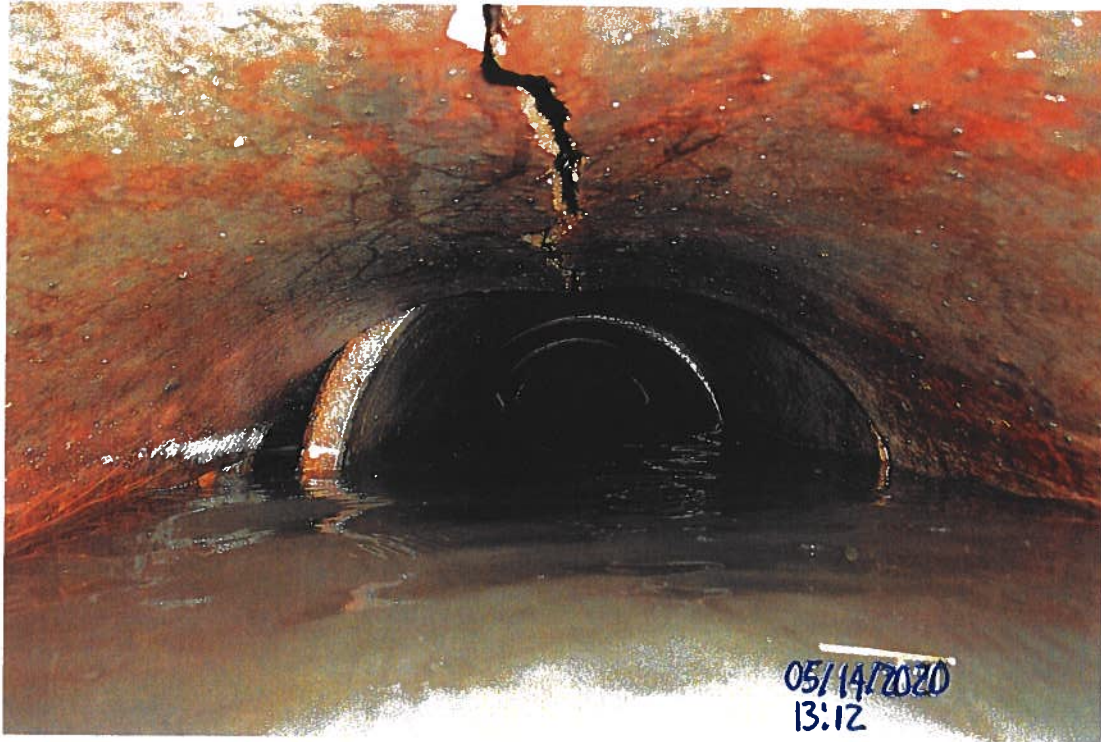
PICTURE # 3552 IS LOOKING SE SHOWING 1ST SECTION OF CLAY TILE  
WITH LONGITUDINAL CRACKS AND CAVING DOWN DOWNSTREAM FROM CPS#  
139 WITH REST OF SECTIONS OF TILE NOT LOOKING TOO BAD

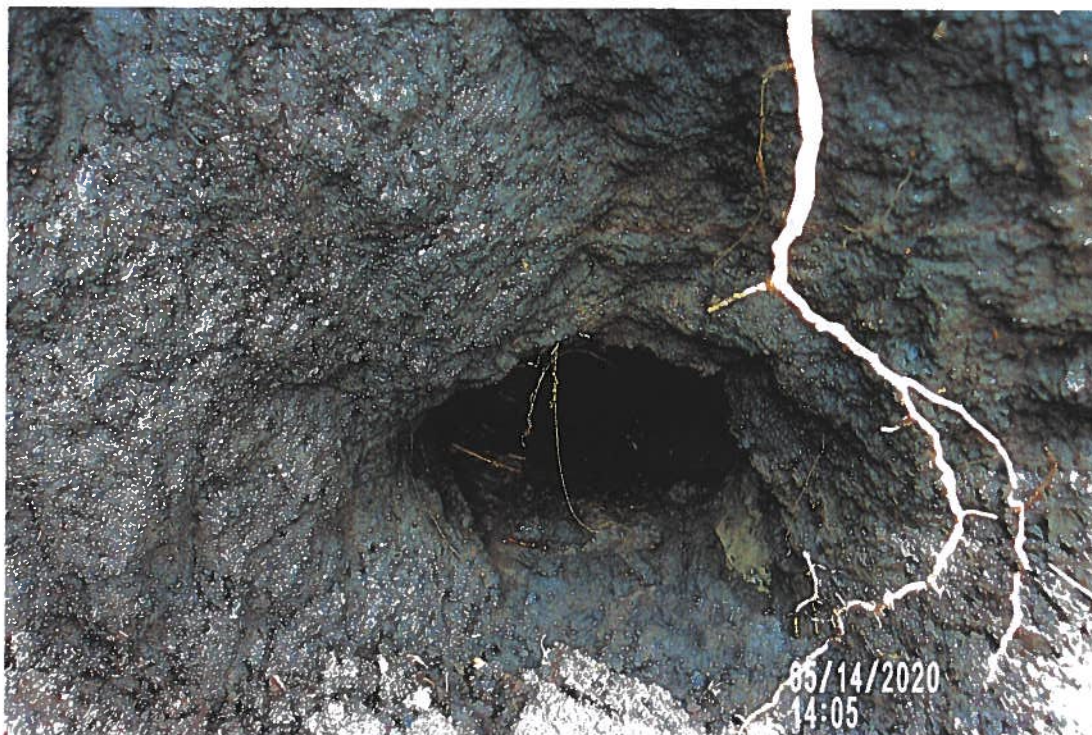
PICTURE# 3557 IS LOOKING NW SHOWING 4.0' LONG ERODED SOIL CAVITY  
ON WEST SIDE OF TILE IN IN TILE BLOWOUT #IN FROM  
GPS# 147

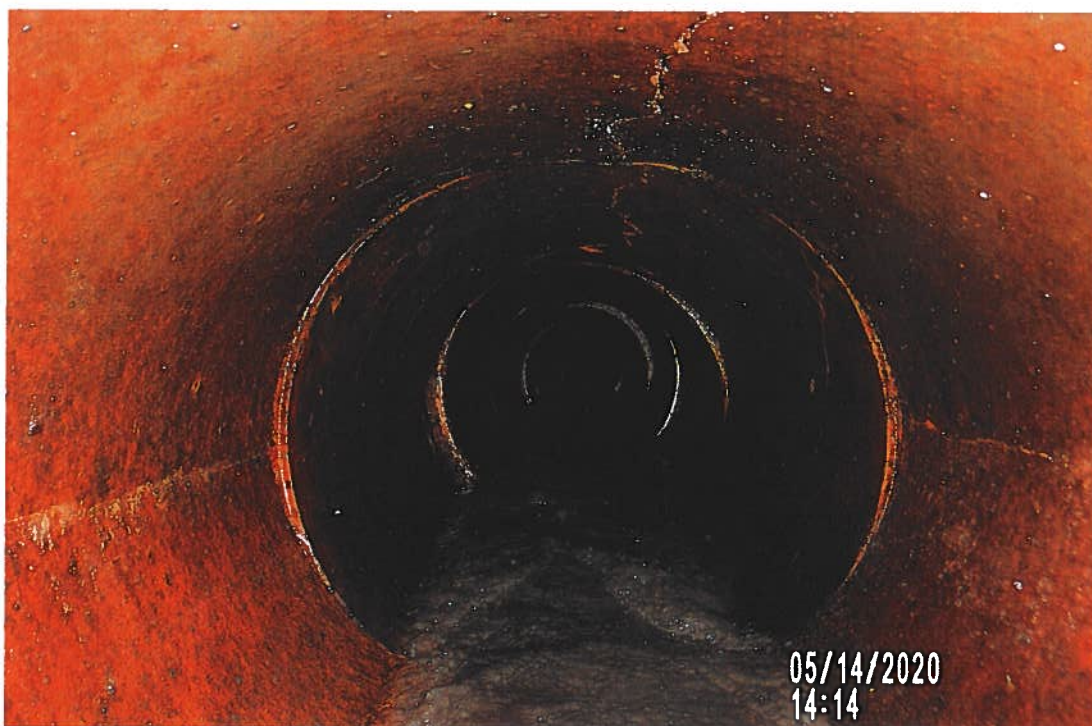
PICTURE# 3558 IS LOOKING SE INSIDE CLAY TILE IN TILE BLOWOUT  
#IN FROM GPS# 146 SHOWING TILE CRACKED BUT NOT LEAVING DOWN,

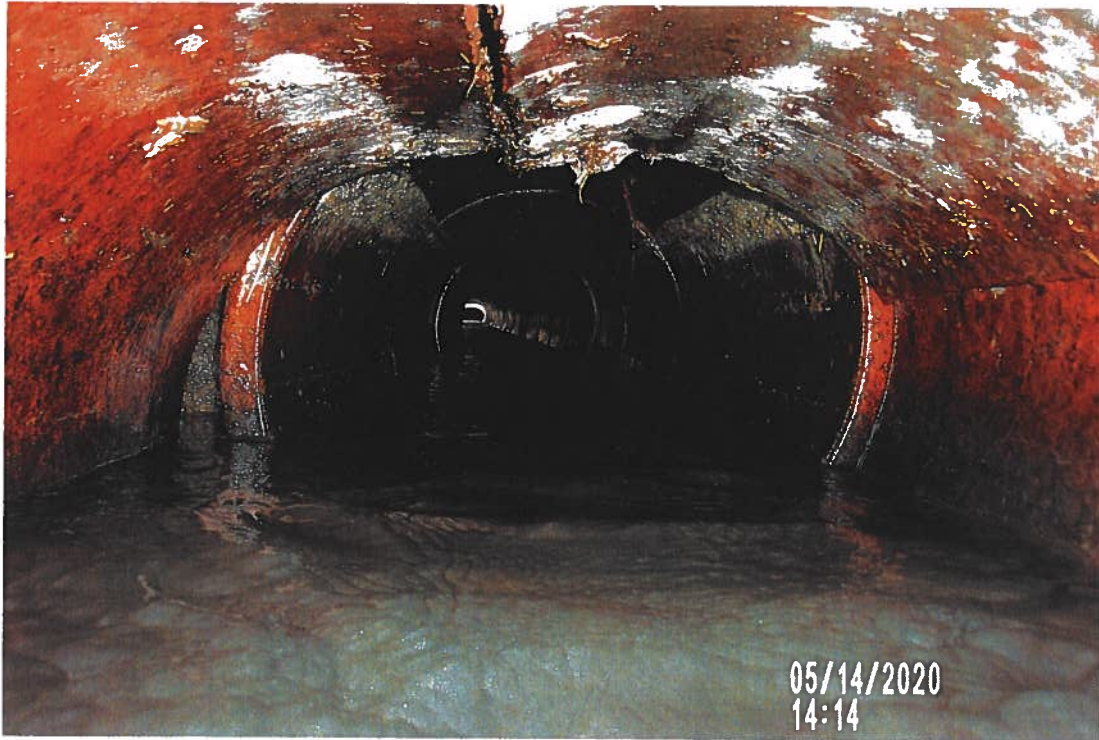
PICTURE #3559 IS LOOKING NW INSIDE CLAY TILE FROM GPS#  
147 IN TILE BLOWOUT # 1N SHOWING TOP CRACKED AND CAVING  
DOWN

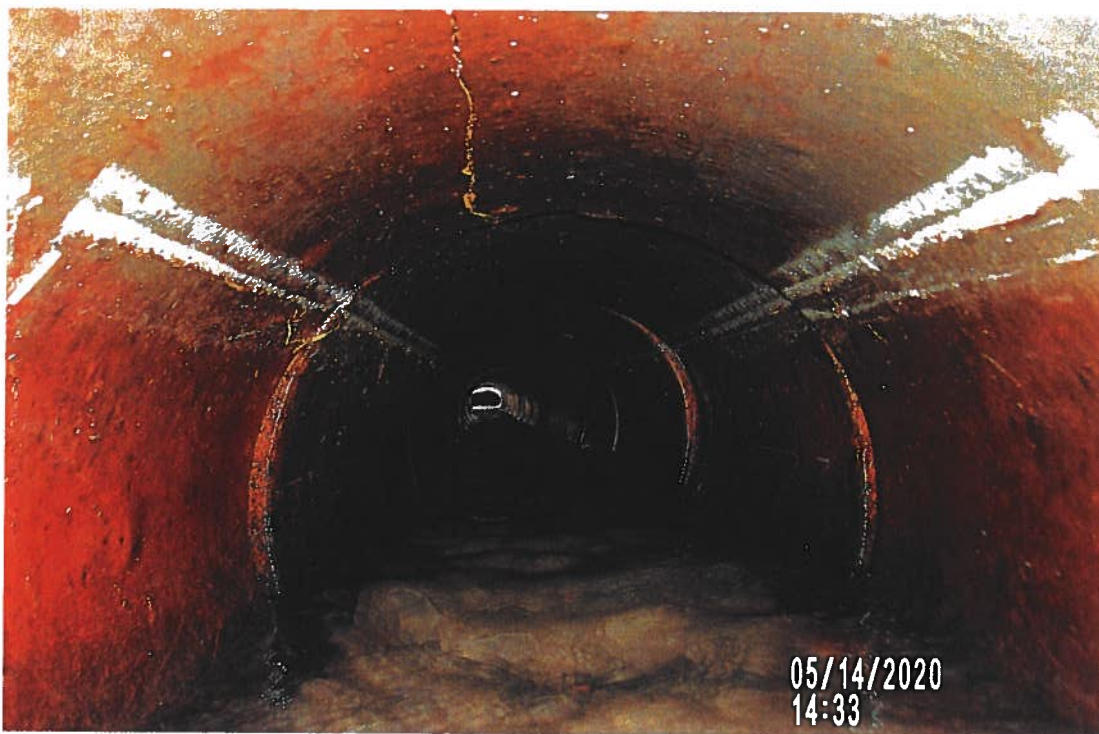
PICTURE # 3560 IS LOOKING NW INSIDE CLAY TILE FROM GPS # 152  
IN TILE BLOWOUT # 1N SHOWING TILE CRACKED BUT NOT CAVING  
DOWN.

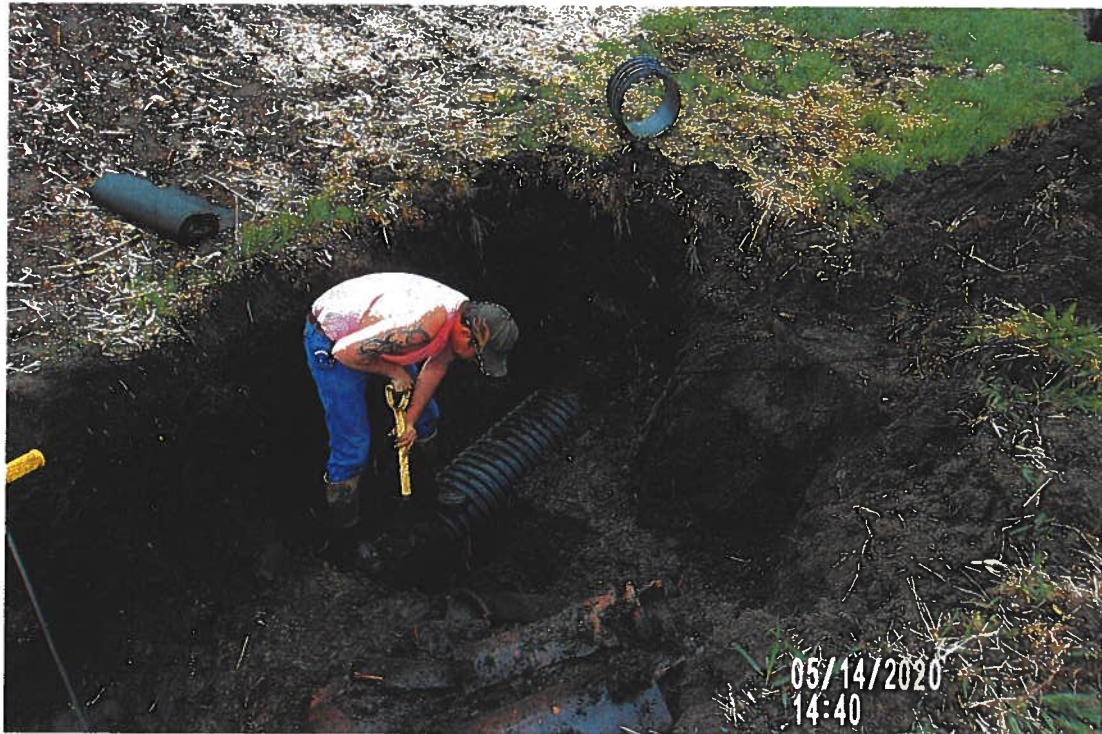
PICTURE # 3561 IS LOOKING NW SHOWING TEMPORARY REPAIR OF  
6.3 LF OF 15" Ø DUAL WALL NON PERF HDPE TILE INSTALLED  
IN TILE BLOWOUT #1N WITH BOTH JOINTS WRAPPED WITH FABRIC.

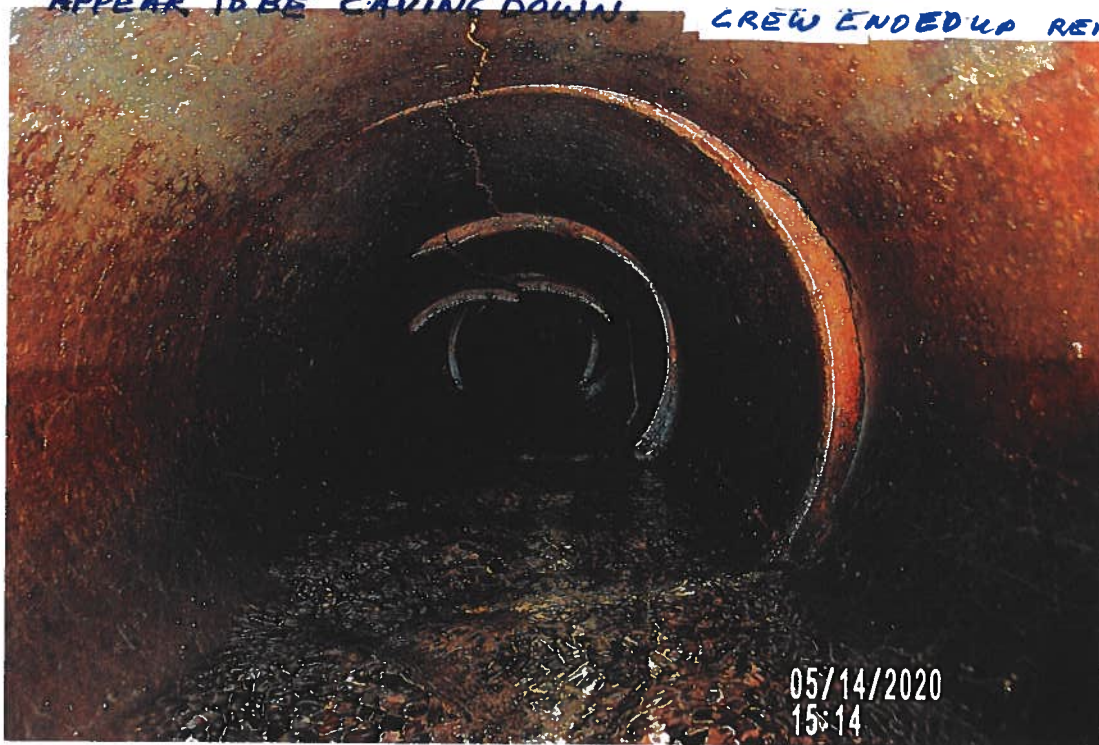
PICTURE # 3562 IS LOOKING SE INSIDE CLAY TILE FROM GPS# 175  
IN TILE BLOWOUT #2N SHOWING TILE WITH FINE CRACKS BUT  
NOT CAVING DOWN

IN TILE BLOWOUT # 2N SHOWING TILE WITH FINE CRACKS BUT NOT CAVING DOWN IN 1ST TWO SECTIONS BUT NEXT TWO SECTIONS APPEAR TO BE CAVING DOWN. CREW ENDED UP REMOVING

2 SECTIONS  
OF CLAY  
TILE ON  
NORTH END  
DUE TO NEXT  
SECTION  
COLLAPSING  
DURING  
REMOVAL  
N ↑

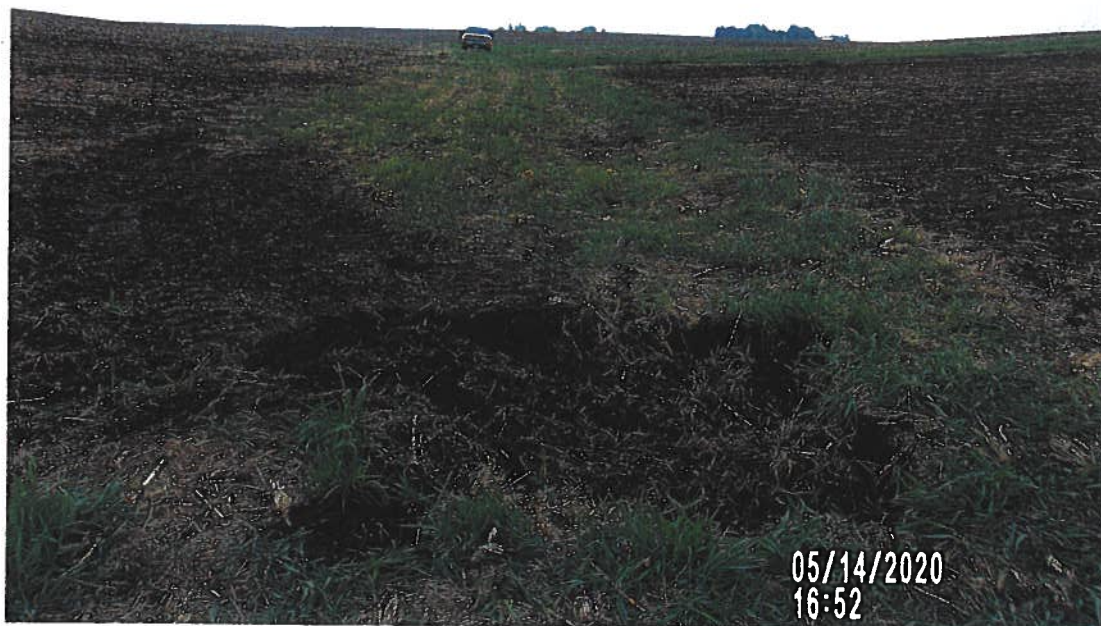
PICTURE # 3571 IS LOOKING NORTH SHOWING BLOWOUT 2S  
BACK FILLED AND DRESSED UP BUT NEEDS SEED  
YET.

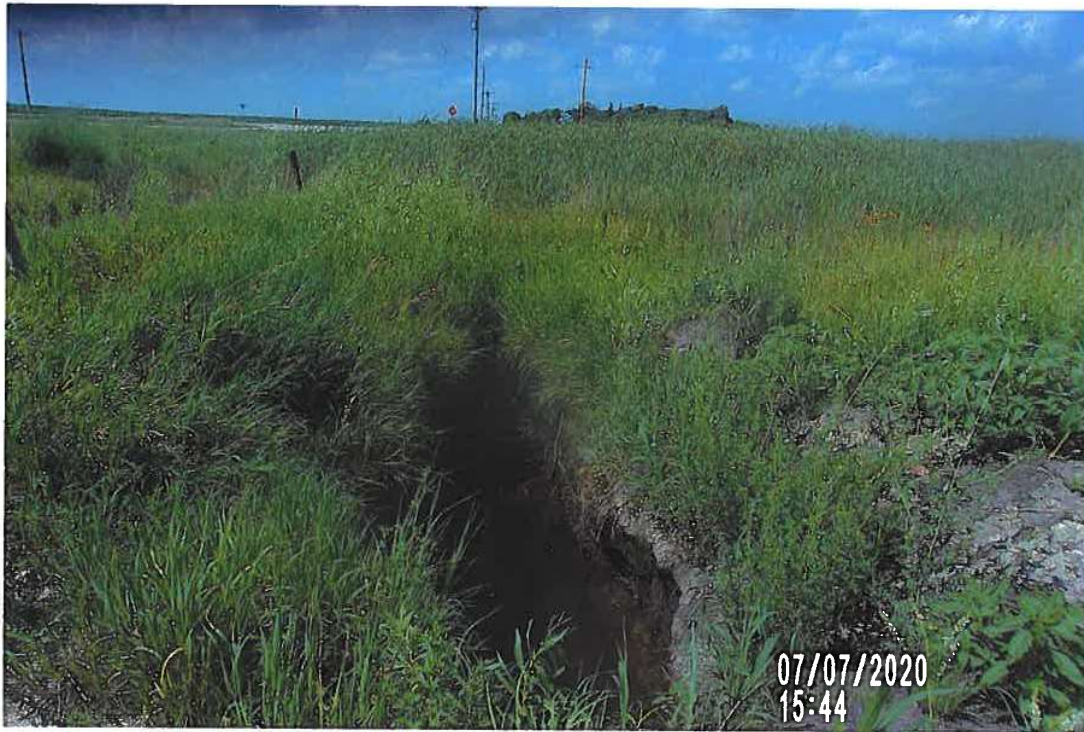
PICTURE # 4048 IS LOOKING NORTH ALONG EASTROW FENCE  
322'± SOUTH OF CO HWY D-41 SHOWING WATER SITING IN HOLE

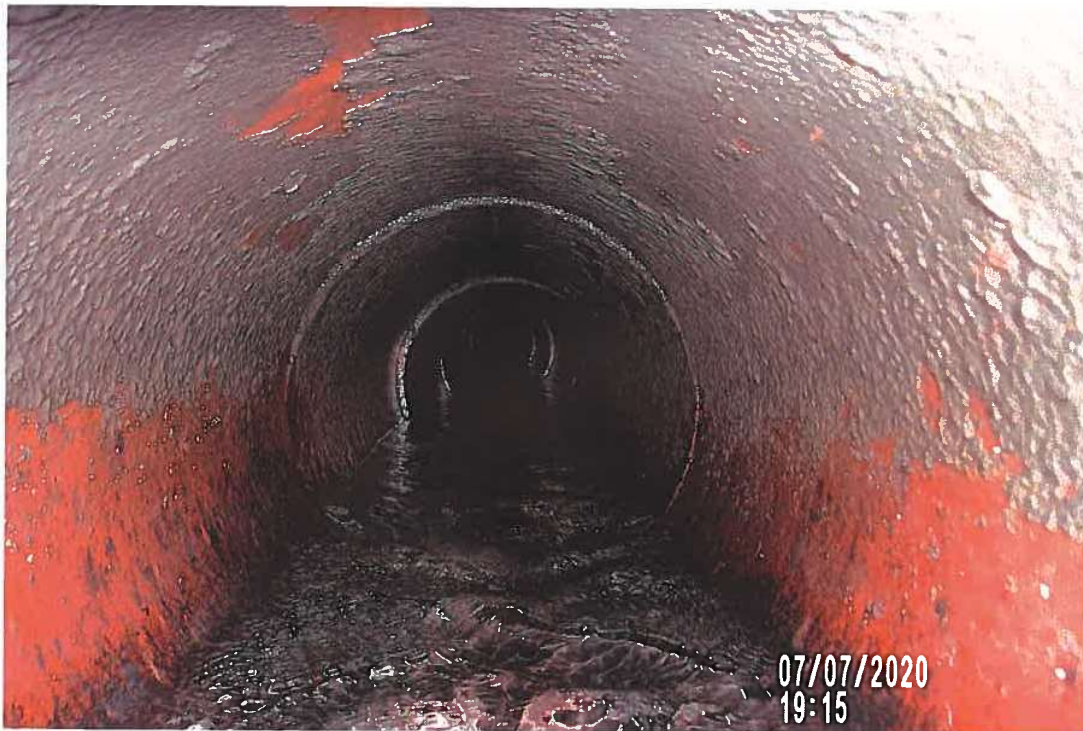
PICTURE # 4049 IS LOOKING NW UPSTREAM INSIDE 14" CLAY  
TILE (GPS# 248 1.28' TO TOP FL). TILE IS IN GOOD SHAPE  
WITH 3" FLOW (5.1" DEEP)

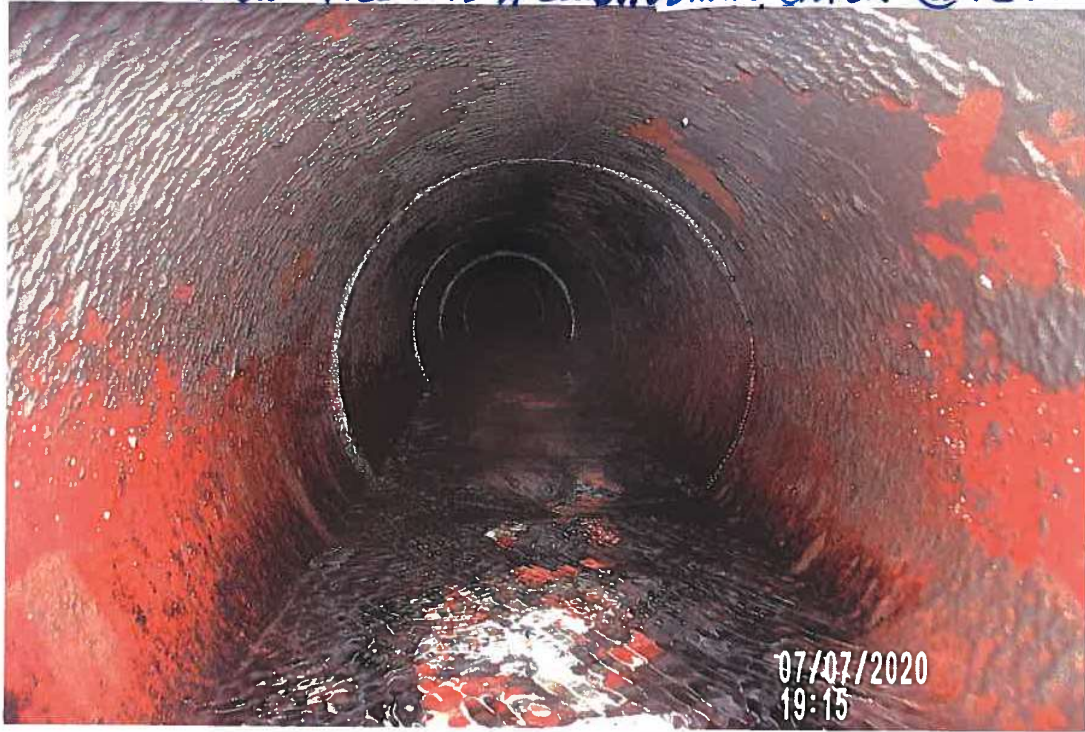
PICTURE # 4050 IS LOOKING NW, DOWN STREAM INSIDE 14" CLAY  
(5.1' ± DEEP)  
TILE (GPS# 247 1.24' TO TOP FL) TILE IN GOOD SHAPE  
WITH 3" FLOW TILE HAS A LONGITUDINAL CRACK @ 12 O'CLOCK BUT

NOT  
CAVING  
DOWN

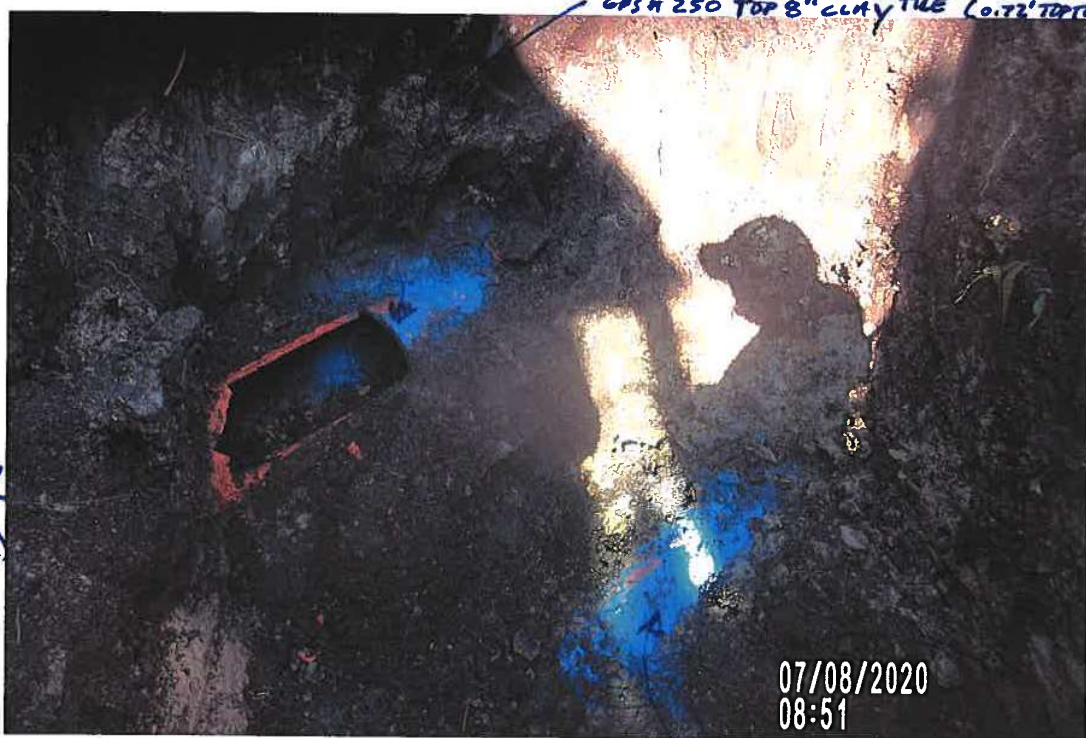
PICTURE# 4051 IS LOOKING SW SHOWING 8" CLAY TILE THAT WAS DAMAGED WHILE EXCAVATING TO EXPOSE 14" CLAY @ LOCATION WHERE WATERMAIN GOES UNDER TILE

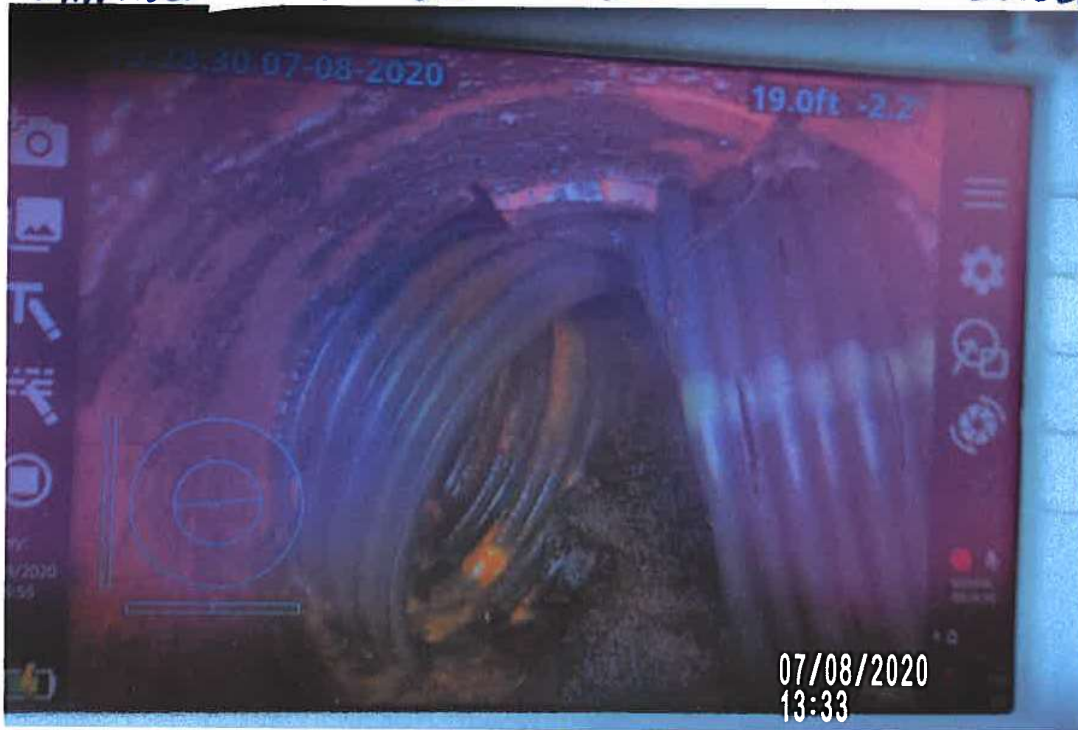
PICTURE # 4060 IS LOOKING UPSTREAM INSIDE 8" CLAY TILE @ 21.3' UPSTREAM FROM BEEHIVE INTAKE SHOWING 5" PERF SW HOPE TILE FROM EAST & FROM WEST CONNECTING AT SAME LOCATION WITH SIDES CRACKED AND TOP CAVING DOWN WITH TILE PLUGGED UPSTREAM WITH SOIL & ROOTS

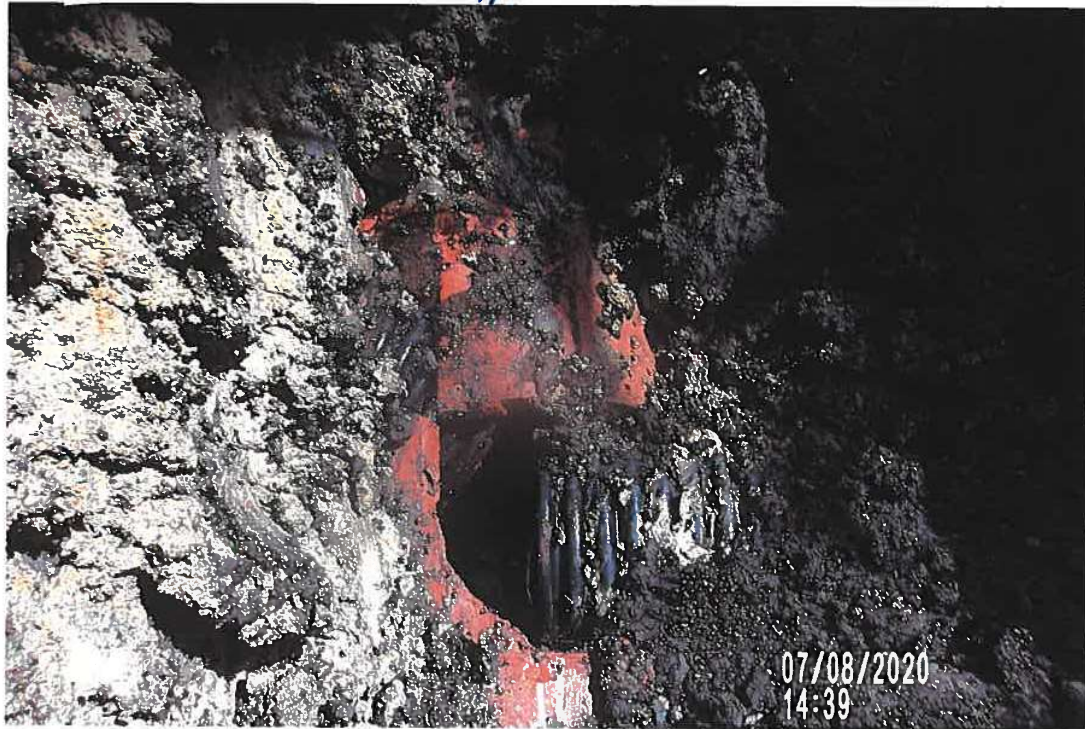
PICTURE # 4061 IS LOOKING SW AT EXPOSED LOCATION WHERE 5" HOPE SW PERF TILE FROM EAST & FROM WEST TIE INTO 8" CLAY TILE LATERAL 2

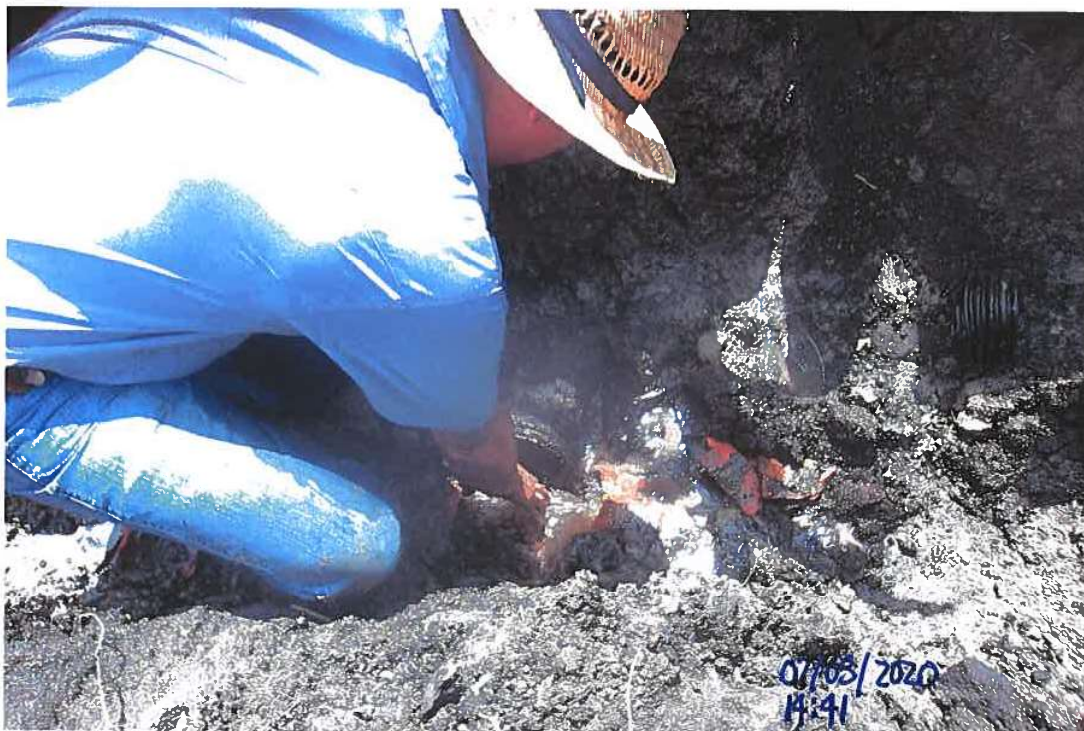
PICTURE # 4062 IS LOOKING SE AT TOP VIEW OF 5" HDPE  
SW PERF TILE FROM WEST & EAST TIEING INTO SAME LOCATION  
INTO BROKEN 8" CLAY TILE AND PLUGGED LINE

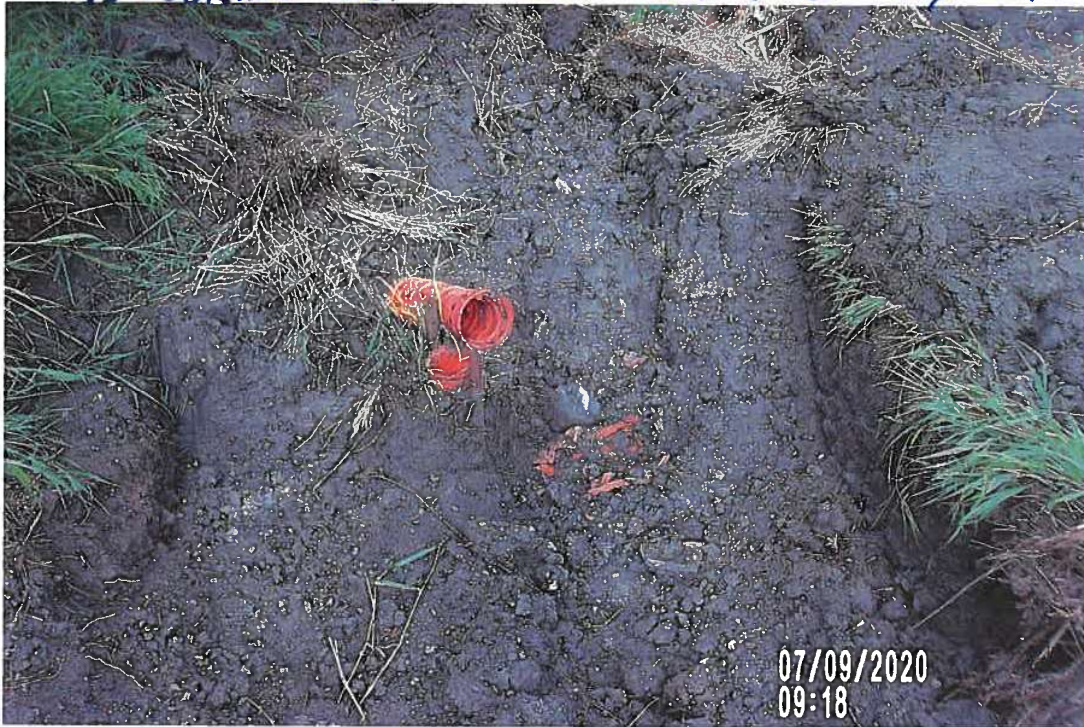
(GPS#269)  
 PICTURE# 4090 SHOWING 6" HICKEN BOTTOM WITH TOP COMPLETELY  
 BROKE OFF AND FL COMPLETELY FULL OF SOIL WITH 6" CLAY  
 TILE OUTLET BROKE AND COMPLETELY FULL OF SOIL. PICTURE  
 IS LOOKING WEST IN NORTH DITCH OF CO HWY 041

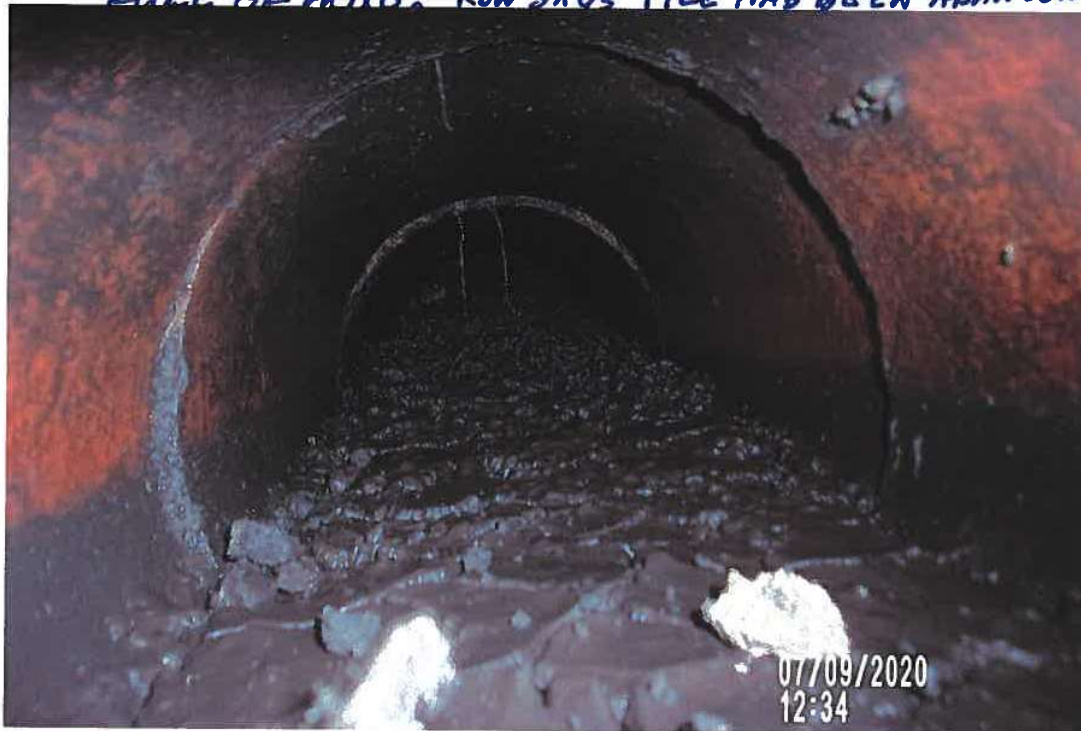
PICTURE #4098 IS LOOKING SE DOWNSTREAM FROM GPS #251  
 TOP 8" CLAY TILE (0.75' TOPTOFL) AFTER ANOTHER DAMAGED  
 40' SECTION OF TILE WAS REMOVED. 2" MUD IN FL TO COMPLETELY  
 FULL OF MUD. RON SAYS TILE HAS BEEN ABANDONED BUT

WILL CONNECT  
 TOGETHER  
 IN CASE  
 ANY TILE  
 UPSTREAM  
 IS CONNECTED  
 YES

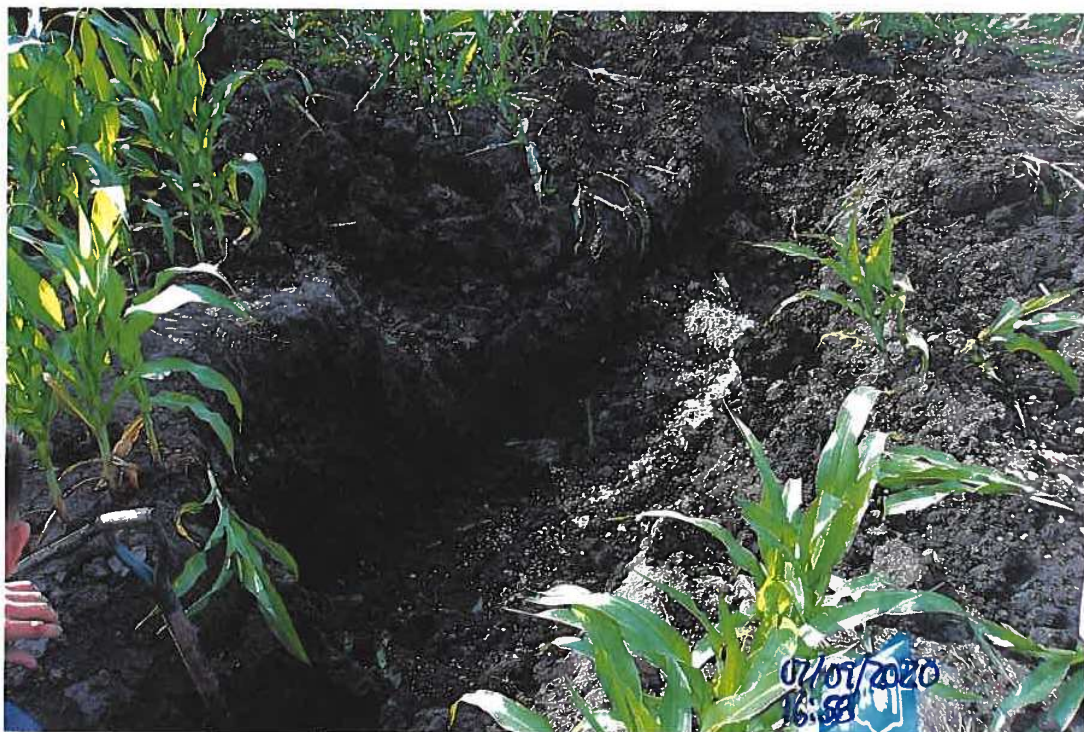
PICTURE #4122 IS LOOKING NW SHOWING 4" SW HOPE PERF TILE THAT NEEDS REPLACED AFTER CUTTING TILE WHILE EXCAVATING TO CHECK LAT #2 TILE FLOW STATUS ON EAST SIDE OF CO HWY S-27.

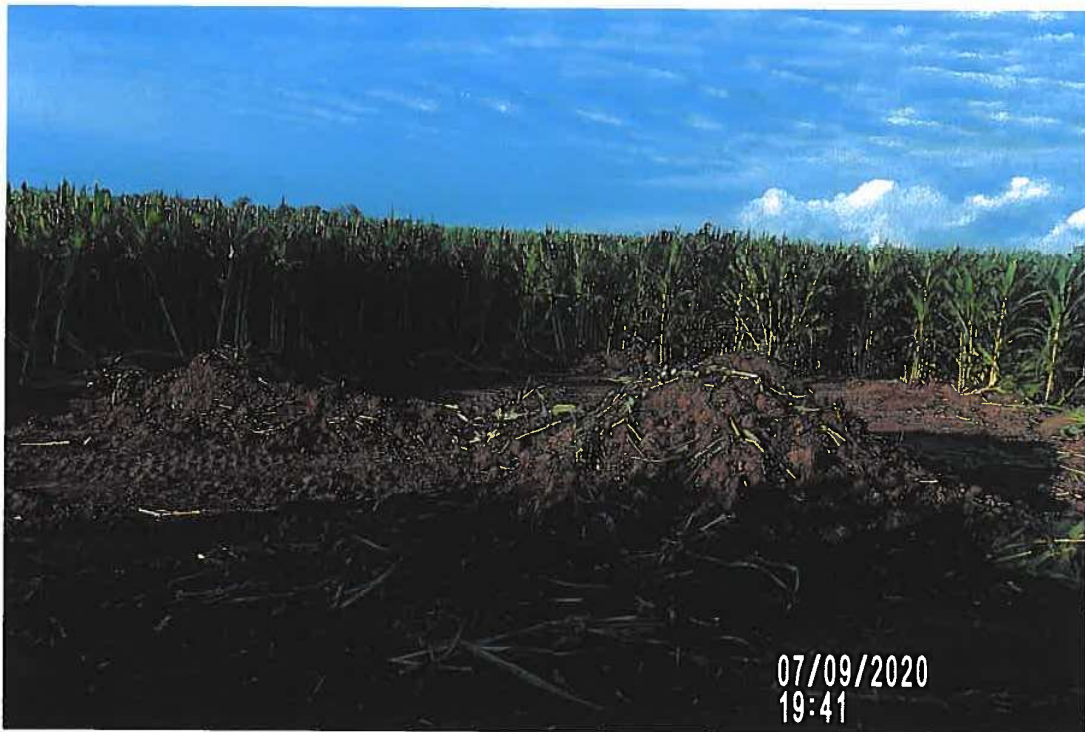
PICTURE# 4130 IS LOOKING EAST SHOWING PILE OF  
EXTRA SOIL THAT WAS USED TO BACKFILL (14" CLAY TILE NORTH OF  
TILE TRENCH. CORN STALKS WERE MIXED WITH SOIL CREATING CO HWY D41)  
VOIDS AND EXTRA SOIL AREA WILL SETTLE DUE TO THIS.

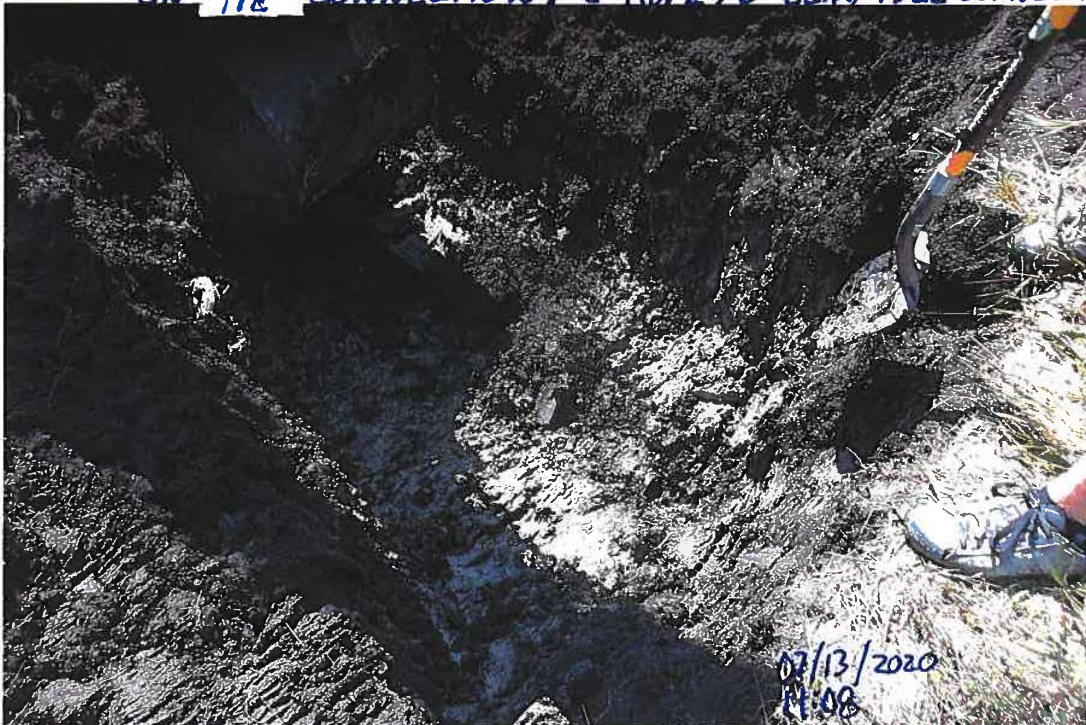
PICTURE# 4142 IS LOOKING SE SHOWING 6" HDPE PERF  
TILE CONNECTION TO 6" CLAY TILE EAST OF BEEHIVE  
INTAKE. PICTURE SHOWS CREW EXCAVATING TO CHECK  
ON TILE CONNECTION. 6" HDPE / 6" CLAY TILE CONNECTION CLAY  
TILE  
BROKE  
& WILL  
NEED  
REPLACED.

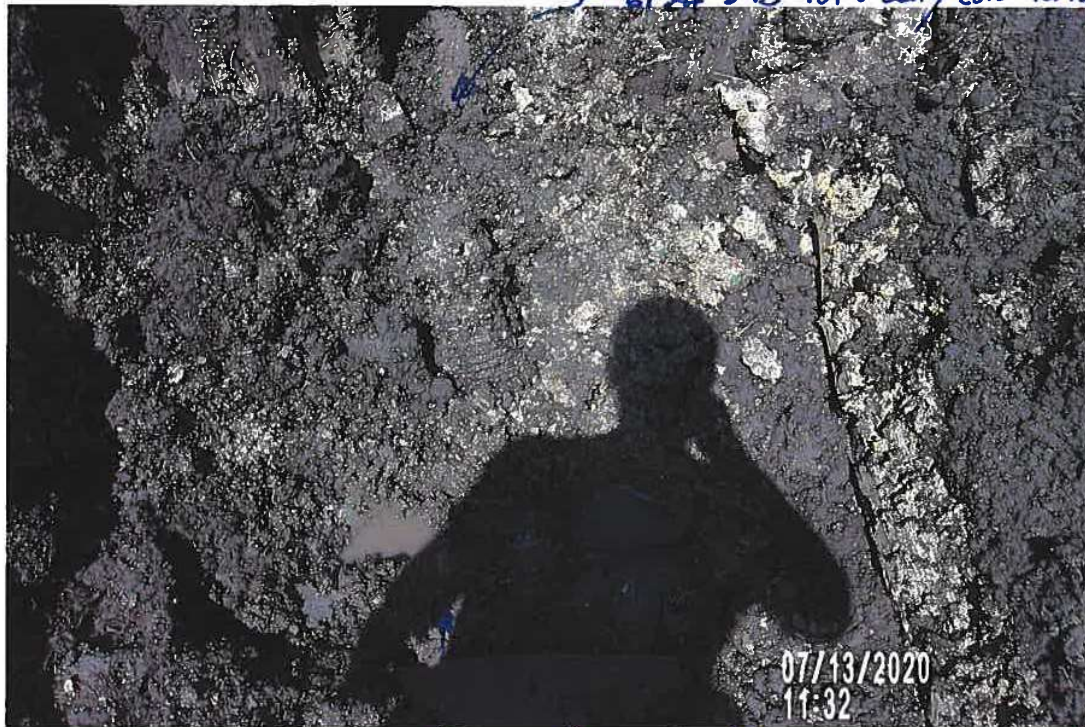
PICTURE # 4144 IS LOOKING WEST SHOWING 6"x6"x6" HOPE TEE CONNECTION & 6" HOPE PERFTILE / 6" CLAY TILE WITH ISSUE BETWEEN PLASTIC & CLAY TILE
