AGENDA
REGULAR DRAINAGE MEETING
Wednesday, December 30, 2020 9:30 AM
Large Conference Room

Drainage Work Order Request For Repair Hardin County

Investigation and Repair Summary:

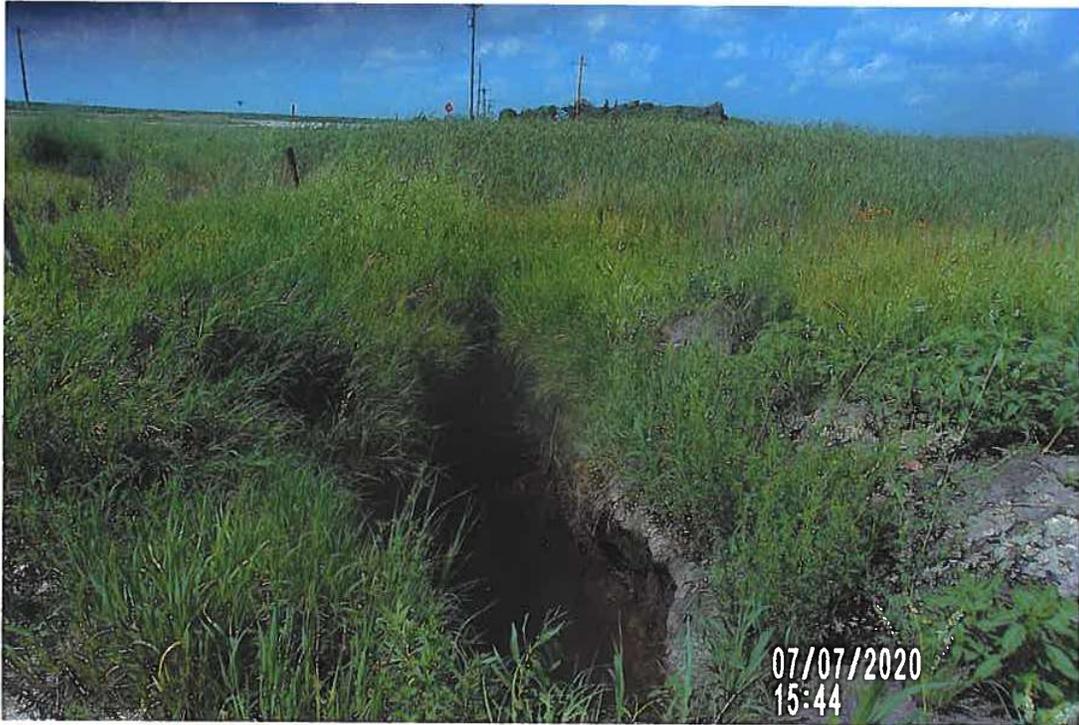
PICTURE # 4048 IS LOOKING NORTH ALONG EAST ROW FENCE
322'± SOUTH OF CO HWY D-41 SHOWING WATER SITING IN HOLE

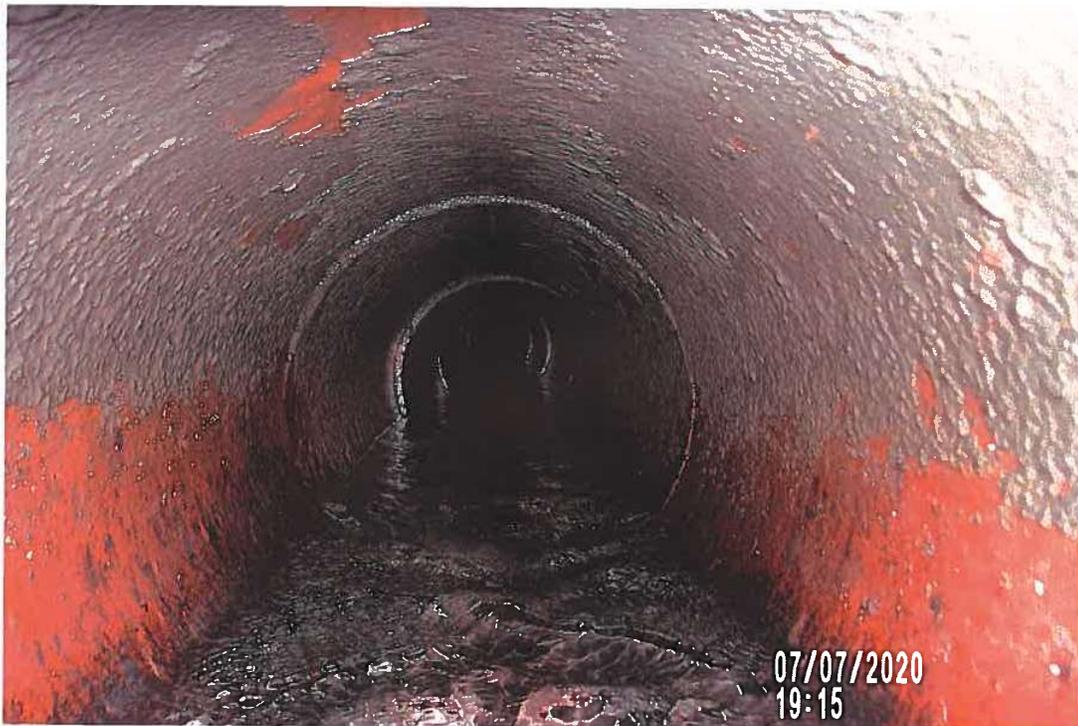
PICTURE # 4049 IS LOOKING NW UPSTREAM INSIDE 14" CLAY
TILE (GPS# 248 1.28' TOPTOFL). TILE IS IN GOOD SHAPE
WITH 3" FLOW (5.1" DEEP)

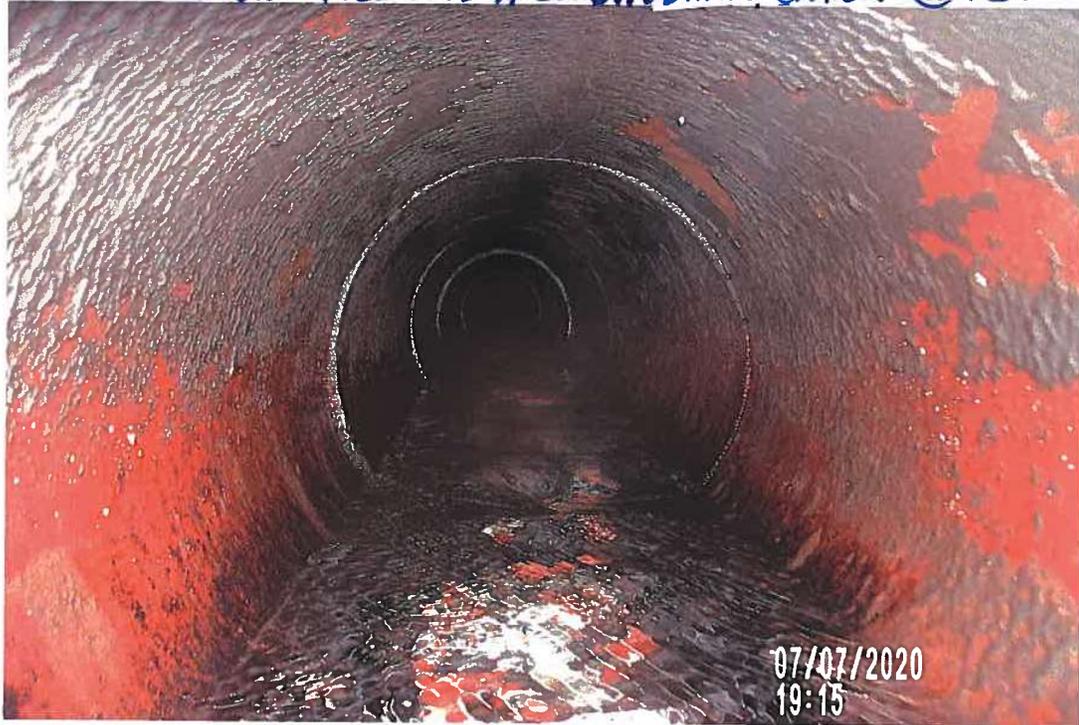
PICTURE # 4050 IS LOOKING NW. DOWN STREAM INSIDE 14" CLAY
(5.1'±DEEP)
TILE (GPS# 247 1.24' TO TOP FL) TILE IN GOOD SHAPE
WITH 3" FLOW TILE HAS A LONGITUDINAL CRACK @ 12 O'CLOCK BUT

NOT
CAVING
DOWN

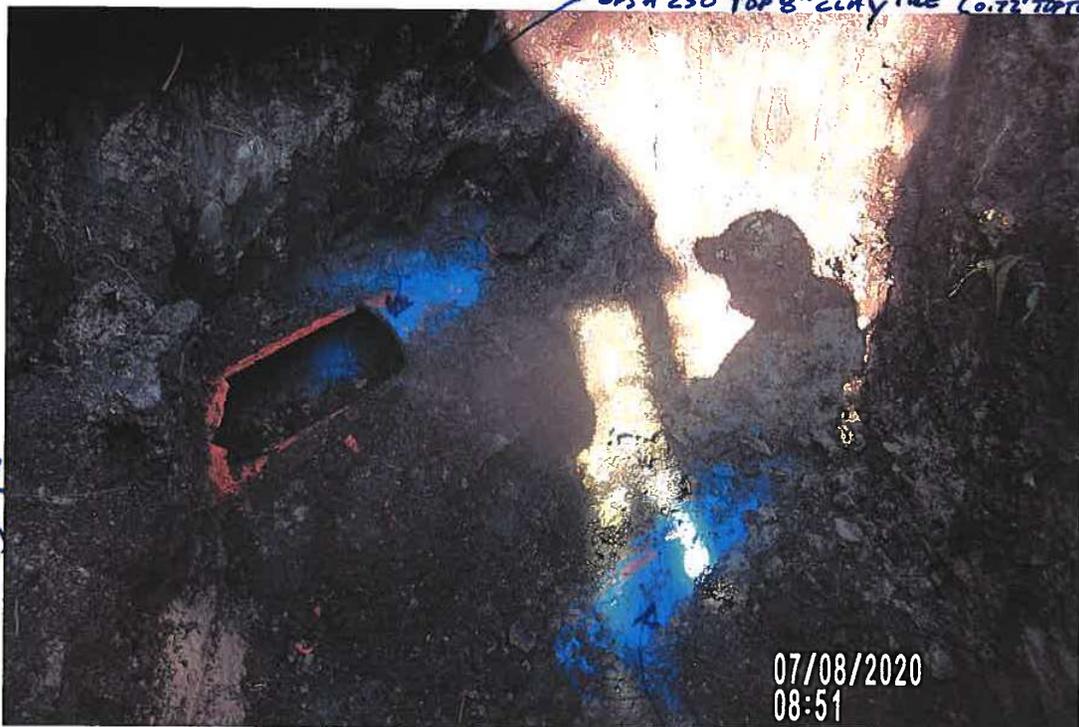
PICTURE# 4051 IS LOOKING SW SHOWING 8" CLAY TILE THAT WAS DAMAGED WHILE EXCAVATING TO EXPOSE 14" CLAY @ LOCATION WHERE WATERMAIN GOES UNDER TILE

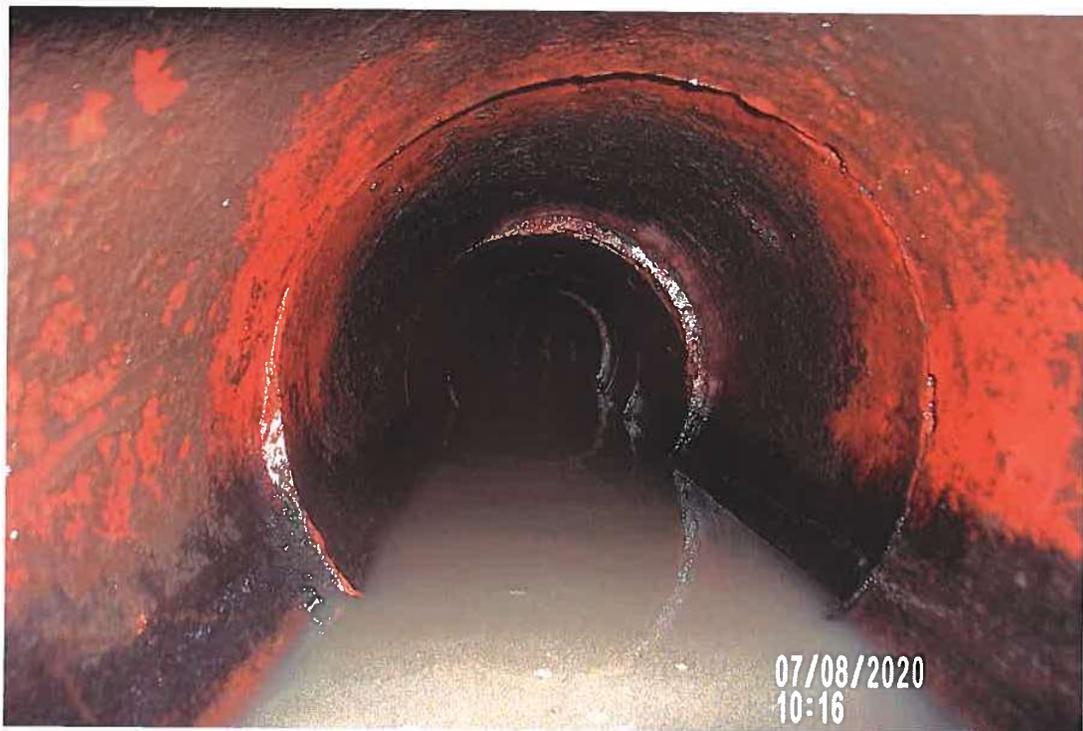
PICTURE #4055 IS LOOKING ^{NW} DOWNSTREAM INSIDE 8" CLAY TILE
FROM GPS # 255' SHOWING TILE IN GOOD CONDITION WITH $\frac{3}{4}$ " OF
WATER AND NOT MUCH FLOW. TILE IS 3.1' \pm DEEP.

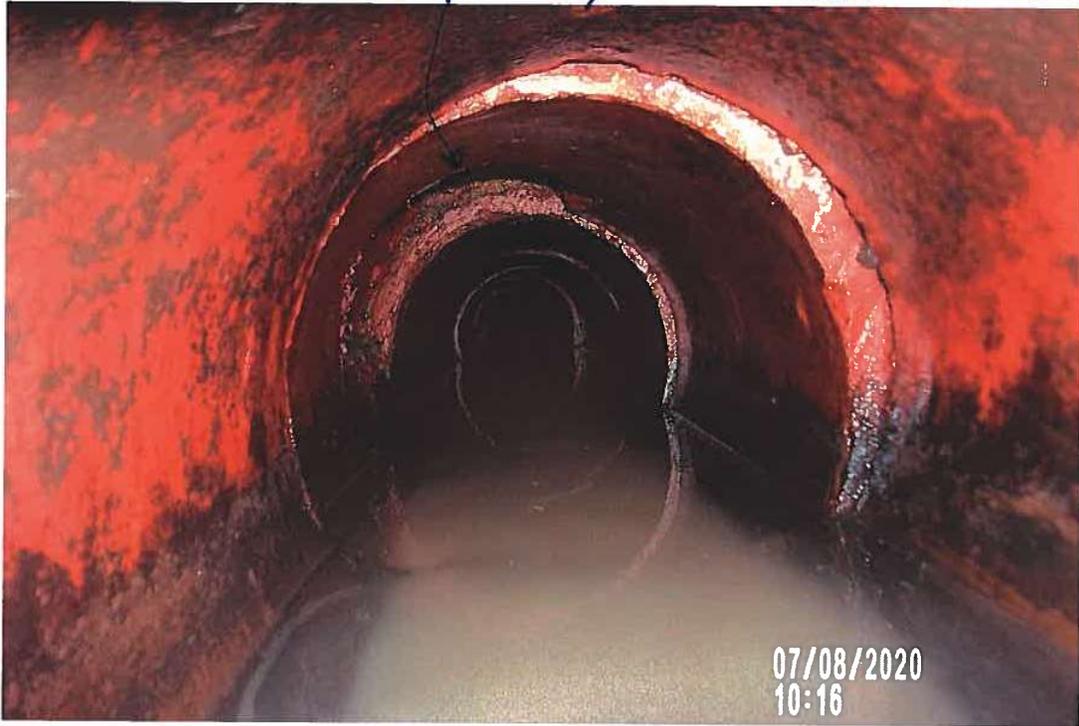
PICTURE# 4056 IS LOOKING SE UPSTREAM INSIDE 8" CLAY TILE
SHOWING TILE IN GOOD CONDITION WITH 3/4" WATER IN FL &
NOT MUCH FLOW. TILE IS 3.11' ± DEEP.
↑ 6" CLAY TILE INLET FROM BEEHIVE INTAKE.

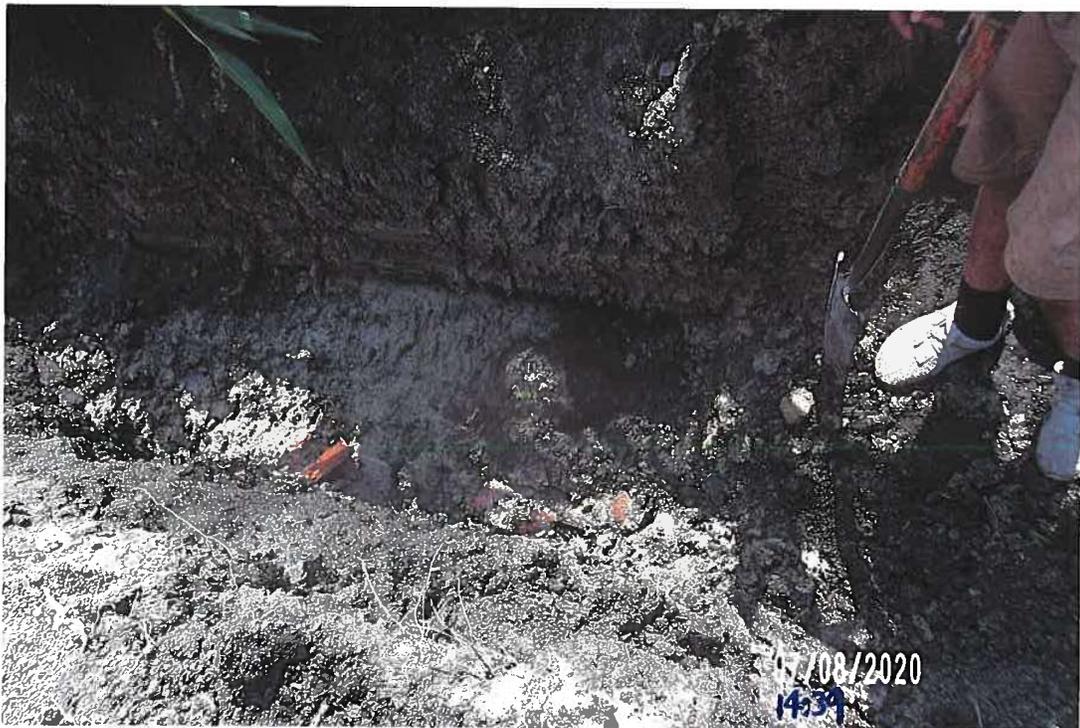
PICTURE # 4060 IS LOOKING UPSTREAM INSIDE 8" CLAY TILE @ 2 1/3' UPSTREAM FROM BEEHIVE INTAKE SHOWING 5" PERF SW HOPE TILE FROM EAST & FROM WEST CONNECTING AT SAME LOCATION WITH SIDES CRACKED AND TOP CAVING DOWN WITH TILE PLUGGED UPSTREAM WITH SOIL & ROOTS

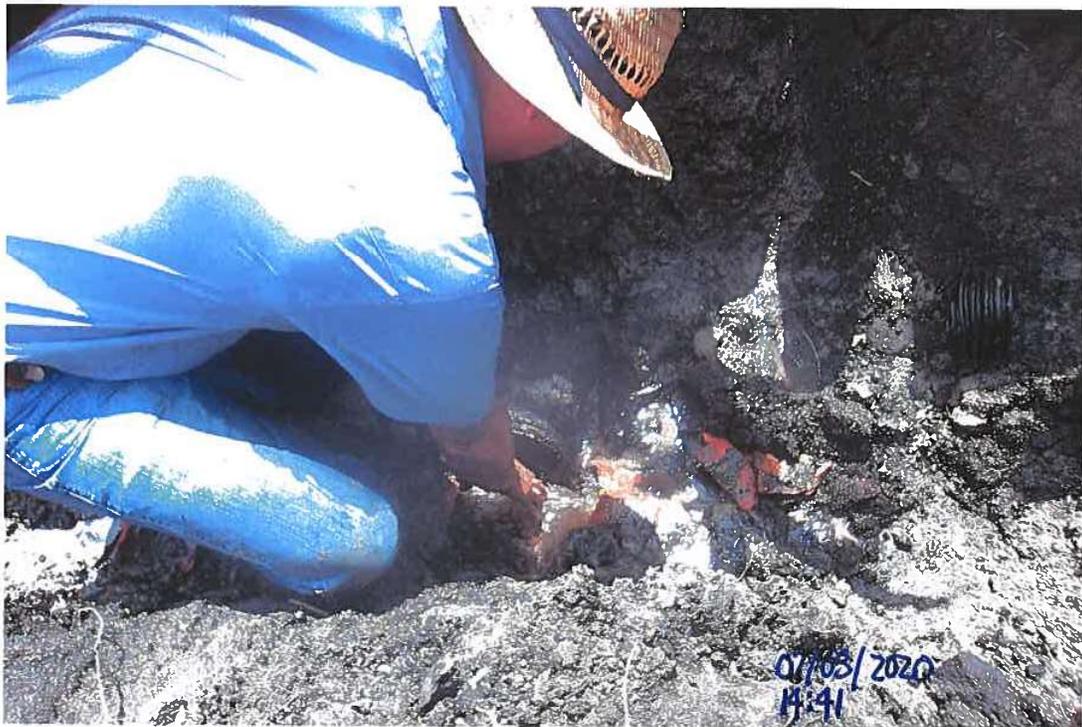
PICTURE # 4062 IS LOOKING SE AT TOP VIEW OF 5" HDPE SW PERF TILE FROM WEST & EAST TIEING INTO SAME LOCATION INTO BROKEN 8" CLAY TILE AND PLUGGED LINE

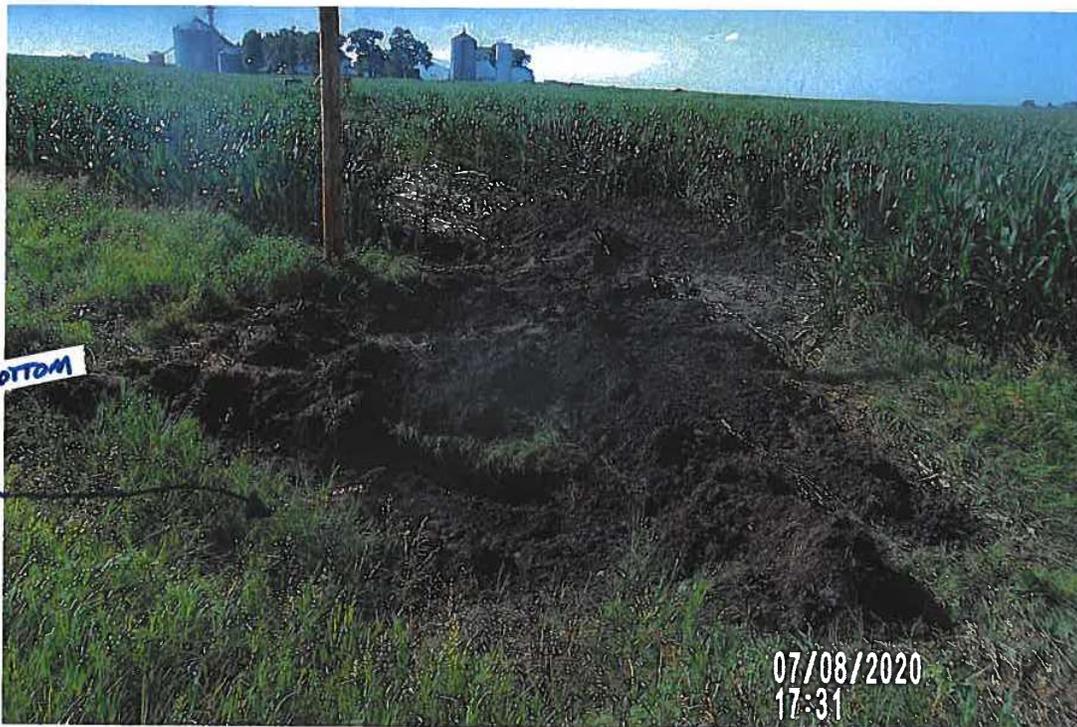
6" CHICKEN BOTTOM
R_L FULL OF
SOIL &
6" CLAY TILE
OUTLET
BROKEN
& FULL
OF SOIL

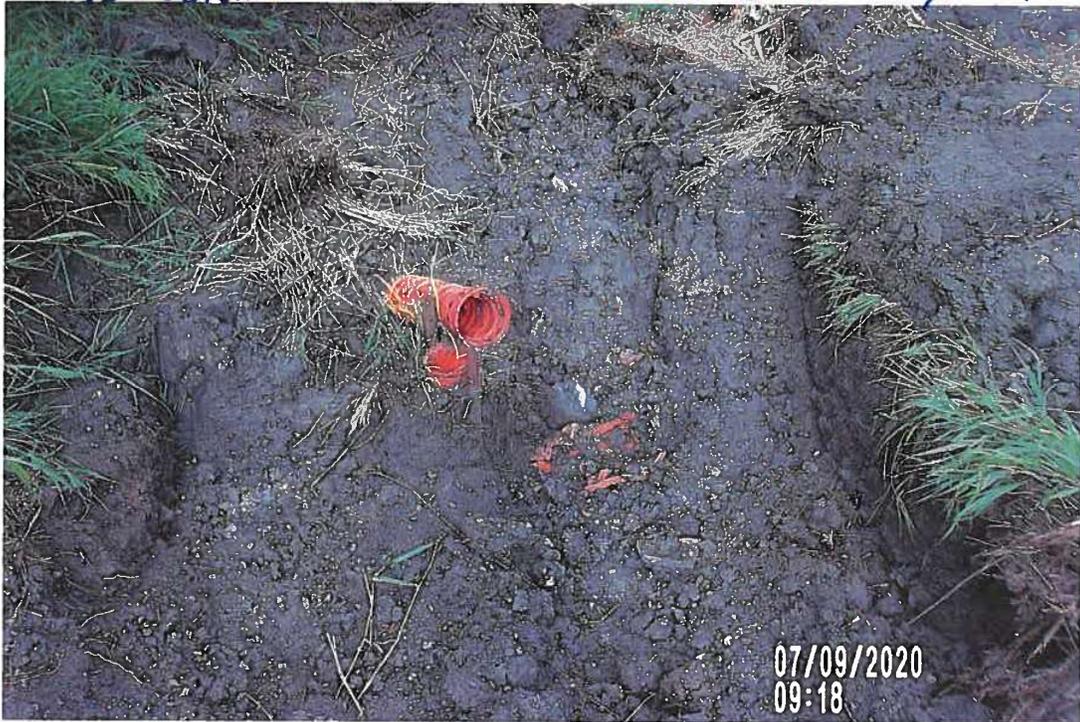
(GPS#269)
PICTURE# 4090 SHOWING 6" HICKEN BOTTOM WITH TOP COMPLETELY
BROKE OFF AND FL COMPLETELY FULL OF SOIL WITH 6" CLAY
TILE OUTLET BROKE AND COMPLETELY FULL OF SOIL. PICTURE
IS LOOKING WEST IN NORTH DITCH OF CO HWY 041

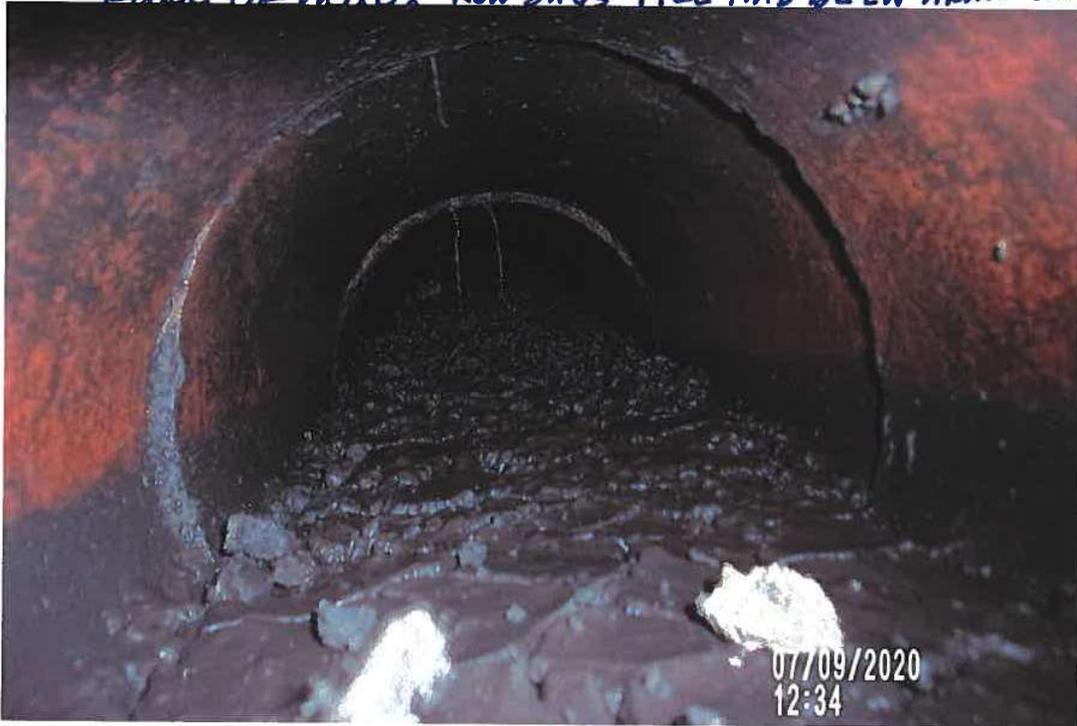
PICTURE #4098 IS LOOKING SE DOWNSTREAM FROM GPS #251
 TOP 8" CLAY TILE (0.75' TOP TO FL) AFTER ANOTHER DAMAGED
 4.0' SECTION OF TILE WAS REMOVED. 2" MUD IN FL TO COMPLETELY
 FULL OF MUD. RON SAYS TILE HAS BEEN ABANDONED BUT

WILL CONNECT
 TOGETHER
 IN CASE
 ANY TILE
 UPSTREAM
 IS CONNECTED
 YES
 N
 ↓

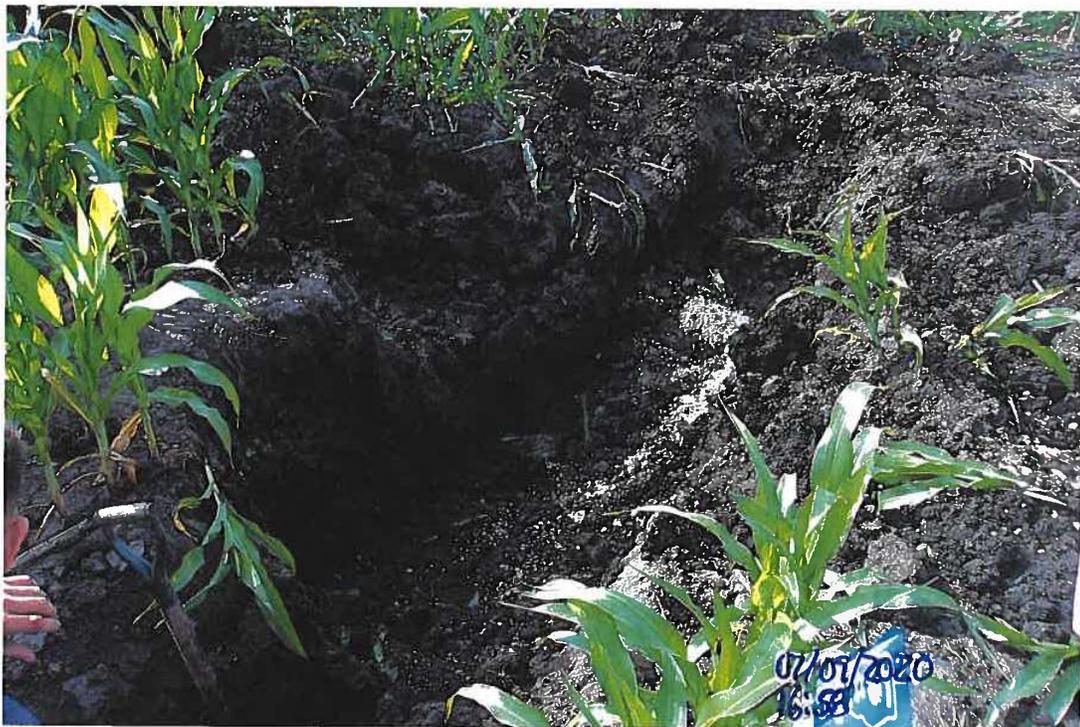
PICTURE #4122 IS LOOKING NW SHOWING 4" SW HOPE PERF TILE THAT NEEDS REPLACED AFTER CUTTING TILE WHILE EXCAVATING TO CHECK LAT #2 TILE FLOW STATUS ON EAST SIDE OF CO HWY S-27.

PICTURE # 4123 IS LOOKING NORTH SHOWING 9.8 LF OF 4" HDPE SW PERF TILE INSTALLED WITH 4" HDPE INTERNAL COUPLERS AND OFF TO SIDE SOME FOR FIRMER GROUND & BEDDED WITH ROCK UNDER. GPS # 312 TOP EXISTING 4" HDPE PERF TILE

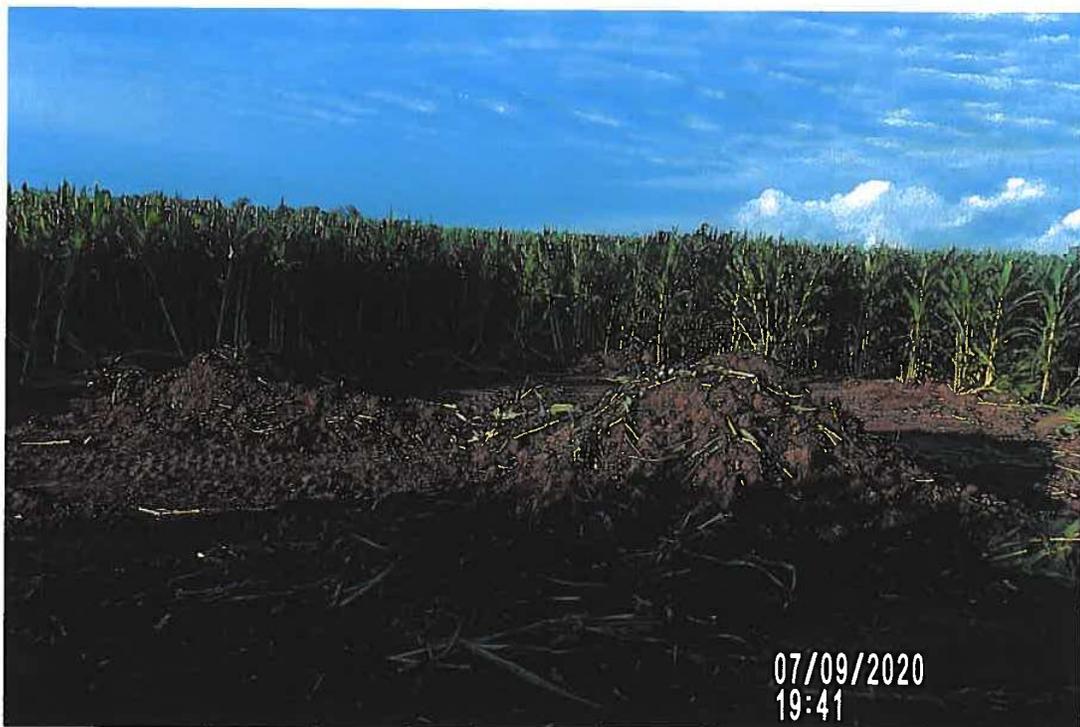
PICTURE # 4130 IS LOOKING EAST SHOWING PILE OF
EXTRA SOIL THAT WAS USED TO BACKFILL (14" CLAY TILE NORTH OF
TILE TRENCH. CORN STALKS WERE MIXED WITH SOIL CREATING
CO HWY D41)
VOIDS AND EXTRA SOIL AREA WILL SETTLE DUE TO THIS.

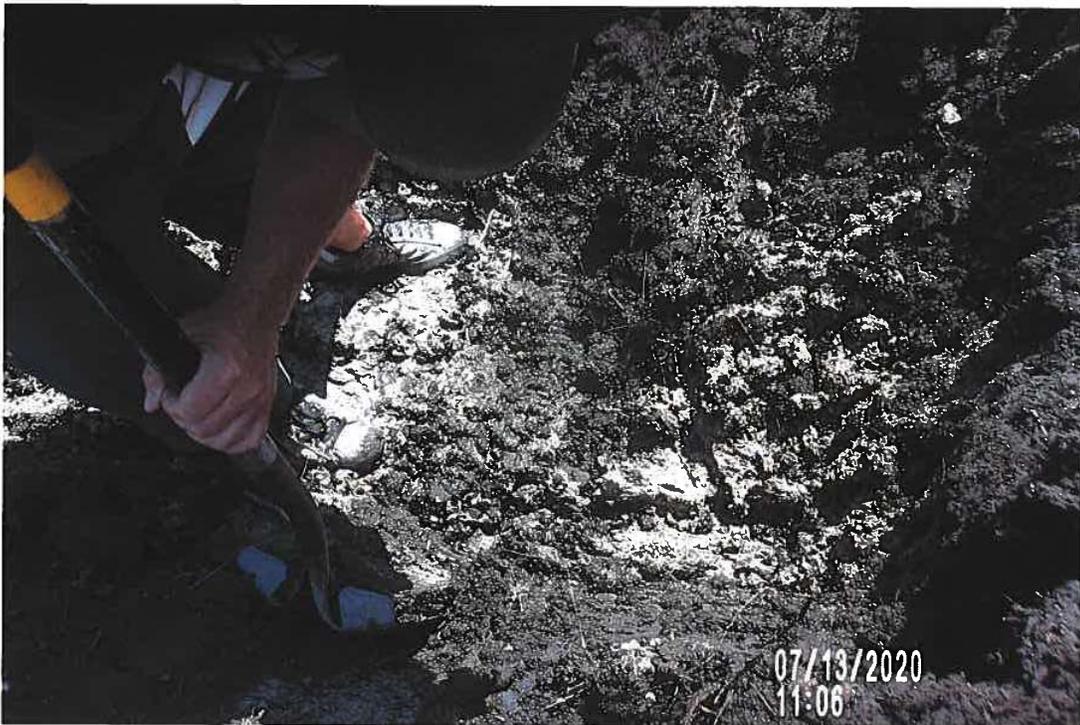
SINKHOLE
 EAST OF
 BEEHIVE
 INTAKE

PICTURE# 4141 IS LOOKING EAST ON EAST SIDE OF
 BEEHIVE INTAKE SHOWING 6" HDPE PERF TILE CONNECTION
 TO 6" CLAY TILE OUTLET EAST FROM BEEHIVE INTAKE,

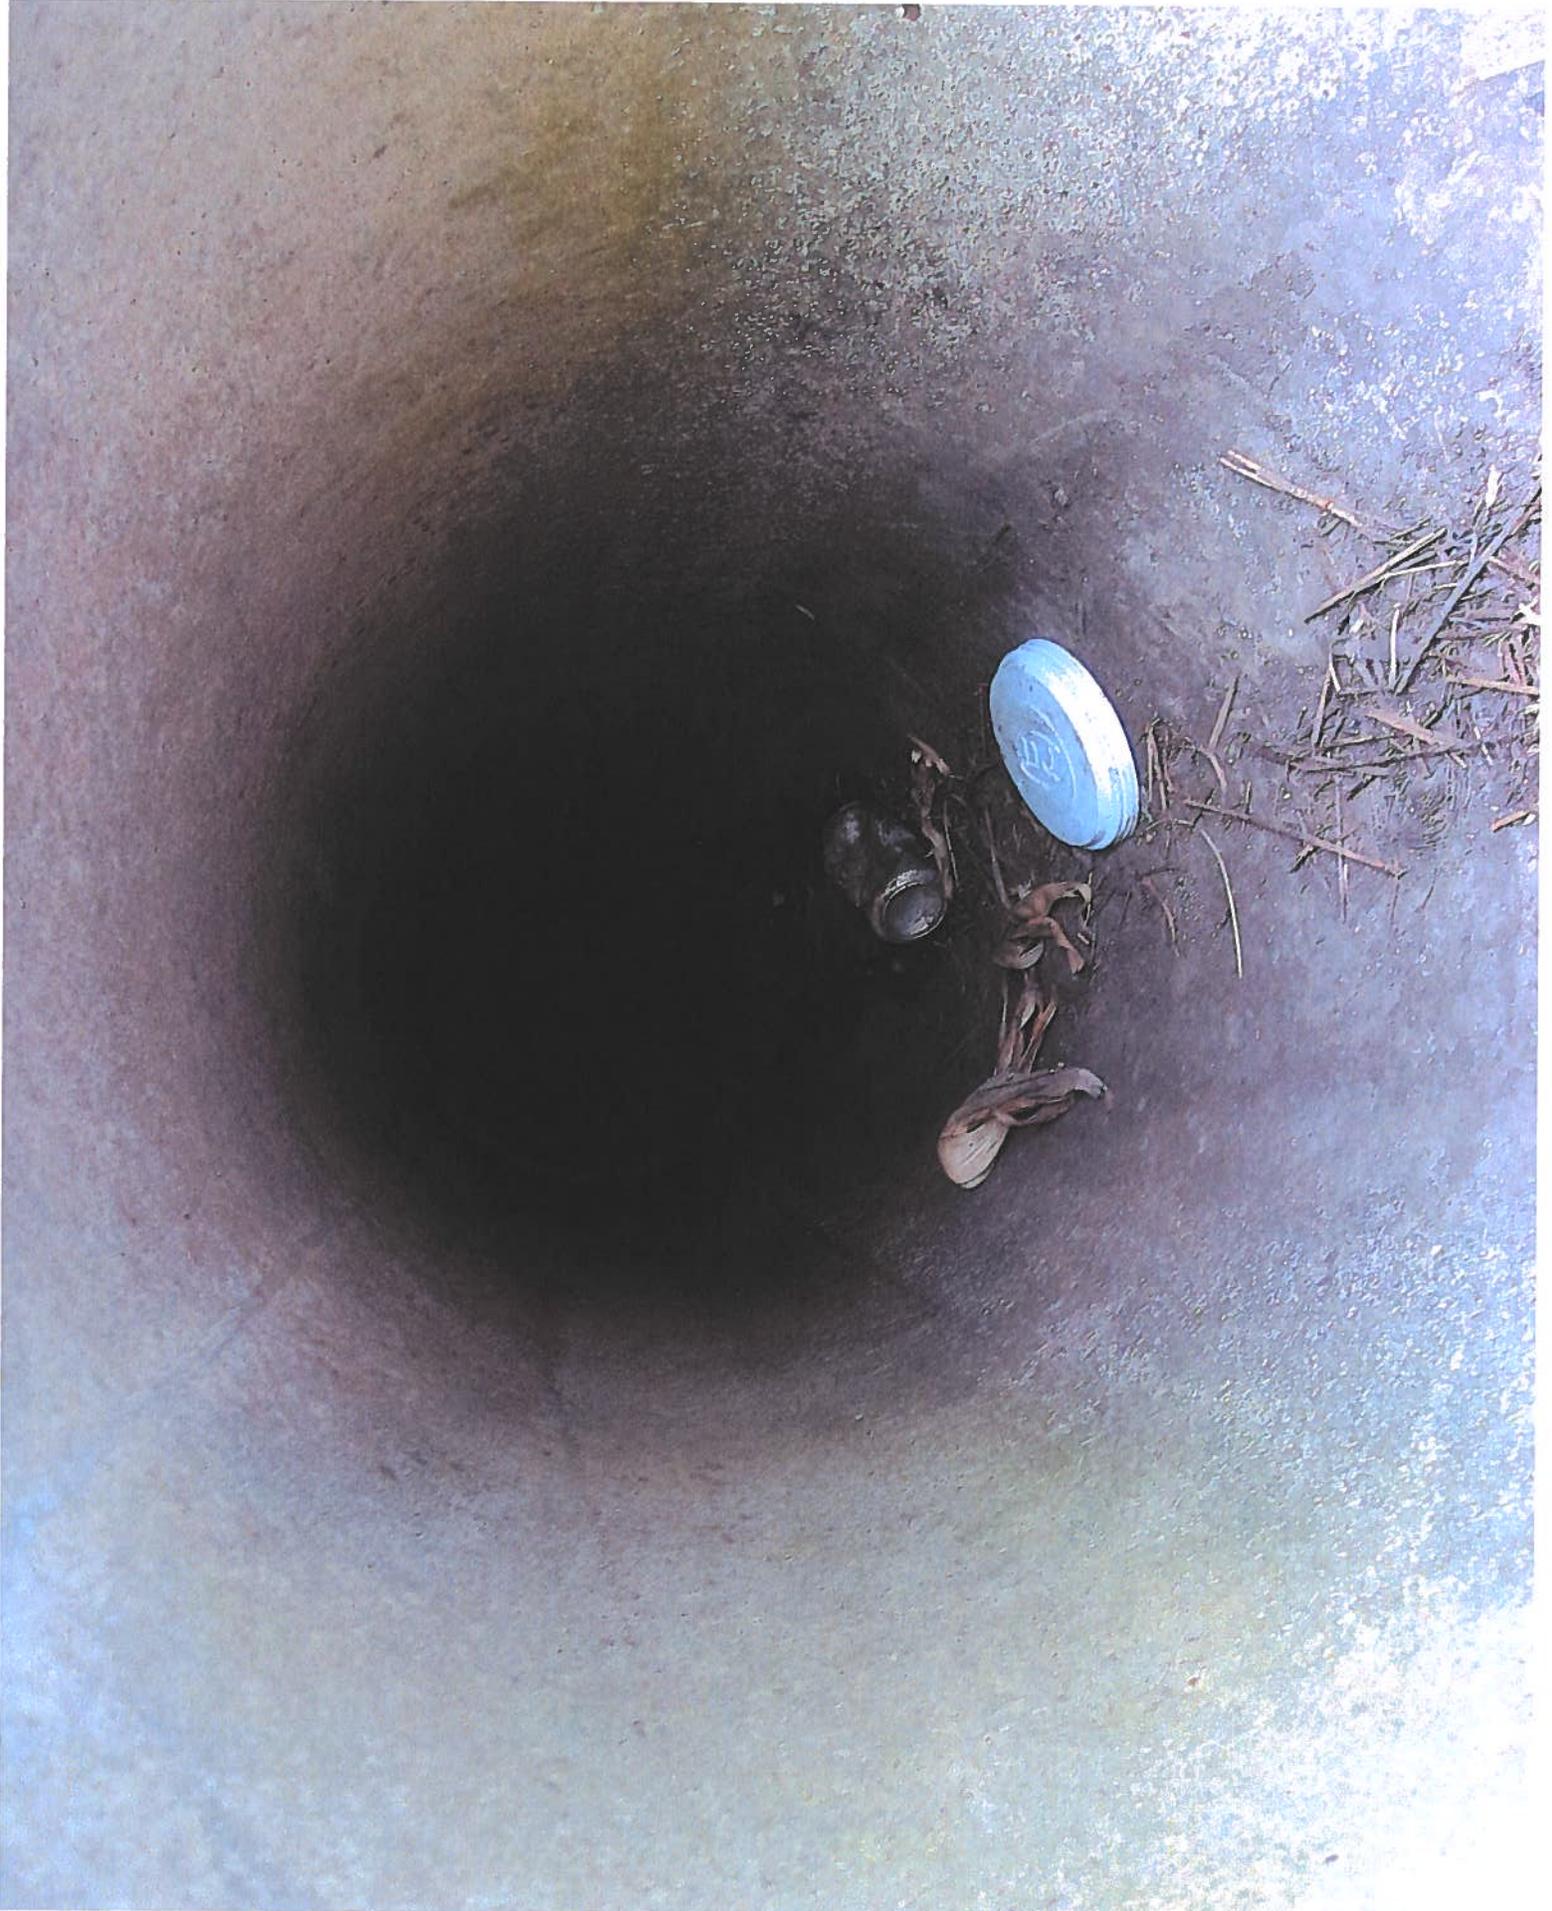
SURF. DRAIN RCP WITH SUCK HOLE OVER TOP RCP AND LAT 2

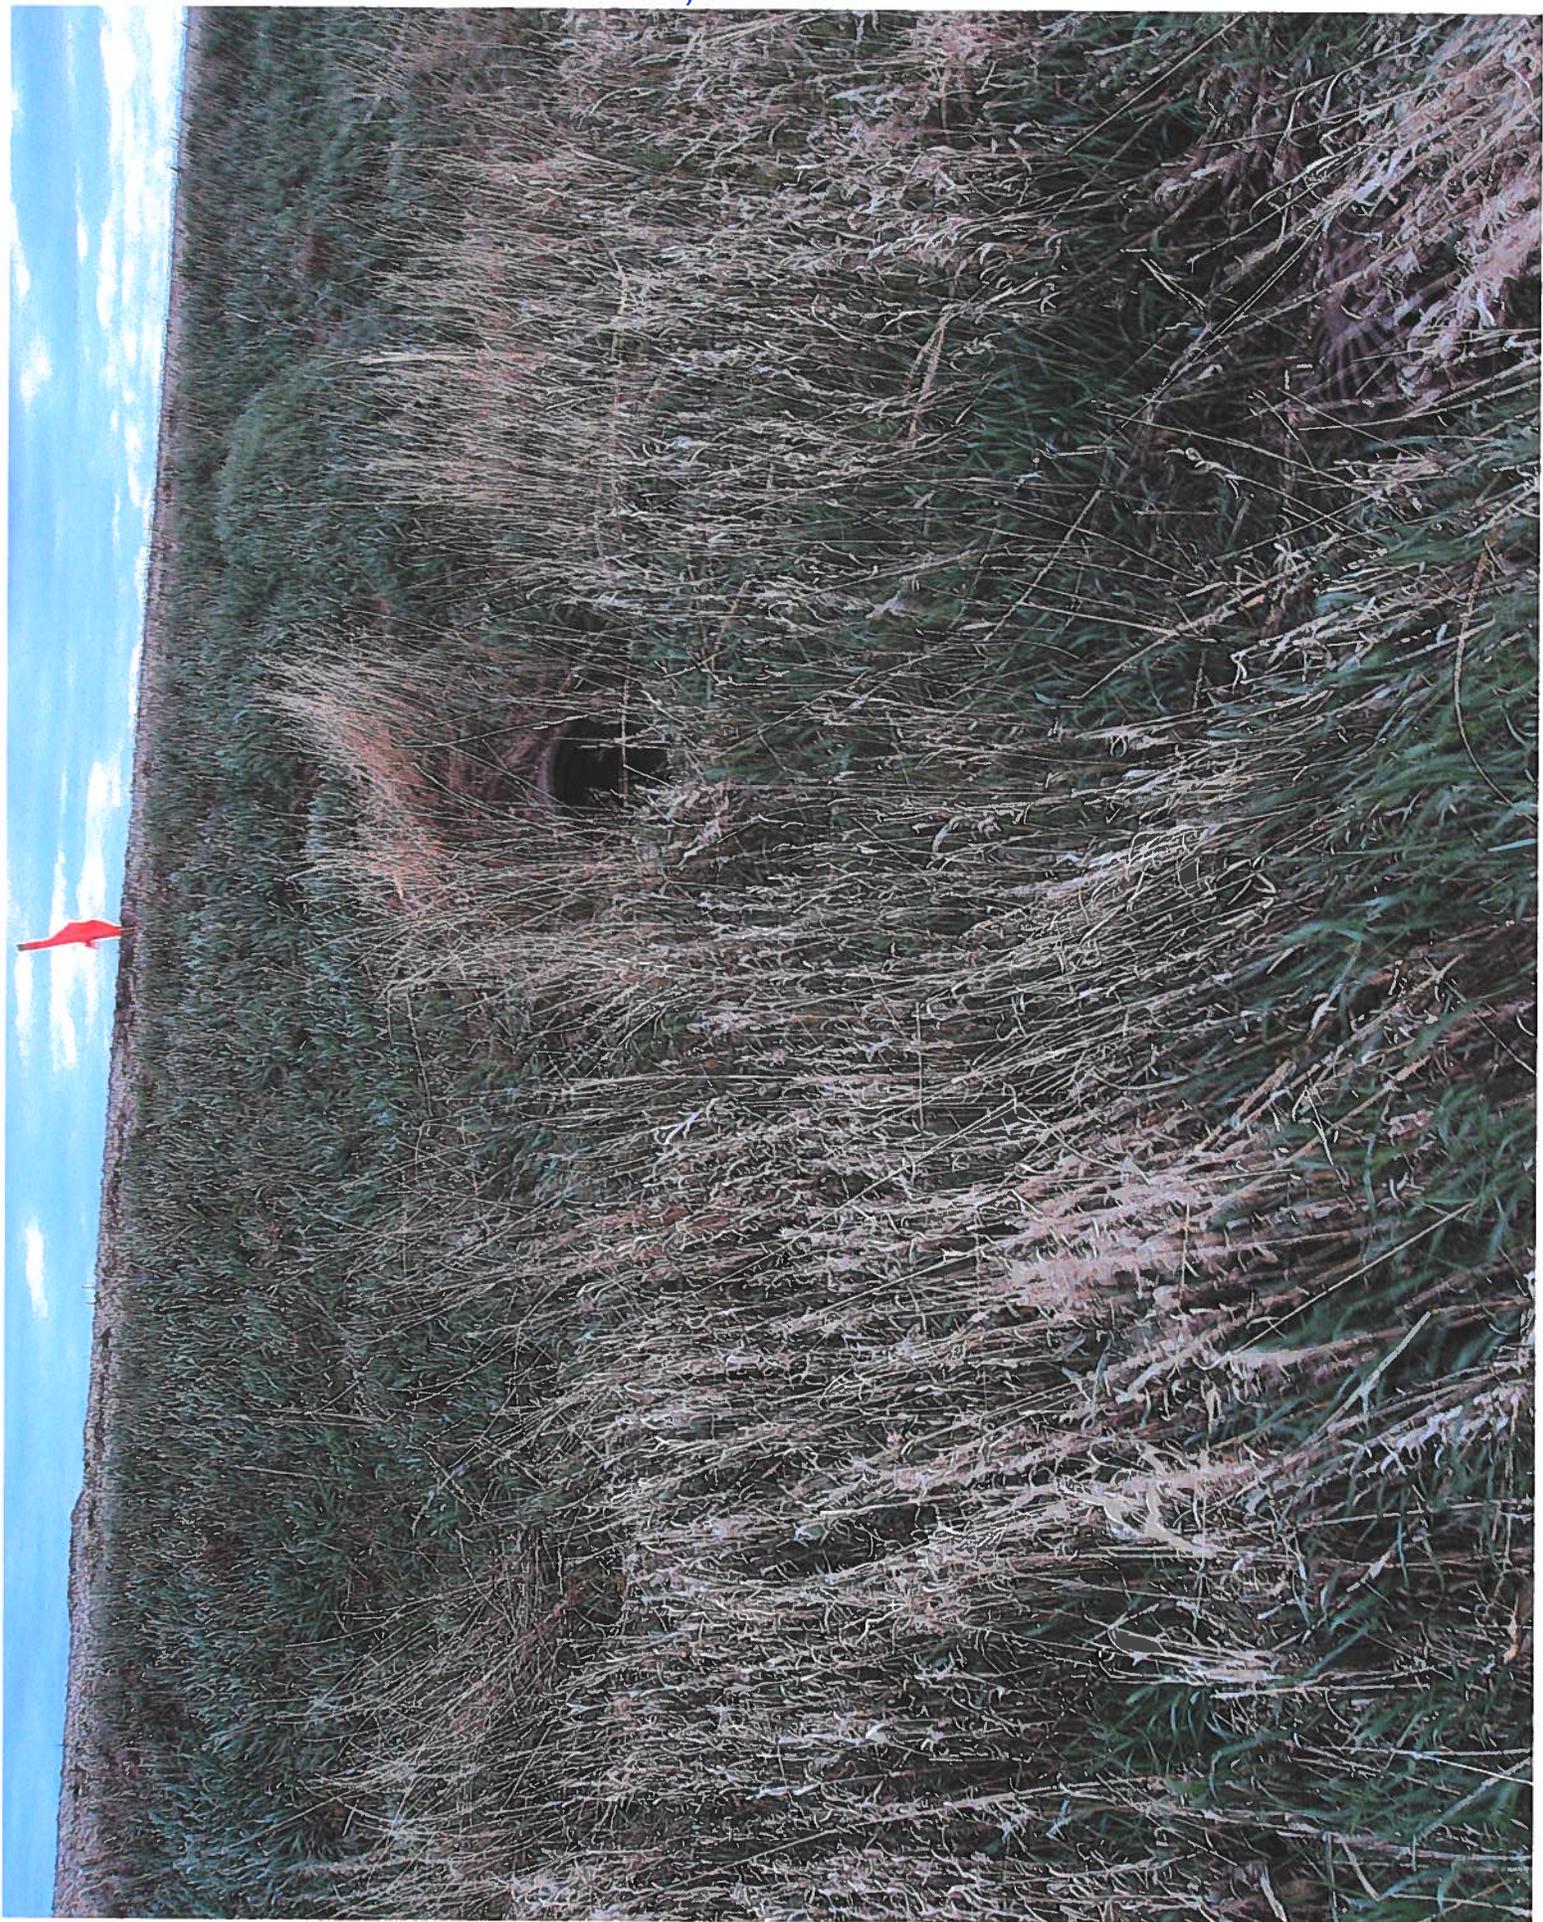
LOOKING S. ON LAT 2 ROUTE, FLAG ON SIXK HOLE ON N.S.H. D41

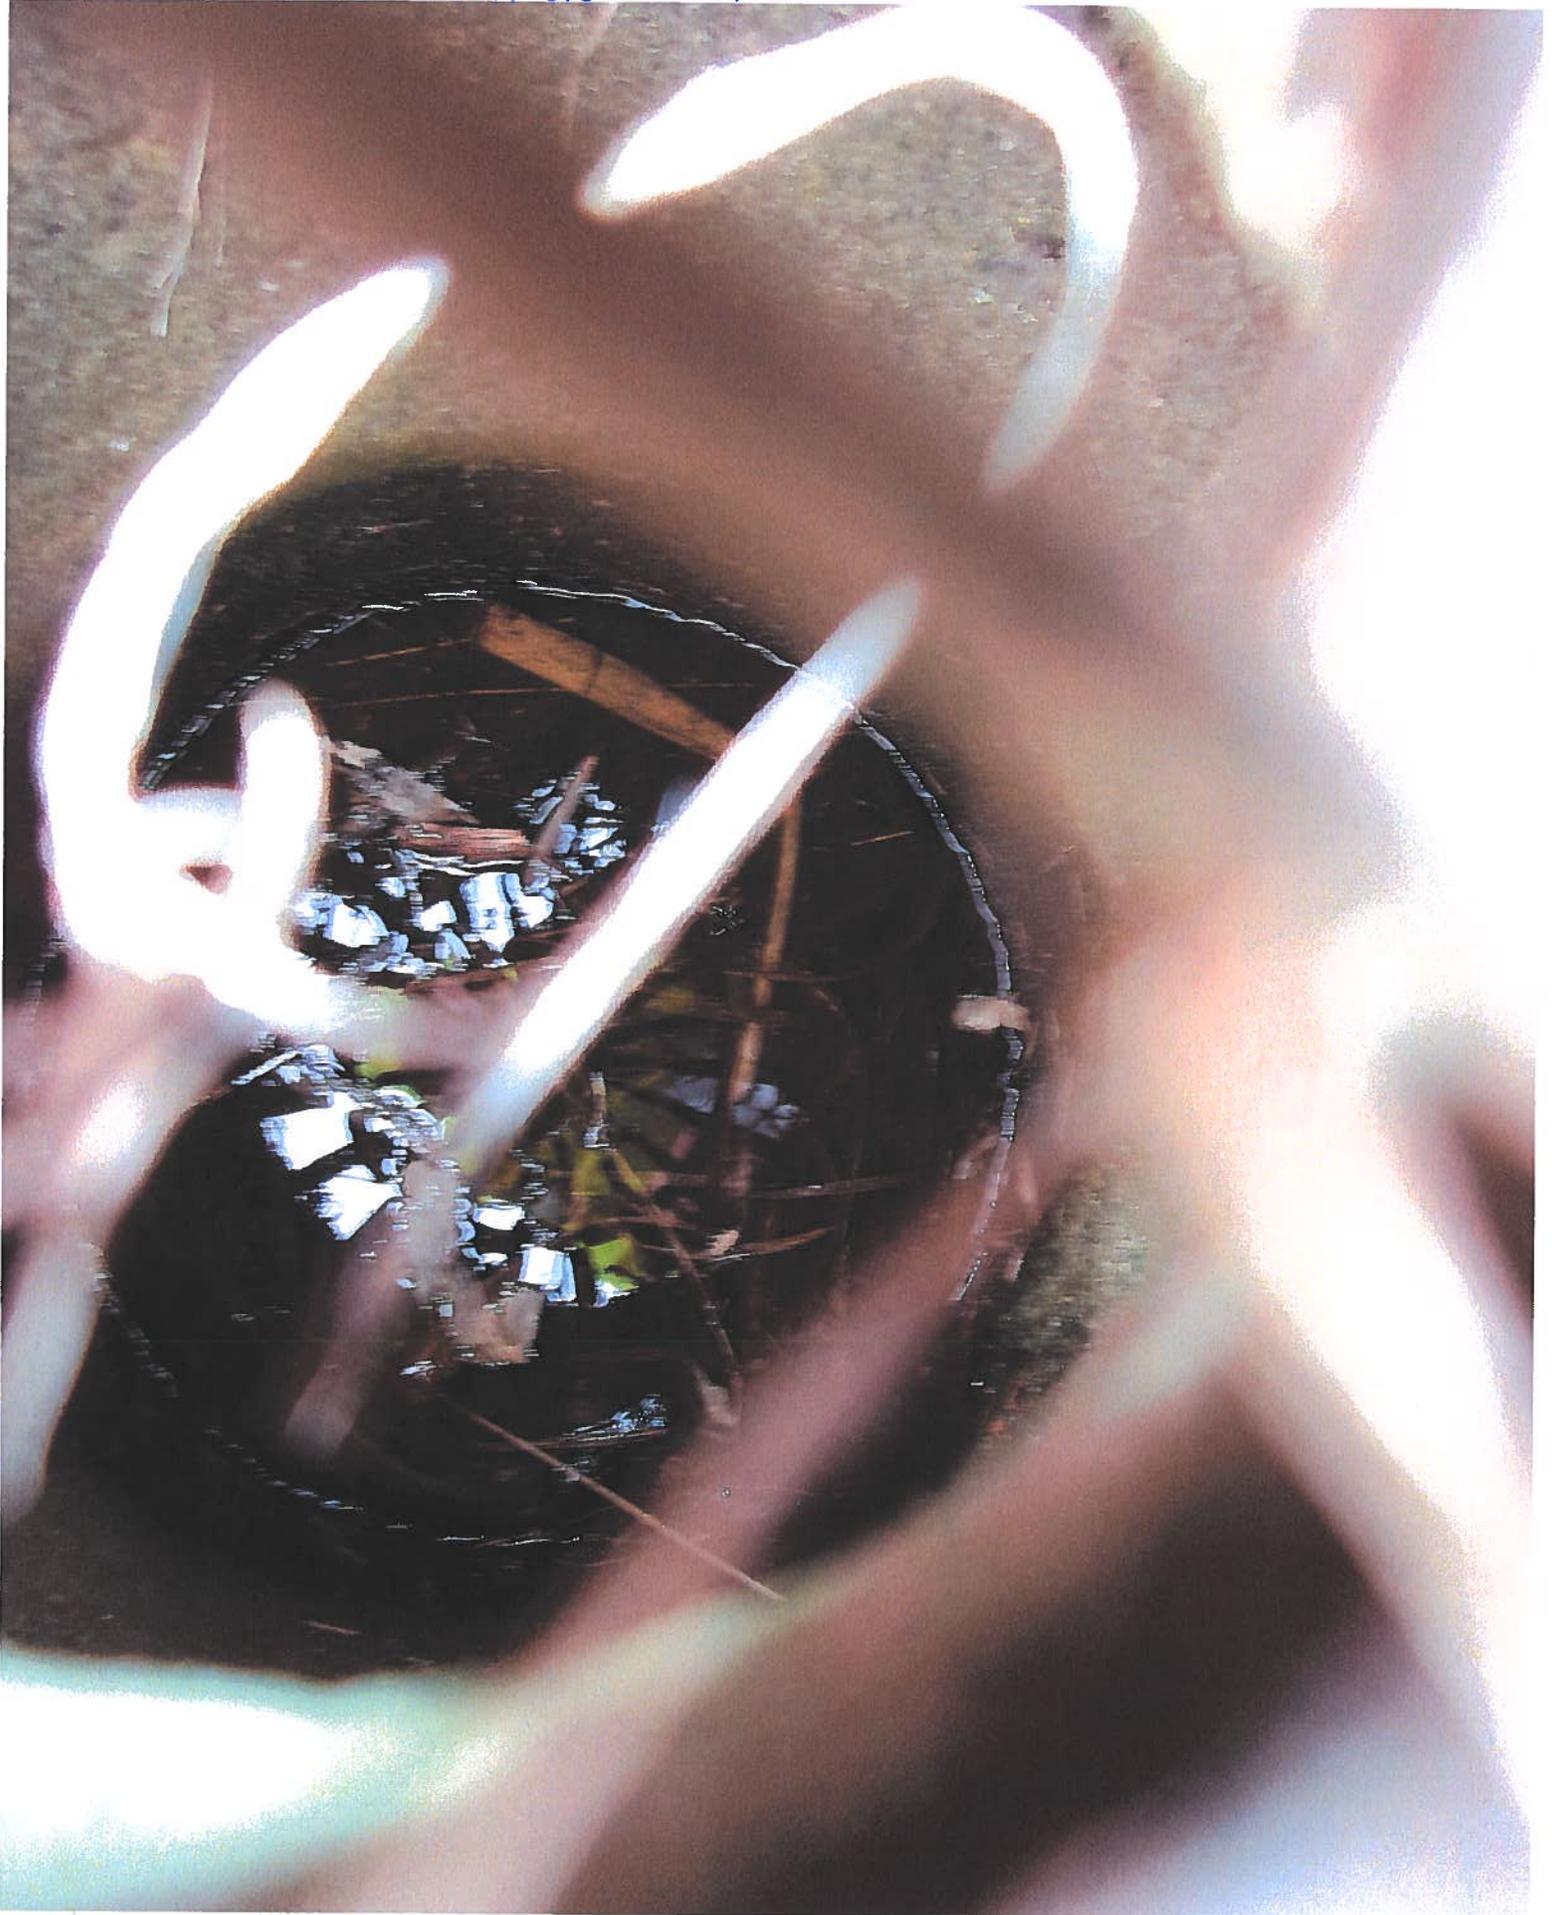
INTAKE ON N. SIDE D41 ON LAT 2, FULL OF WATER
