AGENDA
REGULAR DRAINAGE MEETING
February 5, 2020 9:30 AM

**ENGINEER'S REPORT
ON REPAIRS
TO MAIN TILE
DRAINAGE DISTRICT
NO. 86
HARDIN COUNTY,
IOWA**

SUPPLEMENT TO
ENGINEER'S REPORT
ON REPAIRS
TO MAIN TILE
DRAINAGE DISTRICT
NO. 86
HARDIN COUNTY,
IOWA

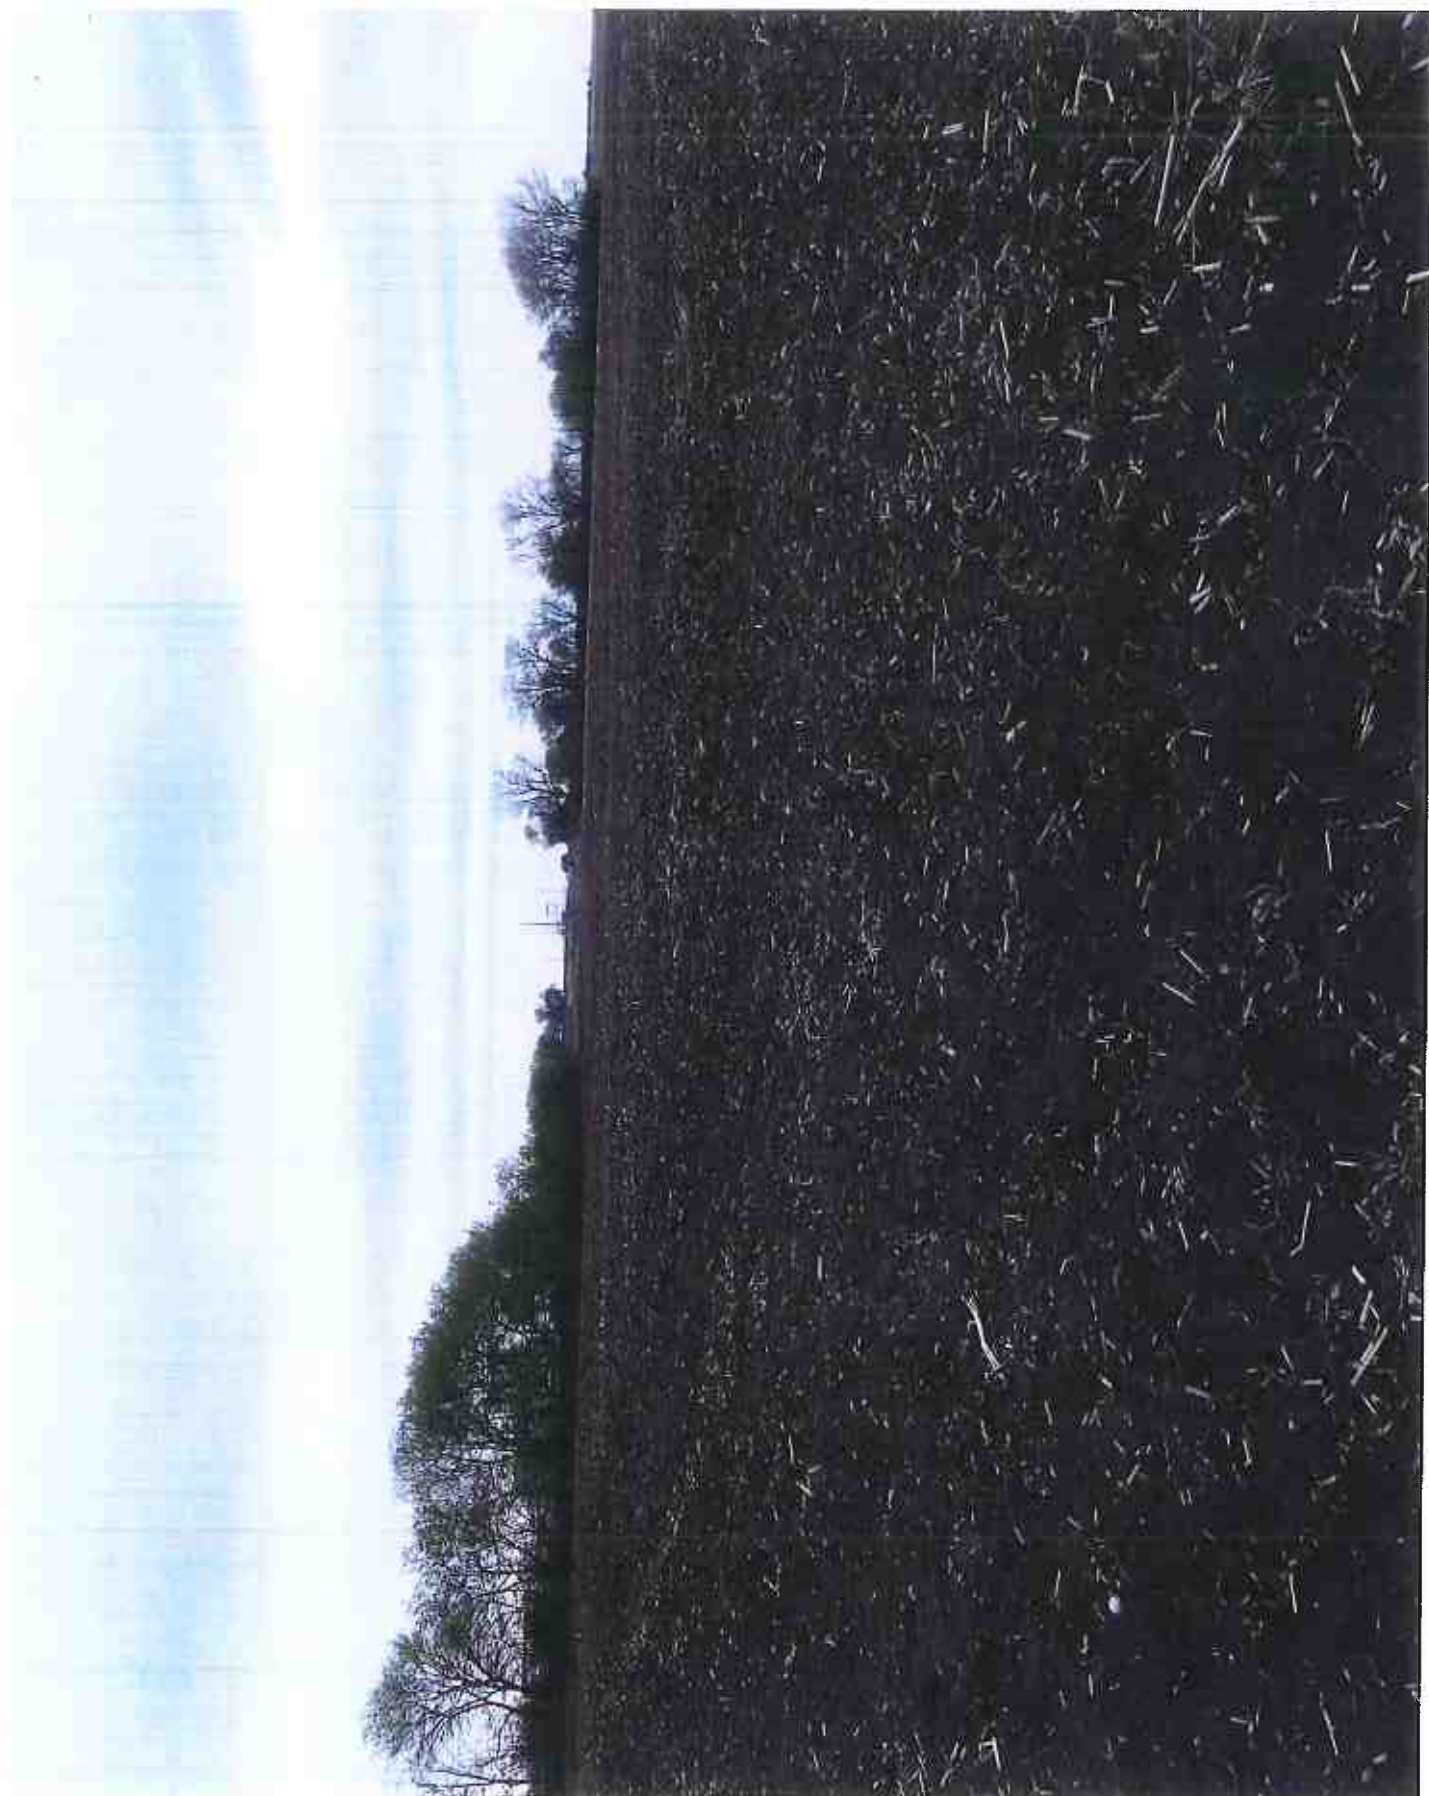
Looking East @ Monarch Lake Tule Route (5) Trees Need Removed (Not Cedar Trees)

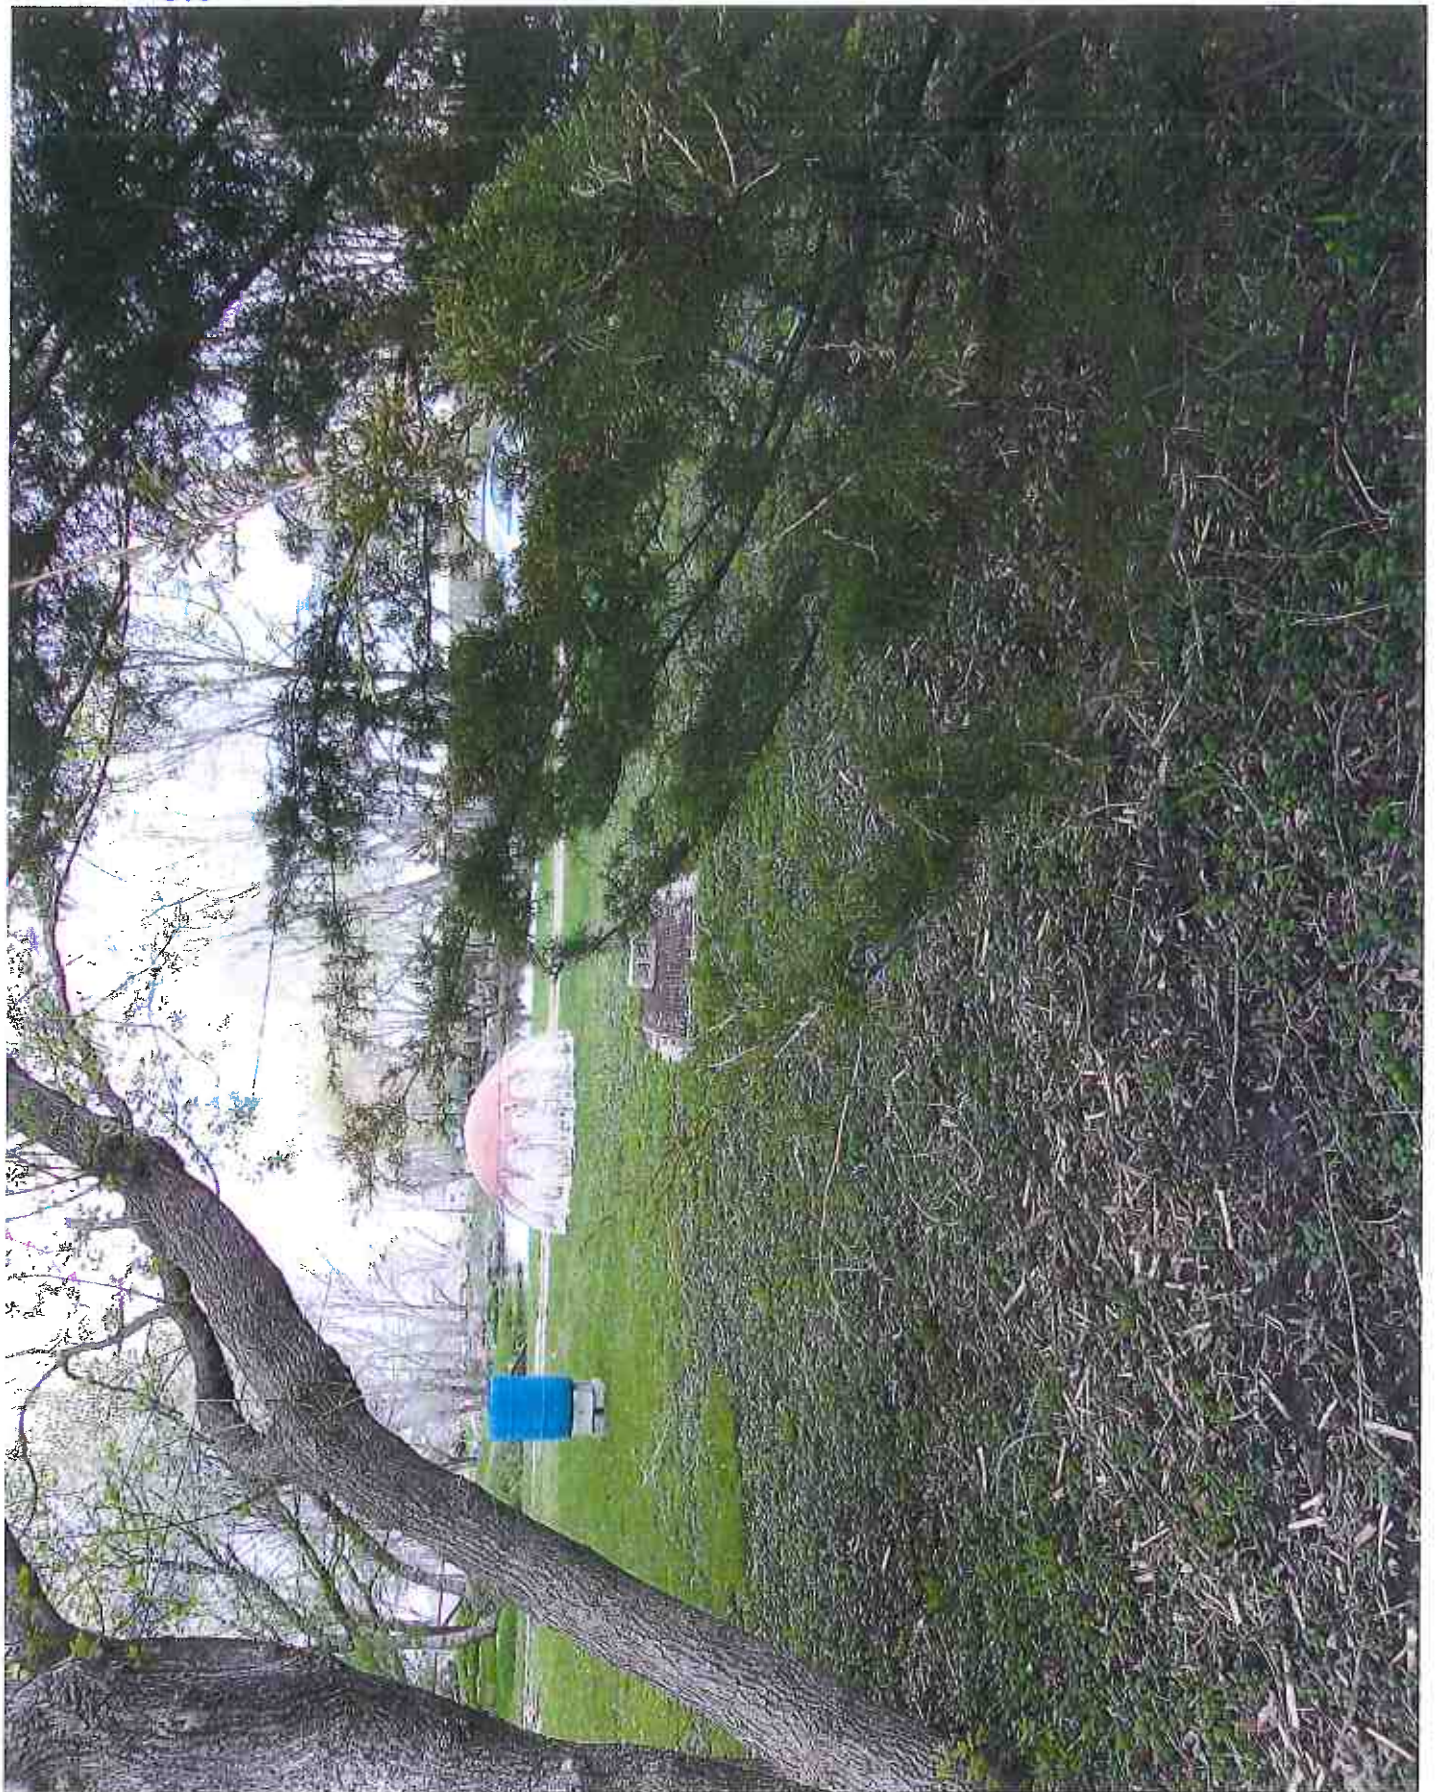
Looking W. From INTAKE

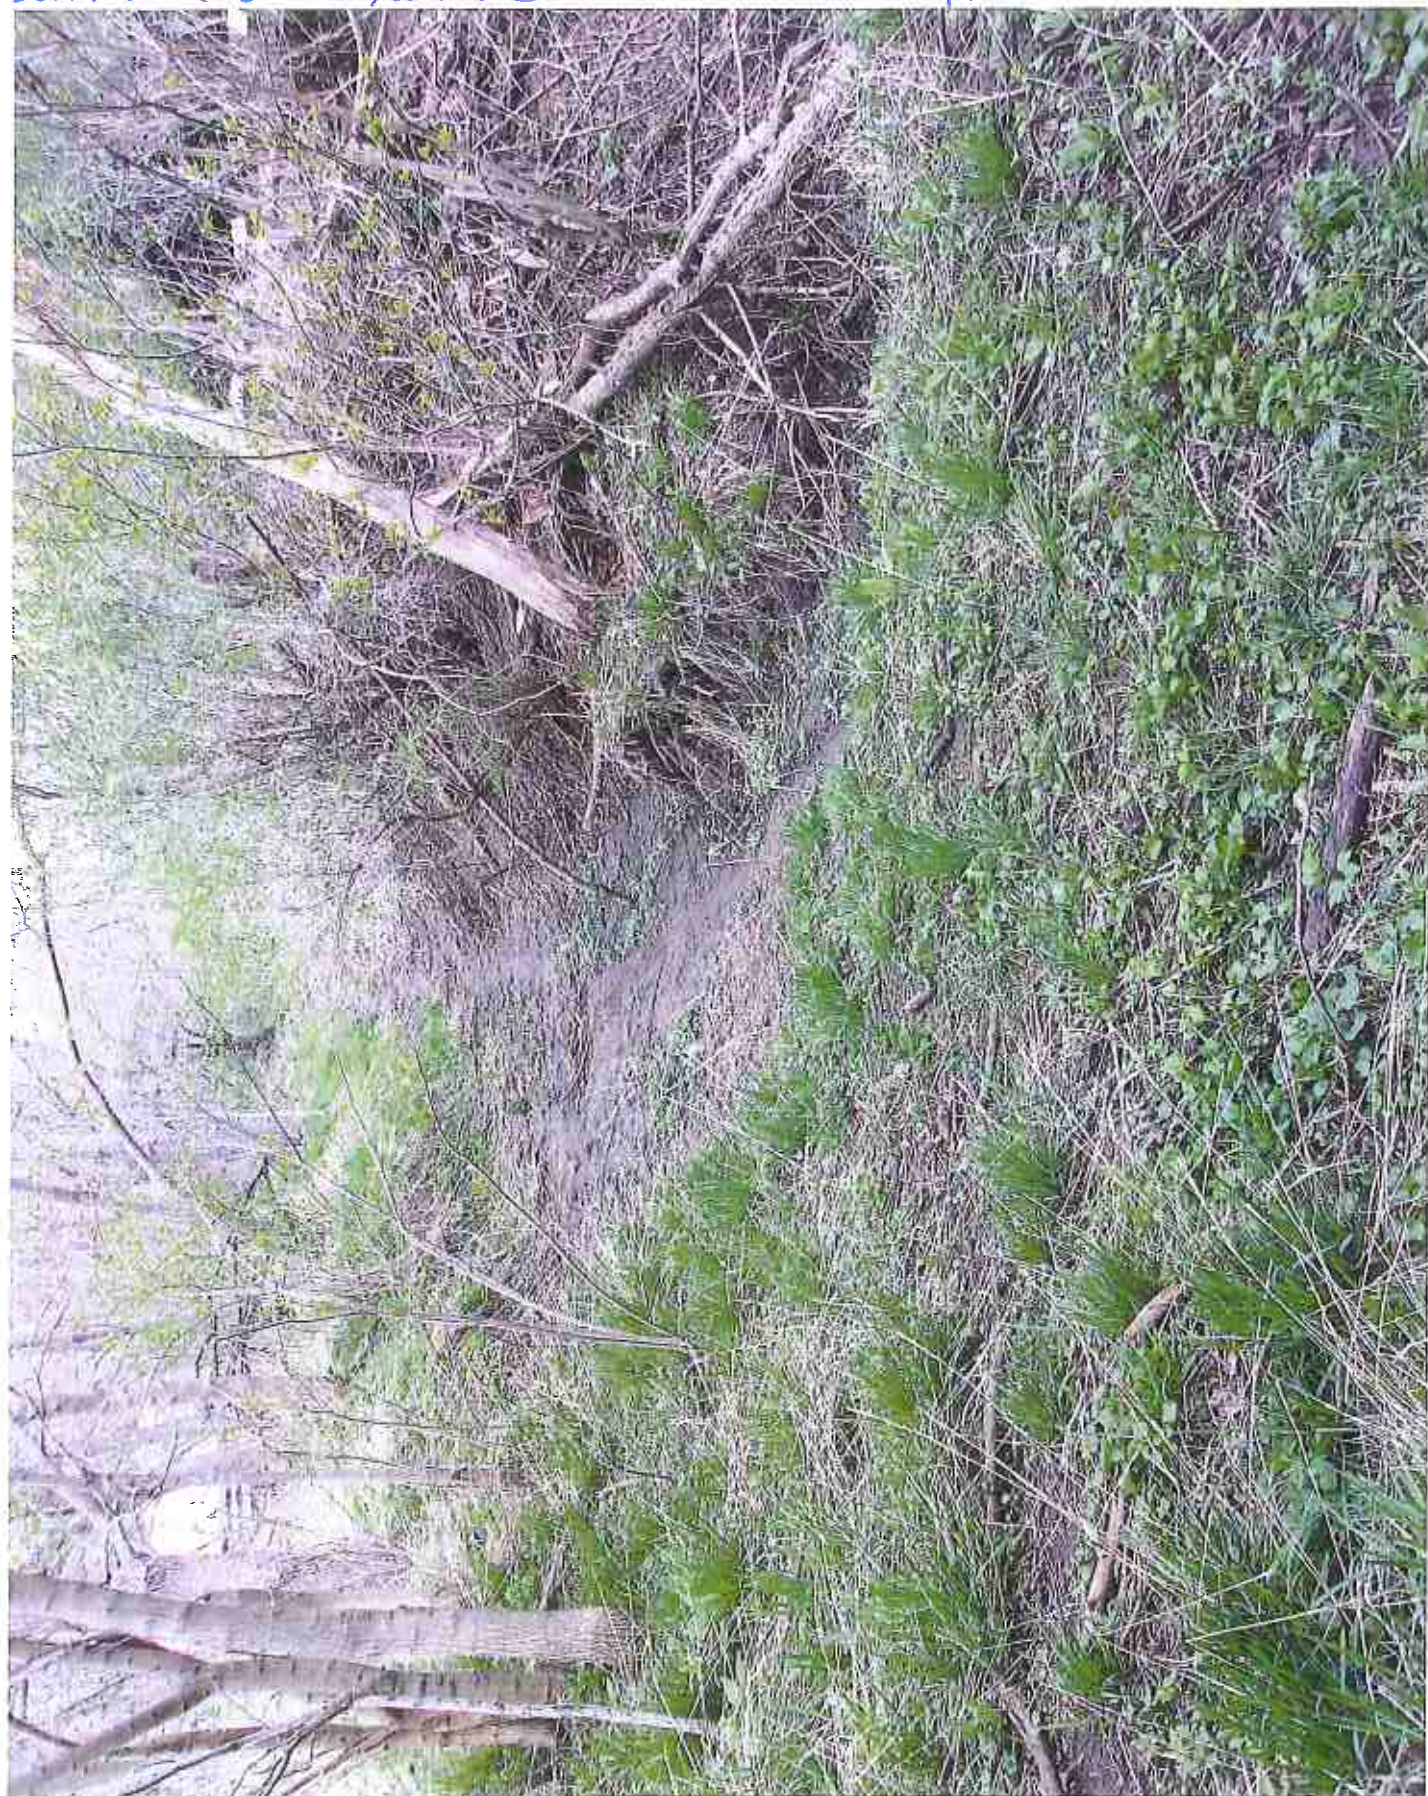
Looking upstream From Georgetown Road

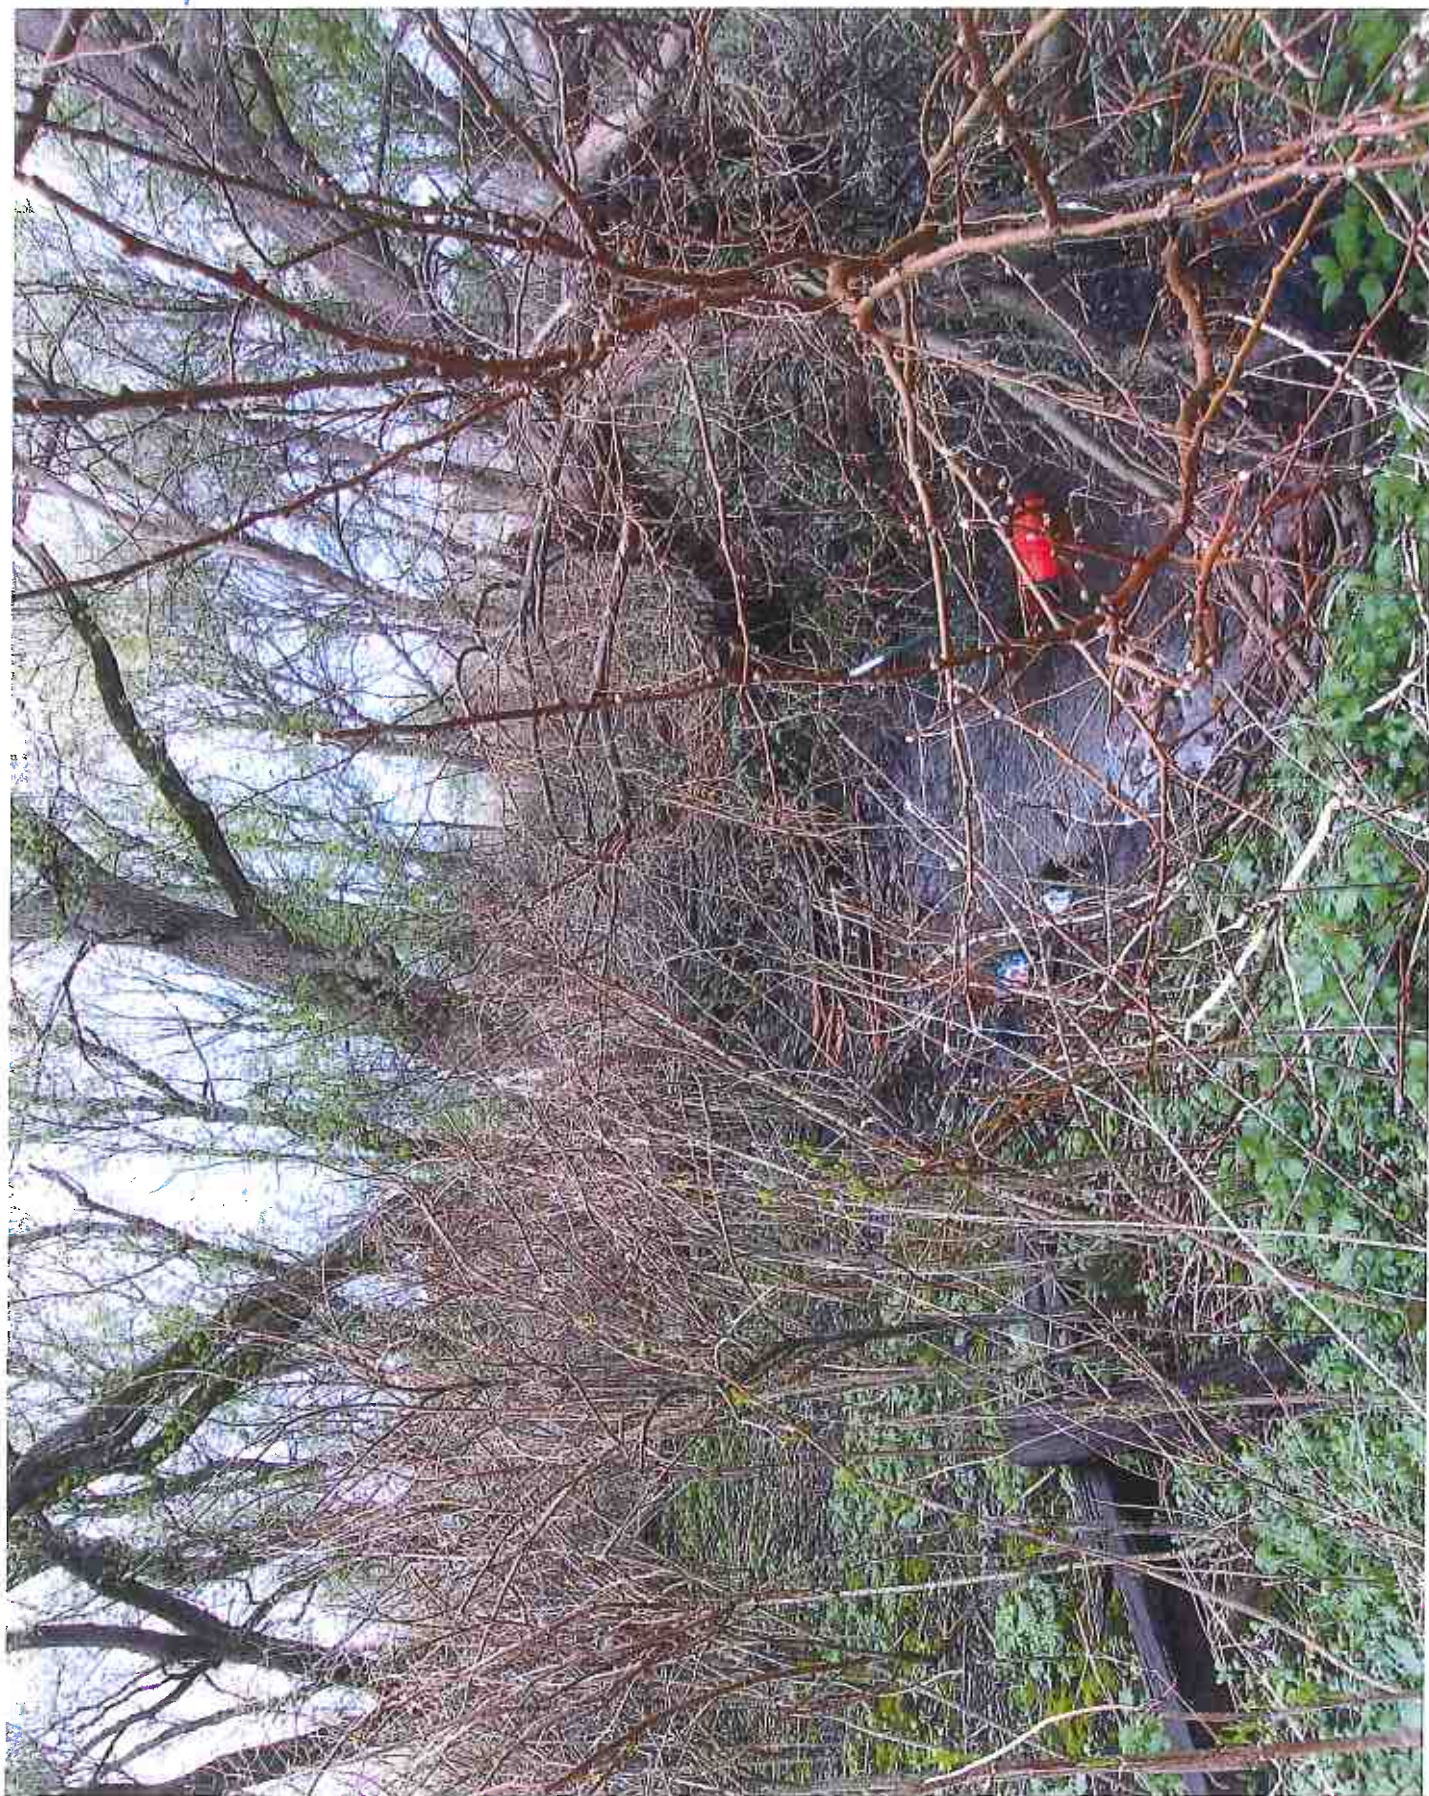
Looking downstream @ RR mainline, surface Turb drains into DD86 tile

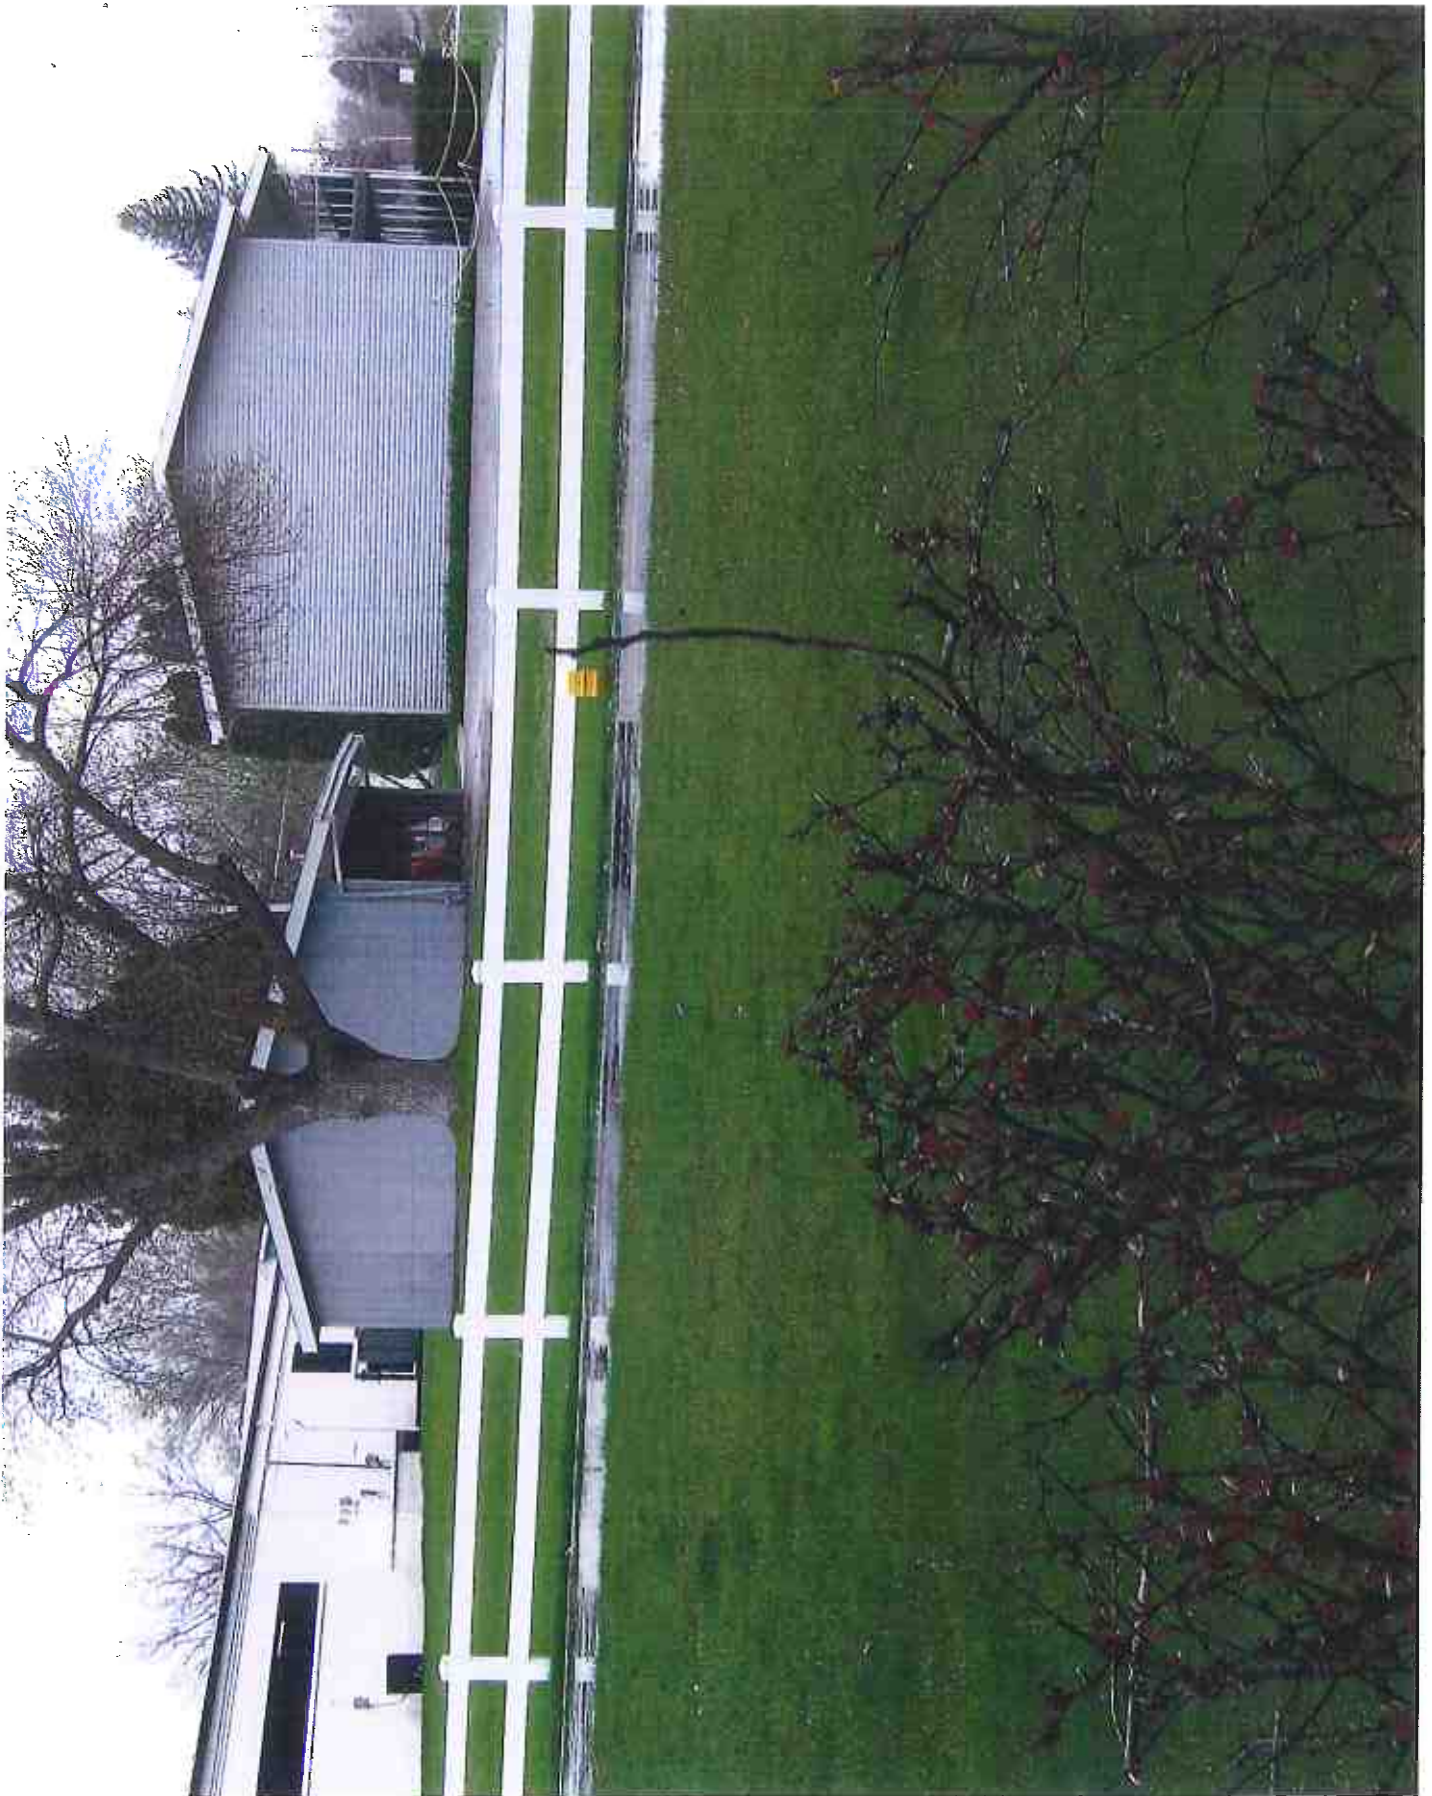
BEEHIVE INTAKE IS IN TREES SOMEWHERE 90+ TREES IN THE R/W N. OF RR

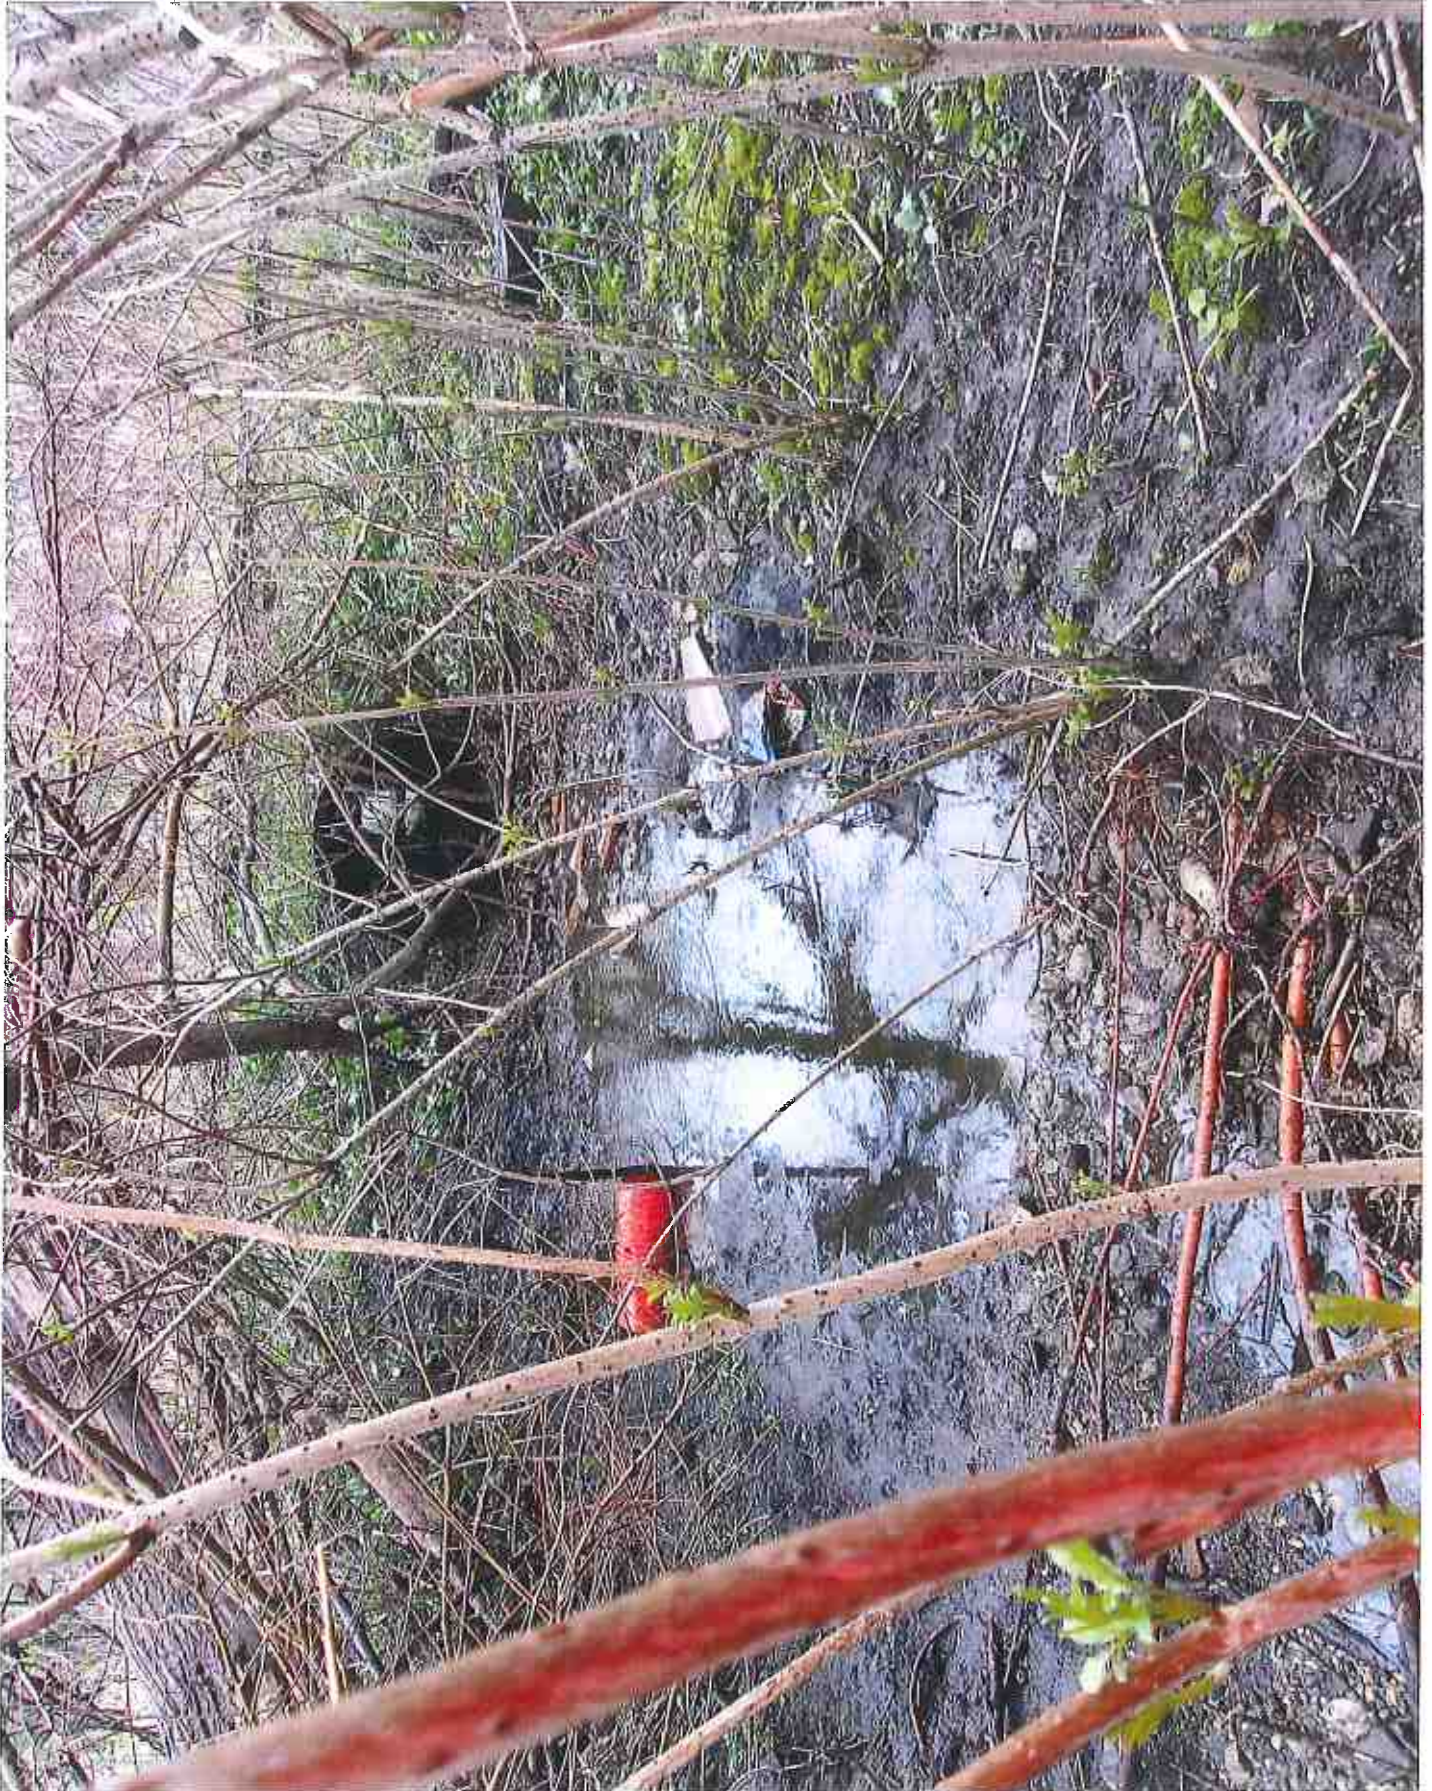
TILE ROUTE MARKED WITH BROKEN TILE

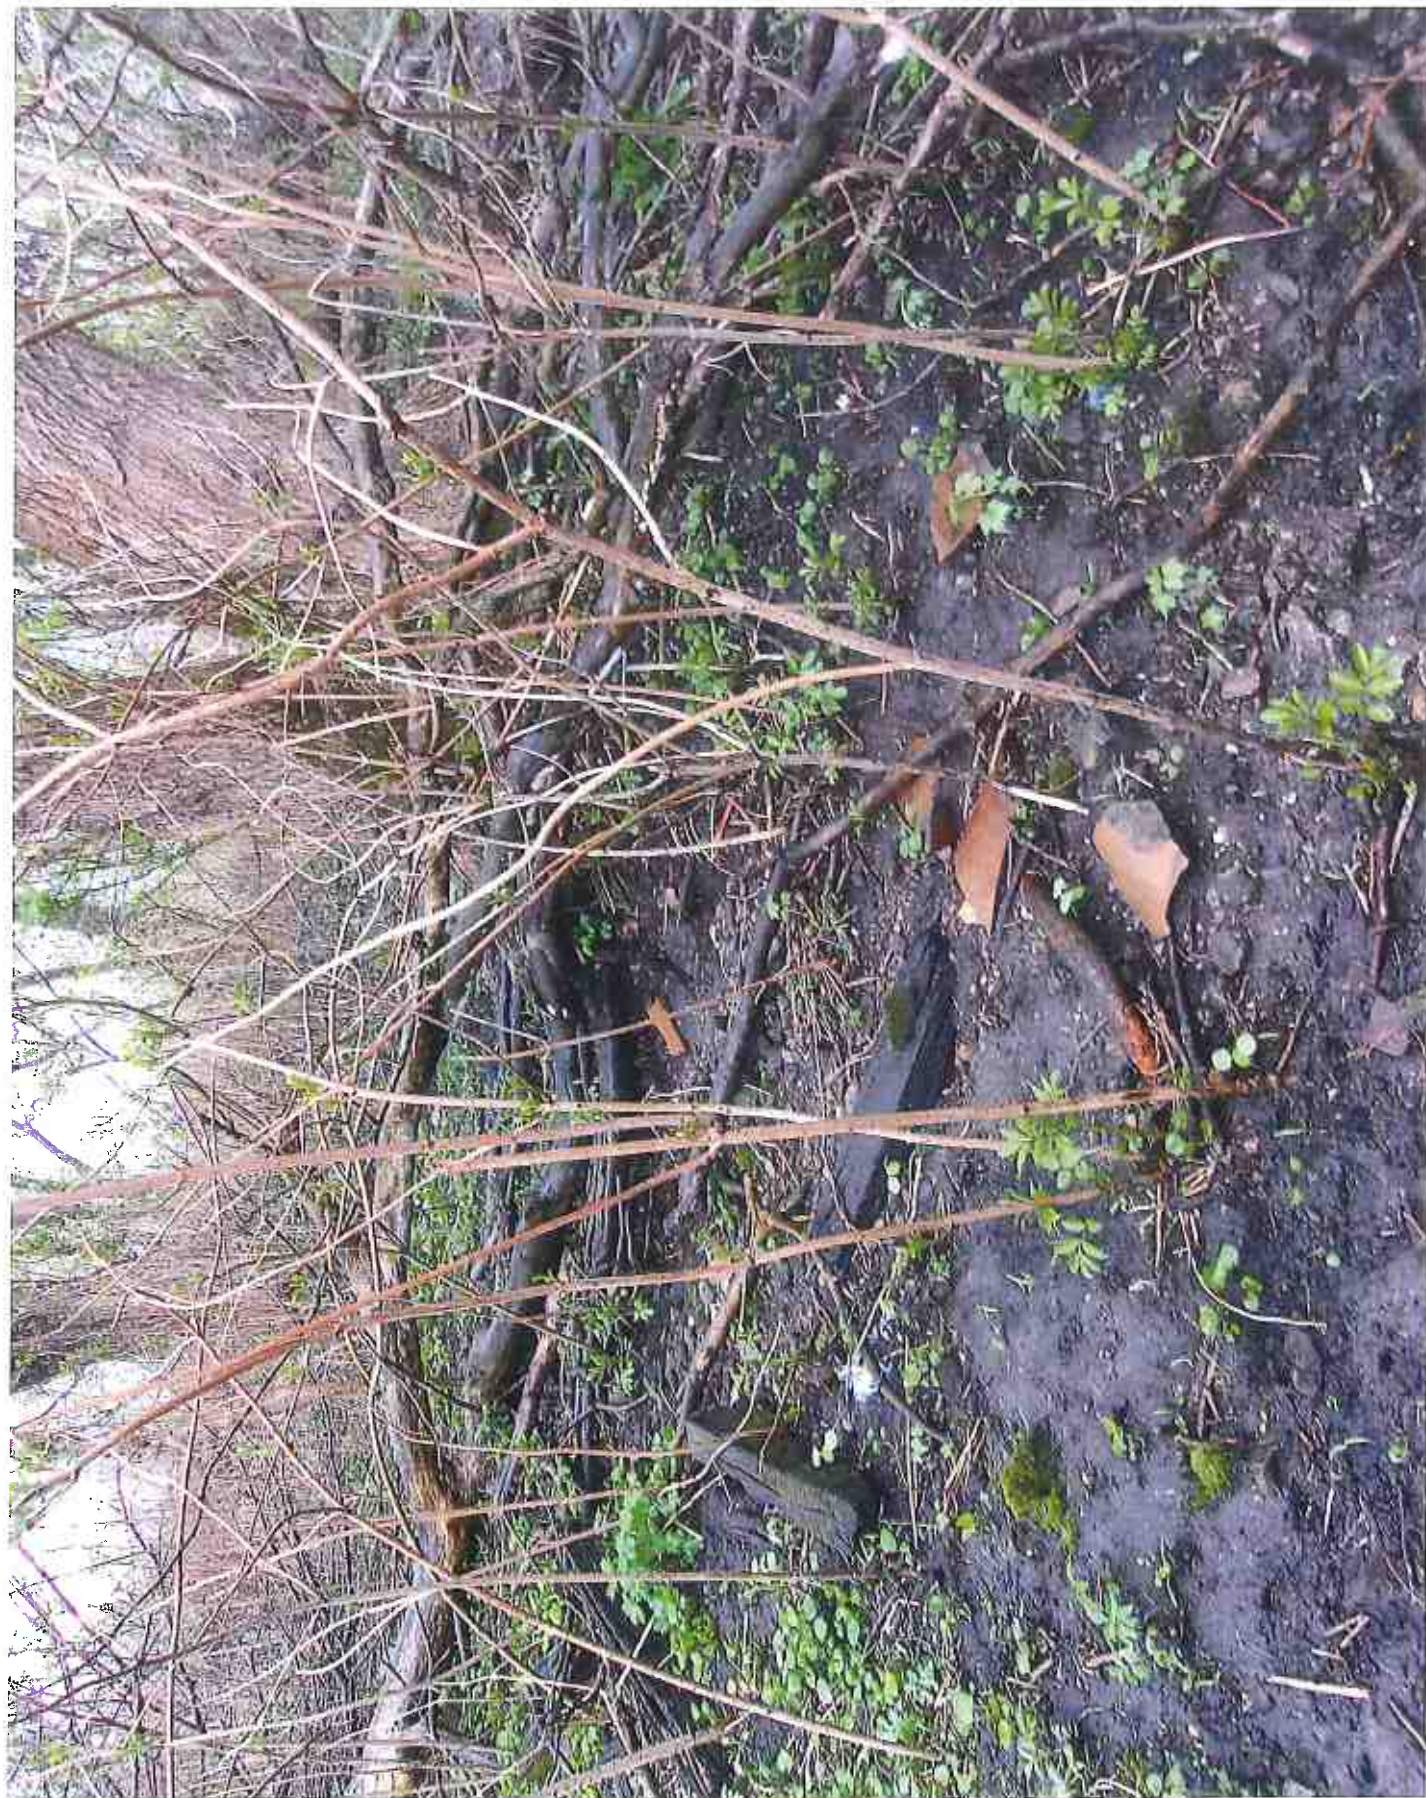
TILE ROUTE WITH CHARDS IN TREE ROOTS

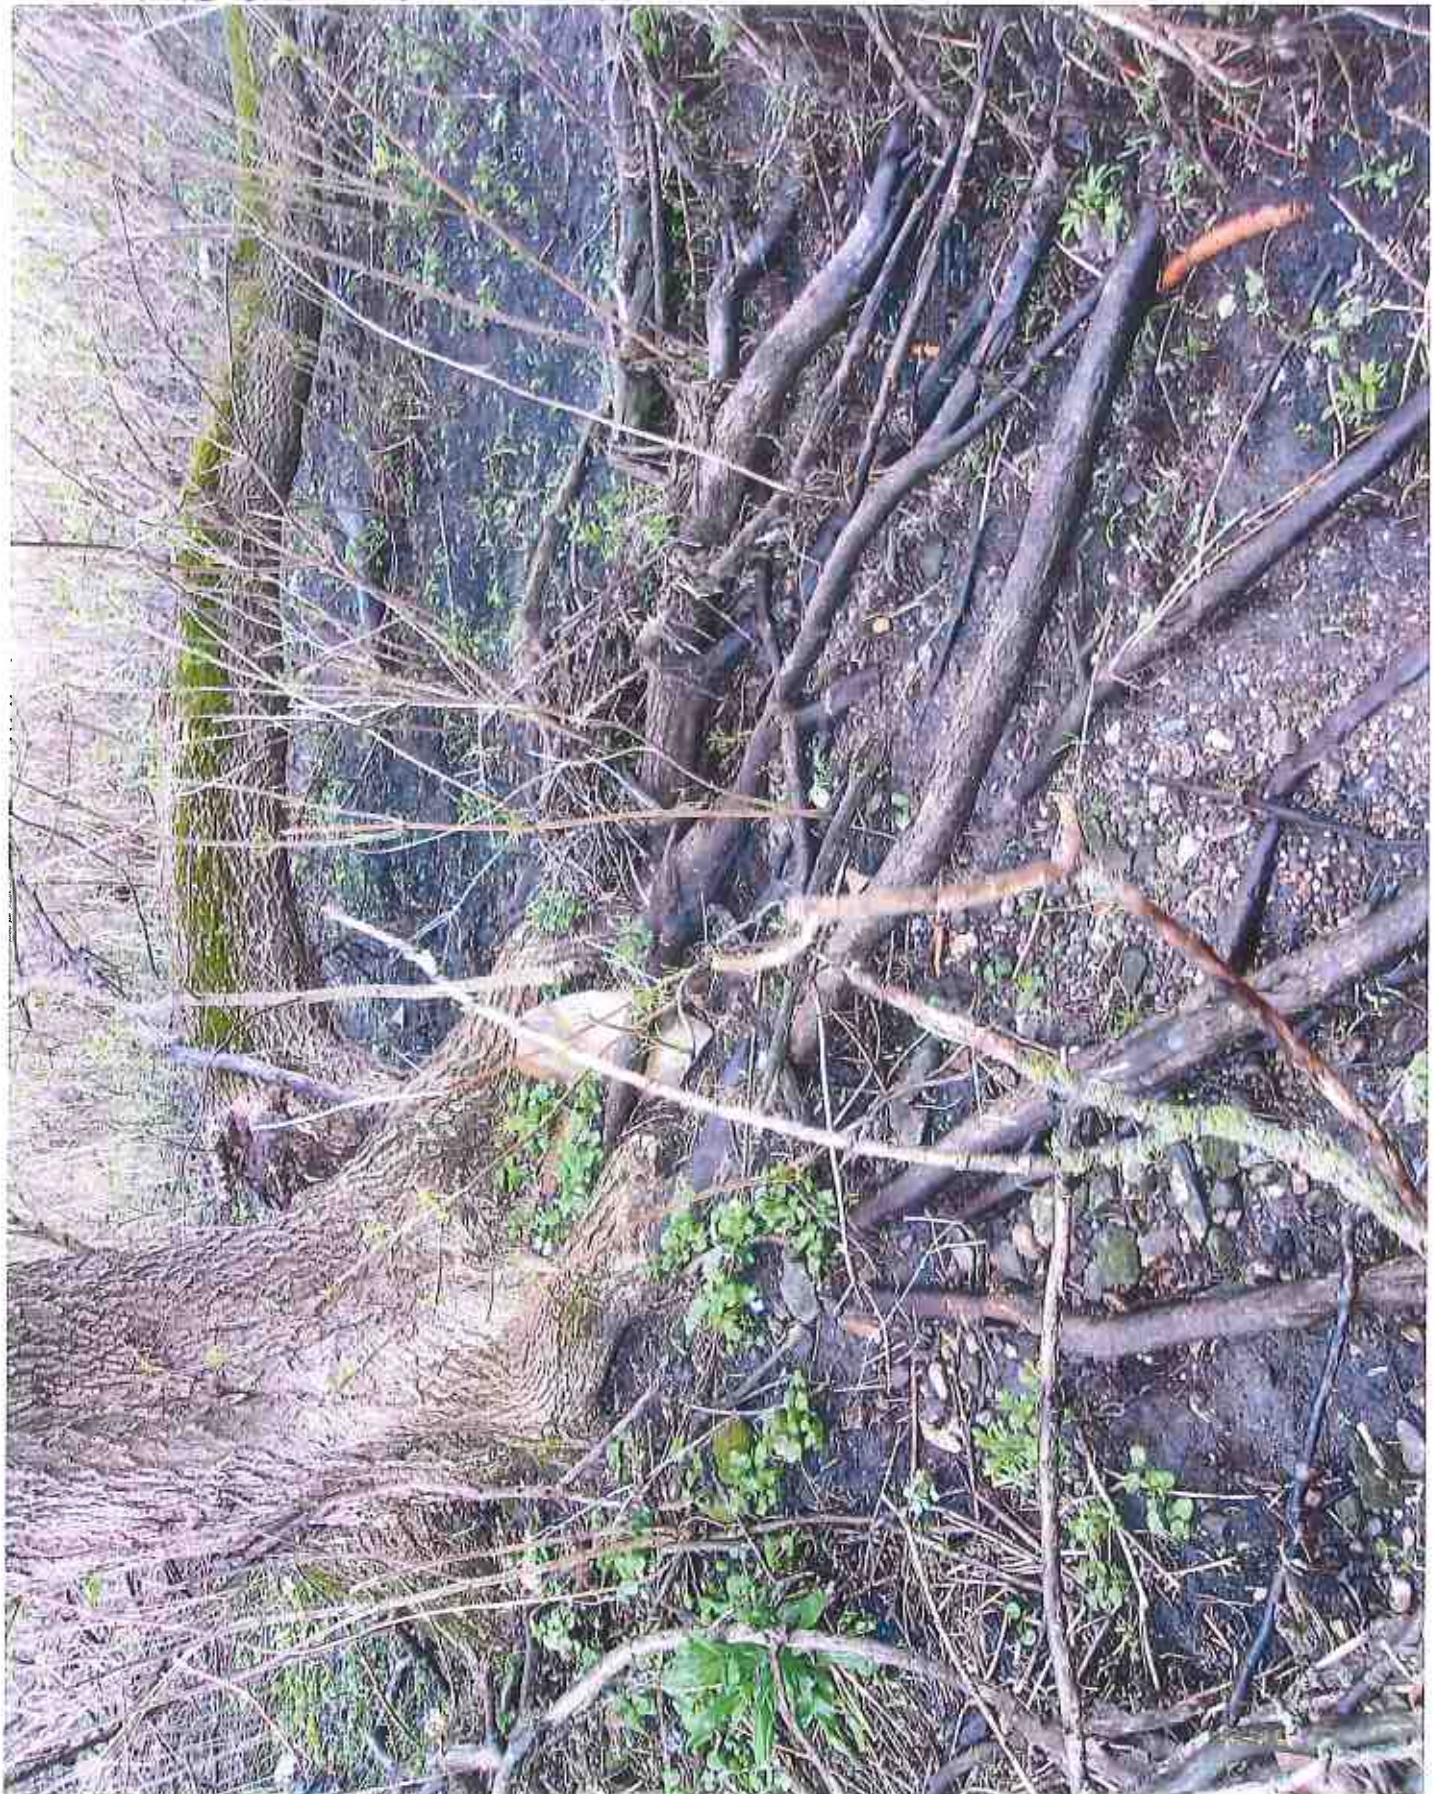
TILE CHARDS THRU ELDERBERRY BRUSH

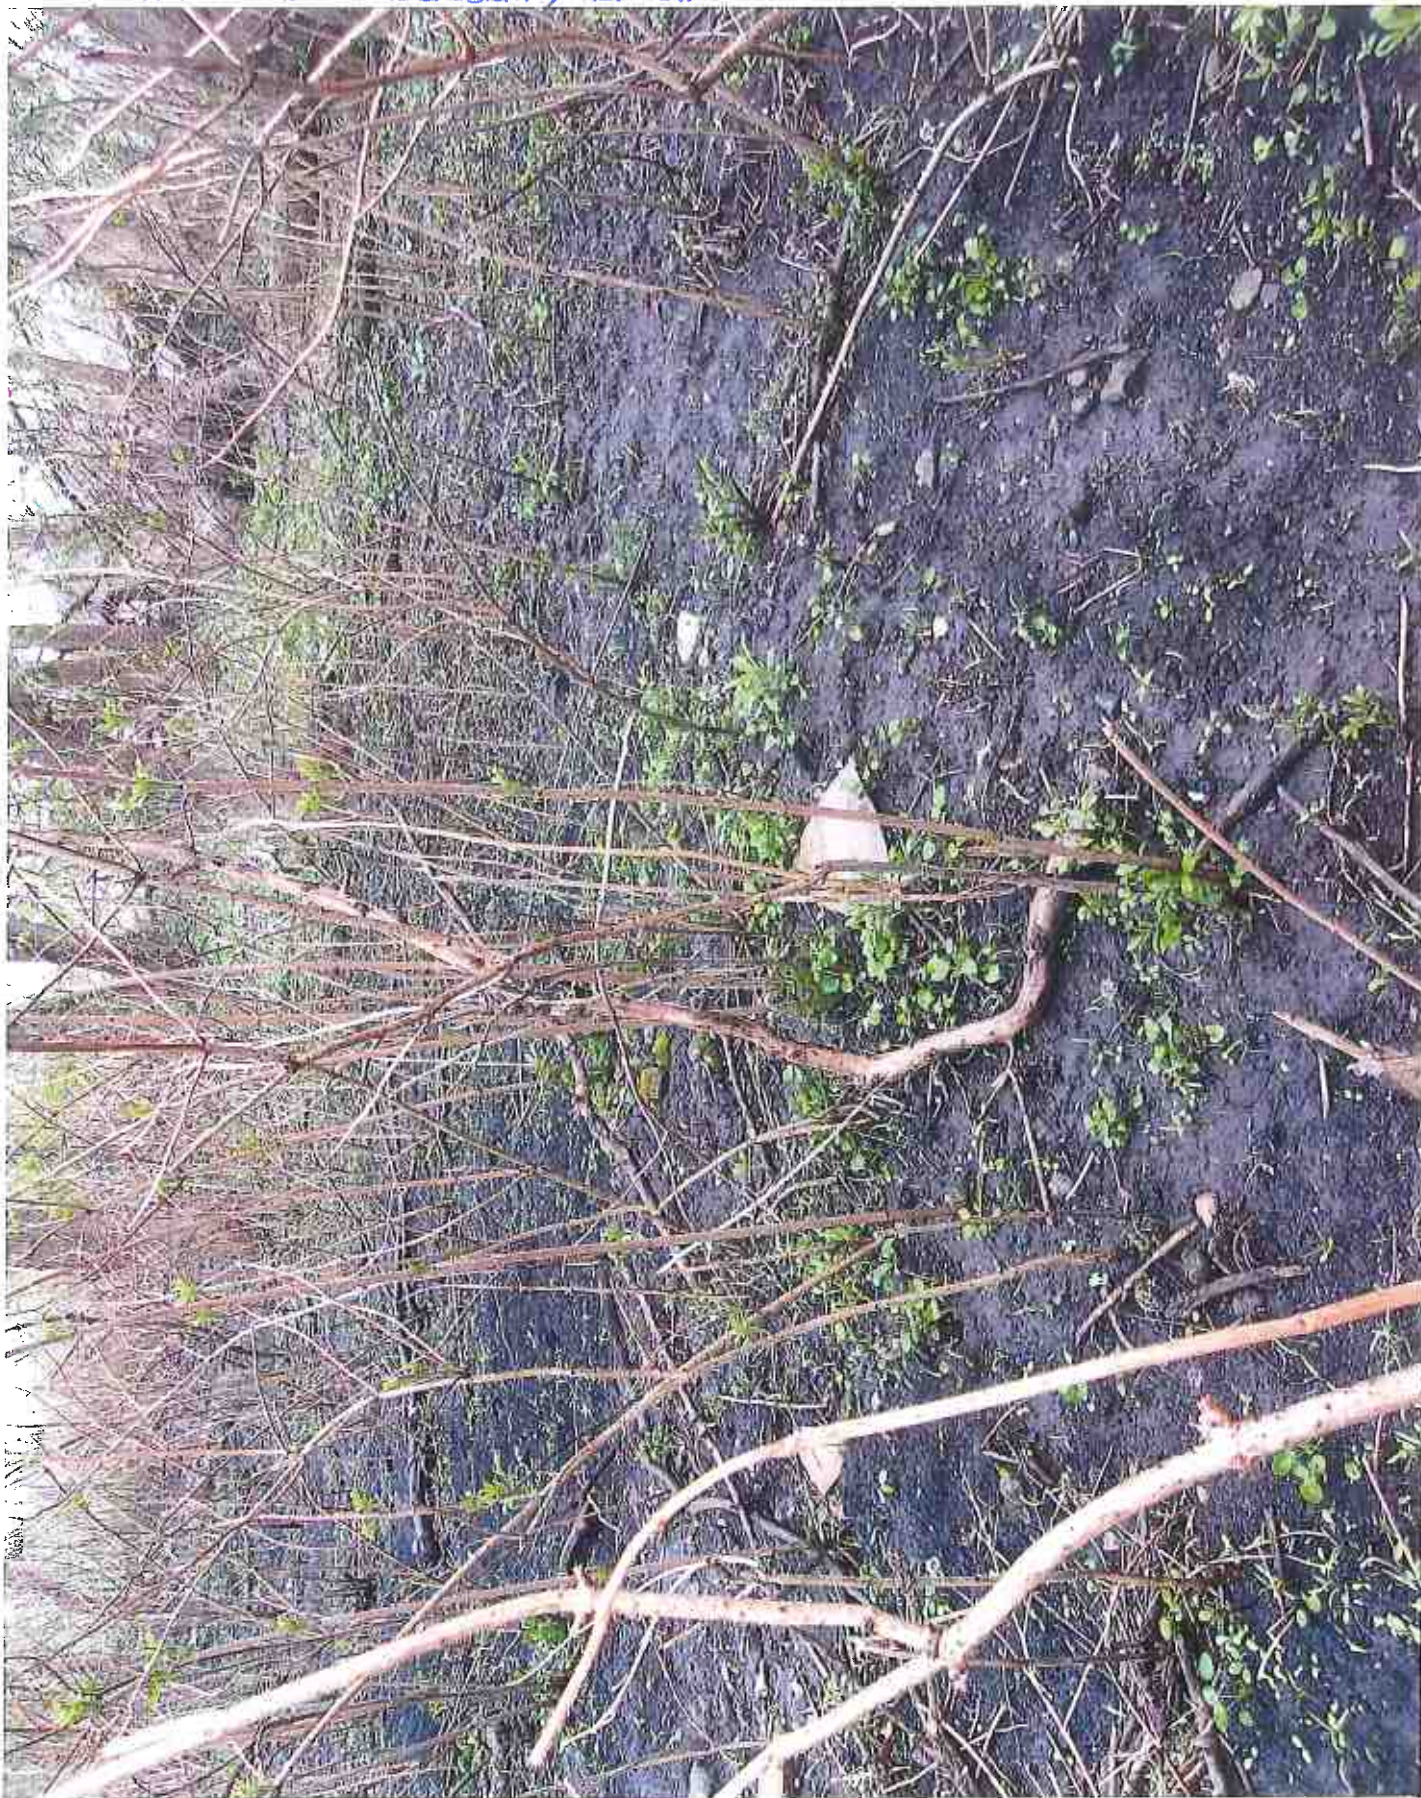
TILE REPAIR PIECES DISCARDED
