AGENDA
REGULAR DRAINAGE MEETING
February 5, 2020 9:30 AM

**ENGINEER'S REPORT
ON REPAIRS
TO MAIN TILE
DRAINAGE DISTRICT
NO. 86
HARDIN COUNTY,
IOWA**

SUPPLEMENT TO
ENGINEER'S REPORT
ON REPAIRS
TO MAIN TILE
DRAINAGE DISTRICT
NO. 86
HARDIN COUNTY,
IOWA

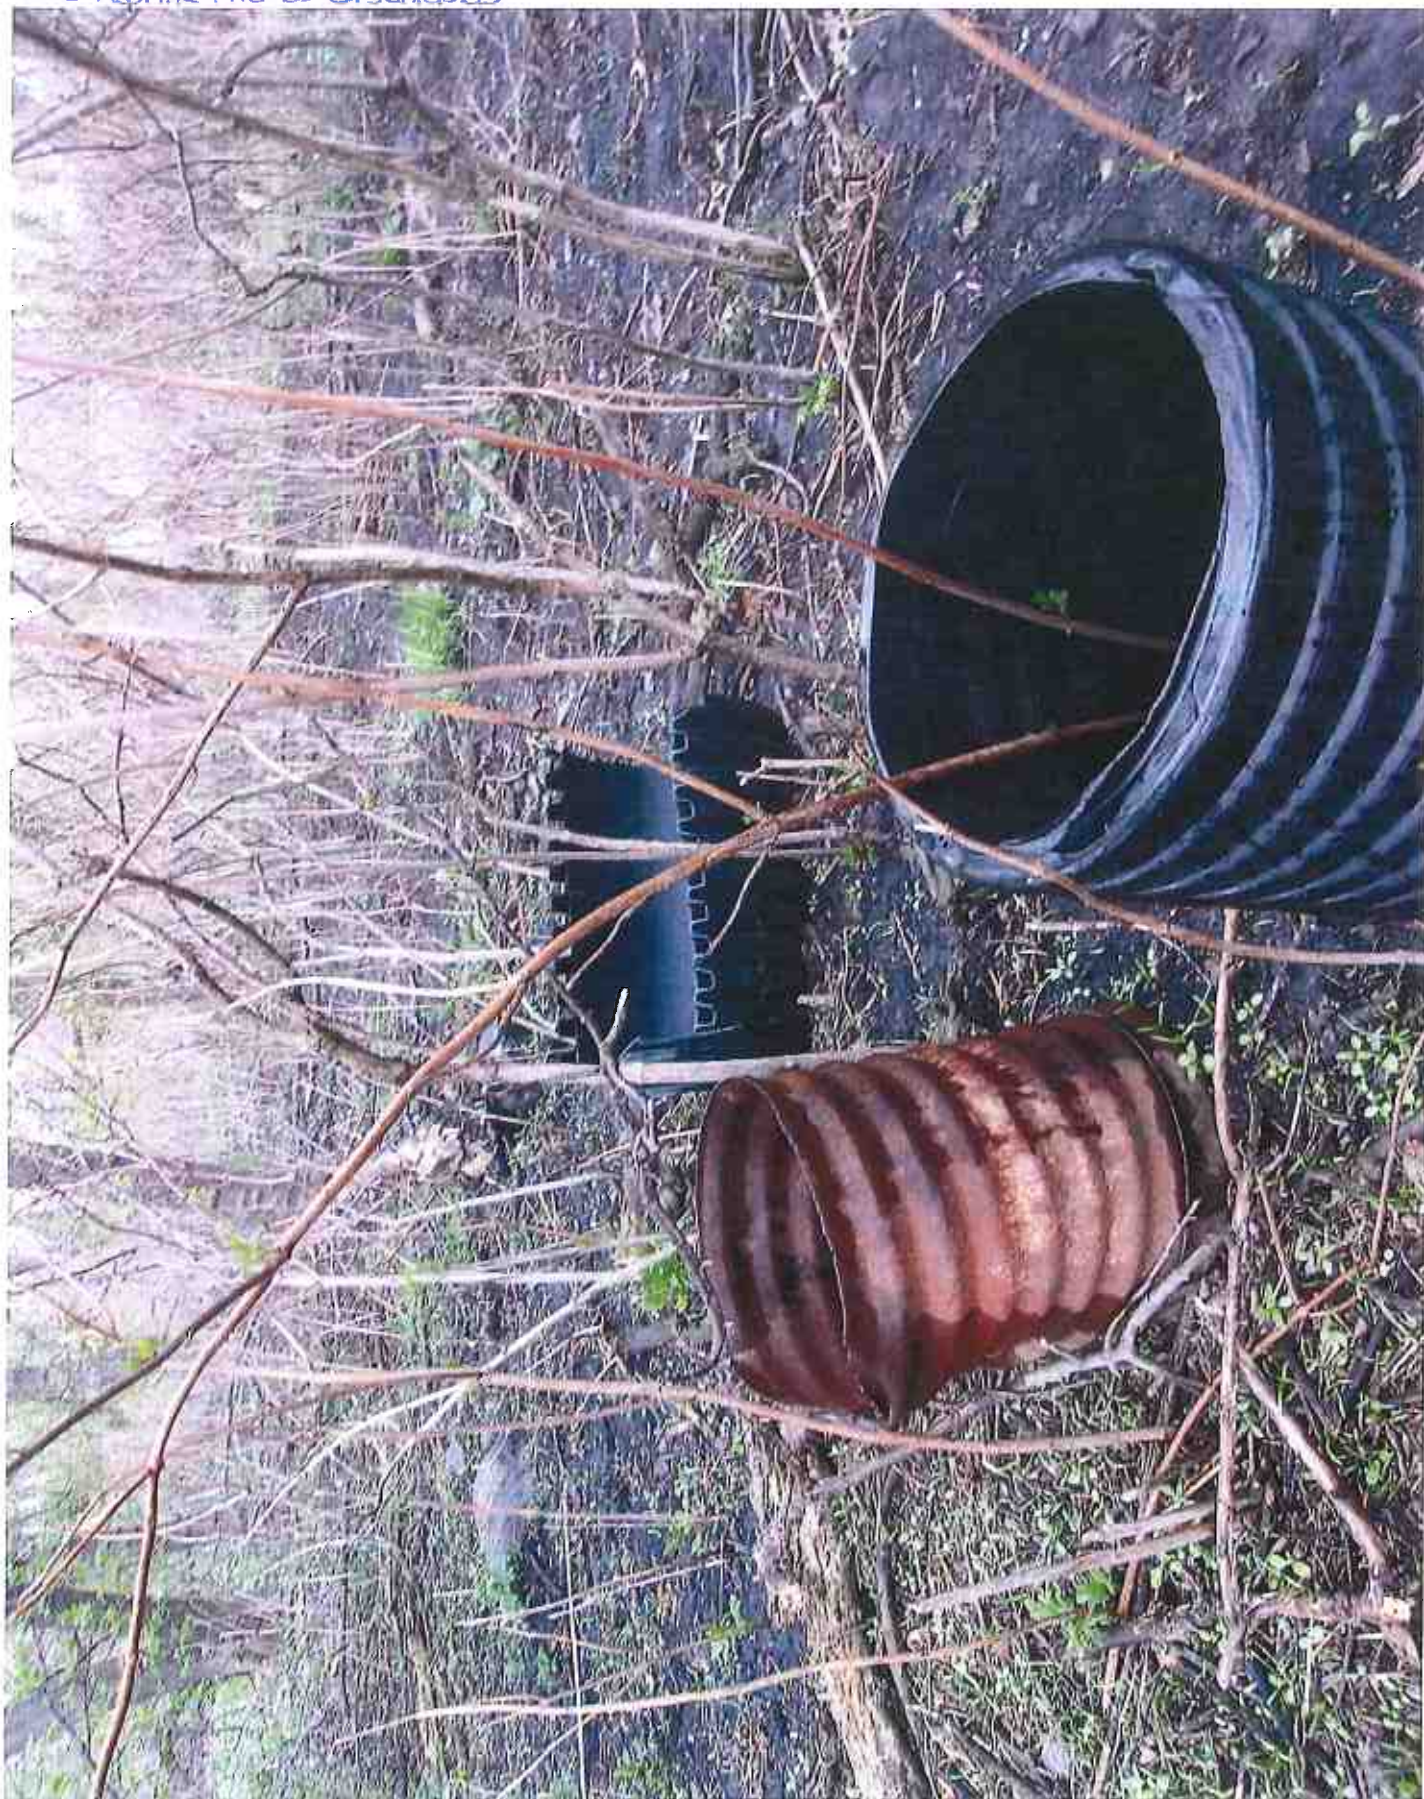
BREEZIE OVERFLOWING @ NE COR OF GEORGETOWN ADD.

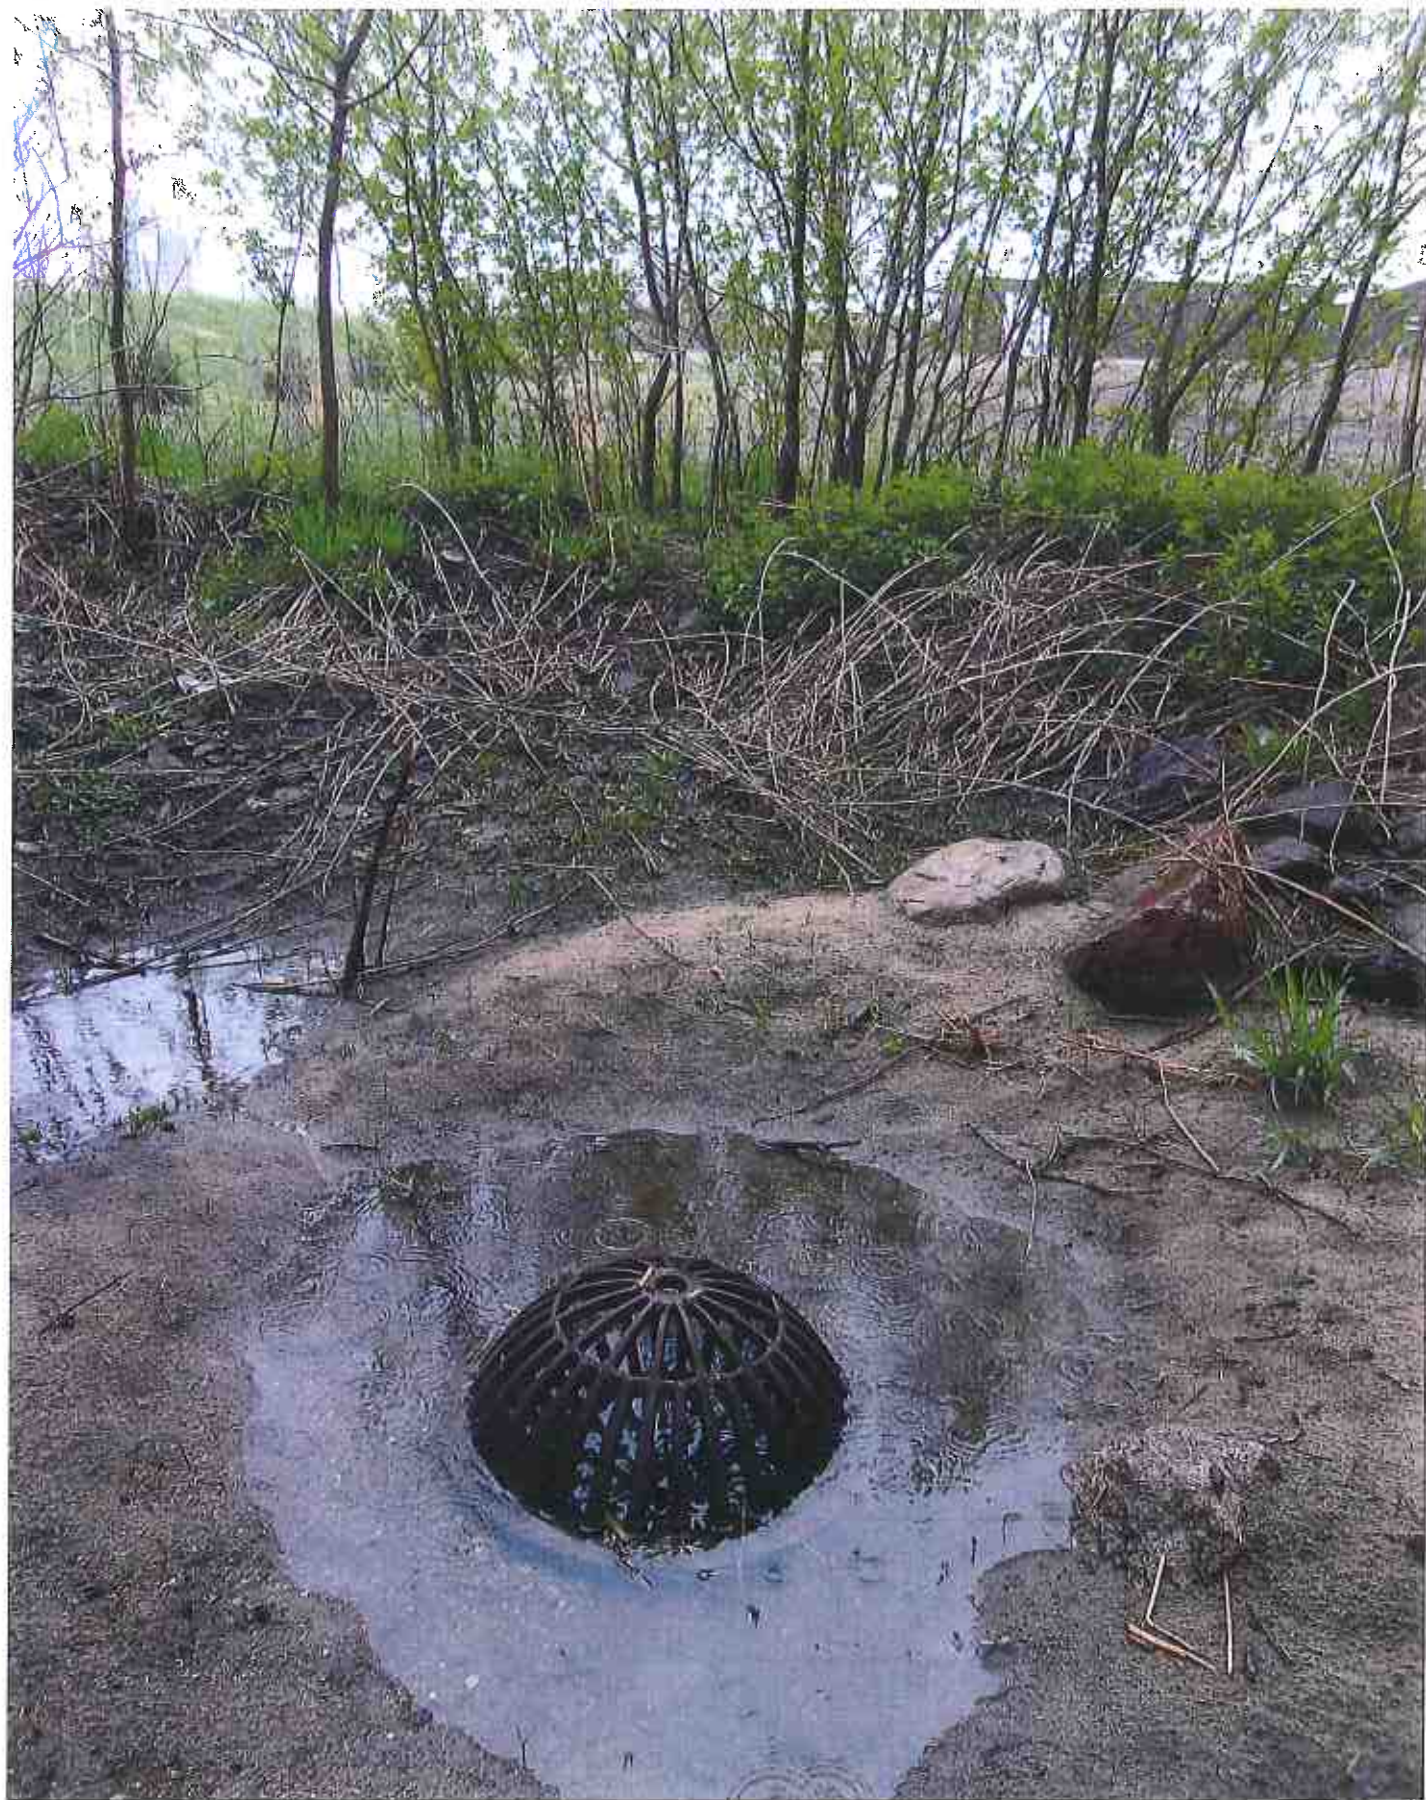
TILE HAS BEEN PARTIALLY PLUGGED FOR SOME TIME
LOOKING DOWN STREAM, NOTE ALL SEDIMENT SAND BLOWN OUT OF INTAKE

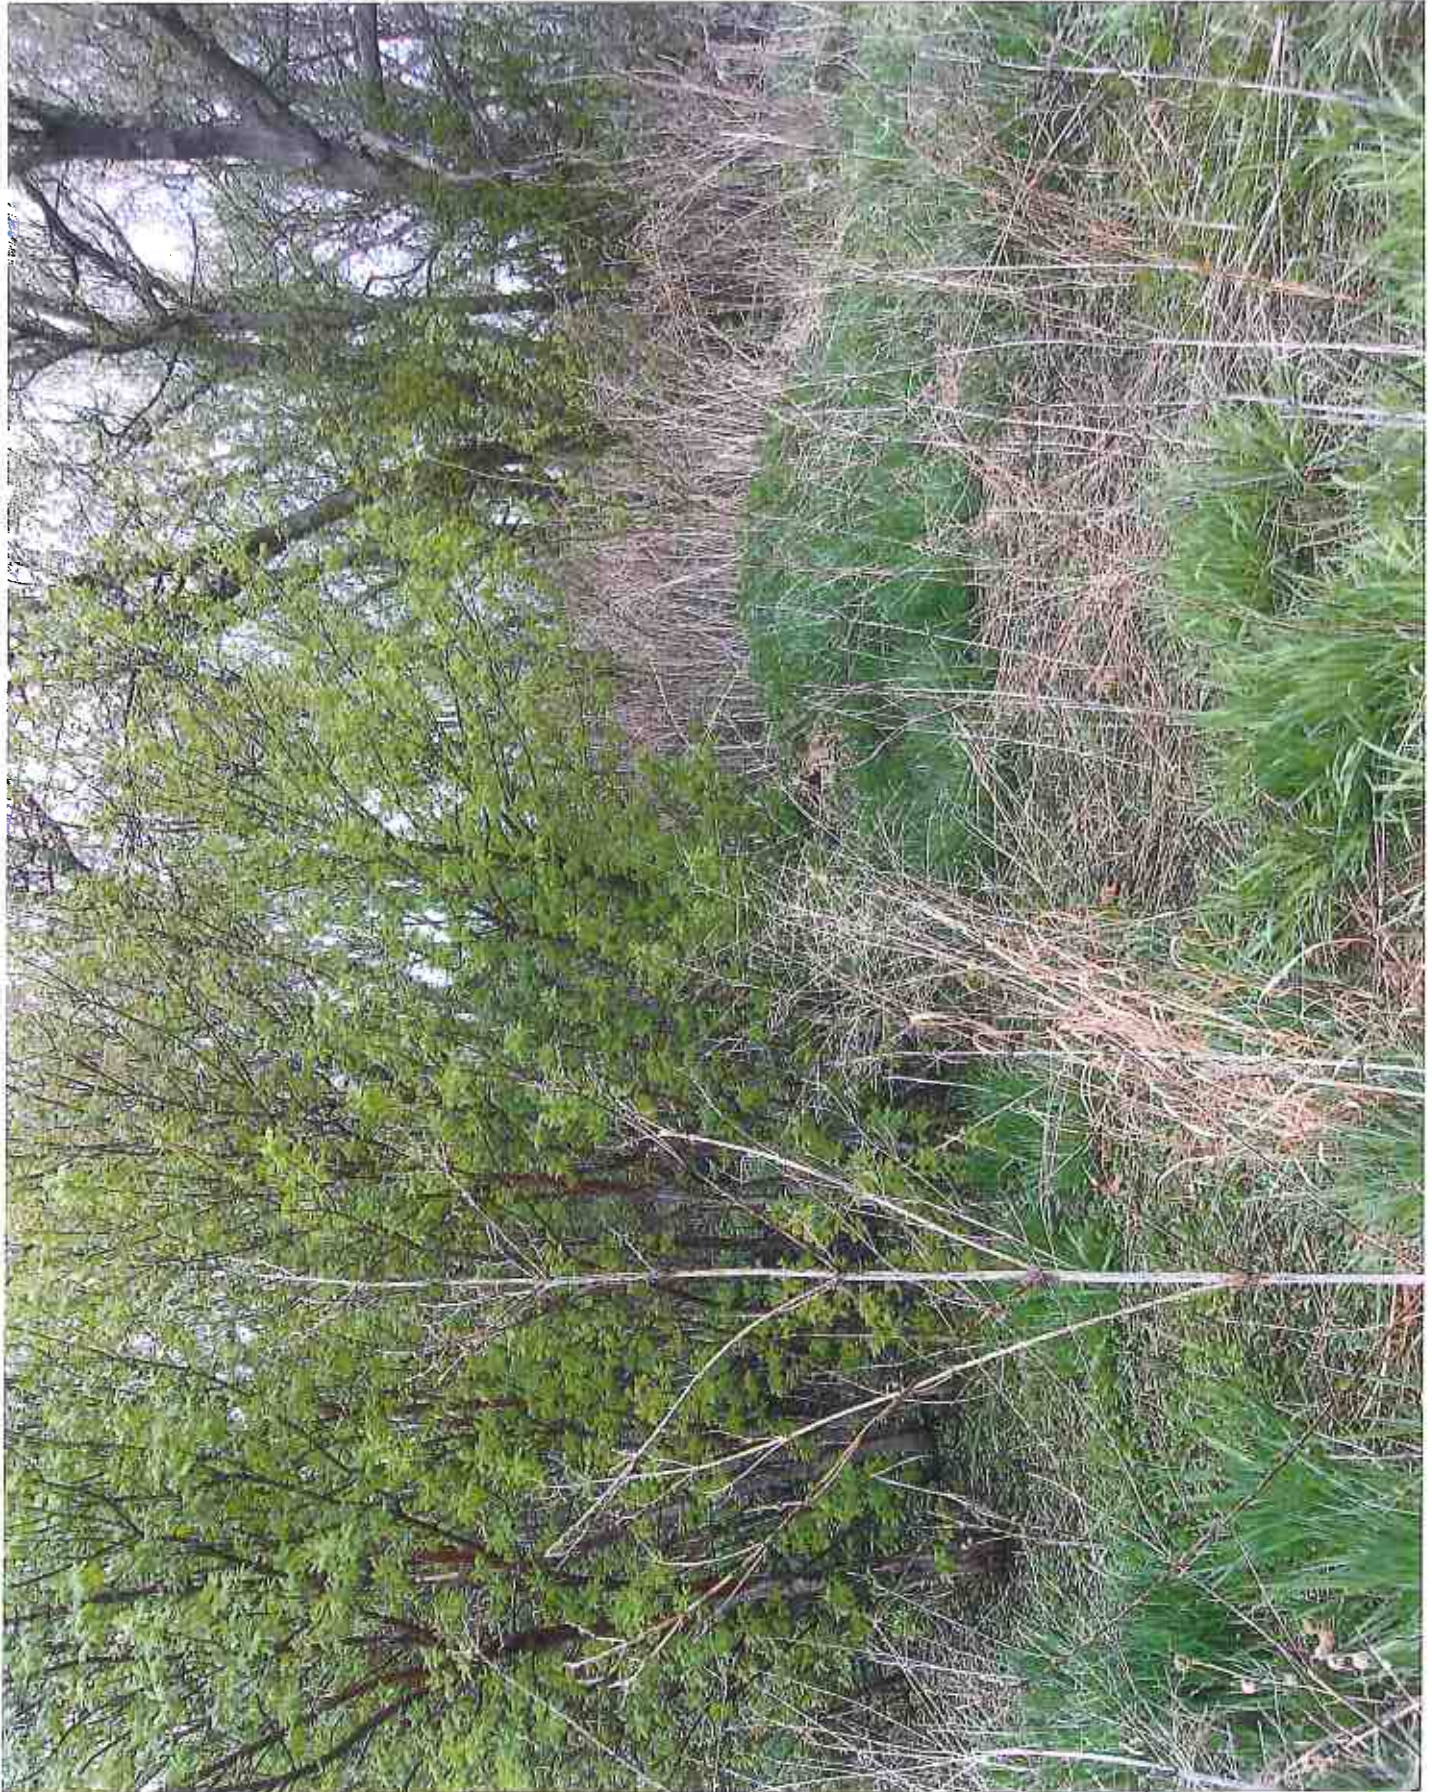
12" HICK INTAKE FULL OF WATER, SWIRLING

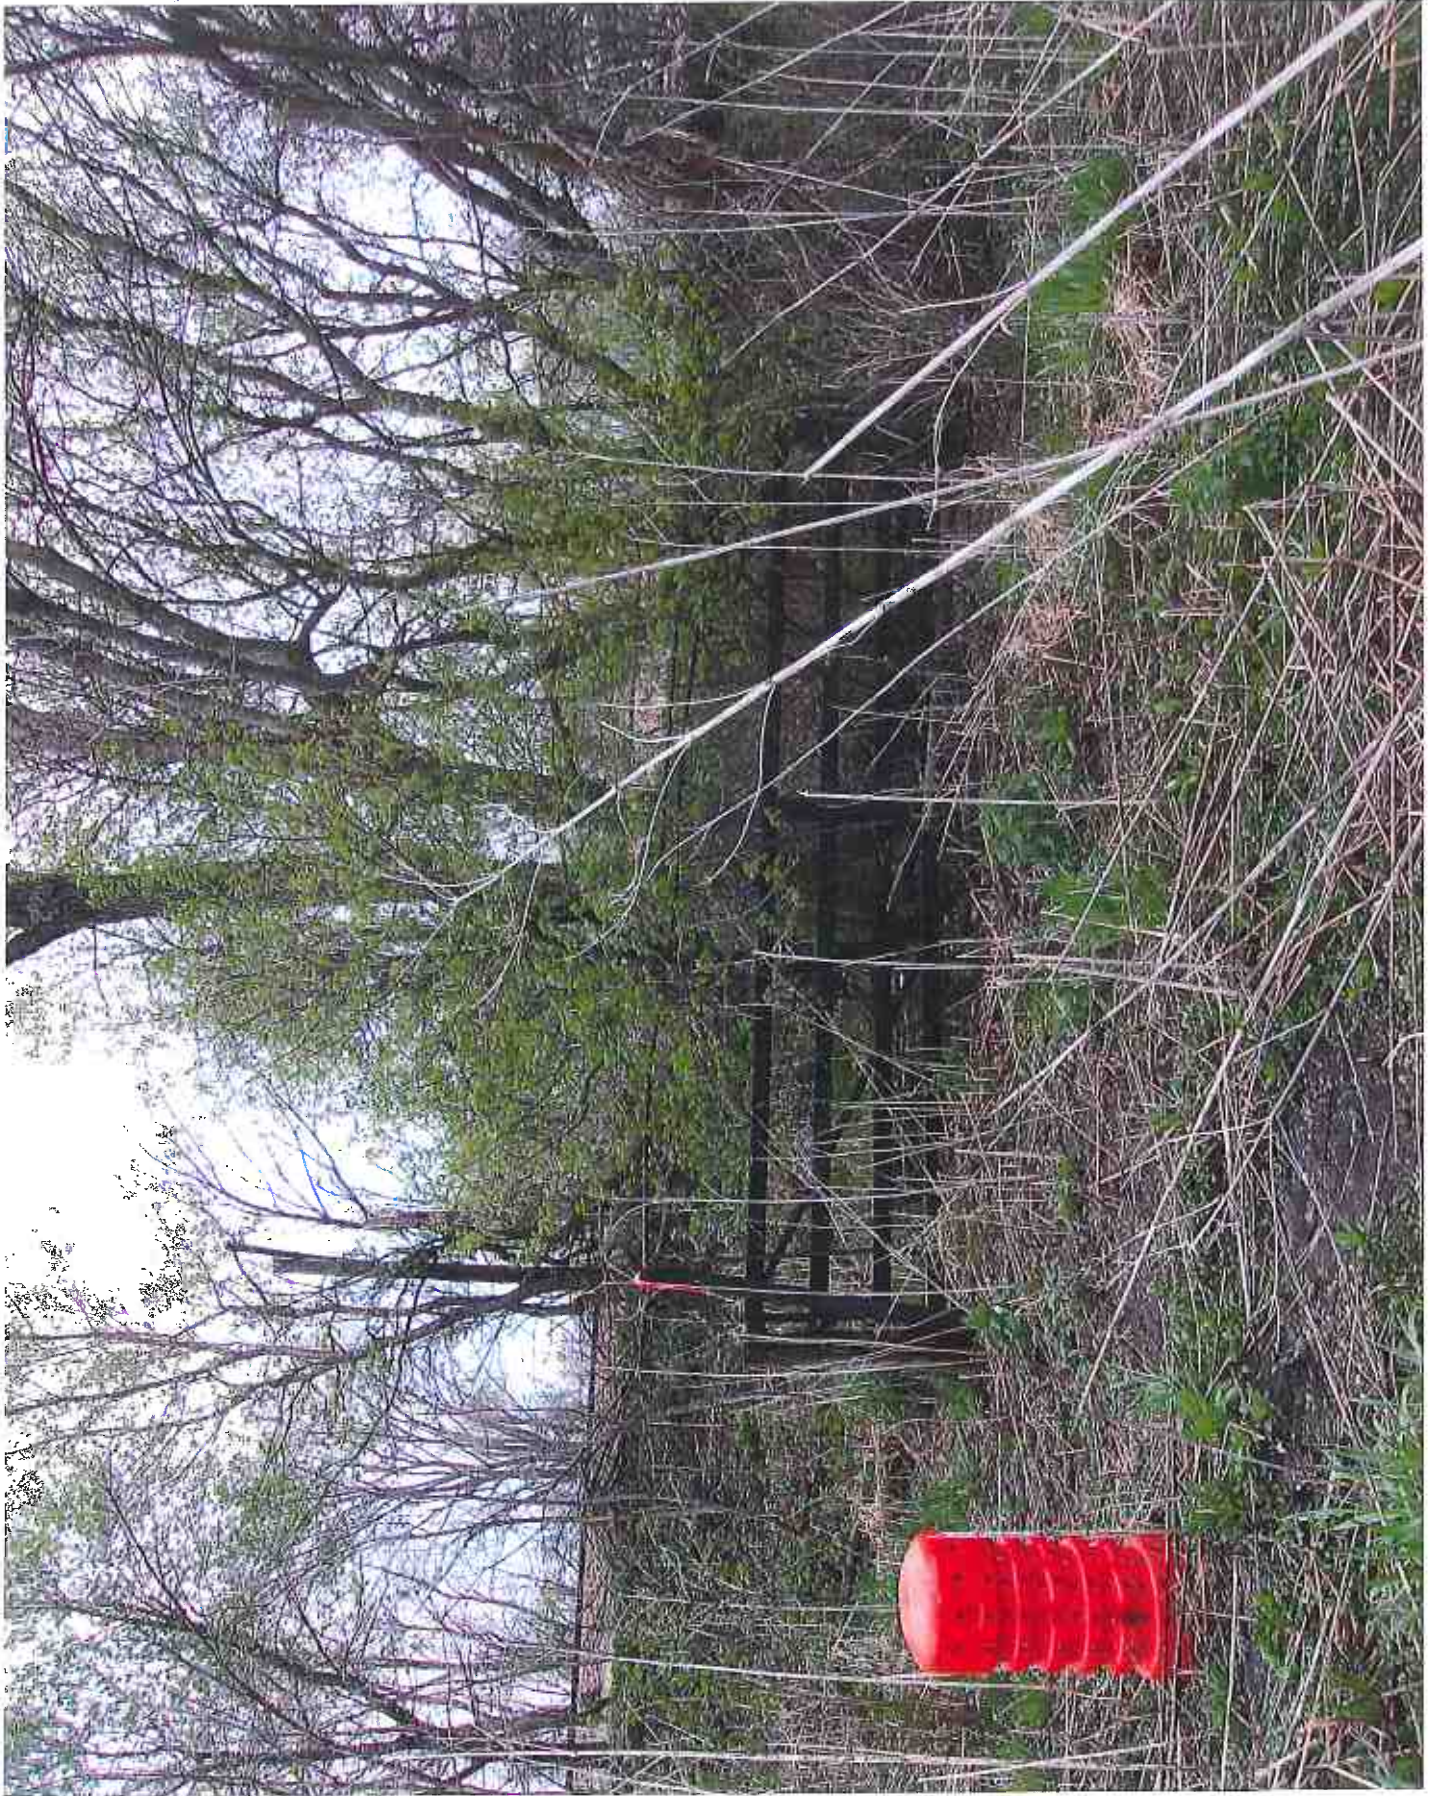
TREES IN RR R/W

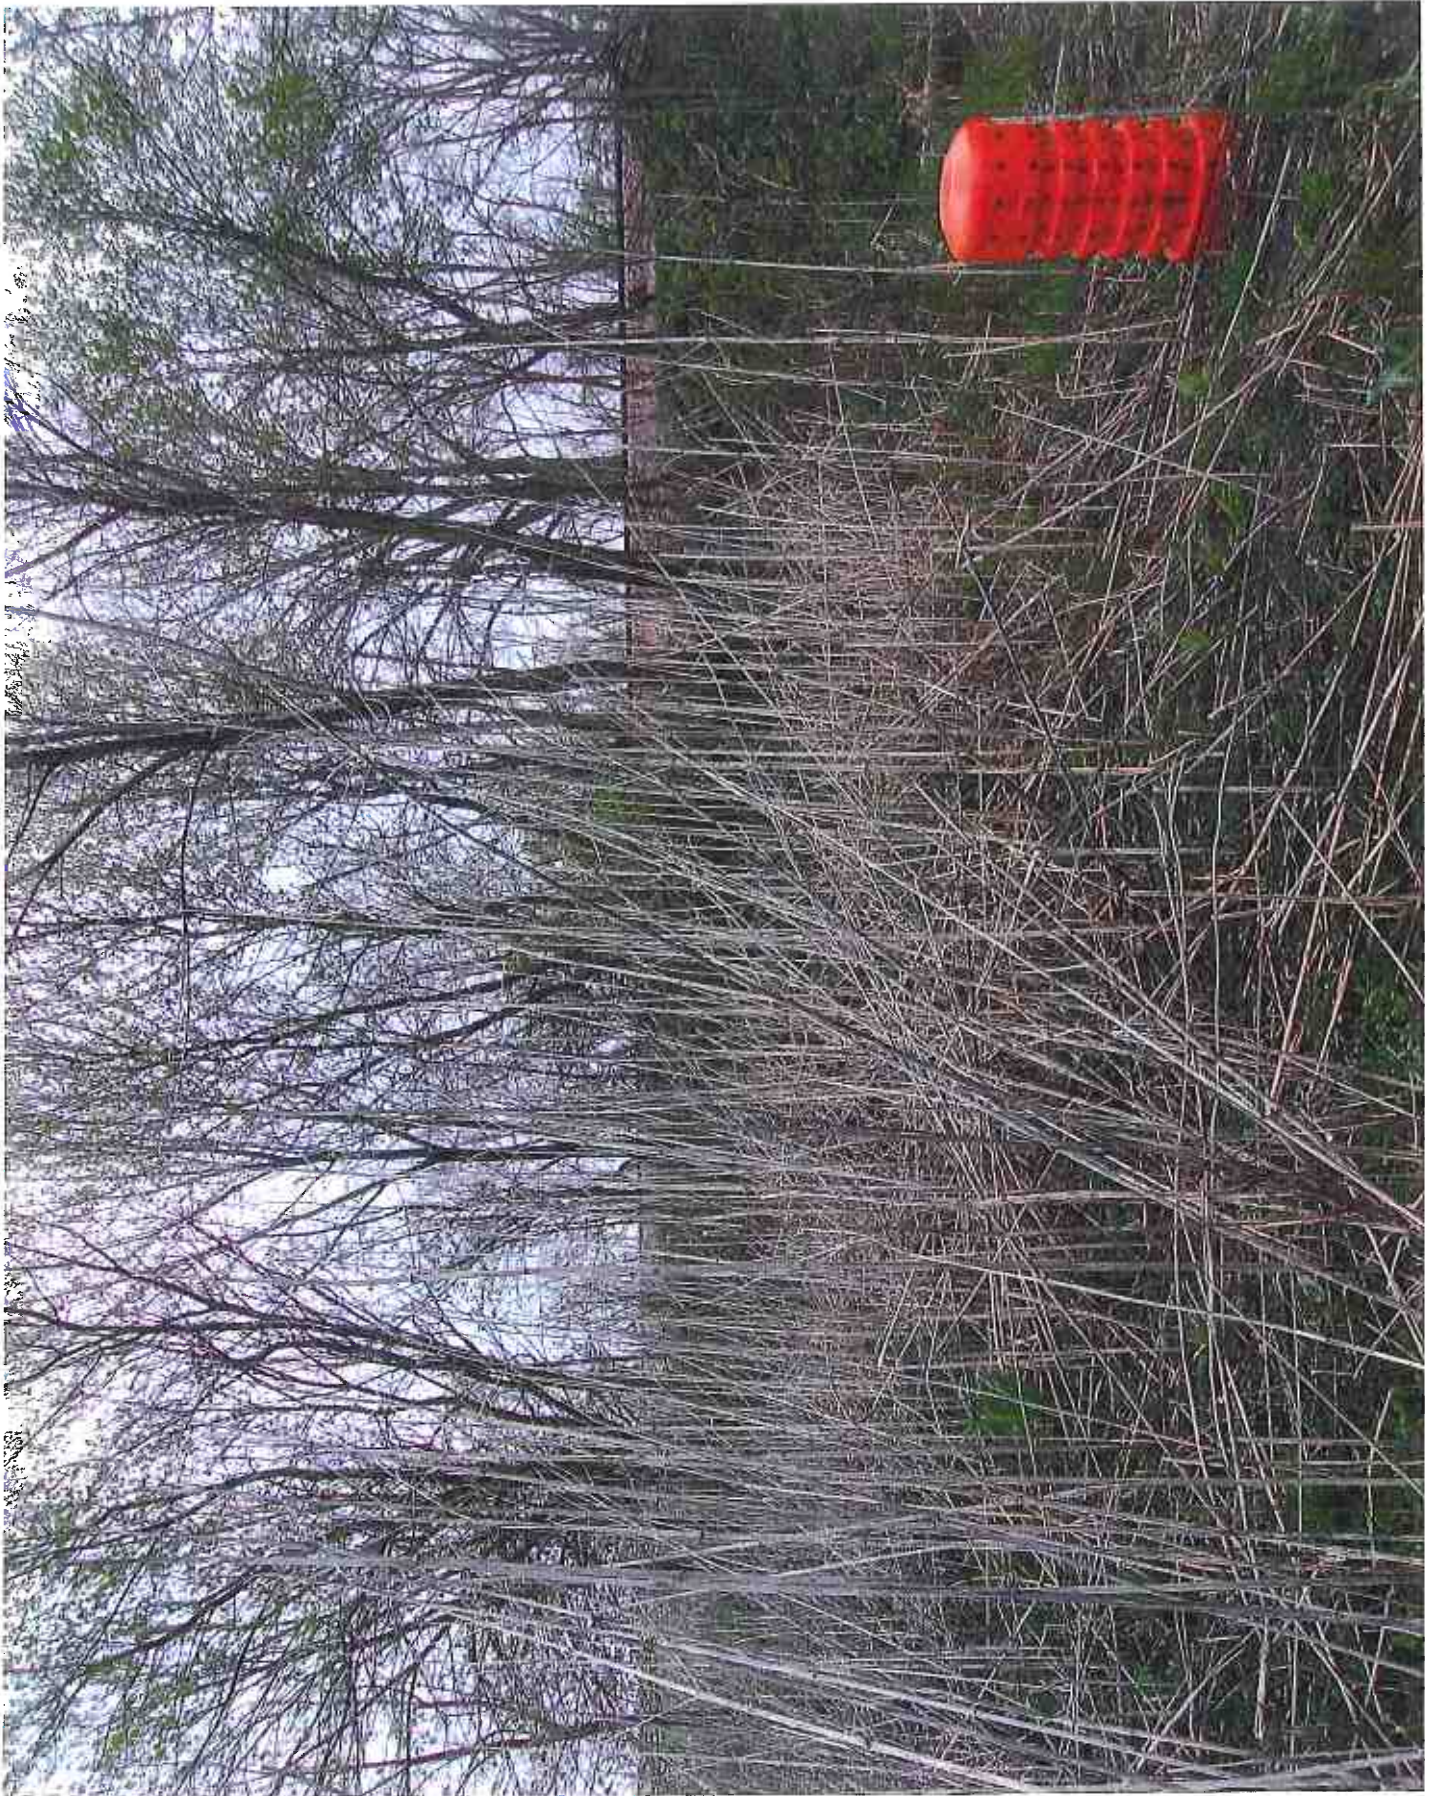
Looking downstream with 5' Ø maple that needs removed

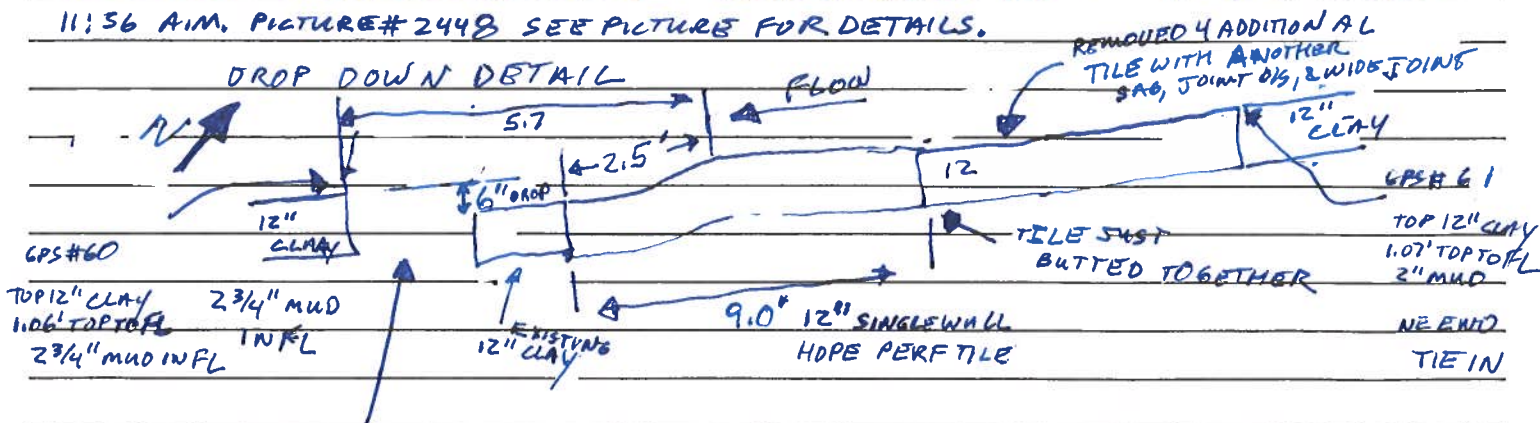
EXISTING 12" CLAY TILE BROKE & DROPPED DOWN

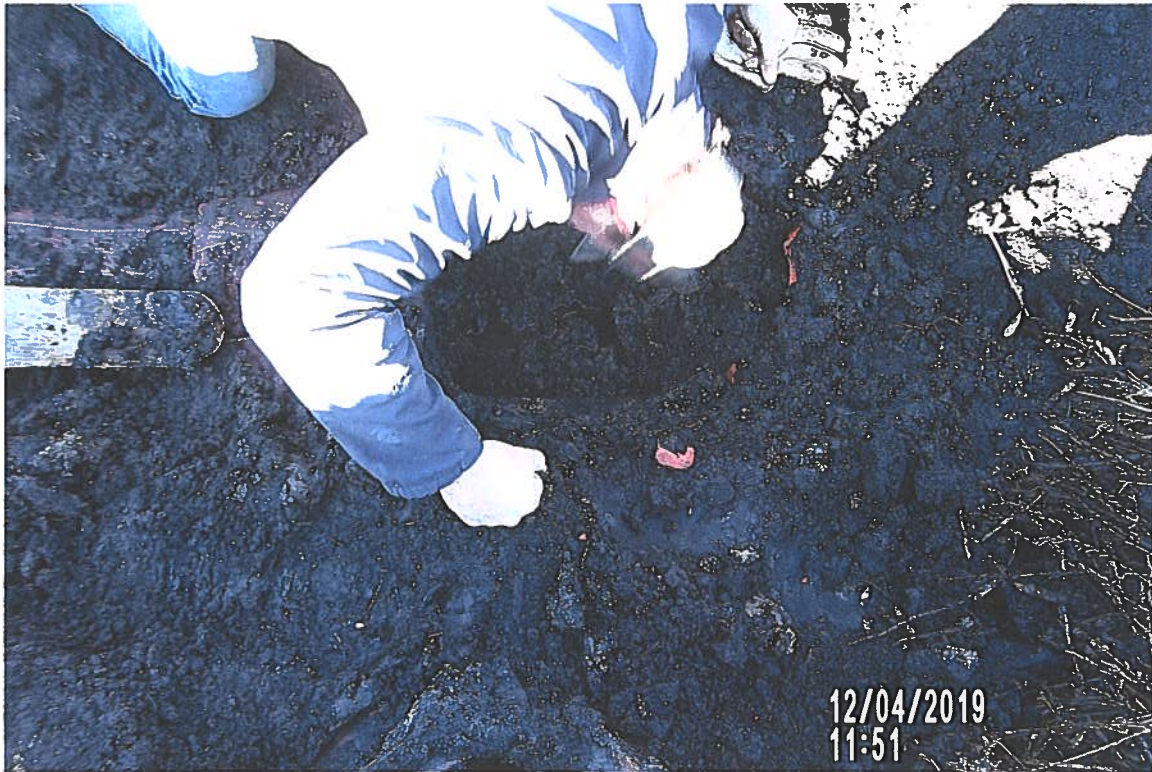
PICTURE # 2443 IS LOOKING NORTH AT 8.0' N-S X 6.0' E-W X
3.7' DEEP TILE BLOWOUT IN FIELD 593' ± NORTH OF NORTH GRAVEL
LAWE EDGE FOR WIND TOWERS E-W, 133' SOUTH OF 1/4-1/4 FENCE E-W & 741' ±
WEST OF 1/2 MILE FENCE N-S

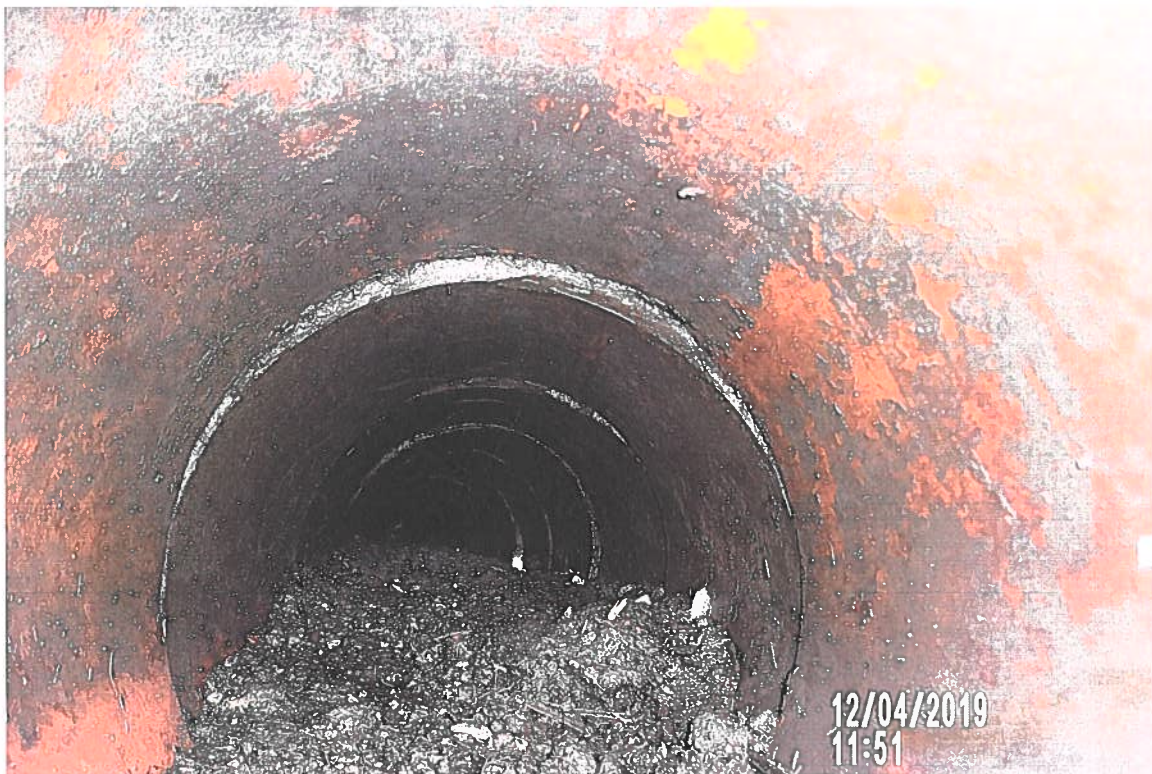
PICTURE# 2444 IS LOOKING NW SHOWING EXISTING CLAY
TILE EXPOSED WHERE TILE WAS EXPOSED IN BOTTOM
OF SINKHOLE WITH TOP OF TILE BROKE TO EAST OF EXPOSED CLAY TILE.

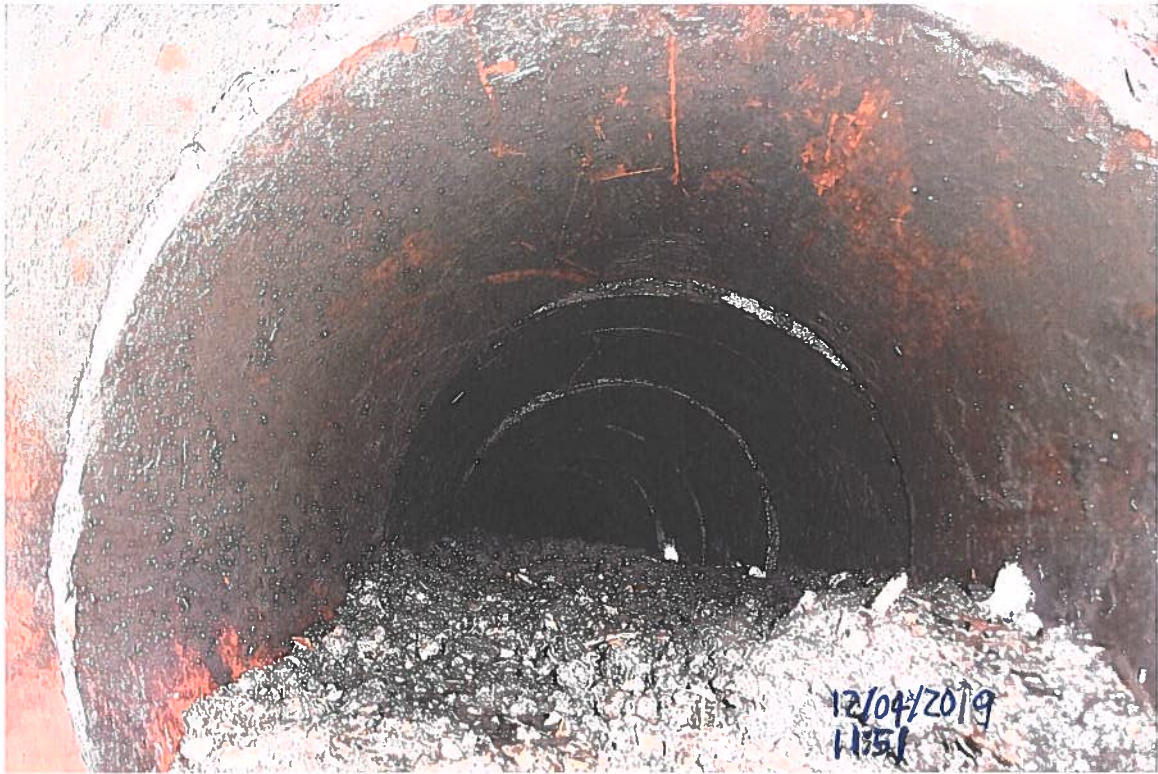
PICTURE# 2445 IS LOOKING SW AT SW END TIE IN
SHOWING 2 3/4" MUD IN FLOW LINE, NEXT JOINT SLIGHT OFFSET
BUT TILE IN GOOD SHAPE, SINCE DOWN STREAM OFFSET (NOT LIP UP)

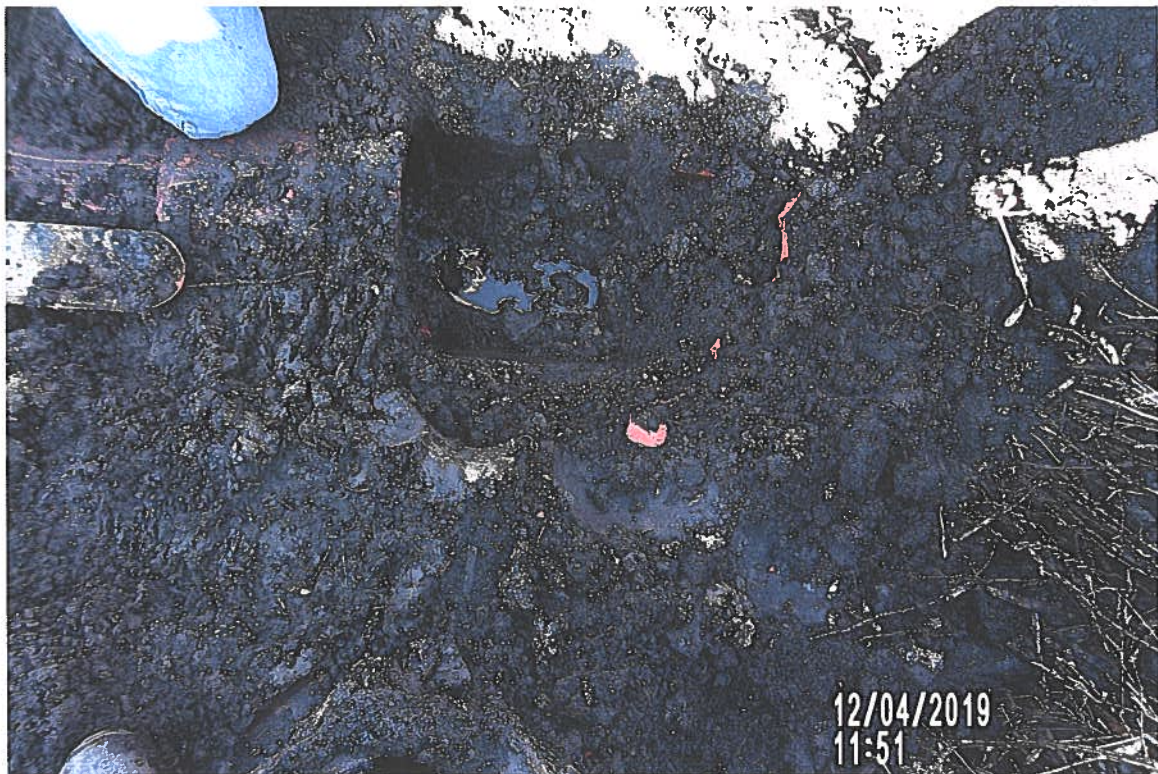
PICTURE # 2446 IS LOOKING SW INSIDE EXISTING 12" CLAY TILE
ON WEST SIDE OF REPAIR GPS#60 (1.06' TOPTO FL) 3.5'± DEEP,
TILE HAS 2¾" MUD IN FLOWLINE

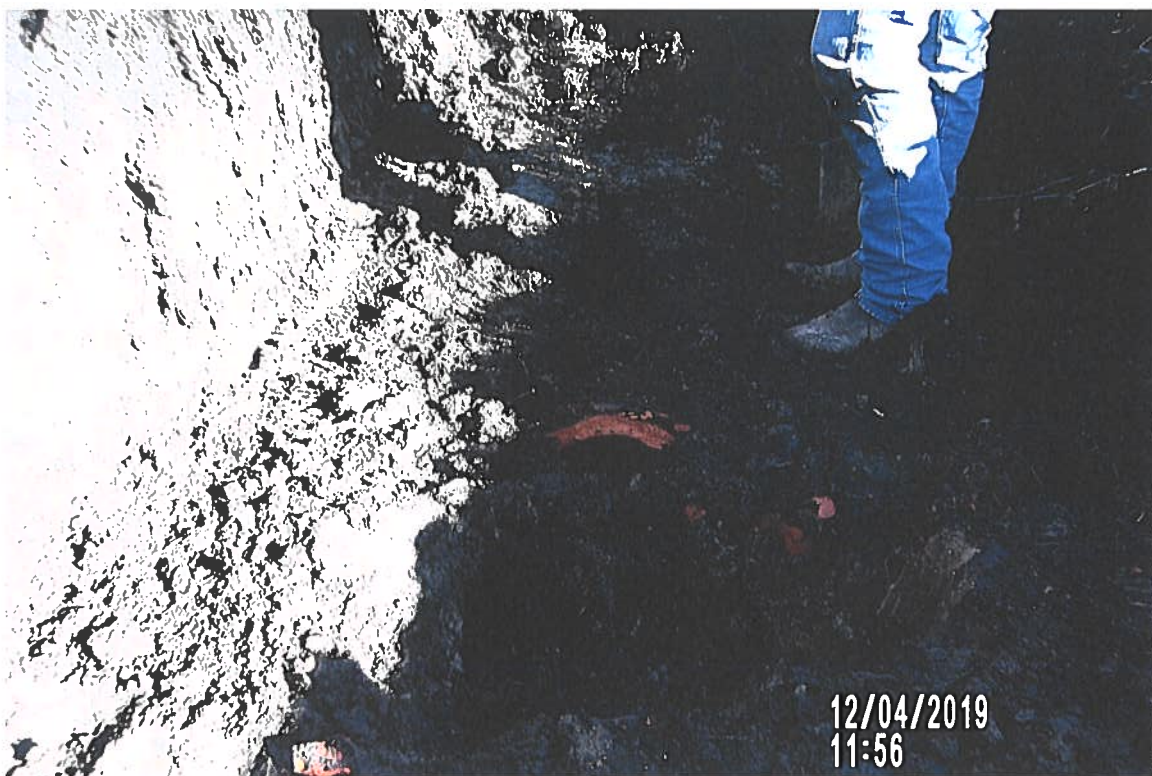
PICTURE # 2447 IS LOOKING NW SHOWING EXPOSED 8" CLAY TILE
THAT IS FULL OF MUD TO NE (UPSTREAM) AT TILE BLOWOUT (TOP SECTION)
BROKE OUT. DOWNSTREAM TO SW HAS 2¾" MUD IN FLOW LINE,

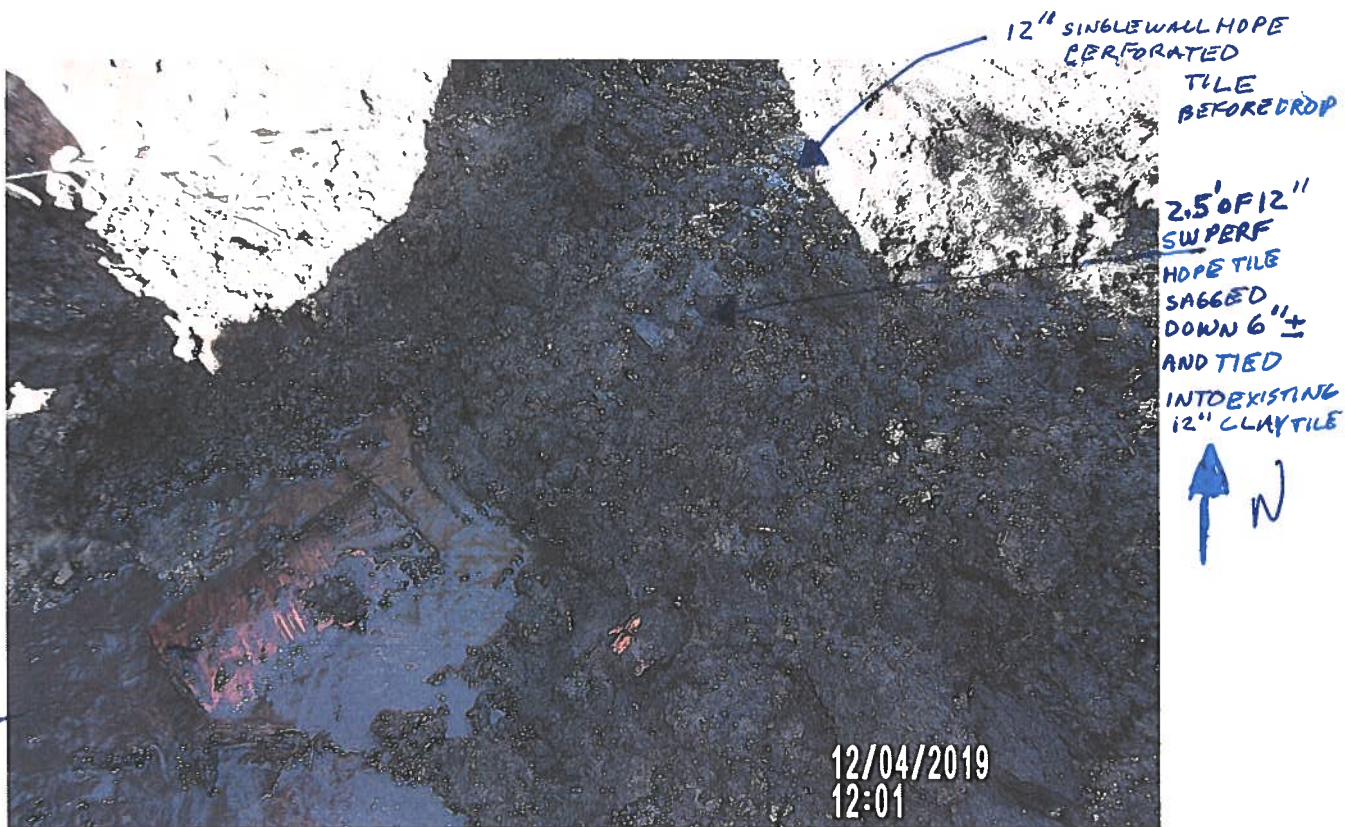
PICTURE #2448 IS LOOKING NE ON EAST END OF REPAIR SHOWING SLIGHT SAG IN CLAY TILE THAT WILL BE REMOVED WITH 4 ADDITIONAL CLAY TILE.

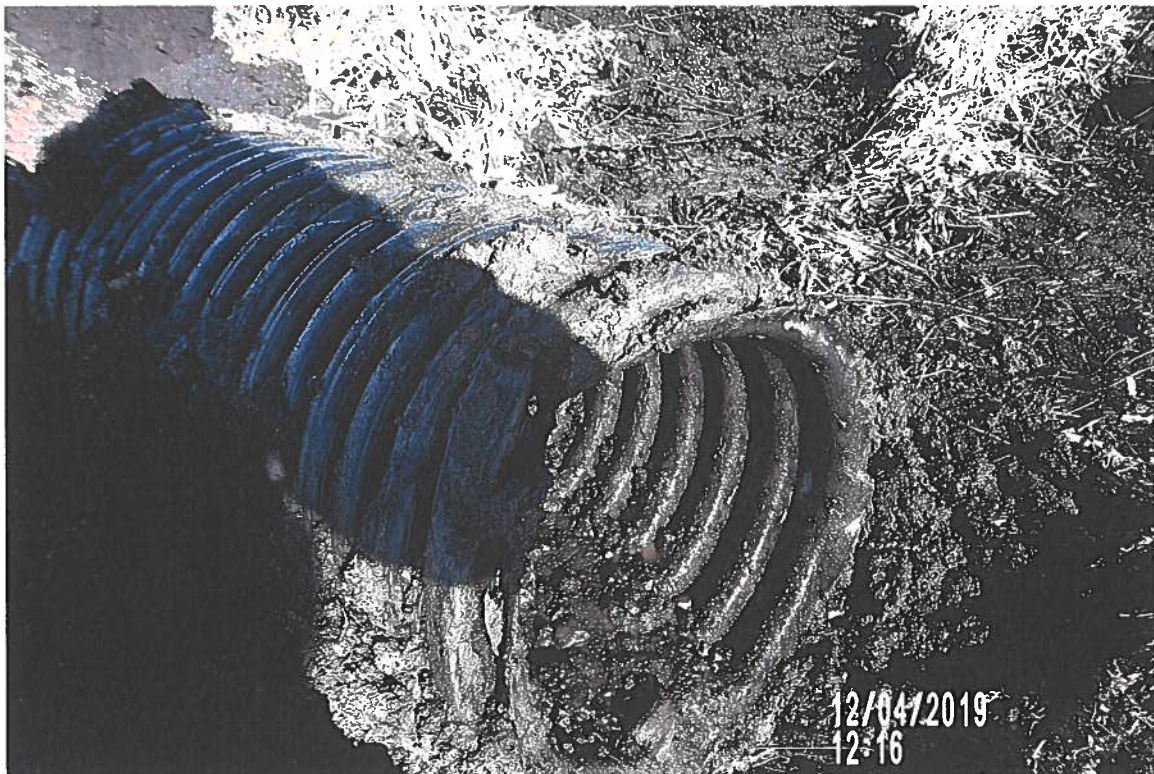
PICTURE# 2451 SHOWING 12" SINGLE WALL PERFORATED TILE
 IN DROP DOWN AREA FOR PREVIOUS REPAIR

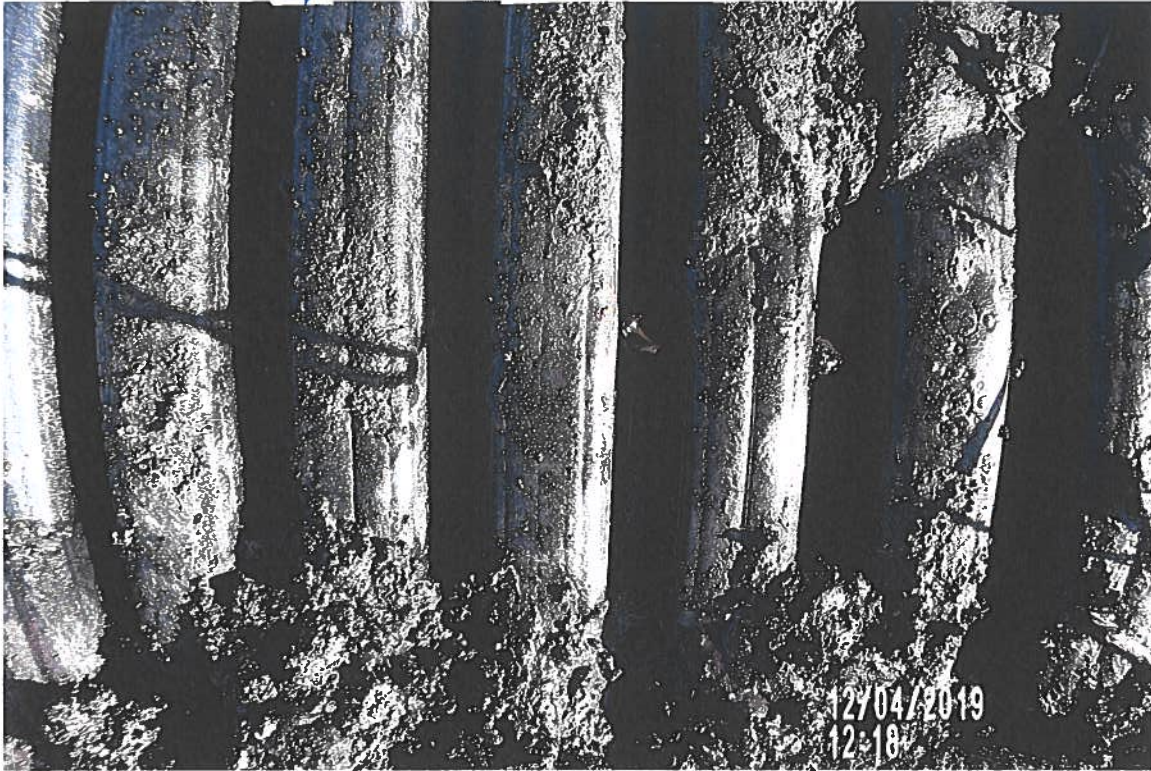
PICTURE # 2452 . SHOWING PERFORATIONS ON THE 9.0' OF
 12" SINGLE WALL HDPE TILE THAT LATERAL #1 WAS REPAIRED WITH
 AT SOMETIME. WEST 2.5' OF THIS TILE DROVE DOWN SEVERELY AND TIED INTO
 EAST END OF EXISTING 12" CLAY TILE THAT HAD SAGGED DOWN 6" COMPARED TO EXISTING

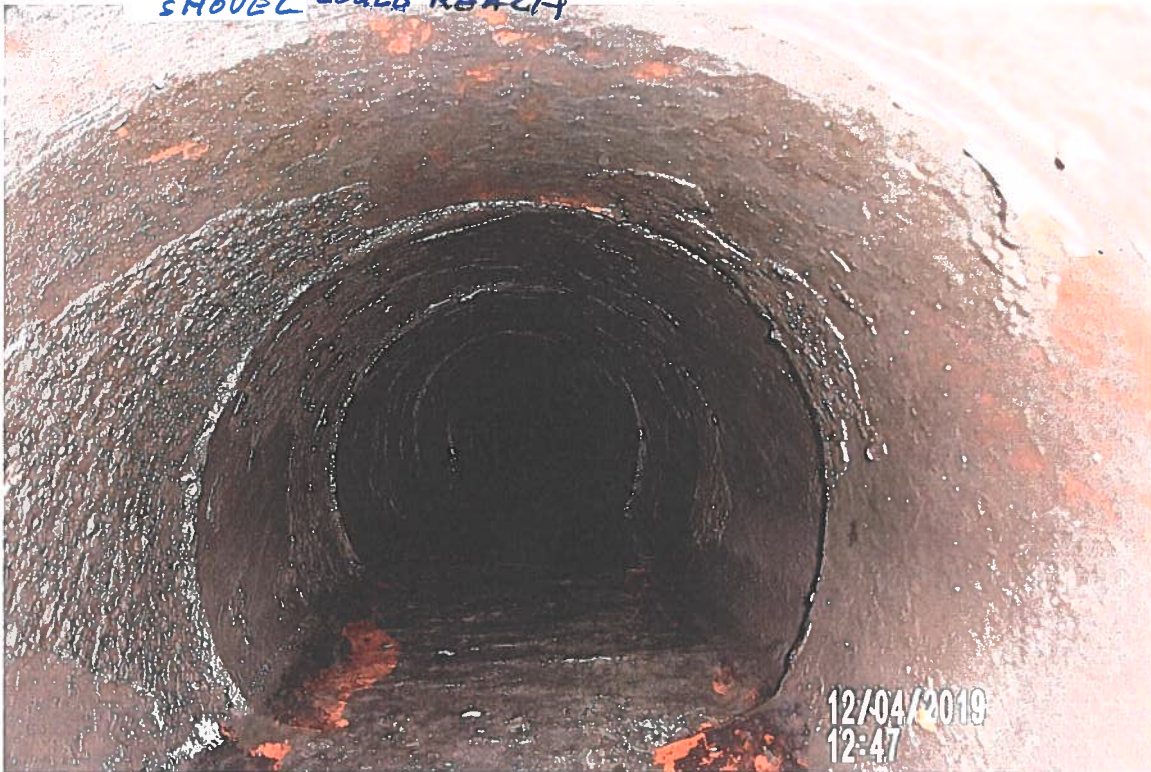
PICTURE # 2453 IS LOOKING SW SHOWING 4 SECTIONS OF
 CLAY TILE THAT WILL BE REPLACED DUE TO A SLIGHT SAG &
 ONE WITH AN OFFSET/WIDE JOINT ON EAST END OF REPAIR.
