AGENDA
REGULAR DRAINAGE MEETING
February 5, 2020 9:30 AM

**ENGINEER'S REPORT
ON REPAIRS
TO MAIN TILE
DRAINAGE DISTRICT
NO. 86
HARDIN COUNTY,
IOWA**

SUPPLEMENT TO
ENGINEER'S REPORT
ON REPAIRS
TO MAIN TILE
DRAINAGE DISTRICT
NO. 86
HARDIN COUNTY,
IOWA

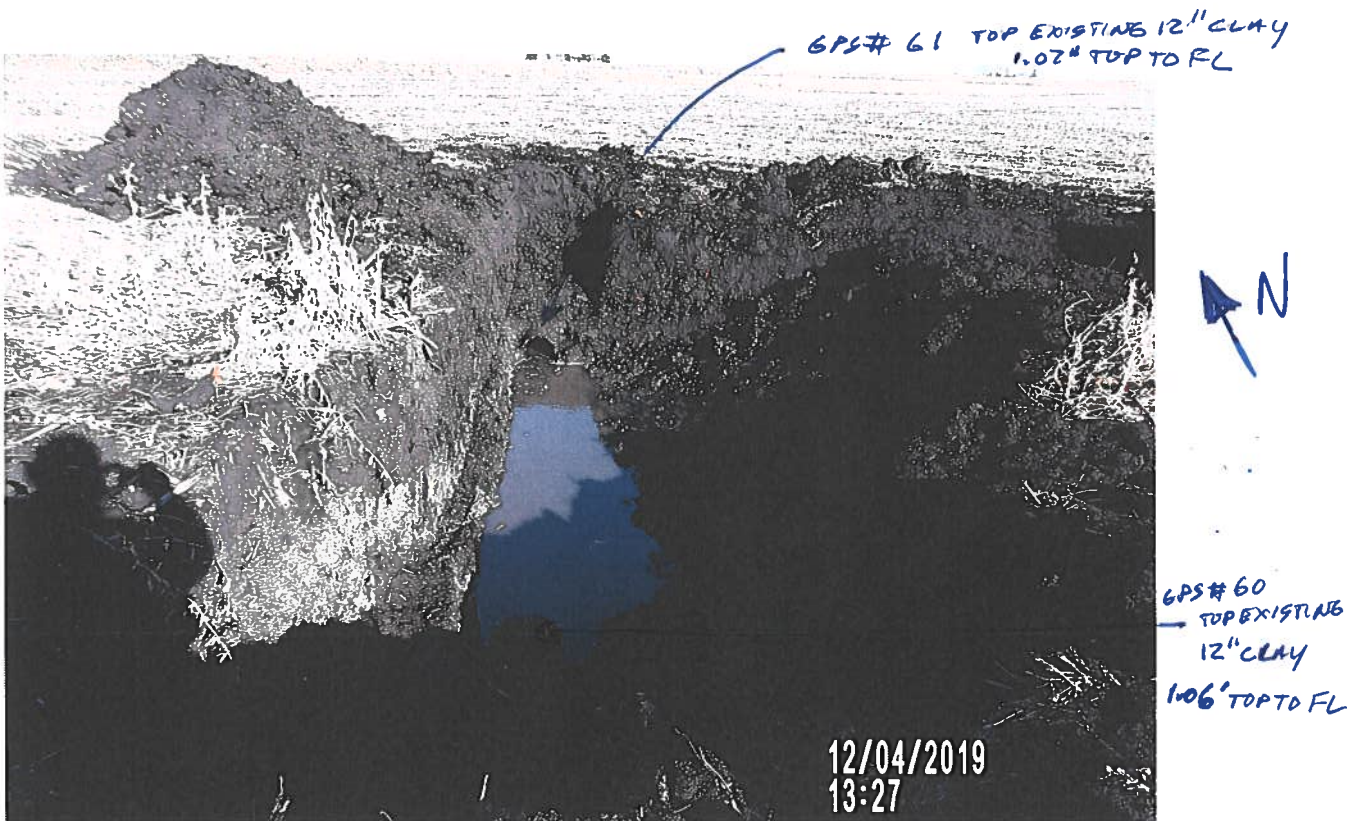
PICTURE# 2454 IS LOOKING NE INSIDE 12" CLAY TILE
ON NE END TIE IN OF REPAIR, HAD 2" MUCK IN FLOW
LINE BUT RAN SHOVEL UP & REMOVED AS FAR AS
SHOVEL COULD REACH

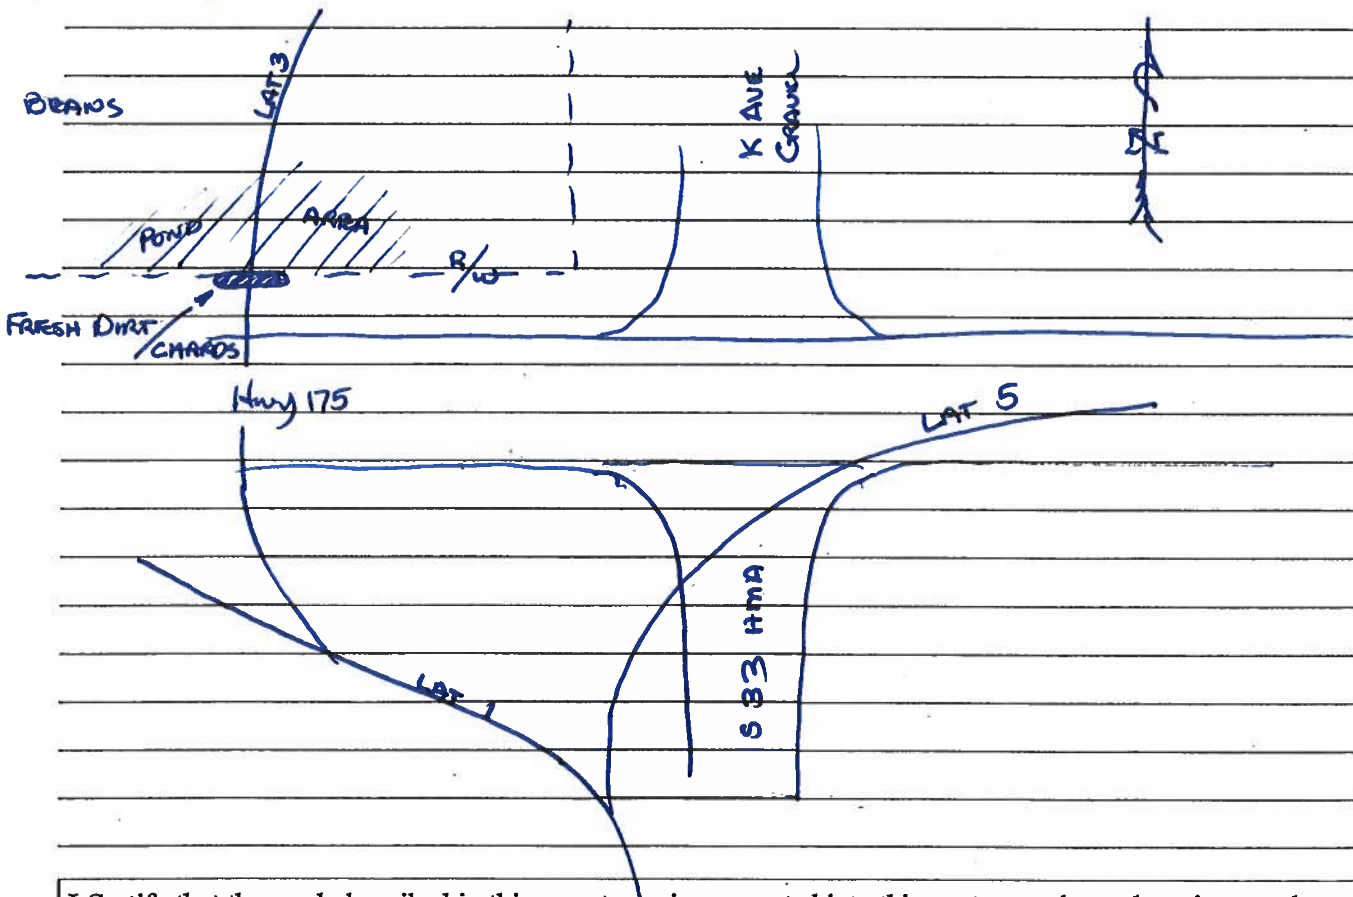
DROVE TO INTERSECTION OF Hwy 175 AND HUBBARD BLACKTOP STREET LAT
S33, WALKED ALONG N. R/W OF Hwy. FOUND FRESHLY DUG
TILE REPAIR DIRT WITH OLD VGP CHARDS OF 12"±, KEPT WALKING
TO 1/2 MILE POINT OF LAT 1. DID NOT SEE ANY OTHER TILE HOUSES OR
REPAIRS. THE PLACE OF THE FRESH DIRT WAS @ LAT 3 (MOST LIKELY) ROUTE.
LOOKS LIKE A POND OF WATER WAS SETTING THERE WITH CORN STALKS
PILED UP @ R/W GRASS DRAIN LINE.

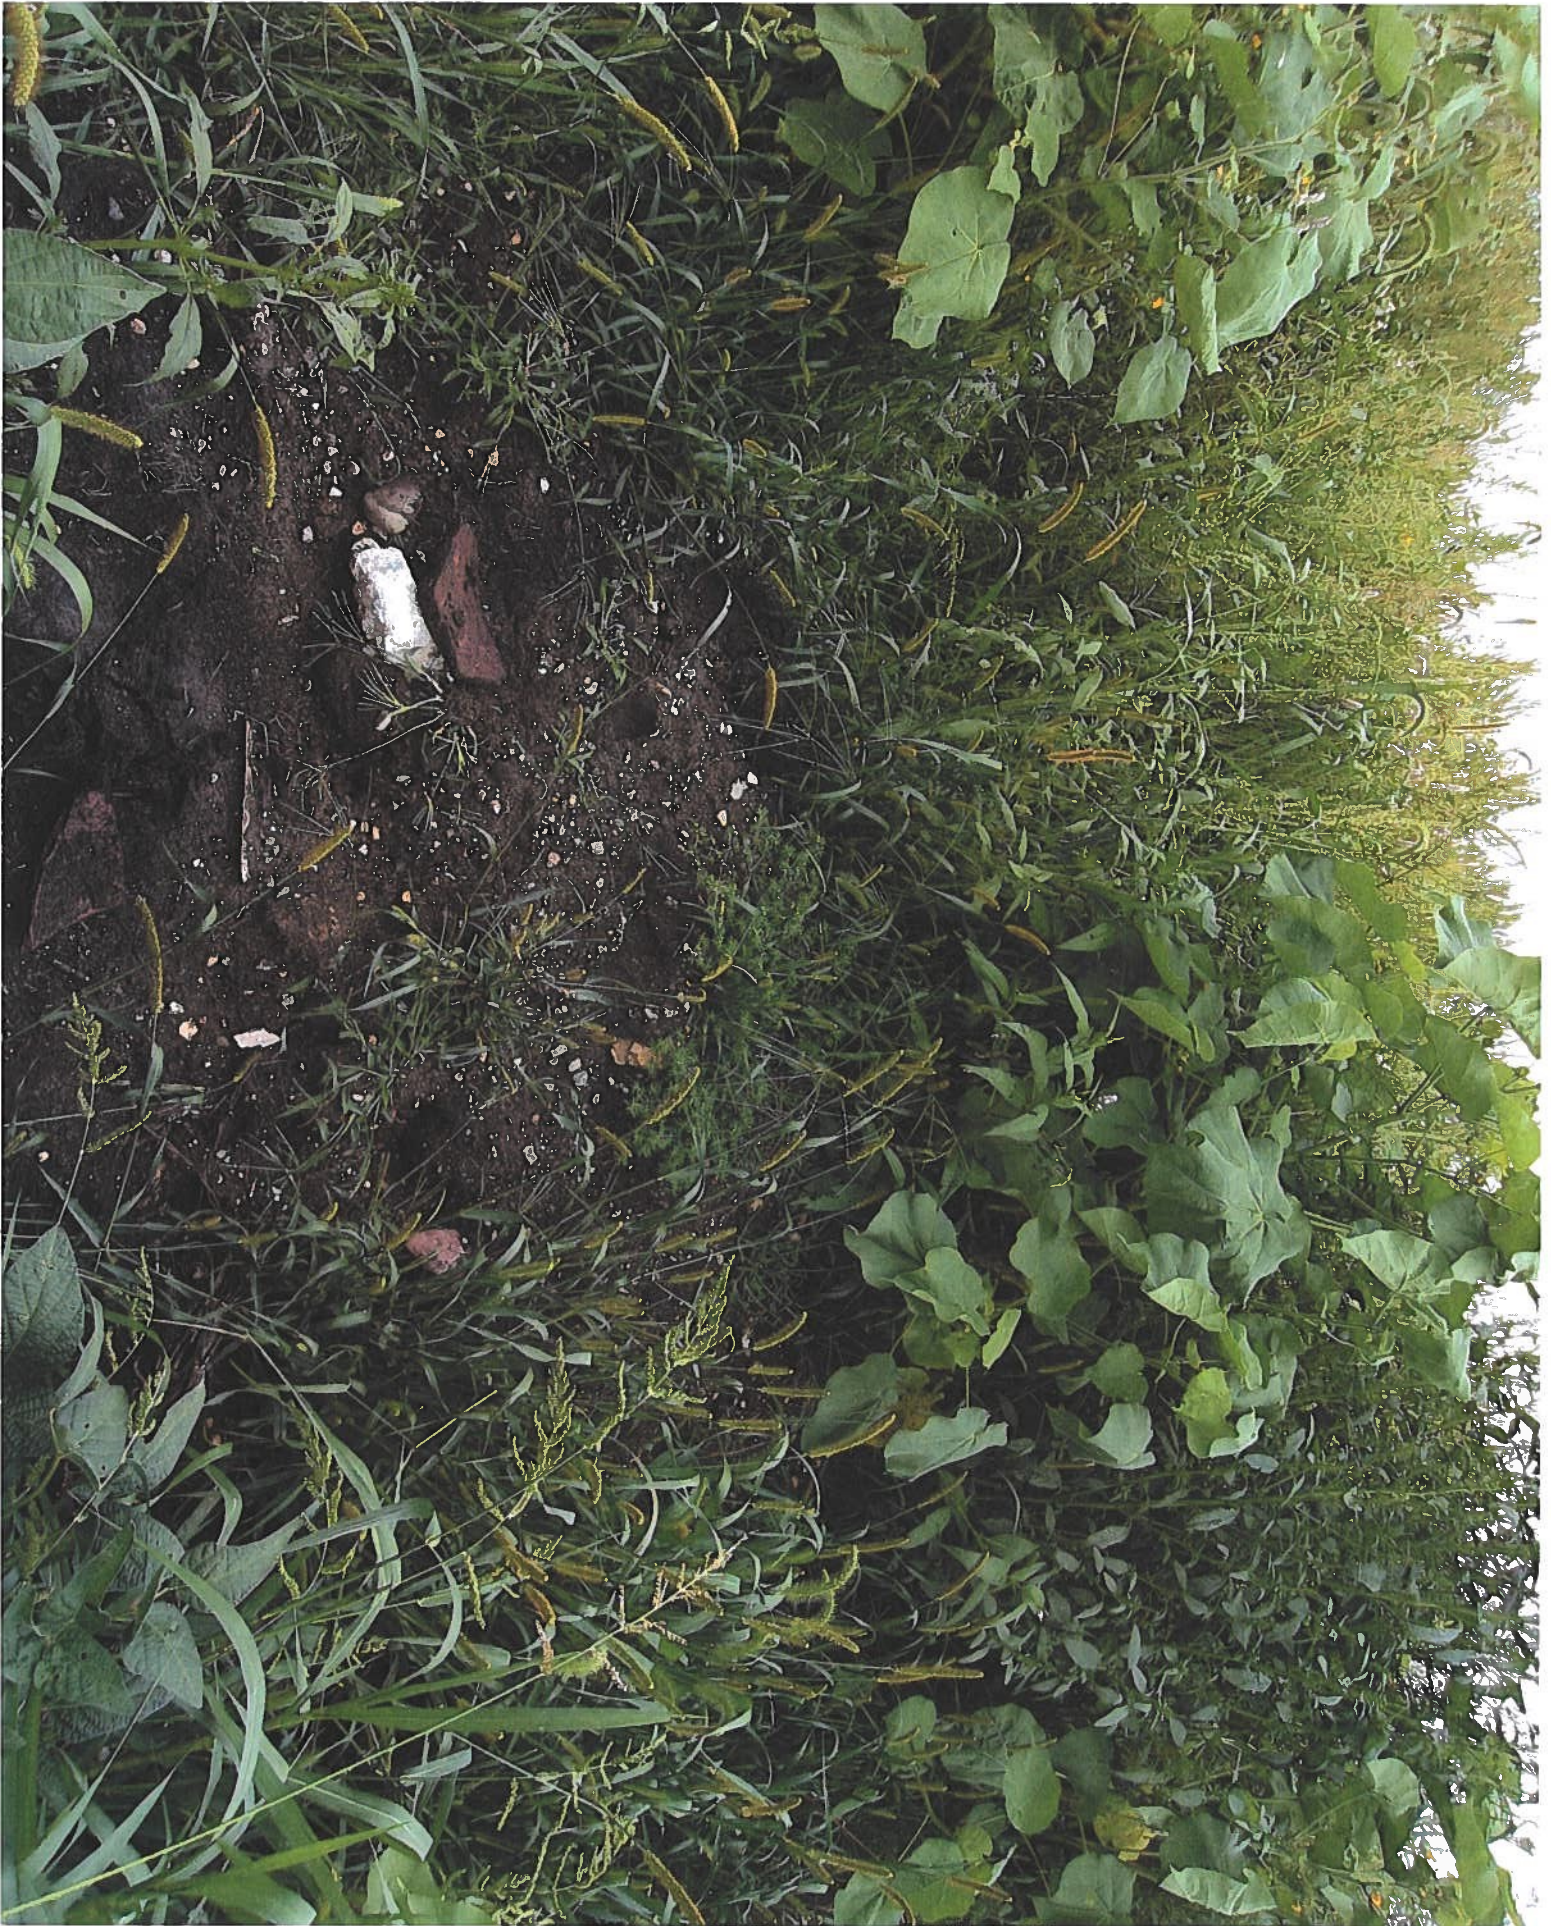
FRESH DIRT WITH 12" ± BROKEN VEP CHADS

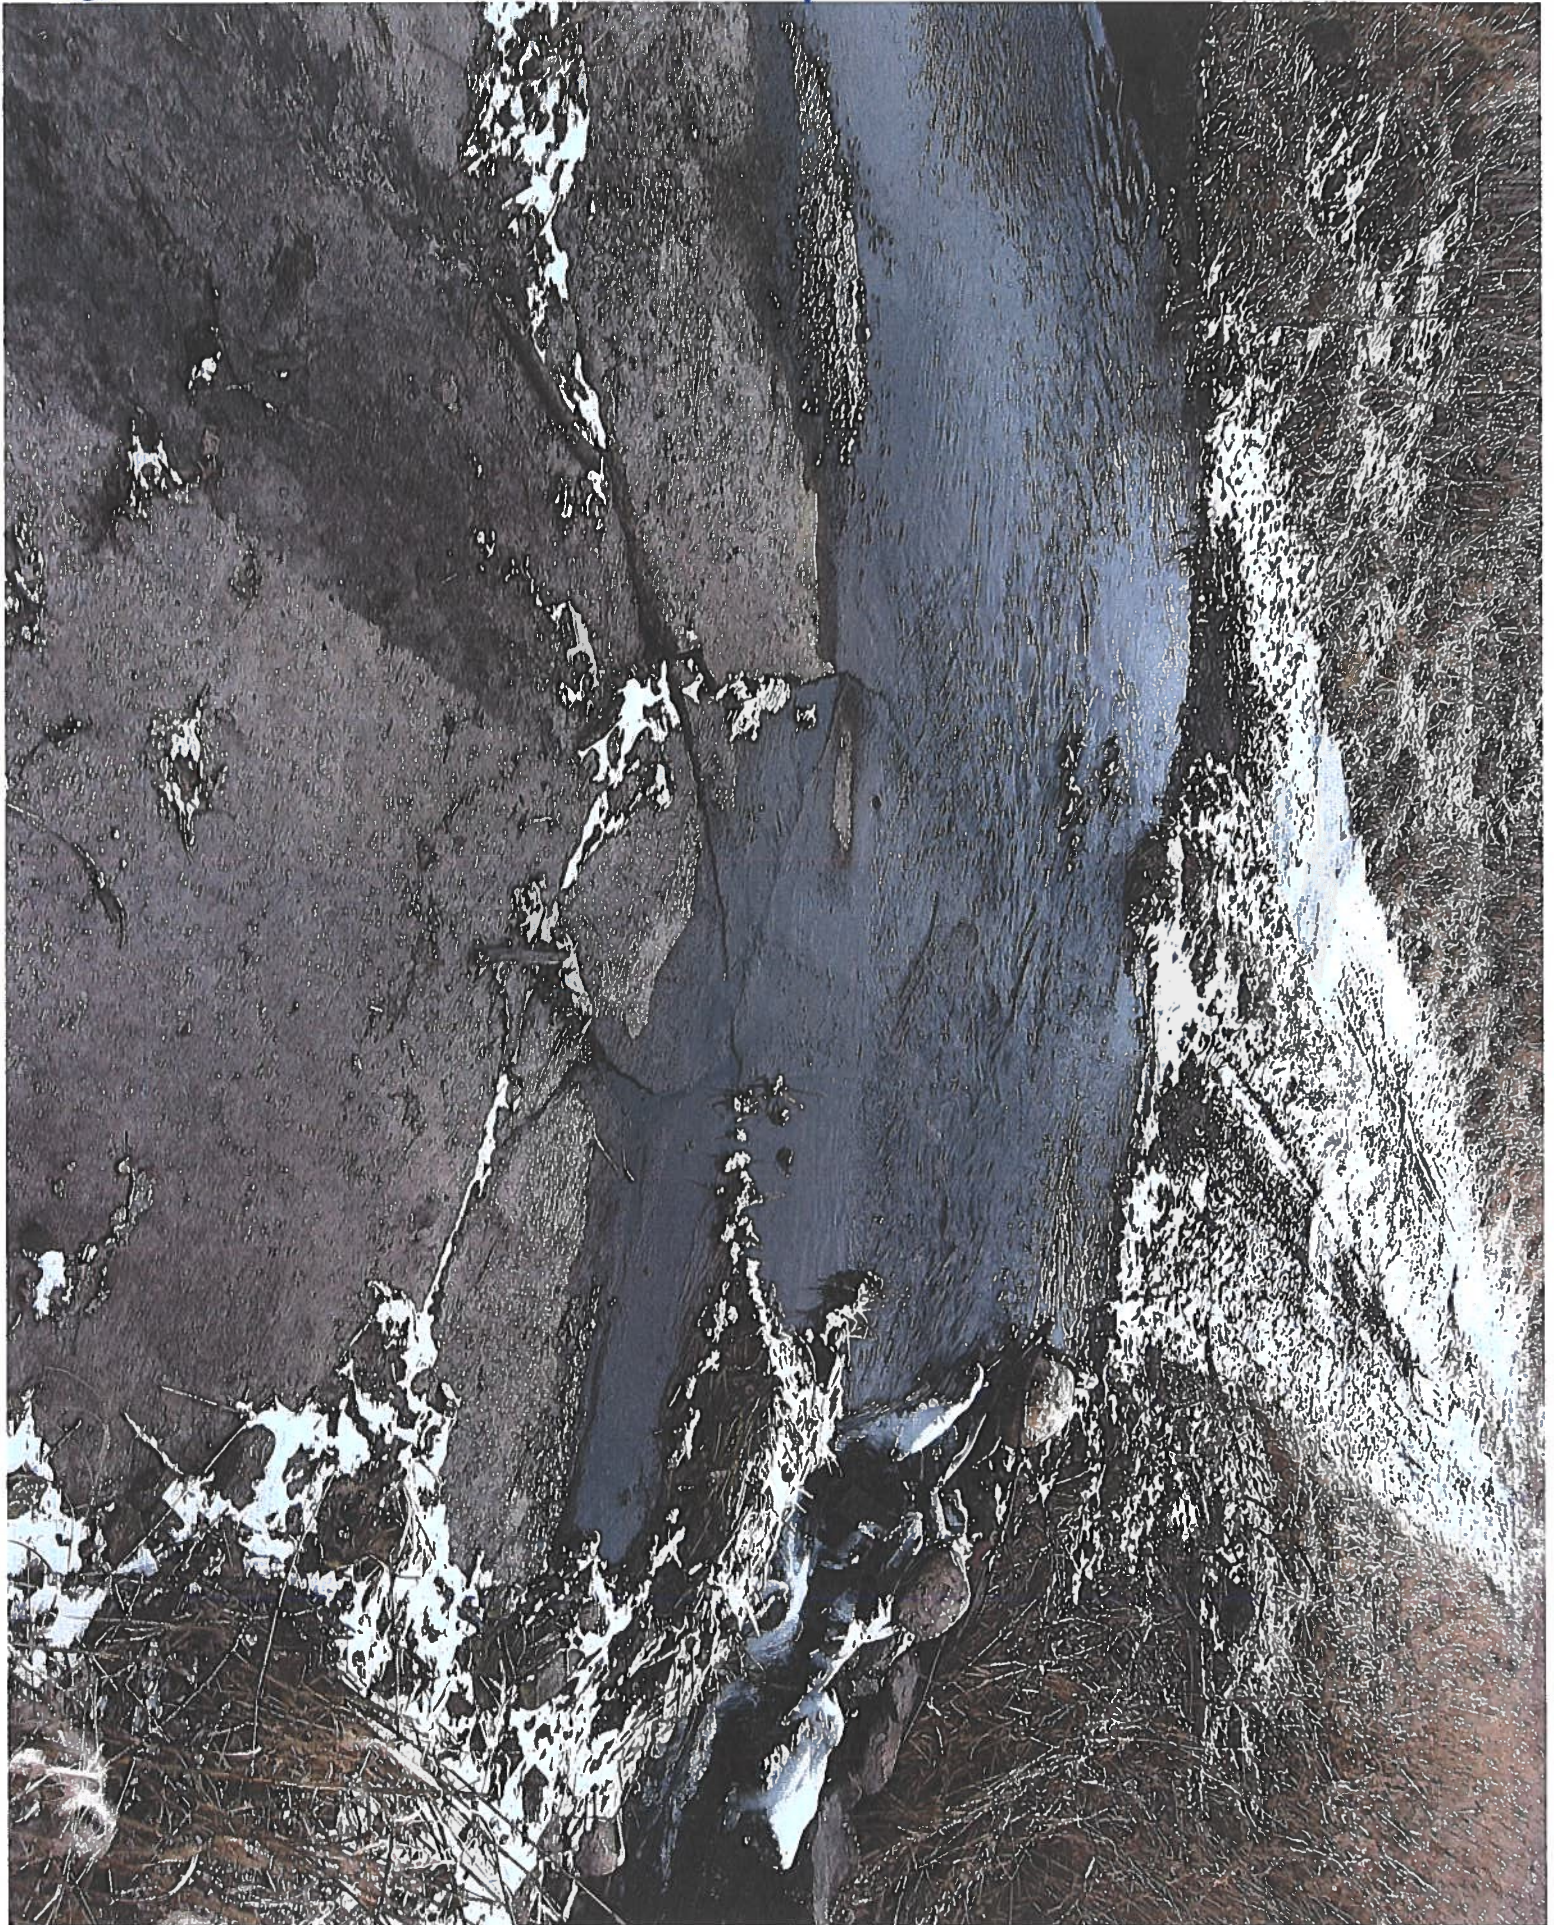
LOOKING N. @ FARM XING, BACKING UP WATER

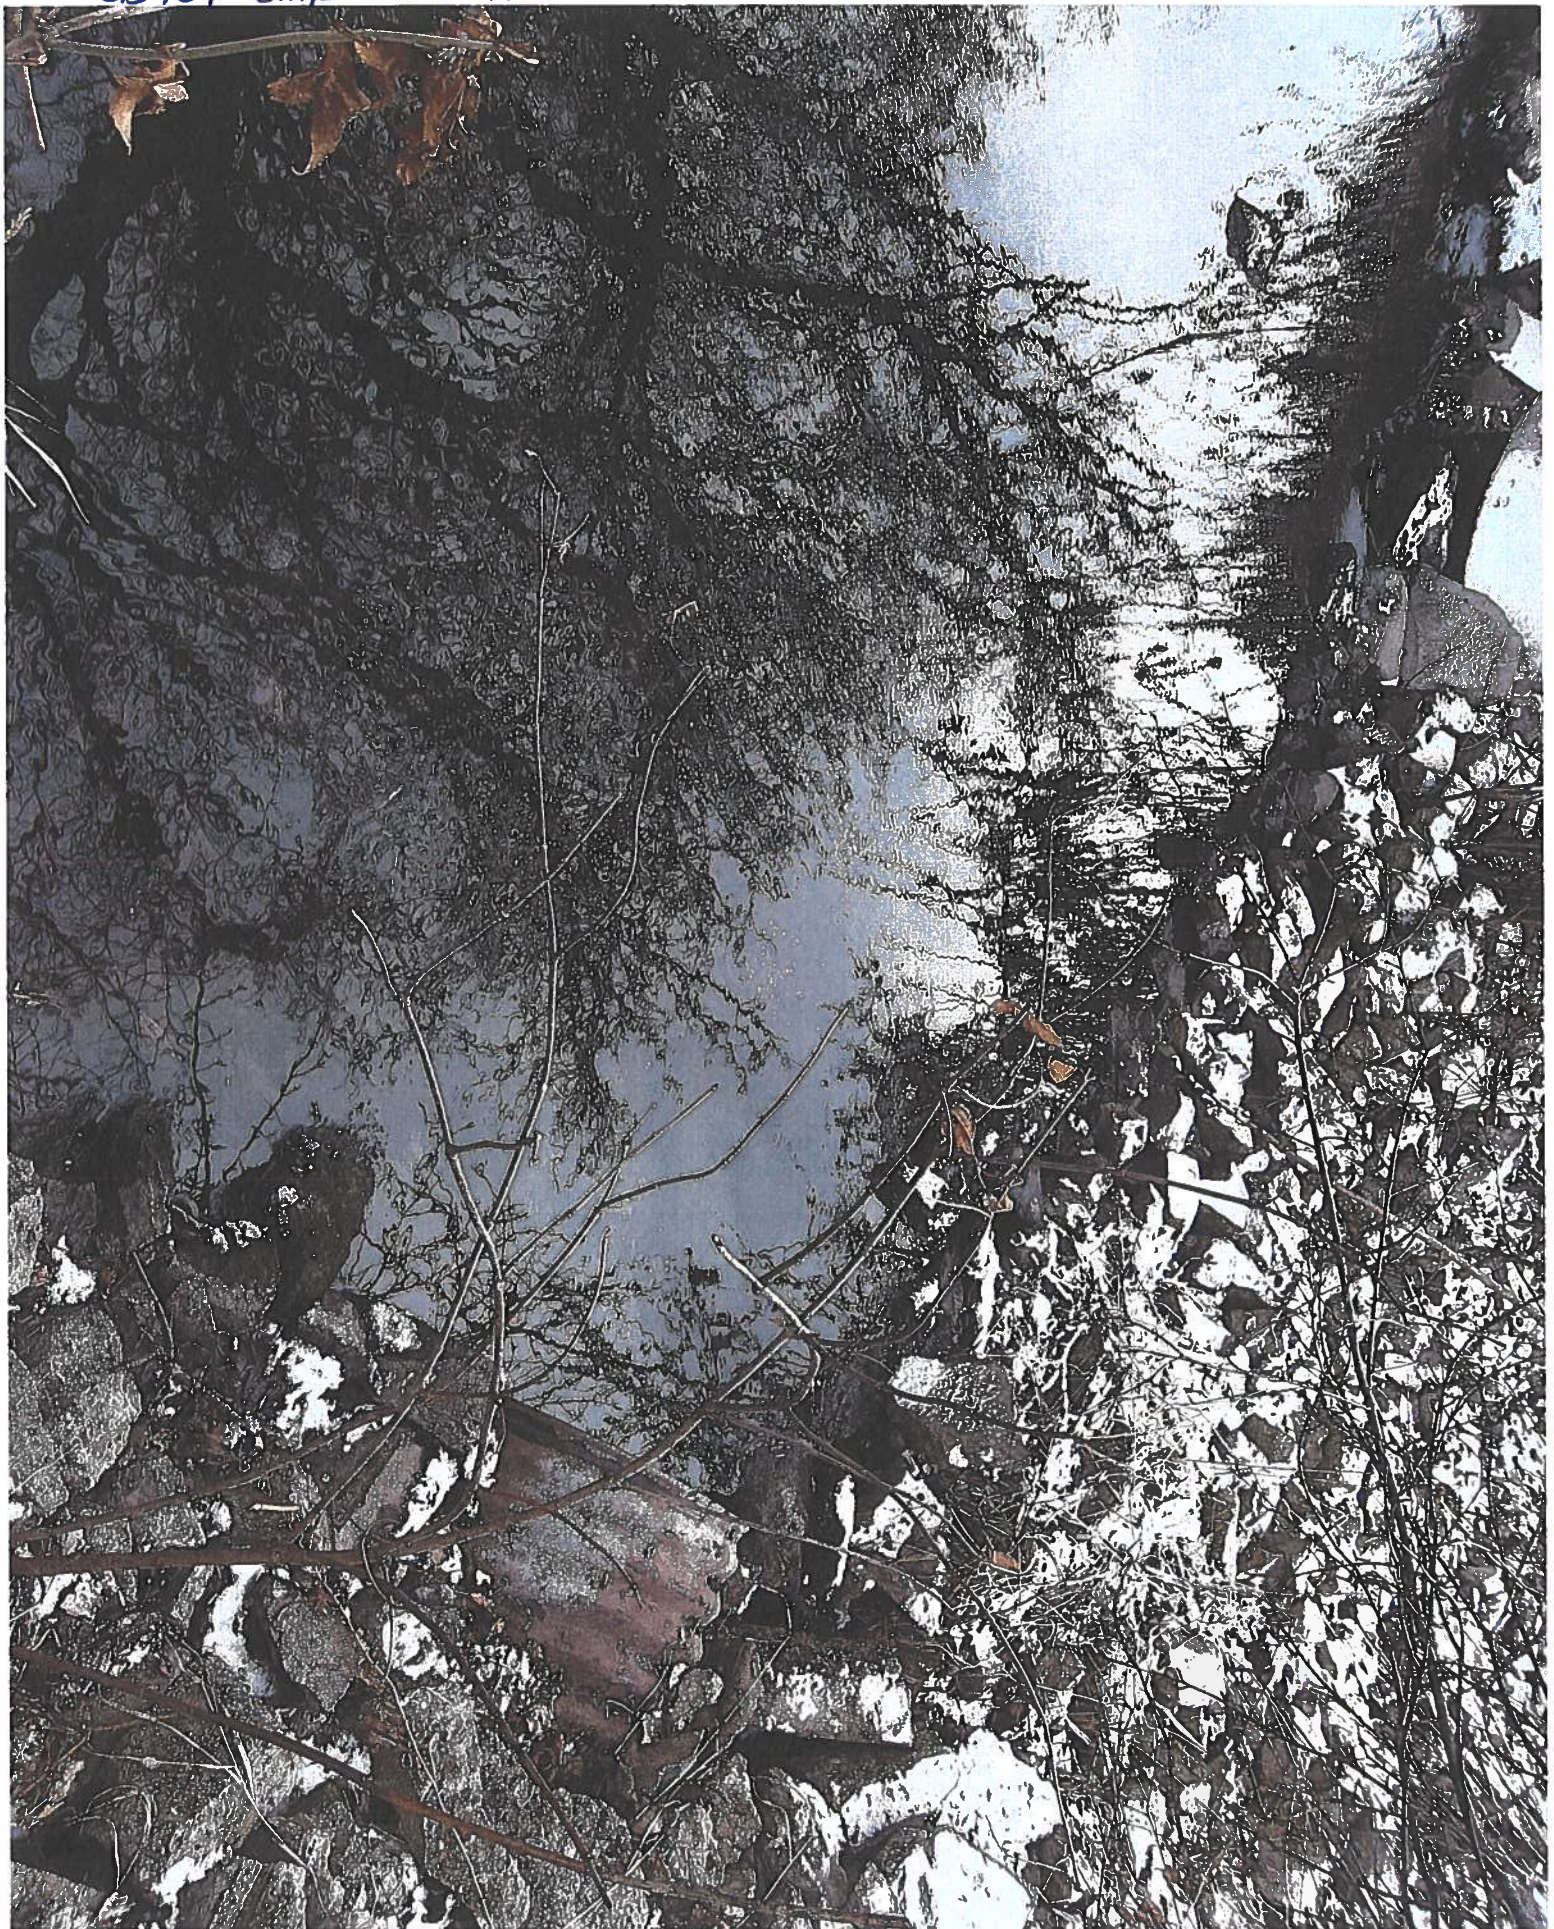
00134 Cmp OUTLET, 1/2 SUBMERGED

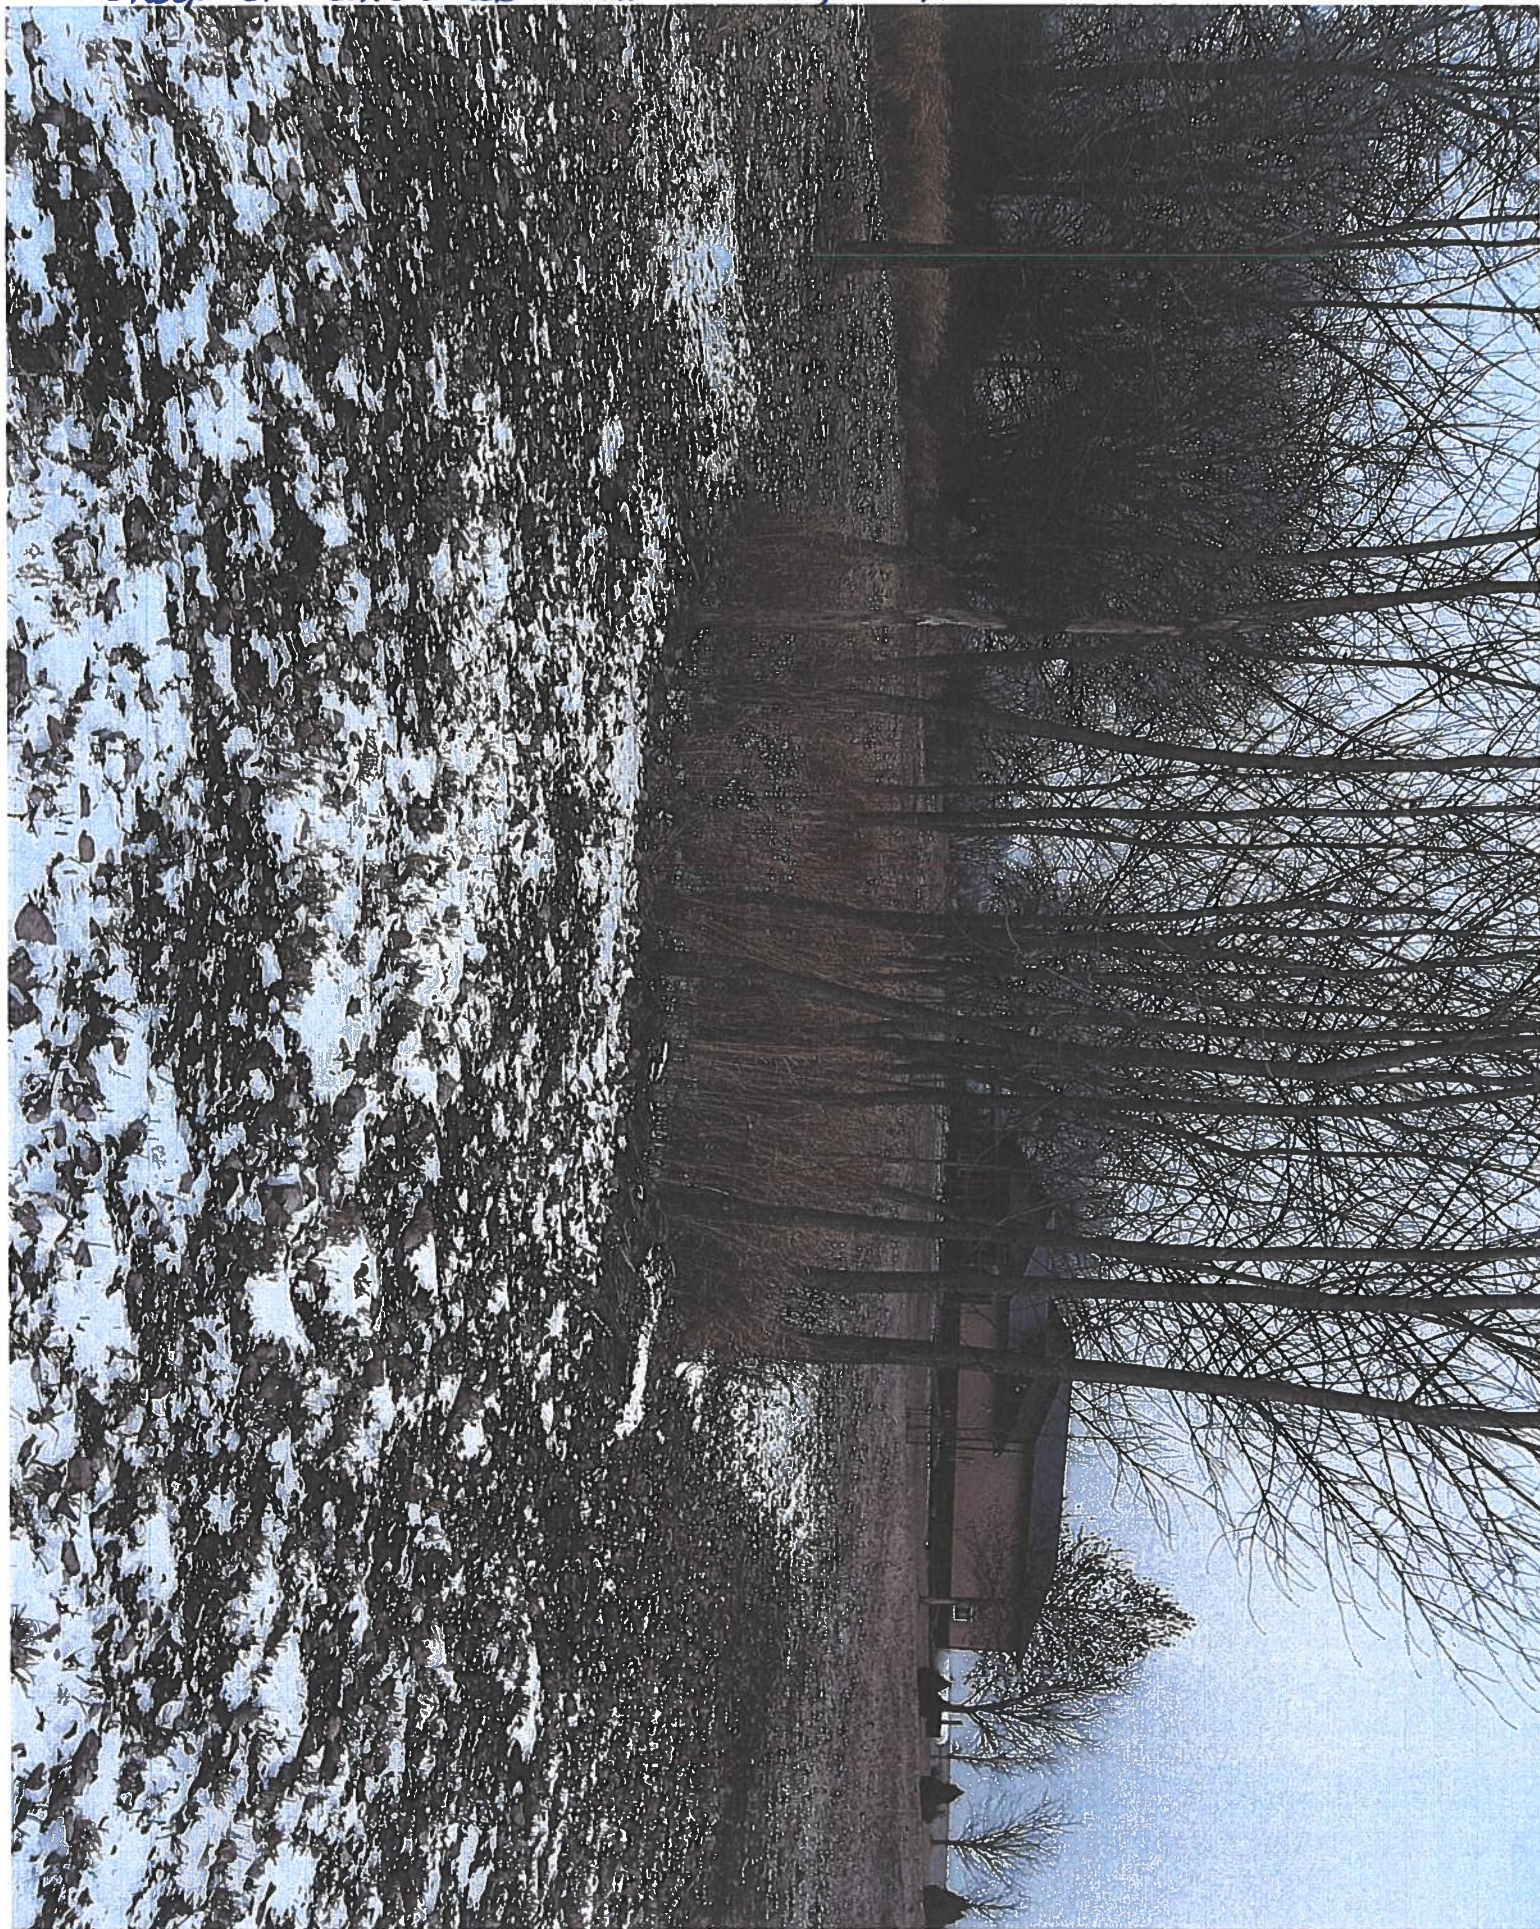
GROUP OF COTTONWOOD TREES PROBABLY ON TIRE LINE
