AGENDA
REGULAR DRAINAGE MEETING
Wednesday, October 14, 2020 9:30 AM
Large Conference Room

PAY ESTIMATE NO. 6
REPAIRS TO MAIN TILE AND LATERAL 3 DD#25 & REPAIRS TO MAIN TILE DD#1, HARDIN CO.
PROJECT NUMBER: 6501
DATE: 10-5-20

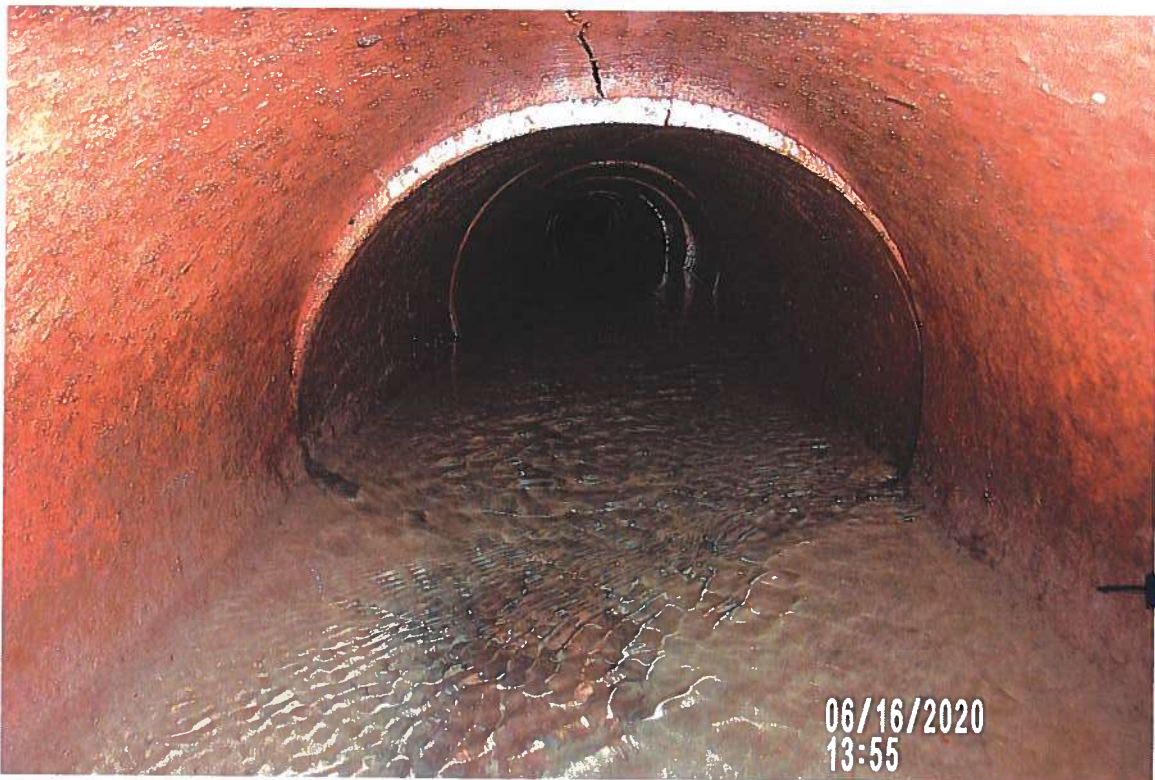
PICTURE # 3780 IS LOOKING NE DOWNSTREAM APPROXIMATELY 12.5'
FROM GPS # 392 SHOWING TILE STILL CRACKED, SQUATTED,
AND CAVING DOWN. AFTER APPROXIMATELY 5 SECTIONS OF
TILE REMOVED

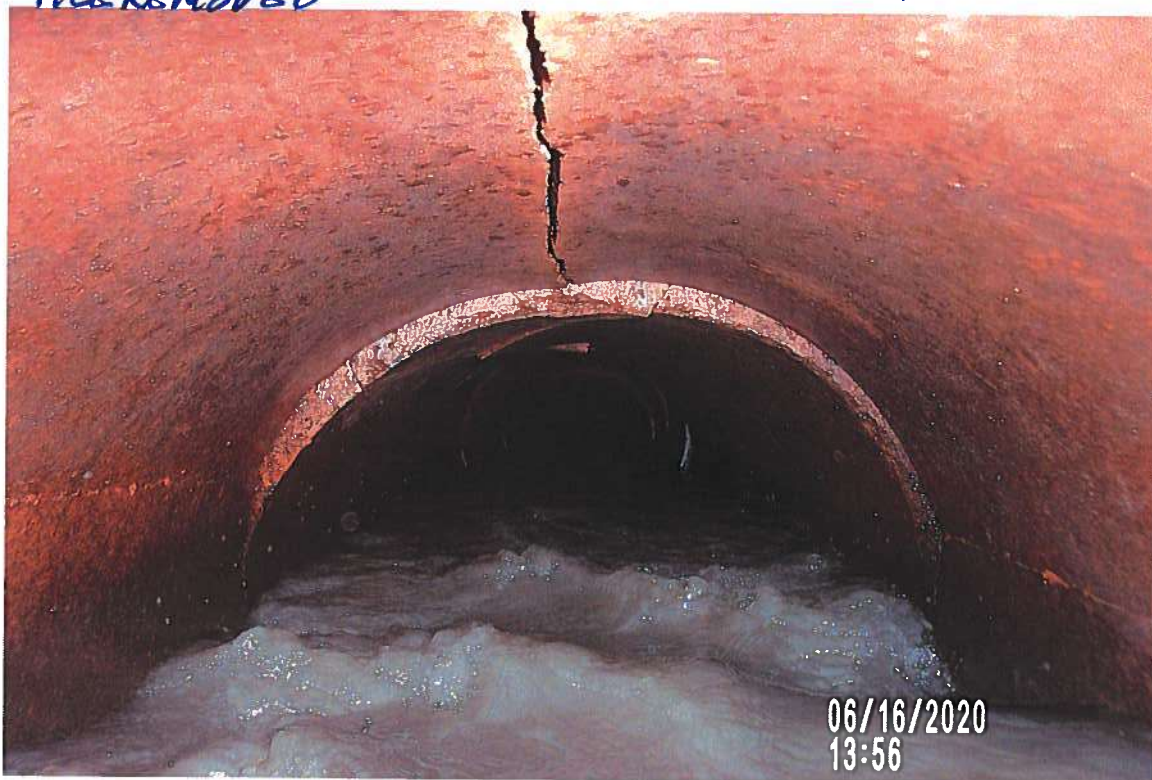
PICTURE # 3781 IS LOOKING NE DOWNSTREAM APPROXIMATELY
(23.5' FROM GPS # 392) (GPS # 393) SHOWING TILE STILL CRACKED, SQUATTED,
AND CAVING DOWN AFTER 4 SECTIONS OF TILE REMOVED.

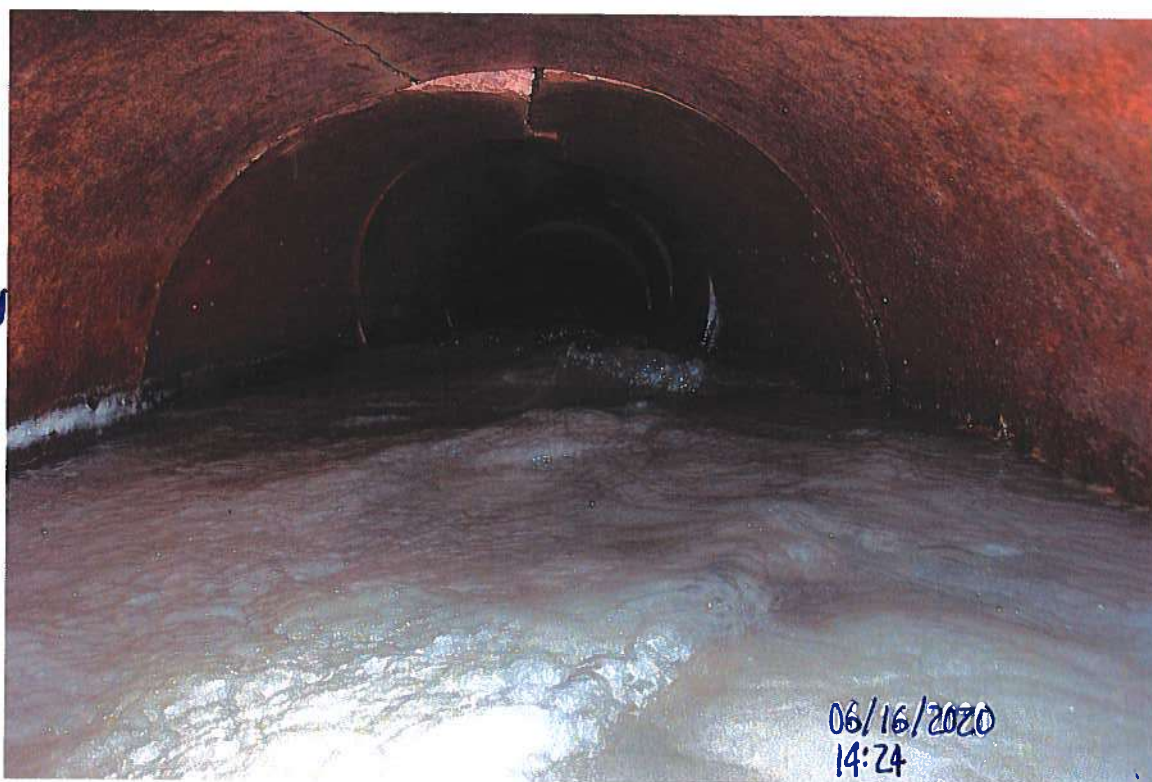
PICTURE# 3782 IS LOOKING SLIGHTLY NW SHOWING $1\frac{1}{2}$ " TO 2" WIDE JOINT ON CLAY TILE @ 28.5' ± DOWNSTREAM FROM GPS#392 WITH CLAY PIECES OVER JOINT AND UPSTREAM TILE CAVING DOWN.

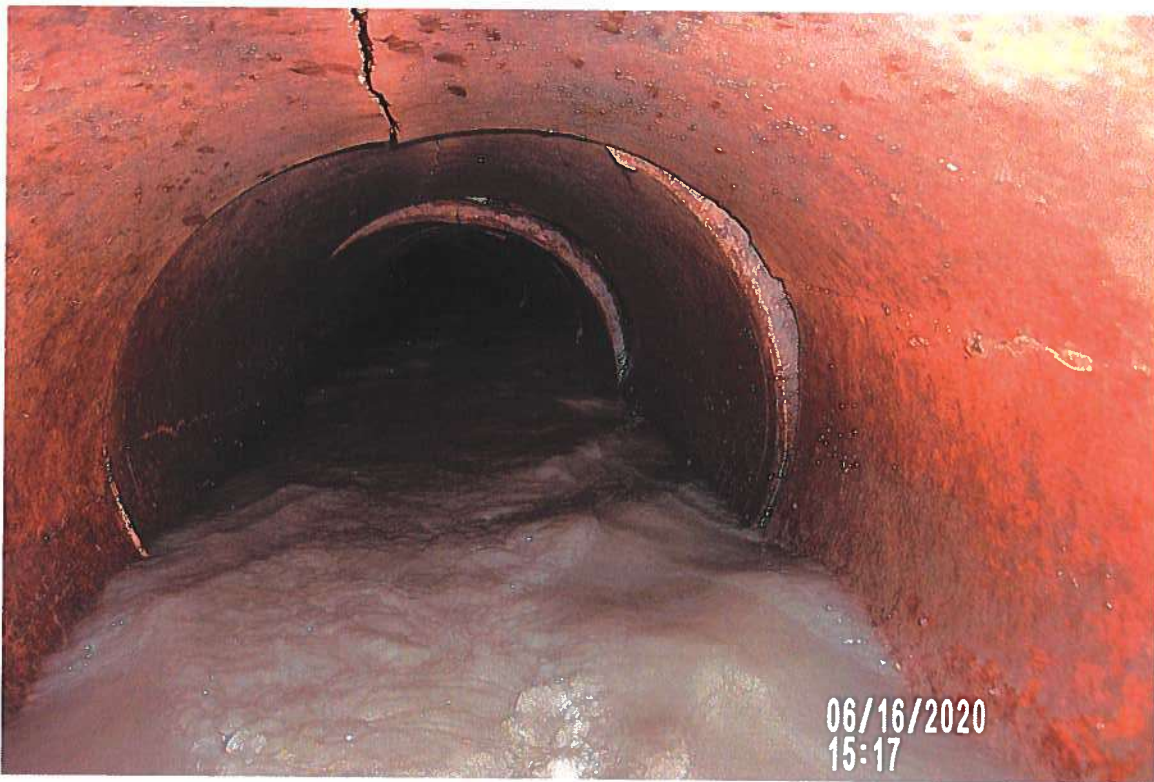
PICTURE #3786 IS LOOKING NE FROM GPS #393 INSIDE 21" CLAY TILE SHOWING TOP TILE CRACKED AND CAVING DOWN WITH JOINT O/S & WIDE JOINT 2 JOINTS DOWNSTREAM.

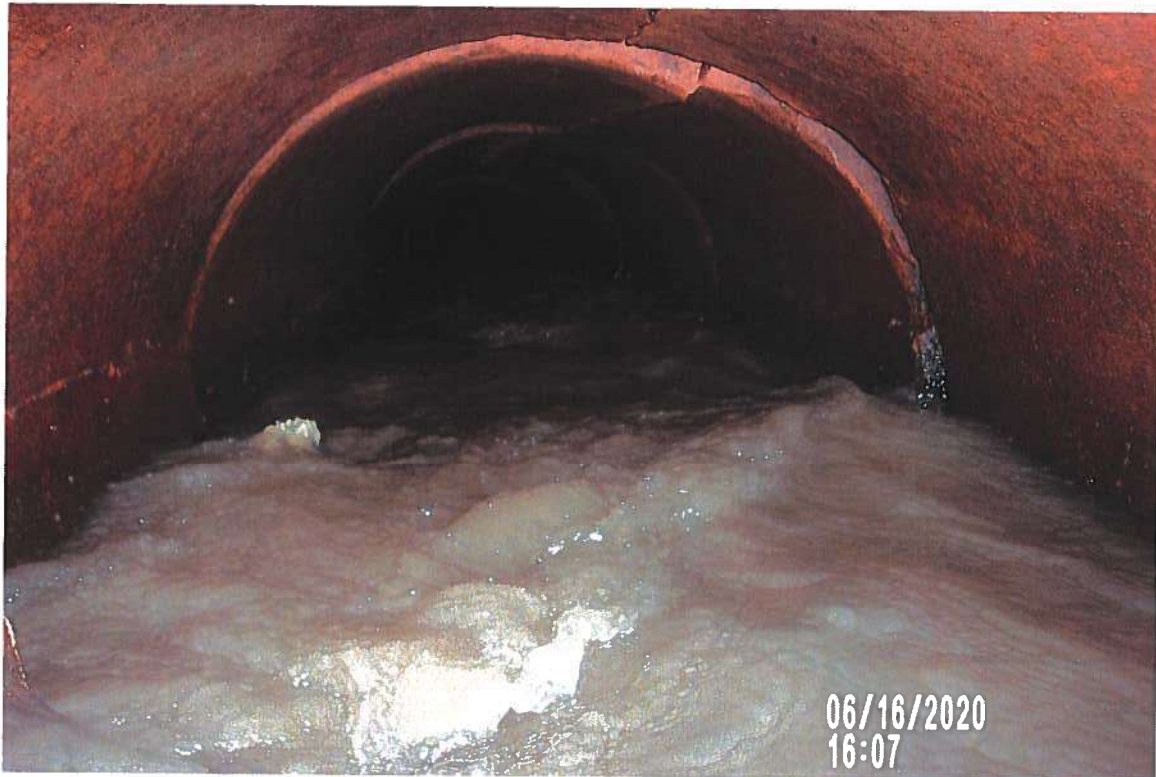
PICTURE # 3790 IS LOOKING DOWN STREAM FROM 28.5'± DOWNSTREAM
FROM GPS # 392 SHOWING TILE STILL CRACKED AND CAVING
DOWN

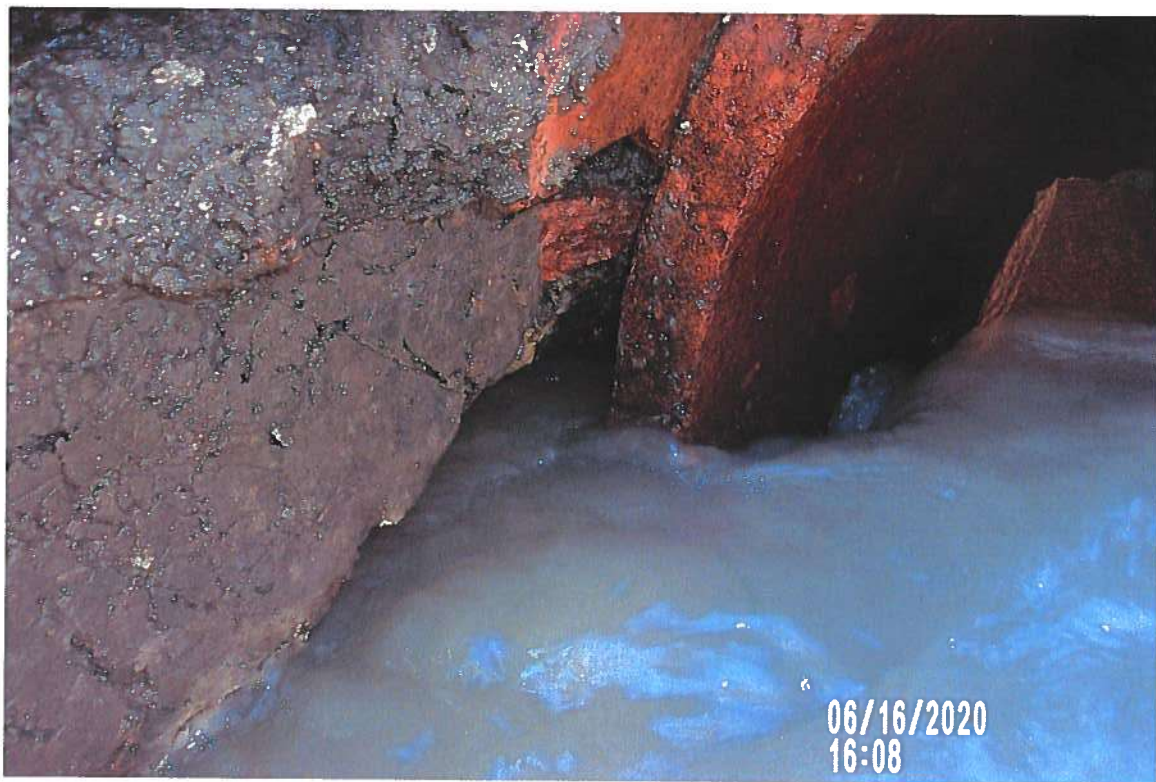
PICTURE # 3791 IS LOOKING ON WEST SIDE OF 21" TILE
SHOWING VOID BESIDE TILE @ WIDE JOINT (28.5'± DOWNSTREAM
FROM GPS # 392)

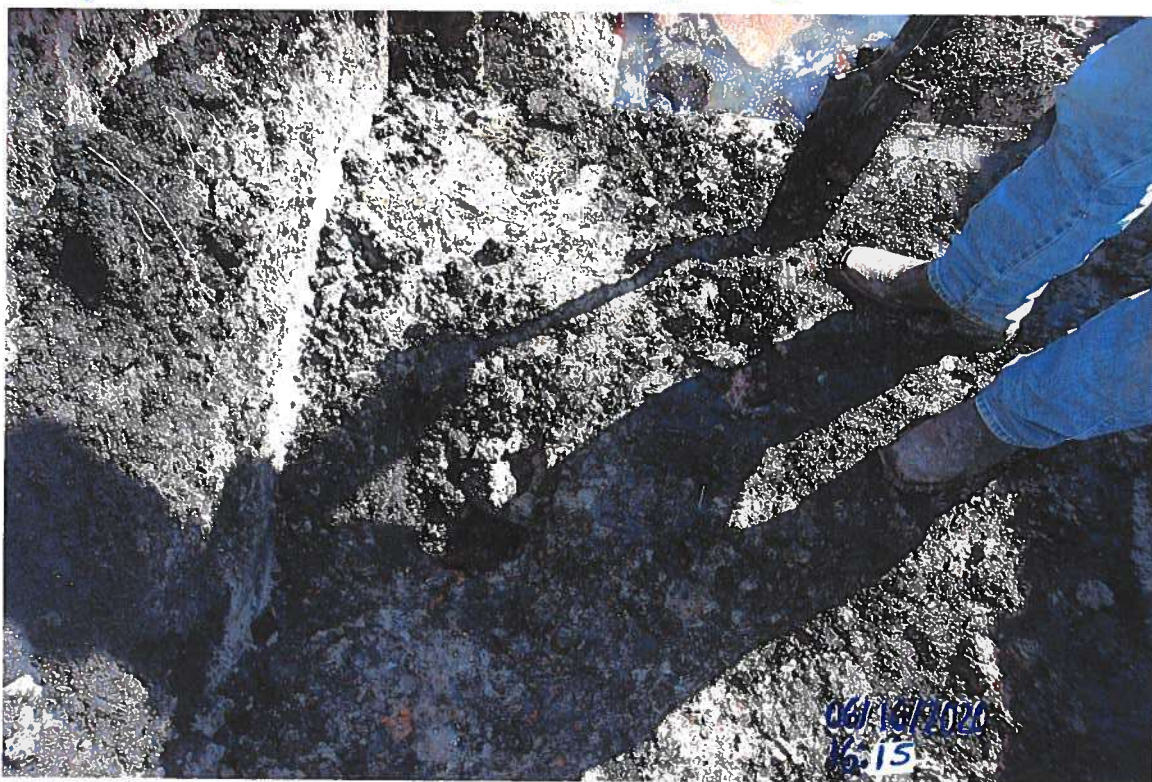
PICTURE # 3792 IS LOOKING SOUTH SHOWING BOOT HOLE AFTER
CONTRACTOR STEPPED ABOVE VOID ON EAST SIDE OF TILE
31' DOWNSTREAM OF GPS # 392!

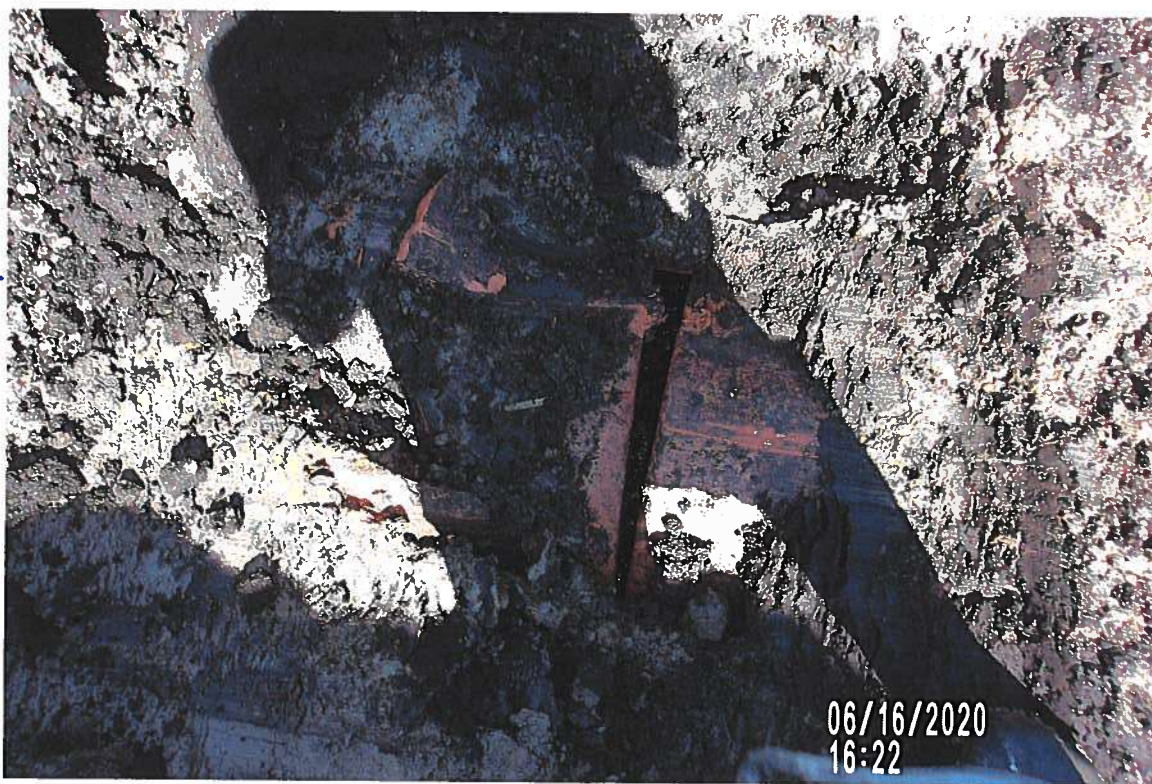
PICTURE # 3793 IS LOOKING EAST SHOWING 2" WIDE
JOINT WITH CLAY PIECES OVER ON EAST SIDE OF TILE (31' DOWNSTREAM
OF GPS # 392. CLAY PIECES ARE JUST ON TOP OF JOINT BUT NOT ON SIDES.
CAUSING VIDS ON SIDES

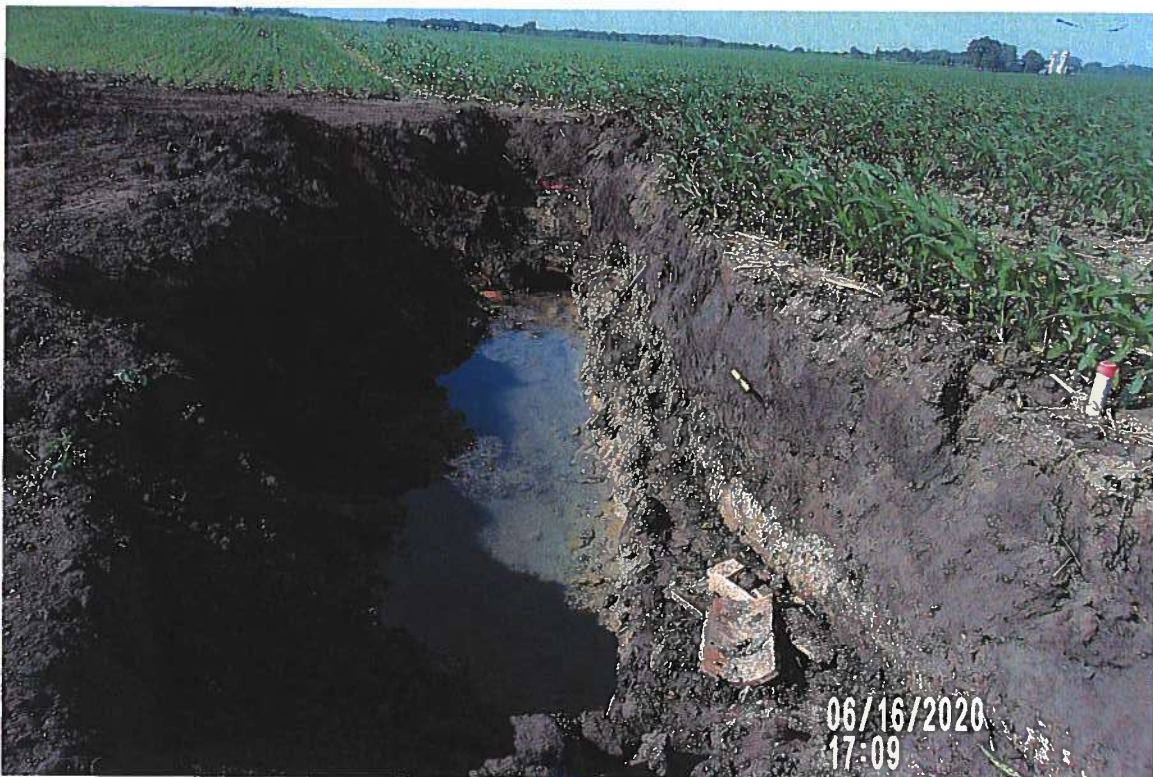
PICTURE# 3794 IS LOOKING NORTH @ 21" CLAY TILE SHOWING
TILE STILL CRACKED AND CAVING DOWN

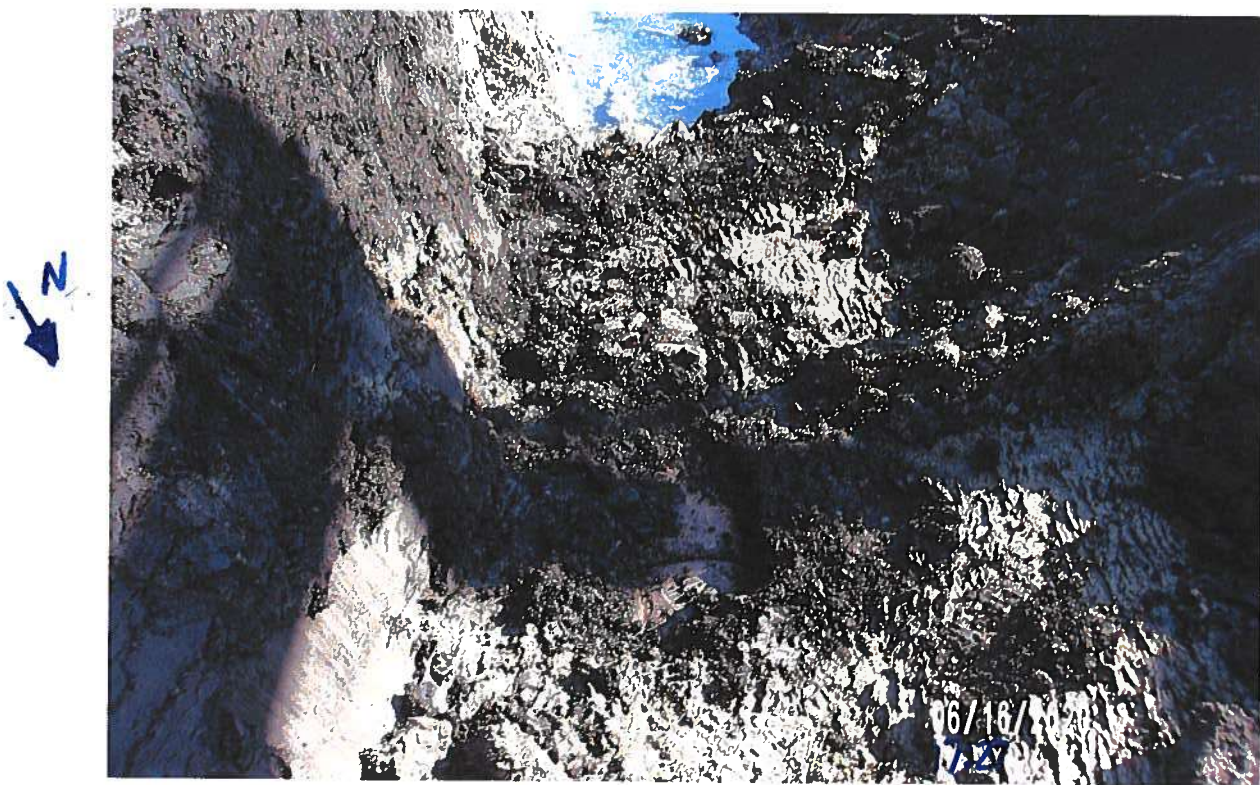
PICTURE# 379.7 IS LOOKING SW SHOWING TILE EXPOSED @ GPS 13 WITH TILE STILL CRACKED AND CAVING DOWN, (NO DIFFERENCE ON CONDITION) JOINTS ARE TIGHTER,

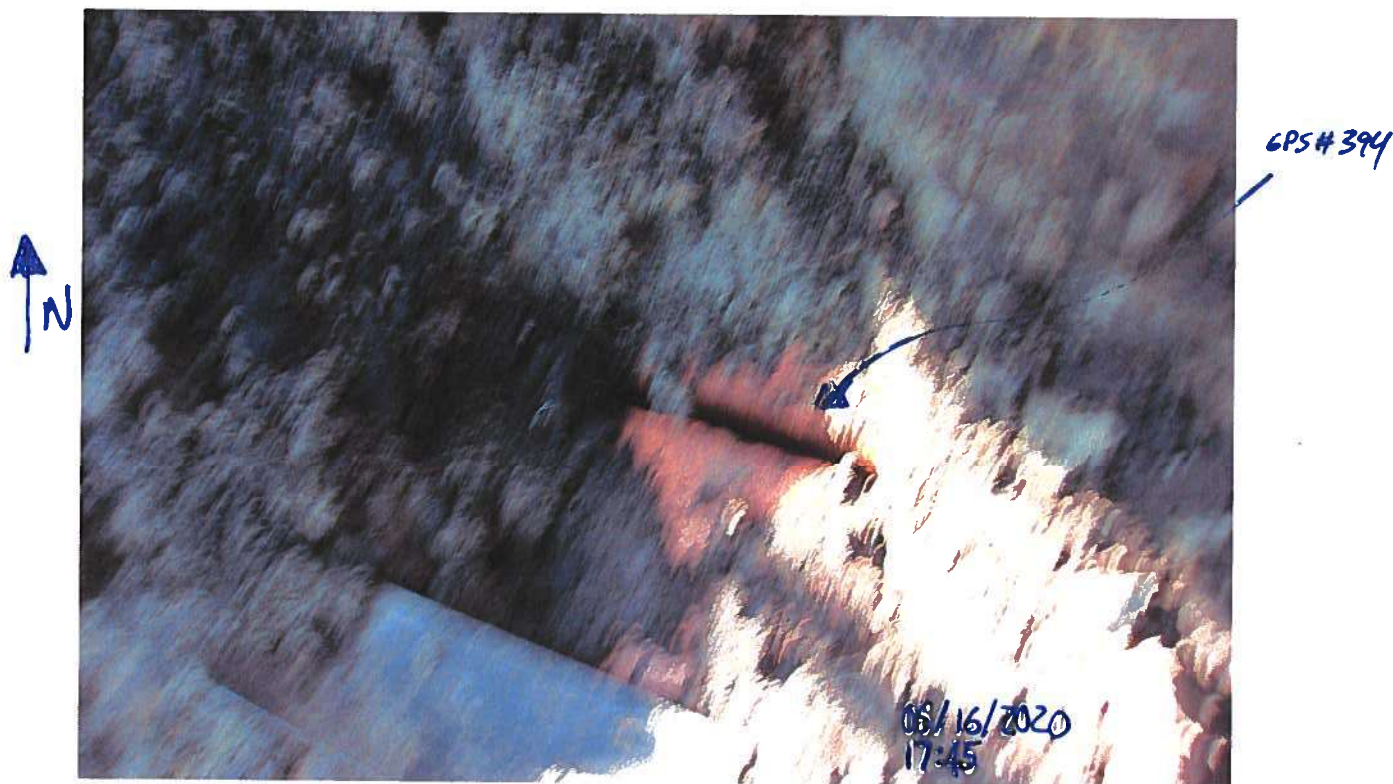
PICTURE# 3800 IS LOOKING NORTH SHOWING ANOTHER WIDE JOINT
AT GPS# 394.

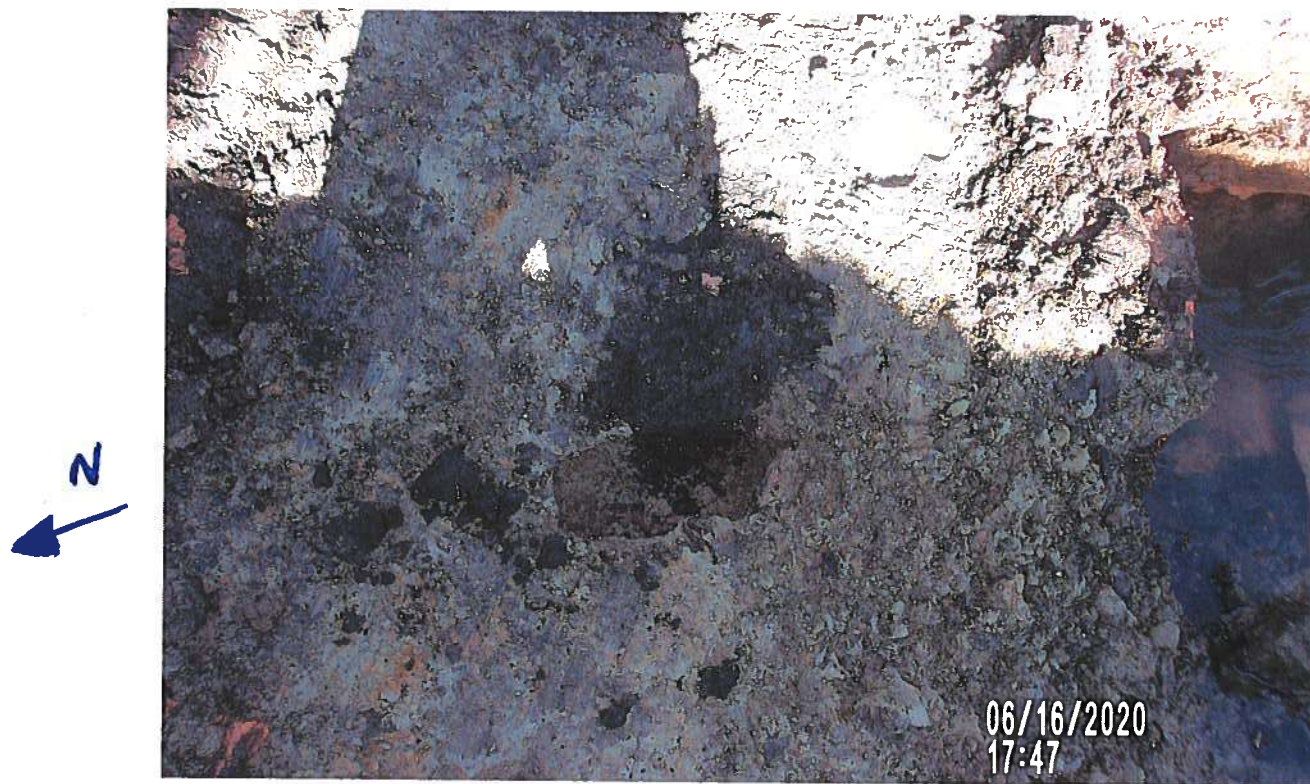
PICTURE# 3801 IS LOOKING SE SHOWING ANOTHER VOID BESIDE
WEST SIDE OF TILE

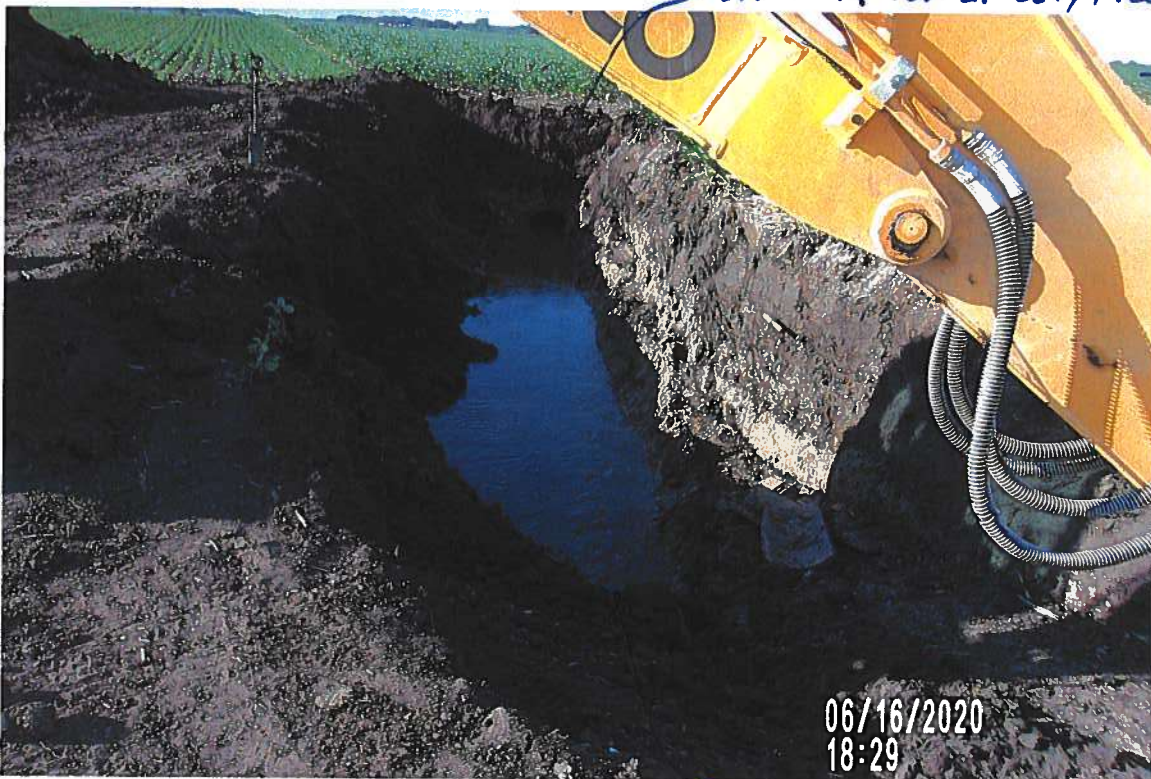
PICTURE # 3802 IS LOOKING NE FROM GPS # 394 SHOWING INSIDE OF 21" CLAY TILE WITH TOP CRACKED AND CAVING DOWN. APPEARS NEXT 3 JOINTS ARE IN SAME CONDITION BUT ARE CLOSE TO OUR 50' MAX REPAIR LIMIT. LEE WILL TALK

PICTURE # 3803 IS LOOKING NE SHOWING 41.8 LF OF TILE REMOVED WITH NEXT THREE DOWNSTREAM TILE IN SAME CONDITION. CREW IS WAITING ON DECISION FROM DRAINAGE DISTRICT ON HOW FAR TO REPLACE TILE

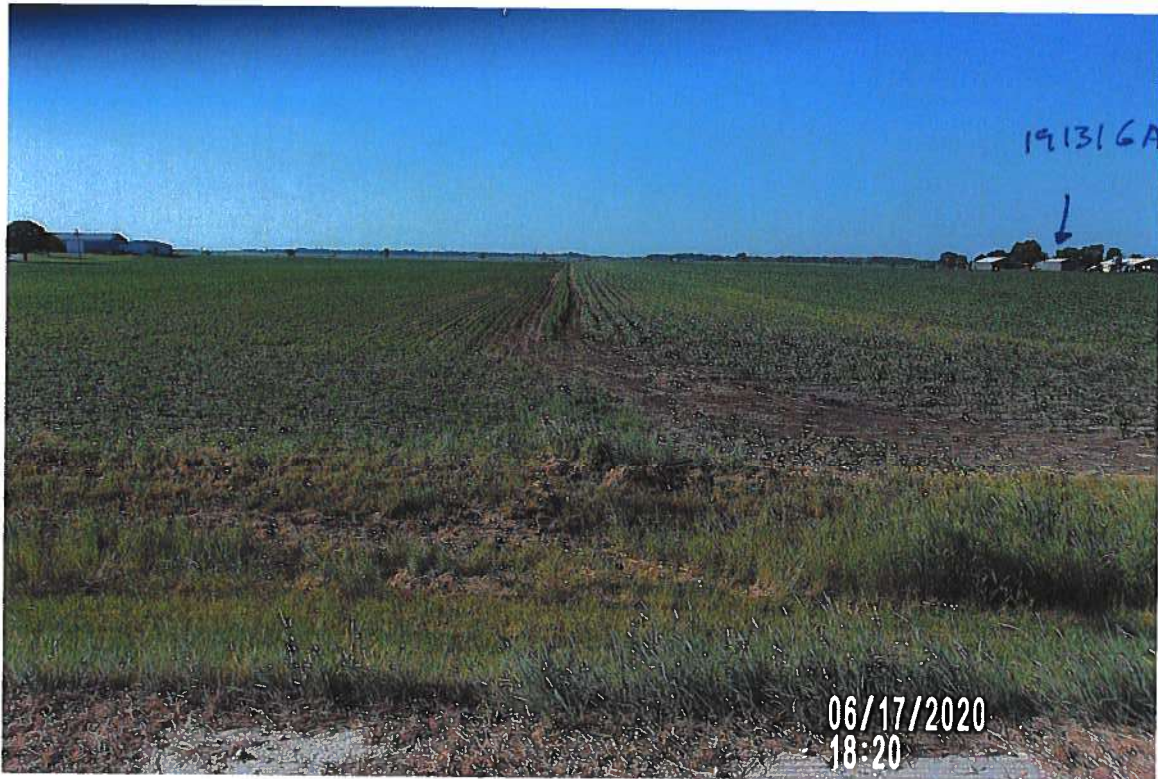
PICTURE#3815 IS LOOKING SOUTH AT BEAN & CORN DAMAGE
ON ACCESS LANE OUT TO TILE REPAIR

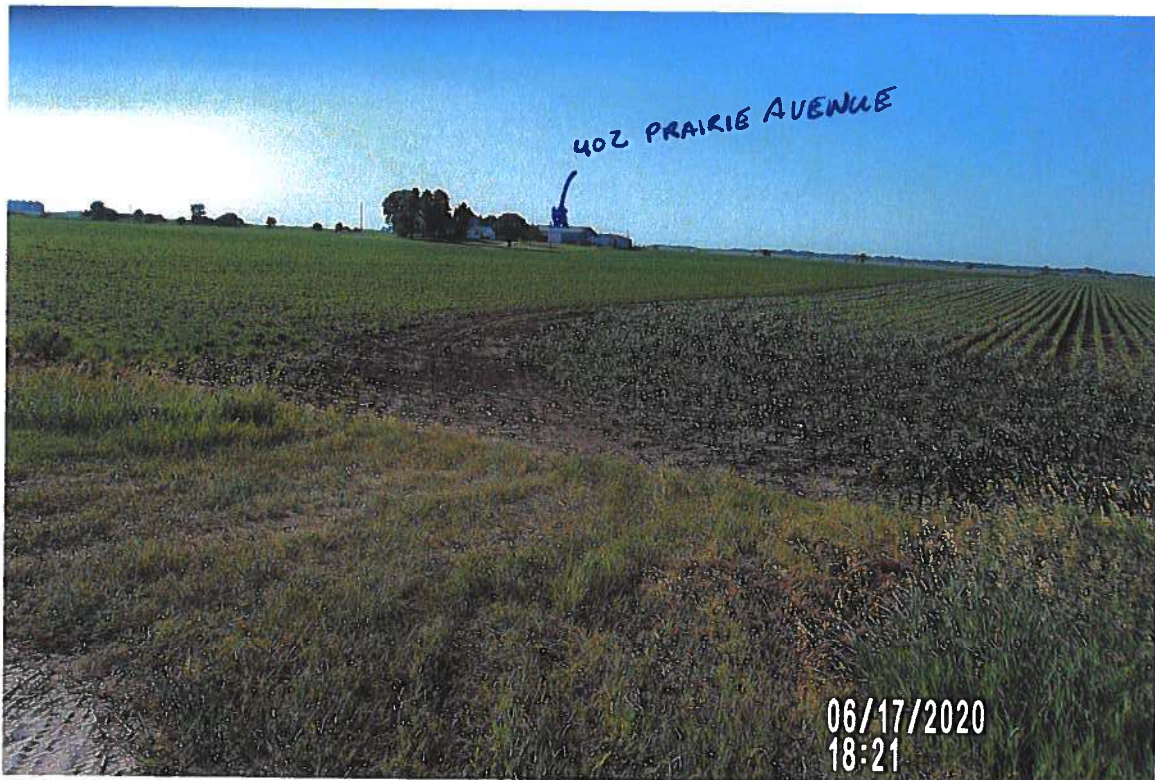
PICTURE # 3816 IS LOOKING NORTH FROM 195TH ST / PRAIRIE ST
(GRAVEL ROAD) @ CORN/BEAN DAMAGE ON ACCESS LANE OUT TO TILE
REPAIR.

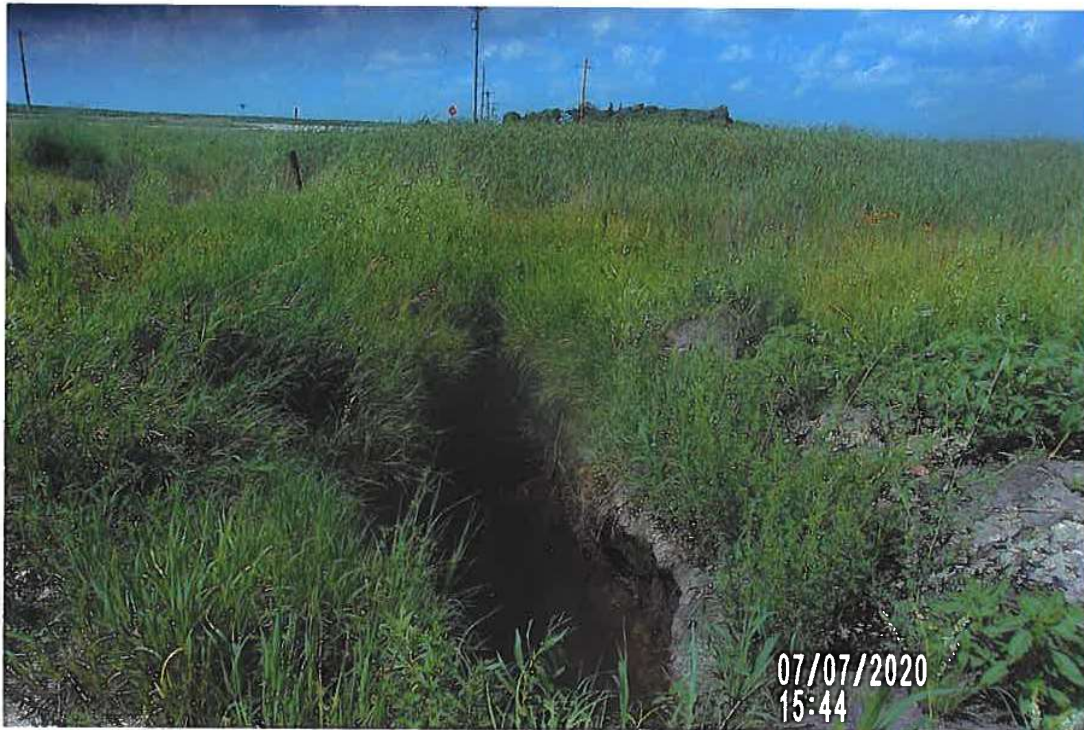
PICTURE # 4048 IS LOOKING NORTH ALONG EASTROW FENCE
322'± SOUTH OF CO HWY D-41 SHOWING WATER SITING IN HOLE

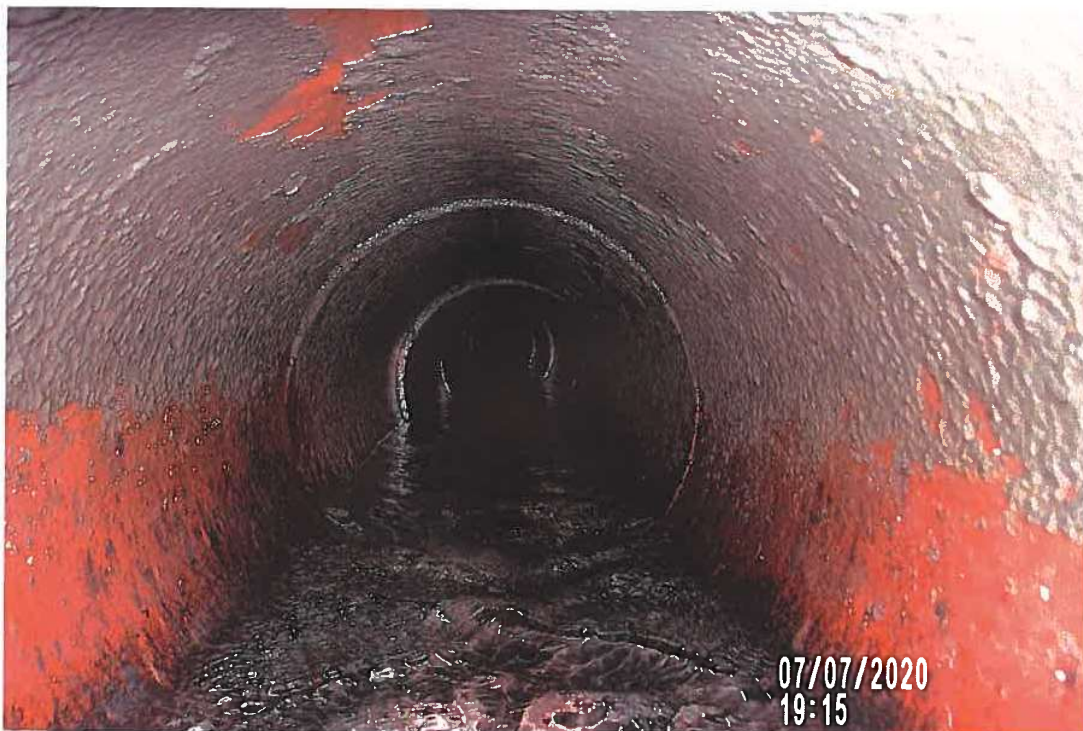
PICTURE # 4049 IS LOOKING NW UPSTREAM INSIDE 14" CLAY
TILE (GPS# 248 1.28' TOPTOFL). TILE IS IN GOOD SHAPE
WITH 3" FLOW (5.1" DEEP)

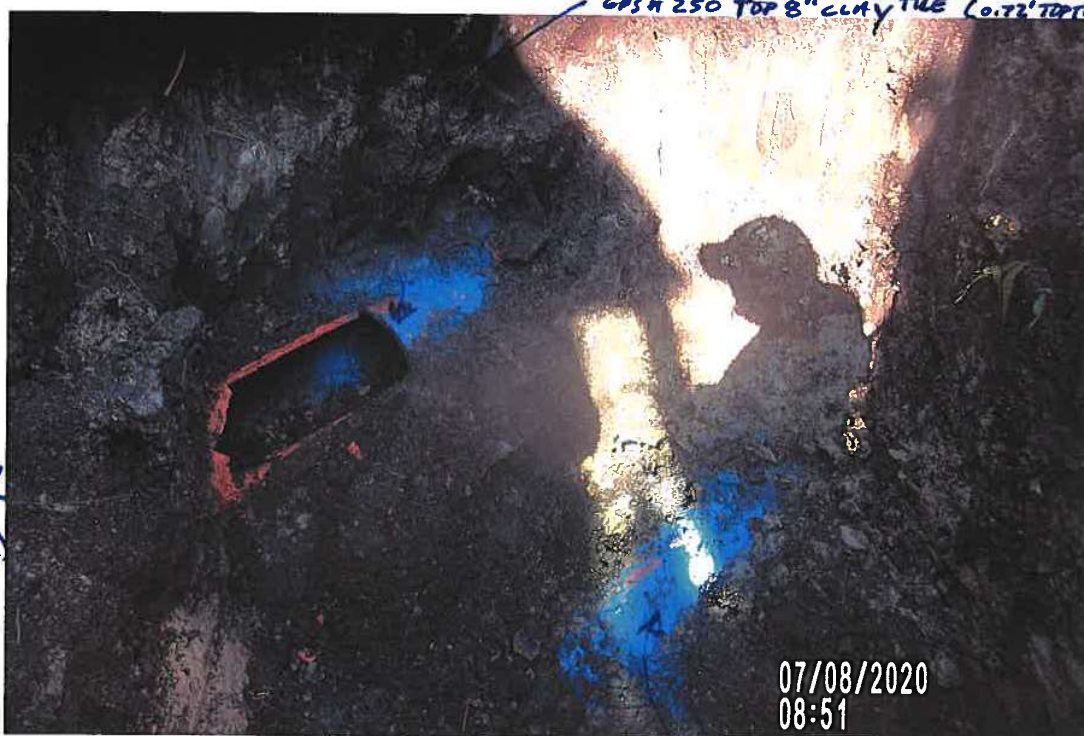
PICTURE# 4051 IS LOOKING SW SHOWING 8" CLAY TILE THAT WAS DAMAGED WHILE EXCAVATING TO EXPOSE 14" CLAY @ LOCATION WHERE WATERMAIN GOES UNDER TILE

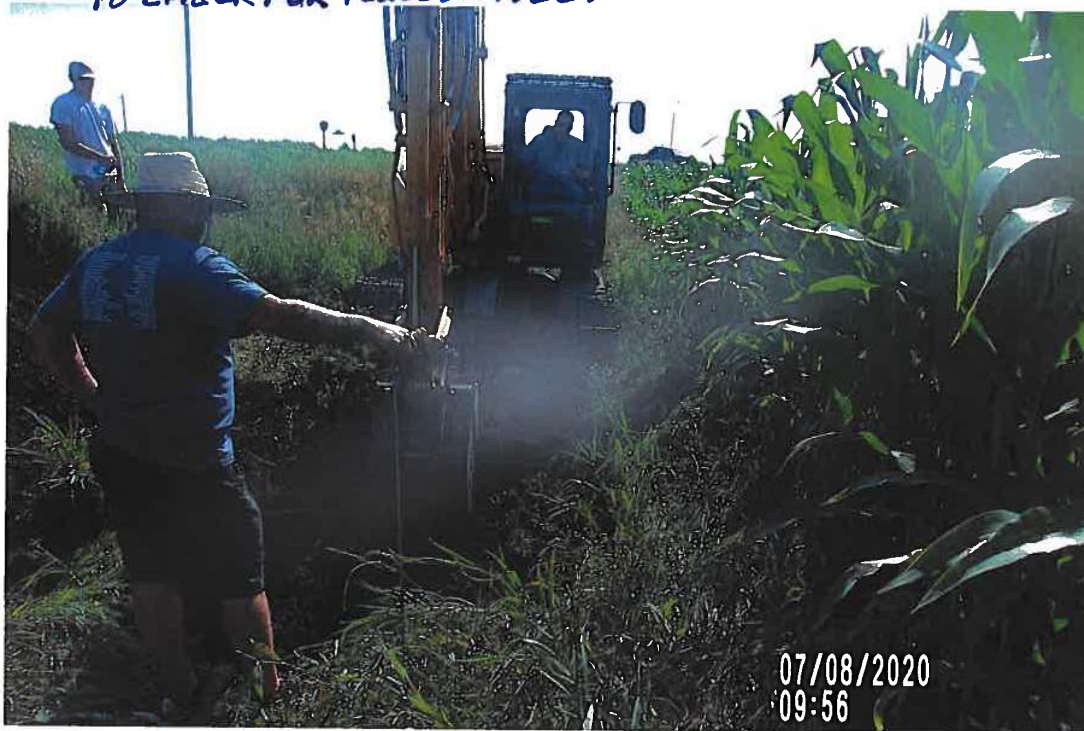
PICTURE #4054 IS LOOKING EAST IN SOUTH DITCH CO HWY 04/
297[±] WEST OF E CO HWY 5-27 SHOWING CREW EXPOSING LATZ TILE
WEST OF BEEHIVE INTAKE SO CREW CAN RUN LOCATE CABLE UPSTREAM
TO CHECK FOR PLUGGED TILE.

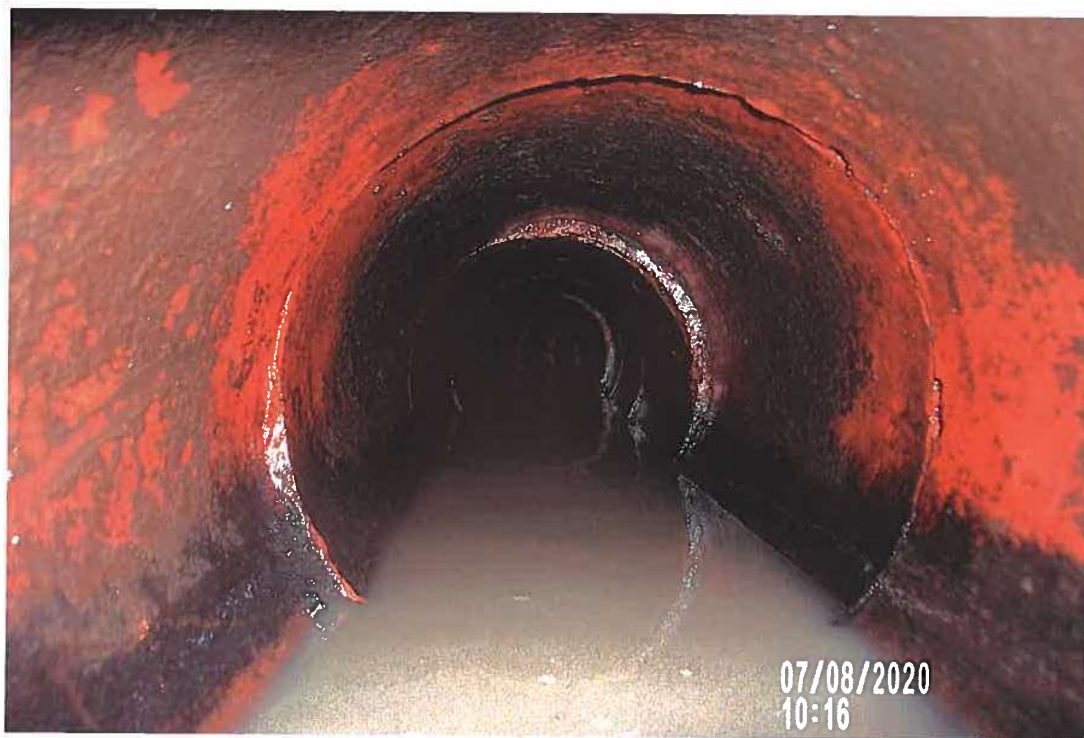
PICTURE #4055 IS LOOKING ^{NW} DOWNSTREAM INSIDE 8" CLAY TILE
FROM GPS # 255' SHOWING TILE IN GOOD CONDITION WITH $\frac{3}{4}$ " OF
WATER AND NOT MUCH FLOW. TILE IS 3.1' \pm DEEP.

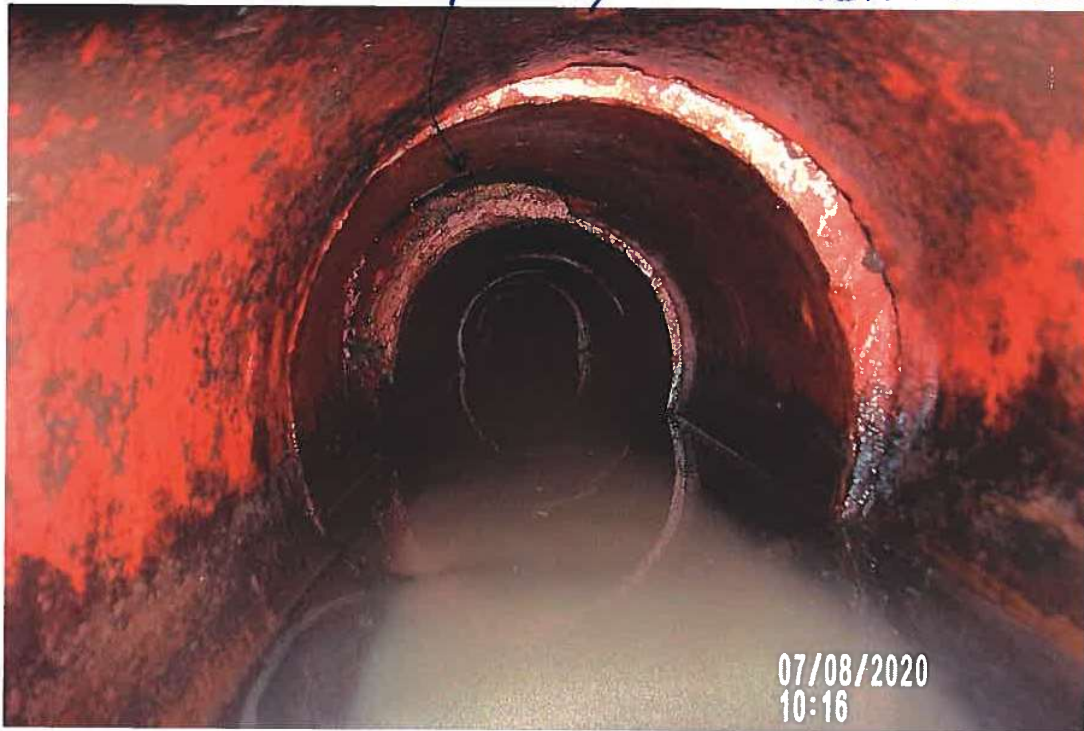
PICTURE# 4056 IS LOOKING SE UPSTREAM INSIDE 8" CLAY TILE
 SHOWING TILE IN GOOD CONDITION WITH $\frac{3}{4}$ " WATER IN FL &
 NOT MUCH FLOW. TILE IS 3.11' ± DEEP.
 ↑ 6" CLAY TILE INLET FROM BEEHIVE INTAKE.

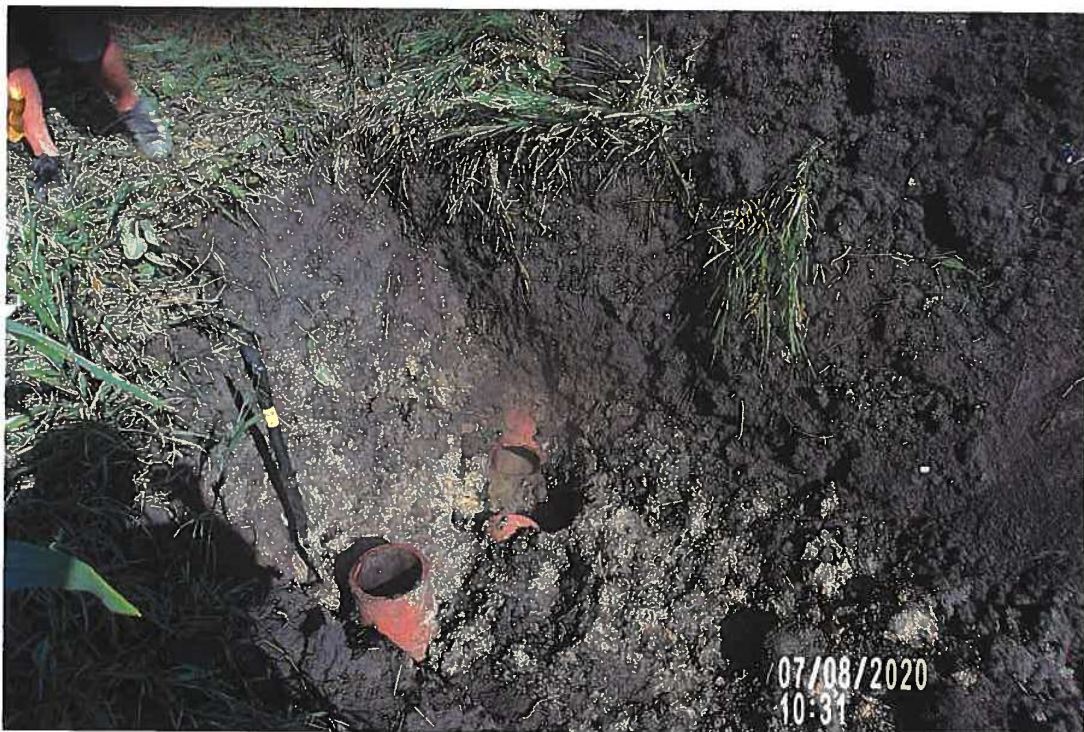
PICTURE# 4057 IS LOOKING NW SHOWING SECTION OF 8" CLAY
 TILE ROLLED OUT IN SOUTH DITCH OF CO HWY 041 NW OF BEEHIVE INTAKE
 FOR CREW TO RUN LOCATOR CABLE UPSTREAM TO FIND PLUG
 IN TILE.

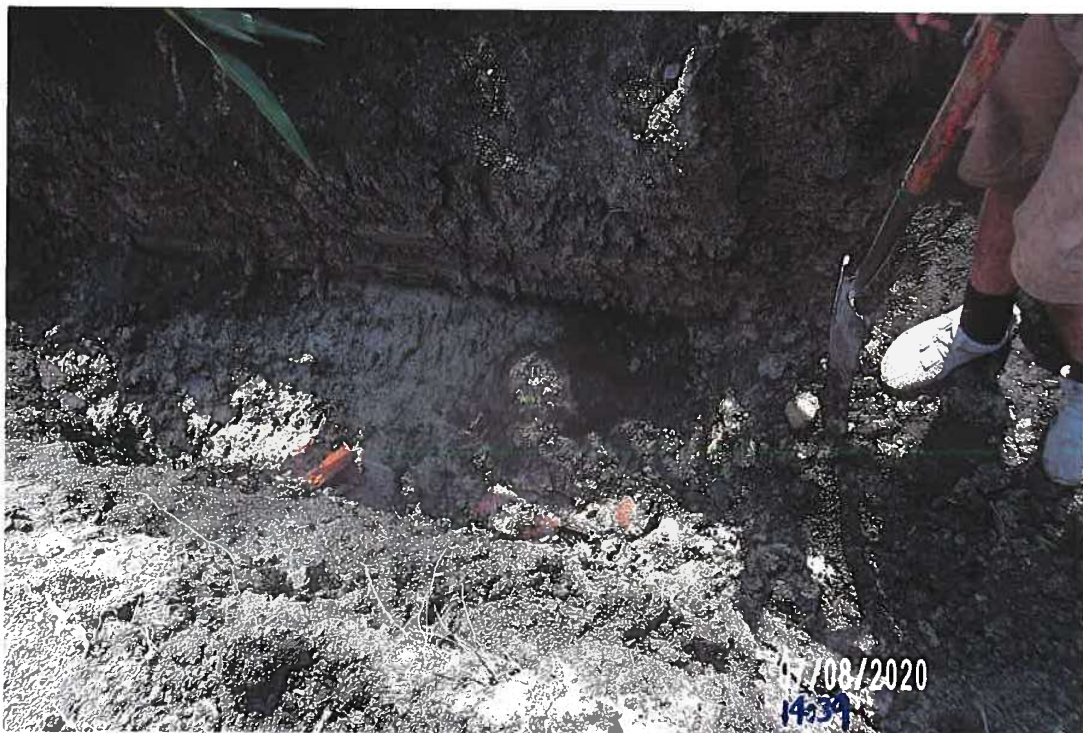
PICTURE # 4060 IS LOOKING UPSTREAM INSIDE 8" CLAY TILE @ 21.3' UPSTREAM FROM BEEHIVE INTAKE SHOWING 5" PERF SW HOPE TILE FROM EAST & FROM WEST CONNECTING AT SAME LOCATION WITH SIDES CRACKED AND TOP CAVING DOWN WITH TILE PLUGGED UPSTREAM WITH SOIL & ROOTS

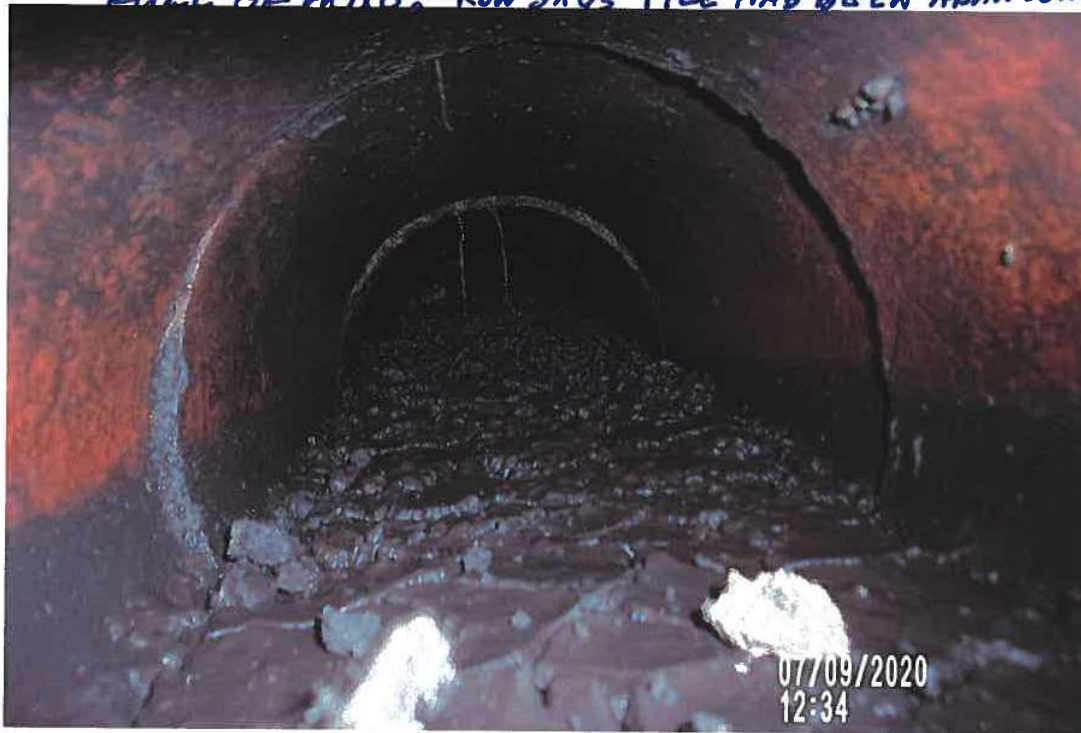
PICTURE #4098 IS LOOKING SE DOWNSTREAM FROM GPS #251
 TOP 8" CLAY TILE (0.75' TOPTOFL) AFTER ANOTHER DAMAGED
 40' SECTION OF TILE WAS REMOVED. 2" MUD IN FL TO COMPLETELY
 FULL OF MUD. RON SAYS TILE HAS BEEN ABANDONED BUT

WILL CONNECT
 TOGETHER
 IN CASE
 ANY TILE
 UPSTREAM
 IS CONNECTED
 YES

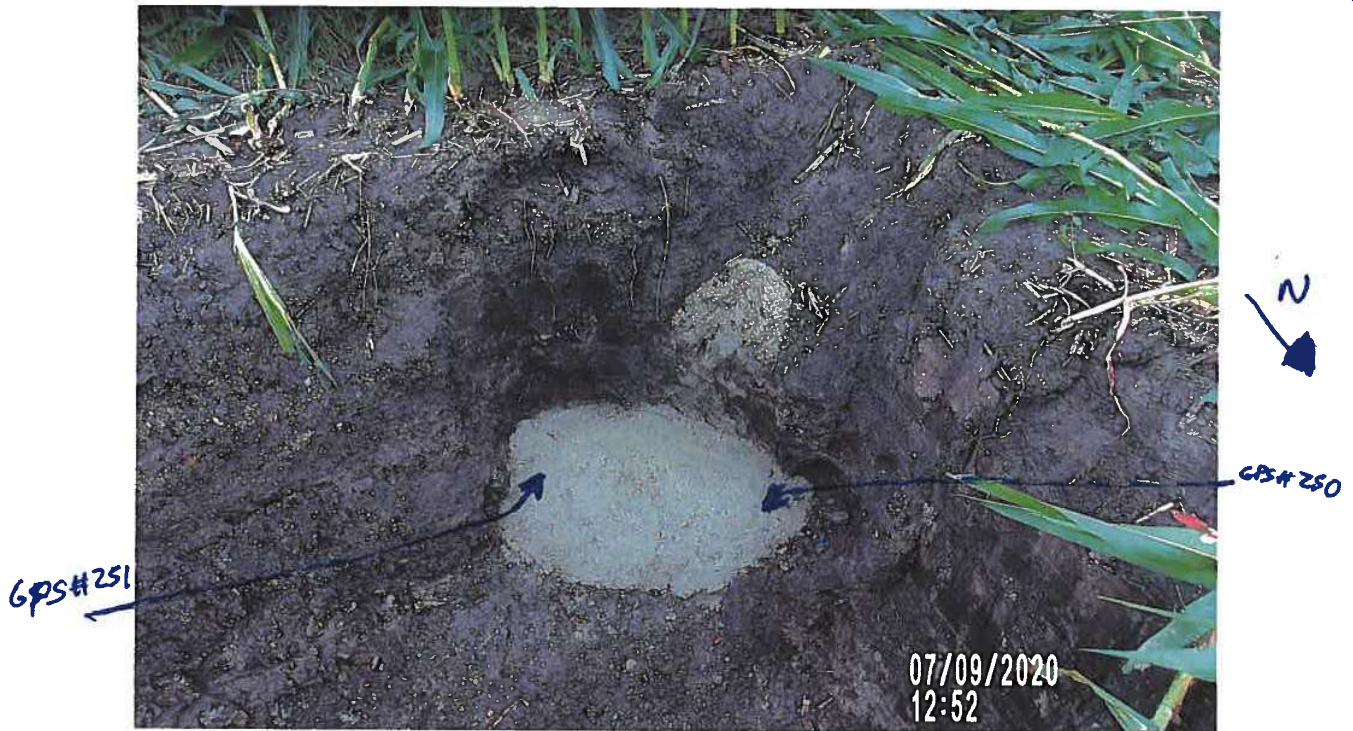
PICTURE # 4100 IS LOOKING SW AT FINISHED $\frac{3}{4}$ CONCRETE COLLAR FOR 8" CLAY TILE REPAIR 55'± NORTH OF E HWY D41. CREW USED 8-60LB QUIKRETE HIGH STRENGTH CONCRETE BAGS.
