AGENDA
REGULAR DRAINAGE MEETING
Wednesday, October 14, 2020 9:30 AM
Large Conference Room

PAY ESTIMATE NO. 6
REPAIRS TO MAIN TILE AND LATERAL 3 DD#25 & REPAIRS TO MAIN TILE DD#1, HARDIN CO.
PROJECT NUMBER: 6501
DATE: 10-5-20

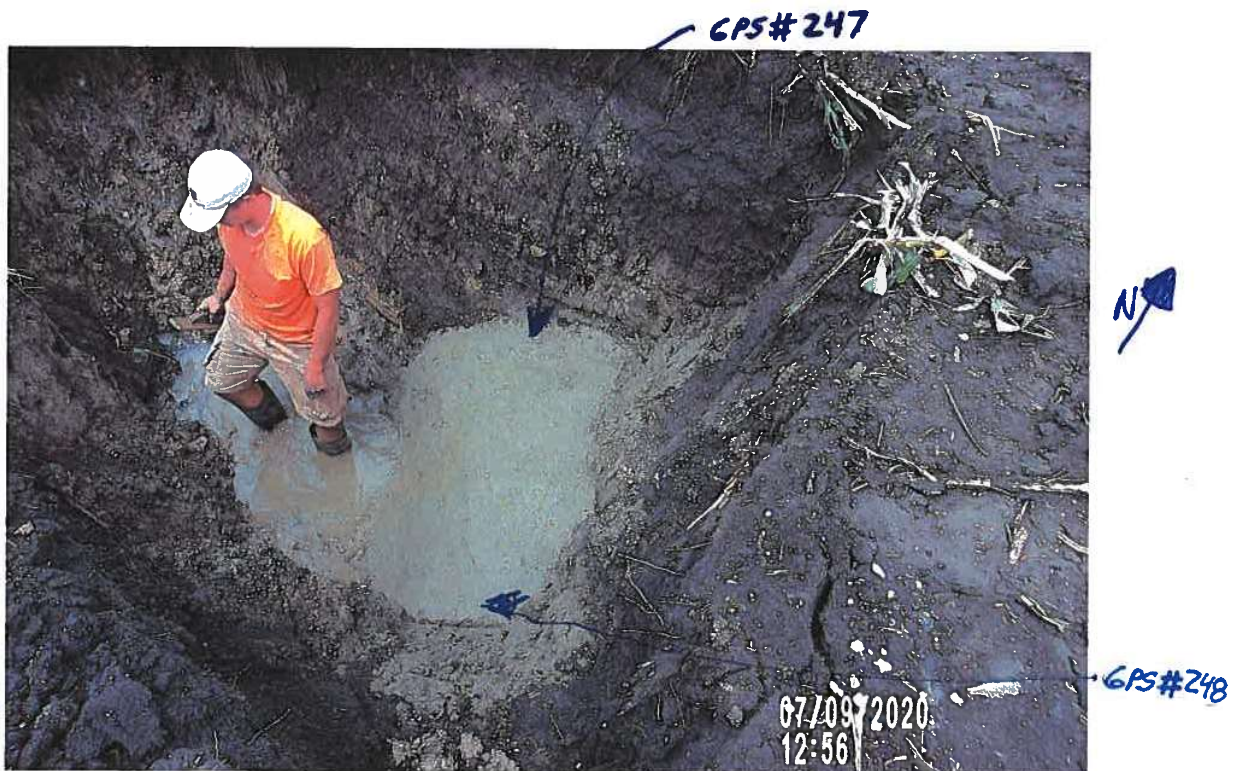
PICTURE #4101 IS LOOKING NW AT FINISHED $\frac{3}{4}$ CONCRETE COLLAR FOR 14" CLAY TILE REPAIR 168'± NORTH OF E HWY D41. CREW USED 18-60LB QUIKRETE HIGH STRENGTH CONCRETE BAGS FOR CONCRETE COLLARS.

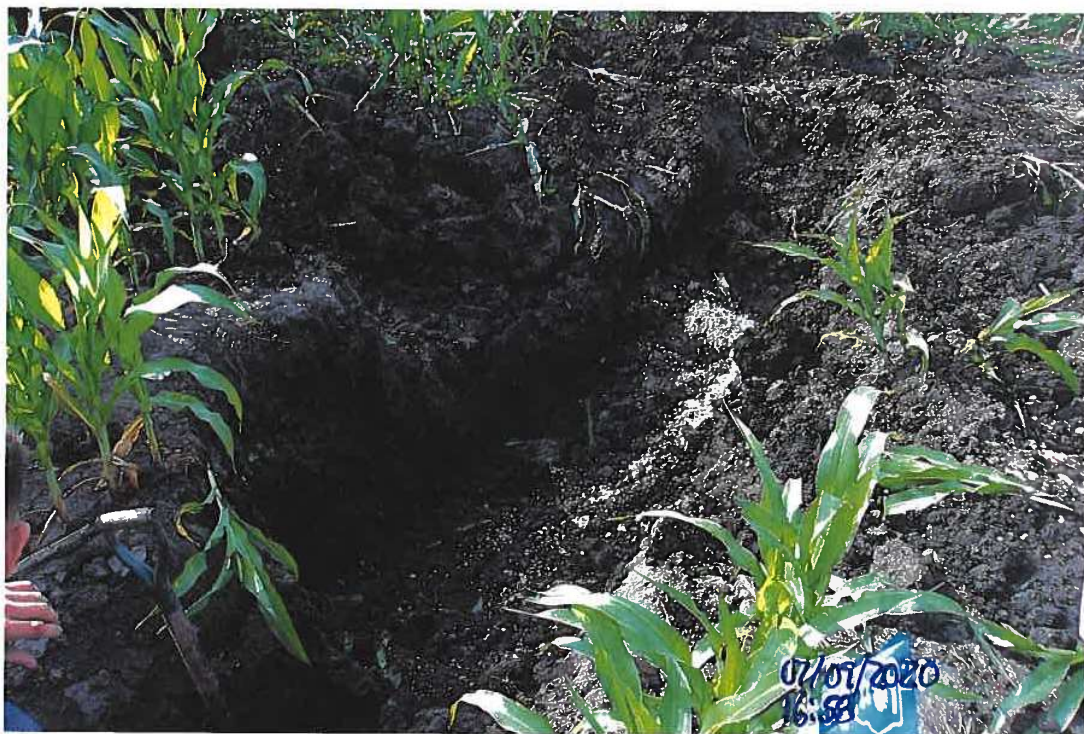
PICTURE #4121 IS LOOKING AT FINISHED $\frac{3}{4}$ CONCRETE COLLAR OVER HOLE IN 8" SW HOPE NON PERF TILE. CREW USED 4 - 60 LB BAGS OF QUIKRETE HIGH STRENGTH CONCRETE ON COLLAR
