**AGENDA**  
**REGULAR DRAINAGE MEETING**  
**Wednesday, January 20, 2021 9:30 AM**  
**Large Conference Room**

[DD 20 WO 302 - 6502.5 - INVESTIGATION-REPAIR SUMMARY 01\\_05\\_20.PDF](#)

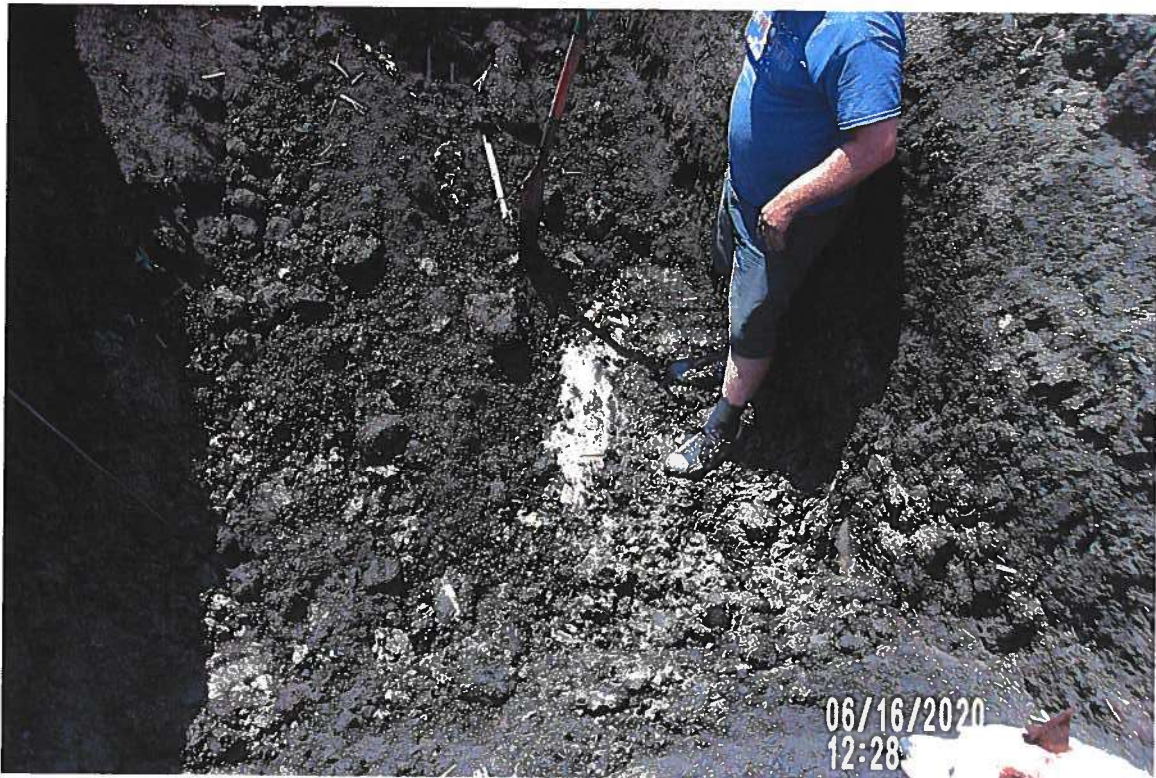
PICTURE#3775 IS LOOKING SOUTH TOWARDS 195TH STREET  
AT 5.0'  $\phi$  X 2.0' DEEP BLOWOUT IN BEAN GROUND  
(WEST SIDE) OF CROP CHANGE

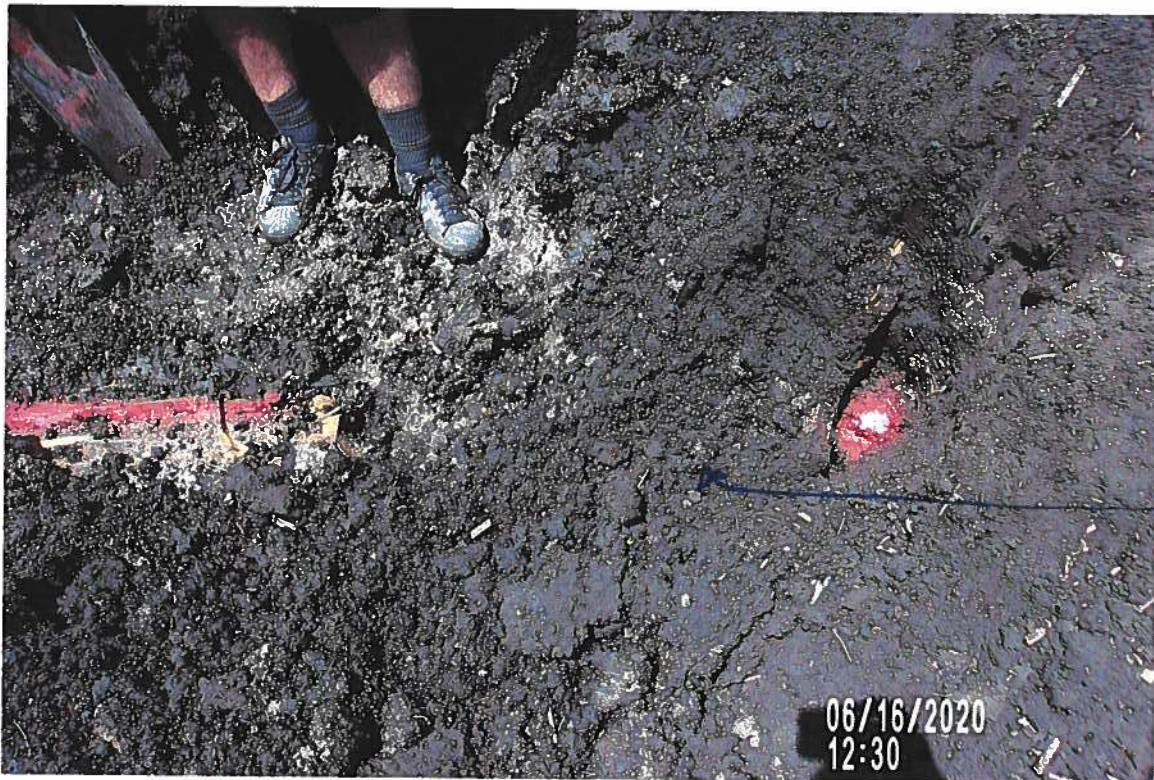
PICTURE #3776 IS LOOKING SW SHOWING EXISTING CLAY TILE  
EXPOSED NEAR TILE BLOWOUT WITH NO VISIBLE ISSUES YET  
(JOINT IS TIGHT)

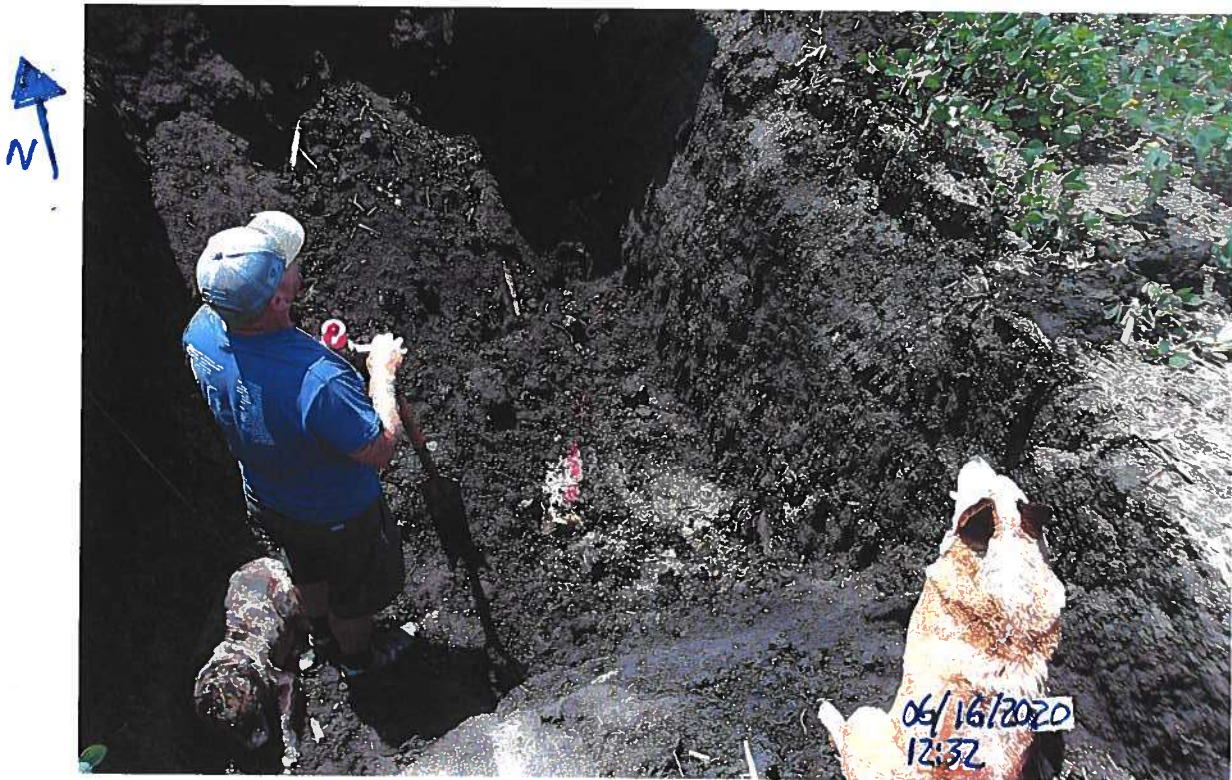
TILE  
SECTION  
COLLAPSING  
& BROKEN

PICTURE #3777 IS LOOKING SLIGHTLY NW SHOWING EXISTING  
CLAY TILE TO SW IN GOOD SHAPE AND SECTION OF CLAY  
TILE COLLAPSED (GOOD CLAY AROUND TILE)

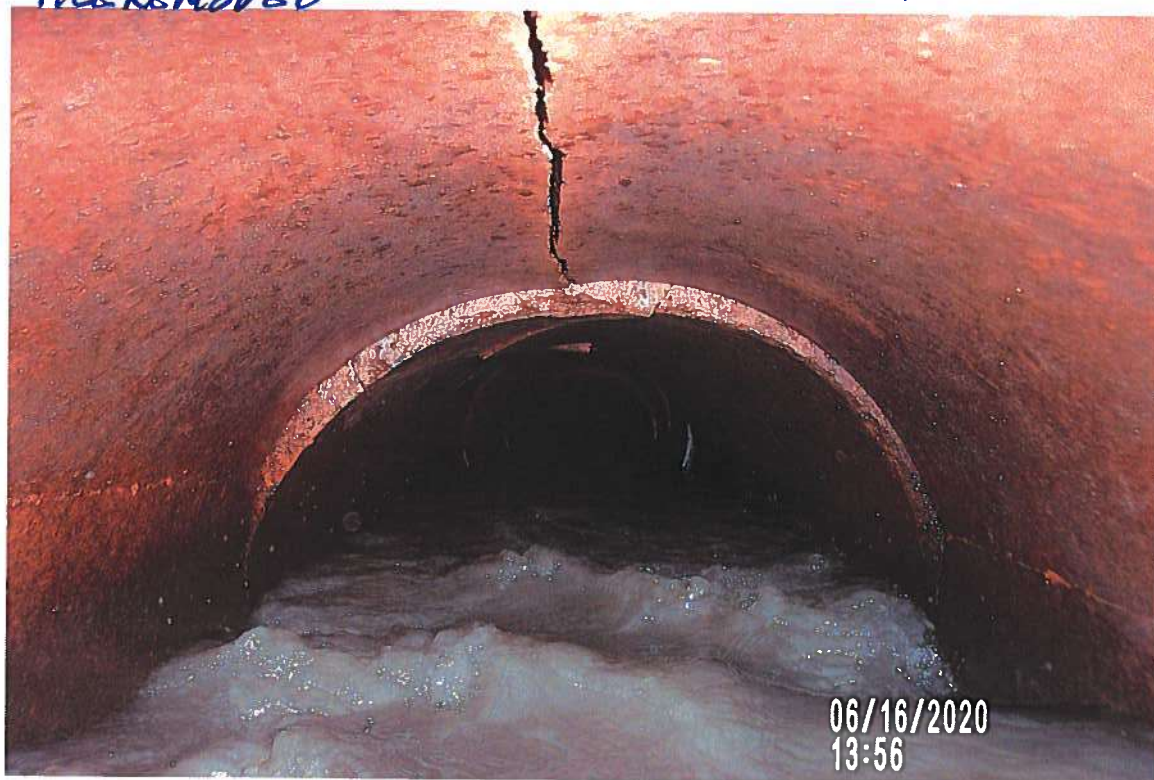
PICTURE # 3779 IS LOOKING SW UPSTREAM FROM GPS#392.  
INSIDE- 21" CLAY TILE WITH SMOOTH CRACKS @ 6 & 12 O'CLOCK,  
TILE IS CRACKED, SLIGHTLY SQUATTED, BUT DOES NOT APPEAR TO BE LEAVING DOWN.

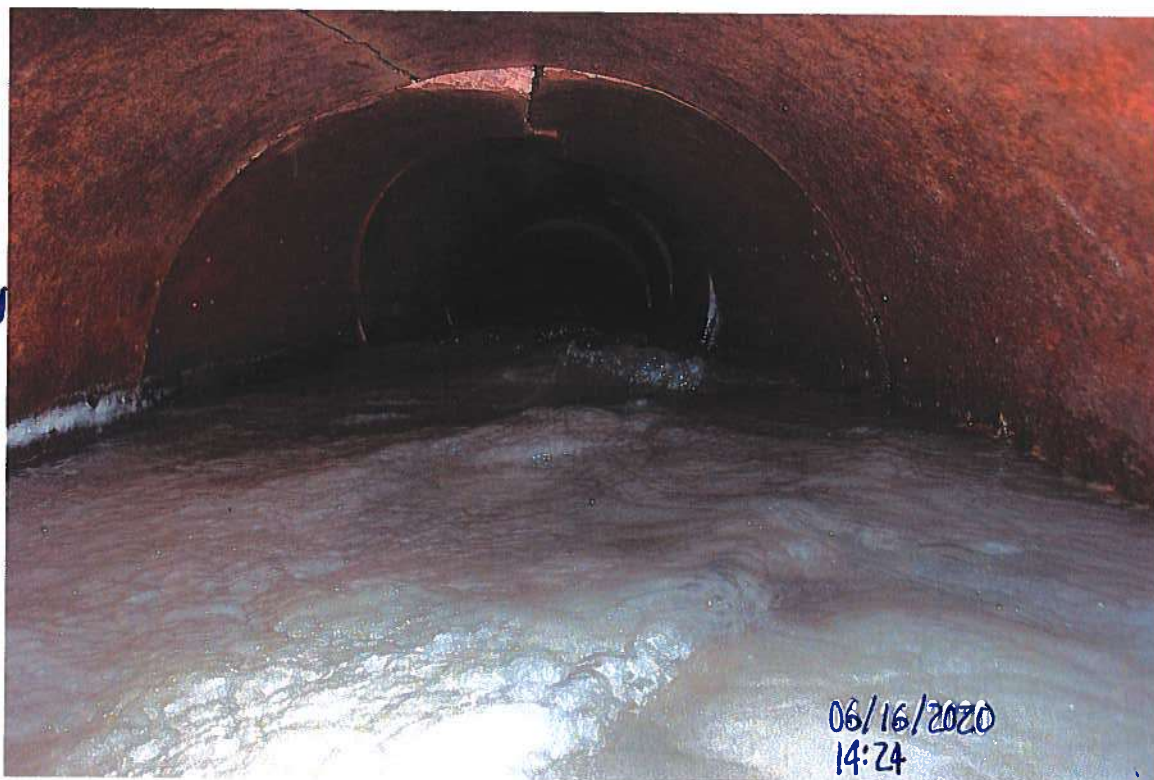
PICTURE # 3780 IS LOOKING NE DOWNSTREAM APPROXIMATELY 12.5'  
FROM GPS # 392 SHOWING TILE STILL CRACKED, SQUATTED,  
AND CAVING DOWN. AFTER APPROXIMATELY 5 SECTIONS OF  
TILE REMOVED

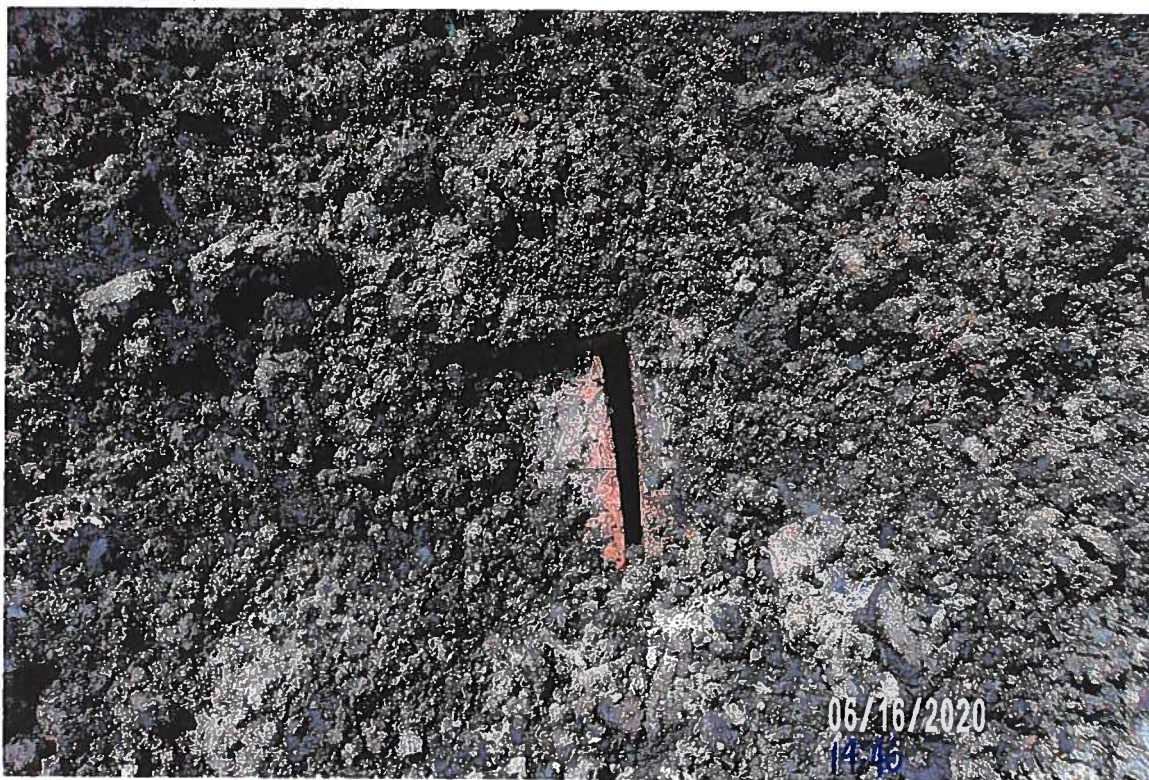
PICTURE # 3781 IS LOOKING NE DOWNSTREAM APPROXIMATELY  
(23.5' FROM GPS # 392) (GPS # 393) SHOWING TILE STILL CRACKED, SQUATTED,  
AND CAVING DOWN AFTER 4 SECTIONS OF TILE REMOVED.

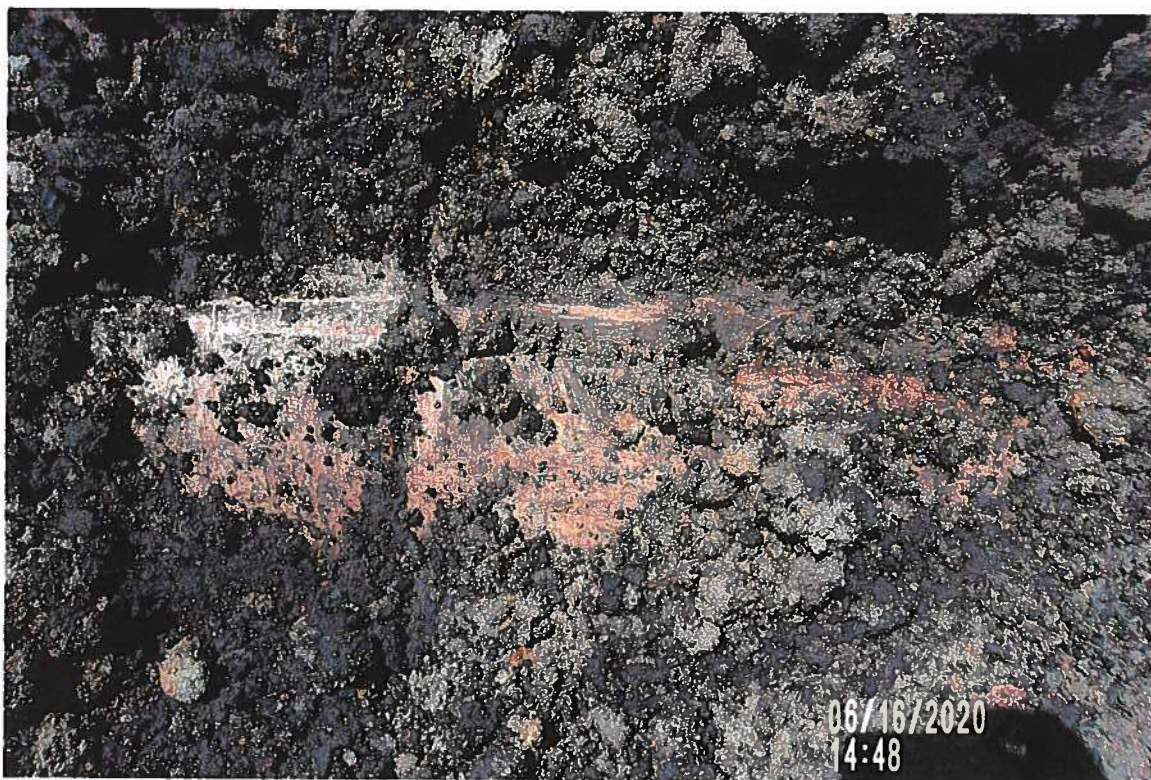
PICTURE# 3782 IS LOOKING SLIGHTLY NW SHOWING  $1\frac{1}{2}$ " TO 2" WIDE JOINT ON CLAY TILE @ 28.5' ± DOWNSTREAM FROM GPS#392 WITH CLAY PIECES OVER JOINT AND UPSTREAM TILE CAVING DOWN.

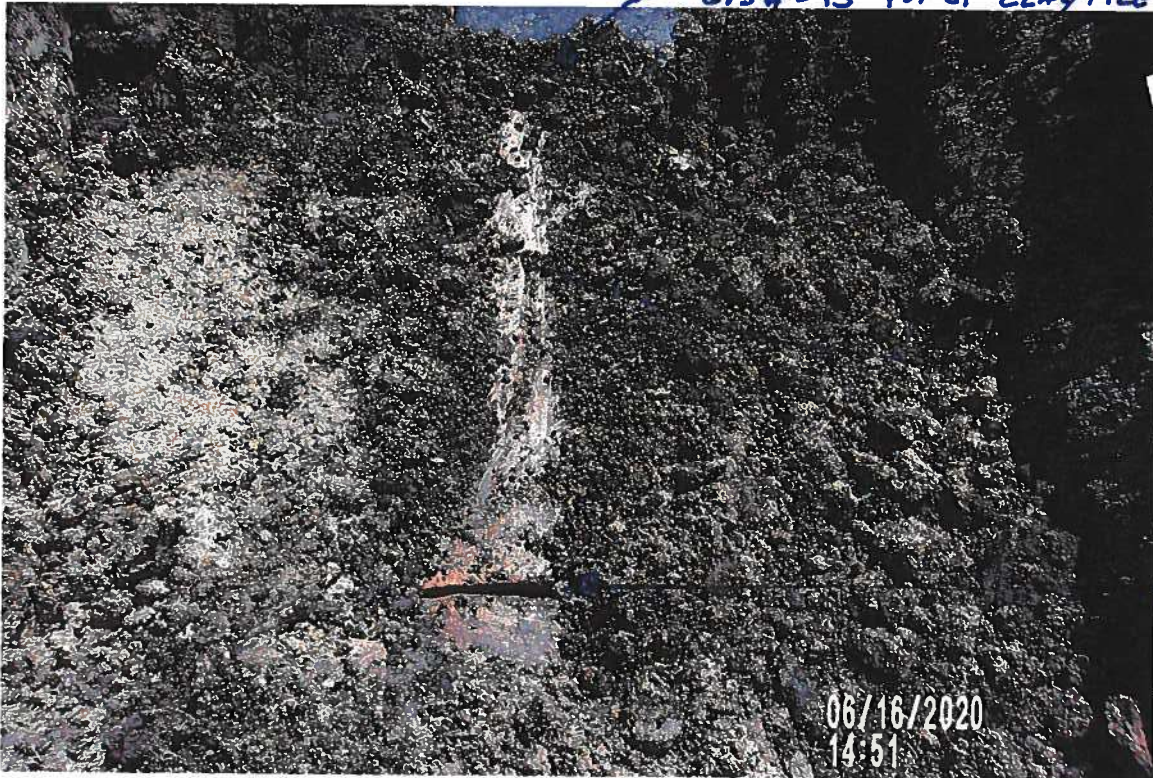
PICTURE# 3783 IS LOOKING NW SHOWING TOP OF CLAY TILE CRACKED AND CAVING DOWN @ 26.0' DOWNSTREAM FROM GPS#392.

PICTURE #3784 IS LOOKING SW SHOWING WIDE GAP & TOP OF TILE CRACKED AND CAVING DOWN

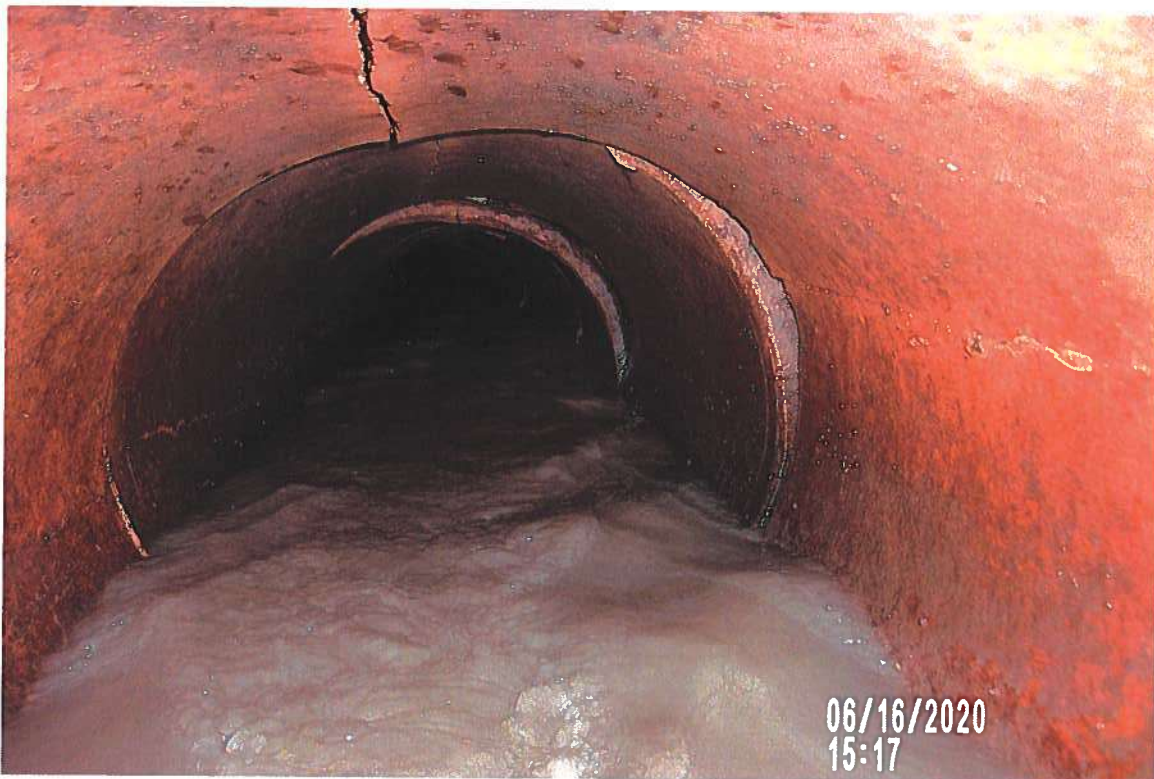
TOP TILE  
CRACKED  
& CAVING  
DOWN.

1 1/2" TO 2"  
WIDE GAP  
@ 28.5' ±  
FROM GPS #392

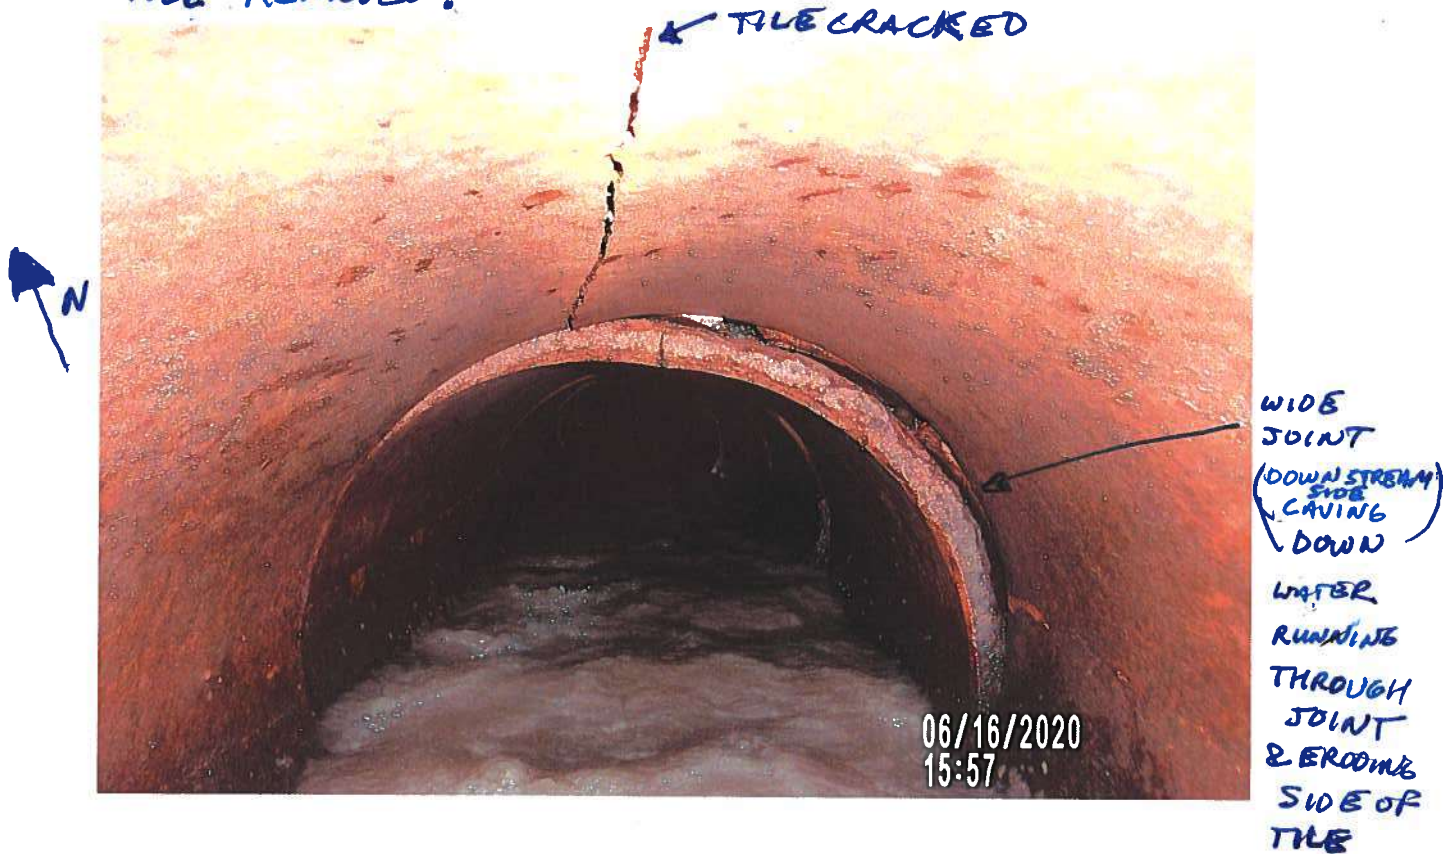
PICTURE #3786 IS LOOKING NE FROM GPS #393 INSIDE 21" CLAY TILE SHOWING TOP TILE CRACKED AND CAVING DOWN WITH JOINT O/S & WIDE JOINT 2 JOINTS DOWNSTREAM.

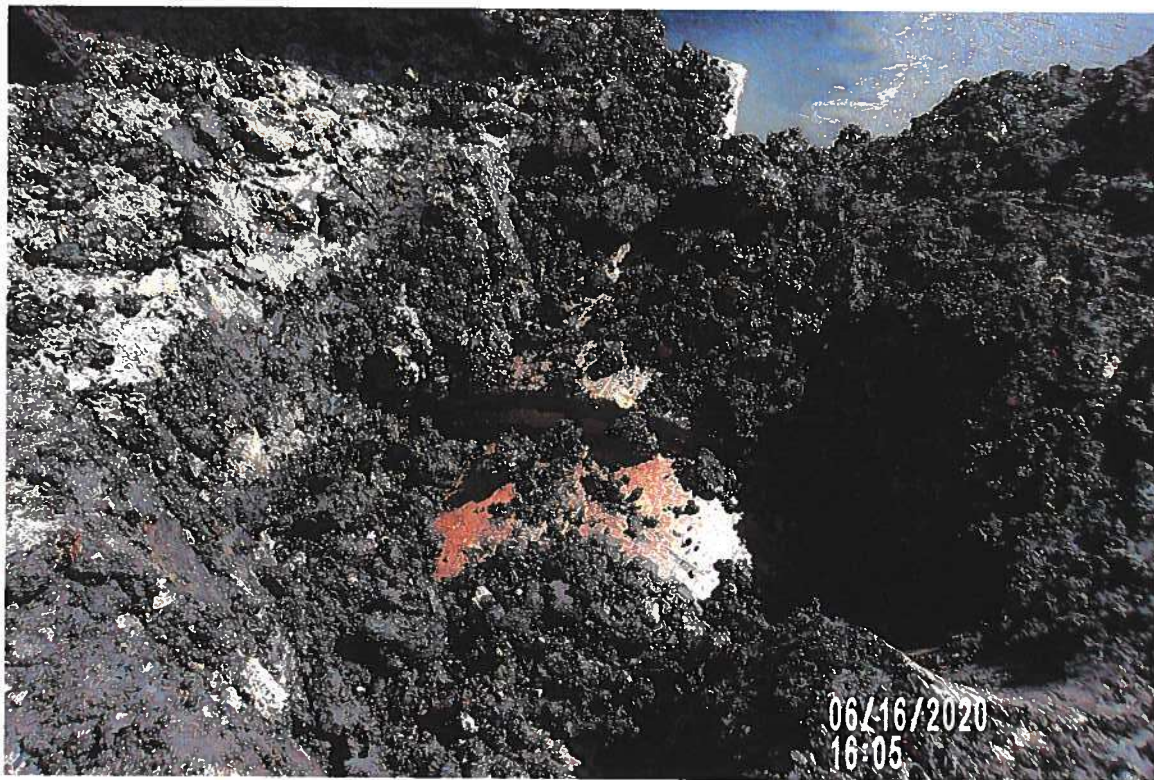
PICTURE #3787 IS LOOKING NE (2.5' NE OF GPS#393) SHOWING  
INSIDE 21" CLAY TILE AFTER ANOTHER SECTION CLAY  
TILE REMOVED.

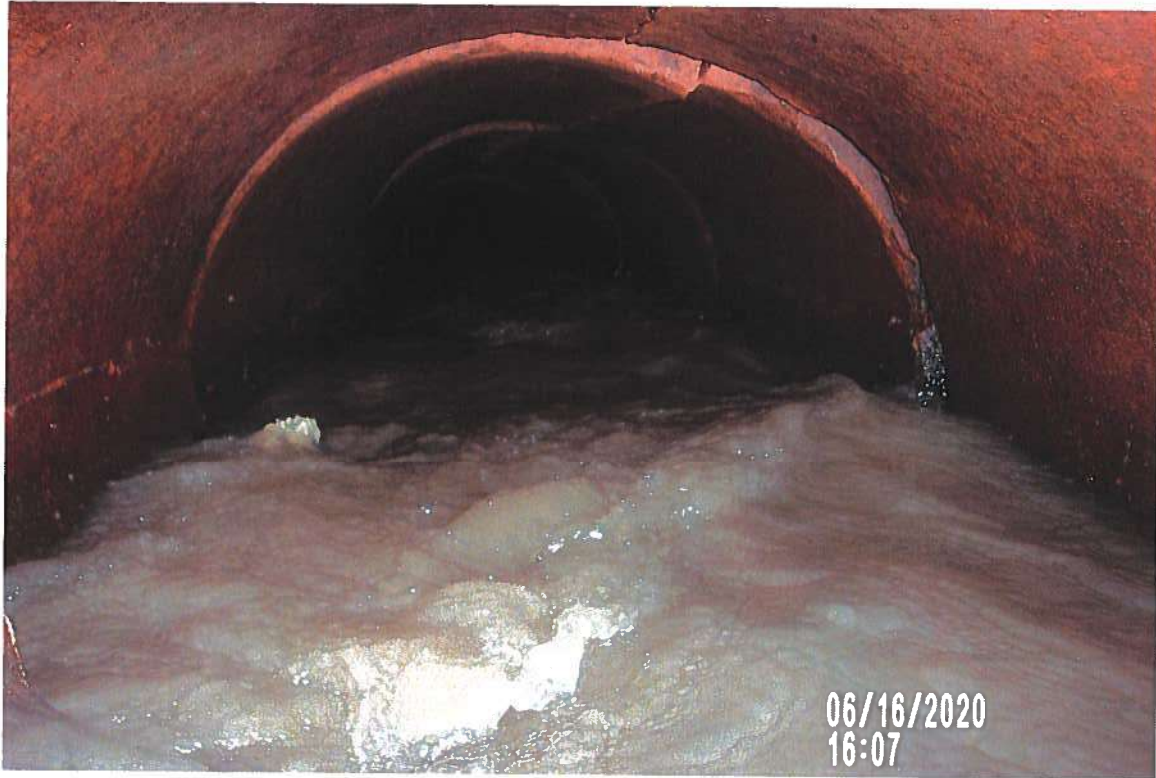
PICTURE #3789 IS LOOKING SOUTH SHOWING TILE CAVING  
DOWN 5.0' DOWN STREAM FROM GPS#393.

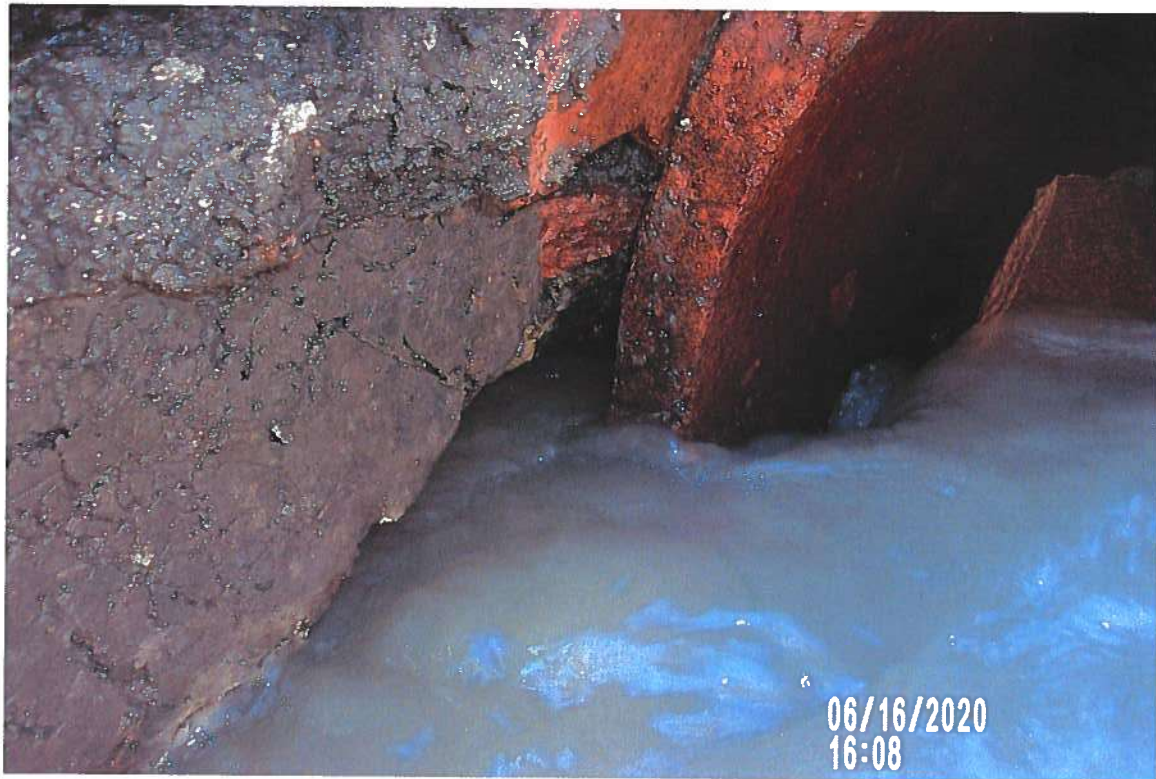
PICTURE # 3790 IS LOOKING DOWN STREAM FROM 28.5'± DOWNSTREAM  
FROM GPS # 392 SHOWING TILE STILL CRACKED AND CAVING  
DOWN

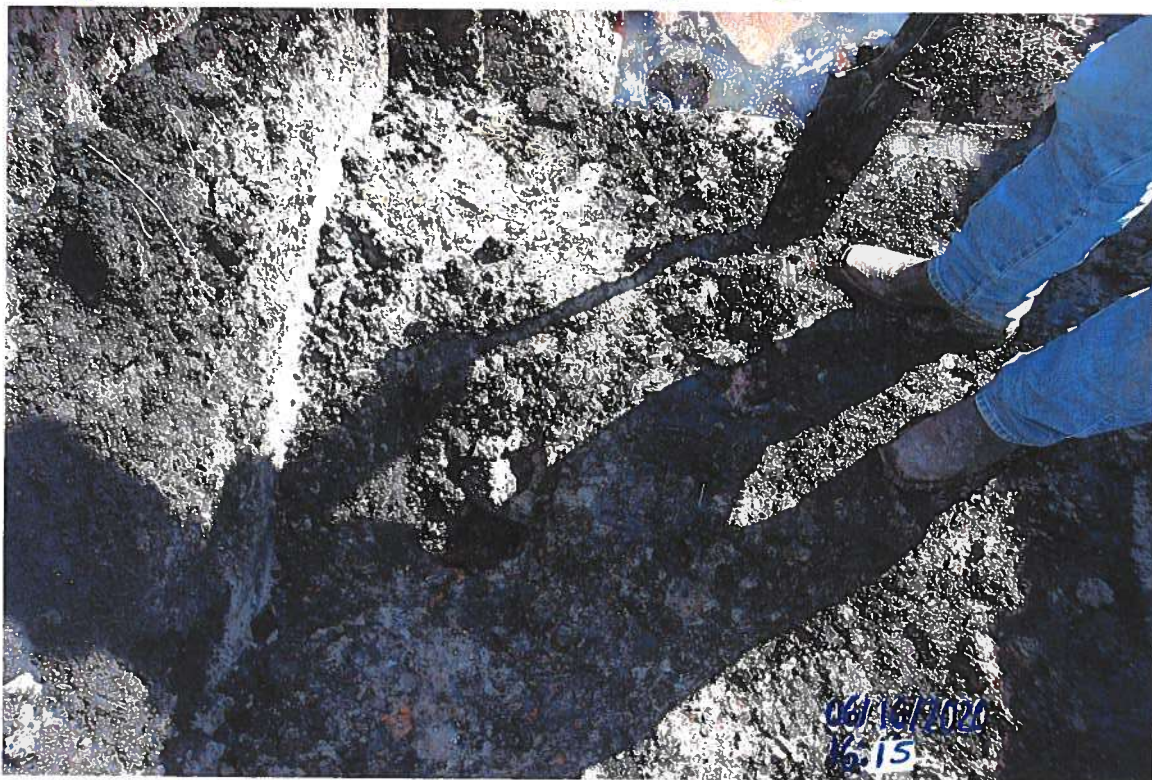
PICTURE # 3791 IS LOOKING ON WEST SIDE OF 21" TILE  
SHOWING VOID BESIDE TILE @ WIDE JOINT (28.5'± DOWNSTREAM  
FROM GPS # 392)

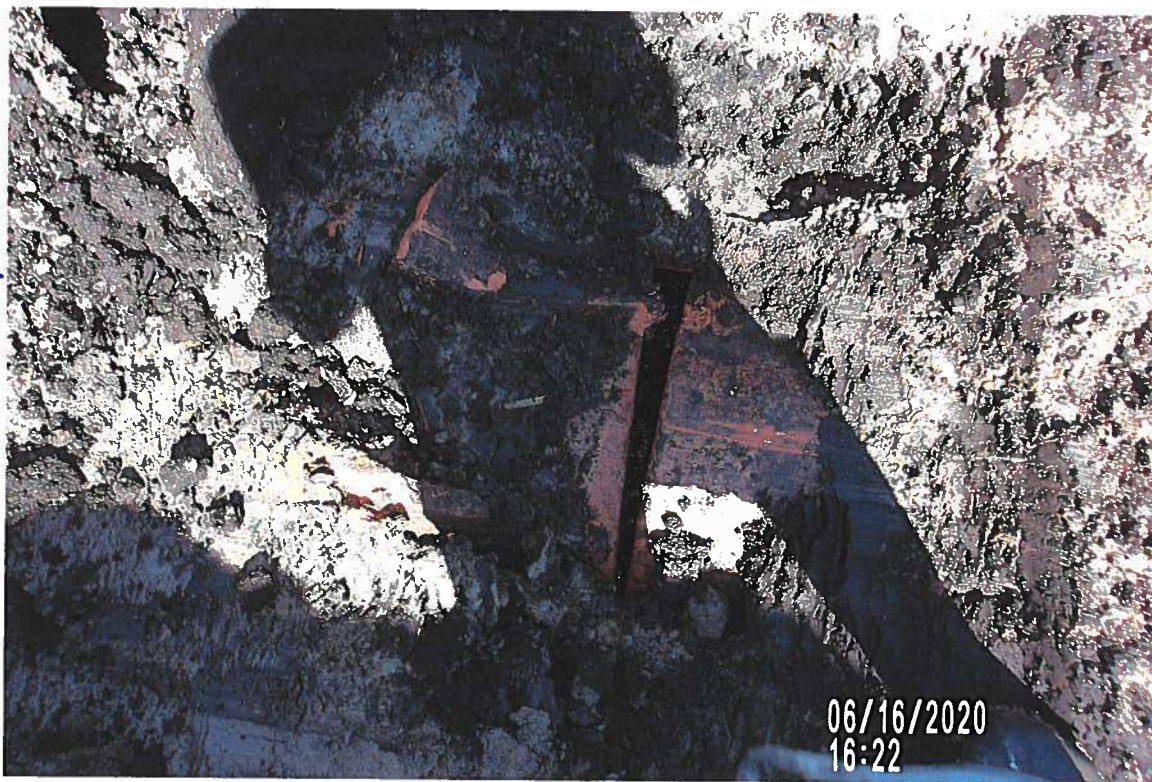
PICTURE # 3792 IS LOOKING SOUTH SHOWING BOOT HOLE AFTER  
CONTRACTOR STEPPED ABOVE VOID ON EAST SIDE OF TILE  
31' DOWNSTREAM OF GPS # 392!

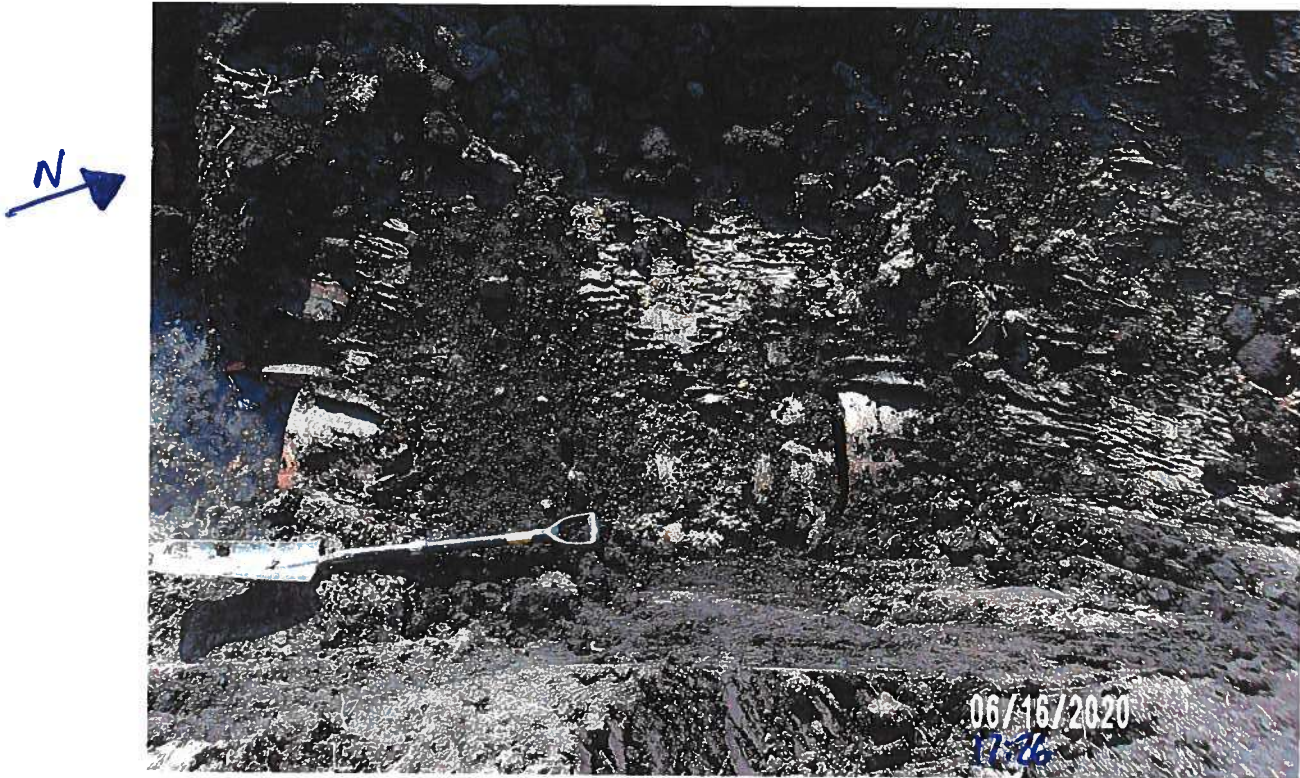
PICTURE# 379.6 IS LOOKING NW SHOWING JOINTS @ 33.5' & 36' DOWN STREAM FROM GPS #392 HAVING WIDE JOINTS

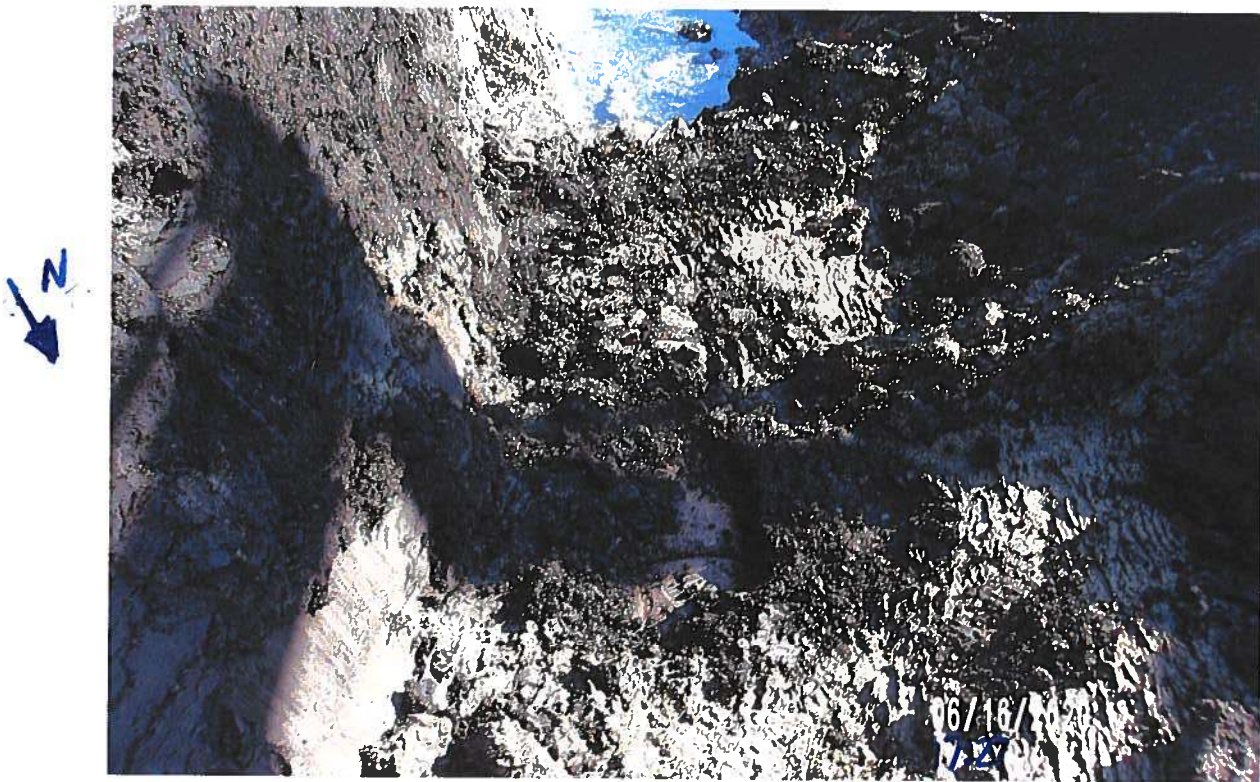
PICTURE# 379.7 IS LOOKING SW SHOWING TILE EXPOSED @ GPS 13 WITH TILE STILL CRACKED AND CAVING DOWN, (NO DIFFERENCE ON CONDITION) JOINTS ARE TIGHTER,

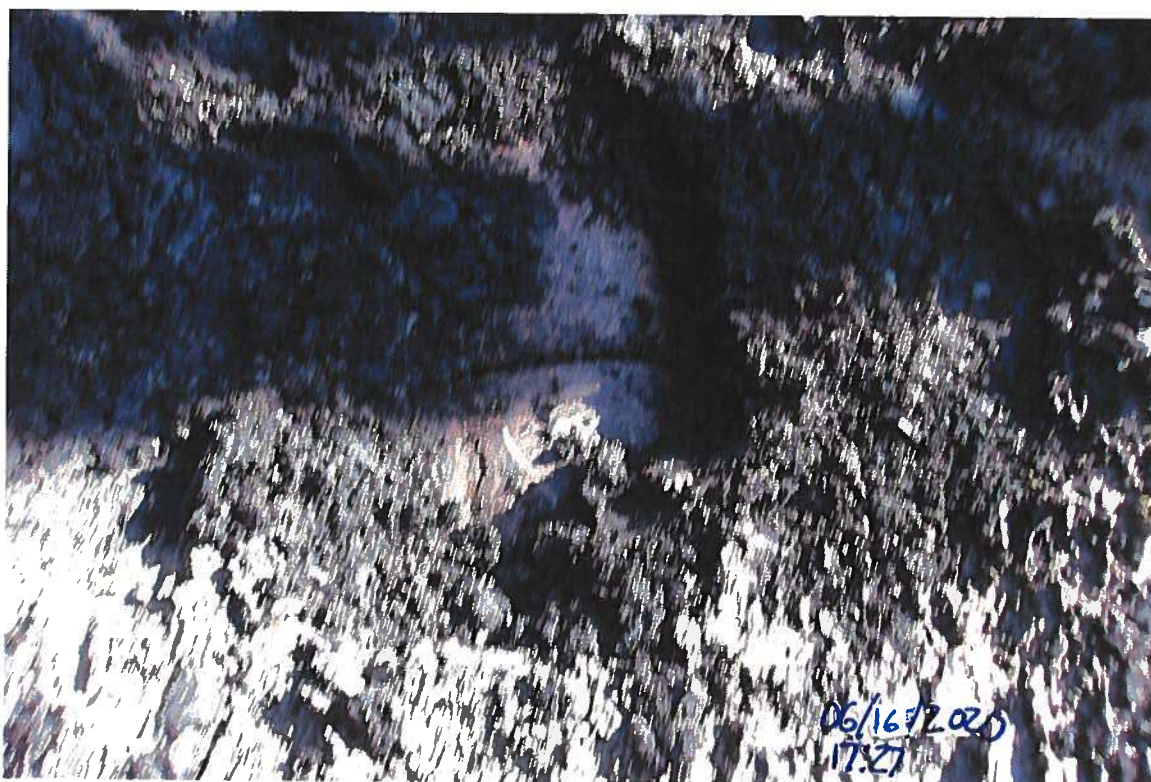
PICTURE# 3798 CLOSER UP PICTURE OF TILE CONDITION  
TIGHTER JOINT BUT STILL CRACKED AND CAVING  
DOWN.

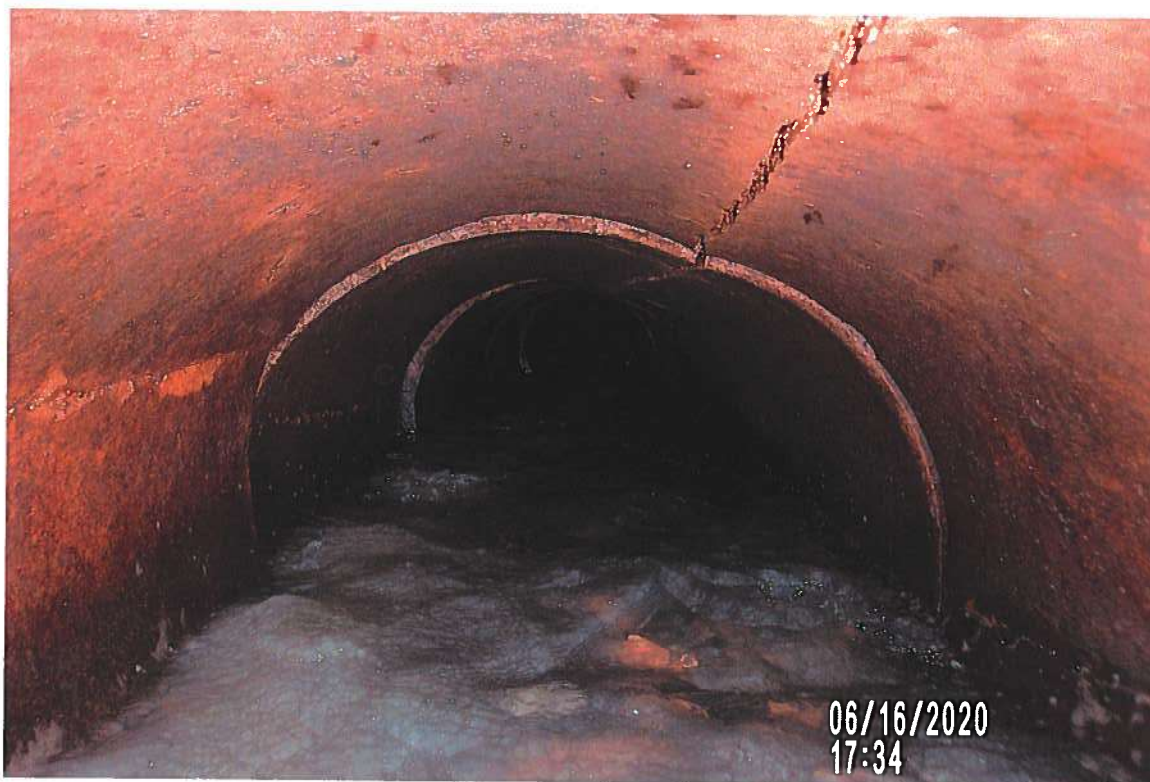
PICTURE# 3799 IS LOOKING NE SHOWING TILE STILL  
CRACKED, SQUATTED AND CAVING DOWN

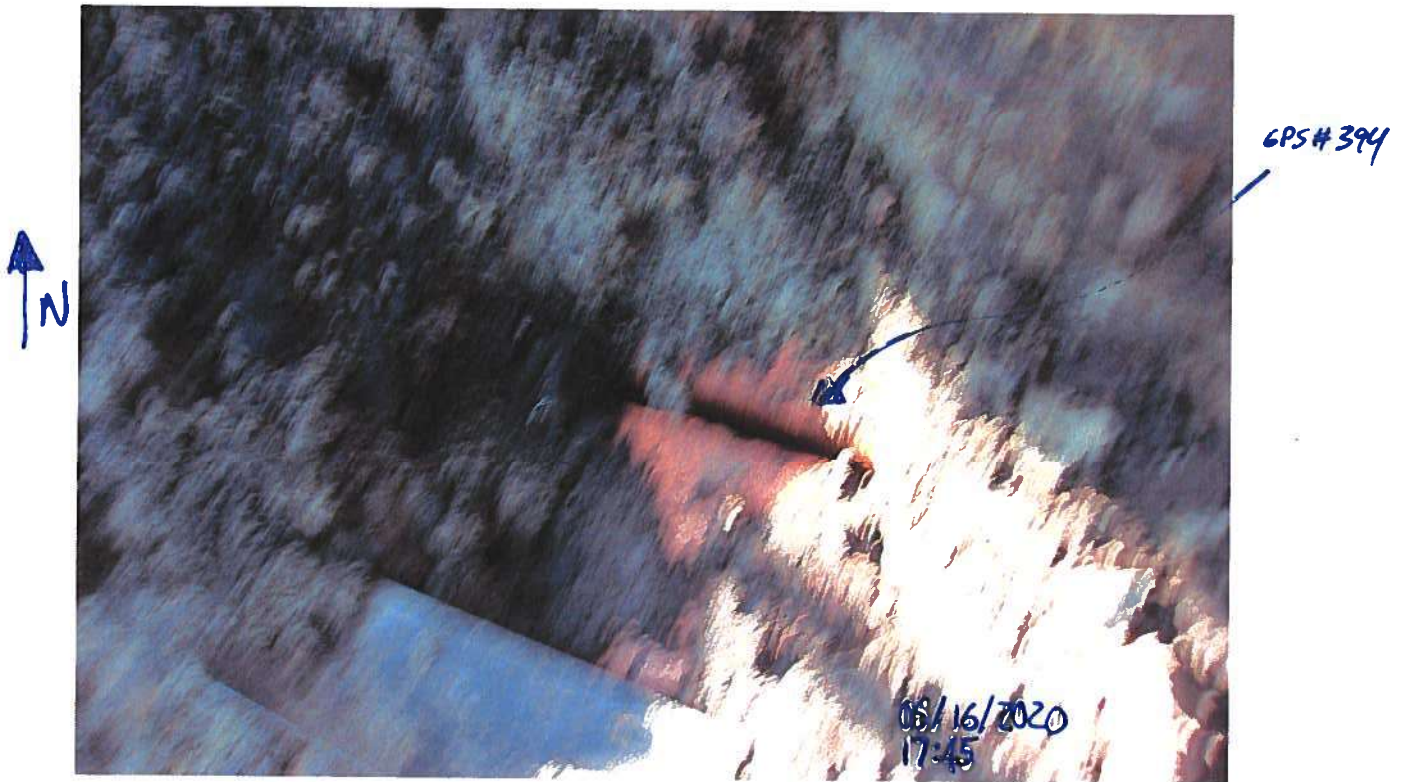
PICTURE# 3800 IS LOOKING NORTH SHOWING ANOTHER WIDE JOINT  
AT GPS# 394.

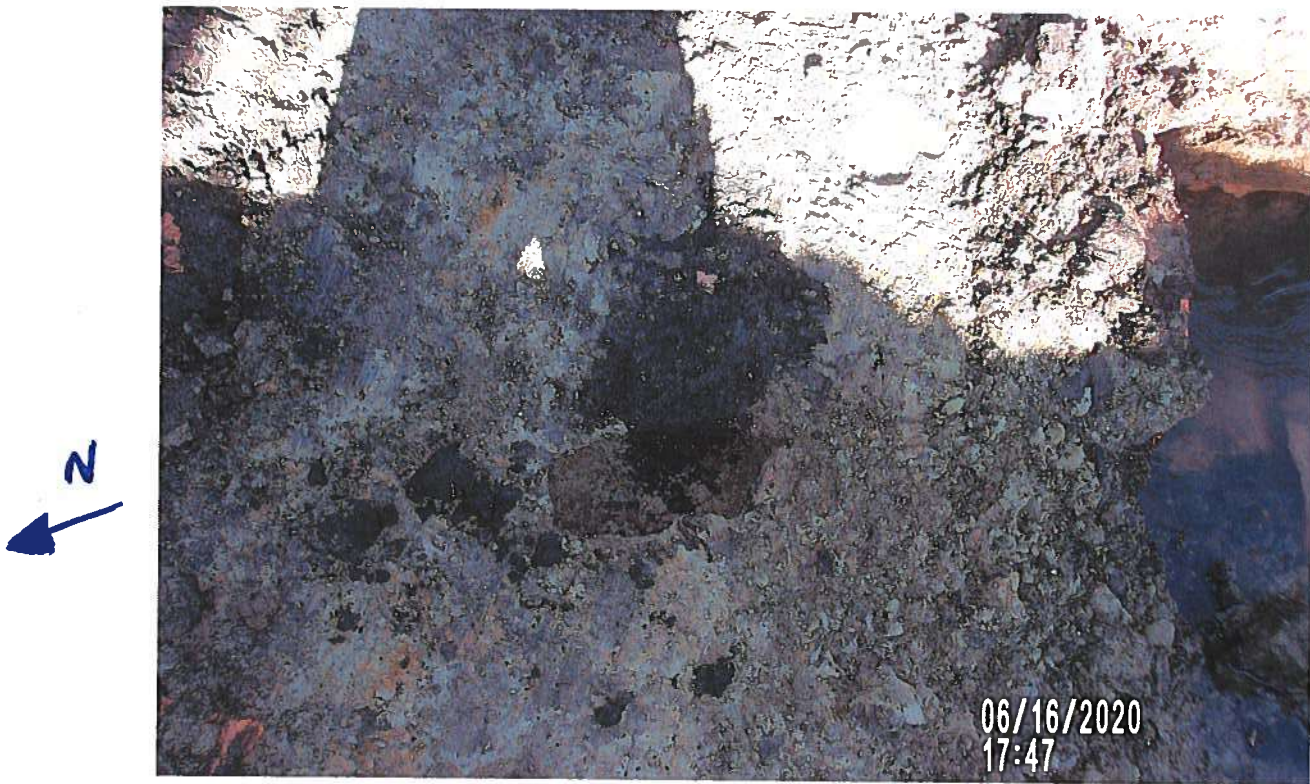
PICTURE# 3801 IS LOOKING SE SHOWING ANOTHER VOID BESIDE  
WEST SIDE OF TILE

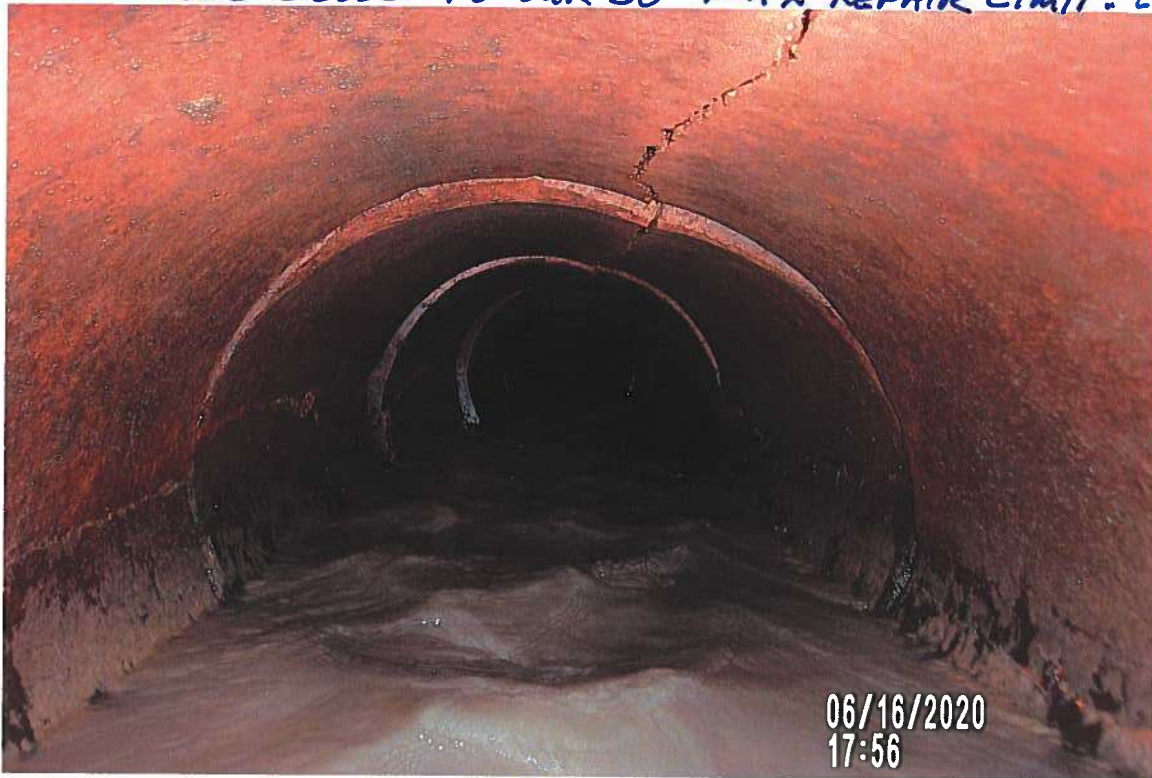
PICTURE # 3802 IS LOOKING NE FROM GPS # 394 SHOWING INSIDE OF 21" CLAY TILE WITH TOP CRACKED AND CAVING DOWN. APPEARS NEXT 3 JOINTS ARE IN SAME CONDITION BUT ARE CLOSE TO OUR 50' MAX REPAIR LIMIT. LEE WILL TALK TO SUPERVISORS IN MORNING ABOUT TELEVISIONING LINE,
