**AGENDA**  
**REGULAR DRAINAGE MEETING**  
**Wednesday, January 20, 2021 9:30 AM**  
**Large Conference Room**

[DD 20 WO 302 - 6502.5 - INVESTIGATION-REPAIR SUMMARY 01\\_05\\_20.PDF](#)

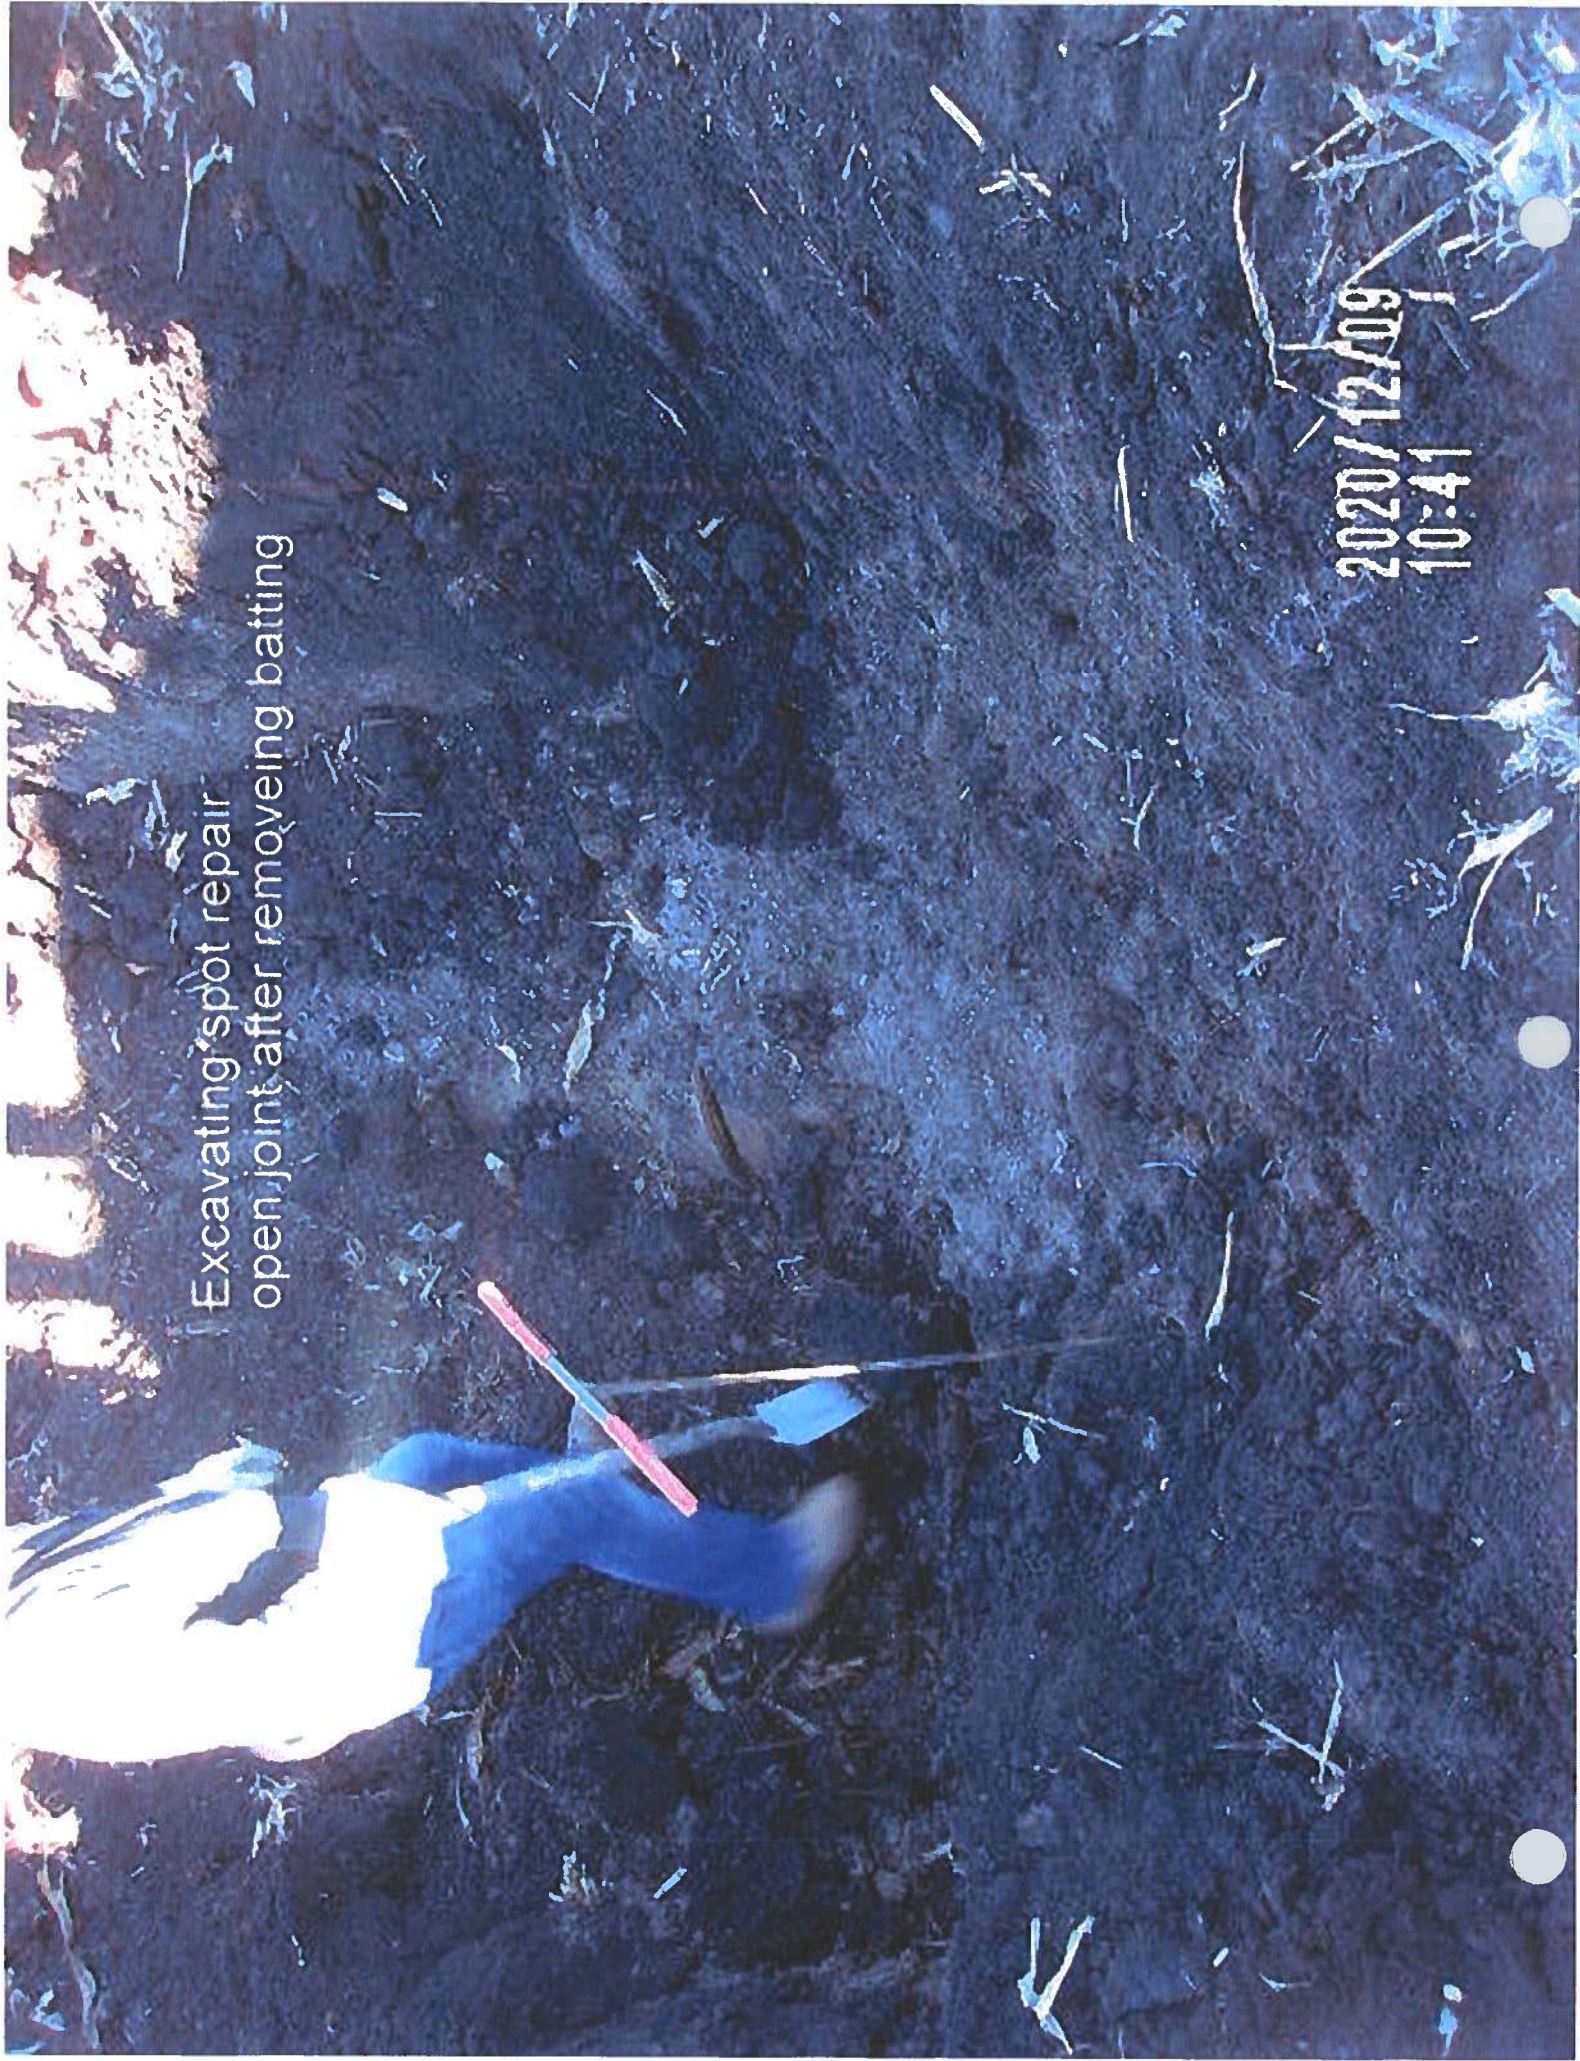
Excavating spot repair  
open joint after removing batting

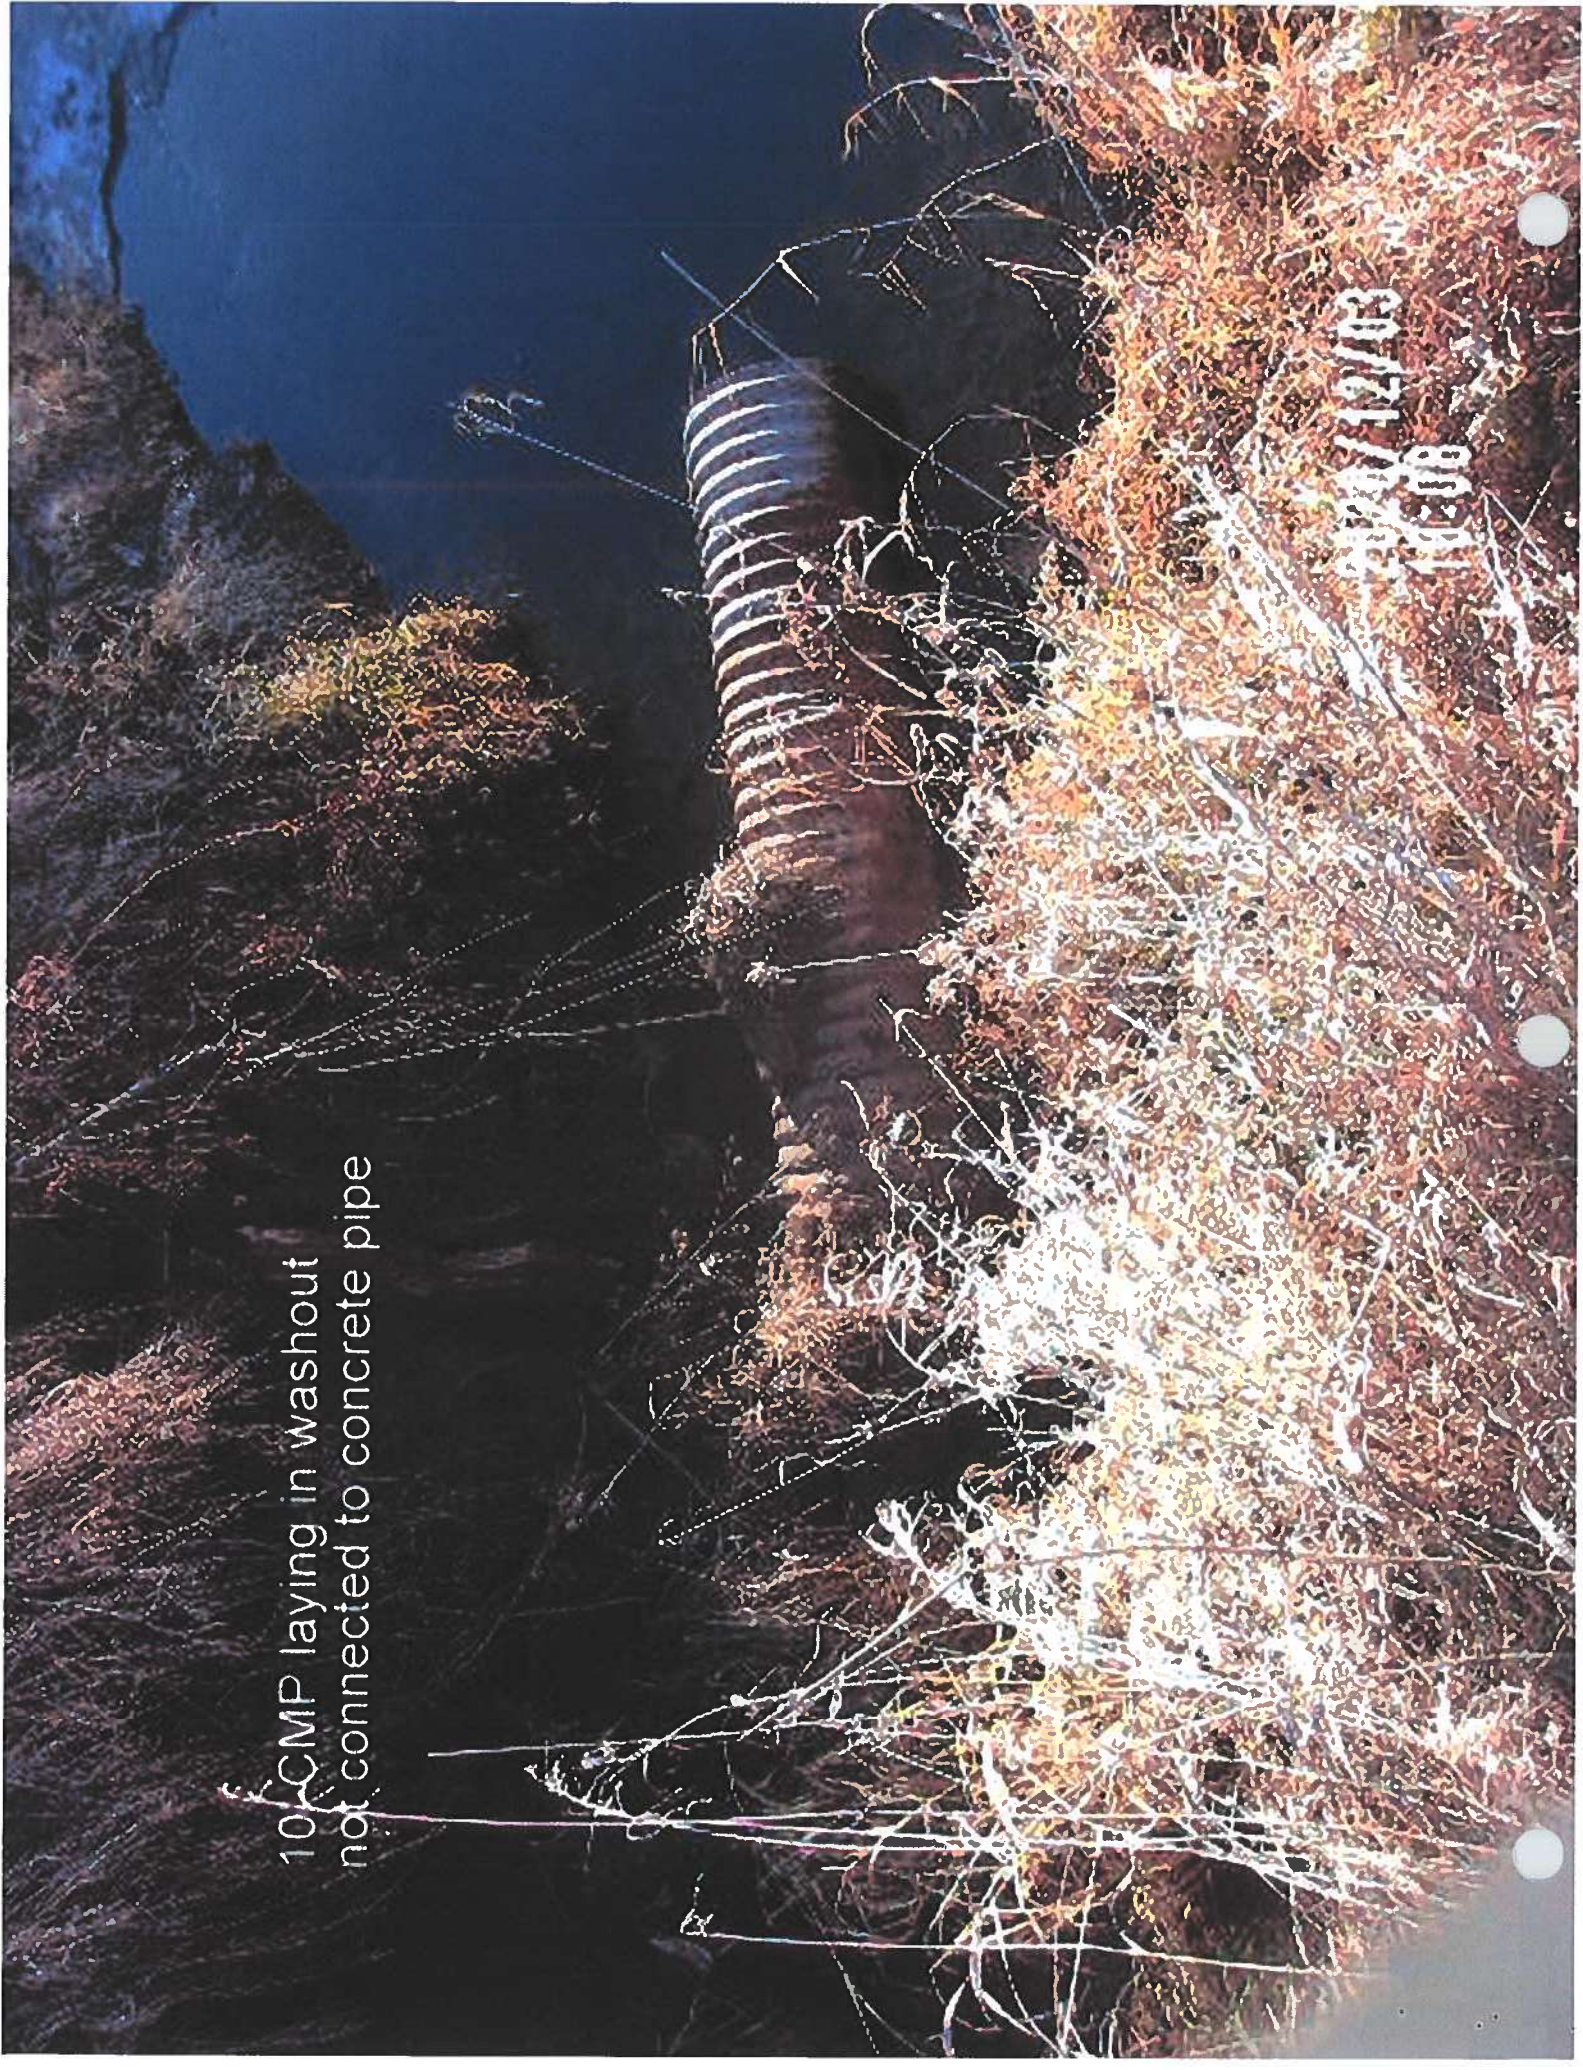
10 CMP laying in washout  
not connected to concrete pipe

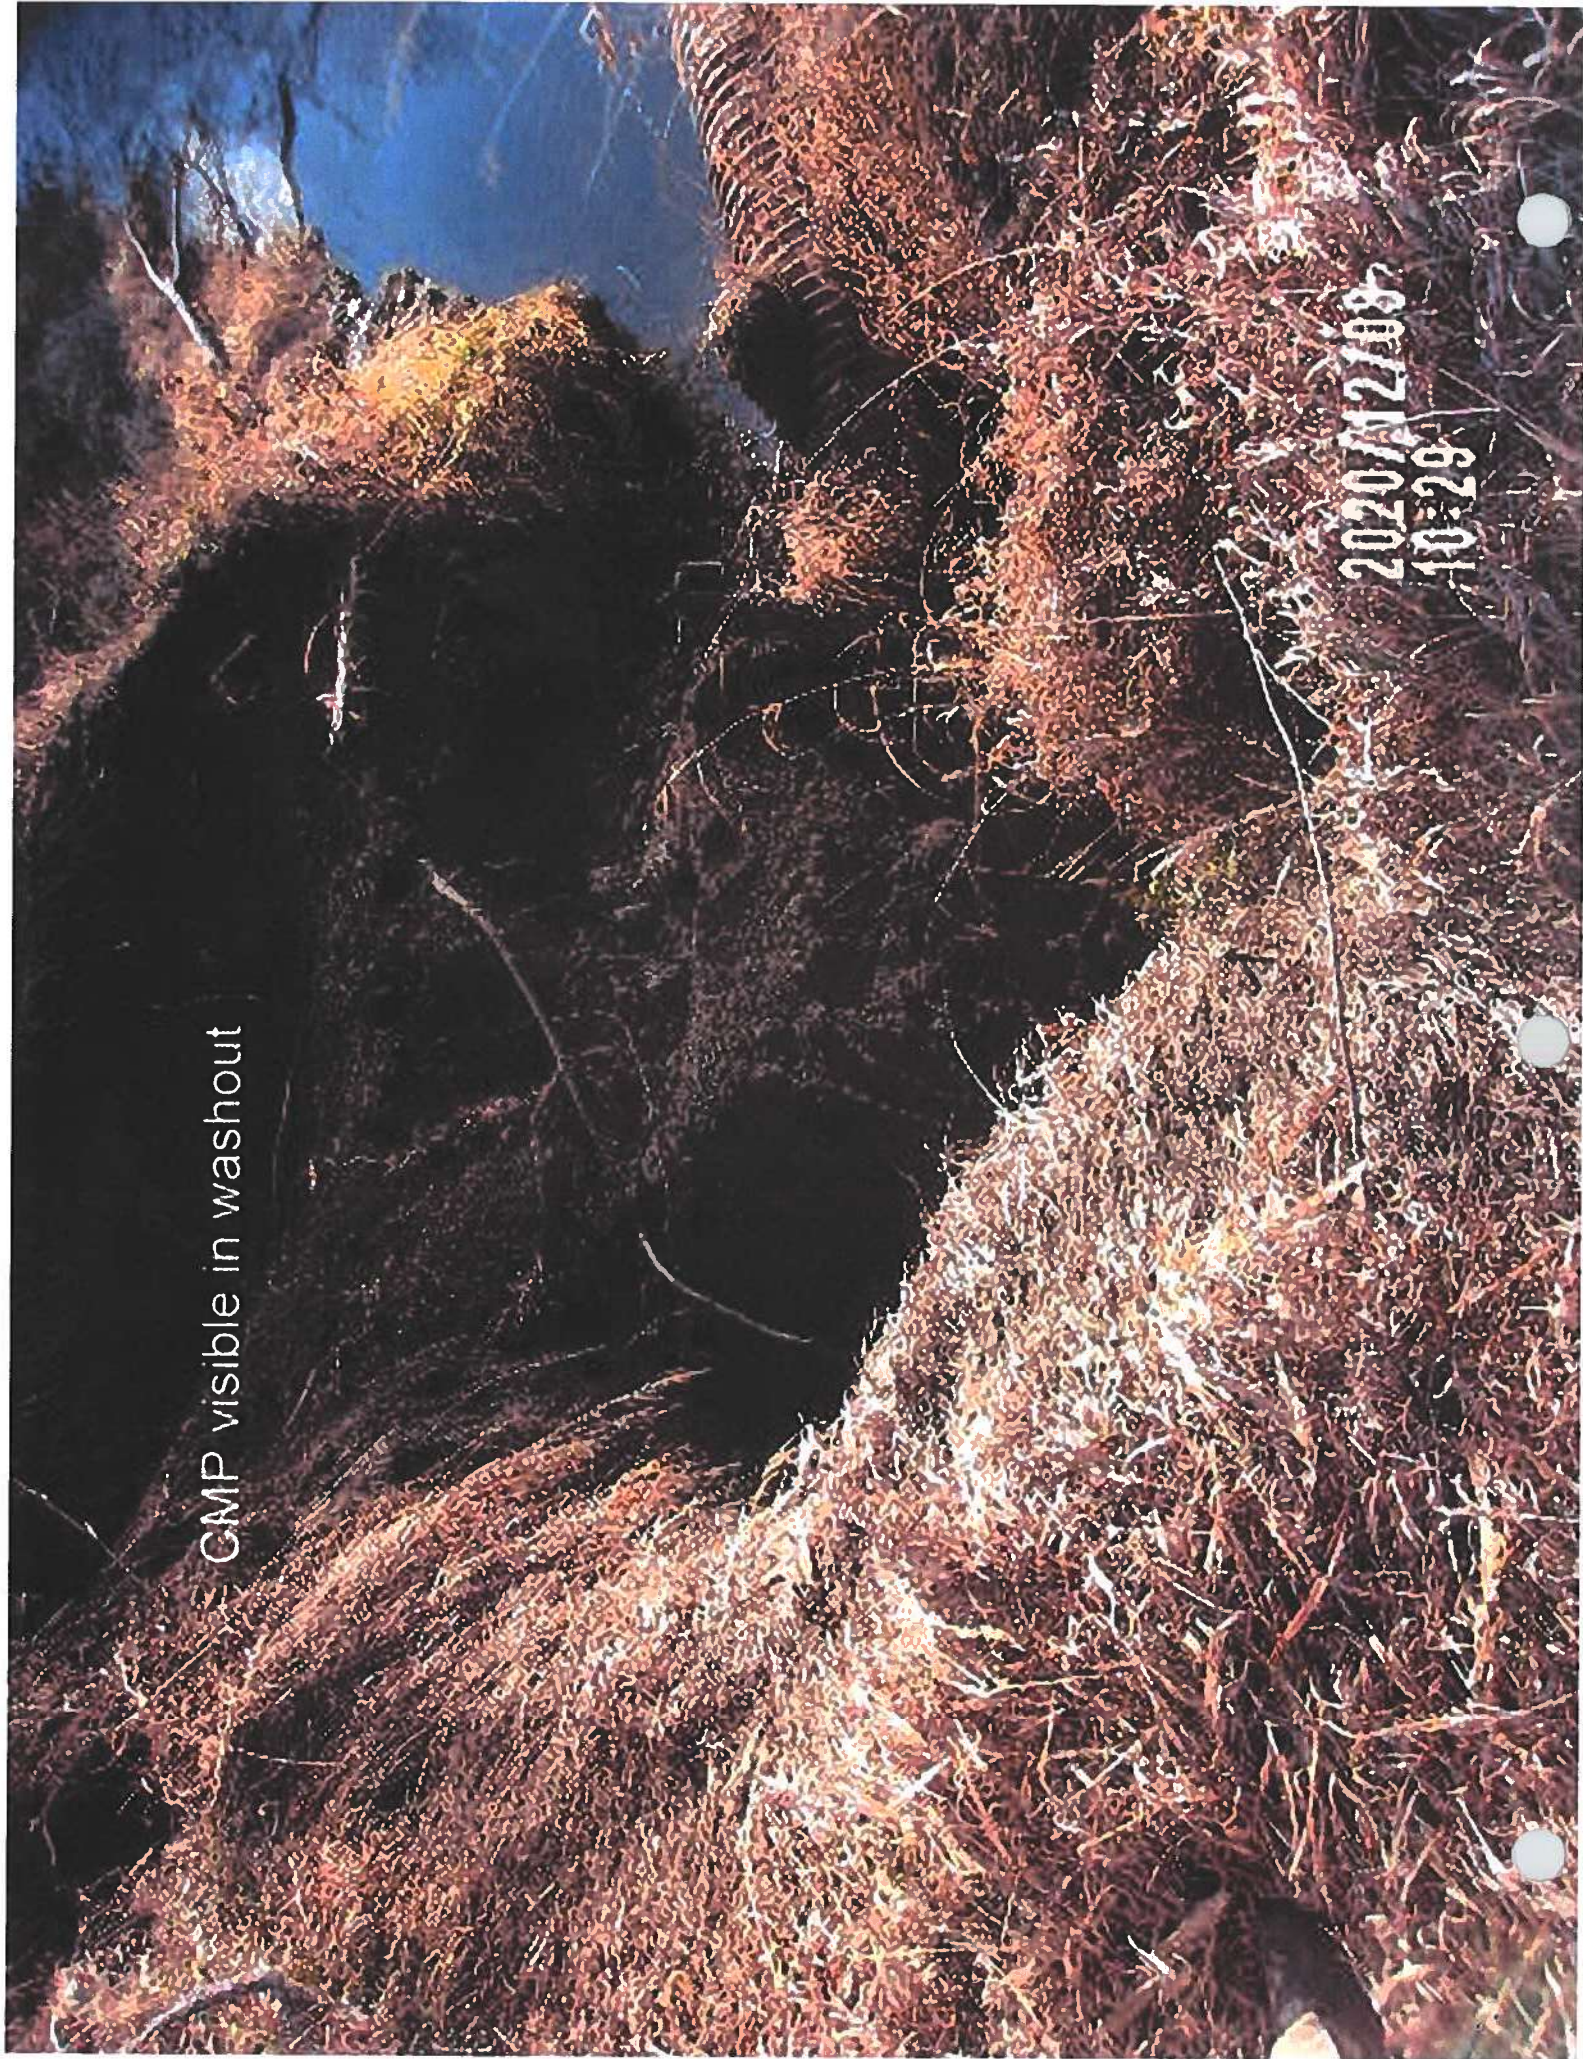
- CMP visible in washout

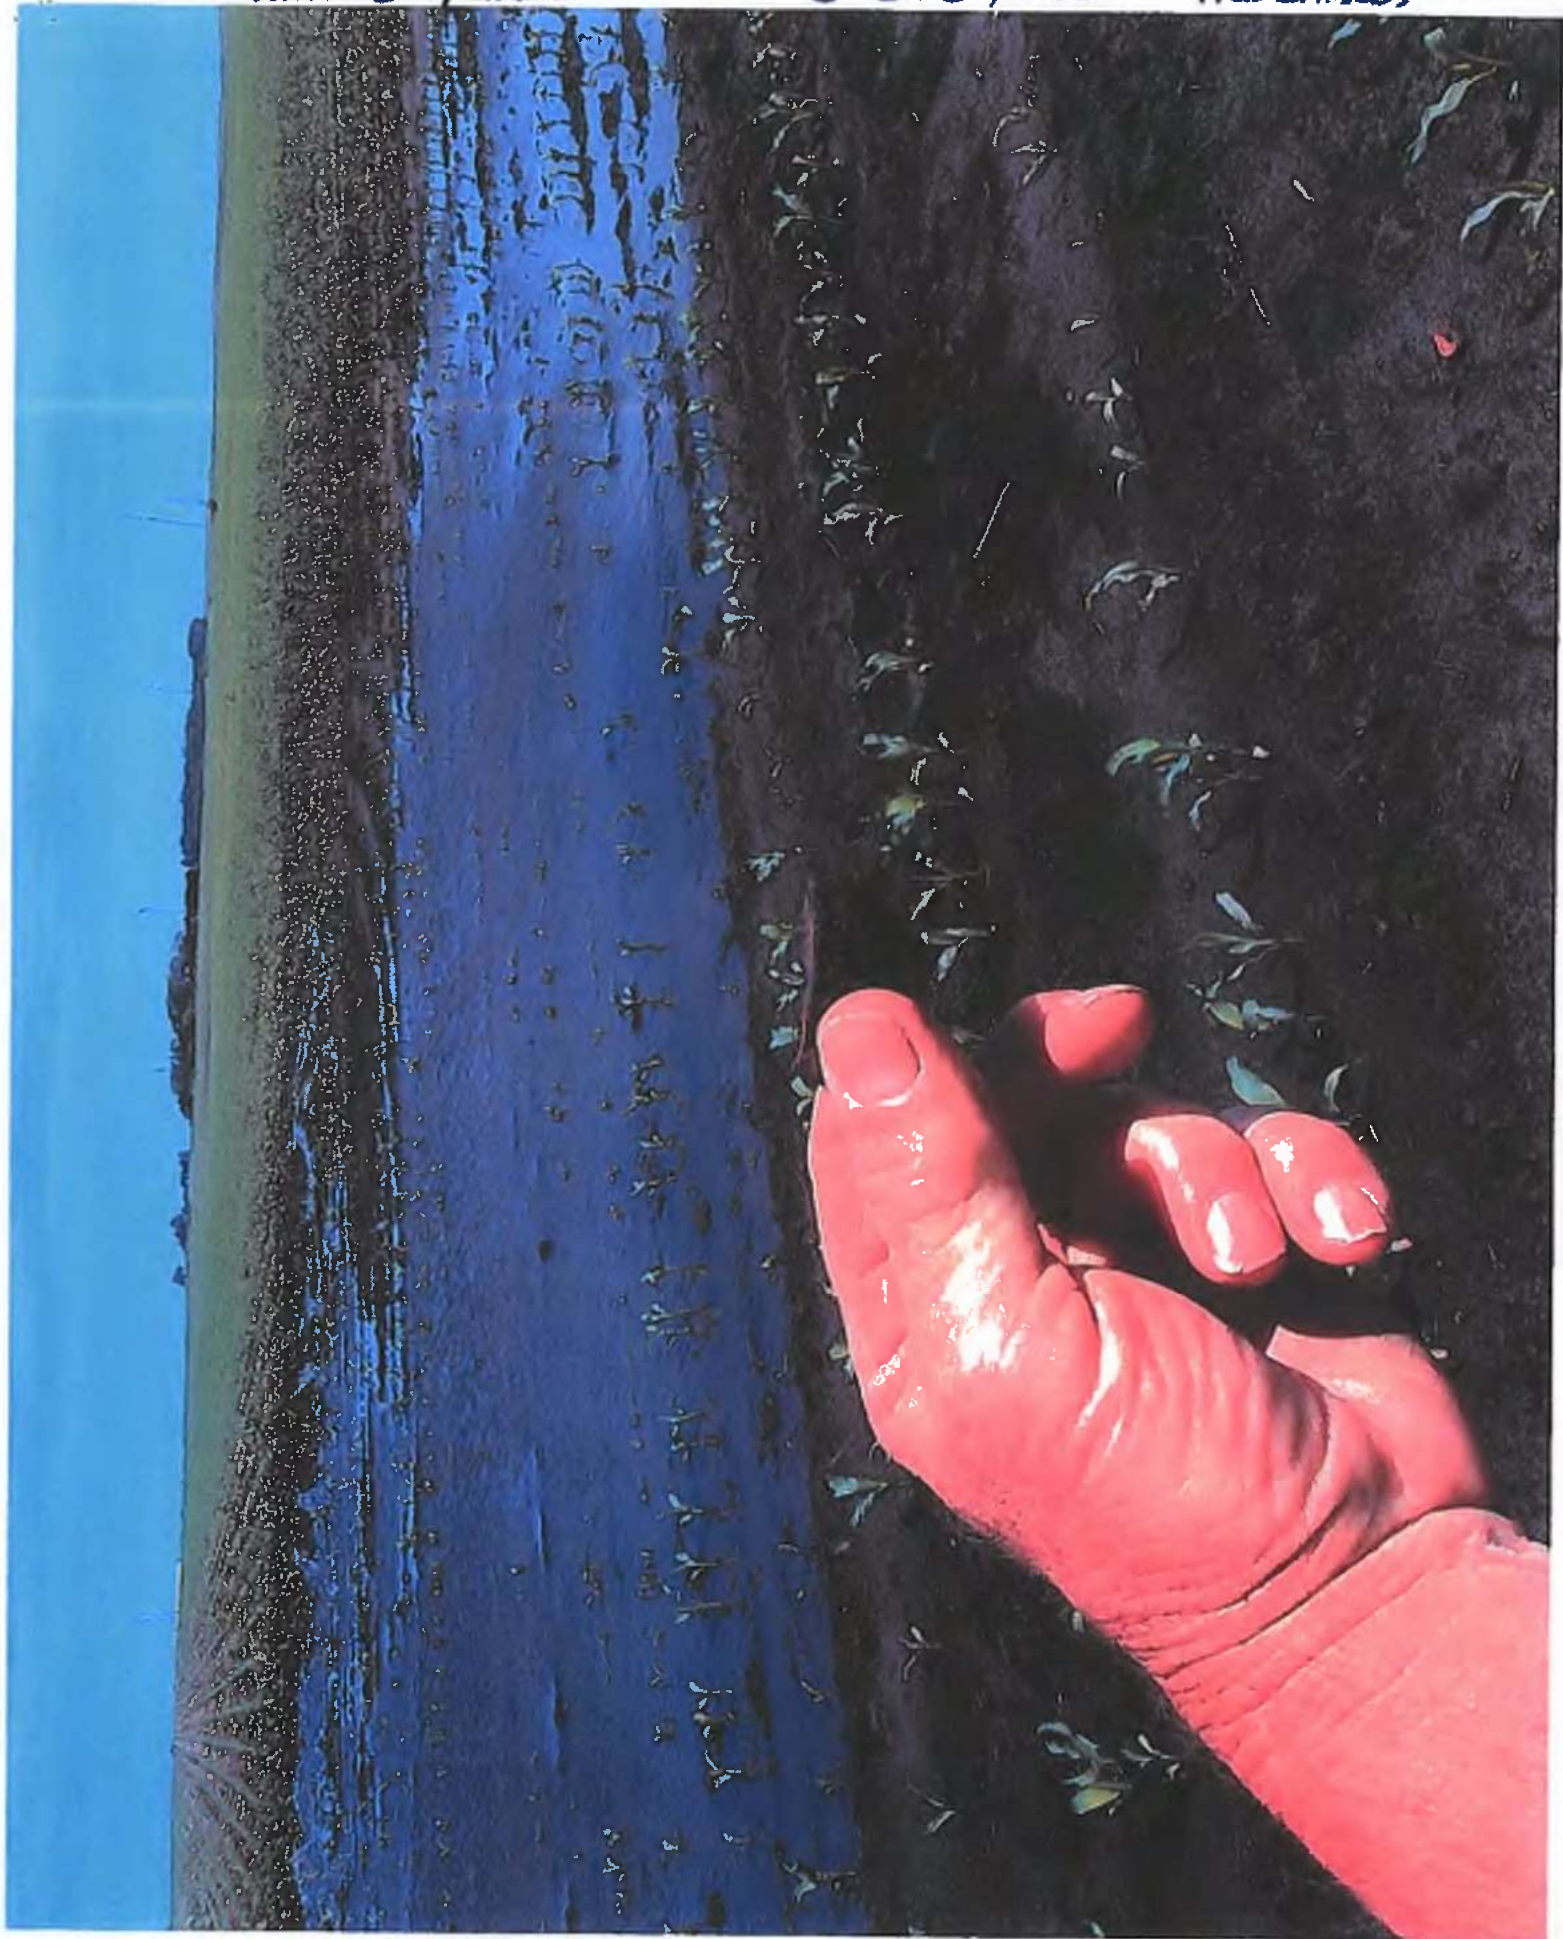
LOOKING UPSTREAM ON LAT 4 @ C73, LOTS OF TILACITAROS

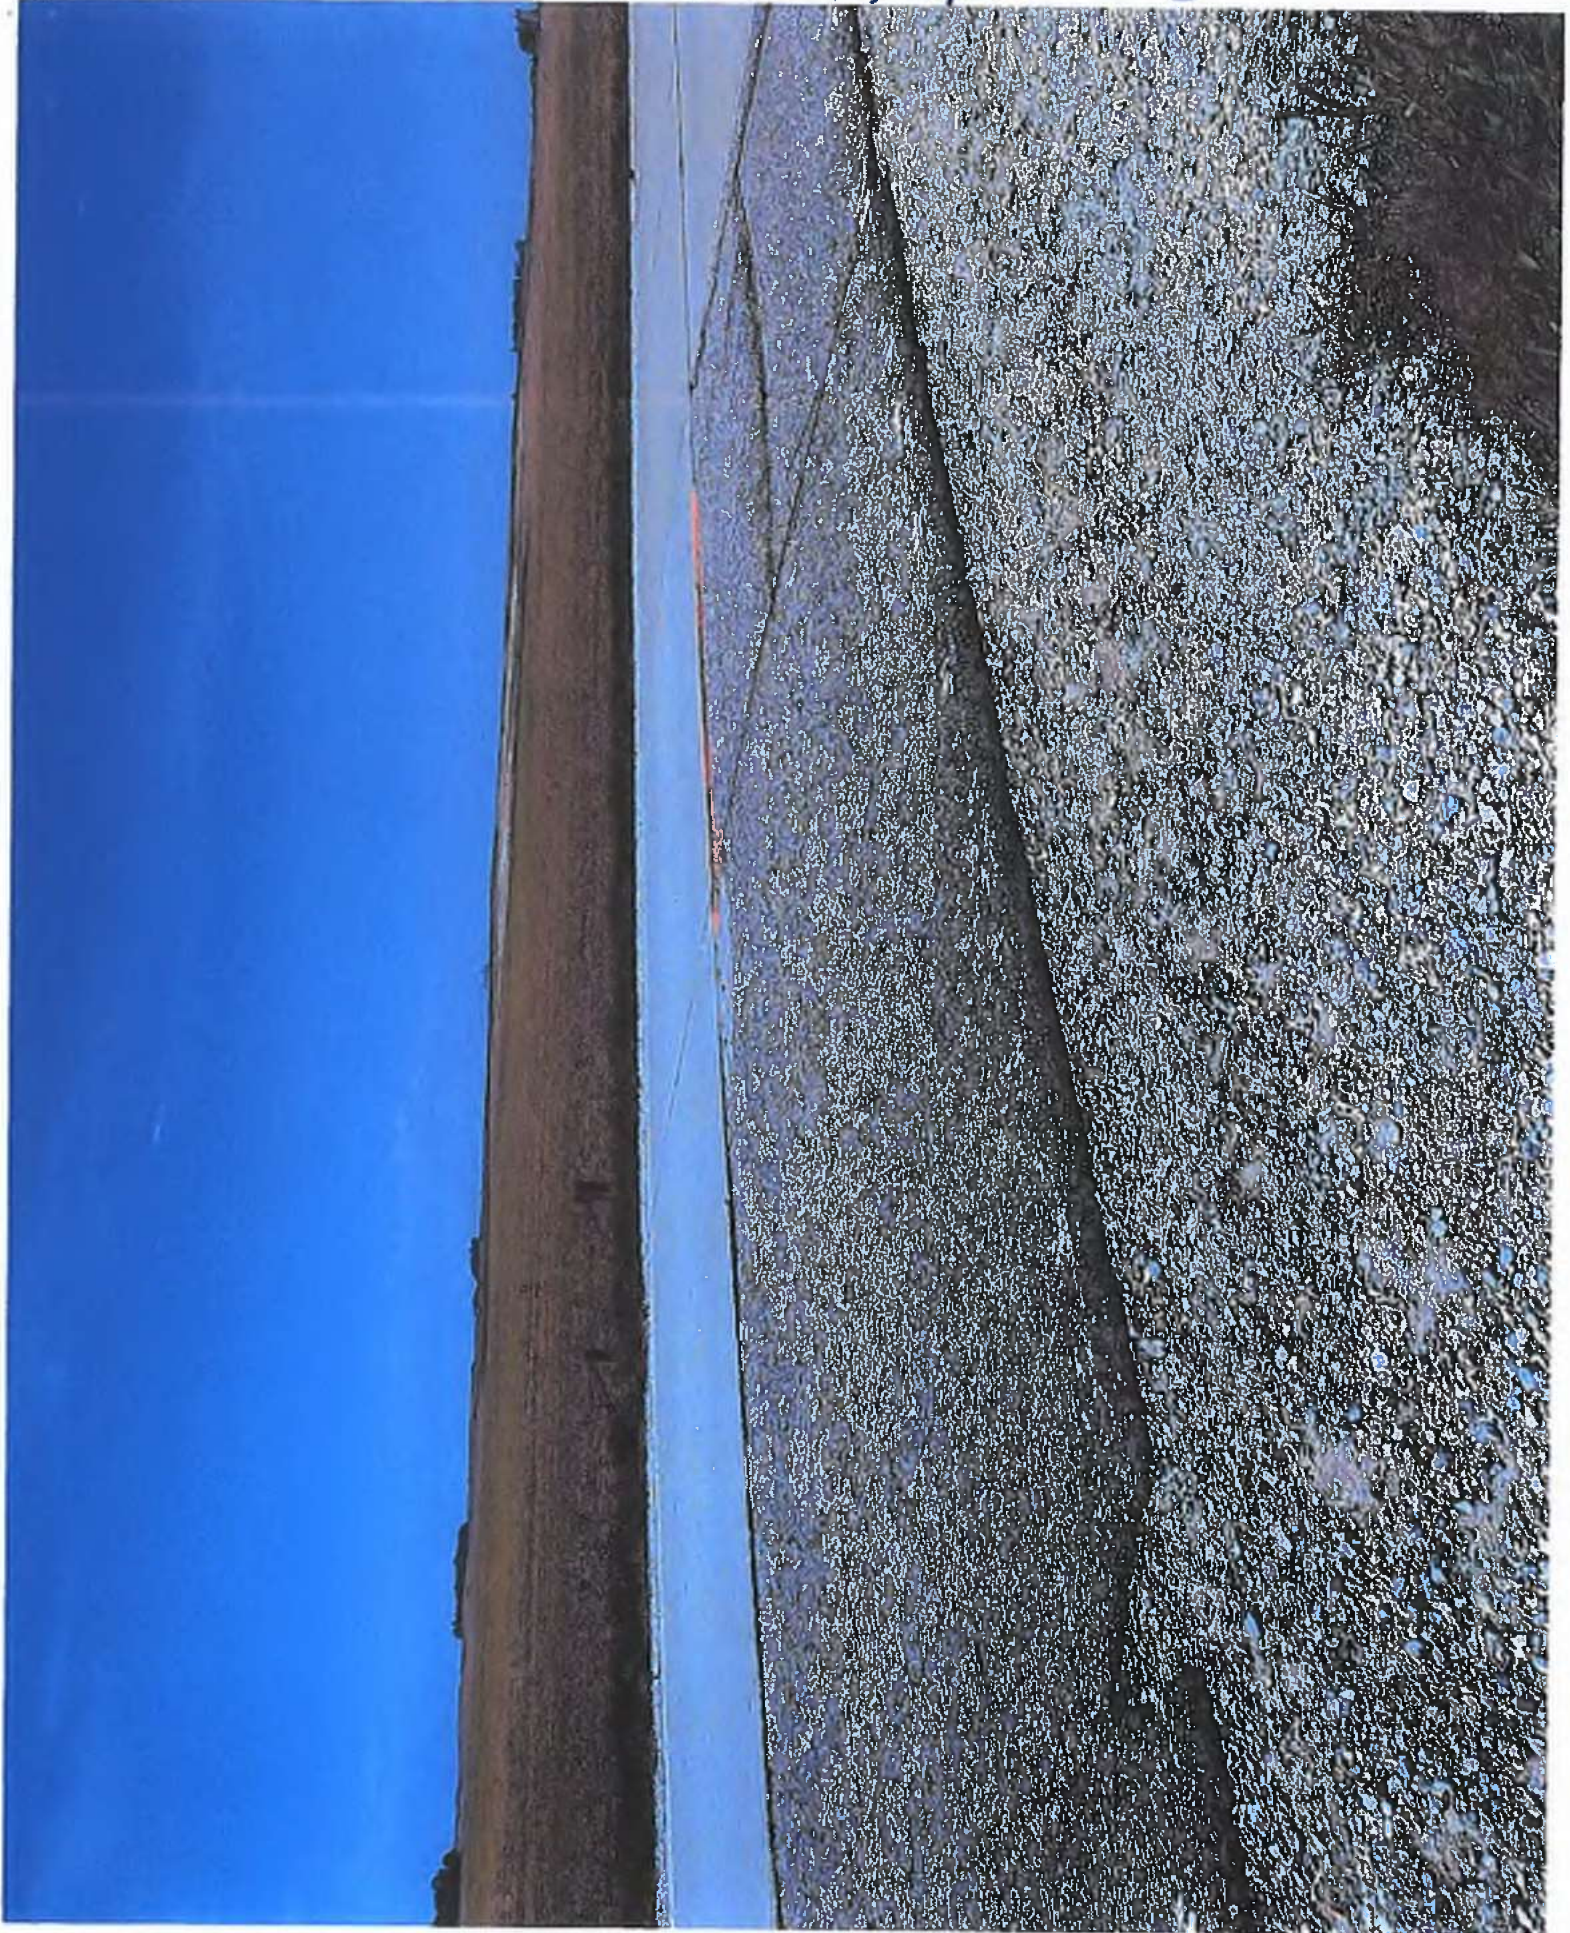
LOOKING DOWNSTREAM @ LAT 4, REPAIR IN C73
