**UPDATED
ENGINEER'S REPORT
ON REPAIRS
TO MAIN TILE
DRAINAGE DISTRICT
NO. 86
HARDIN COUNTY,
IOWA**

Updated Engineer's Report on Repairs to Main Tile, Drainage District No. 86 Hardin County, Iowa

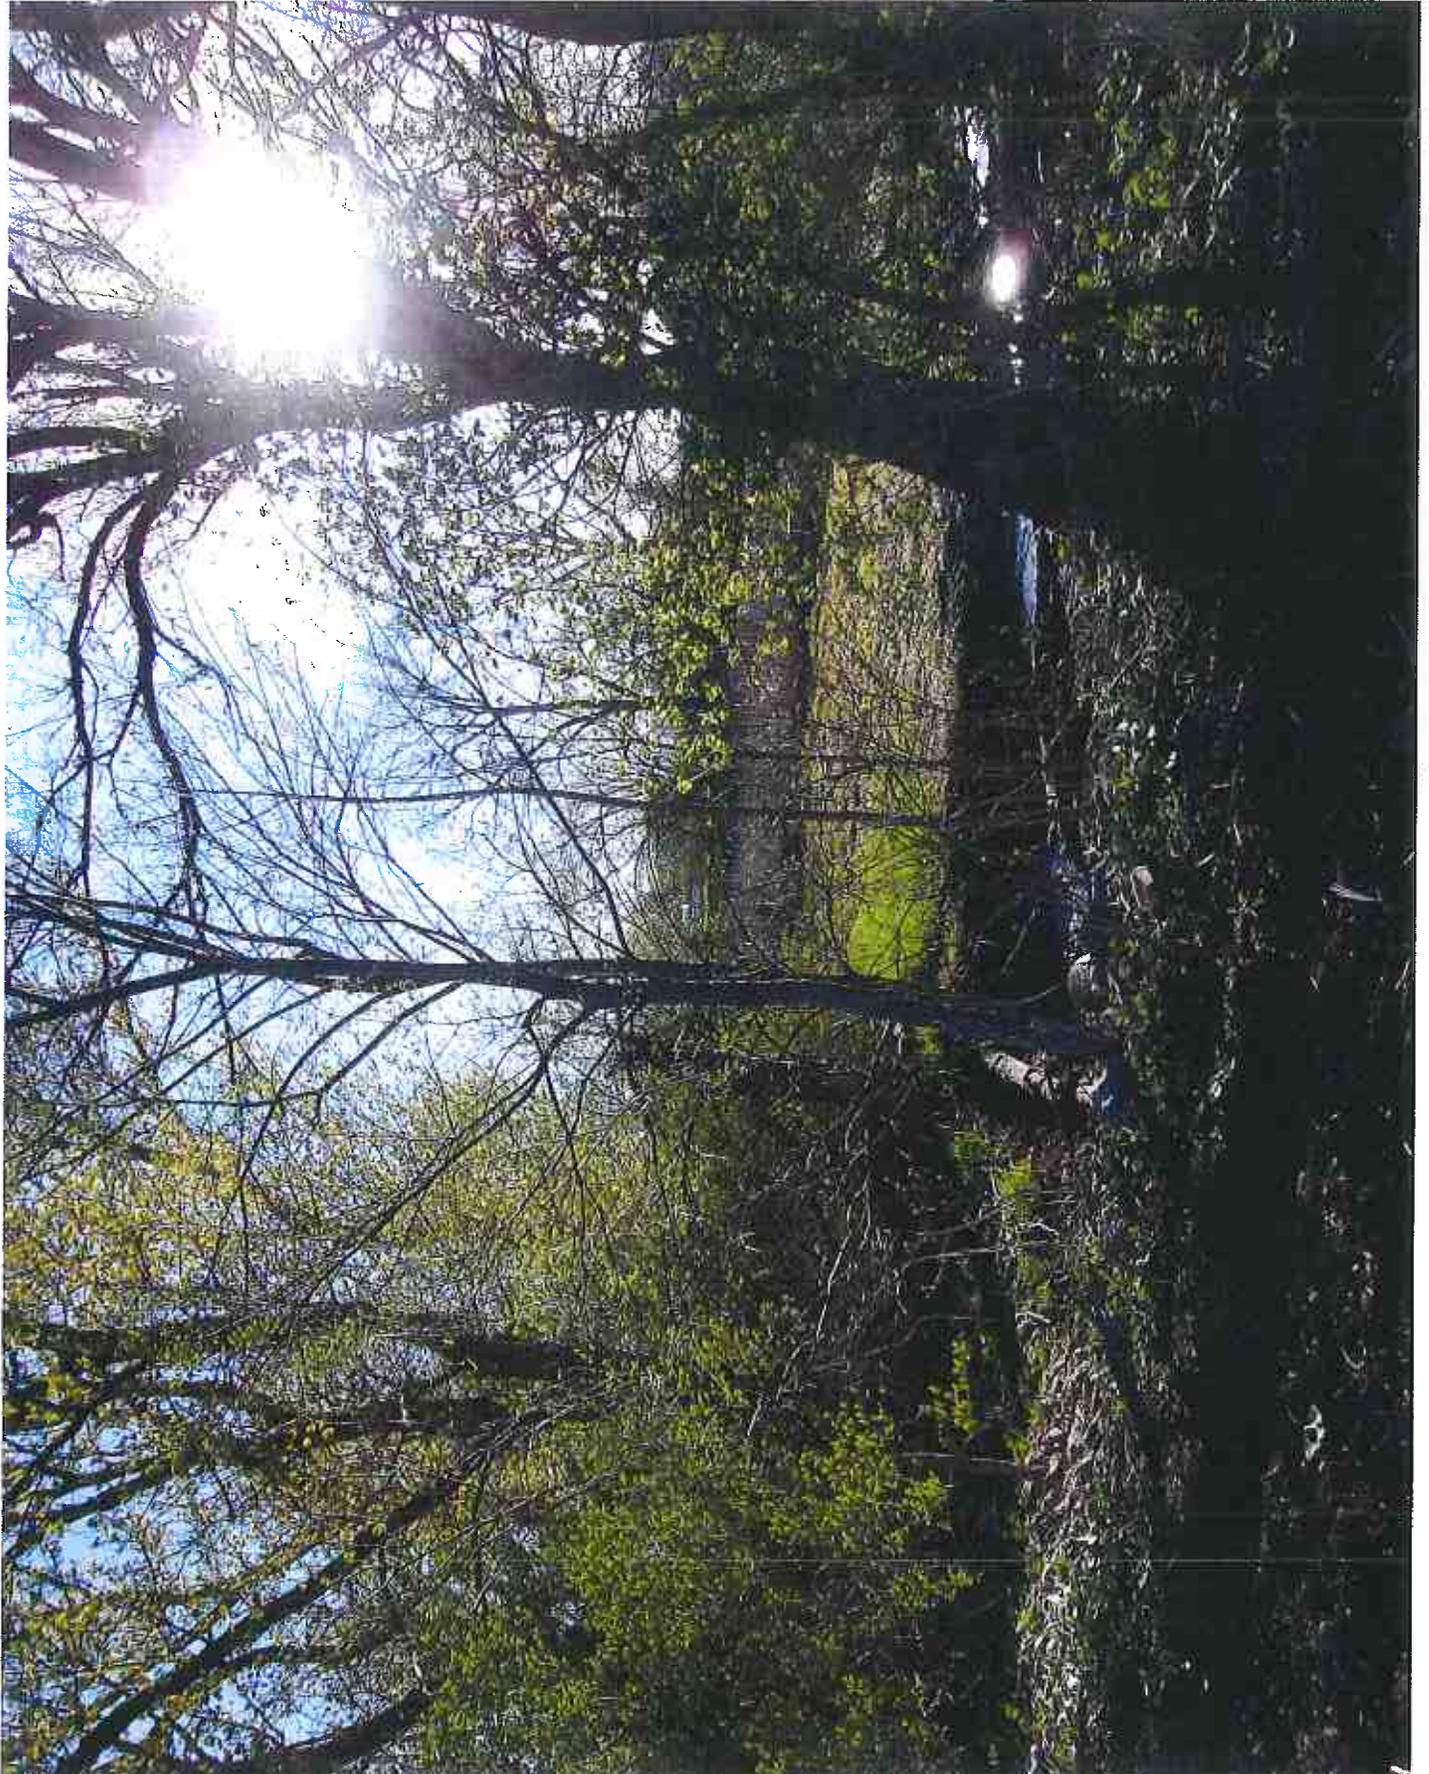
DAGO LAKE INLET (DD86 OLD MAIN) (14) 15" BOX ELDER AND HONEYSUCKLE BRUSH NEEDS REMOVED

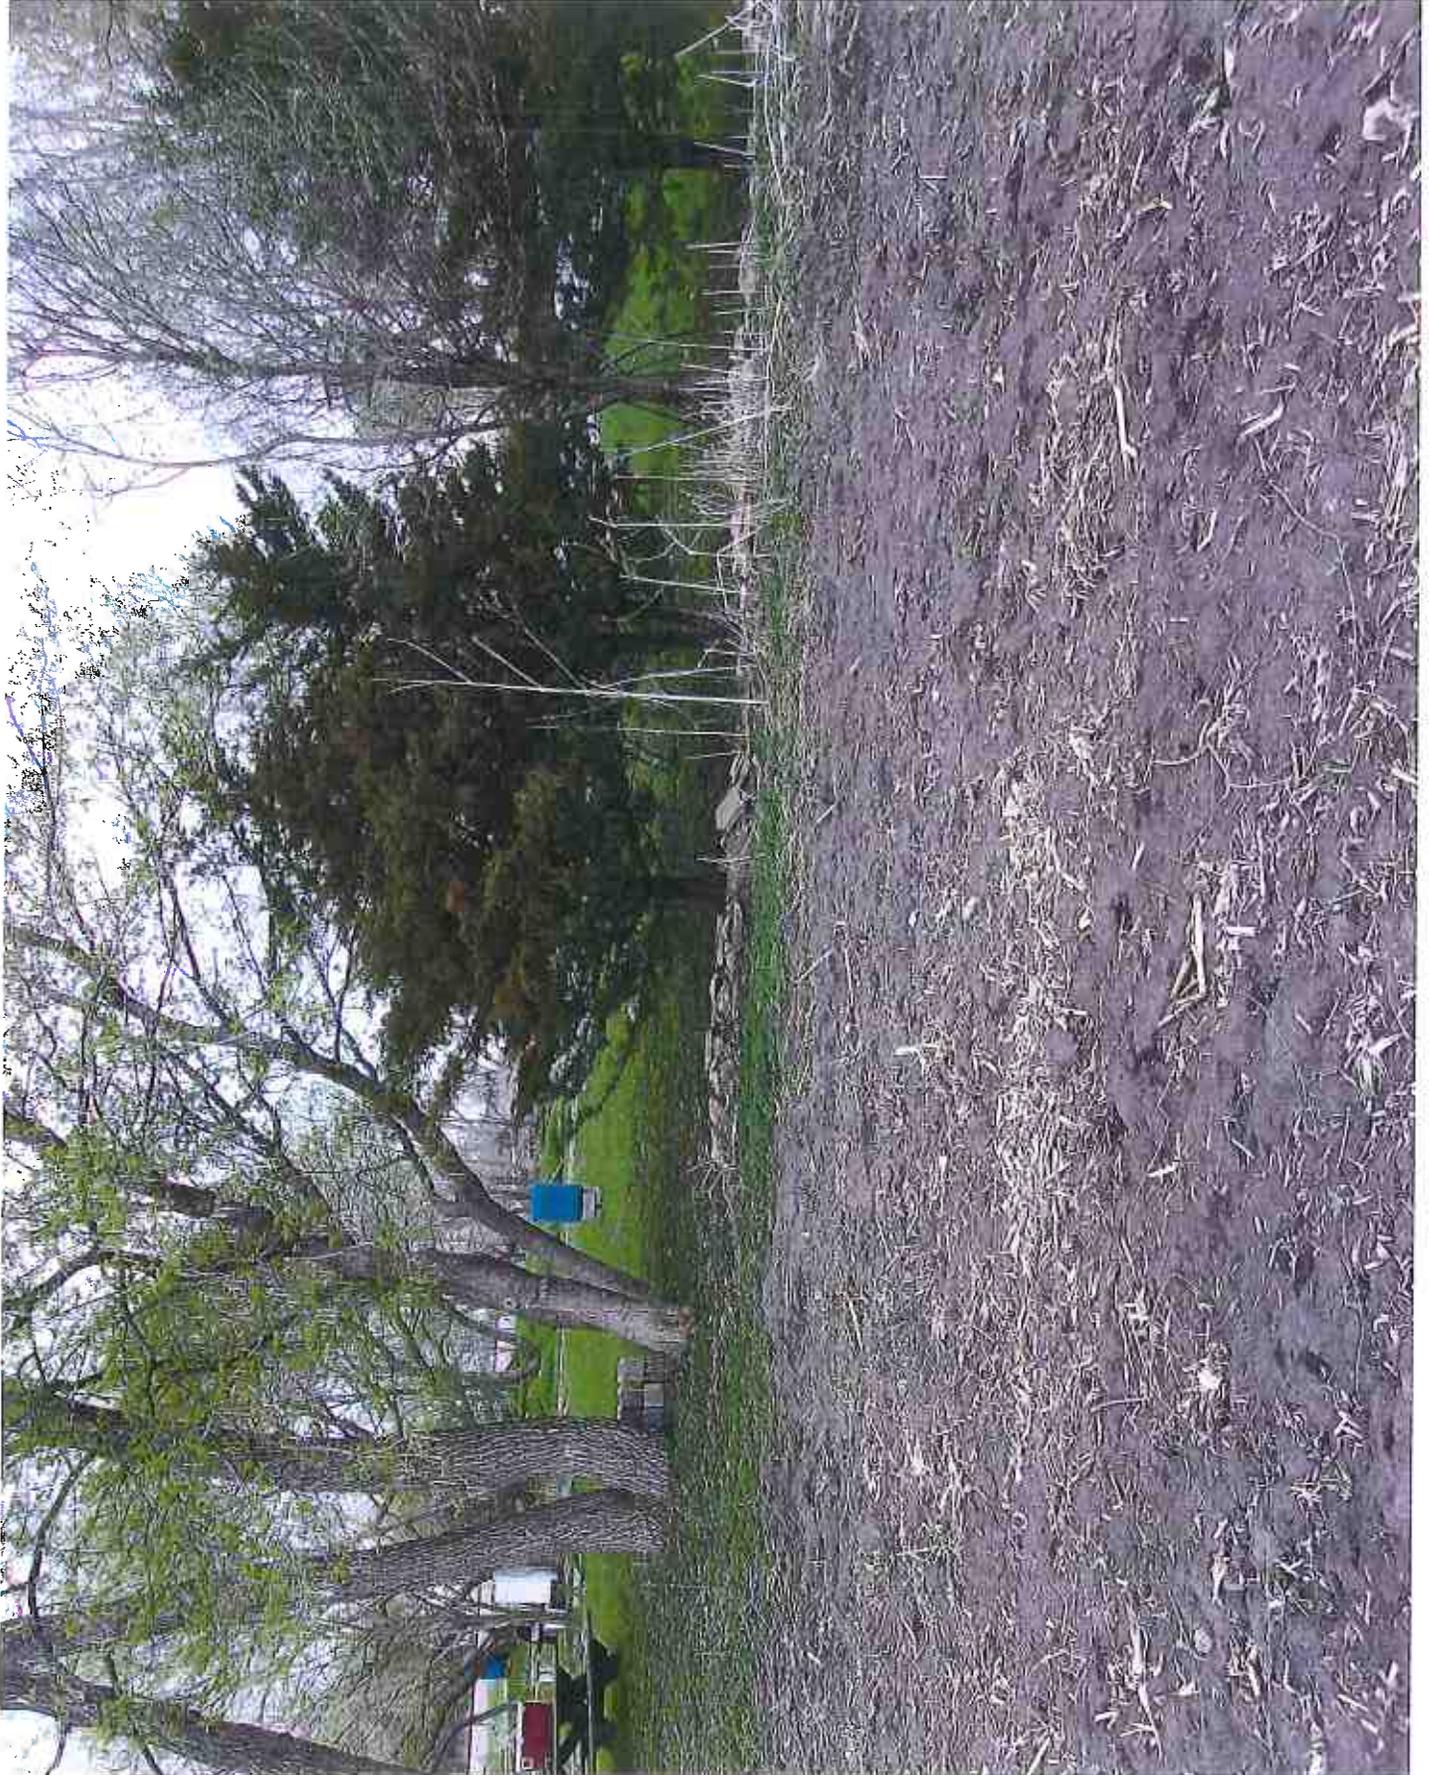
LOOKING EAST @ MONARCH LAKE TIRE ROUTE (5) TREES NEED REMOVED (NOT CEDAR TREES)

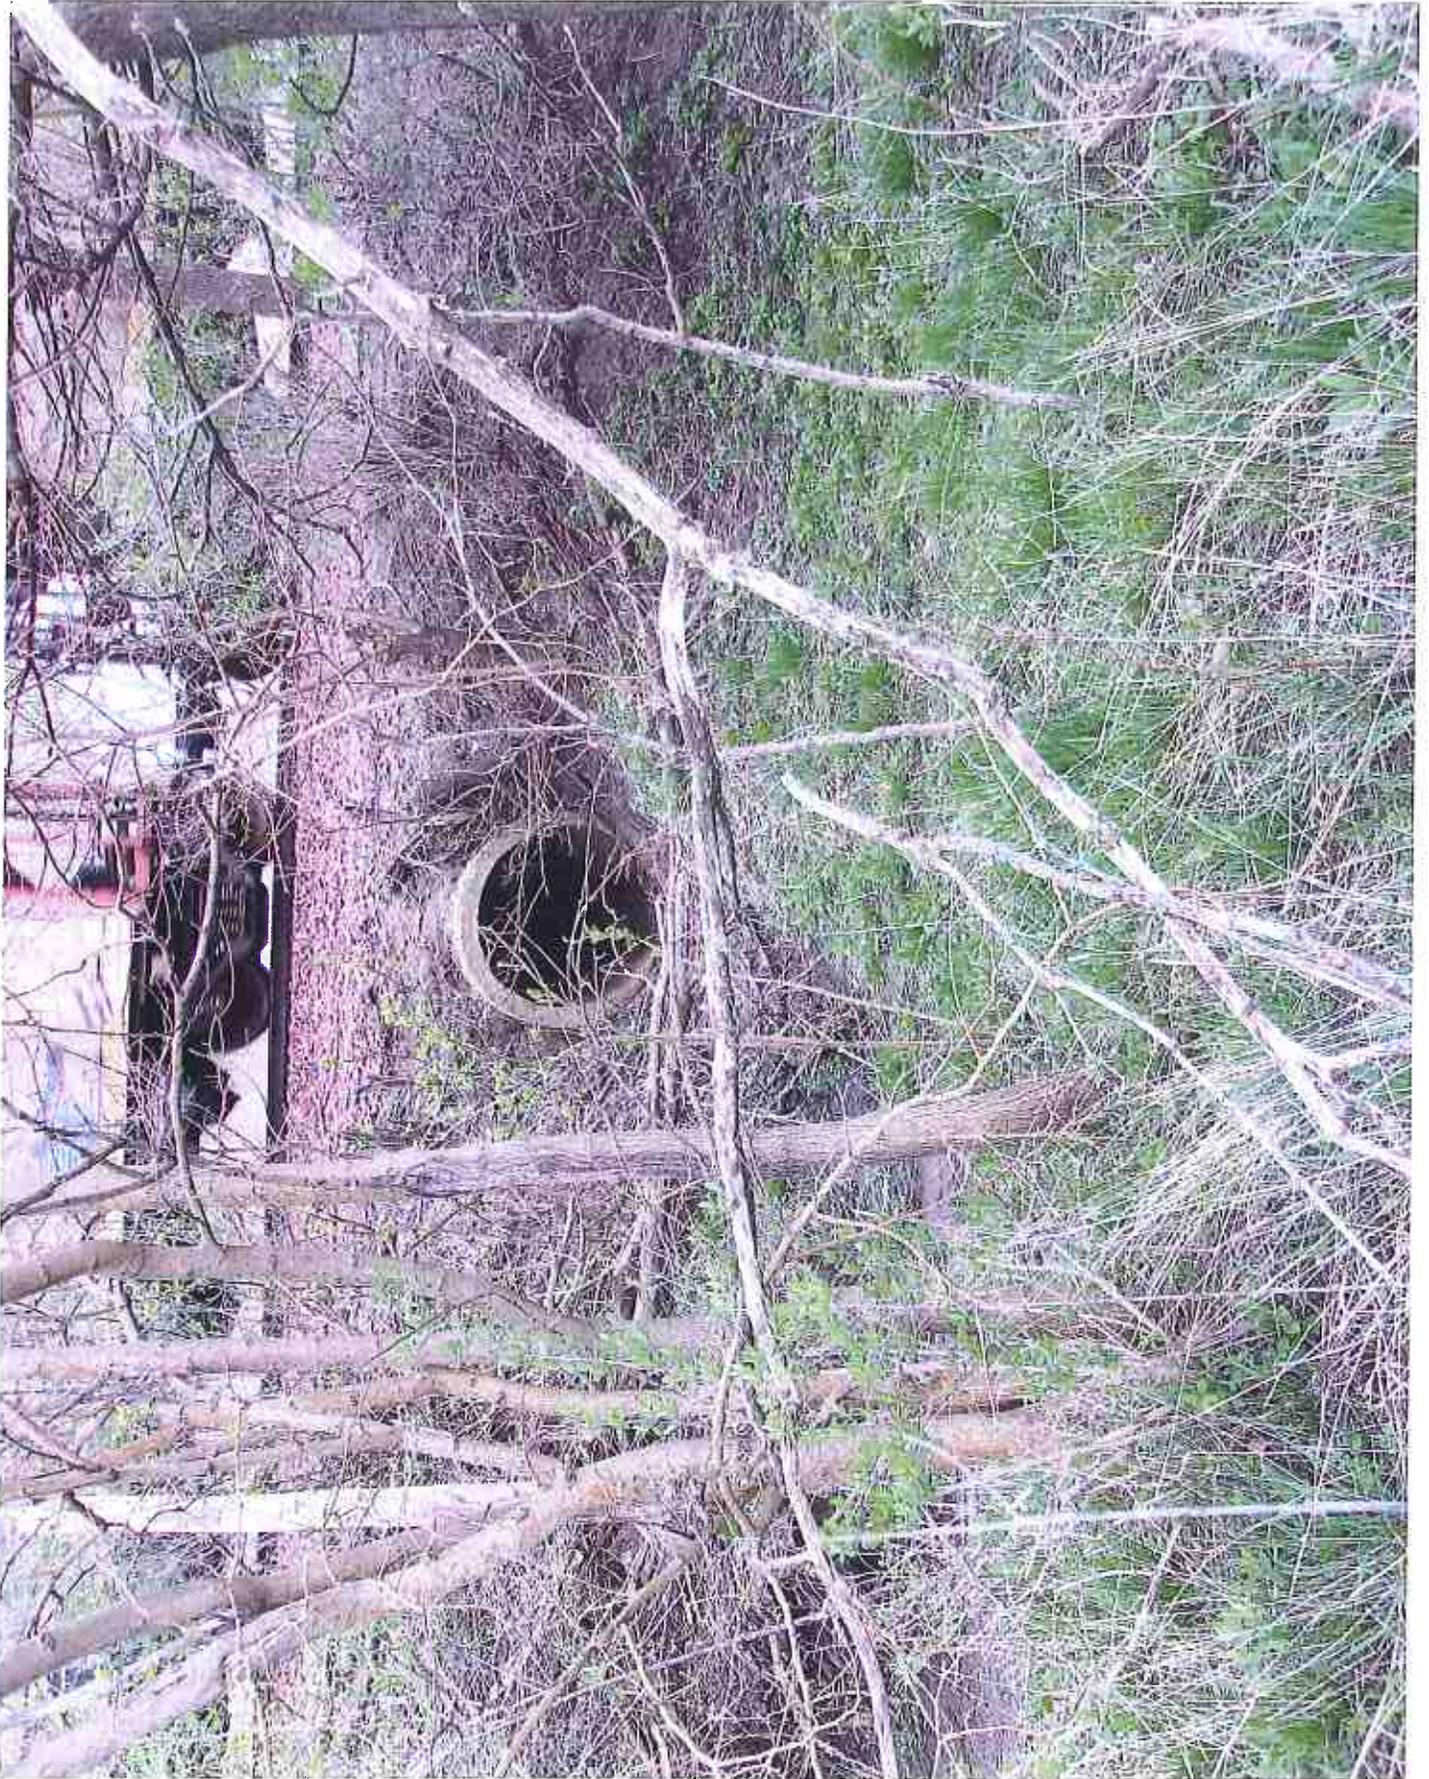
SURFACE DRAINAGE From S. RR @ MONARCH LAKE

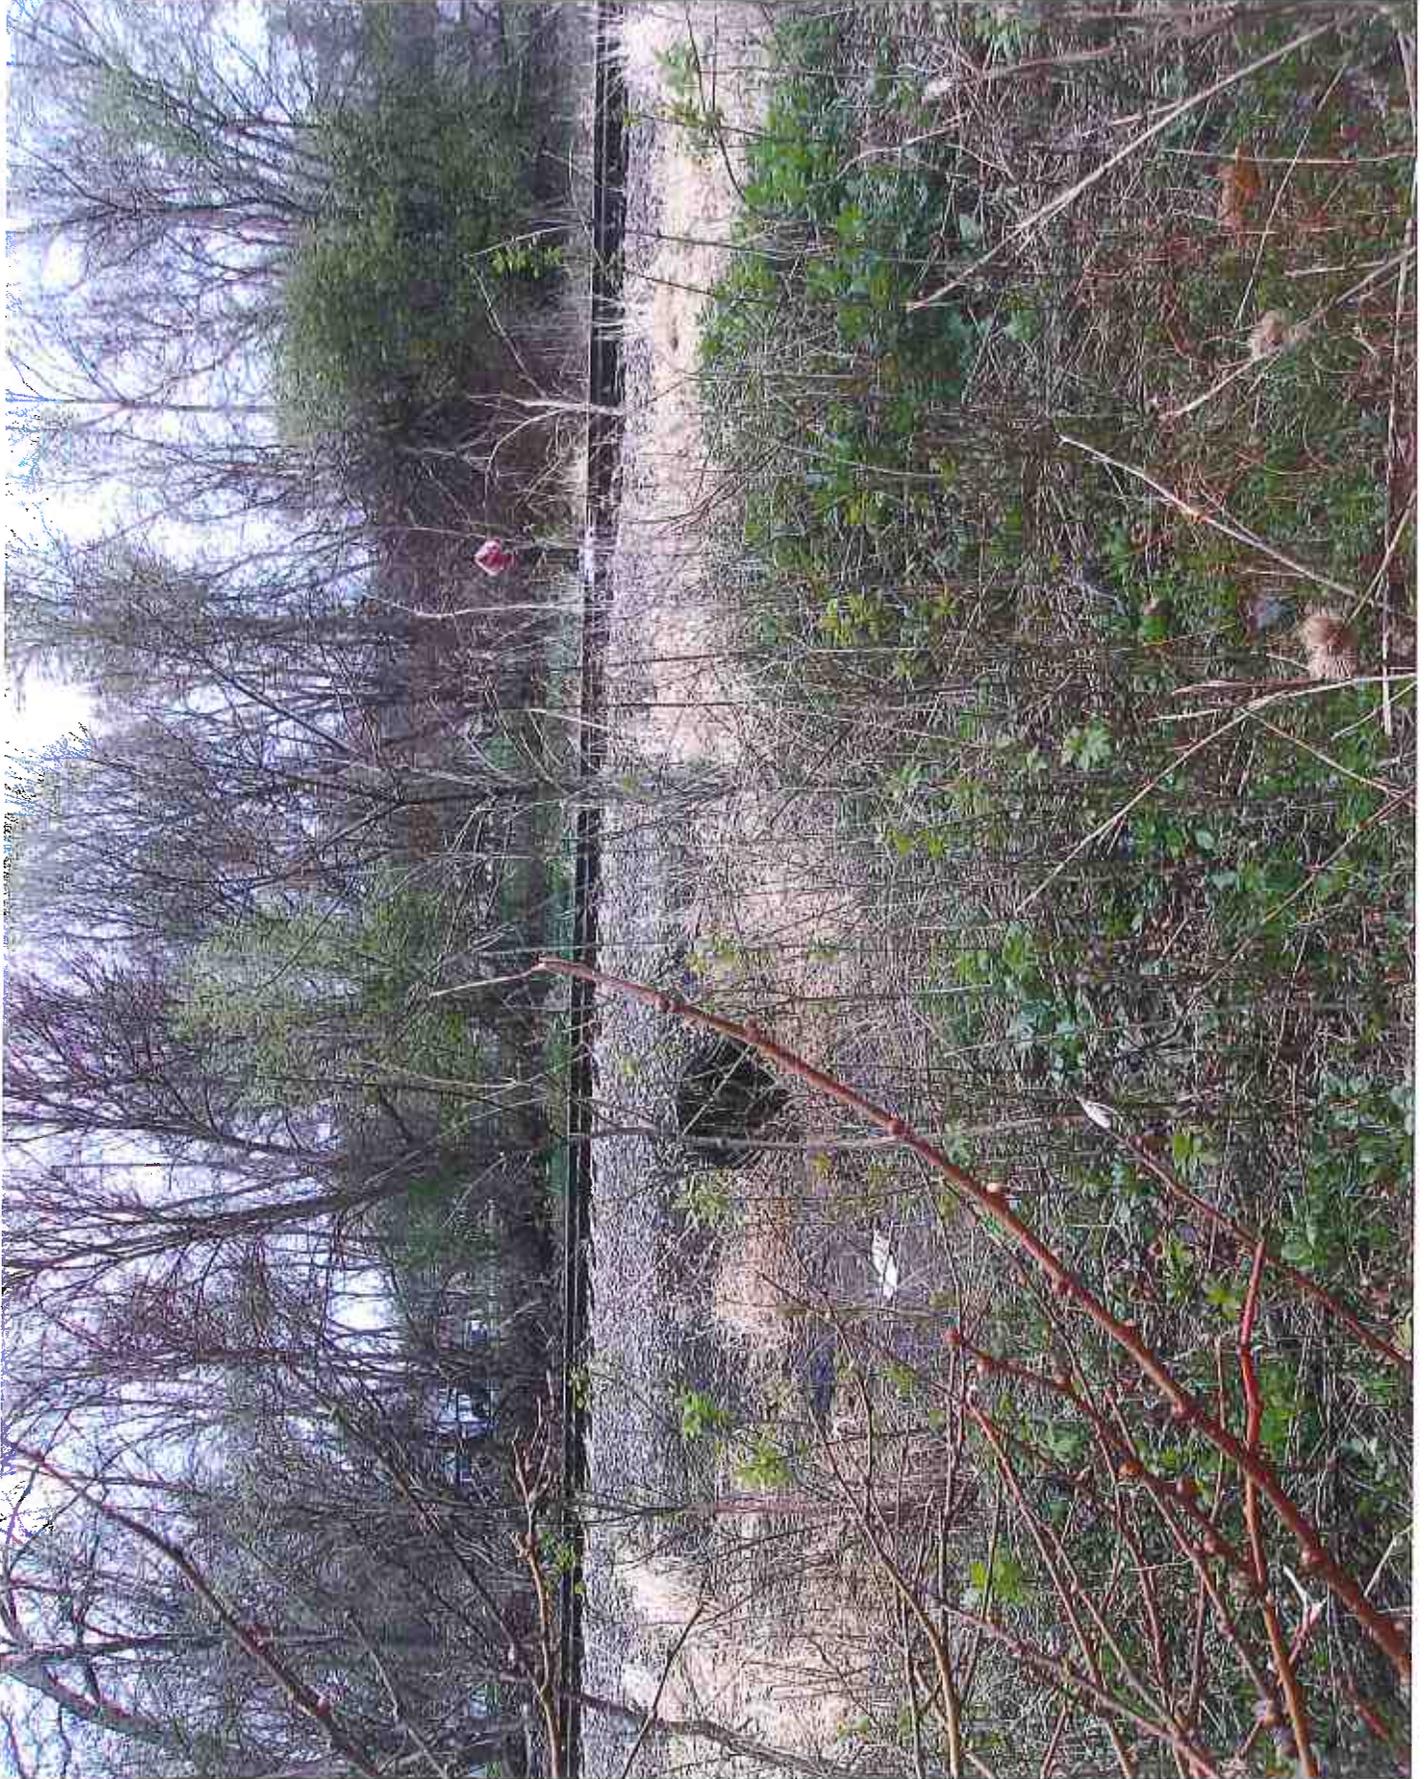
LOOKING DOWNSTREAM @ RR MAINLINE, SURFACE TUBE DRAINS INTO DD86 TILE

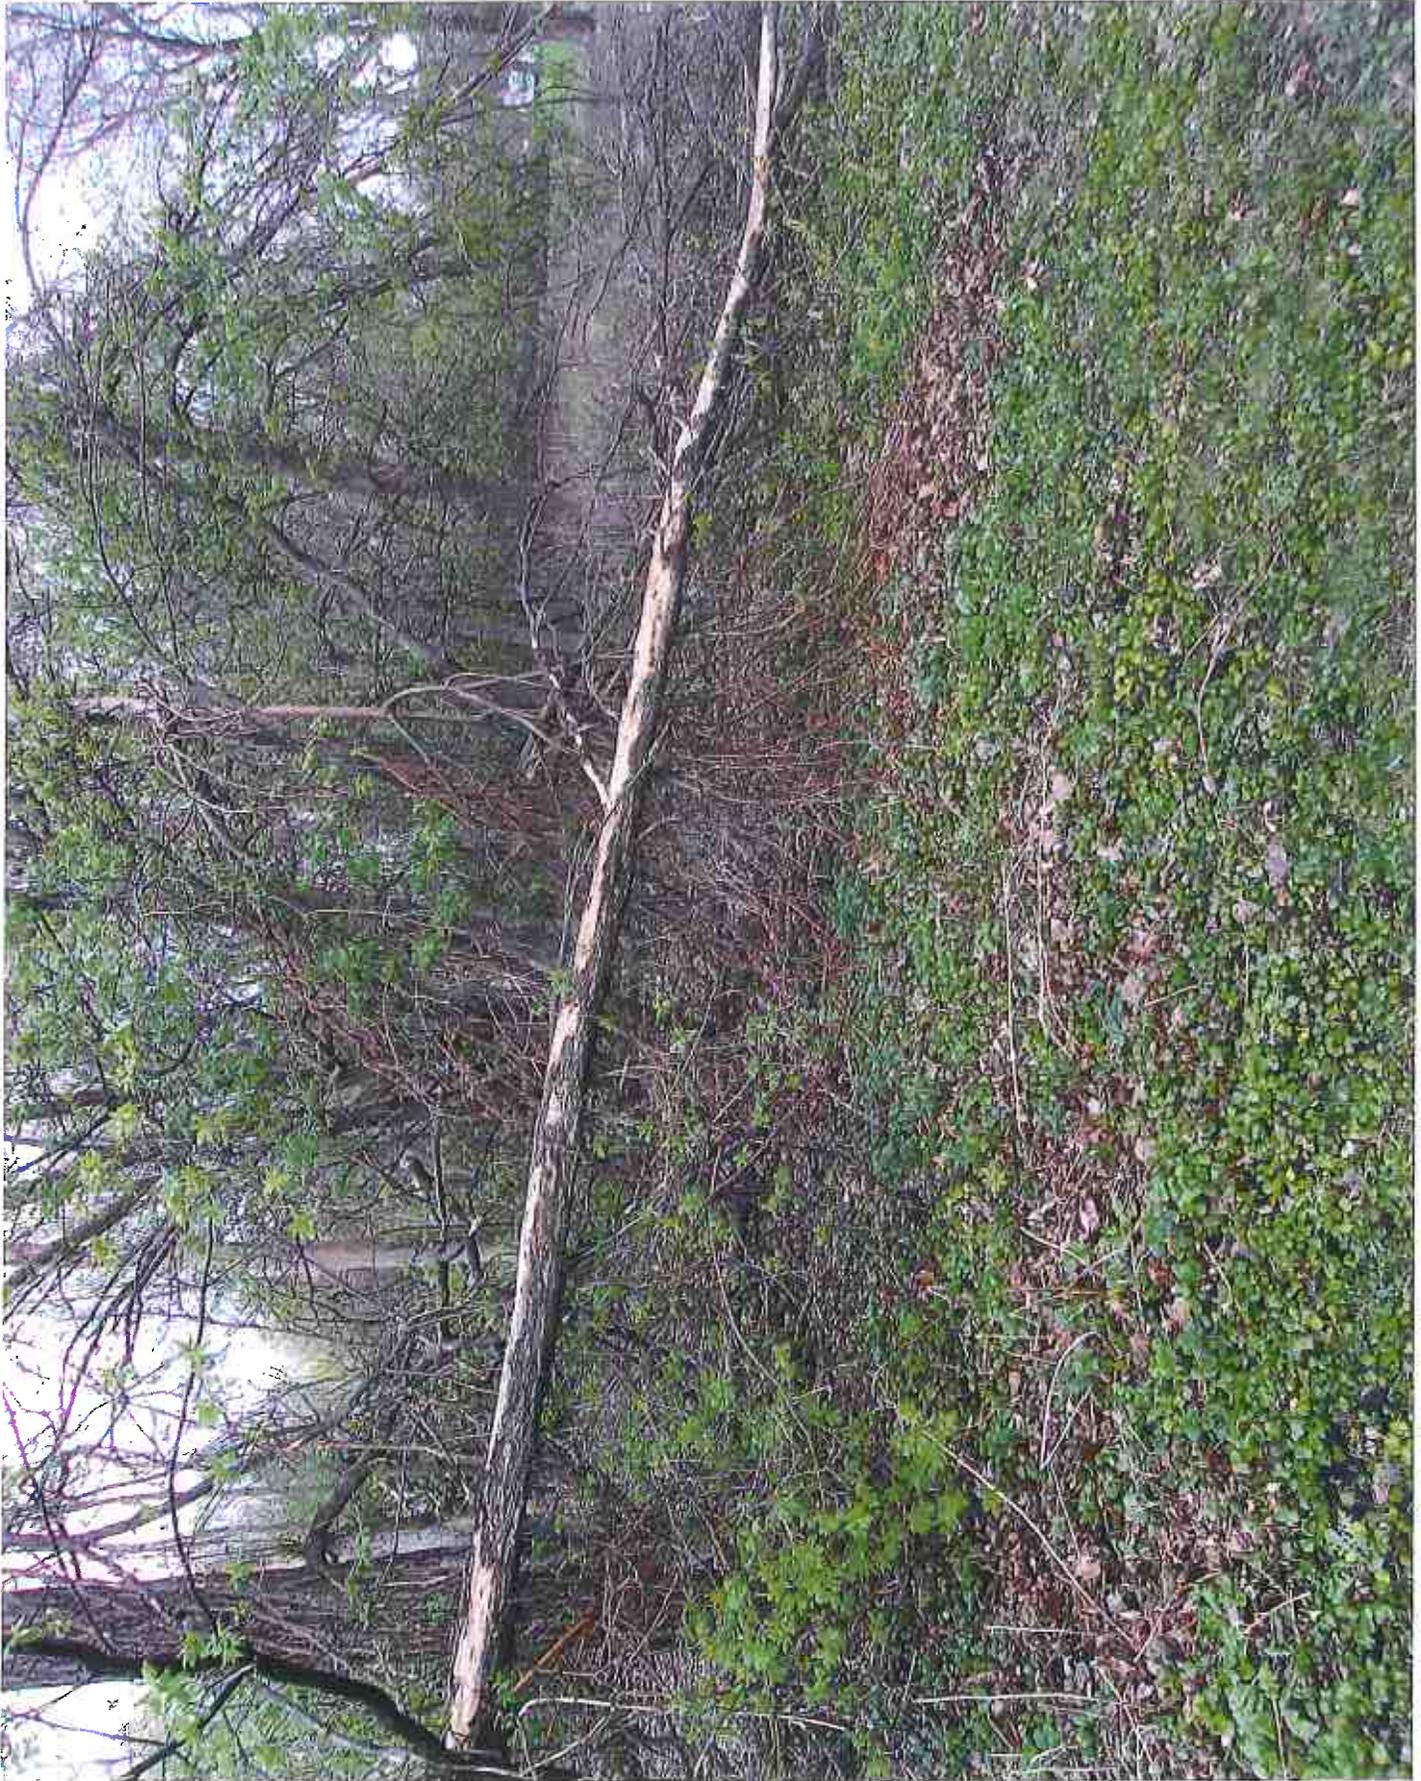
BEEHIVE INTAKE IS IN TREES SOMEWHERE 90+ TREES IN THE R/W N. OF RR

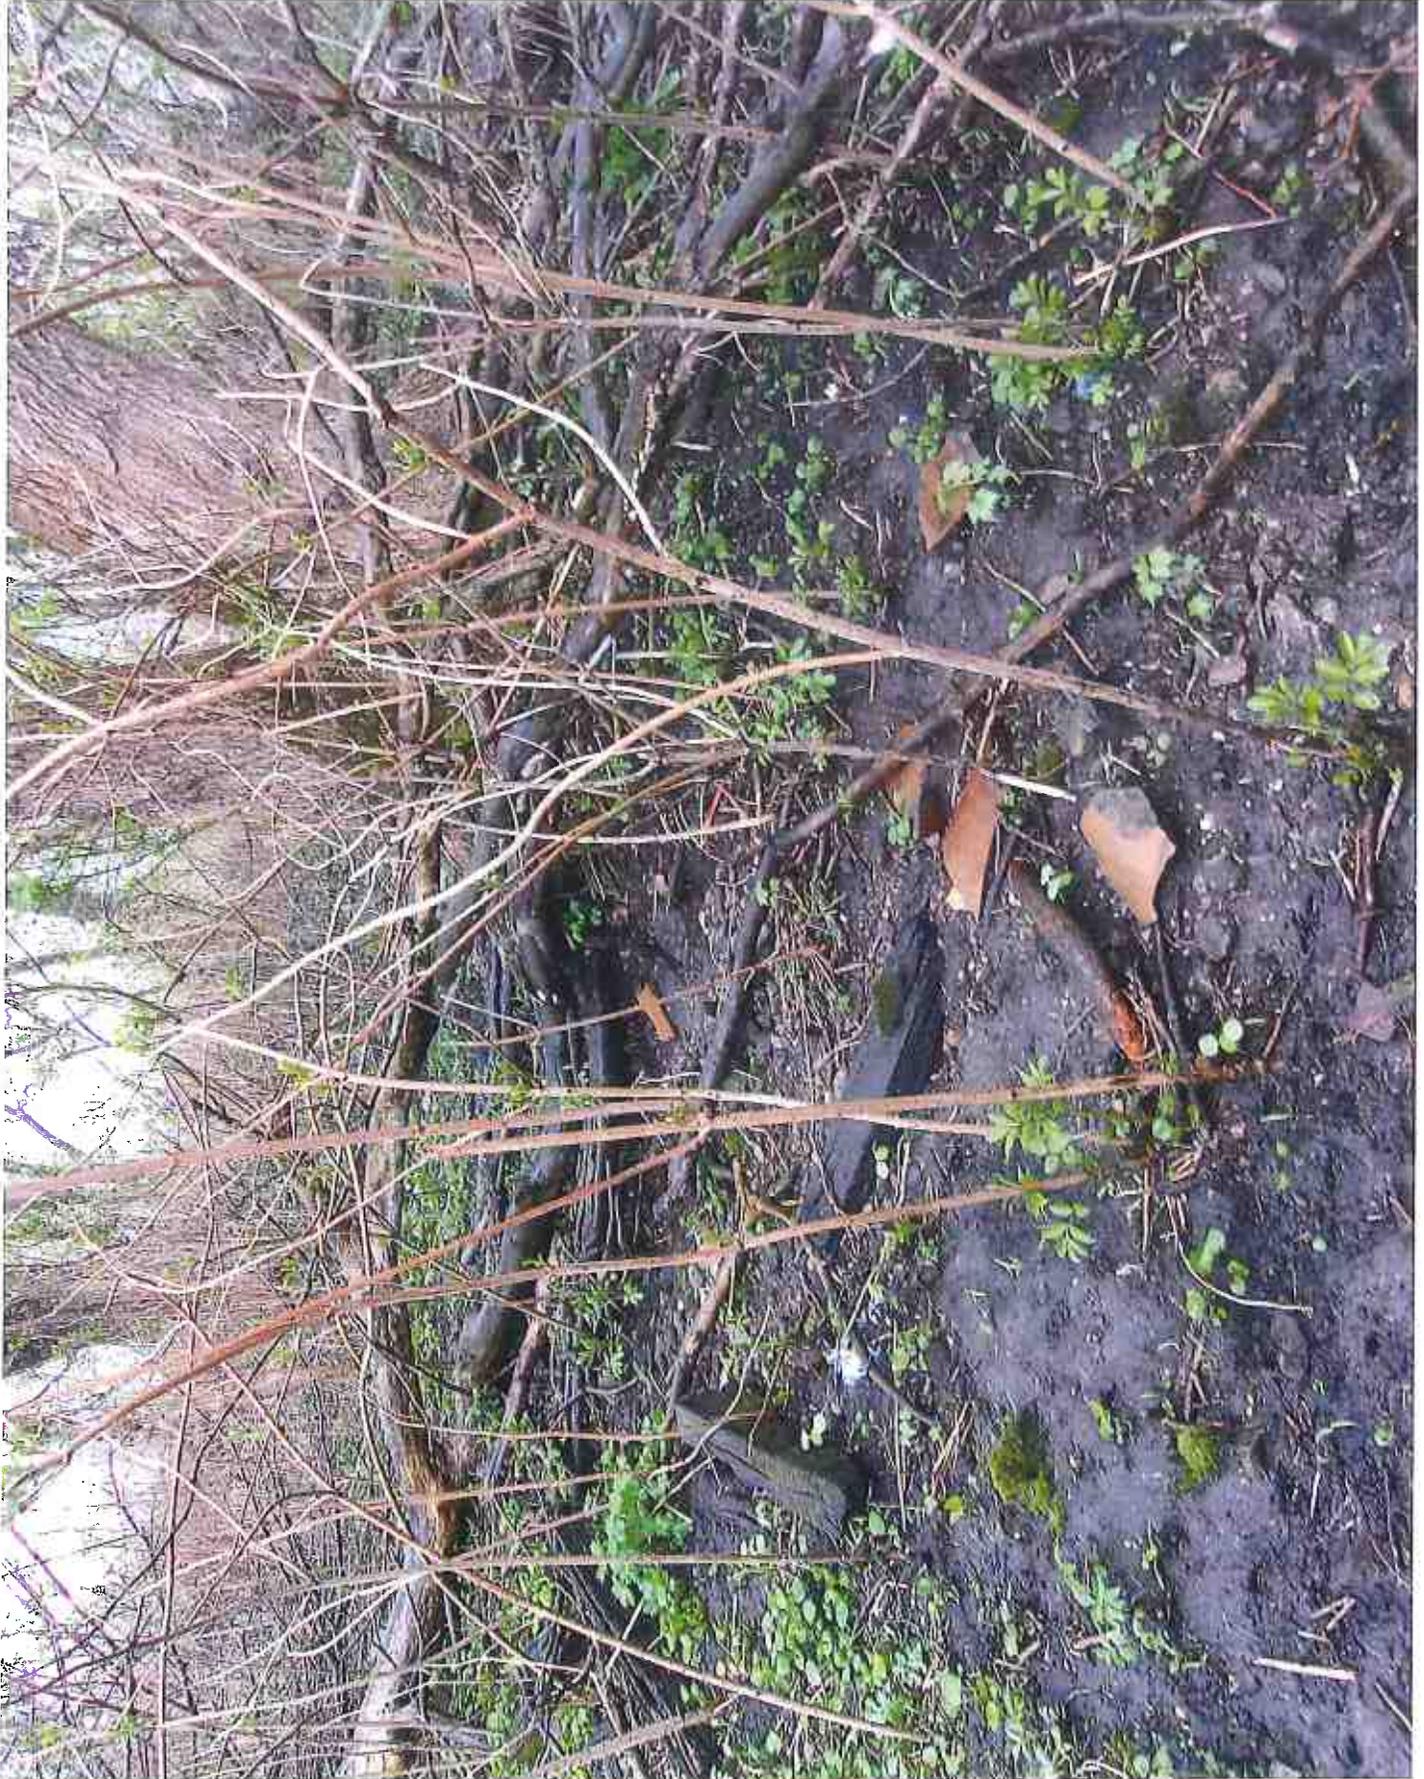
TILE ROUTE MARKED WITH BROKEN TILE

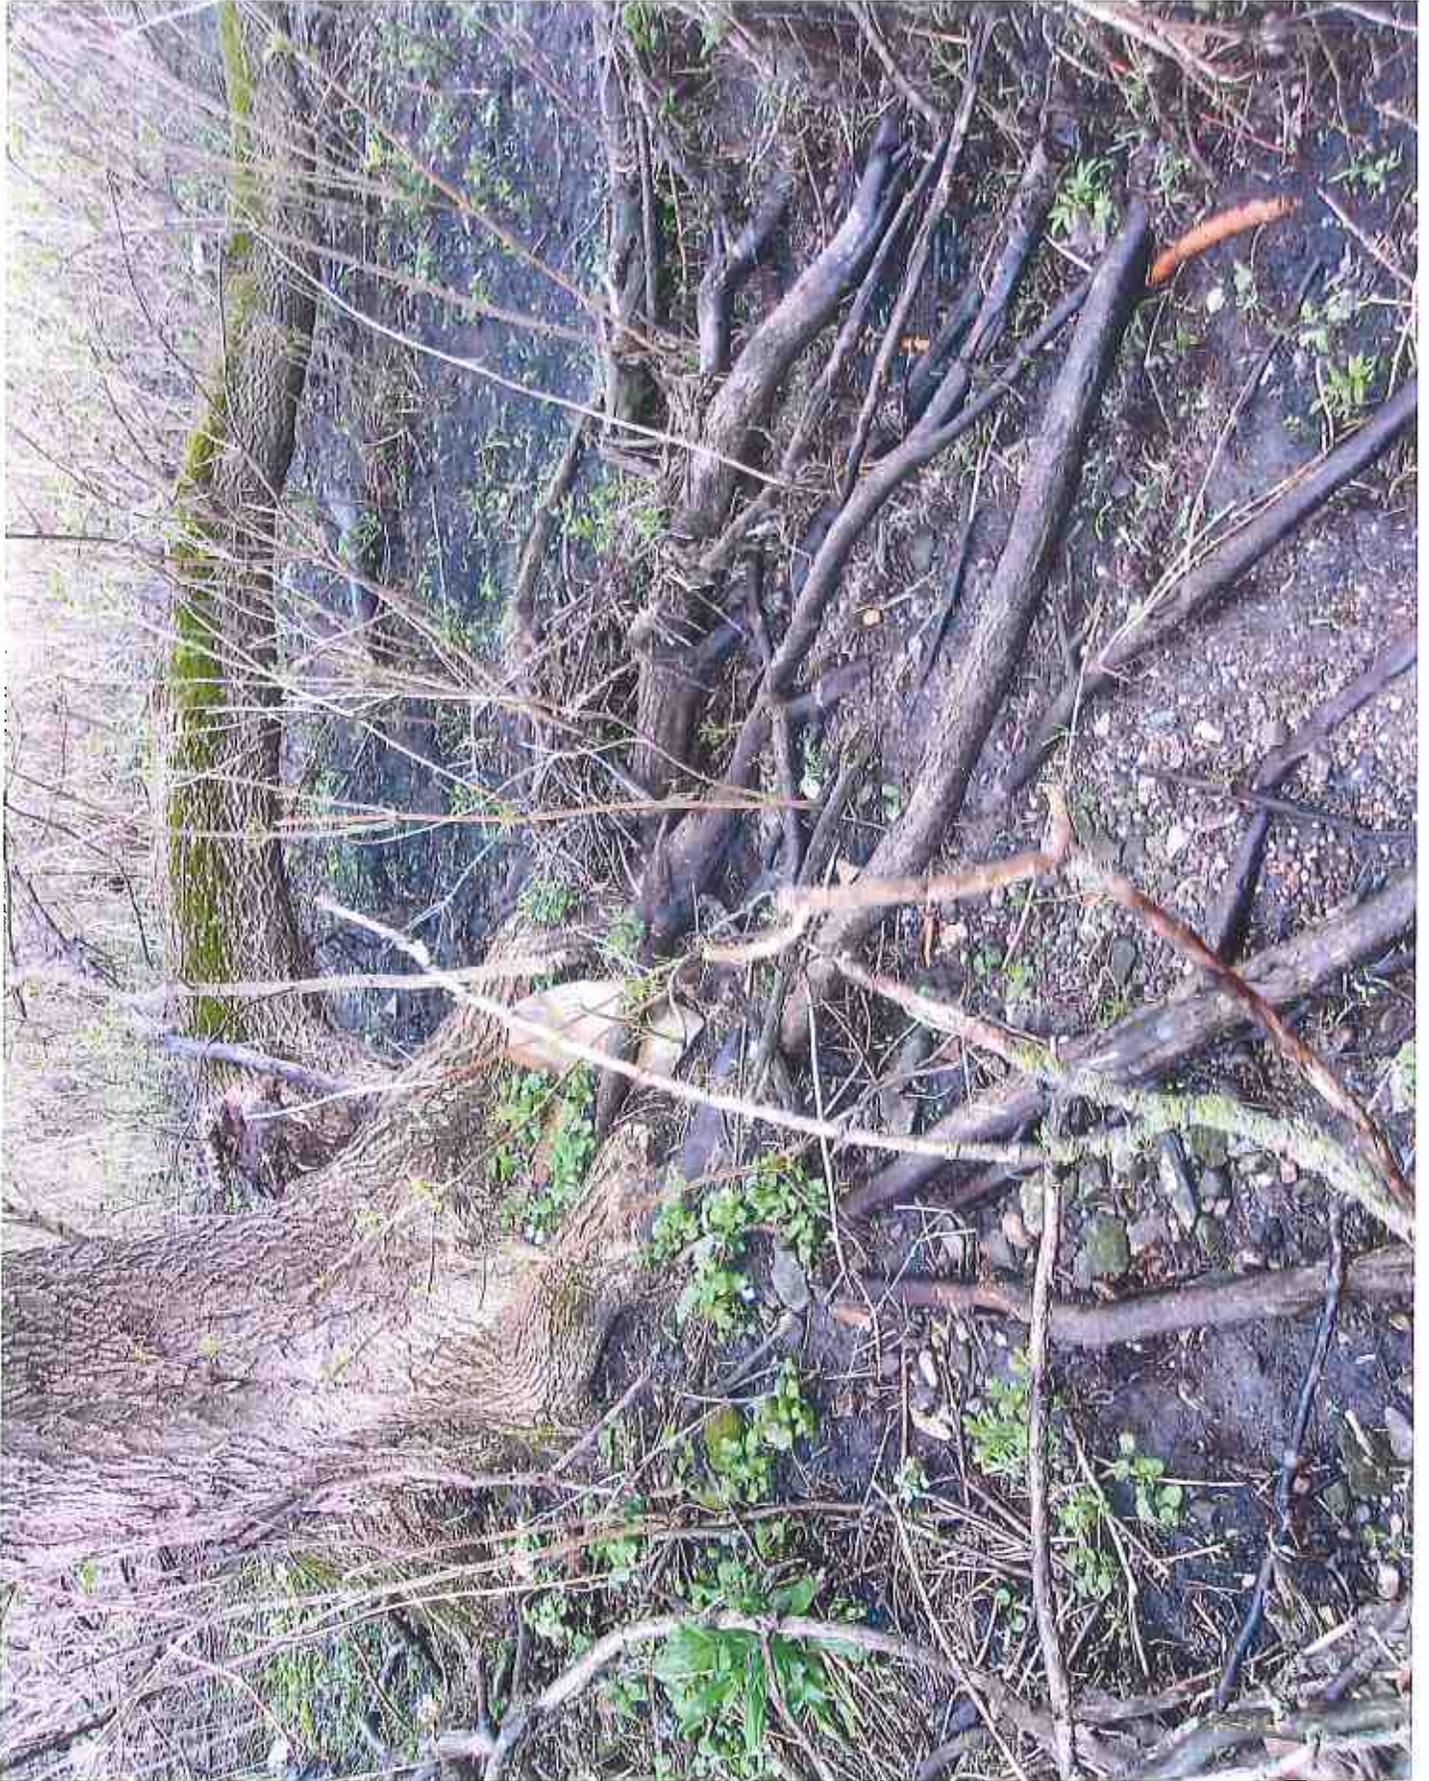
TILE ROUTE WITH CHARDS IN TREE ROOTS

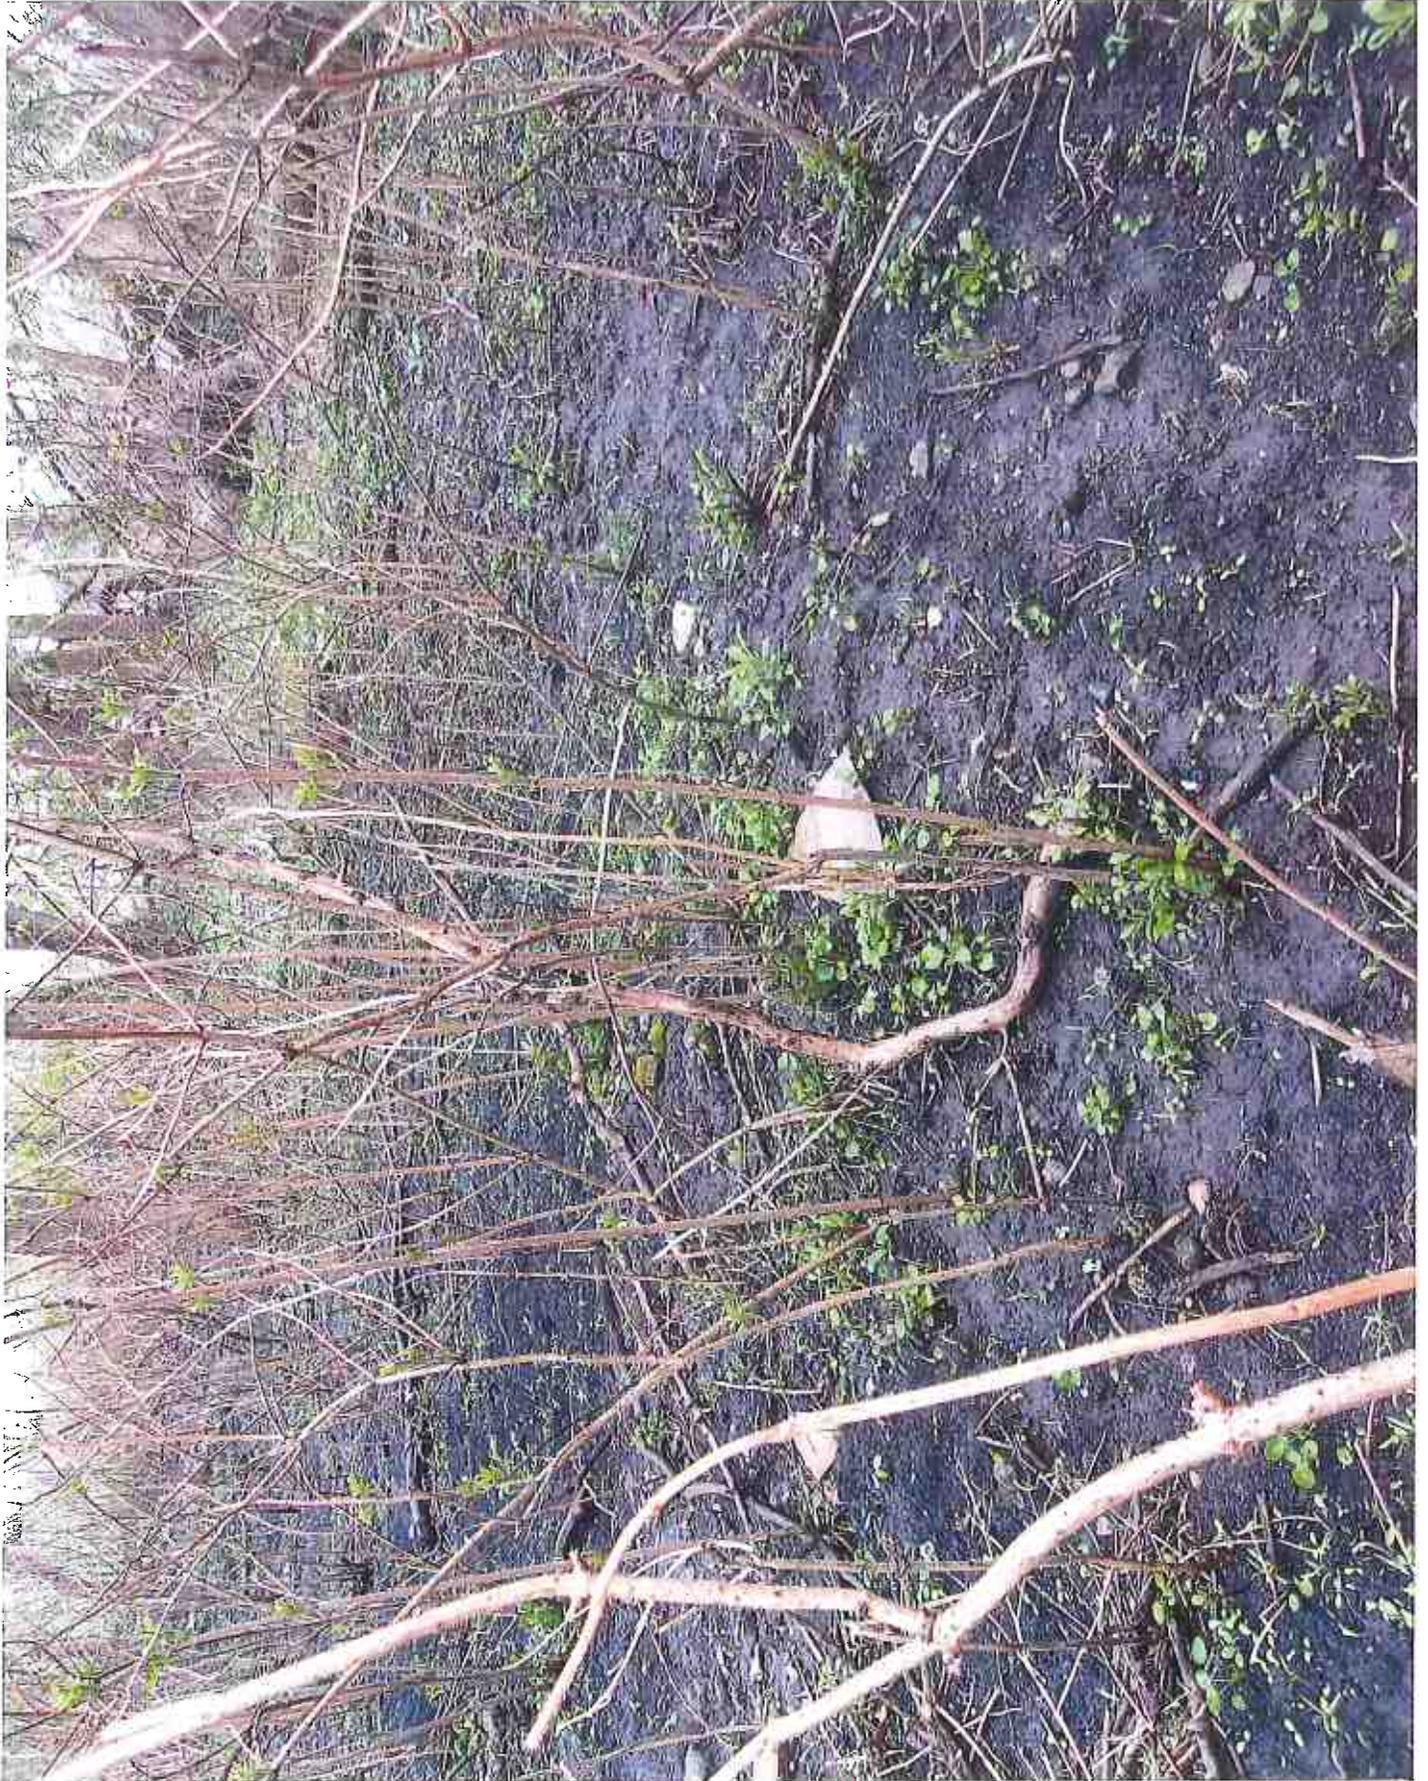
TILE CHARDS THRU ELDERBERRY BRUSH

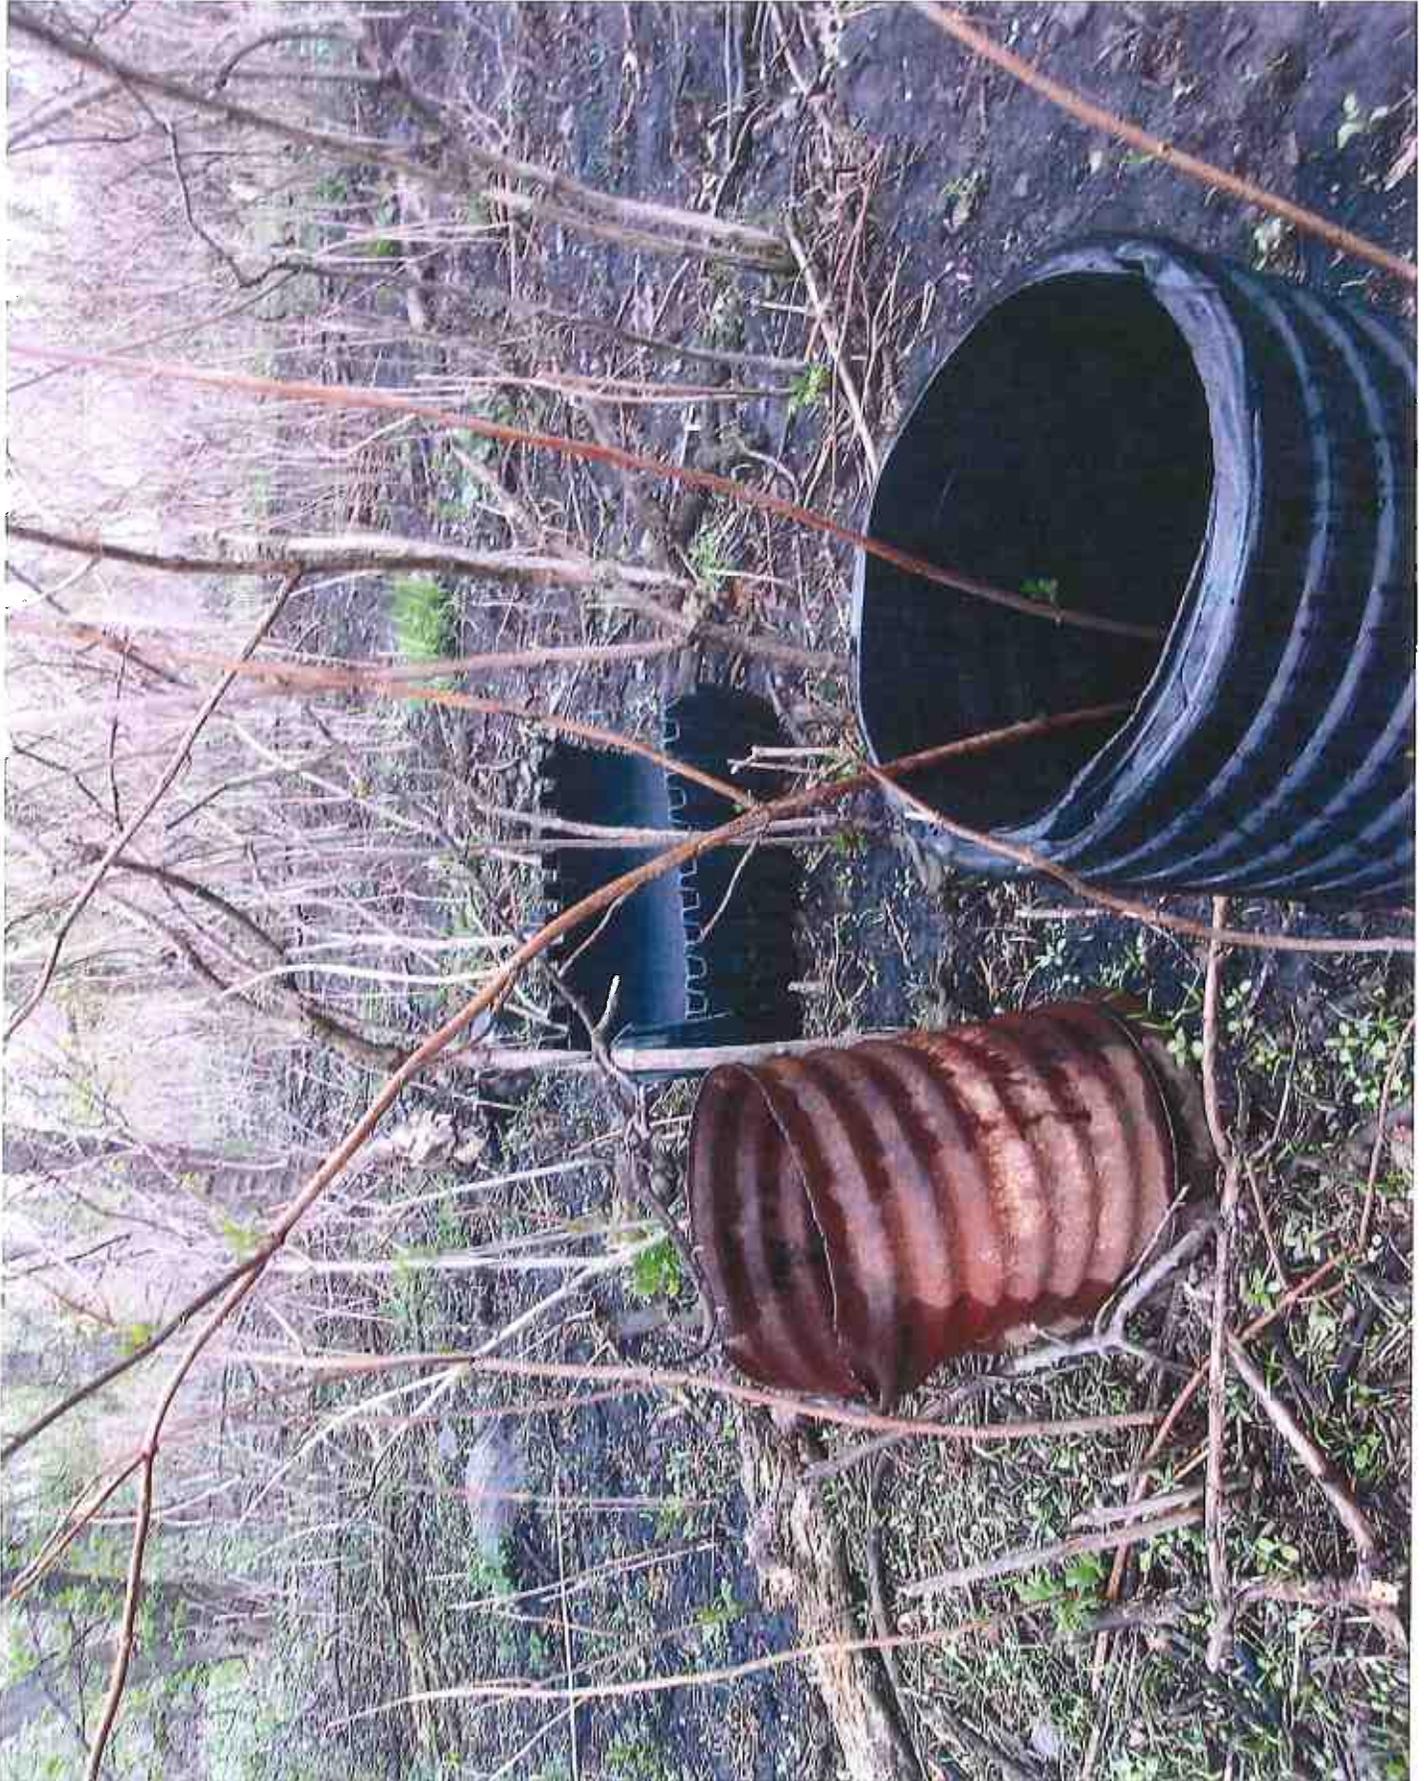
TILE REPAIR PIECES DISCARDED
