**UPDATED
ENGINEER'S REPORT
ON REPAIRS
TO MAIN TILE
DRAINAGE DISTRICT
NO. 86
HARDIN COUNTY,
IOWA**

Updated Engineer's Report on Repairs to Main Tile, Drainage District No. 86 Hardin County, Iowa

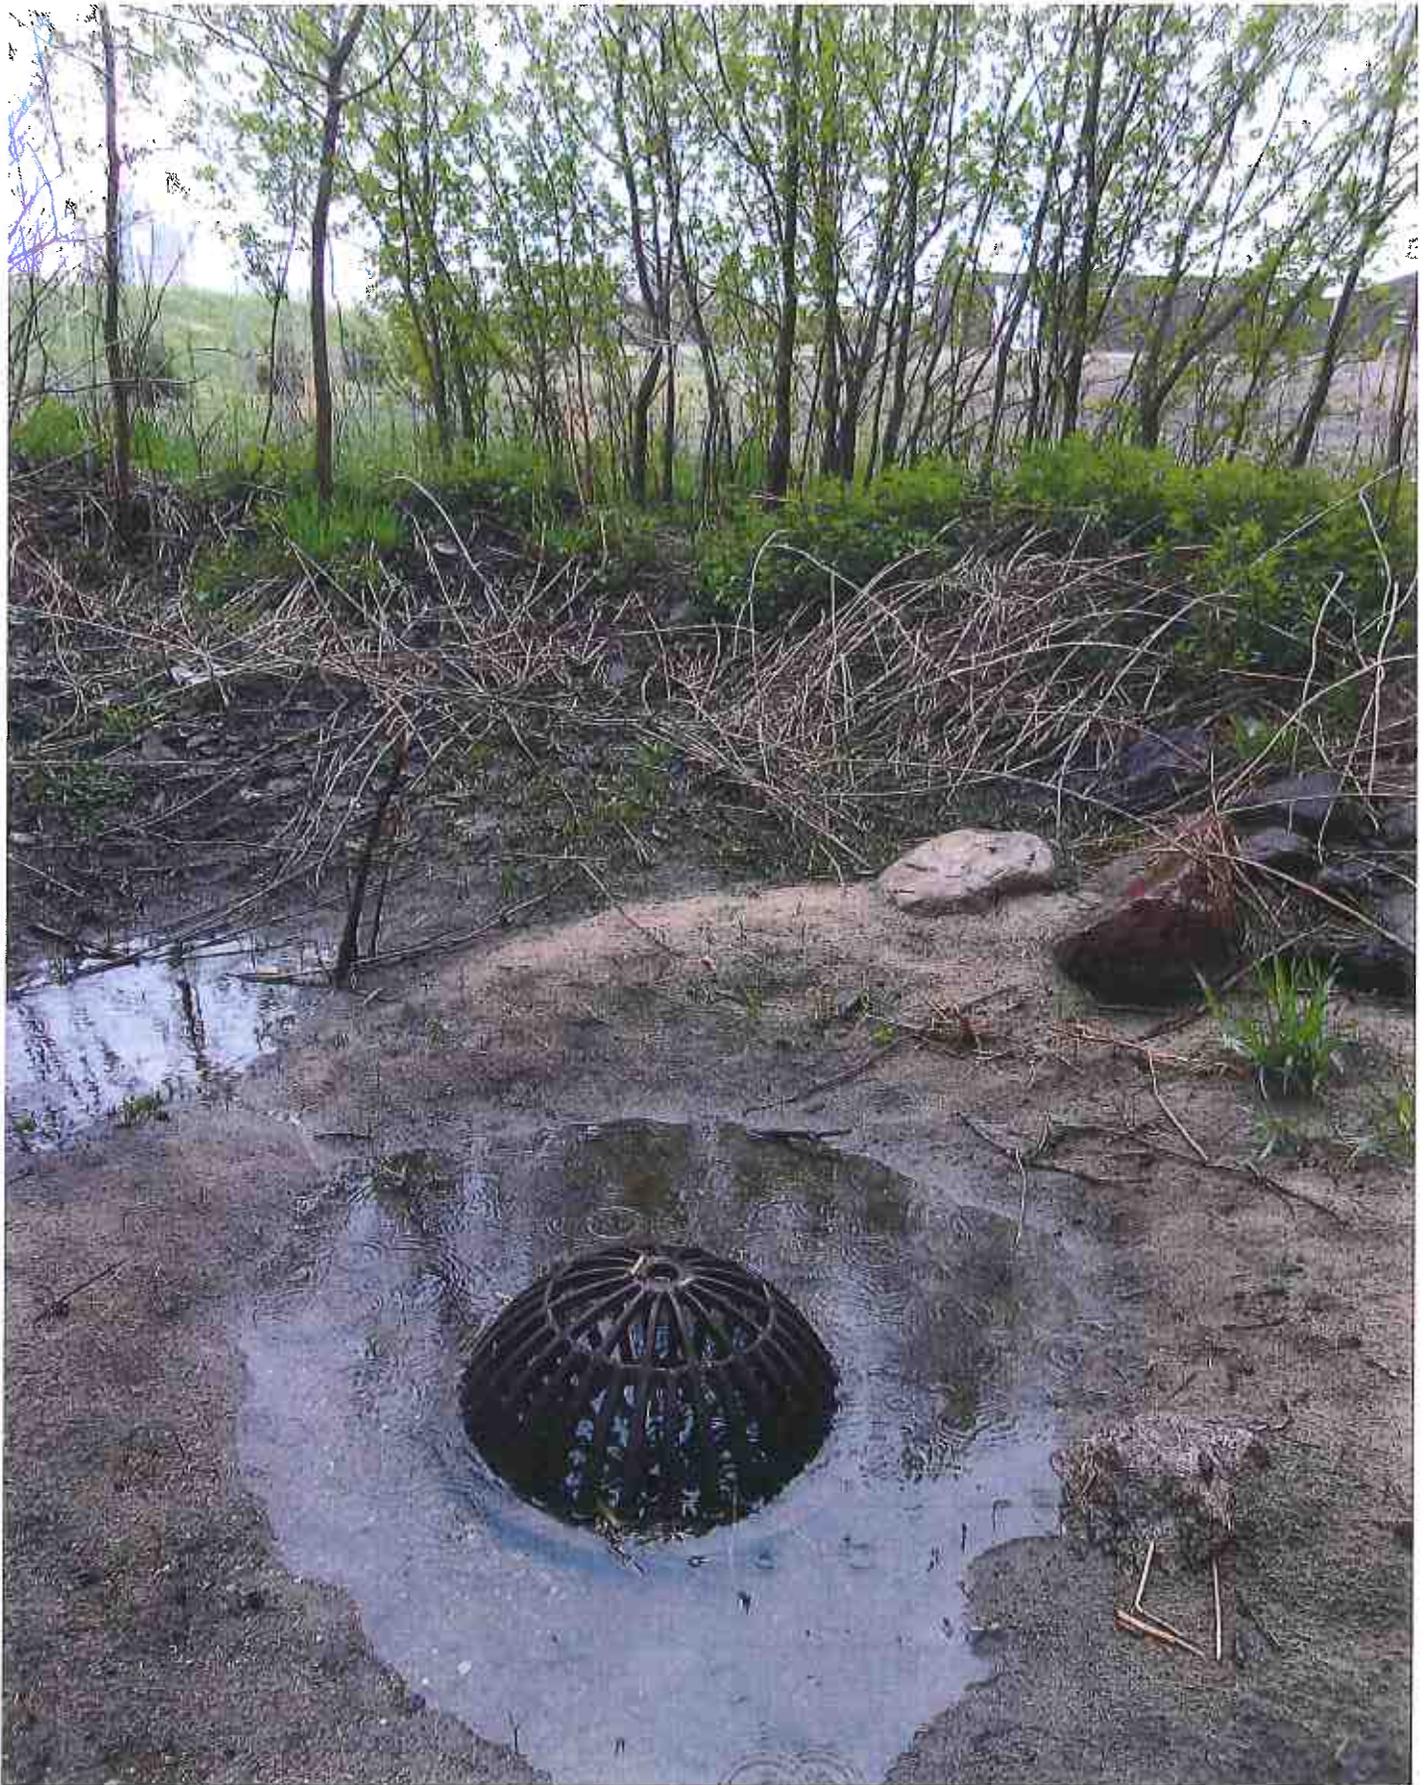
BEEHIVE OVERFLOWING @ NE COR OF GEORGETOWN ADD.

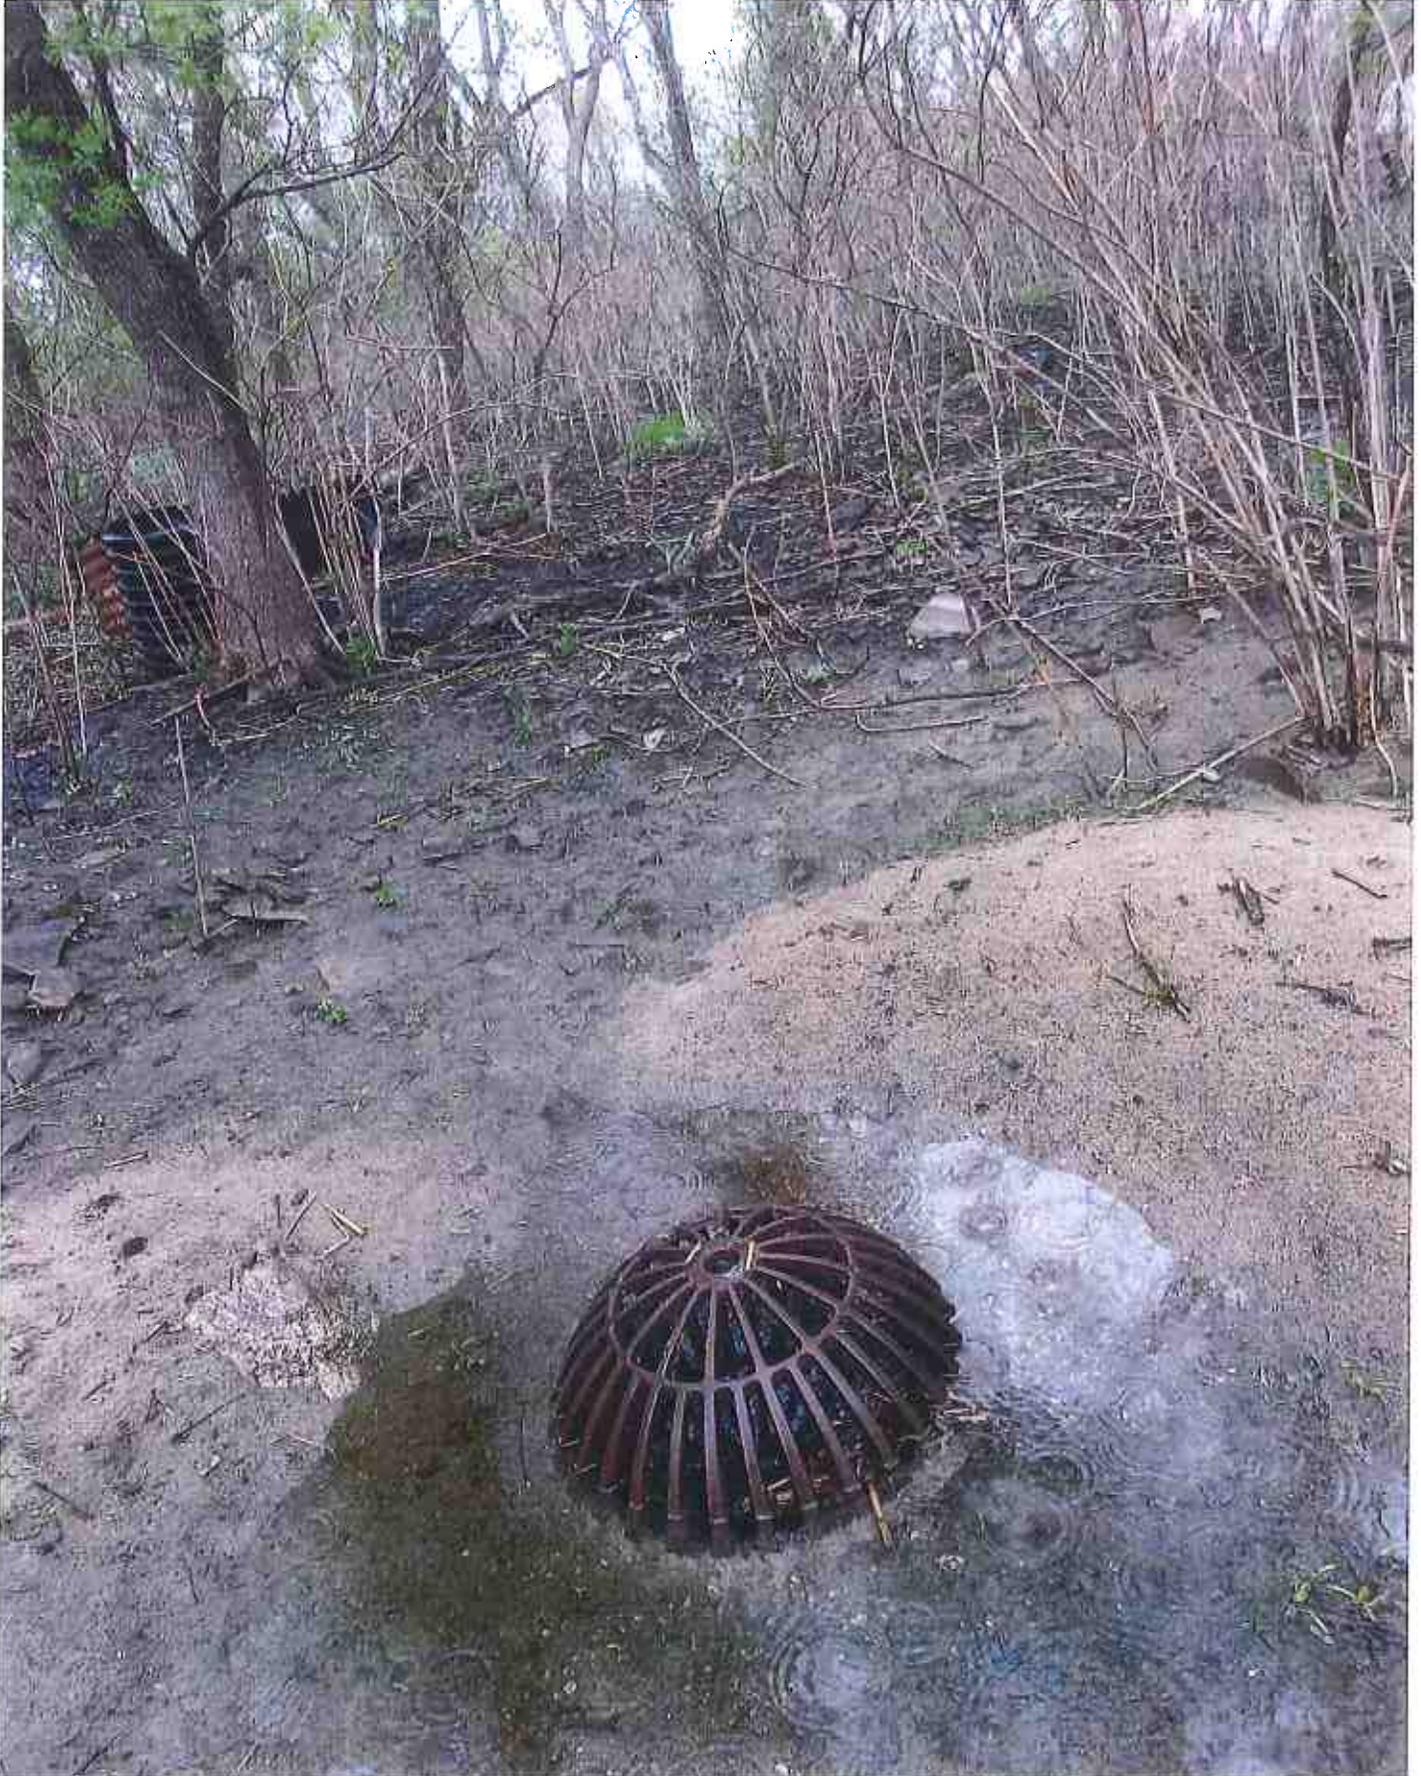
TILE HAS BEEN PARTIALLY PLUGGED FOR SOME TIME
LOOKING DOWN STREAM, NOTE ALL SEDIMENT SAND BLOWN OUT OF INTAKE

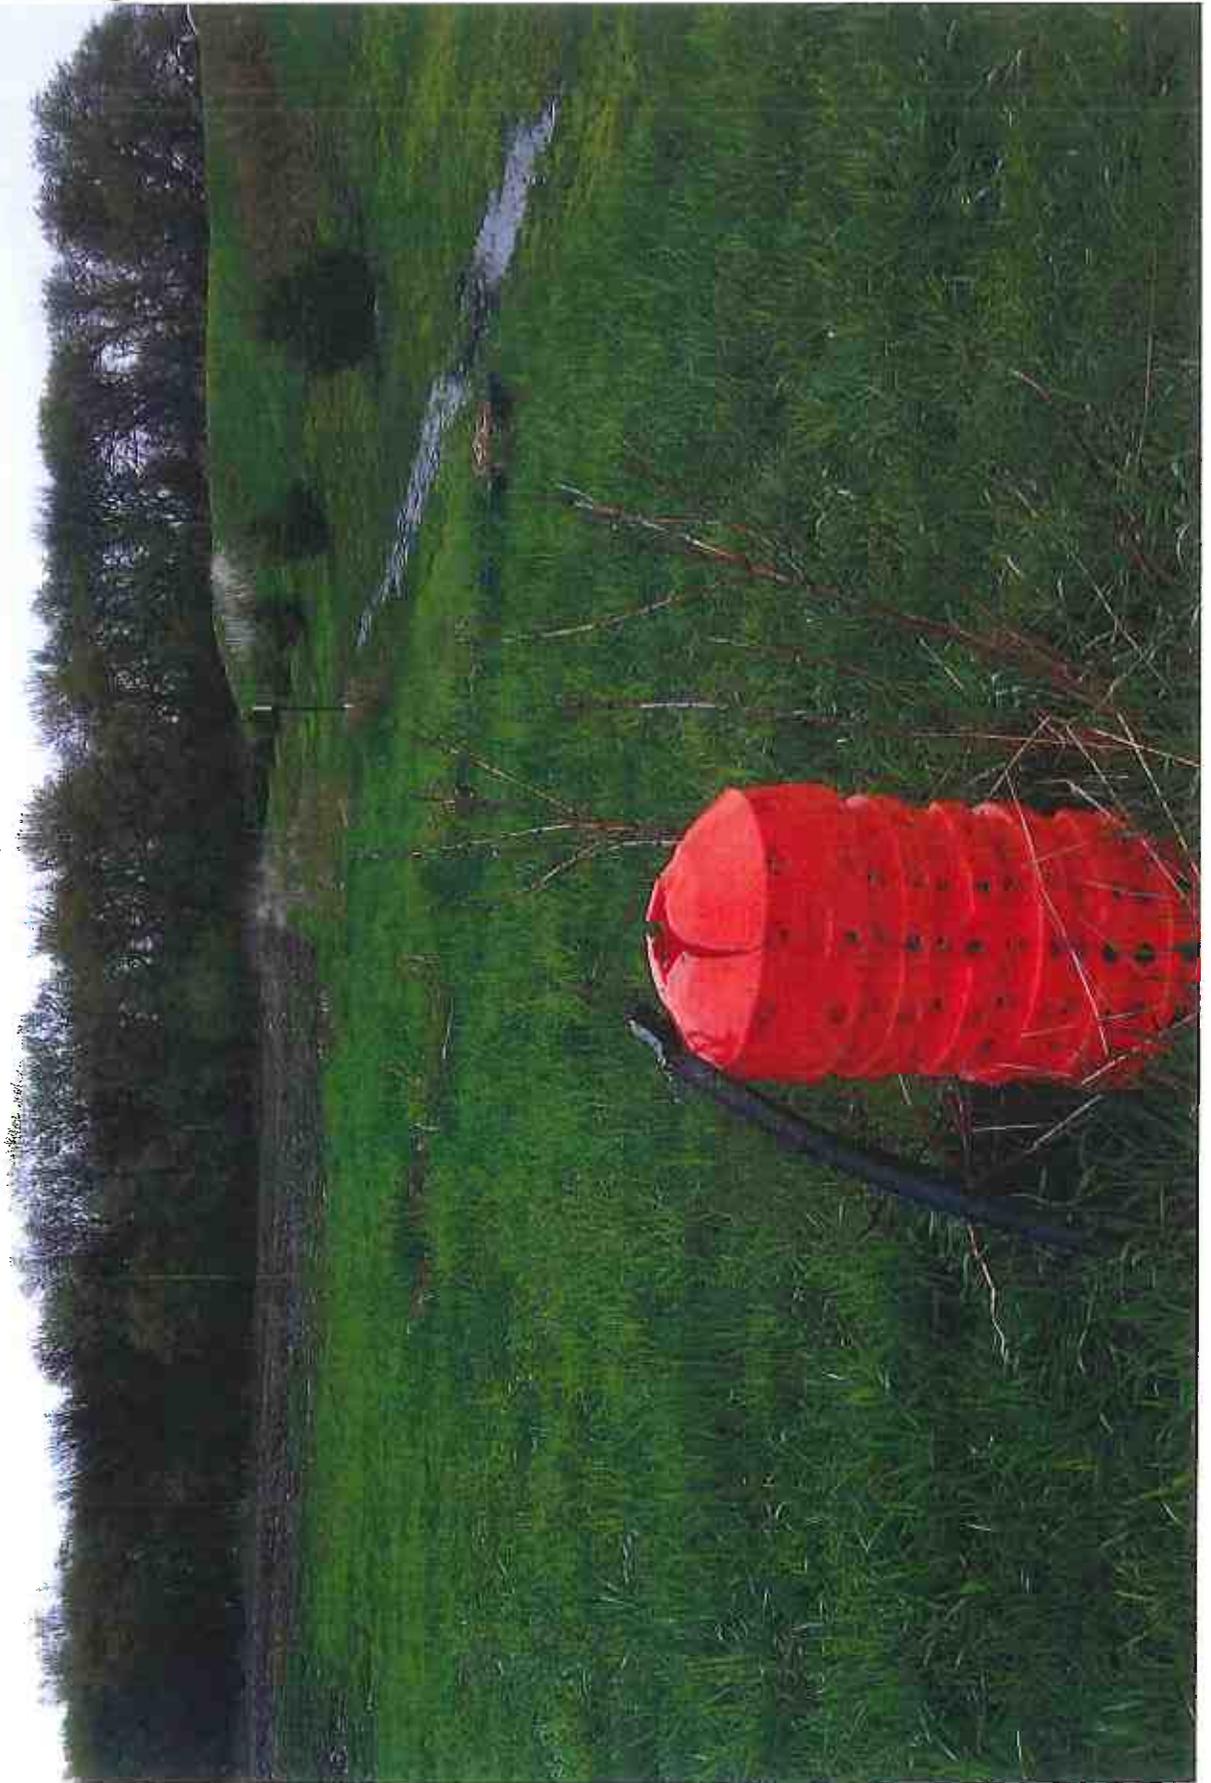
12" HICK INTAKE FULL OF WATER, SWIRLING

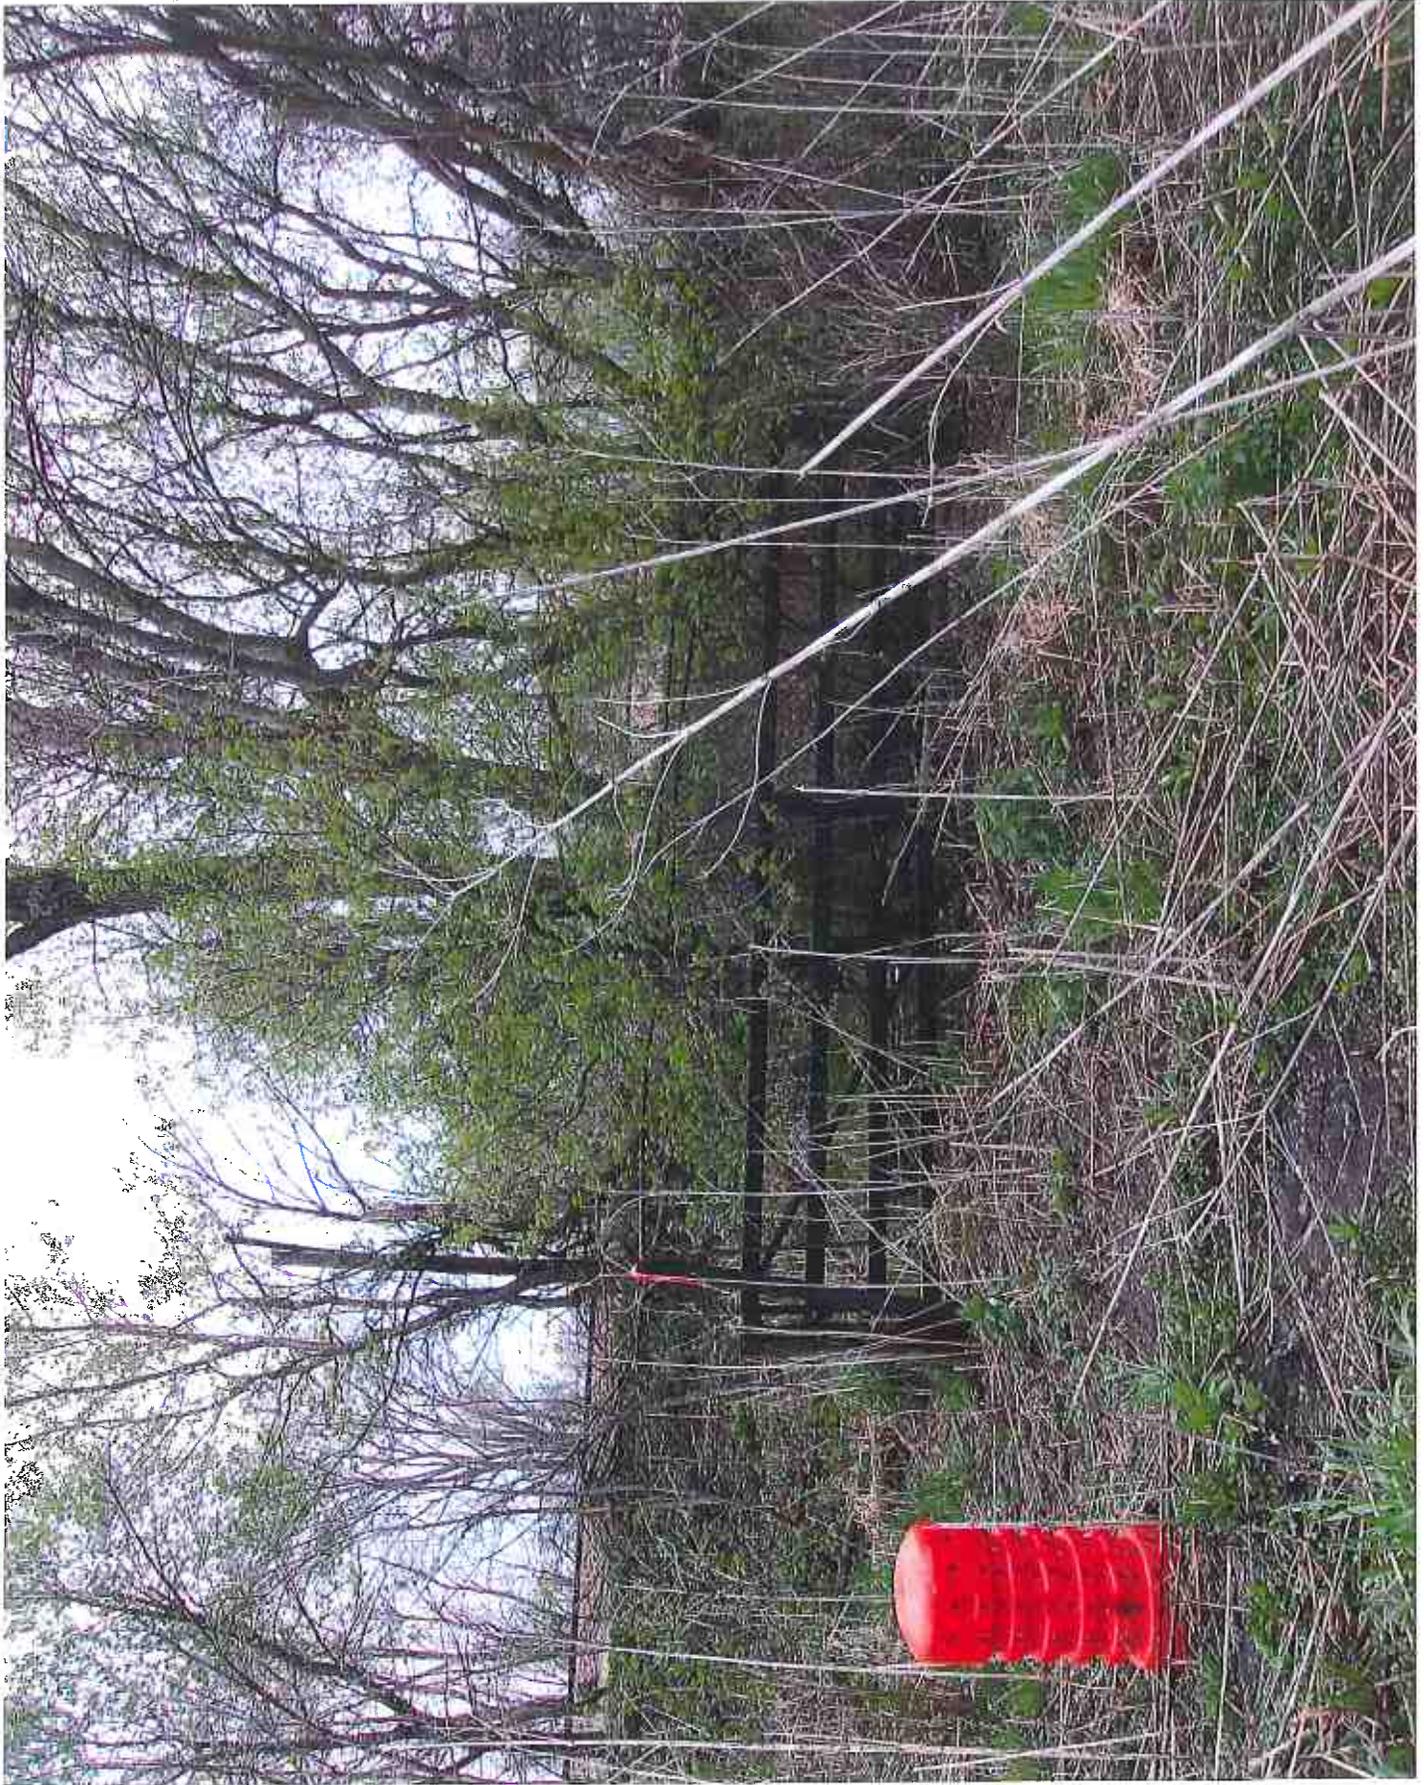
LOOKING UPSTREAM @ RR @ N. SIDE MONARCH LAKE, 40± <12"Ø TREES IN RR R/W

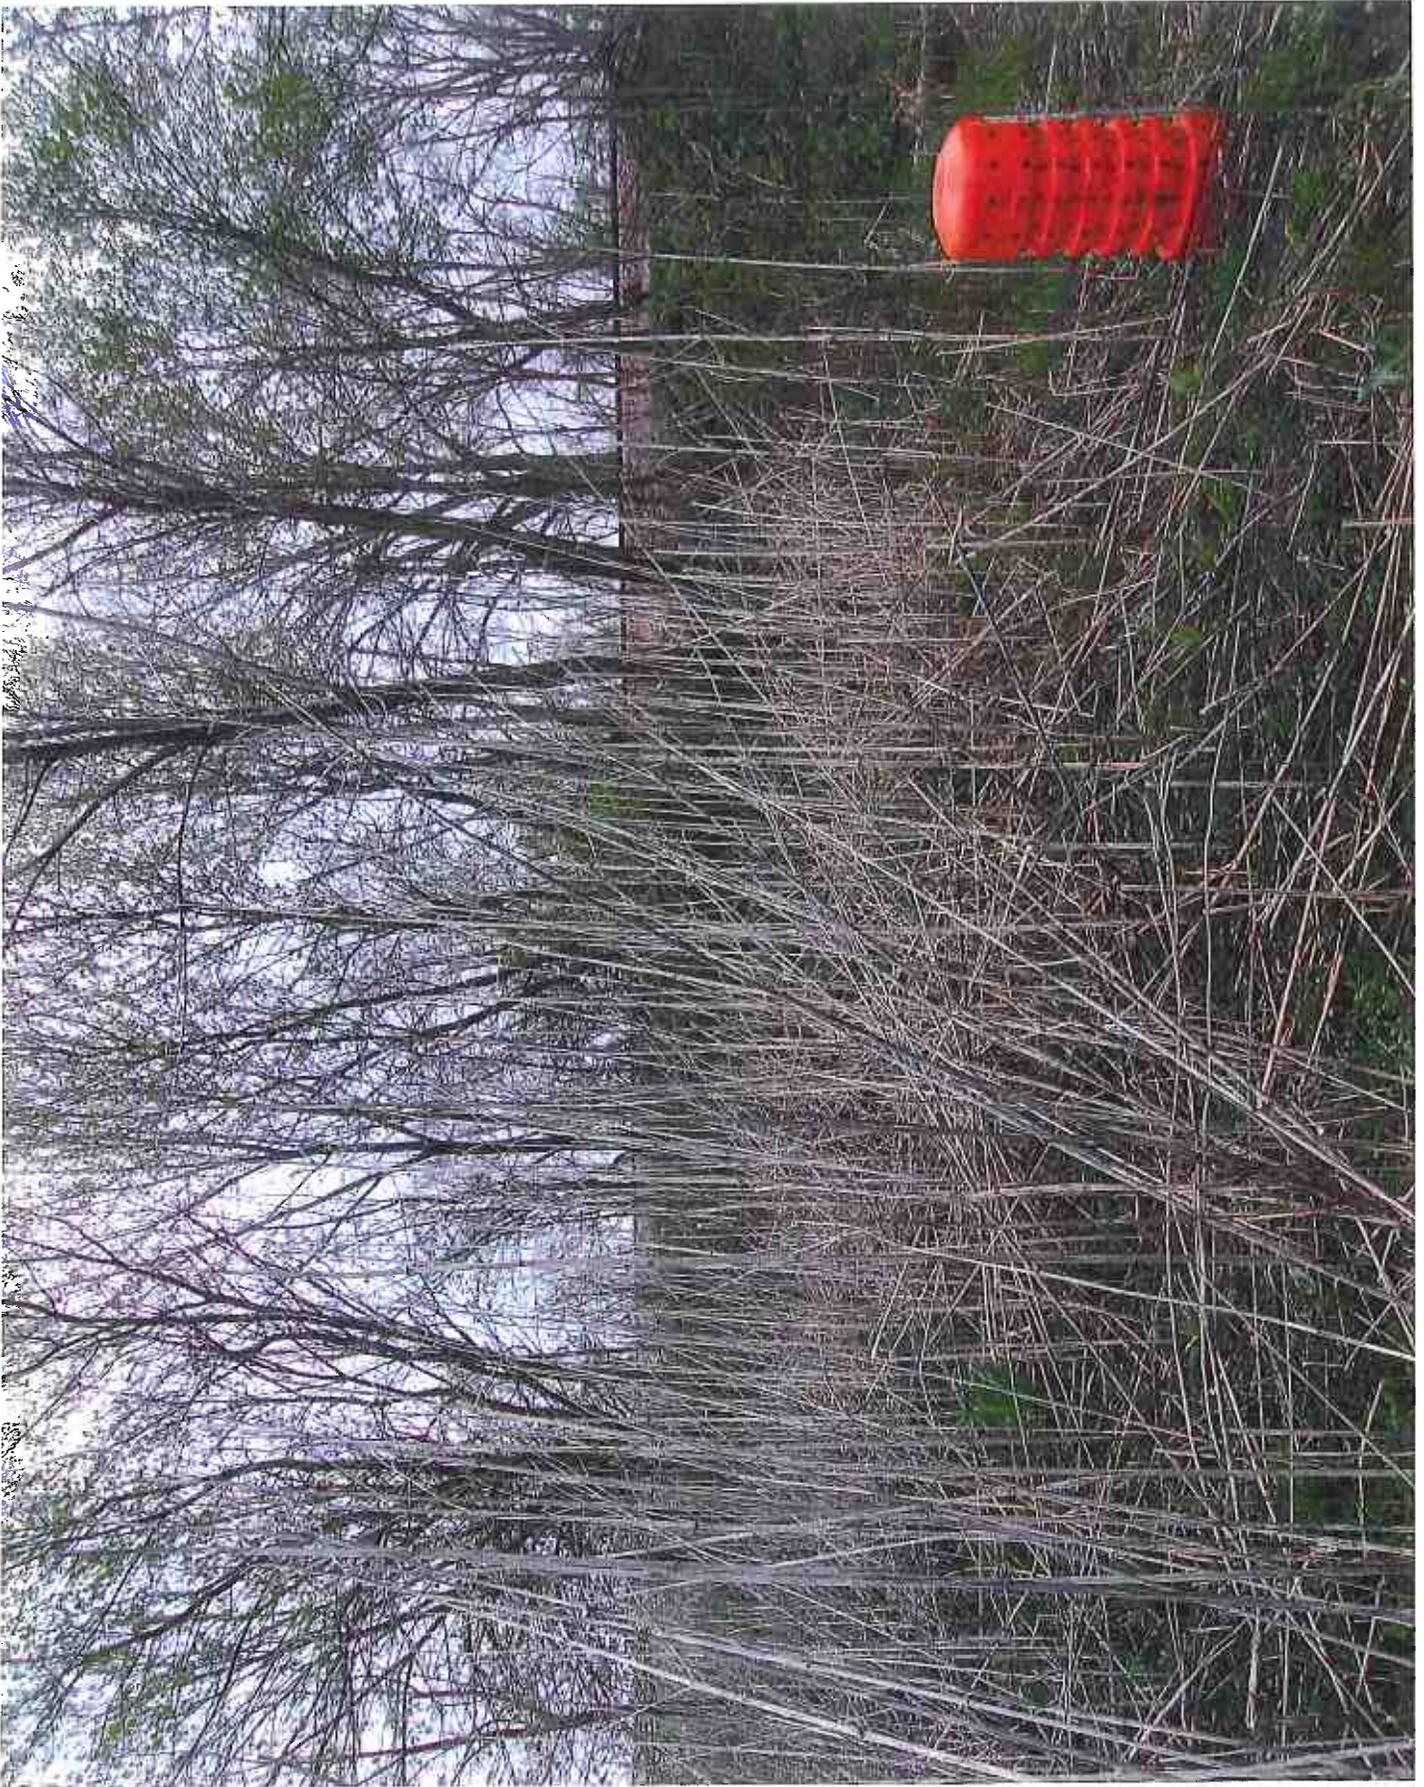
TREES IN RR R/W

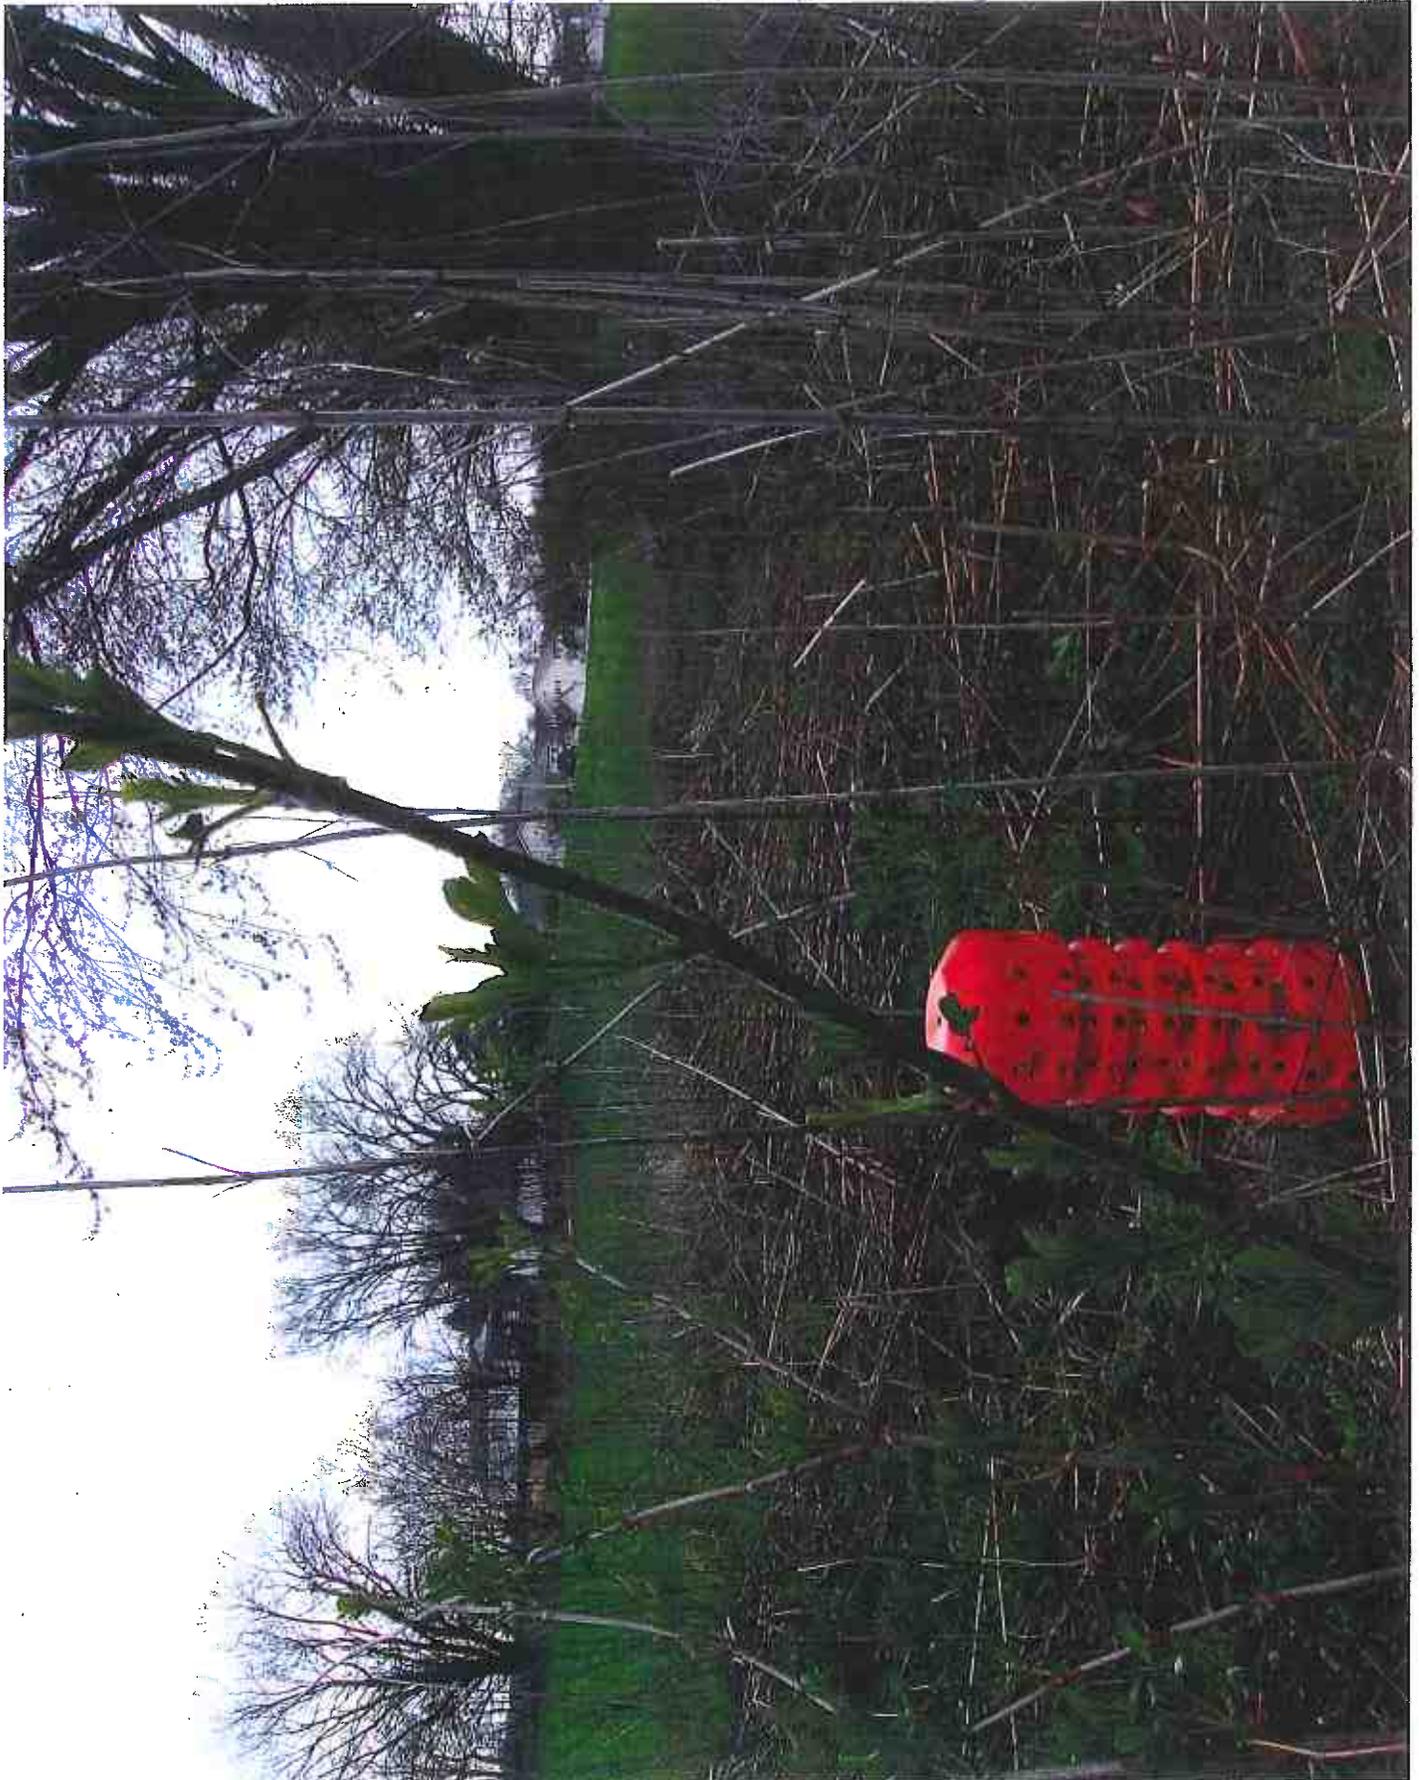
LOOKING DOWNSTREAM WITH 5' Ø MAPLE THAT NEEDS REMOVED
