Drainage Work Order Request For Repair

Hardin County

Work Order #: WO00000294

Investigation Summary:

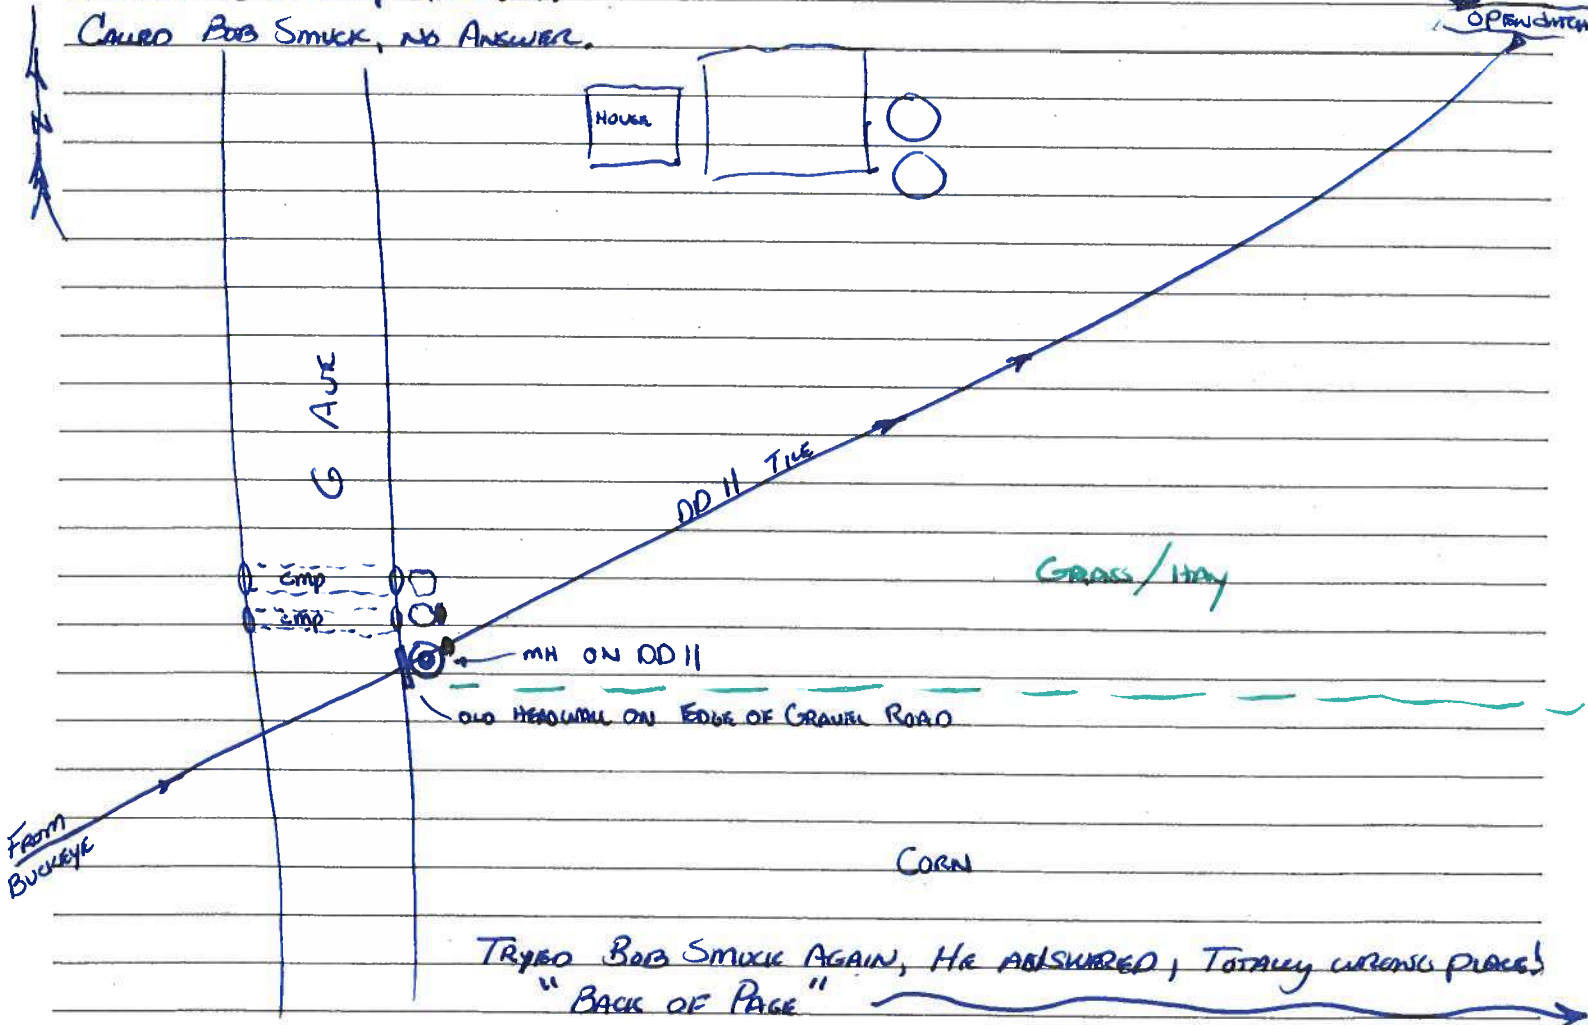
Did not find 2' Blow-out as described in Report from Clerk. No Fence Line, just crop change. MH on E side of "G" Ave has hole and exposed tile on E-side. Walked tile route downstream 300'±, saw no problems.

I couldn't get lid of MH, lots of water noise, I think its a drop structure.

- Repair the hole found at the manhole in the east road ditch of G avenue and restore soil as needed over the Main tile.
- Excavate the Main tile at the location of the blowout/sinkhole to determine the cause and repair as necessary.

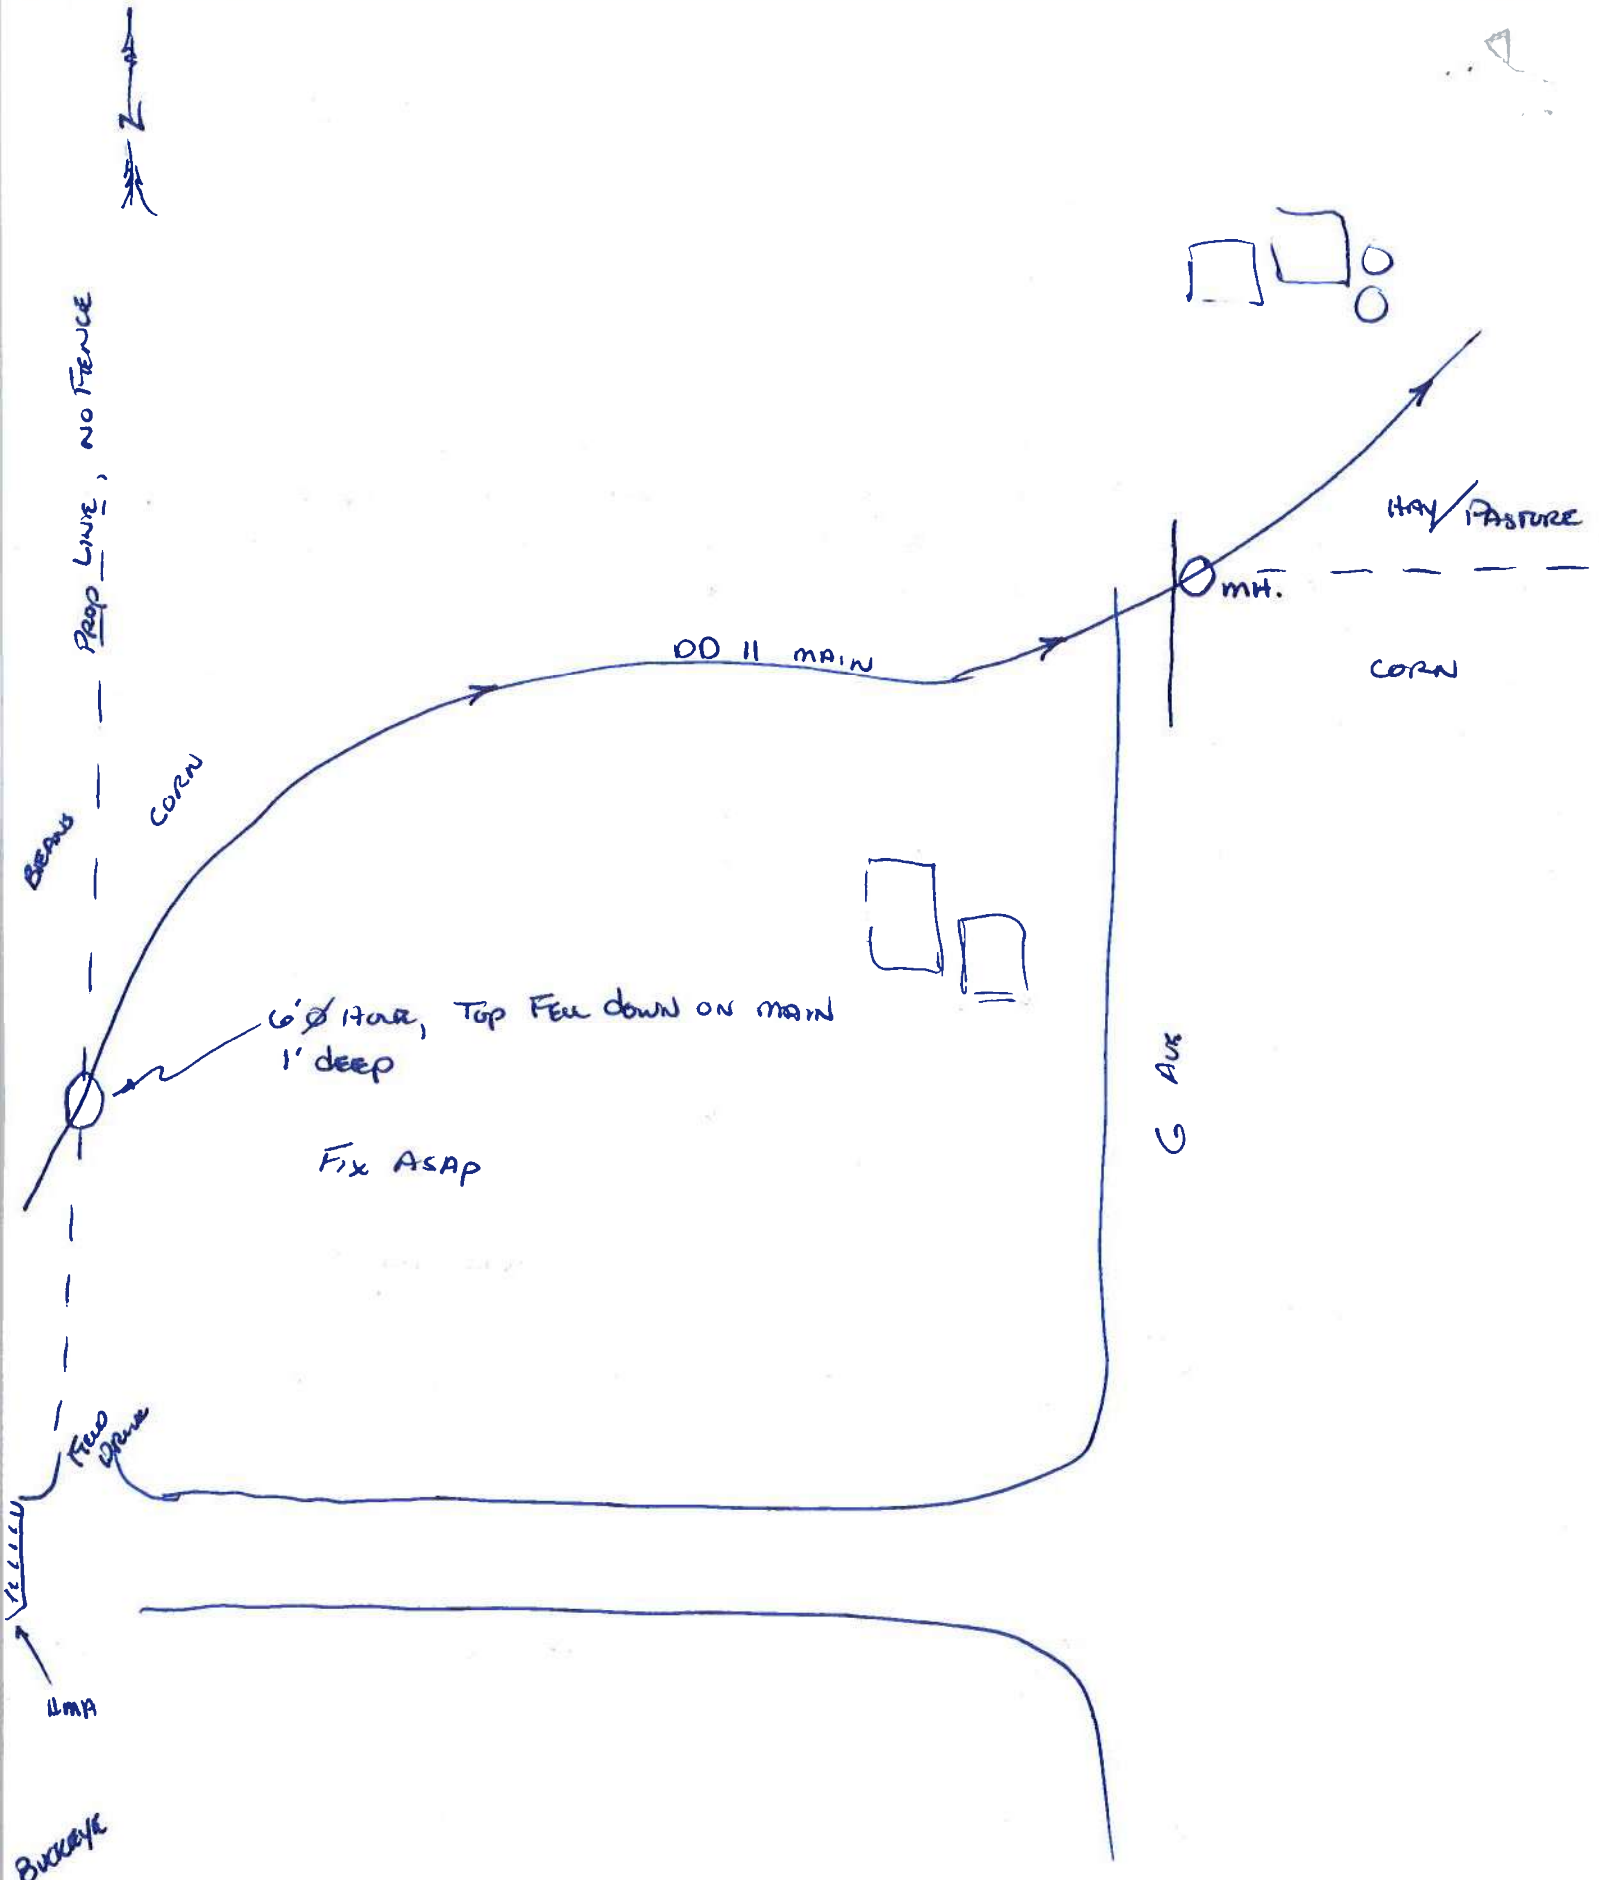
6" Ø Hole, Top Fell down on main
1' deep

Fix ASAP

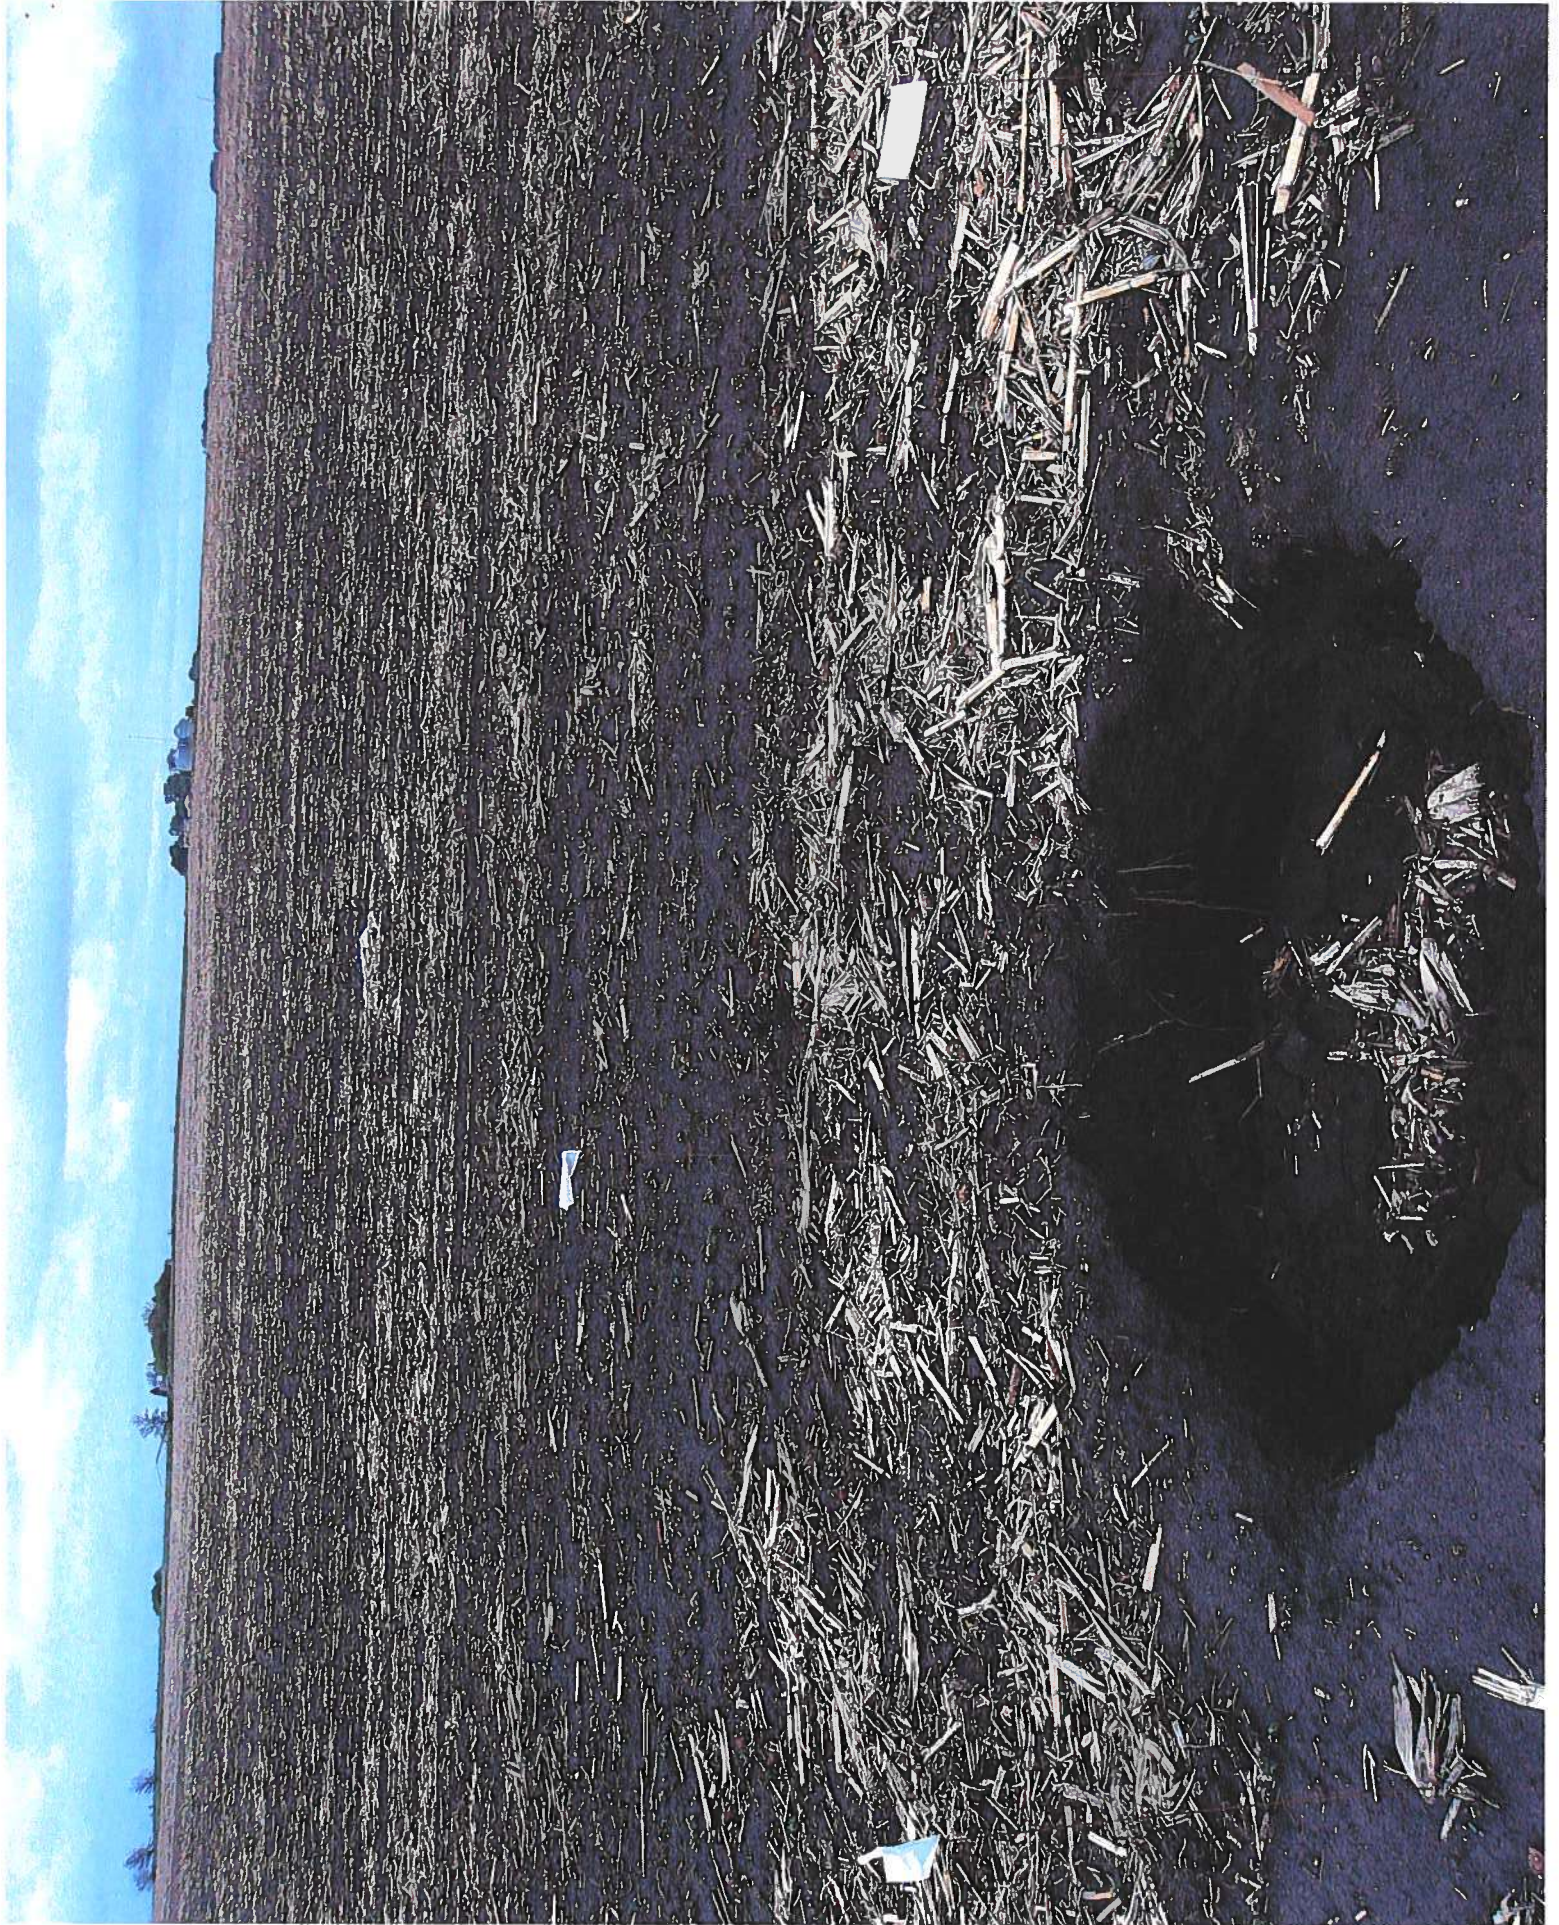
LOOKING WEST @ BLOW-OUT

- Landowner in the SW¼ Section 13, Township 88 North, Range 22 West reported a 2-foot diameter blowout/sinkhole on the southwest corner of the farmstead parcel. Phone conversation with the landowner indicated that the blowout/sinkhole was on the NW¼ NE¼ of section 23, Township 88 North, Range 22 West, and not as described on the Work Order.
- While observing the location as described on the Work Order request, a manhole on the Main tile was found in the east road ditch of G avenue with a hole in it, the tile exposed, but water flowing freely.
- After the phone conversation with the landowner, the reported blowout/sinkhole was located on the assumed Main tile route and was found to be approximately 6-feet in diameter and 1-foot deep with no tile visible in the depression.
