Drainage Work Order Request For Repair

Hardin County

Work Order #: WO00000294

Investigation Summary:

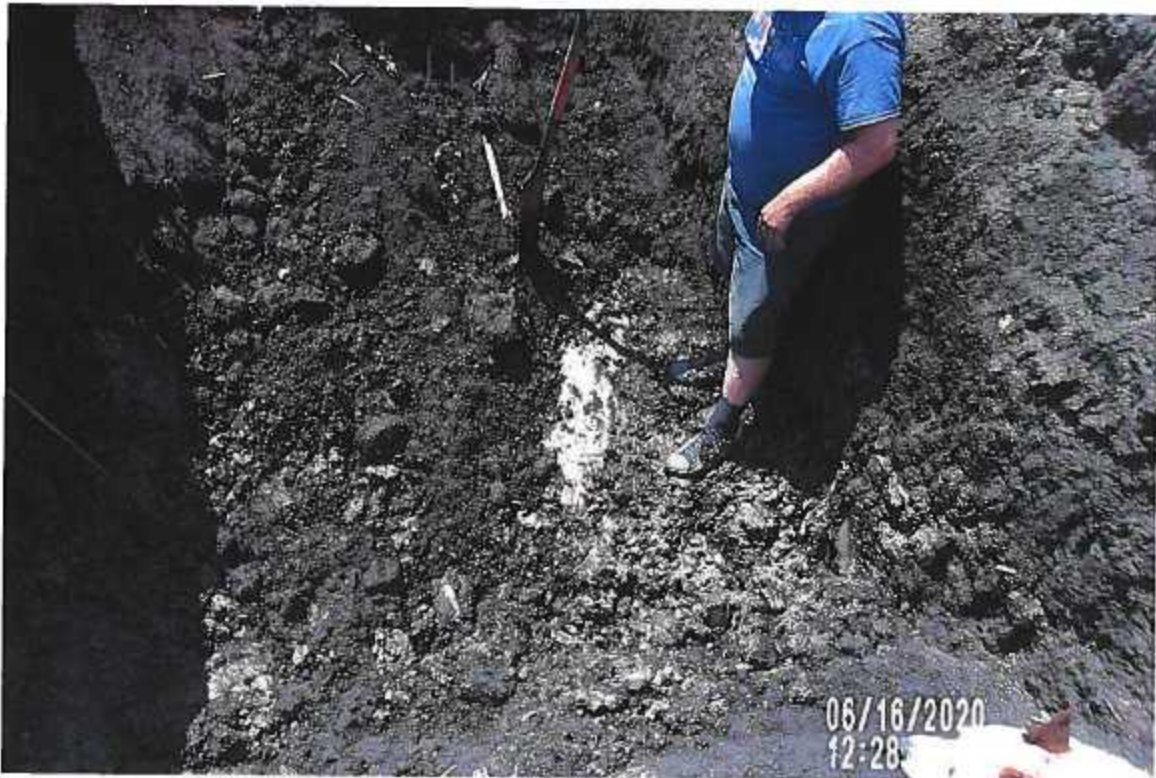
PICTURE#3775 IS LOOKING SOUTH TOWARDS 195TH STREET
AT 5.0' ϕ X 2.0' DEEP BLOWOUT IN BEAN GROUND
(WEST SIDE) OF CROP CHANGE

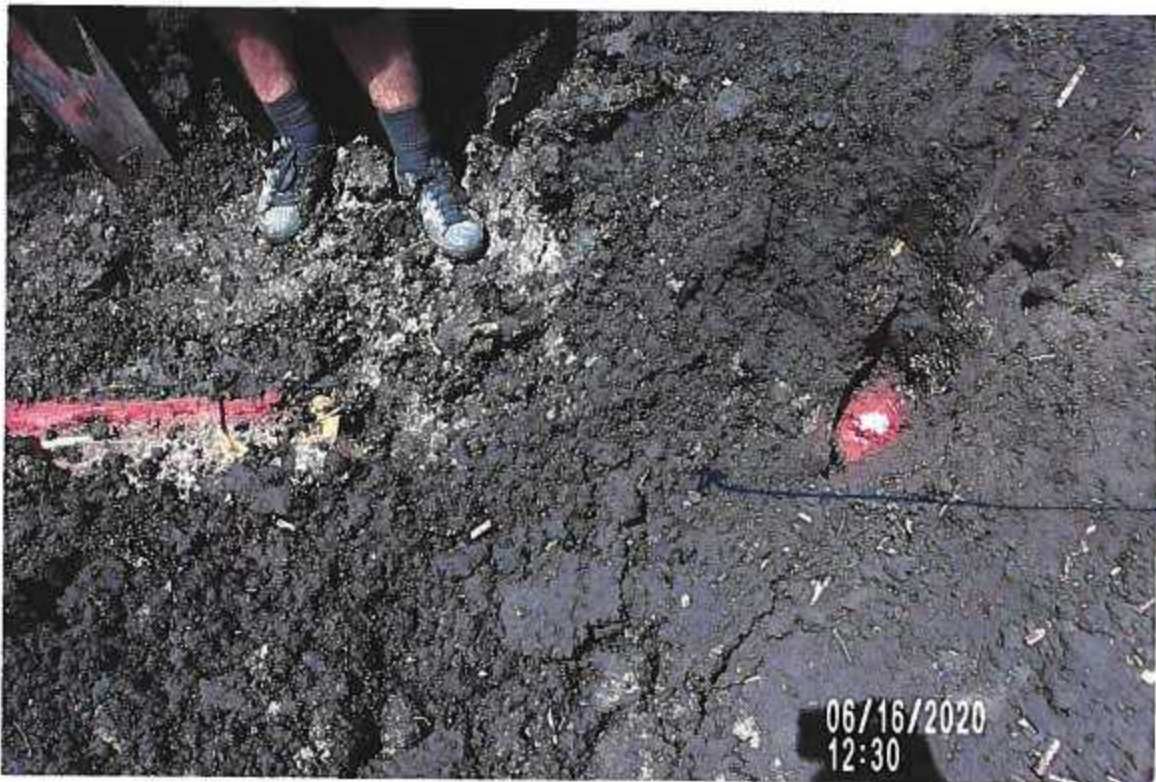
PICTURE #3776 IS LOOKING SW SHOWING EXISTING CLAY TILE EXPOSED NEAR TILE BLOWOUT WITH NO VISIBLE ISSUES YET (JOINT IS TIGHT)

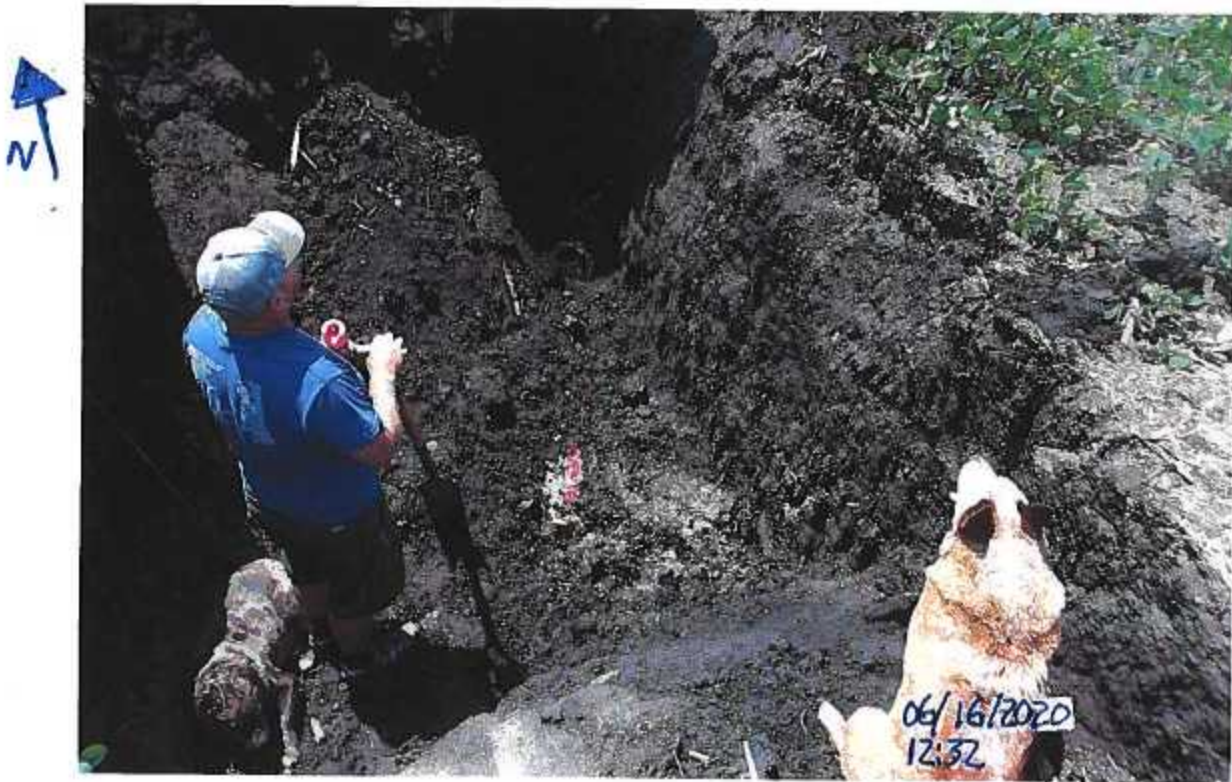
TILE SECTION COLLAPSING & BROKEN

PICTURE #3777 IS LOOKING SLIGHTLY NW SHOWING EXISTING CLAY TILE TO SW IN GOOD SHAPE AND SECTION OF CLAY TILE COLLAPSED (GOOD CLAY AROUND TILE)

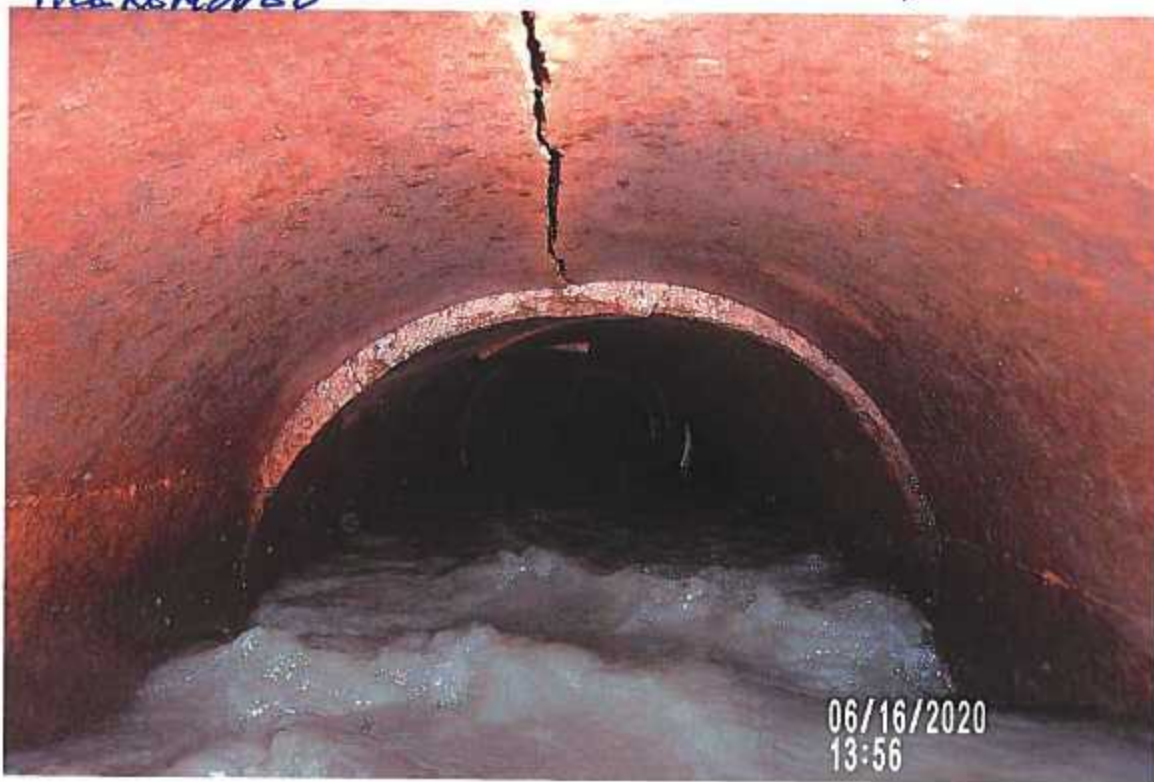
PICTURE # 3779 IS LOOKING SW UPSTREAM FROM GPS#392. INSIDE - 21" CLAY TILE WITH SMOOTH CRACKS @ 6 & 12 O'CLOCK, TILE IS CRACKED, SLIGHTLY SQUATTED, BUT DOES NOT APPEAR TO BE LEAVING DOWN.

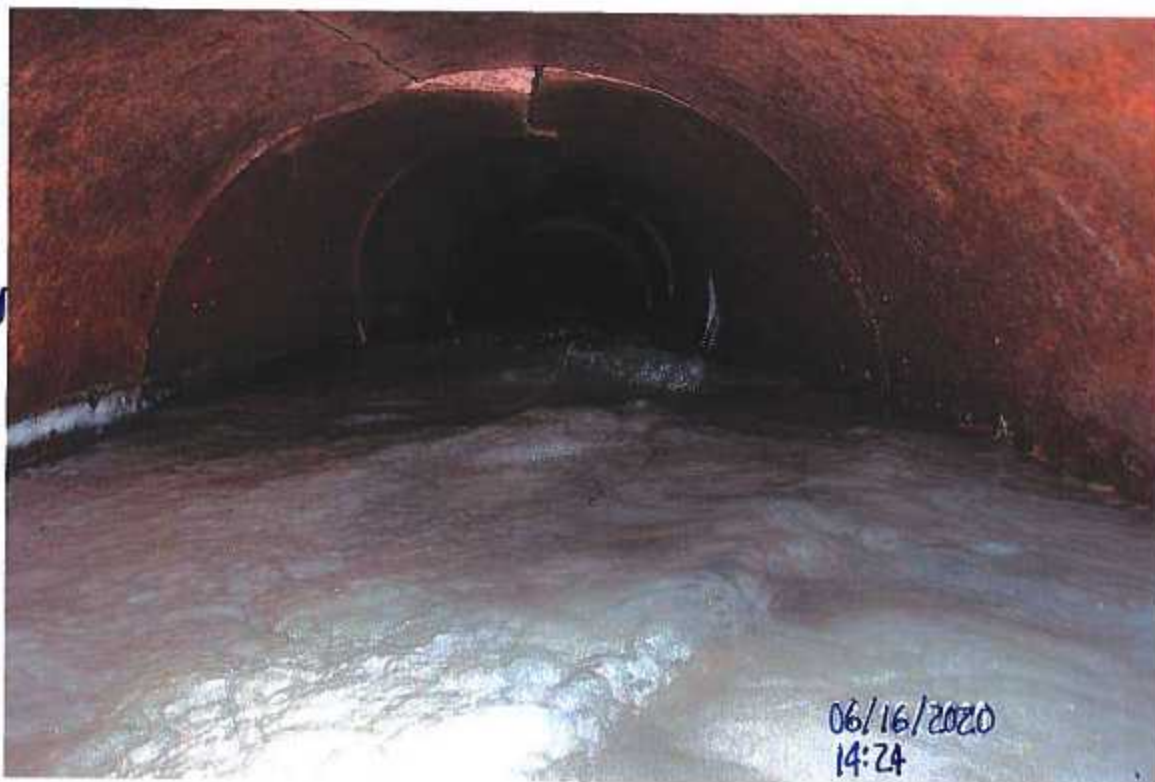
PICTURE # 3780 IS LOOKING NE DOWNSTREAM APPROXIMATELY 12.5'
FROM GPS # 392 SHOWING TILE STILL CRACKED, SQUATTED,
AND CAVING DOWN. AFTER APPROXIMATELY 5 SECTIONS OF
TILE REMOVED

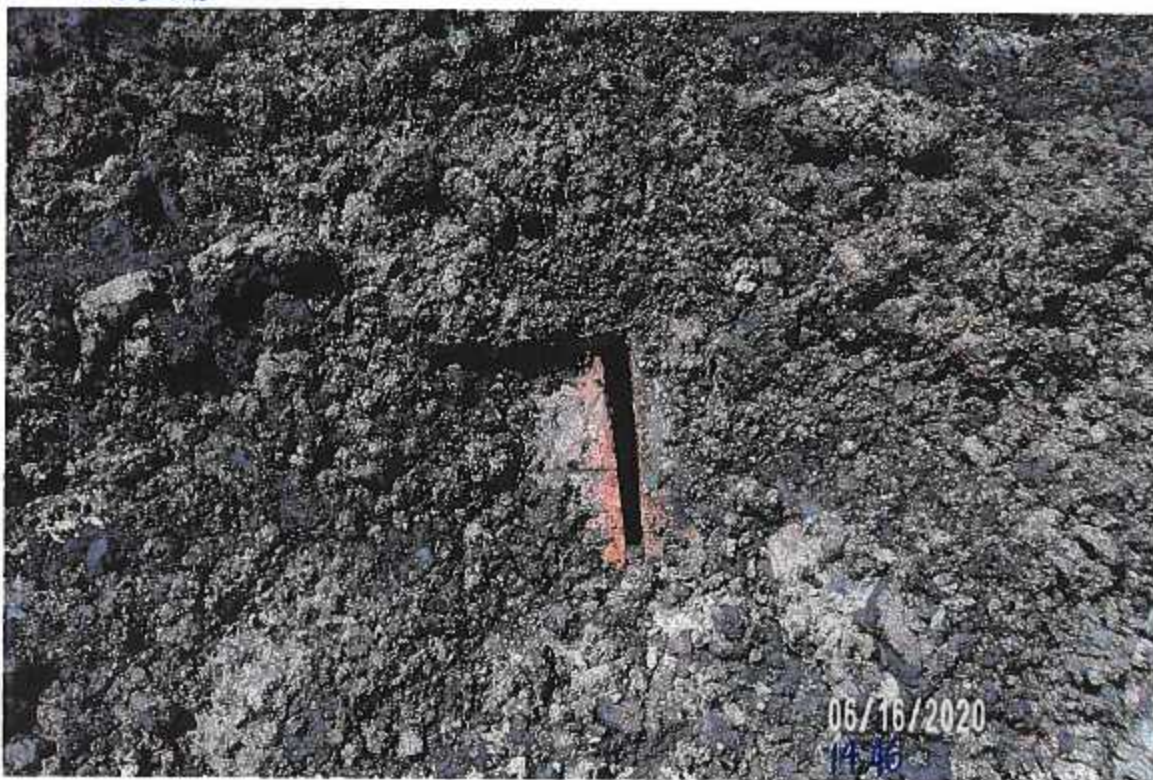
PICTURE # 3781 IS LOOKING NE DOWNSTREAM APPROXIMATELY
(23.5' FROM GPS # 392) (GPS # 393) SHOWING TILE STILL CRACKED,
SQUATTED, AND CAVING DOWN AFTER 4 SECTIONS OF TILE REMOVED.

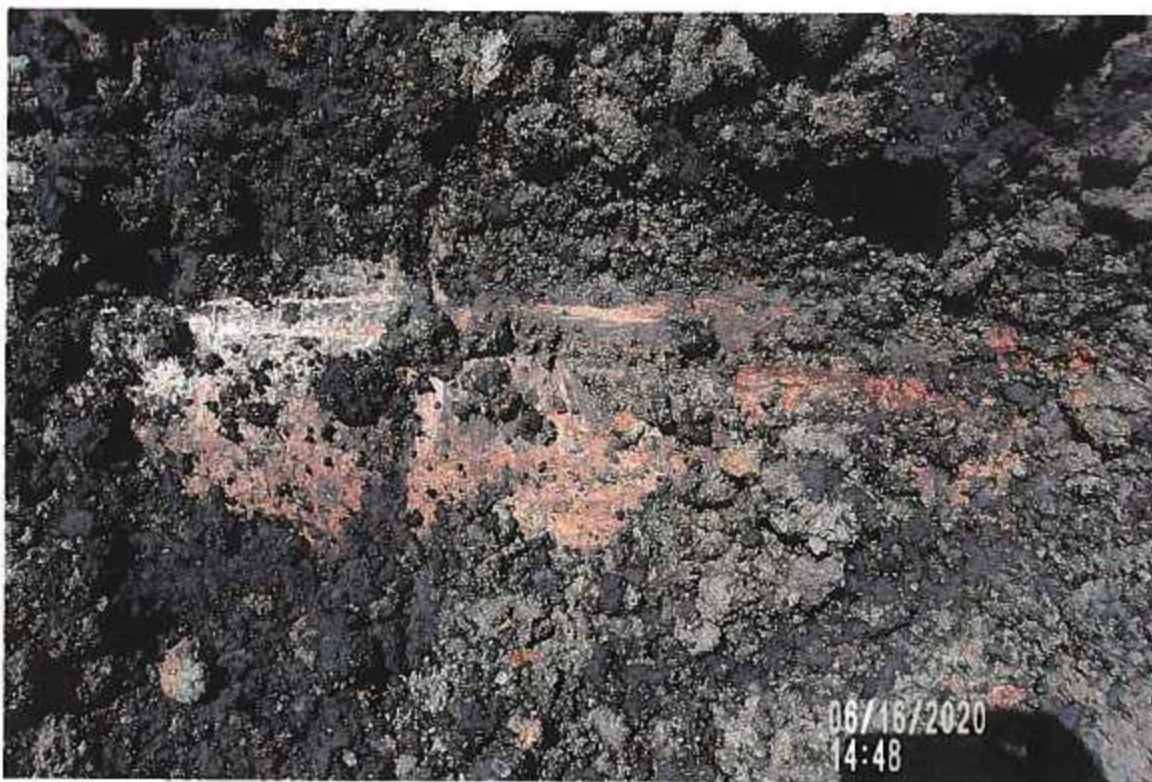
PICTURE# 3782 IS LOOKING SLIGHTLY NW SHOWING 1/2" TO 2" WIDE JOINT ON CLAY TILE @ 28.5' ± DOWNSTREAM FROM GPS#392 WITH CLAY PIECES OVER JOINT AND UPSTREAM TILE CAVING DOWN.

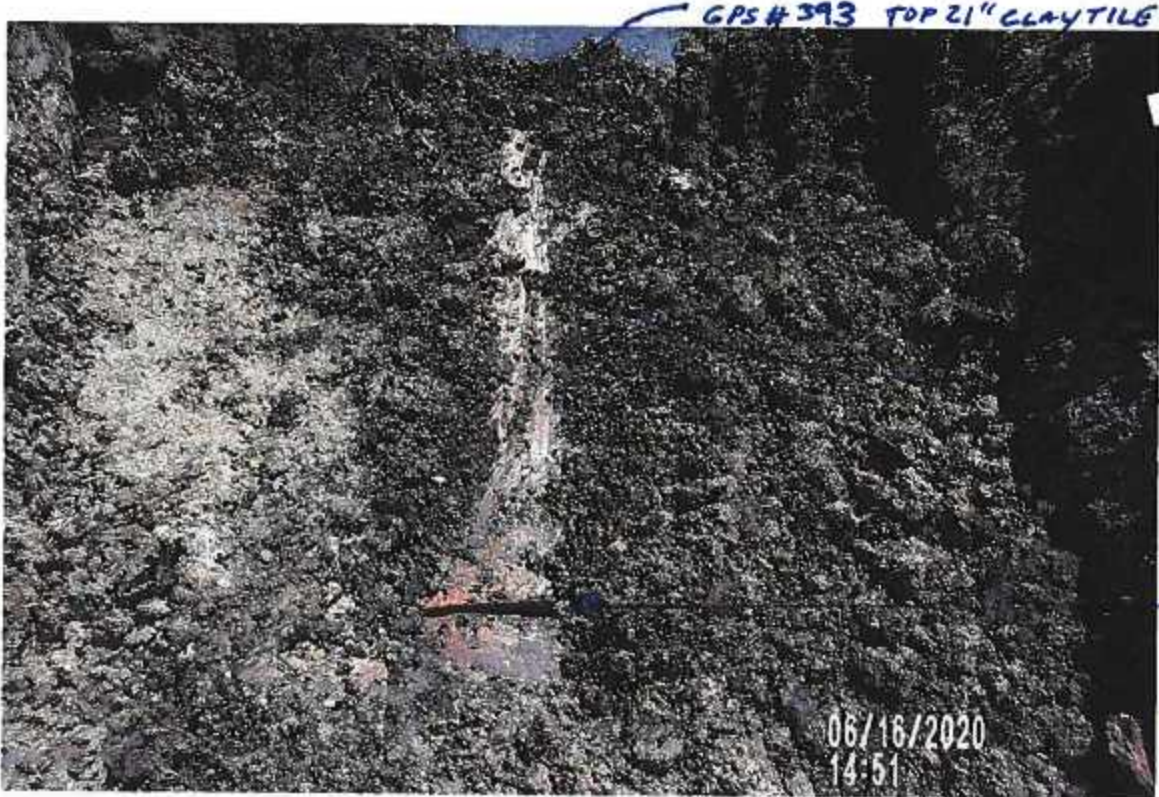
PICTURE# 3783 IS LOOKING NW SHOWING TOP OF CLAY TILE CRACKED AND CAVING DOWN @ 26.0' DOWNSTREAM FROM GPS#392.

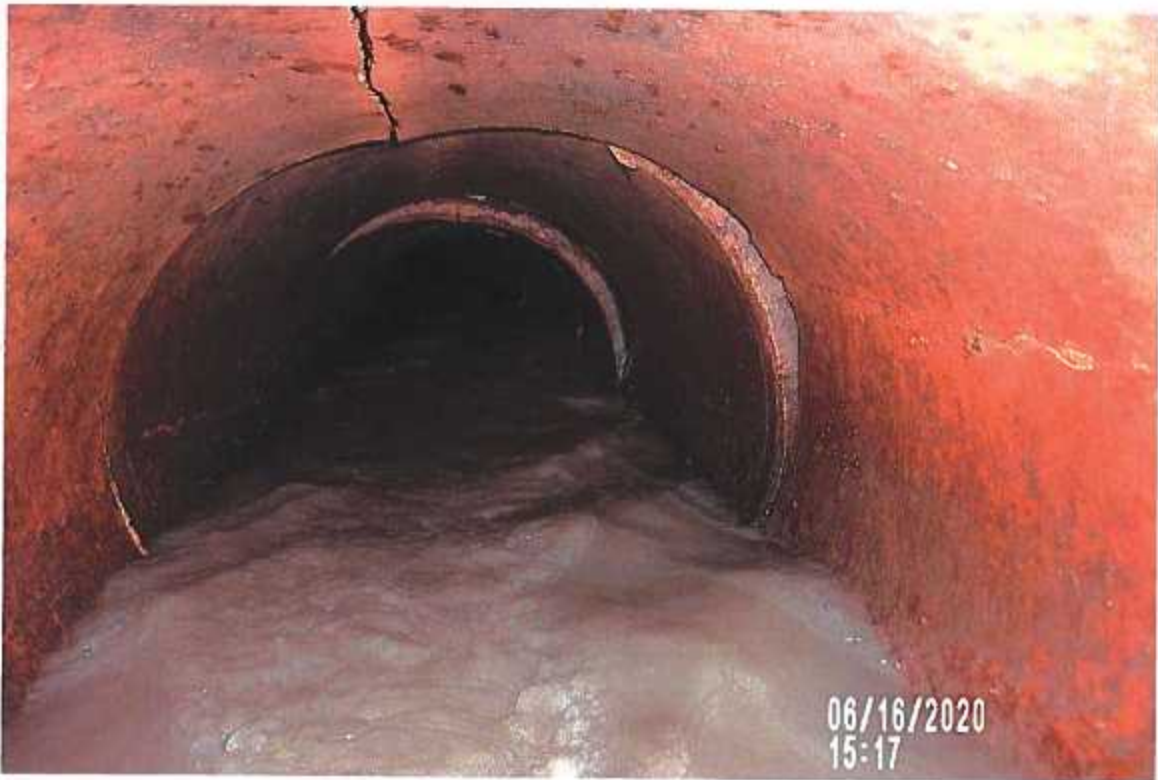
PICTURE # 3784 IS LOOKING SW SHOWING WIDE GAP & TOP OF TILE CRACKED AND CAVING DOWN

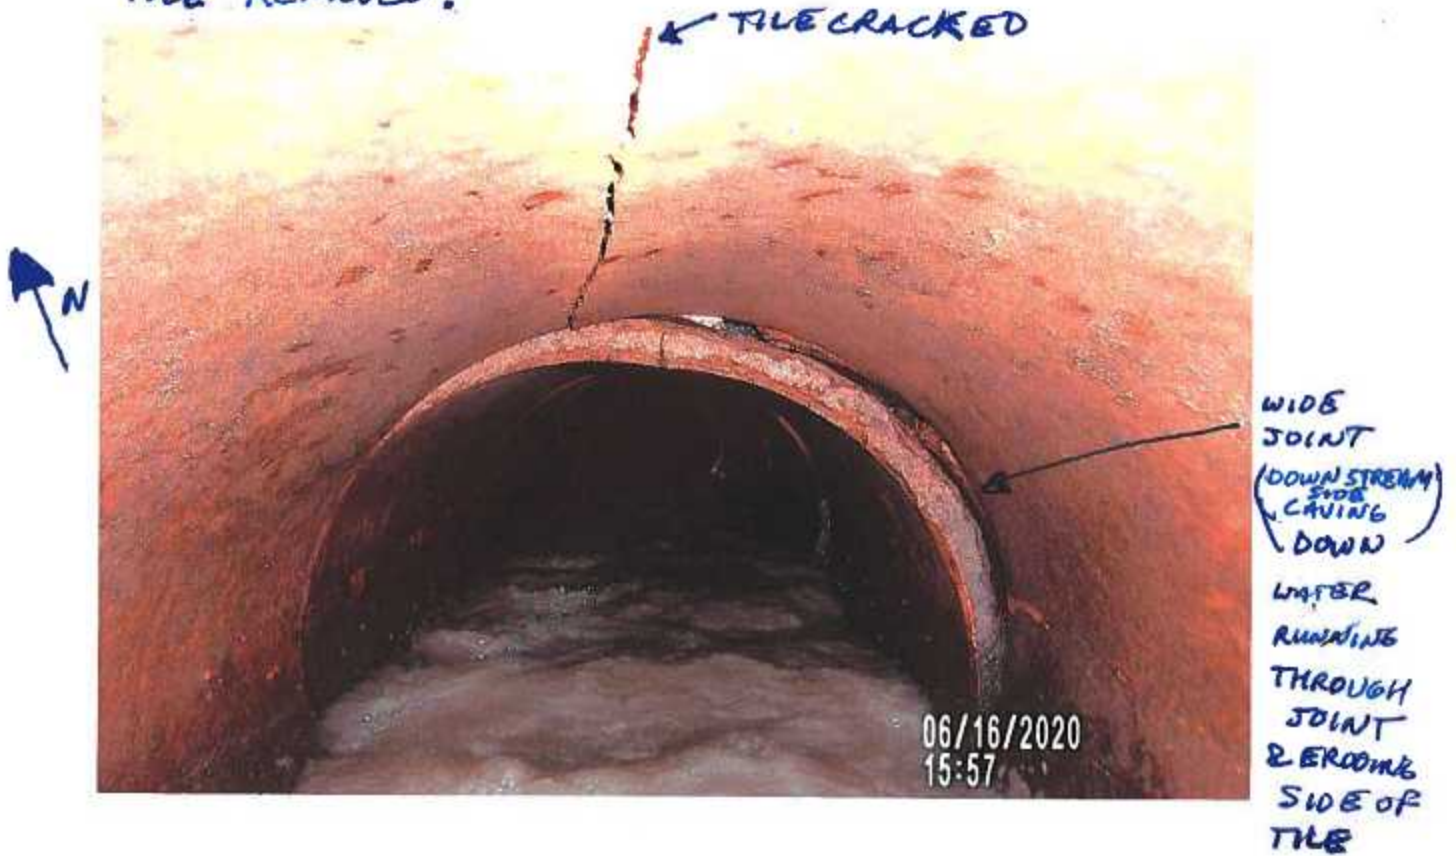
PICTURE # 3786 IS LOOKING NE FROM GPS # 393 INSIDE 21" CLAY TILE SHOWING TOP TILE CRACKED AND CAVING DOWN WITH JOINT OIS & WIDE JOINT 2 JOINTS DOWNSTREAM.

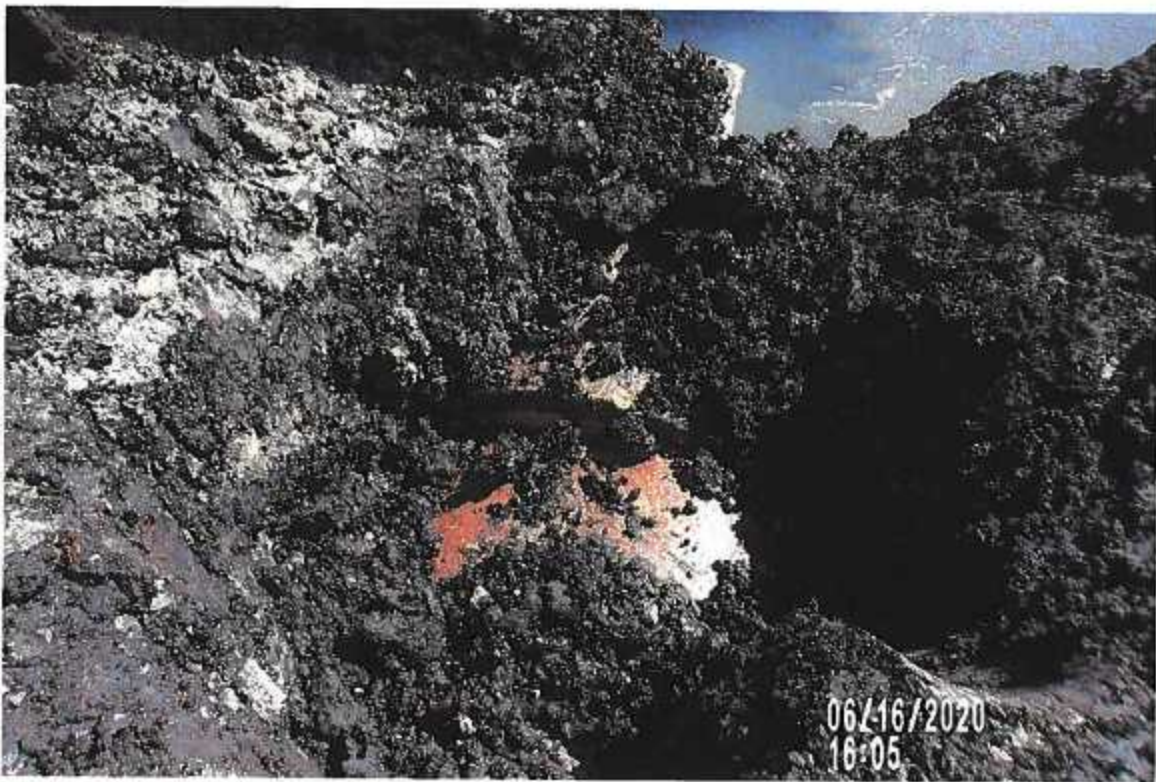
PICTURE #3787 IS LOOKING NE (2.5' NE OF GPS#393) SHOWING INSIDE 21" CLAY TILE AFTER ANOTHER SECTION CLAY TILE REMOVED.

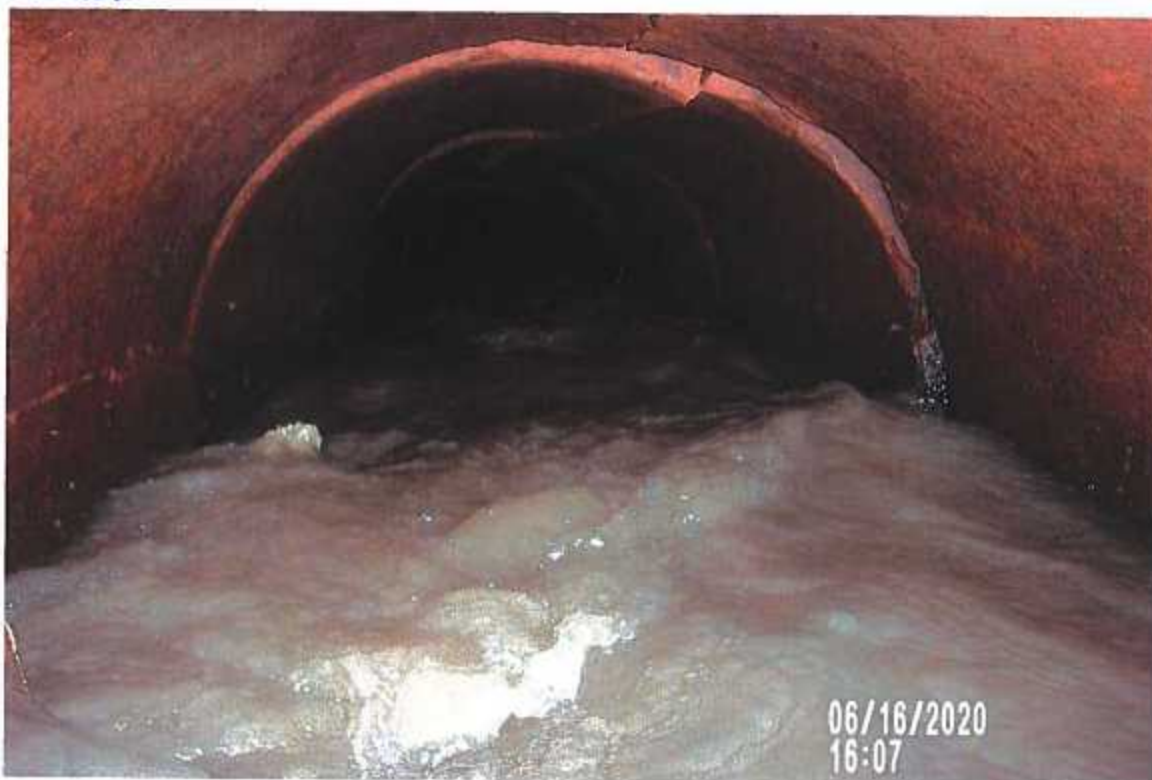
PICTURE #3789 IS LOOKING SOUTH SHOWING TILE CAVING DOWN 5.0' DOWN STREAM FROM GPS#393.

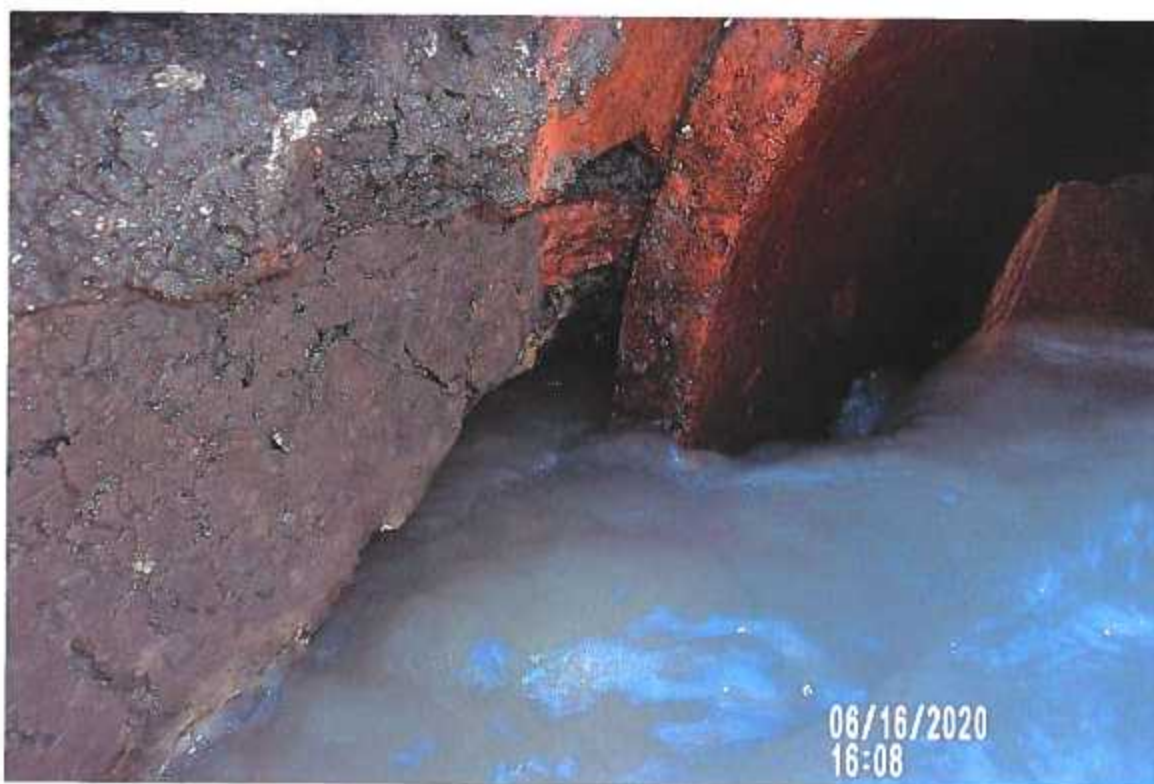
PICTURE # 3790 IS LOOKING DOWN STREAM FROM 28.5'± DOWNSTREAM FROM GPS # 392 SHOWING TILE STILL CRACKED AND CAVING DOWN

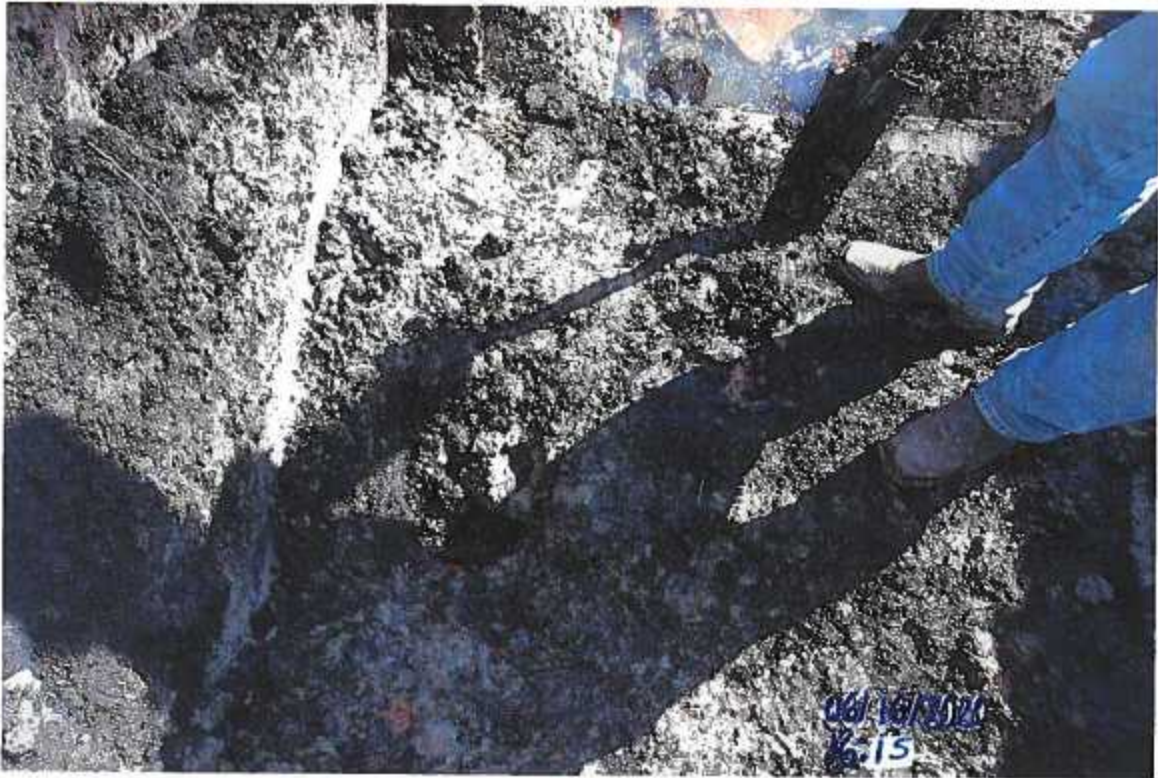
PICTURE # 3791 IS LOOKING ON WEST SIDE OF 21" TILE SHOWING VOID BESIDE TILE @ WIDE JOINT (28.5'± DOWNSTREAM FROM GPS # 392)

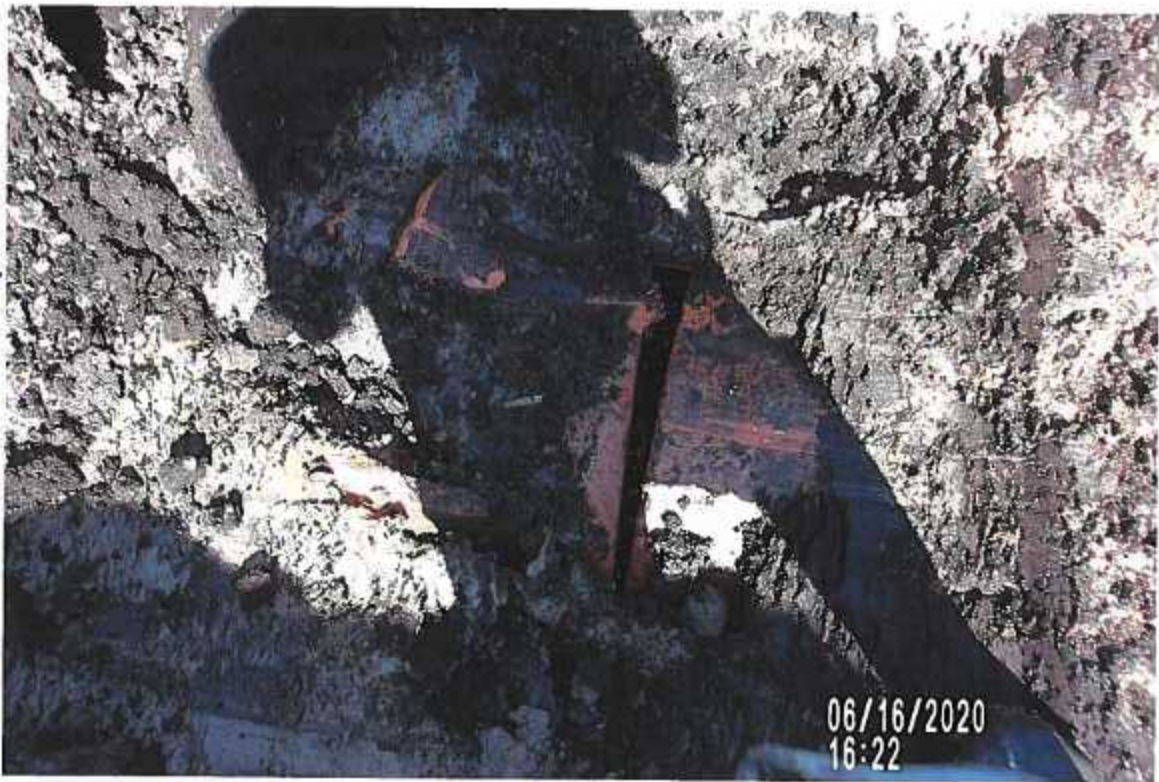
PICTURE # 3792 IS LOOKING SOUTH SHOWING BOOT HOLE AFTER CONTRACTOR STEPPED ABOVE-VOID ON EAST SIDE OF TILE 31' DOWNSTREAM OF GPS # 392!

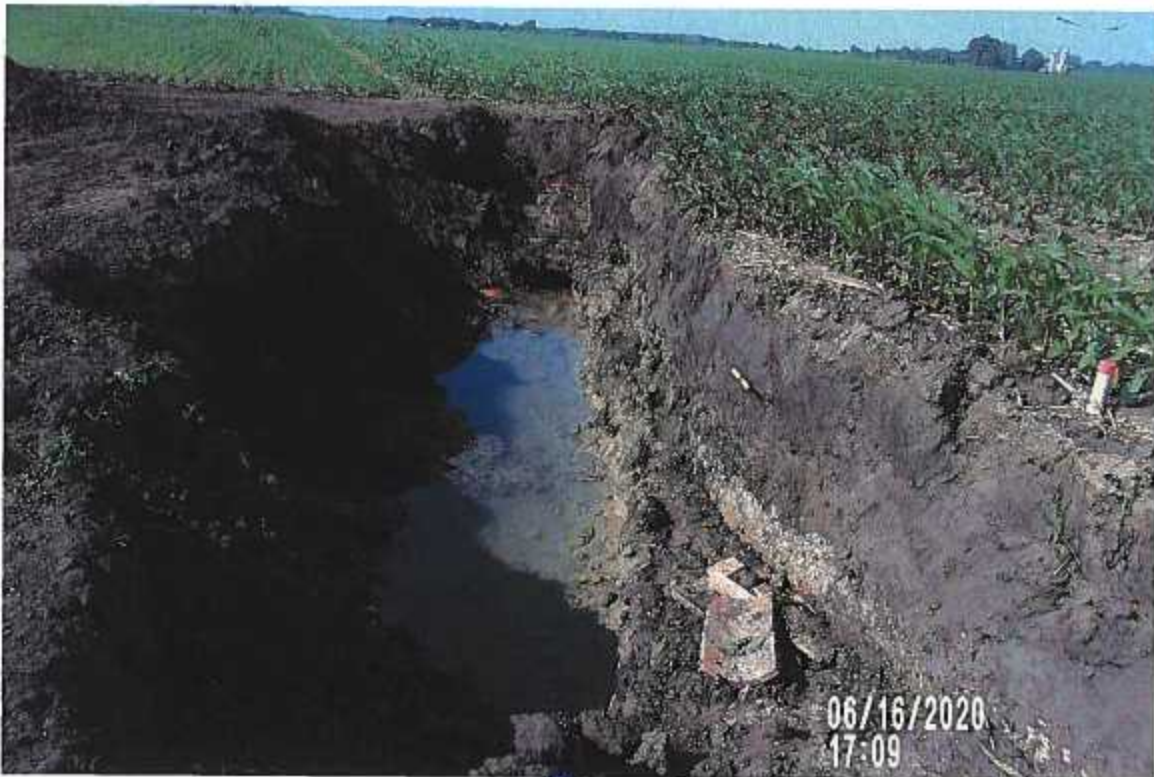
PICTURE# 3795 IS LOOKING NORTH SHOWING TRENCH WITH
DAMAGED TILE REMOVED.

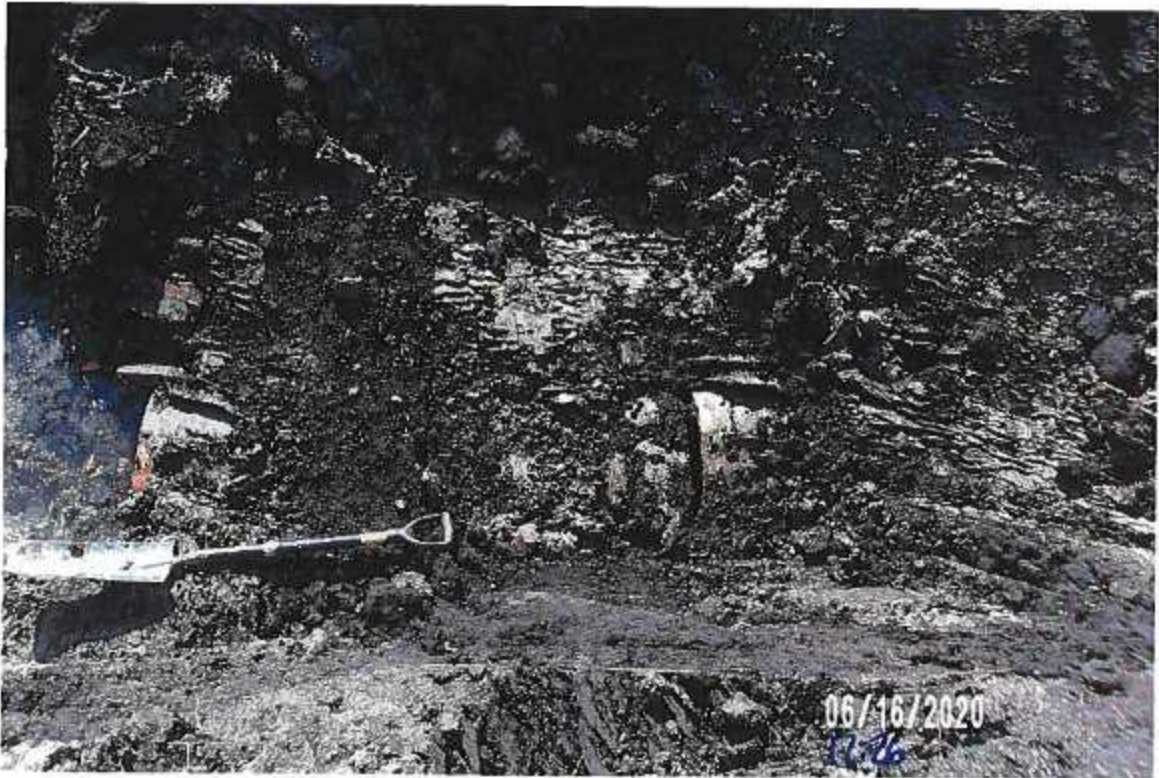
PICTURE# 3796 IS LOOKING NW SHOWING JOINTS @ 33.5' & 36" DOWN STREAM FROM GPS #392 HAVING WIDE JOINTS

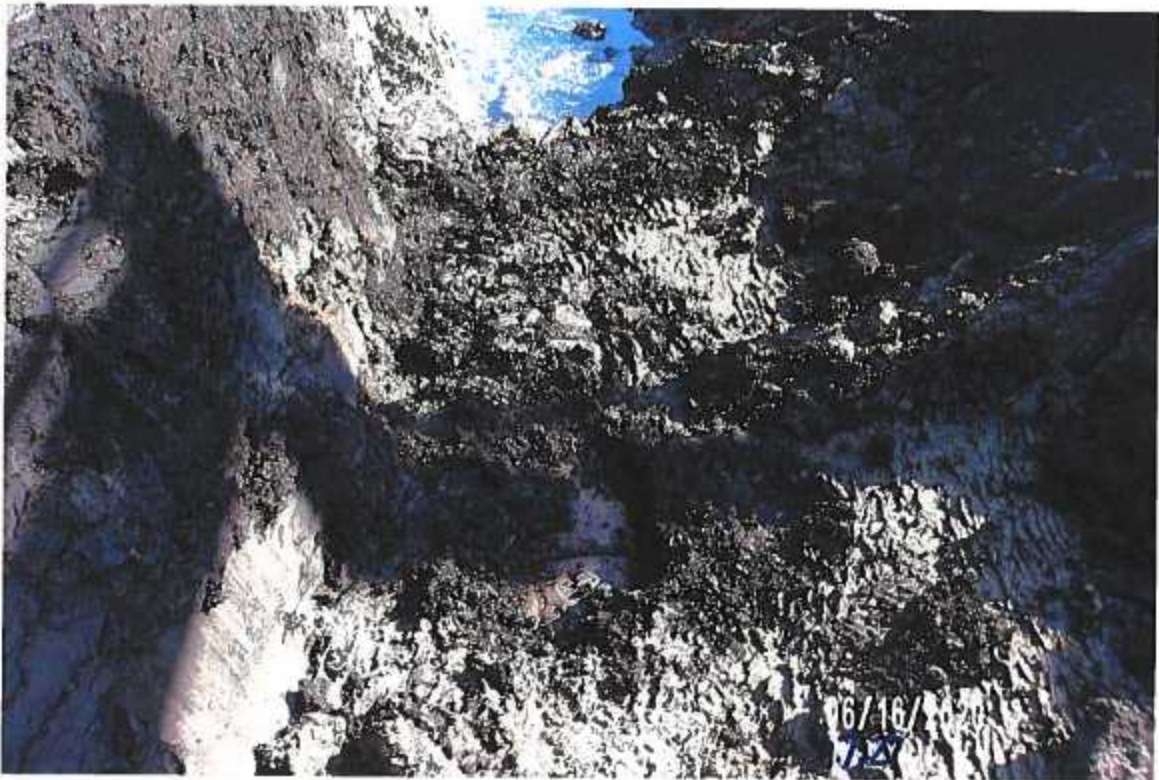
PICTURE# 379.7 IS LOOKING SW SHOWING TILE EXPOSED @ GPS 23 WITH TILE STILL CRACKED AND CAVING DOWN, (NO DIFFERENCE ON CONDITION) JOINTS ARE TIGHTER,

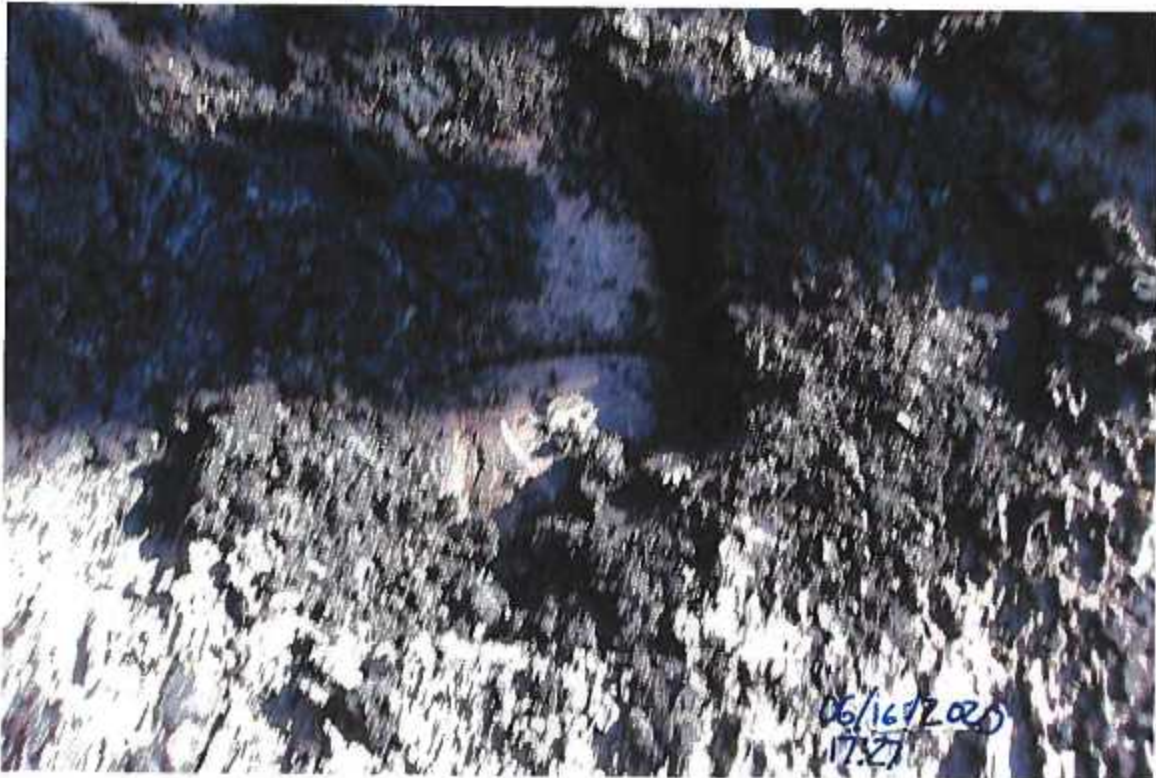
PICTURE# 3798 CLOSER UP PICTURE OF TILE CONDITION
TIGHTER JOINT BUT STILL CRACKED AND CAVING
DOWN.

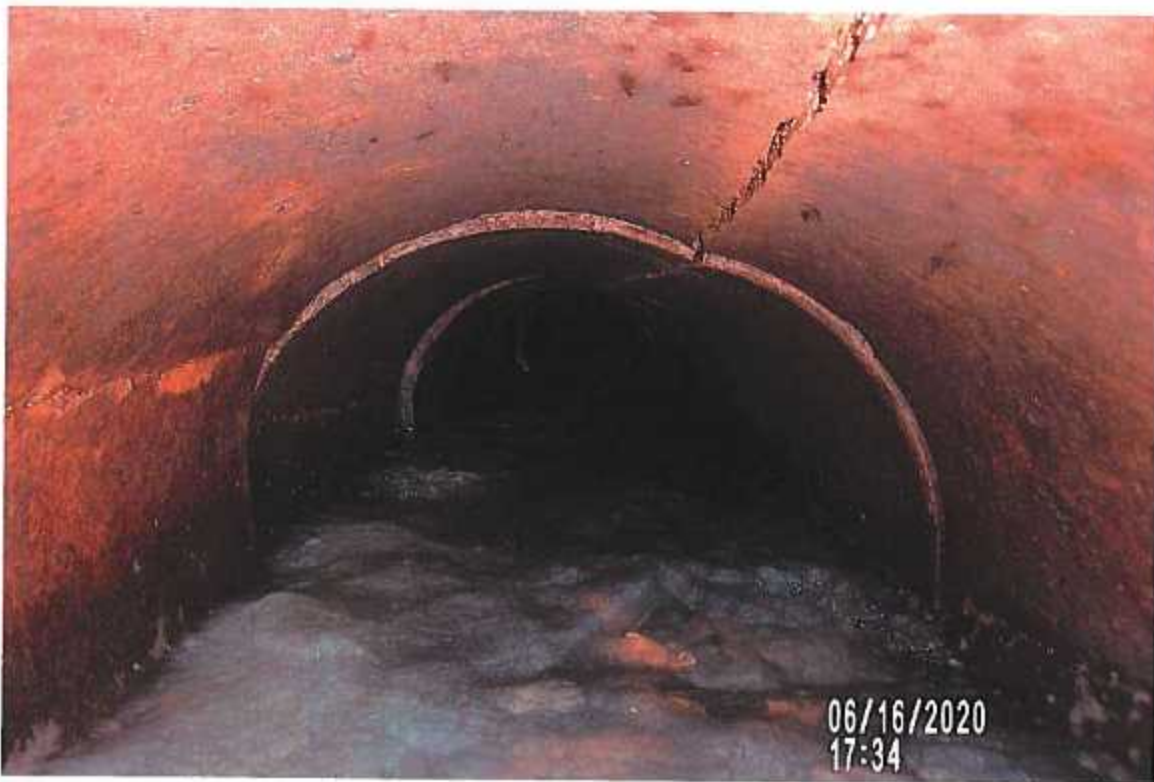
PICTURE# 3799 IS LOOKING NE SHOWING TILE STILL
CRACKED, SQUATTED AND CAVING DOWN

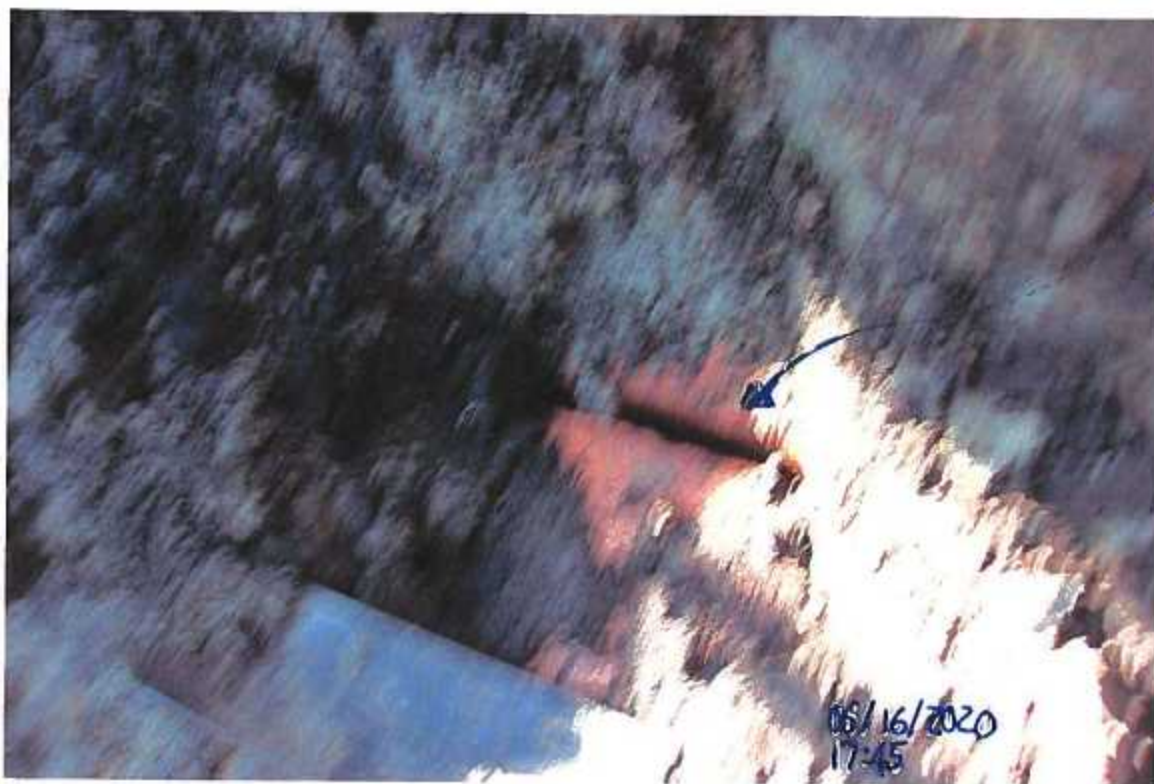
GPS# 394

PICTURE# 3800 IS LOOKING NORTH SHOWING ANOTHER WIDE JOINT
AT GPS# 394.

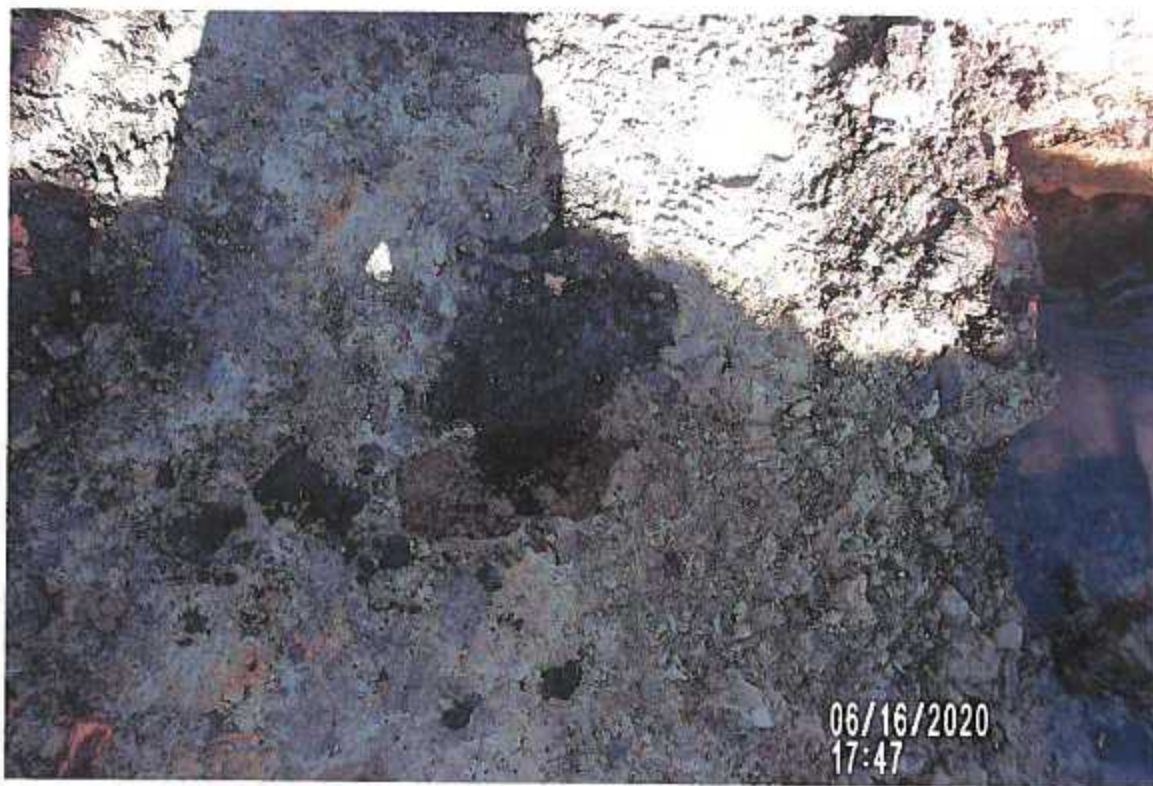
PICTURE# 3801 IS LOOKING SE SHOWING ANOTHER VOID BESIDE
WEST SIDE OF TILE

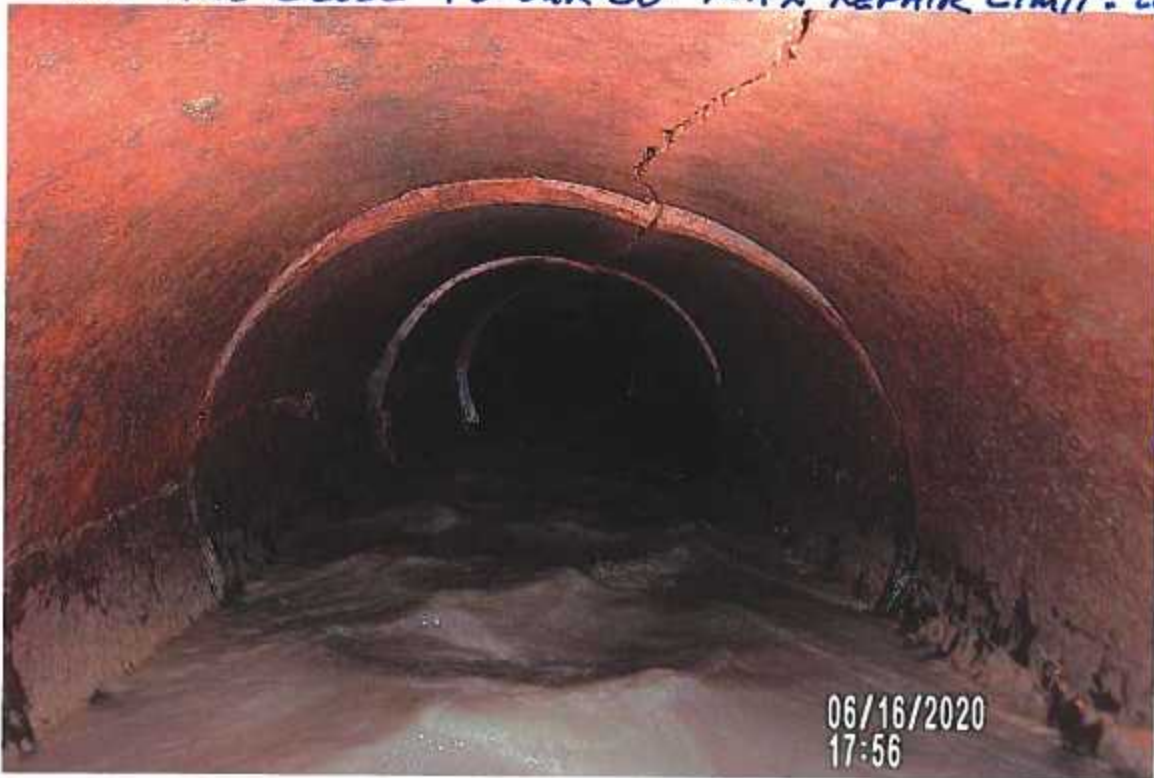
PICTURE # 3802 IS LOOKING NE FROM GPS # 394 SHOWING INSIDE OF 21" CLAY TILE WITH TOP CRACKED AND CAVING DOWN. APPEARS NEXT 3 JOINTS ARE IN SAME CONDITION BUT ARE CLOSE TO OUR 50' MAX REPAIR LIMIT. LEE WILL TALK TO SUPERVISORS IN MORNING ABOUT TELEVISIONING LINE.

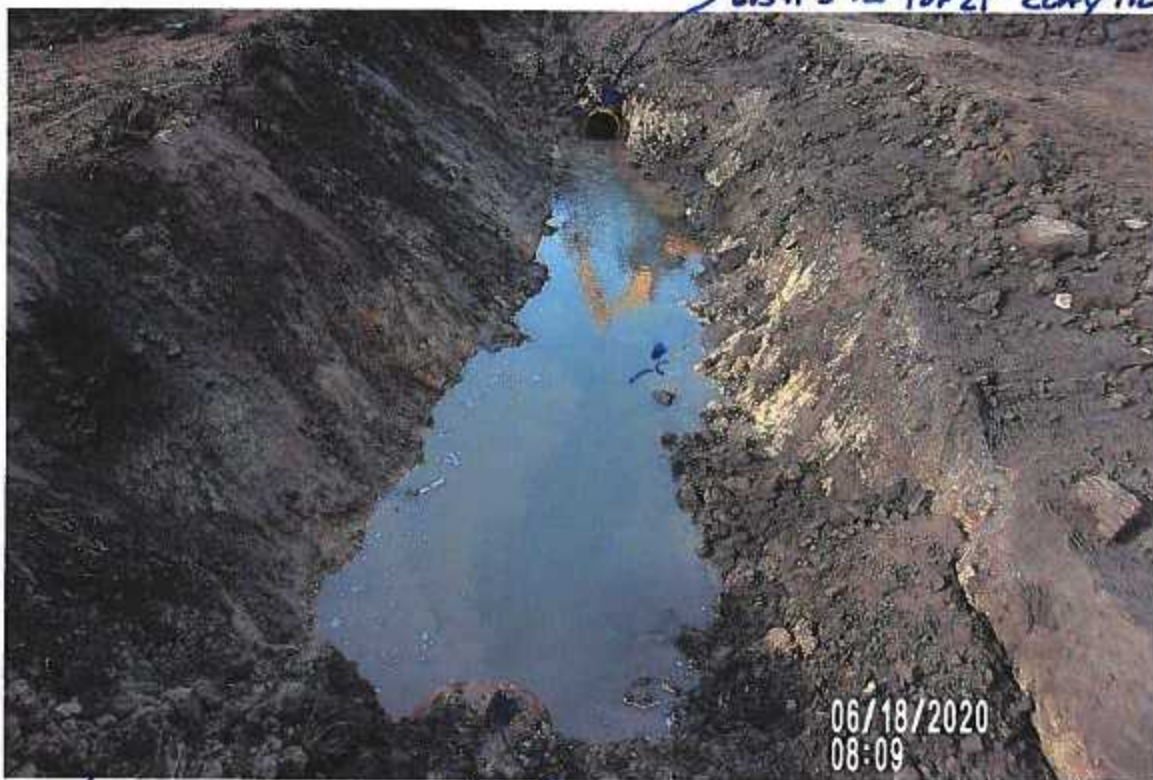
(TEMPORARY REPAIR)
PICTURE# 3819 GPS# 394 TILE TOP 21" CLAY (1.72' TOP TO FL) IS LOOKING SOUTH UPSTREAM 5.4'± DEEP WITH MUCK CLEANED OUT OF BOTTOM OF TRENCH & READY TO INSTALL 24" HOPE DW NONPERF TILE. BOTTOM IS SOFT IN AREAS AND WILL USE SOME ROCK TO FIRM UP ON INSTALLATION
