Drainage Work Order Request For Repair

Hardin County

Work Order #: WO00000294

Investigation Summary:

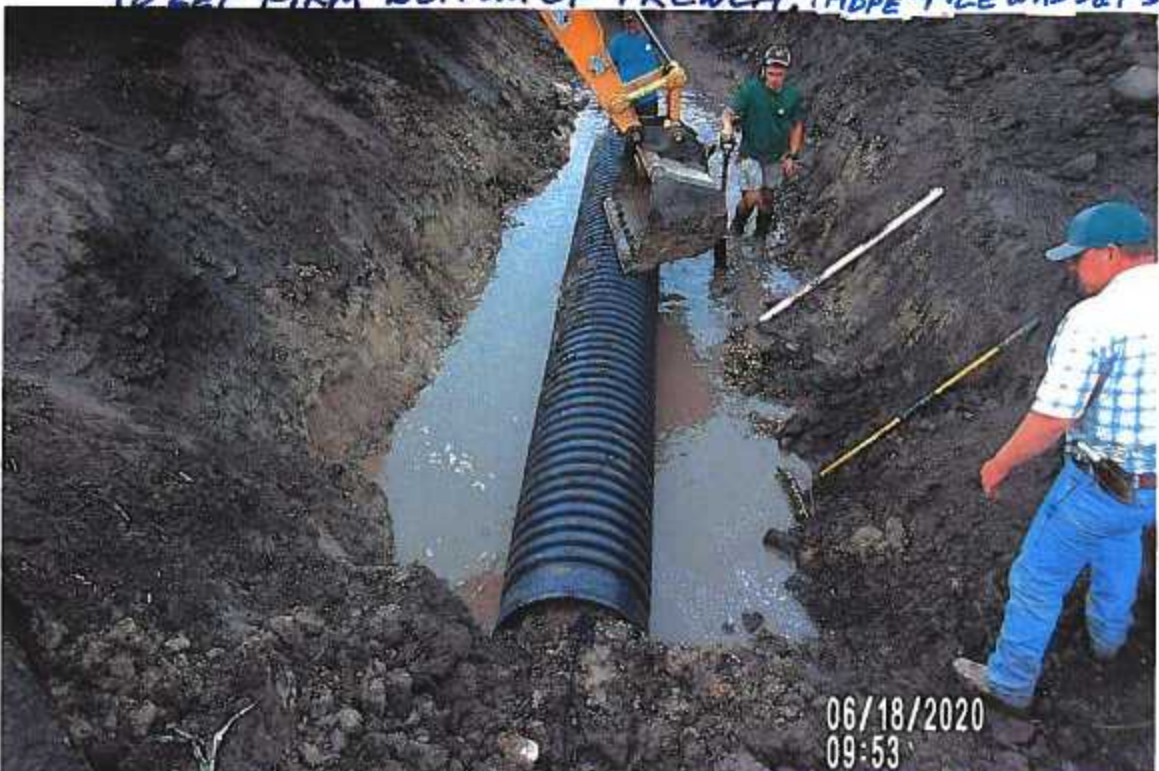
GPS # 392 TOP 21" CLAY TILE (1.79' TO TOP FL)
 4.8' ± DEEP

(TEMPORARY REPAIR)
 PICTURE # 3820 IS LOOKING NE SHOWING FIRST
 FULL SECTION OF 24" DW HDPE NONPERF TILE IN PLACE
 WITH BELL END ON UPSTREAM END WITH JUST ENOUGH ROCK
 TO GET FIRM BOTTOM OF TRENCH. HDPE TILE WAS SET SO

INSIDE
 BOTTOM
 OF BELL
 IS RESTING
 ON BOTTOM
 OF CLAY
 TILE
 AT TIE IN

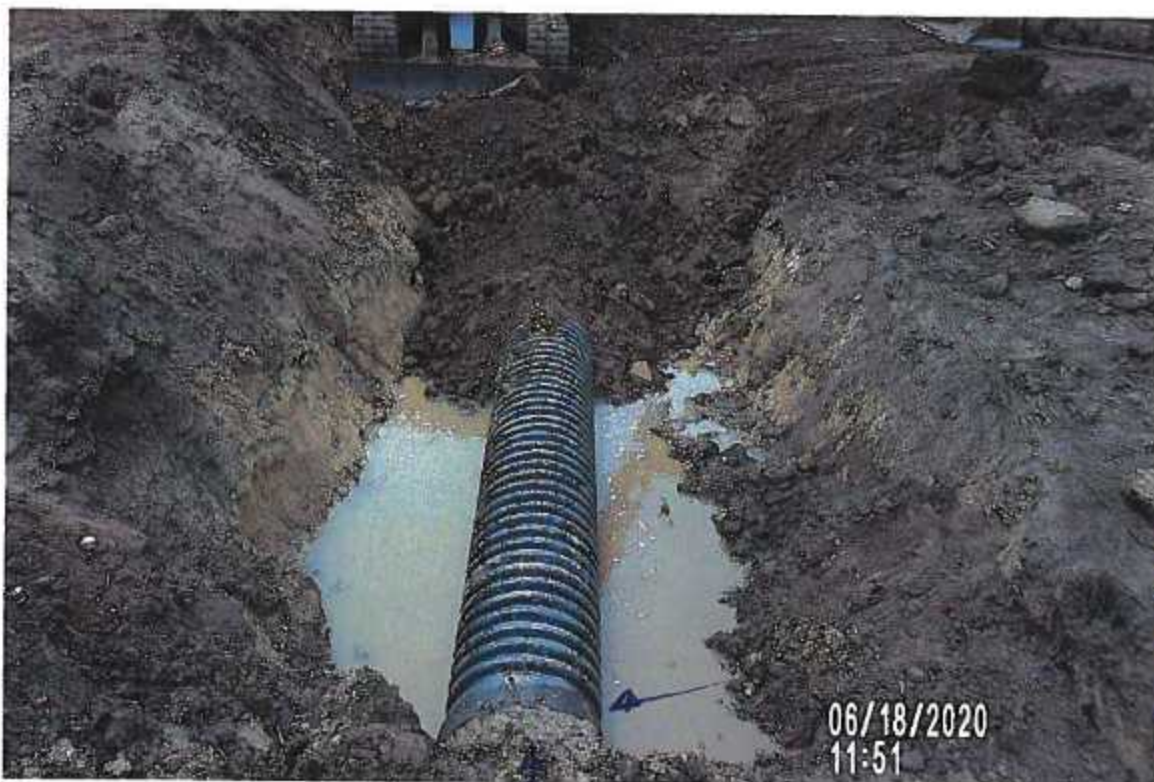
BEDDING ROCK
TAPPED UNDER
HDPSTILE
TO KEEP BOTTOM
OF INSIDE OF
BELL TIGHT
UP TO BOTTOM
OF CLAY TILE

PICTURE # 3827 AS LOOKING SW SHOWING LOOSE SOIL BEING BACKFILLED AROUND TILE. CREW STUFFED FABRIC IN GAP BETWEEN INSIDE BELL AND TOP OF CLAY. CREW PLACED 2.0' x 5.0' PIECE OF ENGINEERING FABRIC OVER JOINT AND STOMPED CLAY AROUND EDGE HDPSTILE BEFORE BACKFILLING

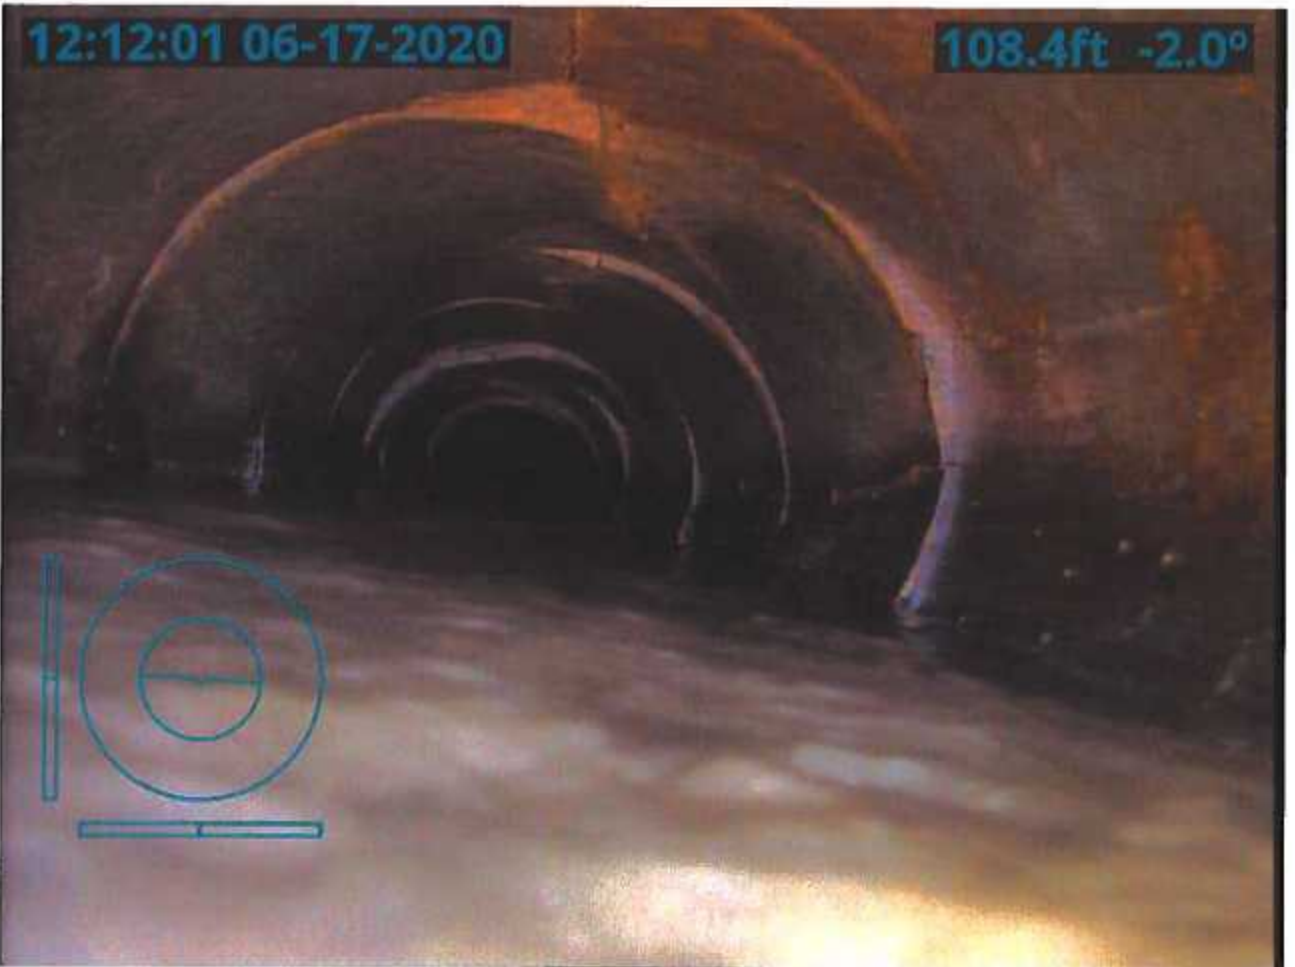
12:12:01 06-17-2020

12	11			MULTIPLE CRACKS ALL AROUND AS FAR AS CAMERA CAN SEE
0:14:24	108.4	YES	B	2020_06_17-12_12_01_891.jpg

12	11			LOTS OF BROKEN PIPE AS FAR AS VISIBLE

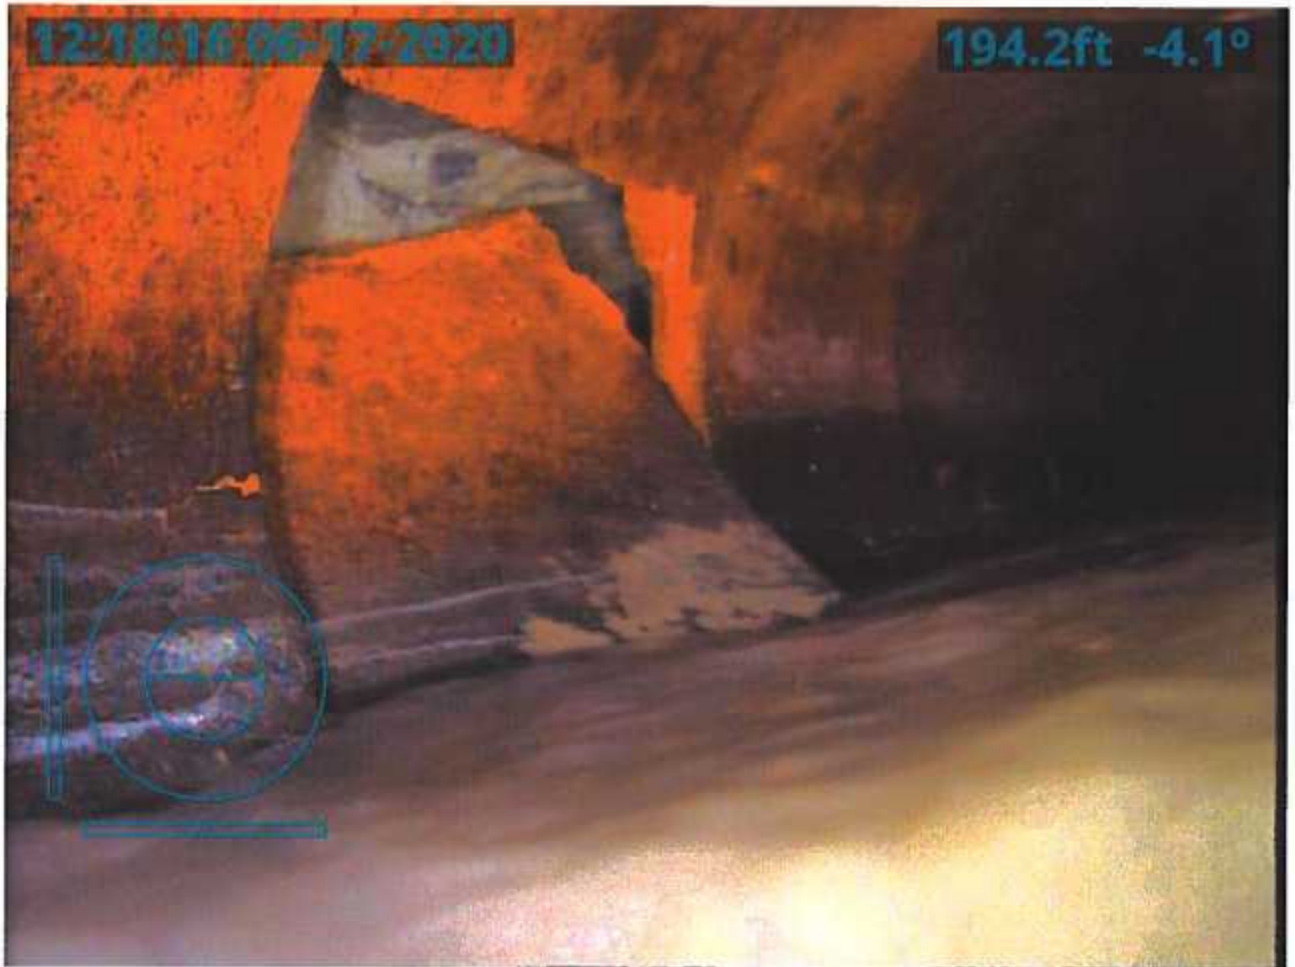
12:18:16 06-17-2020

12	11			BROKEN AN BUCKLING DOWN
0:19:23	194.2		B	2020_06_17-12_18_17_103.jpg

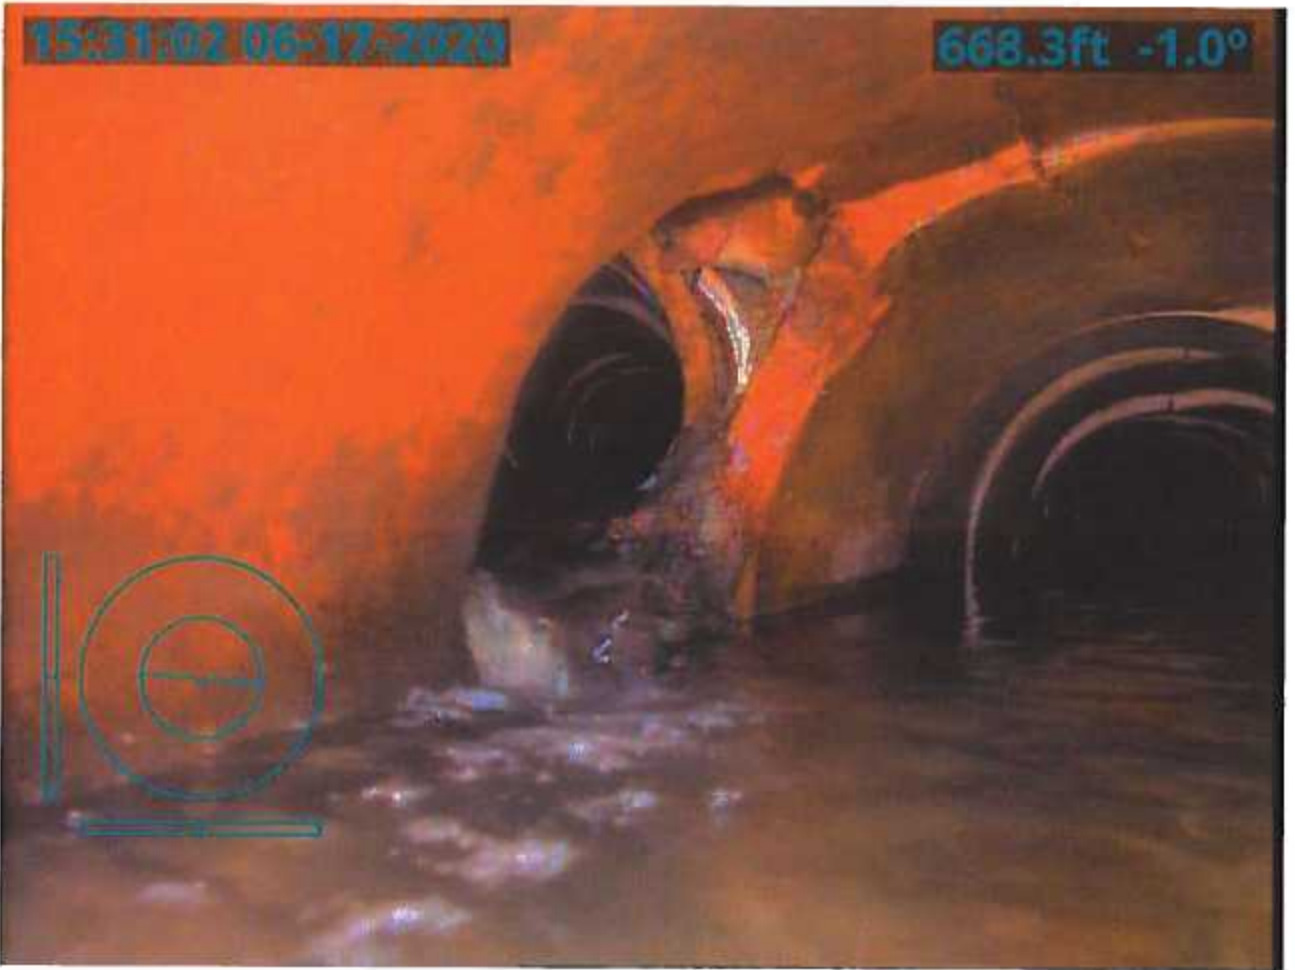
15:31:02 06-17-2020

06	05			MULTIPLE CRACKS AND SQUAT
0:55:10	668.3		CN	2020_06_17-15_31_02_162.jpg
