# Engineer's Report on Improvements to the Main Tiles, Drainage District No. 120 Hardin County, Iowa

# **Engineer's Report on Improvements to Main Tiles, Drainage District No. 120 Hardin County, Iowa**

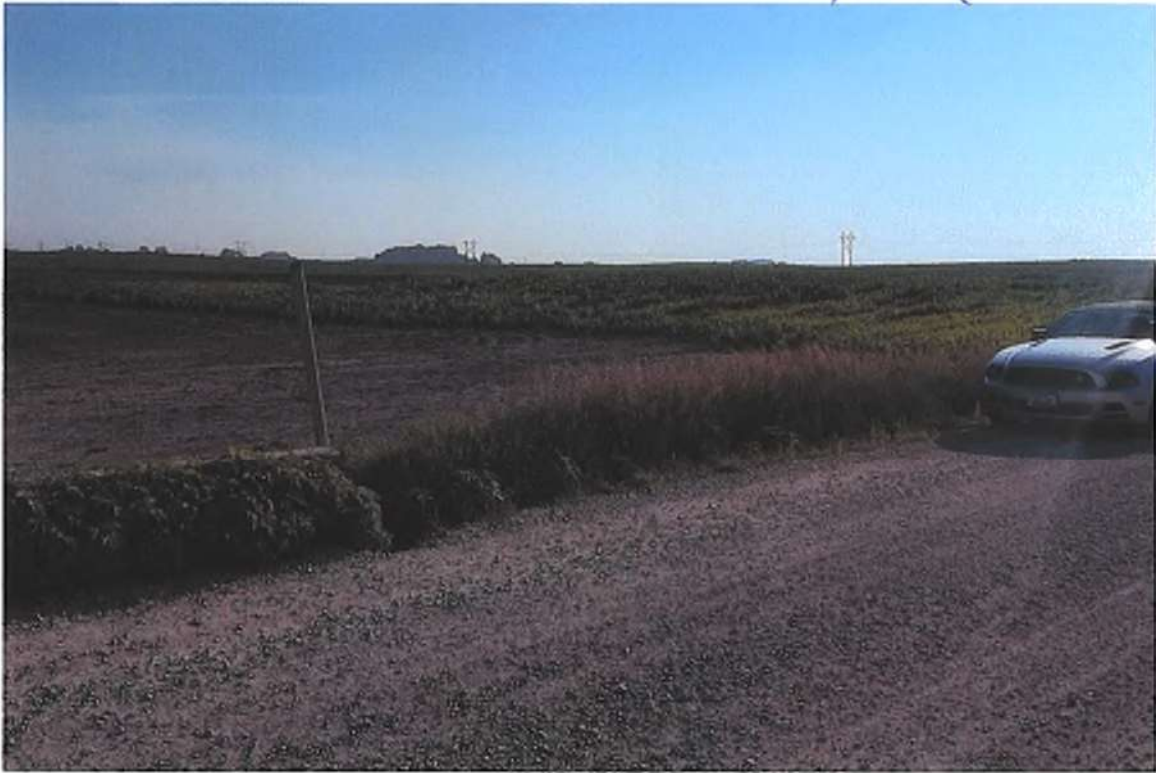
E end drawn spot @ 115+4

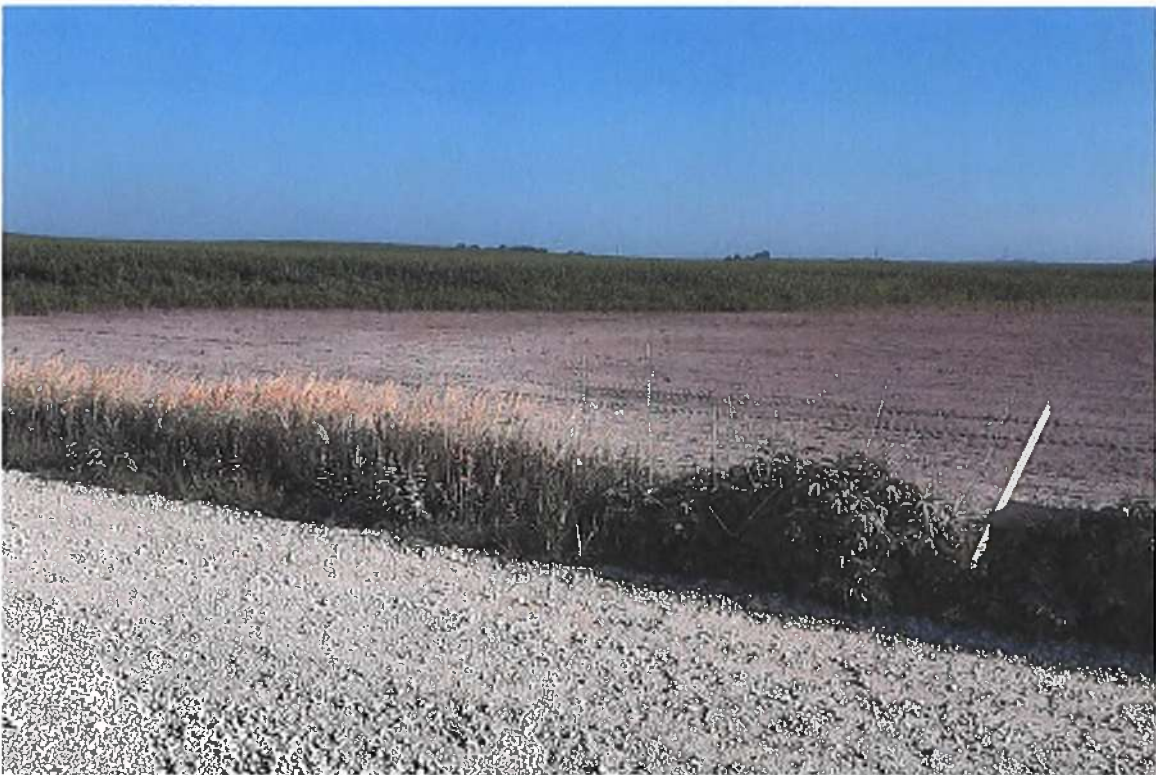
W end drawn spot @ 115+4

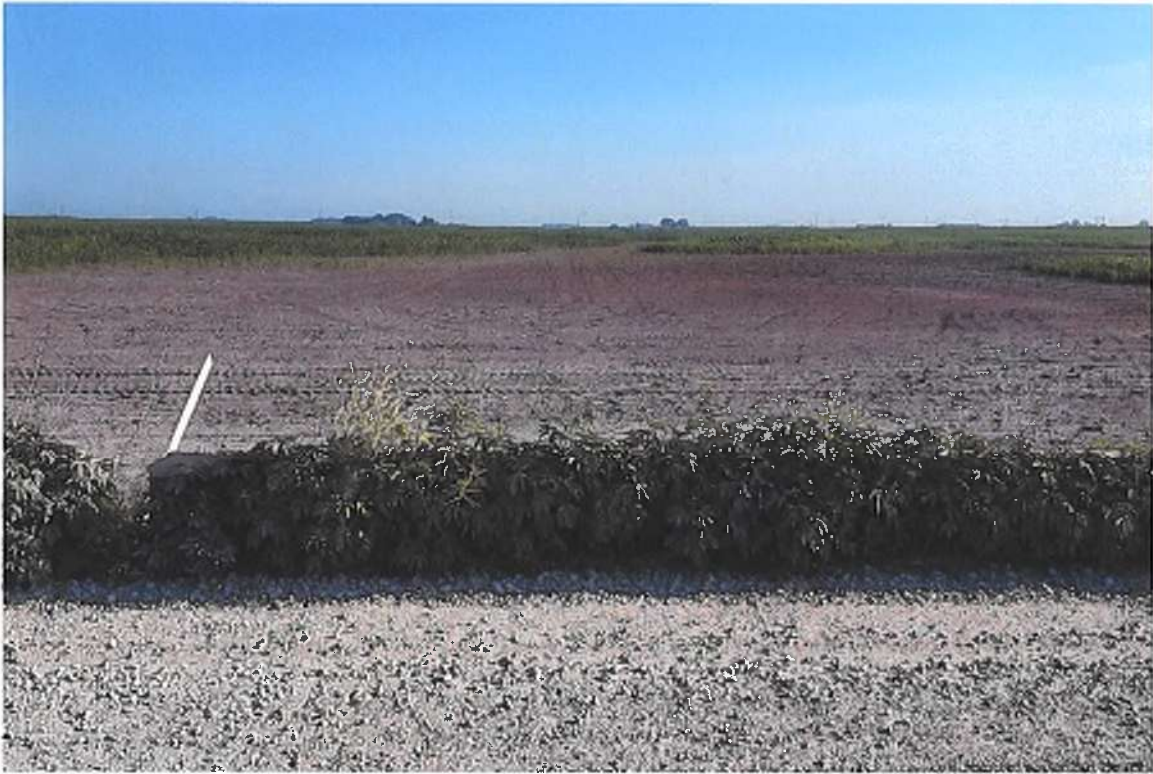
Middle down spot @ 115ft

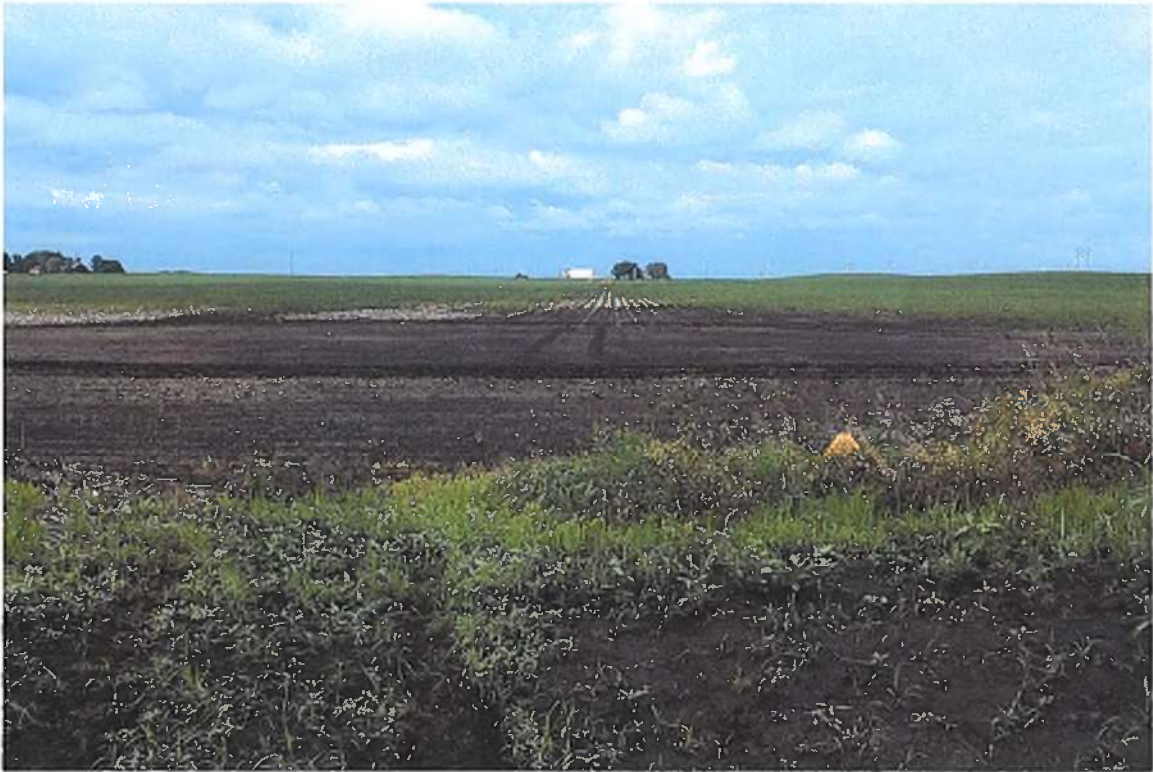
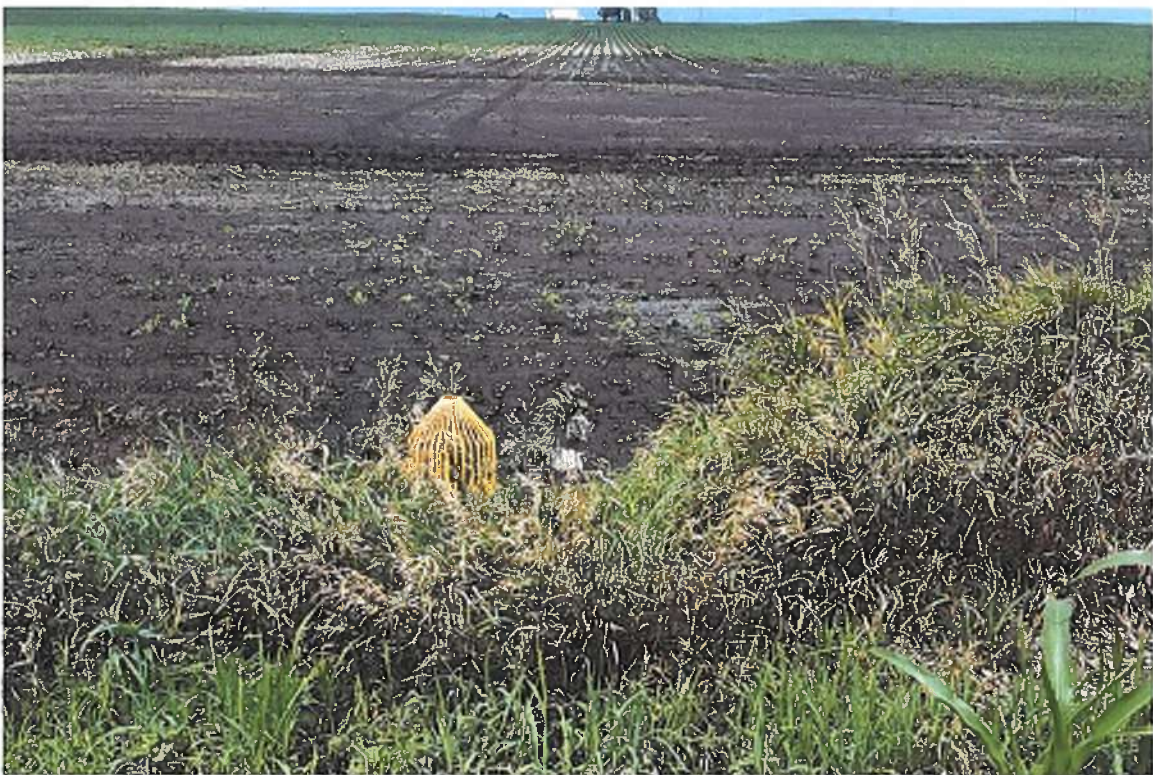
7-15-2020  
Wet spot in adjoiners field

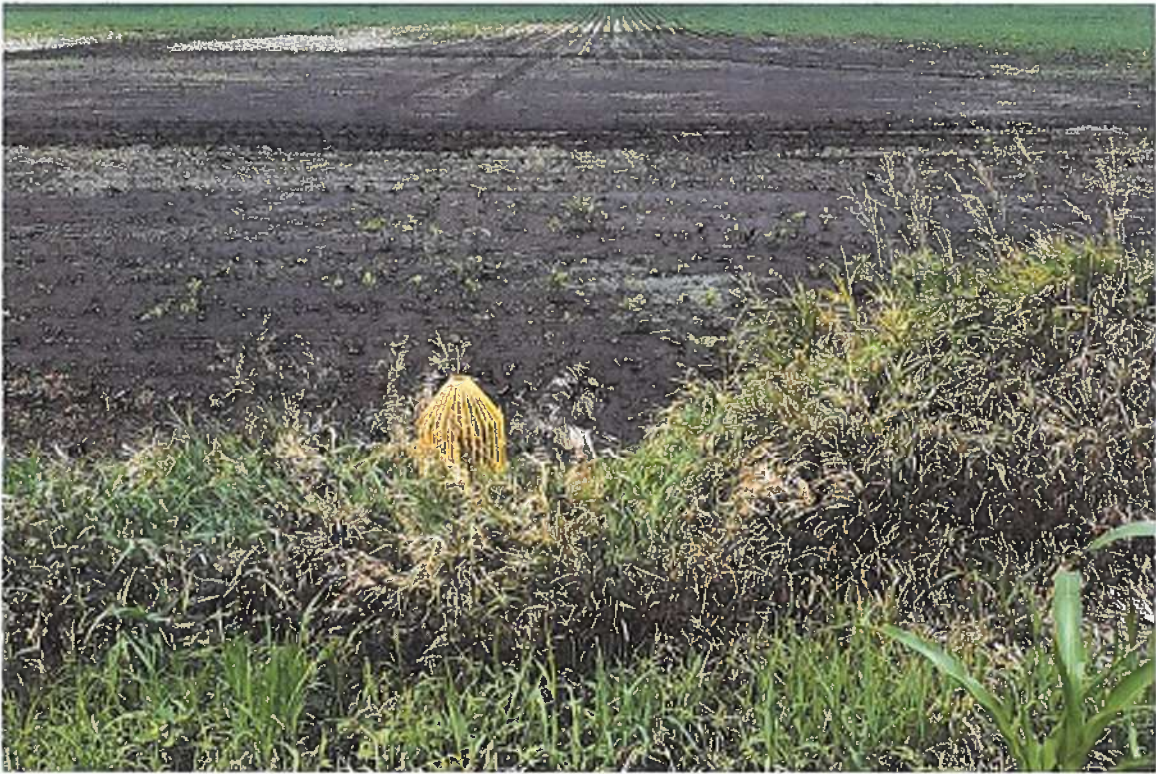
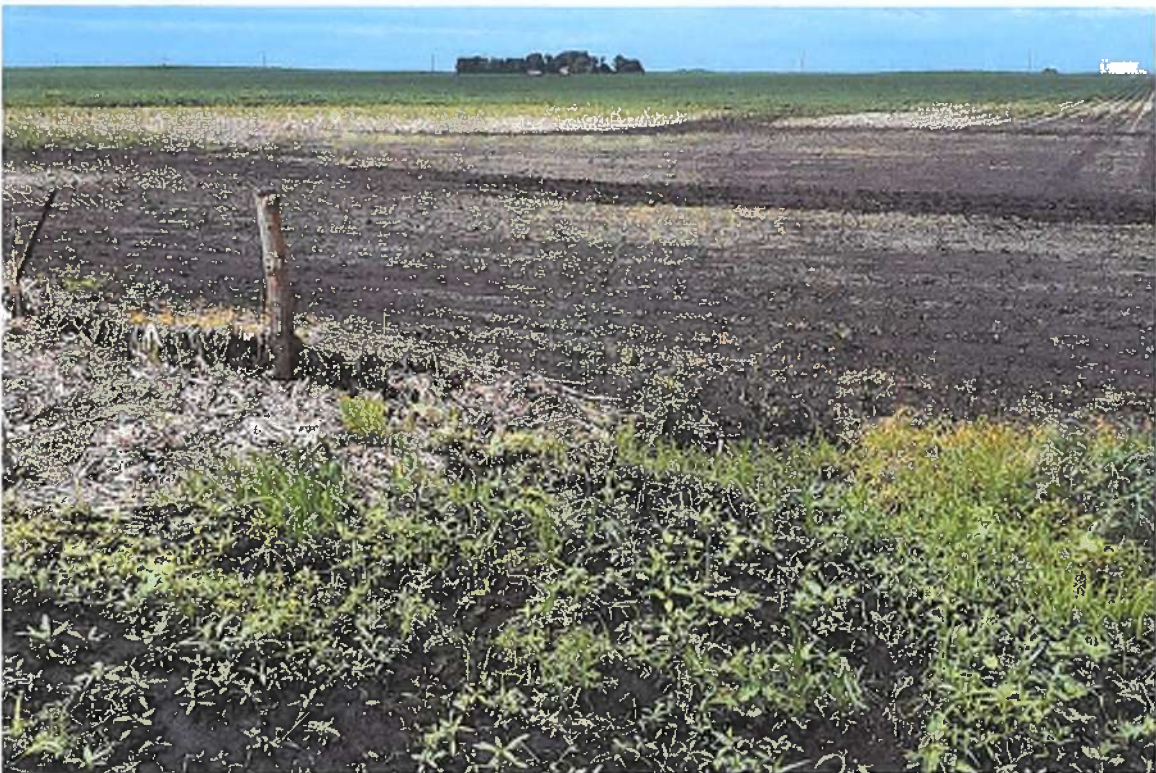
- Woven portion of said fenceline appears to have cut.
  - Sod “fenceline hump” is no longer in place allowing the free flow of surface water.
  - Yellow wire topped intake is just north of fenceline on neighbor’s property and not in the low point of the neighbor’s wet area.

7-15-2020  
Yellow topped intake just  
north of fence line

The immediate problem at the fenceline between the S½ SW¼ Section 4, Township 89 North Range 20 West and the N½ SW¼ Section 4, Township 89 North Range 20 West appears to be on a private tile and not a district facility based on the above review. If desired, a detailed record search could be performed to verify that the maps accurately represent the district facilities. If the tile is private, then the primary solution that the district could offer for the immediate area would be to construct a lateral from the Main tile to the N½ SW¼ Section 4, Township 89 North Range 20 West.

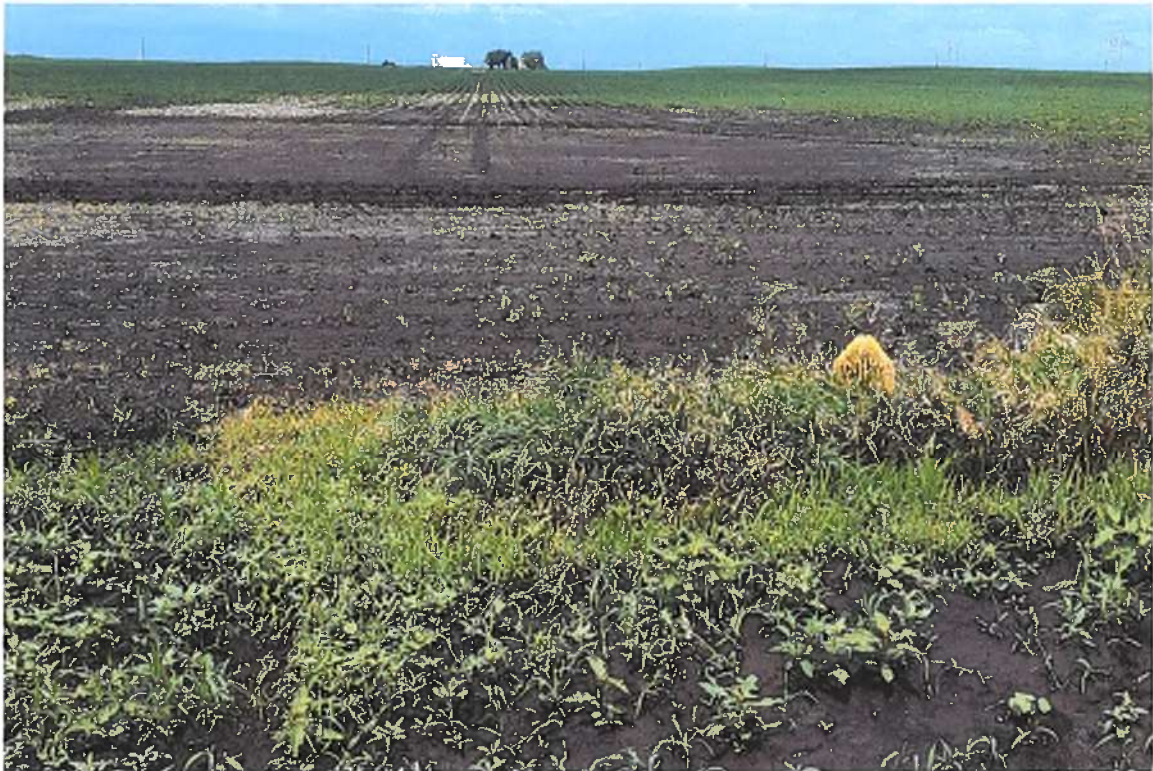
7-15-2020 W side of missing  
soil "hump"

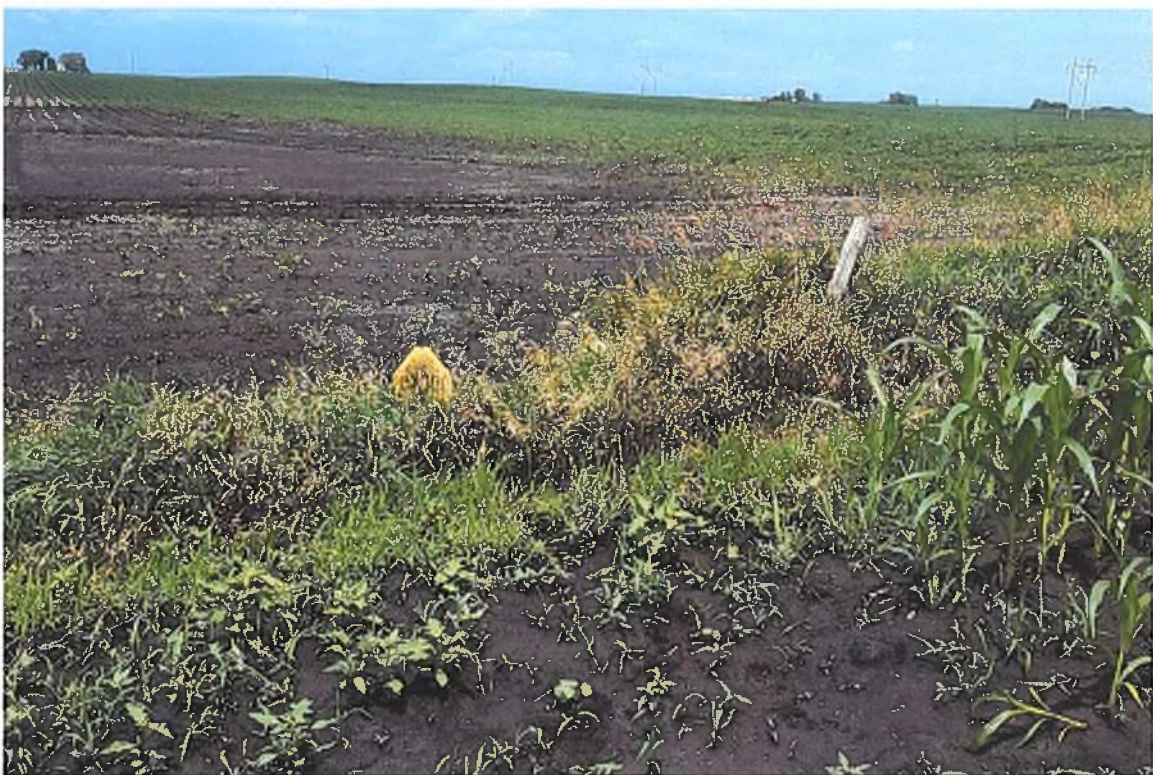
7-15-2020 middle of missing soil "hump"

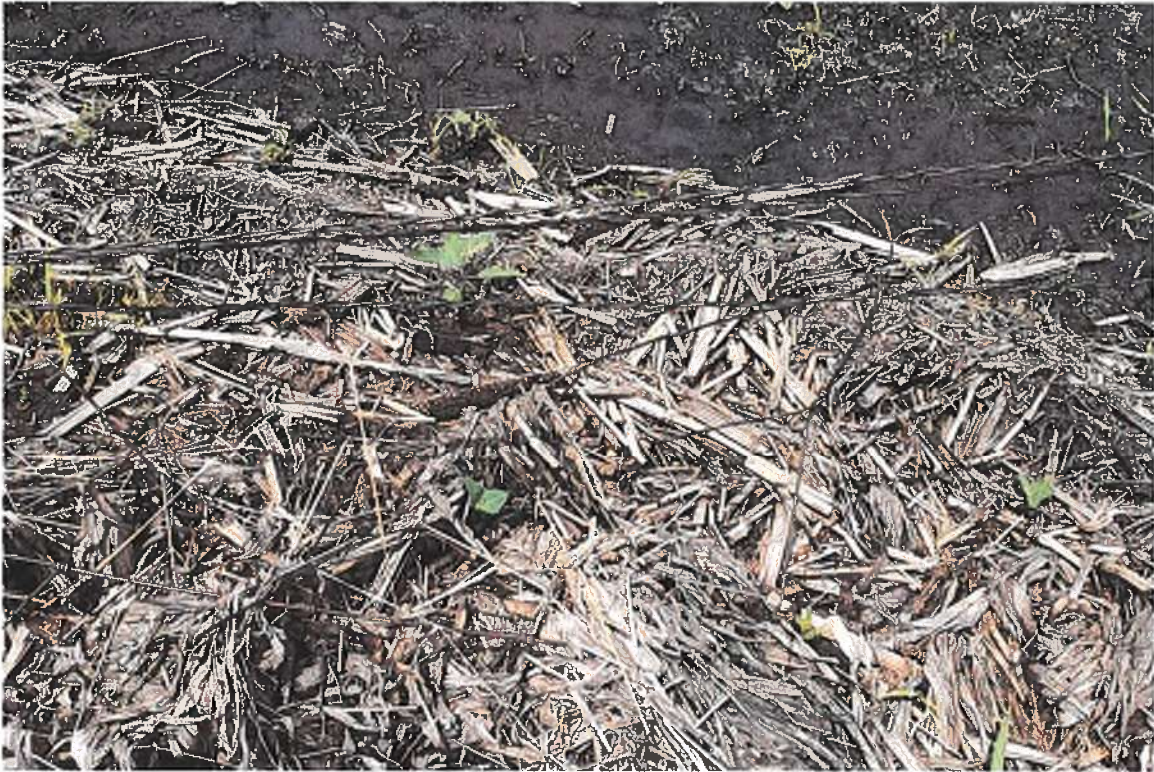
7-15-2020 East side of missing soil "hump"

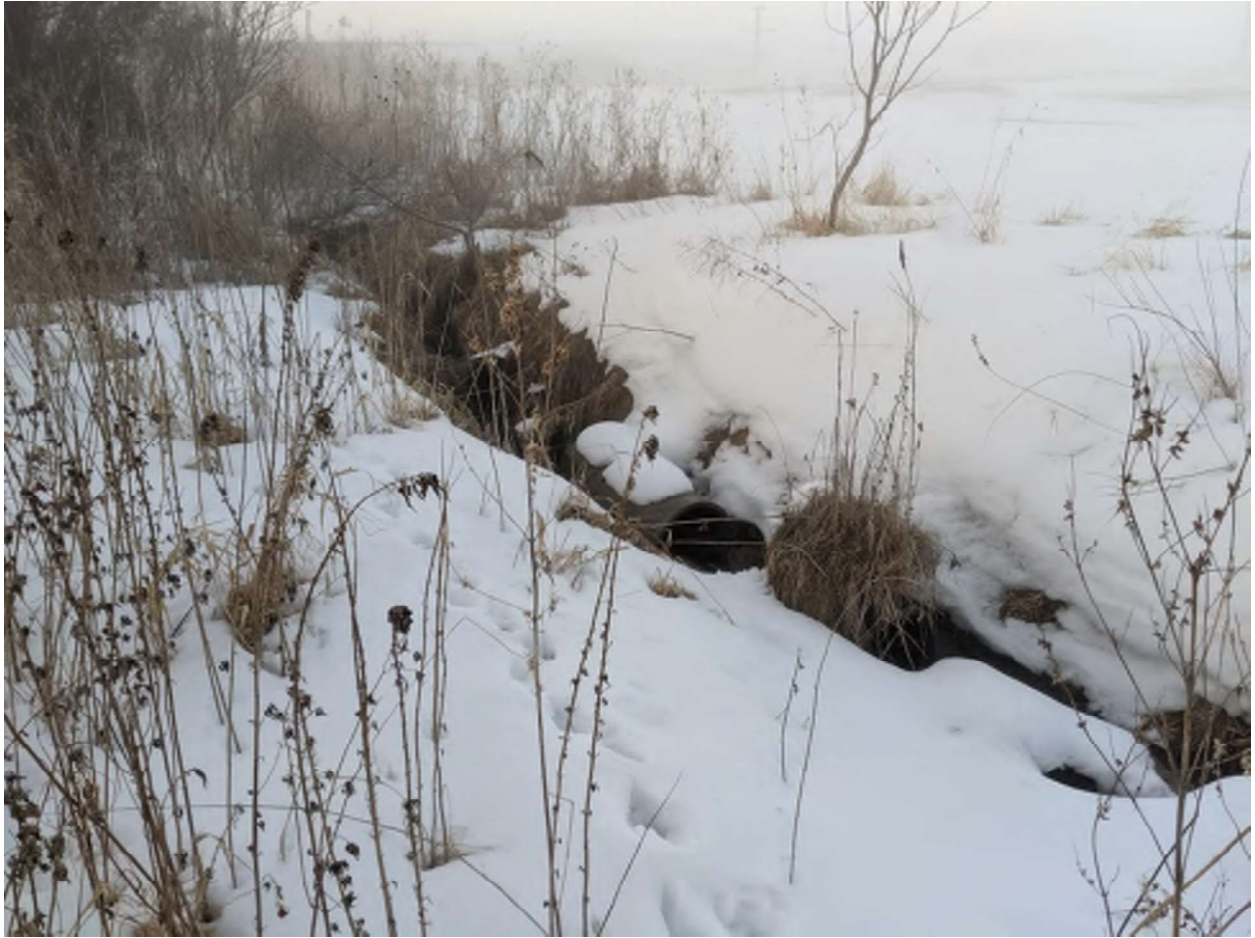
*Figure 1: 1922 Main completely exposed and broken above outlet.*

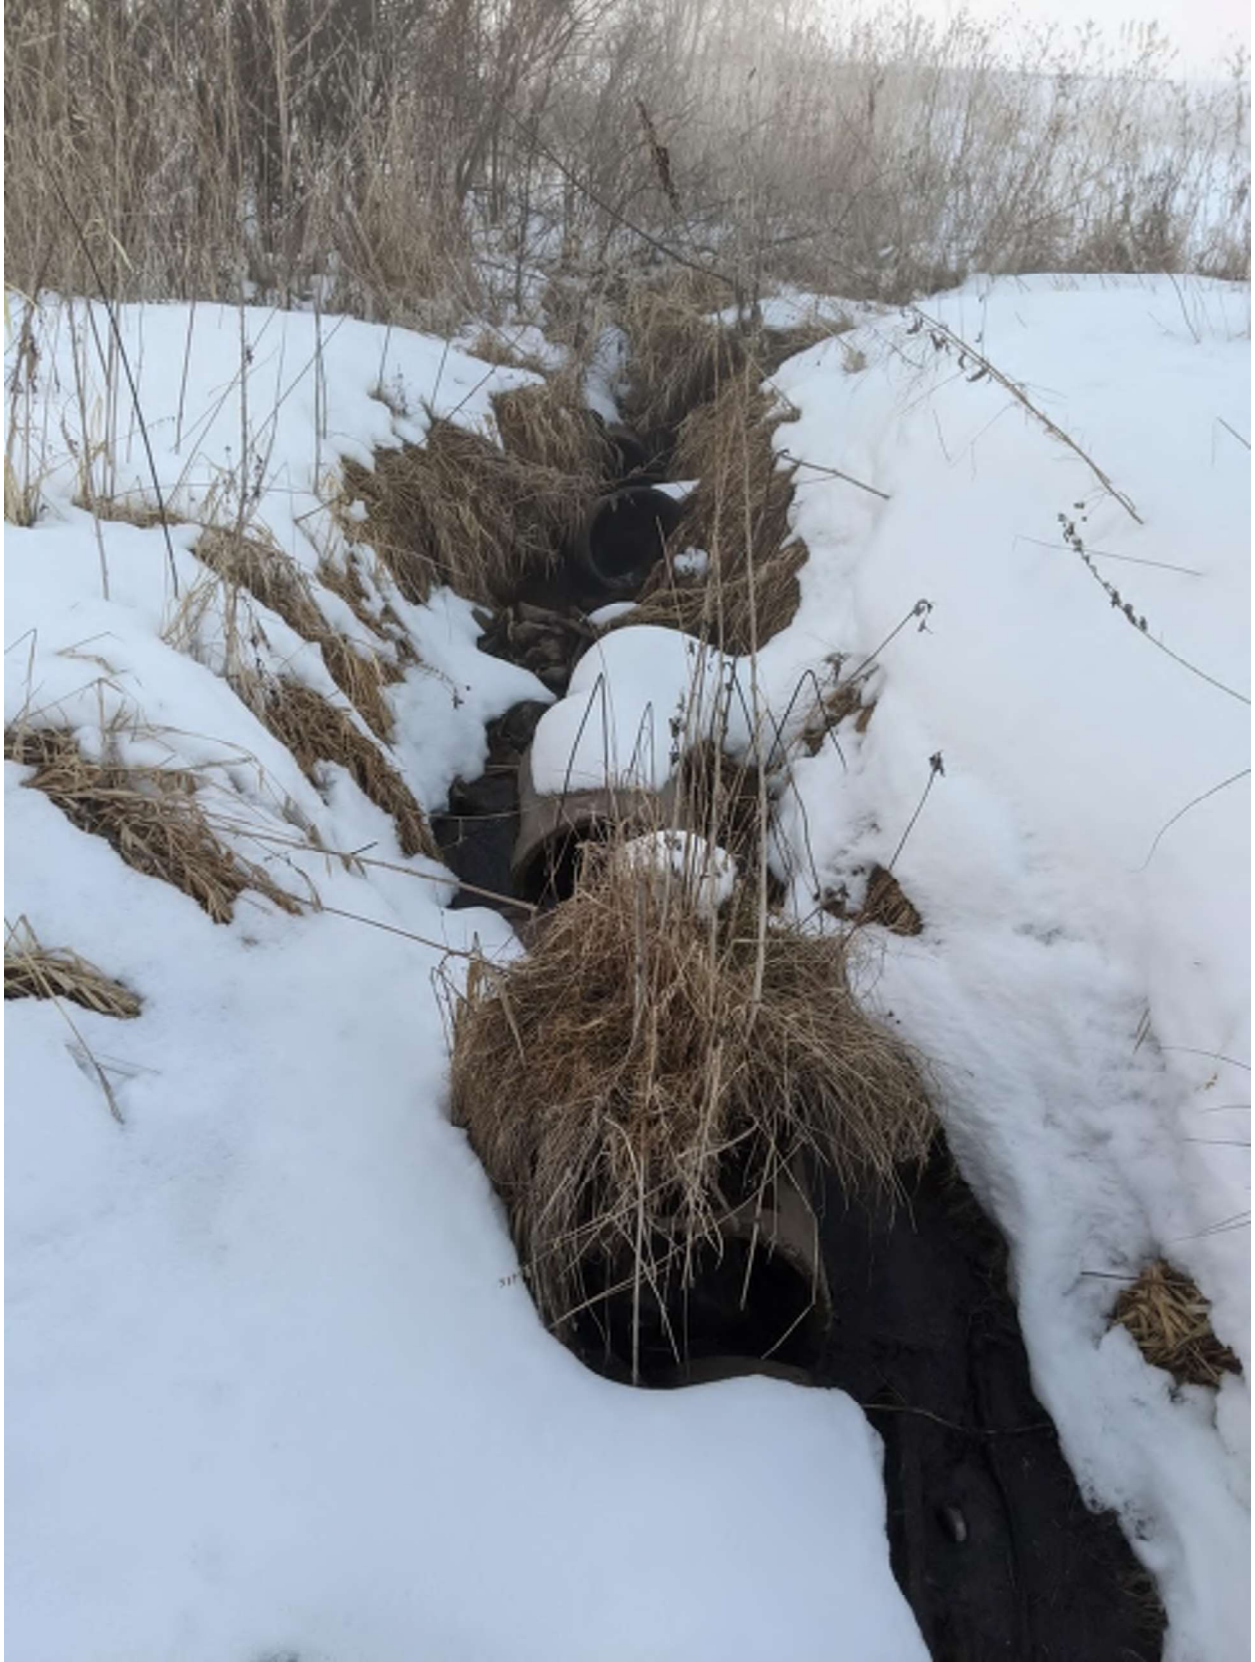
Figure 2: Lower 100 feet of 1922 Main.

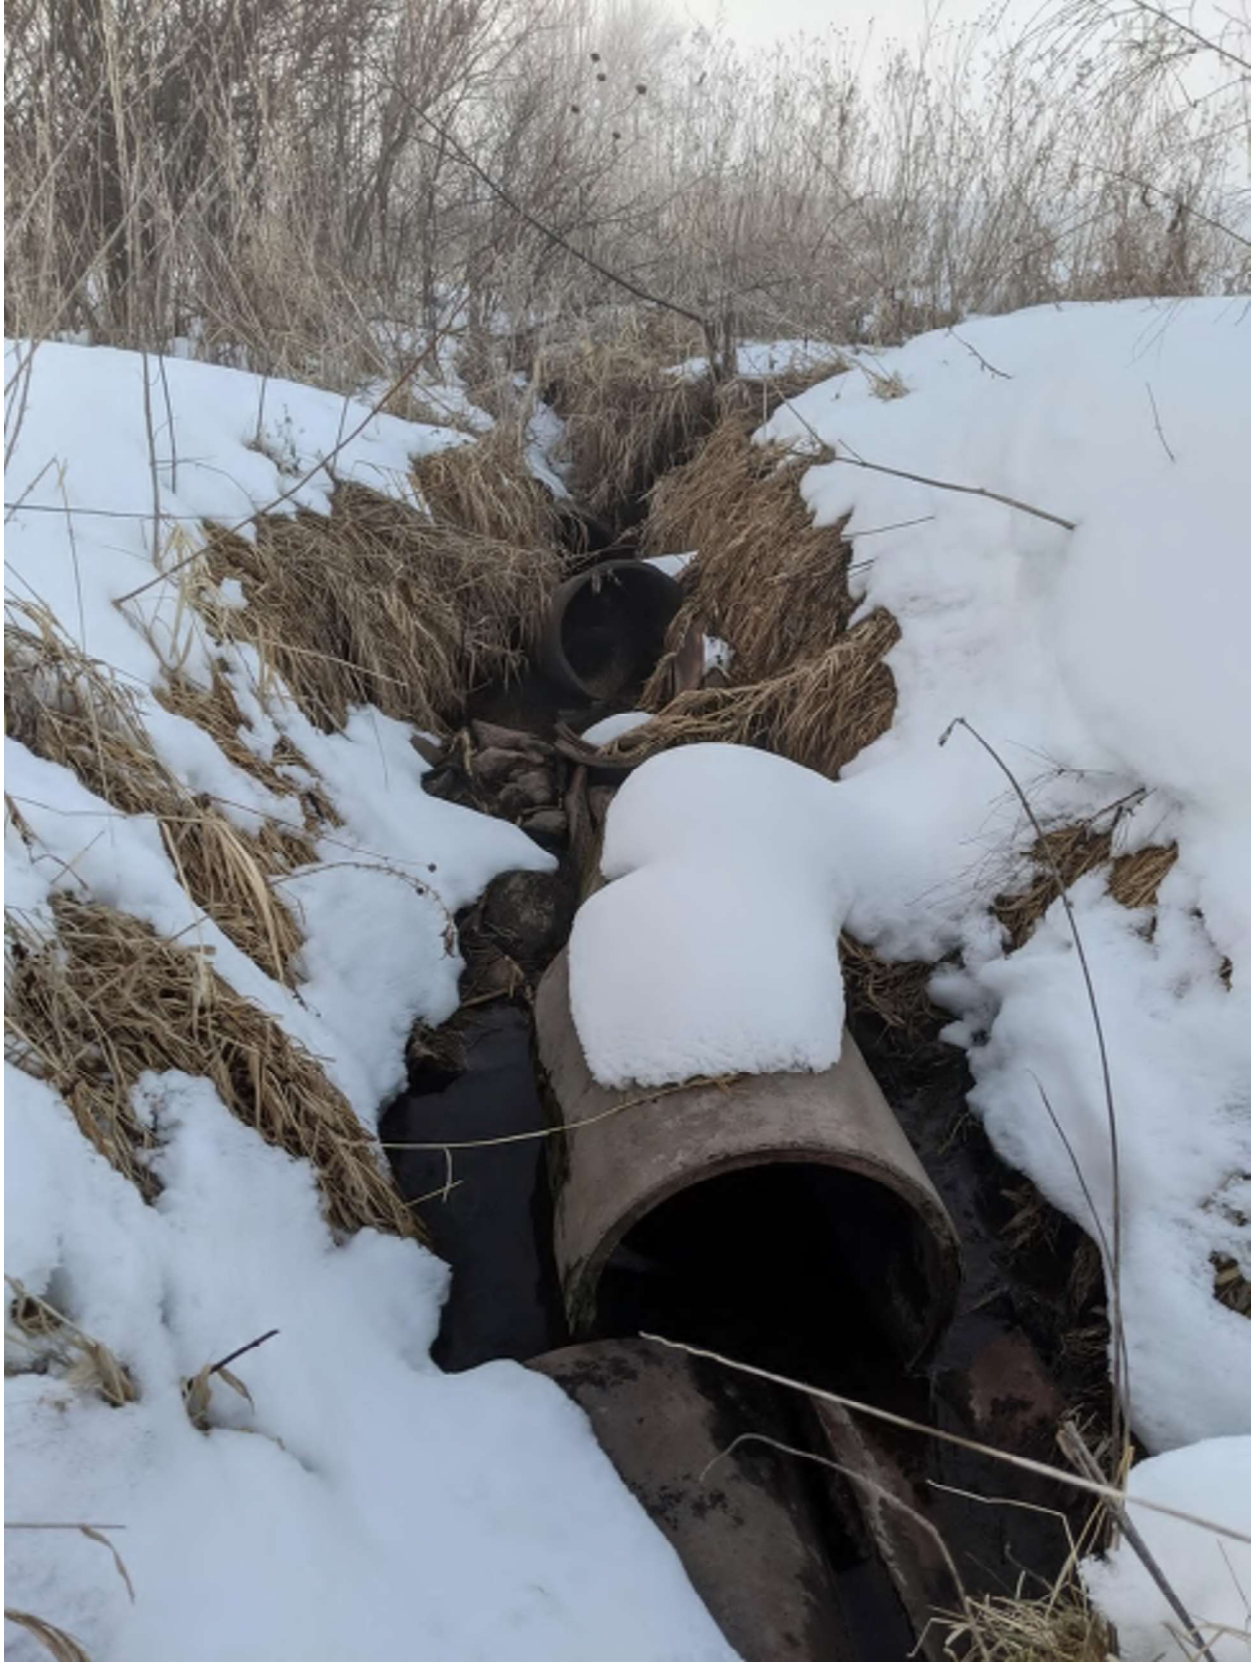
Figure 3: Lower 100 feet of 1922 Main tile

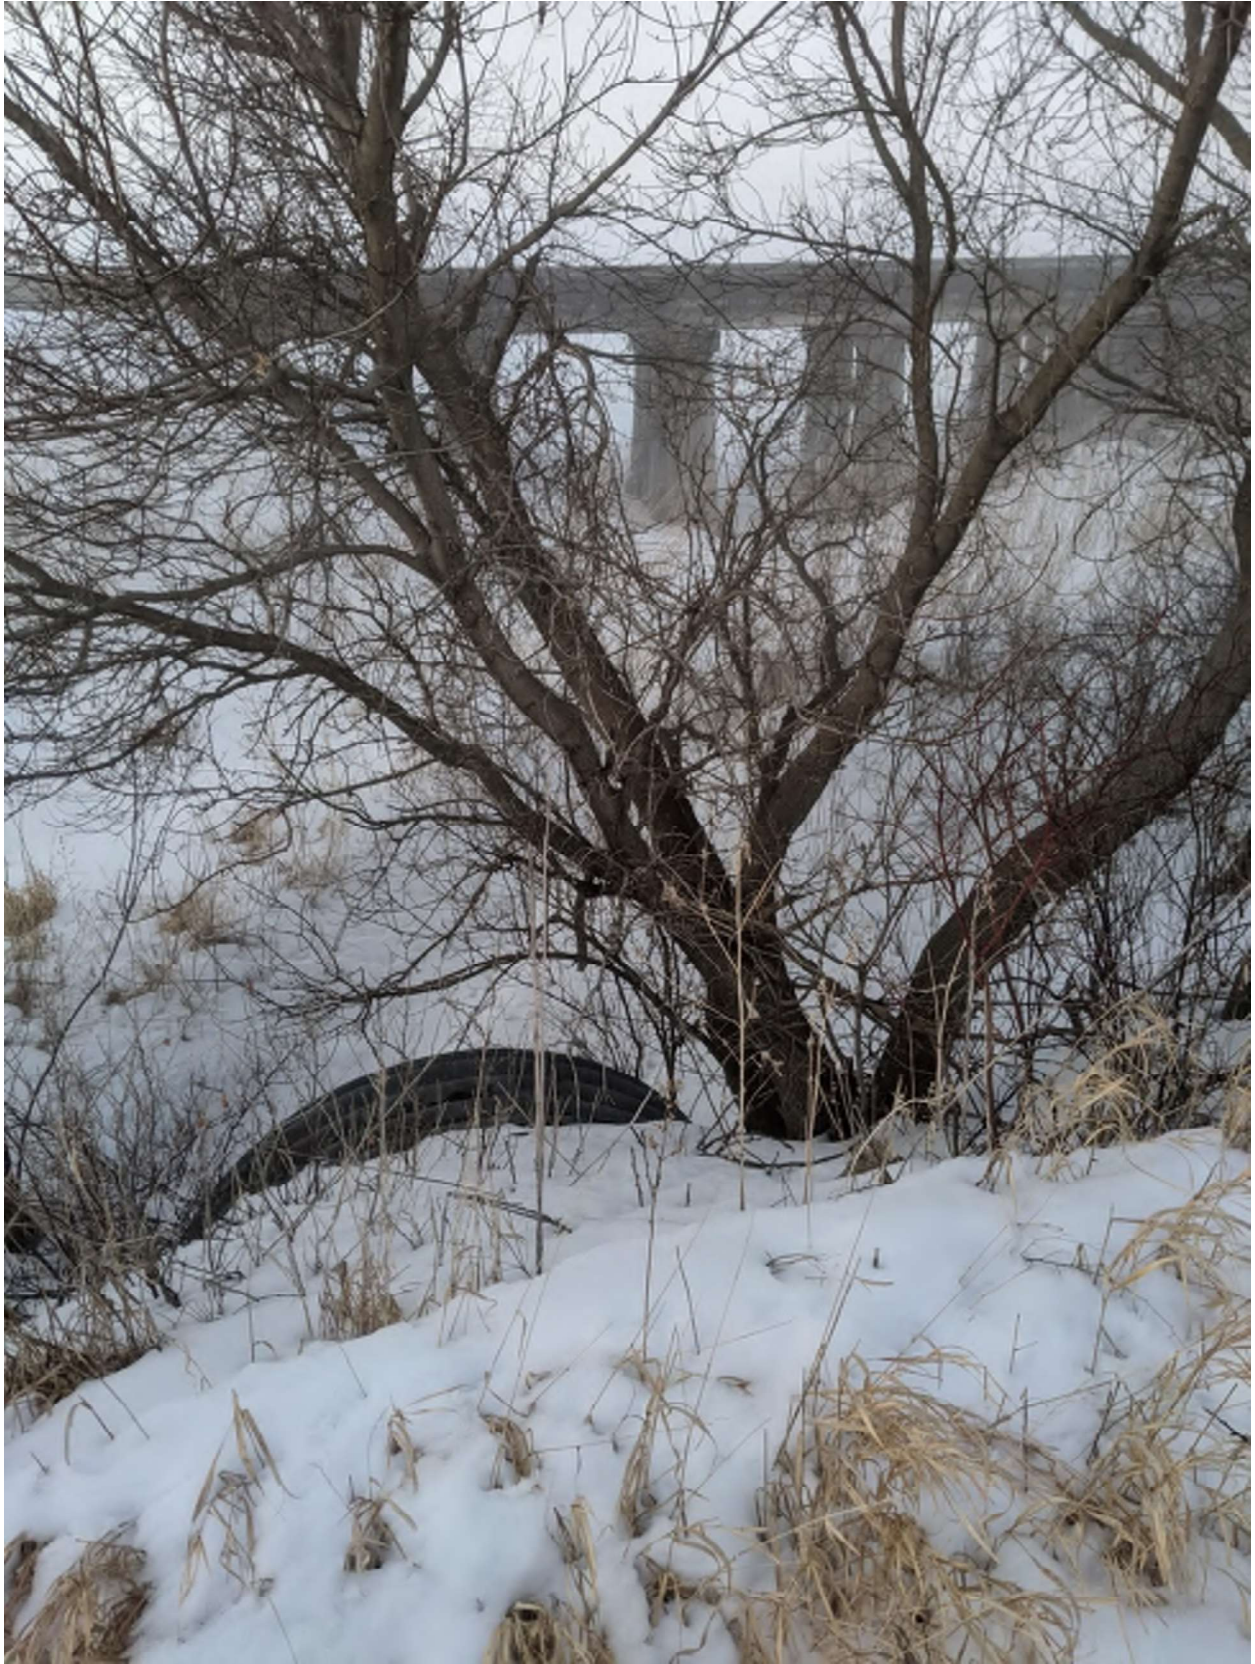
*Figure 4: Large trees and woody brush growing over the lower 200 feet of both Main tiles.*

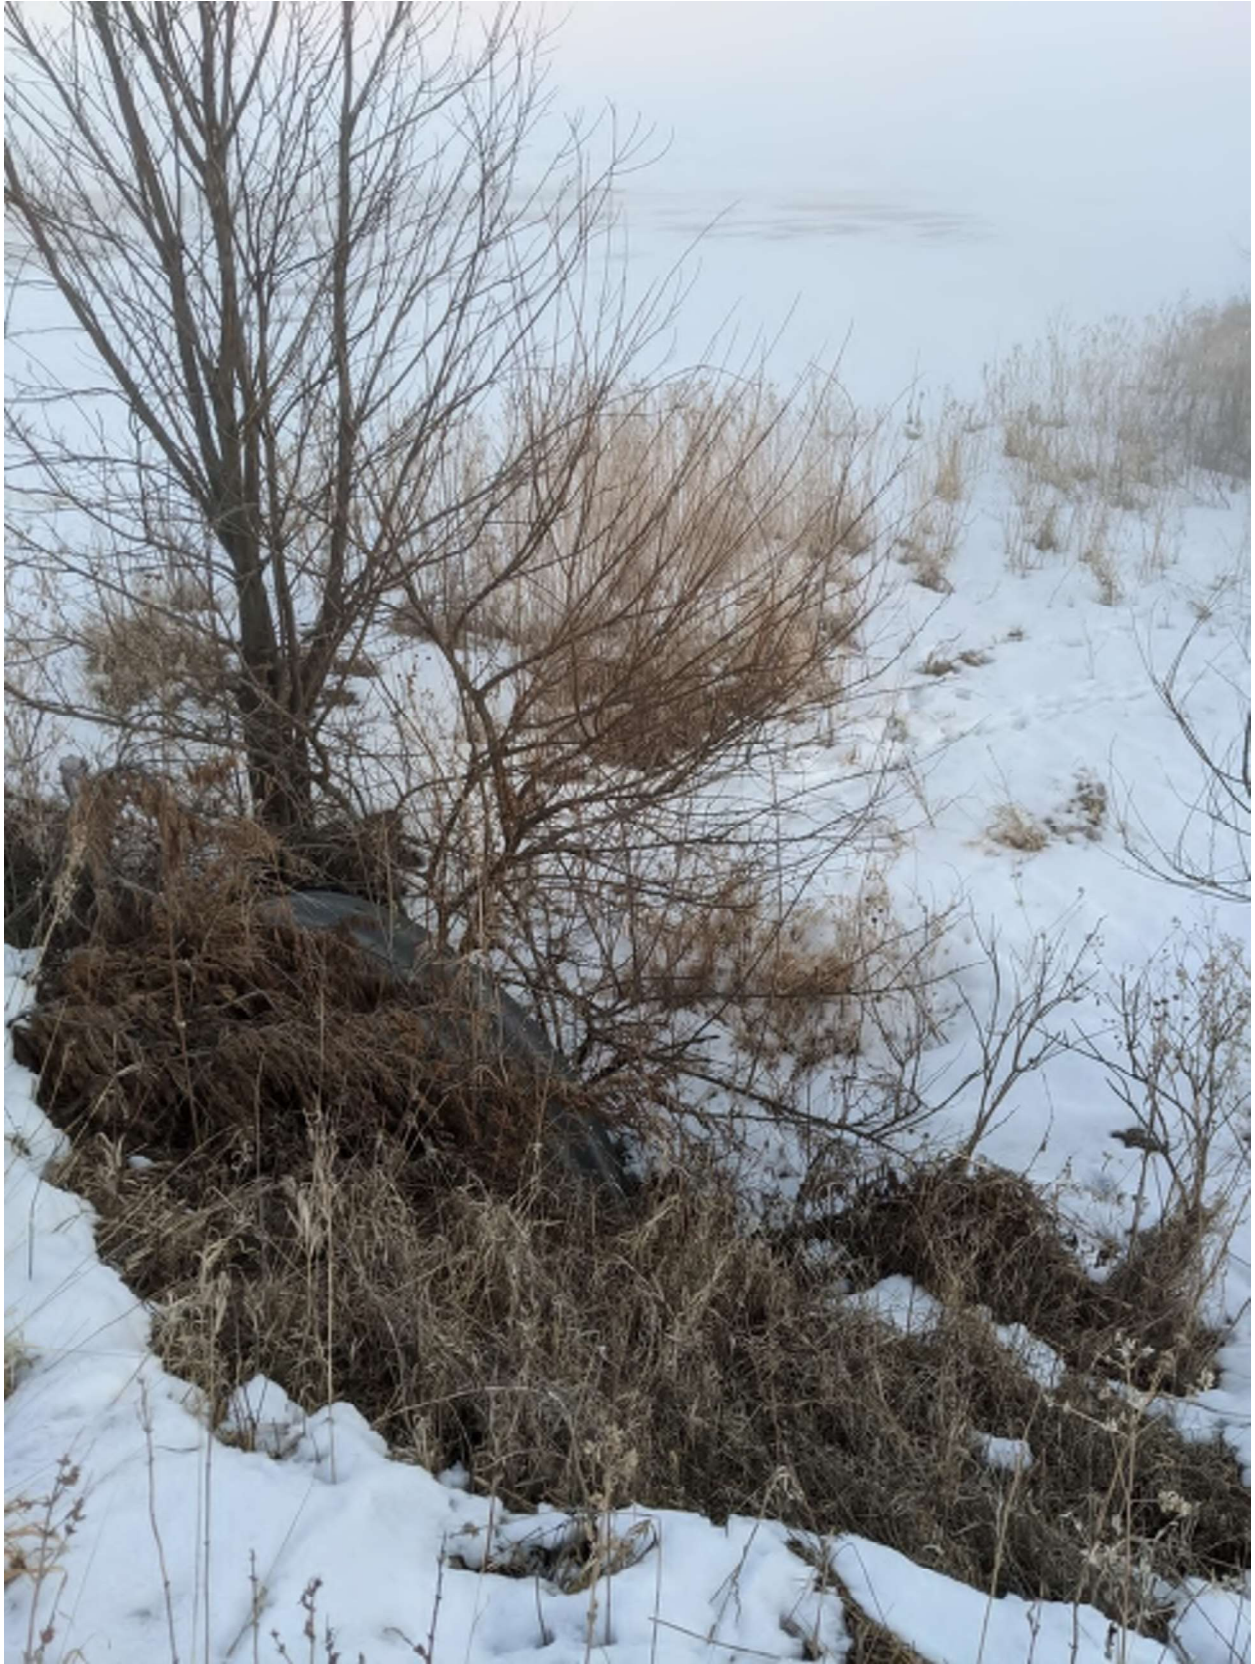
*Figure 5: Trees and woody brush over lower 100 feet of 1922 Main tile.*

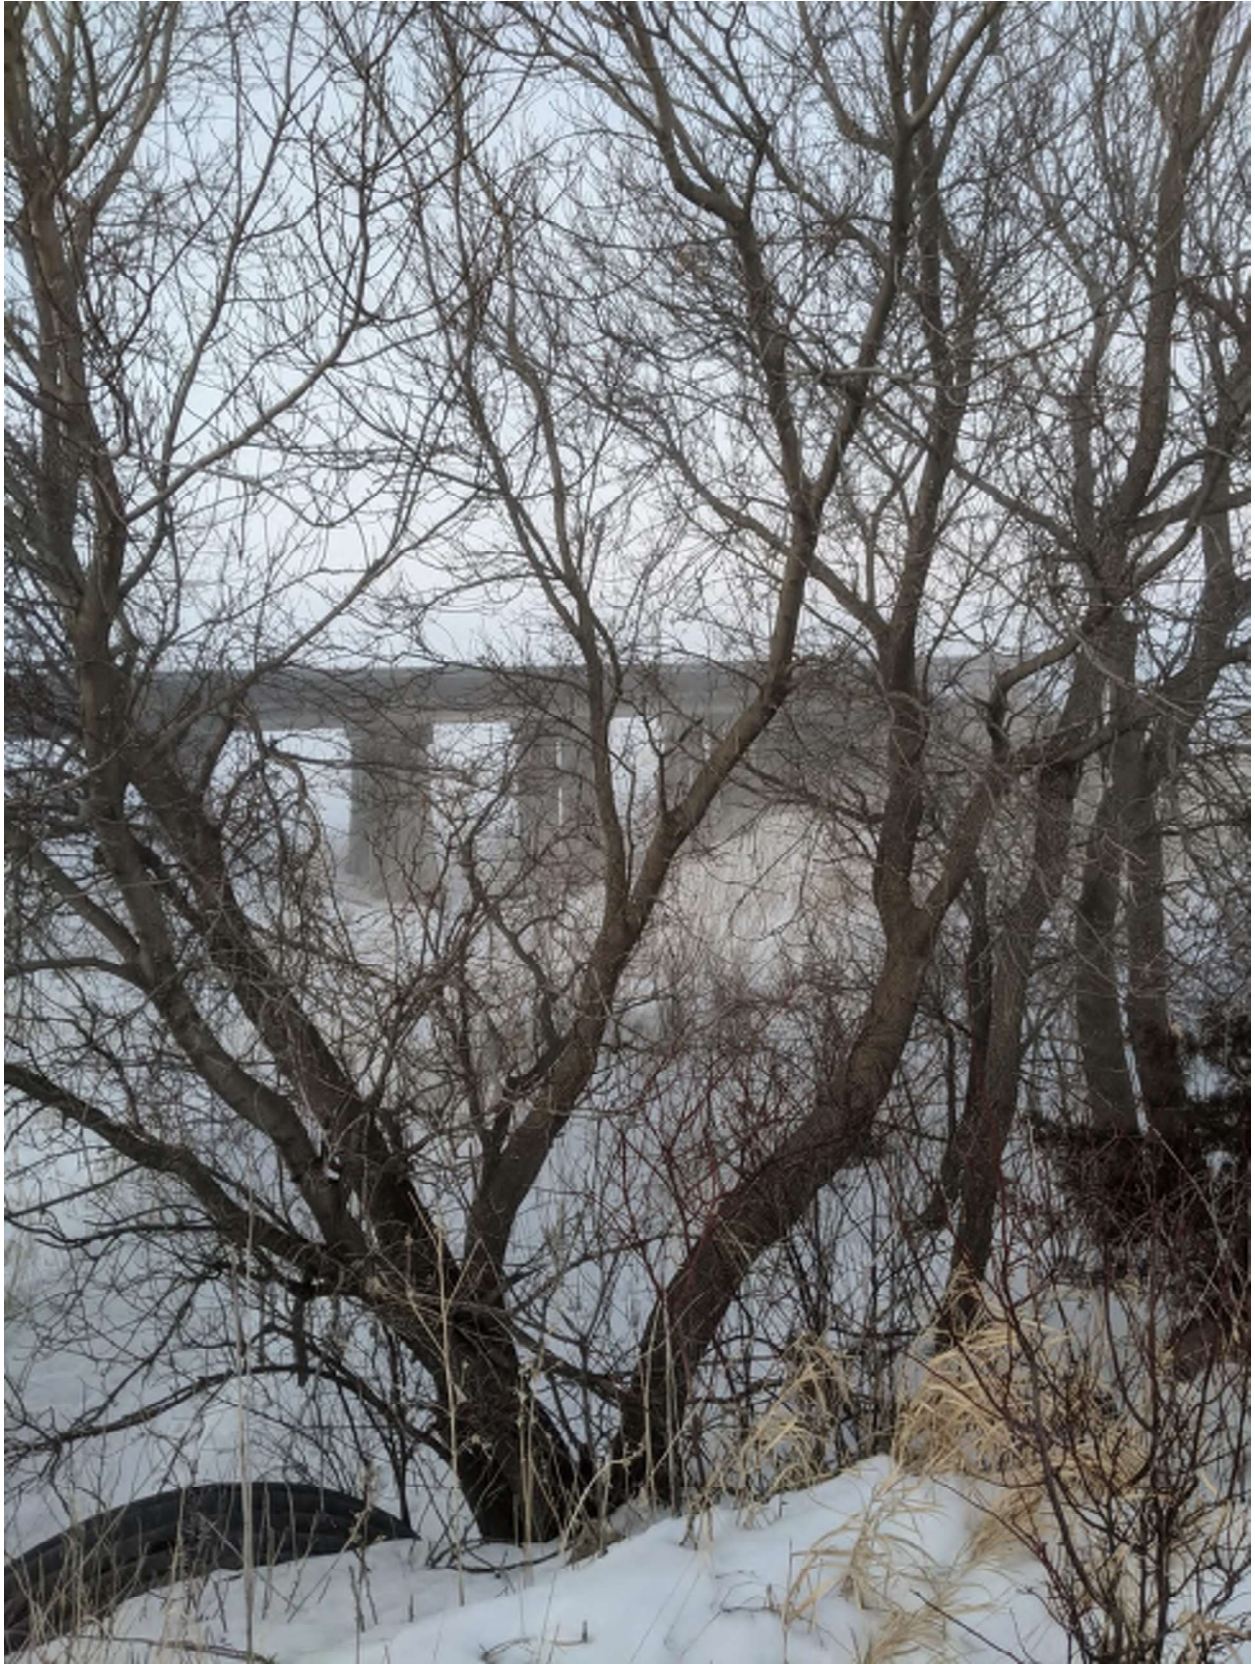
*Figure 6: Lower 200 feet of Main travels below bridge and then through heavily wooded area.*

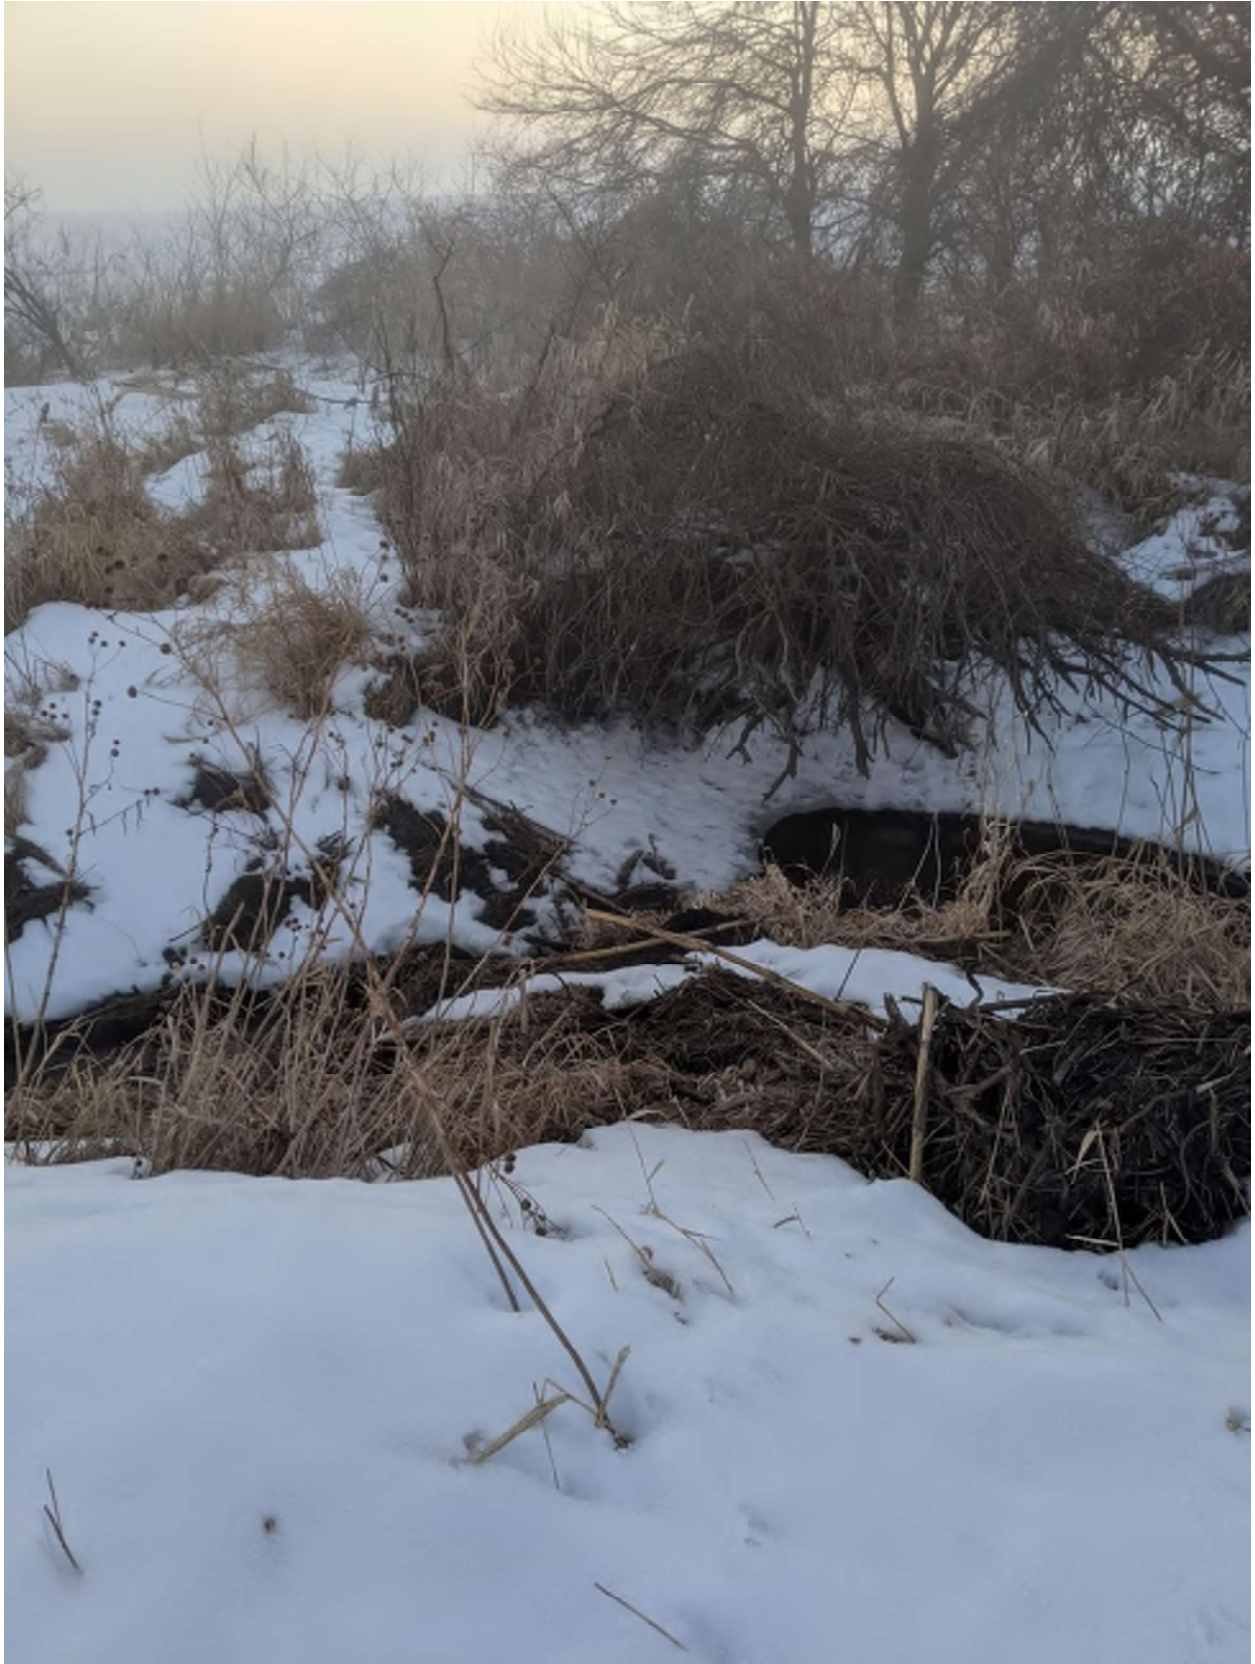
*Figure 7: Beaver dam below the Main tile outlet.*
